Your Ref: TP/IP/10579/2019  
Our Ref : CI/TPD19008269/P

### **Fatal Accident Investigation Team**

### **MECHANICAL INSPECTION REPORT OF MOTOR LORRY GBH 4382E**

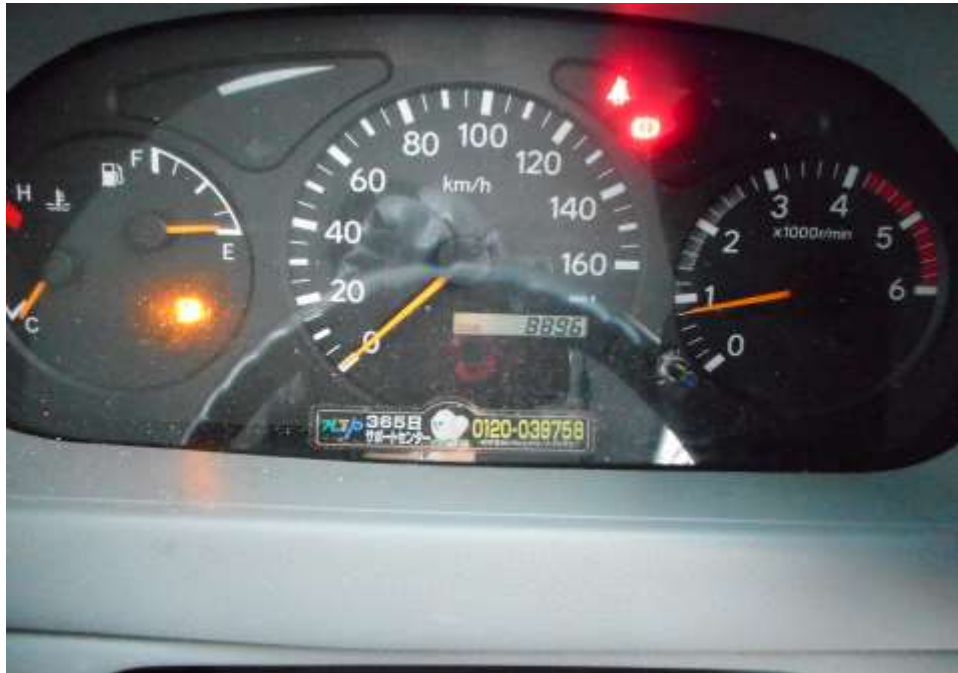
**Photo 1** shows a general view of the instrument cluster of the Motor Lorry at the time of my inspection. The mileage of the Motor Lorry was 8,896km

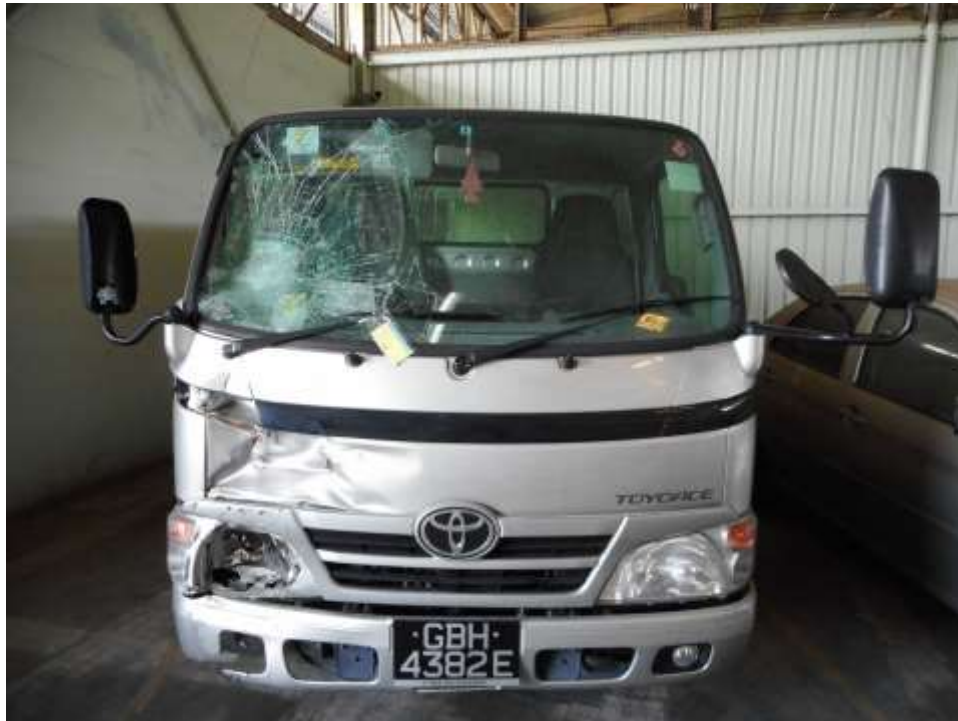
4. The mileage of the Motor Lorry at the time of my inspection was 8,896km.
5. The Motor Lorry appeared to have sustained major damage at its frontal portion. Its front windscreen, right side mirrors, front panel body panel, right headlamp, fog lights, front bumper, right side undercarriage wheel arch panel and mud flap were damaged at the time of my inspection.

**Photo 2** shows a general view of the Motor Lorry's front body at the time of my inspection. It was observed to have sustained major damage at its frontal portion. Its front windscreen, right side mirrors, front panel body panel, right headlamp, fog lights, front bumper, right side undercarriage wheel arch panel and mud flap were damage as a result of the accident.

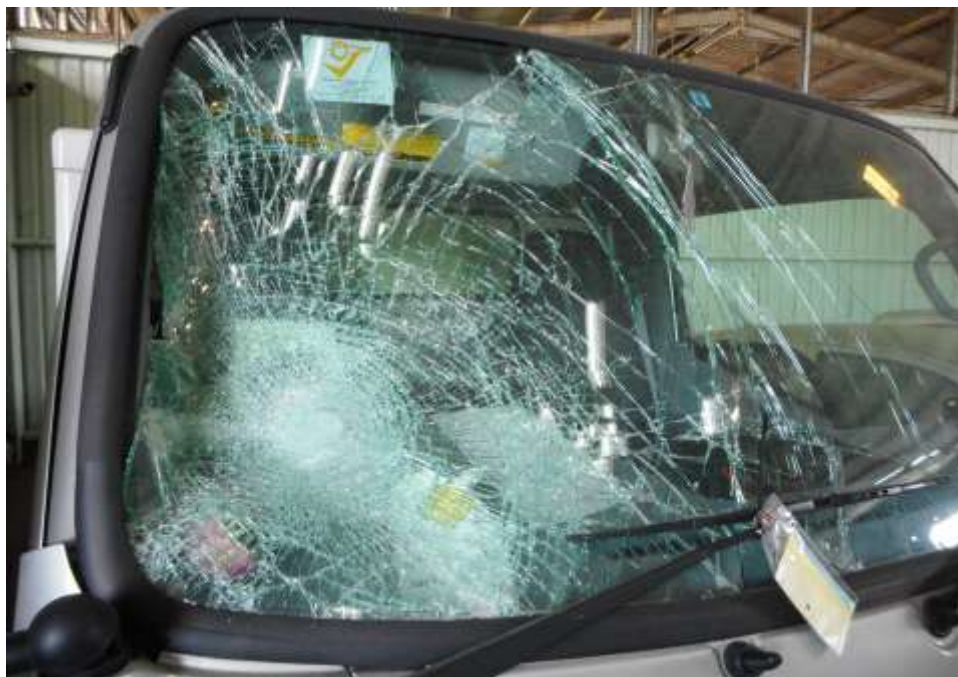
**Photo 3** shows a close up view of the Motor Lorry's front body at the time of my inspection. It was observed to have sustained major damage at its frontal portion. Its front windscreen was damage as a result of the accident.

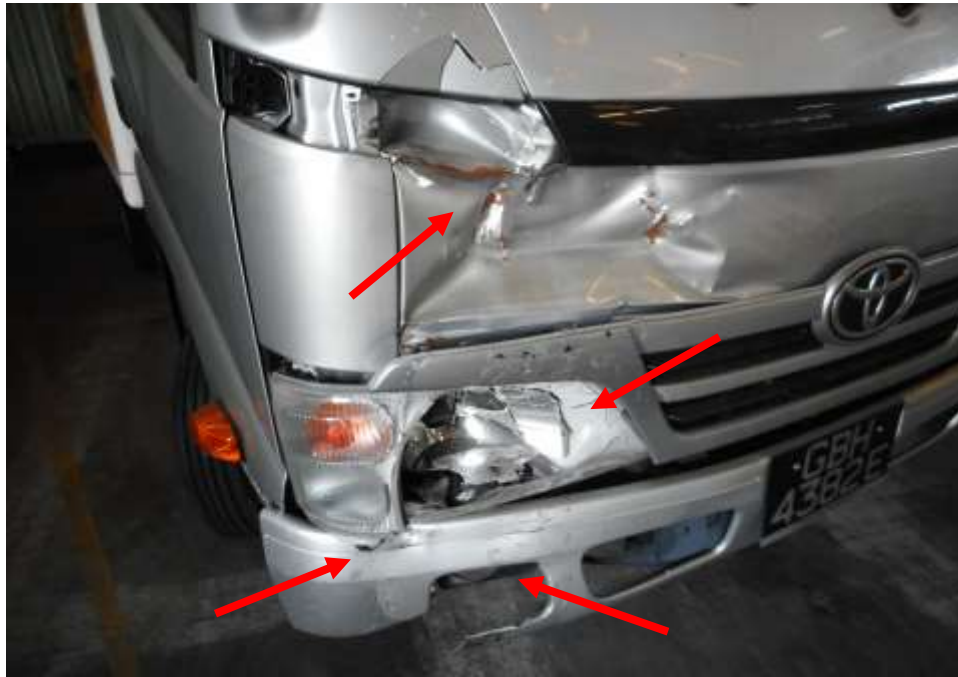
**Photo 4** shows a close up view of the Motor Lorry's front body at the time of my inspection. It was observed to have sustained major damage at its frontal portion. Its front panel body panel, right headlamp, fog lights and front bumper (arrowed) were damage as a result of the accident.

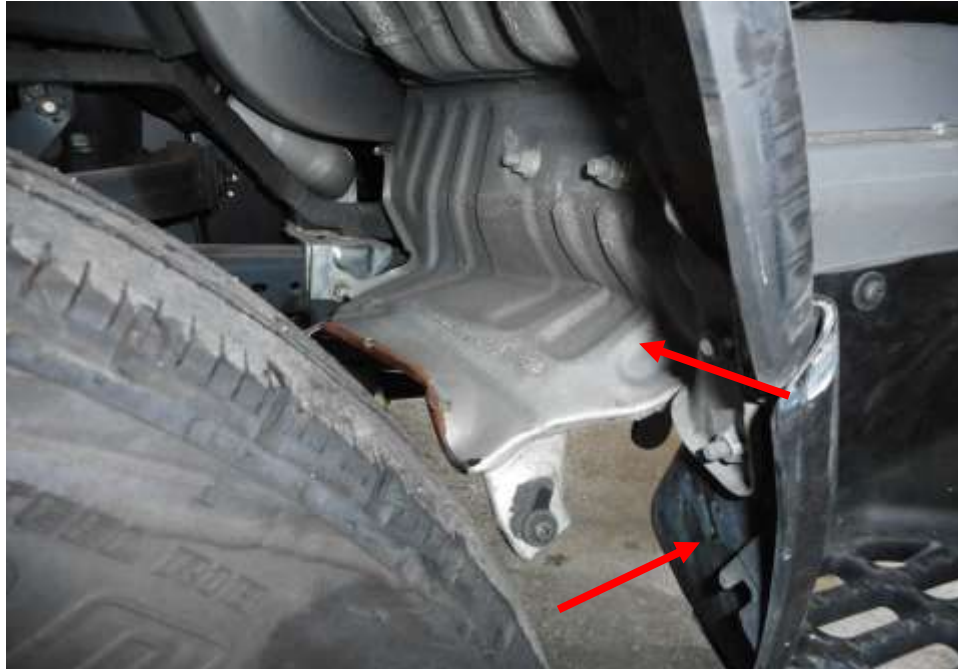
**Photo 5** shows a close up view of the Motor Lorry's front body at the time of my inspection. It was observed to have sustained major damage at its frontal portion. Its right side undercarriage wheel arch panel and mud flap (arrowed) were damage as a result of the accident.

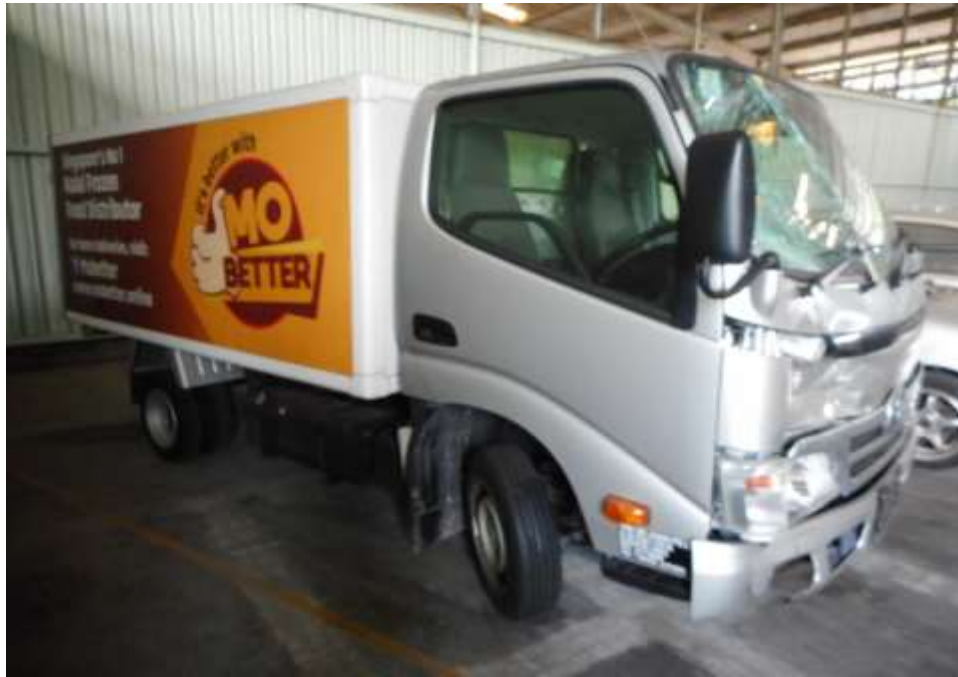
**Photo 6** shows a general view of the front right body of the Motor Lorry at the time of my inspection. The Motor Lorry was observed to be in good general condition and unaffected from the accident.

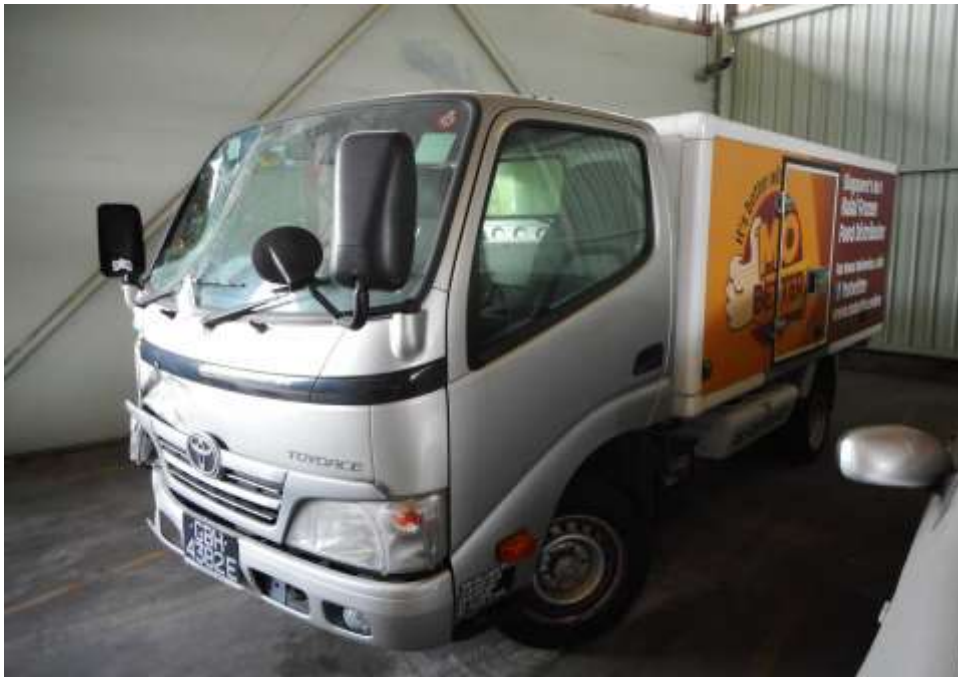
**Photo 7** shows a general view of the front left body of the Motor Lorry at the time of my inspection. The Motor Lorry was observed to be in good general condition and unaffected from the accident.

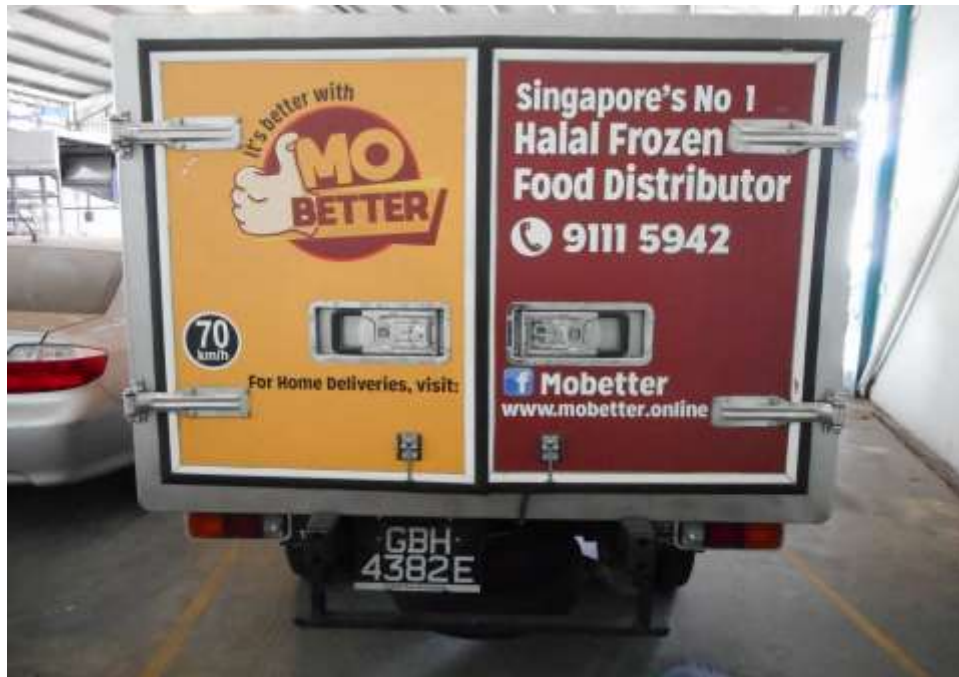
**Photo 8** shows a general view of the rear body of the Motor Lorry at the time of my inspection. The Motor Lorry was observed to be in good general condition and unaffected from the accident.

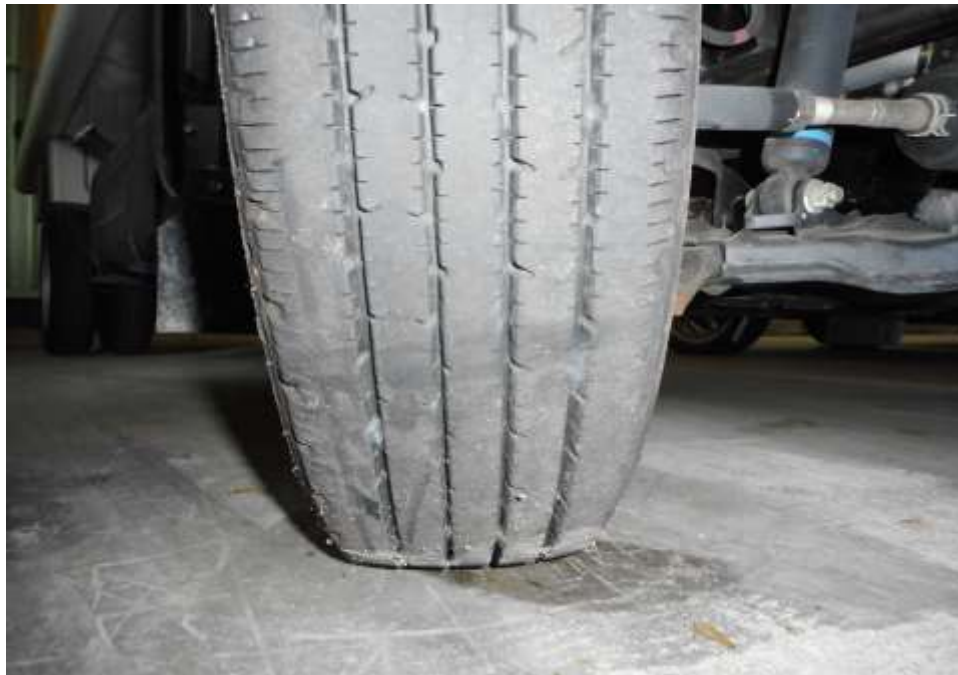
**Photo 9** shows the condition of the front right tyre of the Motor Lorry, which was observed to be in serviceable condition with remaining tread depth of approximately 5.9mm. The tyre, which was wrapped around standard steel wheel rim, was also observed to be sufficiently inflated for vehicular operation. There was no tear, cut or burst mark(s) on the outer and the inner sidewalls as well as across the tread of the 6 tyres that were fitted on the Motor Lorry.

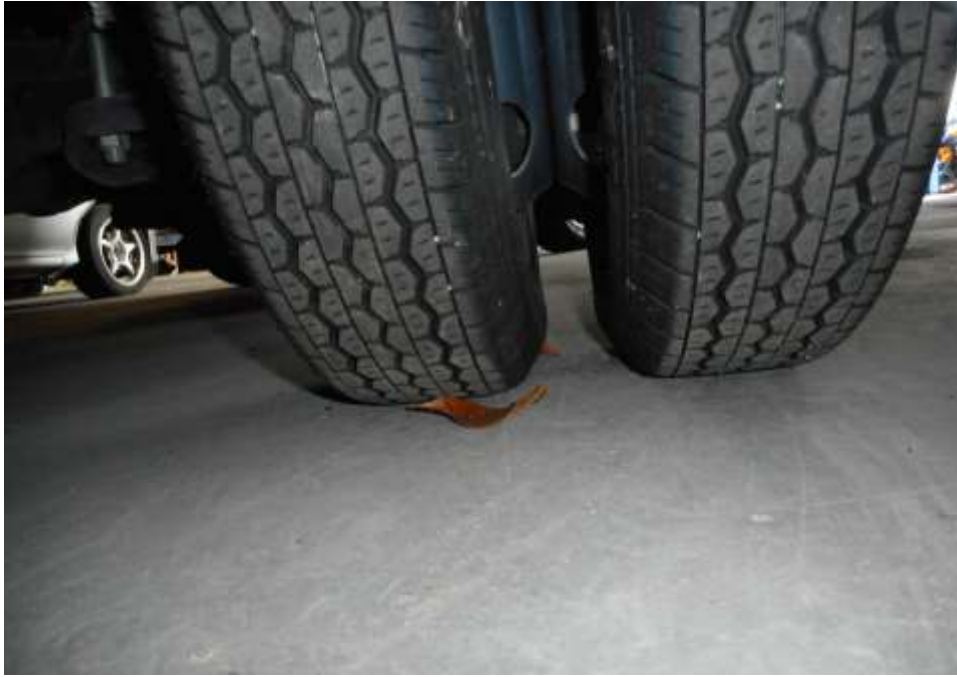
**Photo 10** shows the condition of the rear right tyre of the Motor Lorry, which was observed to be in serviceable condition with remaining tread depth of approximately 4.7mm. The tyre, which was wrapped around standard steel wheel rim, was also observed to be sufficiently inflated for vehicular operation.

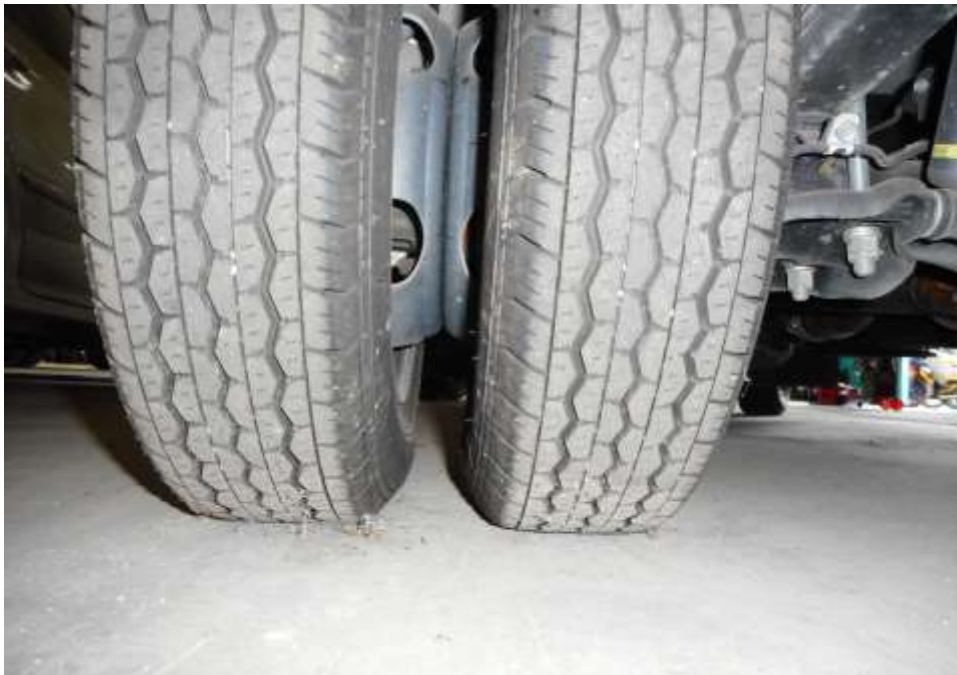
**Photo 11** shows the condition of the rear left tyres of the Motor Lorry, which was observed to be in serviceable condition with remaining tread depth of approximately 4.7mm. The tyres, which were wrapped around standard steel wheel rim, were also observed to be sufficiently inflated for vehicular operation. There was also no damage found on all 6 steel wheel rims of the Motor Lorry.

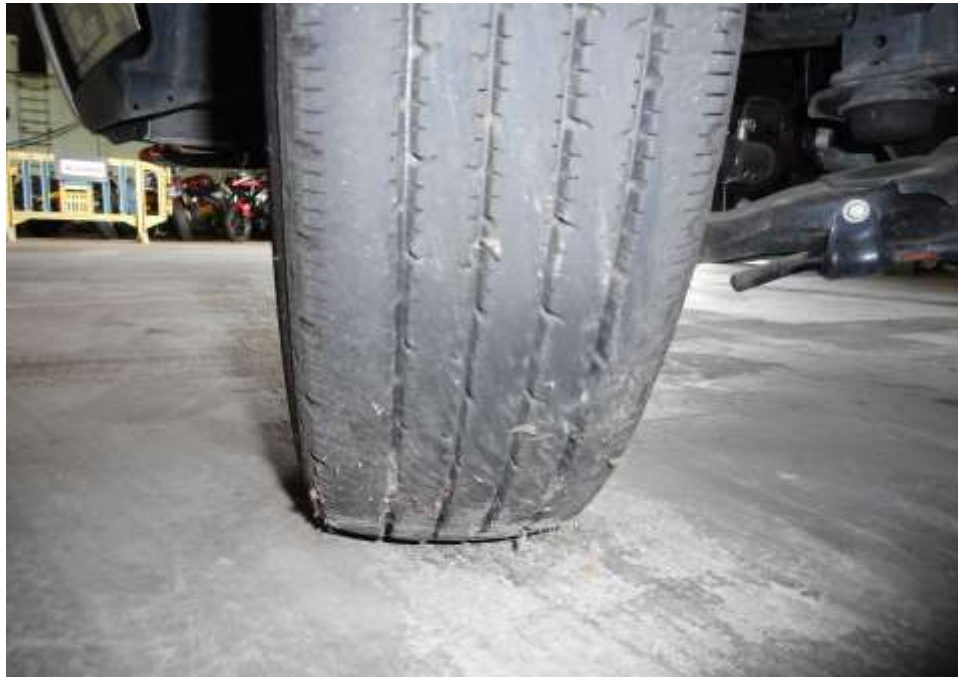
**Photo 12** shows the condition of the front left tyres of the Motor Lorry, which were observed to be in serviceable condition with remaining, tread depth of approximately 7.2mm. There was also no tear, cut or burst mark(s) on the outer and the inner sidewalls as well as across the tread of the 6 tyres that were fitted on the Motor Lorry.

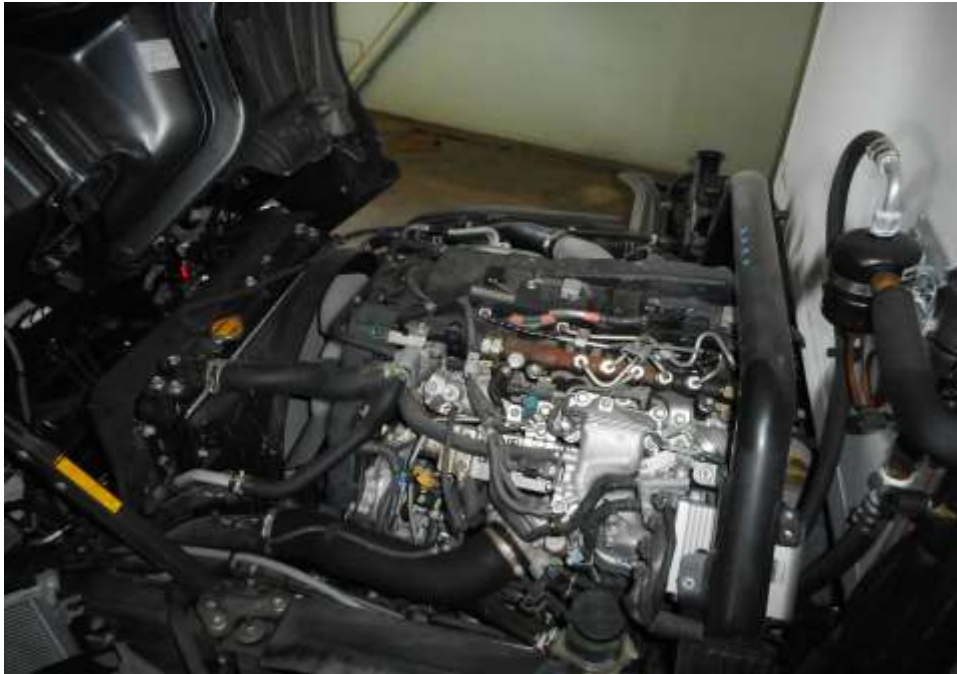
**Photo 13** shows a general view of the Motor Lorry's engine compartment, which was accessed by lifting the front cabin of the Motor Lorry. The various parts and components inside the engine compartment were unaffected by the accident. There was also no sign(s) or indication(s) of fresh fluid leakage and/or fluid stain within the engine compartment

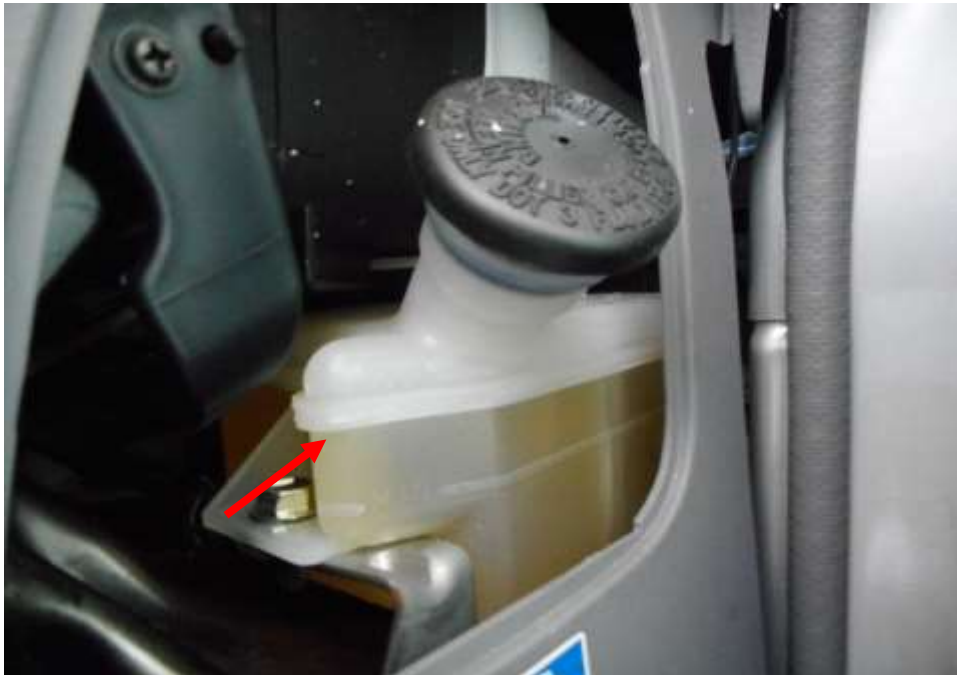
**Photo 14** shows the brake fluid reservoir of the Motor Lorry at the time of my inspection. The brake fluid was observed to be of sufficient level (arrowed) and without any visible contamination

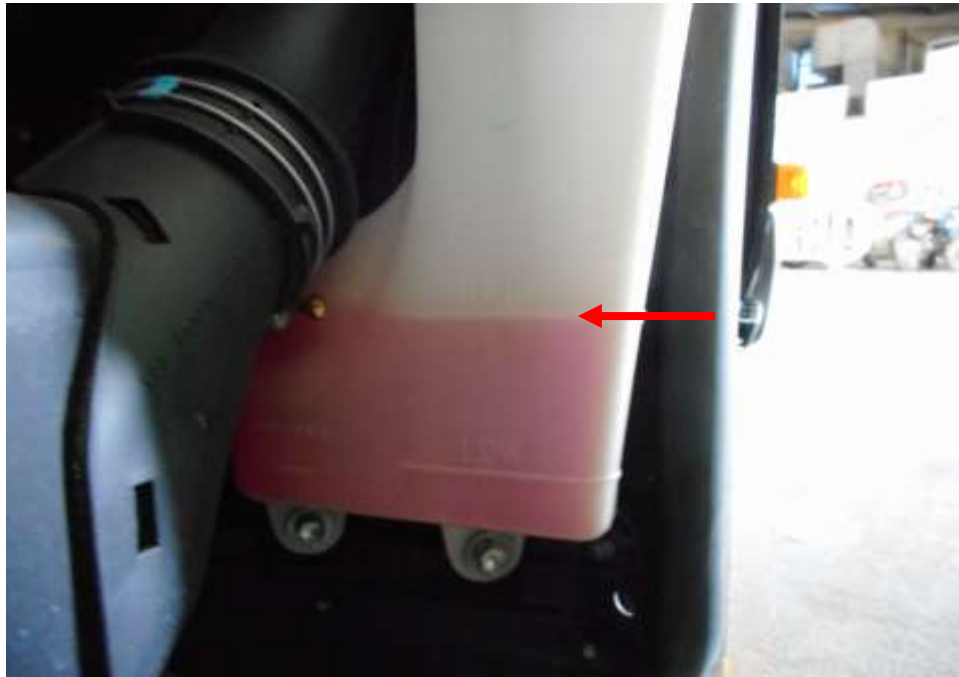
**Photo 15** shows the engine coolant reservoir of the Motor Lorry at the time of my inspection. The engine coolant was observed to be of sufficient level and without any visible contamination.

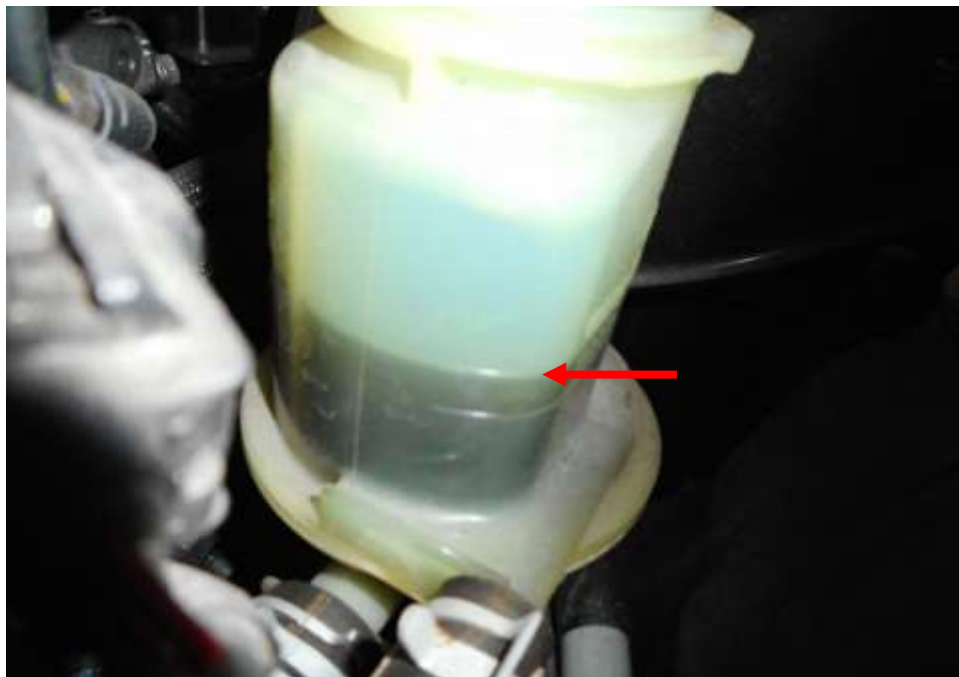
**Photo 16** shows the power steering fluid reservoir of the Motor Lorry at the time of my inspection. The power steering fluid was observed to be of sufficient level (arrowed) and without any visible contamination.

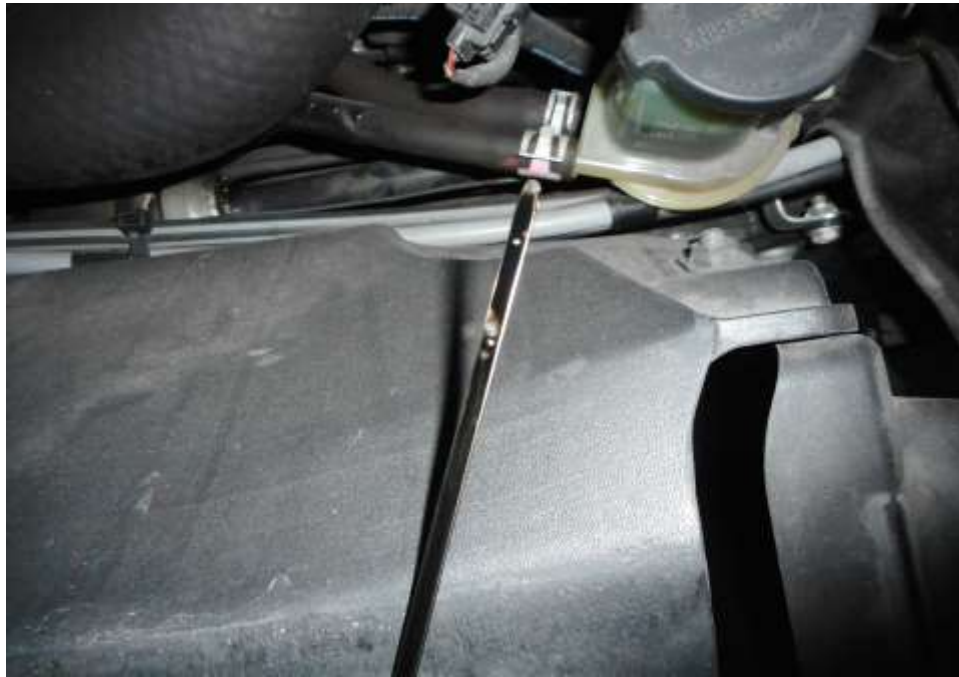
**Photo 17** shows the engine dip stick of the Motor Lorry at the time of my inspection. The engine oil was observed to be of sufficient level and without any visible contamination.

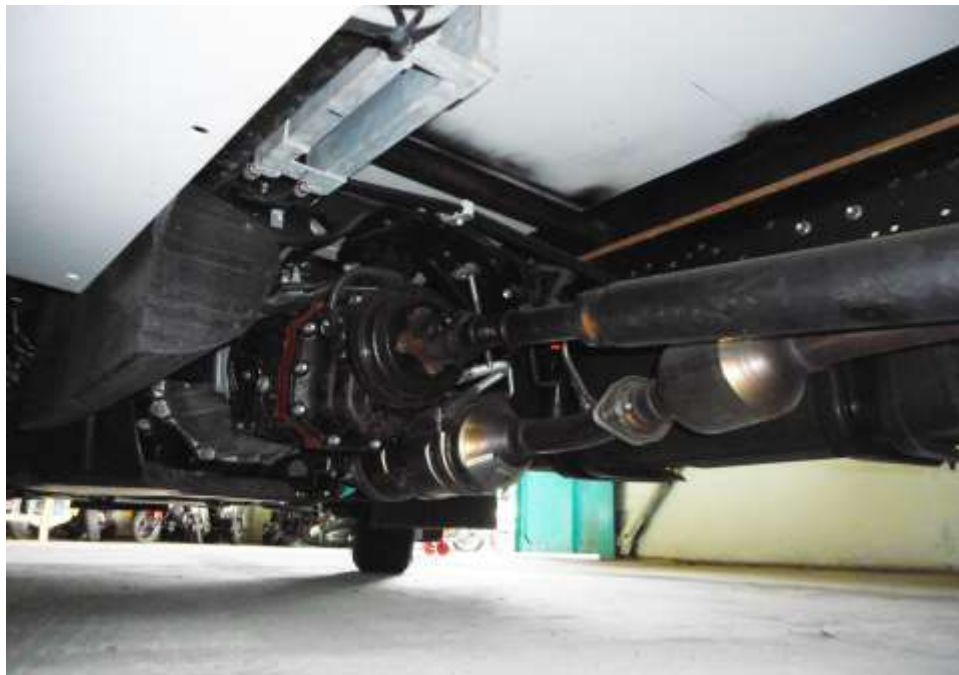
**Photo 18** shows the undercarriage of the Motor Lorry, at the area where the engine housing and transmission housing are located. I did not find any sign(s) or indication(s) of fluid leak and/or fluid stain(s) on the underside of the Motor Lorry.

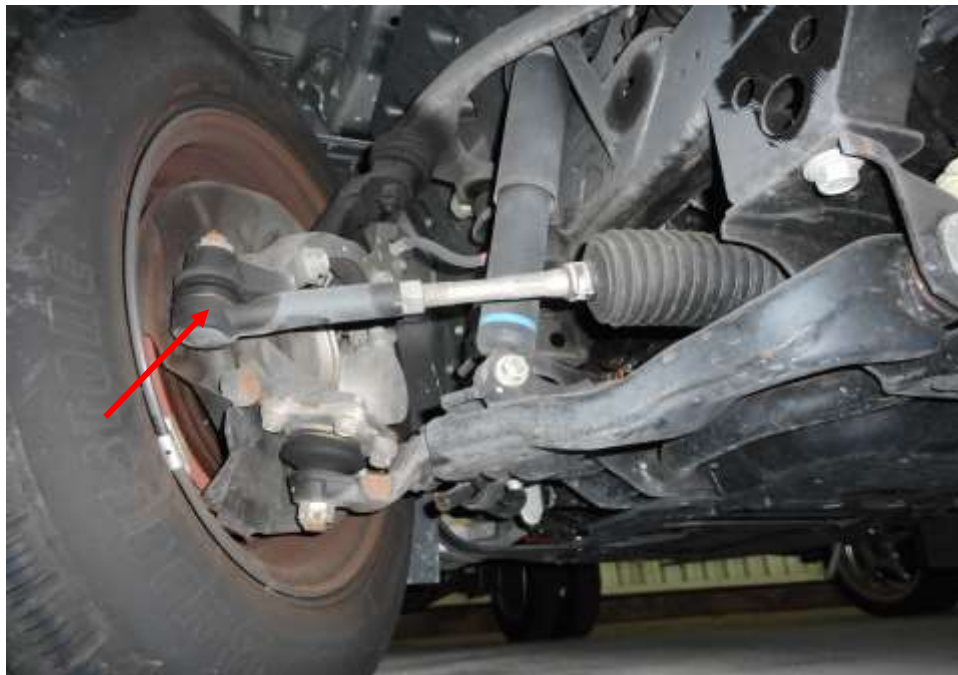
**Photo 19** shows the various undercarriage components at the front right wheel of the Motor Lorry, in particular the steering tie rod end (arrowed). The various steering components were all found to be intact, suggesting that the steering system of the Motor Lorry was likely to be in serviceable condition at the material time of accident. There was also no sign of fluid stain(s) observed on the various undercarriage components.

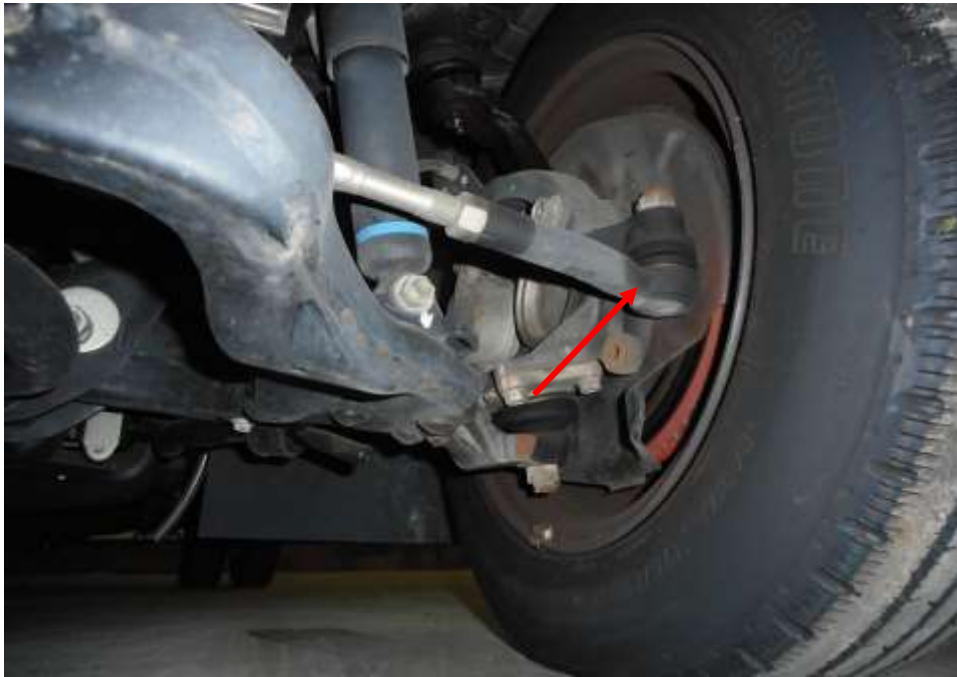
**Photo 20** shows the various undercarriage components at the front left wheel of the Motor Lorry, in particular the steering tie rod end (arrowed). The various steering components were all found to be intact, suggesting that the steering system of the Motor Lorry was likely to be in serviceable condition at the material time of accident. There was also no sign of fluid stain(s) observed on the various undercarriage components.

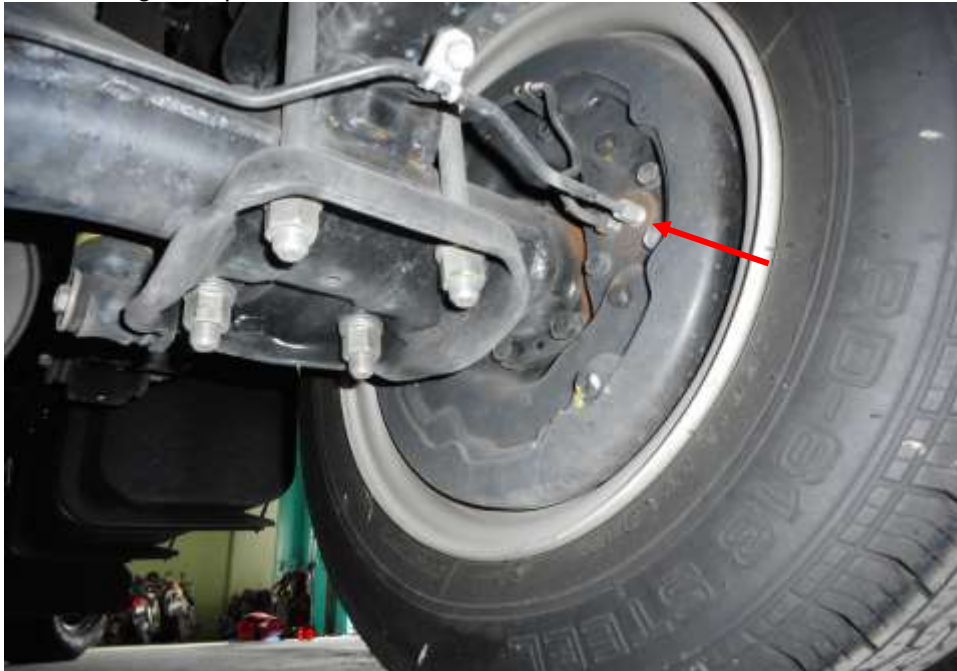
**Photo 21** shows the brake pipe (arrowed) at the rear right wheel of the Motor Lorry. I did not observe any leakage of brake fluid at the time of my inspection of the Motor Lorry. My static tests of the Motor Lorry's braking system, along with my visual examination of the various mechanical components in the braking system, had indicated that there was no internal leakage of pressure/vacuum. Hence the braking system of the Motor Lorry was likely to be in serviceable condition at the material time of accident.

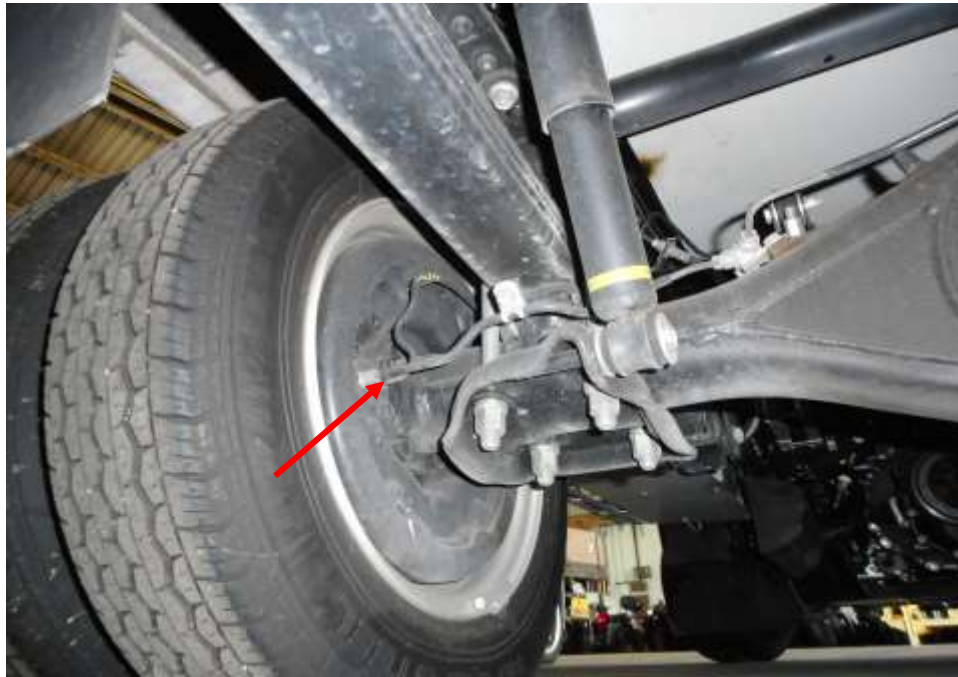
**Photo 22** shows the brake pipe (arrowed) at the rear left wheel of the Motor Lorry. I did not observe any leakage of brake fluid at the time of my inspection of the Motor Lorry. My static tests of the Motor Lorry's braking system, along with my visual examination of the various mechanical components in the braking System had indicated that there was no internal leakage of pressure/vacuum. Hence the braking system of the Motor Lorry was likely to be in serviceable condition at the material time of accident.

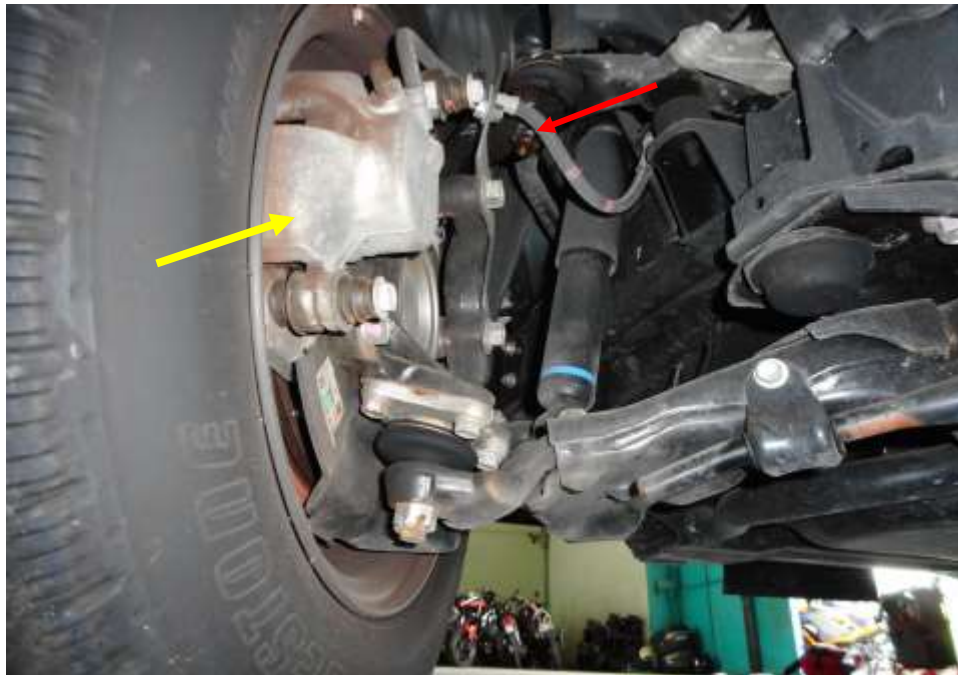
**Photo 23** shows the brake hose/pipe (red arrow) at the front left wheel of the Motor Lorry. No leakage of brake fluid was observed. Visual examination of the various components of the braking system like the brake caliper (yellow arrow), brake booster, brake pedal etc had revealed all to be intact and without visible damage at the time of accident. There was also no sign of fluid stain(s) observed on the various undercarriage components.

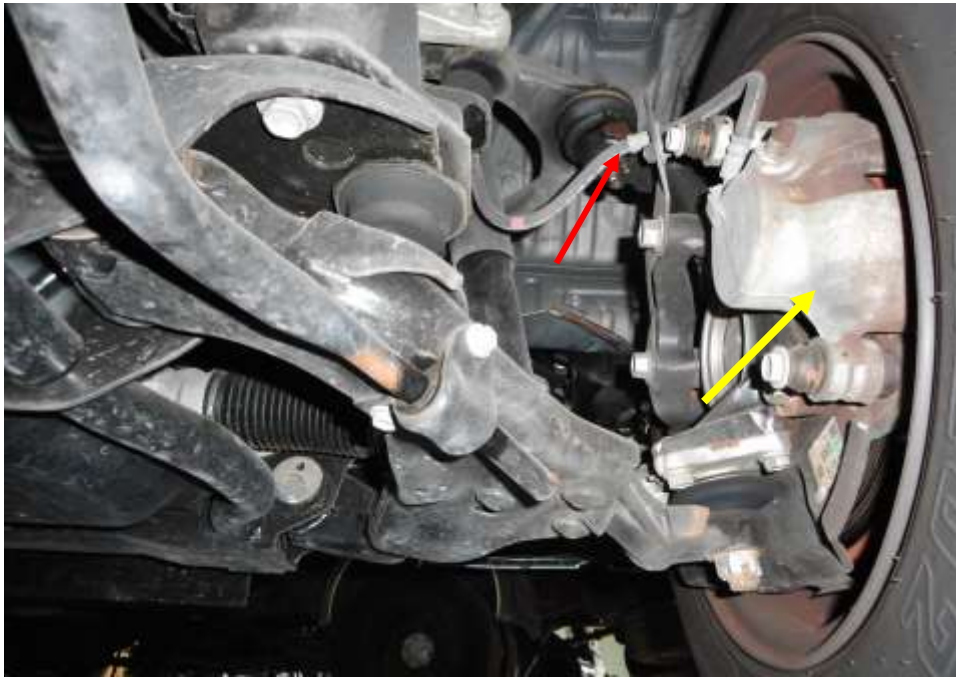
**Photo 24** shows the brake hose/pipe (red arrow) at the front right wheel of the Motor Lorry. No leakage of brake fluid was observed. Visual examination of the various components of the braking system like the brake caliper (yellow arrow), brake booster, brake pedal etc had revealed all to be intact and without visible damage at the time of accident. There was also no sign of fluid stain(s) observed on the various undercarriage components.

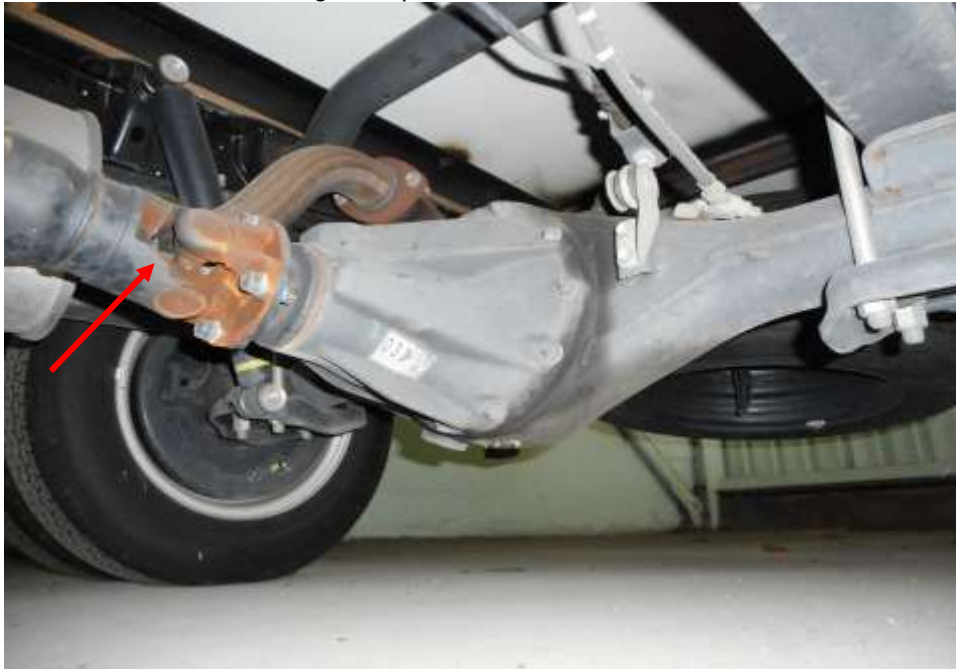
**Photo 25** shows the various undercarriage components at the drive shaft of the Motor Lorry, in particular the rear drive shaft and the rear differential (arrowed). The various steering components were all found to be intact and there was also no sign of fluid stain(s) observed, suggesting that the steering system of the Motor Lorry was likely to be in serviceable condition at the material time of accident. There was also no sign of fluid stain(s) observed on the various undercarriage components.
