Your Ref: TP/IP/10579/2019
Our Ref : CI/TPD19008270/P

25th July 2019

MECHANICAL INSPECTION REPORT OF MOTOR BUS SBS 7637T

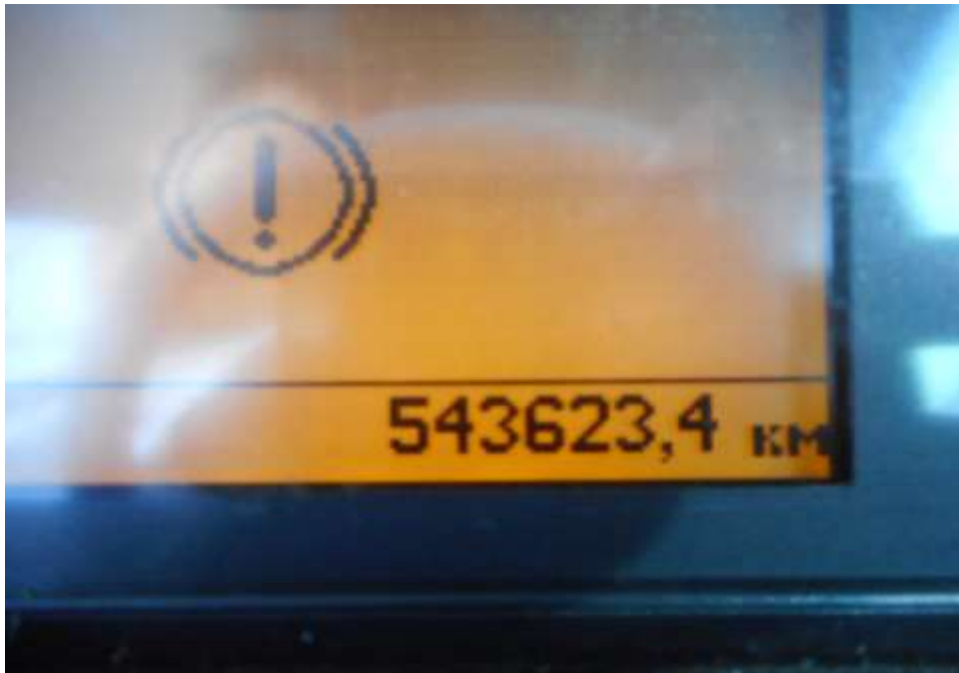
4. The mileage of the Motor Bus at the time of my inspection was 543,623km.
5. The Motor Bus did not appear to sustain any visible damage at the time of my inspection.

Photo 1 shows a general view of the instrument cluster of the Motor Bus at the time of my inspection. The mileage of the Motor Bus was 543,623km

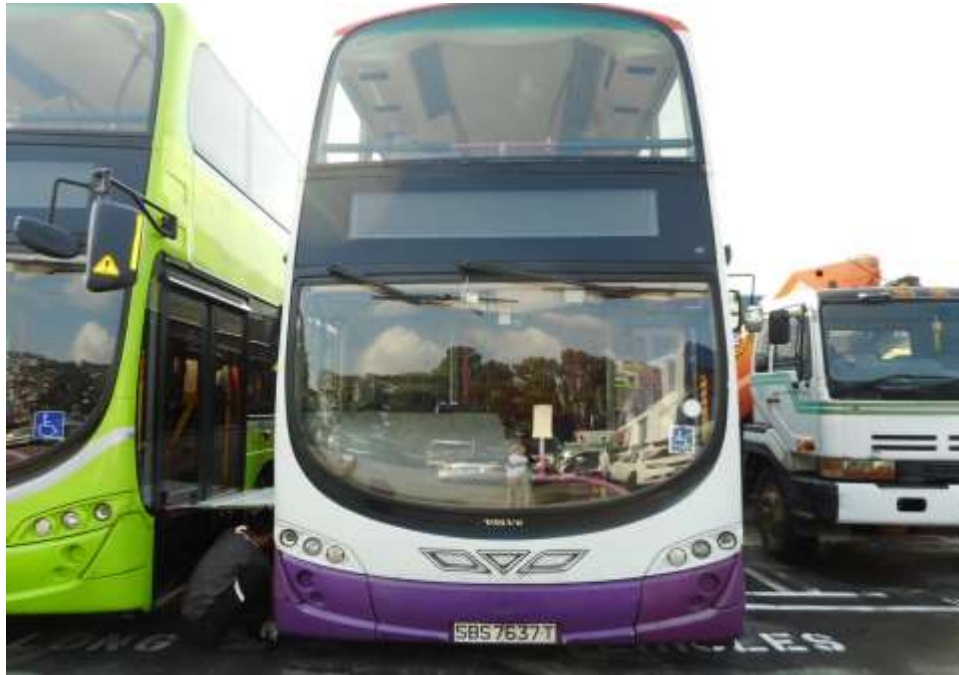
Photo 2 shows a general view of the front body of the Motor Bus at the time of my inspection. The Motor Bus was observed to be in good general condition and unaffected by the accident.

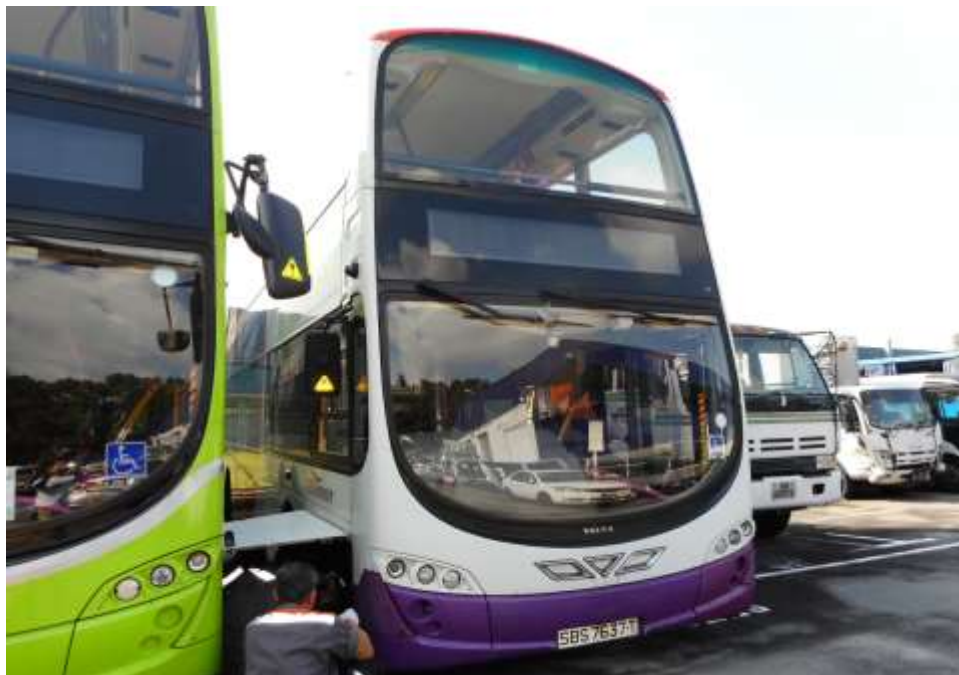
Photo 3 shows a general view of the right body of the Motor Bus at the time of my inspection. The Motor Bus was observed to be in good general condition and unaffected by the accident.

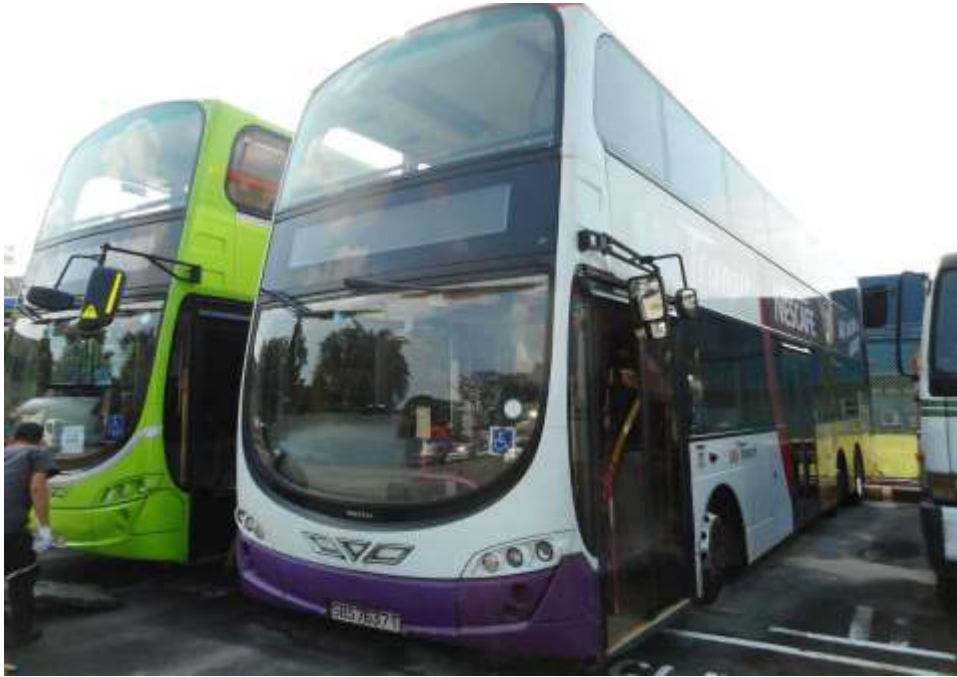
Photo 4 shows a general view of the left body of the Motor Bus at the time of my inspection. The Motor Bus was observed to be in good general condition and unaffected to by the accident.

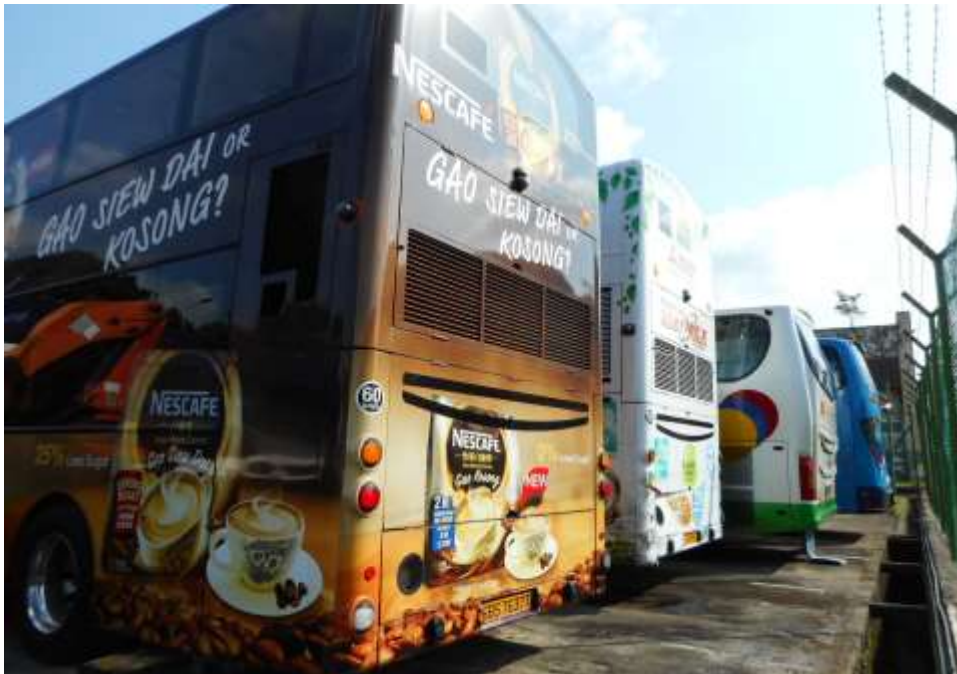
Photo 5 shows a general view of the Motor Bus's rear body at the time of my inspection. The Motor Bus was observed to be in good general condition and unaffected to by the accident.

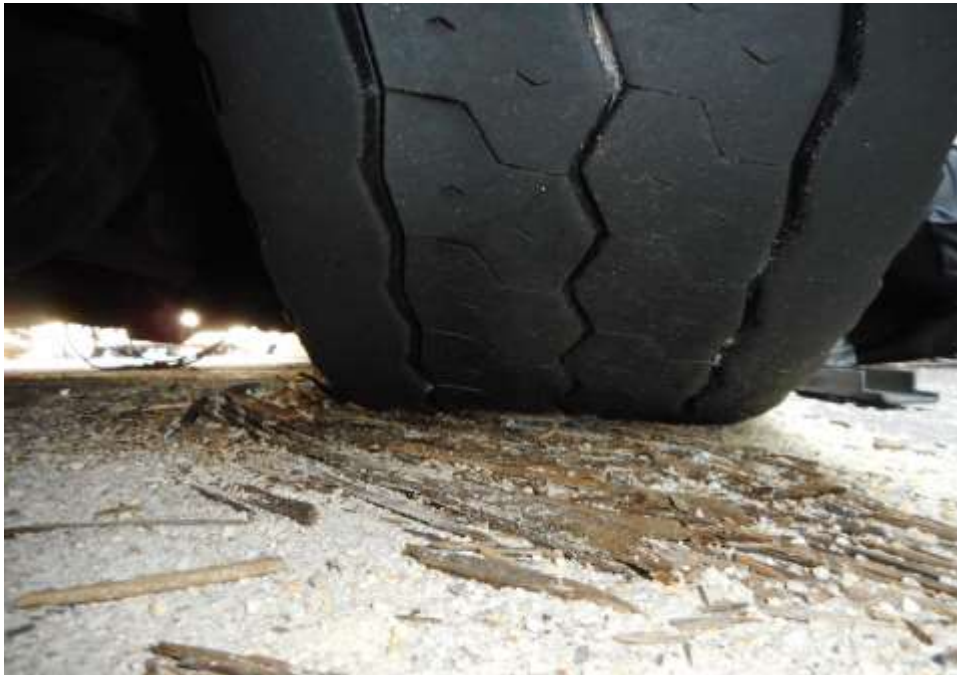
Photo 6 shows the condition of the front right tyre of the Motor Bus, which was observed to be in serviceable condition with remaining tread depth of approximately 10.2 mm. The tyre, which was wrapped around standard steel wheel rim, was also observed to be sufficiently inflated for vehicular operation. There was no tear, cut or burst mark(s) on the outer and the inner sidewalls as well as across the tread of the 6 tyres that were fitted on the Motor Bus.

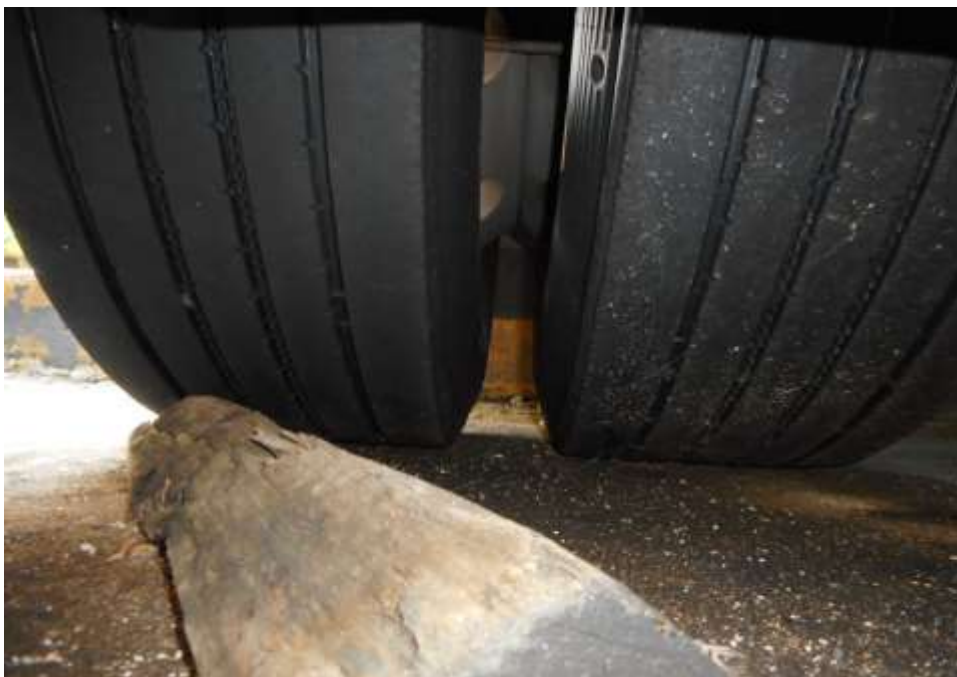
Photo 7 shows the condition of the rear right tyre of the Motor Bus, which was observed to be in serviceable condition with remaining tread depth of approximately 6.6mm. The tyre, which was wrapped around standard steel wheel rim, was also observed to be sufficiently inflated for vehicular operation.

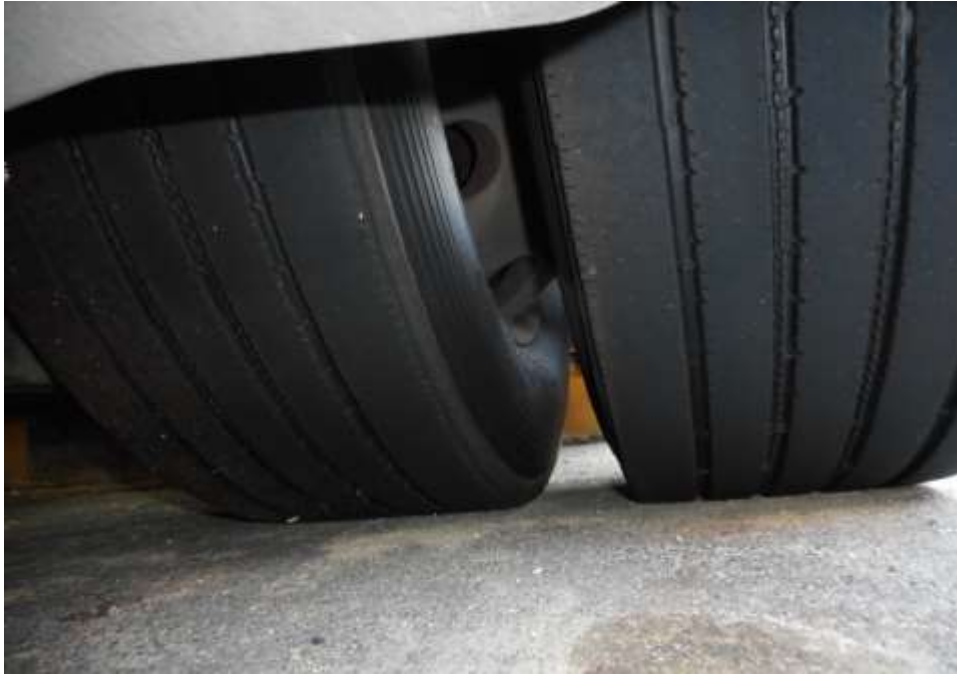
Photo 8 shows the condition of the rear left tyres of the Motor Bus, which was observed to be in serviceable condition with remaining tread depth of approximately 6.4mm. The tyres, which were wrapped around standard steel wheel rim, were also observed to be sufficiently inflated for vehicular operation. There was also no damage found on all 6 steel wheel rims of the Motor Bus.

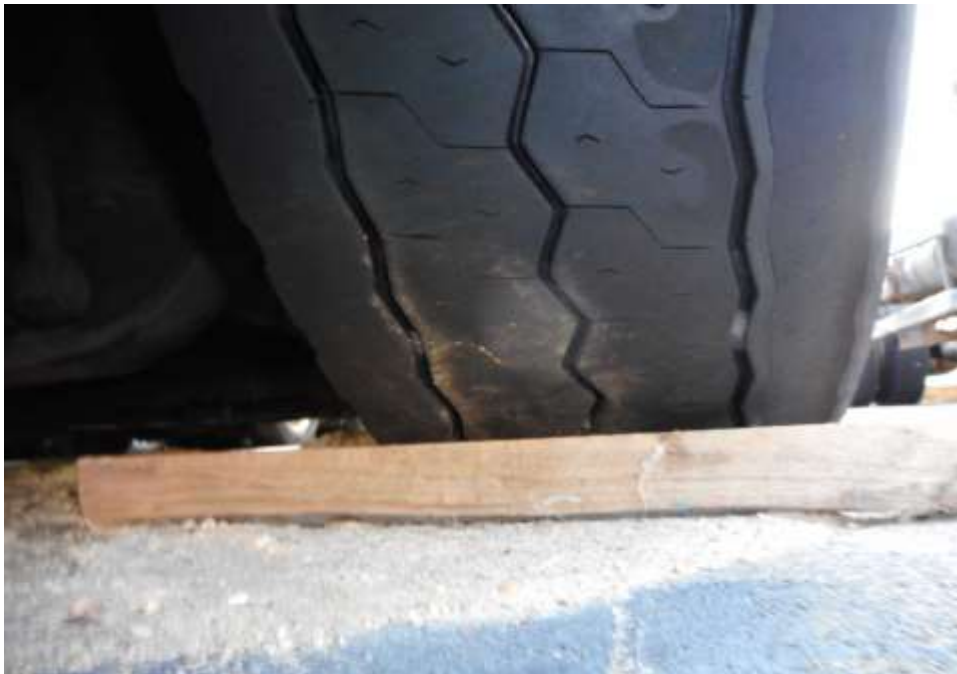
Photo 9 shows the condition of the front left tyres of the Motor Bus, which were observed to be in serviceable condition with remaining tread depth of approximately 8.6mm. There was also no tear, cut or burst mark(s) on the outer and the inner sidewalls as well as across the tread of the 6 tyres that were fitted on the Motor Bus.

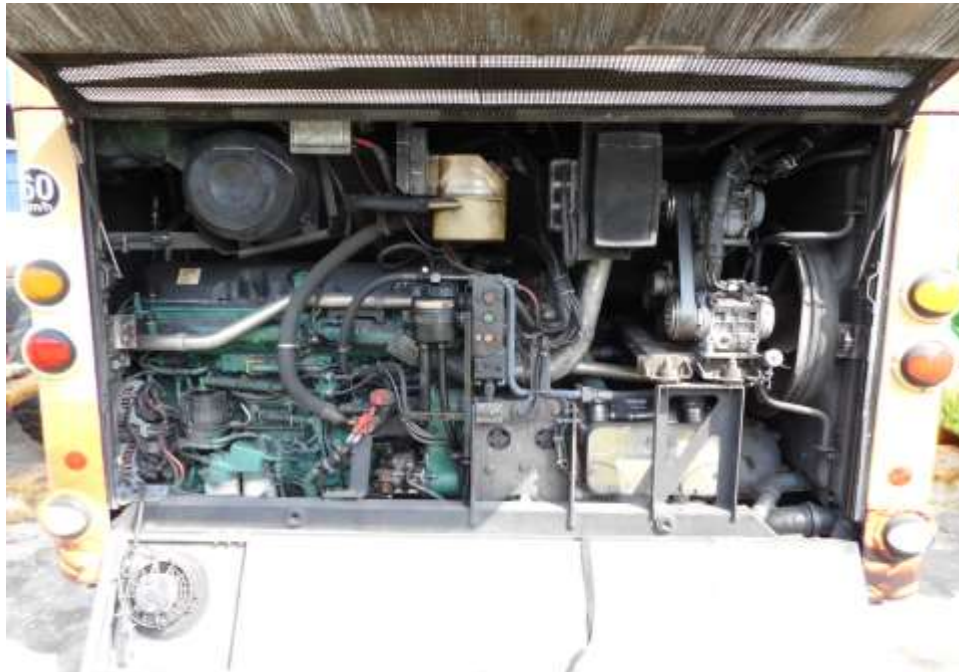
8. Upon examination of the Motor Bus's engine compartment, I had observed all the parts and components inside the engine compartment to be intact and unaffected by the accident. The brake fluid, engine oil, power steering fluid and engine coolant were all found to be of sufficient level for operating purposes. Visually, there was also no contamination found to these fluids.

9. Further examination of the engine compartment revealed, there was no sign(s) or indication(s) of fresh fluid leakage and/or fluid stain within the engine compartment of the Motor Bus.

Photo 10 shows a general view of the Motor Bus's engine compartment, which was accessed by lifting the front cabin of the Motor Bus. The various parts and components inside the engine compartment were unaffected by the accident. There was also no sign(s) or indication(s) of fresh fluid leakage and/or fluid stain within the engine compartment.

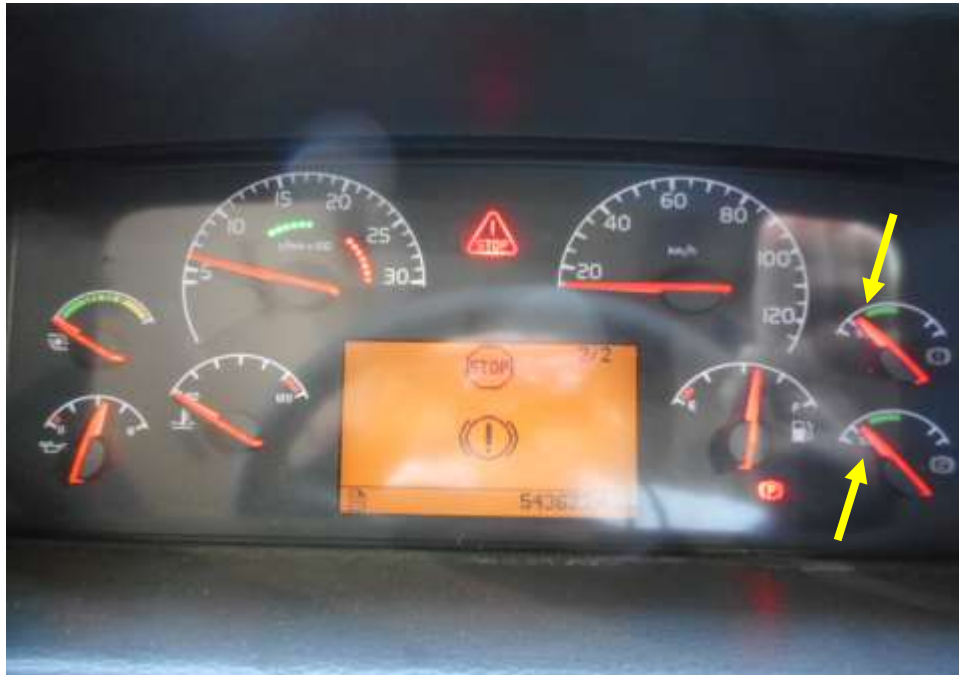
Photo 11 shows the air readings from the air brake cylinders of the Motor Bus at the time of my inspection. The air in the cylinder (arrowed) was observed to be of insufficient level at the time of my inspection as damage to the air brake hoses and as components was found which caused an air leak, due to the towing process of the Motor Bus.

11. Static brake tests could not be conducted on the Motor as because there was damage to the air brake hoses and its components which caused an air leak to the bus air brake system due to the towing process of the Motor Bus. Refer to photo 11 – 14

12. The rear undercarriage components and rear braking systems of the Motor Bus could not be visually inspected due to the Motor Bus height lifter system (unable to operate) as it uses the air from the air brake cylinder to lift, which was damaged in the towing process of the Motor Bus. However the visual inspection of the front brake components revealed to be intact.

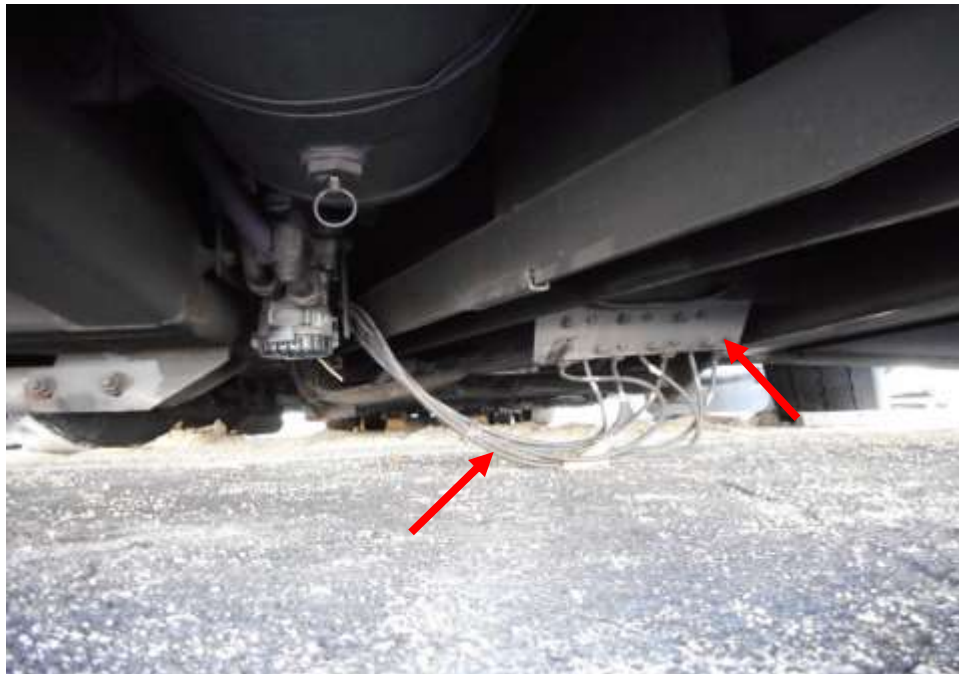
10. My subsequent checks on the underside of the Motor Bus revealed that the undercarriage components and the air brake components was damaged which caused an air leak to the system as impact marks was found undercarriage due to the towing process of the Motor Bus from the accident scene to the Traffic Police Vehicle Pound. See photo 10 – 17 below.

Photo 12 shows undercarriage of the Motor Bus at the time of my inspection. The hoses and the components of the air brakes (arrowed) were observed to be damaged and dislodged from the Motor Bus at the time of my inspection due to the towing process of the Motor Bus.

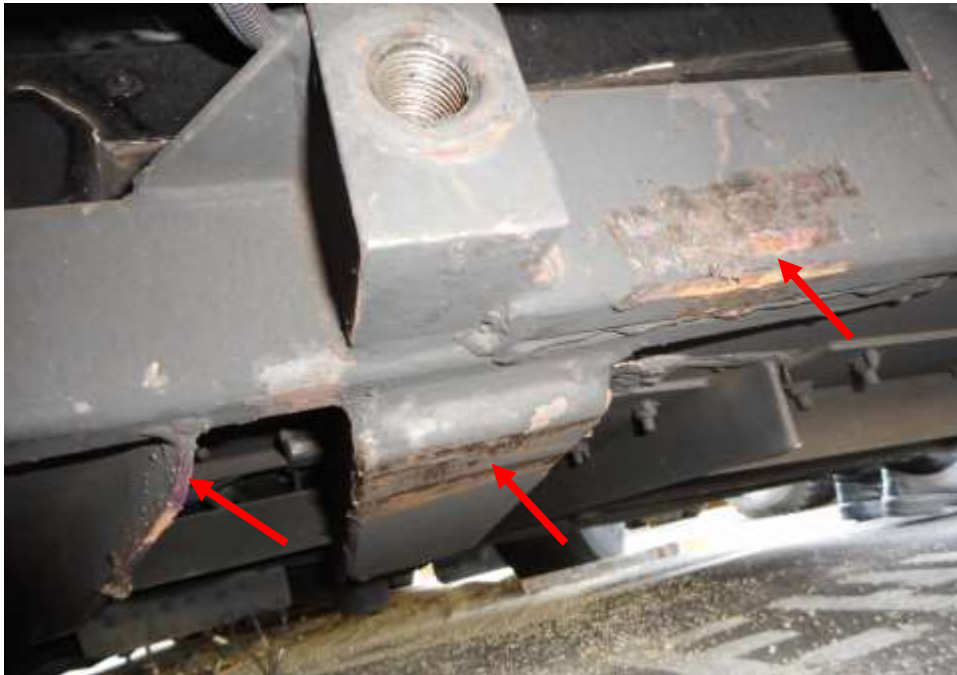
Photo 13 shows undercarriage of the Motor Bus at the time of my inspection. The undercarriage components of Motor Bus (arrowed) was observed to have received impact marks and damaged at the time of my inspection due to the towing process of the Motor Bus.

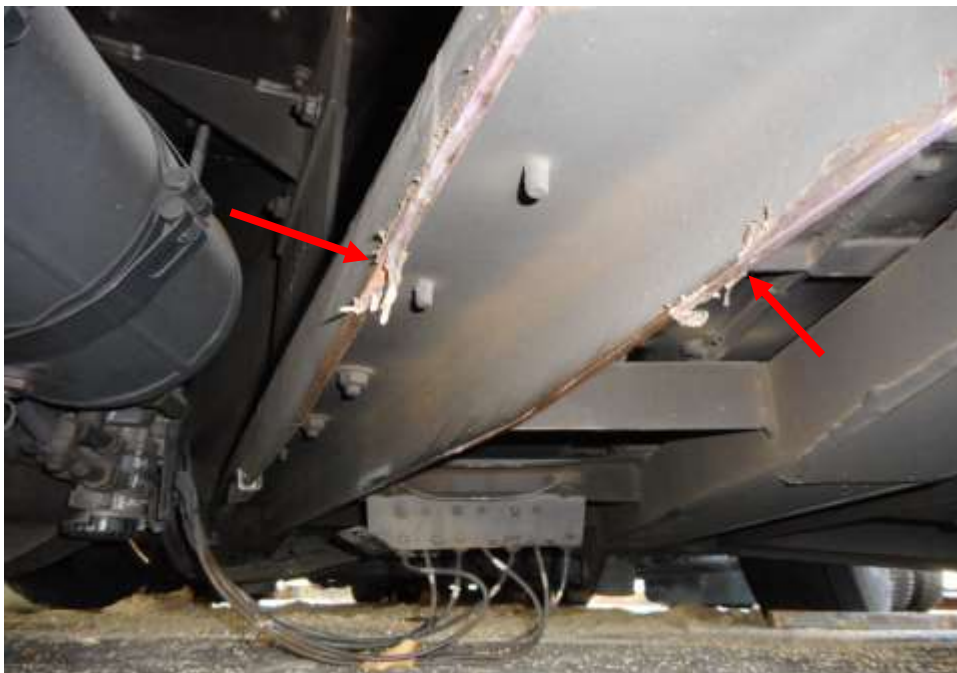
Photo 14 shows undercarriage of the Motor Bus at the time of my inspection. The undercarriage components of Motor Bus (arrowed) was observed to have received impact marks and damaged at the time of my inspection due to the towing process of the Motor Bus.

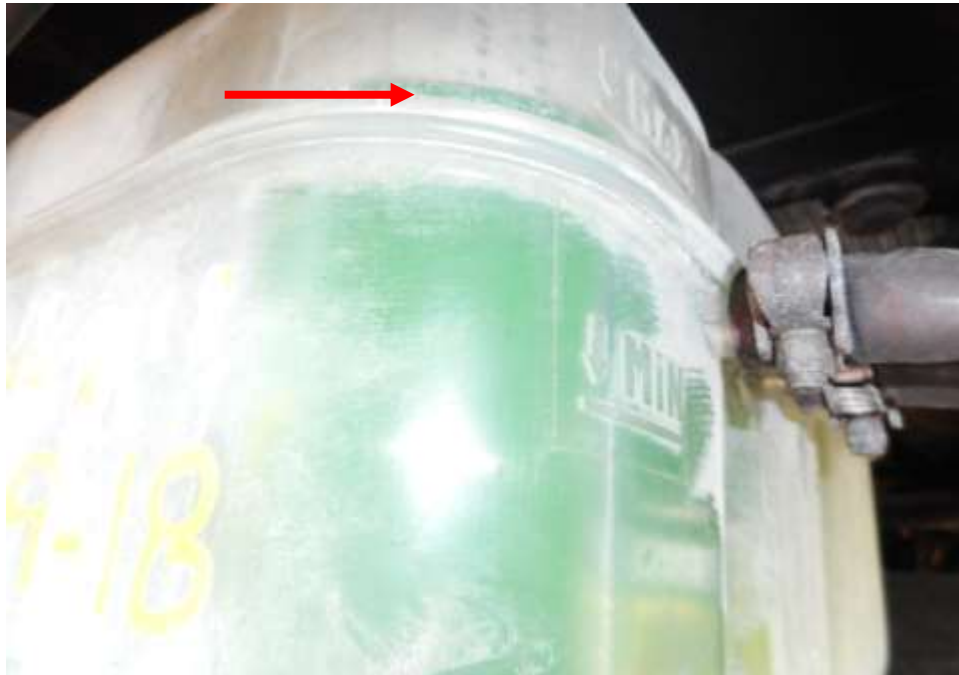
Photo 15 shows the engine coolant reservoir of the Motor Bus at the time of my inspection. The engine coolant was observed to be of sufficient level and without any visible contamination.

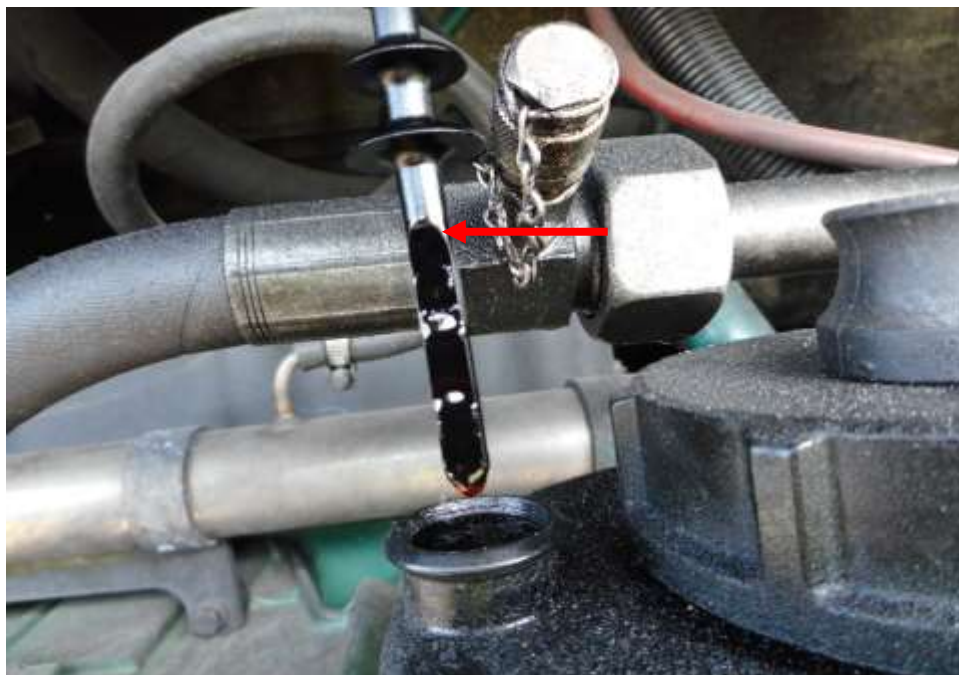
Photo 16 shows the power steering fluid reservoir of the Motor Bus at the time of my inspection. The power steering fluid was observed to be of sufficient level (arrowed) and without any visible contamination.

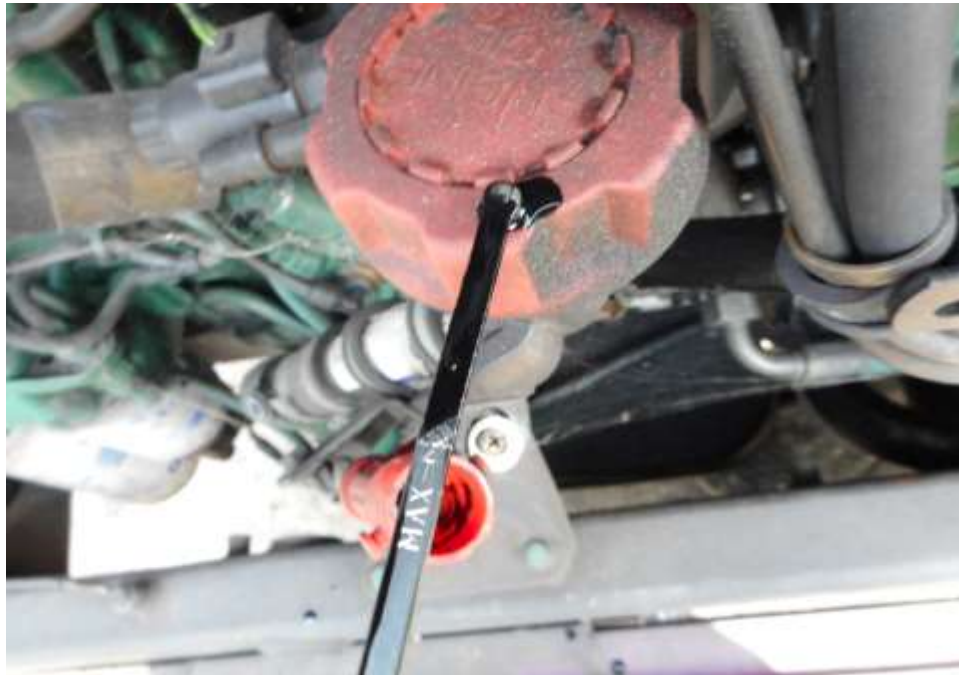
Photo 17 shows the engine oil dip stick of the Motor Bus at the time of my inspection. The engine oil was observed to be of sufficient level and without any visible contamination.

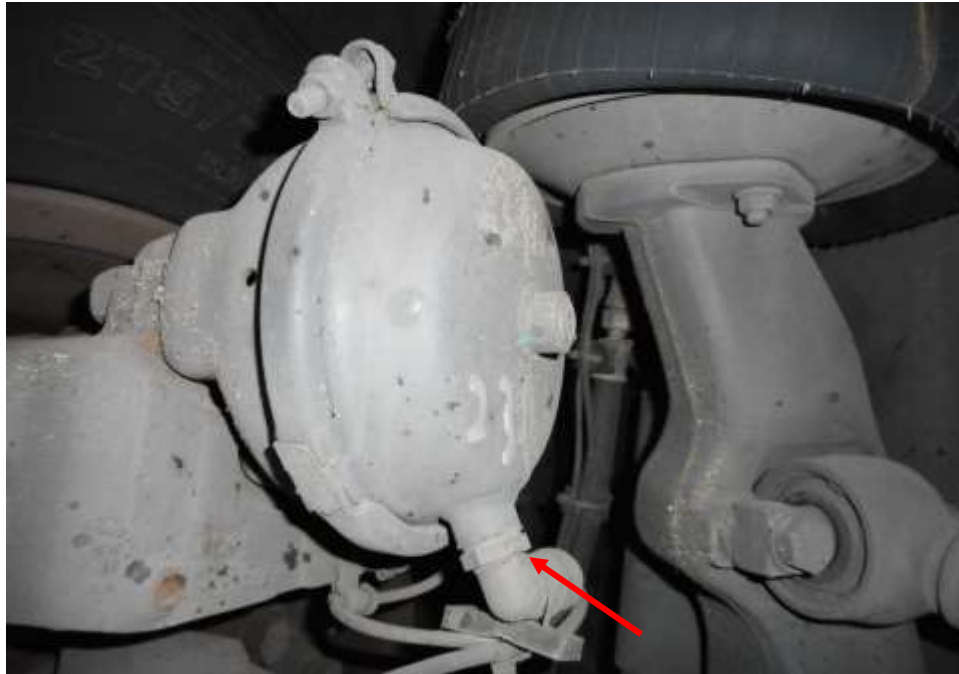
Photo 18 shows the brake pipe (arrowed) at the front right wheel of the Motor Bus was observed to be intact at the time of my inspection.

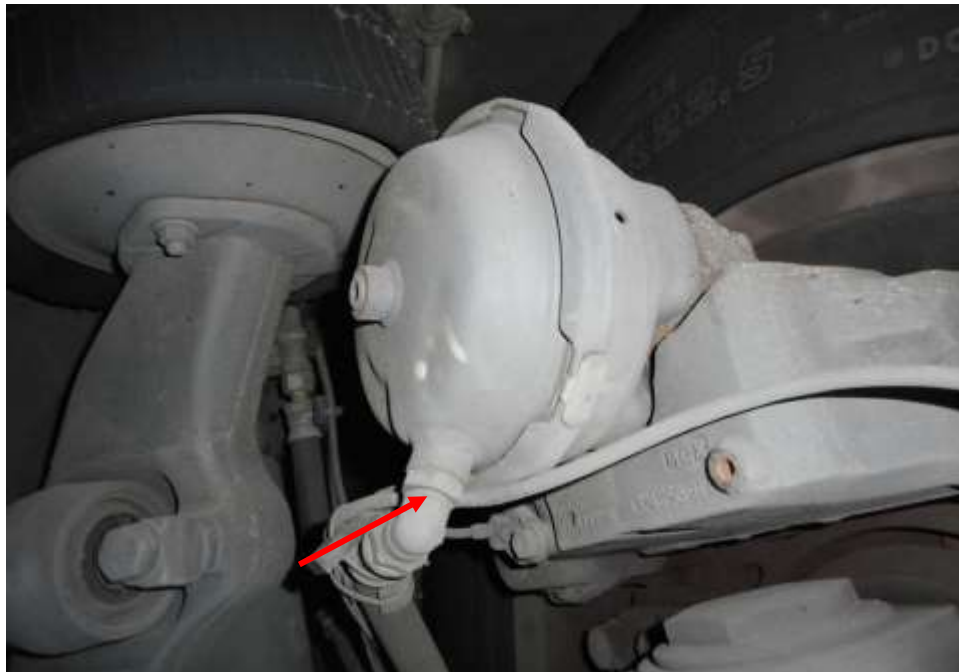
Photo 19 shows the brake pipe (arrowed) at the front left wheel of the Motor Bus was observed to be intact at the time of my inspection.

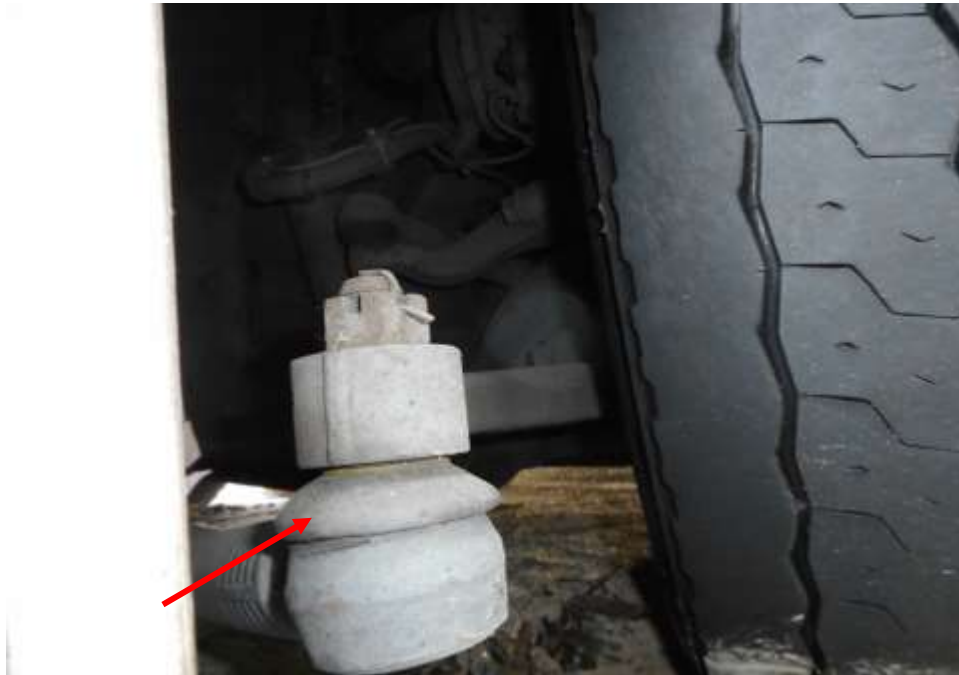
Photo 20 shows the various undercarriage components at the front left wheel of the Motor Bus, in particular the steering tie rod end (arrowed). The various undercarriage components of the Motor Bus were all found to be intact without any visible damage. There was also no sign of fluid stain(s) observed on the various undercarriage components.

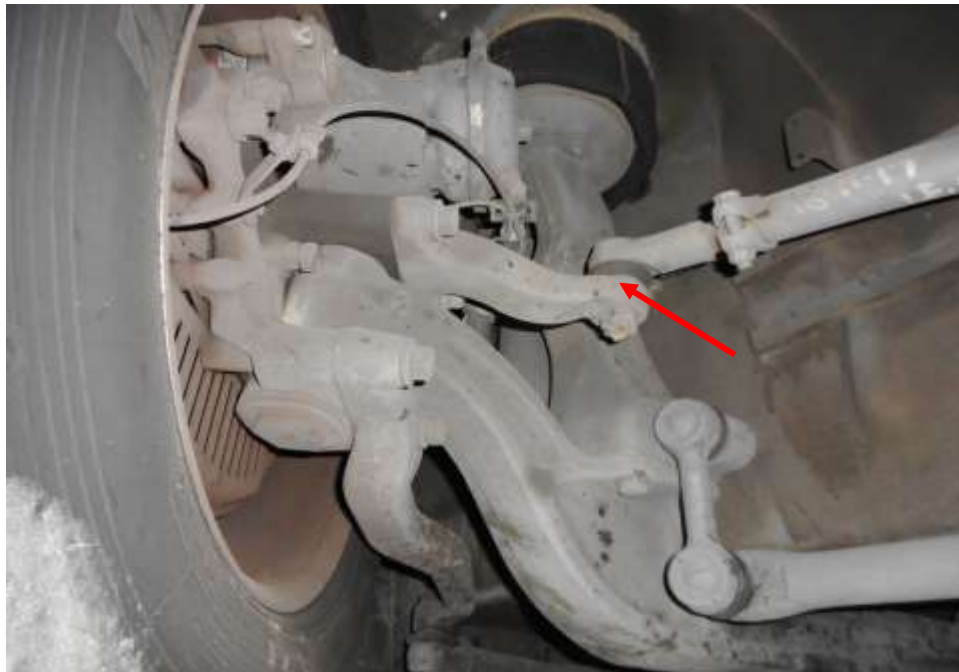
Photo 21 shows the various undercarriage components at the front right wheel of the Motor Bus, in particular the steering tie rod end (arrowed). The various steering components were all found to be intact, suggesting that the steering system of the Motor Bus was likely to be in serviceable condition at the material time of accident. There was also no sign of fluid stain(s) observed on the various undercarriage components.

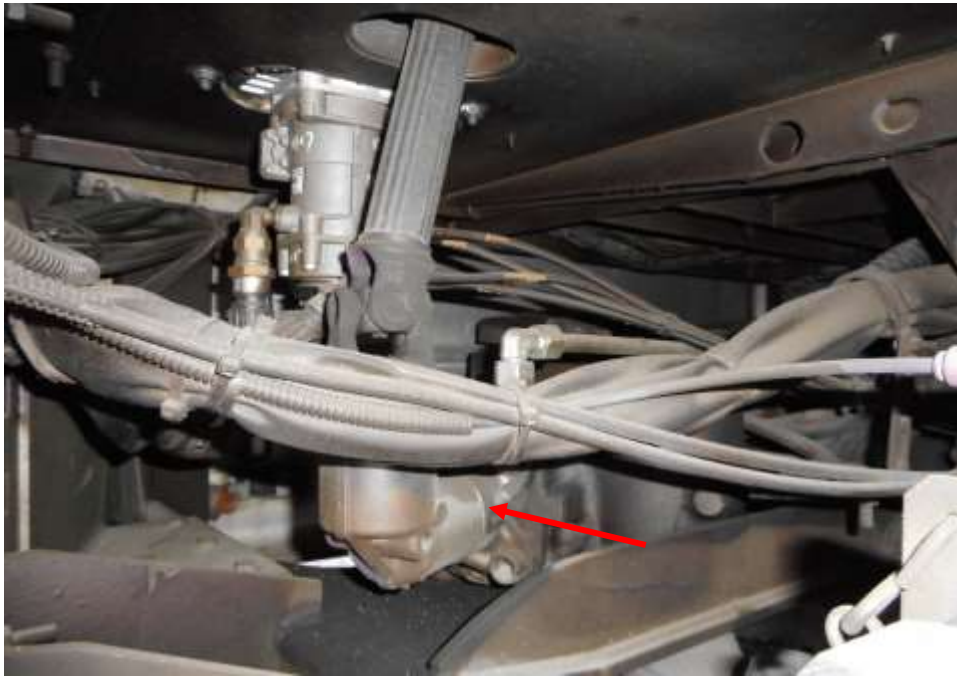
Photo 22 shows the steering box component (arrowed) at the undercarriage of the Motor Bus was found to be intact without any visible damage. There was also no sign of fluid stain(s) observed on the various undercarriage components.

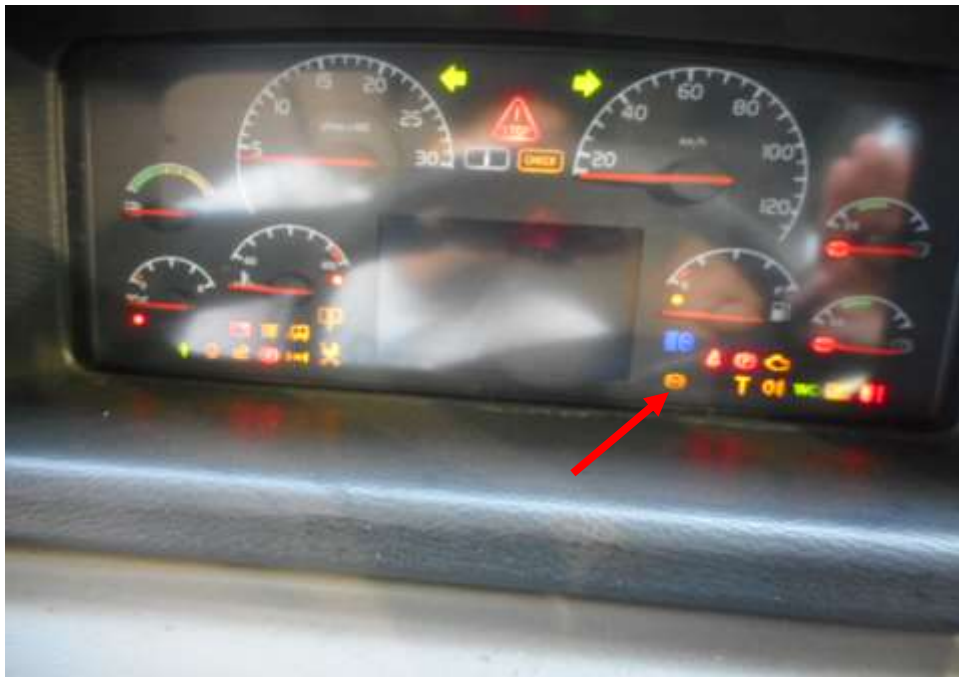
Photo 23 shows the warning light for Anti-Lock Brake System (ABS) appearing on the instrument panel of the Motor Bus during the self-test of its various electronic operating systems when its engine was cranked.

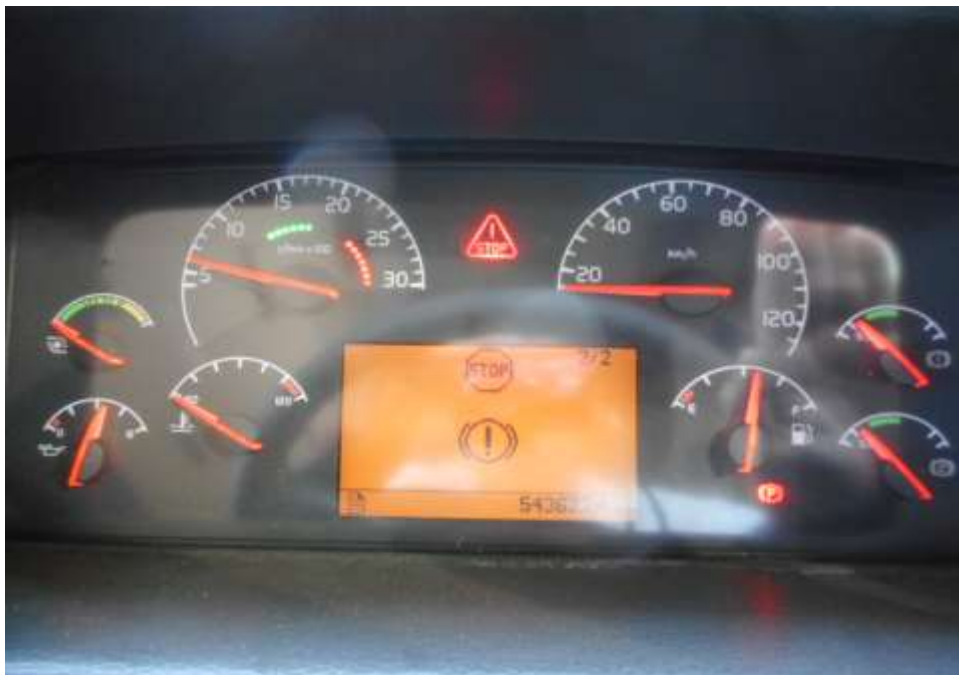
14. The Motor Bus automatic self-test of the functionality of its electronic operating systems like the Anti-Lock Brake System (ABS) during cranking of the engine had indicated that these systems were in working condition and without abnormality. See photo 23 & 24.

Photo 24 shows no warning lights illuminated on the instrument panel of the Motor Bus after the engine was cranked. This would suggest that there was no abnormality to the various electronic operating systems of the Motor Bus, like the ABS.
