Your Ref: TP/IP/10591/2019
Our Ref : CI/TPD19008273/P

13th August 2019

MECHANICAL INSPECTION REPORT OF MOTOR BUS PA 49R

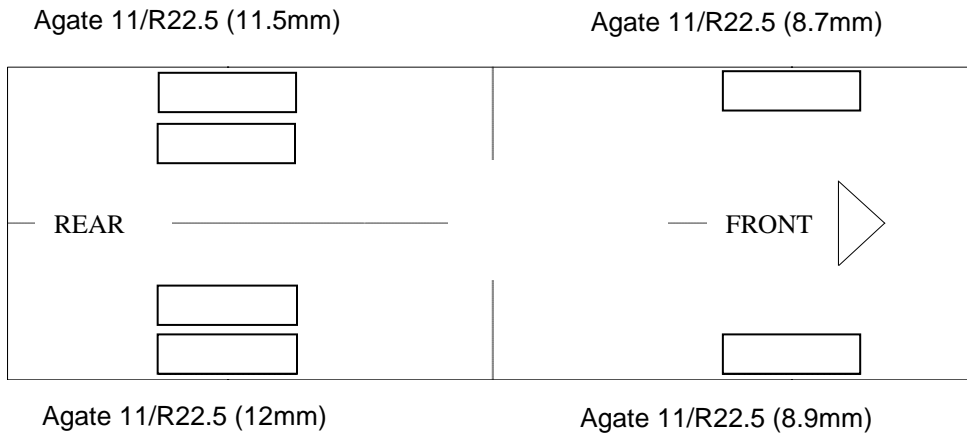
6. The 2 front tyres and 4 rear tyres of the Motor Bus were observed to be in serviceable condition and sufficiently inflated for vehicular operation. I did not find any tear, cut or burst mark(s) on the outer and the inner sidewalls as well as across the tread of the 6 tyres. The tyre brand, tyre size and remaining tread depth of the 6 tyres of the Motor Bus were recorded as follows:-

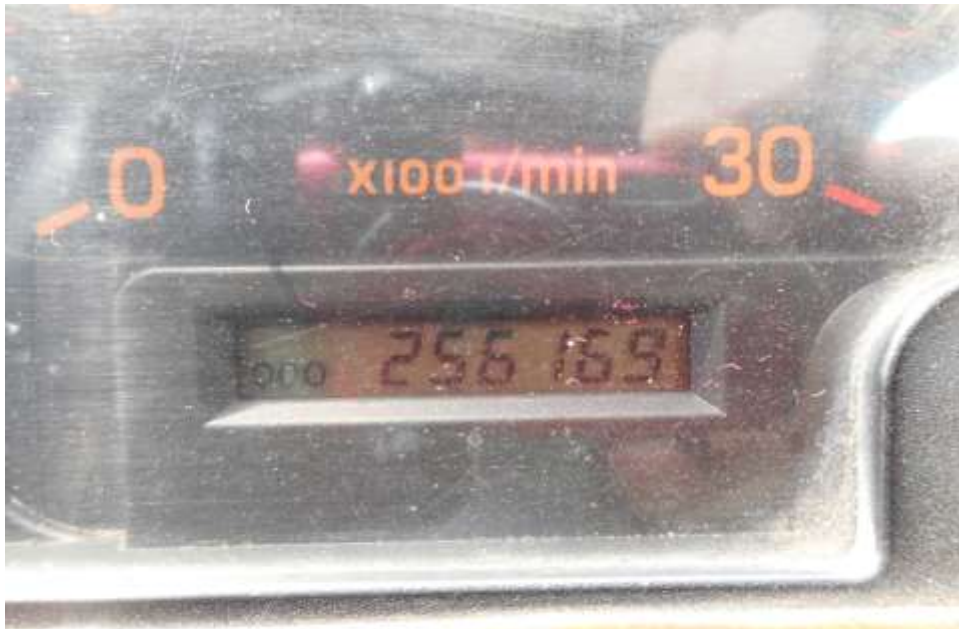
Photo 1 shows a general view of the instrument cluster of the Motor Bus at the time of my inspection. The mileage of the Motor Bus was 256,169km

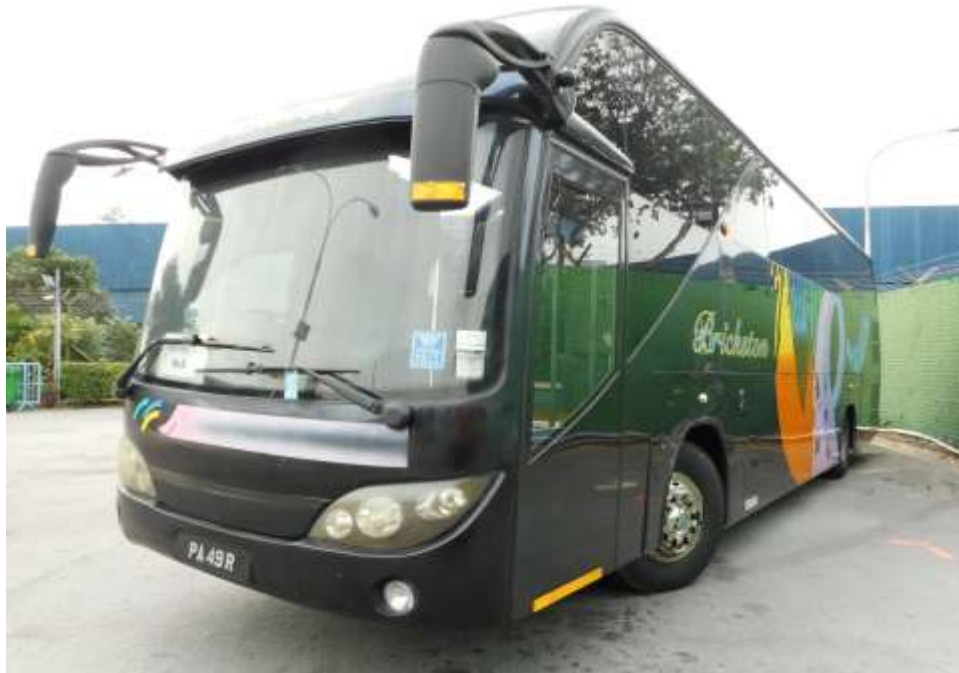
Photo 2 shows a general view of the front left body of the Motor Bus at the time of my inspection. The Motor Bus was observed to have sustained minor damages at its left portion. Its front left body panel and front left wheel cover was damaged as a result of the accident at the time of my inspection.

15. During the operational test, the various transmission gears of the Motor Bus were able to be engaged without any difficulty by stepping on the clutch pedal and manually shifting the gear lever. There were no abnormal sounds heard and/or abnormal behaviour of the Motor Bus's engine system. It was able to move forward and backward normally. The braking system was also found to be in working condition as the Motor Bus was able to slow down and come to a complete stop upon depressing of the brake pedal. Refer to photo 2 and 26.

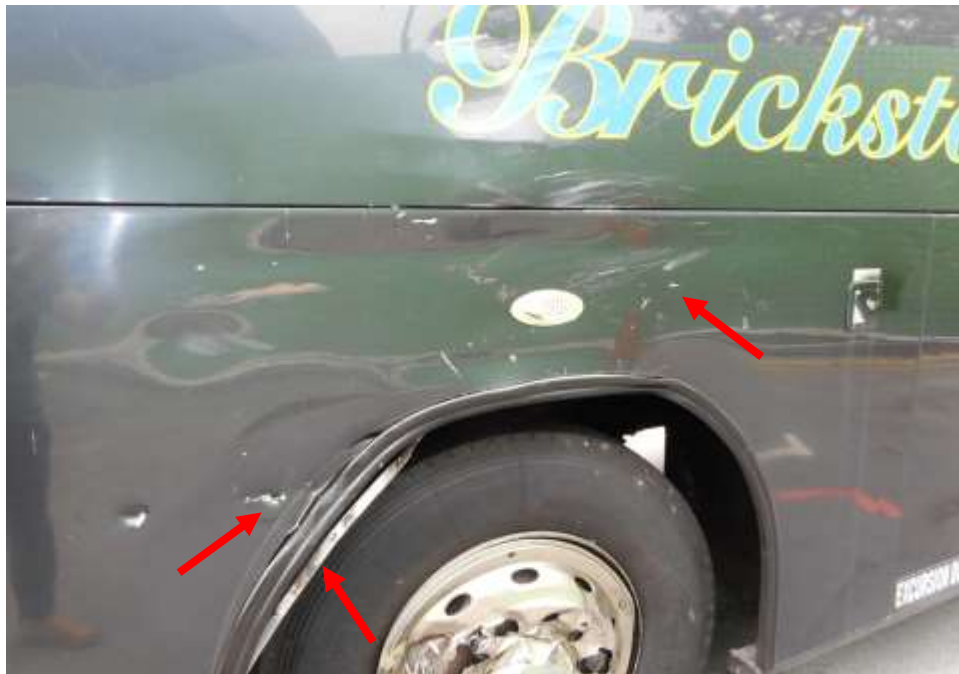
Photo 3 shows a close up view of the front body of the Motor Bus at the time of my inspection. The Motor Bus was observed to have sustained minor damages at its left portion. Its front left body panel (arrowed) was damaged as a result of the accident at the time of my inspection.

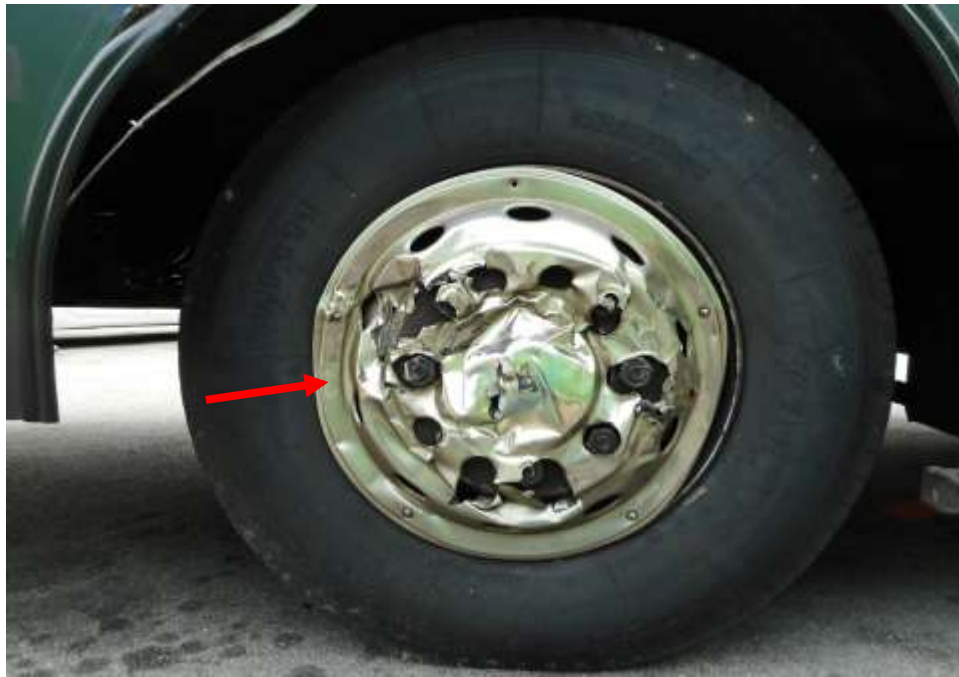
Photo 4 shows a close up view of the front left wheel of the Motor Bus at the time of my inspection. The Motor Bus was observed to have sustained minor damages at its front left wheel portion. Its front left wheel cover (arrowed) was damaged as a result of the accident at the time of my inspection.

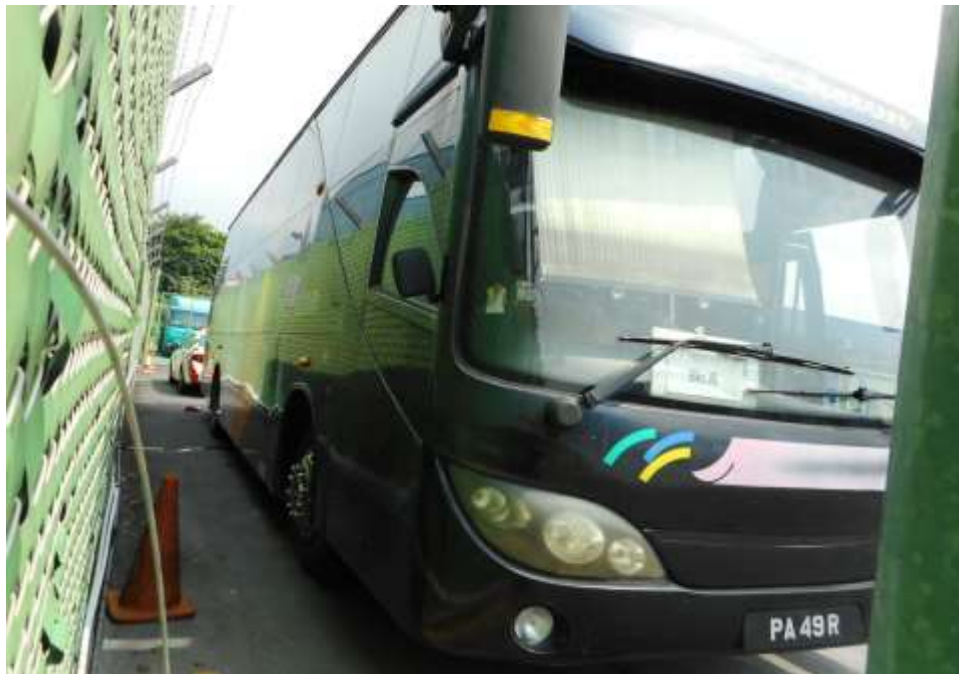
Photo 5 shows a general view of the right body of the Motor Bus at the time of my inspection. The Motor Bus was observed to be in good general condition and unaffected by the accident.

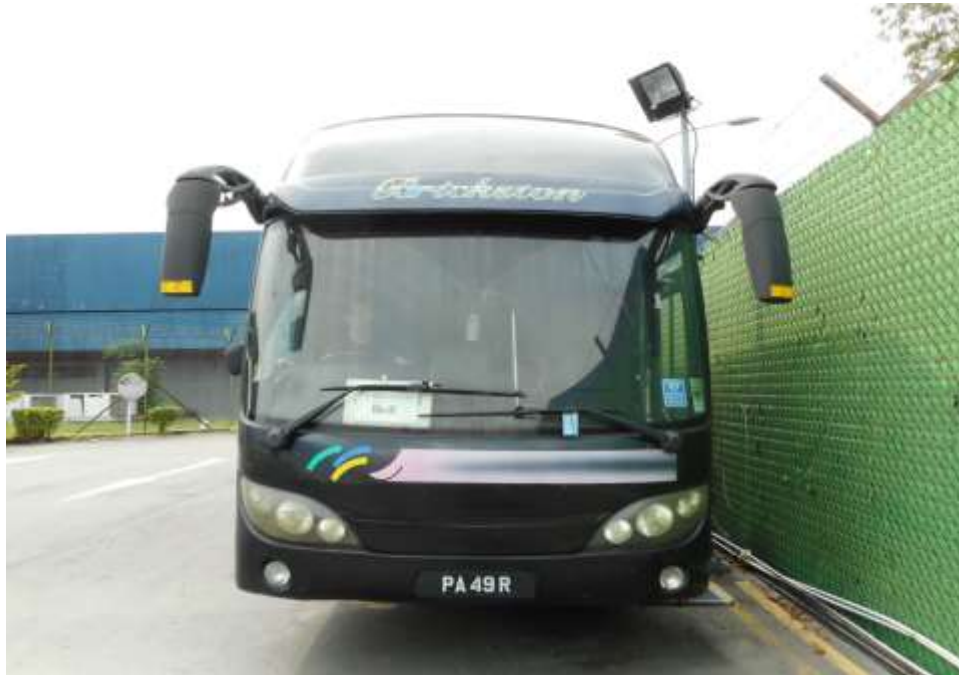
Photo 6 shows a general view of the front body of the Motor Bus at the time of my inspection. The Motor Bus was observed to be in good general condition and unaffected to by the accident.

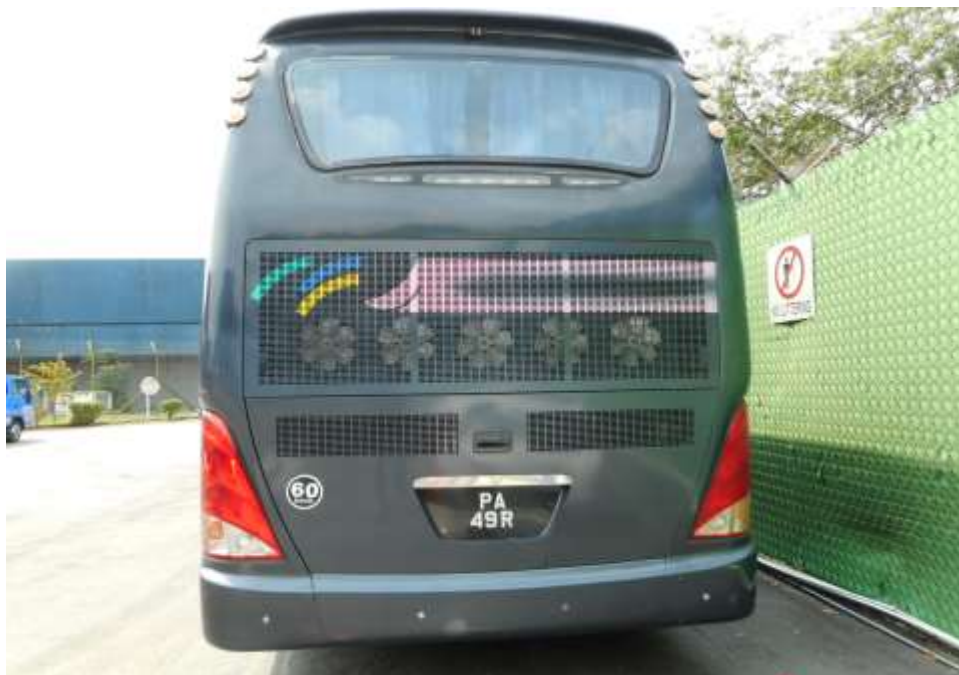
Photo 7 shows a general view of the Motor Bus's rear body at the time of my inspection. The Motor Bus was observed to be in good general condition and unaffected to by the accident.

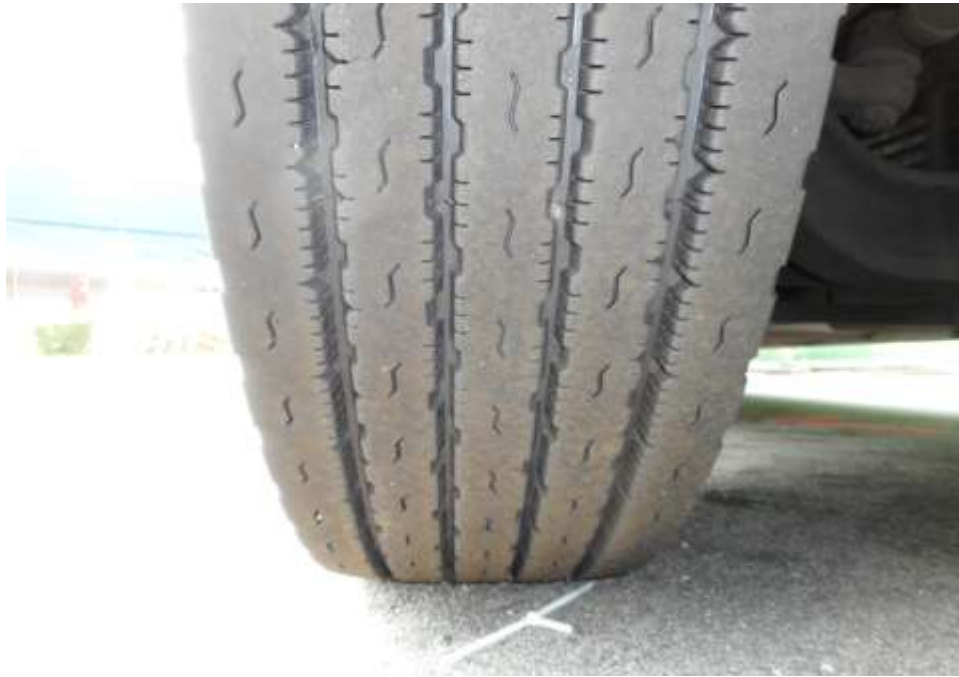
Photo 8 shows the condition of the front right tyre of the Motor Bus, which was observed to be in serviceable condition with remaining tread depth of approximately 8.9mm. The tyre, which was wrapped around standard steel wheel rim, was also observed to be sufficiently inflated for vehicular operation. There was no tear, cut or burst mark(s) on the outer and the inner sidewalls as well as across the tread of the 6 tyres that were fitted on the Motor Bus.

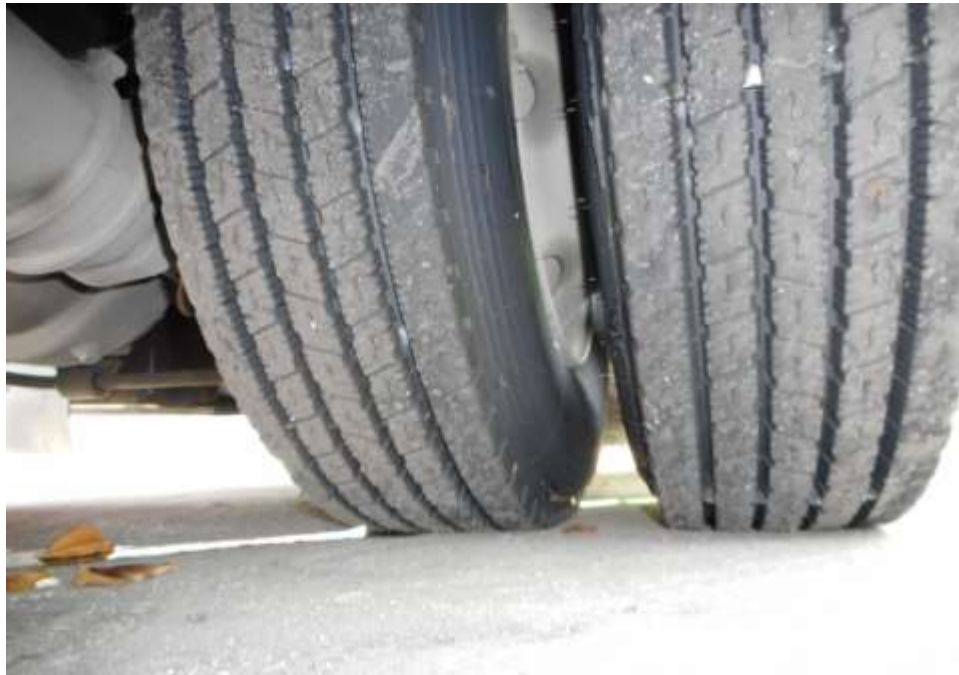
Photo 10 shows the condition of the rear left tyres of the Motor Bus, which was observed to be in serviceable condition with remaining tread depth of approximately 11.5mm. The tyres, which were wrapped around standard steel wheel rim, were also observed to be sufficiently inflated for vehicular operation. There was also no damage found on all 6 steel wheel rims of the Motor Bus.

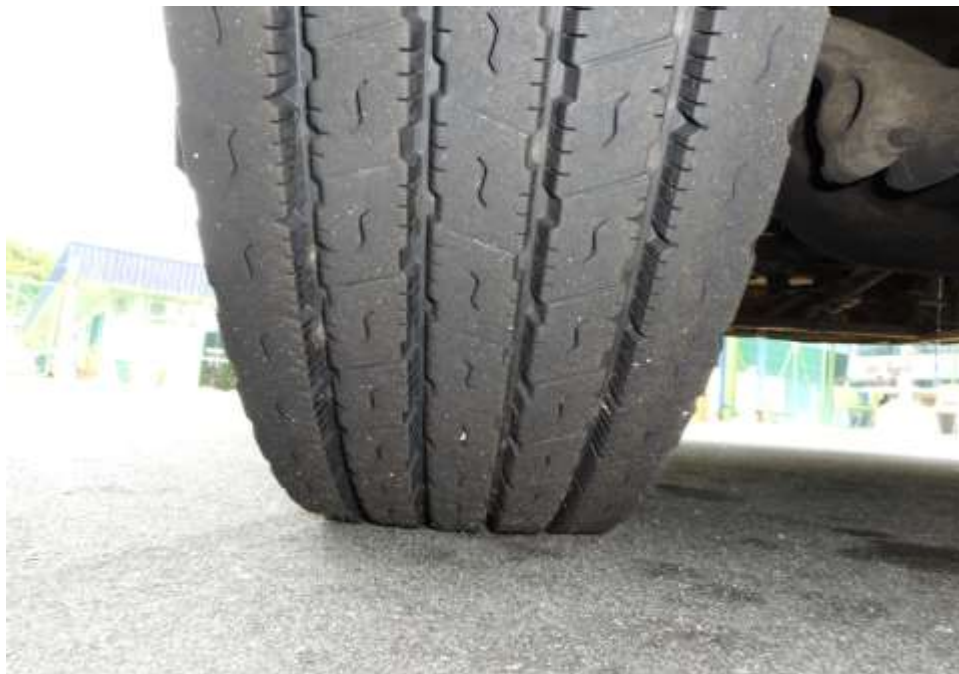
Photo 11 shows the condition of the front left tyres of the Motor Bus, which were observed to be in serviceable condition with remaining tread depth of approximately 8.7mm. There was also no tear, cut or burst mark(s) on the outer and the inner sidewalls as well as across the tread of the 6 tyres that were fitted on the Motor Bus.

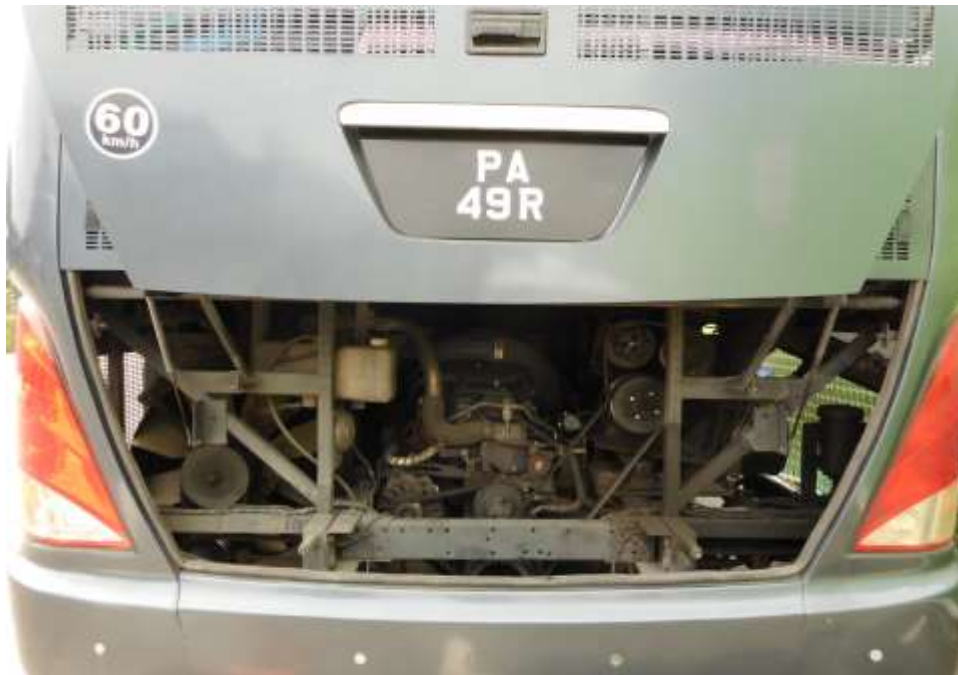
Photo 12 shows a general view of the Motor Bus's engine compartment, which was accessed by lifting the front cabin of the Motor Bus. The various parts and components inside the engine compartment were unaffected by the accident. There was also no sign(s) or indication(s) of fresh fluid leakage and/or fluid stain within the engine compartment

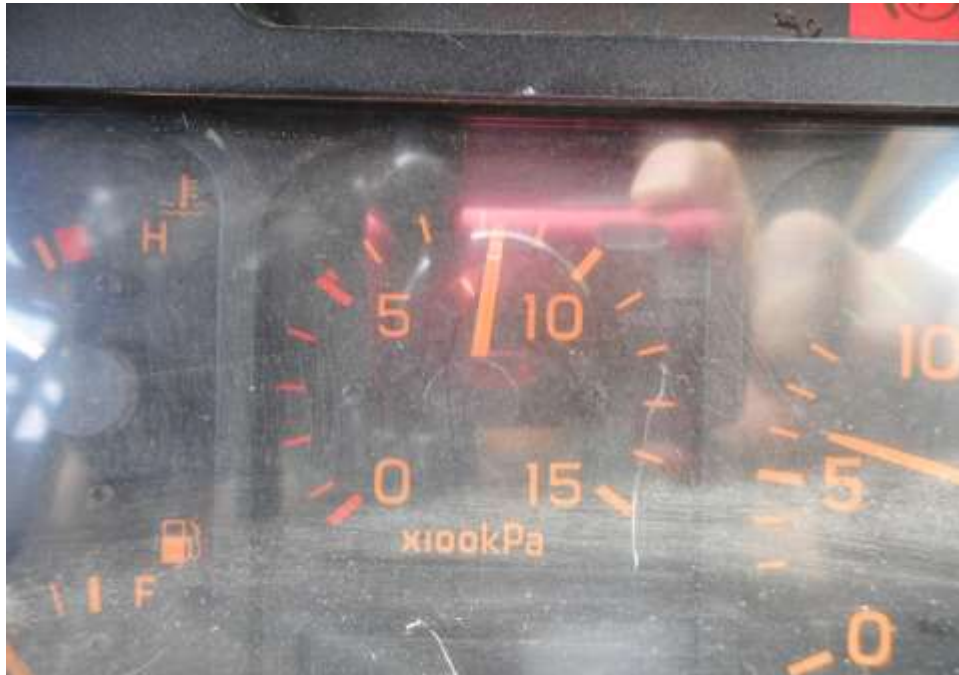
Photo 13 shows the air in the air brake cylinder of the Motor Bus at the time of my inspection. The air in the cylinder was observed to be of sufficient level & serviceable at the time of the accident.

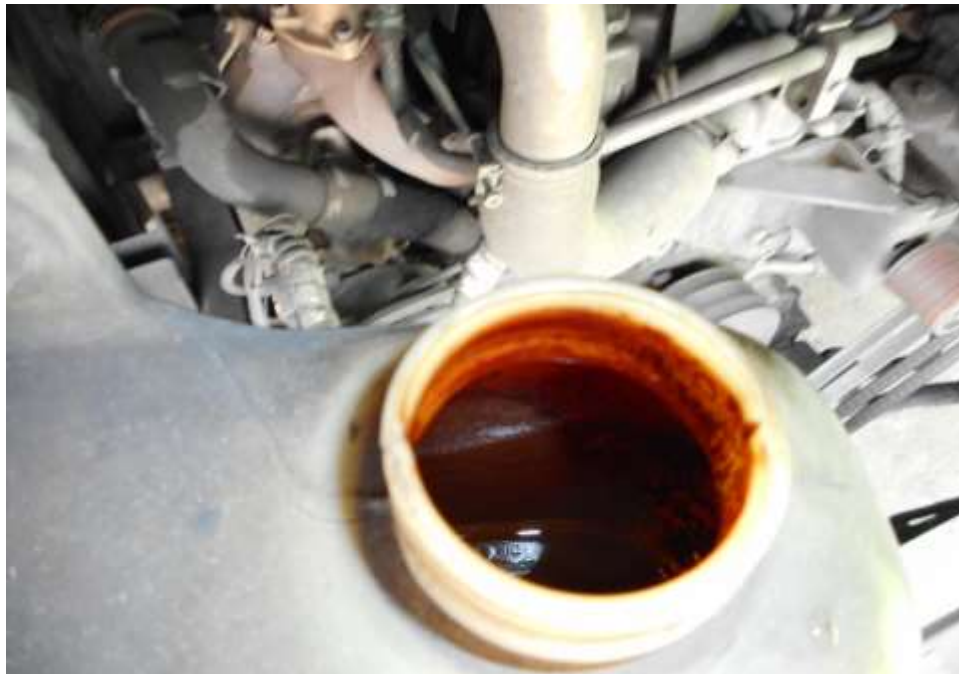
Photo 14 shows the engine coolant reservoir of the Motor Bus at the time of my inspection. The engine coolant was observed to be of sufficient level and without any visible contamination.

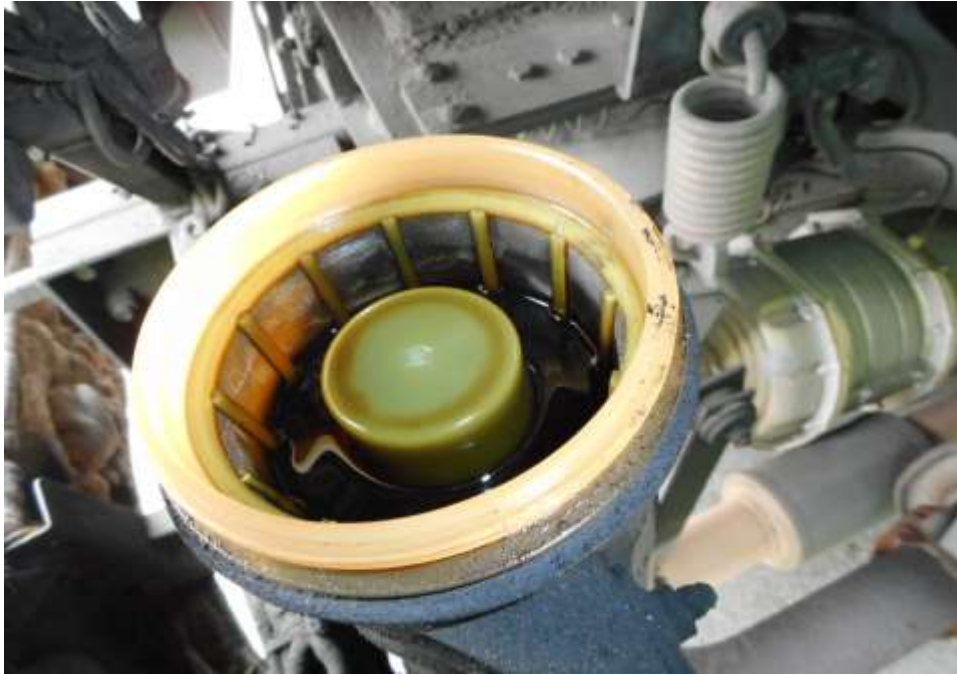
Photo 15 shows the power steering fluid reservoir of the Motor Bus at the time of my inspection. The power steering fluid was observed to be of sufficient level and without any visible contamination.

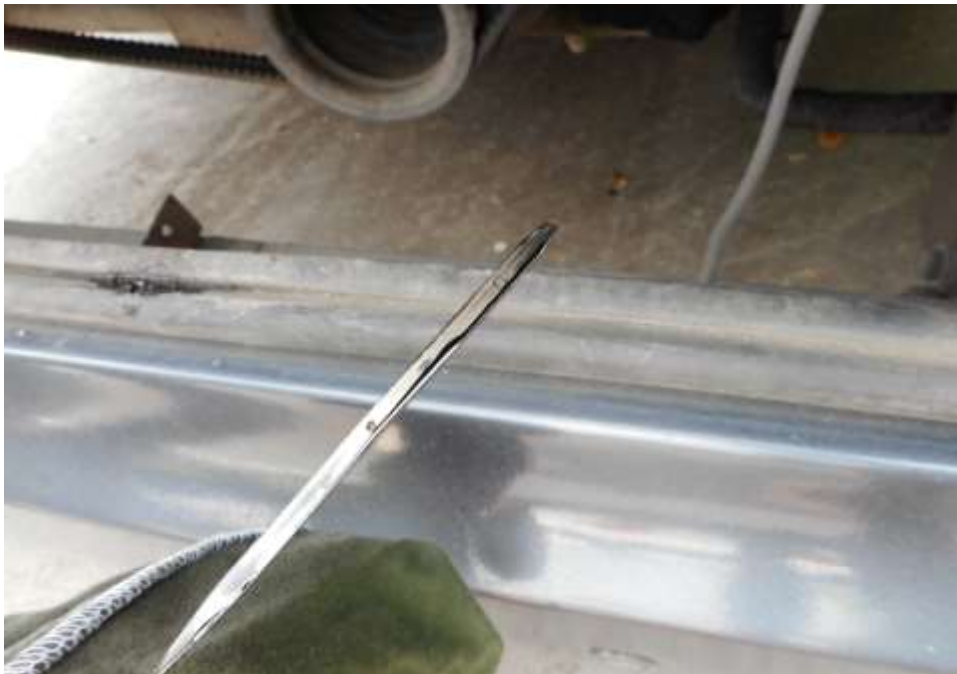
Photo 16 shows the engine oil dip stick system of the Motor Bus at the time of my inspection. The engine oil was observed to be of in the lower level but sufficient for operation and without any visible contamination.

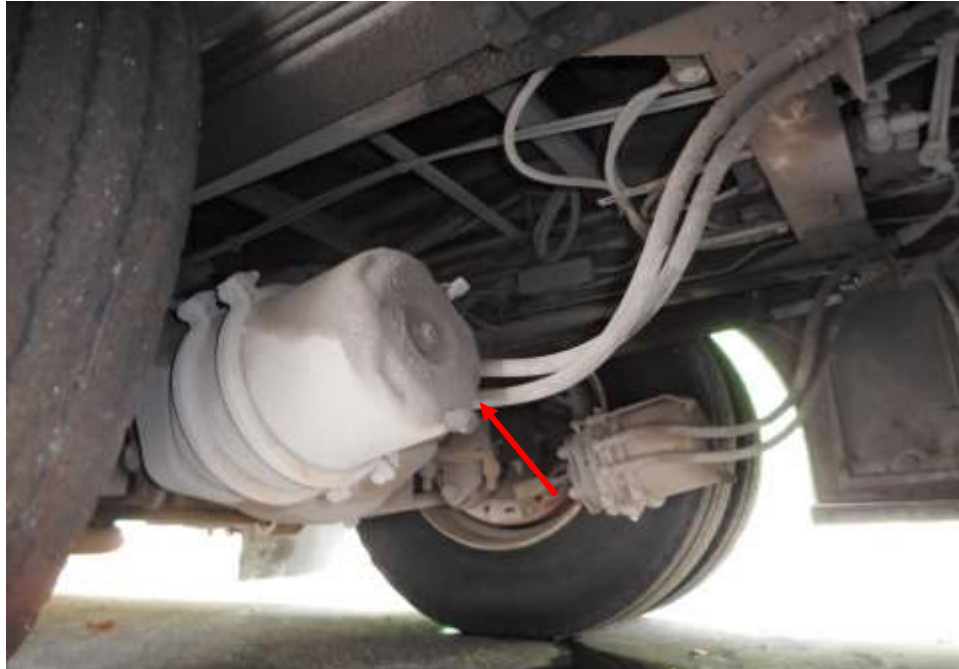
Photo 17 shows the brake pipe (arrowed) at the rear right wheel of the Motor Bus. I did not observe any leakage of brake fluid at the time of my inspection of the Motor Bus. My static tests of the Motor Bus's braking system, along with my visual examination of the various mechanical components in the braking system, had indicated that there was no internal leakage of pressure/vacuum. Hence the braking system of the Motor Bus was likely to be in serviceable condition at the material time of accident.

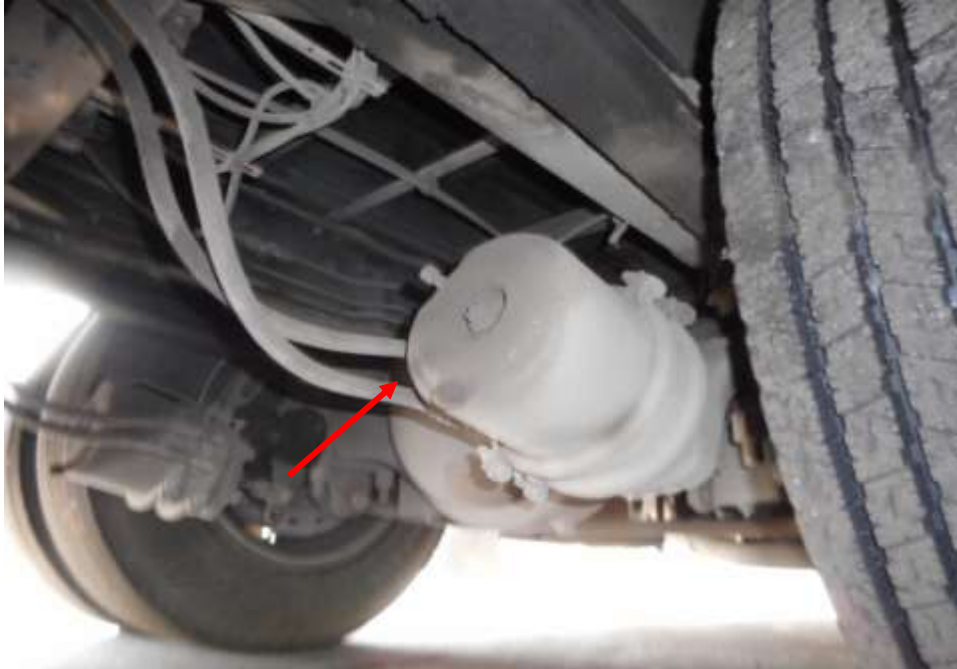
Photo 18 shows the brake pipe (arrowed) at the rear left wheel of the Motor Bus. I did not observe any leakage of brake fluid at the time of my inspection of the Motor Bus. My static tests of the Motor Bus's braking system, along with my visual examination of the various mechanical components in the braking system, had indicated that there was no internal leakage of pressure/vacuum. Hence the braking system of the Motor Bus was likely to be in serviceable condition at the material time of accident.

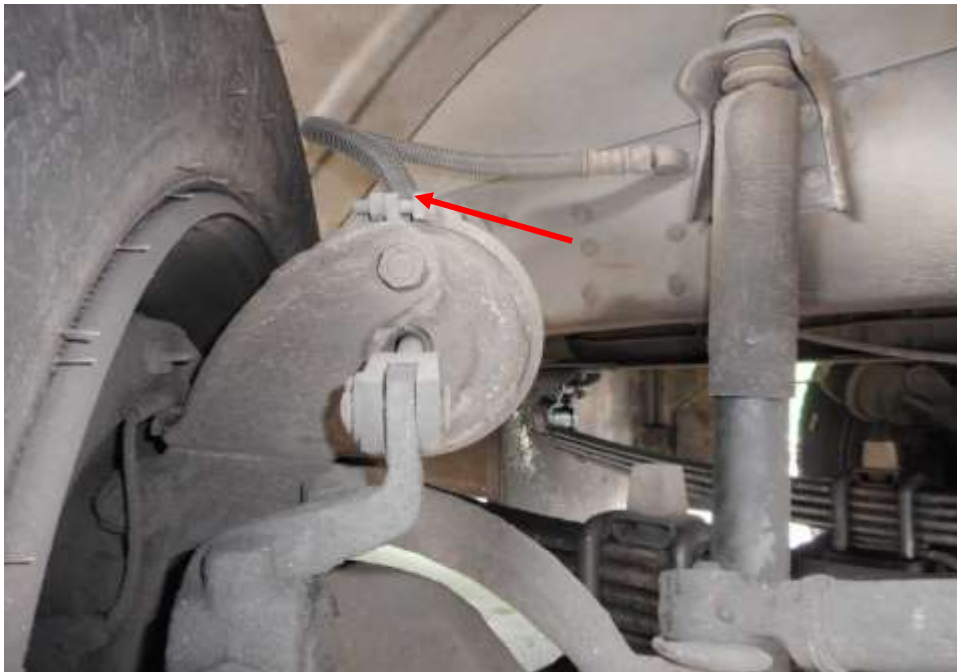
Photo 19 shows the brake pipe (arrowed) at the front right wheel of the Motor Bus. I did not observe any leakage of brake fluid at the time of my inspection of the Motor Bus. My static tests of the Motor Bus's braking system, along with my visual examination of the various mechanical components in the braking system, had indicated that there was no internal leakage of pressure/vacuum. Hence the braking system of the Motor Bus was likely to be in serviceable condition at the material time of accident.

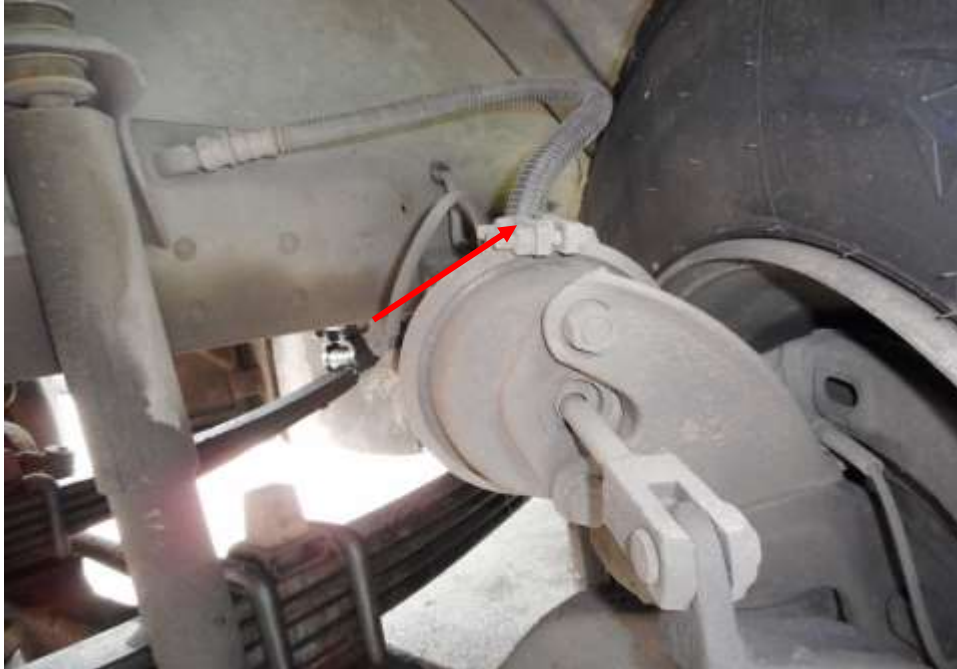
Photo 20 shows the brake pipe (arrowed) at the front left wheel of the Motor Bus. I did not observe any leakage of brake fluid at the time of my inspection of the Motor Bus. My static tests of the Motor Bus's braking system, along with my visual examination of the various mechanical components in the braking system had indicated that there was no internal leakage of pressure/vacuum. Hence the braking system of the Motor Bus was likely to be in serviceable condition at the material time of accident.

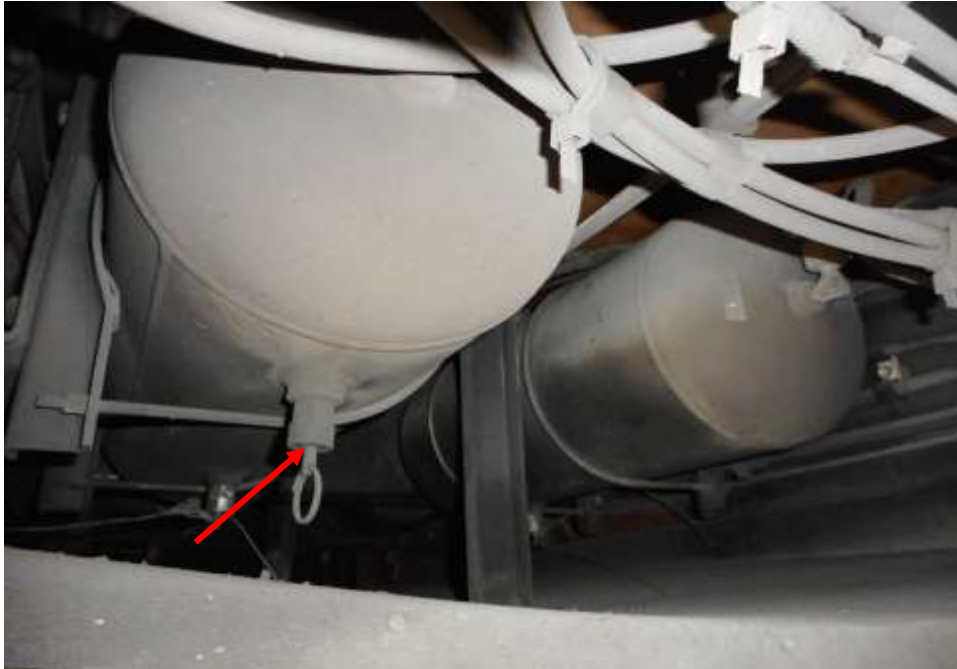
Photo 21 shows the air brake cylinder (arrowed) at the undercarriage of the Motor Bus. I did not observe any leakage of air brake fluid at the time of my inspection of the Motor Bus. My static tests of the Motor Bus's braking system, along with my visual examination of the various mechanical components in the braking system had indicated that there was no internal leakage of pressure/vacuum. Hence the braking system of the Motor Bus was likely to be in serviceable condition at the material time of accident.

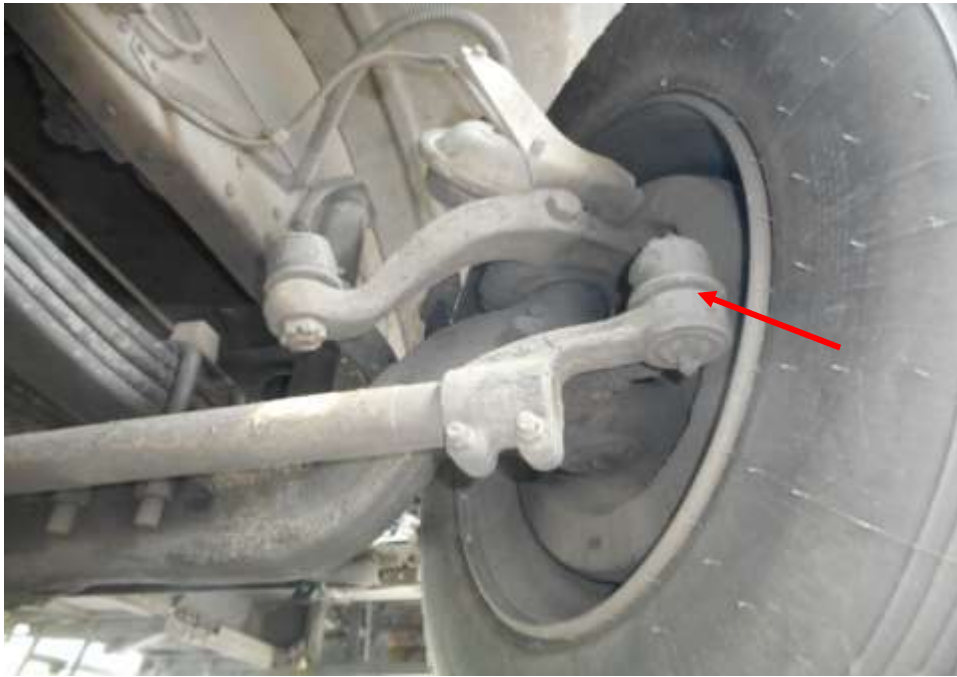
Photo 22 shows the various undercarriage components at the front right wheel of the Motor Bus, in particular the steering tie rod end (arrowed). The various steering components were all found to be intact, suggesting that the steering system of the Motor Bus was likely to be in serviceable condition at the material time of accident. There was also no sign of fluid stain(s) observed on the various undercarriage components.

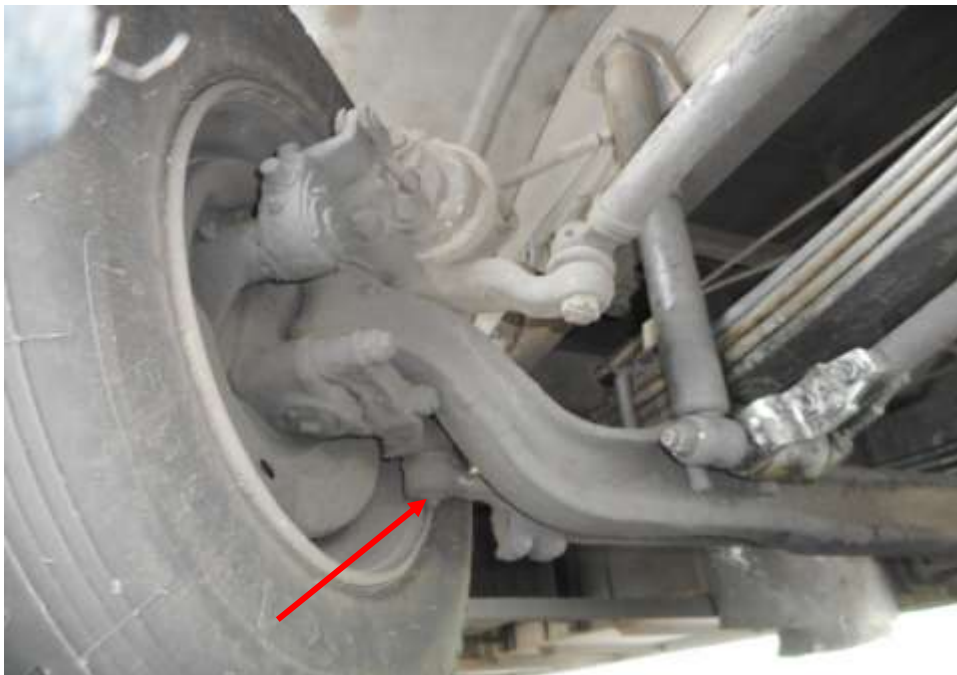
Photo 23 shows the various undercarriage components at the front left wheel of the Motor Bus, in particular the steering tie rod end (arrowed). The various undercarriage components of the Motor Bus were all found to be intact without any visible damage. There was also no sign of fluid stain(s) observed on the various undercarriage components.

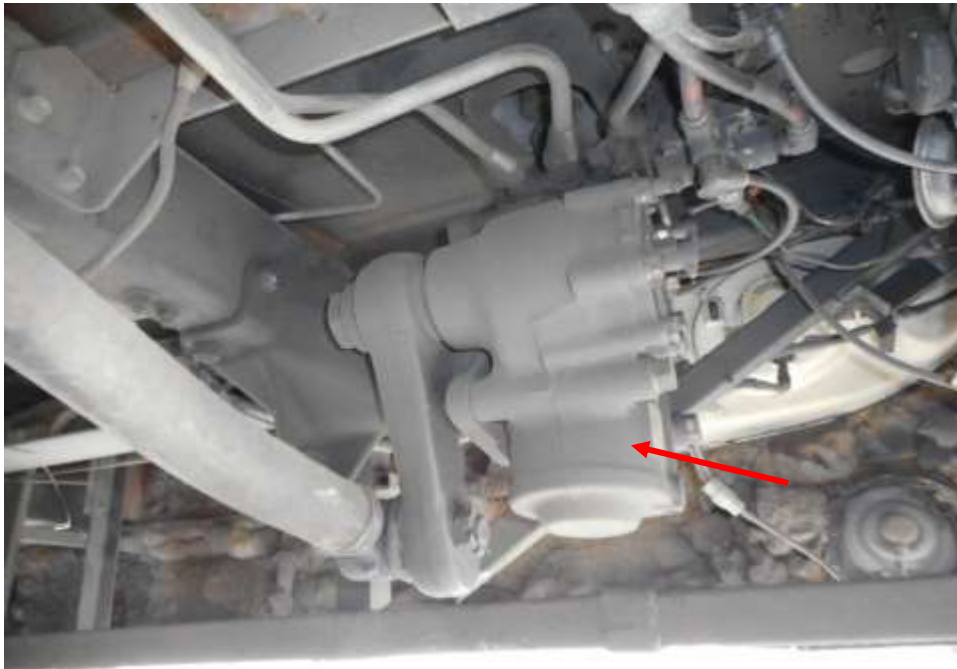
Photo 24 shows the steering box component (arrowed) at the undercarriage of the Motor Bus was found to be intact without any visible damage. There was also no sign of fluid stain(s) observed on the various undercarriage components.

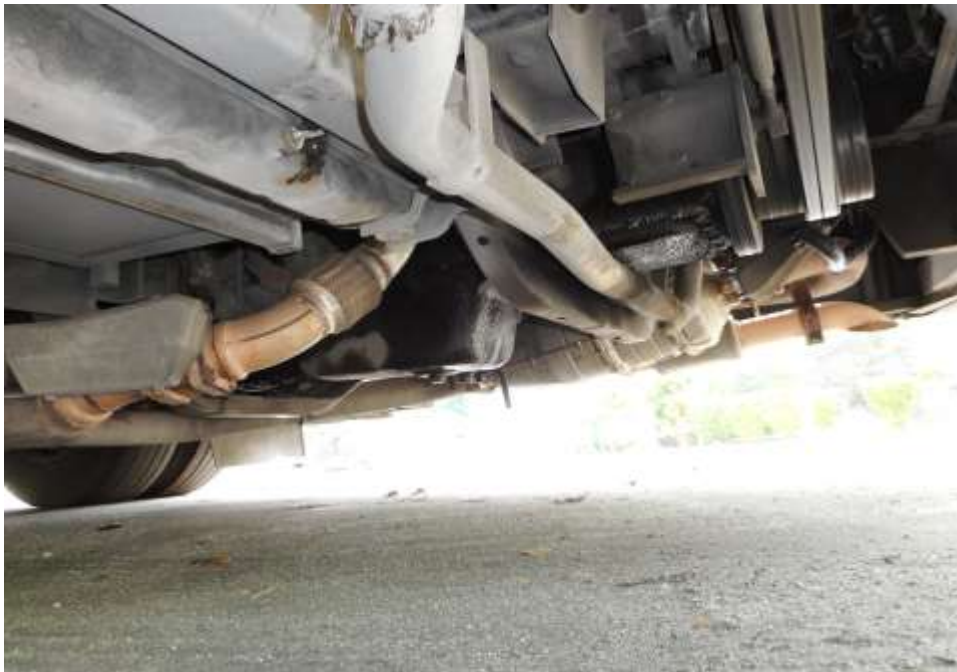
Photo 25 shows the undercarriage of the Motor Bus, at the area where the engine housing located. We observed minor fresh fluid stains on the surface of the engine oil sump. However the Motor Bus is still in serviceable condition.

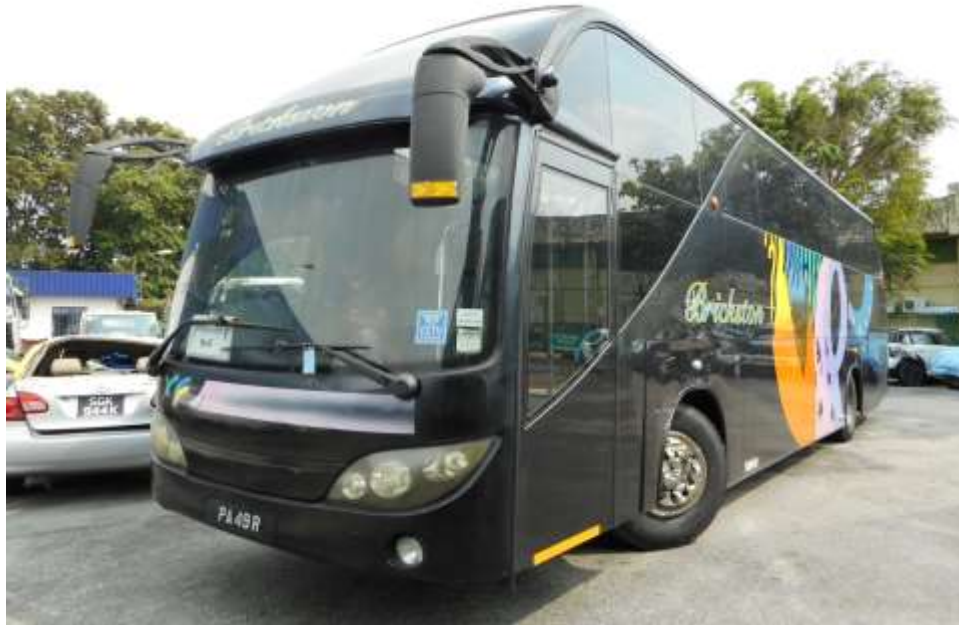
Photo 26 shows the front left wheel of the Motor Bus turned to its full right. During my steering system test, I did not experience any abnormal free play and/or resistance when I had turned the steering wheel towards full left and full right. This would suggest that the steering system of the Motor Bus was likely to be in serviceable condition at the material time of accident.
