Your Ref: TP/IP/13815/2019
Our Ref : CI/TPD19008275/P

Fatal Accident Investigation Team

MECHANICAL INSPECTION REPORT OF MOTOR LORRY YP 2064Y

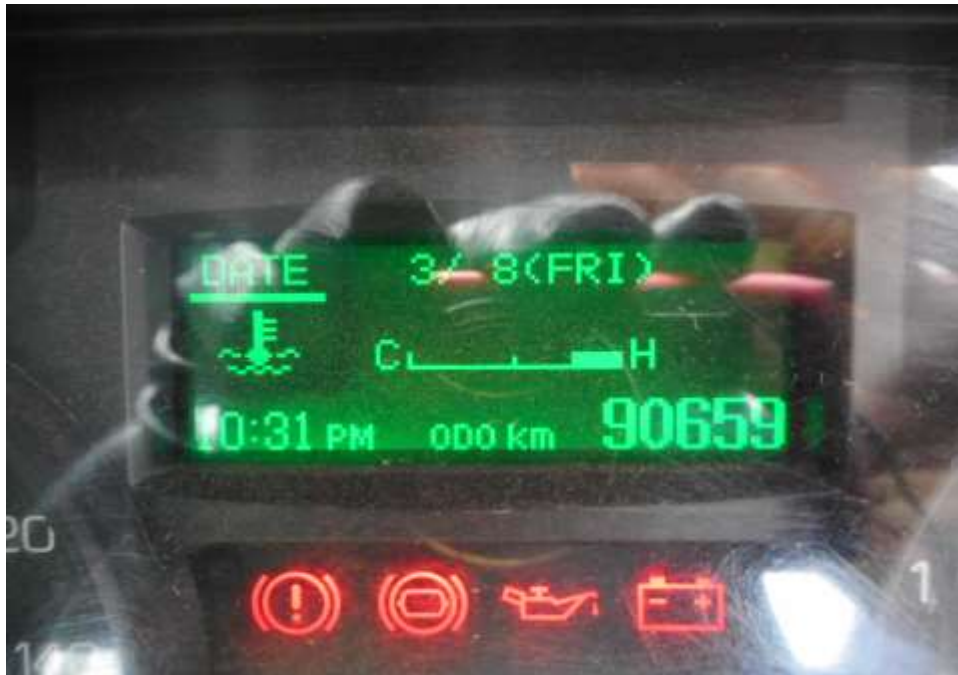
4. The mileage of the Motor Lorry at the time of my inspection was 90,659km.
5. The Motor Lorry appeared to have sustained moderate damage at its left portion. Its left cabin panel were damage at the time of my inspection.

Photo 1 shows a general view of the instrument cluster of the Motor Lorry at the time of my inspection. The mileage of the Motor Lorry was 90,659km

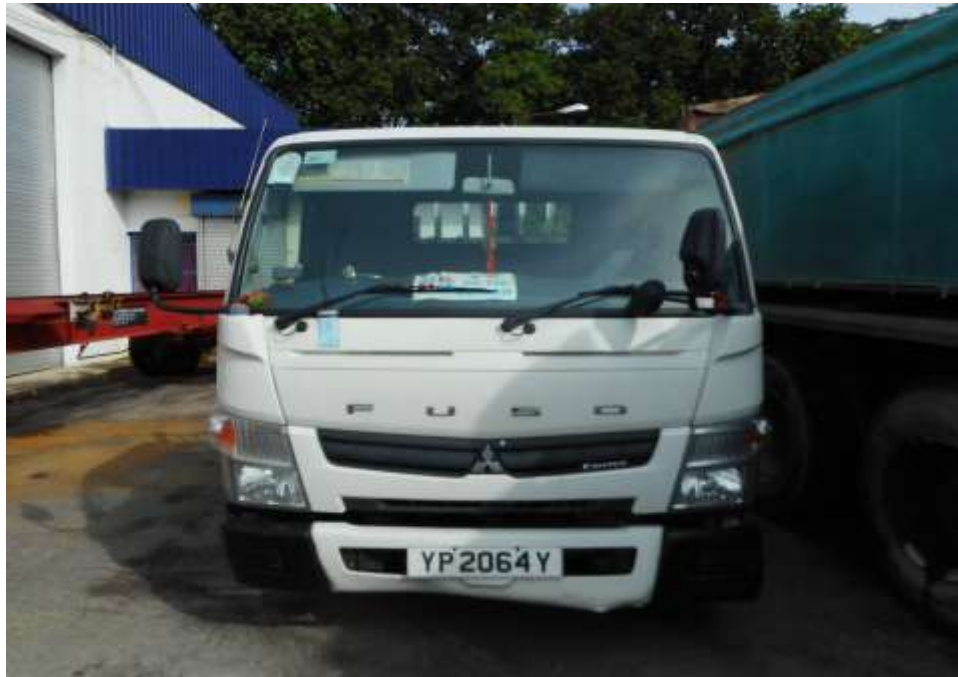
Photo 2 shows a general view of the Motor Lorry's frontal portion at the time of my inspection. There was moderate damage found at its left portion. Its left cabin panel were damage as a result of the accident.

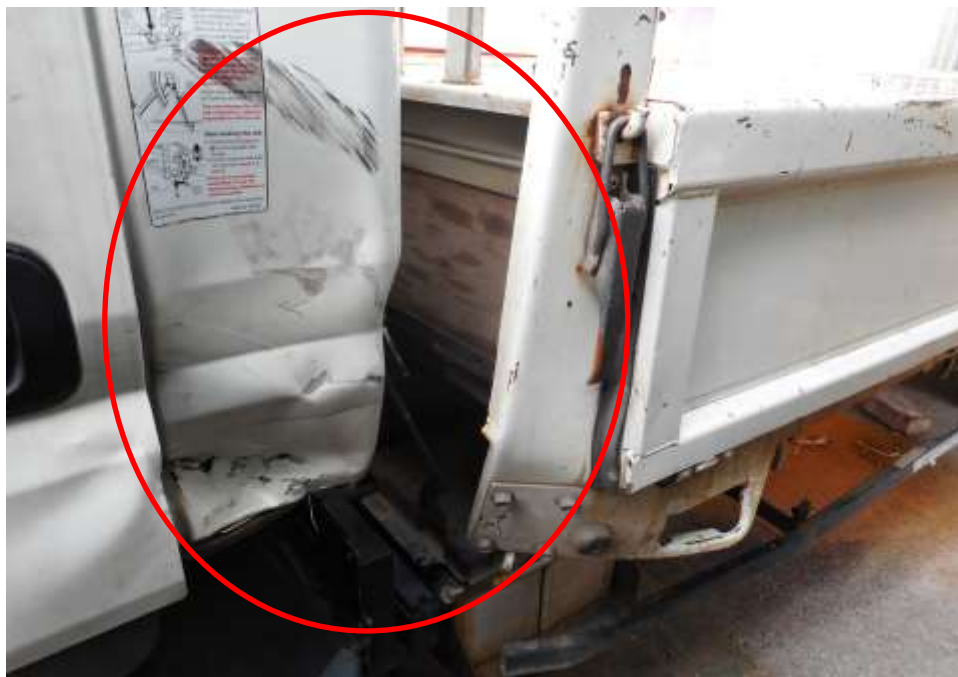
Photo 3 shows a close up view of the Motor Lorry's frontal portion at the time of my inspection. There was minor damage found to the front body panel of the Motor Lorry. Its left cabin panel (circled) were damage as a result of the accident.

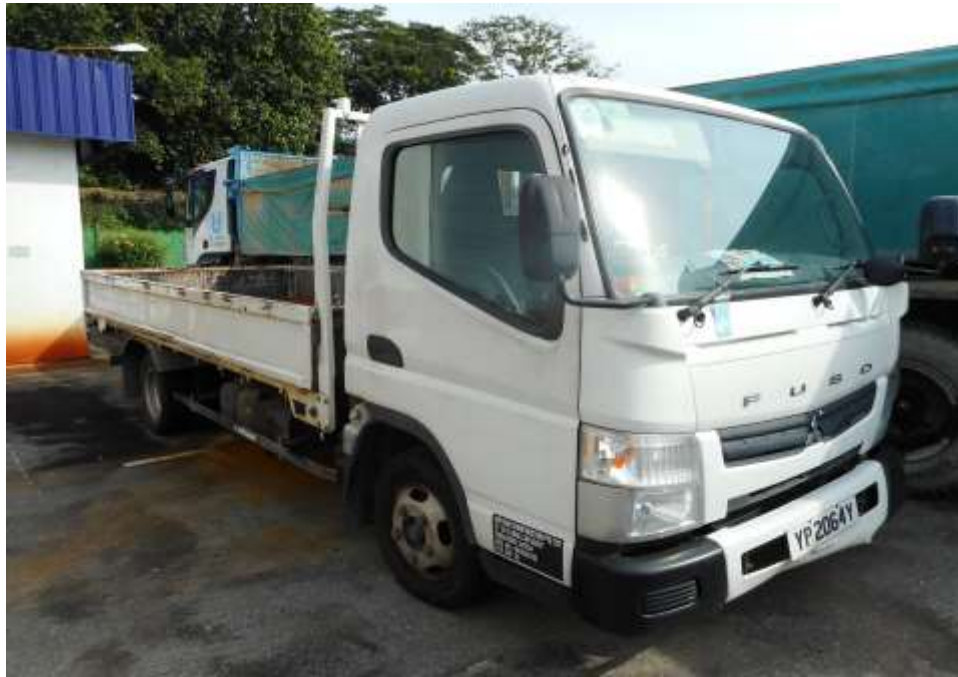
Photo 4 shows a general view of the front right body of the Motor Lorry at the time of my inspection. The Motor Lorry was observed to be intact and unaffected by the accident.

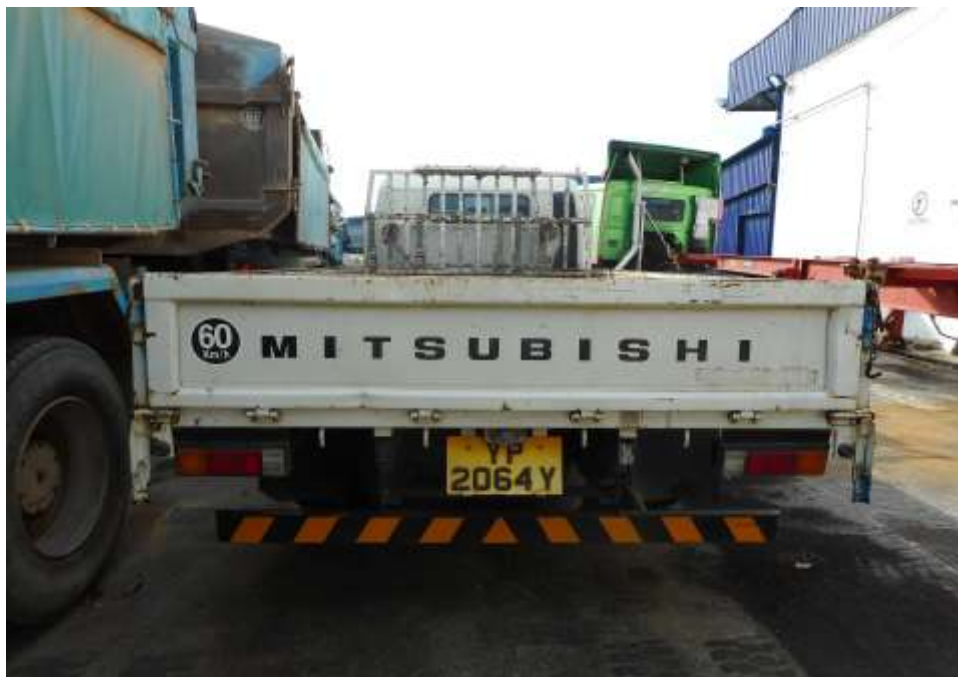
Photo 5 shows a general view of the rear body of the Motor Lorry at the time of my inspection. The Motor Lorry was observed to be intact and unaffected by the accident.

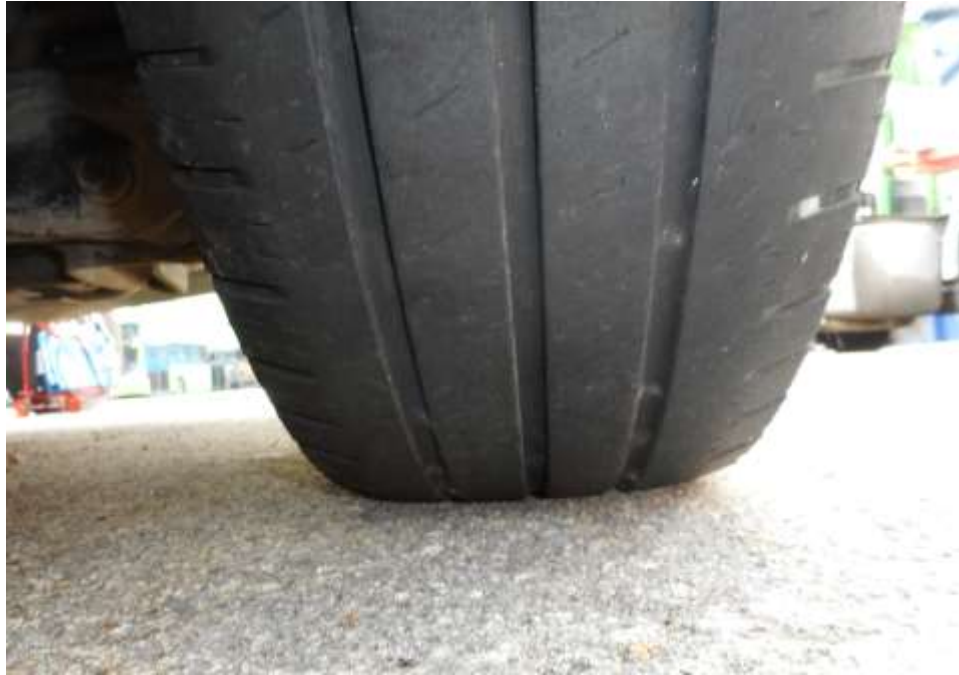
Photo 6 shows the condition of the front right tyre of the Motor Lorry, which was observed to be in serviceable condition with remaining tread depth of approximately 4mm. The tyre, which was wrapped around standard steel wheel rim, was also observed to be sufficiently inflated for vehicular operation. There was no tear, cut or burst mark(s) on the outer and the inner sidewalls as well as across the tread of the 6 tyres that were fitted on the Motor Lorry.

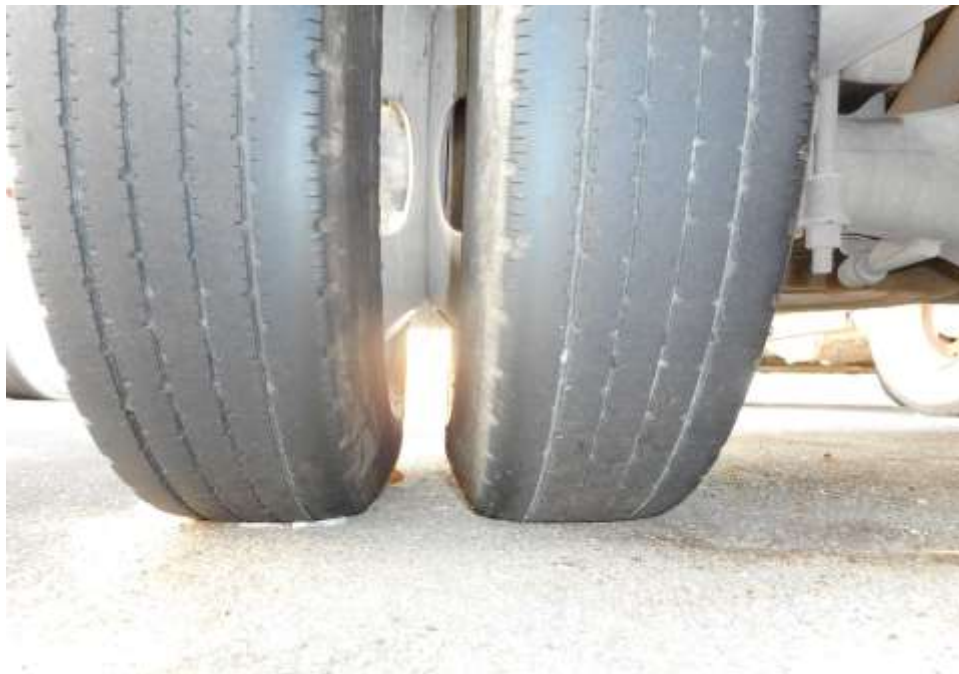
Photo 7 shows the condition of the rear right tyre of the Motor Lorry, which was observed to be in serviceable condition with remaining tread depth of approximately 3mm. The tyre, which was wrapped around standard steel wheel rim, was also observed to be sufficiently inflated for vehicular operation.

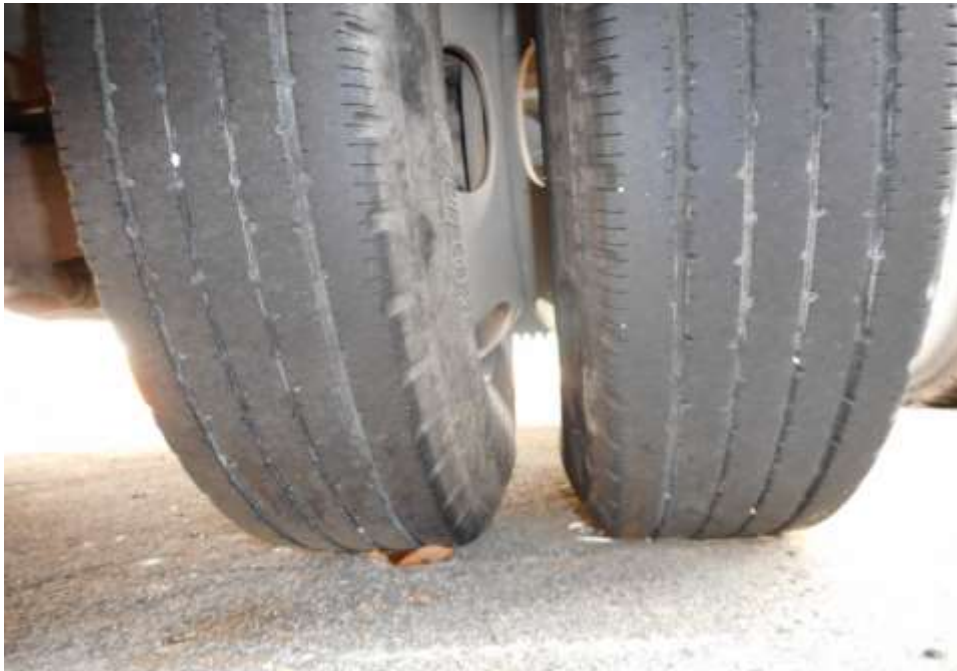
Photo 8 shows the condition of the rear left tyres of the Motor Lorry, which was observed to be in serviceable condition with remaining tread depth of approximately 3.5mm. The tyres, which were wrapped around standard steel wheel rim, were also observed to be sufficiently inflated for vehicular operation. There was also no damage found on all 6 steel wheel rims of the Motor Lorry.

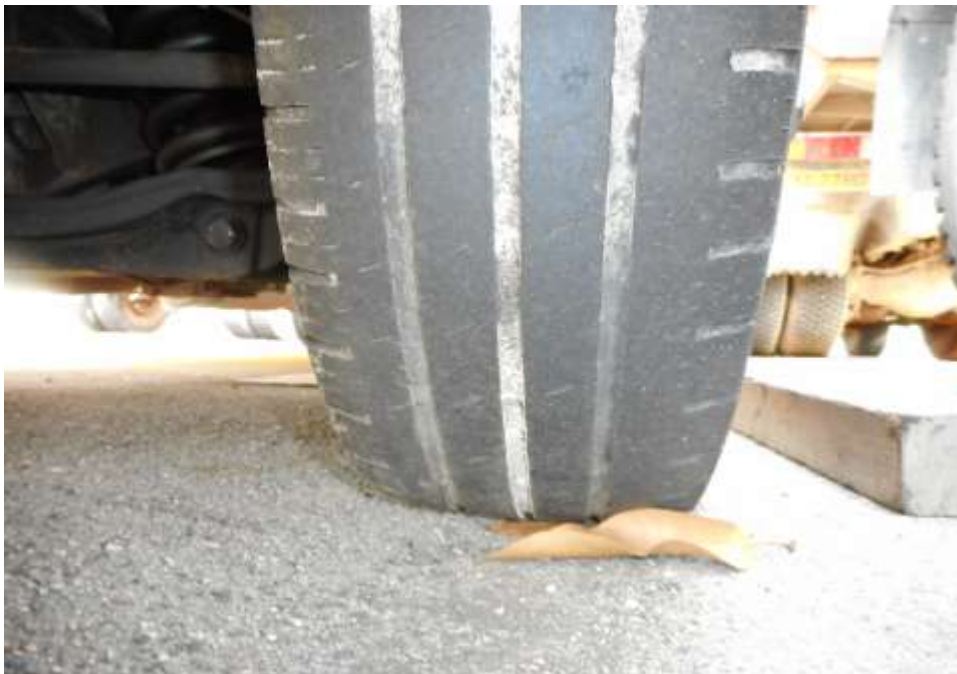
Photo 9 shows the condition of the rear right tyres of the Motor Lorry, which were observed to be in serviceable condition with remaining, tread depth of approximately 3.8mm. There was also no tear, cut or burst mark(s) on the outer and the inner sidewalls as well as across the tread of the 6 tyres that were fitted on the Motor Lorry.

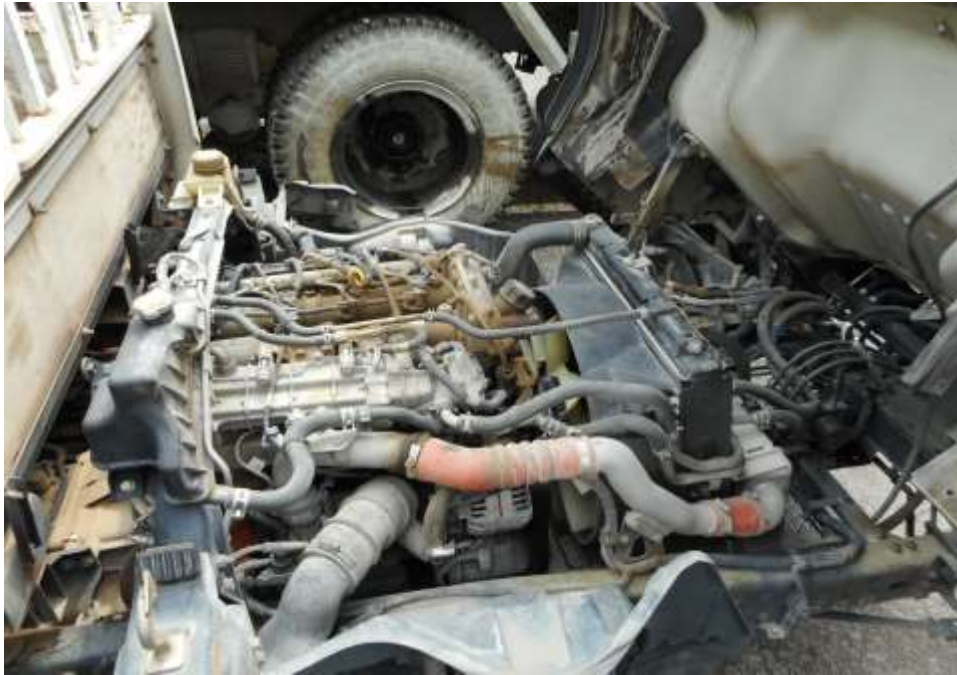
Photo 10 shows a general view of the Motor Lorry's engine compartment, which was accessed by lifting the front cabin of the Motor Lorry. The various parts and components inside the engine compartment were unaffected by the accident. There was also no sign(s) or indication(s) of fresh fluid leakage and/or fluid stain within the engine compartment (photograph shows the engine compartment as viewed from the right front side of the Motor Lorry).

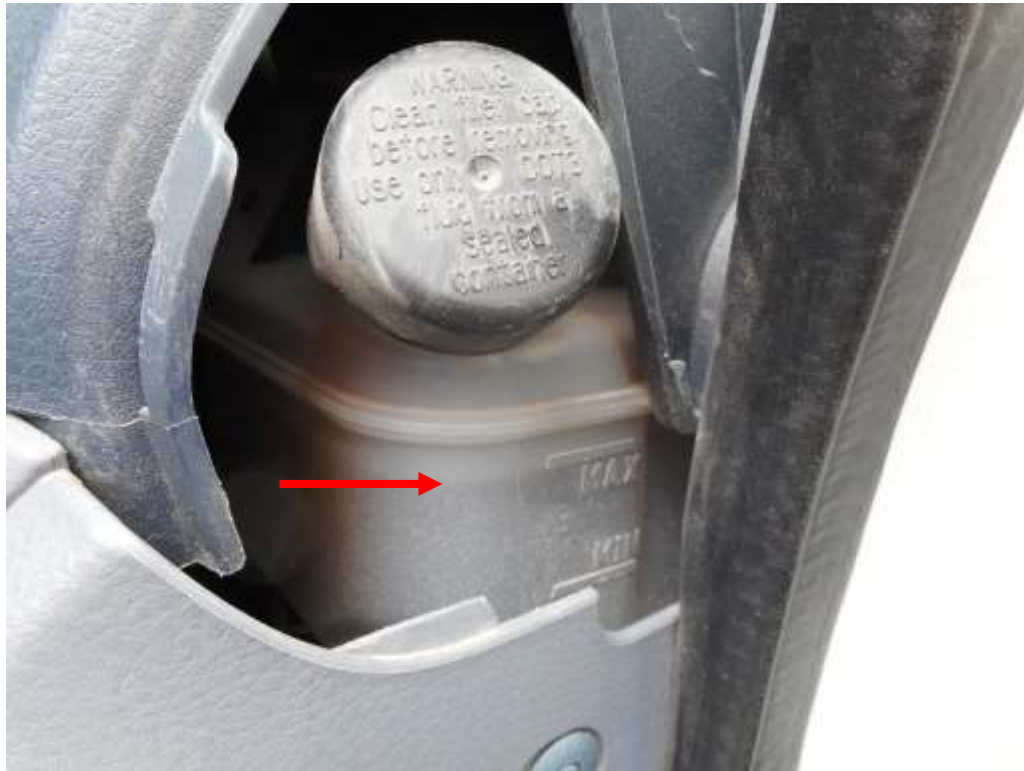
Photo 11 shows the brake fluid reservoir of the Motor Lorry at the time of my inspection. The brake fluid was observed to be of sufficient level (arrowed) and without any visible contamination.

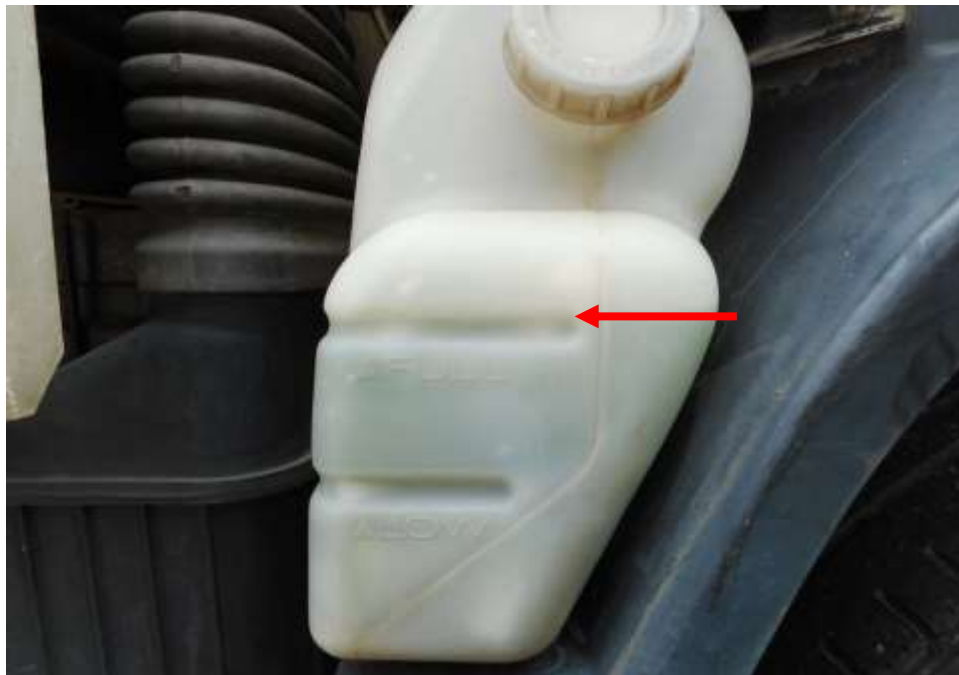
Photo 12 shows the engine coolant reservoir of the Motor Lorry at the time of my inspection. The engine coolant was observed to be of sufficient level (arrowed) and without any visible contamination.

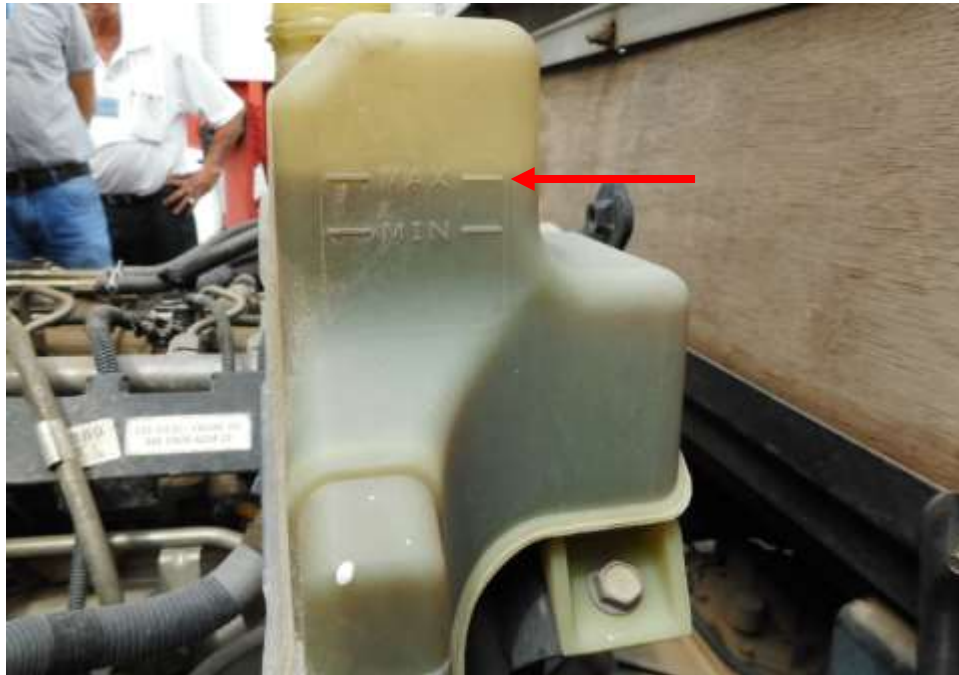
Photo 13 shows the power steering fluid reservoir of the Motor Lorry at the time of my inspection. The power steering fluid was observed to be of sufficient level (arrowed) and without any visible contamination.

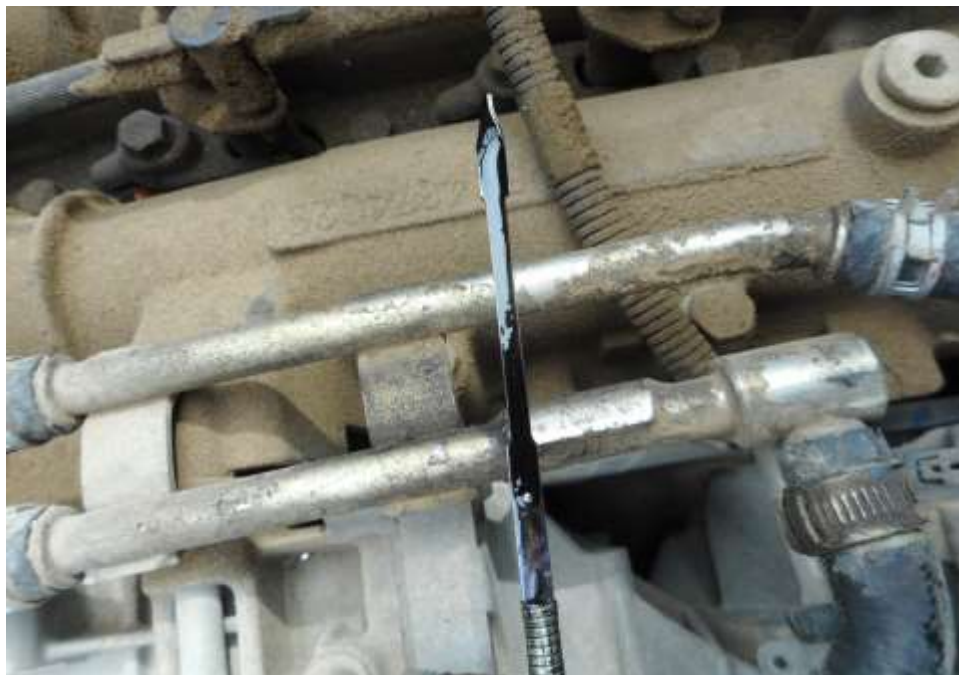
Photo 14 shows the engine dip stick of the Motor Lorry at the time of my inspection. The engine oil was observed to be of sufficient level and without any visible contamination.

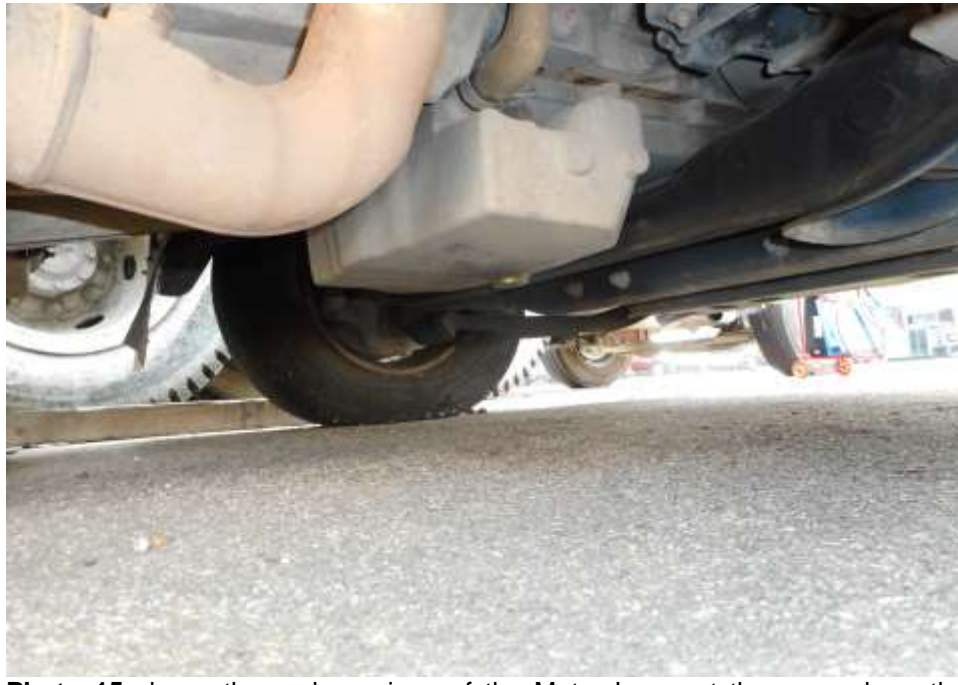
Photo 15 shows the undercarriage of the Motor Lorry, at the area where the engine housing and transmission housing are located. I did not find any sign(s) or indication(s) of fluid leak and/or fluid stain(s) on the underside of the Motor Lorry.

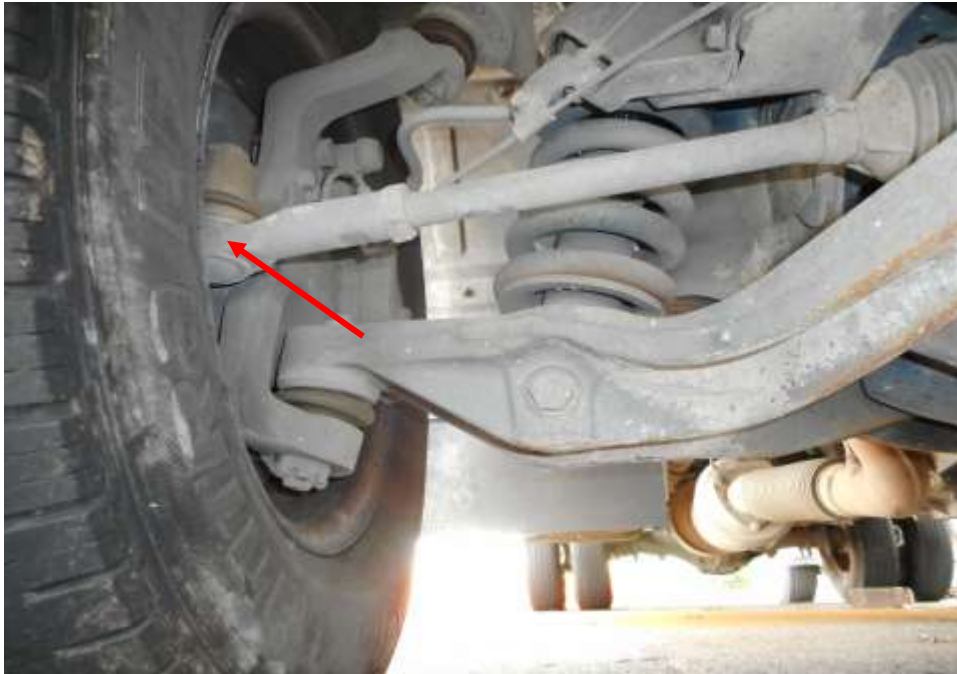
Photo 16 shows the various undercarriage components at the front right wheel of the Motor Lorry, in particular the steering tie rod end (arrowed). The various steering components were all found to be intact, suggesting that the steering system of the Motor Lorry was likely to be in serviceable condition at the material time of accident. There was also no sign of fluid stain(s) observed on the various undercarriage components.

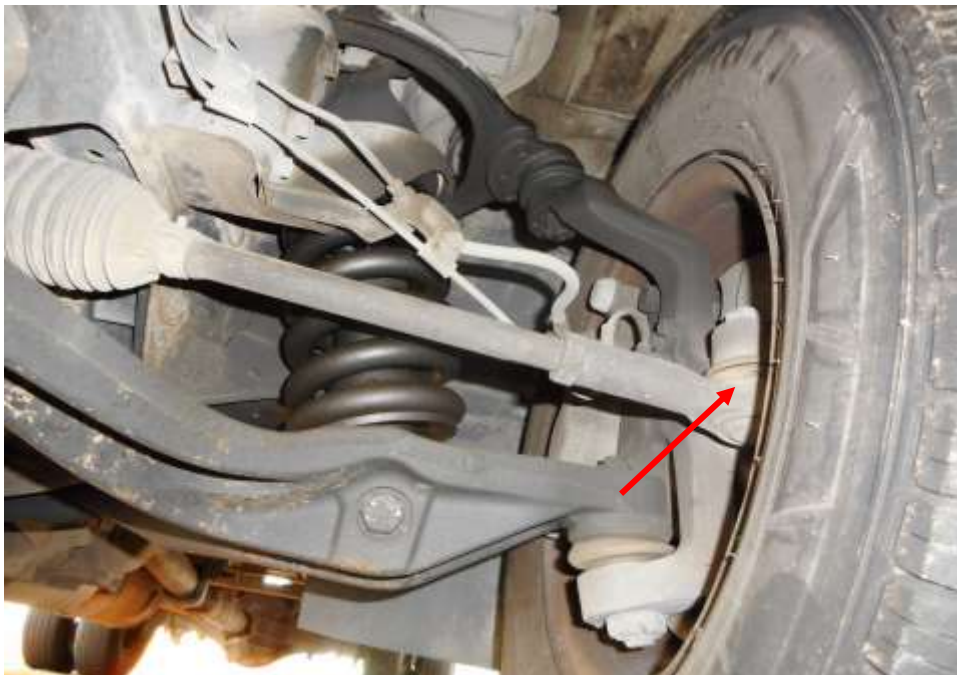
Photo 17 shows the various undercarriage components at the front left wheel of the Motor Lorry, in particular the steering tie rod end (arrowed). The various Undercarriage components of the Motor Lorry were all found to be intact without any visible damage. There was also no sign of fluid stain(s) observed on the various undercarriage components.

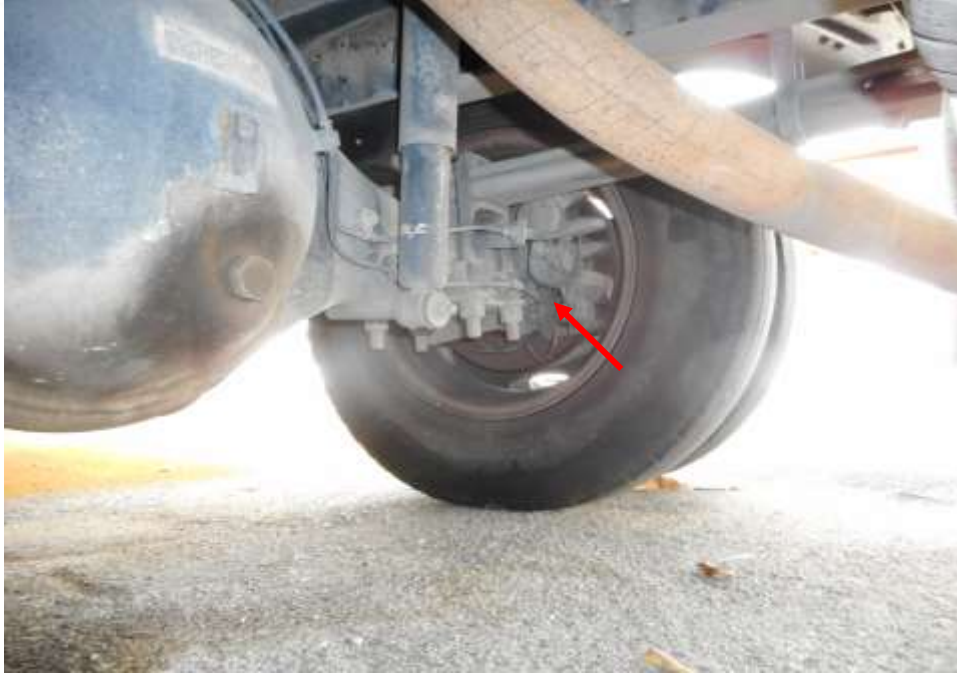
Photo 18 shows the brake pipe (arrowed) at the rear right wheel of the Motor Lorry. I did not observe any leakage of brake fluid at the time of my inspection of the Motor Lorry. My static tests of the Motor Lorry's braking system, along with my visual examination of the various mechanical components in the braking system, had indicated that there was no internal leakage of pressure/vacuum. Hence the braking system of the Motor Lorry was likely to be in serviceable condition at the material time of accident.

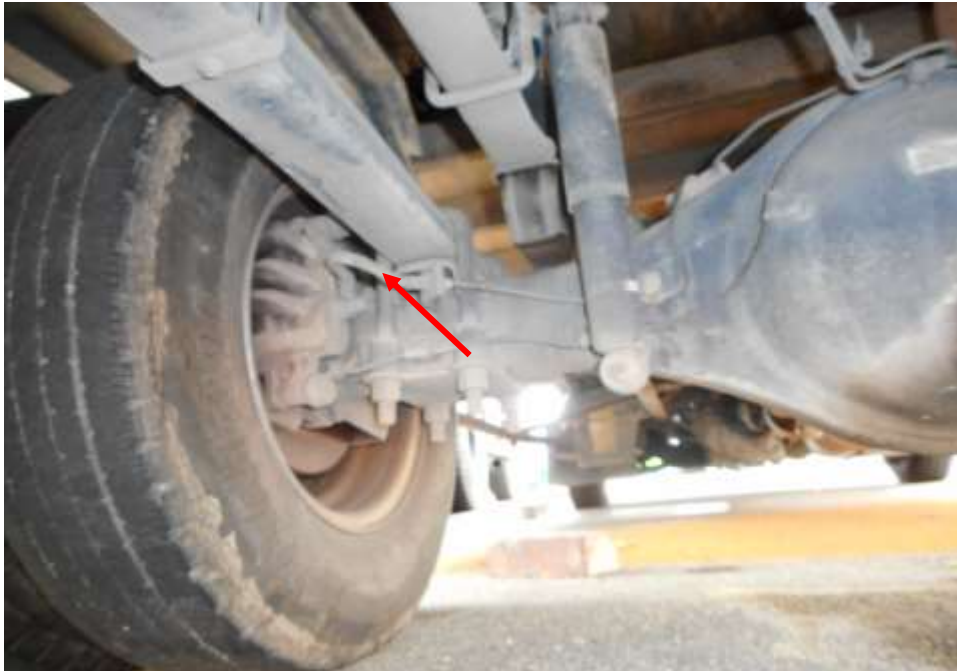
Photo 19 shows the brake pipe (arrowed) at the rear left wheel of the Motor Lorry. I did not observe any leakage of brake fluid at the time of my inspection of the Motor Lorry. My static tests of the Motor Lorry's braking system, along with my visual examination of the various mechanical components in the braking System had indicated that there was no internal leakage of pressure/vacuum. Hence the braking system of the Motor Lorry was likely to be in serviceable condition at the material time of accident.

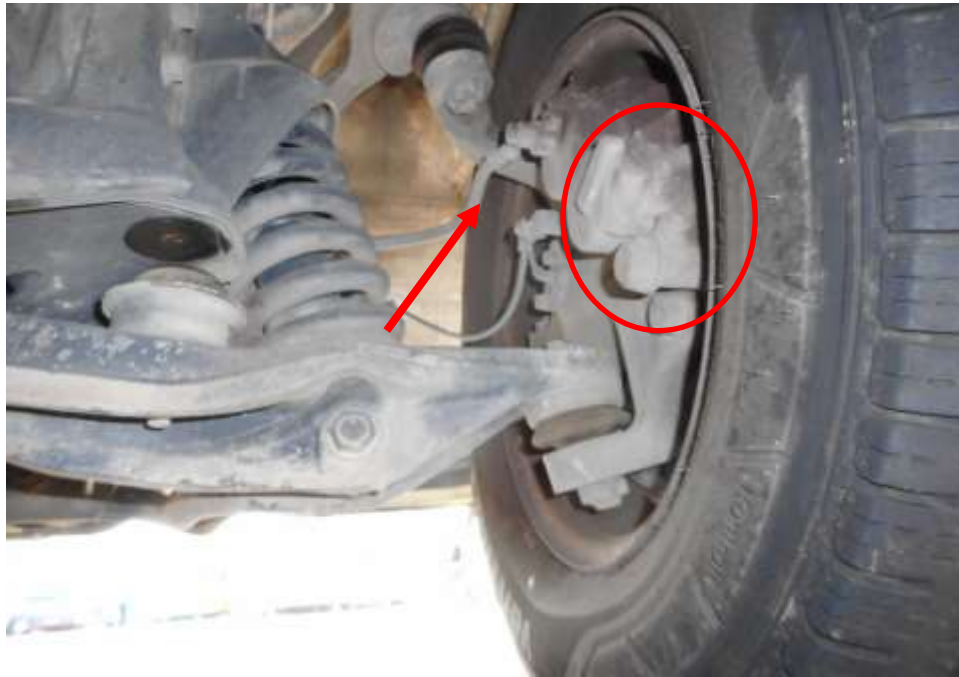
Photo 20 shows the brake hose/pipe (arrowed) at the front right wheel of the Motor Lorry. No leakage of brake fluid was observed. Visual examination of the various components of the braking system like the brake caliper (circled), brake booster, brake pedal etc had revealed all to be intact and without visible damage at the time of accident. There was also no sign of fluid stain(s) observed on the various undercarriage components.

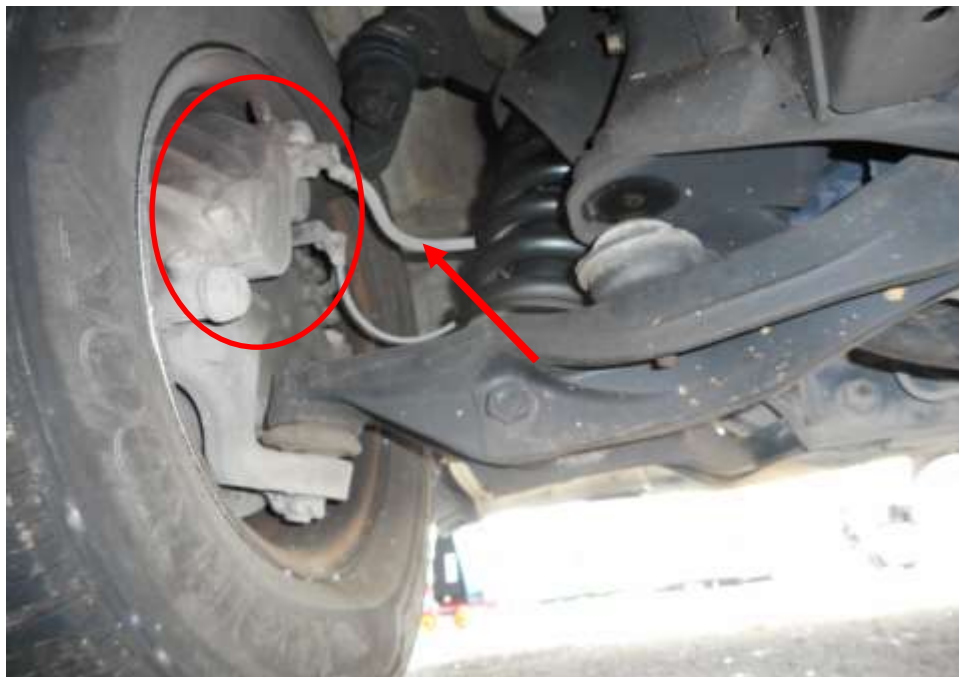
Photo 21 shows the brake hose/pipe (arrowed) at the front left wheel of the Motor Lorry. No leakage of brake fluid was observed. Visual examination of the various components of the braking system like the brake caliper (circled), brake booster, brake pedal etc had revealed all to be intact and without visible damage at the time of accident. There was also no sign of fluid stain(s) observed on the various undercarriage components.

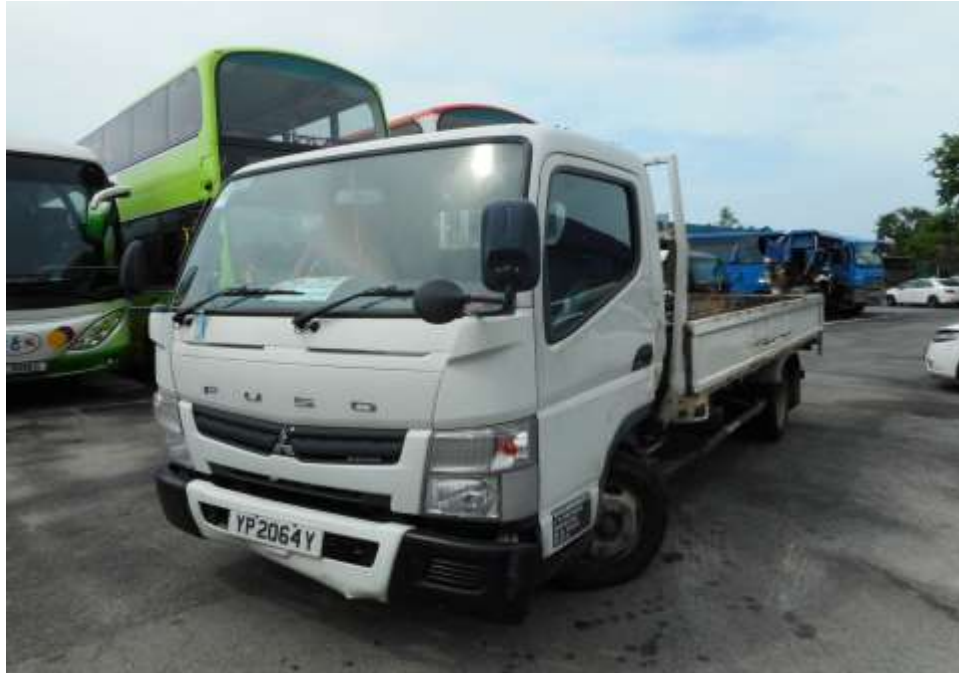
Photo 22 shows the front left wheel of the Motor Lorry turned to its full right. During my steering system test, I did not experience any abnormal free play and/or resistance when I had turned the steering wheel towards full left and full right. This would suggest that the steering system of the Motor Lorry was likely to be in serviceable condition at the material time of accident.

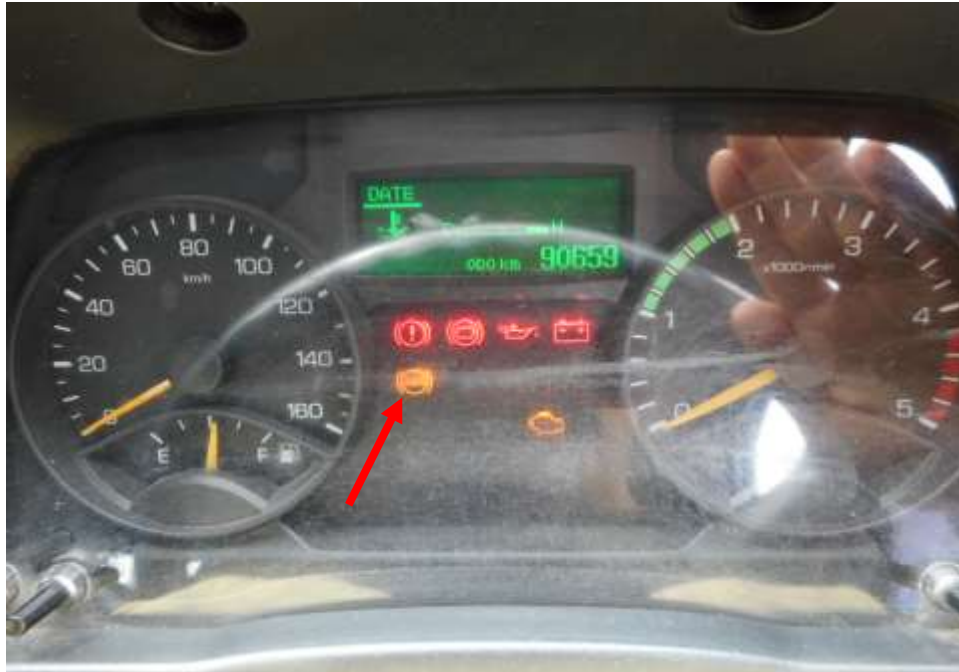
Photo 23 shows the warning light for Anti-Lock Brake System (ABS) (arrowed) appearing on the instrument panel of the Motor Lorry during the self-test of its various electronic operating systems when its engine was cranked.

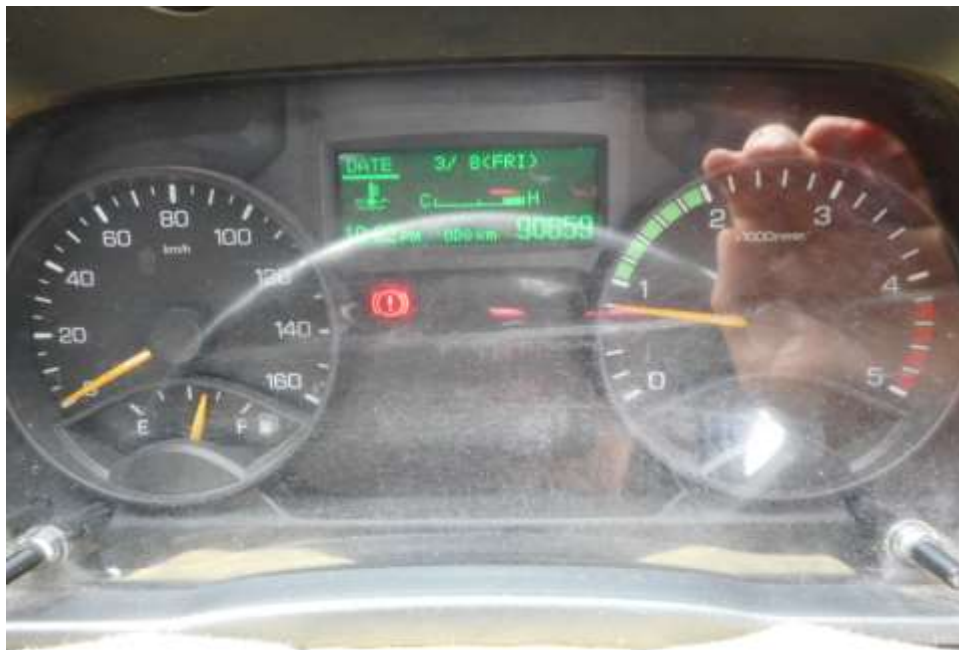
Photo 24 shows no warning lights illuminated on the instrument panel of the Motor Lorry after the engine was cranked. This would suggest that there was no abnormality to the electronic operating system of the Motor Lorry, like the ABS.
