Your Ref: TP/IP/13815/2019
Our Ref : CI/TPD19008276/N

Fatal Accident Investigation Team

MECHANICAL INSPECTION REPORT OF MOTORCYCLE FBE 7418H

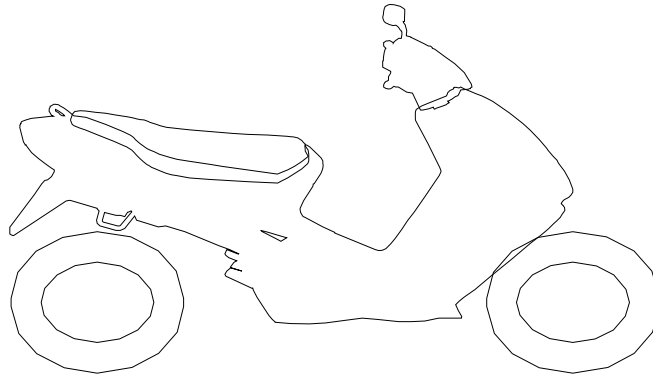
7. The tyre brand, tyre size and remaining tread depth of the 2 tyres of the Motorcycle were recorded as follows:-

Sime 2.50 R18 (3mm)

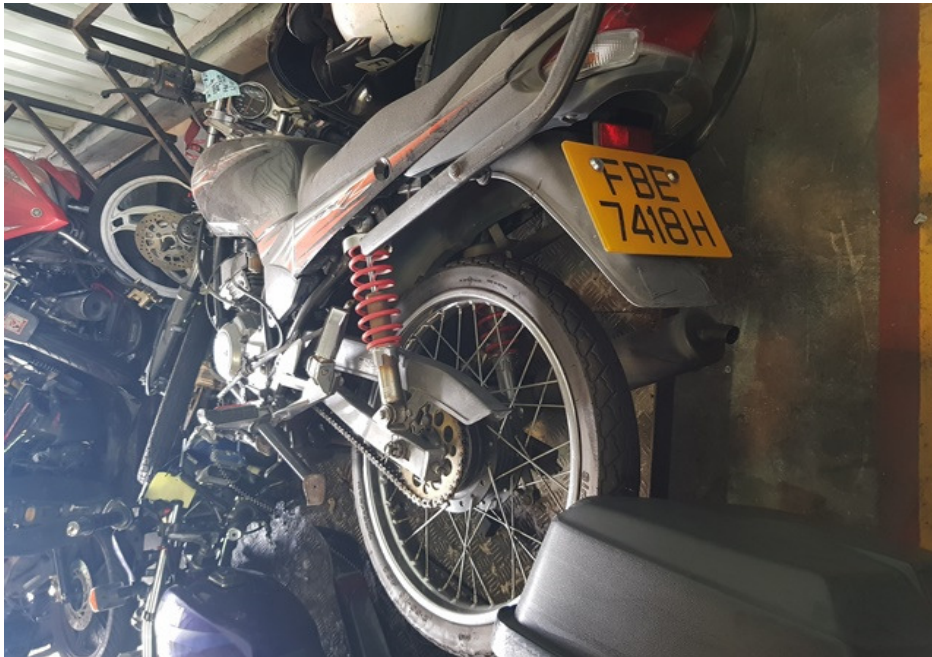
Photo 1 shows a general view of the rear body of the Motorcycle at the time of our inspection. The Motorcycle had sustained damages all around. The mileage of the Motorcycle at the time of our inspection was 72, 888km.

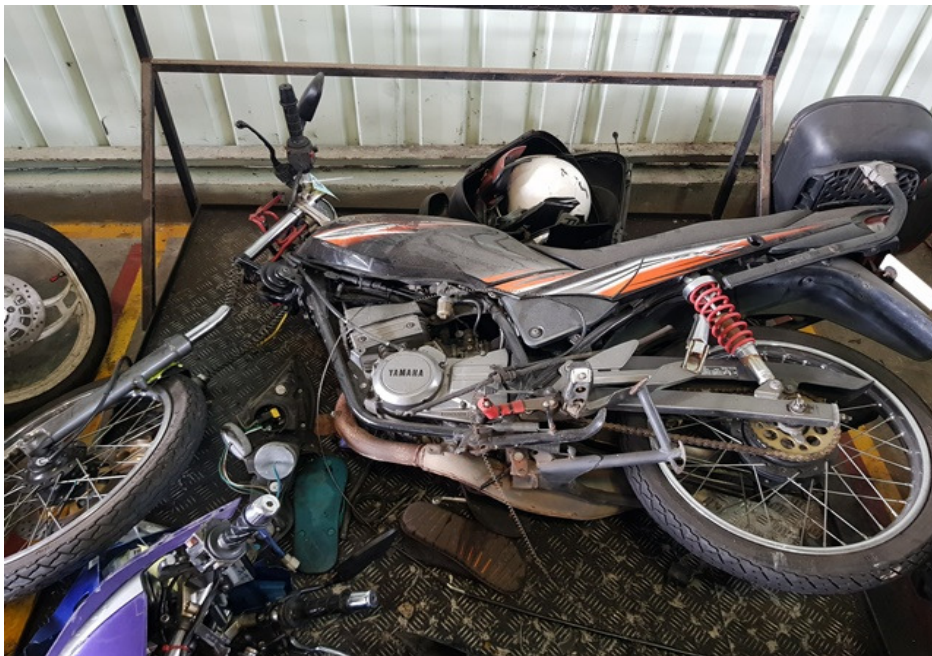
Photo 2 shows a general view of the left body of the Motorcycle at the time of our inspection. Body parts that were found to have been damaged include its headlamp assembly, front fork assembly, front wheel rim, side mirrors, clutch lever, front brake lever, fuel tank, exhaust muffler and rear side covers amongst others.

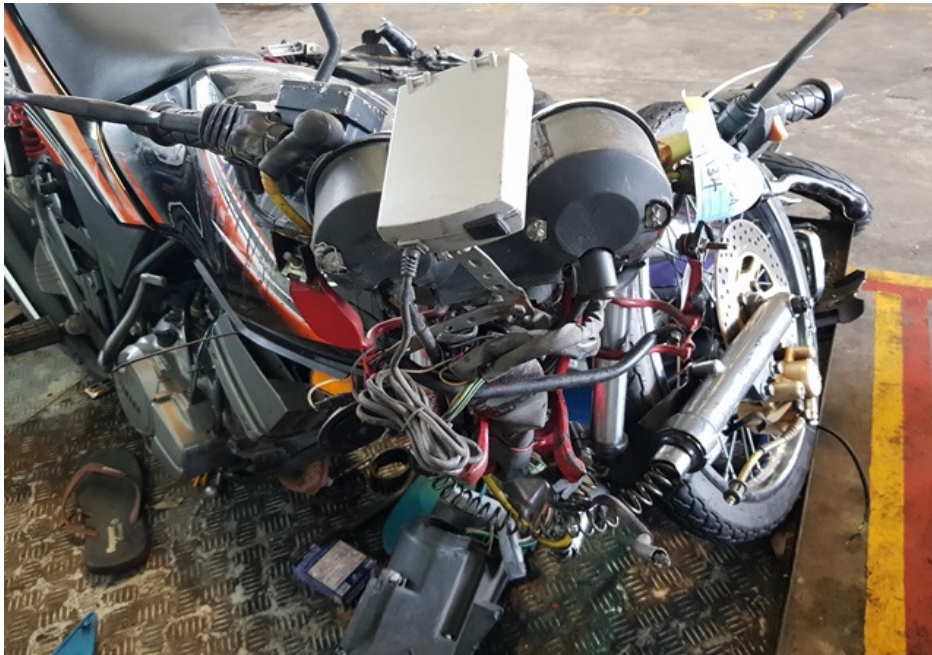
Photo 3 shows a general view of the front body of the Motorcycle at the time of our inspection. Body parts that were found to have been damaged include its headlamp assembly, fork assembly, speedometer gauge, side mirrors, clutch lever, front brake lever and petrol tank amongst others.

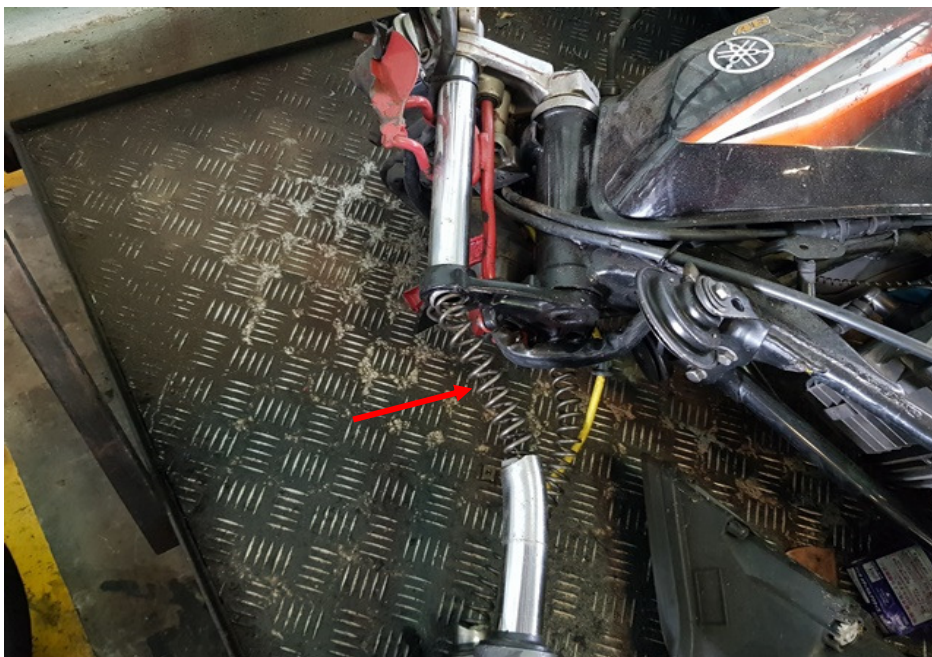
Photo 4 shows a closer view of the front fork assembly (arrowed) which was amongst the body parts at the front body of the Motorcycle that had sustained damage as a result of the accident.

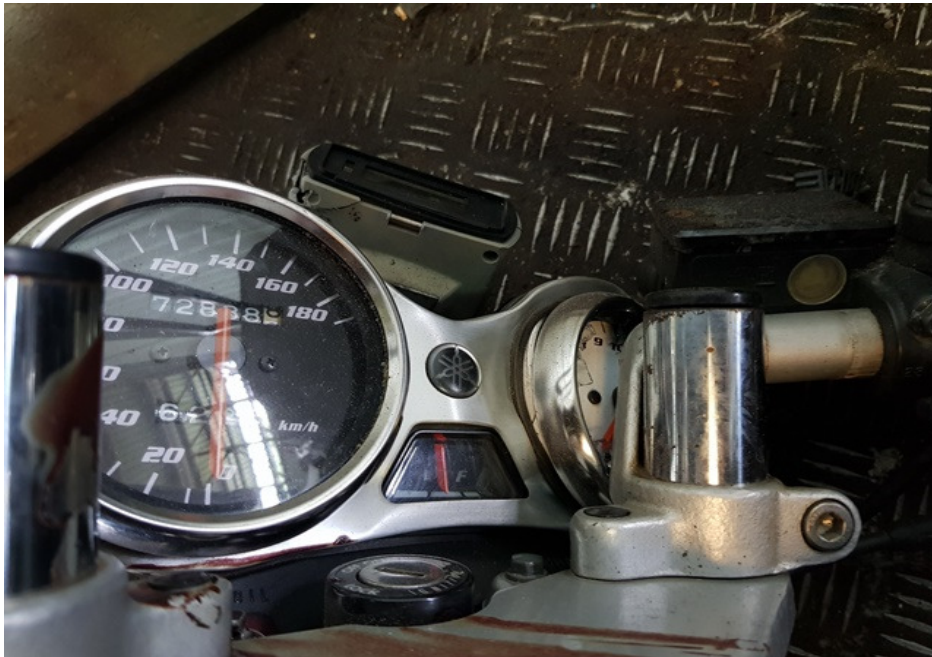
Photo 5 shows a closer view of the speedometer gauge which was amongst the body parts at the front body of the Motorcycle that had sustained damage as a result of the accident.

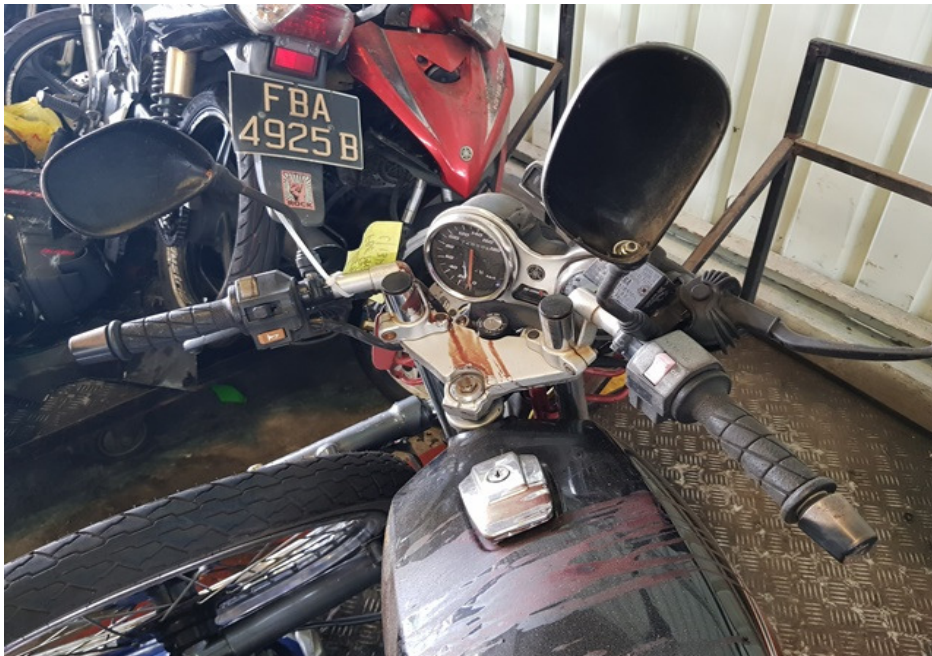
Photo 6 shows a closer view of the side mirrors, clutch lever, front brake lever, handlebars, handlebar grips and handlebar ends of the Motorcycle. These parts were amongst the body parts of the Motorcycle which were damaged as a result of the accident.

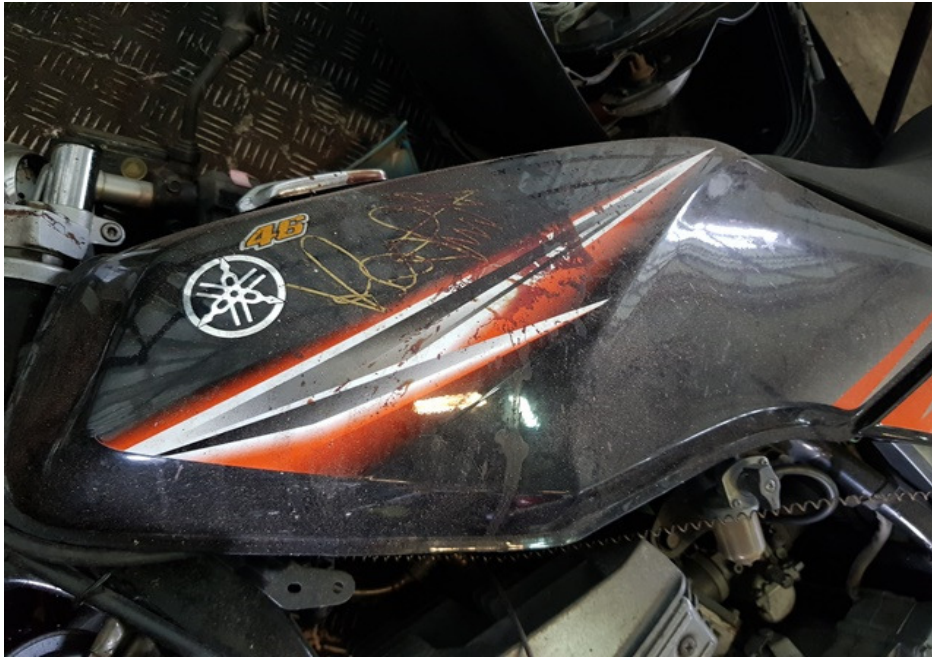
Photo 7 shows a closer view of the petrol tank, which was amongst the body parts of the Motorcycle that had sustained damage as a result of the accident.

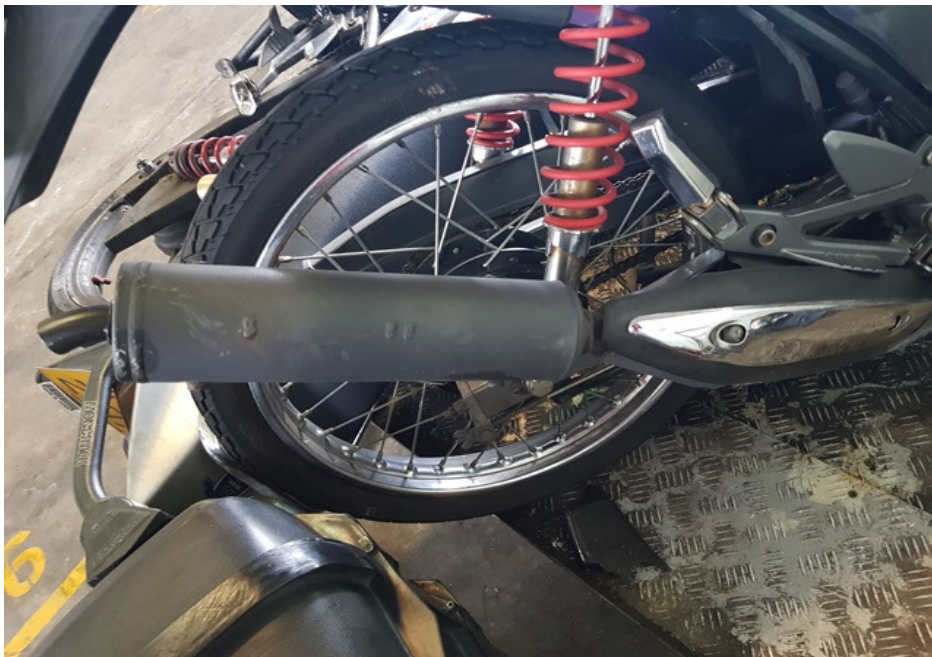
Photo 8 shows a closer view of the exhaust muffler, which was amongst the body parts of the Motorcycle that had sustained damage as a result of the accident.

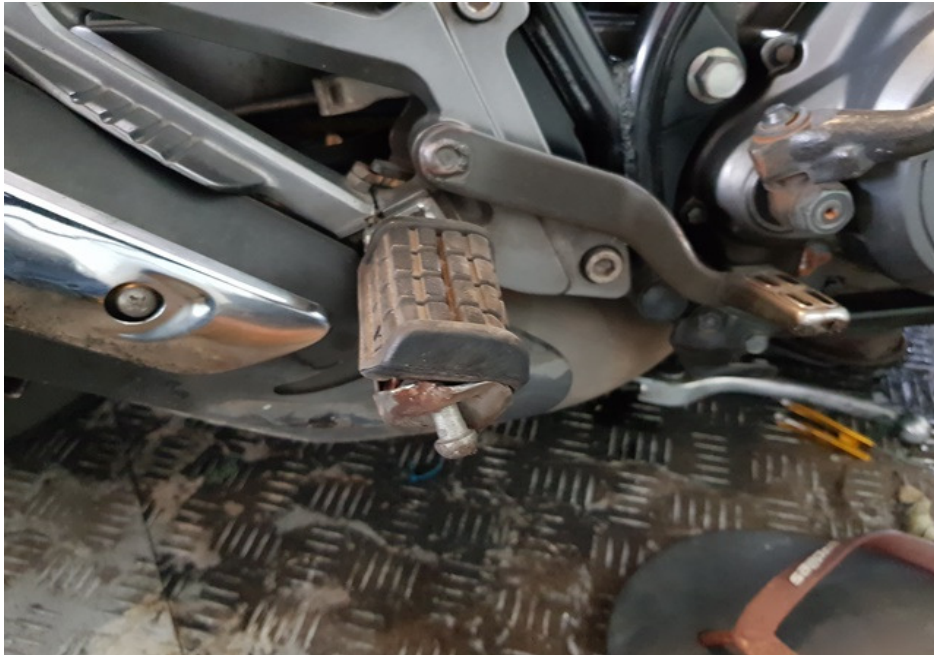
Photo 9 shows a closer view of the rear brake pedal, right front footrest and right front footrest bracket, which were amongst the body parts of the Motorcycle that had sustained damage as a result of the accident.

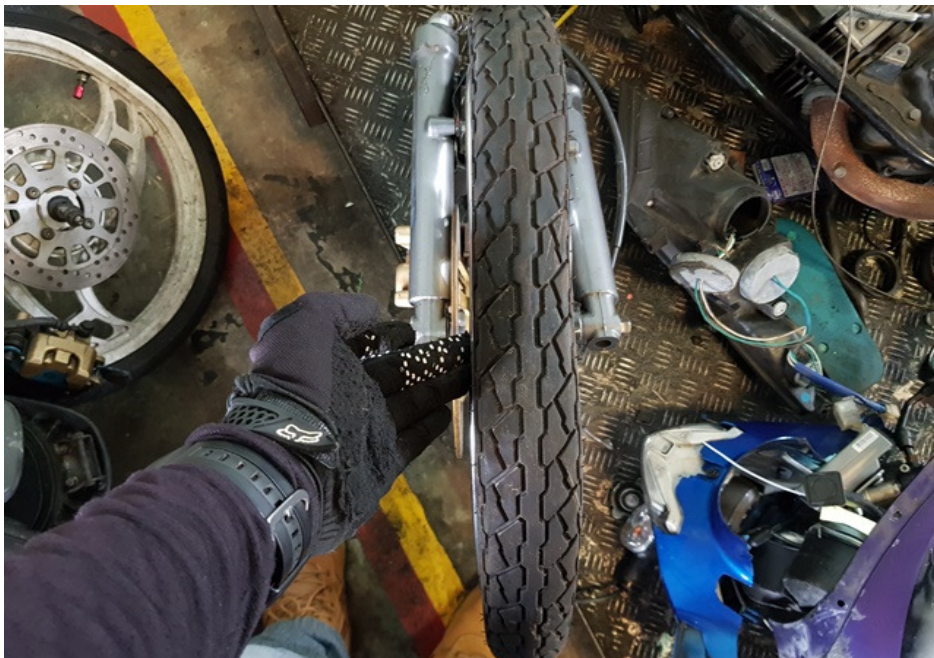
Photo 10 shows the condition of the Motorcycle's front tyre. The front tyre was observed to be in serviceable condition with remaining tread depth of approximately 3mm. The tyre was also observed to be sufficiently inflated for vehicular operation. We did not observe any tear, burst mark(s) and/or punctured hole(s) on the sidewalls as well as across the tread of the front tyre.

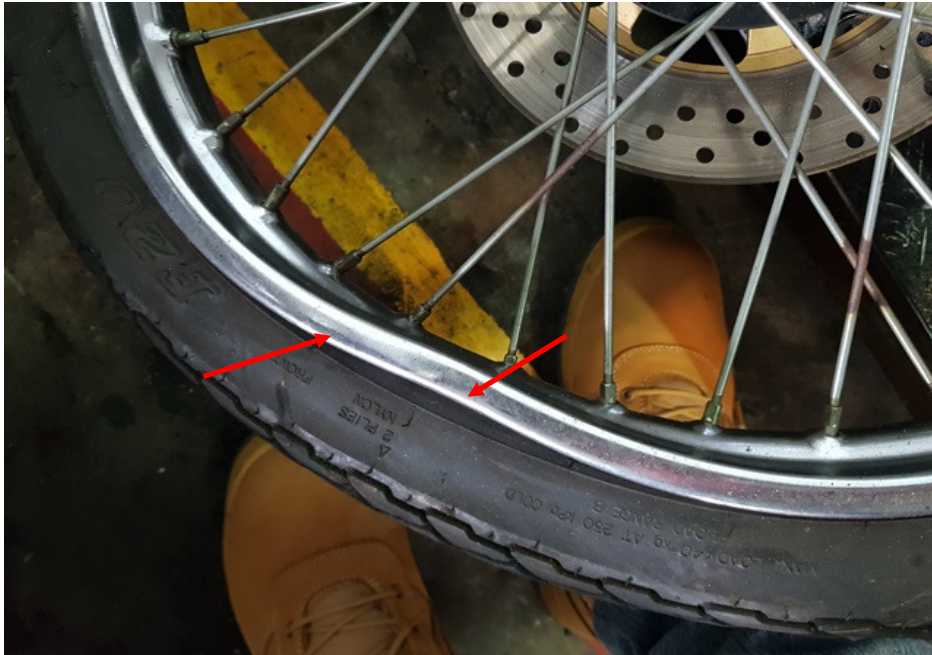
8. The 2 tyres were wrapped around alloy wheel rims. At the time of our inspection, we did not observe any visible damage on the rear wheel rim of the Motorcycle. However we did observe that the front wheel rim was bent. See photos 1 – 12 below.

Photo 11 shows the bent front wheel rim of the Motorcycle at the time of our inspection (arrowed).

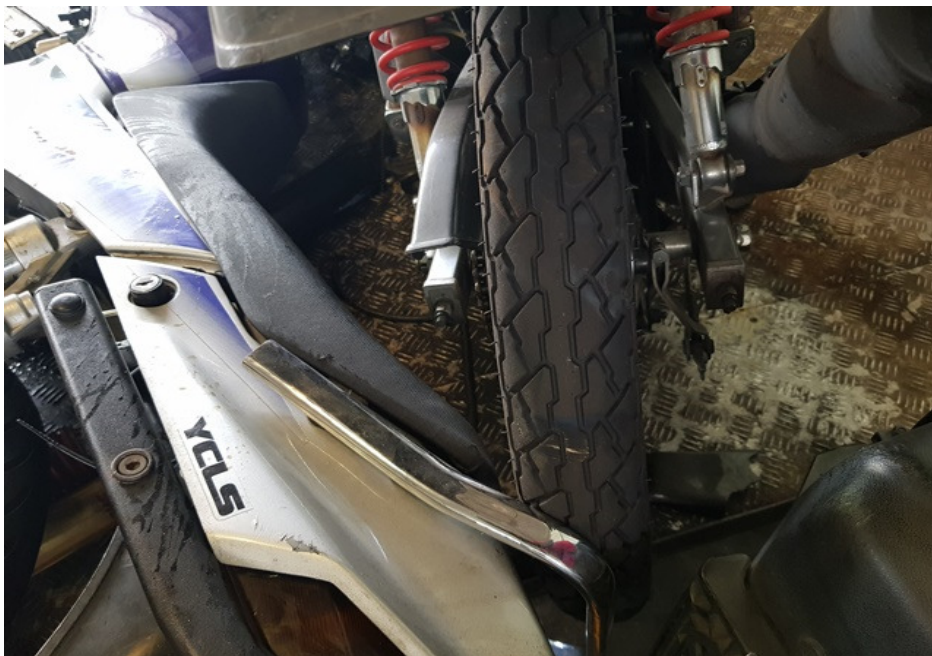
Photo 12 shows the condition of the Motorcycle's rear tyre. The rear tyre was observed to be in serviceable condition with remaining tread depth of approximately 3mm. The tyre was also observed to be sufficiently inflated for vehicular operation. We did not observe any tear, burst mark(s) and/or punctured hole(s) on the sidewalls as well as across the tread of the rear tyre.

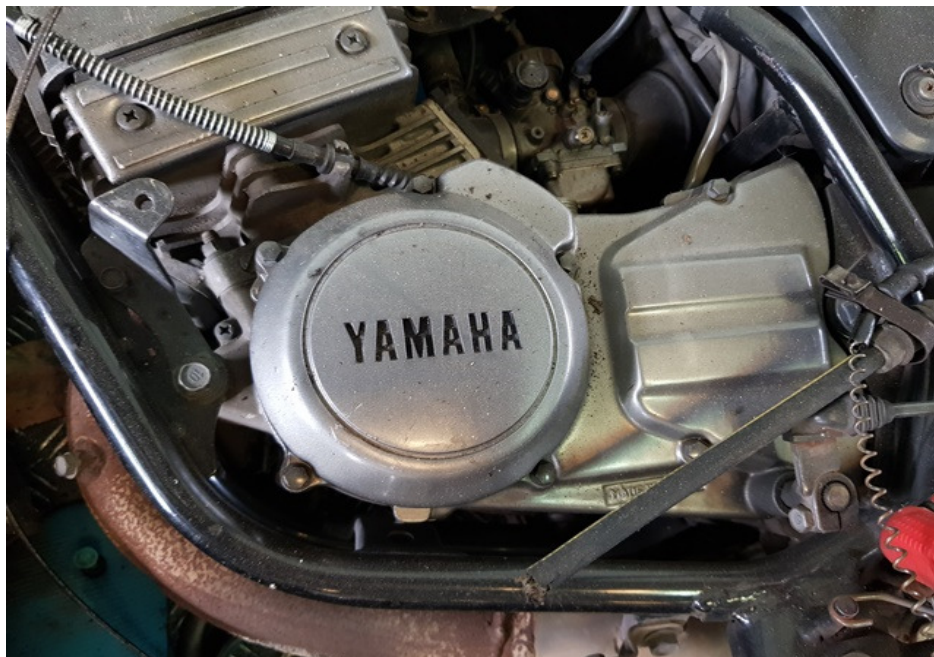
Photo 13 shows the left side of the engine of the Motorcycle at the time of our inspection. The various engine related parts and components were found to be intact with no visible damage. There was also no sign(s) or indication(s) of fluid leak observed around the left engine area of the Motorcycle.

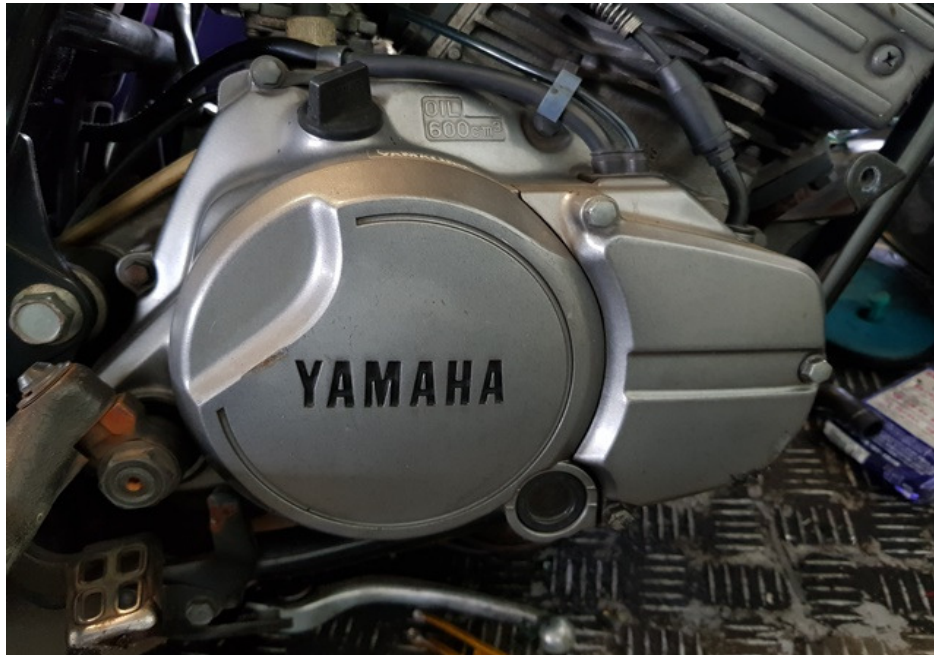
Photo 14 shows the right side of the engine of the Motorcycle at the time of our inspection. The various engine related parts and components were found to be intact with no visible damage. There was also no sign(s) or indication(s) of fluid leak observed around the right engine area of the Motorcycle.

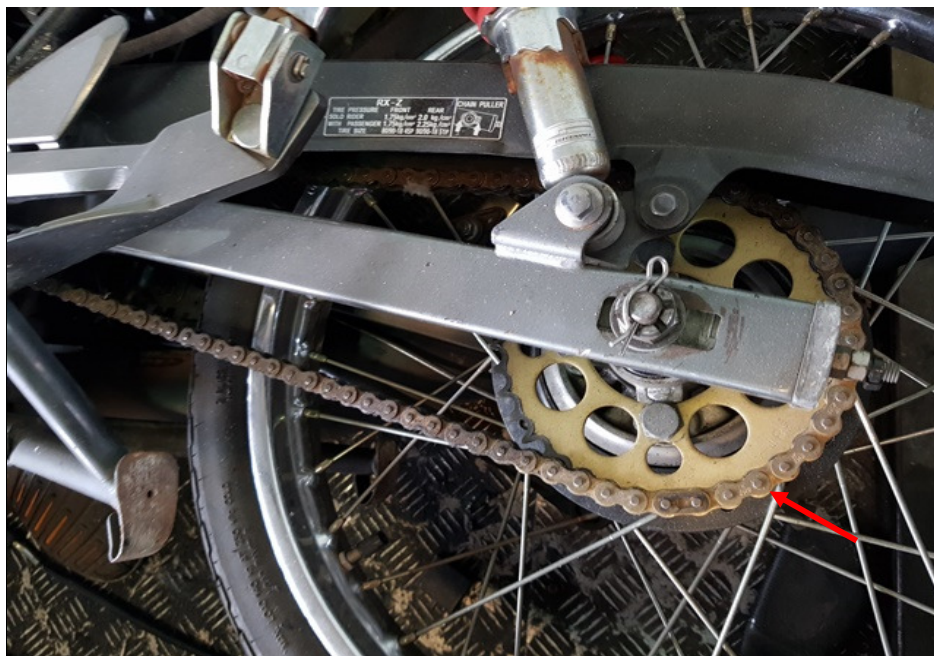
Photo 15 shows the gear chain (arrowed) of the Motorcycle, which was observed to be intact with no misalignment. It was also adequately lubricated for operating purposes. The gear chain rotates the rear wheel of the Motorcycle.

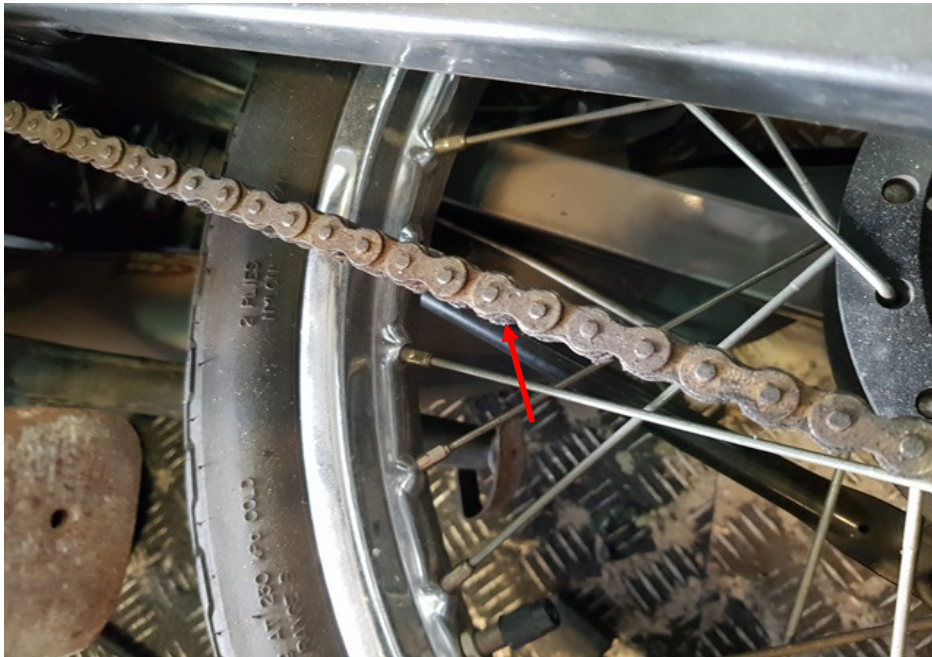
Photo 16 shows the closer view of the gear chain (arrowed) of the Motorcycle, which was observed to be intact with no misalignment. It was also adequately lubricated for operating purposes.

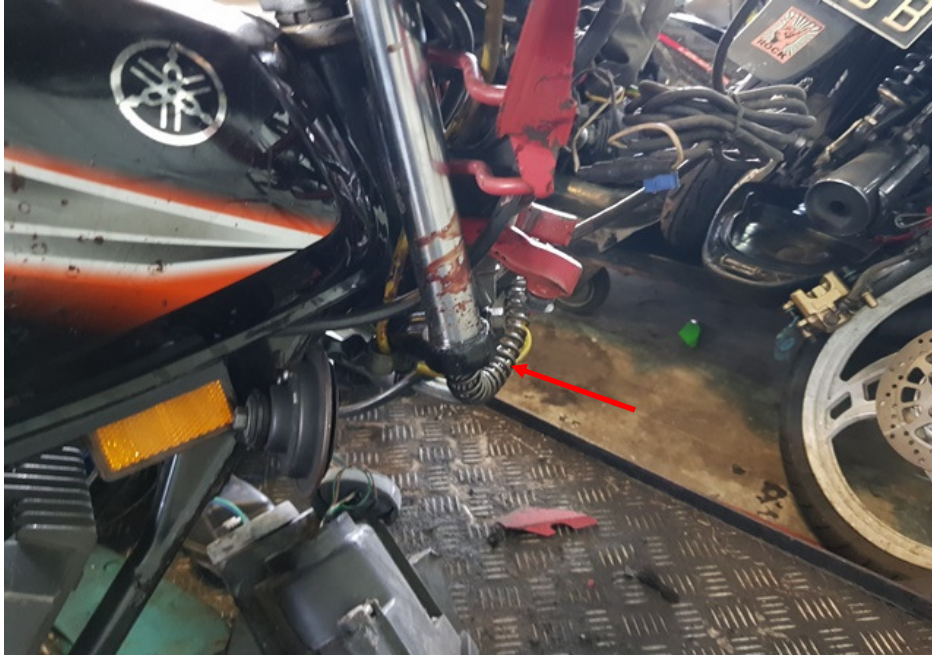
11. For this case, we were not able to conduct any test(s) on the steering system of the Motorcycle due to the damage of its front fork. The front fork was found to be dislodged as a result of the accident.

Photo 17 shows the front right fork of the Motorcycle. The front right fork (arrowed) was observed to be dislodged as a result of the accident. We were hence not able to conduct any tests on the steering system of the Motorcycle.

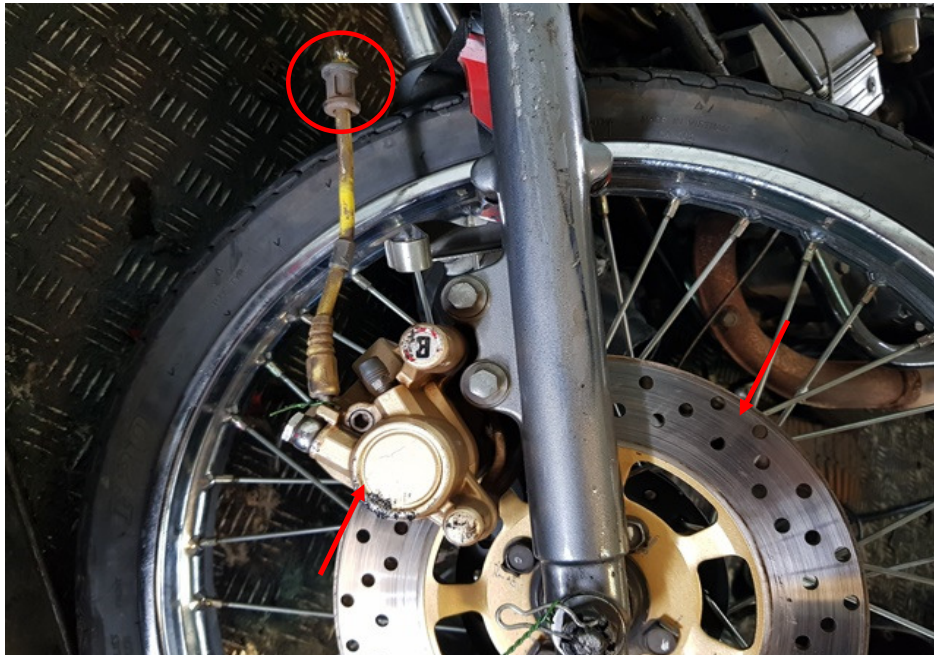
Photo 18 shows a close up view of the front brake caliper, front brake disc (arrowed) and front brake hose of the Motorcycle, which are all part of the components in the hydraulic front brake system of the Motorcycle. Our visual checks of the front brake caliper and front brake disc had revealed all to be intact with no visible damage. However we did observe that the front brake hose had been cut as a result of the accident (circled).

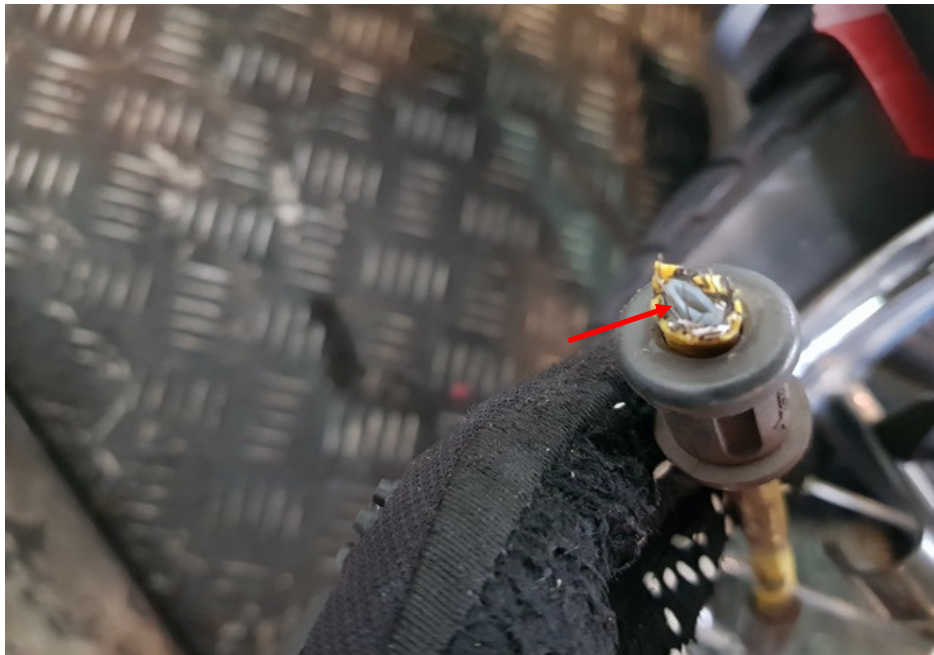
Photo 19 shows a close up view of the front brake hose which was observed to be cut as a result of the accident (arrowed).

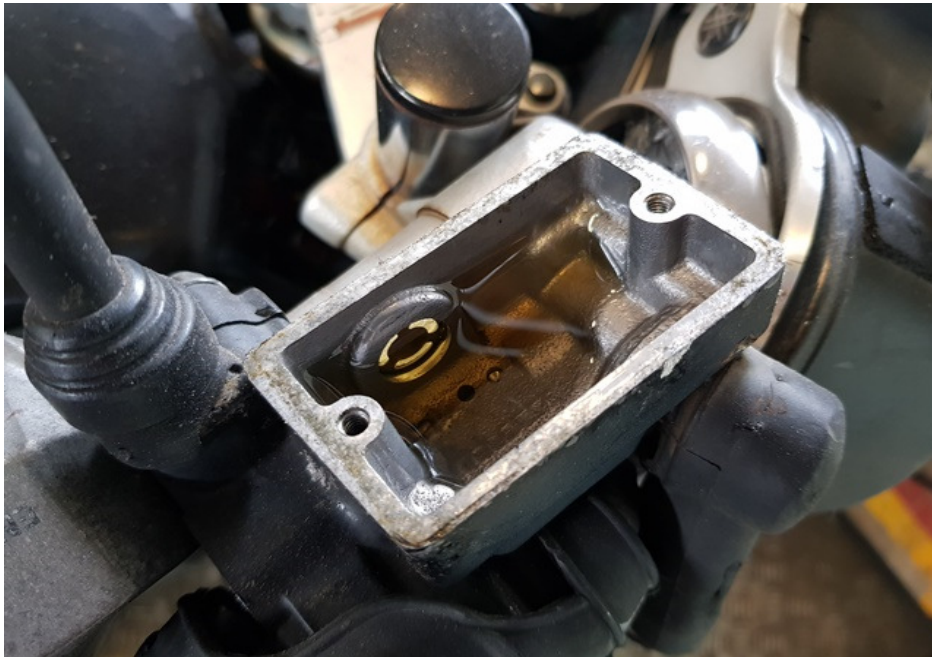
14. Our checks on the brake fluid for the front brake of the Motorcycle revealed it to be at an insufficient level for operating purposes due to the leakage of brake fluid caused by the cut front brake hose as a result of the accident. See photos 17 – 21 below.

Photo 20 shows the brake fluid reservoir for the front brake of the Motorcycle. The brake fluid was observed to be at an insufficient level for operating purposes due to the brake fluid leak caused by the cut front brake hose as a result of the accident.

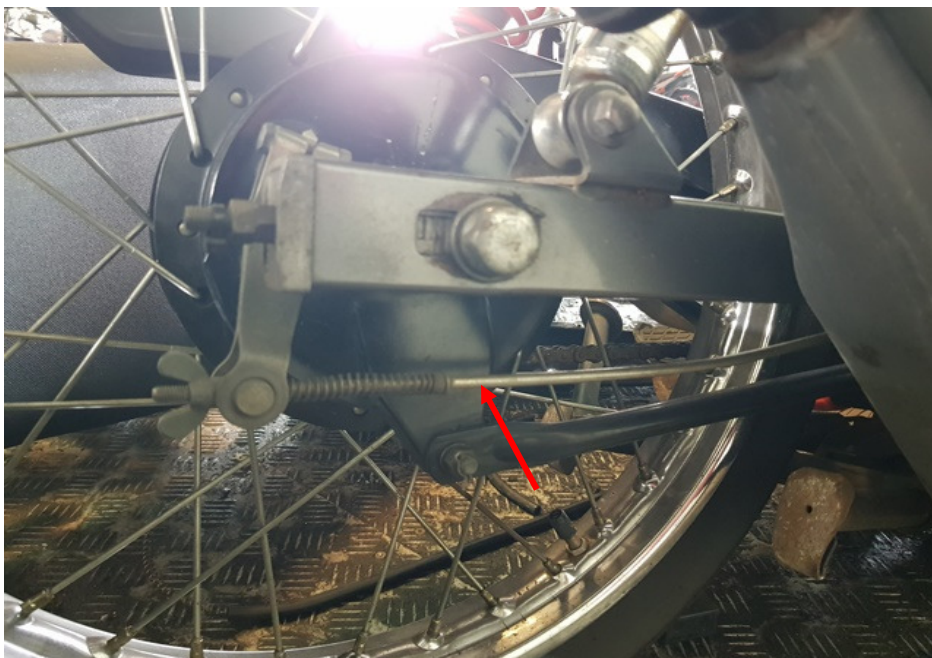
Photo 21 shows the rear wheel of the Motorcycle. The type of brake system for the rear wheel was of a mechanical type, controlled by the brake foot pedal of the Motorcycle. Our checks of the cable (arrowed), spring and drum which are all part of the components in the rear brake system of the Motorcycle reveal all to be intact and without damage.
