Your Ref: TP/IP/17453/2019  
Our Ref : CI/TPD19008278/N

**Fatal Accident Investigation Team**

**INSPECTION REPORT OF MOTORCYCLE FW 4724B**

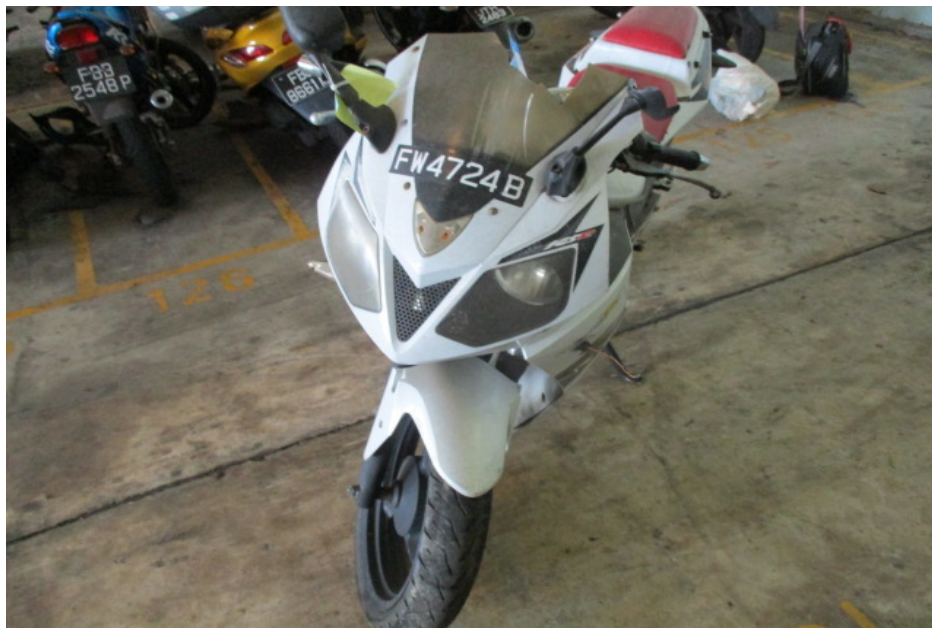
**Photo 1** shows a general view of the front body of the Motorcycle at the time of our inspection. The Motorcycle was observed to have sustained damages along its front and left side. The mileage at the time of inspection was recorded to be 55, 169km.

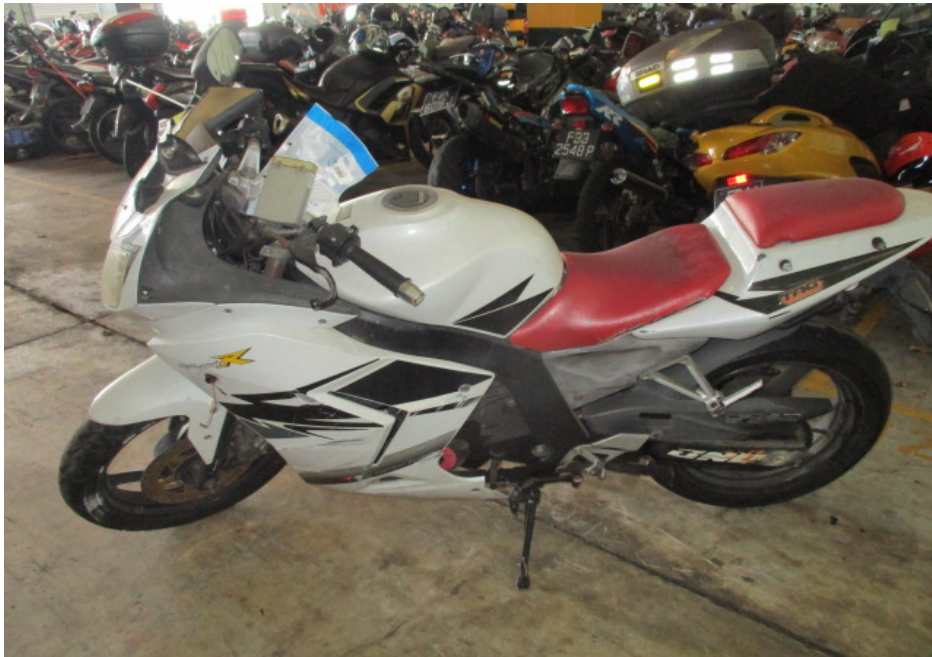
**Photo 2** shows a general view of the left front body of the Motorcycle at the time of our inspection. The Motorcycle was observed to have sustained damages along its front and left side. Amongst the body parts that were found to have been damaged include its front windshield, left side cowling, left side mirror, clutch lever, left front signal lamp, gear shift rod, gear shift pedal, left front footrest, left front footrest bracket and rider seat amongst others.

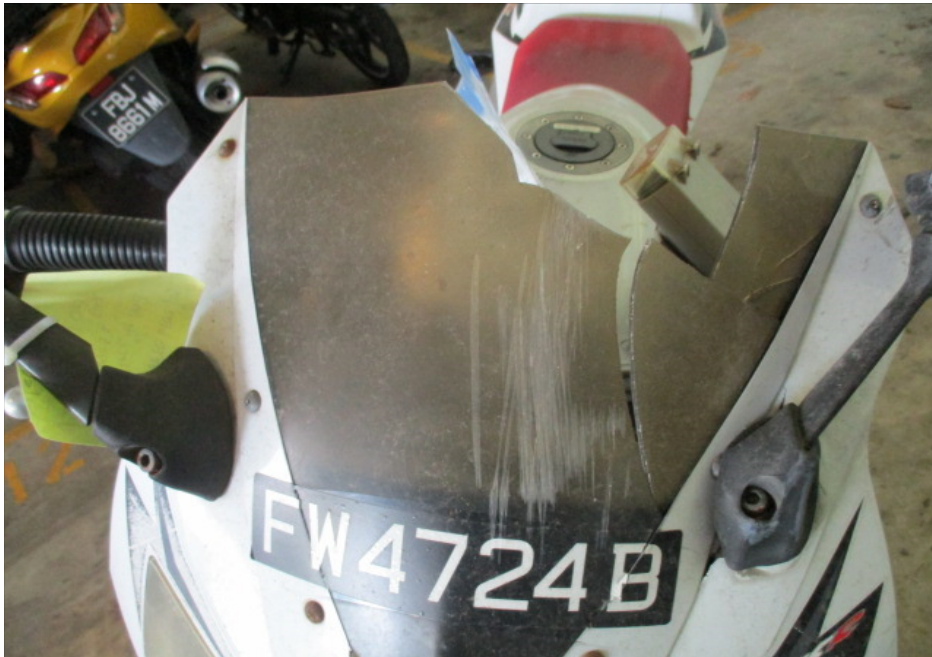
**Photo 3** shows a closer view of the front windshield which was amongst the body parts at the front body of the Motorcycle that had sustained damage as a result of the accident.

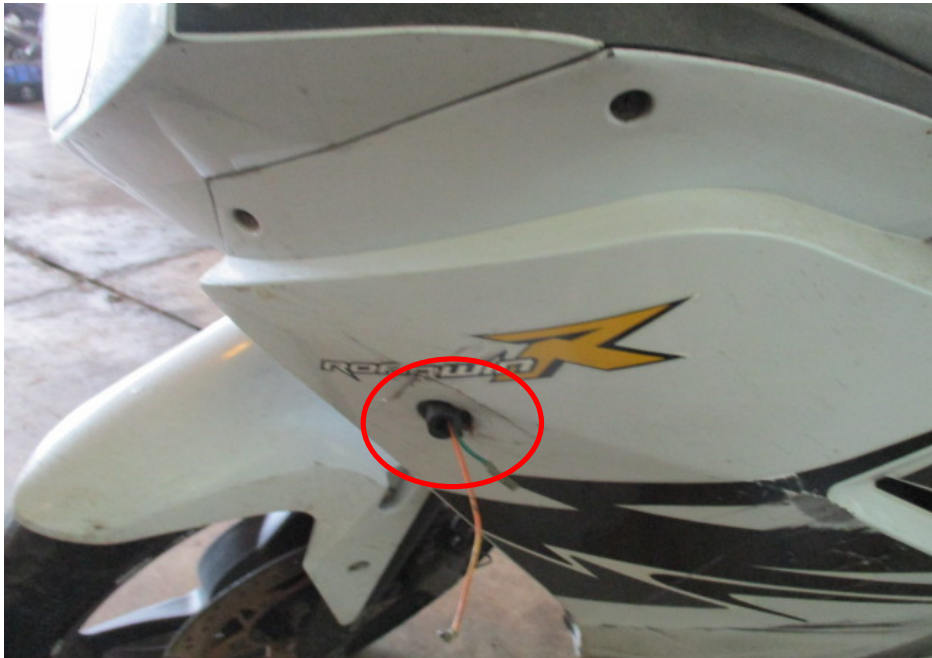
**Photo 4** shows a close up view of the left front signal lamp (circled) which was amongst the body parts of the Motorcycle that had sustained damage as a result of the accident.

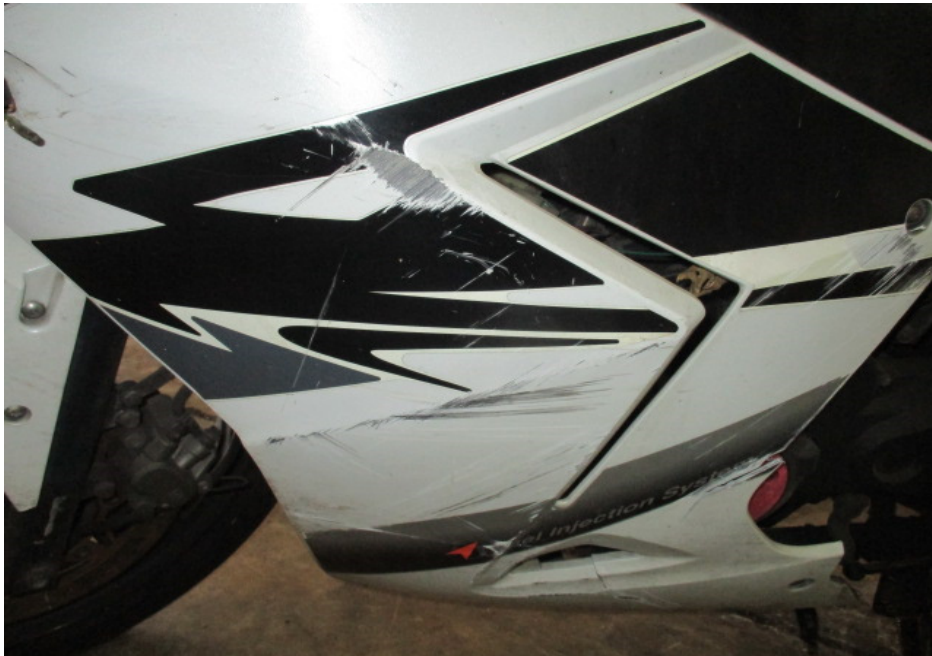
**Photo 5** shows a closer view of the left side cowling of the Motorcycle that had sustained damage as a result of the accident.

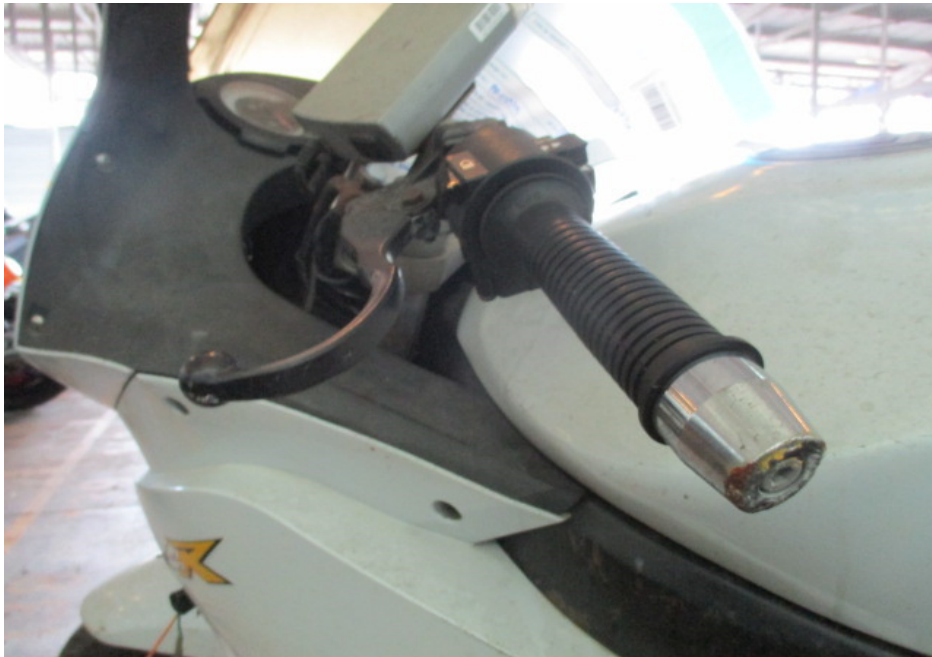
**Photo 6** shows a closer view of the clutch lever, left handlebar grip and left handlebar end which were amongst the body parts of the Motorcycle that had sustained damage as a result of the accident.

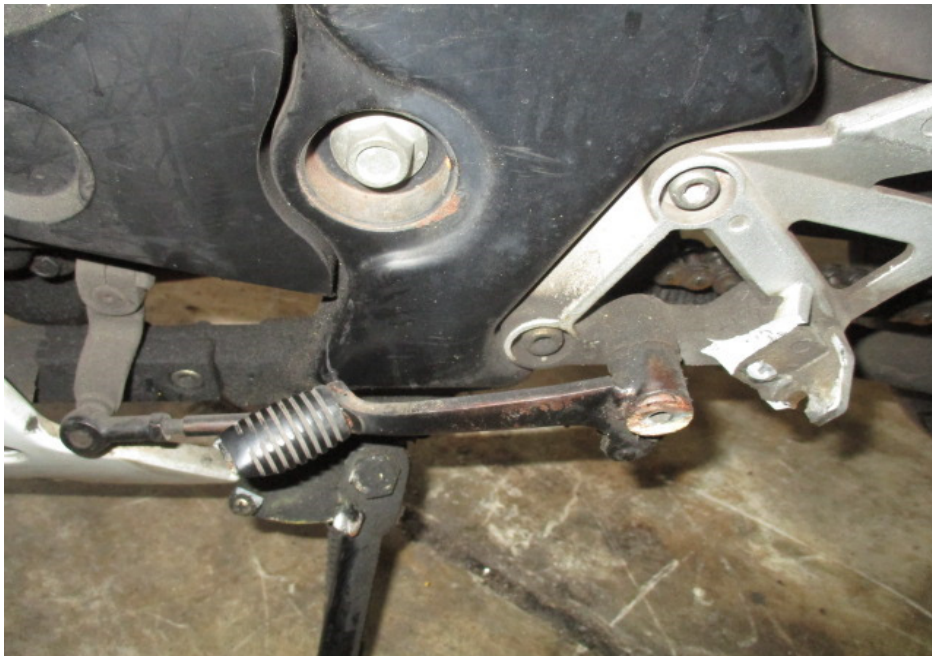
**Photo 7** shows a closer view of the gear shift rod, gear shift pedal, left front footrest and left front footrest bracket, which were amongst the body parts of the Motorcycle that had sustained damage as a result of the accident.

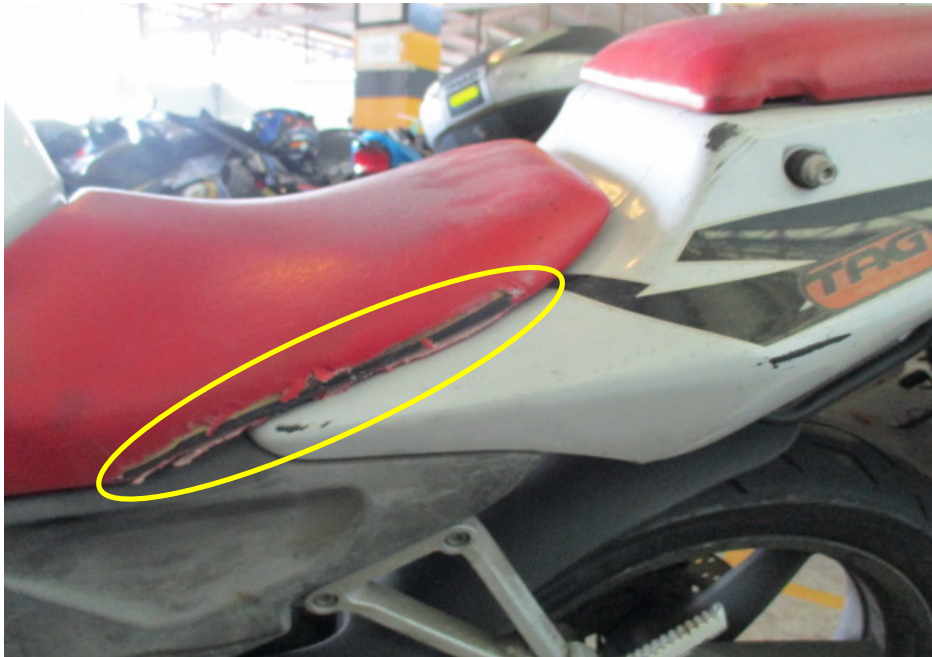
**Photo 8** shows the damaged rider seat (circled) which was amongst the body parts of the Motorcycle that had sustained damage as a result of the accident.

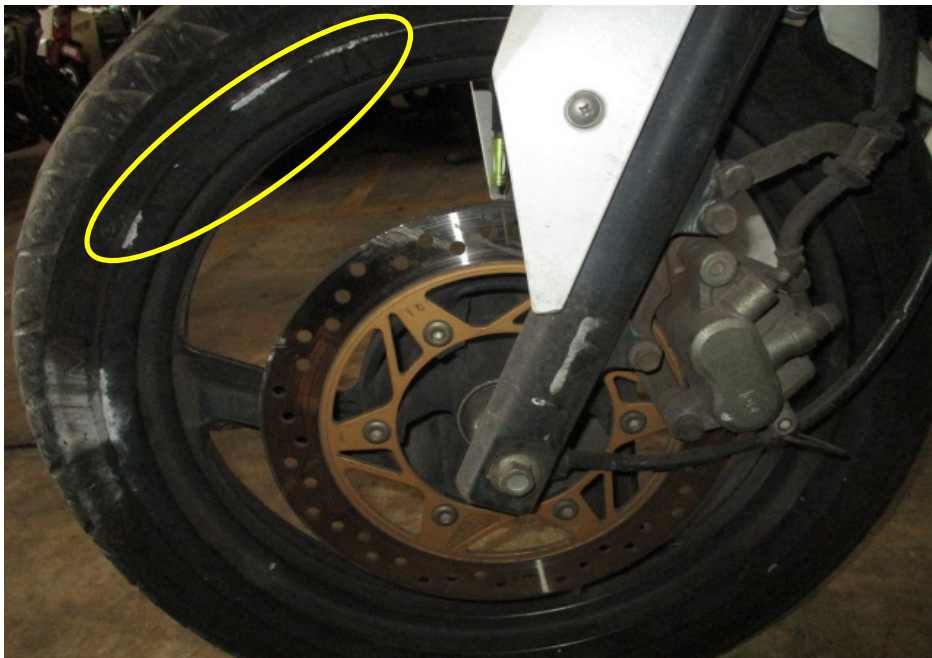
8. At the time of our inspection, we did not observe any visible damage on the rear wheel rim of the Motorcycle. We had however found some relatively minor marks of grazing nature on the edges of the front wheel rim, at the left side of the Motorcycle. See photos 1 – 11 below.

**Photo 9** shows the front wheel rim and front tyre of the Motorcycle at the time of our inspection. The front tyre was observed to be in serviceable condition with remaining tread depth of approximately 3mm. The tyre was also observed to be sufficiently inflated for vehicular operation. Some relatively minor marks of grazing nature were observed on the edges of the front wheel rim (circled), at the left side of the Motorcycle.

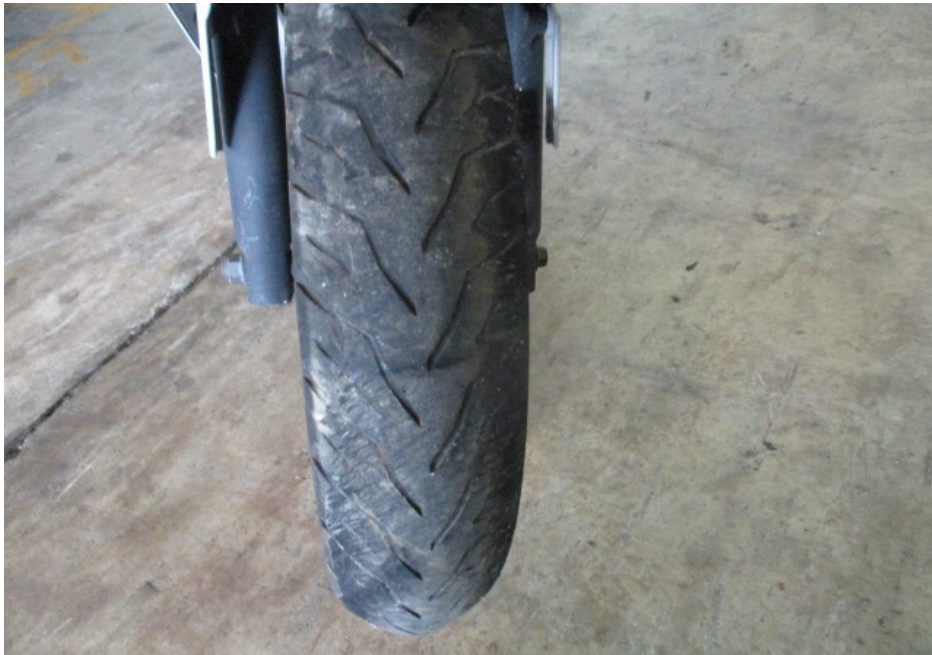
**Photo 10** shows the front tyre of the Motorcycle at the time of our inspection. The front tyre was observed to be in serviceable condition. The pattern of the tread was also clearly visible. There was no tear, burst mark(s) and/or punctured hole(s) on the sidewalls as well as across the tread of the front tyre.

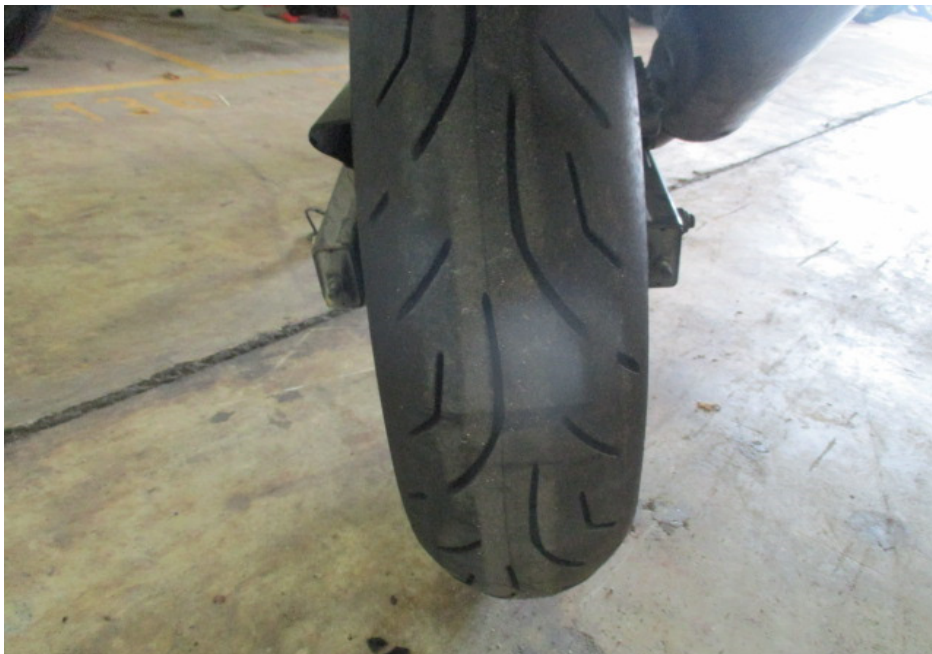
**Photo 11** shows the condition of the Motorcycle's rear tyre. The rear tyre was observed to be in serviceable condition with remaining tread depth of approximately 4mm. The tyre was also observed to be sufficiently inflated for vehicular operation. We did not observe any tear, burst mark(s) and/or punctured hole(s) on the sidewalls as well as across the tread of the rear tyre.

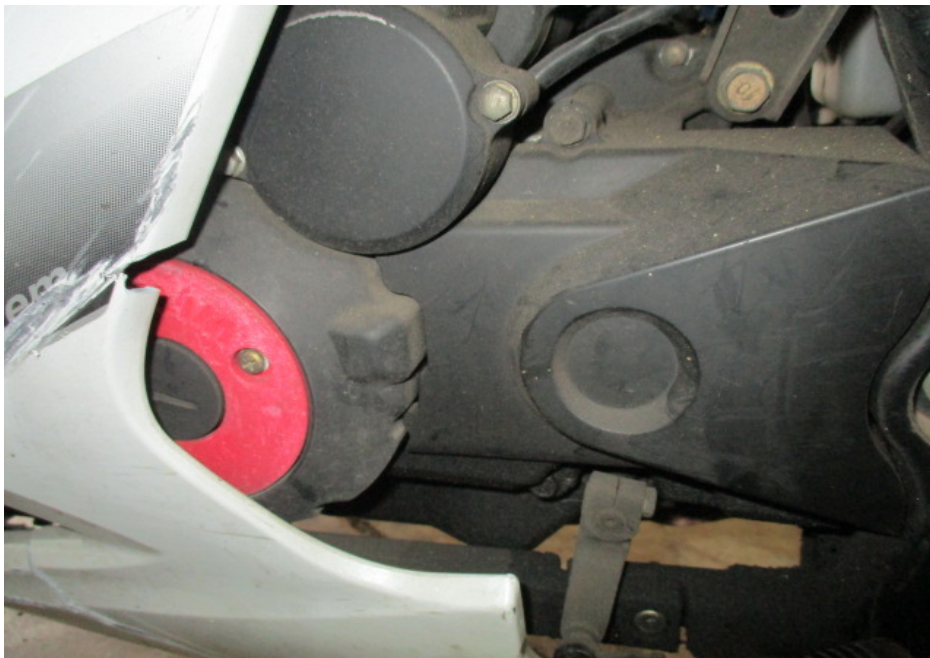
**Photo 12** shows the left side of the engine of the Motorcycle at the time of our inspection. The various engine related parts and components were found to be intact with no visible damage. There was also no sign(s) or indication(s) of fluid leak observed around the left engine area of the Motorcycle.

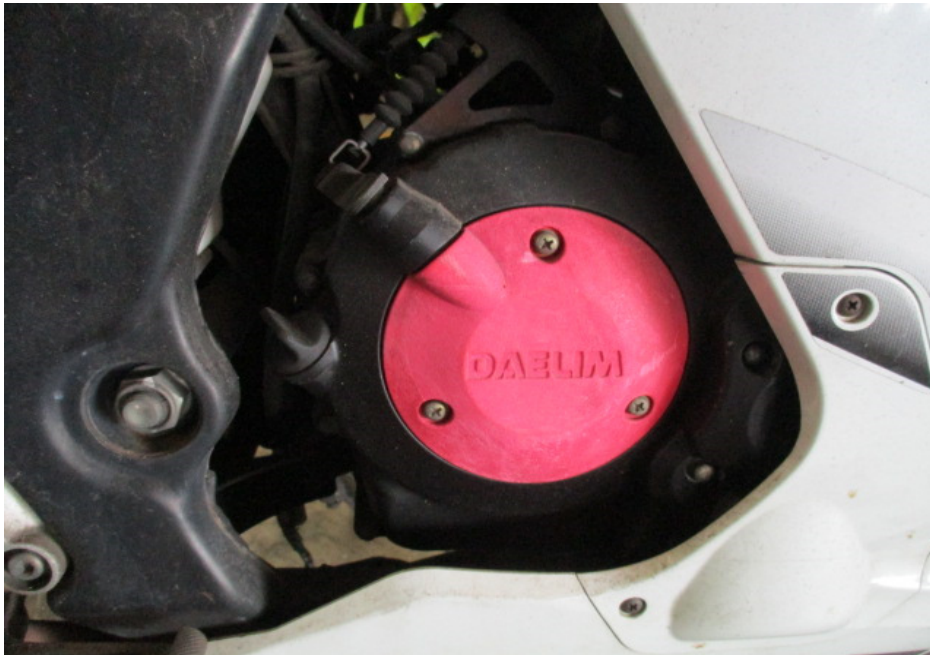
**Photo 13** shows the right side of the engine of the Motorcycle at the time of our inspection. The various engine related parts and components were found to be intact with no visible damage. There was also no sign(s) or indication(s) of fluid leak observed around the right engine area of the Motorcycle.

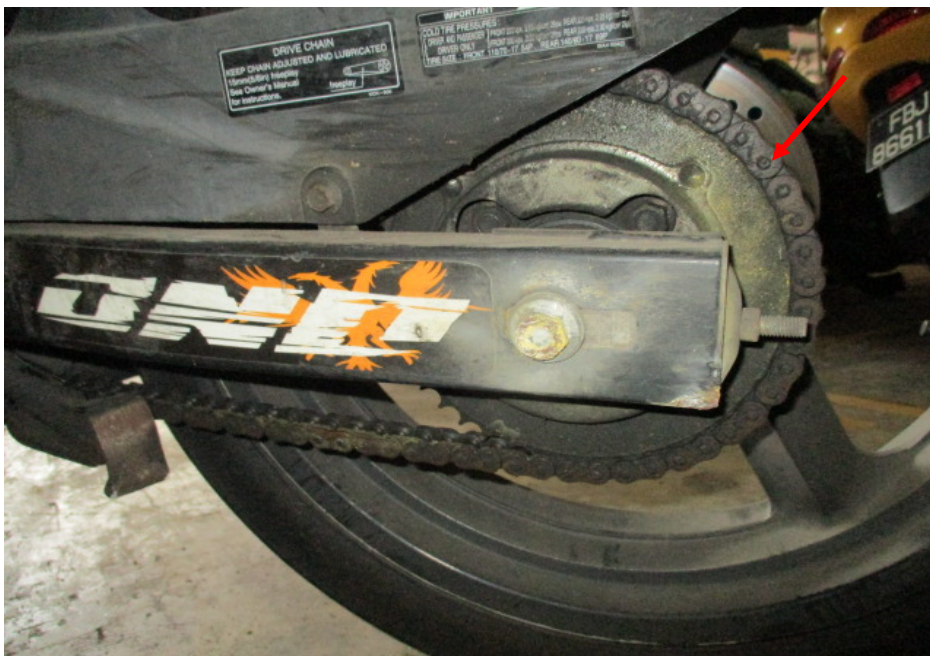
**Photo 14** shows the general view of the gear train (arrowed) of the Motorcycle, which was observed to be intact with no misalignment. It was also adequately lubricated for operating purposes.

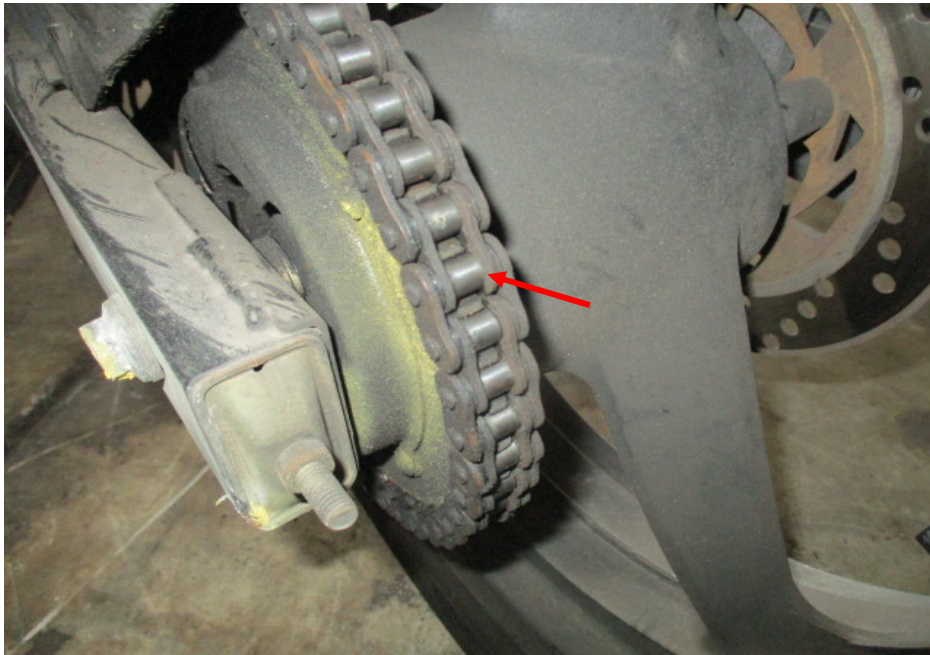
**Photo 15** shows a closer view of the gear train (arrowed) of the Motorcycle, which was observed to be intact with no misalignment. It was also adequately lubricated for operating purposes.

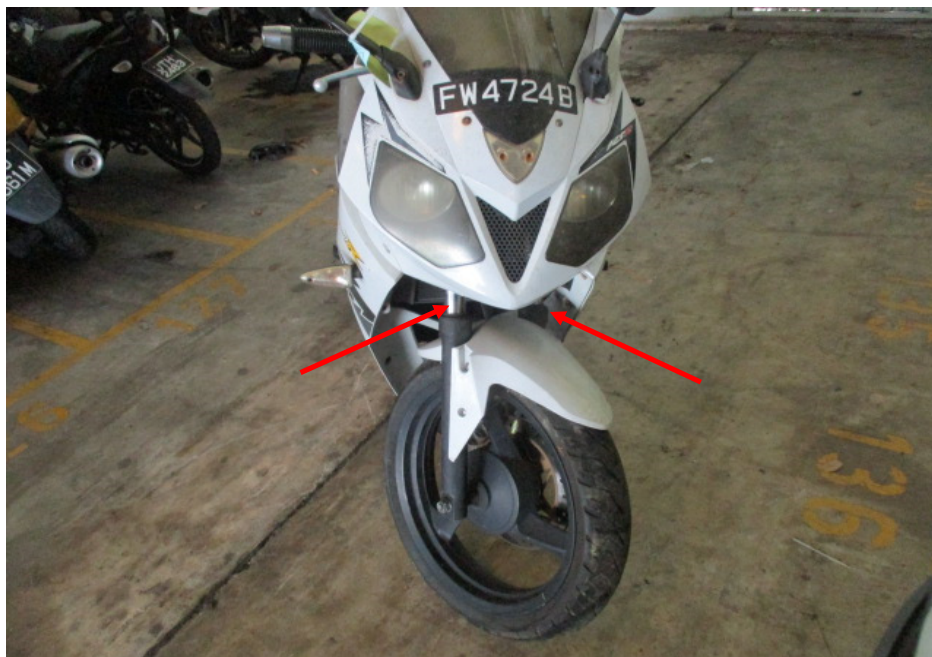
11. Our checks on the various steering components of the Motorcycle revealed that its steering system was in serviceable condition. Its front fork was found to be intact and undamaged. Turning the handle bar towards the left and right also did not produce any abnormal free play and/or resistance.

**Photo 16** shows the front fork (arrowed) of the Motorcycle. The front fork and fork bracket of the Motorcycle were both found to be intact and undamaged. Turning the Motorcycle's handle bar towards the left and right did not produce any abnormal free play and/or resistance. The steering system of the Motorcycle was in serviceable condition at the time of our inspection.

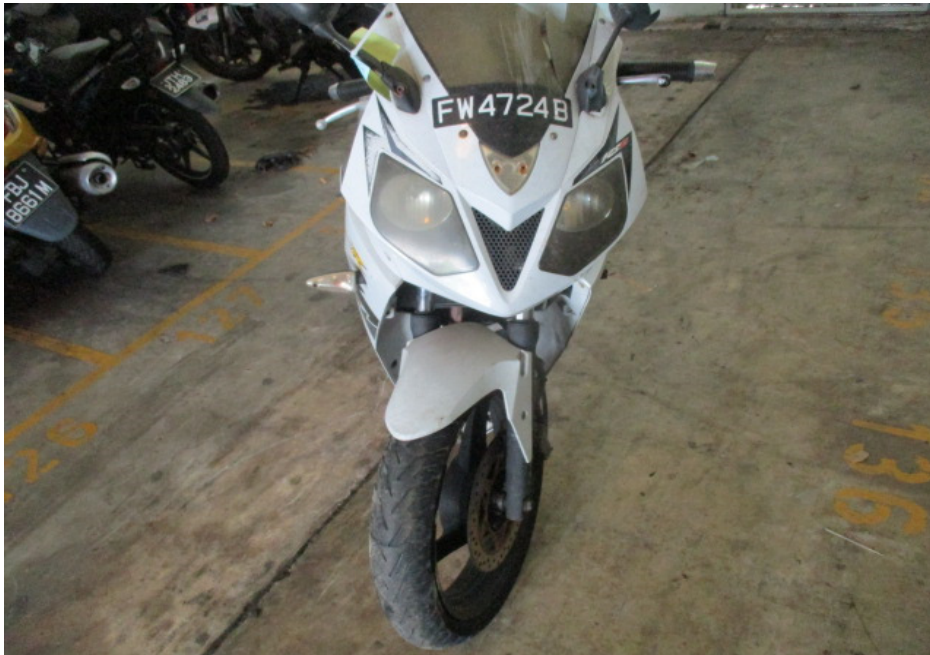
**Photo 17** shows the front wheel of the Motorcycle turned towards its full right. Turning the Motorcycle's handle bar towards the left and right did not produce any abnormal free play and/or resistance. This would indicate that the steering system of the Motorcycle was in serviceable condition at the time of our inspection.

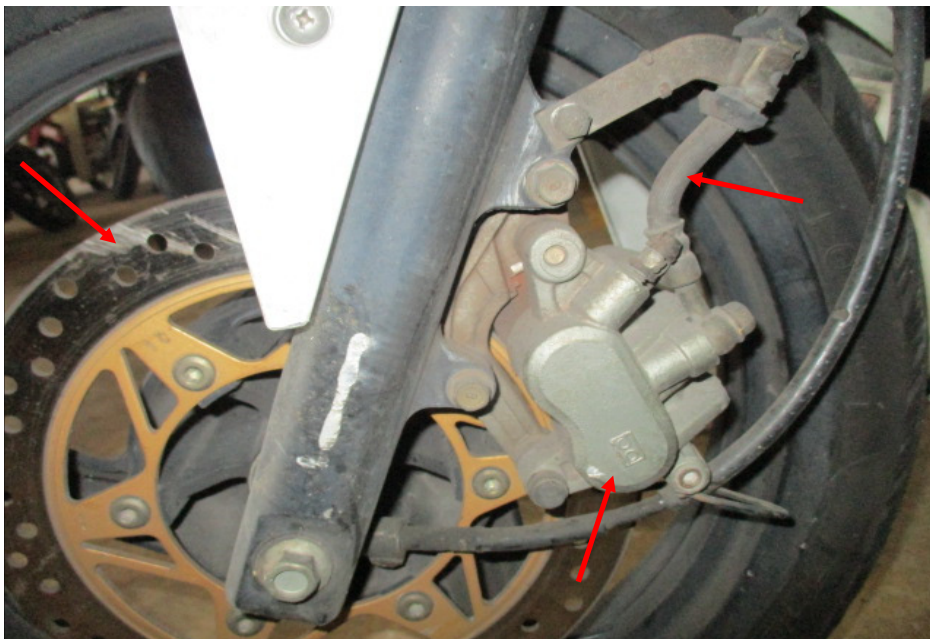
13. Our visual examination of the various components in the Motorcycle's braking system like the brake discs, brake calipers, brake lever, brake foot pedal and brake hoses revealed all to be intact and without damage. There was also no leakage of brake fluid observed along the brake hoses. This was from the respective brake fluid reservoirs to the front brake caliper and rear brake caliper of the Motorcycle. The brake fluid for the front brake and rear brake was also found to be of sufficiently level and without any contamination.

**Photo 18** shows a close up view of the front brake caliper, front brake disc and front brake hose (arrowed) of the Motorcycle, which are all part of the components in the hydraulic front brake system of the Motorcycle. Our visual checks of these various components had revealed all to be intact with no visible damage. No leakage of brake fluid was also observed.

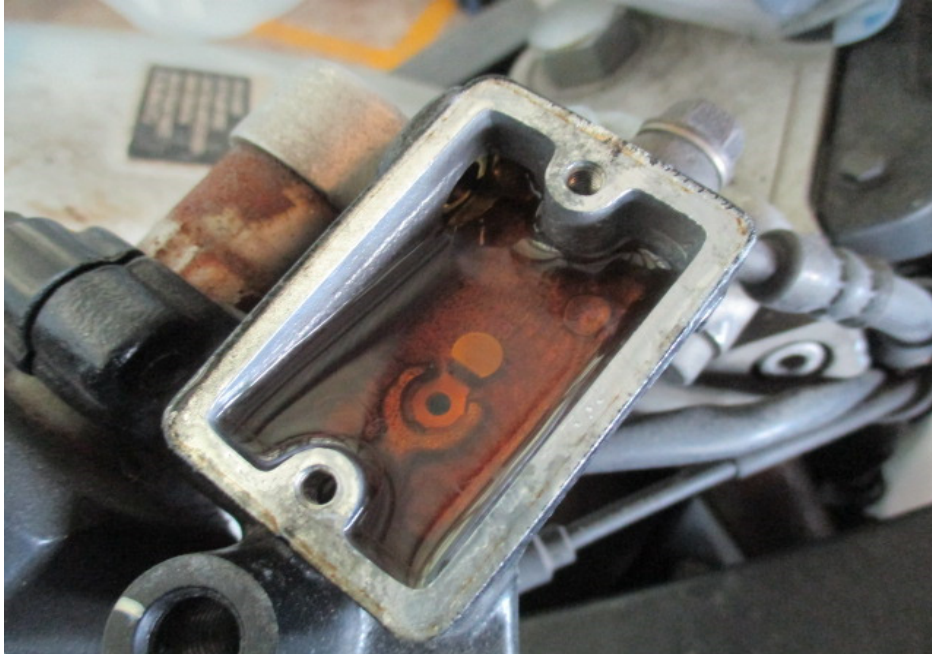
**Photo 19** shows the brake fluid reservoir for the front brake of the Motorcycle. The brake fluid was observed to be of sufficient level and without contamination for operational purposes.

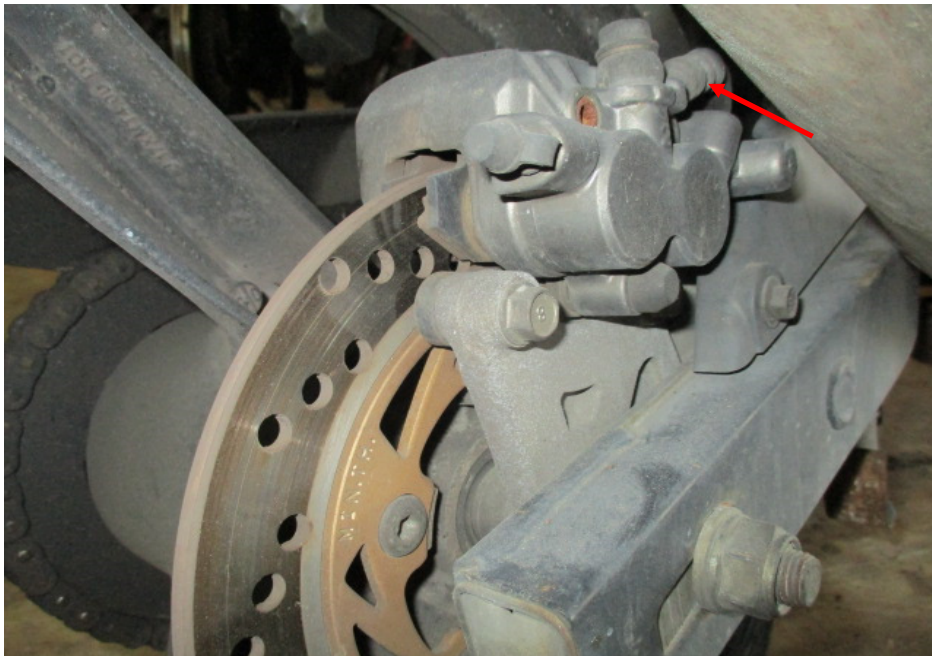
**Photo 20** shows a close up view of the rear brake caliper, rear brake disc and rear brake hose (arrowed) of the Motorcycle, which are all part of the components in the hydraulic rear brake system of the Motorcycle. Our visual checks of these various components had revealed all to be intact with no visible damage. No leakage of brake fluid was also observed.
