Your Ref: TP/IP/12177/2019  
Our Ref : CI/TPD19008280/N

**Fatal Accident Investigation Team**

**INSPECTION REPORT OF MOTORCYCLE FBG 3724P**

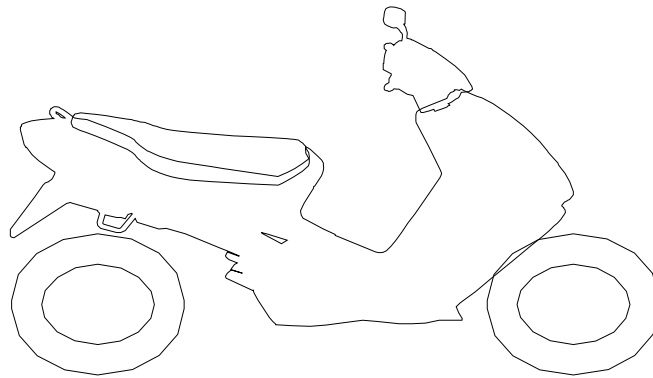
6. The condition of the 2 tyres of the Motorcycle was observed to be in serviceable condition. We did not observe any tear, burst mark(s) and/or punctured hole(s) on the sidewalls as well as across the tread of the 2 tyres. Both the tyres were observed to be sufficiently inflated for vehicular operation.
7. The tyre brand, tyre size and remaining tread depth of the 2 tyres were recorded as follows:-

Golden Boy 3.00 - 16 (8mm)

Golden Boy 2.75 - 19 (5mm)

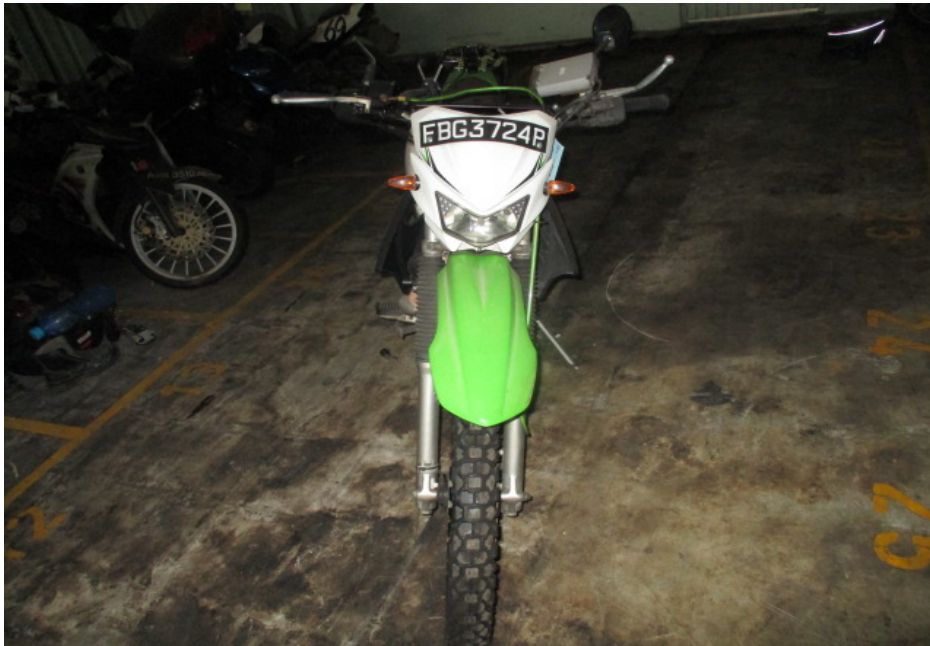
4. The mileage of the Motorcycle at the time of our inspection was not recorded due to a flat battery.
5. The Motorcycle was observed to have sustained damages along its front and left side. The body parts that were found to have been damaged include its front mudguard, left side cowling, left side mirror, clutch lever, left front footrest, left rear signal lamp and rear number plate, amongst others.

**Photo 1** shows a general view of the front body of the Motorcycle at the time of our inspection. The Motorcycle was observed to have sustained damages along its front and left side. The mileage of the Motorcycle at the time of our inspection was not recorded due to a flat battery.

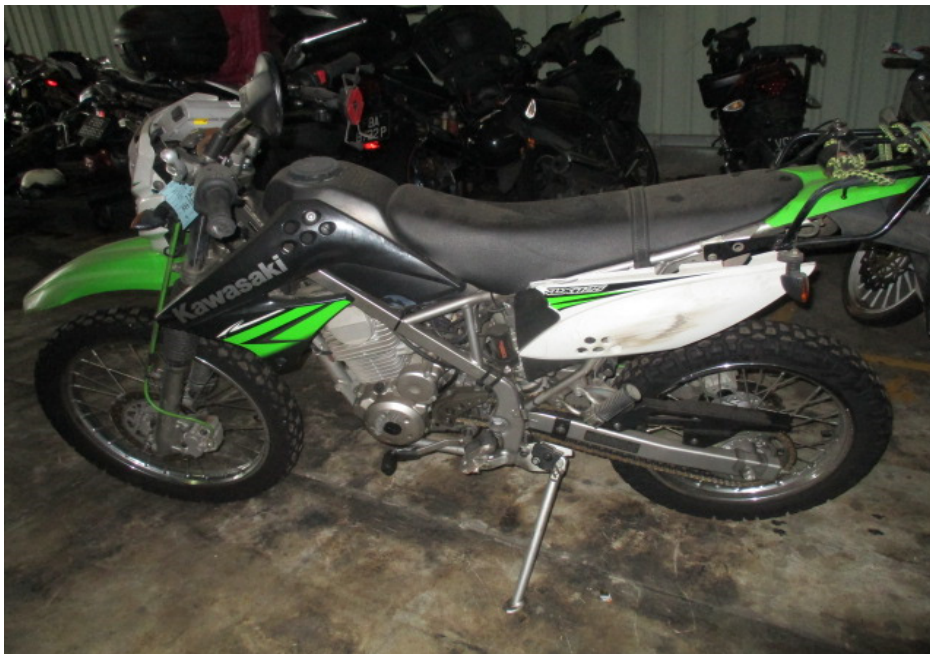
**Photo 2** shows a general view of the right front body of the Motorcycle at the time of our inspection. The Motorcycle was observed to have sustained damages along its front and left side. The body parts that were found to have been damaged include its front mudguard, left side cowling, left side mirror, clutch lever, left front footrest, left rear signal lamp and rear number plate, amongst others.

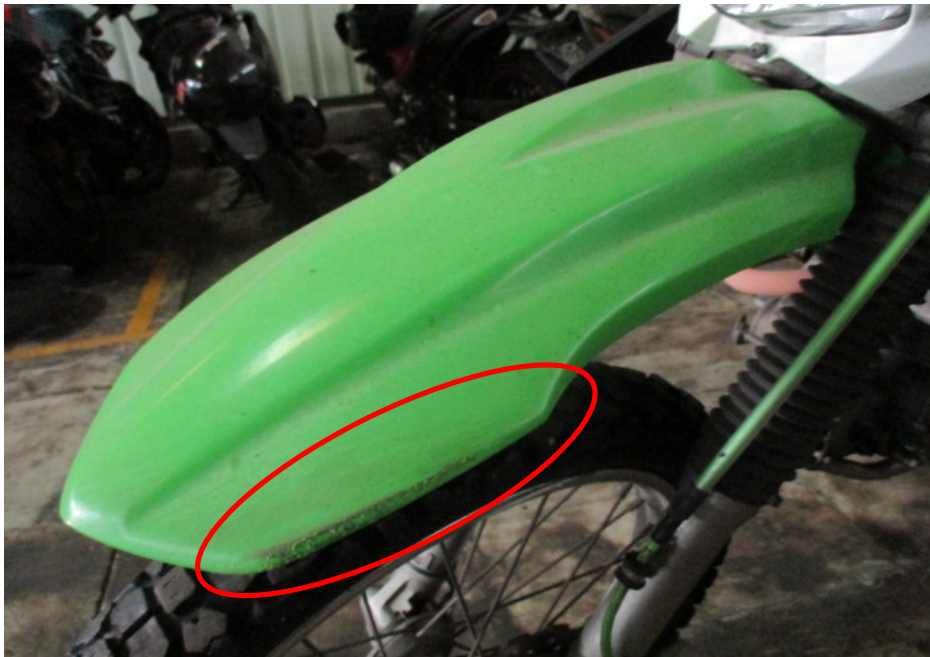
**Photo 3** shows a closer view of the front mudguard (circled) which was amongst the body parts at the front body of the Motorcycle that had sustained damage as a result of the accident.

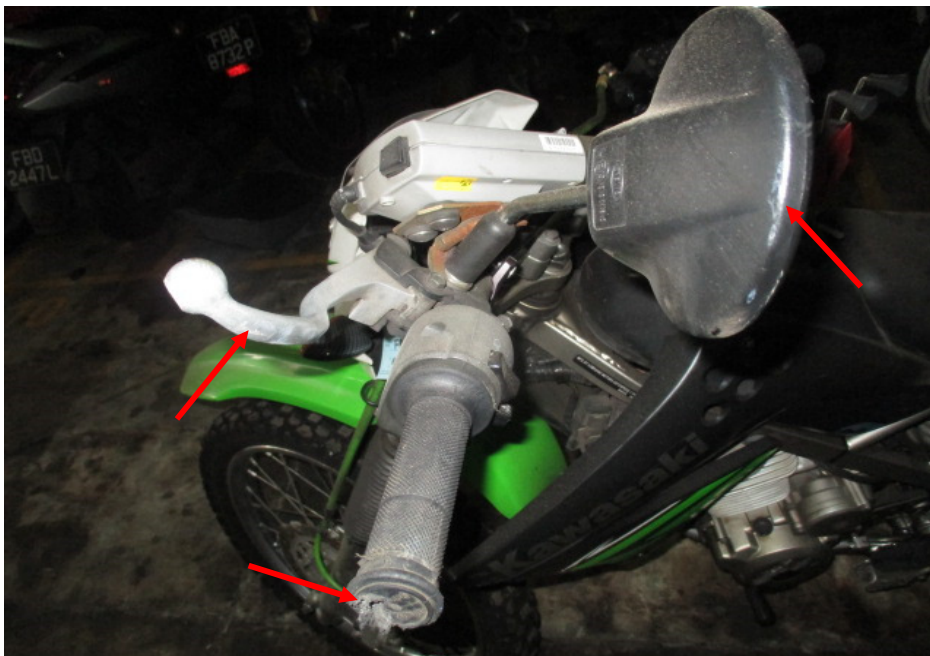
**Photo 4** shows a closer view of the clutch lever, left side mirror and left handlebar end (arrowed) which were amongst the body parts of the Motorcycle that had sustained damage as a result of the accident.

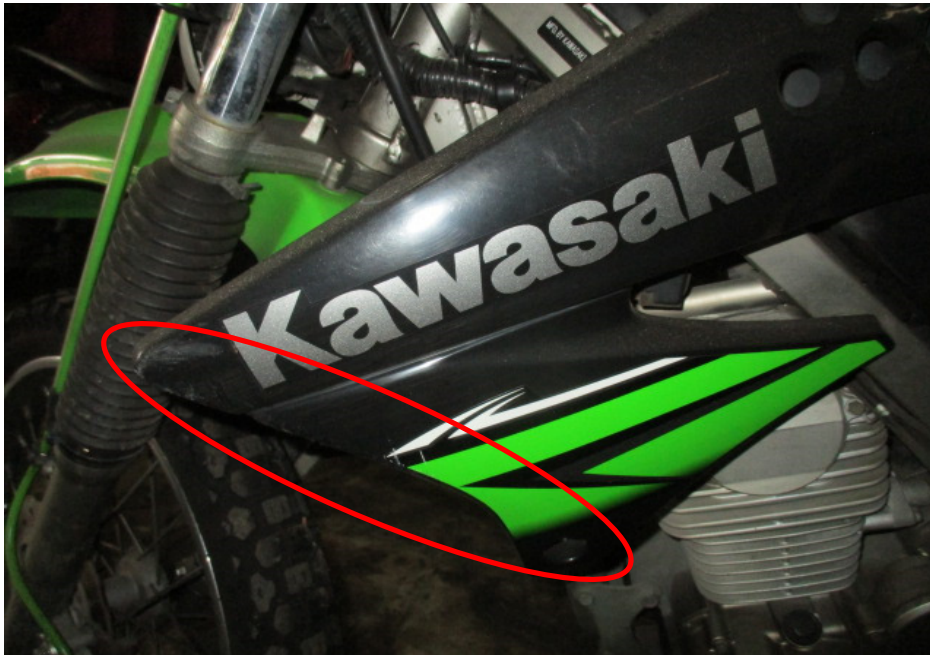
**Photo 5** shows the left side cowling of the Motorcycle (circled) that had sustained damage as a result of the accident.

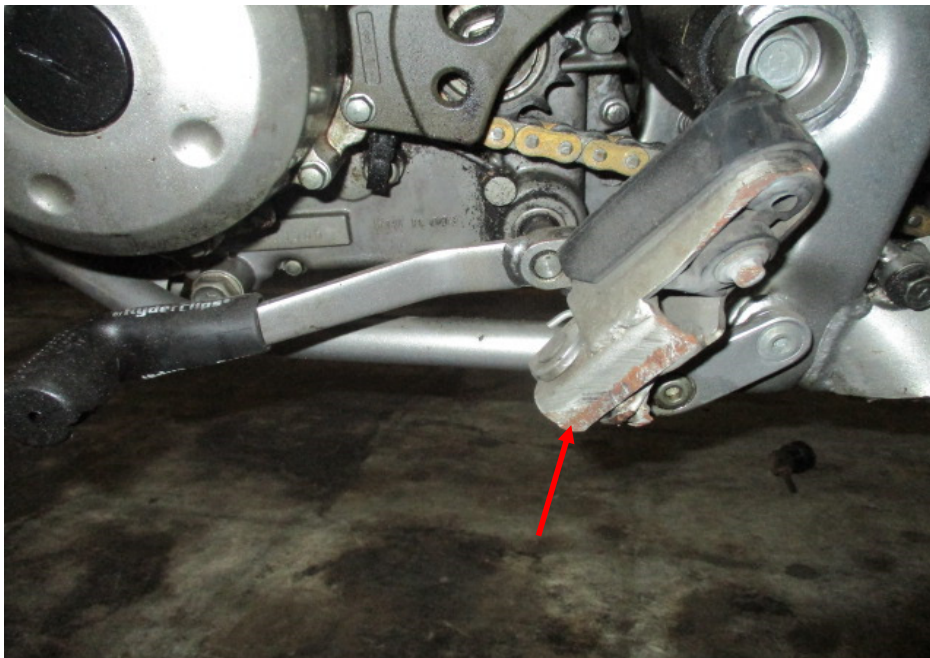
**Photo 6** shows a closer view of the left front footrest (arrowed) which was amongst the body parts of the Motorcycle that had sustained damage as a result of the accident.

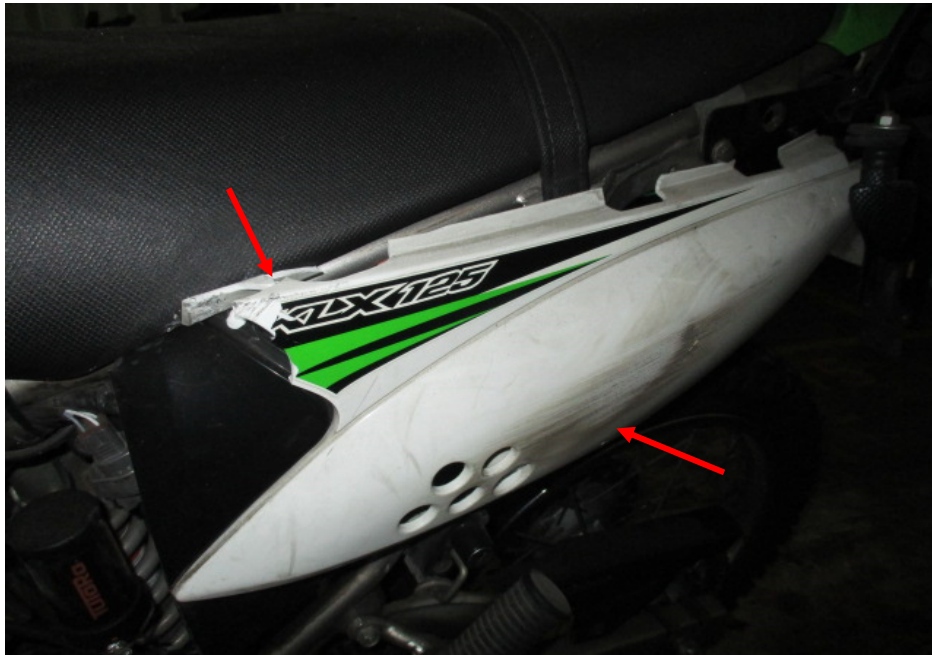
**Photo 7** shows a closer view of the left rear side cover (arrowed) which was amongst the body parts of the Motorcycle that had sustained damage as a result of the accident.

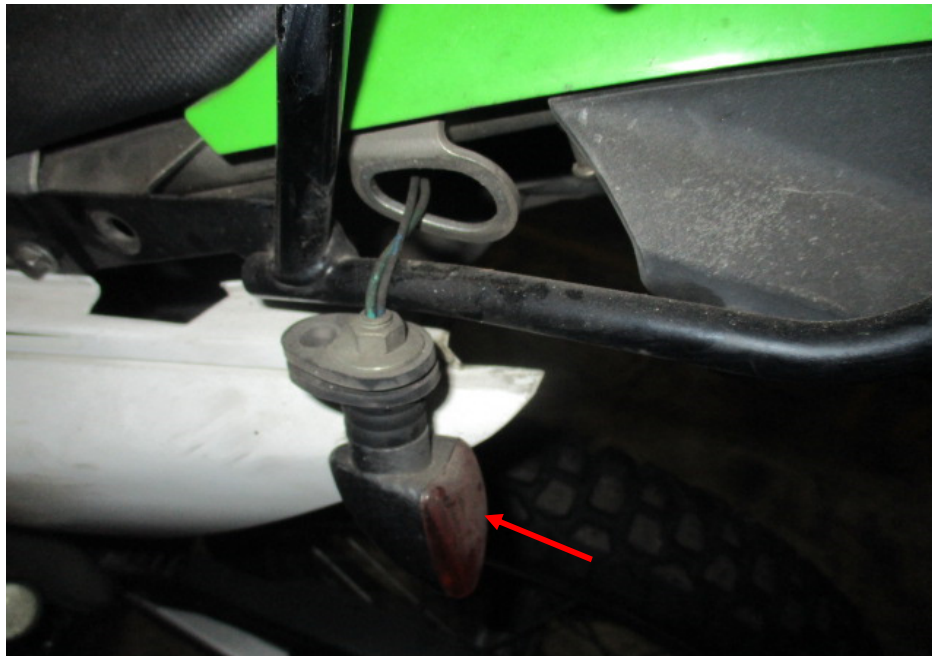
**Photo 8** shows the left rear signal lamp (arrowed) which were amongst the body parts of the Motorcycle that had sustained damage as a result of the accident.

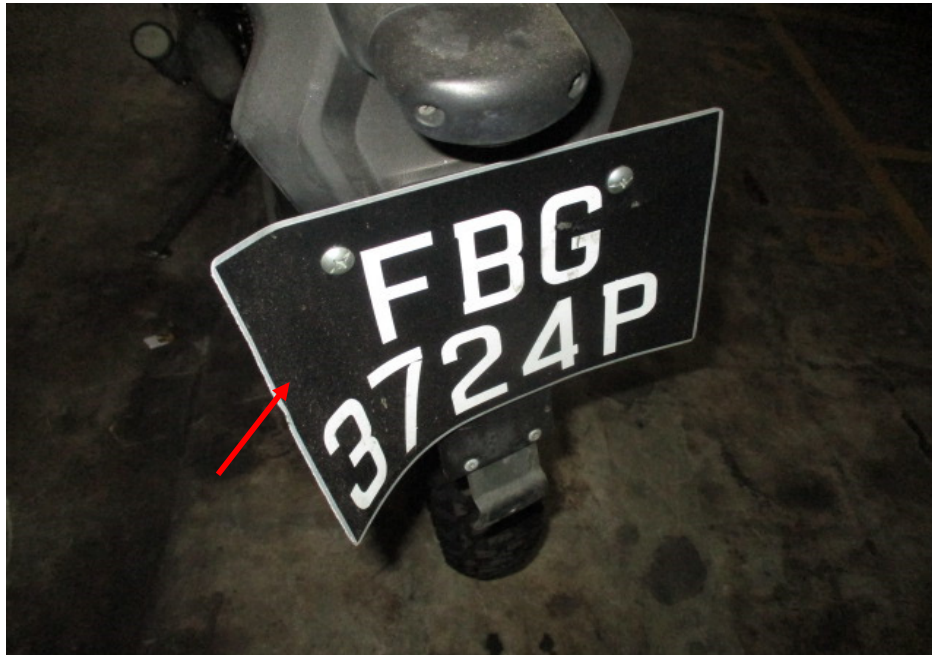
**Photo 9** shows a closer view of the rear number plate (arrowed) which was amongst the body parts of the Motorcycle that had sustained damage as a result of the accident.

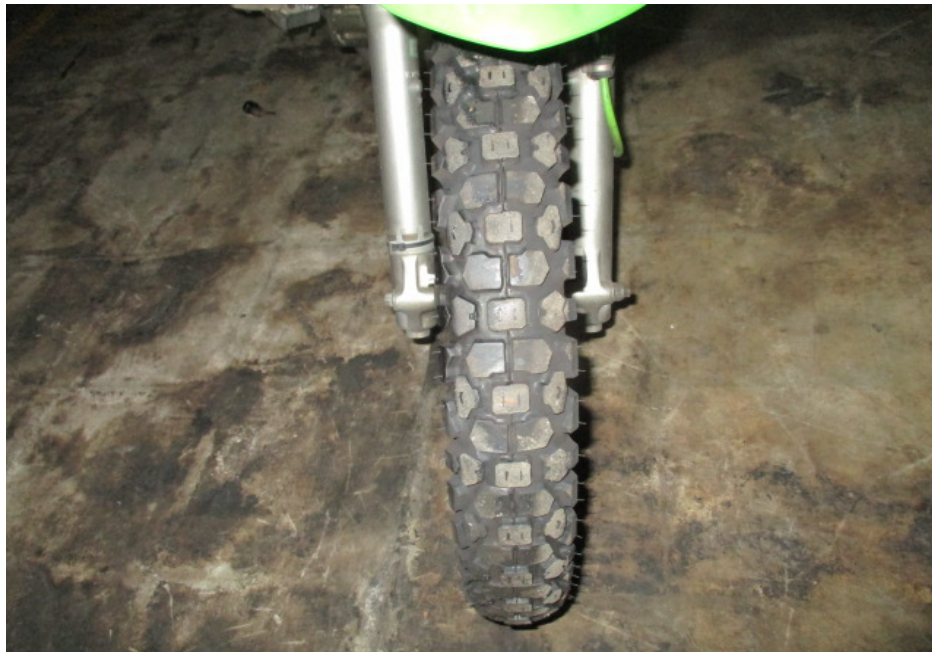
**Photo 10** shows the front tyre of the Motorcycle at the time of our inspection. The front tyre was observed to be in serviceable condition with remaining tread depth of approximately 5mm. The pattern of the tread was also clearly visible. There was no tear, burst mark(s) and/or punctured hole(s) on the sidewalls as well as across the tread of the front tyre.

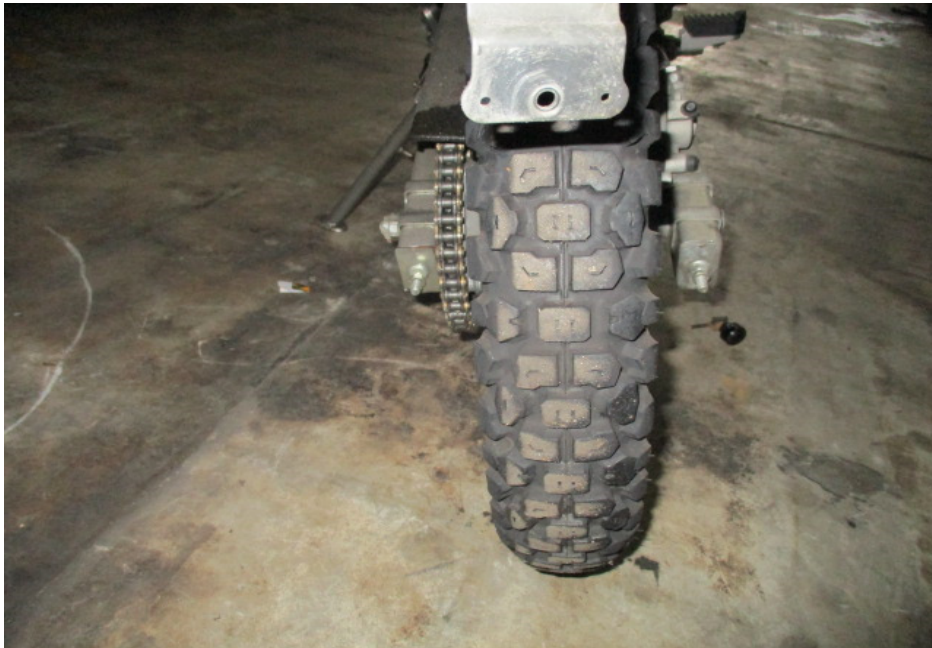
**Photo 11** shows the condition of the Motorcycle's rear tyre. The rear tyre was observed to be in serviceable condition with remaining tread depth of approximately 8mm. The tyre was also observed to be sufficiently inflated for vehicular operation. We did not observe any tear, burst mark(s) and/or punctured hole(s) on the sidewalls as well as across the tread of the rear tyre.

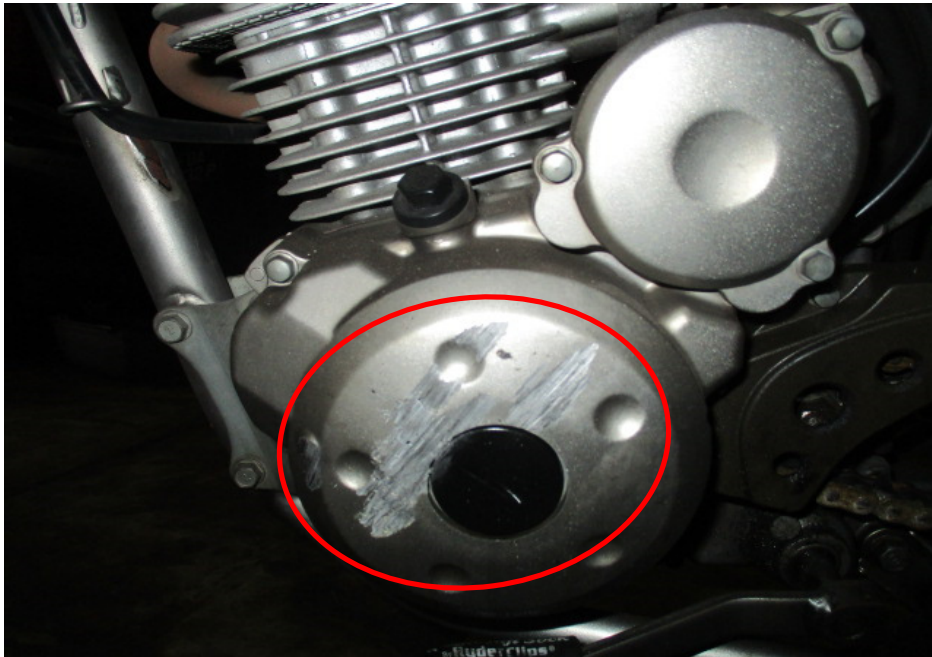
**Photo 12** shows the left side of the engine of the Motorcycle at the time of our inspection. The various left engine components had sustained damage of grazing nature as a result of the accident (circled) however the engine components were still intact. There was also no fluid leak and/or fluid stain found around the left engine area of the Motorcycle.

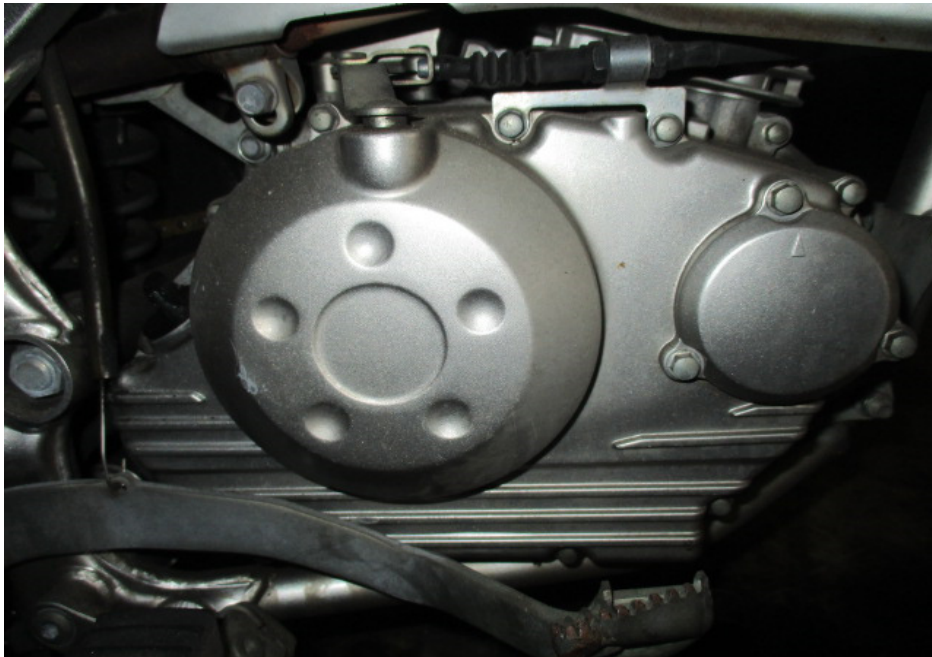
**Photo 13** shows the right side of the engine of the Motorcycle at the time of our inspection. The various engine related parts and components were found to be intact with no visible damage. There was also no sign(s) or indication(s) of fluid leak observed around the right engine area of the Motorcycle.

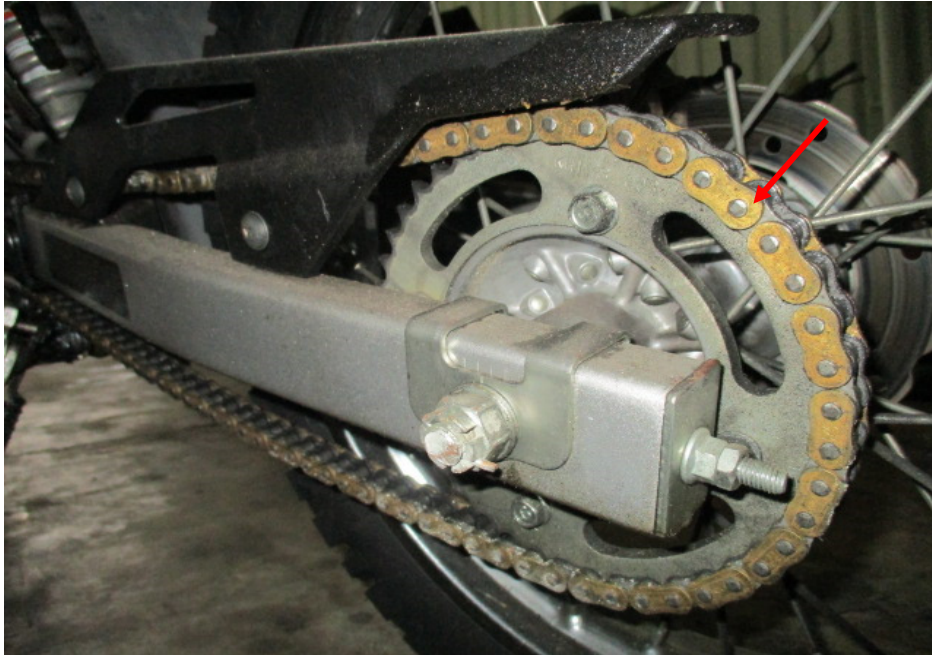
**Photo 14** shows the general view of the gear train (arrowed) of the Motorcycle, which was observed to be intact with no misalignment. It was also adequately lubricated for operating purposes.

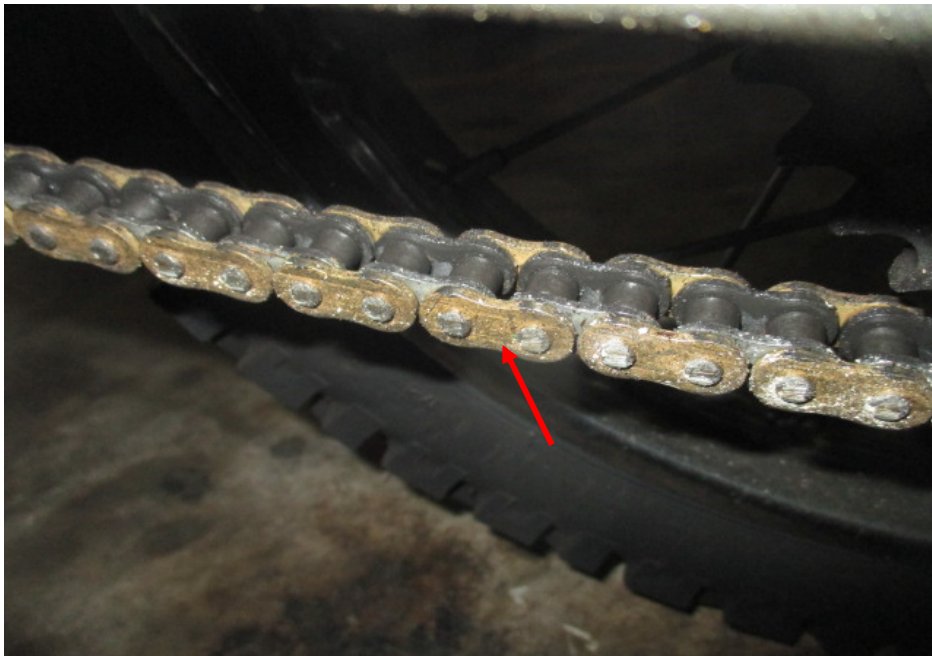
**Photo 15** shows a closer view of the gear train (arrowed) of the Motorcycle, which was observed to be intact with no misalignment. It was also adequately lubricated for operating purposes.

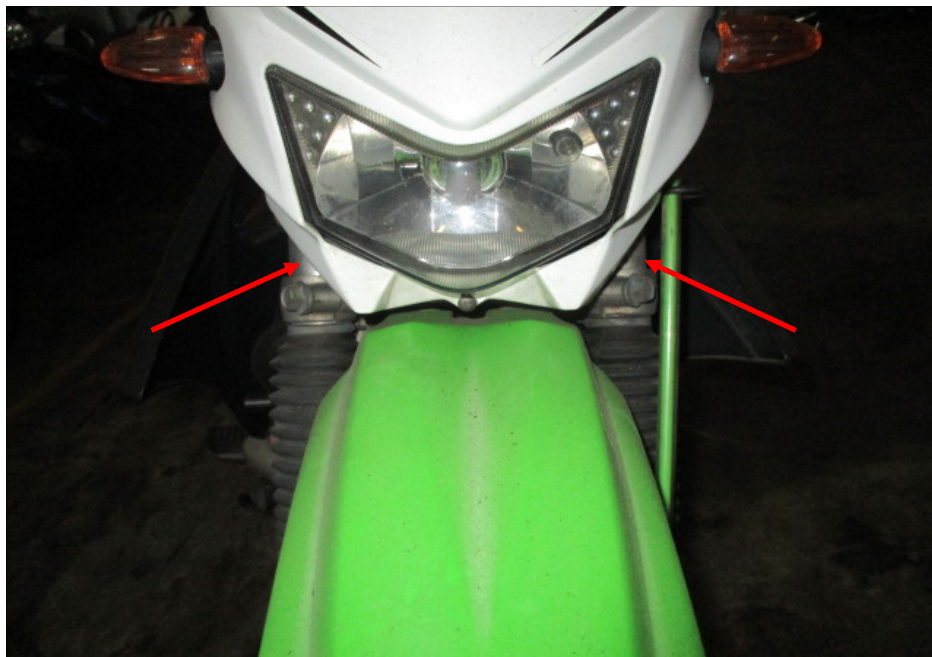
**Photo 16** shows the front fork (arrowed) of the Motorcycle. The front fork and fork bracket of the Motorcycle were both found to be intact and undamaged. Turning the Motorcycle's handle bar towards the left and right did not produce any abnormal free play and/or resistance. The steering system of the Motorcycle was in serviceable condition at the time of our inspection.

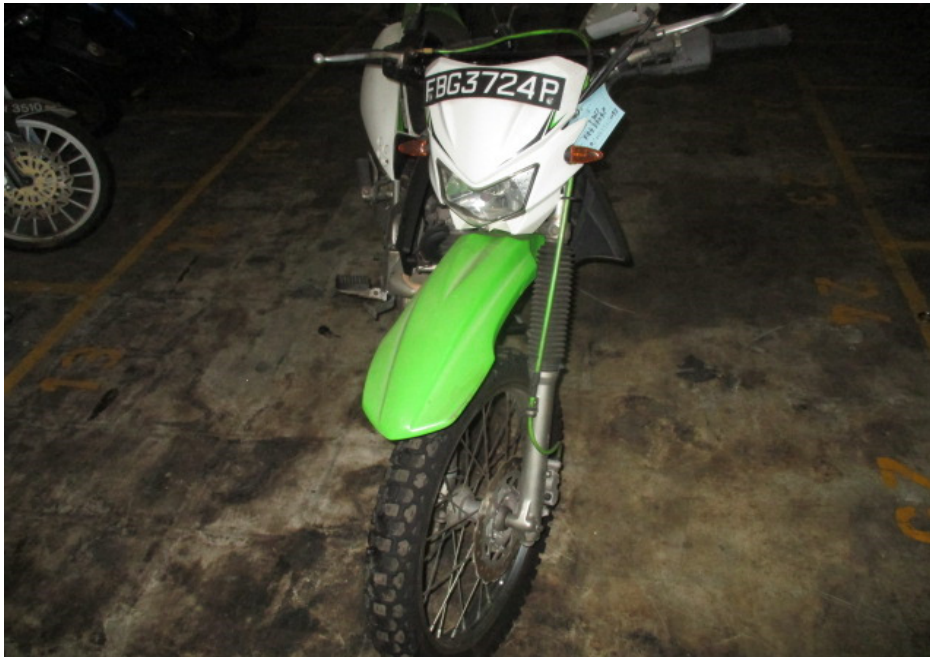
**Photo 17** shows the front wheel of the Motorcycle turned towards its full right. Turning the Motorcycle's handle bar towards the left and right did not produce any abnormal free play and/or resistance. This would indicate that the steering system of the Motorcycle was in serviceable condition at the time of our inspection.

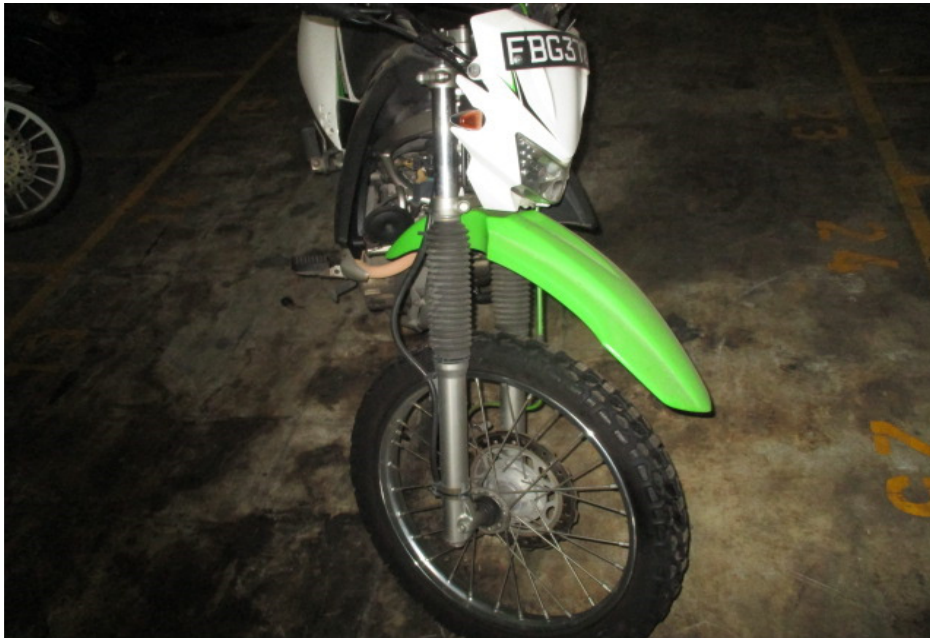
**Photo 18** shows the front wheel of the Motorcycle turned towards its full left. Turning the Motorcycle's handle bar towards the left and right did not produce any abnormal free play and/or resistance. This would indicate that the steering system of the Motorcycle was in serviceable condition at the time of our inspection.

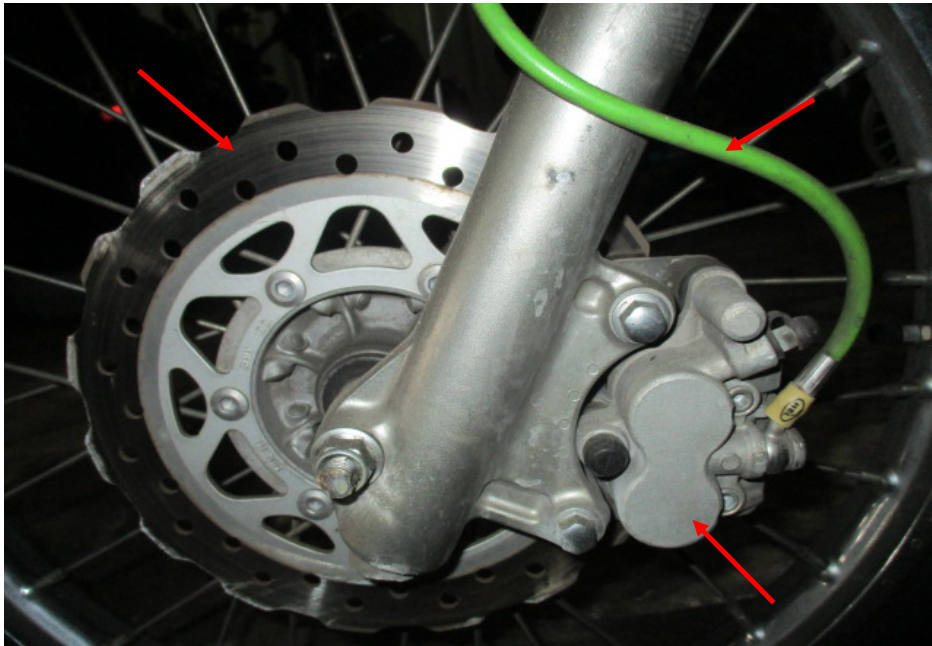
**Photo 19** shows a close up view of the front brake caliper, front brake disc and front brake hose (arrowed) of the Motorcycle, which are all part of the components in the hydraulic front brake system of the Motorcycle. Our visual checks of these various components had revealed all to be intact with no visible damage. No leakage of brake fluid was also observed.

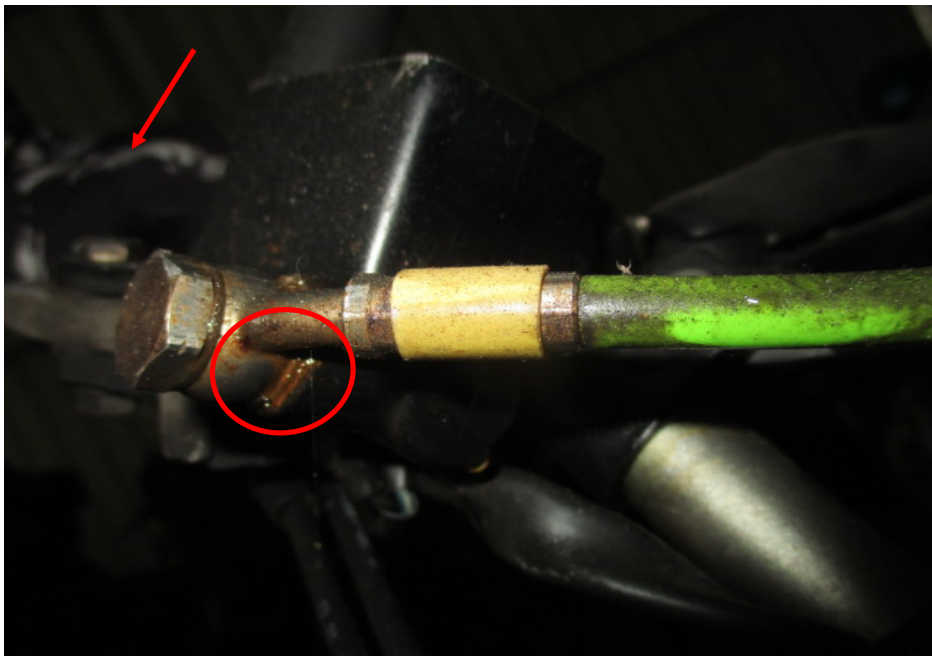
14. However a leakage of brake fluid from the front brake fluid reservoir was observed when the front brake lever was depressed. The leakage of brake fluid from the front brake fluid reservoir could have been due to the accident as the front brake fluid reservoir was found to be bent inwards causing a crack to the front brake fluid reservoir. The front brake reservoir was also found to be corroded.

**Photo 20** shows the brake fluid reservoir for the front brake of the Motorcycle. A leakage of brake fluid from the front brake fluid reservoir was observed (circled) when the front brake lever was depressed (arrowed).

18. Basing on our physical inspection of the Motorcycle, it appears that the steering system and rear braking system of the Motorcycle were all in serviceable condition. However the front braking system of the Motorcycle was not in serviceable condition.
19. Our findings revealed that the front brake fluid reservoir was found to be corroded. Corrosion of metal parts in the front braking system occurs when water absorbed from moisture in the air by the brake fluid disperses through the brake fluid. The water in the contaminated fluid will cause any metal part in the brake system like the master cylinder, wheel cylinder and pistons to corrode which may lead to failure of these parts. This may cause the front brake to be ineffective.

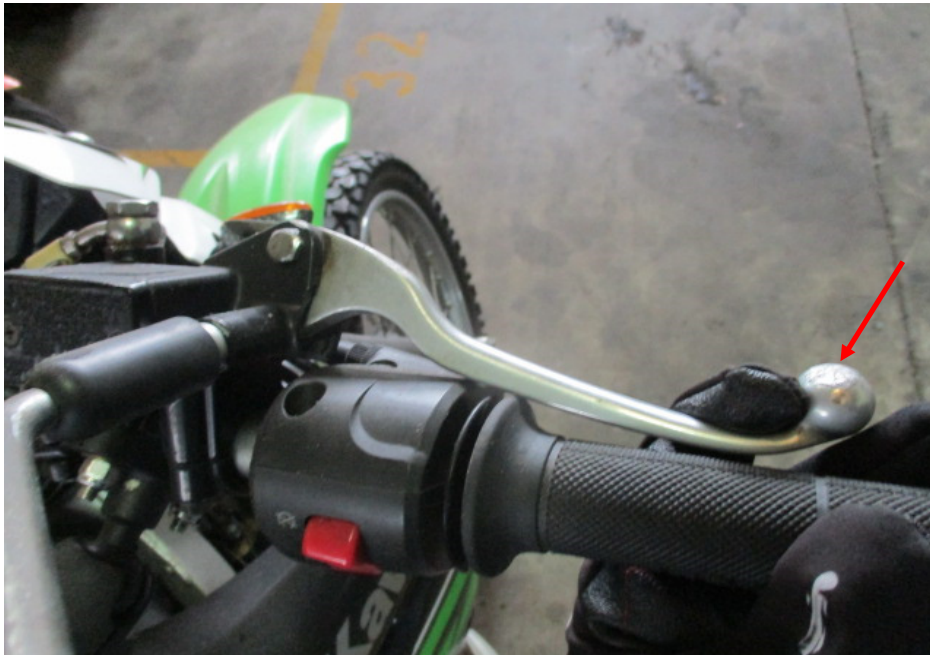
**Photo 21** shows the front brake lever being depressed. There was no resistance felt (spongy like feel) upon pressing the front brake lever (arrowed). This would indicate that there is leakage of pressure/vacuum in the brake system.

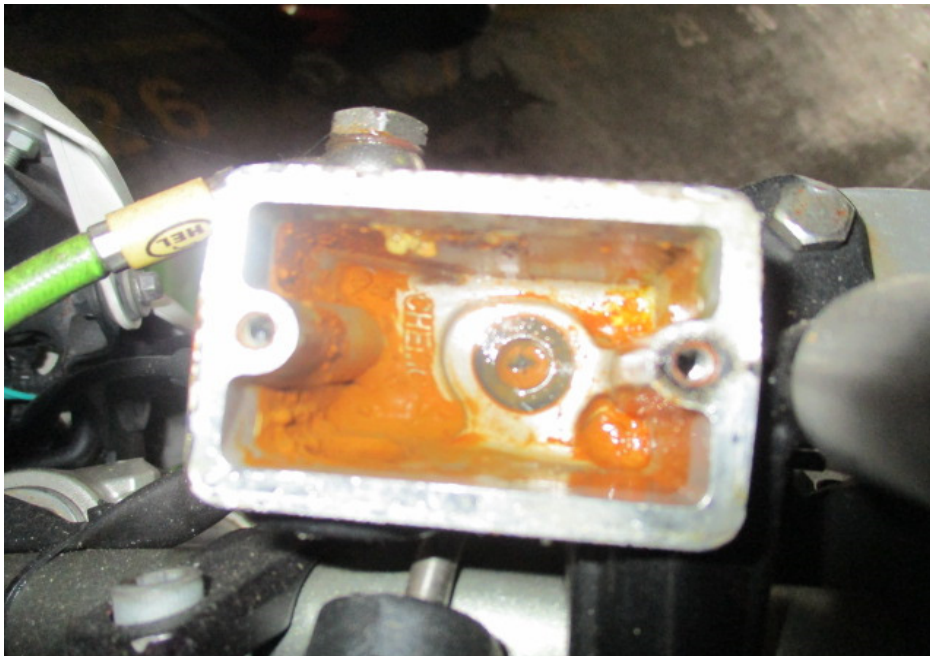
**Photo 22** shows the brake fluid reservoir for the front brake of the Motorcycle. The brake fluid was observed to be of insufficient level for operational purposes, which is most likely due to the leakage from the brake fluid reservoir. The brake fluid reservoir was also observed to be corroded.

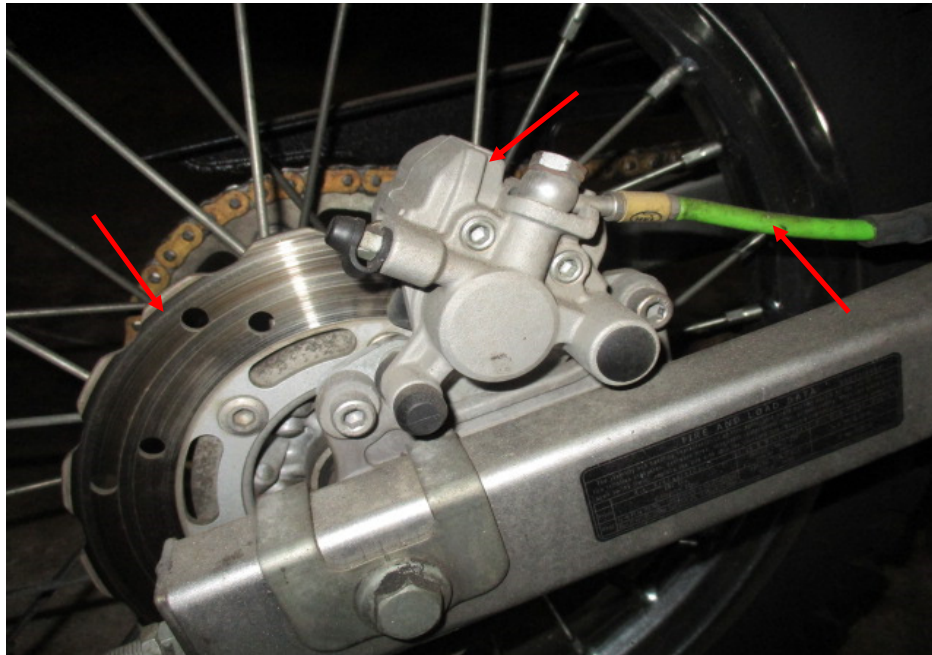
13. Our visual examination of the various components in the Motorcycle's rear braking system like the brake disc, brake caliper, brake foot pedal and brake hose revealed all to be intact and without damage. The brake fluid for the rear brake was also found to be of sufficient level and without any contamination. There was no leakage of brake fluid observed along the brake hose. This was from the respective brake fluid reservoir to the rear brake caliper of the Motorcycle.

**Photo 23** shows a close up view of the rear brake caliper, rear brake disc and rear brake hose (arrowed) of the Motorcycle, which are all part of the components in the hydraulic rear brake system of the Motorcycle. Our visual checks of these various components had revealed all to be intact with no visible damage. No leakage of brake fluid was also observed.
