Your Ref: TP/IP/13095/2019
Our Ref : CI/TPD19008282/P

Fatal accident Investigation Team

MECHANICAL INSPECTION REPORT OF MOTOR CAR SJQ 5827R

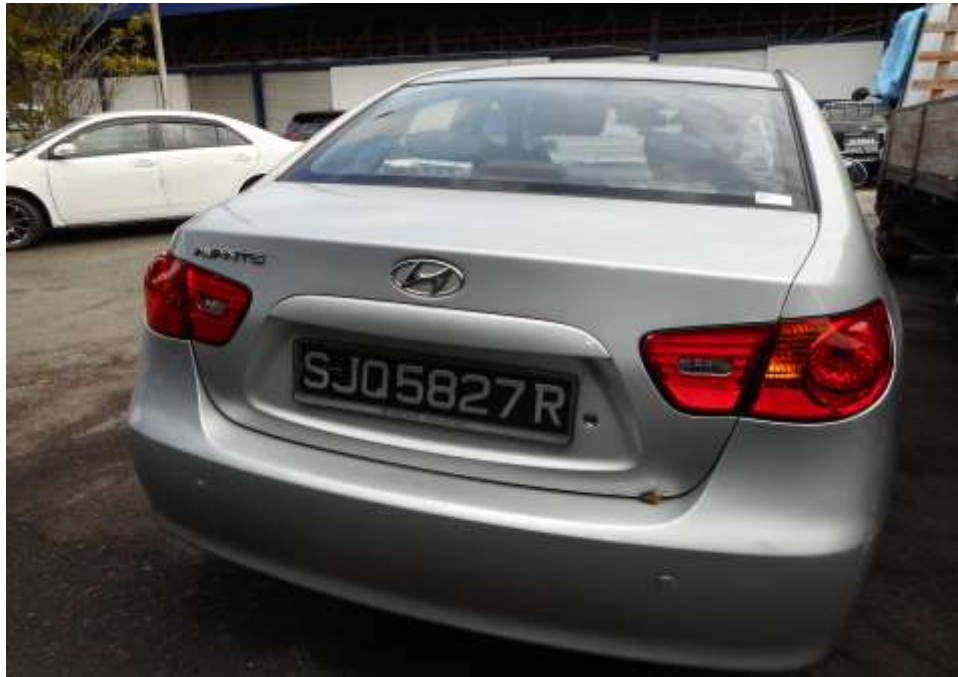
Photo 1 shows a general view of the rear portion of the Motor Car at the time of my inspection. The rear portion of the Motor Car was observed to have been unaffected by the accident.

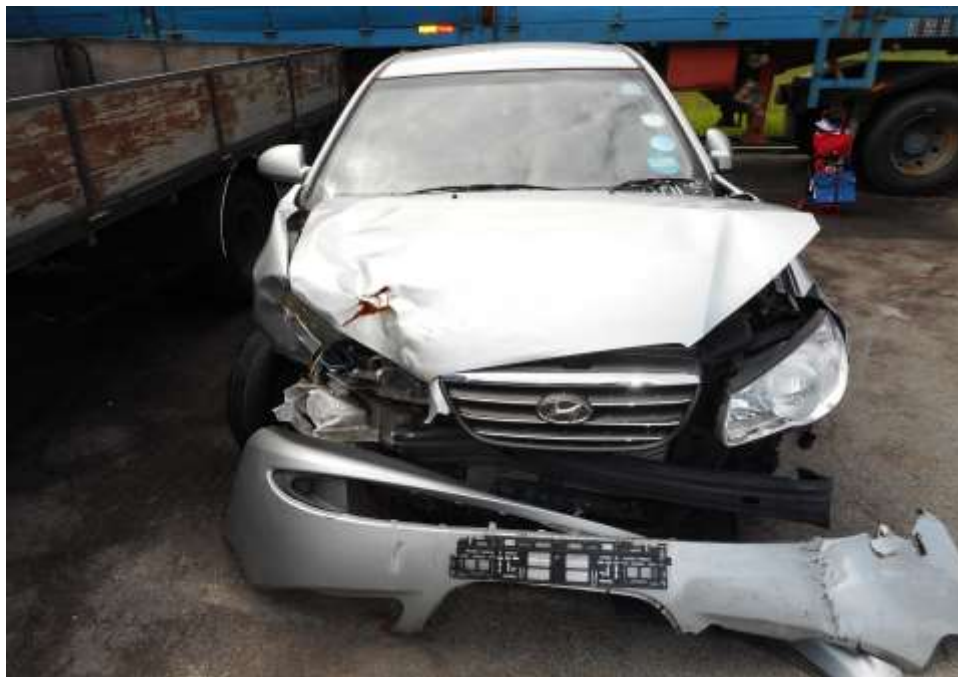
Photo 2 shows a general view of the front portion of the Motor Car at the time of my inspection. The Motor Car was also observed to have sustained extensive impact damage at its frontal and undercarriage portion, damaged parts had included its front windscreen, front bonnet, both front bonnet hinges, bonnet lock mechanism, front bumper, front number plate, left and right fenders, rear left body panel, engine system, radiator, front right headlamp and its undercarriage rear right lower arm were amongst the body parts that were observed to have been damaged as a result of the accident.

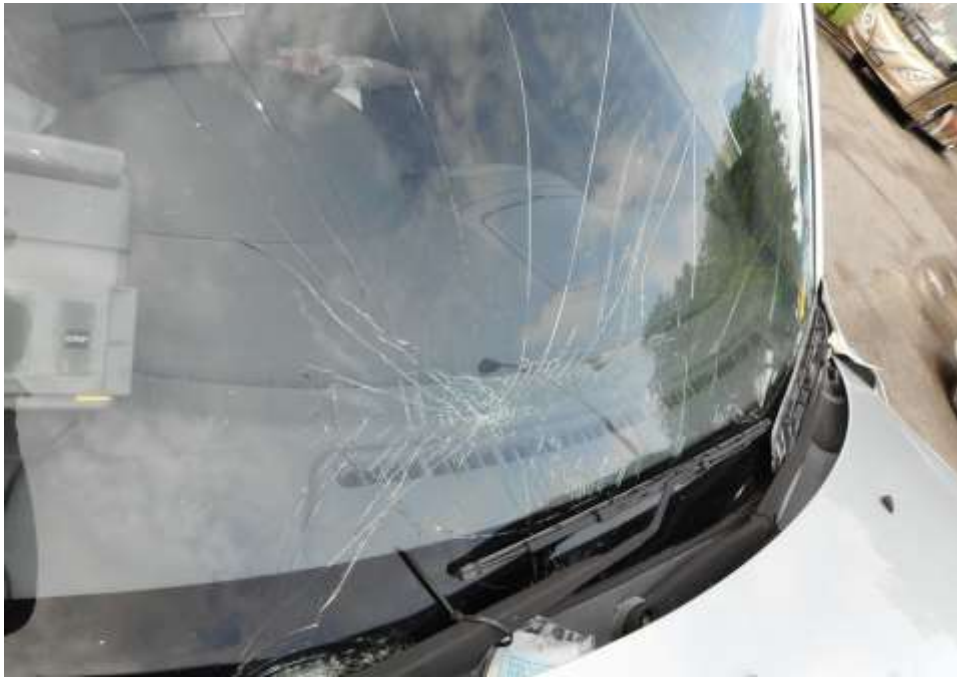
Photo 3 shows a close up view of the front windscreen of the Motor Car at the time of my inspection. The front windscreen of the Motor Car was observed to have been damaged as a result of the accident

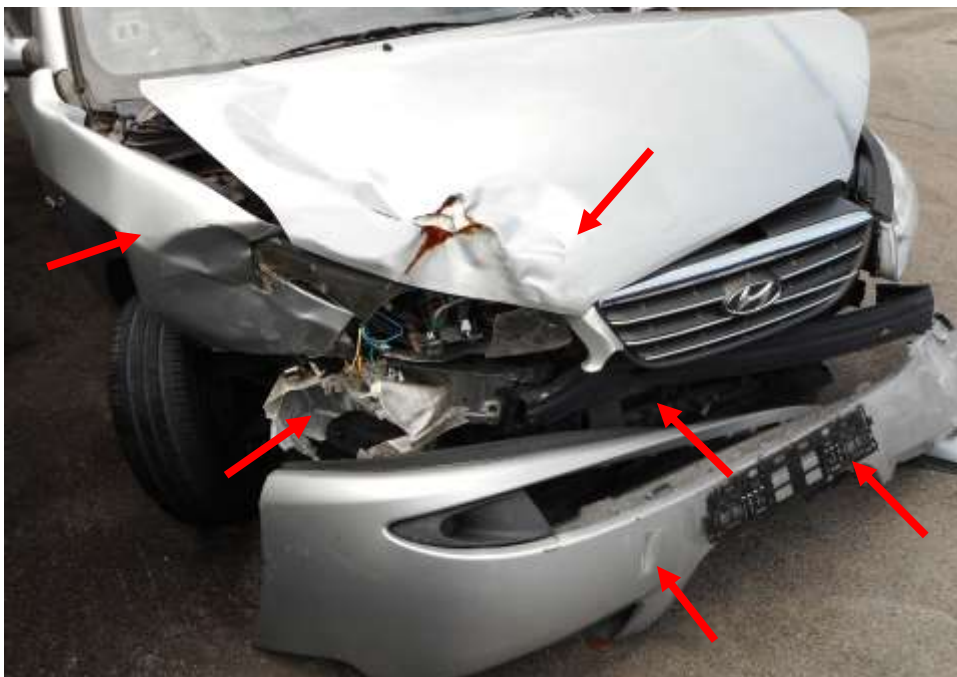
Photo 4 shows a general view of the front right portion of the Motor Car at the time of my inspection. The Motor Car was also observed to have sustained extensive impact damage at its frontal portal, damaged parts had included its, front bonnet, front bumper, right fender, engine system, radiator, front right headlamp (arrowed) were amongst the body parts that were observed to have been damaged as a result of the accident.

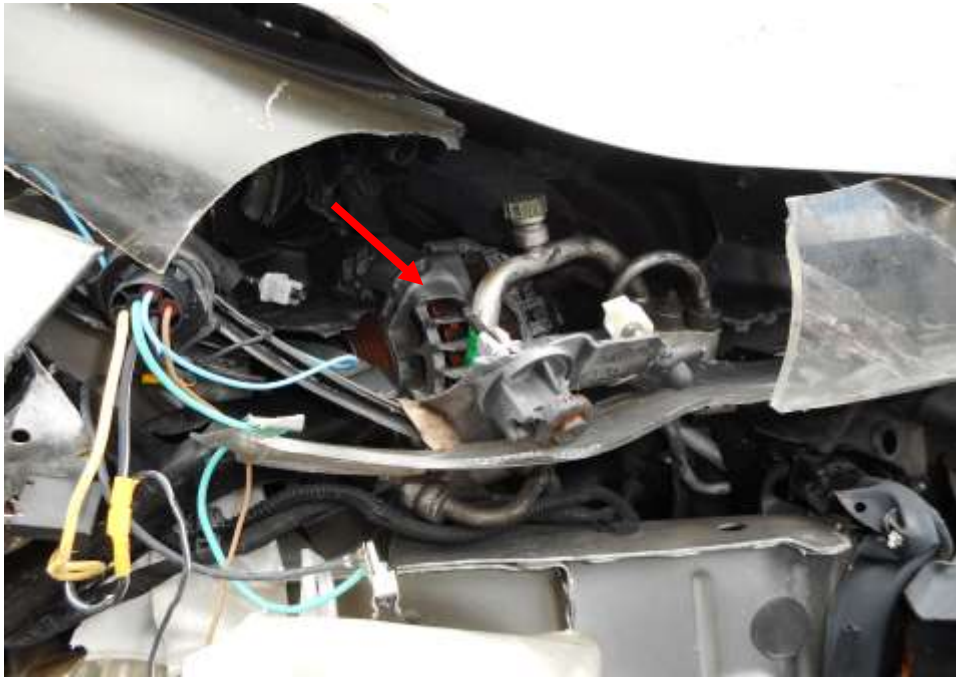
Photo 5 shows a close up view of the front portion of the Motor Car at the time of my inspection. The engine system (arrowed) of the Motor Car was observed to have been damaged as a result of the accident

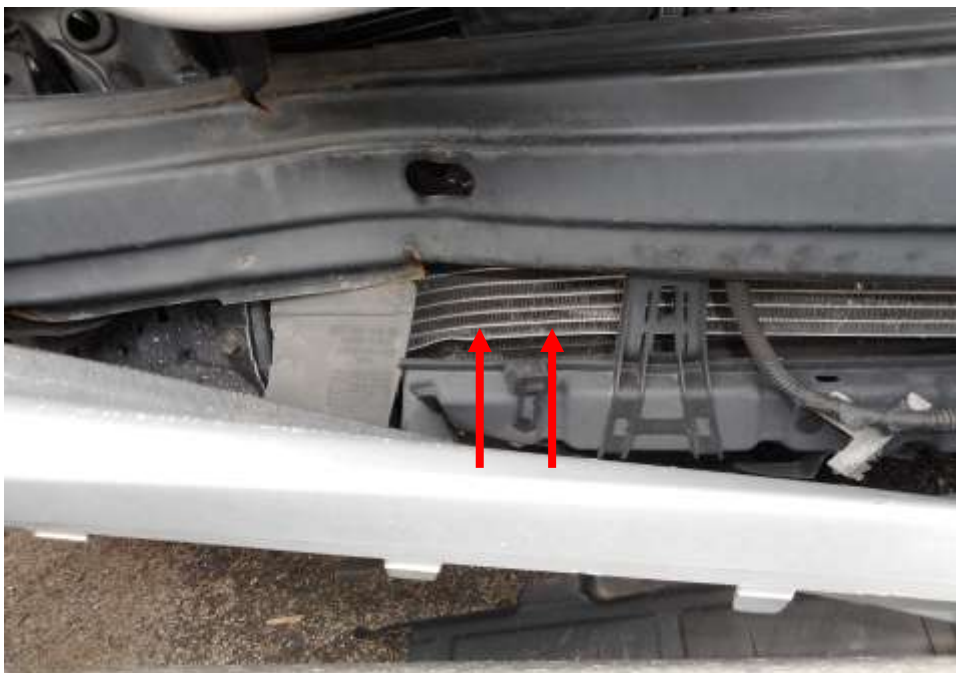
Photo 6 shows a close up view of the front portion of the Motor Car at the time of my inspection. The radiator of the Motor Car was observed to have been damaged by an induced impact as a result of the accident

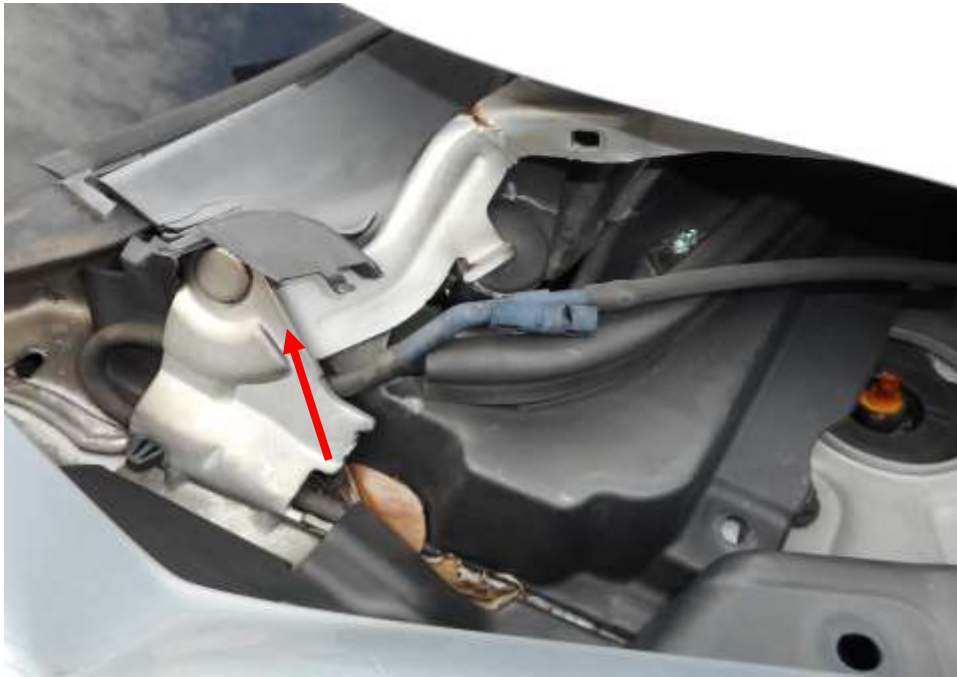
Photo 7 shows a close up view of the right bonnet hinge of the Motor Car at the time of my inspection. The right bonnet hinge of the Motor Car was observed to have been damaged as a result of the accident rendering the bonnet unable to be opened (arrowed)

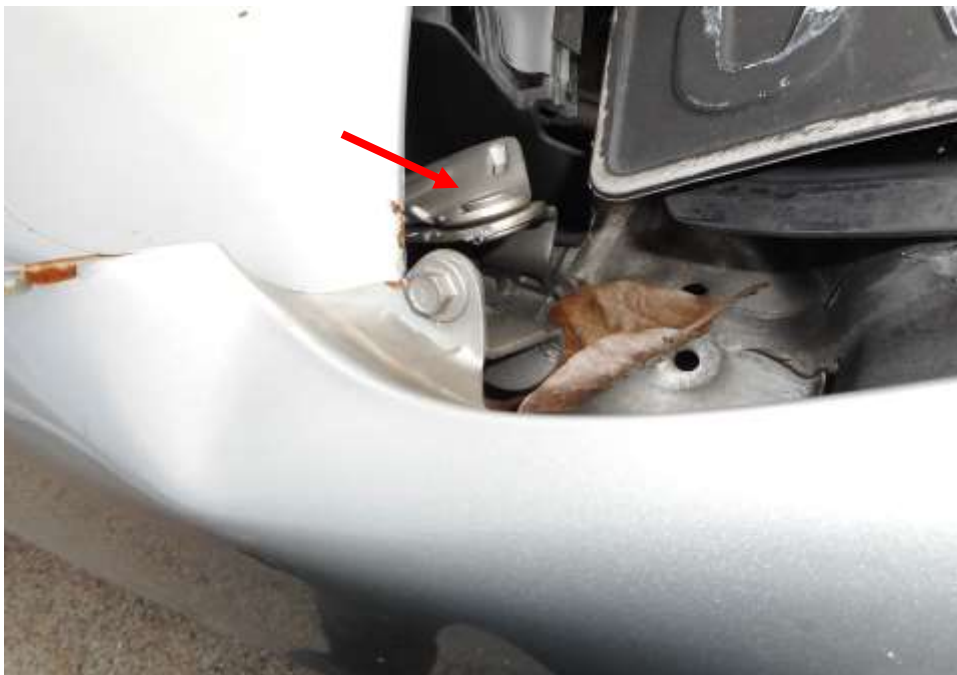
Photo 8 shows a close up view of the left bonnet hinge of the Motor Car at the time of my inspection. The left bonnet hinge of the Motor Car was observed to have been damaged as a result of the accident rendering the bonnet unable to be opened (arrowed)

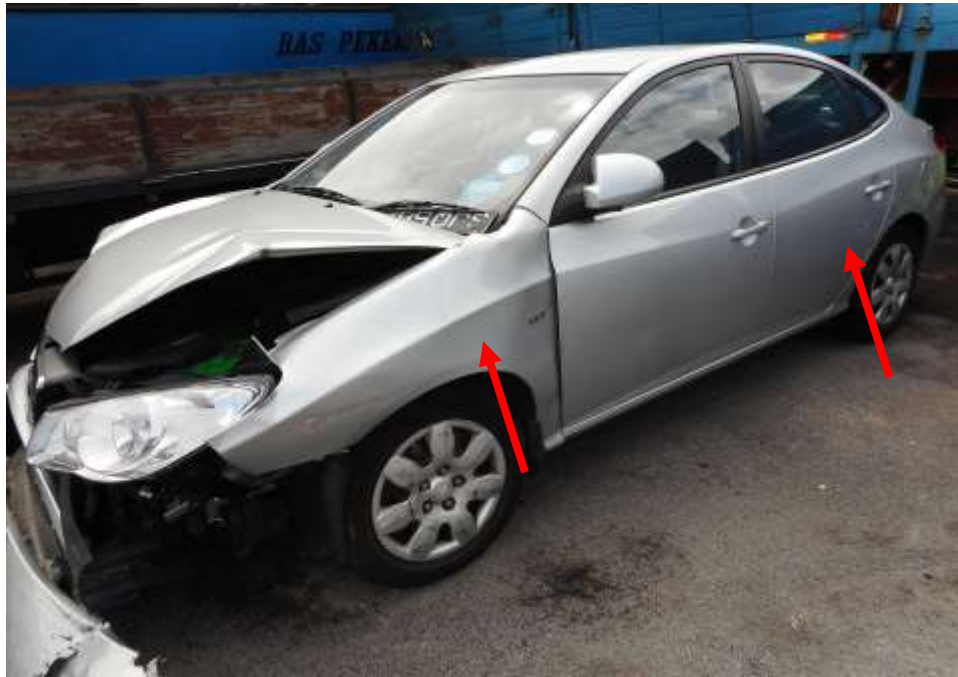
Photo 9 shows a general view of the front left portion of the Motor Car at the time of my inspection. The front left fender and the rear left body panel (arrowed) of the Motor Car was observed to have been damaged as a result of the accident.

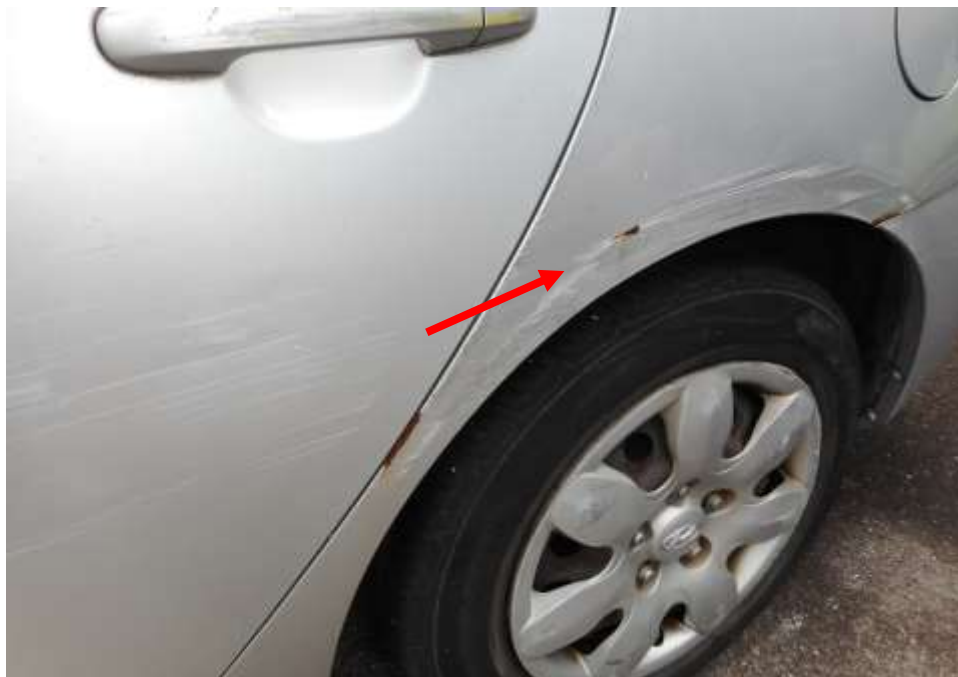
Photo 10 shows the close up view of the rear left panel portion of the Motor Car at the time of my inspection. The rear left body panel (arrowed) of the Motor Car was observed to have been damaged as a result of the accident.

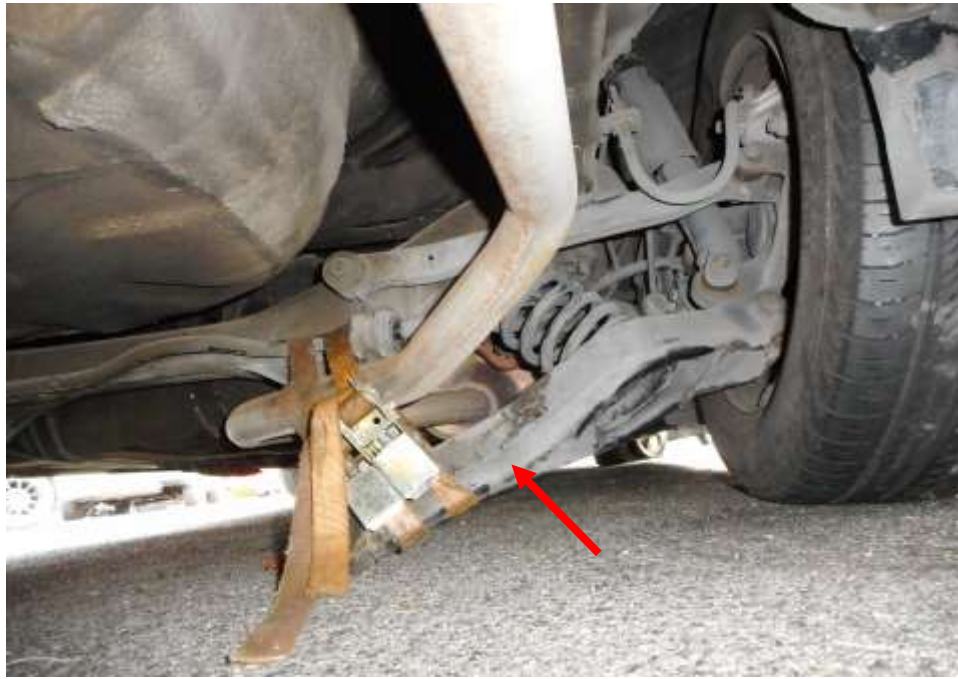
Photo 11 shows the close up view of the rear right suspension system of the Motor Car at the time of my inspection. The rear right lower arm (arrowed) of the Motor Car was observed to have been damaged as a result of the accident.

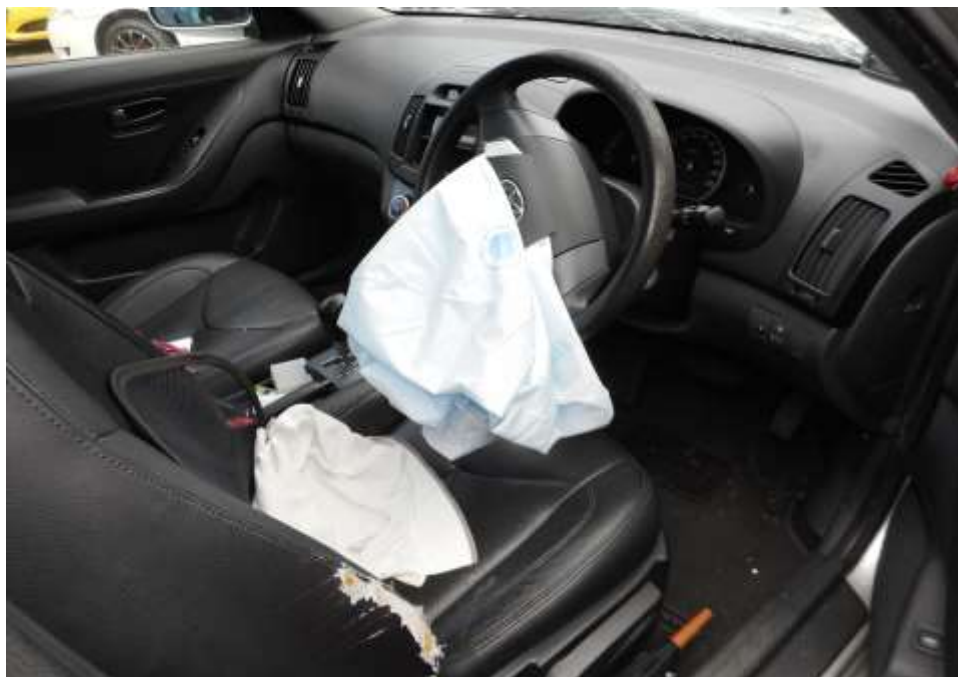
Photo 12 shows a general view of the Motor Car's interior compartment. The driver's air bag, were also deployed as a result of the accident.

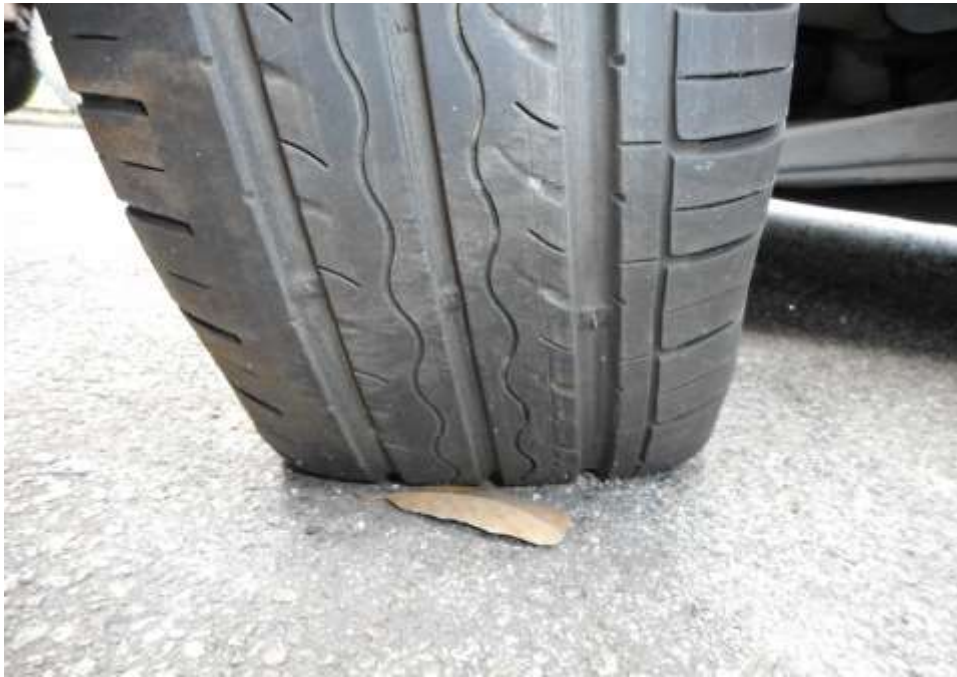
Photo 13 shows the condition of the rear left tyre of the Motor Car, which was observed to be in serviceable condition with remaining tread depth of approximately 4.6mm. There was no tear, cut or burst mark(s) on the outer and the inner sidewalls as well as across the tread of this tyre, however observed to be deflated due to damage to the rims.

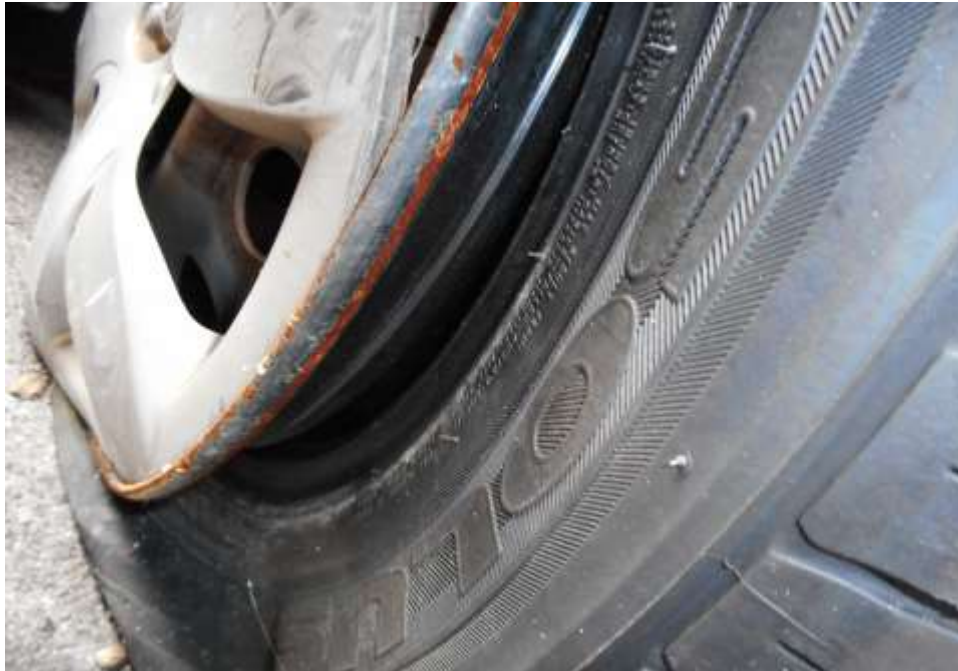
Photo 14 shows the condition of the front right wheel rim of the Motor Car. The tyre was observed to be sustained damage, dislodged from the rim and deflated as a result of the accident.

18. Although the front right tyre was dislodged from the rim and deflated as a result of the accident. The other 3 tyres of the Motor Car were found to be in serviceable condition with remaining tread depth of approximately 3.6mm to 4.6mm which were deflated as a result of the accident.

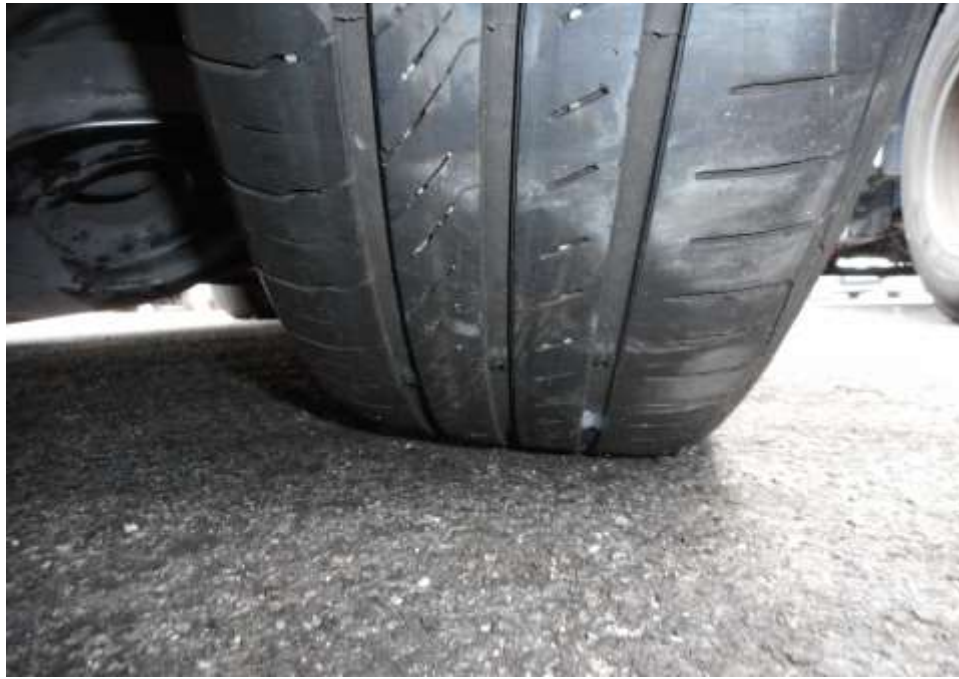
Photo 15 shows the condition of the rear right tyre of the Motor Car, which was observed to be in serviceable condition with remaining tread depth of approximately 4.3mm. There was no tear, cut or burst mark(s) on the outer and the inner sidewalls as well as across the tread of this tyre, however observed to sustained minor scratches to the rim as a result of the accident.

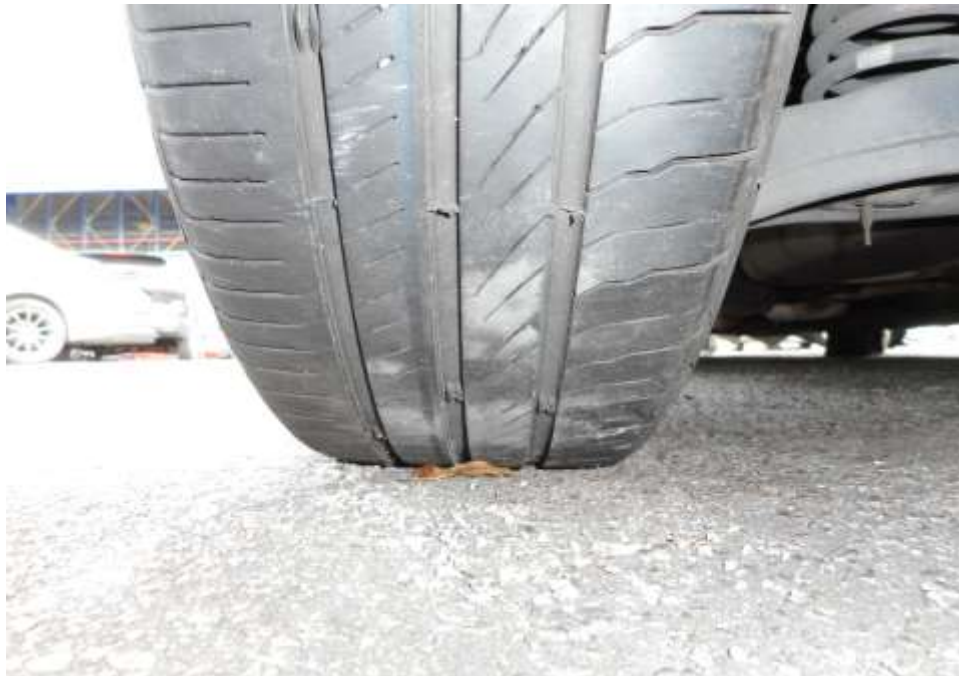
Photo 16 shows the condition of the rear left tyre of the Motor Car, which was observed to be in serviceable condition with remaining tread depth of approximately 4.5mm. There was no tear, cut or burst mark(s) on the outer and the inner sidewalls as well as across the tread of this tyre.

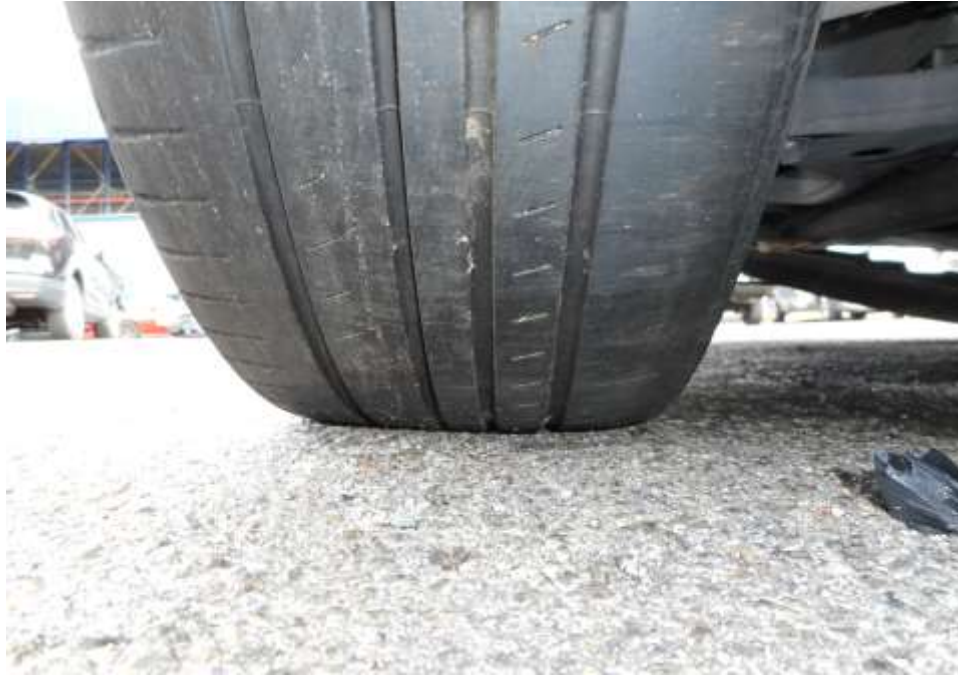
Photo 17 shows the condition of the front left tyre of the Motor Car, which was observed to be in serviceable condition with remaining tread depth of approximately 3.6mm. There was no tear, cut or burst mark(s) on the outer and the inner sidewalls as well as across the tread of this tyre, however observed to be deflated due to damage to the rims.

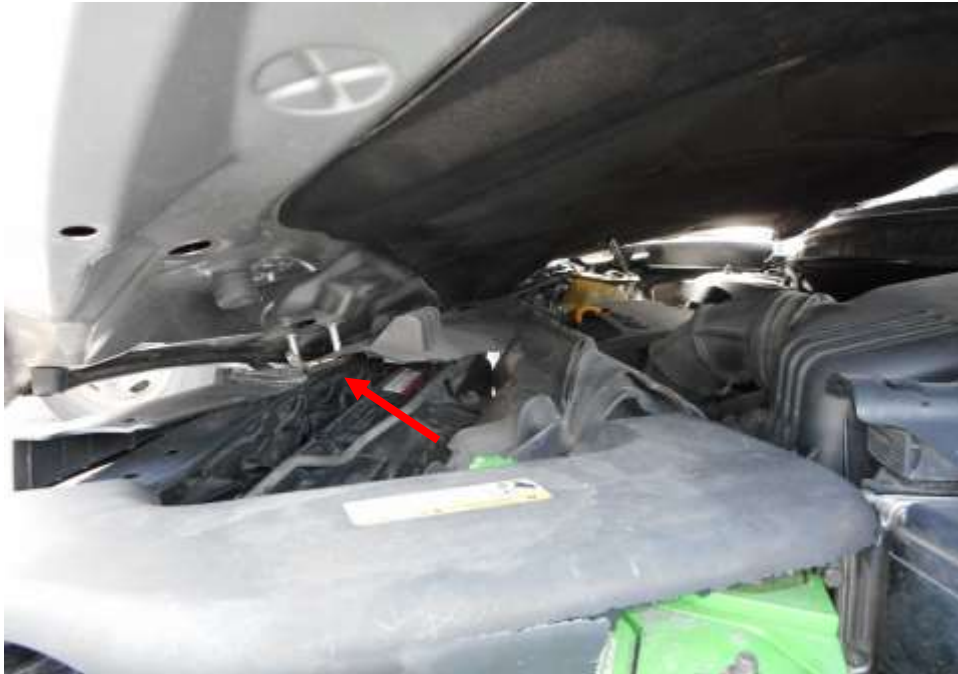
10. The impact from the collision had affected the engine compartment of the Motor Car. Parts towards the front of the engine compartment were observed to be damaged. The locking mechanism and the hinges of the Motor Car's front bonnet were also affected and I was unable to unlock and lift the front bonnet to carry out examination of the Motor Car's engine compartment. The various operating fluids like its engine coolant, brake fluid and transmission fluid etc were hence unable to be inspected. See photo 18 below.

Photo 18 shows the damage to the locking mechanism (arrowed) Motor Car's front bonnet, rendering it unable to be unlocked and lifted up to carry out examination of the Motor Car's engine compartment as a result of the accident.

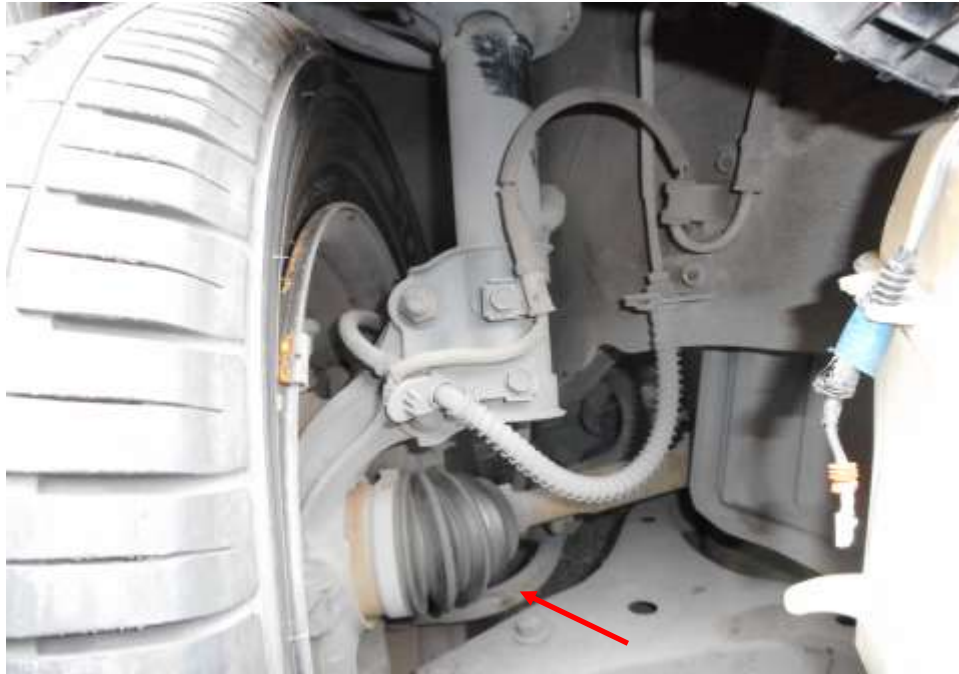
Photo 19 shows the undercarriage components at the front right wheel of the Motor Car. My checks on the underside of the Motor Car revealed damage to the various undercarriage components, the steering rack and pinion, tie rods, tie rod ends and ball joints (arrowed) revealed that these components were all generally in good condition.

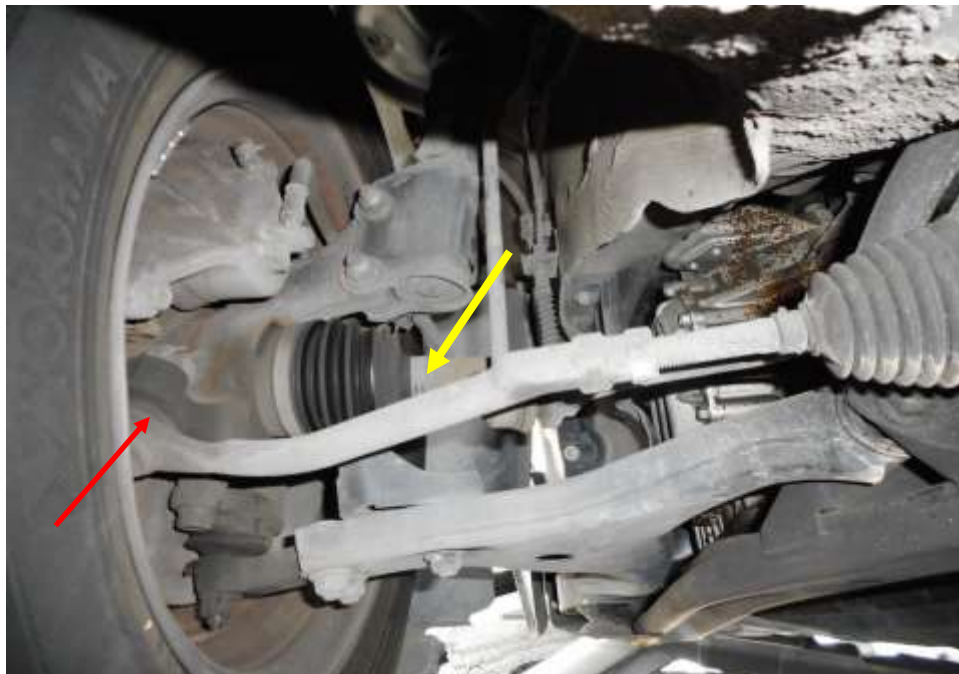
Photo 20 shows the various undercarriage components at the front left wheel of the Motor Car, which had included the steering tie rod (red arrow) and front left drive shaft (yellow arrow). The various undercarriage components of the Motor Car were all found to be intact without any visible damage.

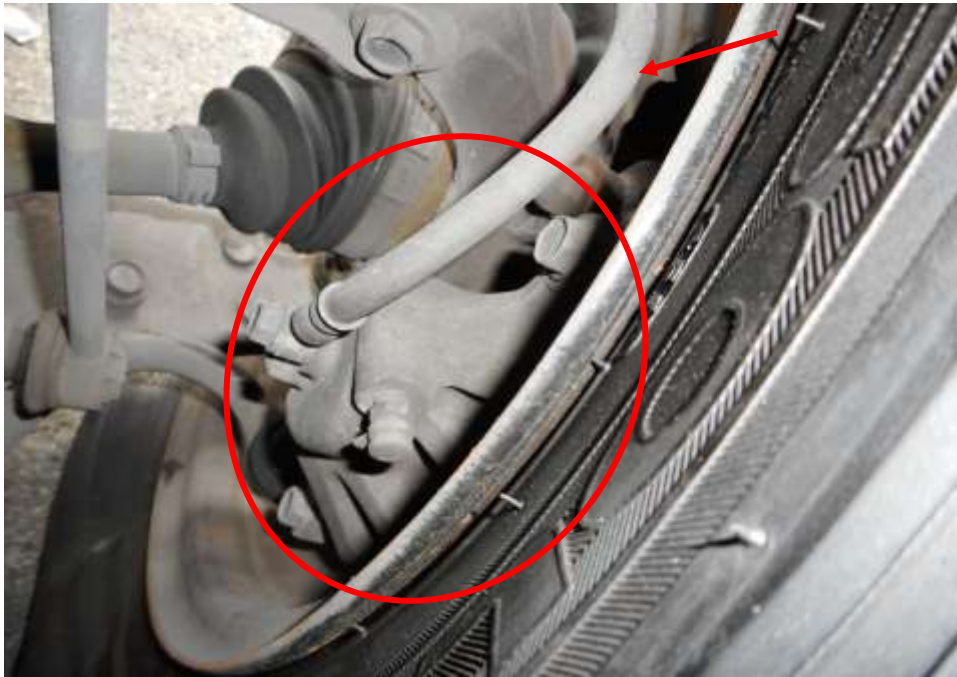
Photo 21 shows the brake hose (arrowed) at the front right wheel of the Motor Car. I did not observe any leakage of brake fluid at the 4 wheels of the Motor Car. My visual inspection of the various mechanical components of the Motor Car's braking system, including its brake caliper (circled), revealed all to be intact and without visible damage.

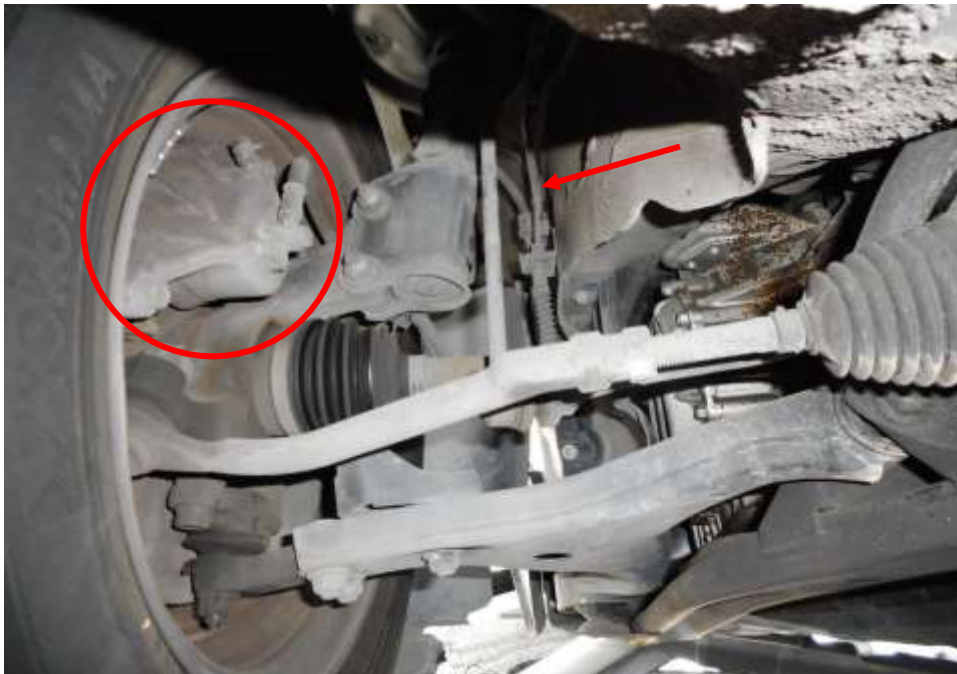
Photo 22 shows the brake hose (arrowed) at the front left wheel of the Motor Car. I did not observe any leakage of brake fluid at the 4 wheels of the Motor Car. My visual inspection of the various mechanical components of the Motor Car's braking system, including its brake caliper (circled), revealed all to be intact and without visible damage.

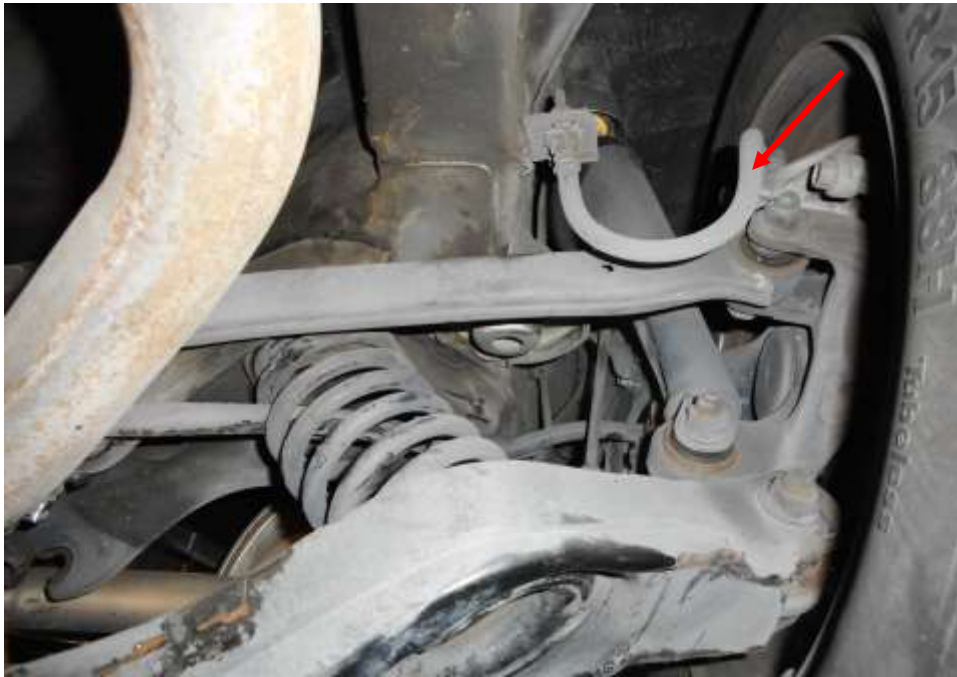
Photo 23 shows the various undercarriage components at the rear right wheel of the Motor Car, in particular the brake hose (arrowed). I did not observe any leakage of brake fluid at the 4 wheels of the Motor Car. My visual inspection of the various mechanical components of the Motor Car's braking system revealed all to be intact and without visible damage.

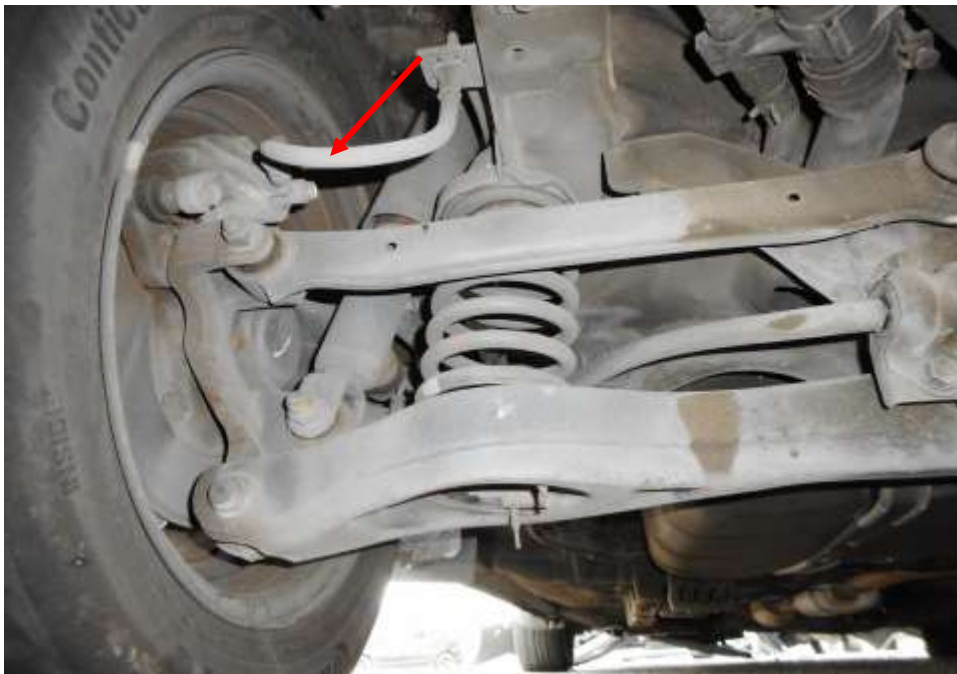
Photo 24 shows the various undercarriage components at the rear left wheel of the Motor Car, in particular the brake hose (arrowed). I did not observe any leakage of brake fluid at the 4 wheels of the Motor Car. My visual inspection of the various mechanical components of the Motor Car's braking system revealed all to be intact and without visible damage.
