Your Ref: BMW 750i  
(chassis number WBA7A820X0G243729)  
Our Ref : CI/TP19008680/D

15 May 2019

**INSPECTION REPORT OF AN UNREGISTERD BMW 750i MOTOR CAR WITH CHASSIS NUMBER WBA7A820X0G243729**

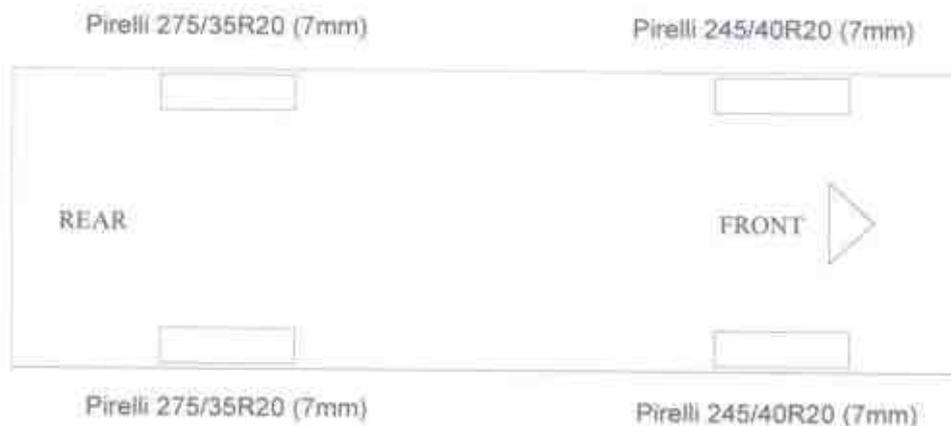
6. It was fitted with 20inch sport wheel rims that were wrapped with tyres that were observed to be of serviceable condition. The tyres were also sufficiently inflated for vehicular operation. The tyre brand, tyre size and approximate remaining tread depth of the 4 tyres of the Motor Car were recorded as follows; -

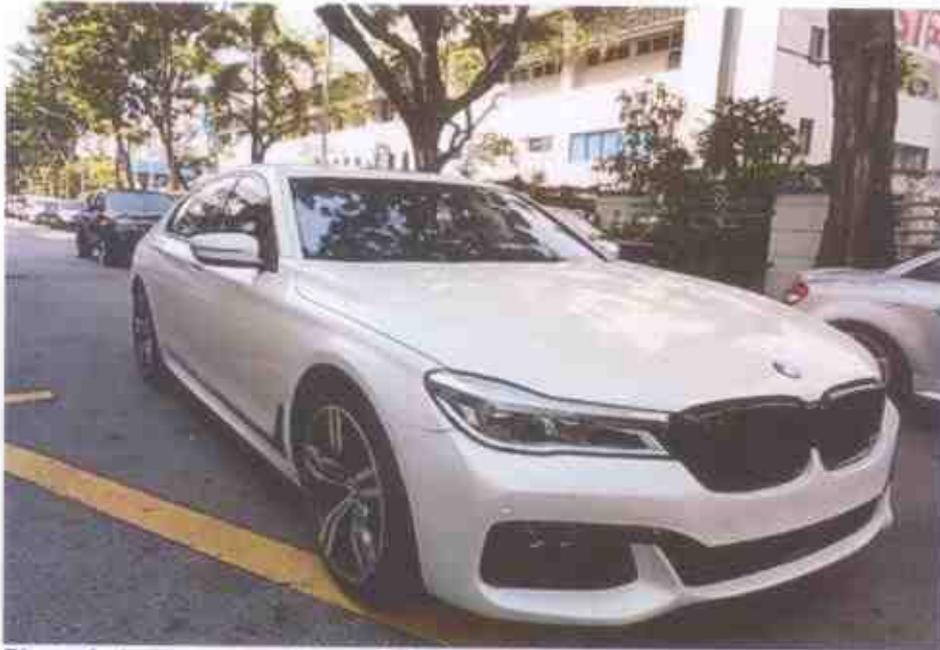
**Photo 1** shows a general view of the front right body of the Motor Car at the time of my inspection. The Motor Car was observed to be in relatively good general condition with no loose exterior fittings observed.

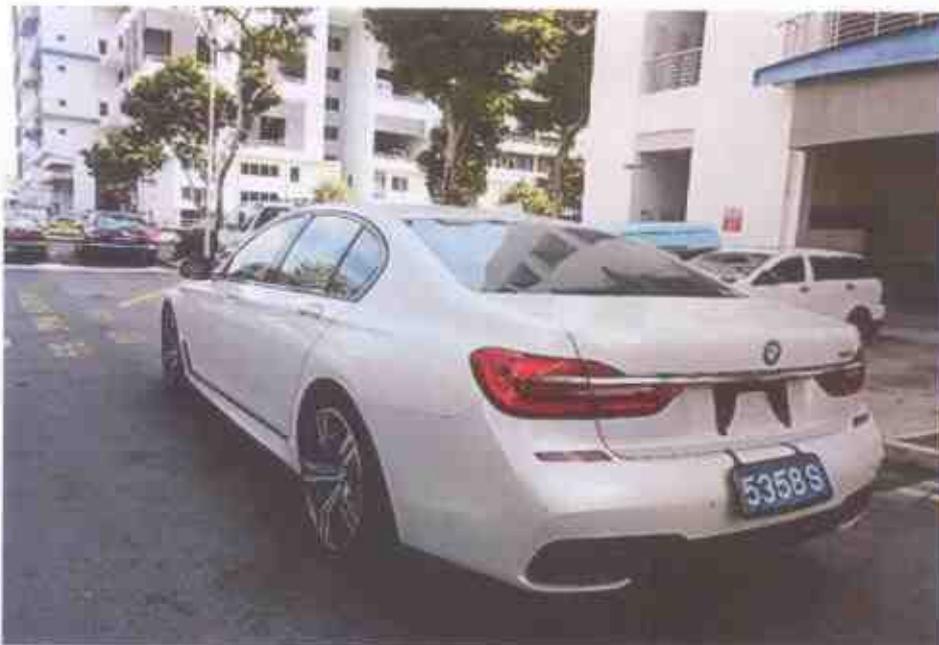
**Photo 2** shows a general view of the rear left body of the Motor Car at the time of my inspection. The Motor Car was observed to be in relatively good general condition with no loose exterior fittings observed.

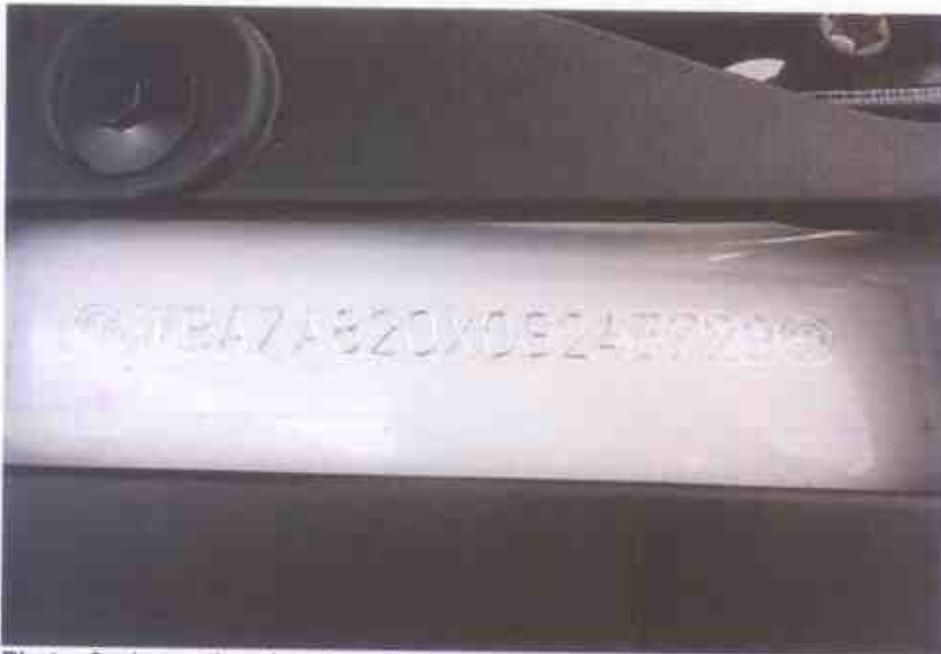
Photo 3 shows the chassis number of the Motor Car. The chassis number recorded was WBA7A820X0G243729.

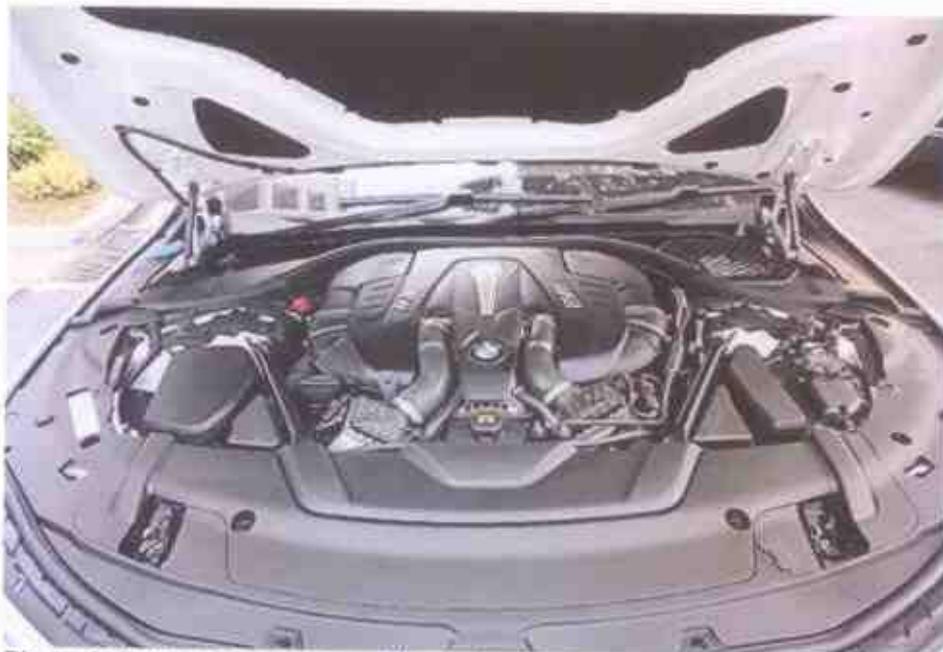
12. My examination of the engine compartment of the Motor Car revealed that the various parts and components inside the engine compartment were all intact and properly fitted. The engine oil, brake fluid and engine coolant were all found to be of sufficient level for operating purposes. Visually, there was also no contamination found to these fluids.
13. My checks on the underside of the Motor Car revealed no sign(s) or indication(s) of fluid leakage and/or fluid stain(s). The engine block and automatic transmission assembly were both secured properly. They were not mounted onto the chassis body or any integral body part of the Motor Car. All undercarriage components of the Motor Car were also observed to be intact and secured in an appropriate manner.

Photo 4 shows a general view of the engine compartment of the Motor Car at the time of my inspection. The various parts and components inside the engine compartment were all observed to be intact and properly fitted. There was also no sign(s) or indication(s) of fluid leak and/or fluid stain found inside the engine compartment.

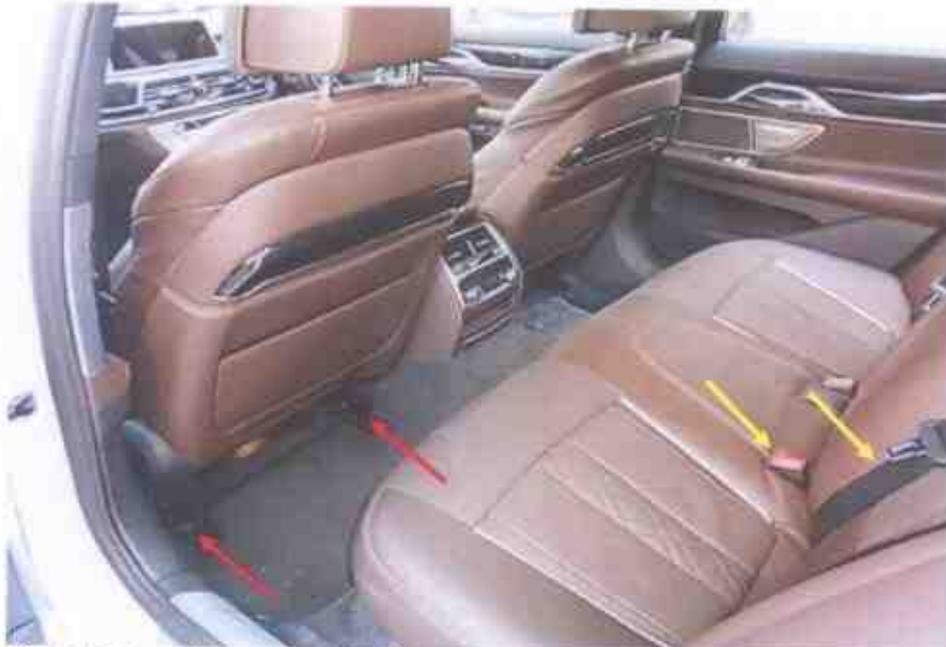
10. The seats of the Motor Car were found to be secured to the floor board of the Motor Car via seat rails bolted onto the floor board. Retractable seat belt reels and pre-tensioners were fitted on all seats of the Motor Car. The seat belt reels were able to be fastened securely into the respective pre-tensioners that are fixed to the side of all the seats.

Photo 5 shows the seats of the Motor Car, which were secured via seat rails (red arrows) to the floor board. All the seats of the Motor Car were fitted with a retractable seat belt reel and pre-tensioner (yellow arrows). The seat belts were also able to be fastened into the respective pretensions that were fitted on the side of each individual seat.

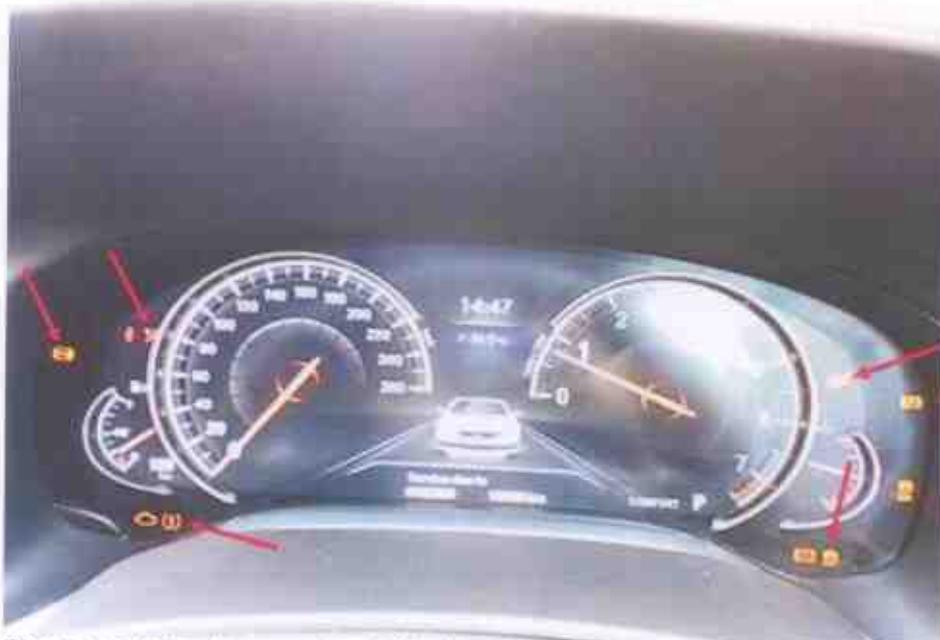
Photo 6 shows the warning lights for the various electronic safety features appearing on the instrument panel of the Motor Car during its self-test when the engine is cranked, in particular the ABS, SRS, IAS, TPM and DSC lights (arrowed).

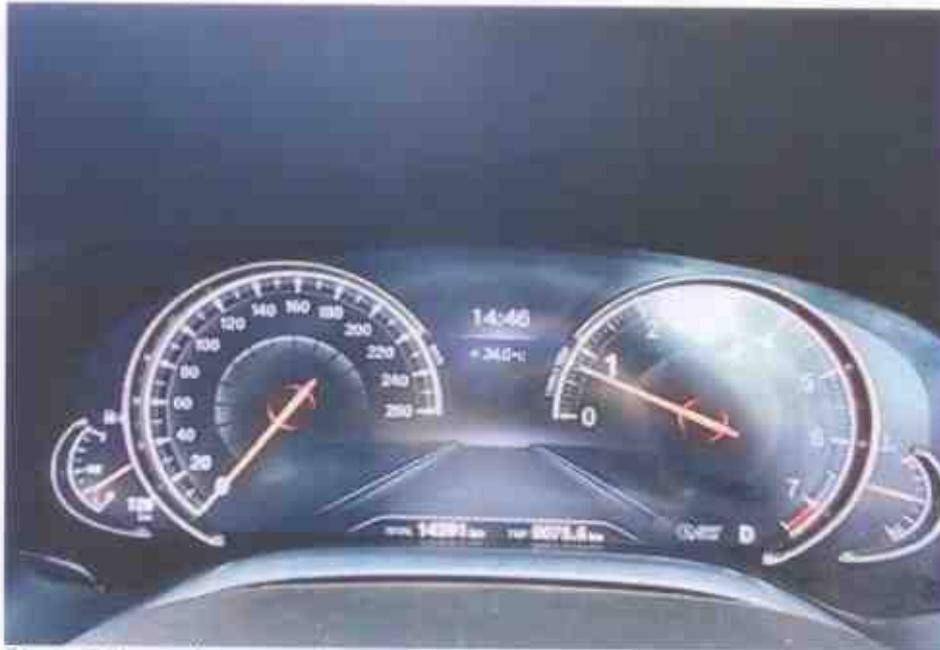
11. The Motor Car's automatic self-test of the functionality of its various electronic safety features like the Anti-Lock Brake System (ABS), Supplemental Restraint System (SRS), Integral Active Steering (IAS), Tyre Pressure Monitor (TPM) and Dynamic Stability Control (DSC) during cranking of the engine had indicated that these electronic systems were in working condition. This was determined from the respective warning lights disappearing from the instrument panel after the self-test.

**Photo 7** shows the respective warning lights no longer illuminated, indicating that there is no fault detected to the ABS, SRS, IAS, TPM and DSC systems of the Motor Car during the self-test. These electronic systems were hence in working condition at the time of my inspection.

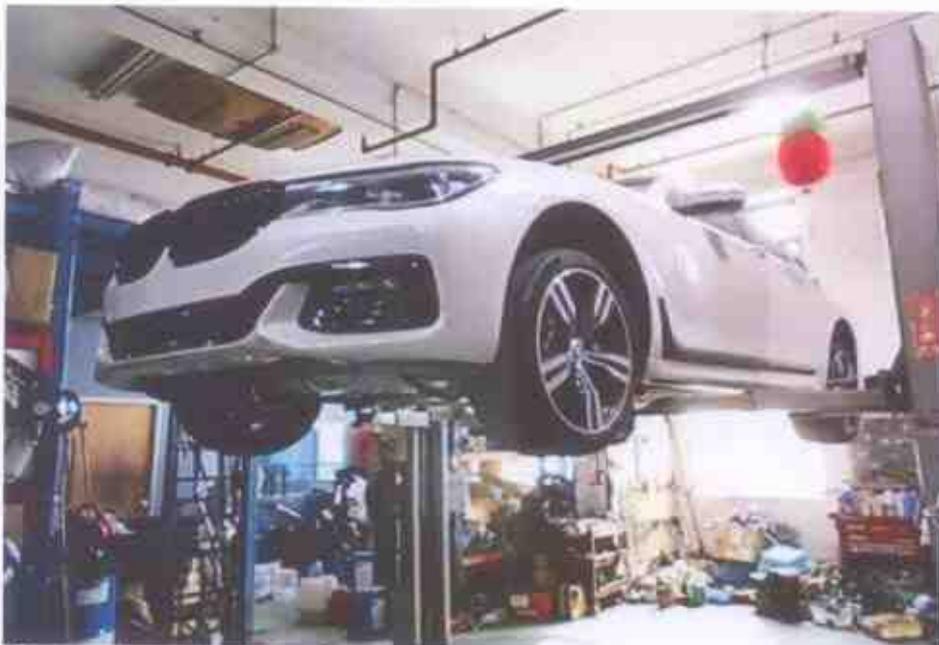
**Photo 8** shows the Motor Car hoisted up for checks on its undercarriage. There was no sign(s) or indication(s) of fluid leakage and/or fluid stain(s) on the underside of the Motor Car. The undercarriage components of the Motor Car were also all observed to be intact and secured in an appropriate manner.

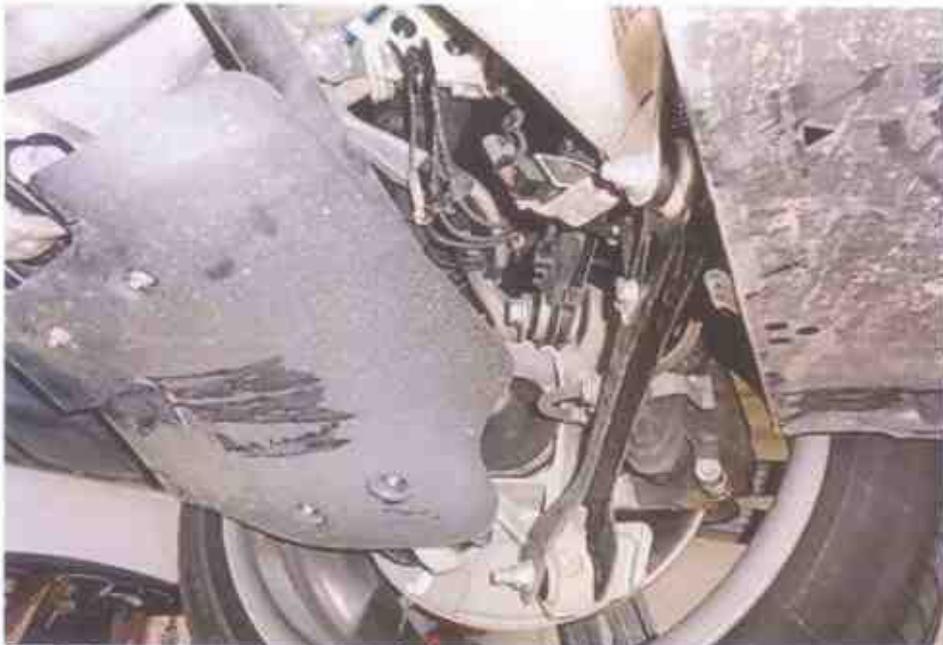
Photo 9 shows a general view of the control arms and linkages at the rear left wheel of the Motor Car. I did not observe any fluid leak and/or fluid stain on the underside of the Motor Car. All of the Motor Car's undercarriage components were observed to be intact and secured in an appropriate manner.

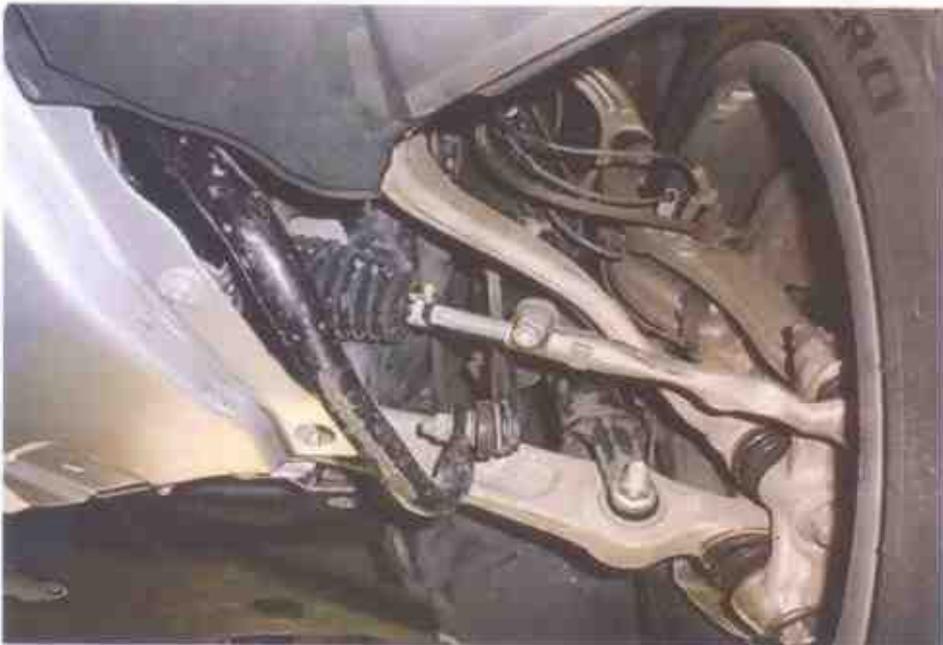
Photo 10 shows the various undercarriage components at the front left wheel of the Motor Car. The mechanical components, control arms and linkages were all found to be intact and secured in an appropriate manner.

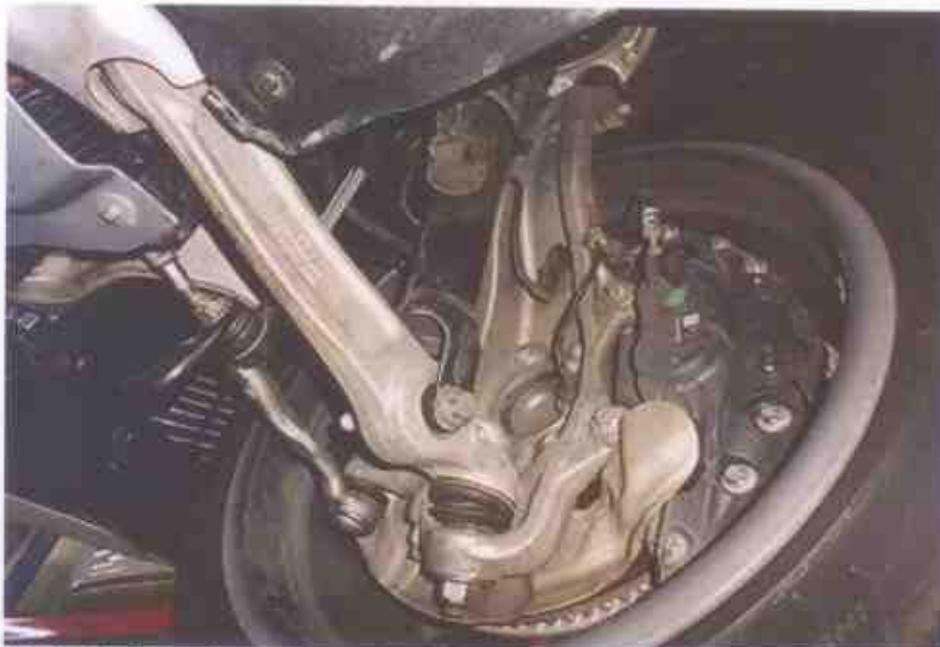
**Photo 11** shows the various undercarriage components at the front right wheel of the Motor Car. The mechanical components, control arms and linkages were all found to be intact and secured in an appropriate manner.

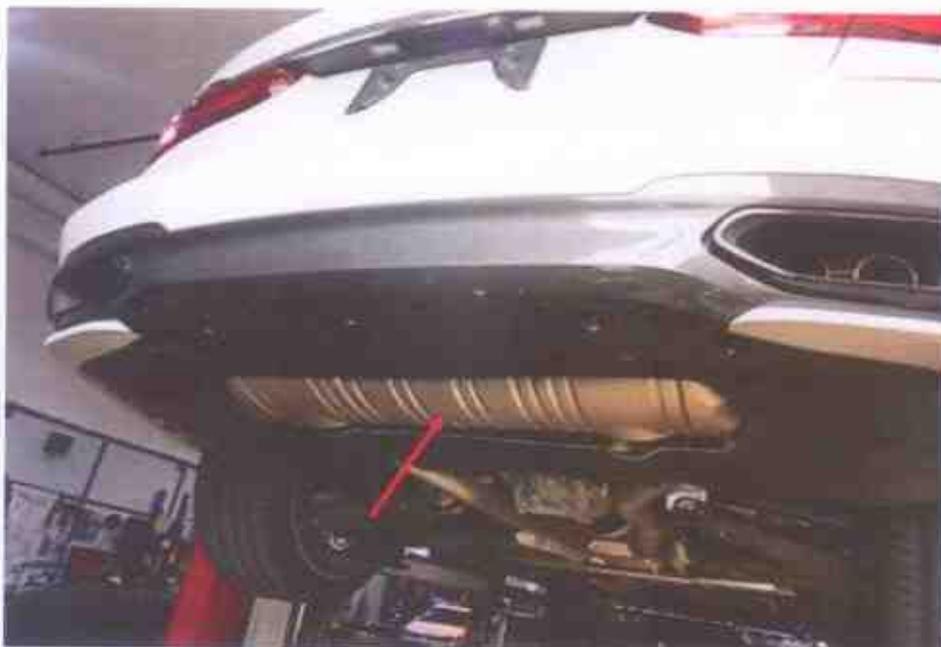
**Photo 12** shows the Motor Car's rear exhaust muffler (arrowed). My examination of the Motor Car's exhaust system revealed no sign(s) or indication(s) of any cut or weld marks along its exhaust pipes and on its rear mufflers.

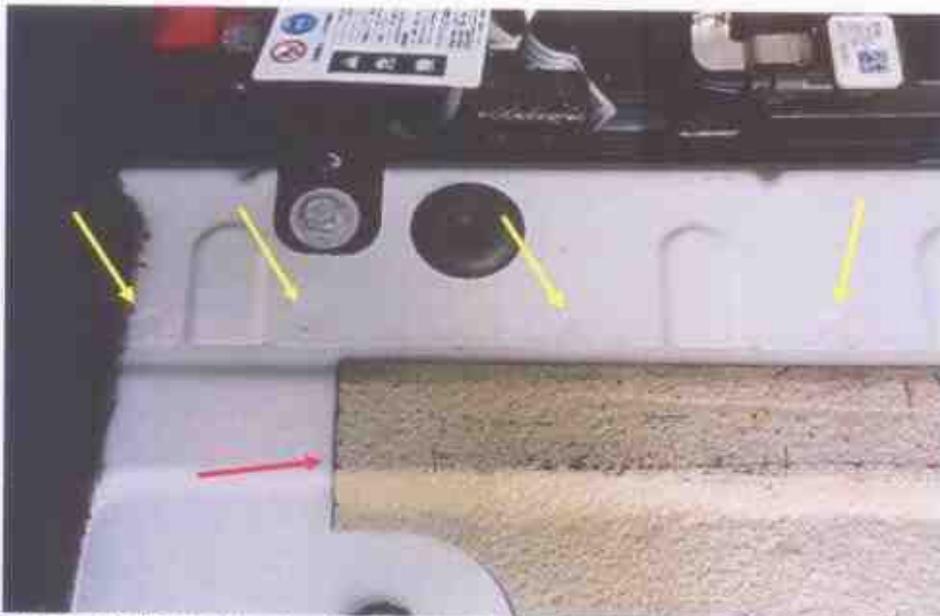
9. Visually, I did not find any weld marks, other than the original spot weld marks, on the chassis body of the Motor Car. The original factory sealant at the joints along the chassis body was also untouched, again indicating that no replacement of the chassis body was carried out; and that the chassis body was originally fitted.

Photo 13 shows the structural body at the rear boot floor of the Motor Car. Visually, I did not find any weld marks other than original spot weld marks (yellow arrow) on the chassis body of the Motor Car. The original factory sealant (red arrow) at the joints along the chassis body was also untouched, indicating no work was done on the chassis body of the Motor Car and that the chassis body was originally fitted.

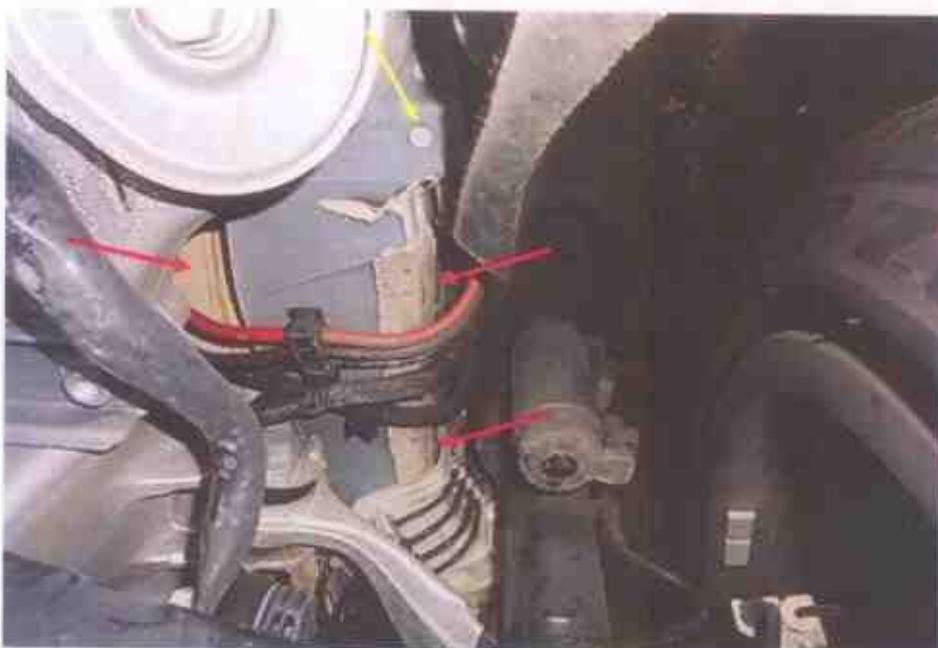
Photo 14 shows the structural body at the underside rear right of the Motor Car. Visually, I did not find any weld marks other than original spot weld marks (yellow arrow) on the chassis body of the Motor Car. The original factory sealant (red arrow) at the joints along the chassis body was also untouched, indicating no work was done on the chassis body of the Motor Car and that the chassis body was originally fitted

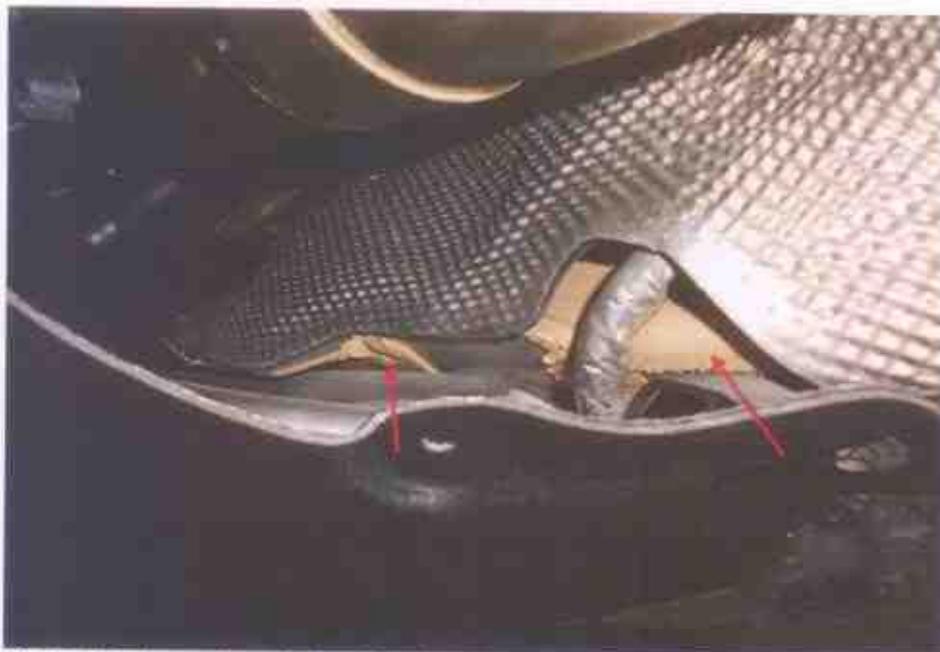
Photo 15 shows the structural body at the underside right centre of the Motor Car. The original factory sealant (arrowed) at the joints along the chassis body was untouched, indicating no work was done on the chassis body of the Motor Car and that the chassis body was originally fitted.

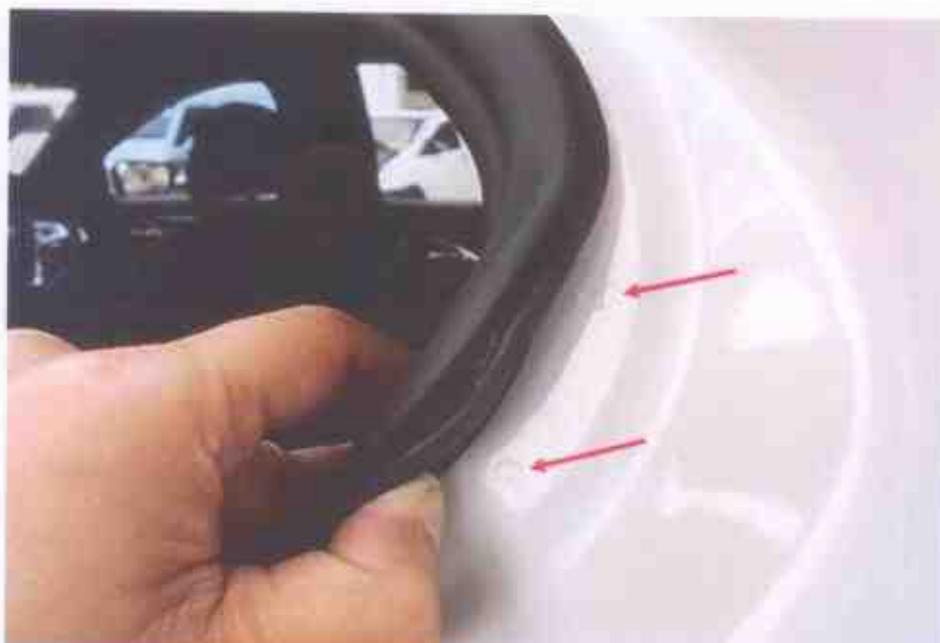
Photo 16 shows the rear left "C" pillar of the Motor Car. I did not find any weld marks other than original spot weld marks (arrowed) on the body panels of the Motor Car, indicating that there was no re-welding works carried out, and that the body panels of the Motor Car were originally fitted.

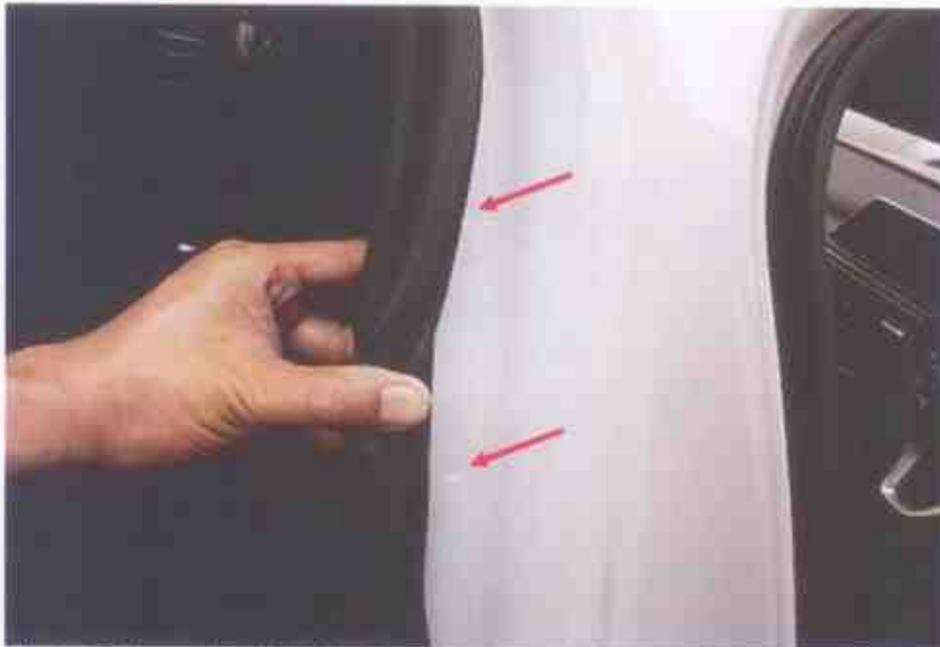
Photo 17 shows the right "B" pillar of the Motor Car. I did not find any weld marks other than original spot weld marks (arrowed) on the body panels of the Motor Car, indicating that there was no re-welding works carried out; and that the body panels of the Motor Car were originally fitted.
