Your Ref: BMW 750i  
(chassis number WBA7A820X0G243729)  
Our Ref : CI/TP19008680/D

15 May 2019

**INSPECTION REPORT OF AN UNREGISTERD BMW 750i MOTOR CAR WITH CHASSIS NUMBER WBA7A820X0G243729**

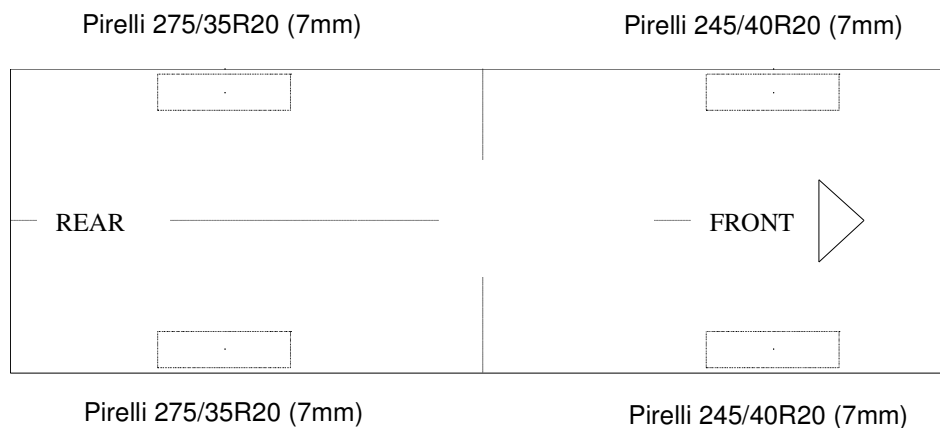
6. It was fitted with 20inch sport wheel rims that were wrapped with tyres that were observed to be of serviceable condition. The tyres were also sufficiently inflated for vehicular operation. The tyre brand, tyre size and approximate remaining tread depth of the 4 tyres of the Motor Car were recorded as follows: -

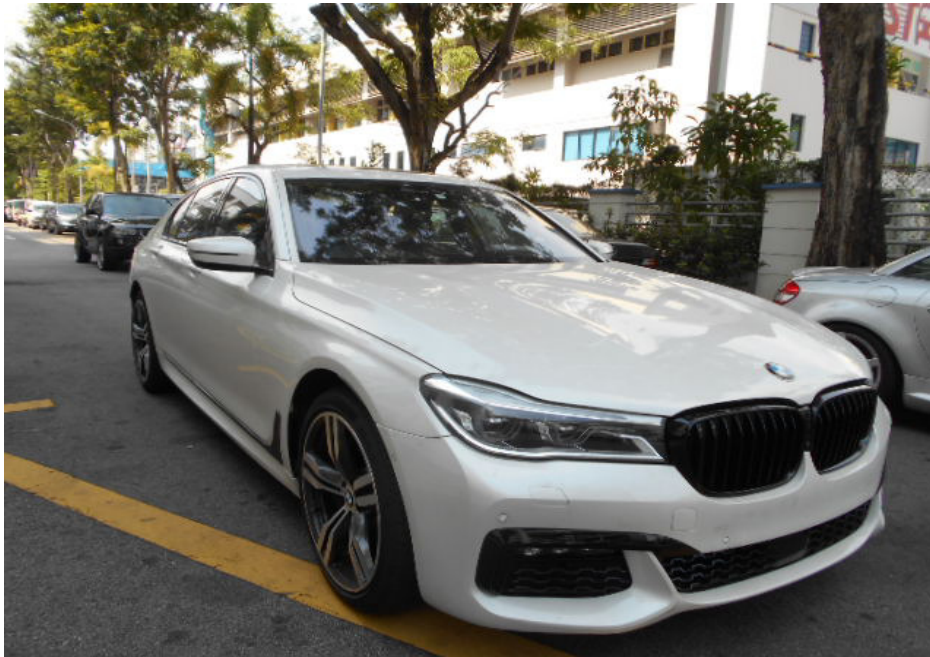
**Photo 1** shows a general view of the front right body of the Motor Car at the time of my inspection. The Motor Car was observed to be in relatively good general condition with no loose exterior fittings observed.

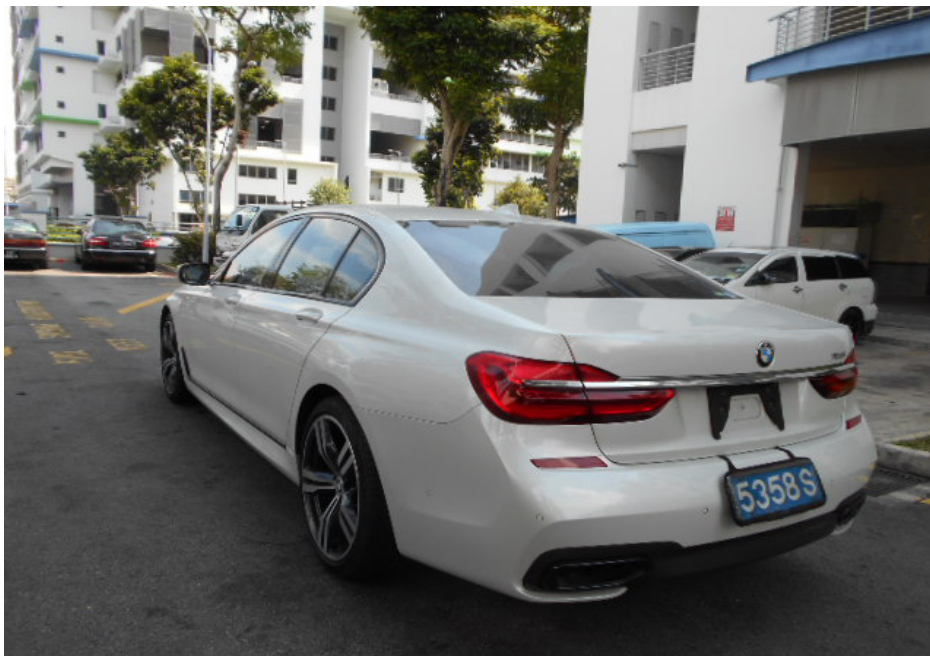
**Photo 2** shows a general view of the rear left body of the Motor Car at the time of my inspection. The Motor Car was observed to be in relatively good general condition with no loose exterior fittings observed.

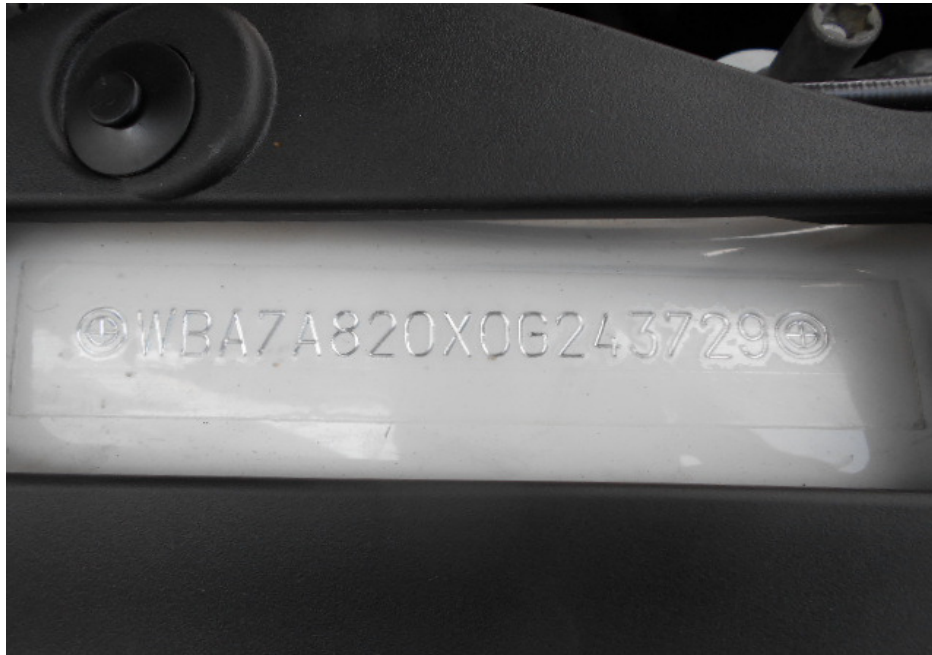
**Photo 3** shows the chassis number of the Motor Car. The chassis number recorded was WBA7A820X0G243729.

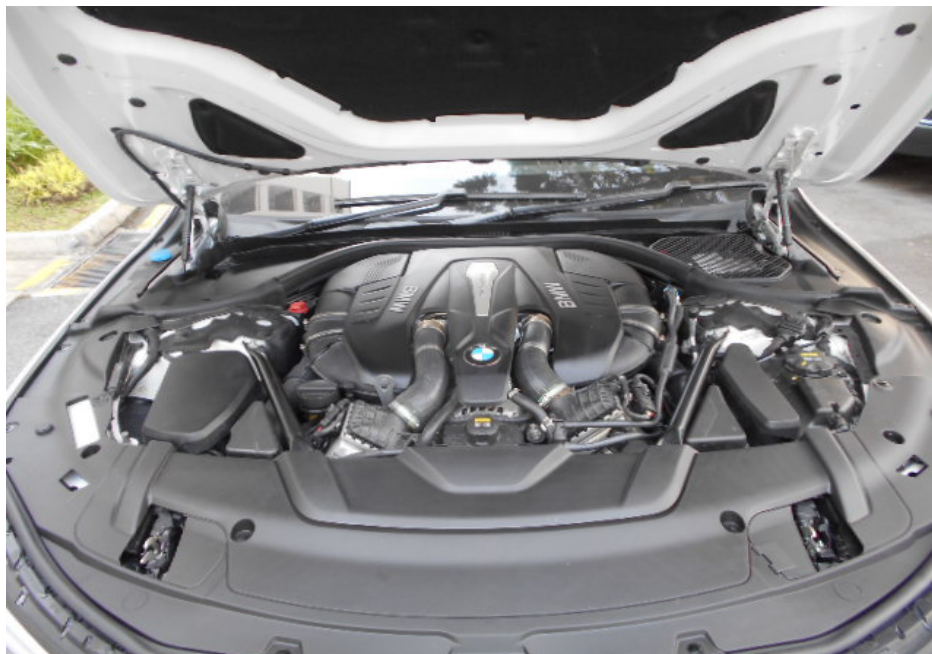
12. My examination of the engine compartment of the Motor Car revealed that the various parts and components inside the engine compartment were all intact and properly fitted. The engine oil, brake fluid and engine coolant were all found to be of sufficient level for operating purposes. Visually, there was also no contamination found to these fluids.

**Photo 4** shows a general view of the engine compartment of the Motor Car at the time of my inspection. The various parts and components inside the engine compartment were all observed to be intact and properly fitted. There was also no sign(s) or indication(s) of fluid leak and/or fluid stain found inside the engine compartment.

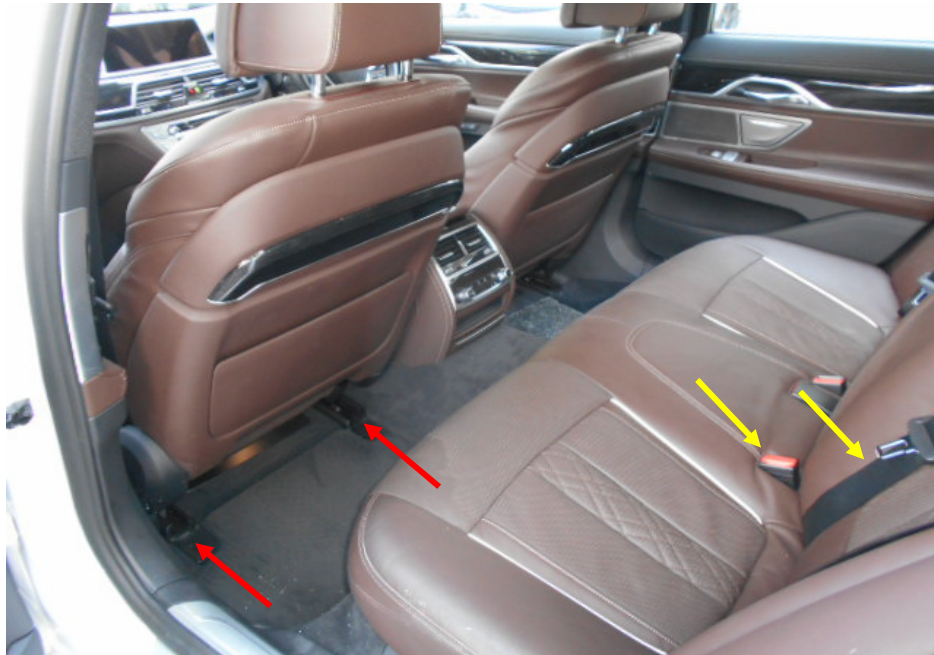
10. The seats of the Motor Car were found to be secured to the floor board of the Motor Car via seat rails bolted onto the floor board. Retractable seat belt reels and pre-tensioners were fitted on all seats of the Motor Car. The seat belt reels were able to be fastened securely into the respective pre-tensioners that are fixed to the side of all the seats.

**Photo 5** shows the seats of the Motor Car, which were secured via seat rails (red arrows) to the floor board. All the seats of the Motor Car were fitted with a retractable seat belt reel and pre-tensioner (yellow arrows). The seat belts were also able to be fastened into the respective pretensions that were fitted on the side of each individual seat.

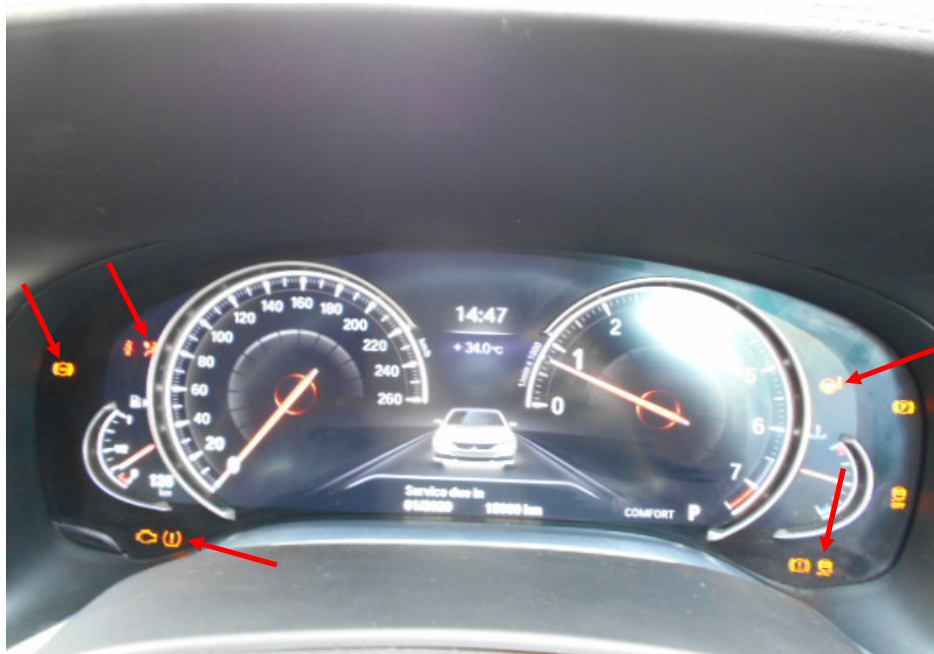
**Photo 6** shows the warning lights for the various electronic safety features appearing on the instrument panel of the Motor Car during its self-test when the engine is cranked, in particular the ABS, SRS, IAS, TPM and DSC lights (arrowed).

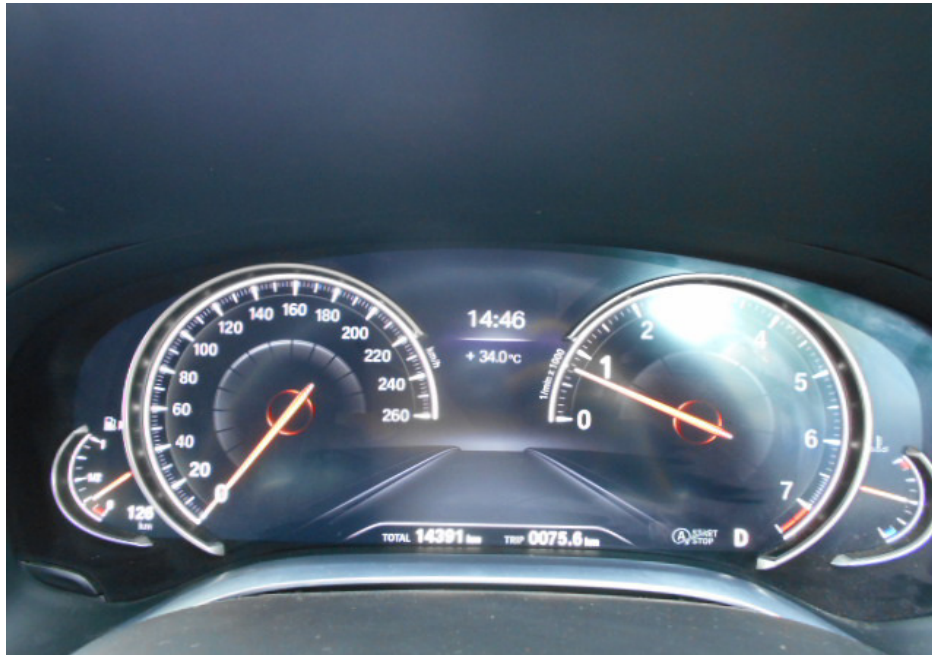
11. The Motor Car's automatic self-test of the functionality of its various electronic safety features like the Anti-Lock Brake System (ABS), Supplemental Restraint System (SRS), Integral Active Steering (IAS), Tyre Pressure Monitor (TPM) and Dynamic Stability Control (DSC) during cranking of the engine had indicated that these electronic systems were in working condition. This was determined from the respective warning lights disappearing from the instrument panel after the self-test.

**Photo 7** shows the respective warning lights no longer illuminated, indicating that there is no fault detected to the ABS, SRS, IAS, TPM and DSC systems of the Motor Car during the self-test. These electronic systems were hence in working condition at the time of my inspection.

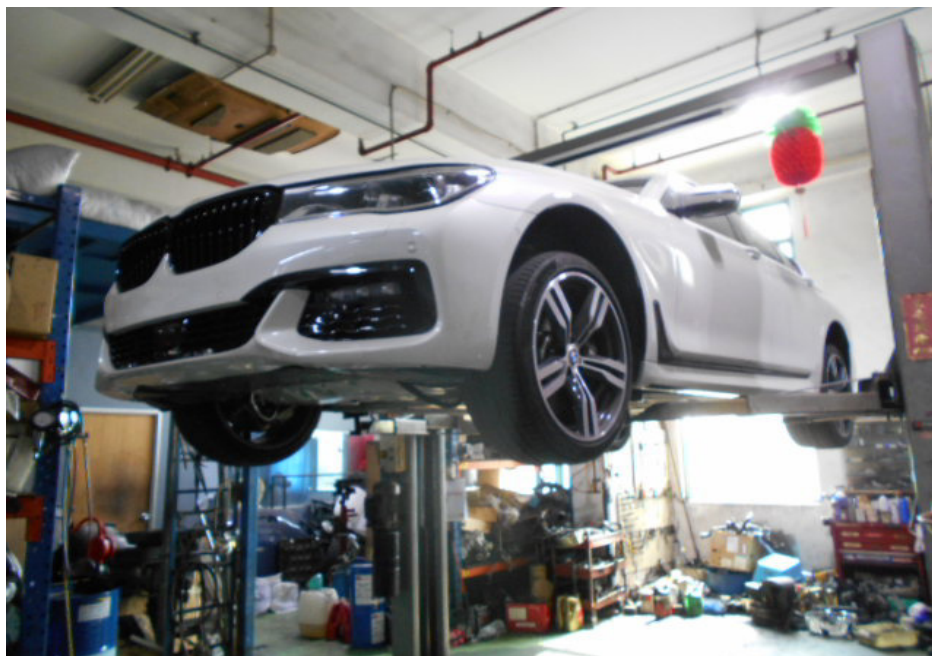
13. My checks on the underside of the Motor Car revealed no sign(s) or indication(s) of fluid leakage and/or fluid stain(s). The engine block and automatic transmission assembly were both secured properly. They were not mounted onto the chassis body or any integral body part of the Motor Car. All undercarriage components of the Motor Car were also observed to be intact and secured in an appropriate manner.

**Photo 8** shows the Motor Car hoisted up for checks on its undercarriage. There was no sign(s) or indication(s) of fluid leakage and/or fluid stain(s) on the underside of the Motor Car. The undercarriage components of the Motor Car were also all observed to be intact and secured in an appropriate manner.

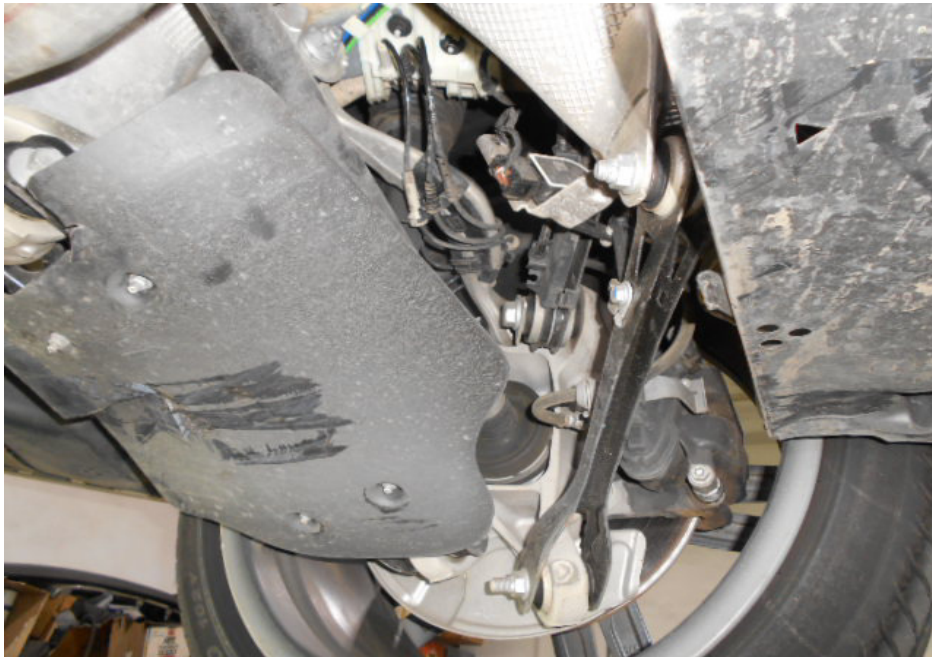
**Photo 9** shows a general view of the control arms and linkages at the rear left wheel of the Motor Car. I did not observe any fluid leak and/or fluid stain on the underside of the Motor Car. All of the Motor Car's undercarriage components were observed to be intact and secured in an appropriate manner.

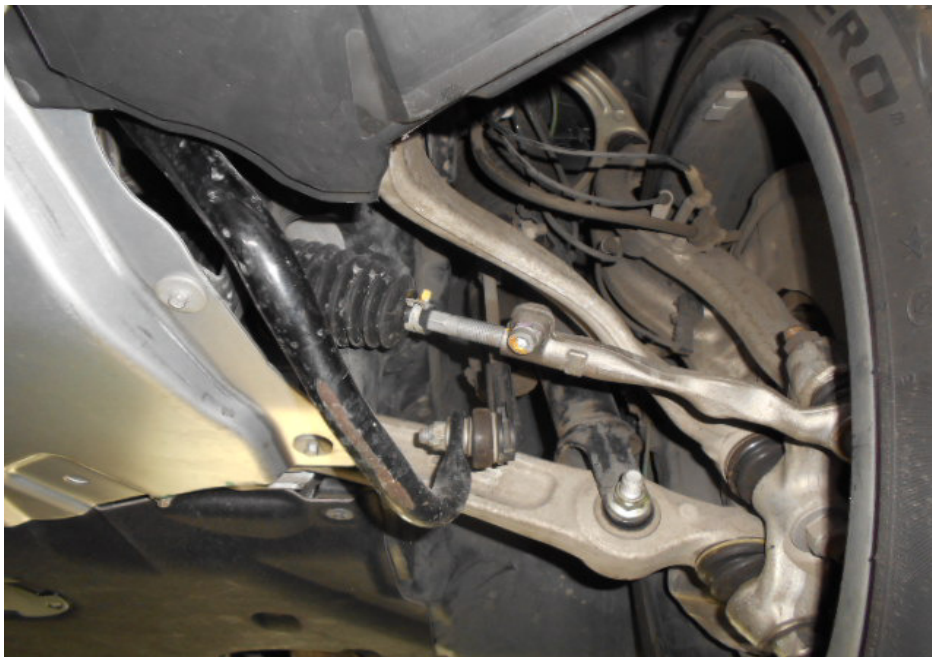
**Photo 10** shows the various undercarriage components at the front left wheel of the Motor Car. The mechanical components, control arms and linkages were all found to be intact and secured in an appropriate manner.

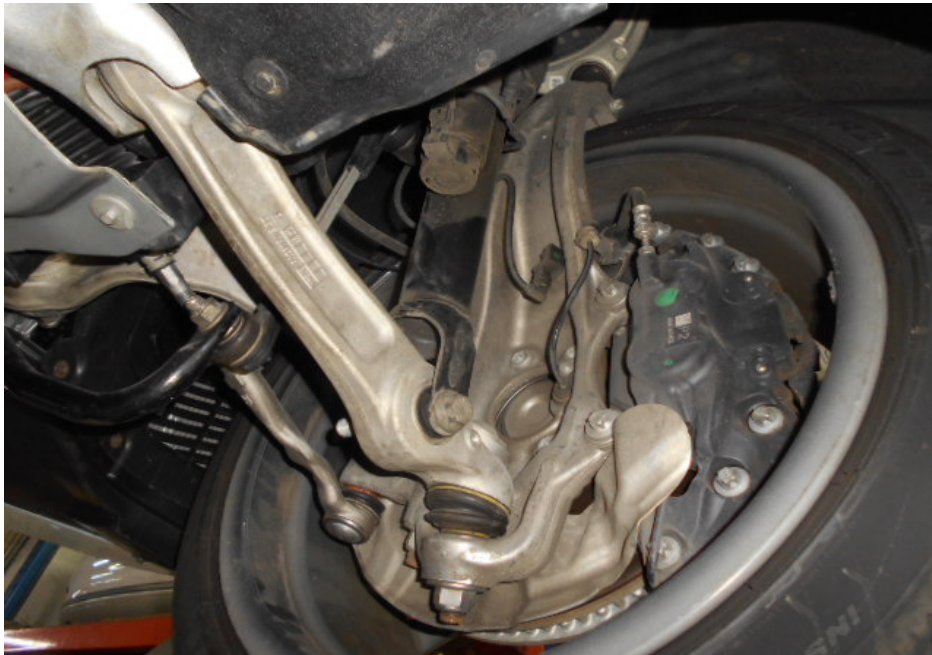
**Photo 11** shows the various undercarriage components at the front right wheel of the Motor Car. The mechanical components, control arms and linkages were all found to be intact and secured in an appropriate manner.

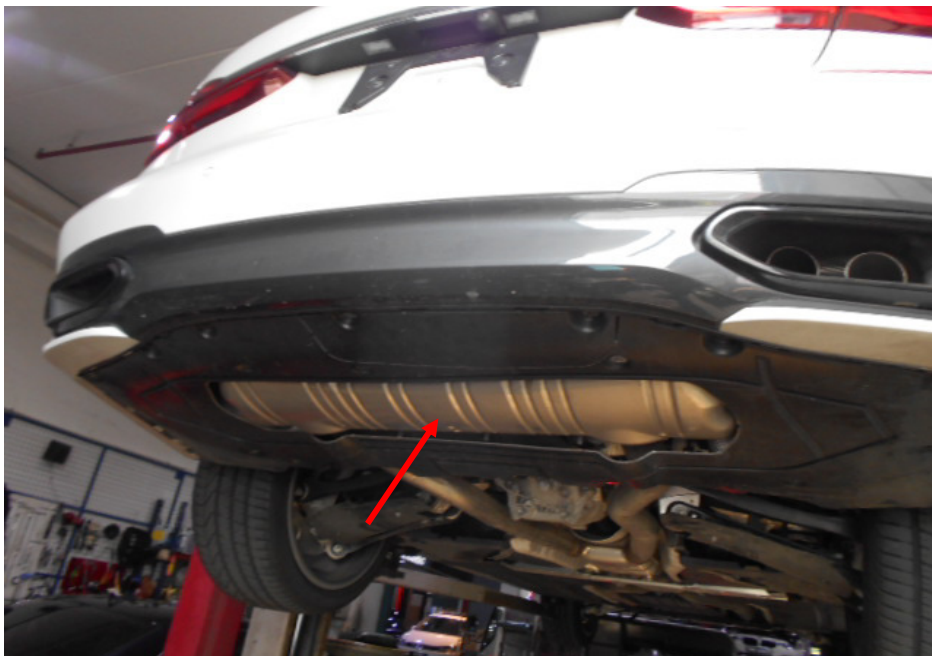
**Photo 12** shows the Motor Car's rear exhaust muffler (arrowed). My examination of the Motor Car's exhaust system revealed no sign(s) or indication(s) of any cut or weld marks along its exhaust pipes and on its rear mufflers.

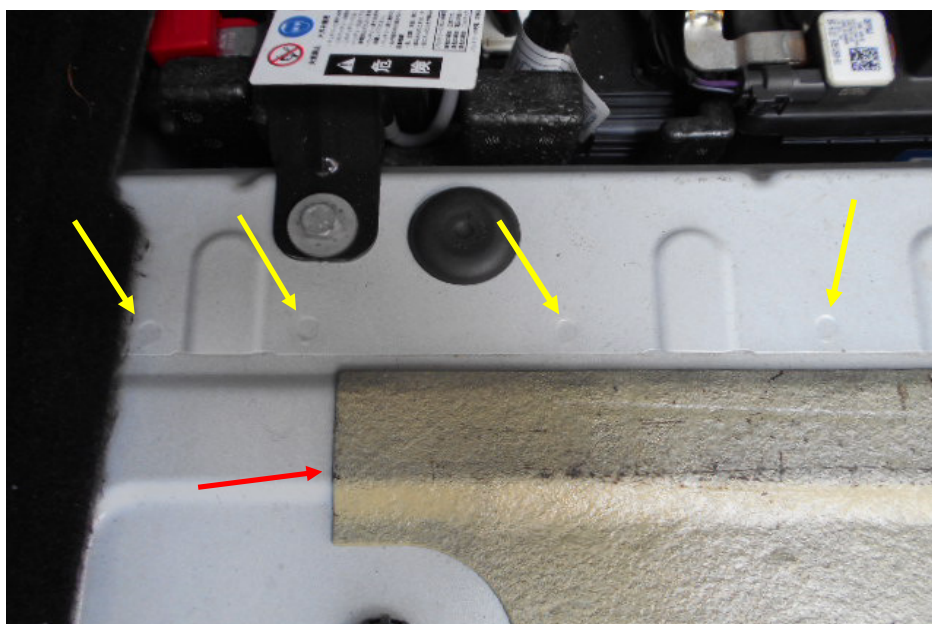
9. Visually, I did not find any weld marks, other than the original spot weld marks, on the chassis body of the Motor Car. The original factory sealant at the joints along the chassis body was also untouched, again indicating that no replacement of the chassis body was carried out; and that the chassis body was originally fitted.

**Photo 13** shows the structural body at the rear boot floor of the Motor Car. Visually, I did not find any weld marks other than original spot weld marks (yellow arrow) on the chassis body of the Motor Car. The original factory sealant (red arrow) at the joints along the chassis body was also untouched, indicating no work was done on the chassis body of the Motor Car and that the chassis body was originally fitted.

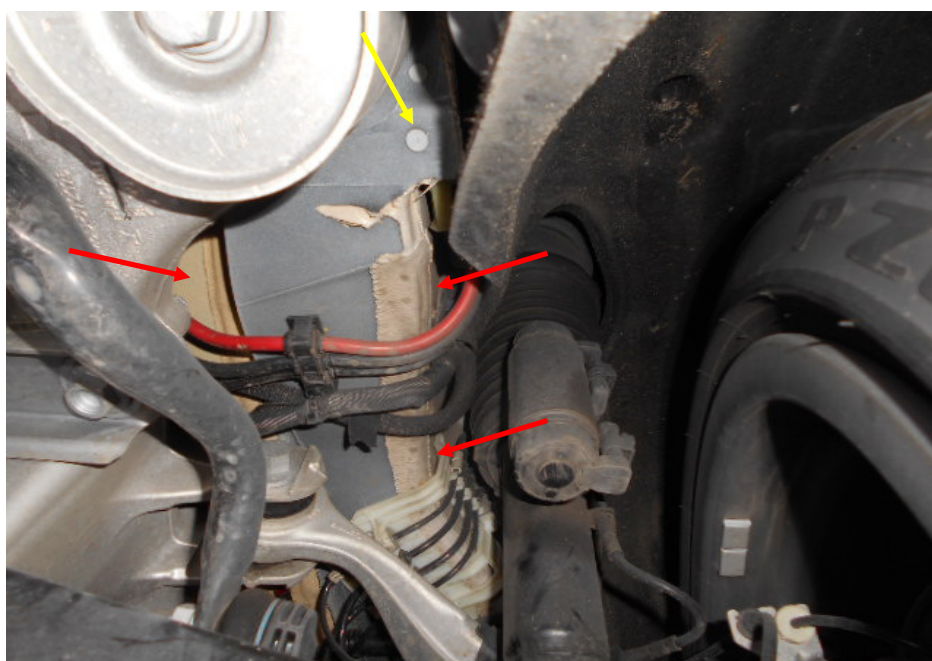
**Photo 14** shows the structural body at the underside rear right of the Motor Car. Visually, I did not find any weld marks other than original spot weld marks (yellow arrow) on the chassis body of the Motor Car. The original factory sealant (red arrow) at the joints along the chassis body was also untouched, indicating no work was done on the chassis body of the Motor Car and that the chassis body was originally fitted.

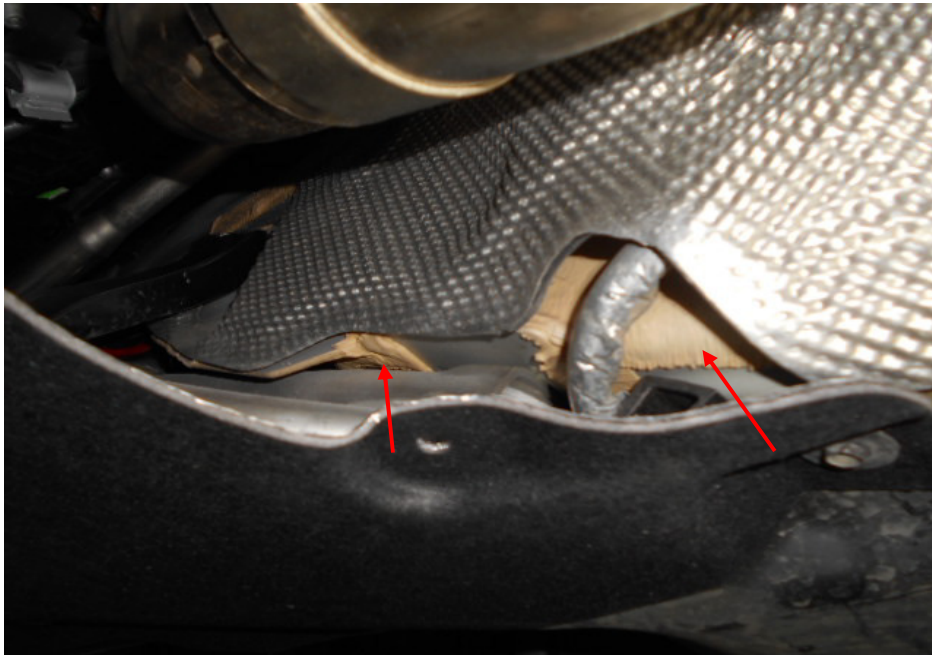
**Photo 15** shows the structural body at the underside right centre of the Motor Car. The original factory sealant (arrowed) at the joints along the chassis body was untouched, indicating no work was done on the chassis body of the Motor Car and that the chassis body was originally fitted.

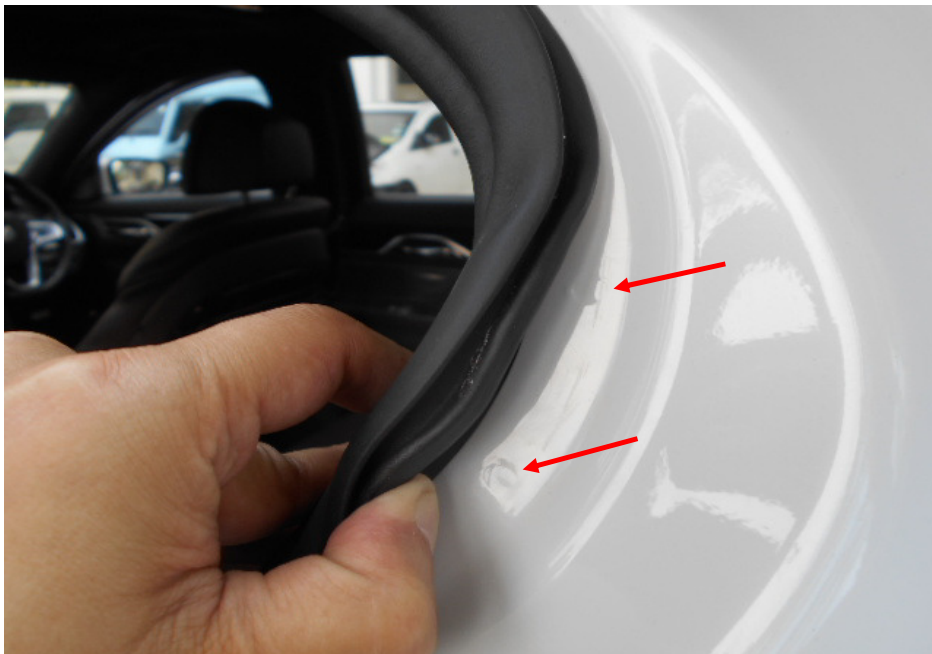
**Photo 16** shows the rear left "C" pillar of the Motor Car. I did not find any weld marks other than original spot weld marks (arrowed) on the body panels of the Motor Car, indicating that there was no re-welding works carried out; and that the body panels of the Motor Car were originally fitted.

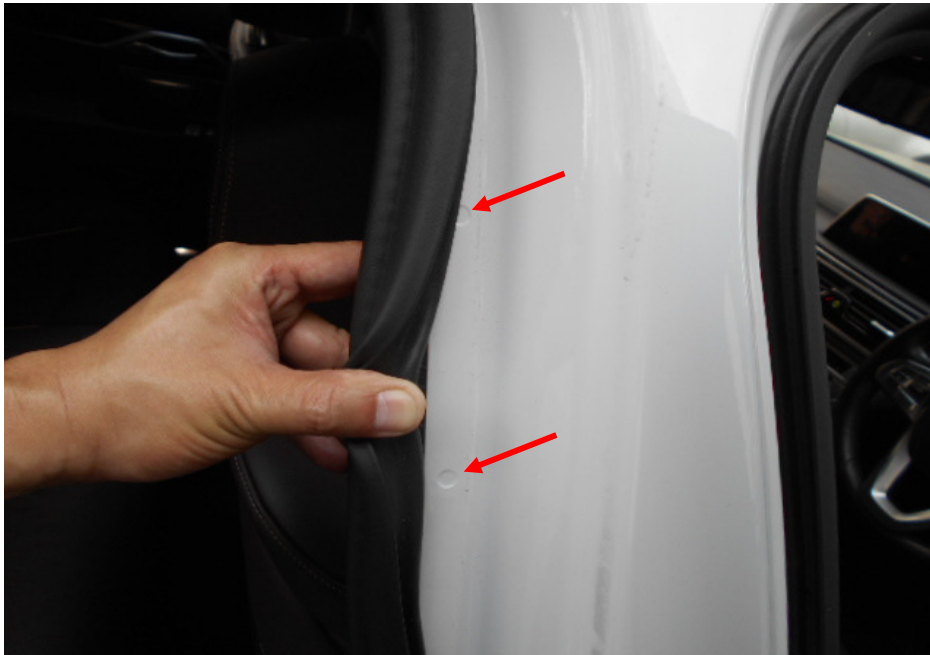
**Photo 17** shows the right “B” pillar of the Motor Car. I did not find any weld marks other than original spot weld marks (arrowed) on the body panels of the Motor Car, indicating that there was no re-welding works carried out; and that the body panels of the Motor Car were originally fitted.
