Your Ref: Porsche Boxster 718  
(chassis number WP0ZZZ98ZHS212936)  
Our Ref : CI/TP19008681/D

16 May 2019

**INSPECTION REPORT OF AN UNREGISTERD PORSCHE BOXSTER 718  
MOTOR CAR WITH CHASSIS NUMBER WP0ZZZ98ZHS212936**

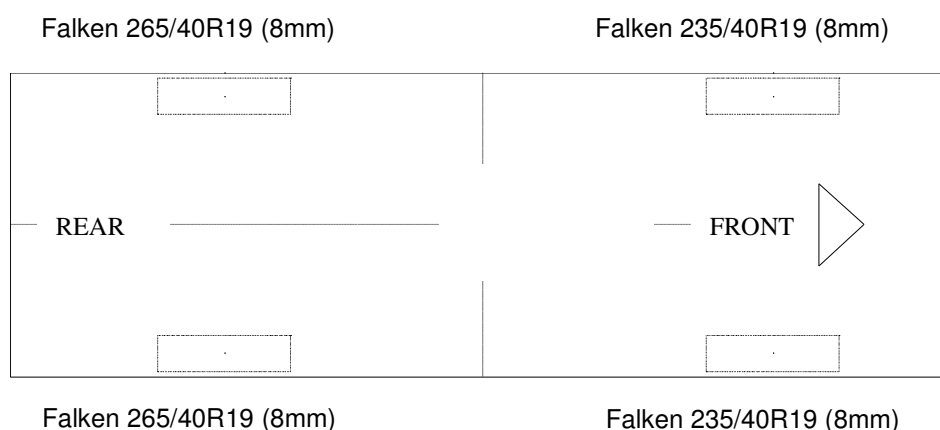
6. It was fitted with 19inch sport wheel rims that were wrapped with tyres that were observed to be of serviceable condition. The tyres were also sufficiently inflated for vehicular operation. The tyre brand, tyre size and approximate remaining tread depth of the 4 tyres of the Motor Car were recorded as follows: -

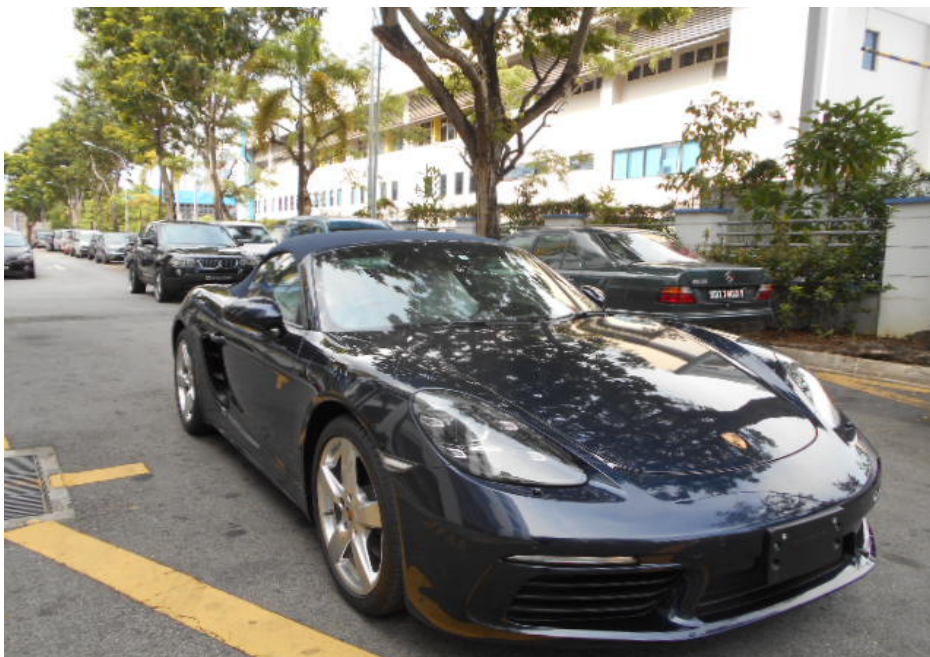
**Photo 1** shows a general view of the front right body of the Motor Car at the time of my inspection. The Motor Car was observed to be in relatively good general condition with no loose exterior fittings observed.

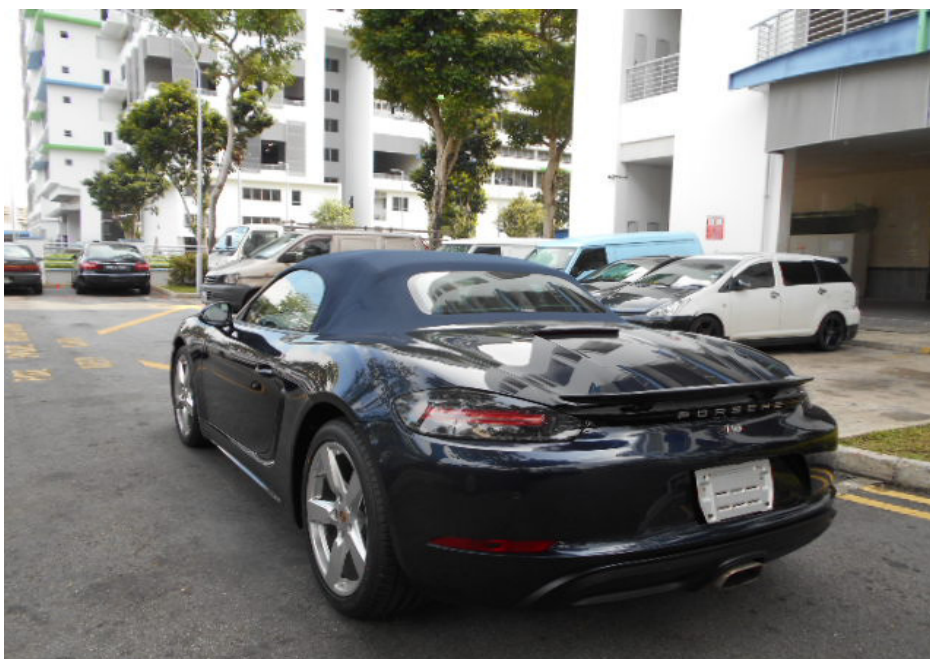
**Photo 2** shows a general view of the rear left body of the Motor Car at the time of my inspection. The Motor Car was observed to be in relatively good general condition with no loose exterior fittings observed.

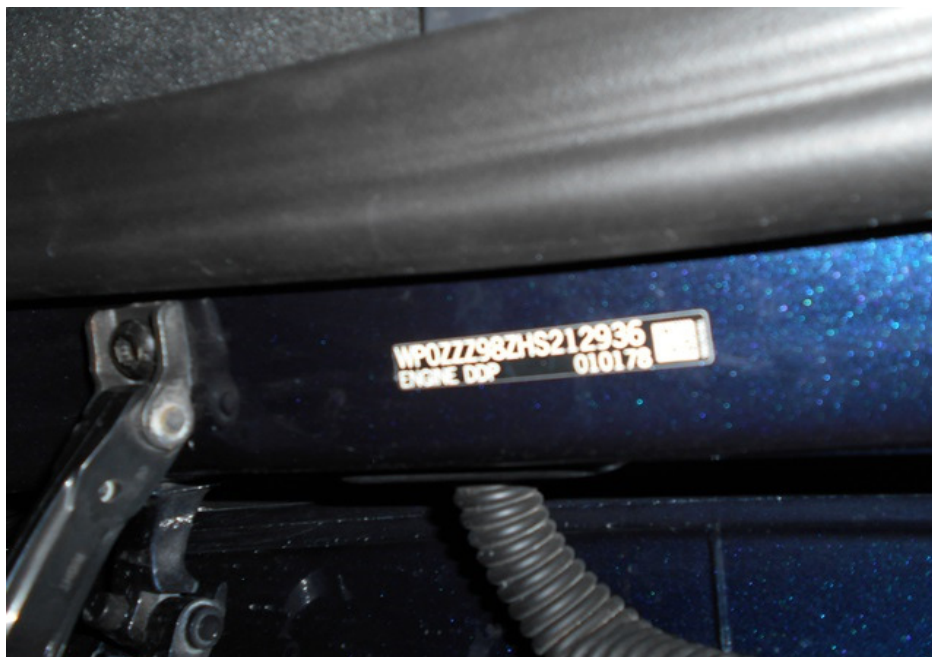
**Photo 3** shows the chassis number of the Motor Car. The chassis number recorded was WP0ZZZ98ZHS212936.

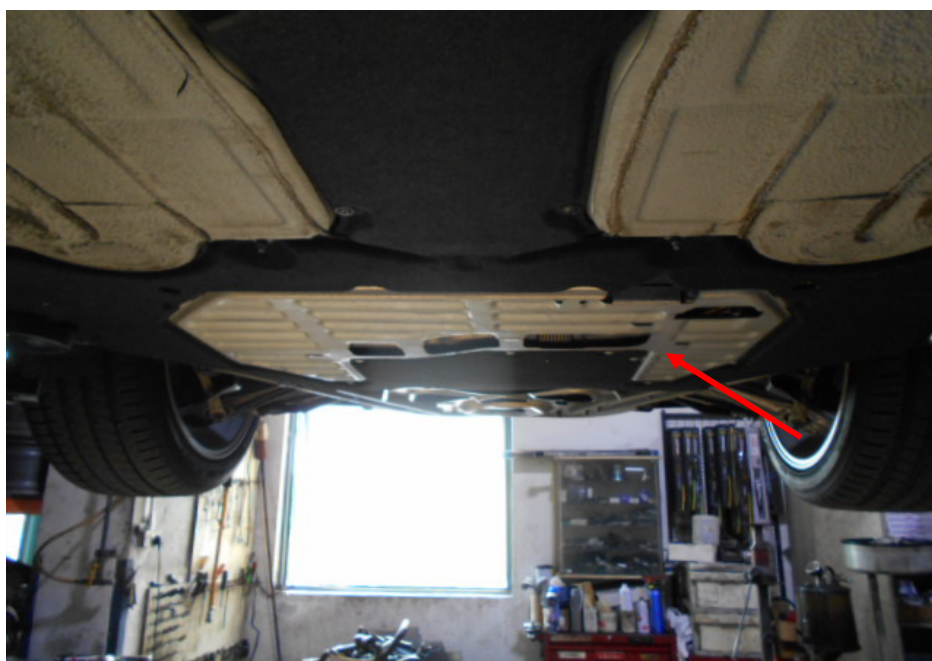
12. The engine compartment of the Motor Car was at its rear underside. Given its remote location, I was not able to carry out thorough checks on the parts and components within the engine compartment. However, from my visual observations, I had found the engine assembly and transmission assembly of the Motor Car to be fitted securely and not mounted onto any part of the Motor Car's chassis body.
13. My subsequent checks on the underside of the Motor Car revealed no sign(s) or indication(s) of fluid leakage and/or fluid stain(s). All undercarriage components of the Motor Car were also observed to be intact and secured in an appropriate manner.

**Photo 4** shows a general view of where the engine compartment of the Motor Car is located. This was at the rear underside (arrowed) of the Motor Car. Given its remote location, I was not able to thoroughly check on the parts and components within the engine compartment. However, from my visual observations, I had found the engine assembly and transmission assembly of the Motor Car to be fitted securely and not mounted onto any part of the Motor Car's chassis body.

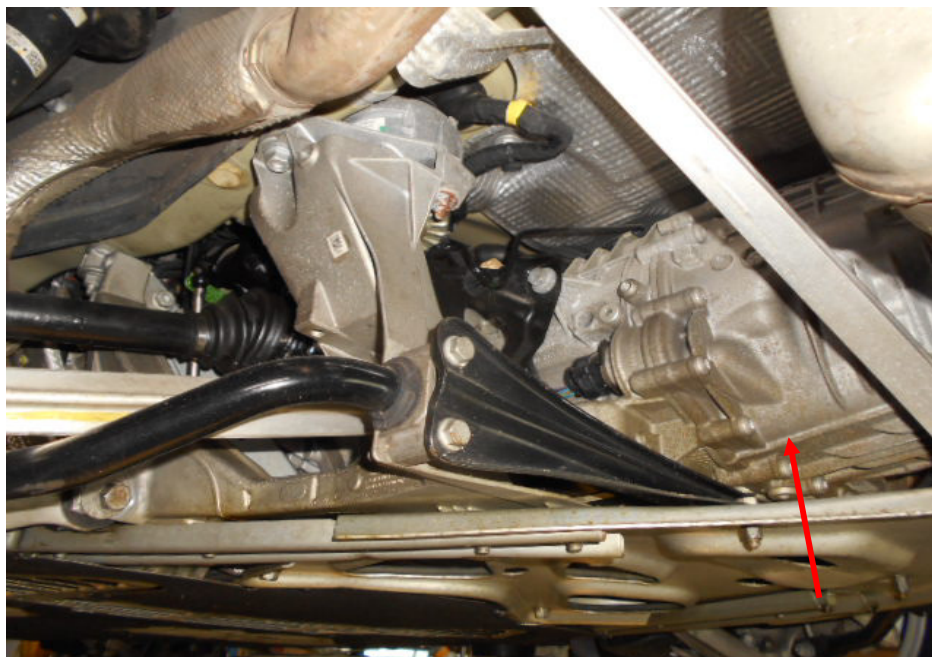
**Photo 5** shows a general view of the transmission assembly (arrowed) of the Motor Car. My visual observations of the engine assembly and transmission assembly of the Motor Car revealed both to be fitted securely and not mounted onto the chassis body of the Motor Car.

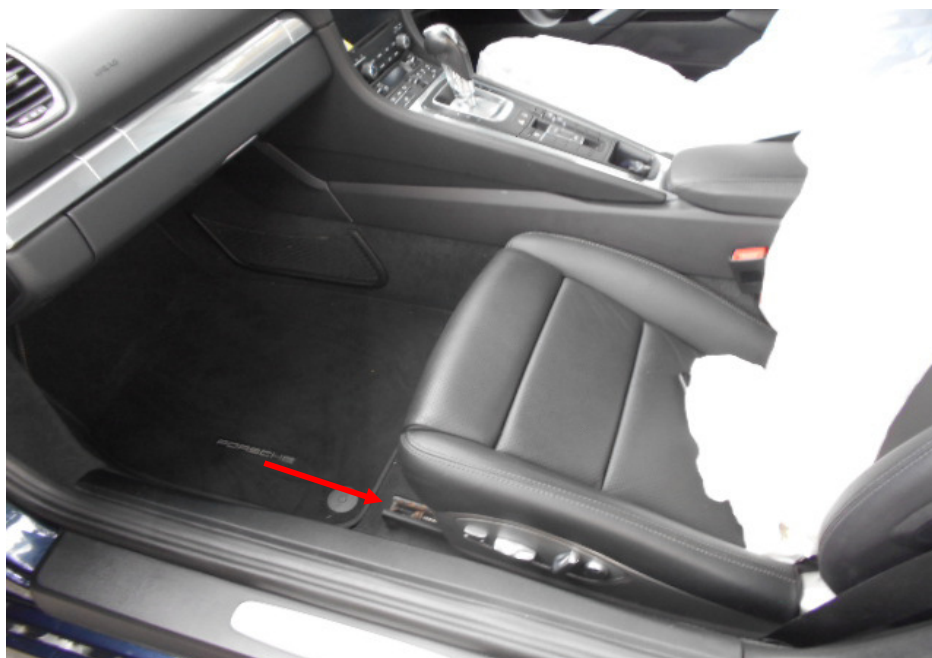
10. The seats of the Motor Car were found to be secured to the floor board of the Motor Car via seat rails bolted onto the floor board. Retractable seat belt reels and pre-tensioners were fitted on all seats of the Motor Car. The seat belt reels were able to be fastened securely into the respective pre-tensioners that were fixed to the side of all the seats.

**Photo 6** shows the front left seat of the Motor Car. The Motor Car is a 2-seater type of Motor Car. The 2 seats were secured via seat rails (arrowed) to the floor board. The seats were also fitted with a retractable seat belt reel and pretensioner. The seat belts were tested and able to be fastened into the respective pretensioners that were fitted on the side of each individual seat.

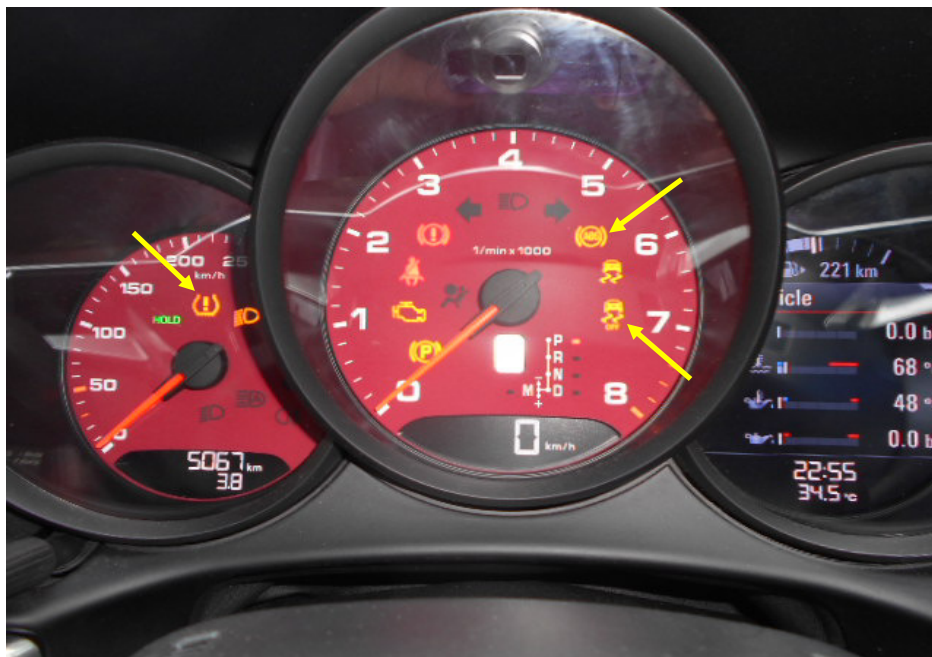
**Photo 7** shows the warning lights for the various electronic safety features appearing on the instrument panel of the Motor Car during its self-test when the engine is cranked, in particular the ABS, TPM and TCS lights (arrowed).

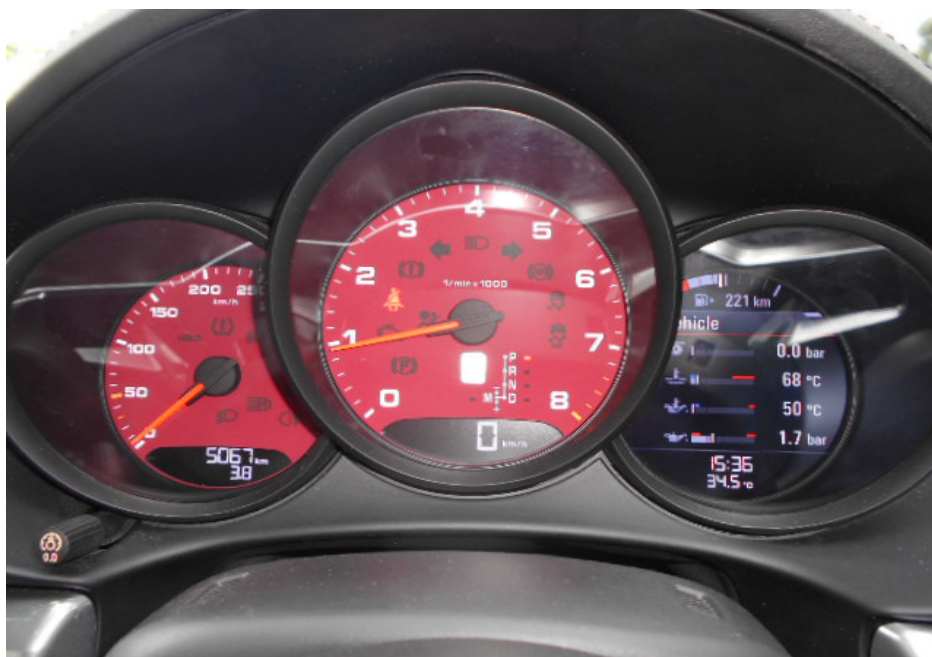
11. The Motor Car's automatic self-test of the functionality of its various electronic safety features like the Anti-Lock Brake System (ABS), Tyre Pressure Monitor (TPM) and Traction Control System (TCS) during cranking of the engine had indicated that these electronic systems were in working condition. This was determined from the respective warning lights disappearing from the instrument panel after the self-test.

**Photo 8** shows the respective warning lights no longer illuminated, indicating that there is no fault detected to the ABS, TPM and TCS systems of the Motor Car during the self-test. These electronic systems were hence in working condition at the time of my inspection.

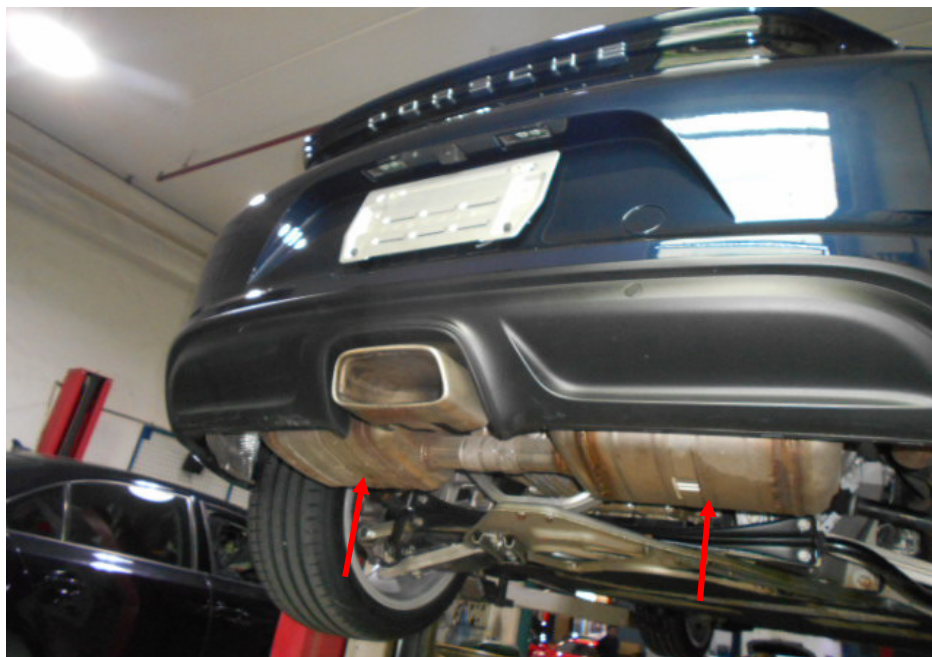
**Photo 9** shows the Motor Car hoisted up for checks on its undercarriage. There was no sign(s) or indication(s) of fluid leakage and/or fluid stain(s) found on the underside of the Motor Car. The undercarriage components were all observed to be intact and secured in an appropriate manner. My examination of the Motor Car's exhaust system revealed no sign(s) or indication(s) of any cut or weld marks along its exhaust pipes and on its rear mufflers (arrowed).

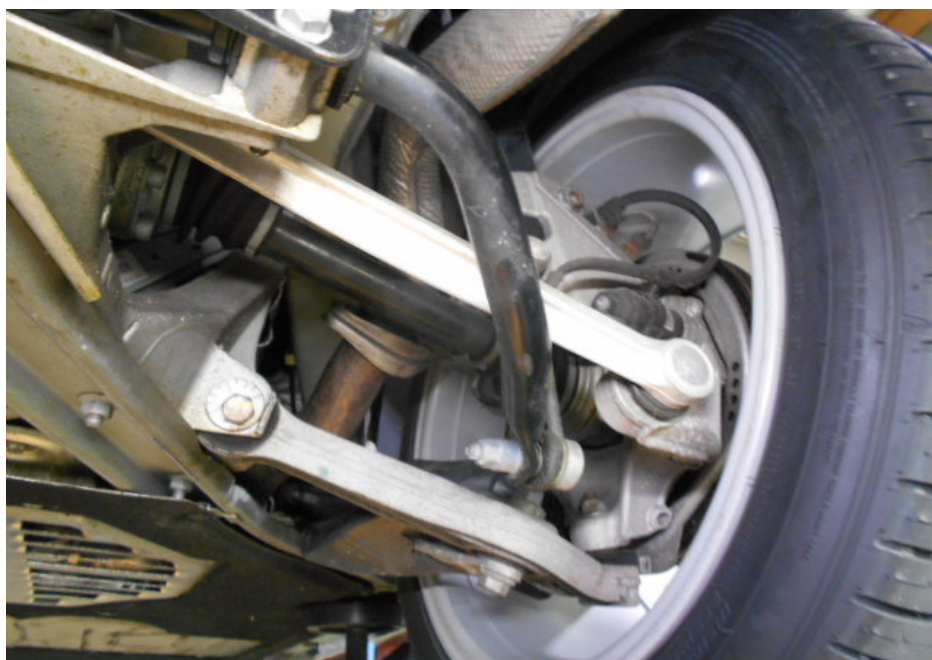
**Photo 10** shows a general view of the control arms and linkages at the rear right wheel of the Motor Car. I did not observe any fluid leak and/or fluid stain on the underside of the Motor Car. All of the Motor Car's undercarriage components were observed to be intact and secured in an appropriate manner.

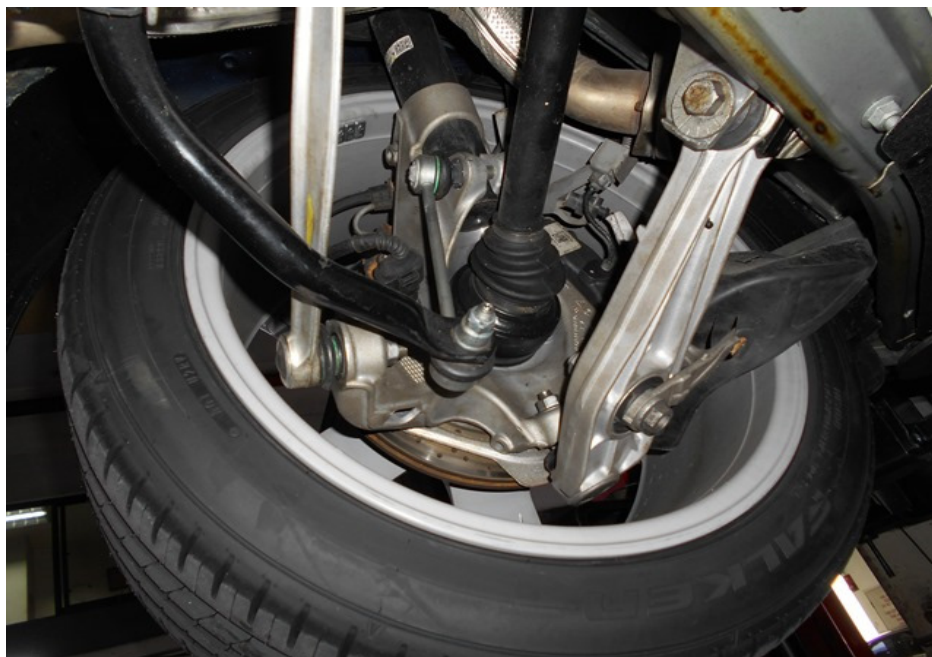
**Photo 11** shows the various undercarriage components at the rear left wheel of the Motor Car. The mechanical components, control arms and linkages were all found to be intact and secured in an appropriate manner.

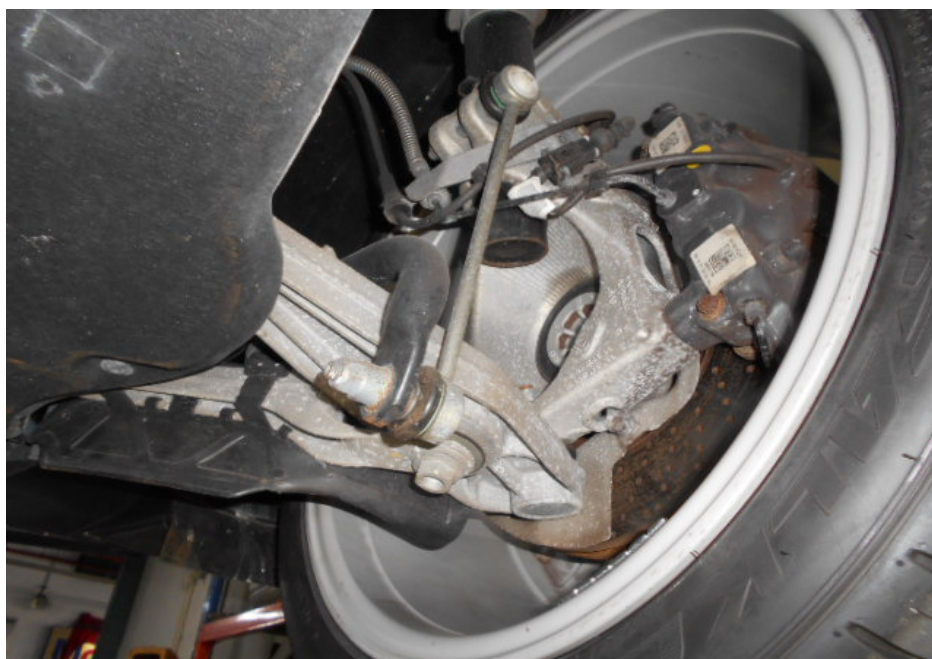
**Photo 12** shows the various undercarriage components at the front right wheel of the Motor Car. The mechanical components, control arms and linkages were all found to be intact and secured in an appropriate manner. I did not observe any fluid leak and/or fluid stain on the underside of the Motor Car.

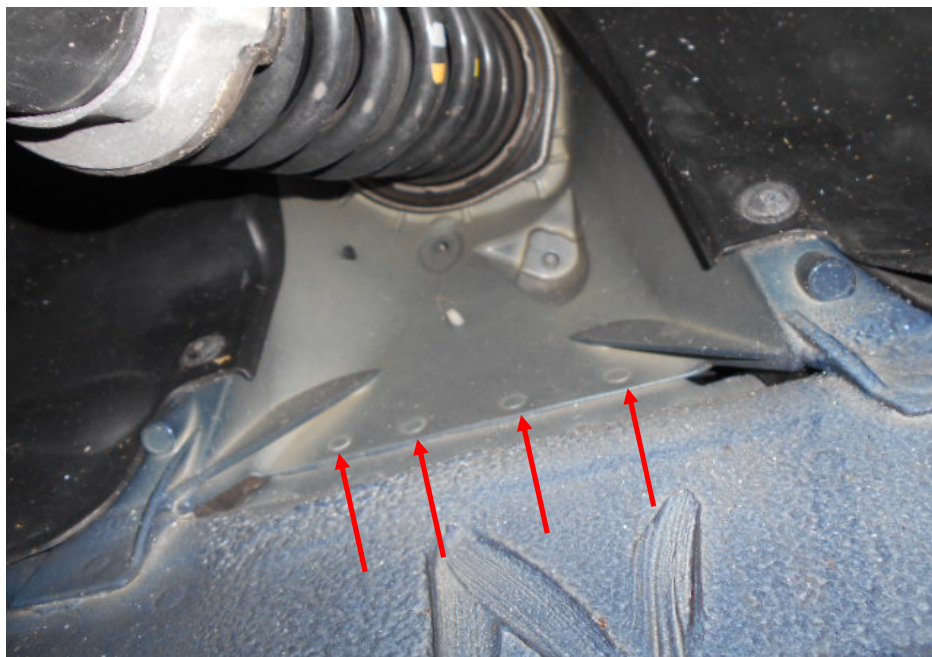
9. Visually, I did not find any weld marks, other than the original spot weld marks, on the chassis body of the Motor Car. The original factory sealant at the joints along the chassis body was also untouched, again indicating that no replacement of the chassis body was carried out; and that the chassis body was originally fitted.

**Photo 13** shows the structural body at the front left chassis of the Motor Car. Visually, I did not find any weld marks other than original spot weld marks (arrowed) at the joints along the chassis. This would indicate that no work was done on the chassis body of the Motor Car and that the chassis body was originally fitted.

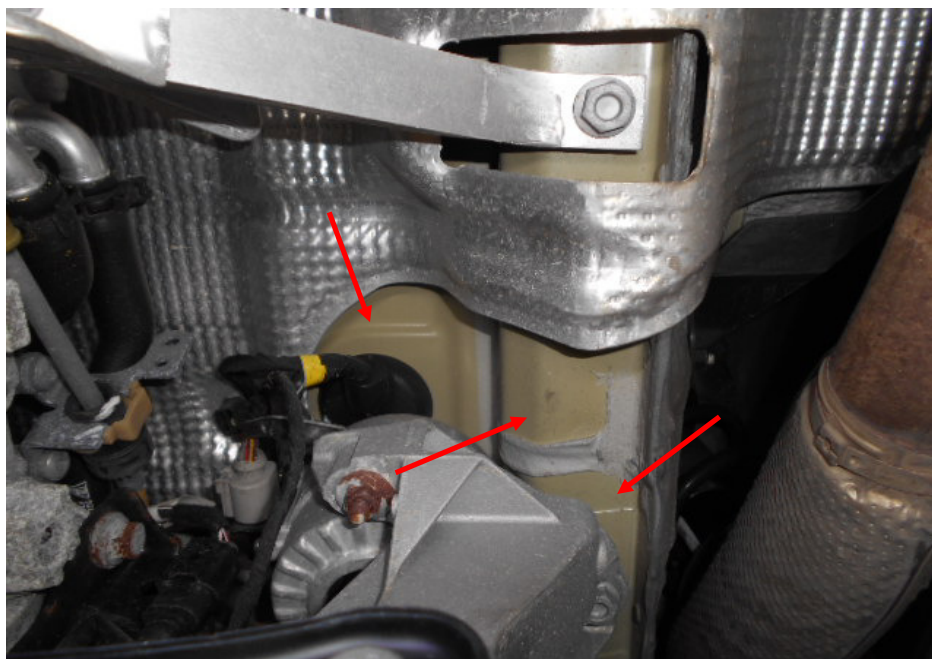
**Photo 14** shows the structural body at the rear right underside of the Motor Car. The original factory sealant (arrowed) at the joints along the chassis body was untouched, indicating no work was done on the chassis body of the Motor Car and that the chassis body was originally fitted.

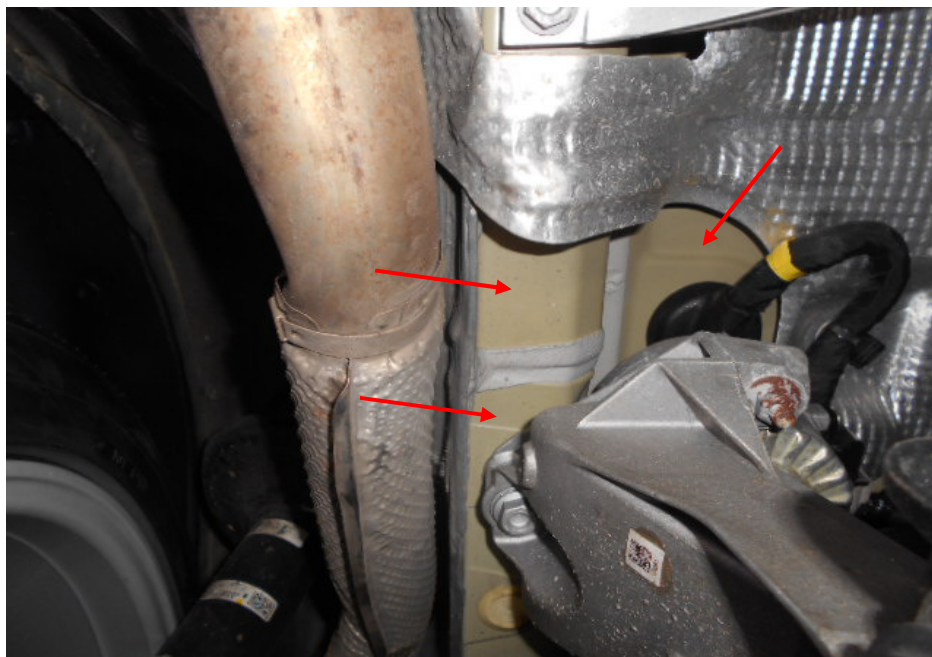
**Photo 15** shows the structural body at the rear left underside of the Motor Car. The original factory sealant (arrowed) at the joints along the chassis body was untouched, indicating no work was done on the chassis body of the Motor Car and that the chassis body was originally fitted.

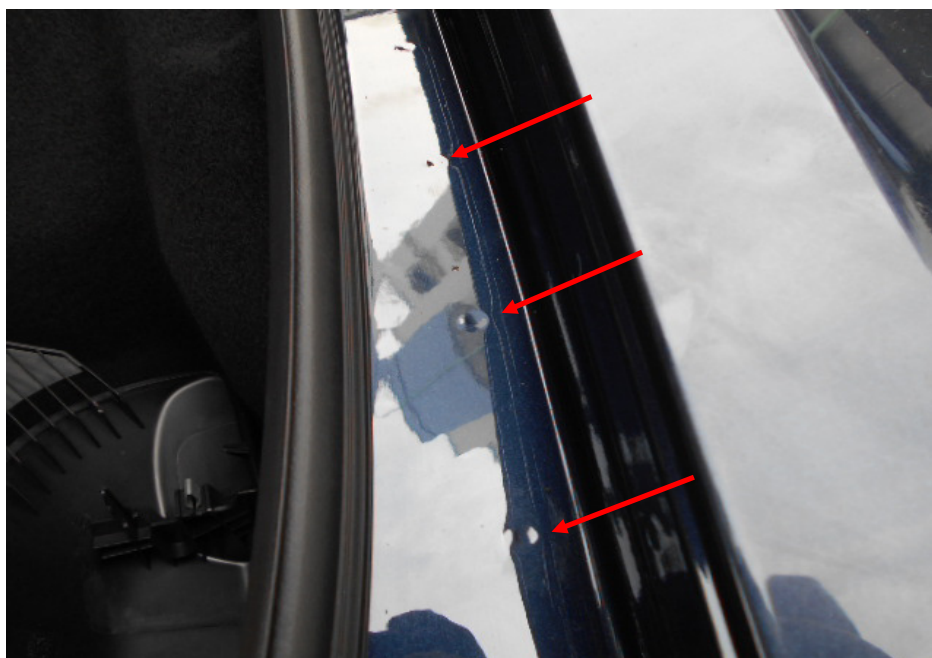
**Photo 16** shows the rear right body panel of the Motor Car. I did not find any weld marks other than original spot weld marks (arrowed) on the body panels of the Motor Car, indicating that there was no re-welding works carried out; and that the body panels of the Motor Car were originally fitted.

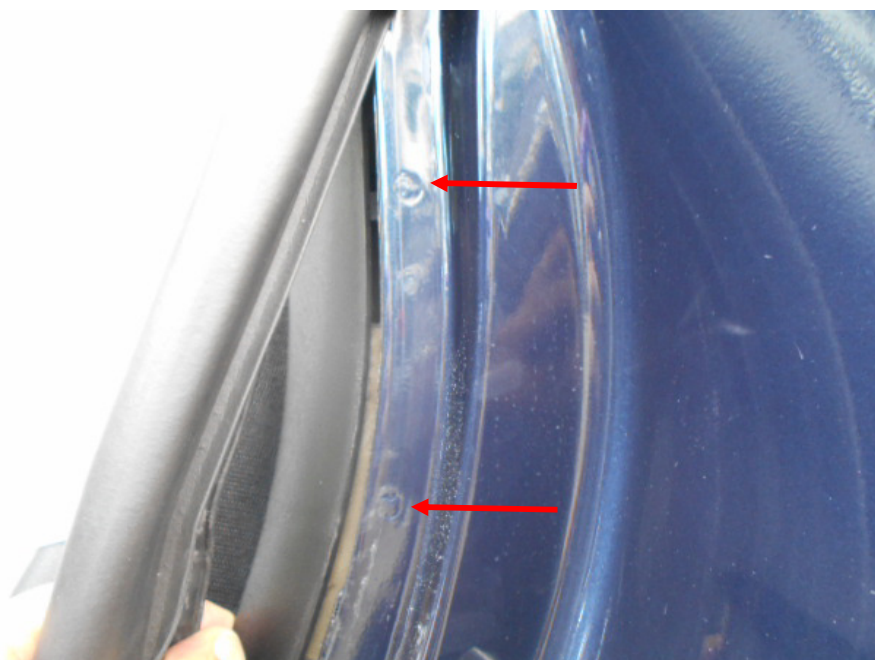
**Photo 17** shows the rear left "C" pillar of the Motor Car. I did not find any weld marks other than original spot weld marks (arrowed) on the body panels of the Motor Car, indicating that there was no re-welding works carried out; and that the body panels of the Motor Car were originally fitted.
