AUTOMOBILE ASSESSMENT REPORT

ASSESSMENT OF VEHICLE NO. SJU 4153 L

**EVALUATION REPORT (PAPER SURVEY) OF ACCIDENT VEHICLE NO: SJU 4153L
INSURED VEHICLE: SGJ 8638Y ACCIDENT DATE: 04/04/2018**

ADJUSTMENT ON REPAIR COST FOR VEHICLE NO. SJU 4153L

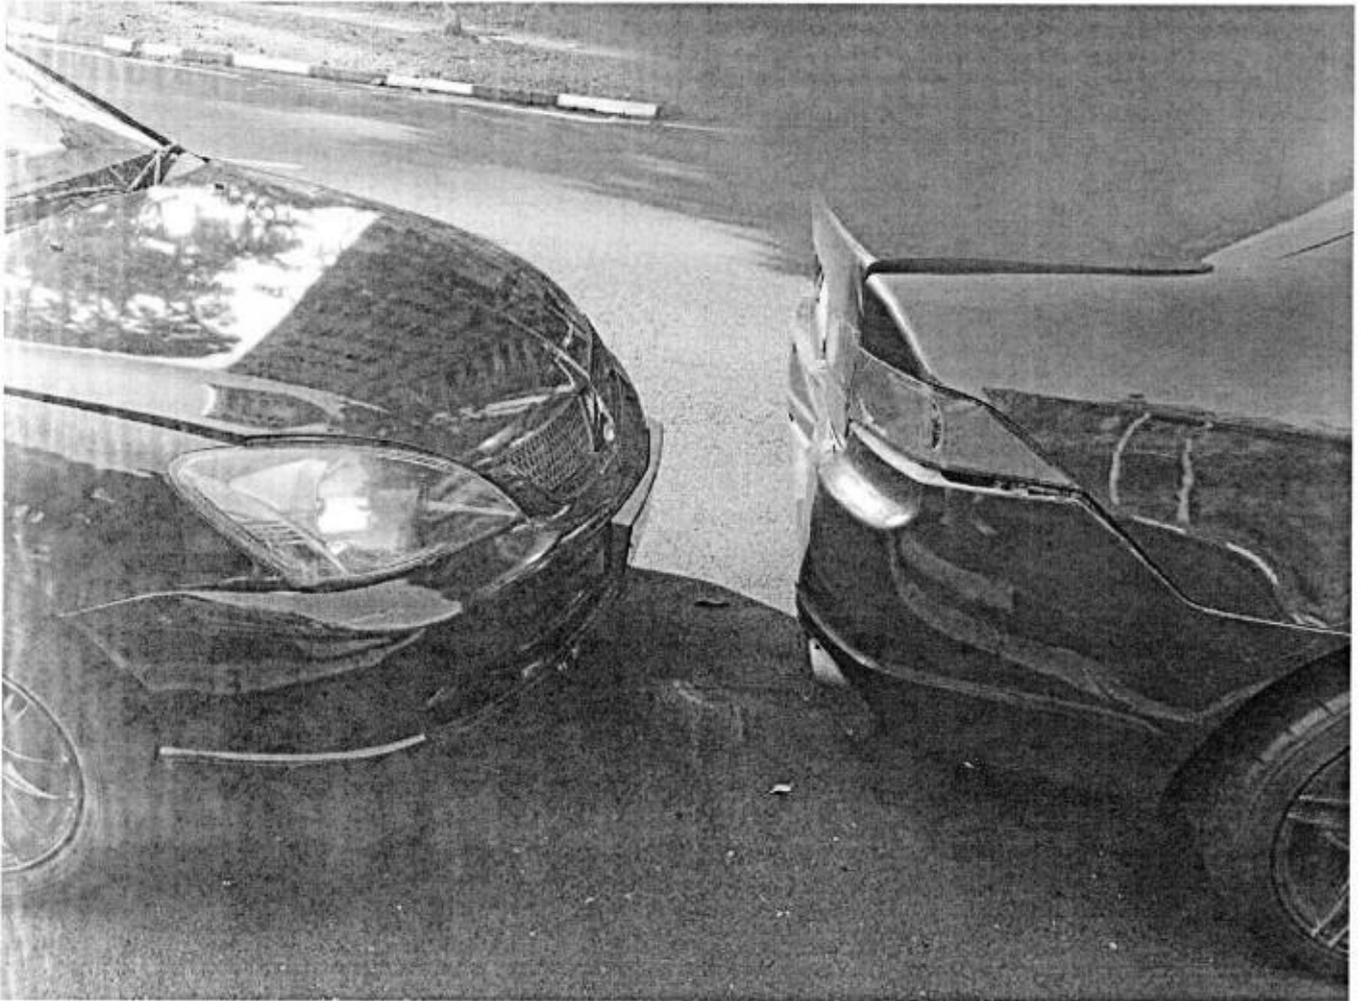
Accident Photo

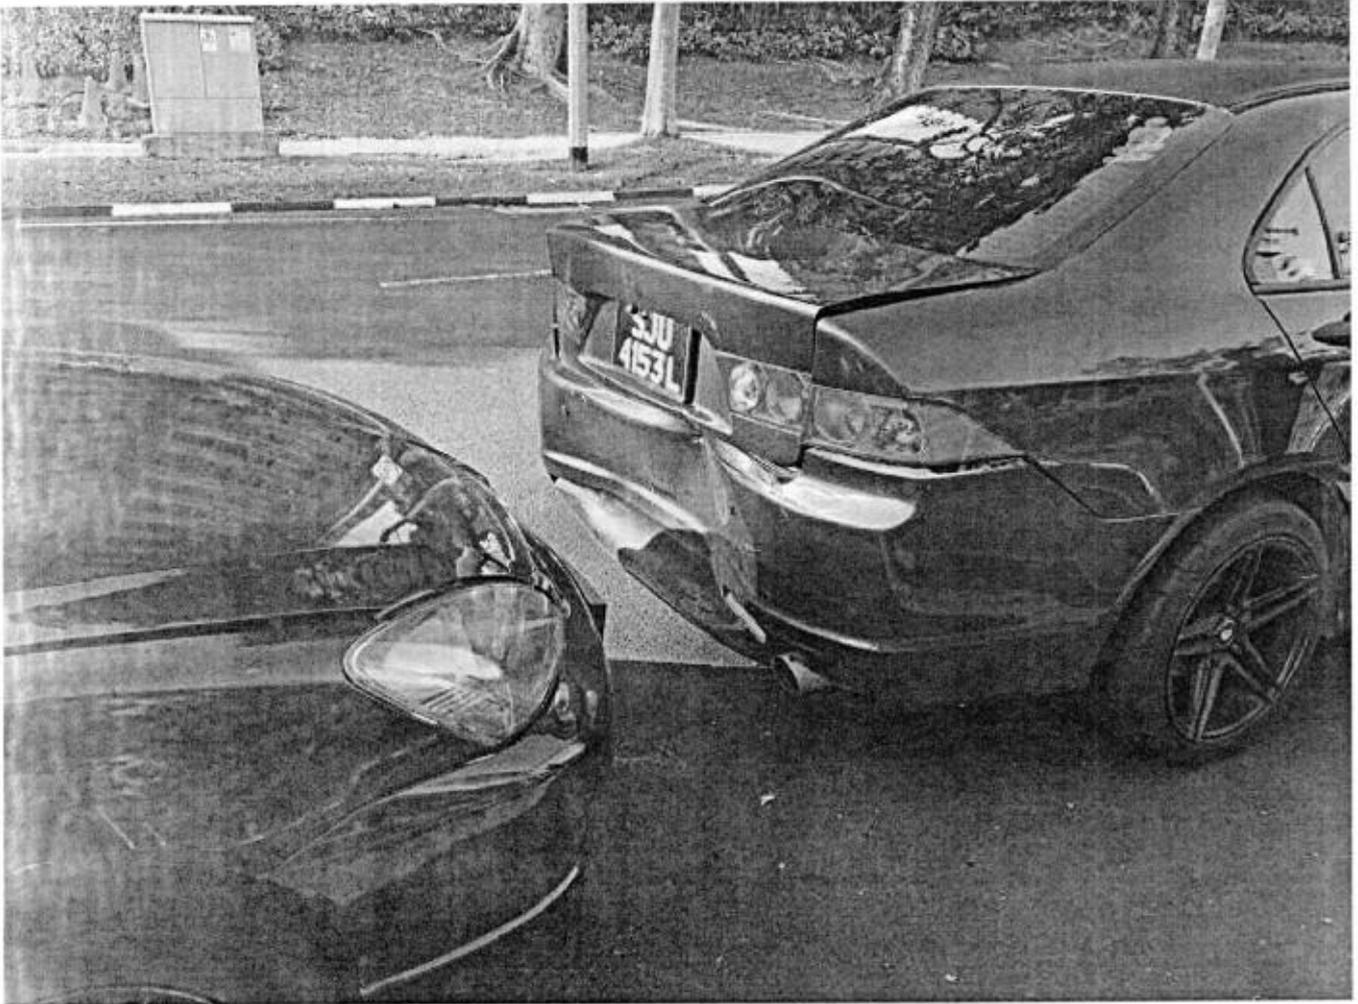
Accident Photo

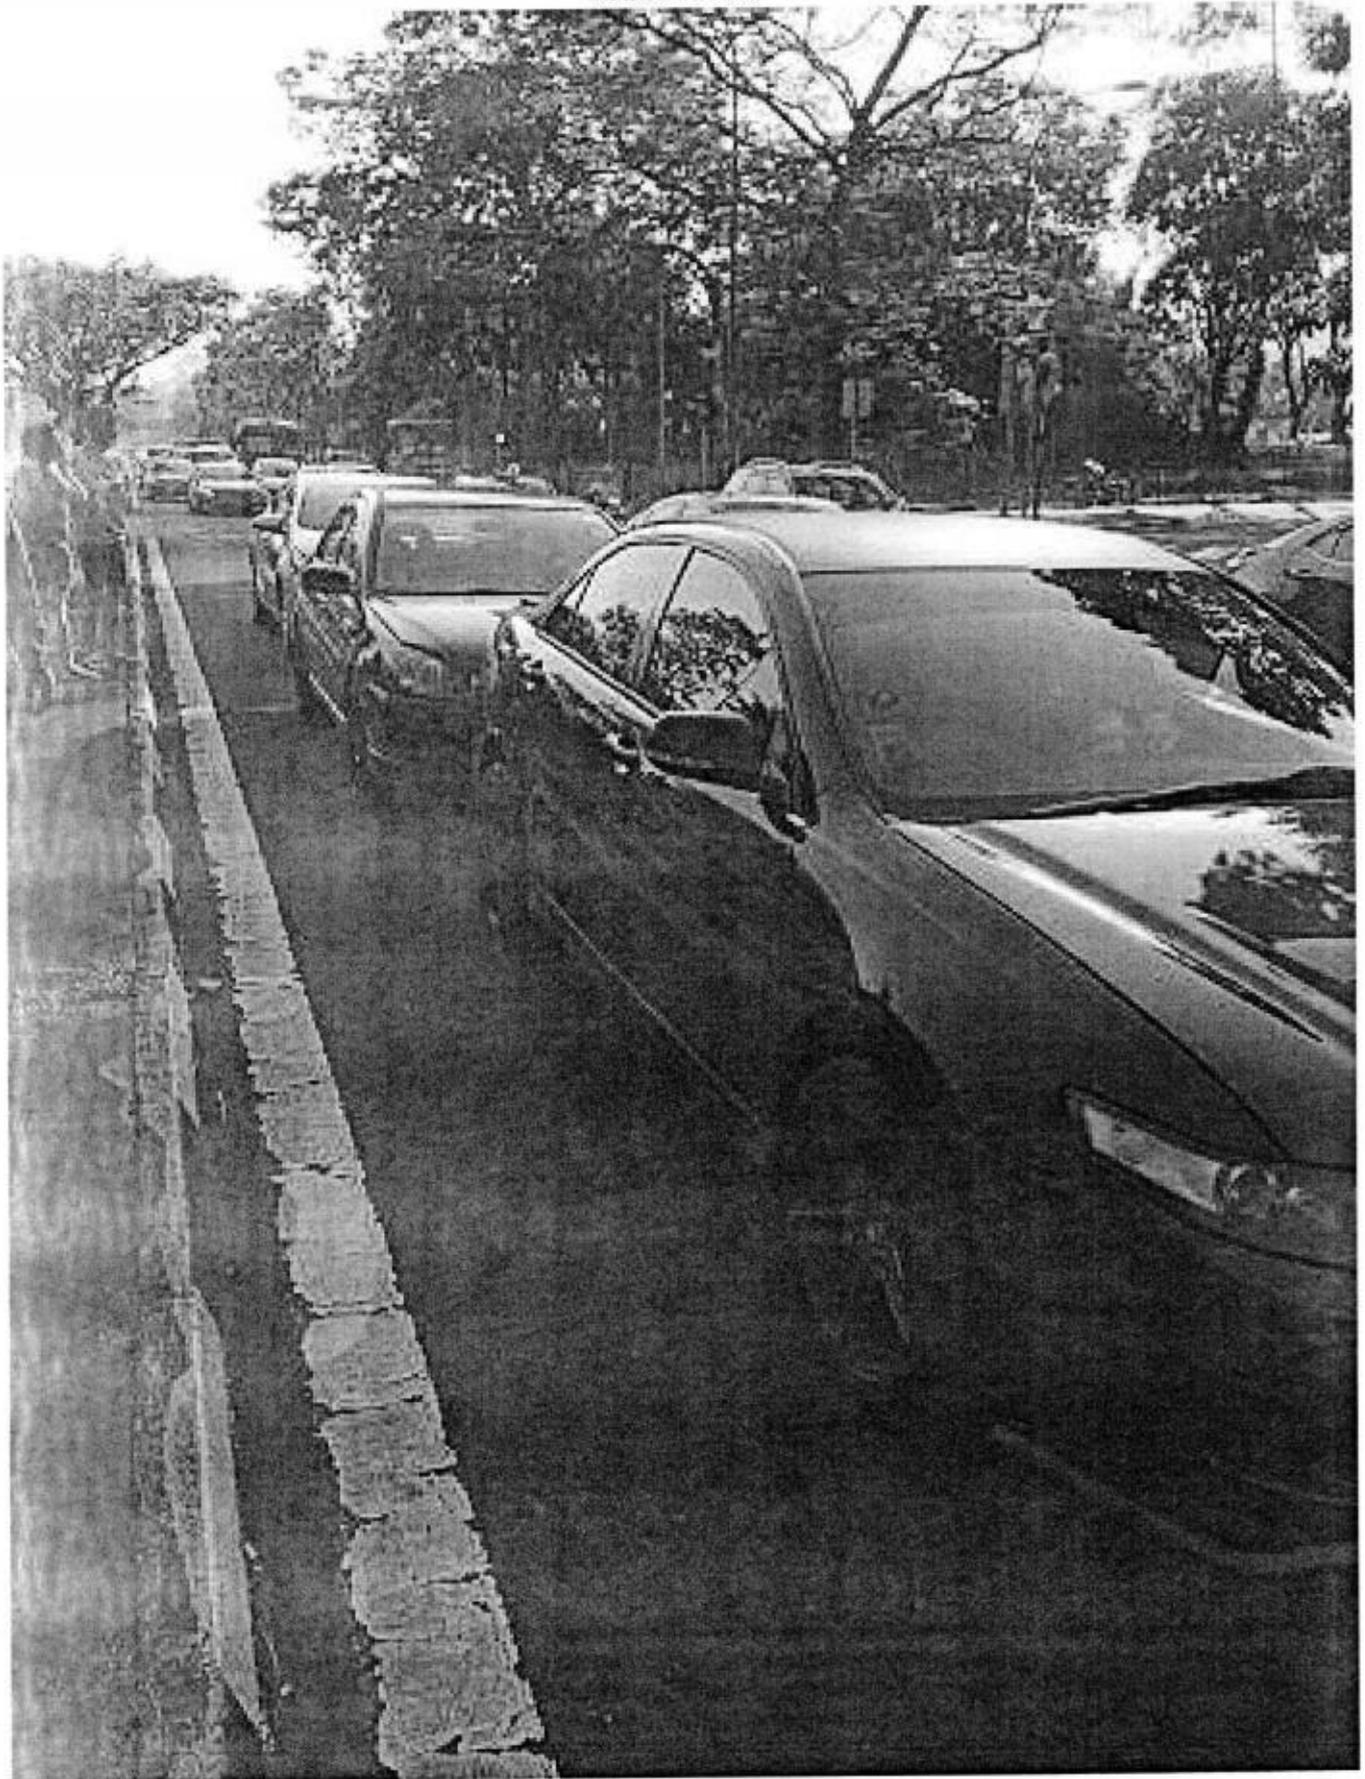
Accident Photo

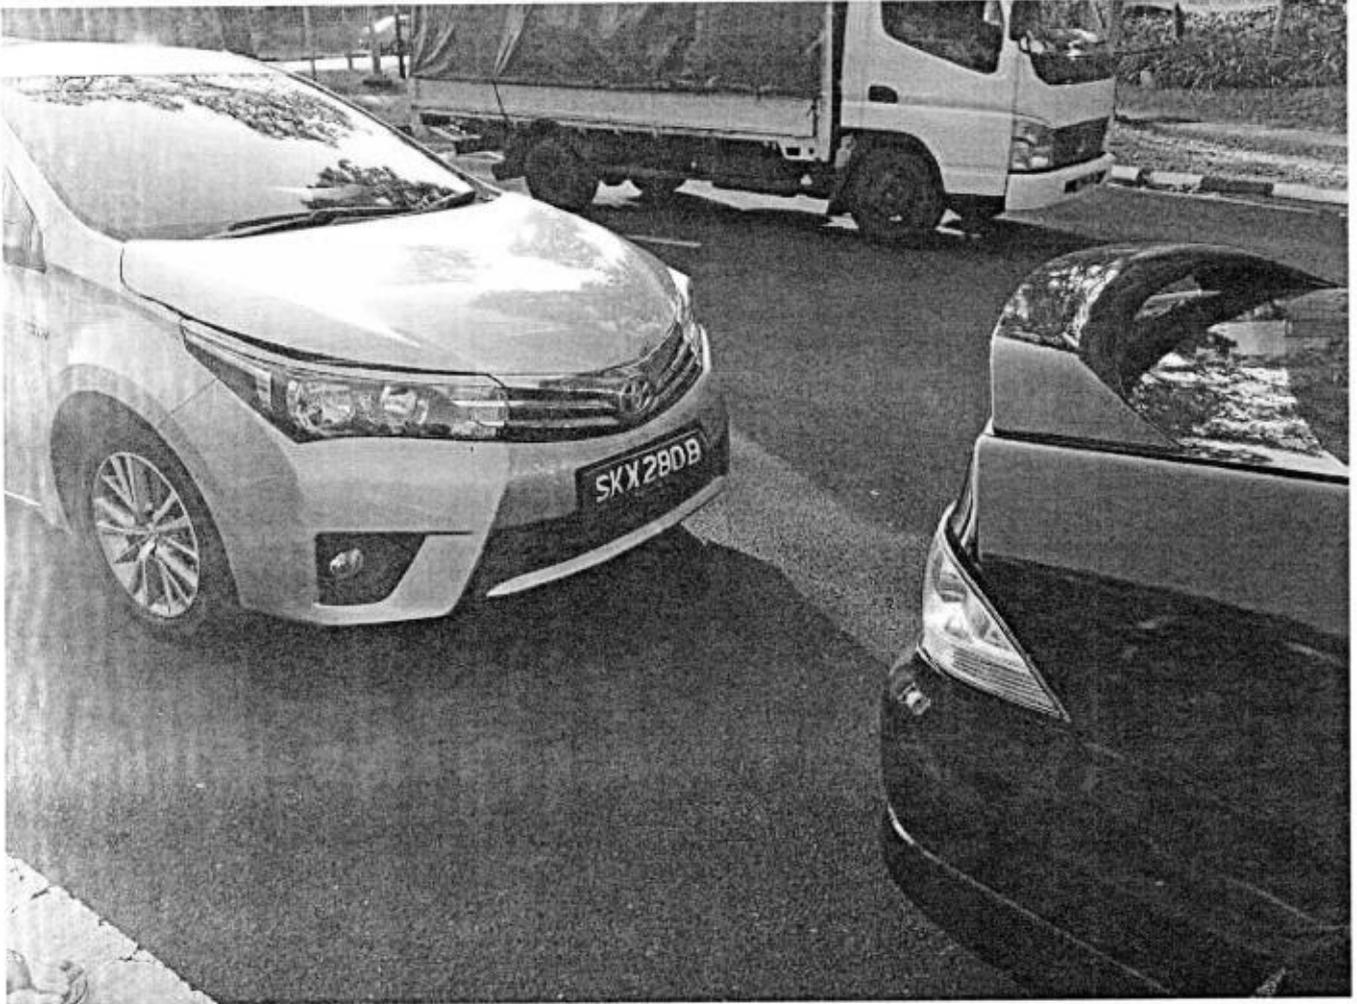
Accident Photo

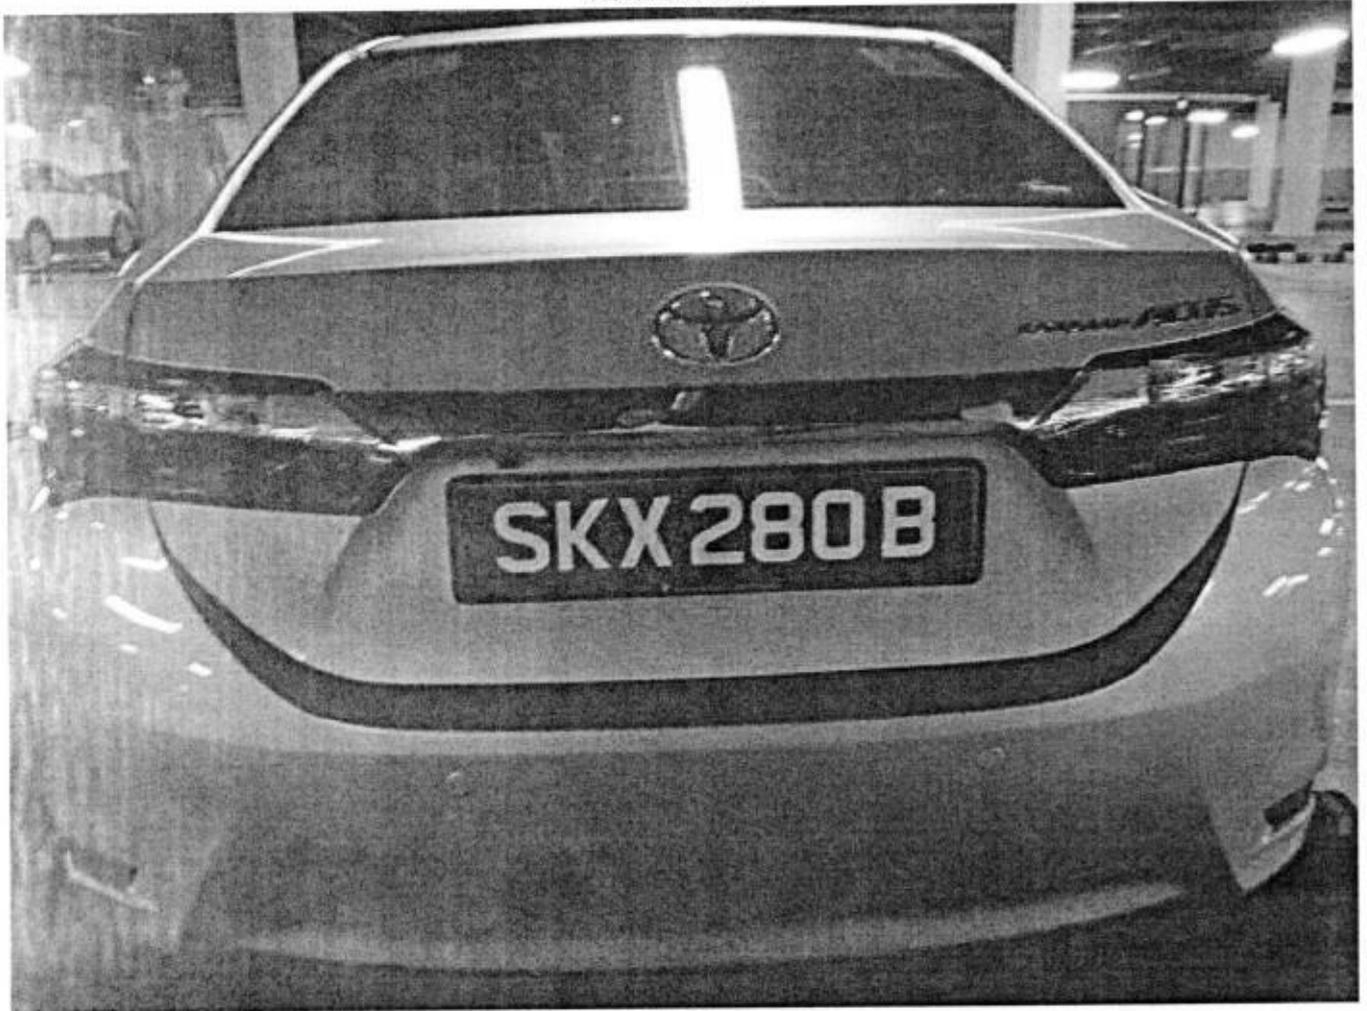
Accident Photo

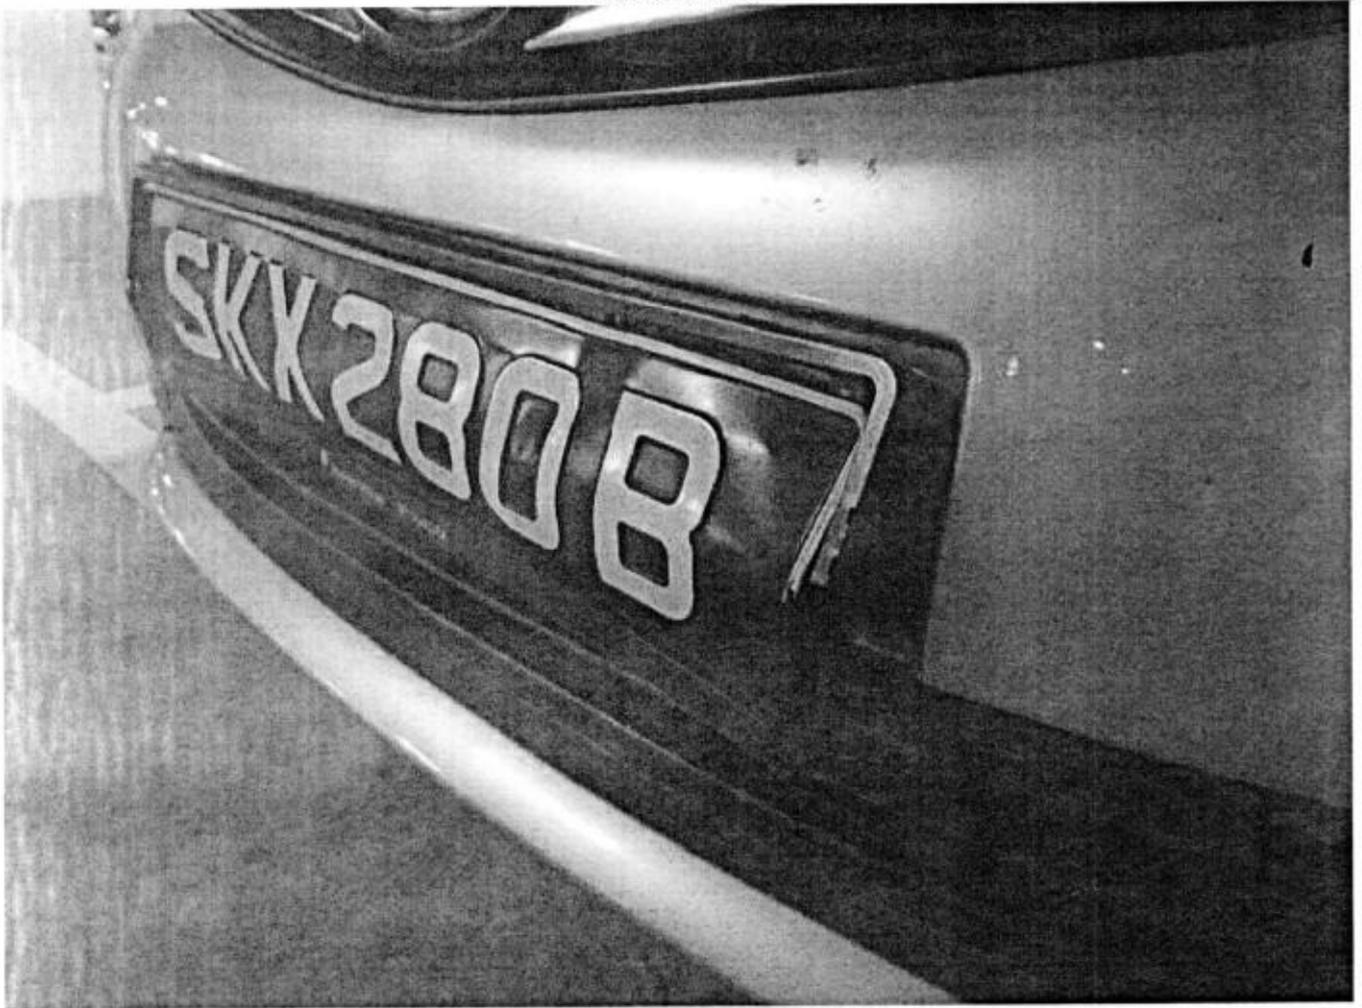
Accident Photo

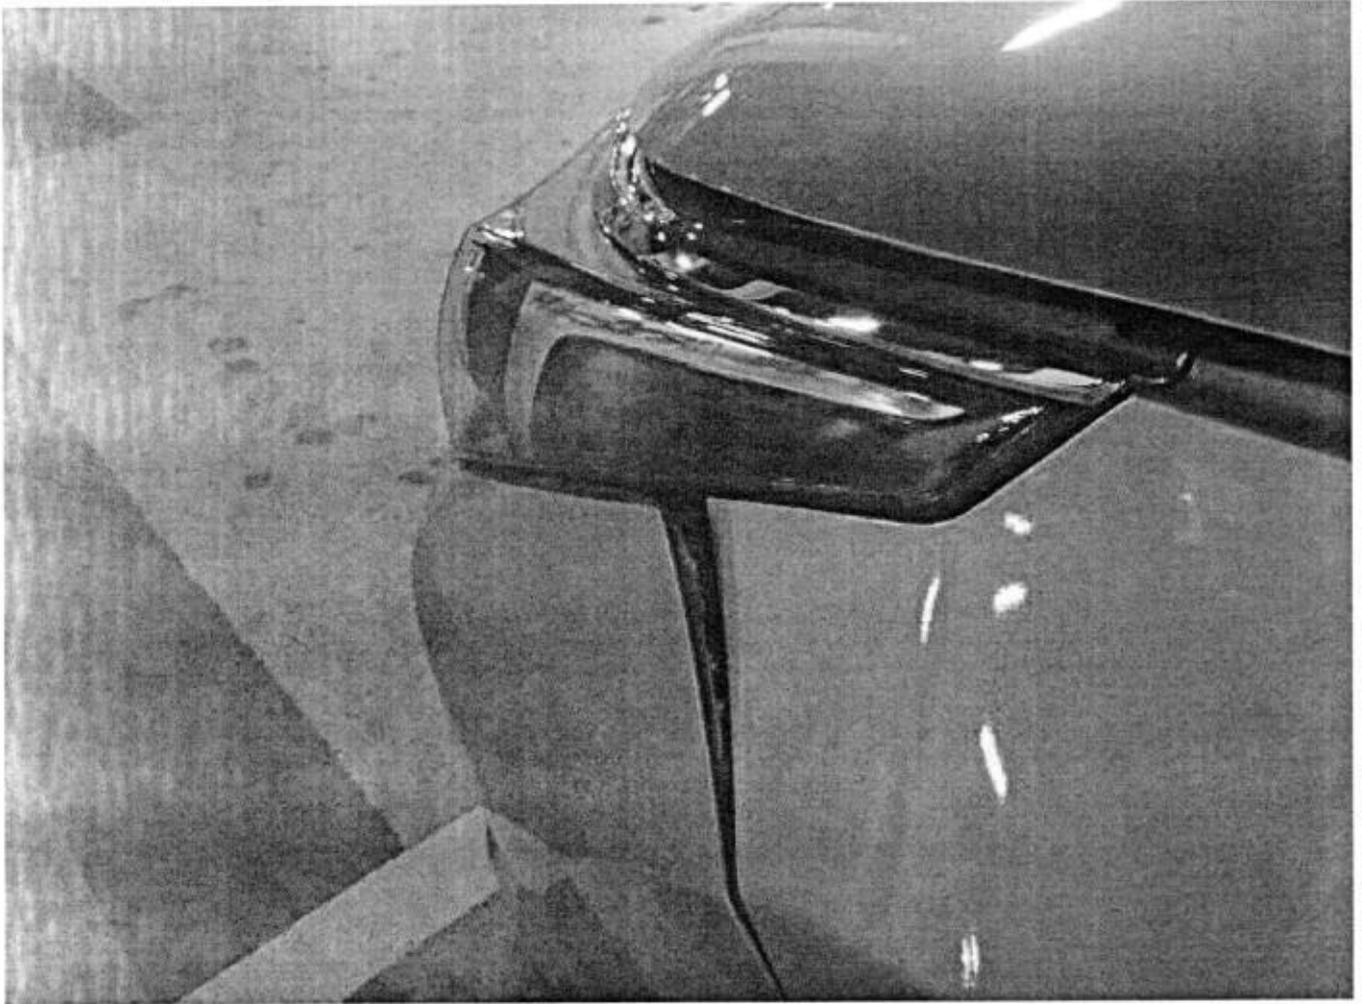
Accident Photo

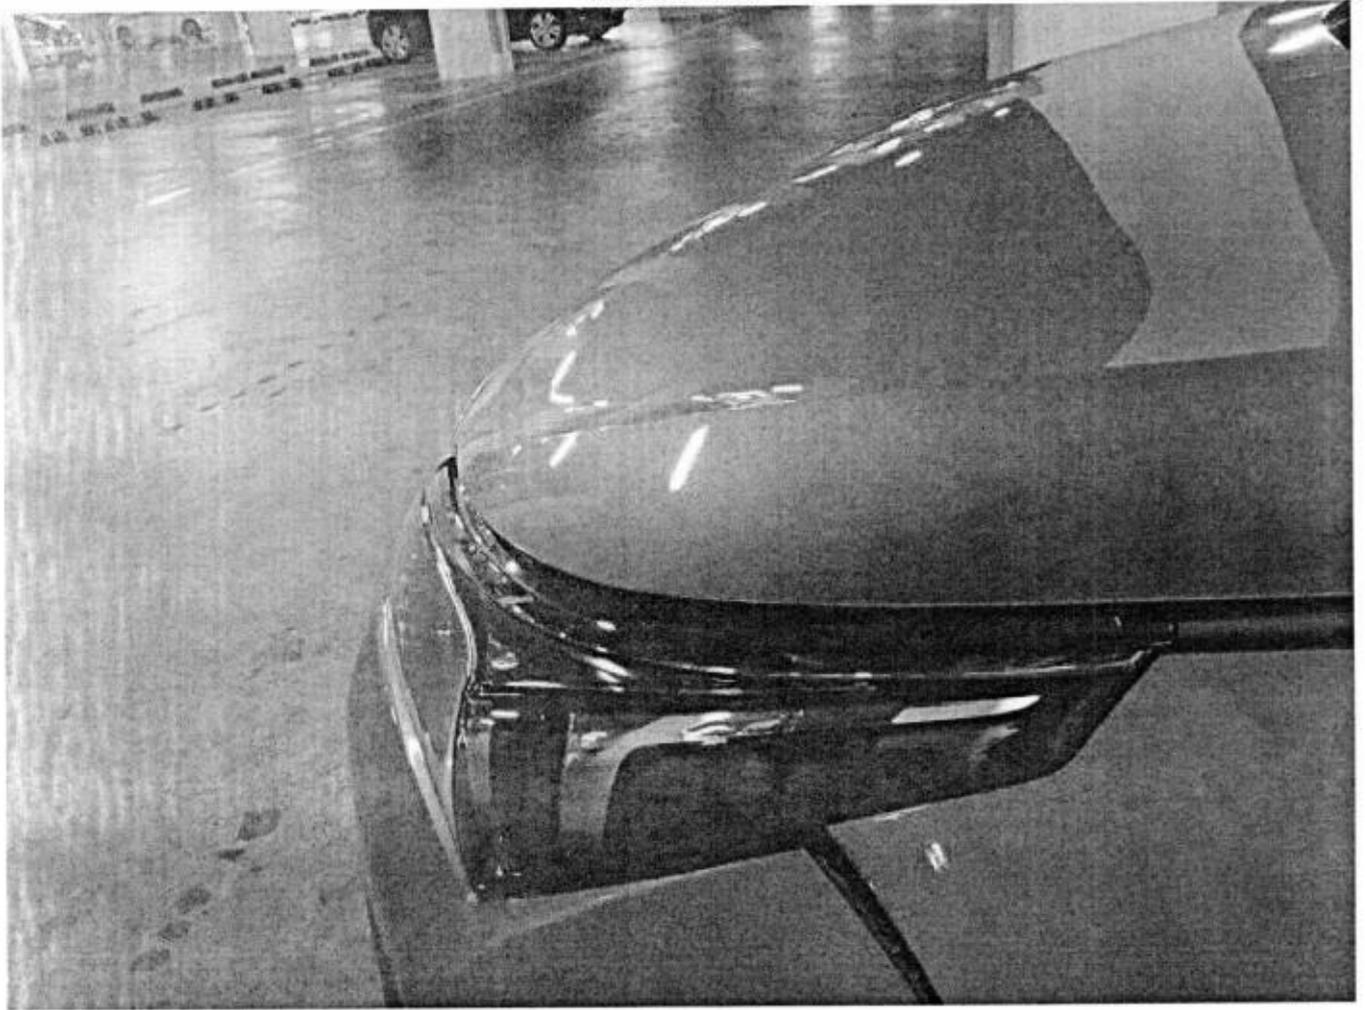
Accident Photo
