**Preliminary Advice**

Insured Vehicle No	: SFF8080M	Accident Date	: 21/05/2019
TP Vehicle No	: SJX867X	Assignment Date	: 27/05/2019
Make	: SUZUKI SX4	Est. Duration of Repair	: 5.00
Date of Inspection	: 28/05/2019		
Inspection At	: POLYMATH GARAGE PTE LTD - KAKI BUKIT (HQ) 10 KAKI BUKIT ROAD 2, #01-21 FIRST EAST CENTRE SINGAPORE 417868

## VEHICLE DAMAGE INSPECTION REPORT

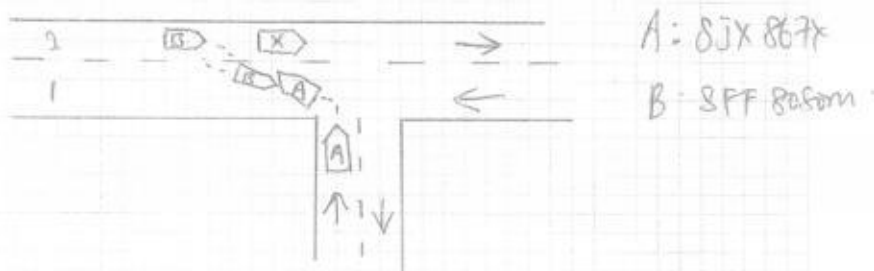
SKETCH PLAN

On 21/05/2019 at 1:700 at Lor Marican junction with 31n Keeloy, I was exiting the side road and turning left in Vehicle A. Vehicle B was overtaking another Vehicle in his lane, by filtering into the opposite direction lane. Vehicle B and my Vehicle A collided head to head in Lane 1.
