REF: CS3/CT19009447/GC d302

To Inspect Vehicle No: SJH 4494X

VEHICLE DAMAGE INSPECTION REPORT

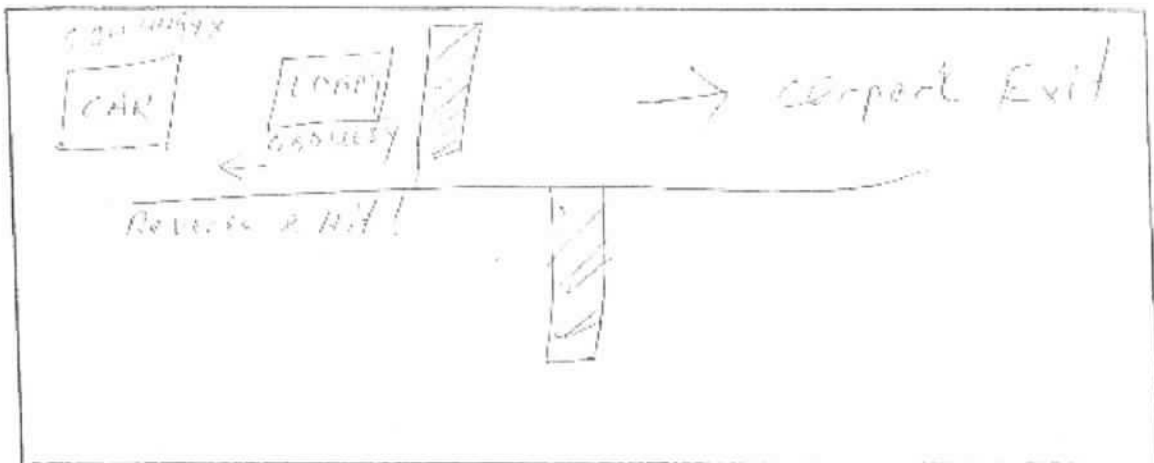
Sketch Plan #2

On 23/08/19 Saturday about 13:00 at blk 3/3A
 Compassvale link I was exiting the carpark
 In front of me was a grey 430 6657 having moved
 to exit I wanted to alert him he reversed his lorry I
 started to honk to alert him but he did not see or
 hear me as his back view was blocked
 He then hit my front side of the car.
