Your Ref: TP/IP/26131/2019  
Our Ref : CI/TPD19009626/N

24 June 2019

**Fatal Accident Investigation Team**

**MECHANICAL INSPECTION REPORT OF MOTORCYCLE FBC 7337T**

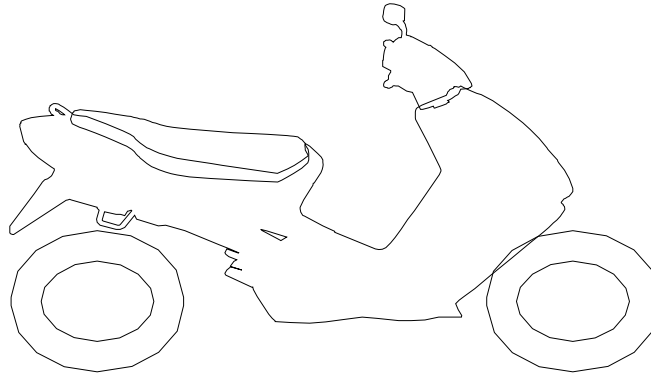
7. Both the tyres were observed to be sufficiently inflated for vehicular operation. The tyre brand, tyre size and remaining tread depth of the 2 tyres of the Motorcycle were recorded as follows:-

Pirelli 180/55 R17 (3mm)

Pirelli 120/70 R17 (3mm)

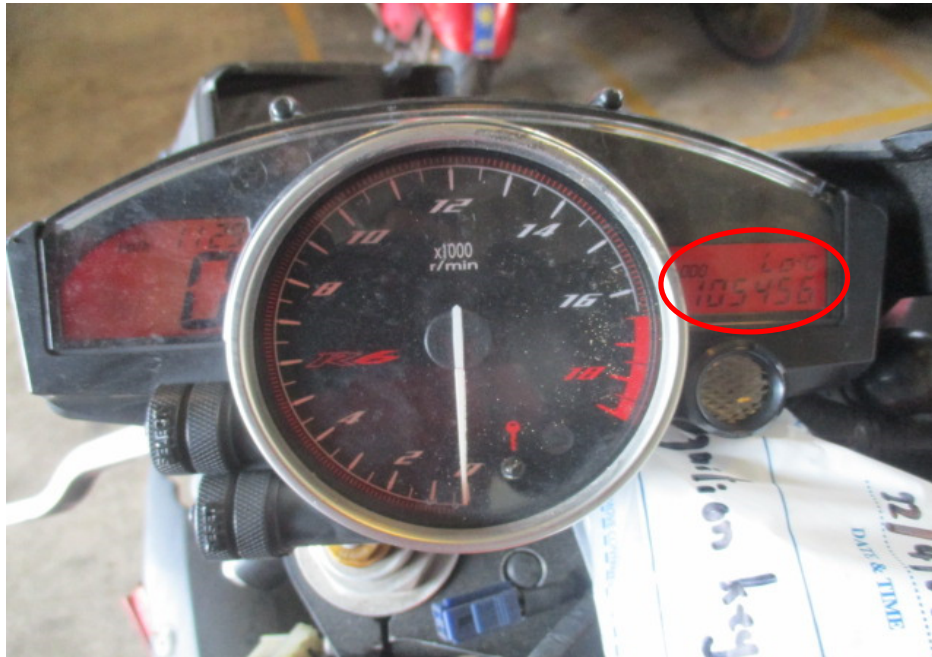
**Photo 1** shows a closer view of the speedometer gauge of the Motorcycle. The mileage of the Motorcycle at the time of our inspection was 105, 456km (circled).

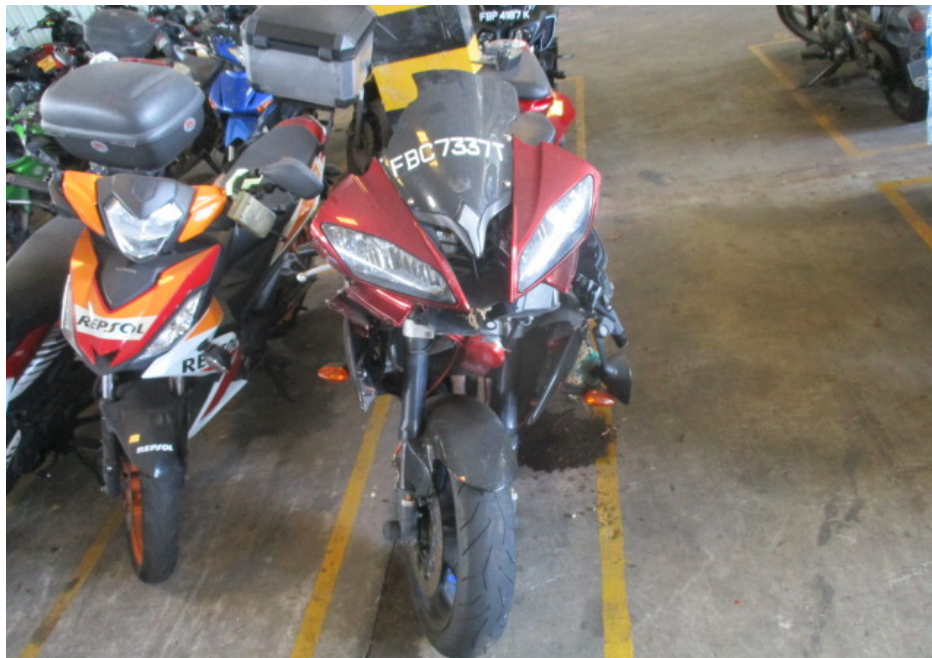
**Photo 2** shows a general view of the front body of the Motorcycle at the time of our inspection. The Motorcycle was observed to have sustained damages at its frontal and left portion.

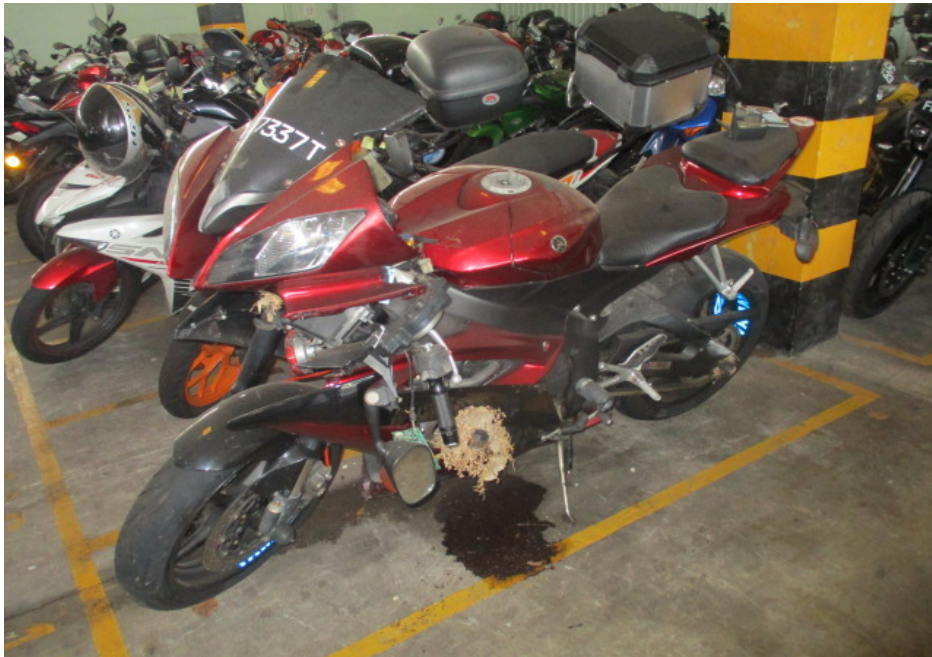
**Photo 3** shows a general view of the left front body of the Motorcycle at the time of our inspection. The Motorcycle was observed to have sustained damages at its frontal and left portion. The body parts that were found to have been damaged include its headlamp assembly, head cowling, speedometer gauge, side mirrors, handlebars, petrol tank, left side cowling, frame sliders, gear shift pedal, left signal lamps and rear number plate, amongst others.

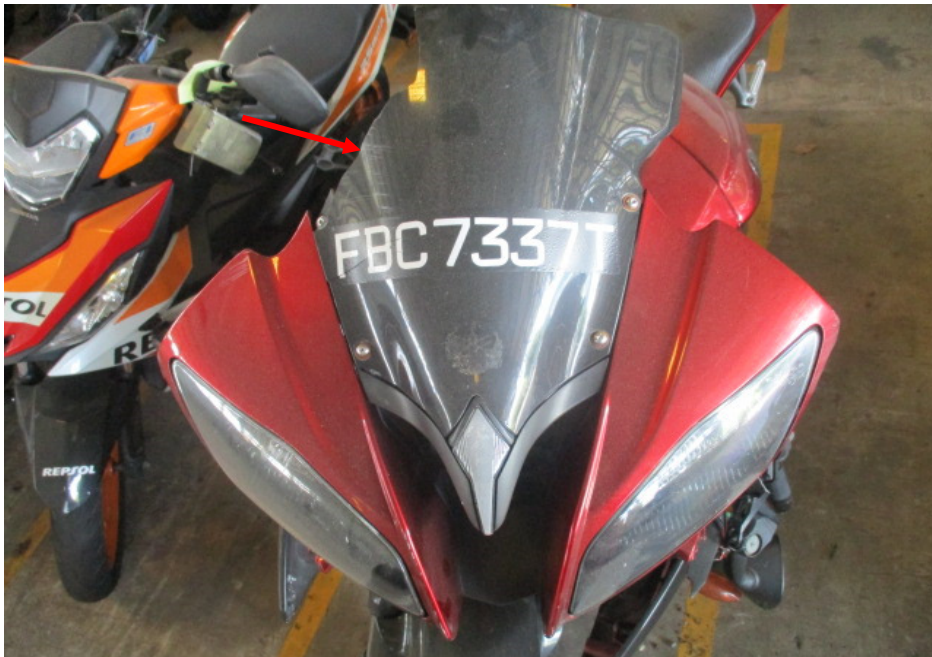
**Photo 4** shows a closer view of the head cowling and windshield (arrowed) of the Motorcycle which had sustained damages as a result of the accident.

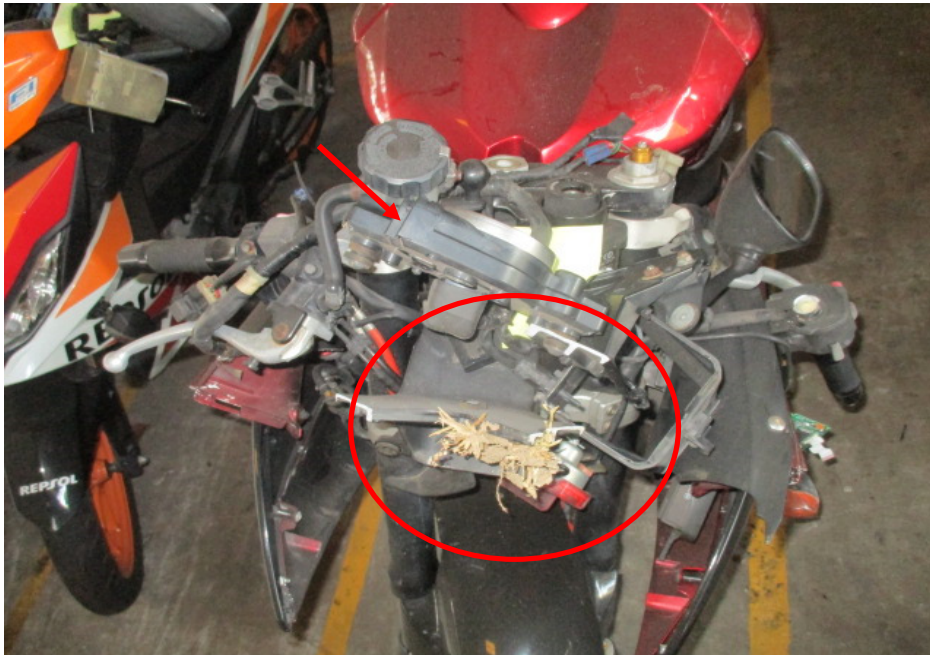
**Photo 5** shows a closer view of the headlamp assembly (circled) and speedometer gauge (arrowed) which were amongst the body parts at the front body of the Motorcycle that had sustained damage as a result of the accident.

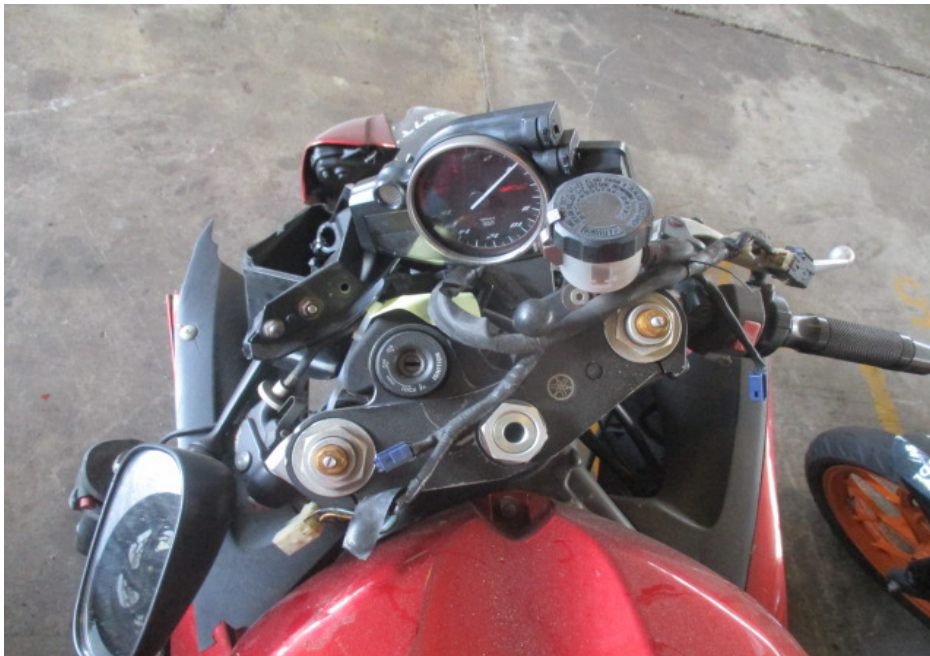
**Photo 6** shows a close up view of the front brake lever, front brake fluid reservoir, side mirrors, clutch lever, handlebars and handlebar ends of the Motorcycle. These parts were amongst the body parts of the Motorcycle which were damaged as a result of the accident.

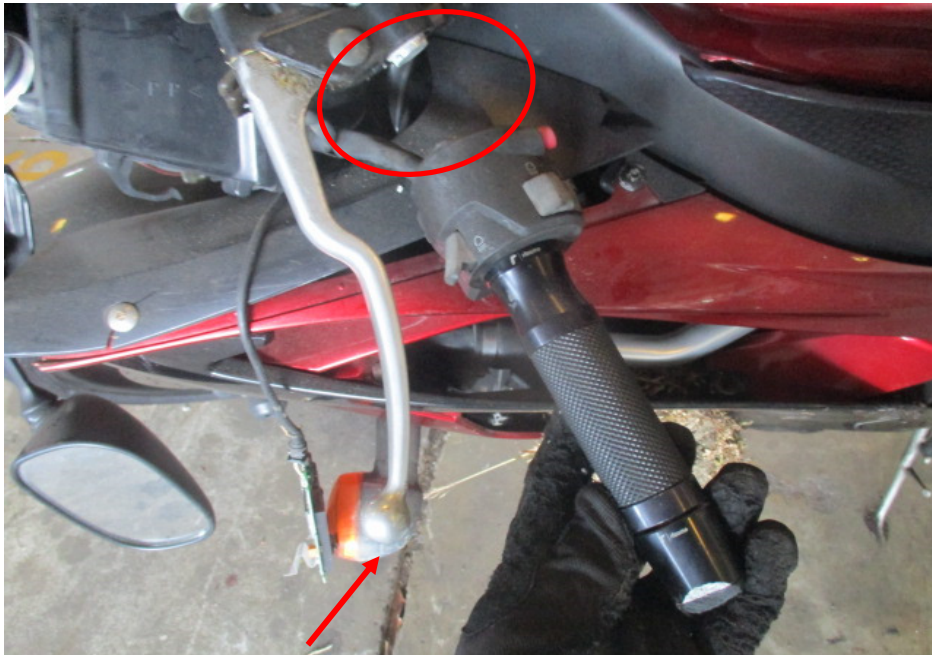
**Photo 7** shows a closer view of the clutch lever (arrowed) and broken left handlebar (circled) which were amongst the body parts at the front body of the Motorcycle that had sustained damage as a result of the accident.

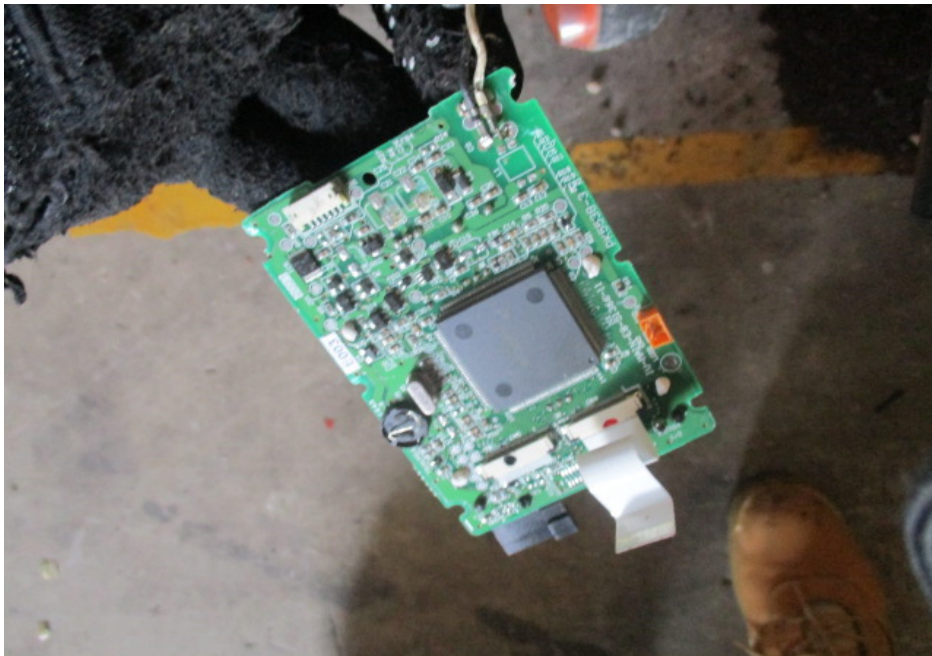
**Photo 8** shows the broken IU unit of the Motorcycle as a result of the accident.

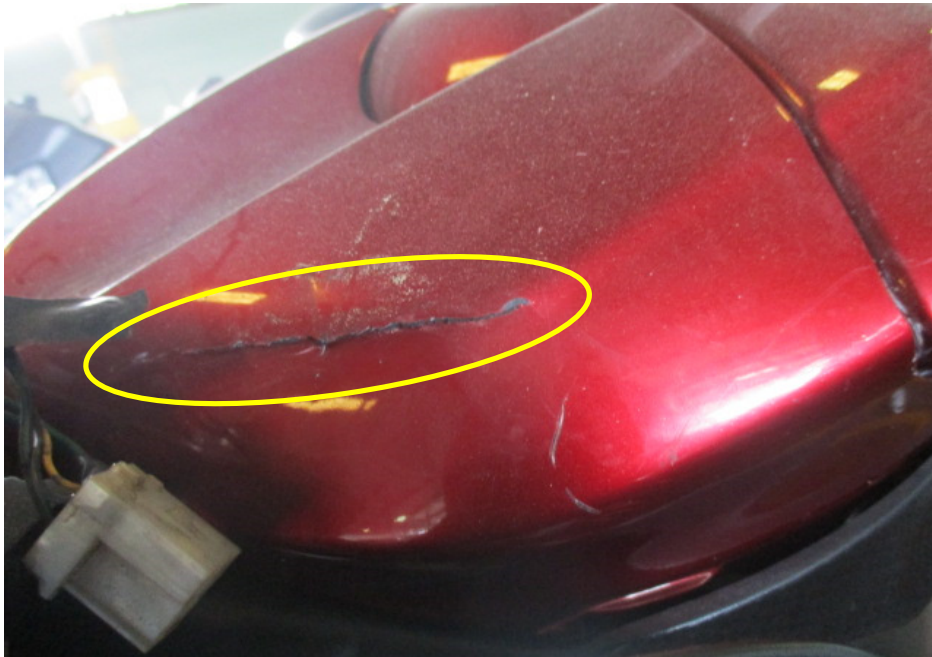
**Photo 9** shows a closer view of the petrol tank, which was amongst the body parts of the Motorcycle that had sustained damage as a result of the accident (circled).

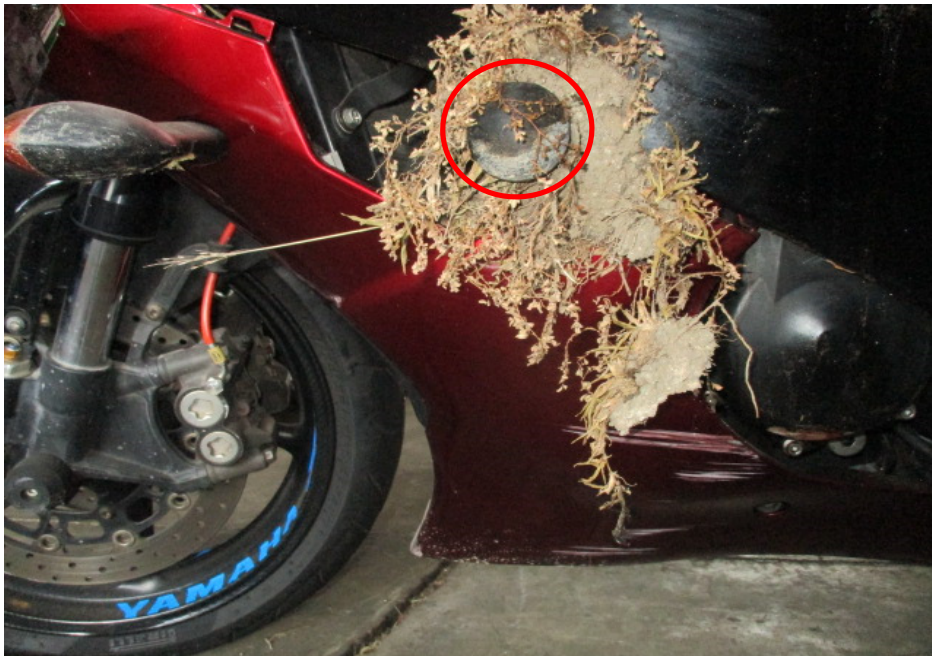
**Photo 10** shows a closer view of the left side cowling and left front frame slider (circled), which were amongst the body parts of the Motorcycle that had sustained damage as a result of the accident.

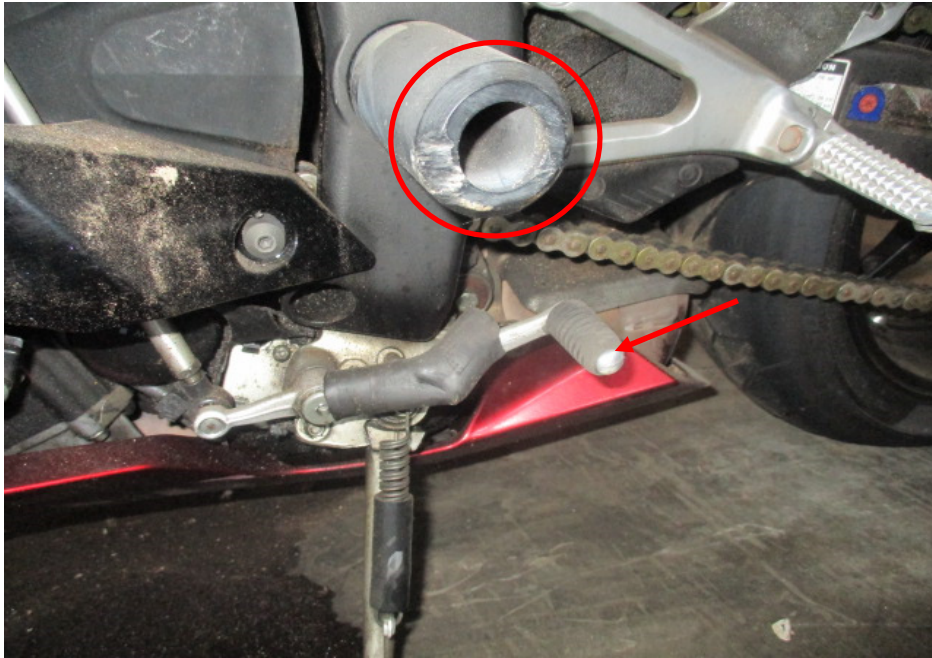
**Photo 11** shows a closer view of the left engine frame slider (circled) and gear shift pedal (arrowed) which was amongst the body parts of the Motorcycle that had sustained damage as a result of the accident.

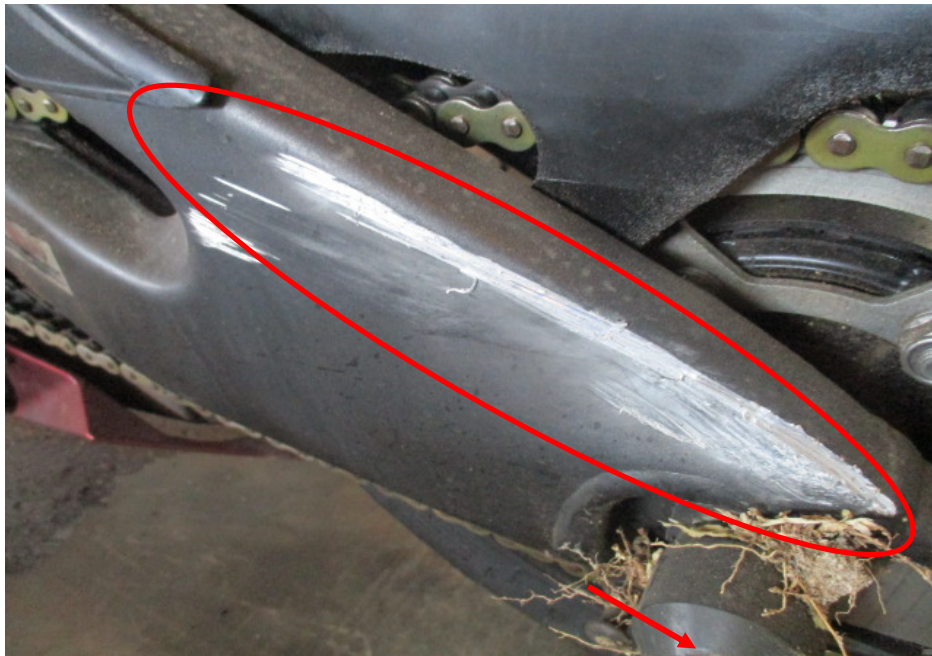
**Photo 12** shows a closer view of the left rear slider (arrowed) and swingarm (circled) which was amongst the body parts of the Motorcycle that had sustained damages of grazing nature as a result of the accident.

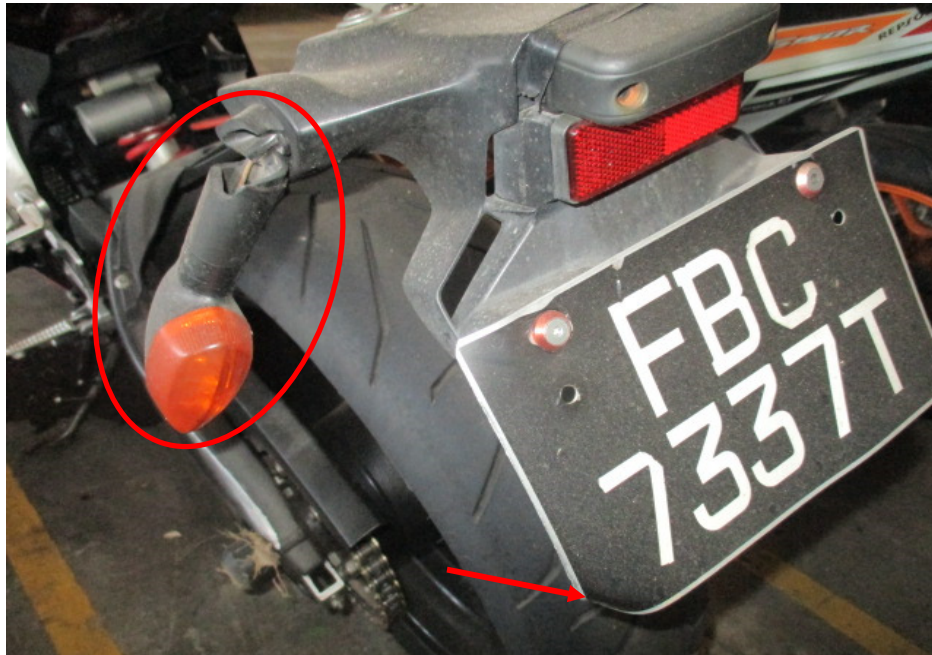
**Photo 13** shows the dislodged left rear signal lamp (circled) and dented rear number plate of the Motorcycle as a result of the accident.

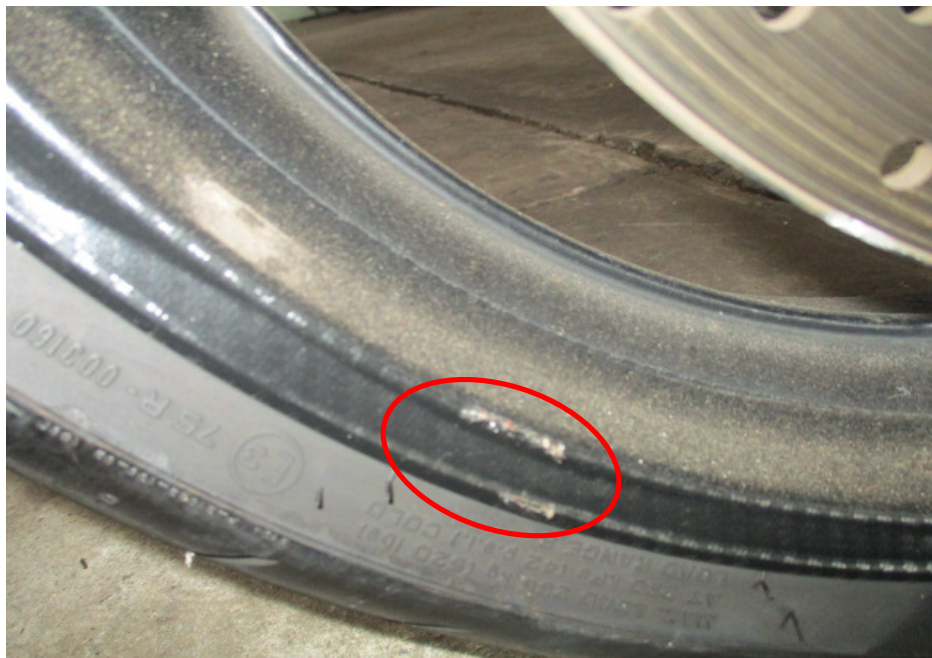
8. The 2 tyres were wrapped around alloy wheel rims. At the time of our inspection, we did not observe any visible damage on the rear wheel rim of the Motorcycle. We had however found some relatively minor marks of grazing nature on the edges of the front wheel rim, at the left side of the Motorcycle. See photos 1 – 16 below.

**Photo 14** shows the front wheel rim of the Motorcycle at the time of our inspection. Some relatively minor marks of grazing nature were observed on the edges of the front wheel rim (circled), at the left side of the Motorcycle.

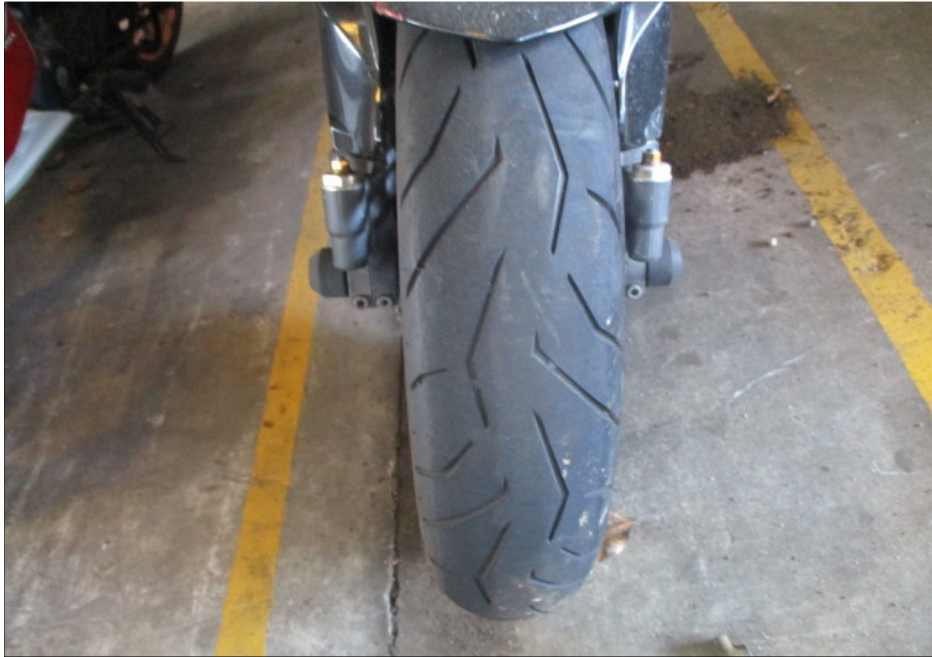
**Photo 15** shows the condition of the Motorcycle's front tyre. The front tyre was observed to be in serviceable condition with remaining tread depth of approximately 3mm. The tyre was also observed to be sufficiently inflated for vehicular operation. We did not observe any tear, burst mark(s) and/or punctured hole(s) on the sidewalls as well as across the tread of the front tyre.

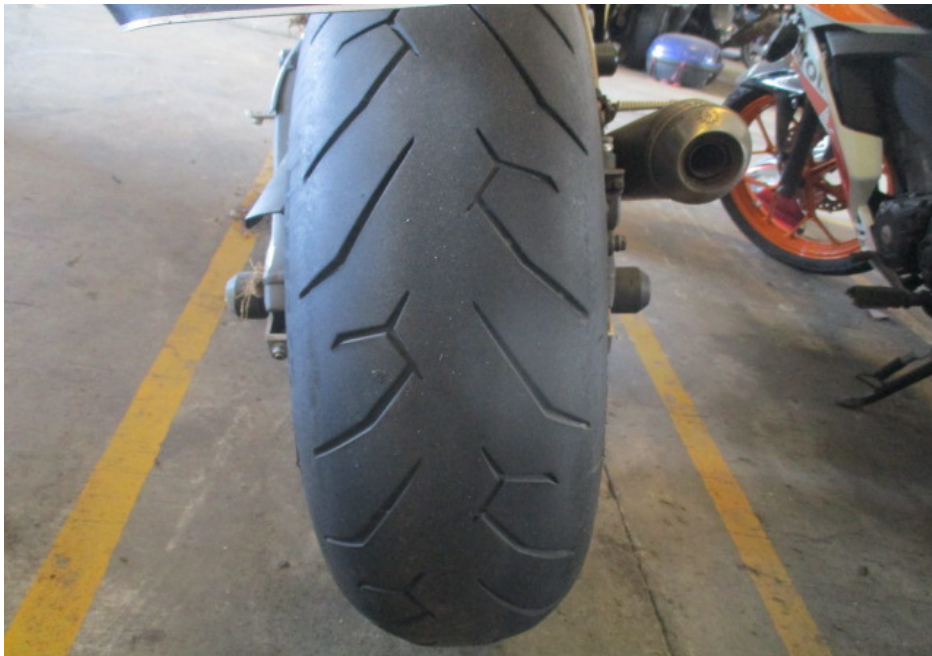
**Photo 16** shows the condition of the Motorcycle's rear tyre. The rear tyre was observed to be in serviceable condition with remaining tread depth of approximately 3mm. The tyre was also observed to be sufficiently inflated for vehicular operation. We did not observe any tear, burst mark(s) and/or punctured hole(s) on the sidewalls as well as across the tread of the rear tyre.

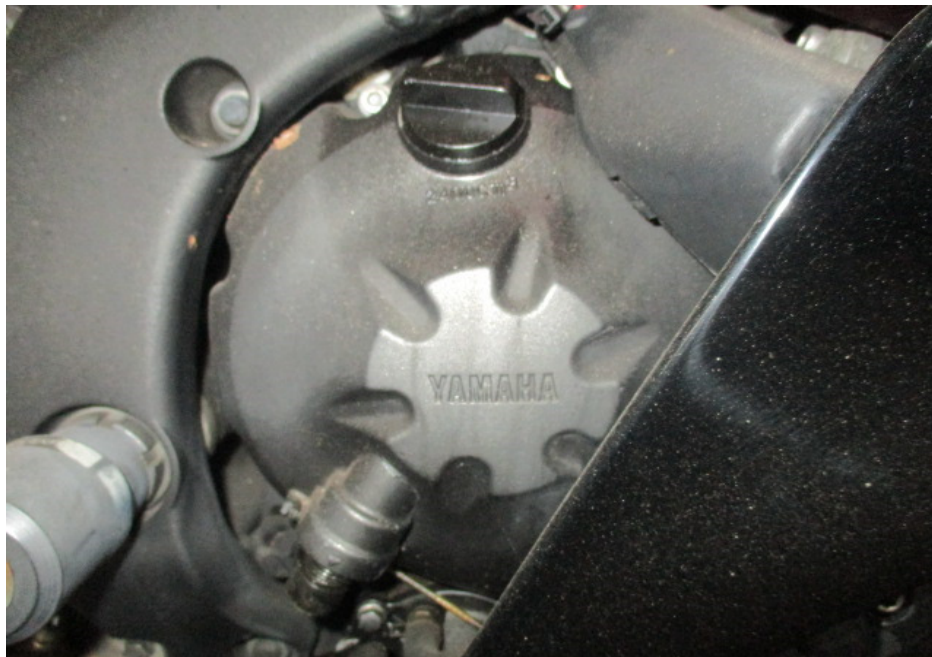
**Photo 17** shows the right side of the engine of the Motorcycle at the time of our inspection. The various engine related parts and components were found to be intact with no visible damage. There was also no sign(s) or indication(s) of fluid leak observed around the right engine area of the Motorcycle.

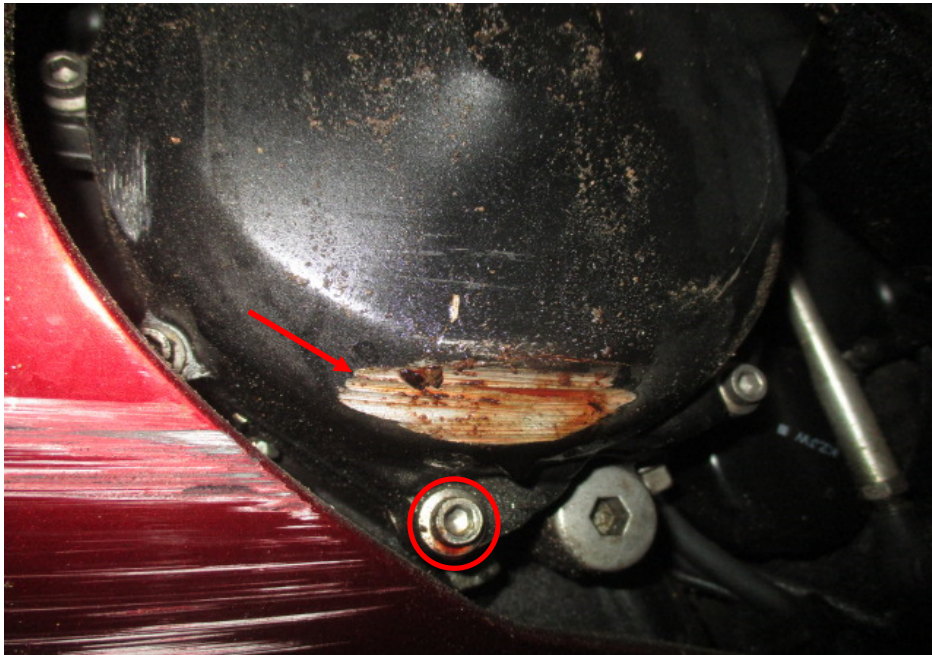
**Photo 18** shows the left side of the engine of the Motorcycle at the time of our inspection. The various left engine components had sustained damage of grazing nature as a result of the accident (arrowed). Wet fluid stains were observed on the underside of the damaged left engine cover of the Motorcycle (circled).

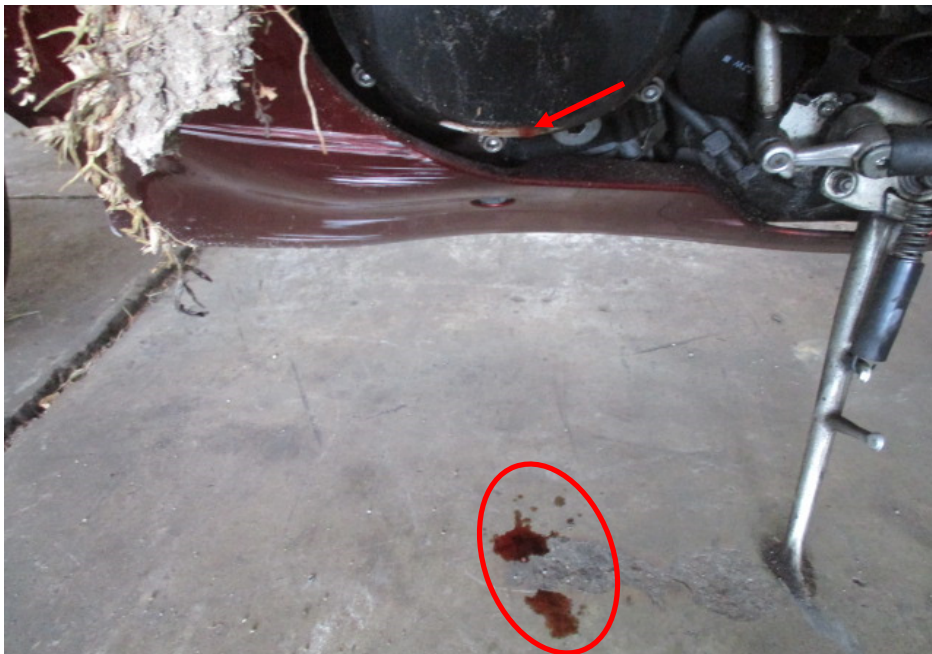
**Photo 19** shows wet fluid stains observed on the ground (circled) directly below the damaged left engine cover of the Motorcycle (arrowed), indicating that a fluid leak had occurred as a result of the accident.

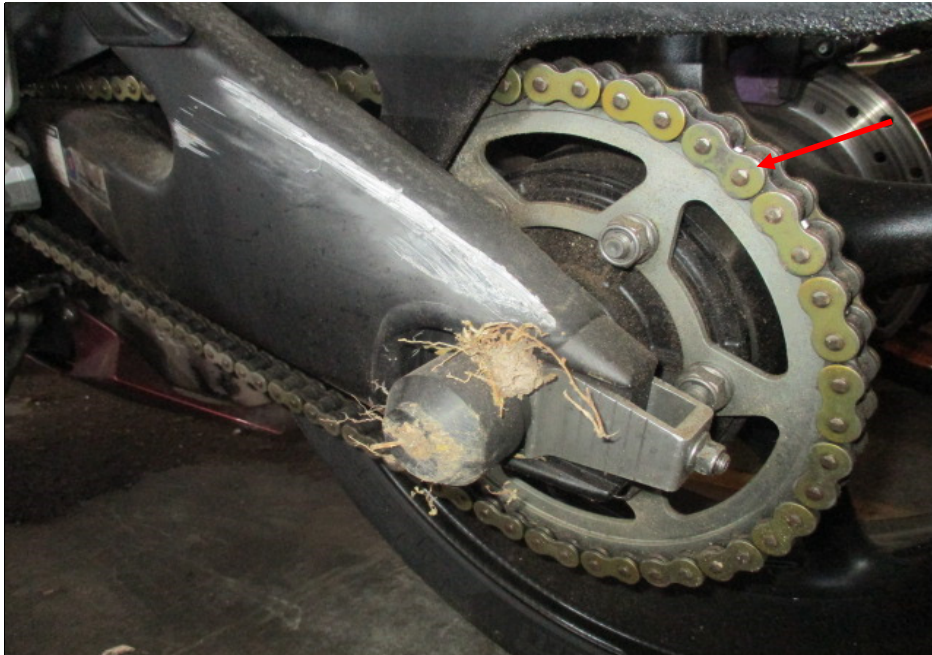
**Photo 20** shows the gear chain (arrowed) of the Motorcycle, which was observed to be intact with no misalignment. It was also adequately lubricated for operating purposes. The gear chain rotates the rear wheel of the Motorcycle.

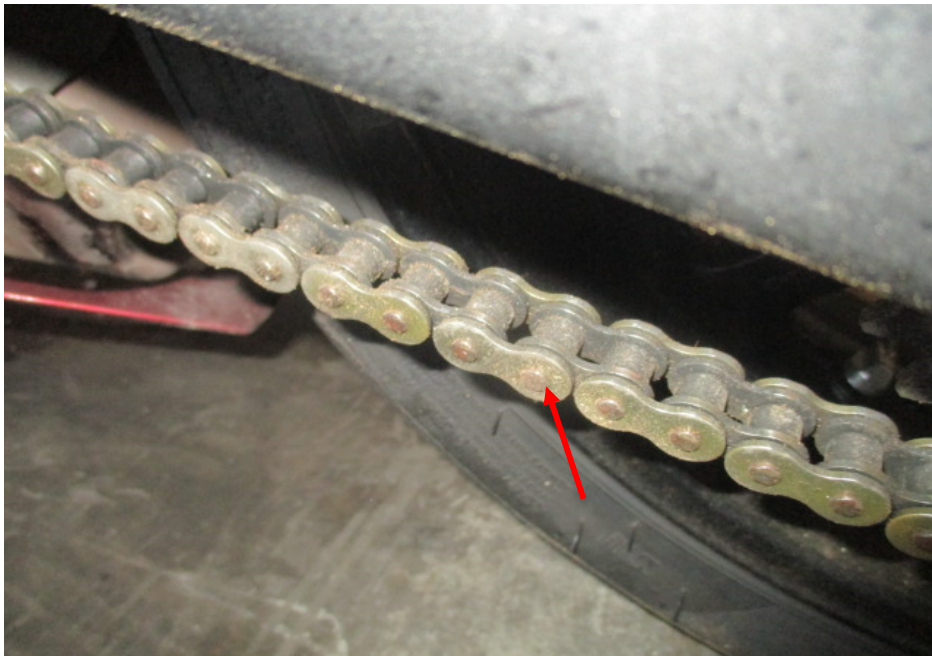
**Photo 21** shows the closer view of the gear chain (arrowed) of the Motorcycle, which was observed to be intact with no misalignment. It was also adequately lubricated for operating purposes.

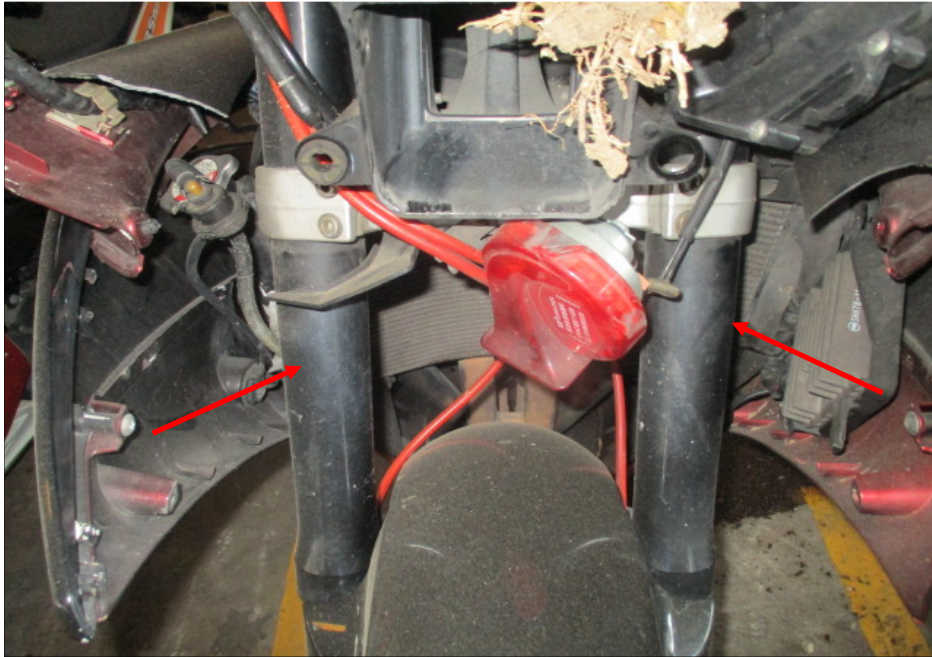
**Photo 22** shows the front fork (arrowed) of the Motorcycle. The front fork and fork bracket of the Motorcycle were both found to be intact and undamaged. Turning the Motorcycle's handle bar towards the left and right did not produce any abnormal free play. The steering system of the Motorcycle was in serviceable condition at the time of our inspection.

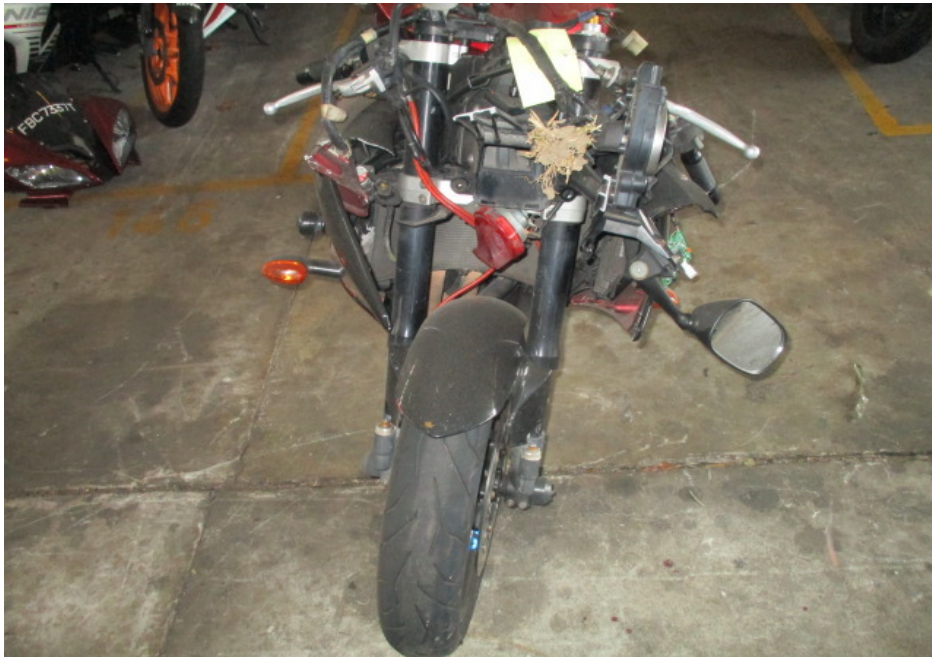
**Photo 23** shows the front wheel of the Motorcycle turned slightly towards the right. We were unable to fully turn the handle bar towards the right due to the resistance from the broken components of the head cowl which were found to be pushed inwards as a result of the accident.

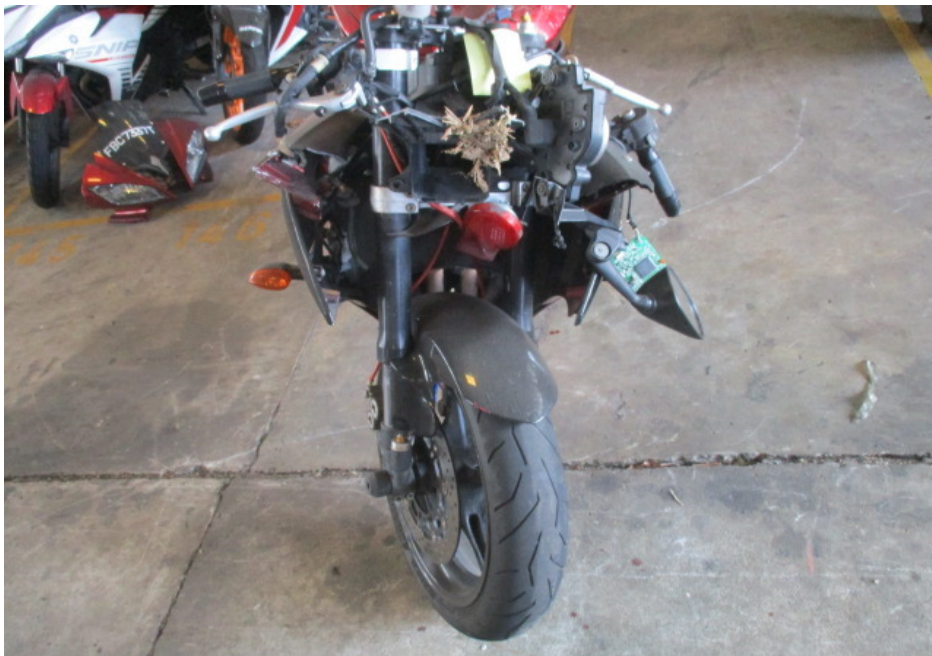
**Photo 24** shows the front wheel of the Motorcycle turned towards its full left. Turning the Motorcycle's handle bar towards the left did not produce any abnormal free play and/or resistance. This would indicate that the steering system of the Motorcycle was in serviceable condition at the time of our inspection.

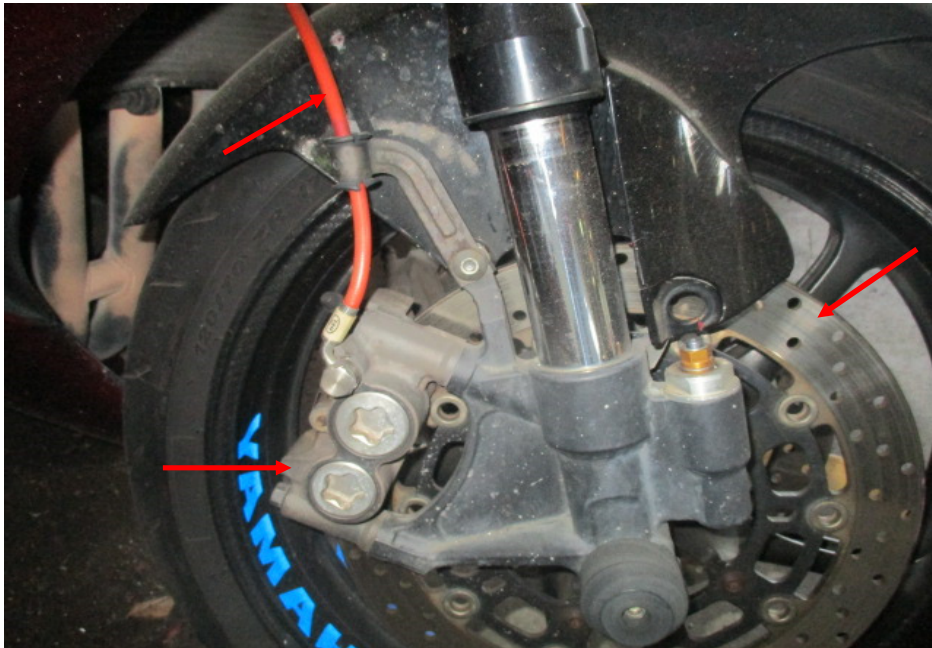
**Photo 25** shows a close up view of the front brake caliper, front brake disc and front brake hose (arrowed) at the right side of the Motorcycle's front wheel, which are all part of the components in the hydraulic front brake system of the Motorcycle. Our visual checks of these various components had revealed all to be intact with no visible damage. No leakage of brake fluid was also observed.

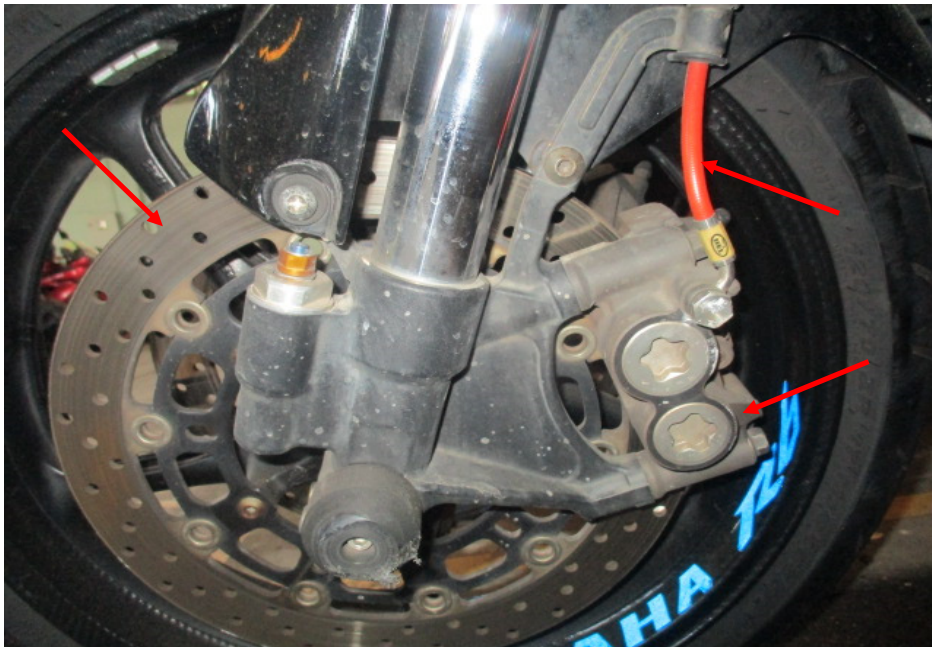
**Photo 26** shows a close up view of the front brake caliper, front brake disc and front brake hose (arrowed) at the left side of the Motorcycle's front wheel, which are all part of the components in the hydraulic front brake system of the Motorcycle. Our visual checks of these various components had revealed all to be intact with no visible damage. No leakage of brake fluid was also observed.

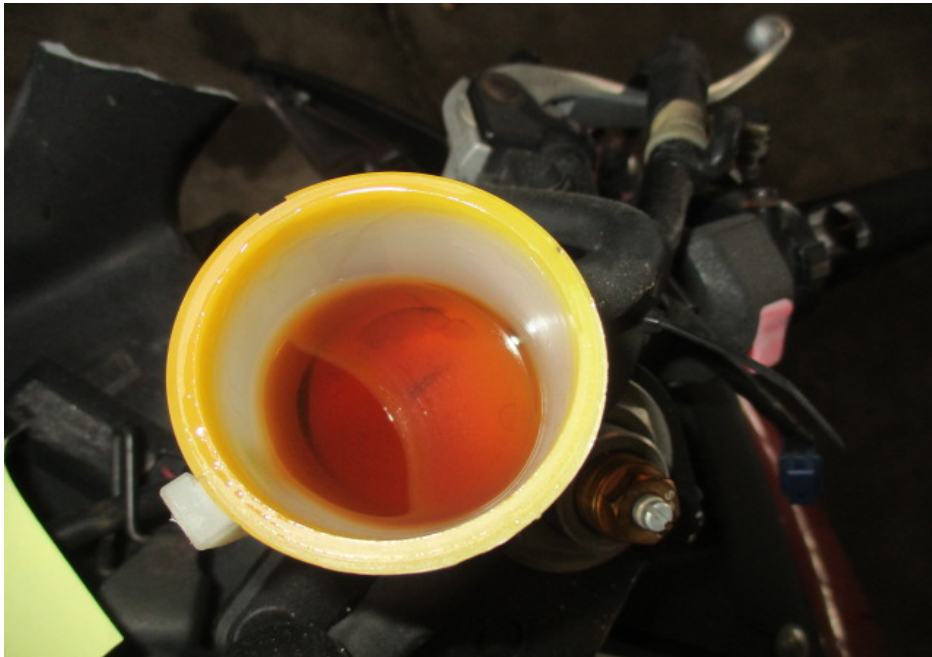
**Photo 27** shows the brake fluid reservoir for the front brake of the Motorcycle. The brake fluid was observed to be of sufficient level and without contamination for operational purposes.

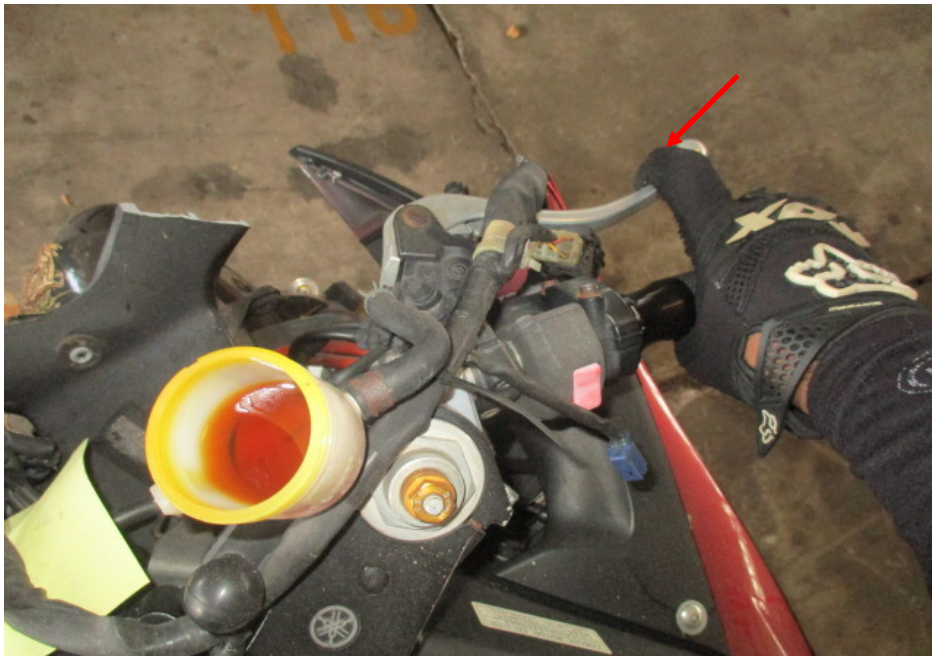
14. Static brake tests conducted on the Motorcycle had appear to indicate that the braking system of the Motorcycle was in serviceable condition. There was some resistance felt (spongy like feel) upon pressing the brake lever. This would indicate that there was no leakage of pressure/vacuum in the brake system.

**Photo 28** shows the front brake lever being depressed. There was some resistance felt (spongy like feel) upon pressing the front brake lever (arrowed). This would indicate that there is no leakage of pressure/vacuum in the brake system.

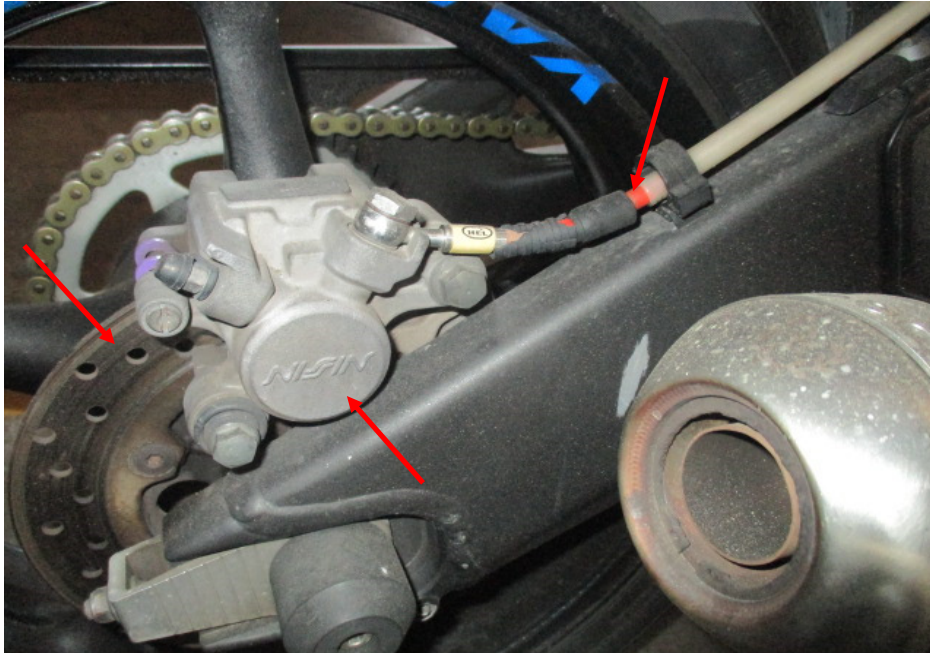
**Photo 29** shows a close up view of the rear brake caliper, rear brake disc and rear brake hose (arrowed) of the Motorcycle, which are all part of the components in the hydraulic rear brake system of the Motorcycle. Our visual checks of these various components had revealed all to be intact with no visible damage. No leakage of brake fluid was also observed.

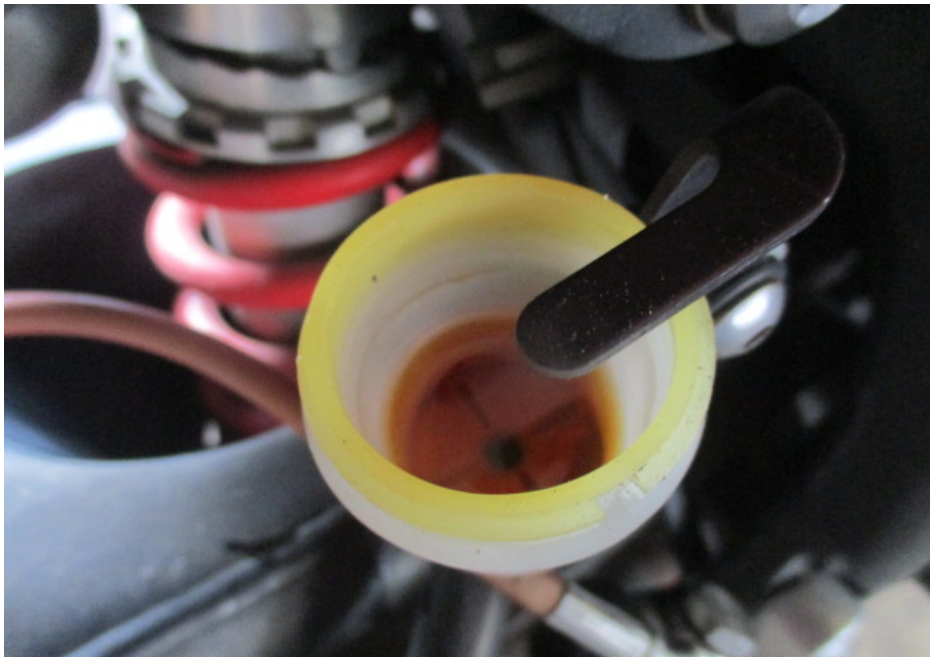
**Photo 30** shows the brake fluid reservoir for the rear brake of the Motorcycle. The brake fluid was observed to be of sufficient level and without contamination for operational purposes.
