Your Ref: TP/IP/32027/2019  
Our Ref :CI/TPD19009627/N

**Fatal Accident Investigation Team**

**INSPECTION REPORT OF MOTORCYCLE FBK 4678L**

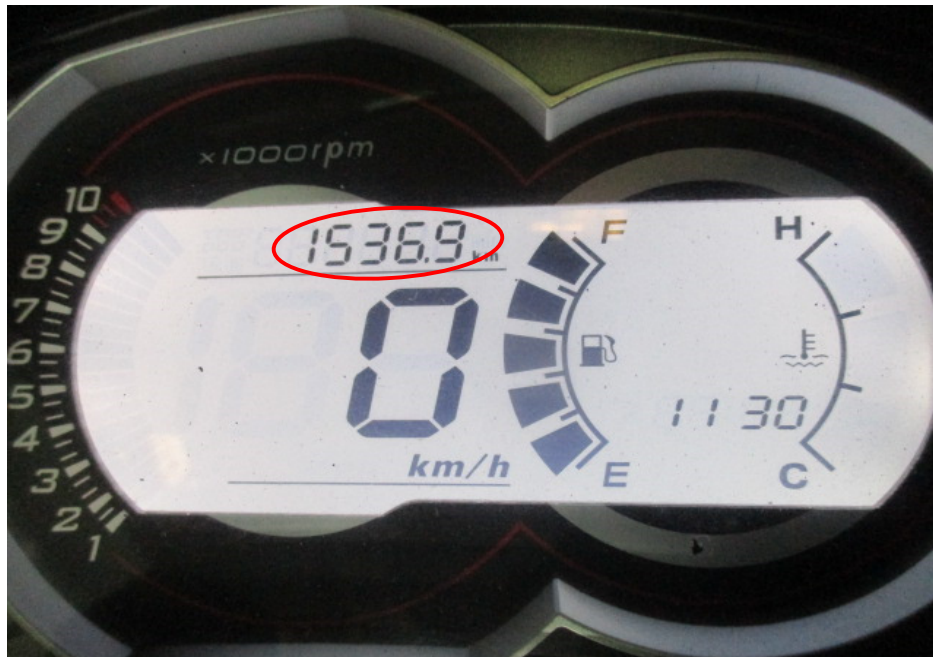
**Photo 1** shows the speedometer gauge of the Motorcycle where the mileage recorded at time of our inspection was 1, 536km (circled).

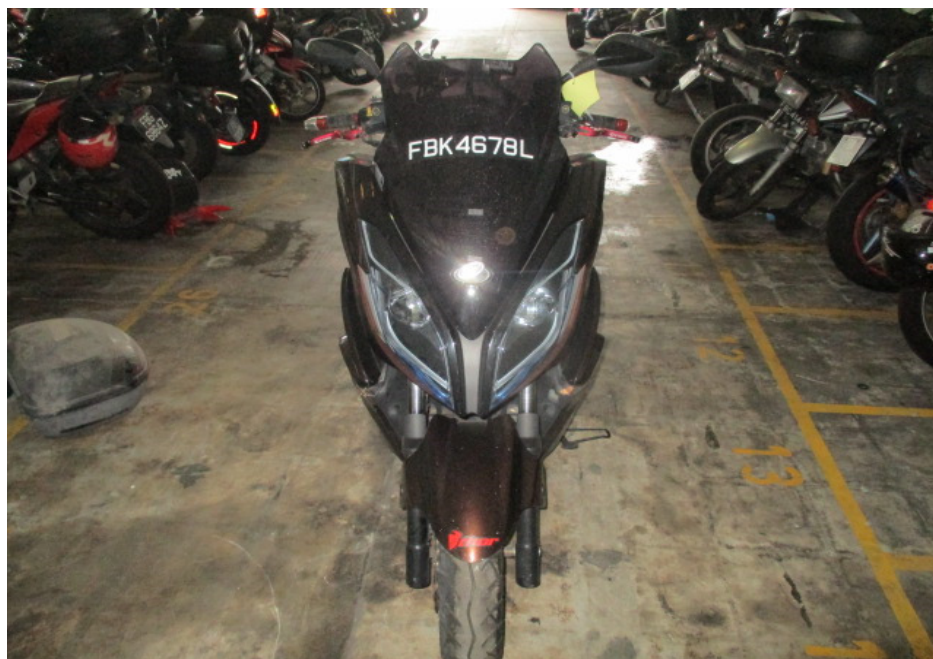
**Photo 2** shows a general view of the front body of the Motorcycle at the time of our inspection. The Motorcycle was observed to have sustained minor damages at the frontal and right portion.

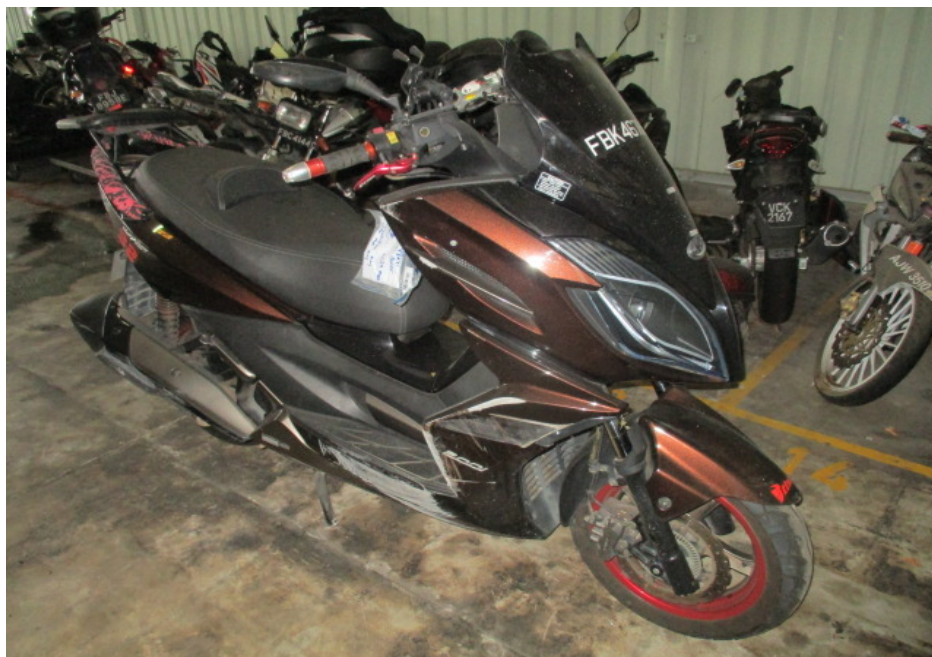
**Photo 3** shows a general view of the right front body of the Motorcycle at the time of our inspection. The Motorcycle was observed to have sustained minor damages at the frontal and right portion. The body parts that were found to have been damaged include its front mudguard, front brake lever, right side mirror, right cowling, right pillion foot rest, exhaust muffler, exhaust muffler heat shield and top box rack, amongst others as a result of the accident.

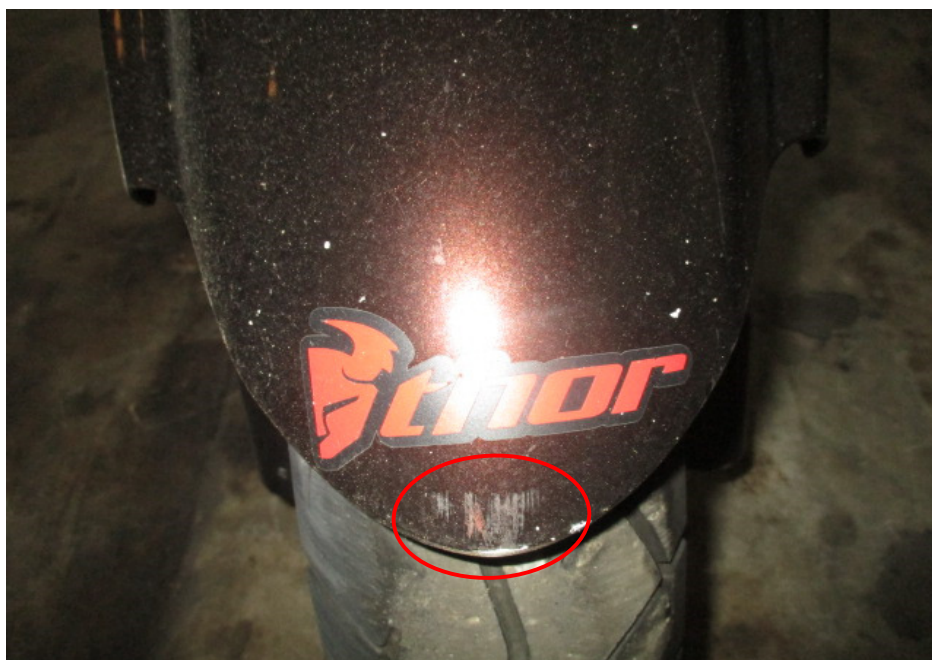
**Photo 4** shows a closer view of the front mudguard (circled) which was amongst the body parts at the front body of the Motorcycle that had sustained damage as a result of the accident.

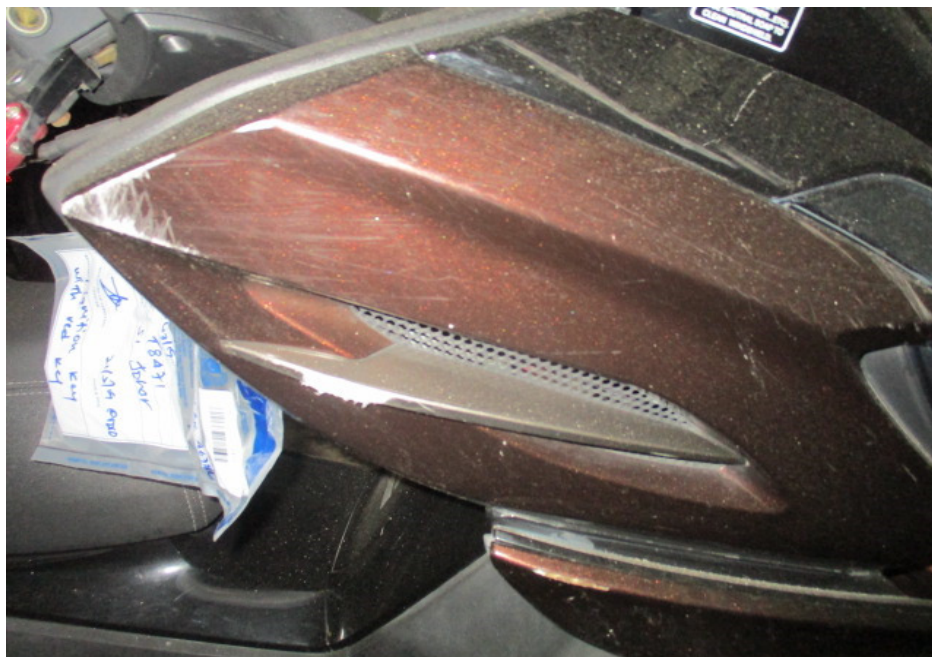
**Photo 5** shows a closer view of the right cowling which was amongst the body parts at the front body of the Motorcycle that had sustained damage as a result of the accident.

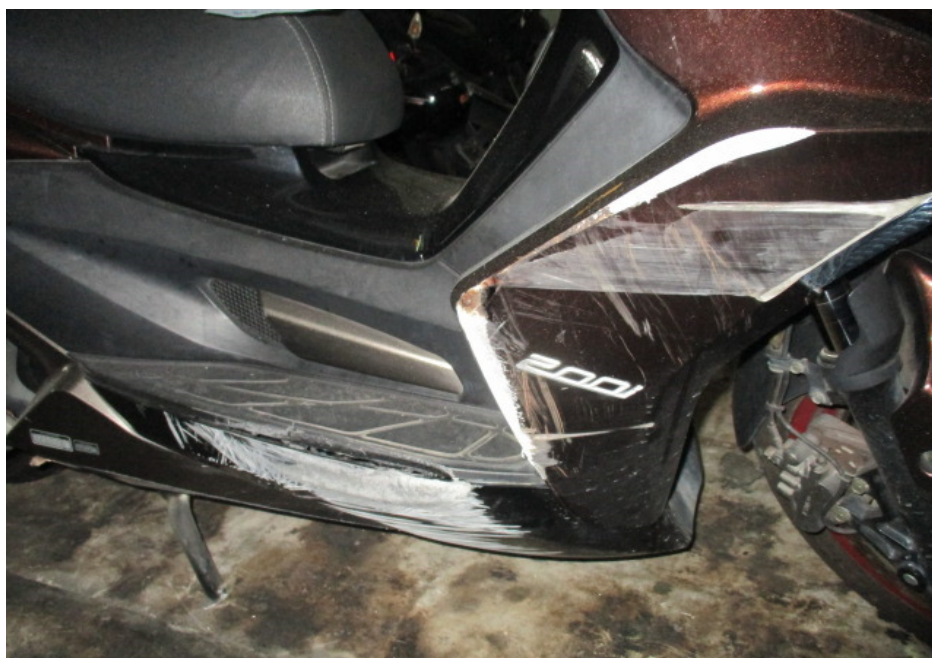
**Photo 6** shows a closer view of the right bottom cowling of the Motorcycle which was observed to be damaged due to the accident.

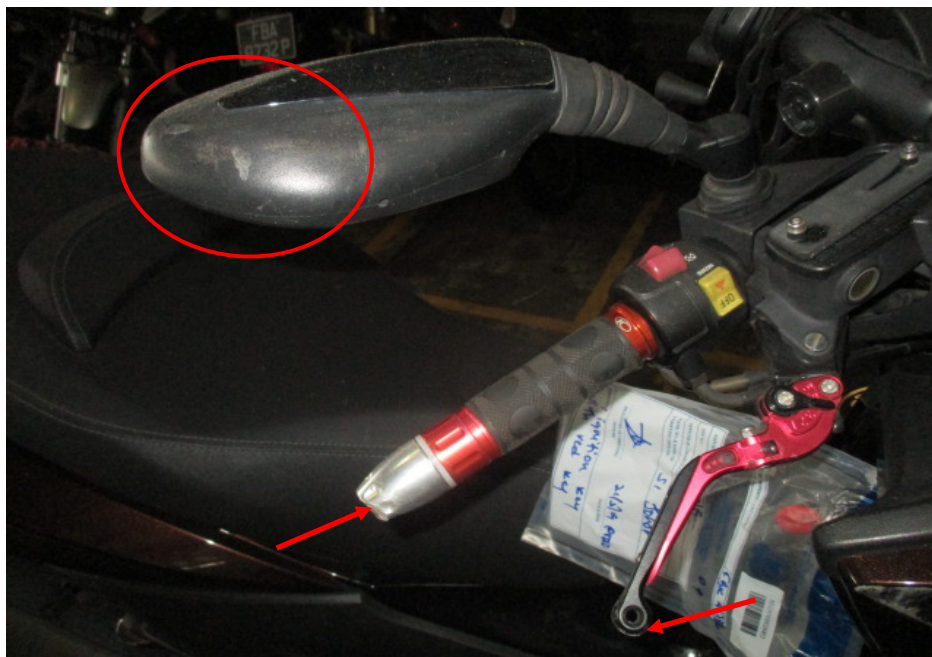
**Photo 7** shows a closer view of the front brake lever and right handlebar end (arrowed) as well as the right side mirror (circled) of the Motorcycle which were observed to be damaged due to the accident

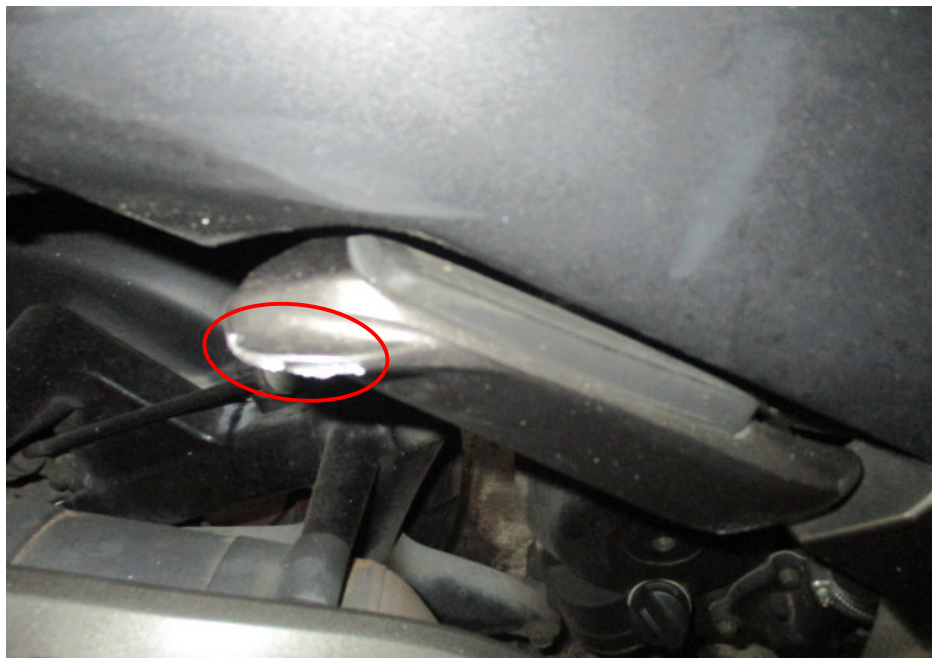
**Photo 8** shows a closer view of the damaged right pillion footrest (circled) of the Motorcycle at the time of our inspection.

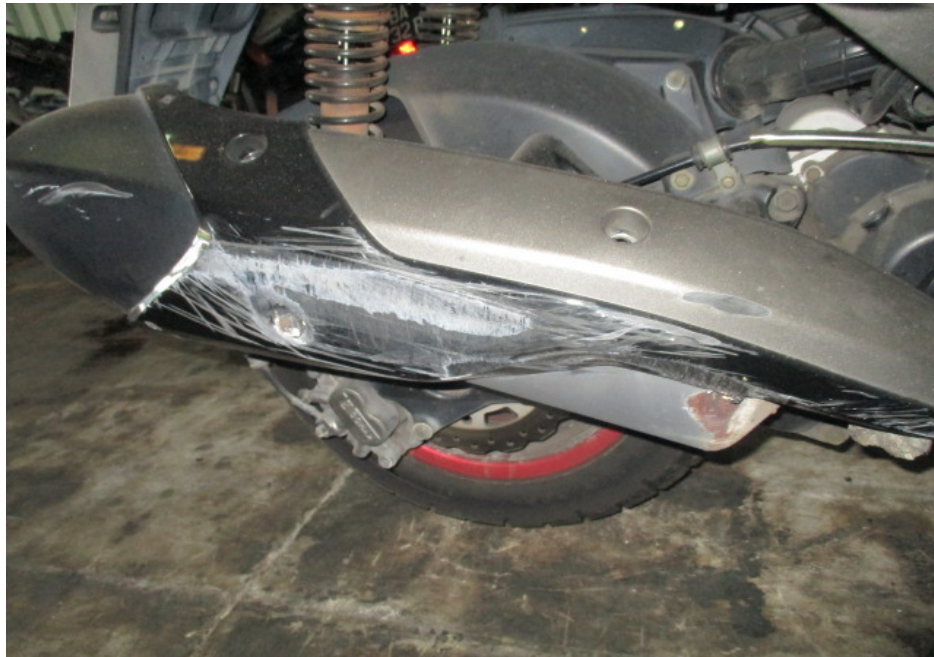
**Photo 9** shows a closer view of the exhaust muffler and exhaust muffler heat shield of the Motorcycle which had sustained damage due to the accident.

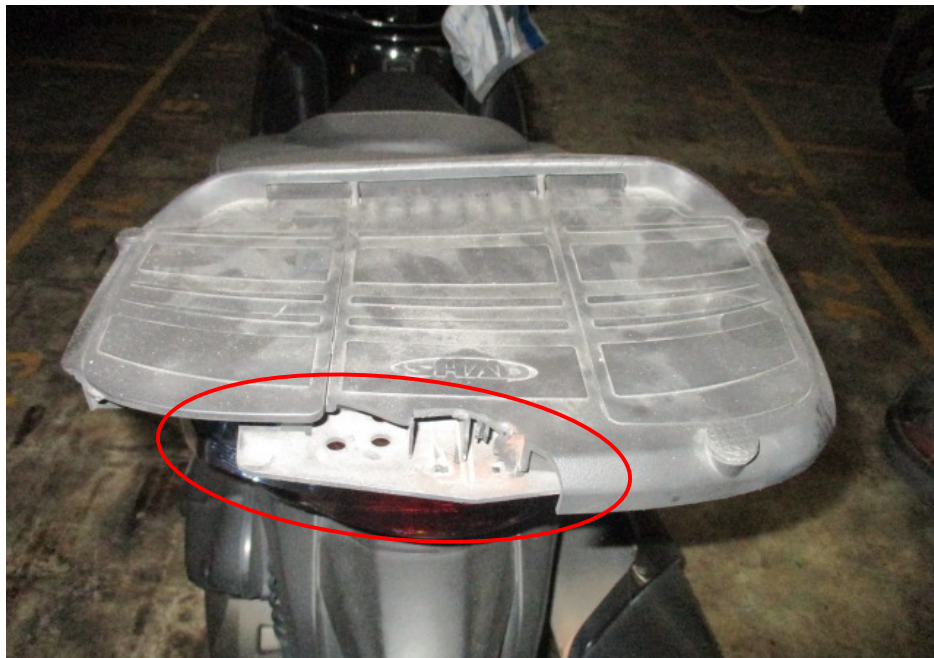
**Photo 10** shows the broken top box rack of the Motorcycle (circled).

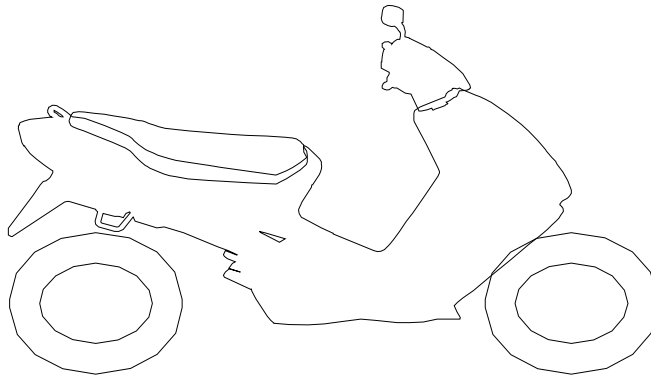
Kenda 150/70 - 13 (5mm)

Kenda 120/70 - 14 (3mm)

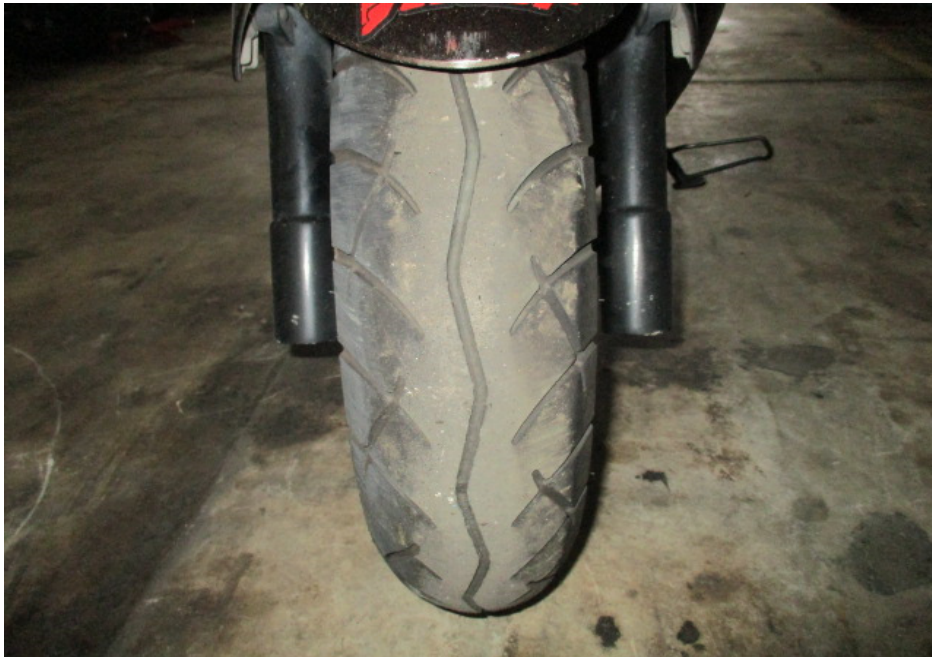
**Photo 11** shows the condition of the Motorcycle's front tyre. The front tyre was observed to be in serviceable condition with remaining tread depth of approximately 3mm. There was no tear, burst mark(s) and/or punctured hole(s) on the sidewalls as well as across the tread of the front tyre.

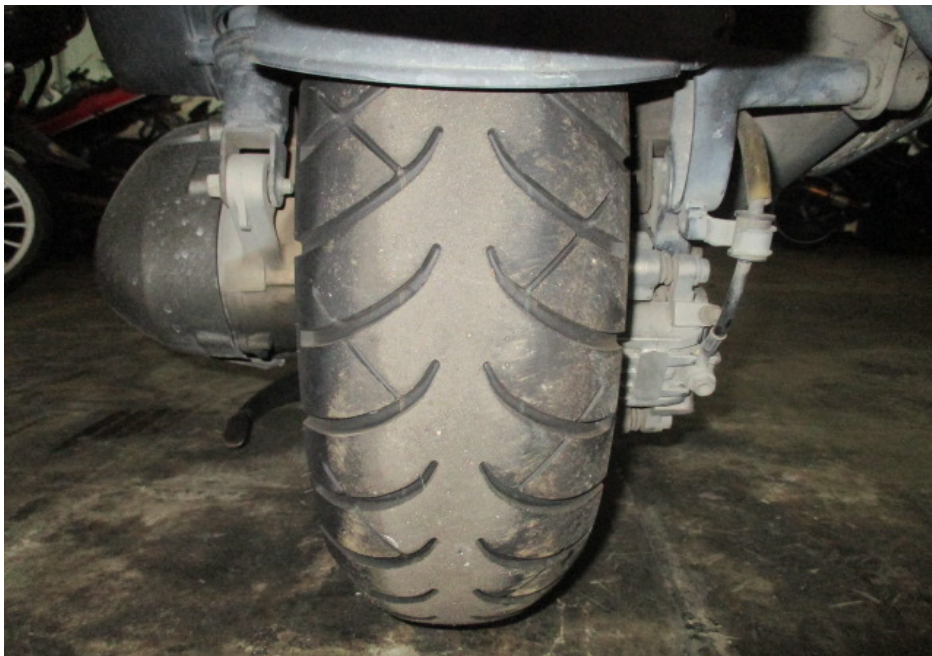
**Photo 12** shows the condition of the Motorcycle's rear tyre. The rear tyre was observed to be in serviceable condition with remaining tread depth of approximately 5mm. The tyre was also observed to be sufficiently inflated for vehicular operation. We did not observe any tear, burst mark(s) and/or punctured hole(s) on the sidewalls as well as across the tread of the rear tyre.

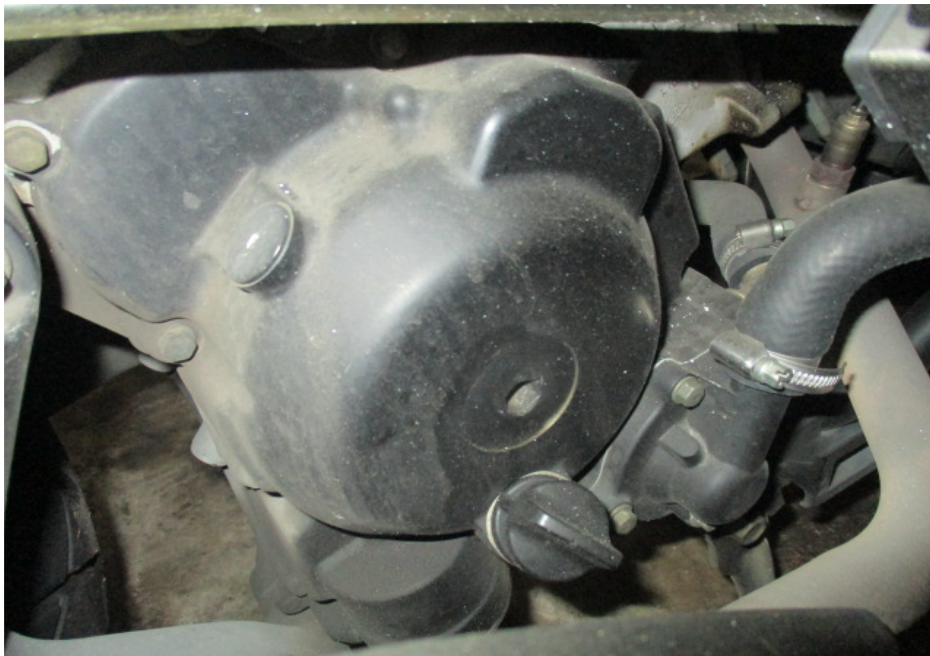
**Photo 13** shows the right side of the engine of the Motorcycle at the time of our inspection. The various engine related parts and components were found to be intact with no visible damage. There was also no sign(s) or indication(s) of fluid leak observed around the right engine area of the Motorcycle.

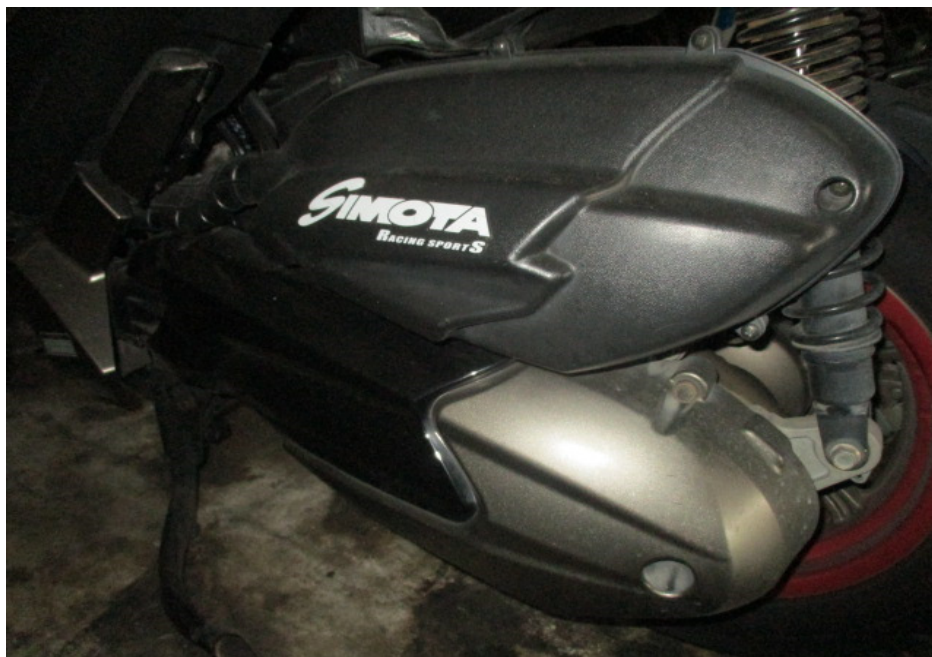
**Photo 14** shows the drive train of the Motorcycle which was found to be intact without any misalignment.

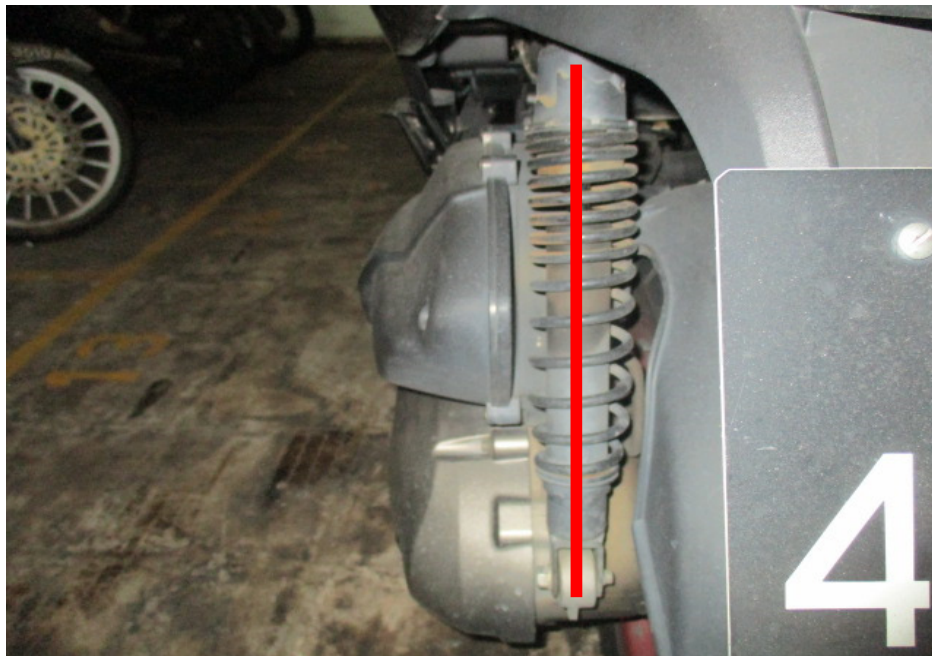
**Photo 15** shows the left shock absorber of the motorcycle was found to be intact without any misalignment.

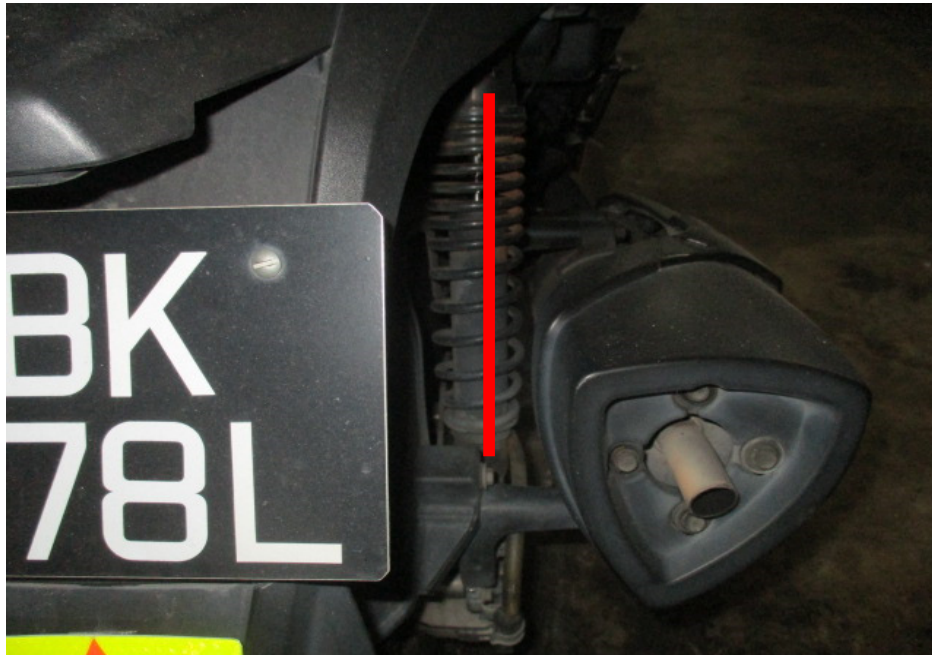
**Photo 16** shows the right shock absorber of the motorcycle was found to be intact without any misalignment.

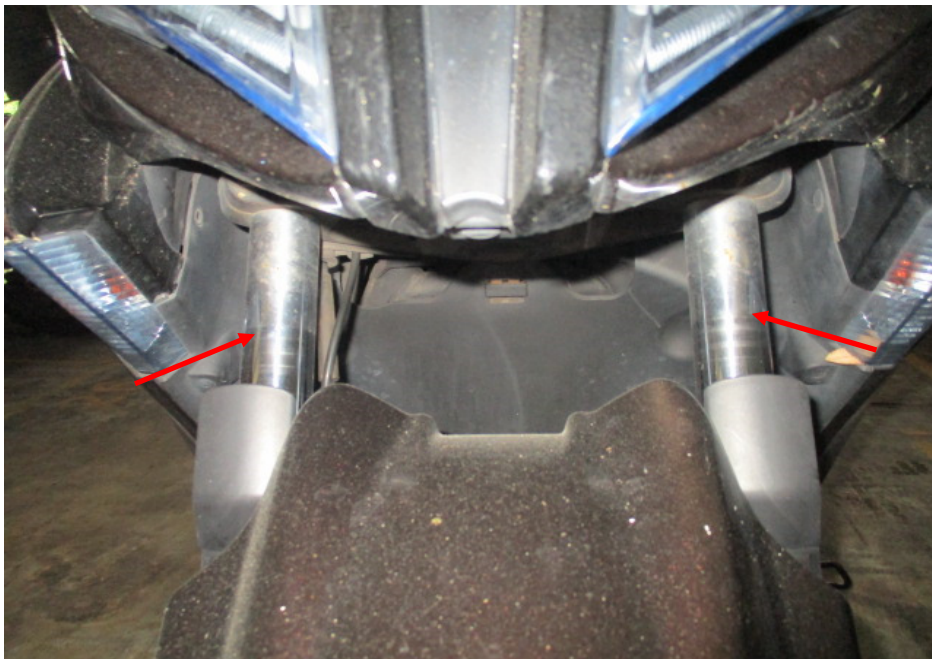
**Photo 17** shows the front forks (arrowed) of the Motorcycle. The front forks and fork brackets of the Motorcycle were both found to be intact and undamaged. Turning the Motorcycle's handle bar towards the left and right did not produce any abnormal free play and/or resistance. The steering system of the Motorcycle was in serviceable condition at the time of our inspection.

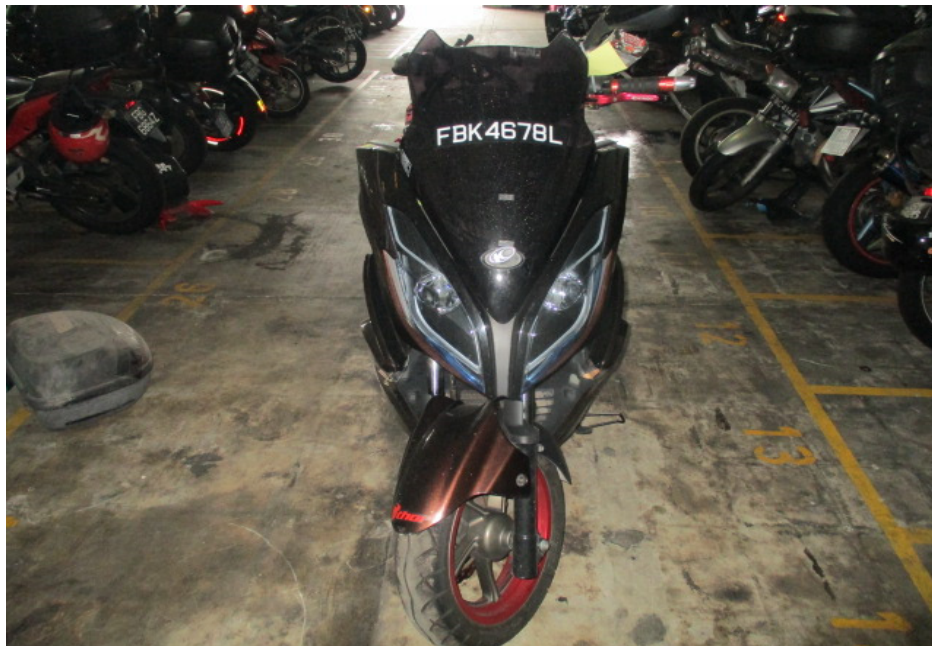
**Photo 18** shows the front wheel of the Motorcycle turned towards its full right. Turning the Motorcycle's handle bar towards the left and right did not produce any abnormal free play and/or resistance. This would indicate that the steering system of the Motorcycle was in serviceable condition at the time of our inspection.

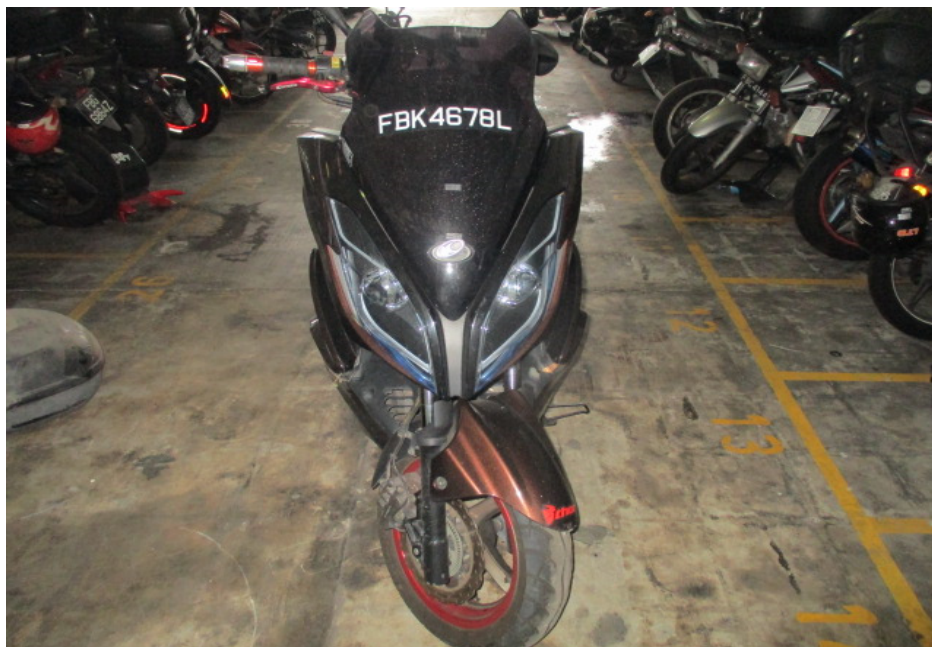
**Photo 19** shows the front wheel of the Motorcycle turned towards its full left. Turning the Motorcycle's handle bar towards the left and right did not produce any abnormal free play and/or resistance. This would indicate that the steering system of the Motorcycle was in serviceable condition at the time of our inspection.

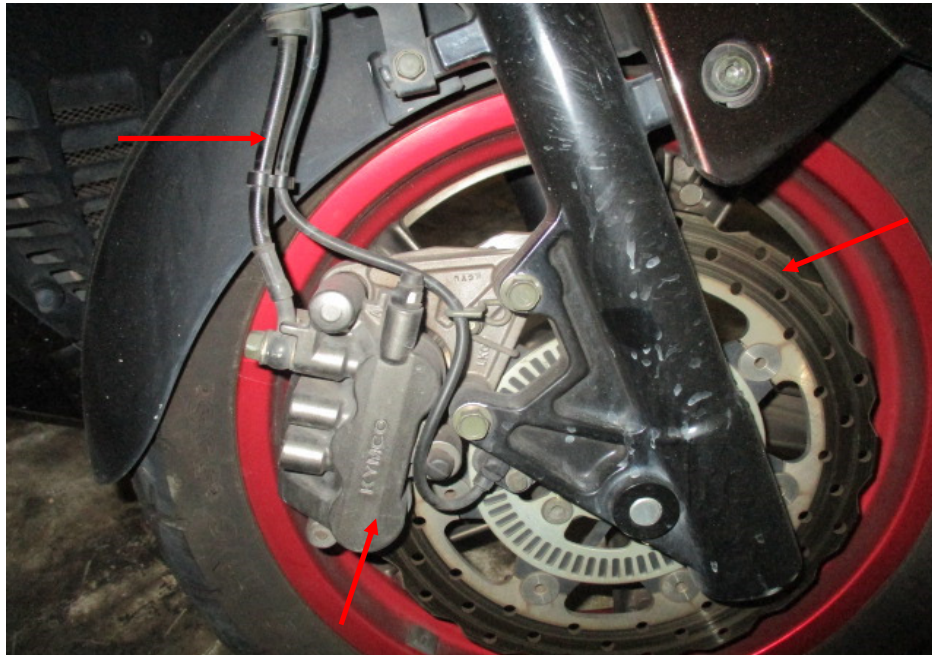
**Photo 20** shows a close up view of the front brake caliper, front brake disc and front brake hose (arrowed) of the Motorcycle, which are all part of the components in the hydraulic front brake system of the Motorcycle. Our visual checks of these various components had revealed all to be intact with no visible damage. No leakage of brake fluid was also observed.

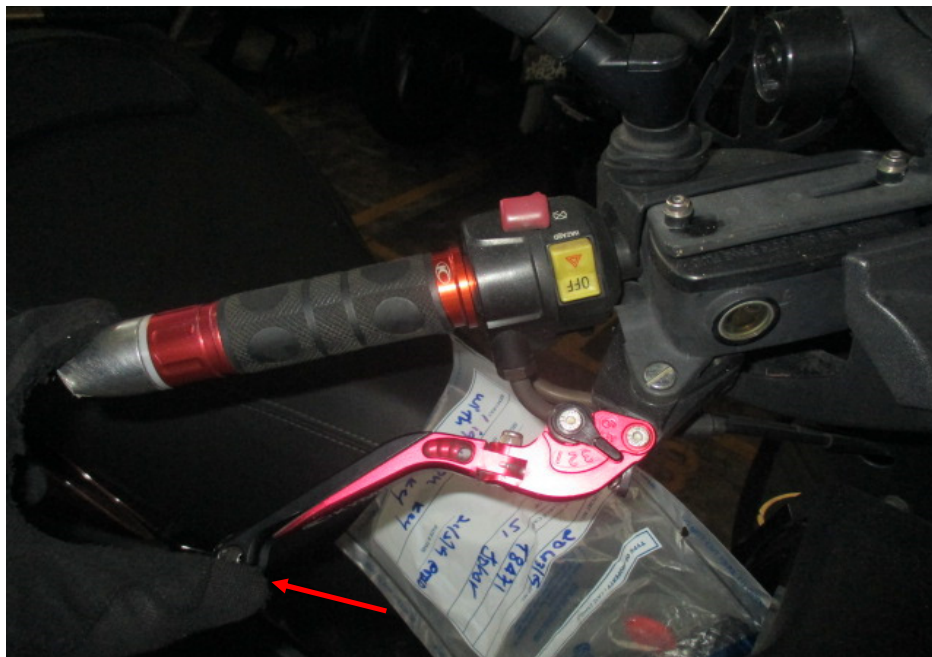
**Photo 21** shows the front brake lever being depressed. There was some resistance felt (spongy like feel) upon pressing the front brake lever (arrowed). This would indicate that there is no leakage of pressure/vacuum in the brake system.

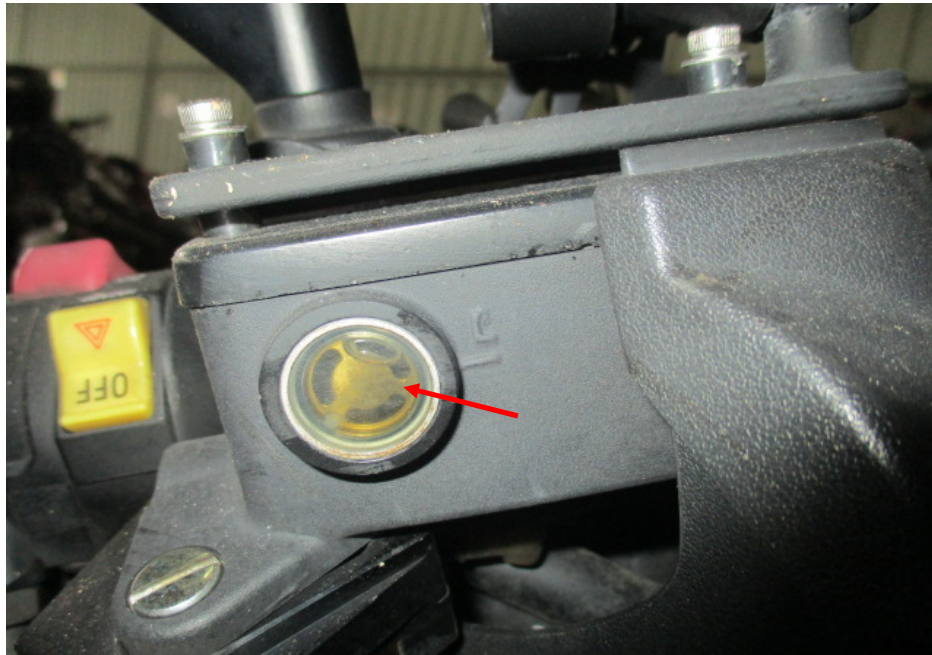
**Photo 22** shows a close up view of the brake fluid reservoir for the front brake of the Motorcycle. The brake fluid was observed to be of sufficient level and without contamination for operational purposes (arrowed).

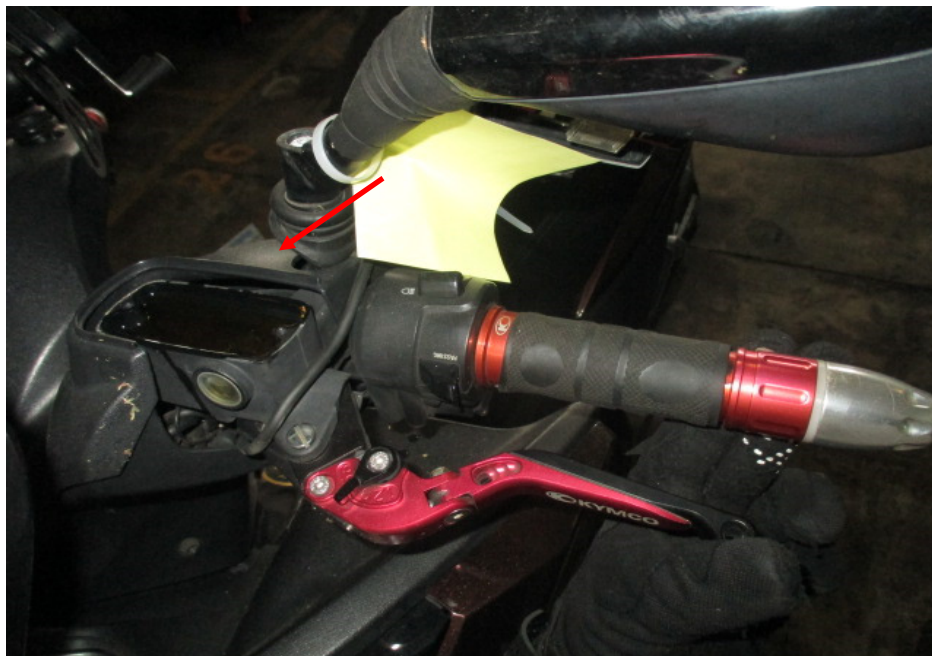
**Photo 23** shows the rear brake lever being depressed. There was some resistance felt (spongy like feel) upon pressing the rear brake lever (arrowed). This would indicate that there is no leakage of pressure/vacuum in the brake system.

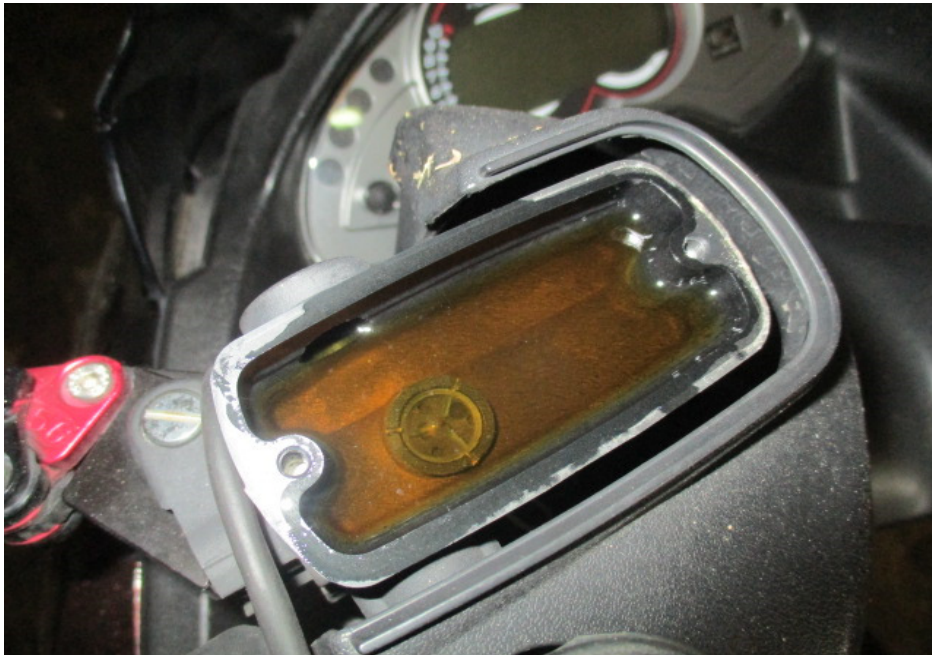
**Photo 24** shows a close up view of the brake fluid reservoir for the rear brake of the Motorcycle. The brake fluid was observed to be of sufficient level and without contamination for operational purposes.

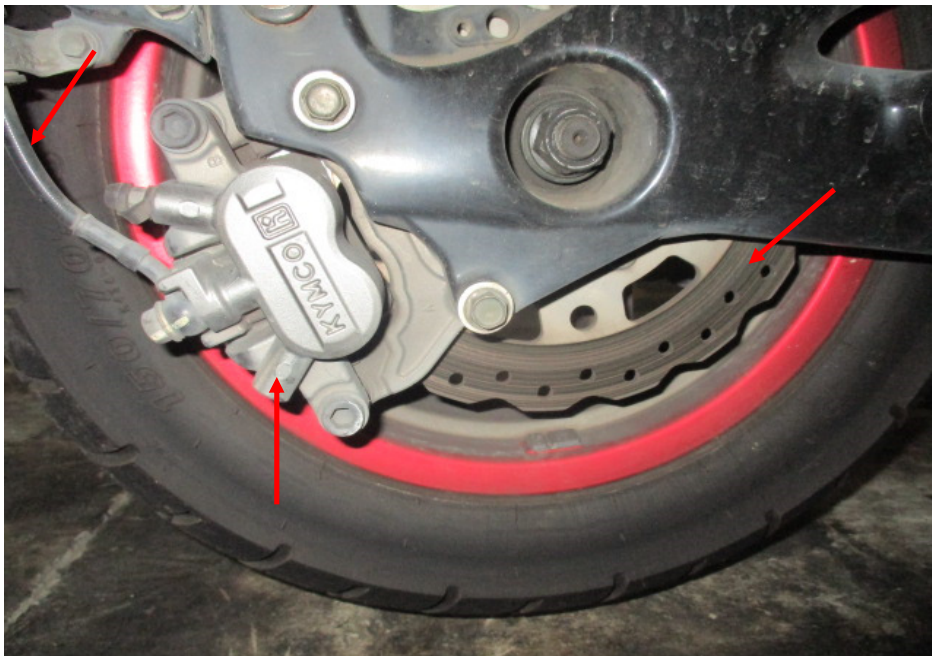
**Photo 25** shows a close up view of the rear brake caliper, rear brake disc and rear brake hose (arrowed) of the Motorcycle, which are all part of the components in the hydraulic rear brake system of the Motorcycle. Our visual checks of these various components revealed all to be intact with no visible damage. No leakage of brake fluid was also observed.
