Your Ref: TP/IP/27053/2019
Our Ref : CI/TPD19009628/N

11 June 2019

INSPECTION REPORT OF MOTORCYCLE JQR 5745

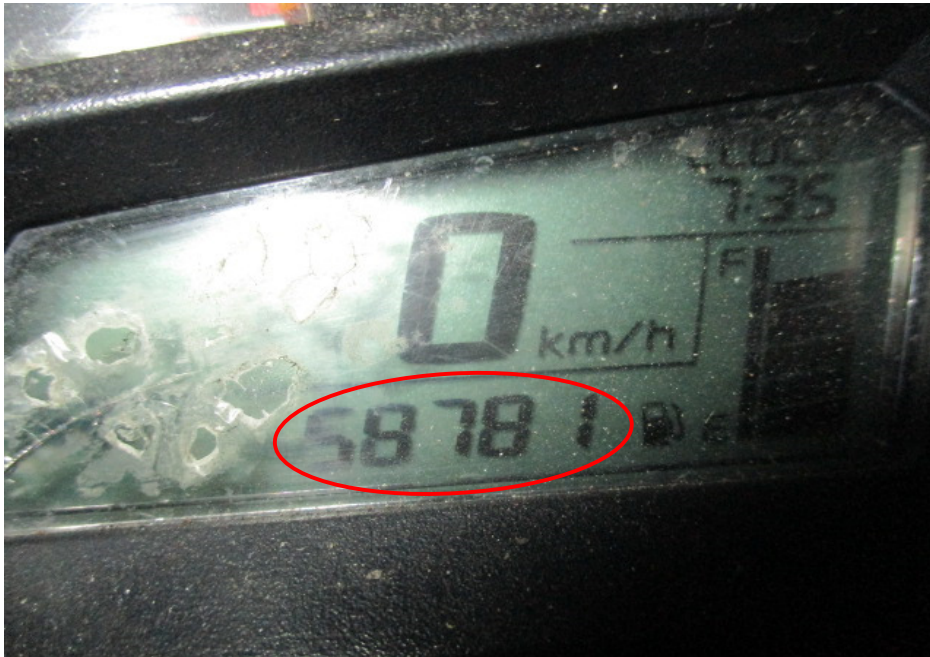
Photo 1 shows the speedometer gauge of the Motorcycle where the mileage recorded at time of our inspection was 58, 781km (circled).

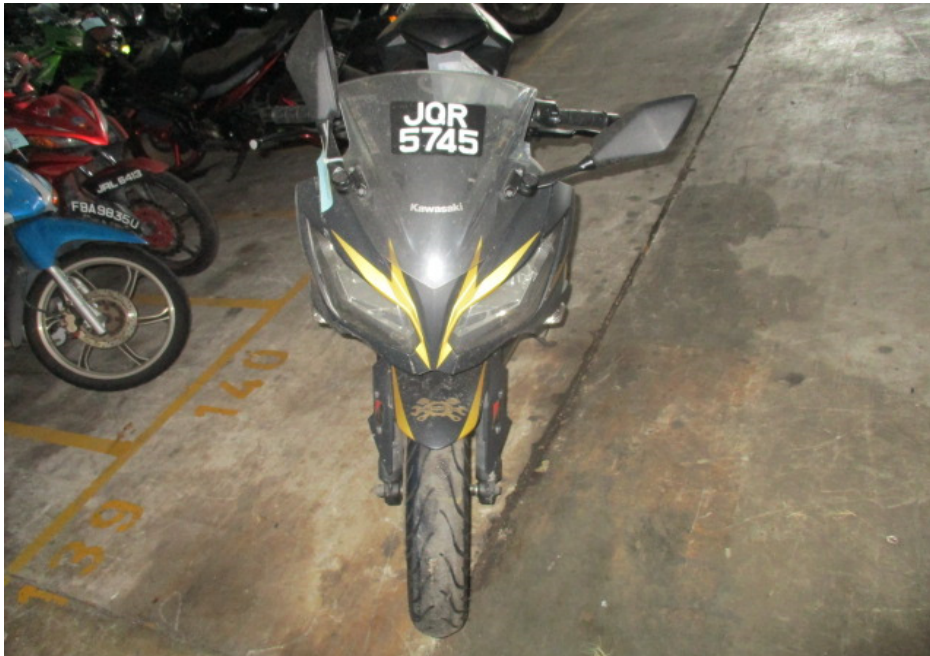
Photo 2 shows a general view of the front body of the Motorcycle at the time of our inspection. The Motorcycle was observed to have sustained damages along its frontal and right portion.

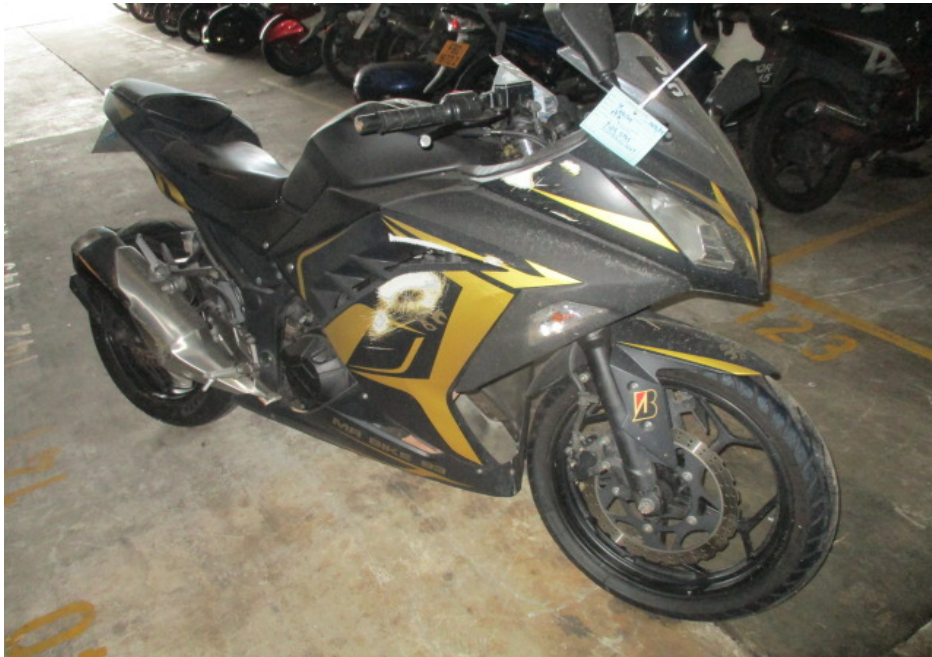
Photo 3 shows a general view of the right front body of the Motorcycle at the time of our inspection. The Motorcycle was observed to have sustained damages along its frontal and right portion. Amongst the body parts that were found to have been damaged include its head cowling, right side cowling, front brake lever, right front signal lamp, rear brake pedal, right front footrest, exhaust muffler and exhaust muffler heat shield, amongst others.

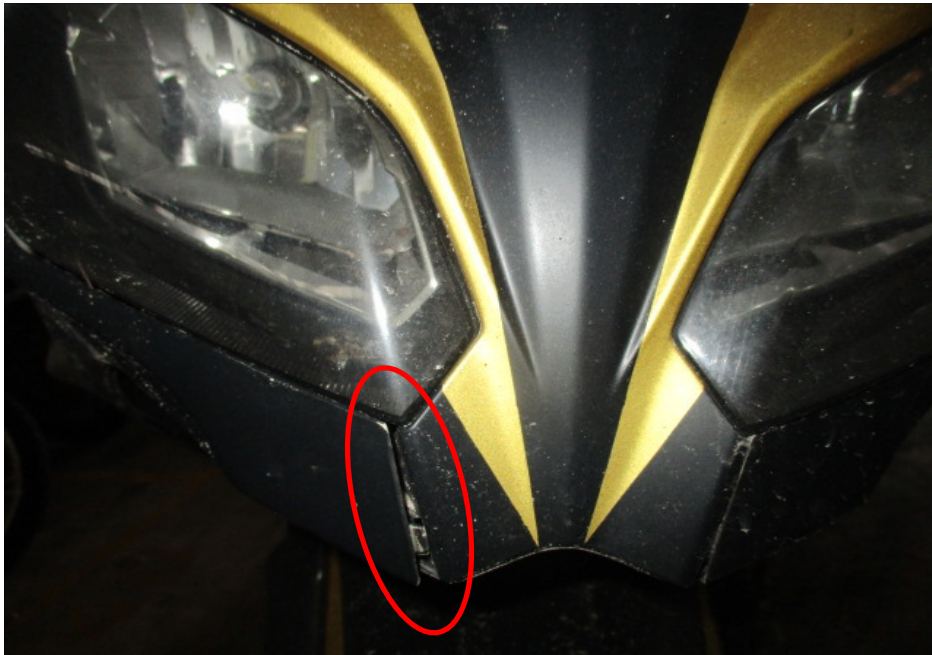
Photo 4 shows a closer view of the head cowling which was amongst the body parts at the front body of the Motorcycle that had sustained damage as a result of the accident (circled).

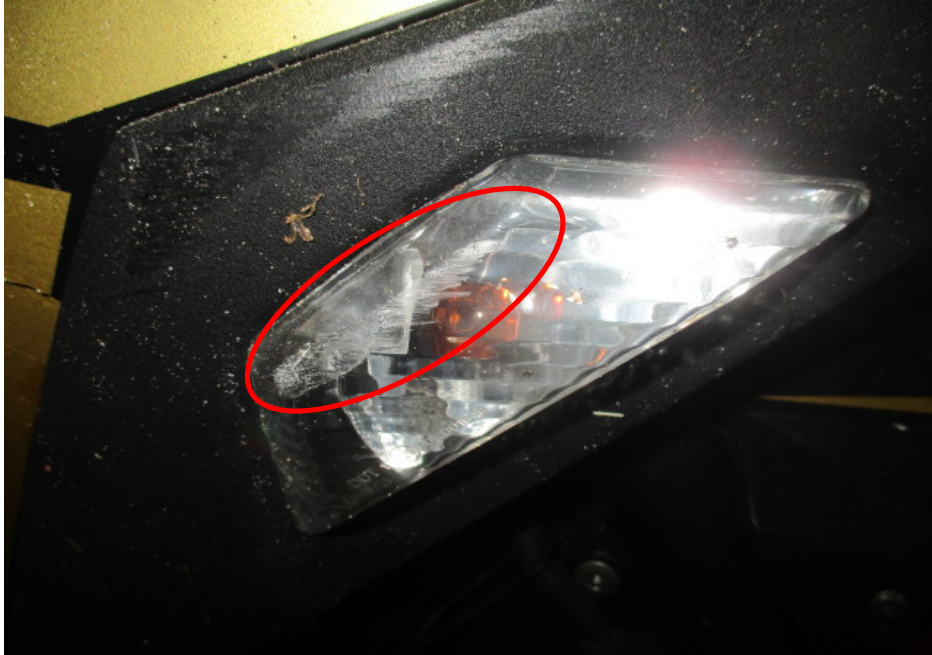
Photo 5 shows a close up view of the right front signal lamp (circled) which was amongst the body parts of the Motorcycle that had sustained damage as a result of the accident.

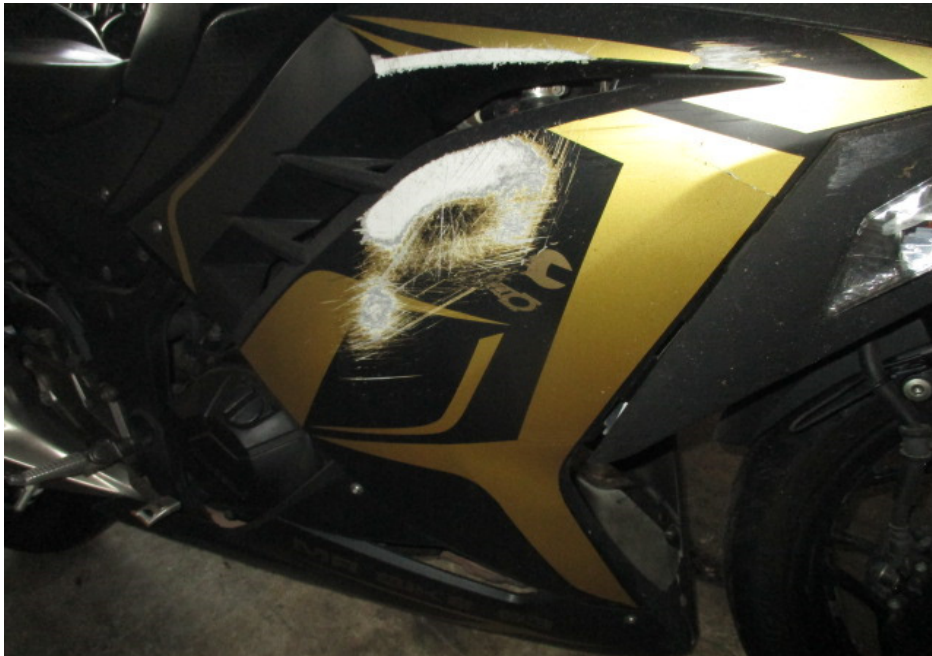
Photo 6 shows a closer view of the right side cowling of the Motorcycle that had sustained damage as a result of the accident.

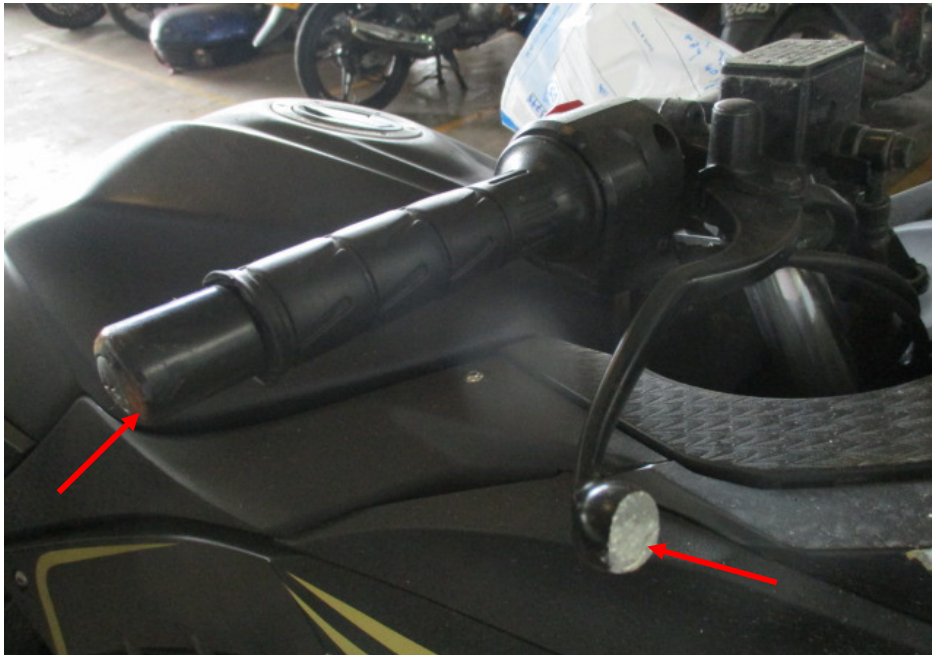
Photo 7 shows a closer view of the front brake lever and left handlebar end (arrowed) which were amongst the body parts of the Motorcycle that had sustained damage as a result of the accident.

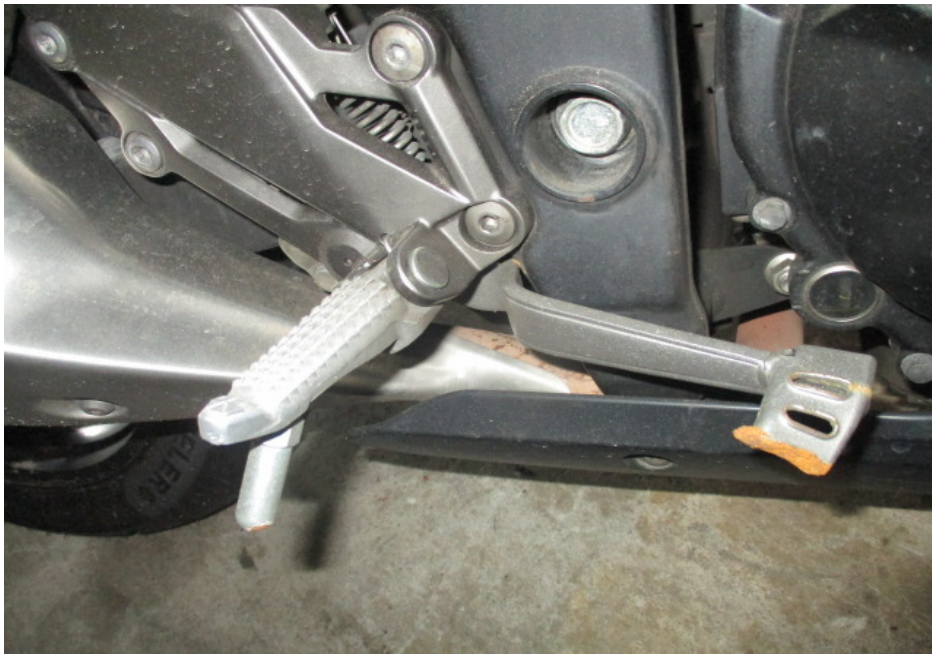
Photo 8 shows a closer view of the rear brake pedal and right front footrest, which were amongst the body parts of the Motorcycle that had sustained damage as a result of the accident.

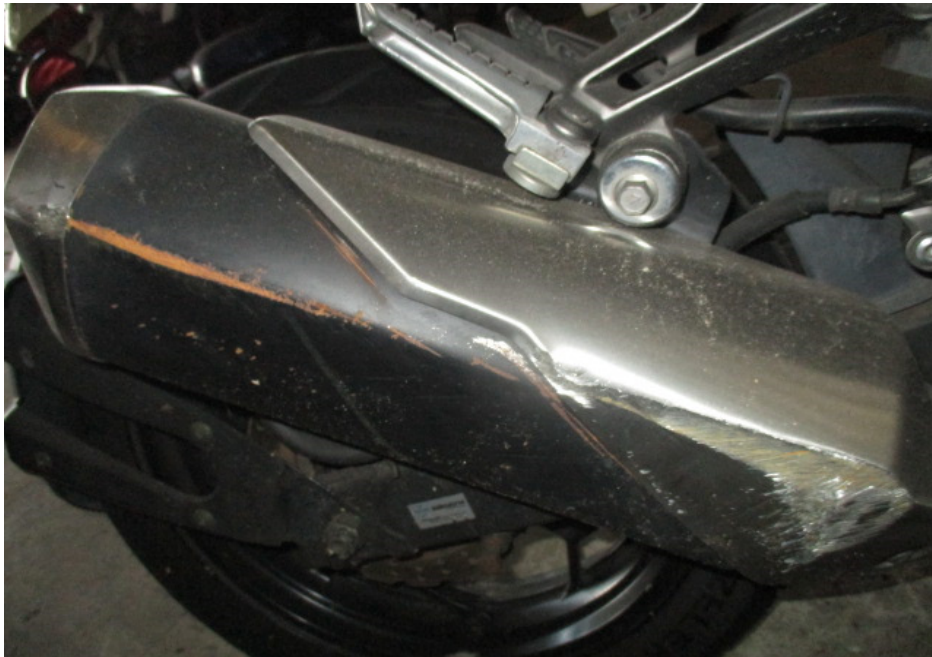
Photo 9 shows the exhaust muffler and exhaust muffler heat shield which were amongst the body parts of the Motorcycle that had sustained damage as a result of the accident.

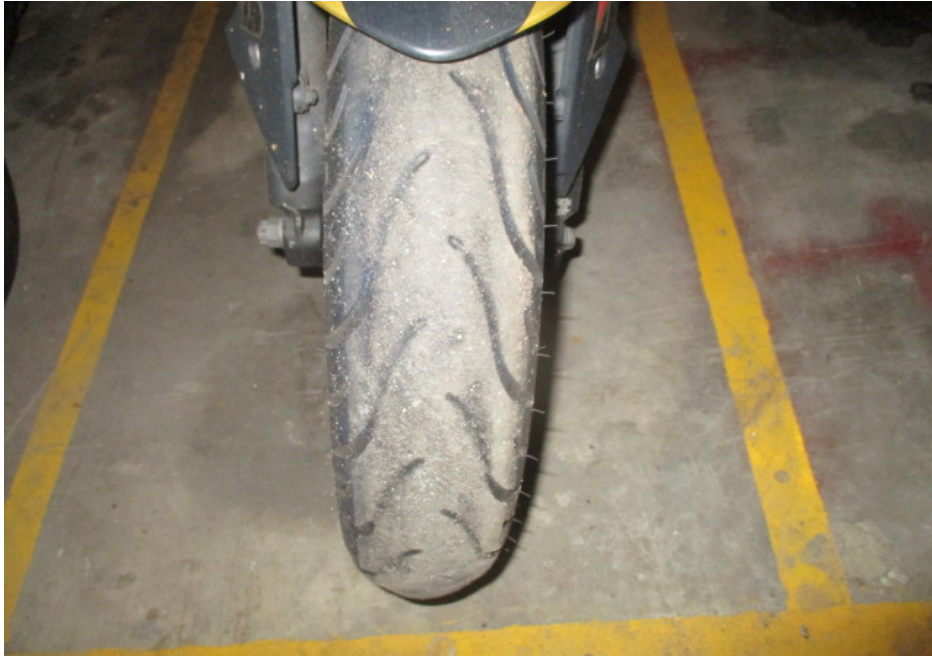
Photo 10 shows the front tyre of the Motorcycle at the time of our inspection. The front tyre was observed to be in serviceable condition with remaining tread depth of approximately 4mm. The pattern of the tread was also clearly visible. There was no tear, burst mark(s) and/or punctured hole(s) on the sidewalls as well as across the tread of the front tyre.

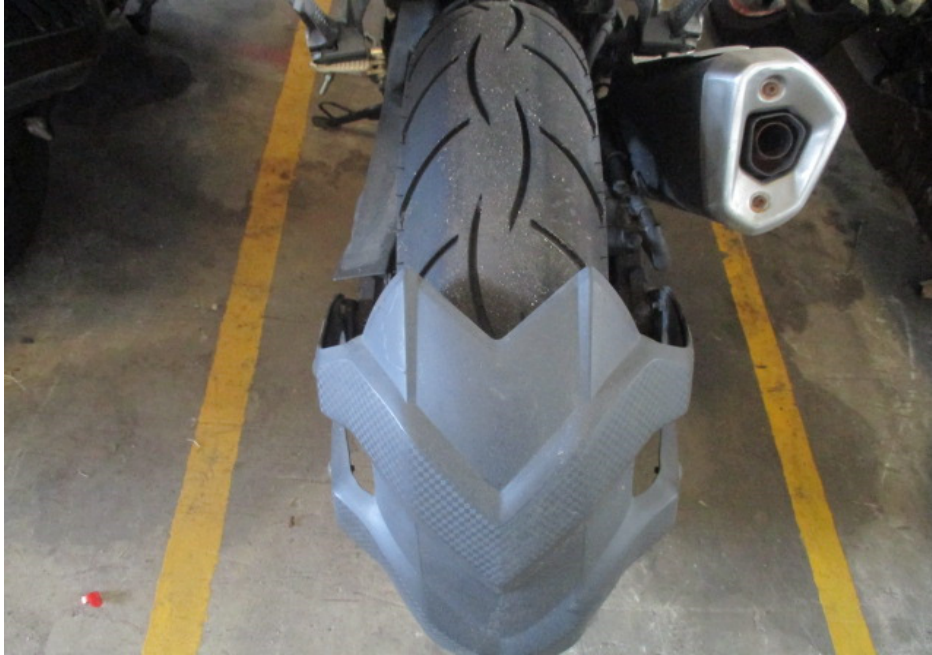
Photo 11 shows the condition of the Motorcycle's rear tyre. The rear tyre was observed to be in serviceable condition with remaining tread depth of approximately 4mm. The tyre was also observed to be sufficiently inflated for vehicular operation. We did not observe any tear, burst mark(s) and/or punctured hole(s) on the sidewalls as well as across the tread of the rear tyre.

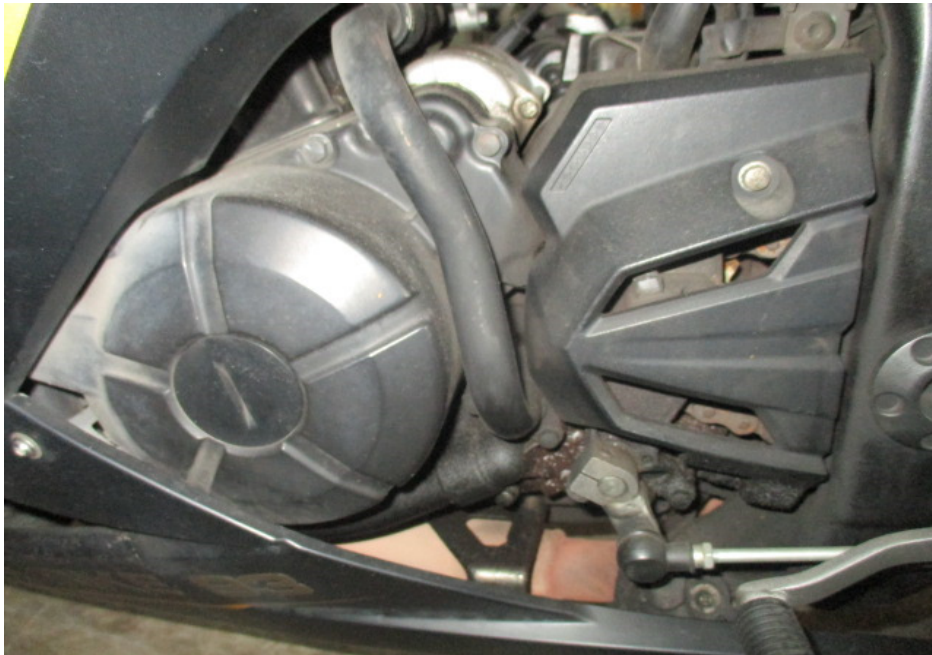
Photo 12 shows the left side of the engine of the Motorcycle at the time of our inspection. The various engine related parts and components were found to be intact with no visible damage. There was also no sign(s) or indication(s) of fluid leak observed around the left engine area of the Motorcycle.

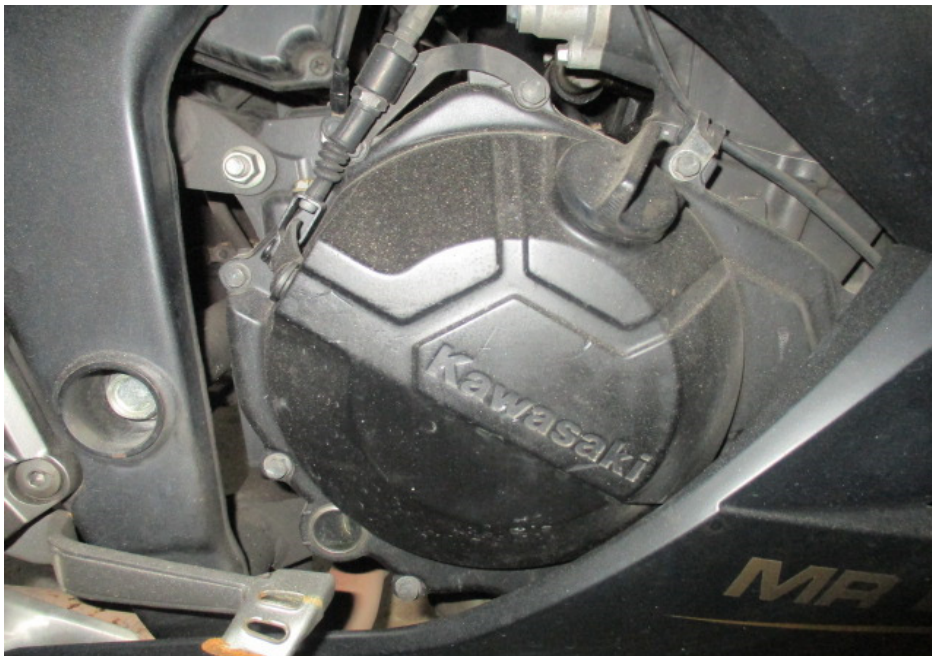
Photo 13 shows the right side of the engine of the Motorcycle at the time of our inspection. The various engine related parts and components were found to be intact with no visible damage. There was also no sign(s) or indication(s) of fluid leak observed around the right engine area of the Motorcycle.

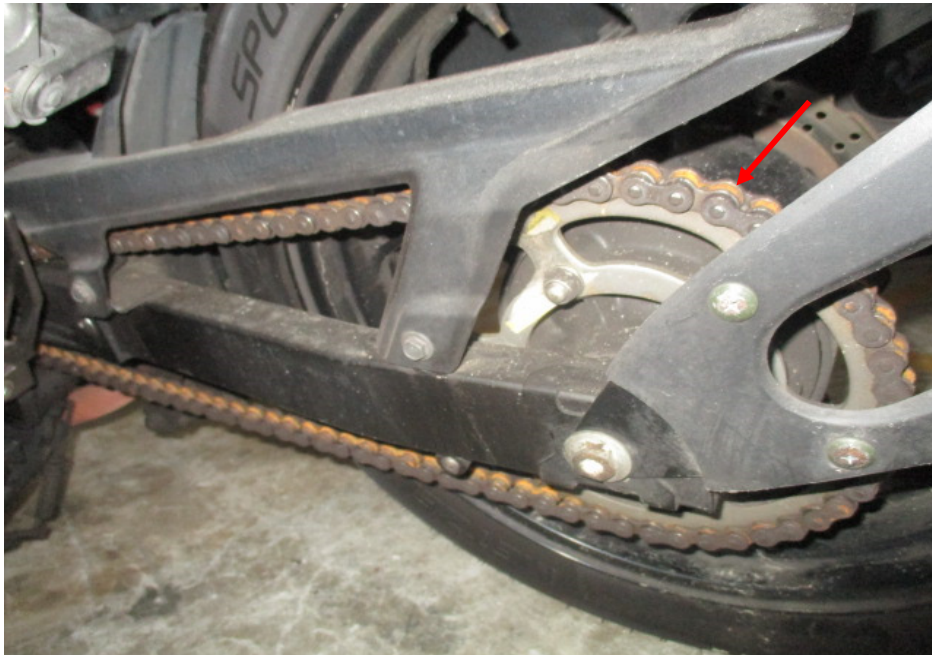
Photo 14 shows the general view of the gear train (arrowed) of the Motorcycle, which was observed to be intact with no misalignment. It was also adequately lubricated for operating purposes.

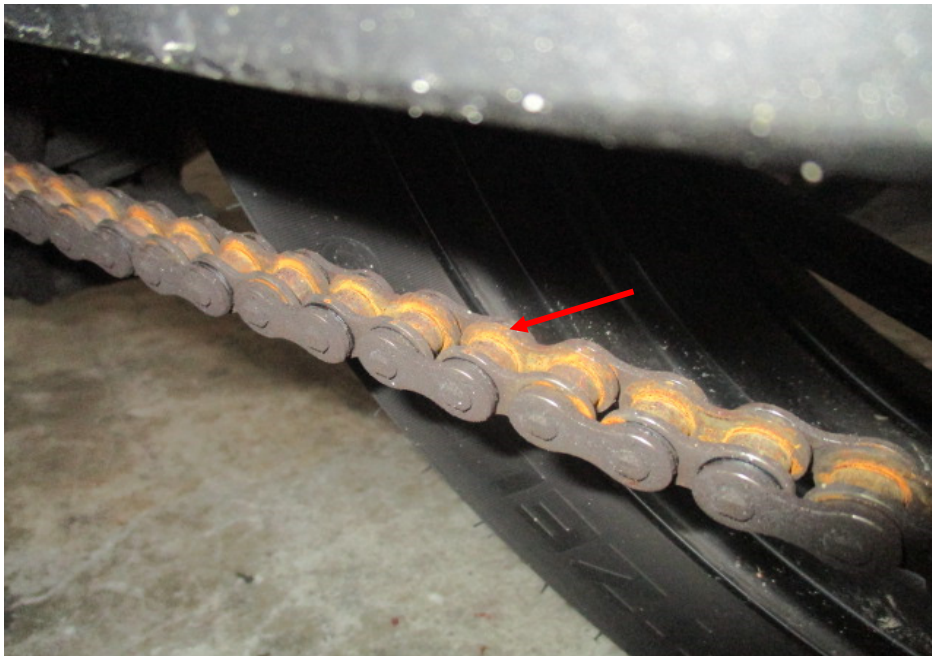
Photo 15 shows a closer view of the gear train (arrowed) of the Motorcycle, which was observed to be intact with no misalignment. It was also adequately lubricated for operating purposes.

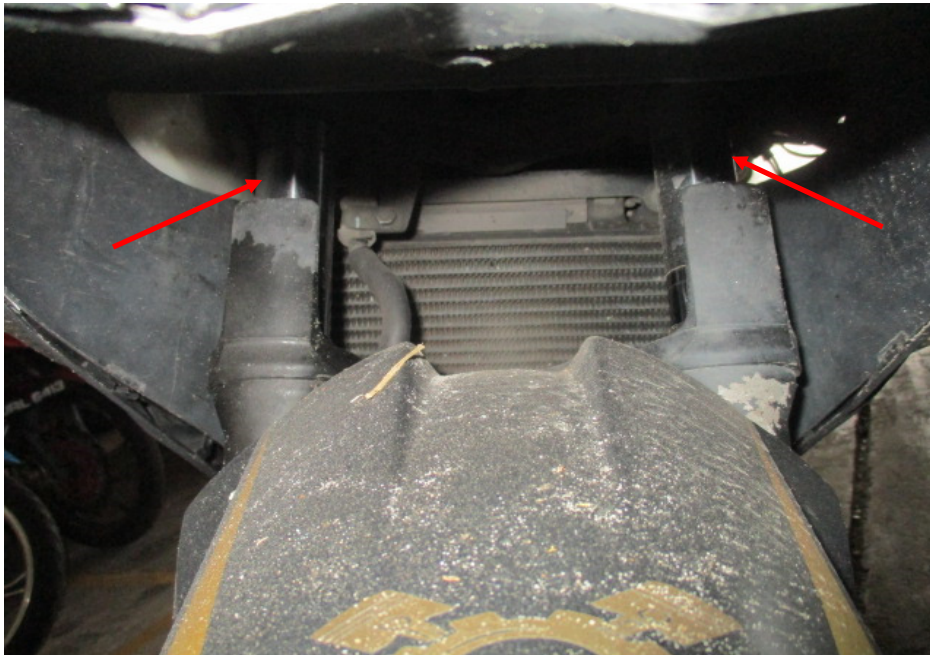
Photo 16 shows the front fork (arrowed) of the Motorcycle. The front fork and fork bracket of the Motorcycle were both found to be intact and undamaged. Turning the Motorcycle's handle bar towards the left and right did not produce any abnormal free play and/or resistance. The steering system of the Motorcycle was in serviceable condition at the time of our inspection.

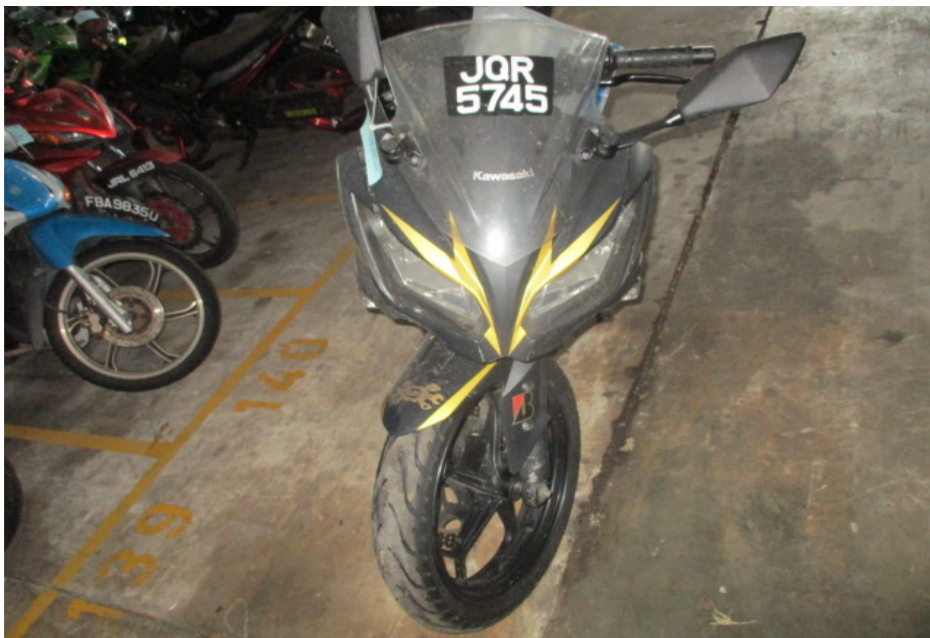
Photo 17 shows the front wheel of the Motorcycle turned towards its full right. Turning the Motorcycle's handle bar towards the left and right did not produce any abnormal free play and/or resistance. This would indicate that the steering system of the Motorcycle was in serviceable condition at the time of our inspection.

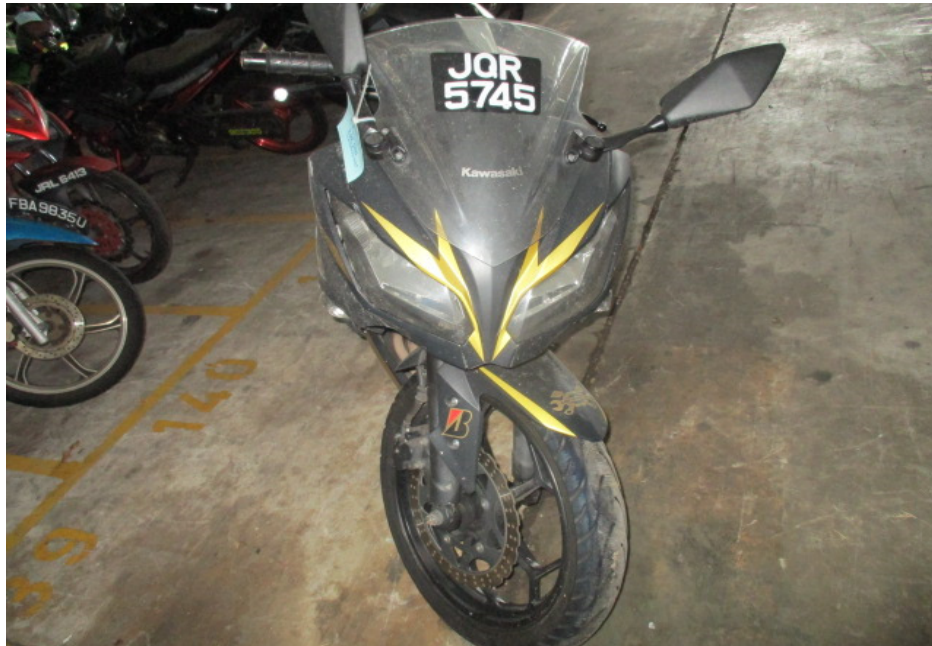
Photo 18 shows the front wheel of the Motorcycle turned towards its full right. Turning the Motorcycle's handle bar towards the left and right did not produce any abnormal free play and/or resistance. This would indicate that the steering system of the Motorcycle was in serviceable condition at the time of our inspection.

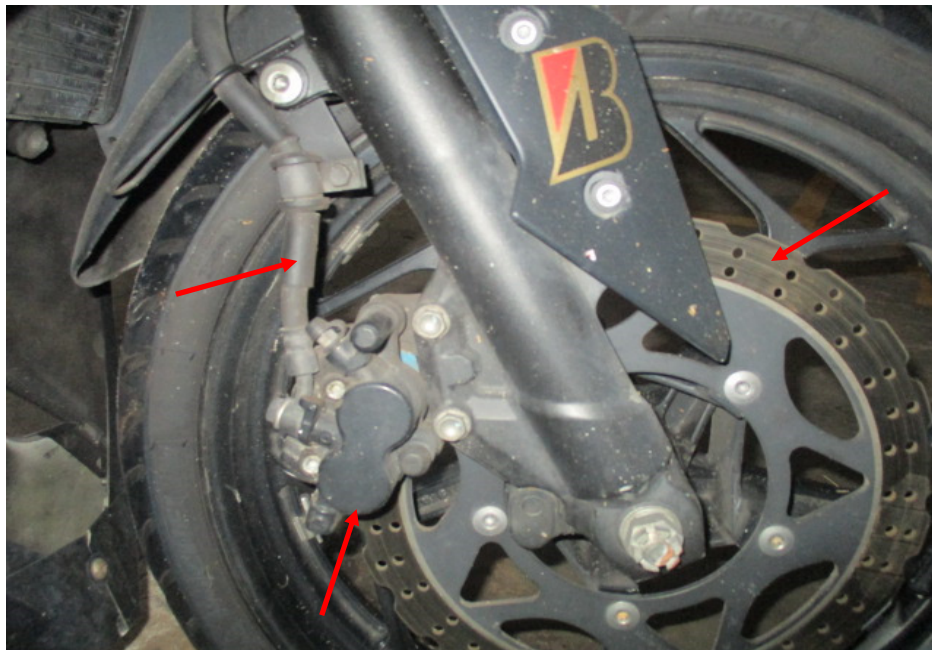
Photo 19 shows a close up view of the front brake caliper, front brake disc and front brake hose (arrowed) of the Motorcycle, which are all part of the components in the hydraulic front brake system of the Motorcycle. Our visual checks of these various components had revealed all to be intact with no visible damage. No leakage of brake fluid was also observed.

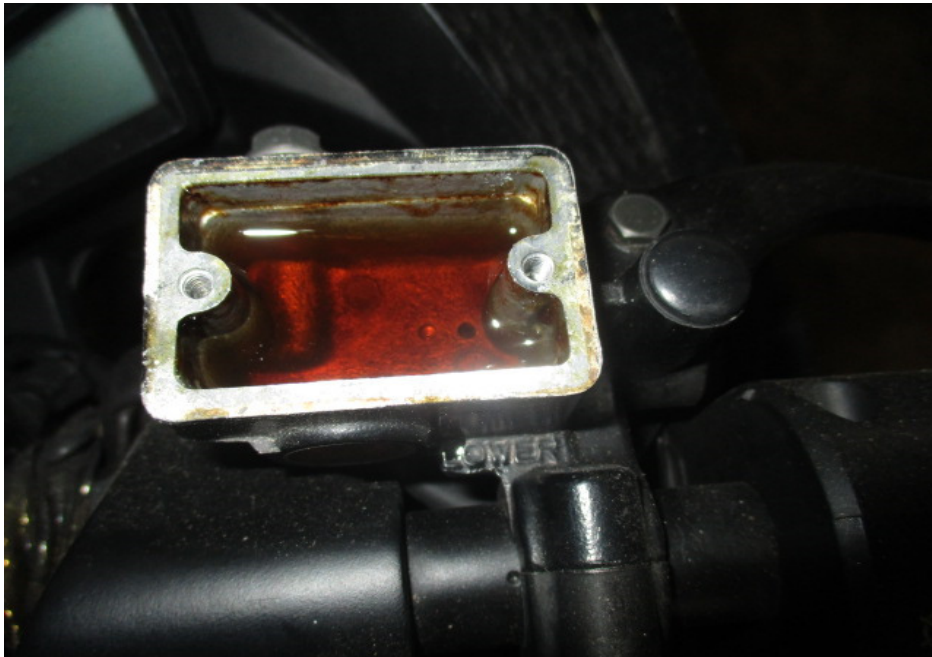
Photo 20 shows the brake fluid reservoir for the front brake of the Motorcycle. The brake fluid was observed to be of sufficient level and without contamination for operational purposes.

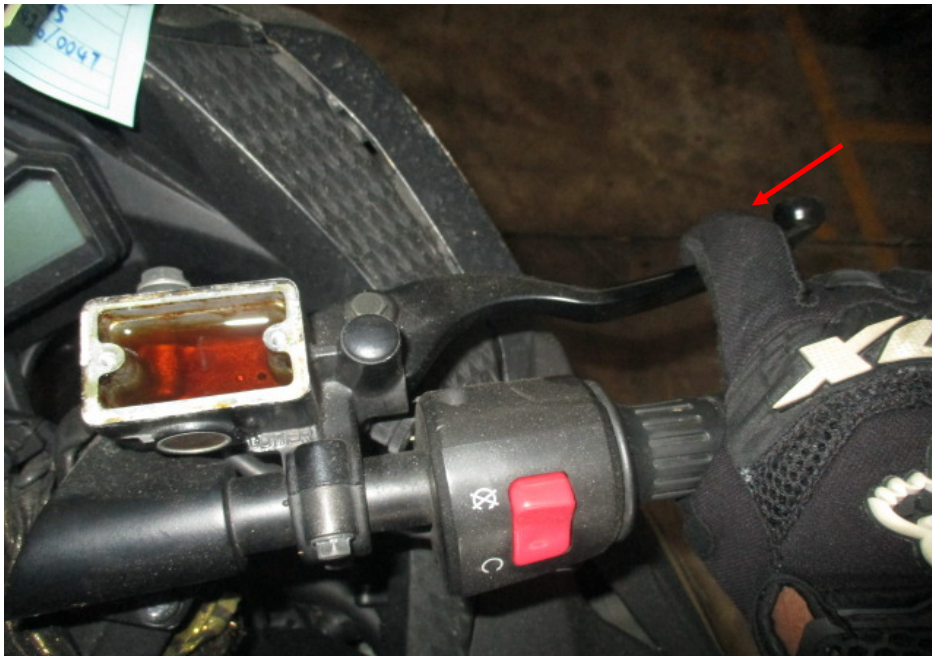
Photo 21 shows the front brake lever being depressed. There was some resistance felt (spongy like feel) upon pressing the front brake lever (arrowed). This would indicate that there is no leakage of pressure/vacuum in the brake system.

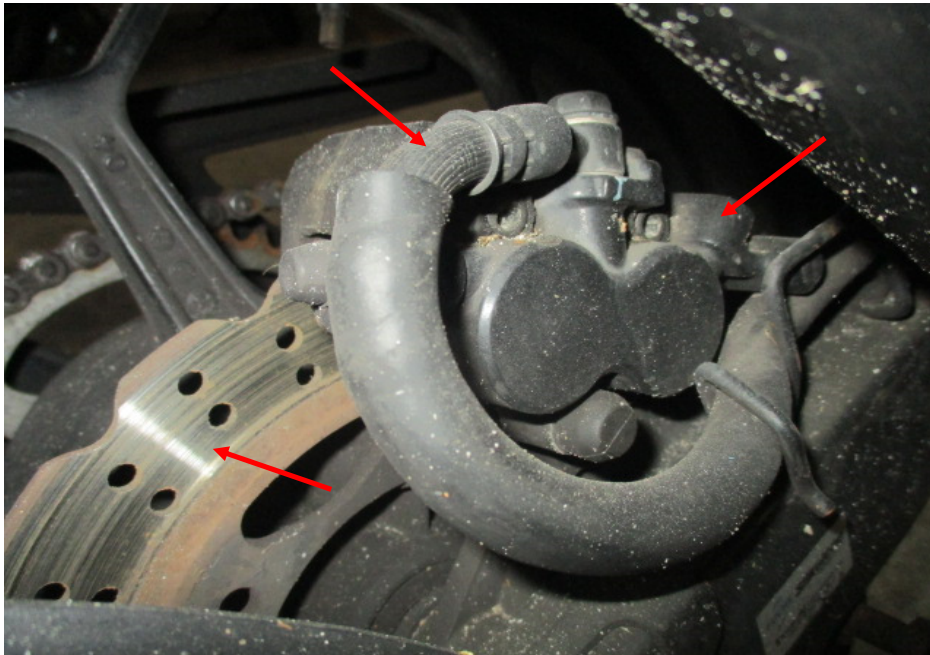
Photo 22 shows a close up view of the rear brake caliper, rear brake disc and rear brake hose (arrowed) of the Motorcycle, which are all part of the components in the hydraulic rear brake system of the Motorcycle. Our visual checks of these various components had revealed all to be intact with no visible damage. No leakage of brake fluid was also observed.

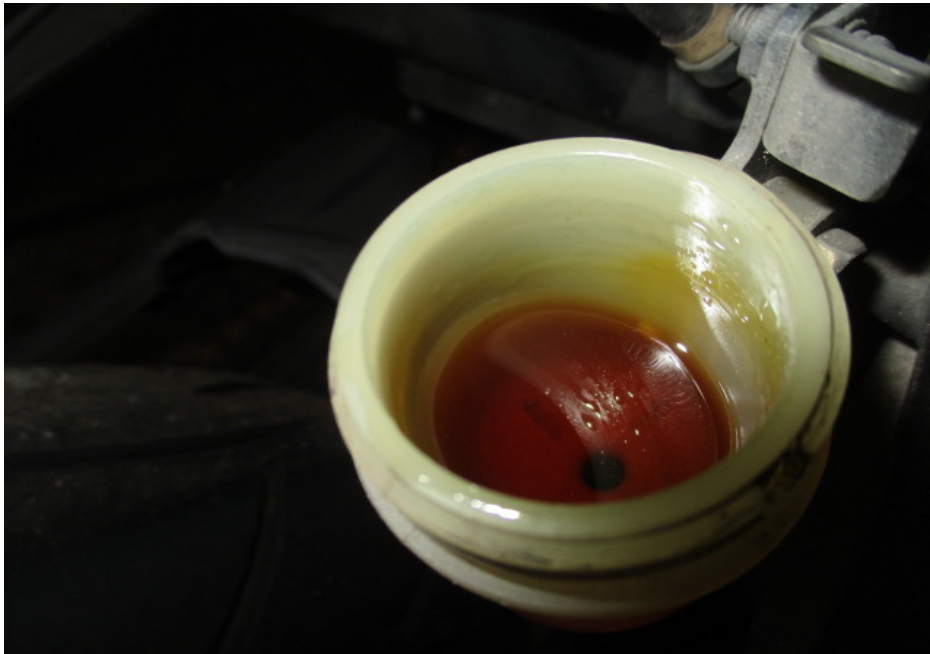
Photo 23 shows the brake fluid reservoir for the rear brake of the Motorcycle. The brake fluid was observed to be of sufficient level and without contamination for operational purposes.
