Your Ref: TP/IP/00753/2019  
Our Ref : CI/TPD19009632/P

11<sup>th</sup> June 2019

**MECHANICAL INSPECTION REPORT OF MOTOR CAR SLJ 7209A**

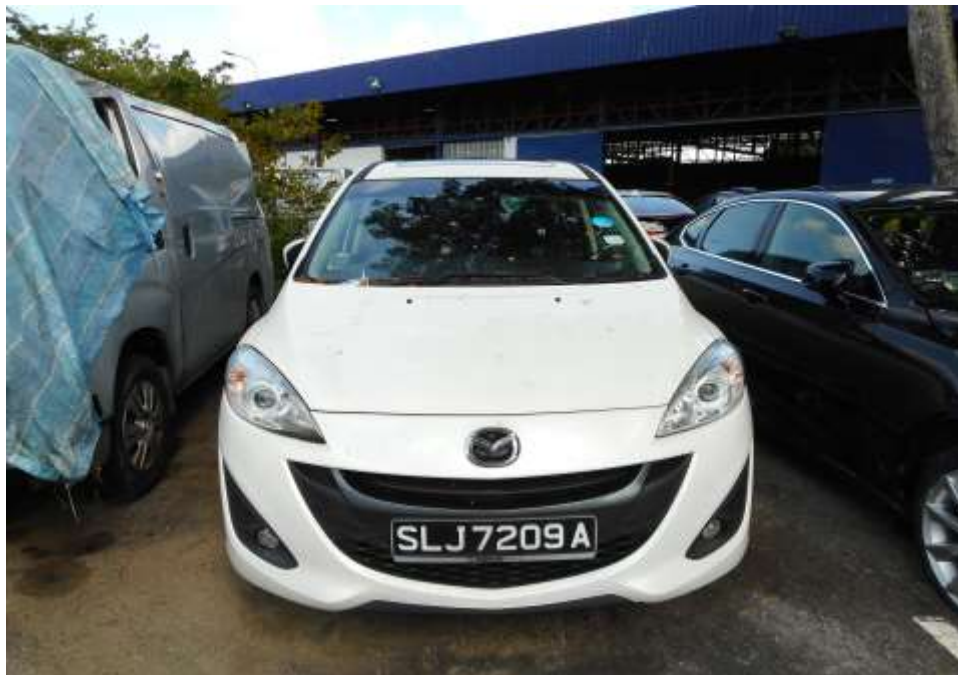
4. The mileage of the Motor car at the time of my inspection was 31,018km.
5. The Motor car was observed to have sustained relatively minor damage at its frontal portion. Its front right headlamp was damaged as a result of the accident.

**Photo 1** shows a general view of the front body of the Motor Car at the time of my inspection. The Motor car was observed to have sustained relatively minor damage at its frontal portion. Its front right headlamp was damaged as a result of the accident. The mileage of the Motor Car at the time of my inspection was recorded to be 31,018km.

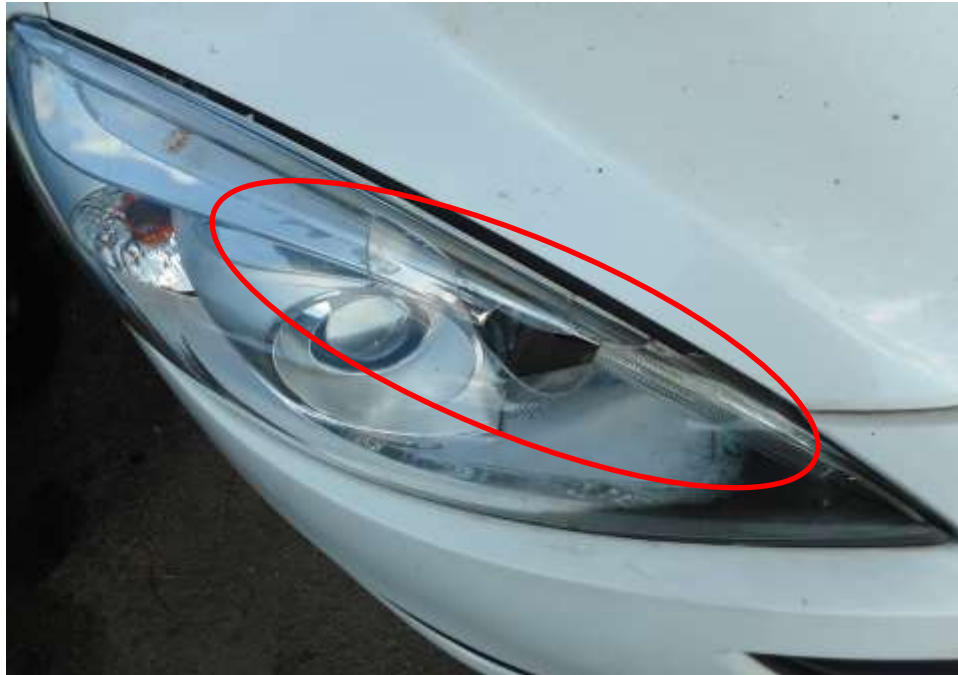
**Photo 2** shows a close up view of the damaged front right headlamp (circled) of the Motor Car as a result of the accident.

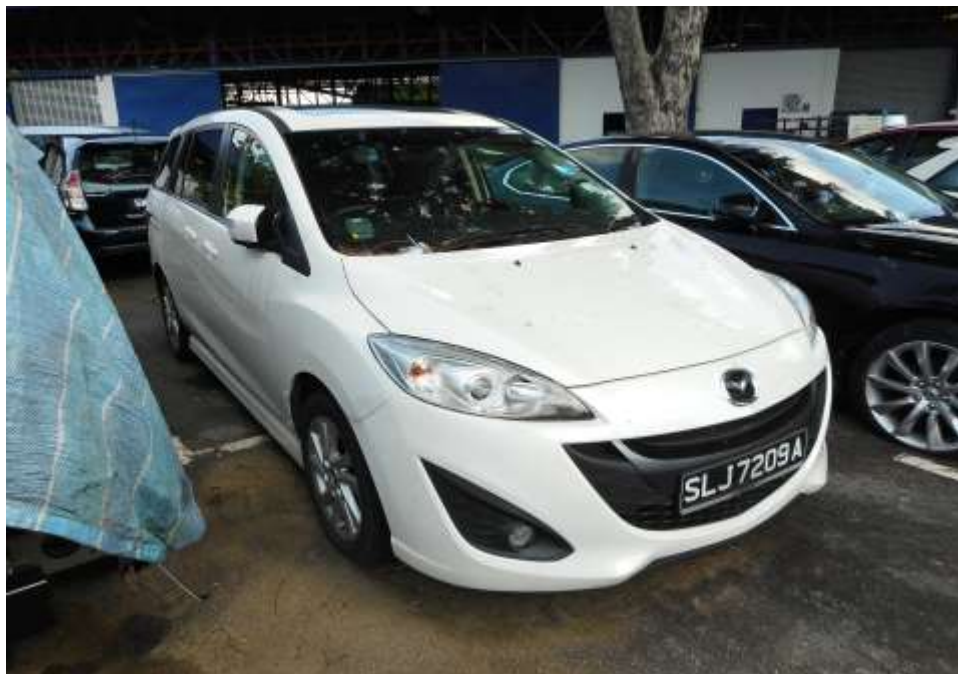
**Photo 3** shows a general view of the Motor Car's right body at the time of my inspection. The right portion of the Motor Car was observed to have been unaffected by the accident.

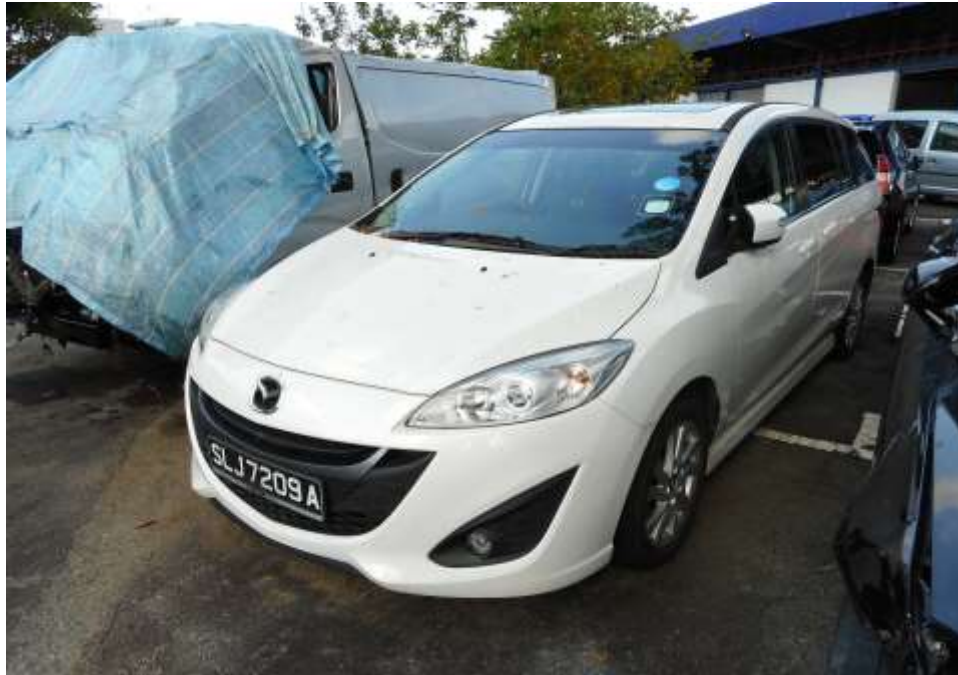
**Photo 4** shows a general view of the Motor Car's rear left body at the time of my inspection. The left portion of the Motor Car was observed to have been unaffected by the accident.

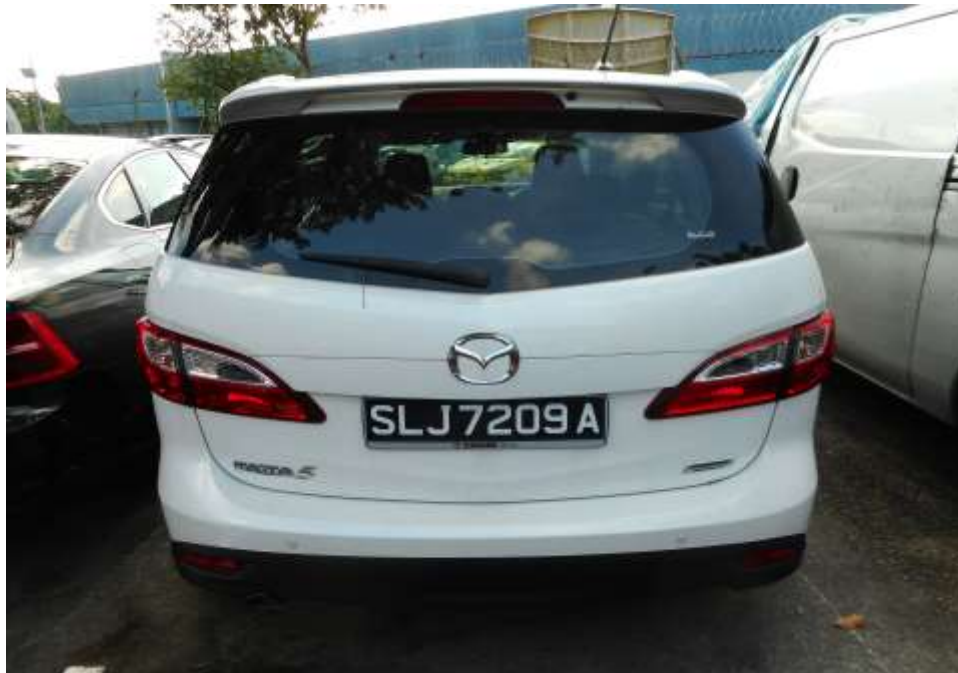
**Photo 5** shows a general view of the Motor Car's rear body at the time of my inspection. The rear portion of the Motor Car was observed to have been unaffected by the accident.

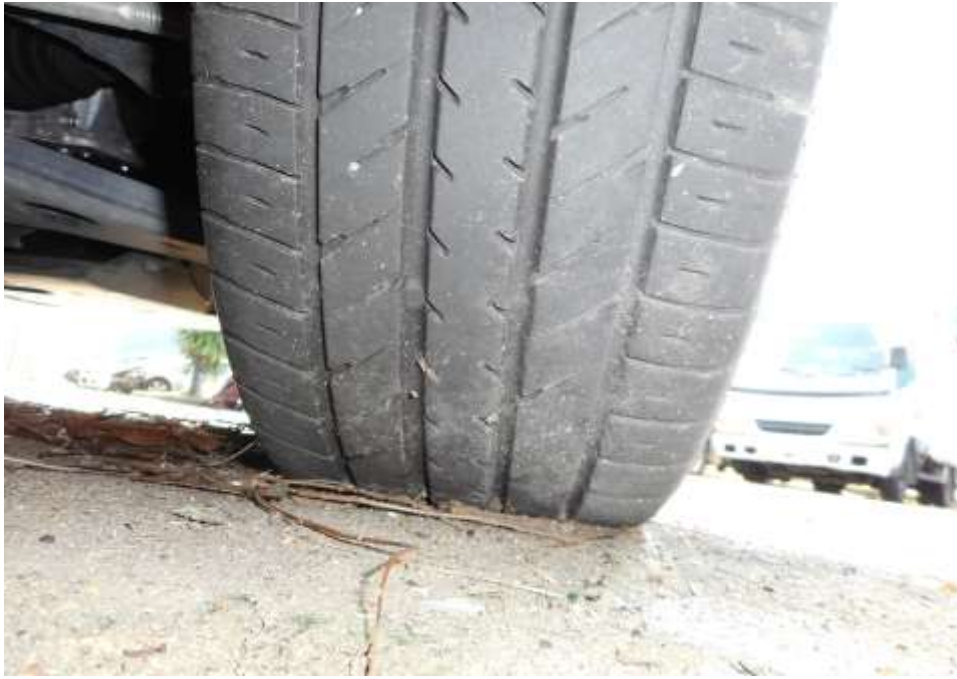
**Photo 6** shows the condition of the front right tyre of the Motor Car, which was observed to be in serviceable condition with remaining tread depth of approximately 6mm. The tyre was sufficiently inflated for vehicular operation with no tear, cut or burst mark(s) on the outer and the inner sidewalls as well as across the tread. The 4 tyres of the Motor Car were wrapped around standard alloy wheel rims without any damage.

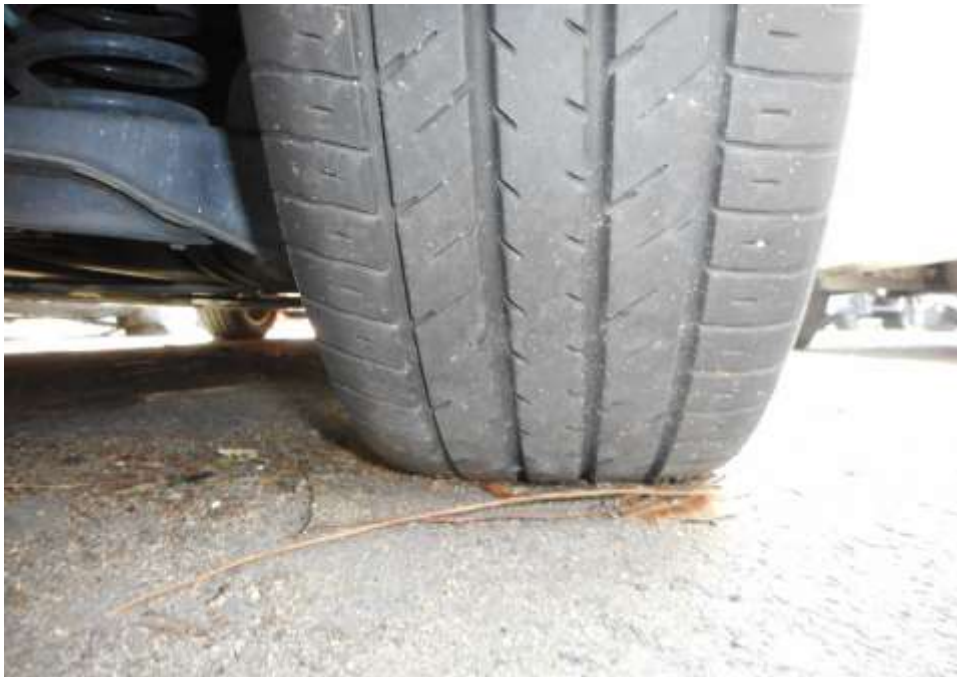
**Photo 7** shows the condition of the rear right tyre of the Motor Car, which was observed to be in serviceable condition with remaining tread depth of approximately 5.3mm. The tyre was also observed to be sufficiently inflated for vehicular operation with no tear, cut or burst mark(s).

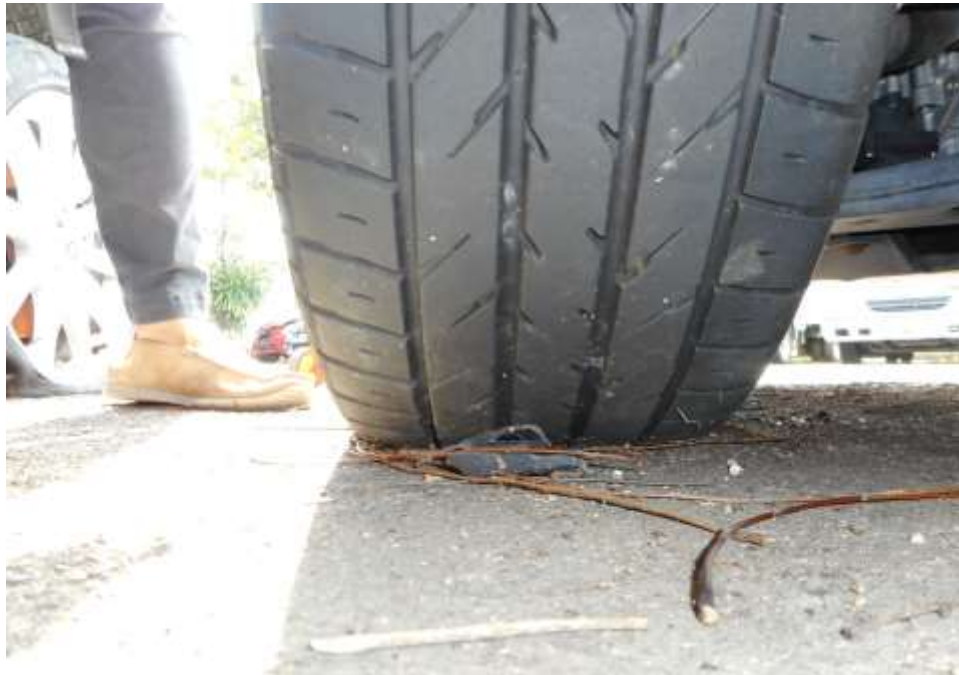
**Photo 8** shows the condition of the front left tyre of the Motor Car, which was observed to be in serviceable condition with remaining tread depth of approximately 5.5mm. The tyre was sufficiently inflated for vehicular operation with no tear, cut or burst mark(s) on the outer and the inner sidewalls as well as across the tread. The 4 tyres of the Motor Car were wrapped around standard alloy wheel rims without any damage.

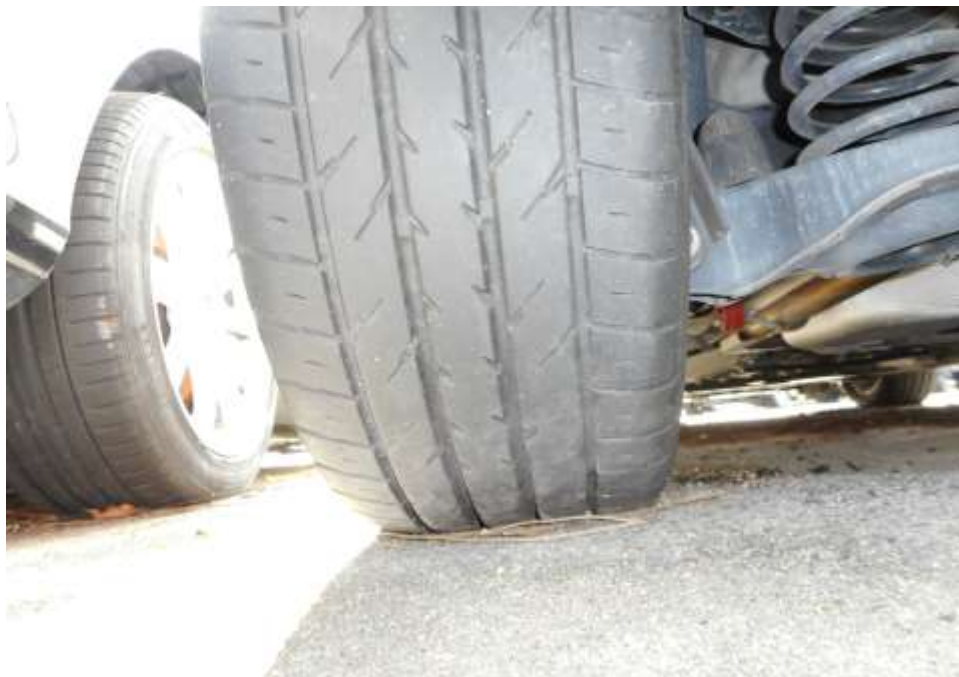
**Photo 9** shows the condition of the rear left tyre of the Motor Car, which was observed to be in serviceable condition with remaining tread depth of approximately 5mm. There was also no tear, cut or burst mark(s) on the outer and the inner sidewalls as well as across the tread of the Motor Car's 4 tyres.

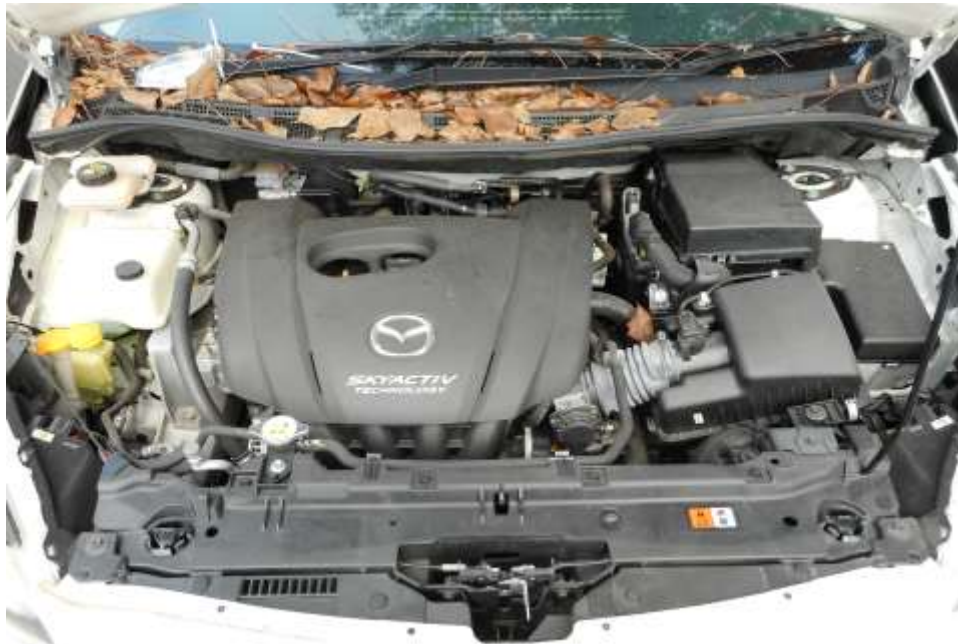
**Photo 10** shows a general view of the Motor Car's engine compartment. The various parts and components inside the engine compartment were unaffected by the accident. There was also no sign(s) or indication(s) of fluid leakage and/or fluid stain within the engine compartment.

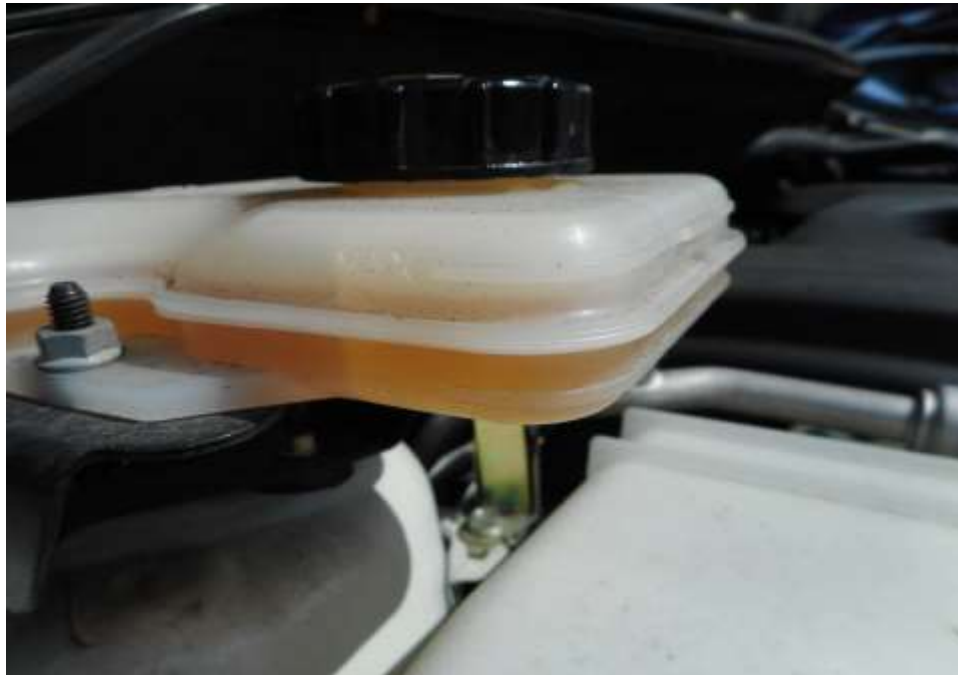
**Photo 11** shows the brake fluid reservoir of the Motor Car at the time of my inspection. The brake fluid was observed to be of sufficient level and without any visible contamination.

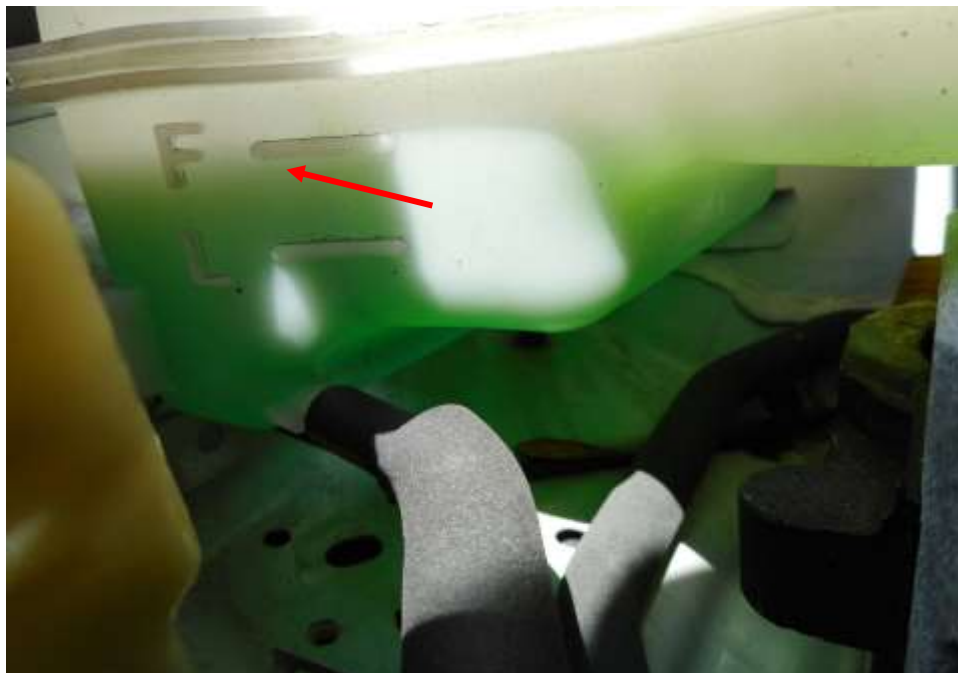
**Photo 12** shows checks being carried out to the engine coolant of the Motor Car at the time of my inspection. The engine coolant was observed to be of sufficient level (arrowed) and without any visible contamination.

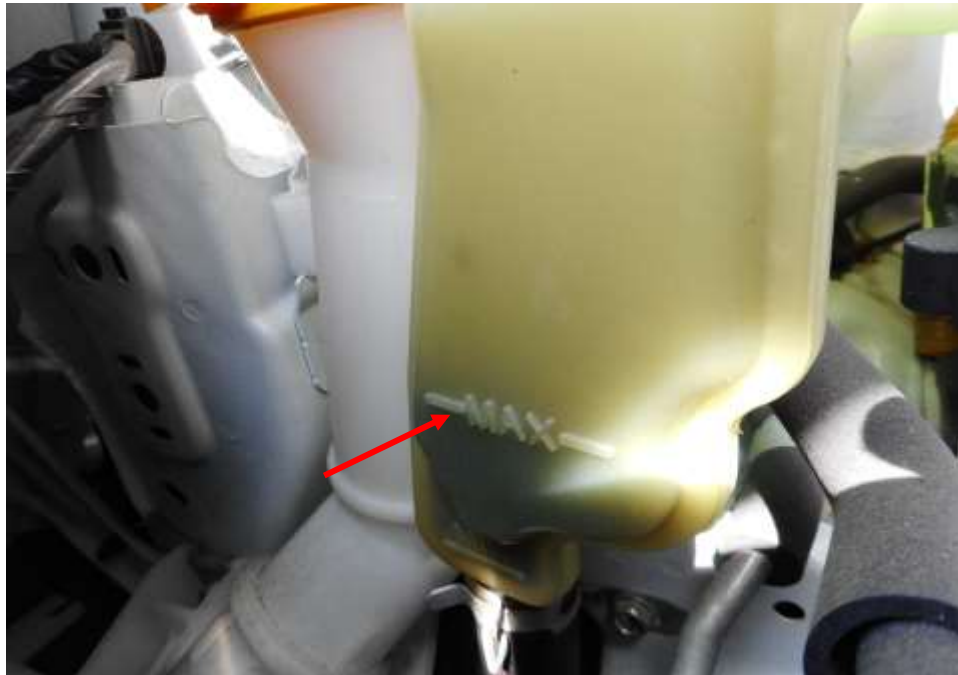
**Photo 13** shows checks being carried out to the power steering fluid reservoir of the Motor Car at the time of my inspection. The steering fluid was observed to be of sufficient level (arrowed) and without any visible contamination.

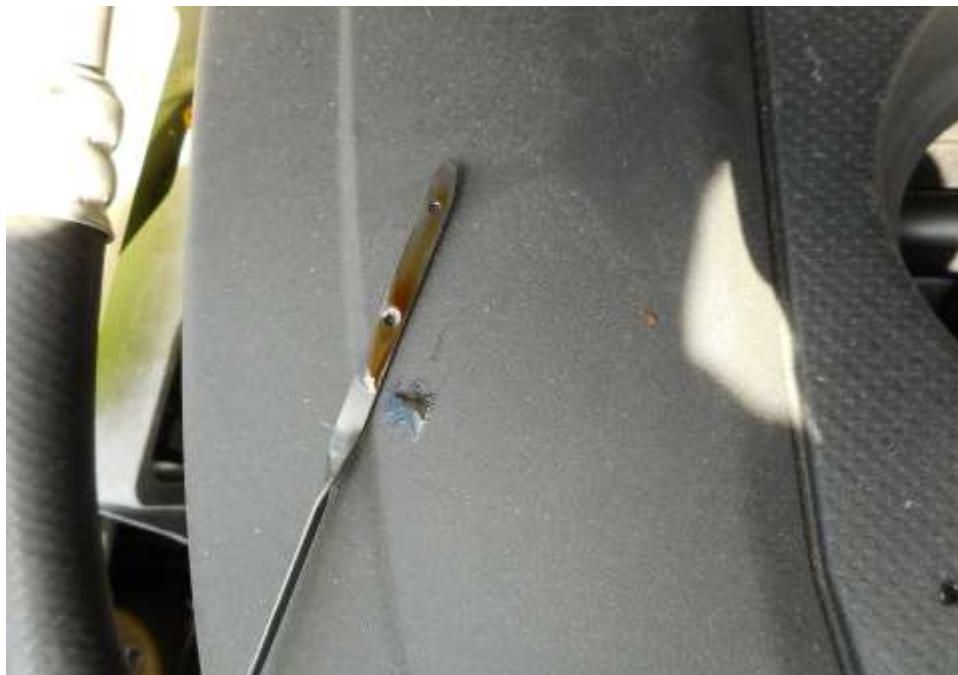
**Photo 14** shows the engine oil dip stick of the Motor Car at the time of my inspection. The engine oil was observed to be of sufficient level and without any visible contamination.

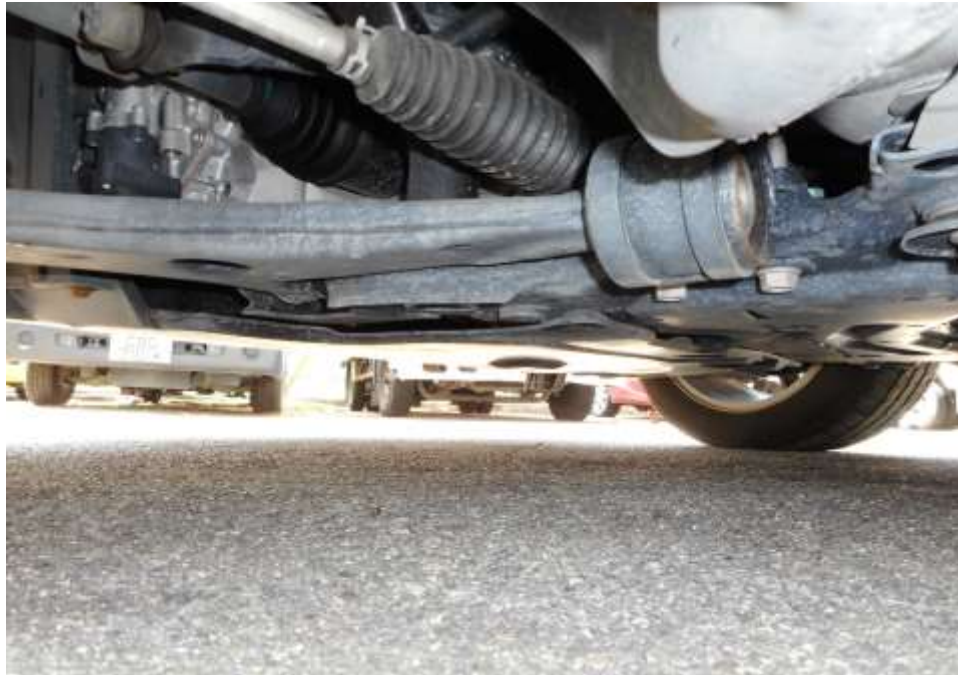
**Photo 15** shows the undercarriage of the Motor Car, at the area where the engine housing and transmission housing are located. I did not find any sign(s) or indication(s) of fluid leak and/or fluid stain(s) on the underside of the Motor Car.

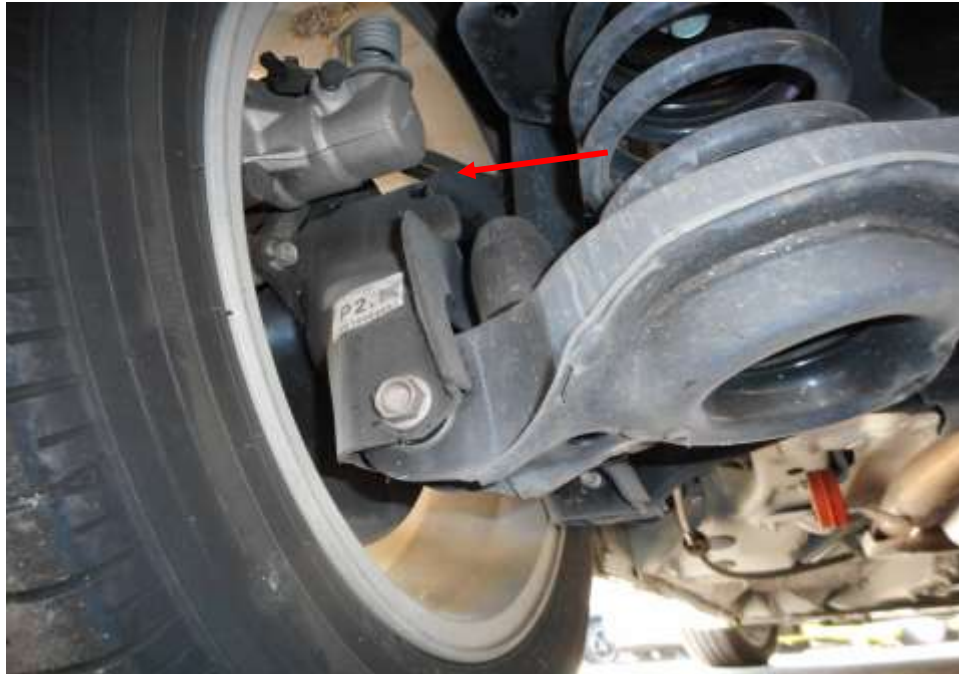
**Photo 16** shows the brake hose/pipe (arrowed) at the rear left wheel of the Motor Car. I did not observe any leakage of brake fluid at the time of my inspection of the Motor Car. Static tests of the Motor Car's braking system had indicated that there was no internal leakage of pressure/vacuum. The undercarriage components of the Motor Car were also all found to be intact and without any visible damage.

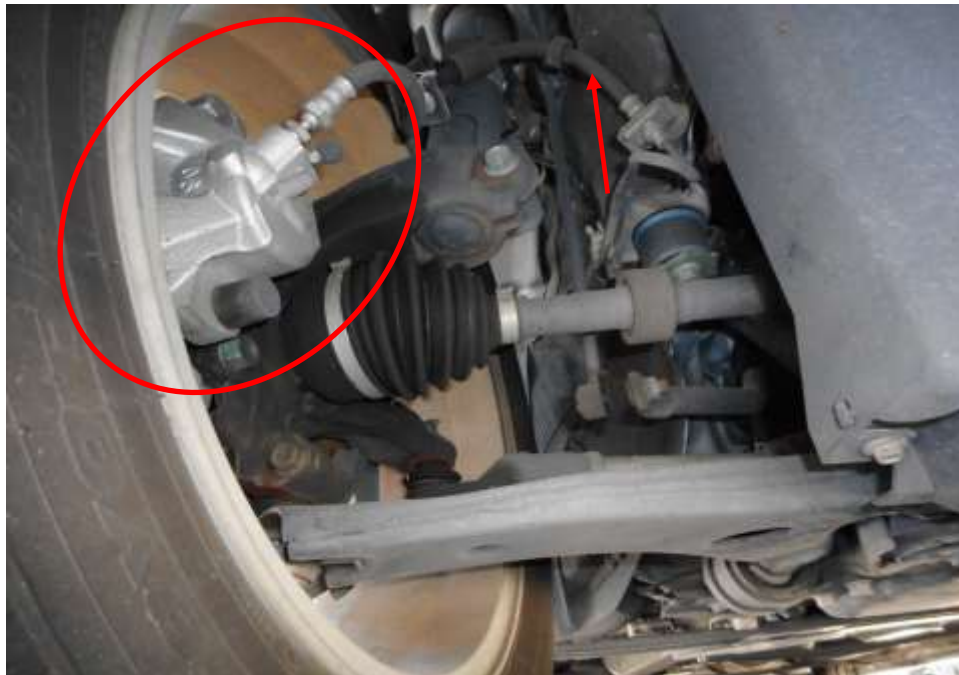
**Photo 17** shows the brake hose/pipe (arrowed) at the front right wheel of the Motor Car. No leakage of brake fluid was observed. Visual examination of the various components of the braking system like the brake caliper (circled), brake booster, brake pedal etc had revealed all to be intact and without visible damage.

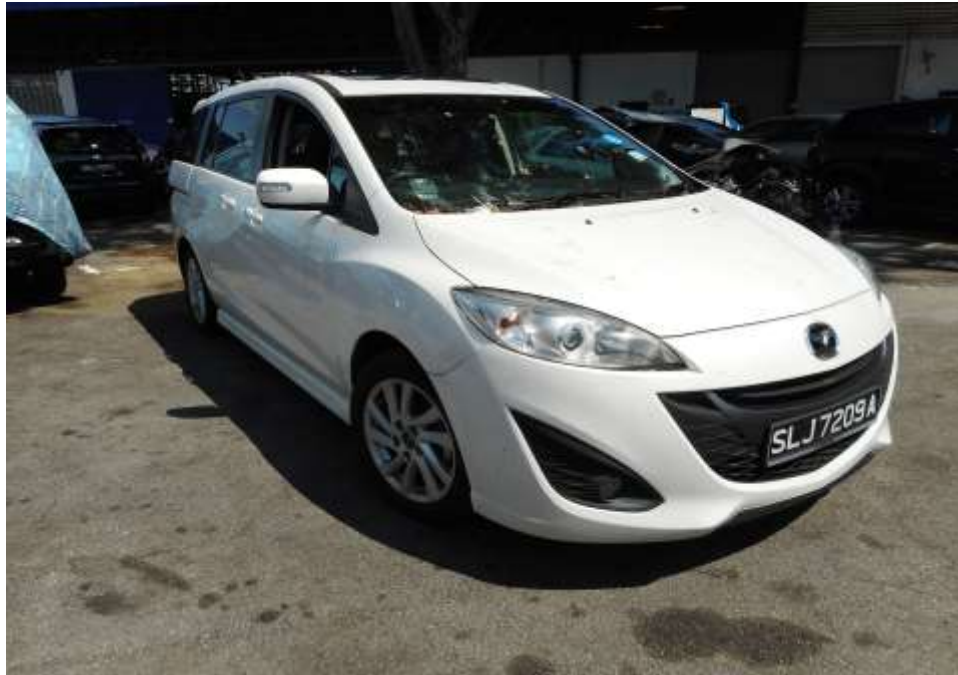
**Photo 18** shows the front right wheel of the Motor Car turned to its full left. During my steering system test, I did not experience any abnormal free play and/or resistance when I had turned the steering wheel towards the left and right. This would suggest that the steering system of the Motor Car was likely to be in serviceable condition at the material time of accident.

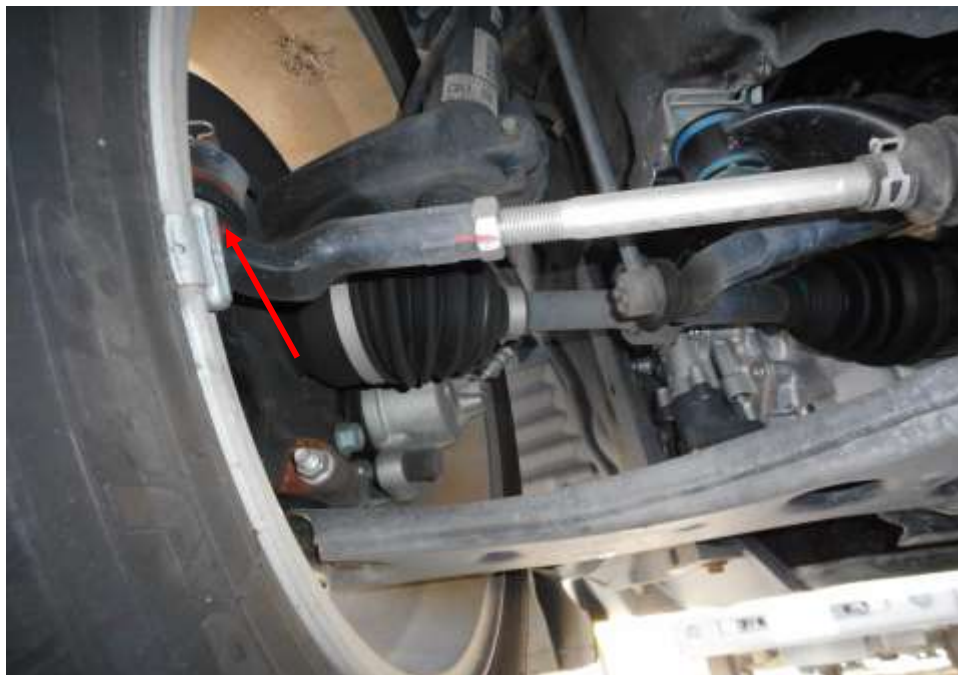
**Photo 19** shows the various undercarriage components at the front right wheel of the Motor Car, in particular the steering tie rod (arrowed). The various steering components were all found to be intact, suggesting that the steering system of the Motor Car was likely to be in serviceable condition at the material time of accident. There was also no sign of fluid stain observed on the various undercarriage components at the front right wheel of the Motor Car.

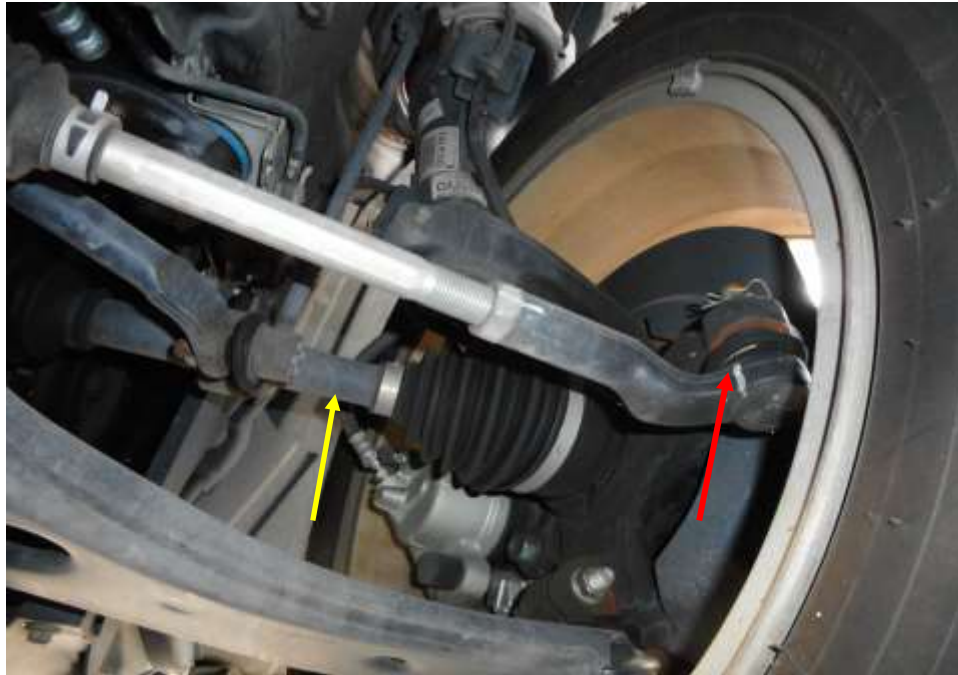
**Photo 20** shows the various undercarriage components at the front left wheel of the Motor Car , which had included the steering tie rod (red arrow) and front left drive shaft (yellow arrow). The various undercarriage components of the Motor Car were all found to be intact without any visible damage.

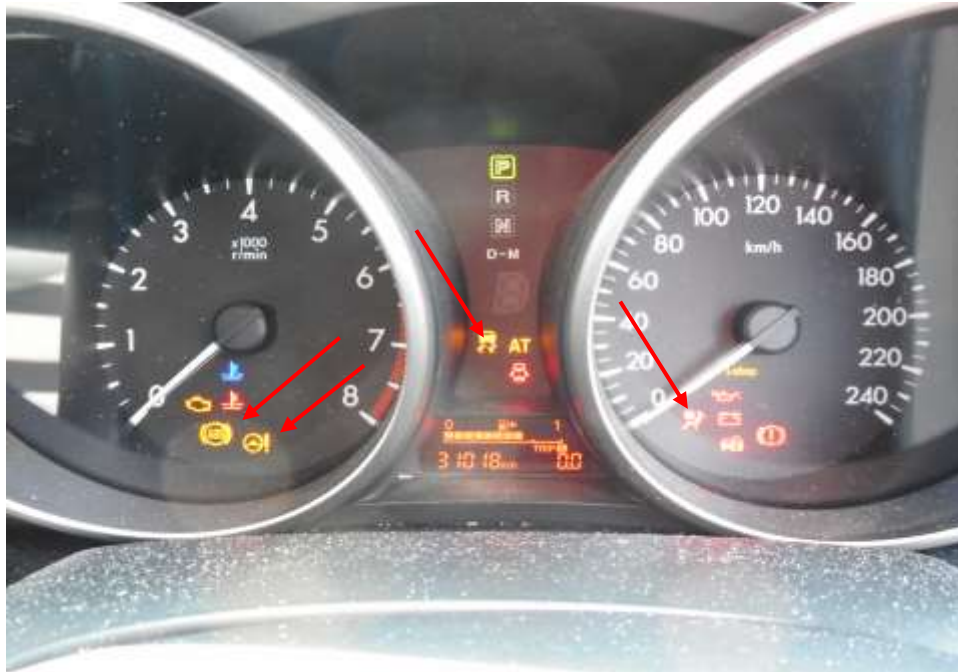
**Photo 21** shows the warning light for Anti-Lock Brake System (ABS), Traction Control (TC) and Supplemental Restraint System (SRS) appearing on the instrument panel of the Motor Car during the self-test of its various electronic operating systems when its engine was cranked.

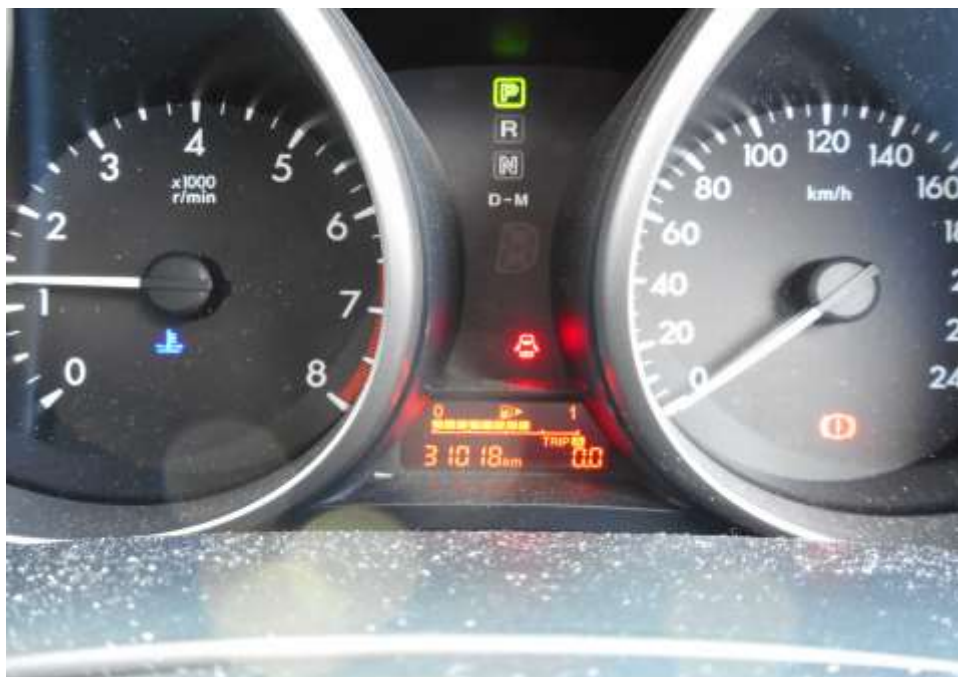
**Photo 22** shows no warning lights illuminated on the instrument panel of the Motor Car after the engine was cranked. This would suggest that there was no abnormality to the various electronic operating systems of the Motor Car, like the ABS, TC and SRS etc.
