Your Ref: TP/IP/27047/2019
Our Ref : CI/TPD19009633/P

Fatal Accident Investigation Team

MECHANICAL INSPECTION REPORT OF MOTOR BUS CB 6190Z

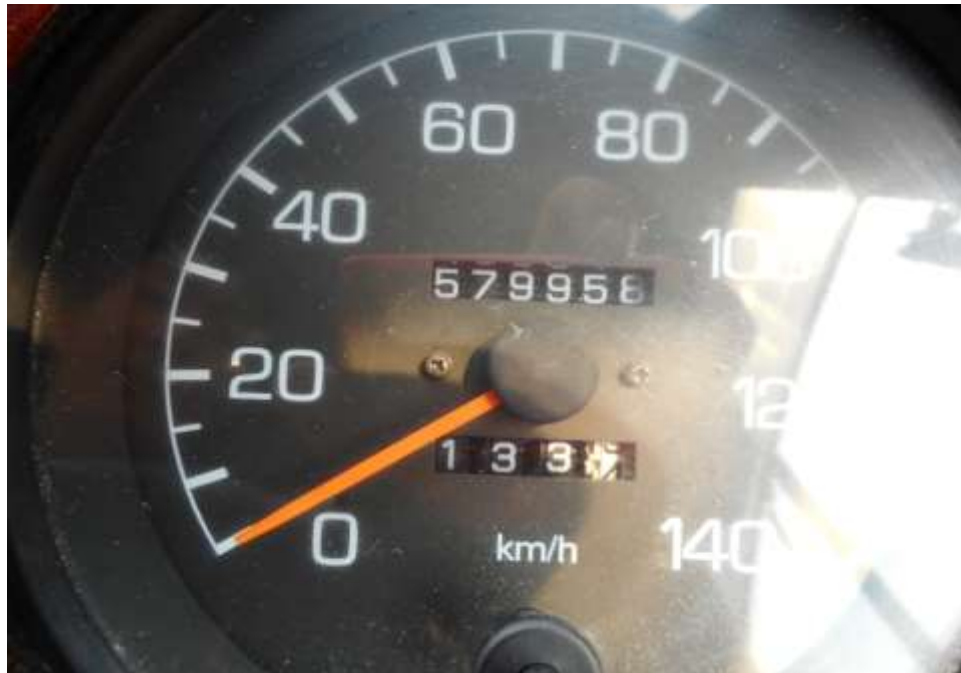
Photo 1 shows a general view of the instrument cluster of the Motor Bus at the time of my inspection. The mileage of the Motor Bus was 579,958km

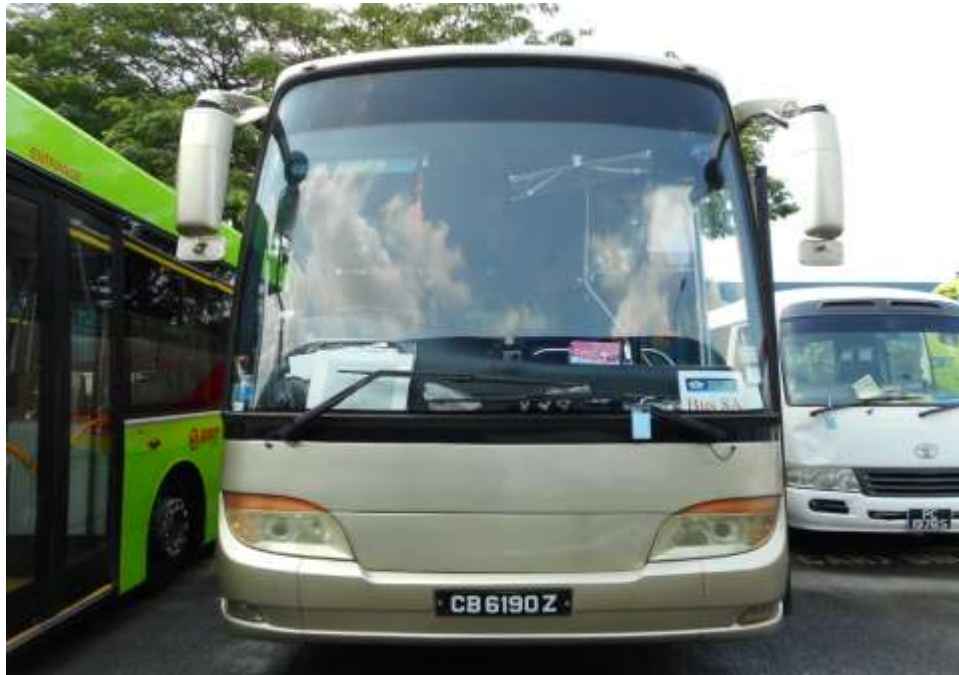
Photo 2 shows a general view of the front body of the Motor Bus at the time of my inspection. The Motor Bus did not appear to sustain any visible damage at the time of my inspection.

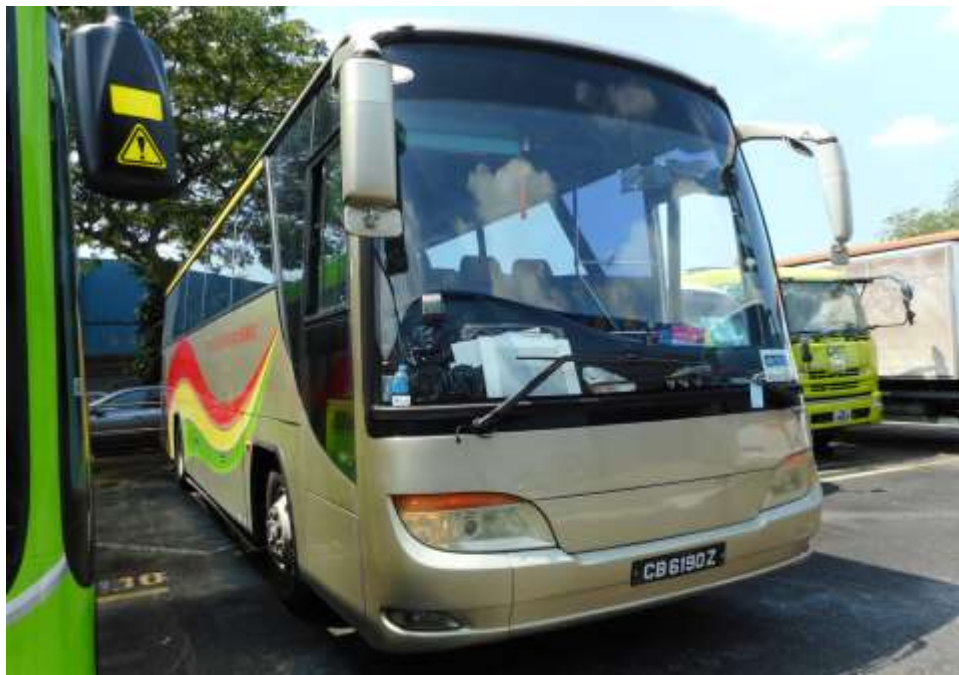
Photo 3 shows a general view of the right body of the Motor Bus at the time of my inspection. The Motor Bus was observed to be in good general condition and unaffected by the accident.

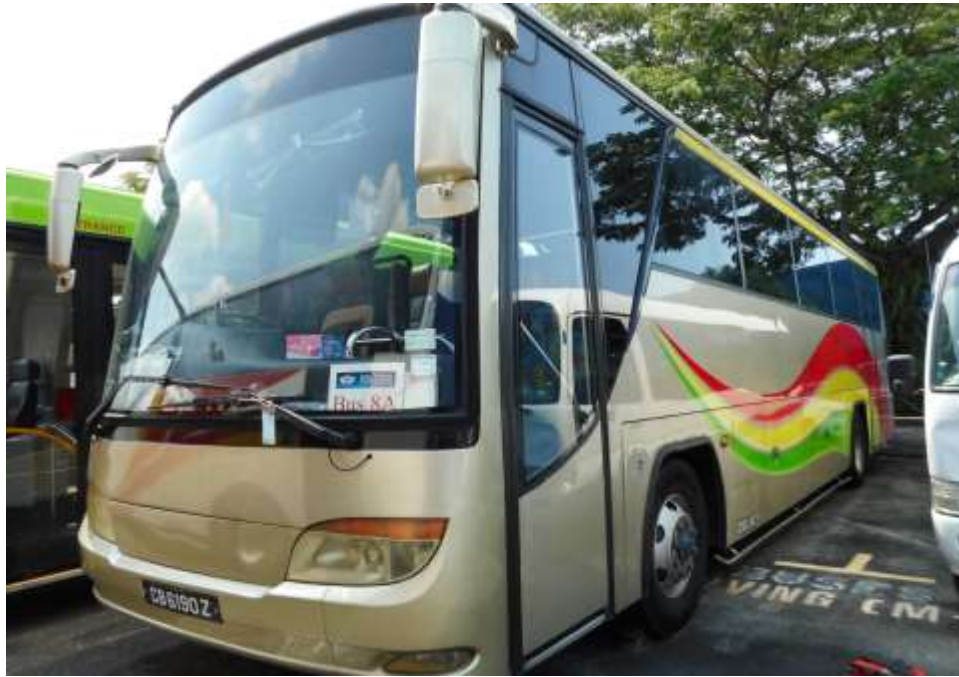
Photo 4 shows a general view of the left body of the Motor Bus at the time of my inspection. The Motor Bus was observed to be in good general condition and unaffected to by the accident.

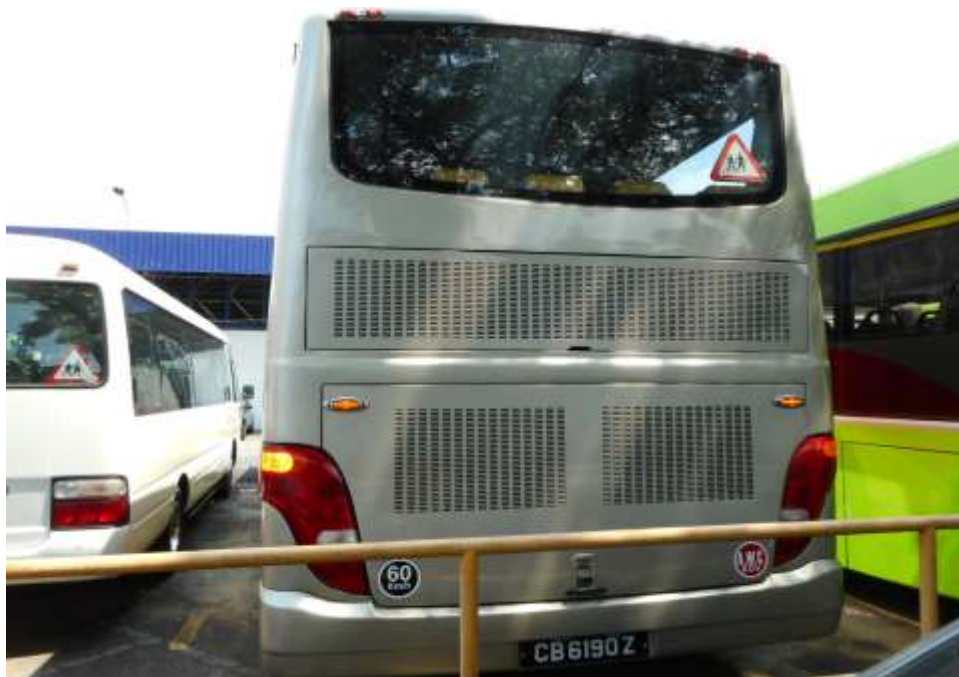
Photo 5 shows a general view of the Motor Bus's rear body at the time of my inspection. The Motor Bus was observed to be in good general condition and unaffected to by the accident.

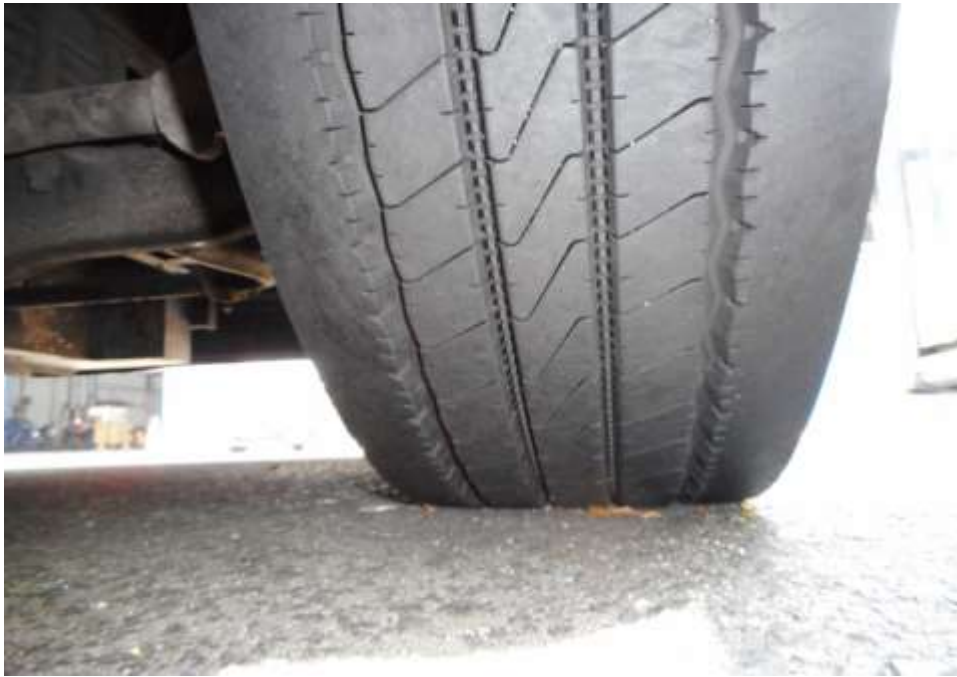
Photo 6 shows the condition of the front right tyre of the Motor Bus, which was observed to be in serviceable condition with remaining tread depth of approximately 9.5mm. The tyre, which was wrapped around standard steel wheel rim, was also observed to be sufficiently inflated for vehicular operation. There was no tear, cut or burst mark(s) on the outer and the inner sidewalls as well as across the tread of the 6 tyres that were fitted on the Motor Bus.

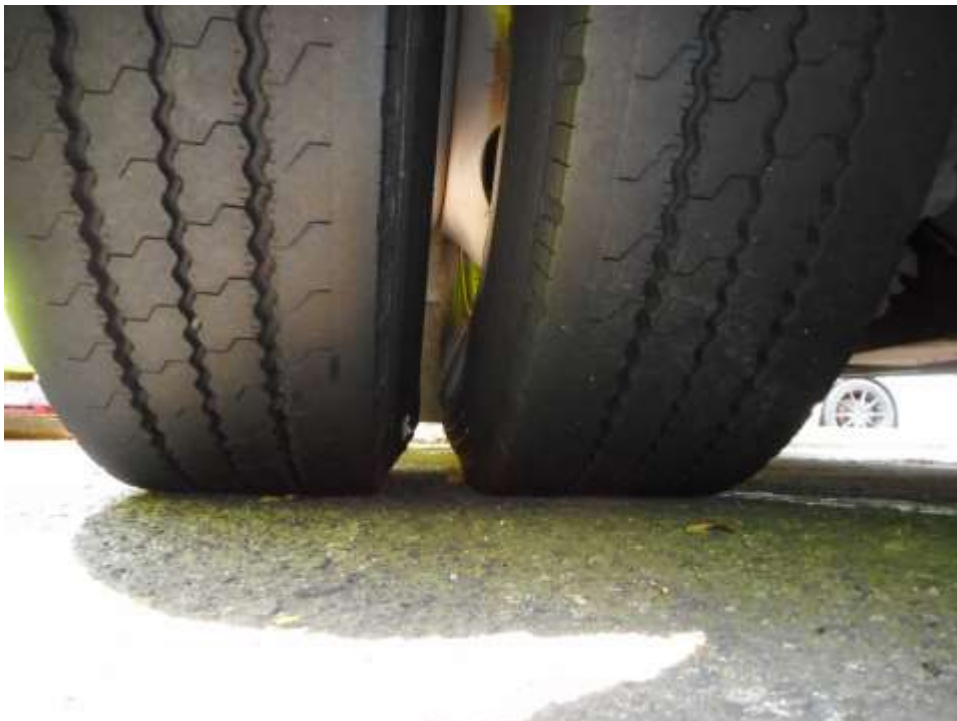
Photo 7 shows the condition of the rear right tyre of the Motor Bus, which was observed to be in serviceable condition with remaining tread depth of approximately 7.2mm. The tyre, which was wrapped around standard steel wheel rim, was also observed to be sufficiently inflated for vehicular operation.

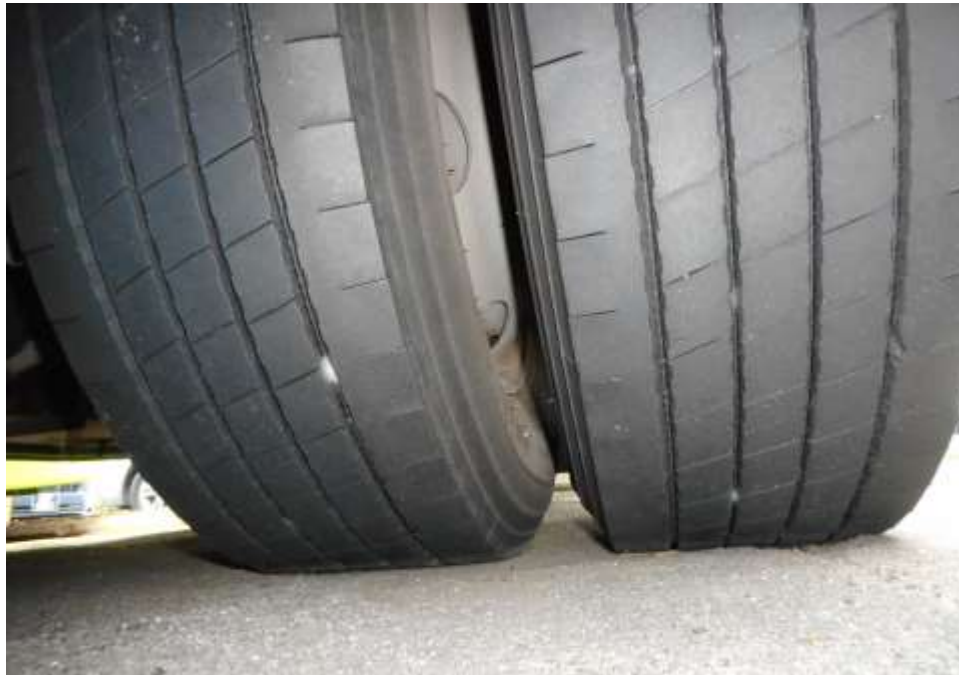
Photo 8 shows the condition of the rear left tyres of the Motor Bus, which was observed to be in serviceable condition with remaining tread depth of approximately 5.6mm. The tyres, which were wrapped around standard steel wheel rim, were also observed to be sufficiently inflated for vehicular operation. There was also no damage found on all 6 steel wheel rims of the Motor Bus.

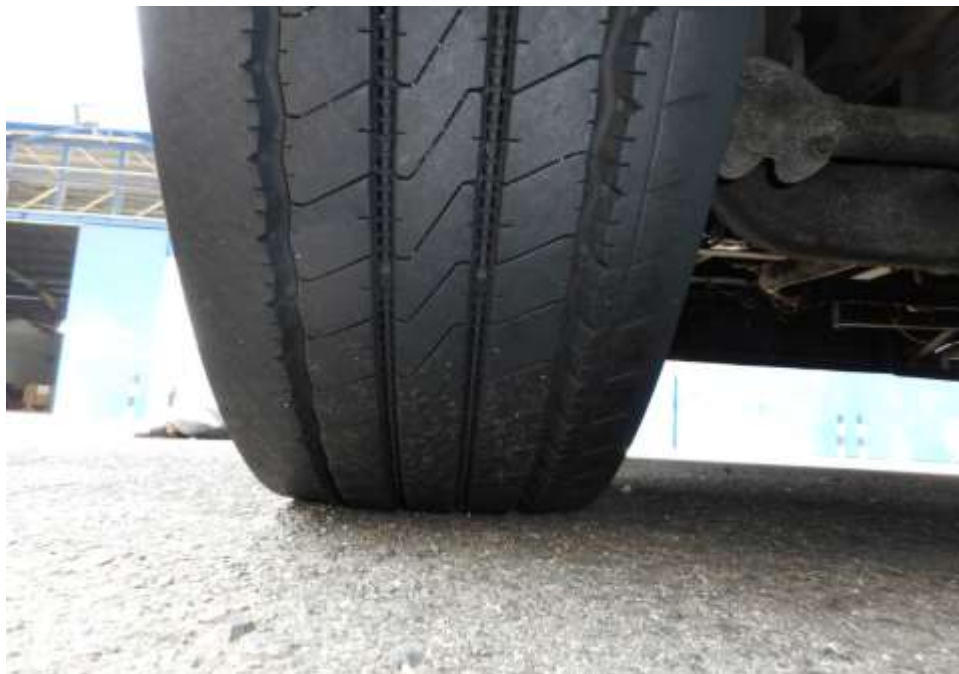
Photo 9 shows the condition of the front left tyres of the Motor Bus, which were observed to be in serviceable condition with remaining tread depth of approximately 8.9mm. There was also no tear, cut or burst mark(s) on the outer and the inner sidewalls as well as across the tread of the 6 tyres that were fitted on the Motor Bus.

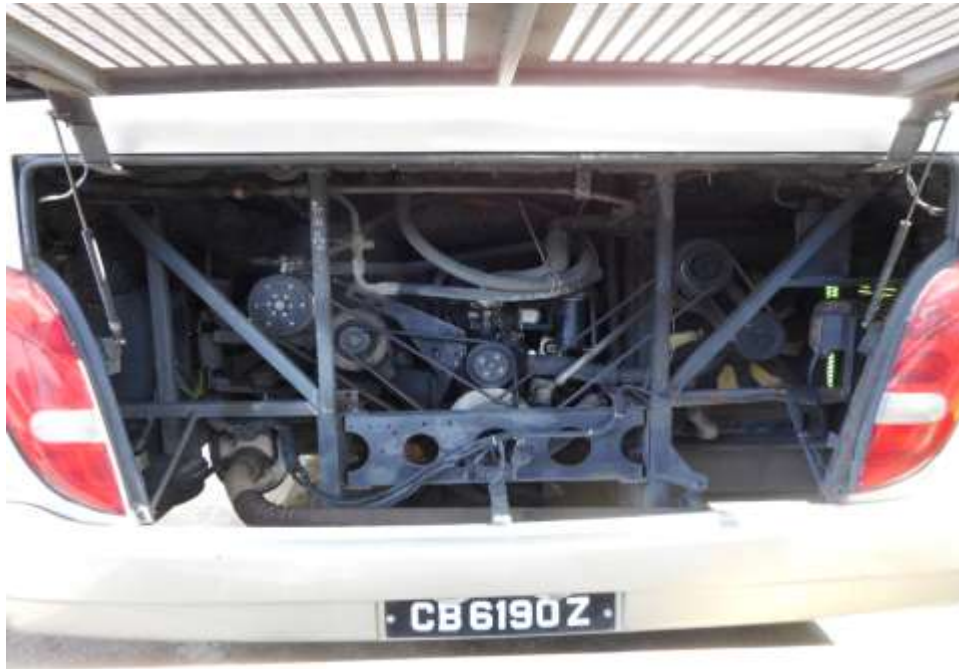
Photo 10 shows a general view of the Motor Bus's engine compartment, which was accessed by lifting the front cabin of the Motor Bus. The various parts and components inside the engine compartment were unaffected by the accident. There was also no sign(s) or indication(s) of fresh fluid leakage and/or fluid stain within the engine compartment

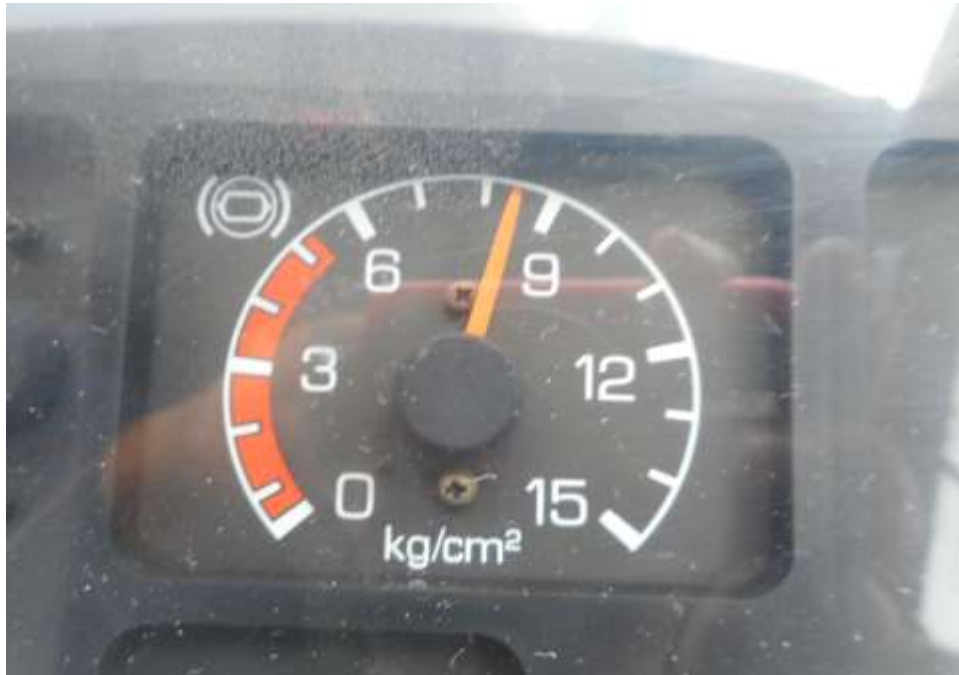
Photo 11 shows the air in the air brake cylinder of the Motor Bus at the time of my inspection. The air in the cylinder was observed to be of sufficient level & serviceable at the time of the accident.

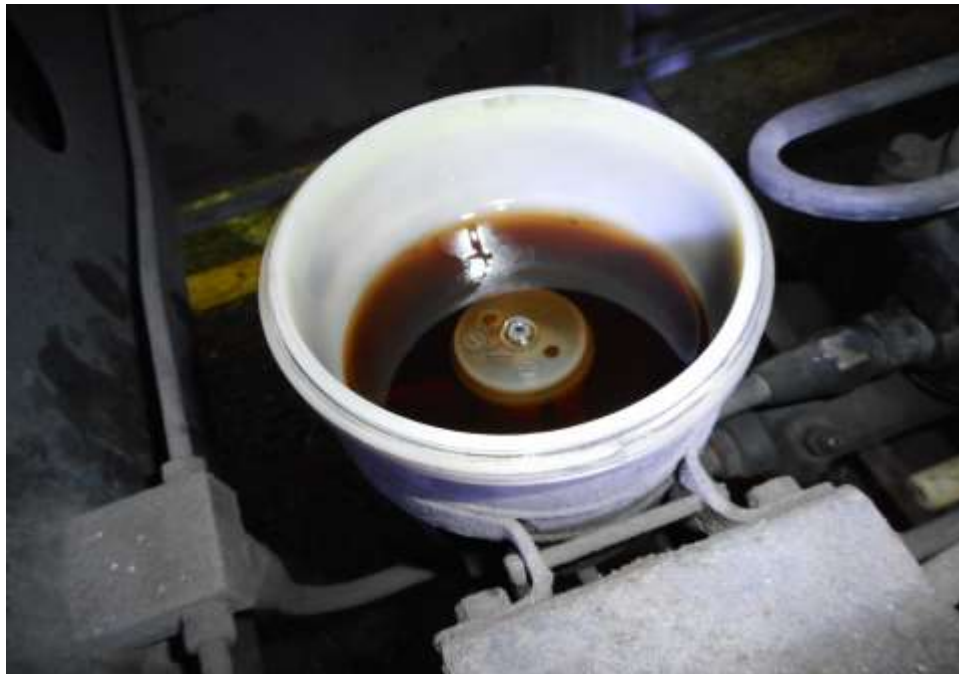
Photo 12 shows the brake reservoir of the Motor Bus at the time of my inspection. The brake fluid was observed to be of sufficient level & serviceable at the time of the accident.

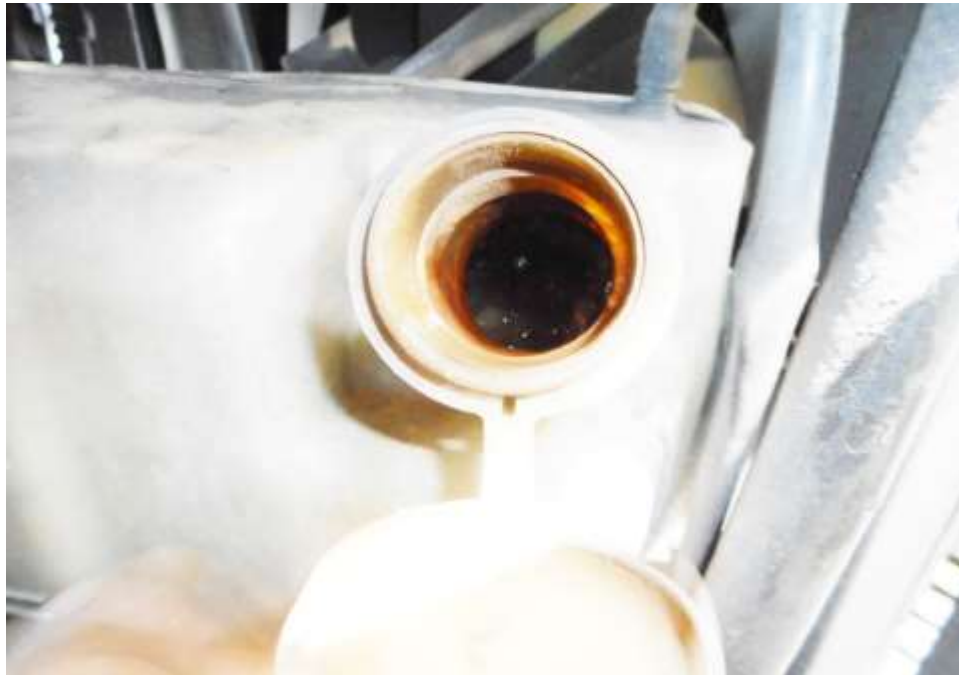
Photo 13 shows the engine coolant reservoir of the Motor Bus at the time of my inspection. The engine coolant was observed to be of sufficient level and without any visible contamination.

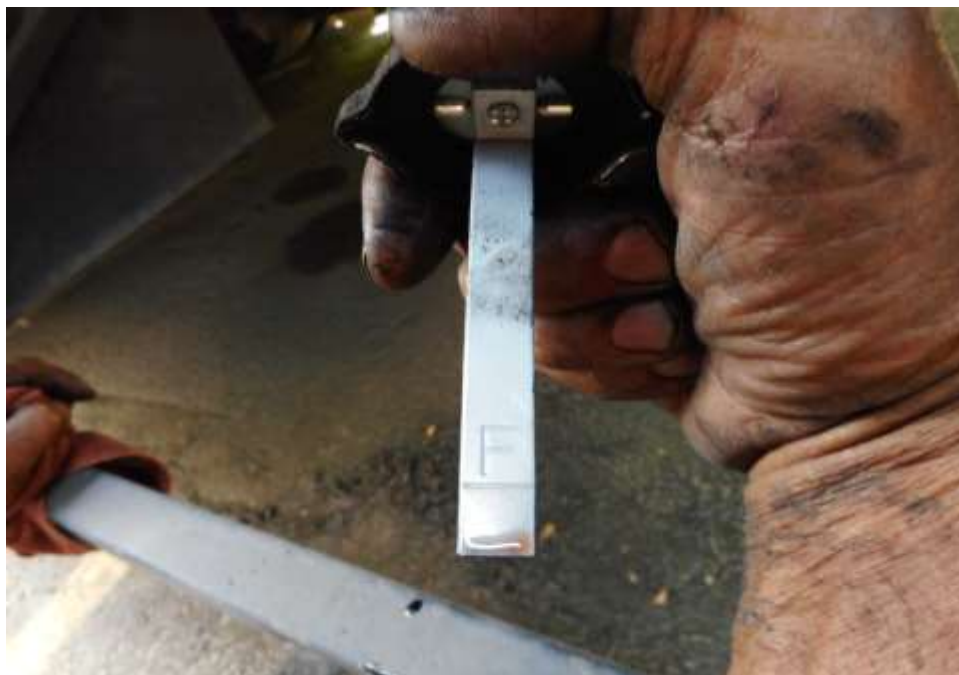
Photo 14 shows the power steering fluid reservoir of the Motor Bus at the time of my inspection. The power steering fluid was observed to be of sufficient level and without any visible contamination.

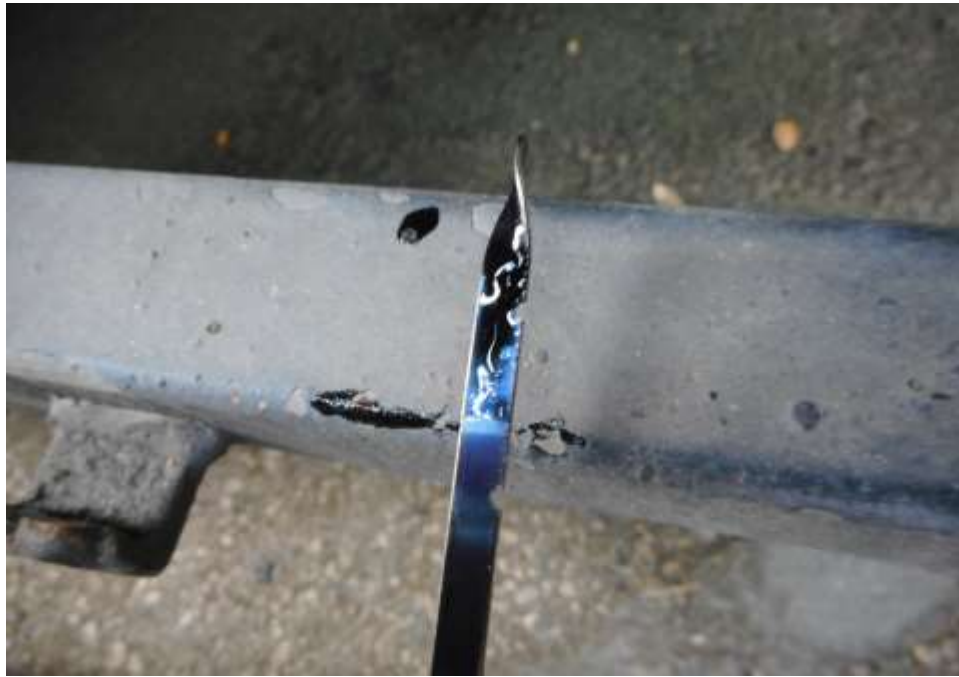
Photo 15 shows the engine oil dip stick system of the Motor Bus at the time of my inspection. The engine oil was observed to be of sufficient level and without any visible contamination.

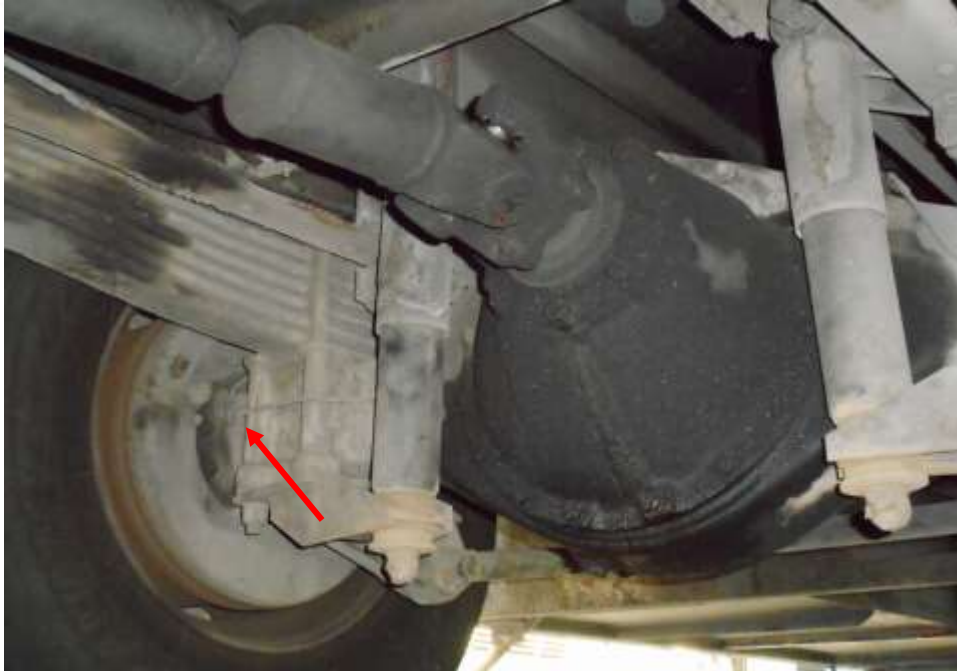
Photo 16 shows the brake pipe (arrowed) at the rear right wheel of the Motor Bus. I did not observe any leakage of brake fluid at the time of my inspection of the Motor Bus. My static tests of the Motor Bus's braking system, along with my visual examination of the various mechanical components in the braking system, had indicated that there was no internal leakage of pressure/vacuum. Hence the braking system of the Motor Bus was likely to be in serviceable condition at the material time of accident.

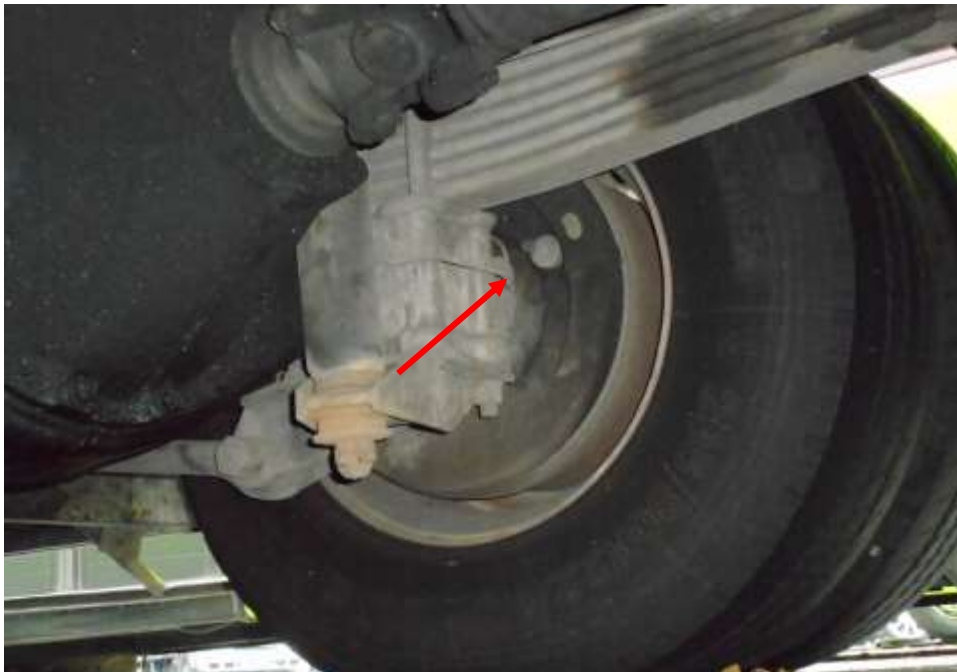
Photo 17 shows the brake pipe (arrowed) at the rear left wheel of the Motor Bus. I did not observe any leakage of brake fluid at the time of my inspection of the Motor Bus. My static tests of the Motor Bus's braking system, along with my visual examination of the various mechanical components in the braking system, had indicated that there was no internal leakage of pressure/vacuum. Hence the braking system of the Motor Bus was likely to be in serviceable condition at the material time of accident.

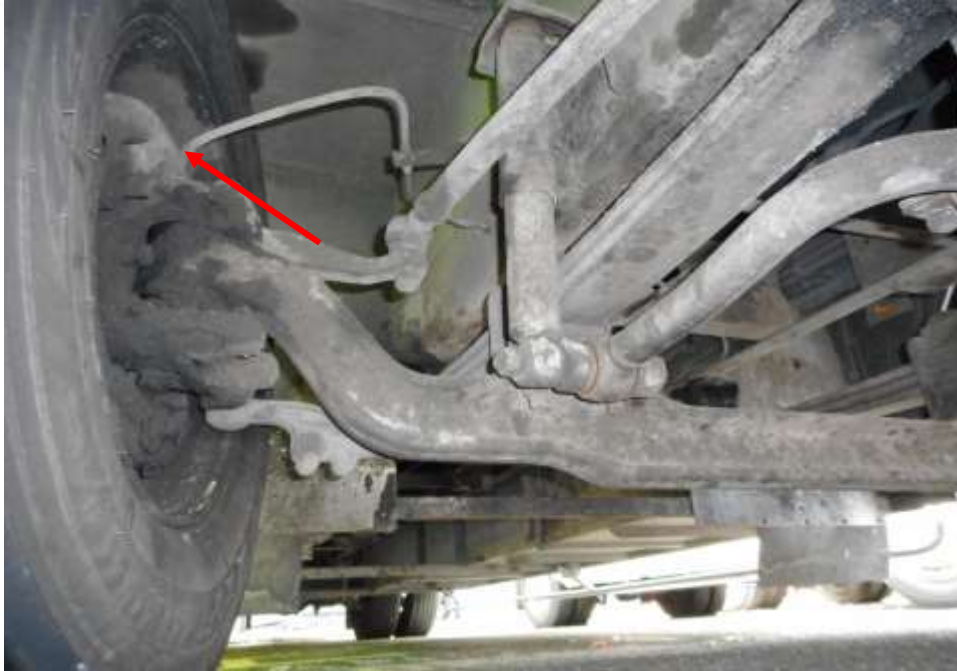
Photo 18 shows the brake pipe (arrowed) at the front right wheel of the Motor Bus. I did not observe any leakage of brake fluid at the time of my inspection of the Motor Bus. My static tests of the Motor Bus's braking system, along with my visual examination of the various mechanical components in the braking system, had indicated that there was no internal leakage of pressure/vacuum. Hence the braking system of the Motor Bus was likely to be in serviceable condition at the material time of accident.

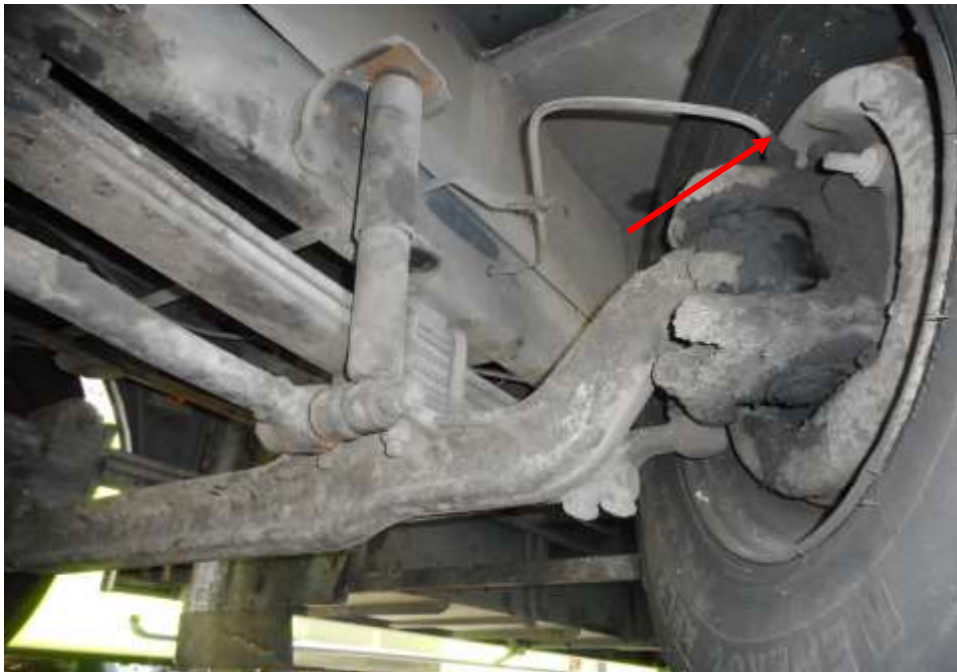
Photo 19 shows the brake pipe (arrowed) at the front left wheel of the Motor Bus. I did not observe any leakage of brake fluid at the time of my inspection of the Motor Bus. My static tests of the Motor Bus's braking system, along with my visual examination of the various mechanical components in the braking system had indicated that there was no internal leakage of pressure/vacuum. Hence the braking system of the Motor Bus was likely to be in serviceable condition at the material time of accident.

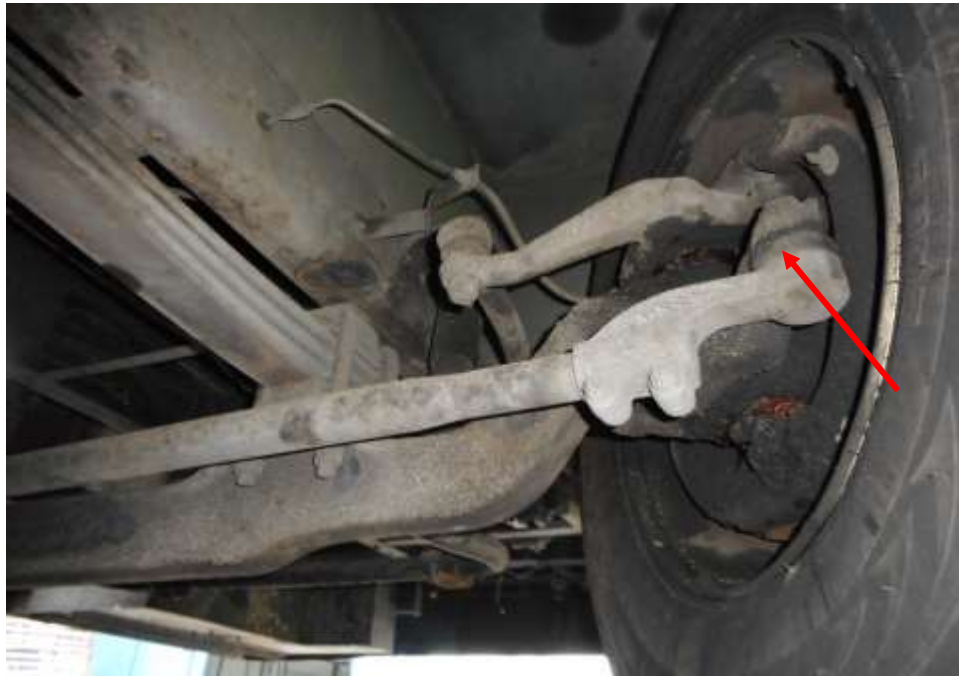
Photo 20 shows the various undercarriage components at the front right wheel of the Motor Bus, in particular the steering tie rod end (arrowed). The various steering components were all found to be intact, suggesting that the steering system of the Motor Bus was likely to be in serviceable condition at the material time of accident. There was also no sign of fluid stain(s) observed on the various undercarriage components.

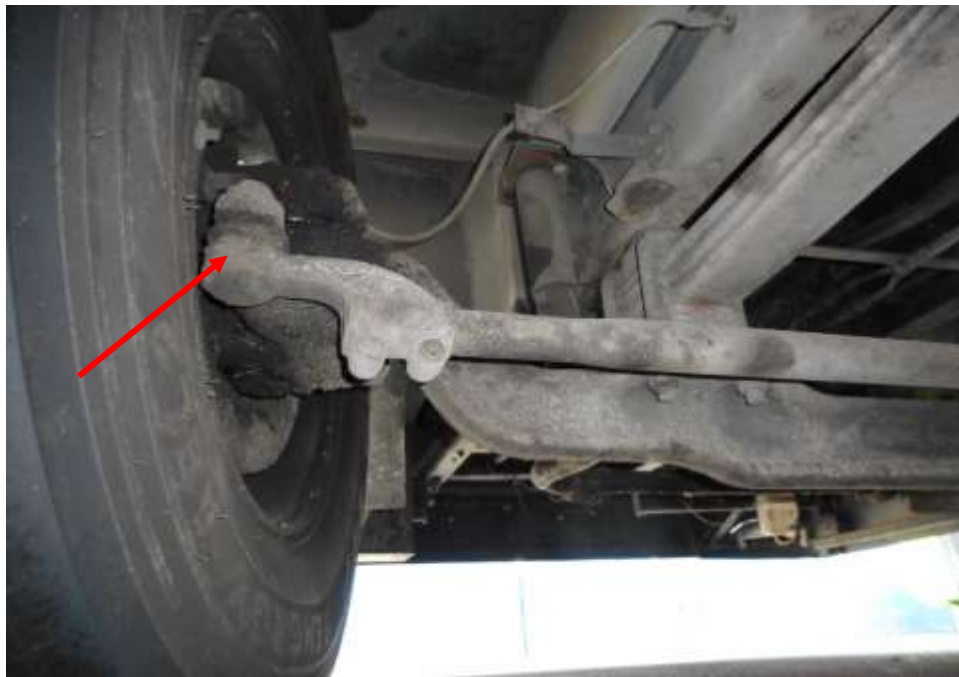
Photo 21 shows the various undercarriage components at the front left wheel of the Motor Bus, in particular the steering tie rod end (arrowed). The various undercarriage components of the Motor Bus were all found to be intact without any visible damage. There was also no sign of fluid stain(s) observed on the various undercarriage components.

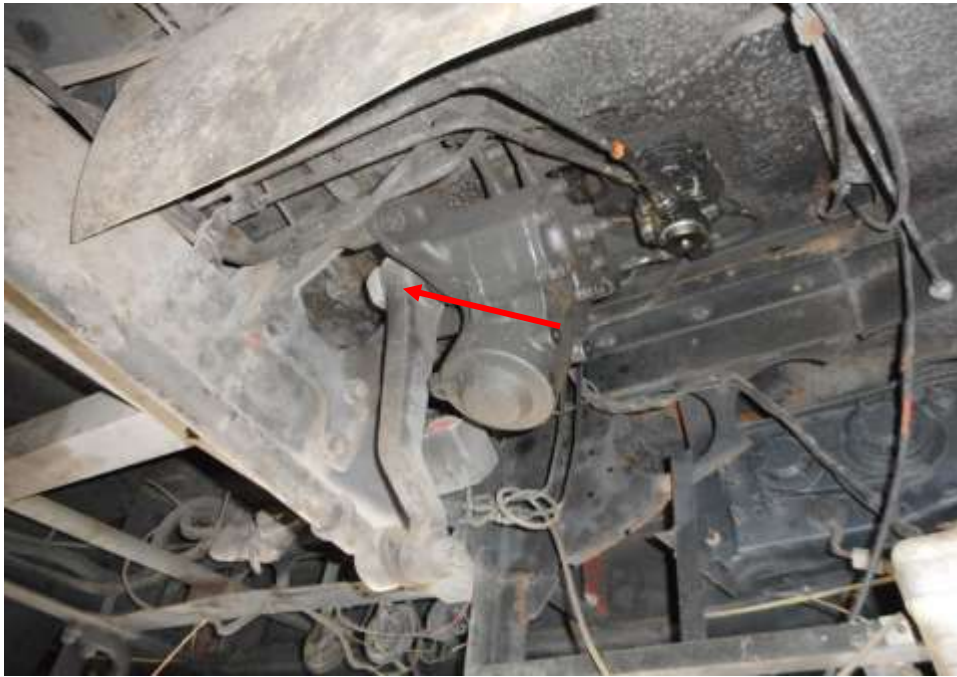
Photo 22 shows the steering box component (arrowed) at the undercarriage of the Motor Bus was found to be intact without any visible damage. There was also no sign of fluid stain(s) observed on the various undercarriage components.

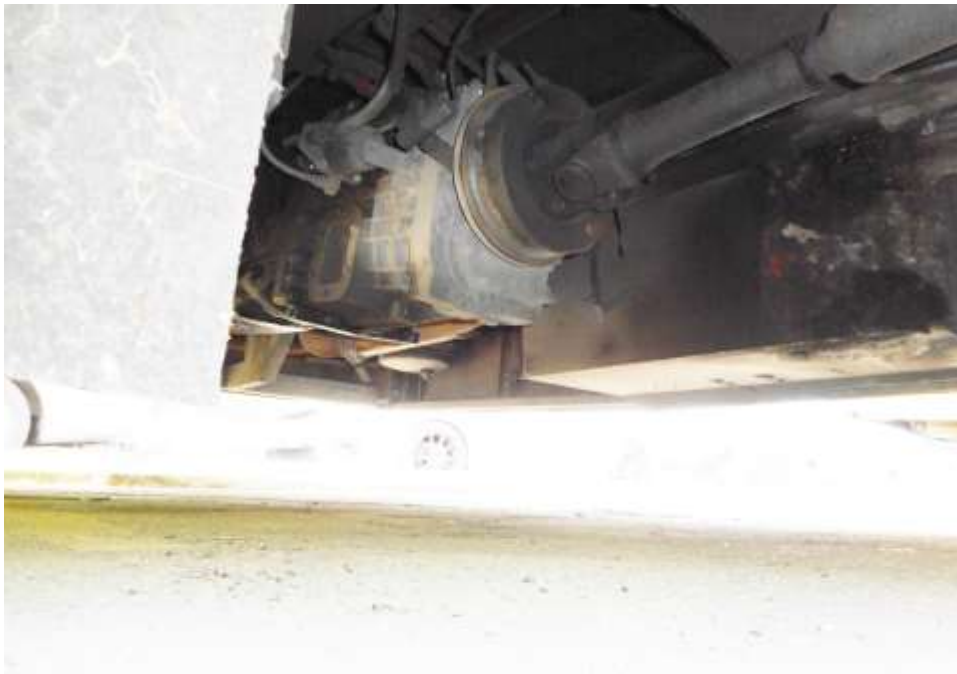
Photo 23 shows the undercarriage of the Motor Bus, at the area where the engine housing located. I did not find any sign(s) or indication(s) of fluid leak and/or fluid stain(s) on the underside of the Motor Bus.

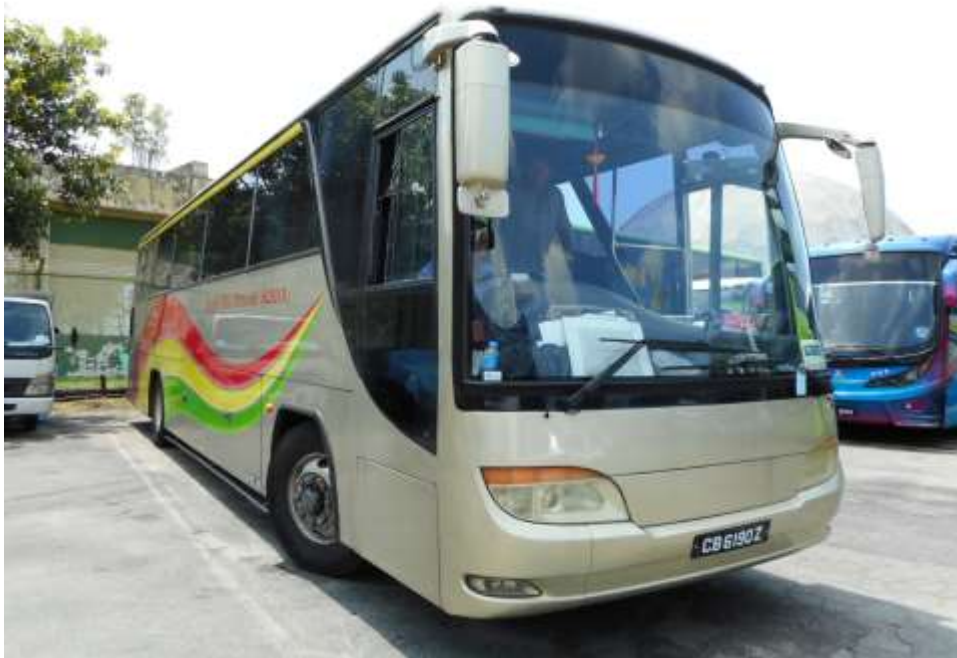
Photo 24 shows the front right wheel of the Motor Bus turned to its full left. During my steering system test, I did not experience any abnormal free play and/or resistance when I had turned the steering wheel towards full left and full right. This would suggest that the steering system of the Motor Bus was likely to be in serviceable condition at the material time of accident.
