Your Ref: TP/IP/29777/2019
Our Ref : CI/TPD19009634/P

Fatal Accident Investigation Team

MECHANICAL INSPECTION REPORT OF MOTOR JEEP GZ 8901C

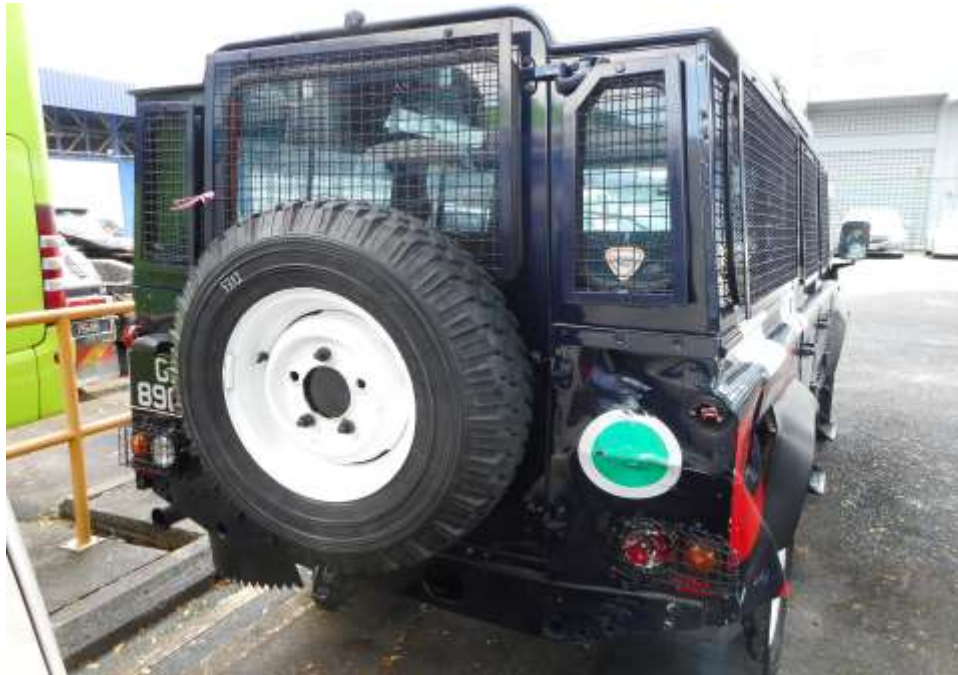
Photo 1 shows a general view of the rear right body of the Motor Jeep at the time of my inspection. The Motor jeep was observed to have sustained relatively minor damage at its rear portion. Its rear right body panel, rear right brake lamp, rear right fender and rear right mud flaps were amongst the body parts that were damaged as a result of the accident. The mileage of the Motor Jeep at the time of my inspection was recorded to be 7,786km.

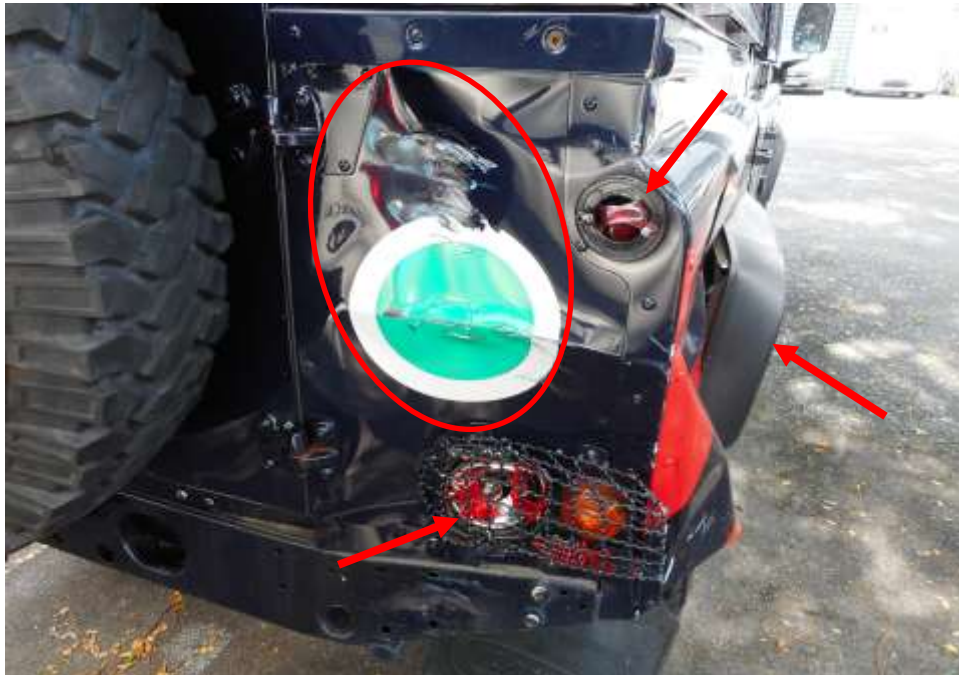
Photo 2 shows a close up view of the damaged rear portion. Its rear right body panel (circled), rear right brake lamp and rear right fender (arrowed) were amongst the body parts that were damaged as a result of the accident.

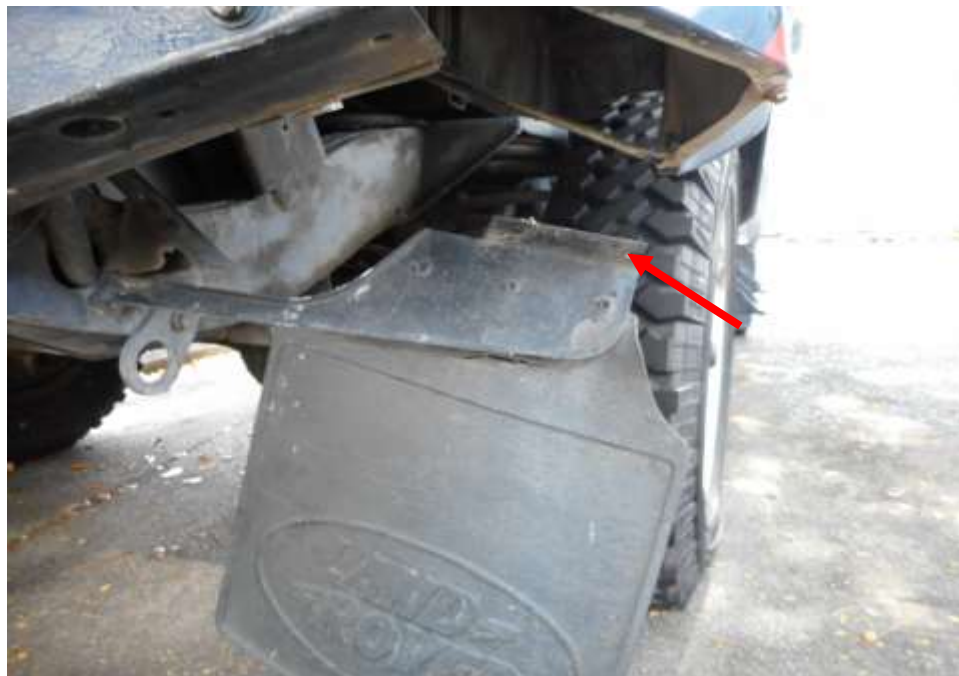
Photo 3 shows a close up view of the damaged rear portion rear right mud flaps were amongst the body parts that were damaged as a result of the accident. (arrowed) were amongst the body parts that were damaged as a result of the accident.

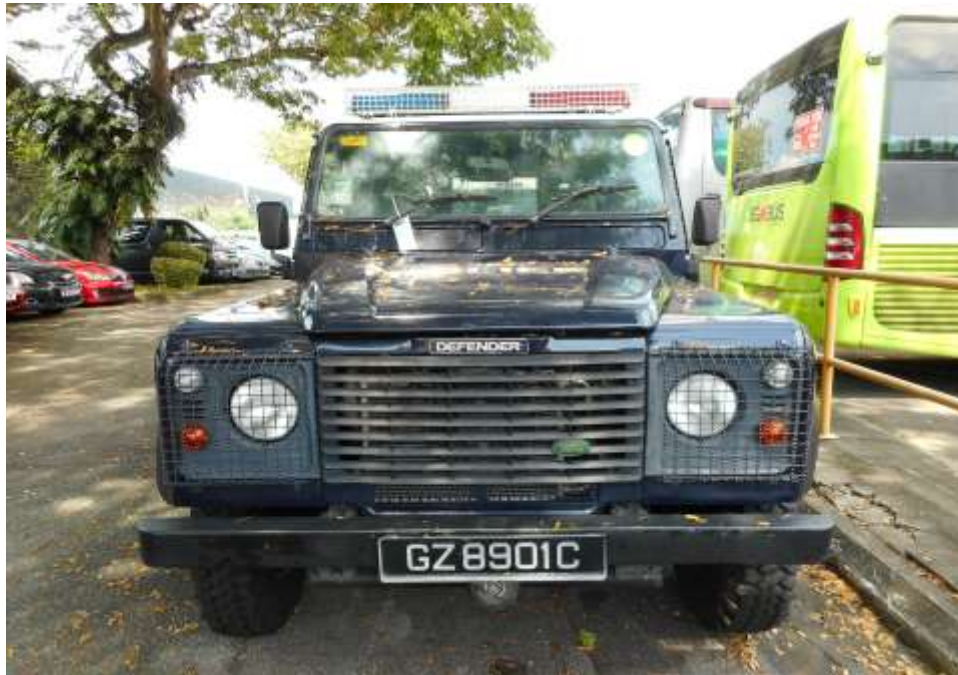
Photo 4 shows a general view of the Motor Jeep's front portion at the time of my inspection. The front portion of the Motor Jeep was observed to have been unaffected by the accident.

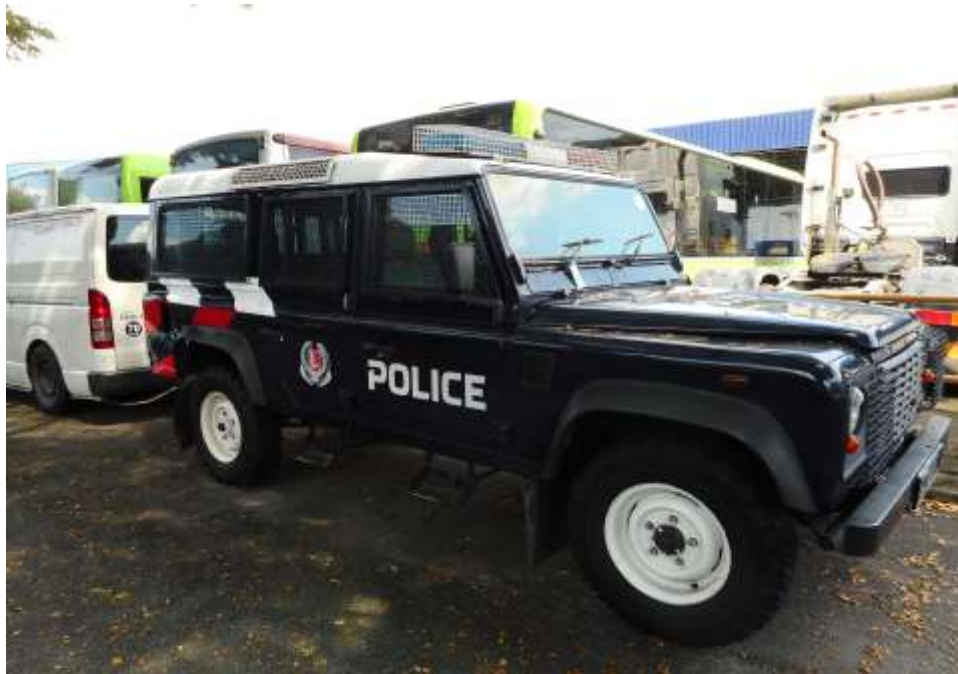
Photo 5 shows a general view of the Motor Jeep's right portion at the time of my inspection. The right portion of the Motor Jeep was observed to have been unaffected by the accident.

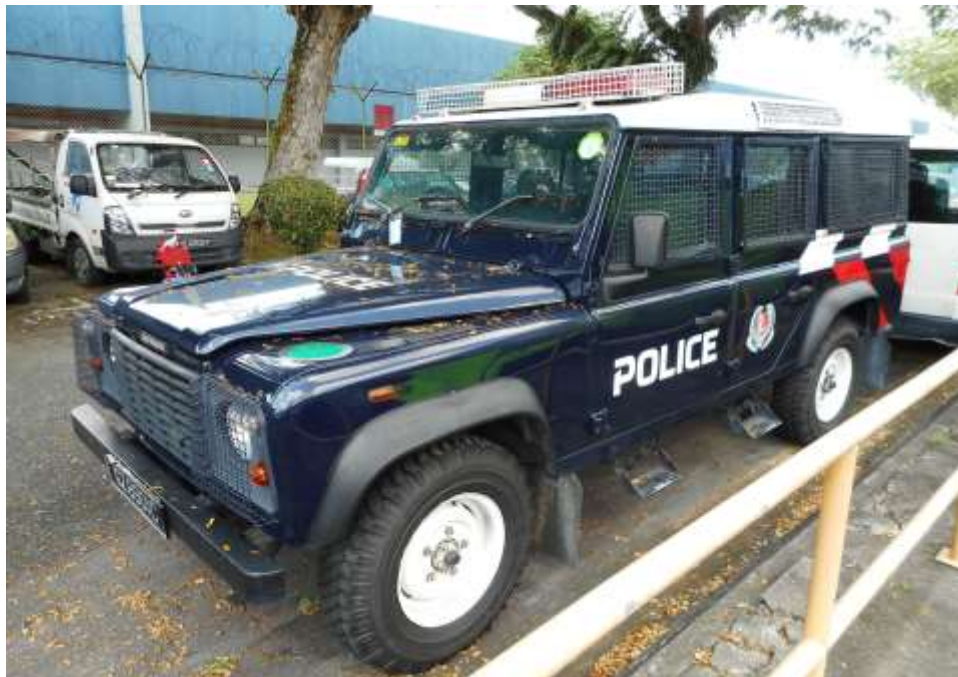
Photo 6 shows a general view of the Motor Jeep's left portion at the time of my inspection. The right portion of the Motor Jeep was observed to have been unaffected by the accident.

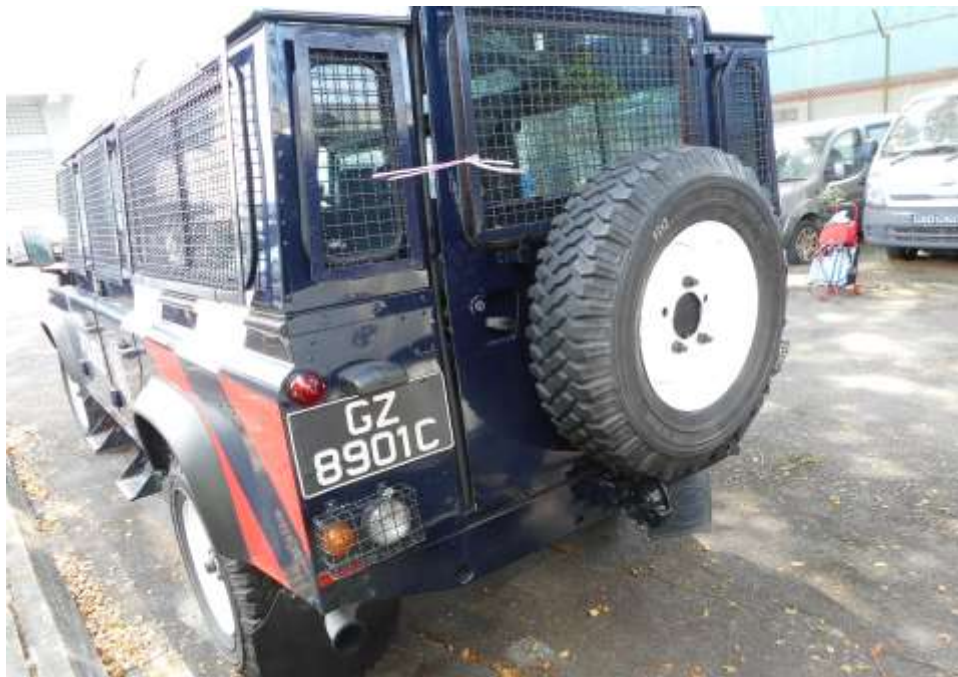
Photo 7 shows a general view of the Motor Jeep's rear left body at the time of my inspection. The rear left portion of the Motor Jeep was observed to have been unaffected by the accident.

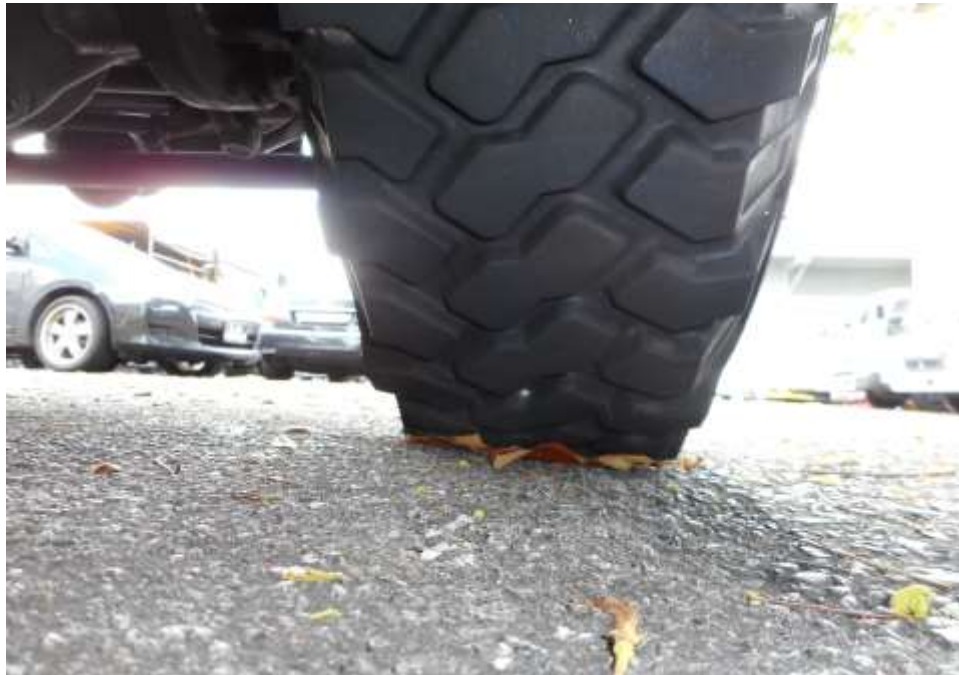
Photo 8 shows the condition of the front right tyre of the Motor Jeep, which was observed to be in serviceable condition with remaining tread depth of approximately 9.6mm. The tyre was sufficiently inflated for vehicular operation with no tear, cut or burst mark(s) on the outer and the inner sidewalls as well as across the tread. The 4 tyres of the Motor Jeep were wrapped around standard steel wheel rims without any damage.

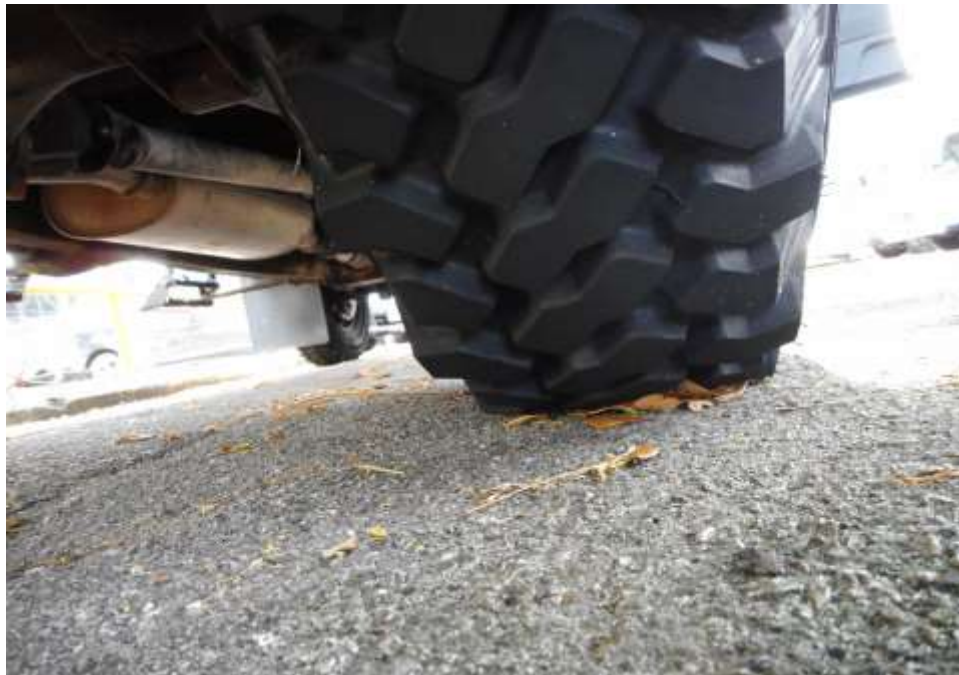
Photo 9 shows the condition of the rear right tyre of the Motor Jeep, which was observed to be in serviceable condition with remaining tread depth of approximately 12.3mm. The tyre was also observed to be sufficiently inflated for vehicular operation with no tear, cut or burst mark(s).

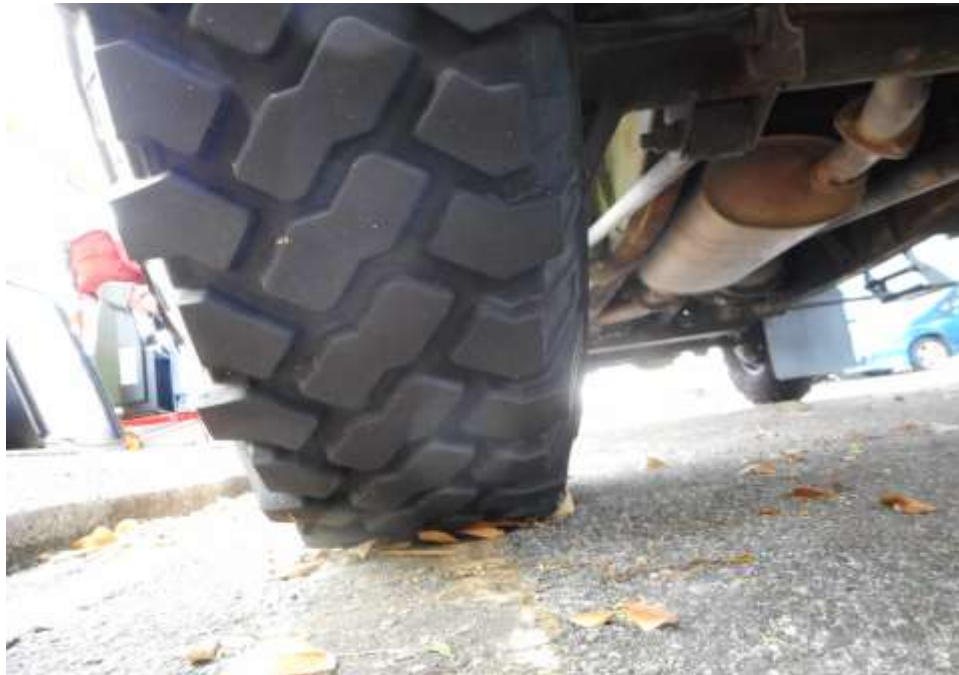
Photo 10 shows the condition of the rear left tyre of the Motor Jeep, which was observed to be in serviceable condition with remaining tread depth of approximately 9mm. The tyre was sufficiently inflated for vehicular operation with no tear, cut or burst mark(s) on the outer and the inner sidewalls as well as across the tread. The 4 tyres of the Motor Jeep were wrapped around standard steel wheel rims without any damage.

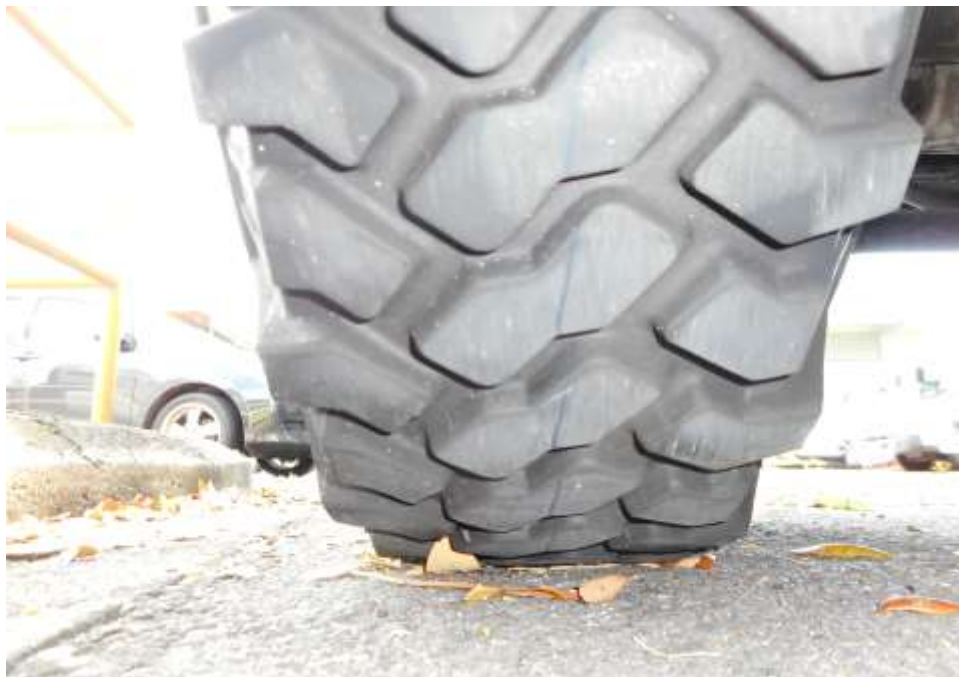
Photo 11 shows the condition of the rear right tyre of the Motor Jeep, which was observed to be in serviceable condition with remaining tread depth of approximately 9.1mm. There was also no tear, cut or burst mark(s) on the outer and the inner sidewalls as well as across the tread of the Motor Jeep's 4 tyres.

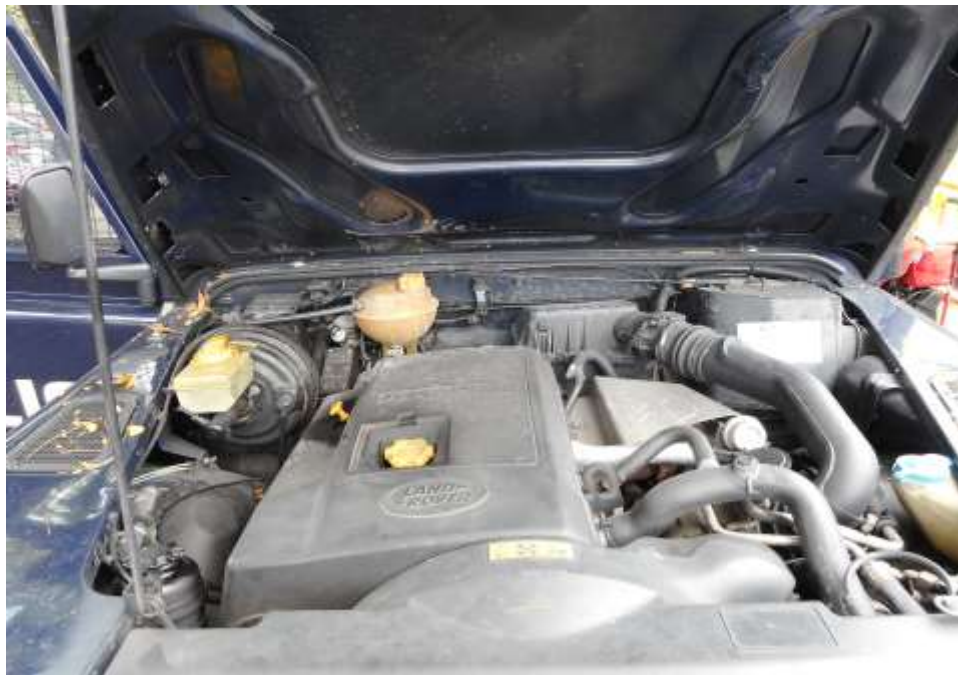
Photo 12 shows a general view of the Motor Jeep's engine compartment. The various parts and components inside the engine compartment were unaffected by the accident. There was also no sign(s) or indication(s) of fluid leakage and/or fluid stain within the engine compartment.

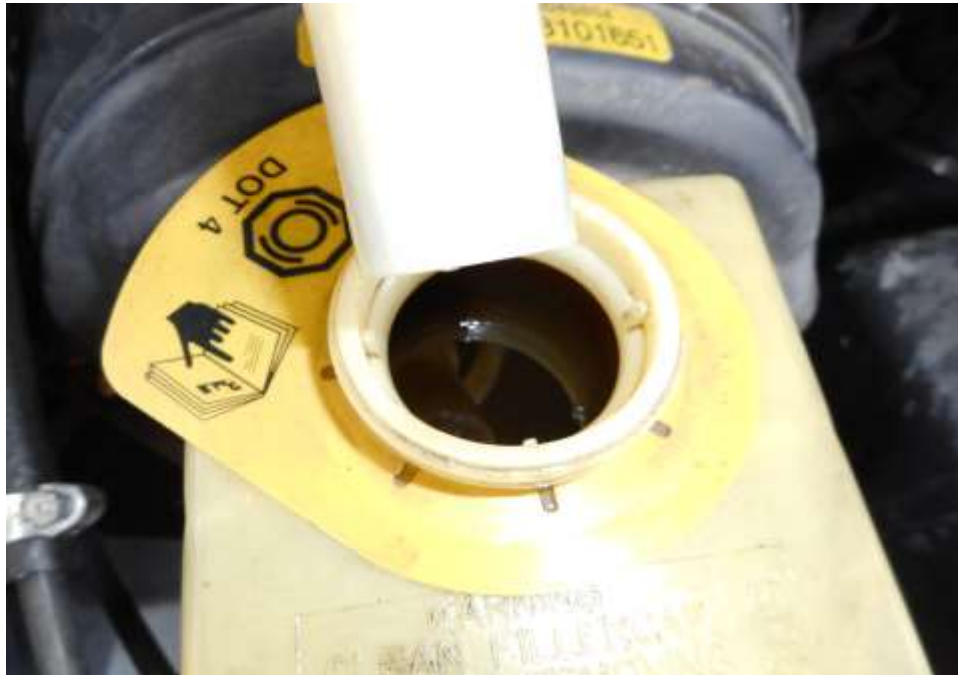
Photo 13 shows the brake fluid reservoir of the Motor Jeep at the time of my inspection. The brake fluid was observed to be of sufficient level and without any visible contamination.

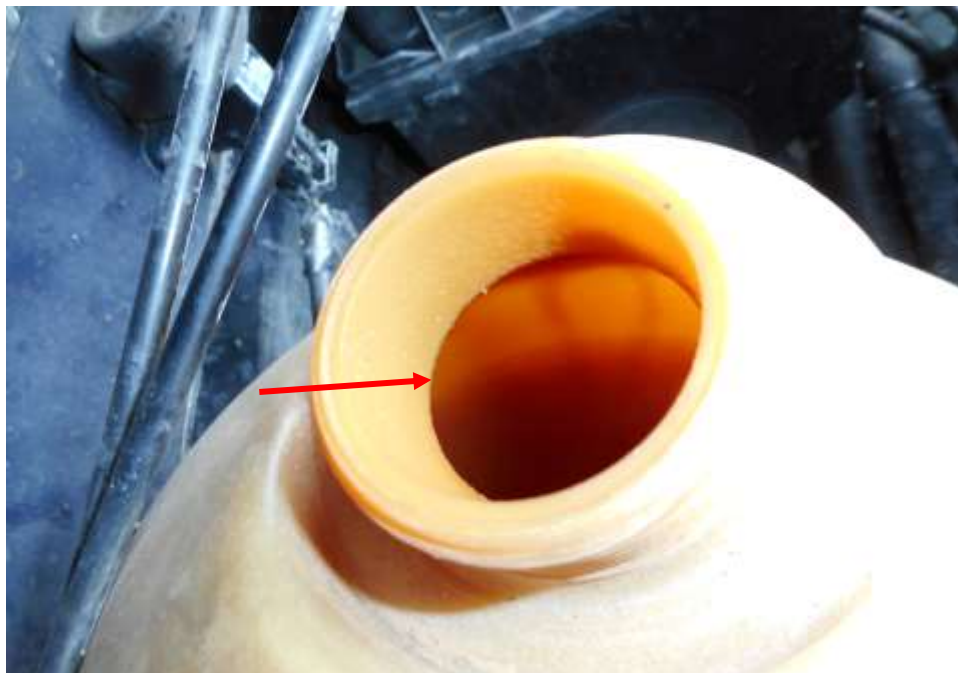
Photo 14 shows checks being carried out to the engine coolant of the Motor Jeep at the time of my inspection. The engine coolant was observed to be of sufficient level (arrowed) and without any visible contamination.

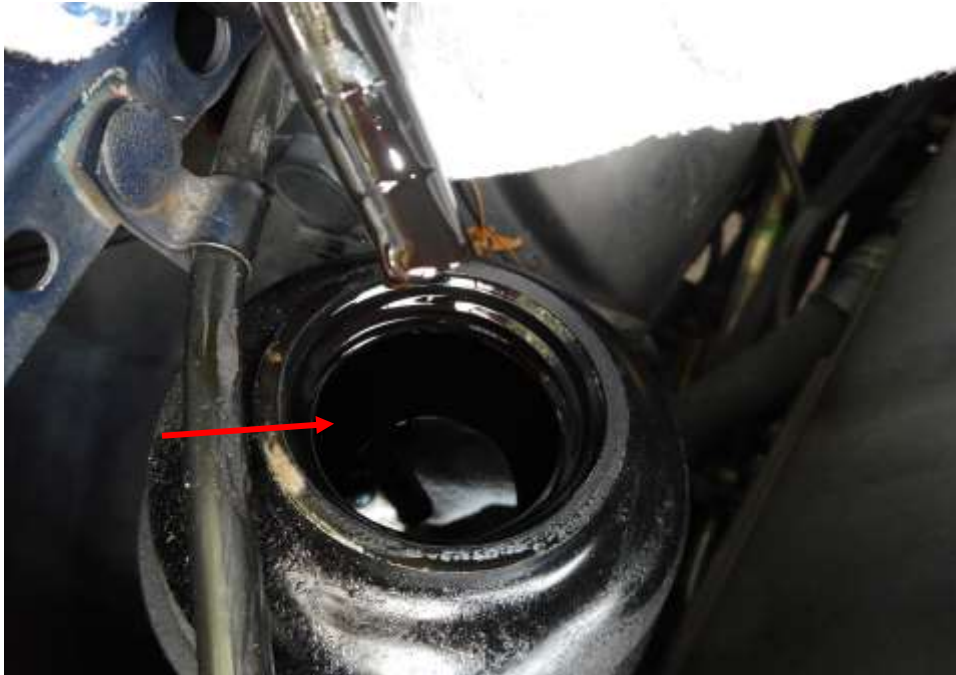
Photo 15 shows checks being carried out to the power steering reservoir of the Motor Jeep at the time of my inspection. The steering fluid was observed to be of sufficient level (arrowed) and without any visible contamination.

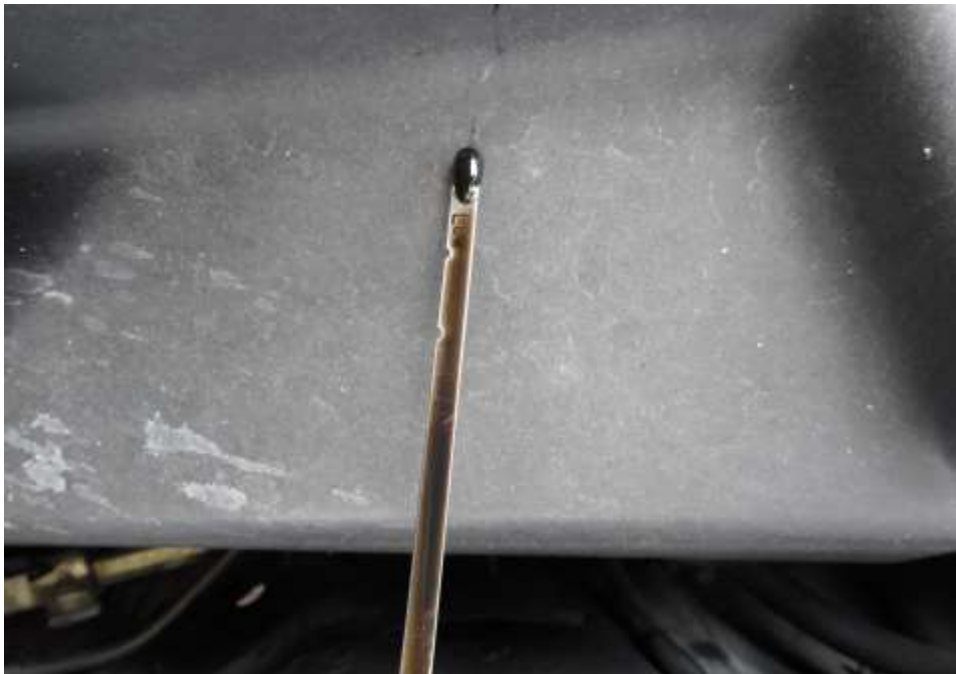
Photo 16 shows the engine oil dip stick of the Motor Jeep at the time of my inspection. The engine oil was observed to be of sufficient level and without any visible contamination.

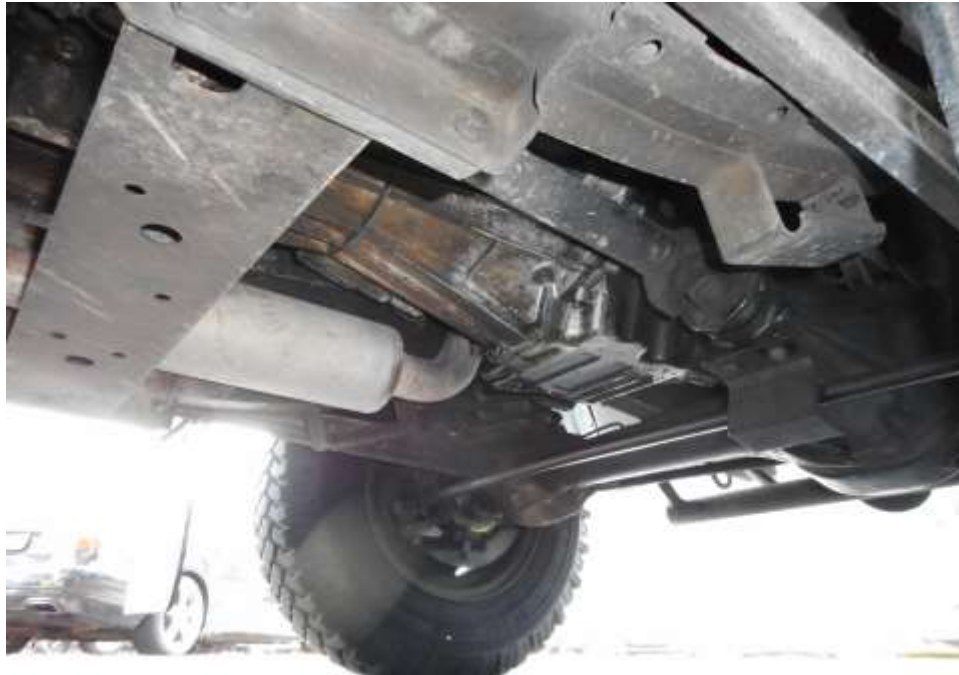
Photo 17 shows the undercarriage of the Motor Jeep, at the area where the engine housing, transmission housing and front axle differential housing are located. I did not find any sign(s) or indication(s) of fluid leak and/or fluid stain(s) on the underside of the Motor Jeep.

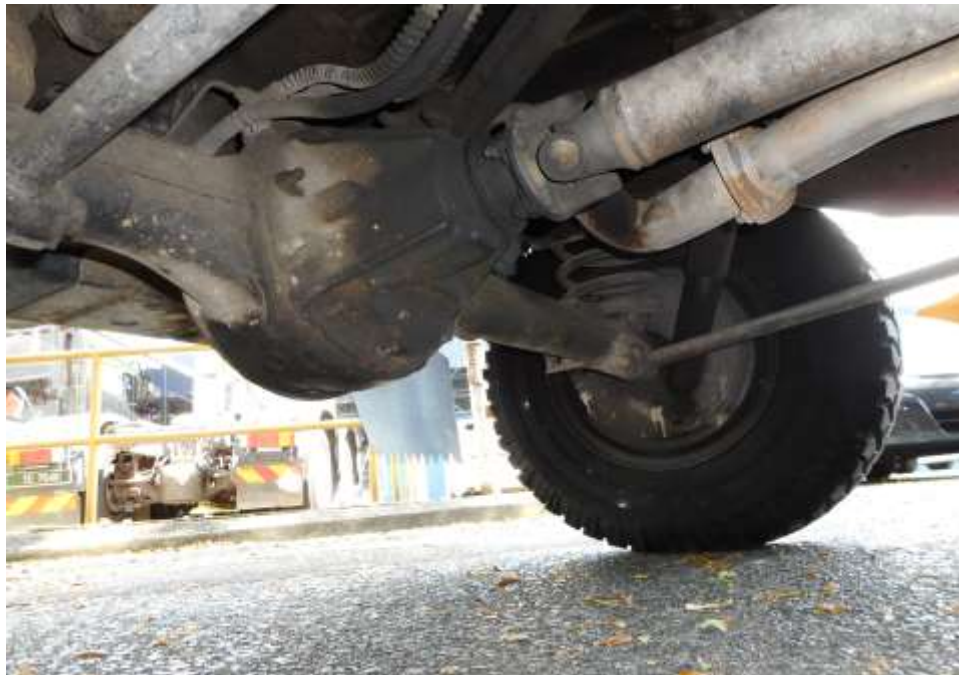
Photo 18 shows the undercarriage of the Motor Jeep, at the area where the rear axle differential housing are located. I did not find any sign(s) or indication(s) of fluid leak and/or fluid stain(s) on the underside of the Motor Jeep.

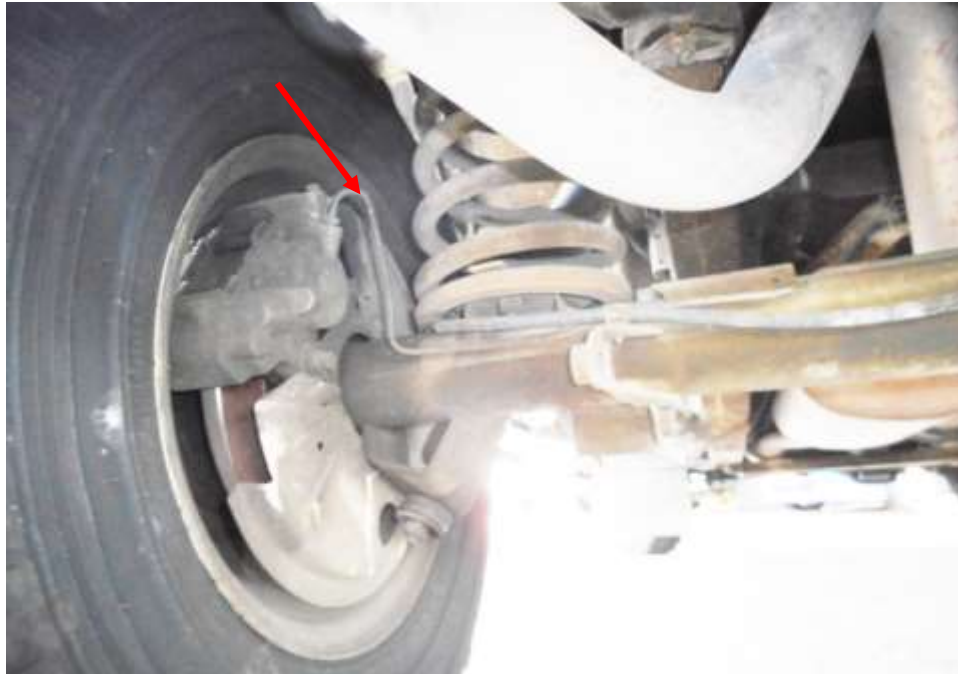
Photo 19 shows the brake hose/pipe (arrowed) at the rear left wheel of the Motor Jeep. I did not observe any leakage of brake fluid at the time of my inspection of the Motor Jeep. Static tests of the Motor Jeep's braking system had indicated that there was no internal leakage of pressure/vacuum. The undercarriage components of the Motor Jeep were also all found to be intact and without any visible damage.

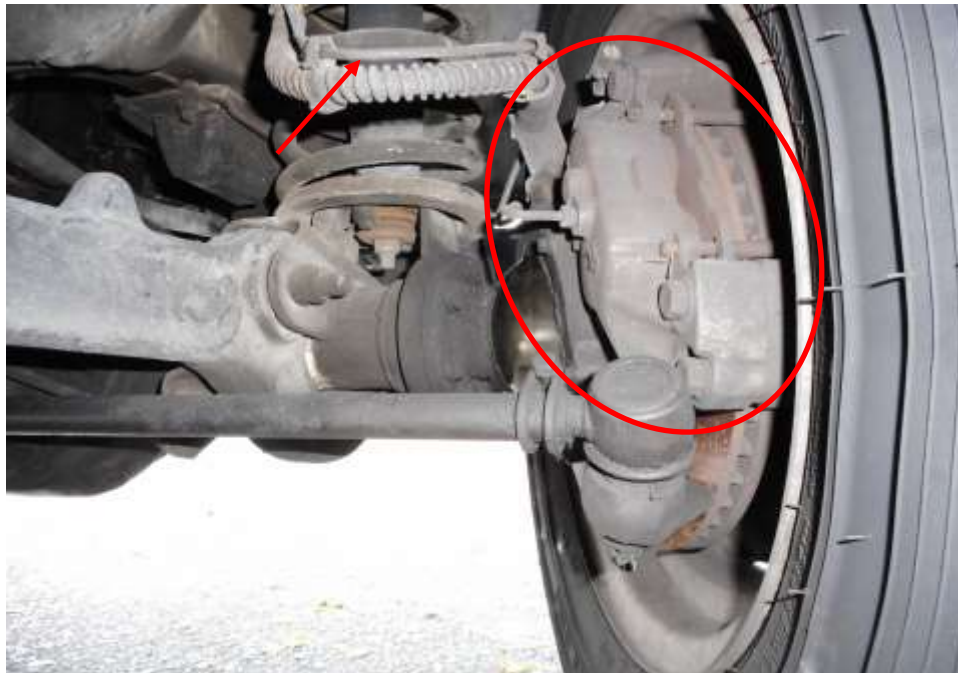
Photo 20 shows the brake hose/pipe (arrowed) at the front right wheel of the Motor Jeep. No leakage of brake fluid was observed. Visual examination of the various components of the braking system like the brake caliper (circled), brake booster, brake pedal etc had revealed all to be intact and without visible damage.

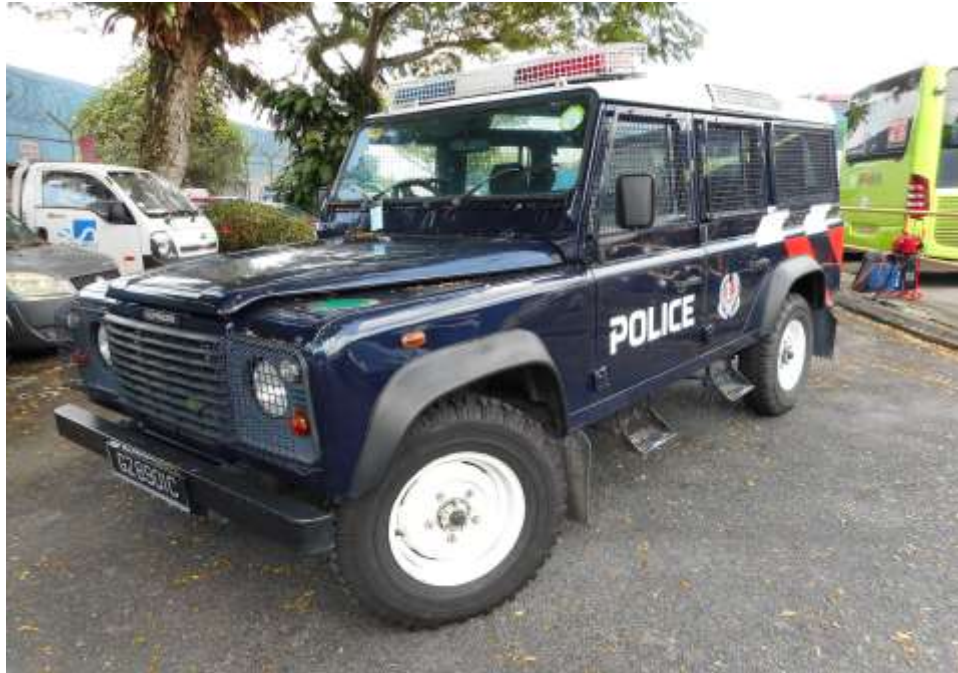
Photo 21 shows the front left wheel of the Motor Jeep turned to its full right. During my steering system test, I did not experience any abnormal free play and/or resistance when I had turned the steering wheel towards the left and right. This would suggest that the steering system of the Motor Jeep was likely to be in serviceable condition at the material time of accident.

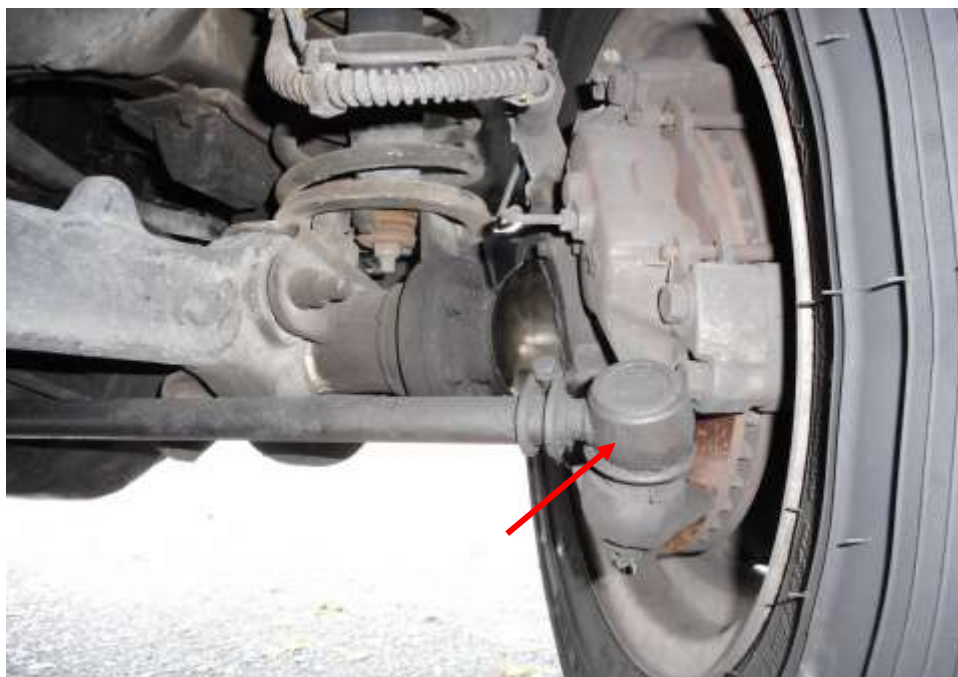
Photo 22 shows the various undercarriage components at the front right wheel of the Motor Jeep, in particular the steering tie rod (arrowed). The various steering components were all found to be intact, suggesting that the steering system of the Motor Jeep was likely to be in serviceable condition at the material time of accident. There was also no sign of fluid stain observed on the various undercarriage components at the front right wheel of the Motor Jeep.

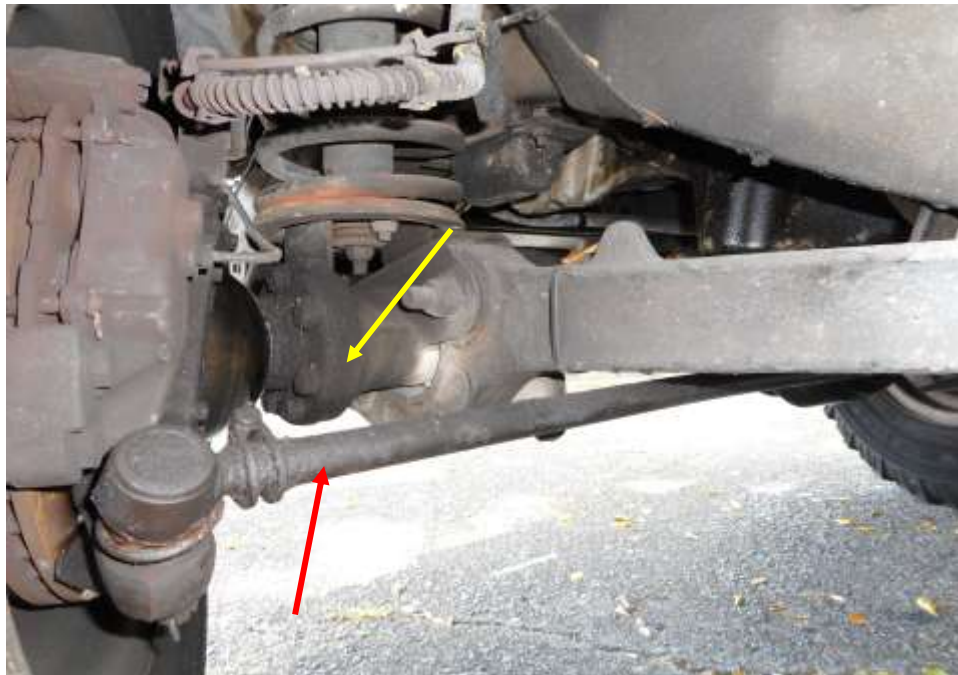
Photo 23 shows the various undercarriage components at the front left wheel of the Motor Jeep , which had included the steering tie rod (red arrow) and front left drive shaft (yellow arrow). The various undercarriage components of the Motor Jeep were all found to be intact without any visible damage.
