## ASSIGNMENT

**Full Report**

**Registration: SLX5250T**

| Model: | VEZEL/HR-V RU1/5 |

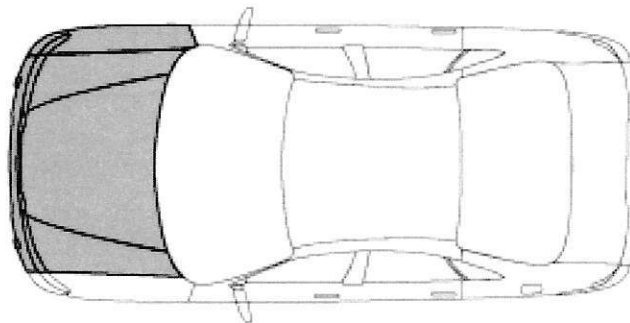
### Damage Areas

Des. of Damages: Frt / Rear / O/S / N/S / U/C / Rooftop or

FR O/S

The U/C / Chassis frame / Body Structure affected due to collision.
