NTUC INCOME INSURANCE CO-OPERATIVE LTD Ref: NS/INC19010082/K1td3n2

1. Policy Particulars :- THIRD PARTY CLAIM

Insured Veh.	SGG 1686U	Veh. Inspected	SHA 4190H
Policy No.	5063566339-05	Coverage (\$)	0.00
Claim No.	MT/1047684-002	Excess (\$)	0.00
Assign From		Assign Date	06/06/2019

ADJUSTMENT ON REPAIR COST FOR VEHICLE NO. SHA 4190H

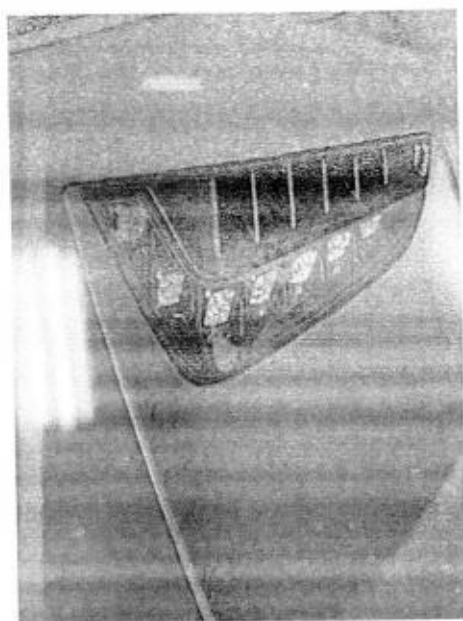
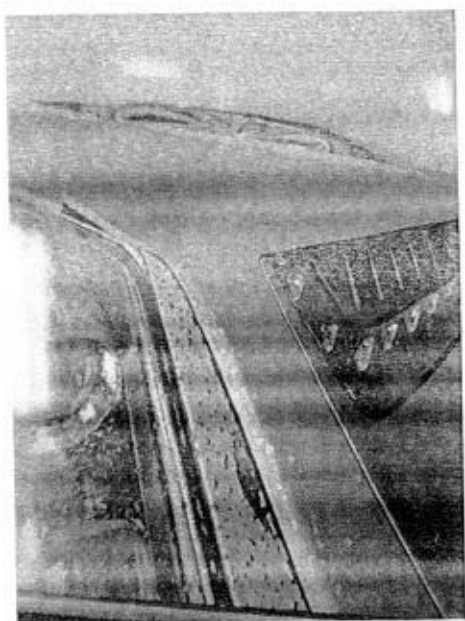
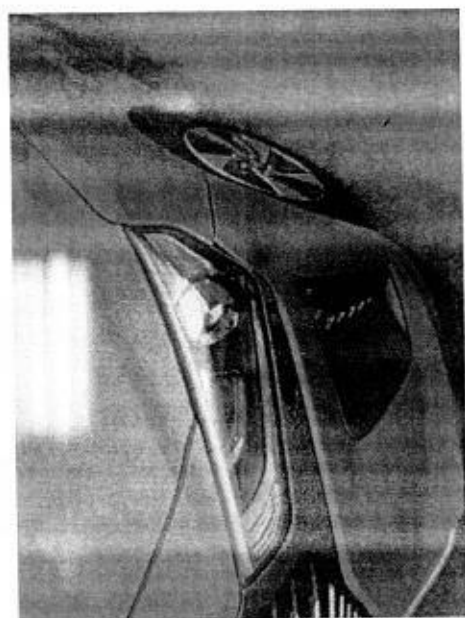
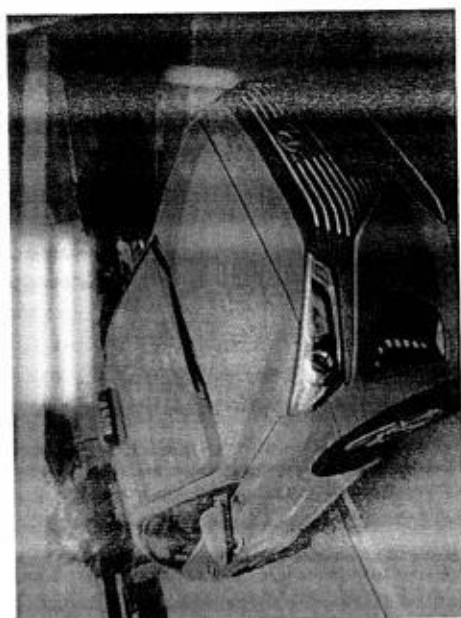
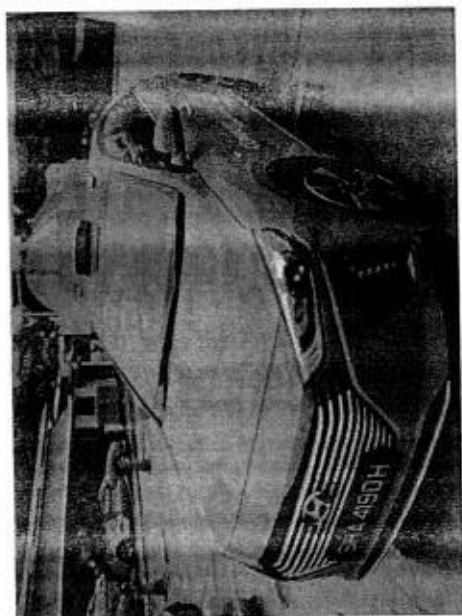
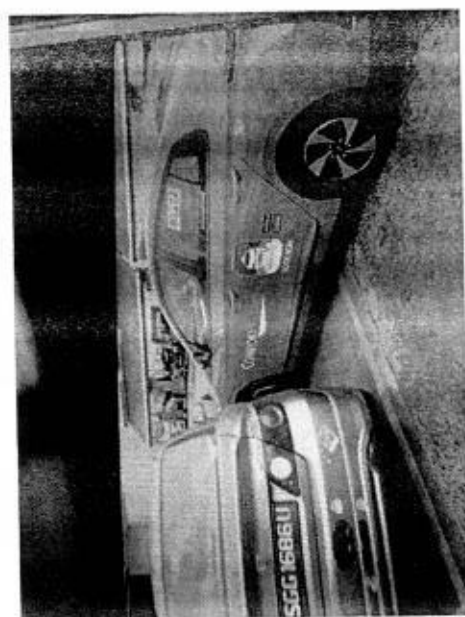
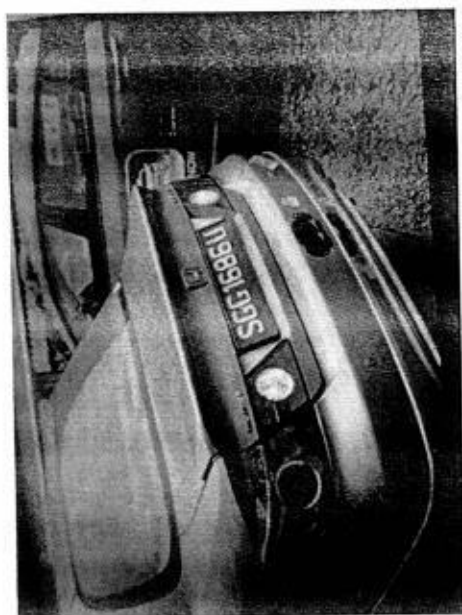
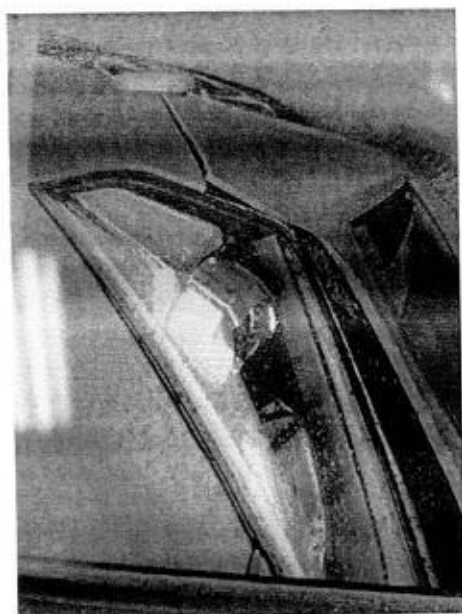
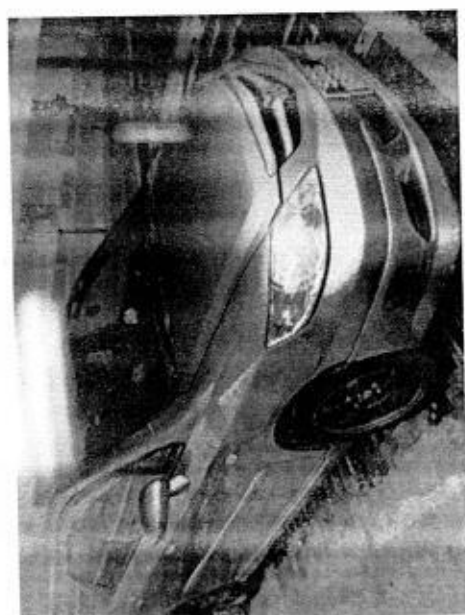
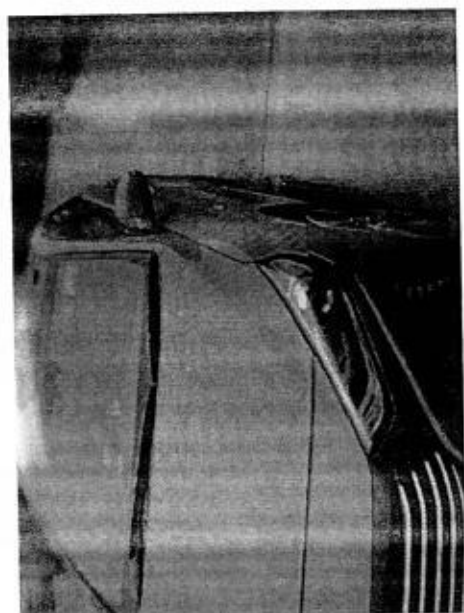
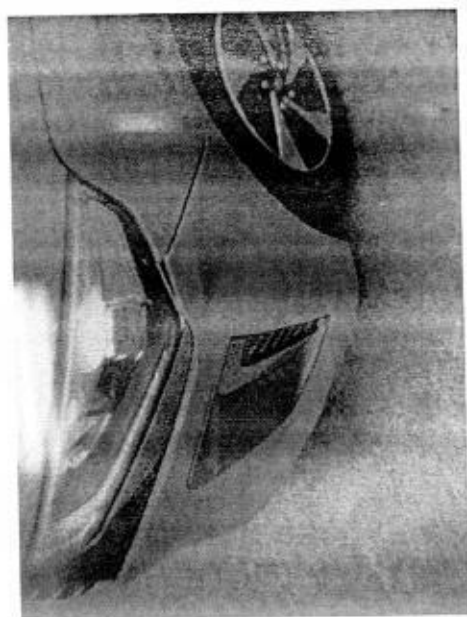
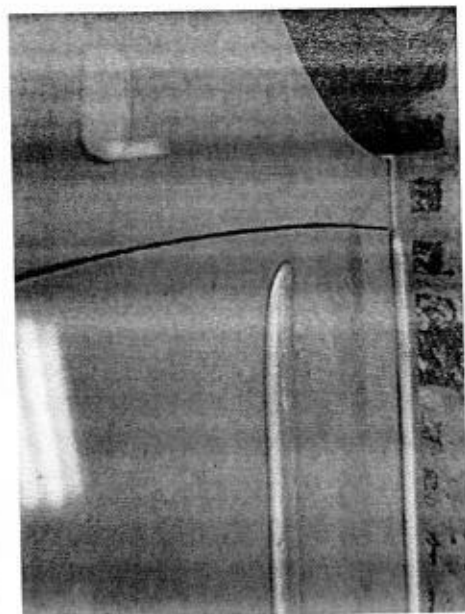
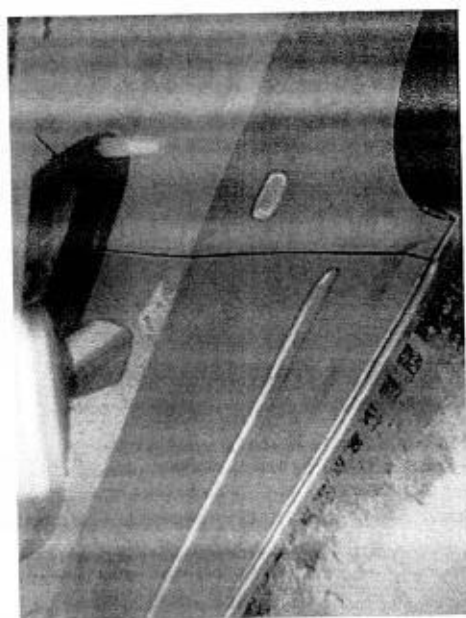
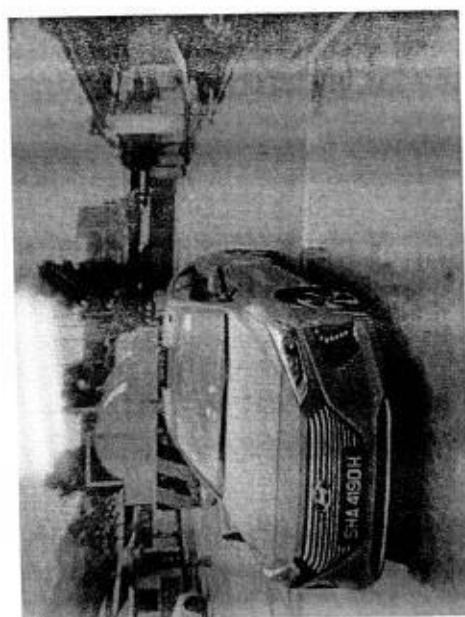
n/s Front

The U/C / Chassis frame / Body Structure affected due to collision.

THE VEHICLE SUSTAINED DAMAGES AT THE N/S FRONT PORTION. DAMAGES SEE DETAILS.

Qty	Description of Parts	Condition	Estimate By Workshop (\$)	Our Adjusted (\$)
REPLACEMENT OF PARTS				
1	FRONT BUMPER COVER	TO REPAIR SEE LABOUR	418.30	-
1	FRONT BUMPER CENTRE MOULDING	SERVICEABLE	188.00	-
1	FRONT BUMPER BRACKET TOP (LH)	SERVICEABLE	35.00	-
1	FRONT BUMPER BRACKET (LH)	SERVICEABLE	28.00	-
10	FRONT BUMPER CLIPS	NOT NECESSARY	22.00	-
1	HEADLAMP (LH)	GRAZED	1,198.80	1,198.80
	LESS 20% DISCOUNT		-378.02	-239.76
			1,512.08	959.04
LABOUR				
	PANEL BEATING.INCLUSIVE OF THE REPAIR OF FRONT BUMPER COVER.		400.00	200.00
	SPRAY PAINTING CHARGE.		300.00	200.00
	WIRING CHARGE.		50.00	20.00
			750.00	420.00
GRAND TOTAL			2,262.08	1,379.04
RECOMMENDED COST OF REPAIRS (CONFIRMED)				1,379.04
