### PRE-REPAIR SURVEY REPORT

Assign Date:	07/02/2018	Survey Date:	07/02/2018	TP Report Date:	05/02/2018
Accident Date:	03/02/2018	TP Policy No:	5074824977-02	Our Ref:	AVS2018-14409/WH
Place of Survey:	Bluwel Automotive Service Pte Ltd 1 Kaki Bukit Avenue 6 #01-55 Autobay @ Kaki Bukit Singapore 417883			Your Ref:	MT/0981104-002
				Claim Type:	Third Party
				Claimant:	Rent & Go 2 Car Rental Pte Ltd

Veh. No:	SJL6357A	Make/Model:	Honda Jazz 1.5L AT ABS D/AB HID 2WD 5DR		
Colour:	White	Engine No:	L15A71001903	Sum Insured (S\$):	Market Value
Engine Capacity:	1,497cc	Chassis No:	IHMGE88509S201590	Mkt Value (S\$):	\$16,000.00
Odometer:	91966	Reg. Date:	05/12/2008	Excess (S\$):	NA

**Adjustment of Repair Cost for Vehicle:****SJL6357A****Our Ref:** AVS2018-14409/WH

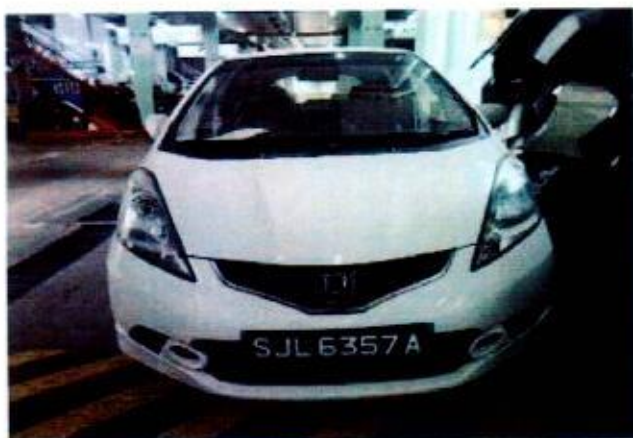
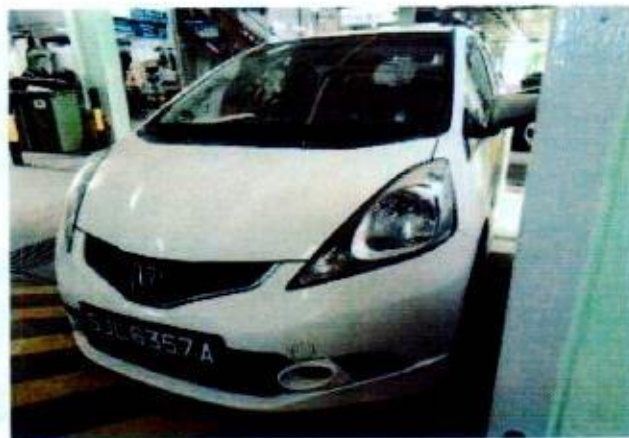
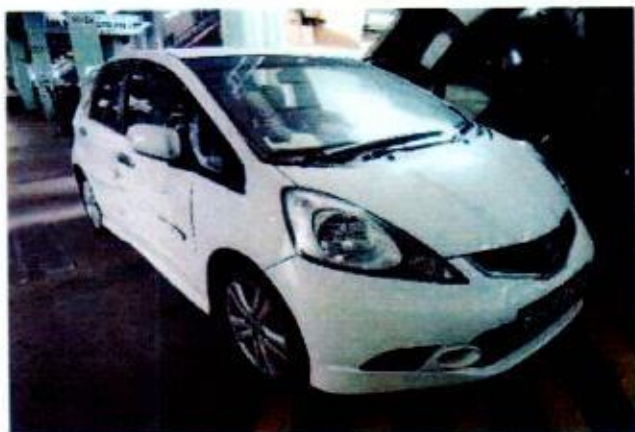
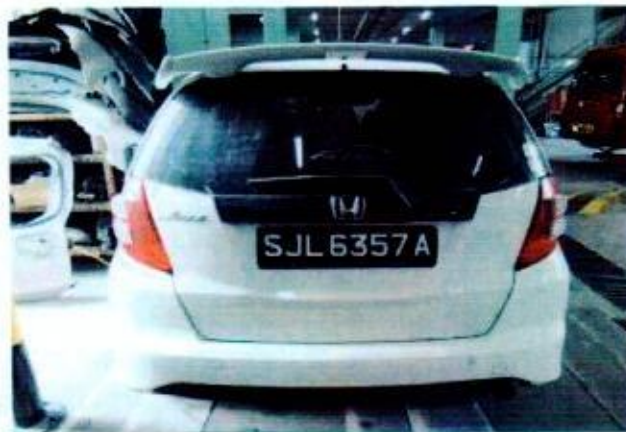
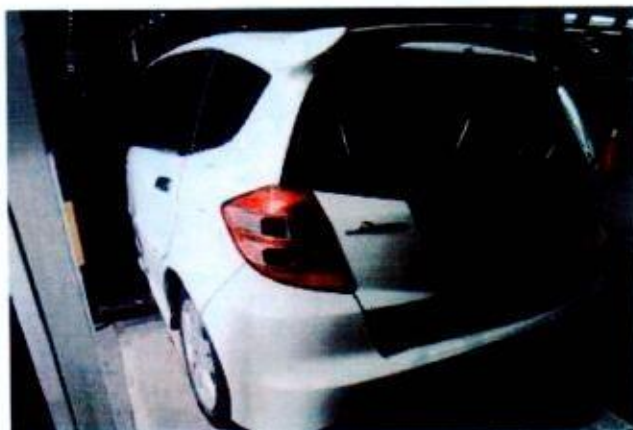
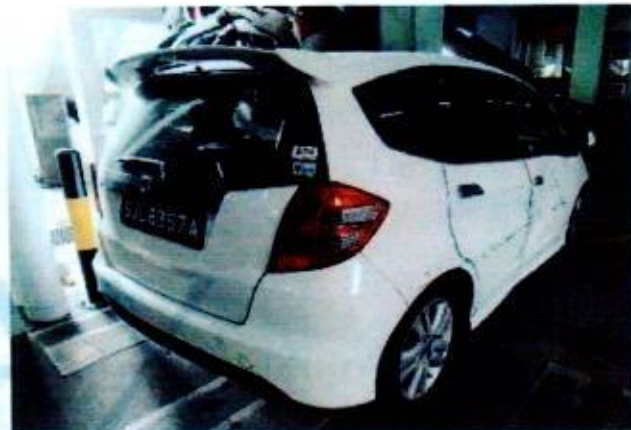
Pre-repair survey - 07/02/2018

The vehicle sustained damage on the right portion.

The right front door, right wing mirror, right rear door, right rear fender, rear bumper and right rear rim were among the items affected.

Based on visual survey of the vehicle without any repair estimate provided, we viewed that the repair cost should not be more than S\$4,500.00 and could take approximately six (6) working days to complete. However, please kindly take note that the economical repair value is about S\$4,000.00.
