VEHICLE DAMAGE INSPECTION REPORT

Our File No: AV-05504
Date: 22/06/2018

Handling Insurer:	Aviva Ltd	Policy No:	
Claimant Vehicle No :	SJM3500S	Insured Vehicle No :	SJM3513E
Date of Loss:	11/06/2018	Nature of Claim:	TP
		Claim No:	N/A

Reg No:	SJM3500S	Engine No:	EQ474I7070319
Make & Model:	DONGFENG EQ6380, 1.3 (M)	Chassis No:	LGK132K7689139812
Reg. Date:	28/11/2008 (Man. Year: 2008)	Odometer:	128543 km
Colour:	Red		
Engine Capacity:	1310 cc		
Market Value/New Car Price:	N/A		
Sum Insured (S\$):	Market Value/New Car Price

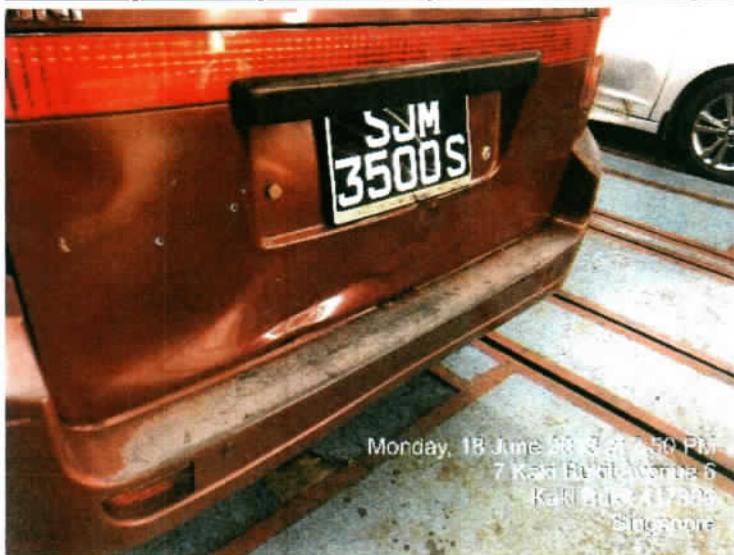
4/16: REAR GENERAL DAMAGED VIEW 1

Impact damage has been occasioned to the rear portion of the Third Party vehicle, damaging the Rear Bumper, Bumper Attachment, Rear Tailgate, Rear Taillamps, End Panel to cut/bent/cracked. Further damage may be apparent upon dismantling.
