Vehicle No. SMH 1356X  
Insured Veh. GBH 8962E  
Claim No. SNM19D202794  
Policy No. DMCVSN3069001800  
Accident Date 11/06/2019  
Inspection Date 13/06/2019

### 1. Policy Particulars :- THIRD PARTY CLAIM

## ADJUSTMENT ON REPAIR COST FOR VEHICLE NO. SMH 1356X

PHOTOGRAPHS FOR VEHICLE NO. SMH 1356X

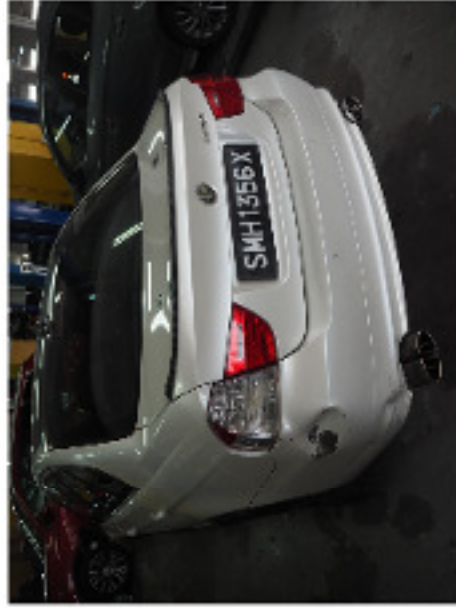
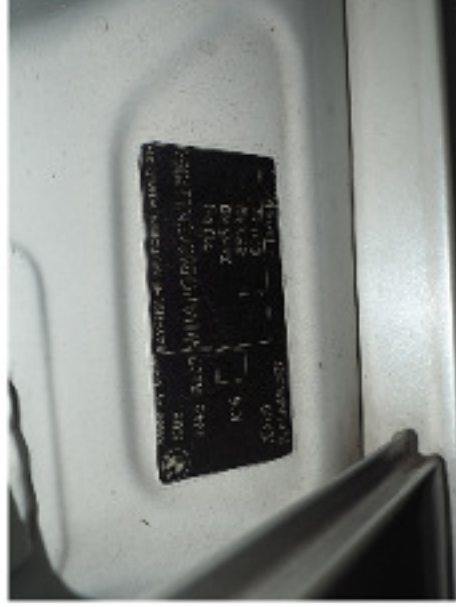
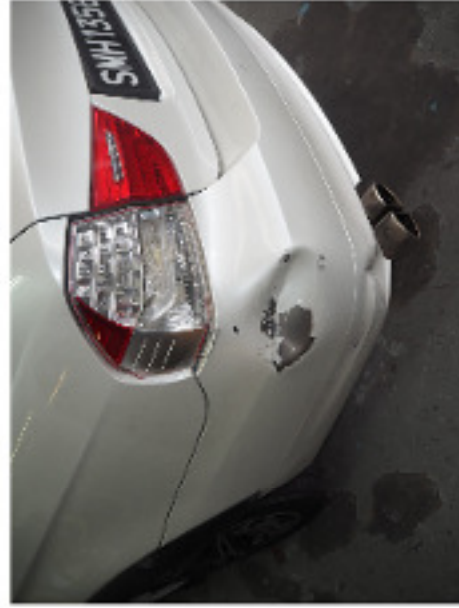
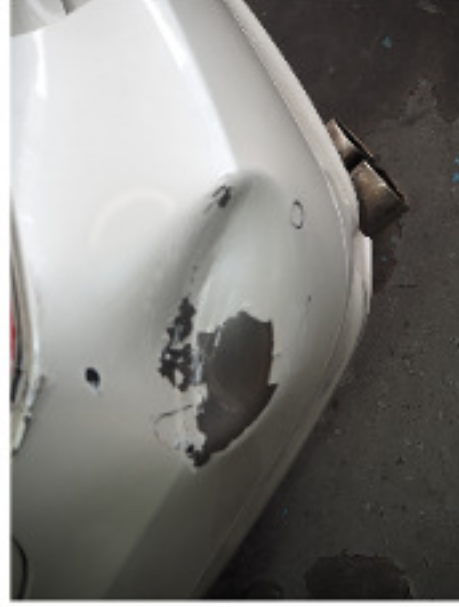
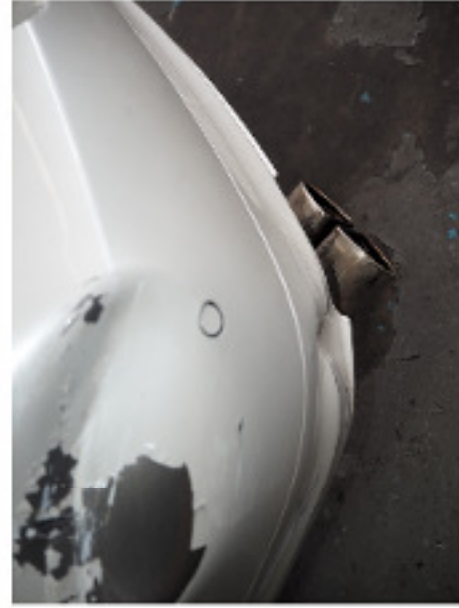
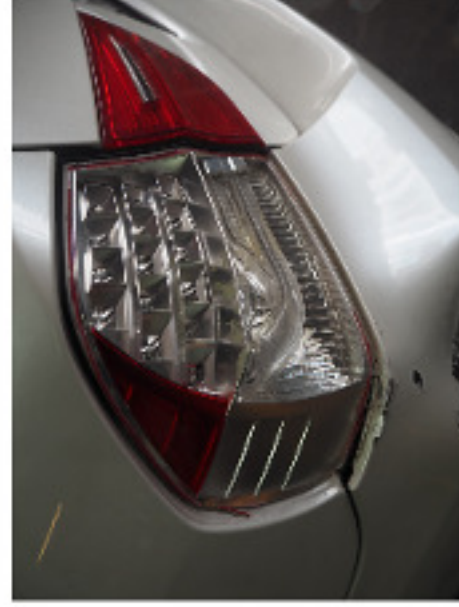
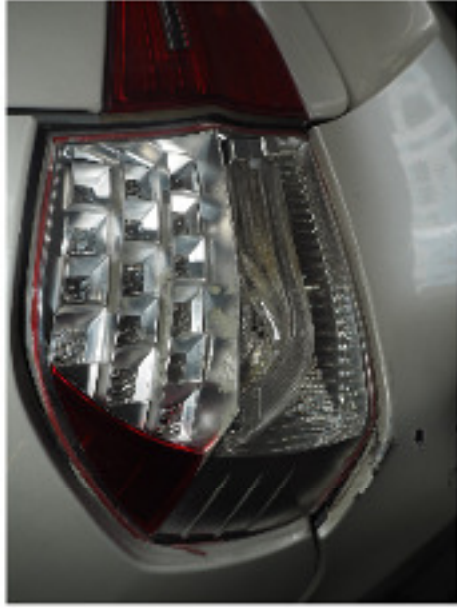
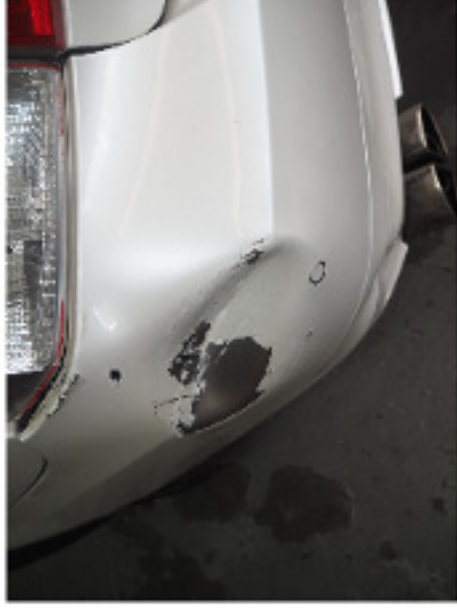
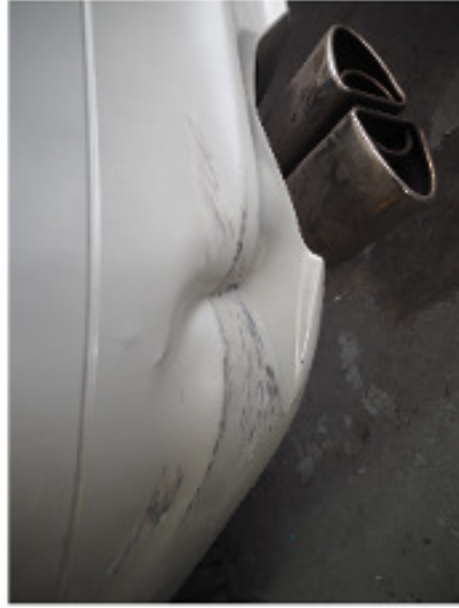
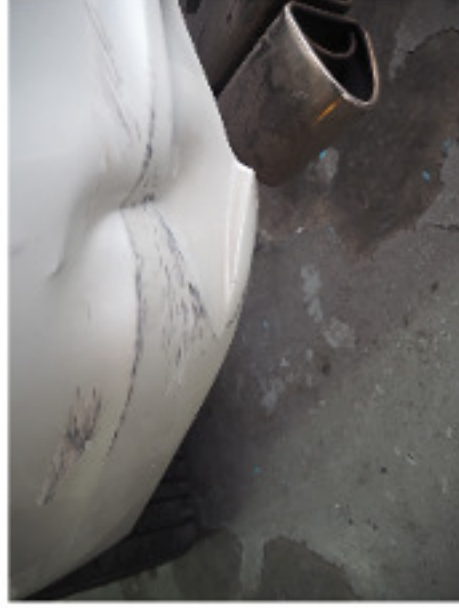
INSPECTION

THE VEHICLE SUSTAINED DAMAGES AT THE REAR N/S PORTION. DAMAGES SEE DETAILS.
--

Qty	Description of Parts	Condition	Estimate By Workshop (\$))	Our Adjusted (\$)
	<b><u>REPLACEMENT OF PARTS</u></b>			
1	REAR BUMPER	DISTORTED	1,530.00	1,250.00
1	REAR BUMPER SIDE RETAINER LH	NECESSARY	115.30	115.30
1	REAR BUMPER SENSOR	DAMAGED	320.00	250.00
1	REAR BUMPER SENSOR RUBBER	NECESSARY	12.00	12.00
1	REAR BUMPER SENSOR HOLDER	NOT NECESSARY	42.00	-
1	REAR BUMPER BEAM	NOT NECESSARY	277.00	-
1	REAR BUMPER REINFORCEMENT	BENT	569.00	569.00
1	TAILLAMP LH	CRACKED	420.00	420.00
1	TAILLAMP LOWER BRACKET LH	CRACKED	90.00	90.00
1	REAR END PANEL	NOT NECESSARY	890.00	-
1	REAR END PANEL TOP GARNISH	NOT NECESSARY	255.60	-
	LESS 5% DISCOUNT		-226.05	-135.32
			4,294.85	2,570.98
	<b><u>SPECIAL NETT ITEMS</u></b>			
1	SET REAR BUMPER CLIP (SN)	NECESSARY	22.00	22.00
1	SET REAR END PANEL TOP GARNISH CLIPS (SN)	NOT NECESSARY	20.00	-
1	REAR END PANEL INSULATION SEAL (SN)	NOT NECESSARY	120.00	-

162.00	22.00
	<b><u>LABOUR</u></b>			
	PANEL BEATING ,REMOVING AND REPLACING PARTS.		1,000.00	300.00
	SPRAY PAINTING TO AFFECTED AREA.		1,000.00	250.00
	TUFF COAT.	NOT NECESSARY	250.00	-
	WIRING CHECK .		150.00	30.00
	REMOVE AND REFIX REVERSE SENSOR AND DISTANCE SETTING.		120.00	50.00
			2,520.00	630.00
	<b>GRAND TOTAL</b>		<b>6,976.85</b>	<b>3,222.98</b>
	<b>RECOMMENDED COST OF LUMP SUM REPAIRS (TO ITS PRE-ACCIDENT CONDITION)</b>			<b>2,500.00</b>
