Your Ref: M1904454
Our Ref :CS/TMI19010772/D

10 July 2019

**TECHNICAL INVESTIGATION REPORT OF FIRE INCIDENT INVOLVING THE
INSURED VEHICLE SJP 4824K ON 17 JUNE 2019**

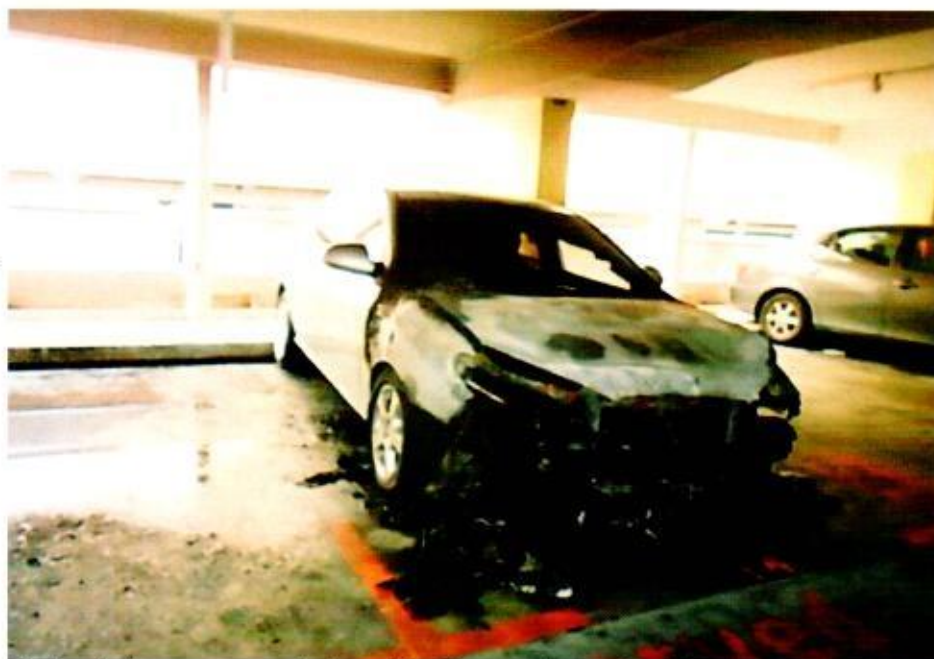
Photo 1 shows a general view of the front right portion of the Insured Vehicle at the time of my inspection. The fire damage to the Insured Vehicle was confined to its frontal portion. Its front bumper, front bonnet, front grille, front right headlamp and front right fender were amongst the body parts that were found to have been affected as a result of the fire.

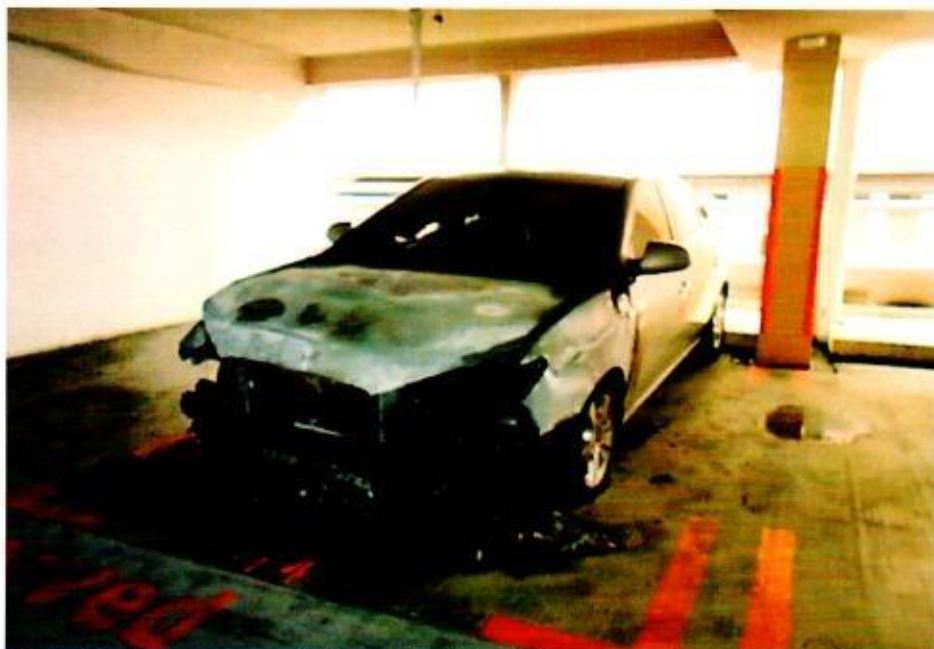
Photo 2 shows a general view of the front left portion of the Insured Vehicle at the time of my inspection. The fire damage to the Insured Vehicle was observed to be relatively severe. Its front bumper, front bonnet, front left headlamp and front left fender were amongst the body parts that were found to have been affected as a result of the fire.

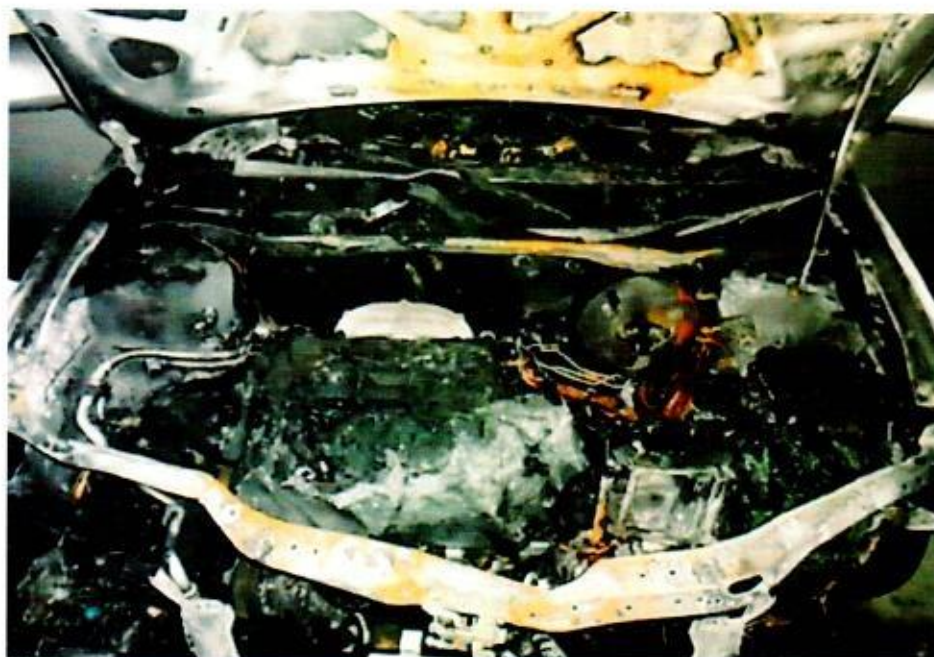
Photo 3 shows the engine compartment of the Insured Vehicle at the time of my inspection. The entire engine compartment of the Insured Vehicle was observed to be severely burnt. Most of the parts inside the engine compartment were found to be burnt and/or melted as a result of the fire.

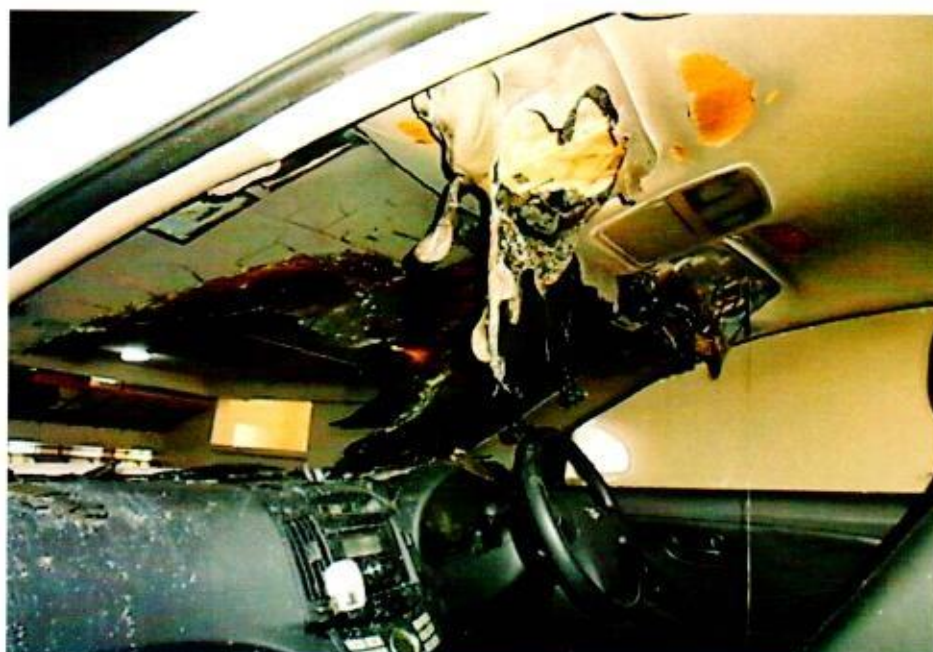
Photo 4 shows the interior compartment of the Insured Vehicle, which was observed to be partially burnt and/or melted at the front area. The front windscreen, front dashboard, plastic trims and roof upholstery were amongst the parts that were found to have been burnt and/or melted as a result of the fire.

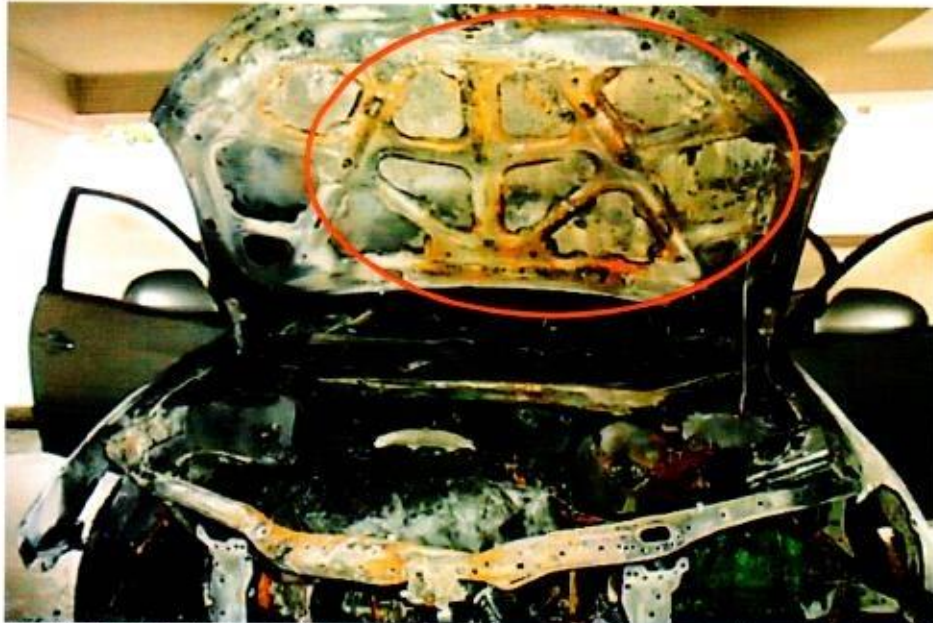
14. Firstly, the burn pattern and the rust that had developed on the underside of Insured Vehicle's front bonnet indicates that the fire had originated within the engine compartment of the Insured Vehicle, somewhere around the centre and towards the rear of the engine compartment.

15. The presence of rust on a steel/metal material body panel of a vehicle that was involved in a fire incident is a consequence of that body panel being exposed to natural environmental condition after layers of paint and its related compounds were melted due to prolong exposure of that particular body panel to high heat intensity. This follows the characteristic of heat rising upwards, and therefore exposing the underside of the Insured Vehicle's front bonnet to high heat intensity. I was hence able to identify the origin of fire basing on the physical evidence seen on the body panels of the Insured Vehicle, in particular from the development of rust that was seen on the underside of the Insured Vehicle's front bonnet. See photo 5 & 6 below.

Photo 5 shows the rust (circled) that was found on the underside of the Insured Vehicle's front bonnet. The presence of rust on a steel/metal material body panel of a vehicle that was involved in a fire incident is a consequence of that body panel being exposed to natural environmental condition after the layers of paint and its related compounds were melted due to prolong exposure of high heat intensity to that body panel. Such physical evidence can normally indicate where the fire of a vehicle had originated.

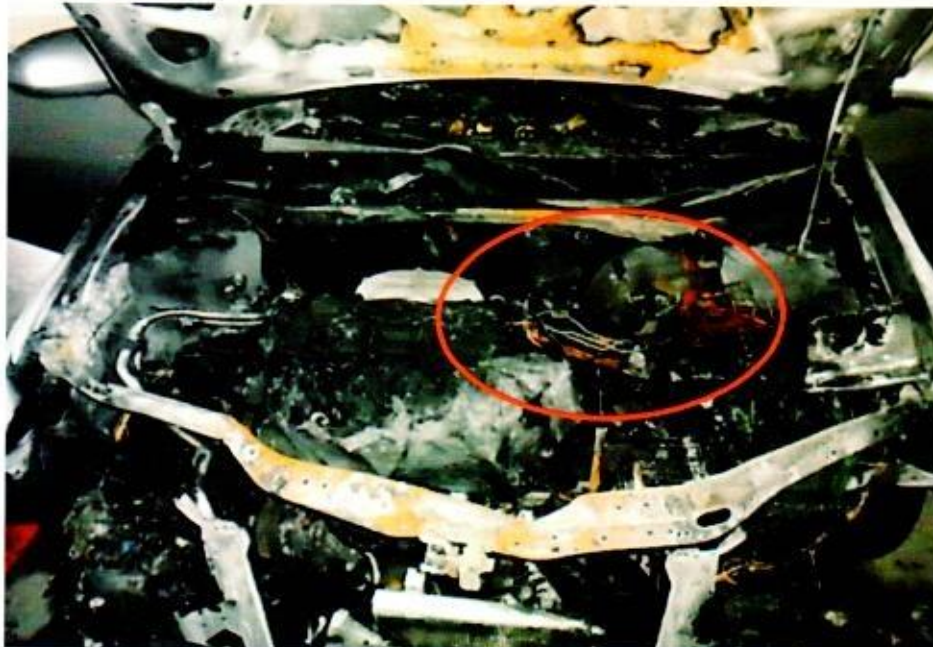
Photo 6 shows a general view of where the fire to the Insured Vehicle had originated, which was somewhere around the centre and towards the rear of the engine compartment (circled). This was established from the burn pattern and the rust that had developed on the underside of Insured Vehicle's front bonnet, as well as taking into consideration the characteristic of heat rising upwards.

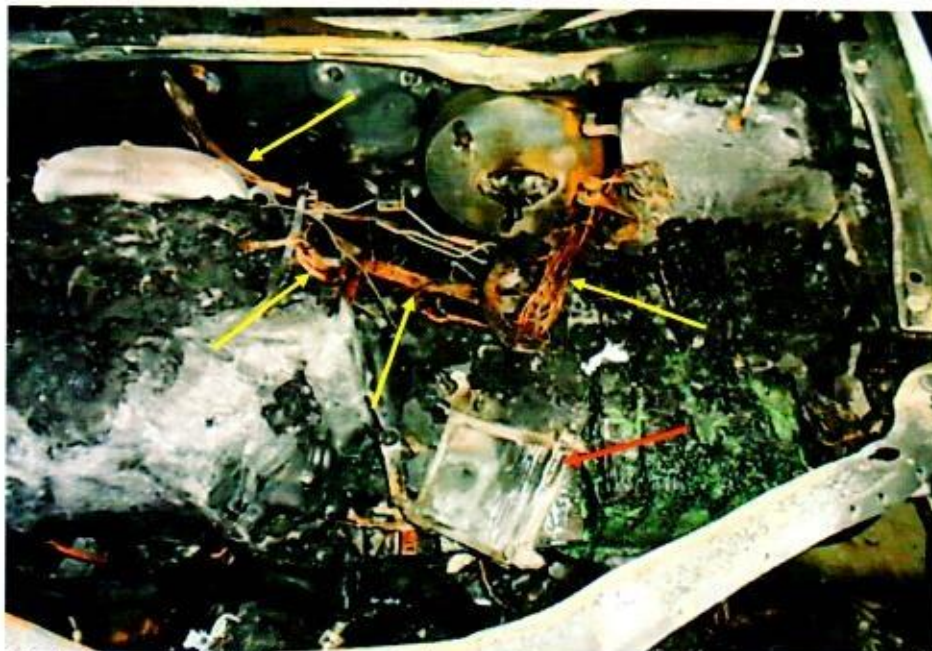
16. Upon examination of the area around the centre and towards the rear of the engine compartment, which was where the fire to the Insured Vehicle had originated, I had found several stretches of wirings that were completely burned to its bare copper state. These wirings were original wire harnesses connecting the Engine Control Module (ECM) of the Insured Vehicle to multiple sub-control units, sensors and actuators for vehicular operation. The bright reddish colour of the copper wires suggest that the wirings were exposed to high heat. Such condition normally indicates internal heating of copper wires which is a sign of an electrical short circuit occurring. This had suggested that the cause of fire to the Insured Vehicle was due to electrical in nature. See photo 7 – 10 below.

Photo 7 shows the wirings around the centre and towards the rear of the engine compartment, which was where the fire to the Insured Vehicle had started. Several stretches of wirings (yellow arrow) were found to be burnt to its bare copper state. The bright reddish colour of the copper wires suggest that the wirings were exposed to high heat. Such condition normally indicates internal heating of copper wires which is a sign of an electrical short circuit. The wirings were original wiring harnesses connecting the Engine Control Module (ECM) (arrowed) of the Insured Vehicle to multiple sub-control units, sensors and actuators for vehicular operation.

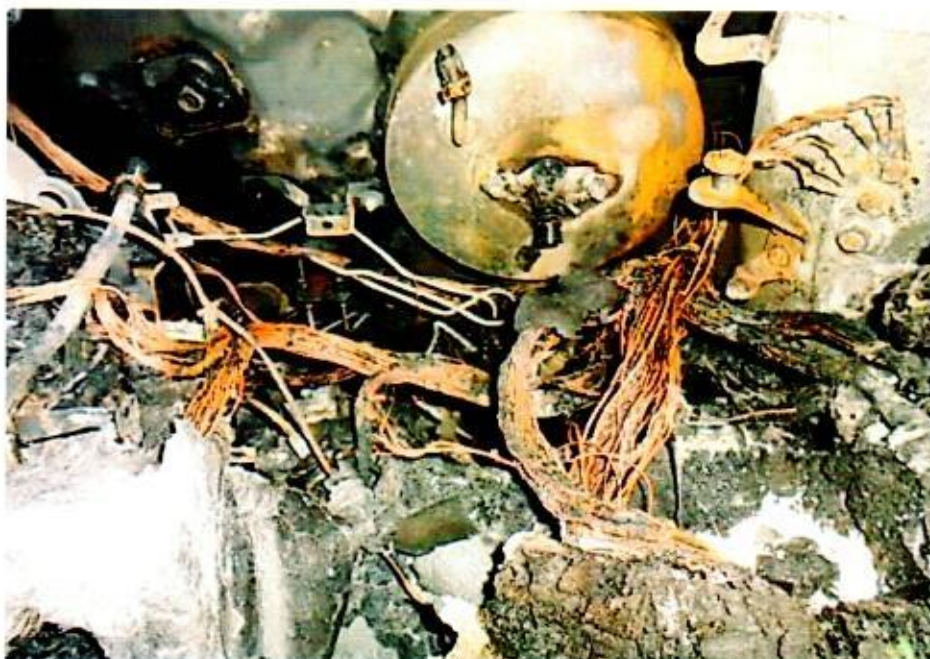
Photo 8 shows a closer view of the wirings that were found to be burnt to its bare copper state. Such condition normally indicates internal heating of copper wires which is a sign of an electrical short circuit occurring. These wirings were all original wiring harnesses of the Insured Vehicle.

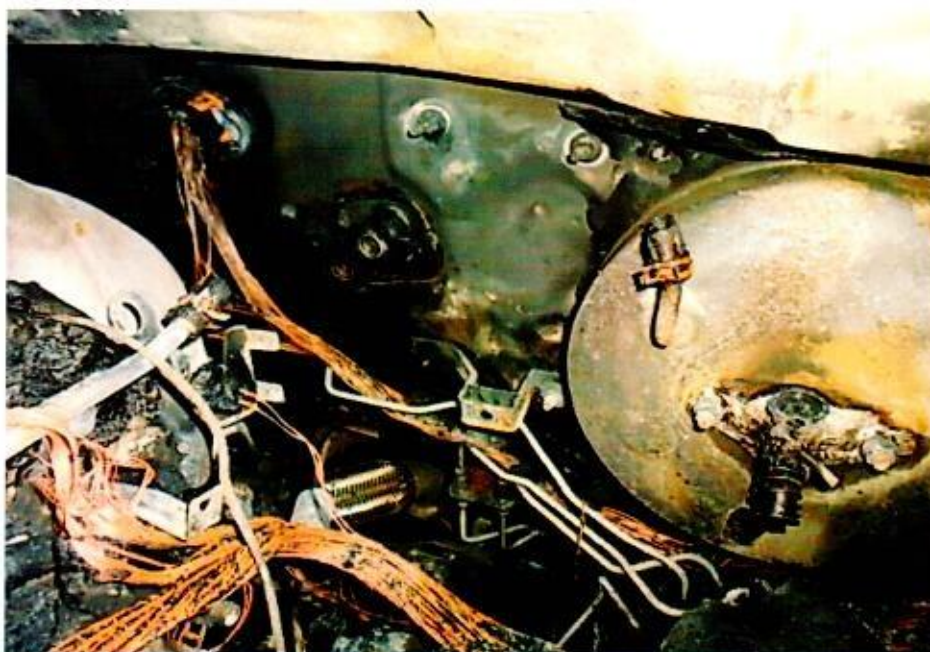
Photo 9 shows a closer view of another stretch of bright reddish coloured copper wires that were found within the engine compartment of the Insured Vehicle. Such condition normally indicates internal heating of copper wires, which is a sign of an electrical short circuit. The wirings were original wiring harnesses of the Insured Vehicle.

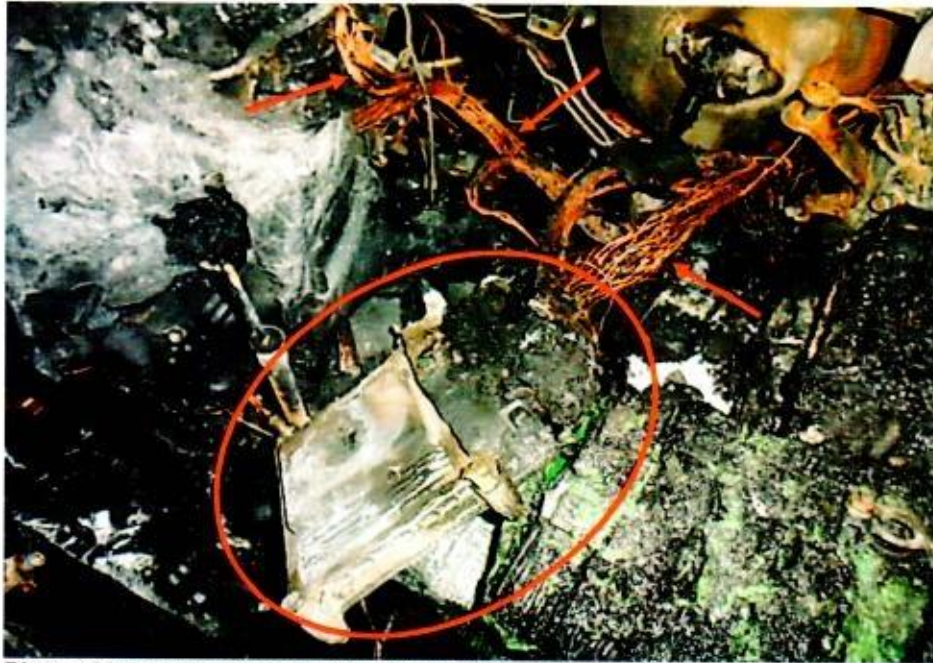
Photo 10 shows a closer view of the wirings (arrowed) that were found to be burnt to its bare copper state. These wirings were all original wiring harnesses leading to the Engine Control Module (ECM) (circled) of the Insured Vehicle.

23. Having investigated and technically analysed the damages of burnt nature to the Insured Vehicle, I am of the view that the cause of fire to the Insured Vehicle was of electrical in nature. For this particular case, the fire had originated along the wirings inside the engine compartment, somewhere around the centre and towards the rear of the engine compartment. The wirings were original factory wirings connecting the Engine Control Module (ECM) of the Insured Vehicle to multiple sub-control units, sensors and actuators for vehicular operation.
