Your Ref: M1904454  
Our Ref :CS/TMI19010772/D

10 July 2019

**TECHNICAL INVESTIGATION REPORT OF FIRE INCIDENT INVOLVING THE INSURED VEHICLE SJP 4824K ON 17 JUNE 2019**

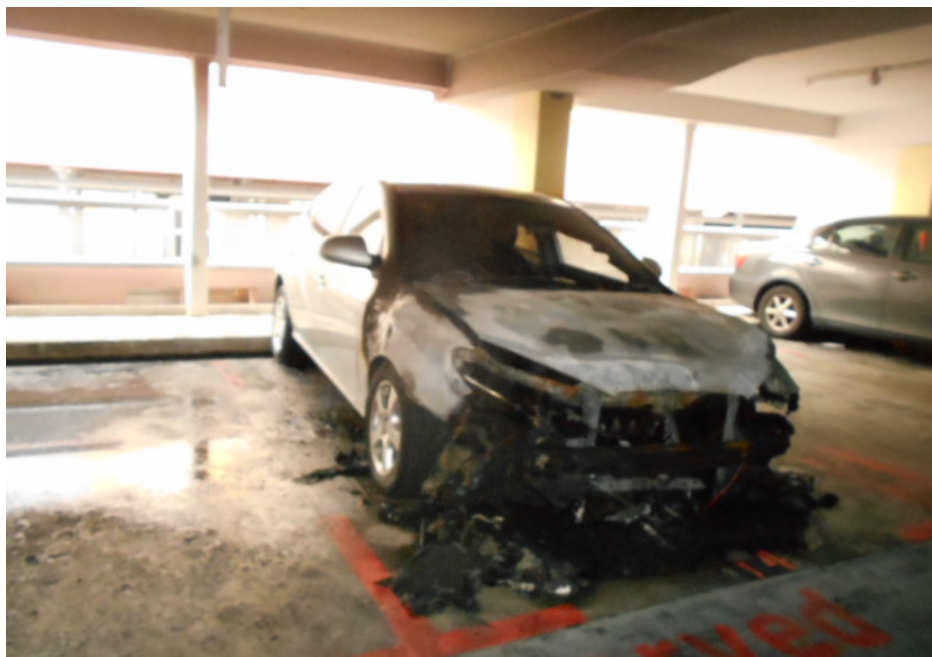
5. The Insured Vehicle was noted to have sustained severe fire damage that was confined to its frontal portion. The entire engine compartment of the Insured Vehicle was observed to be extensively burnt while the interior compartment was observed to be partially burnt and/or melted at the front area.
6. The fire had resulted in the body parts at the frontal portion of the Insured Vehicle to be burnt. This had included its front bumper, front bonnet, front fenders, front support panel, front grille, front headlamps, front windscreen, front dashboard and roof upholstery amongst others. See photo 1 – 4 below.

**Photo 1** shows a general view of the front right portion of the Insured Vehicle at the time of my inspection. The fire damage to the Insured Vehicle was confined to its frontal portion. Its front bumper, front bonnet, front grille, front right headlamp and front right fender were amongst the body parts that were found to have been affected as a result of the fire.

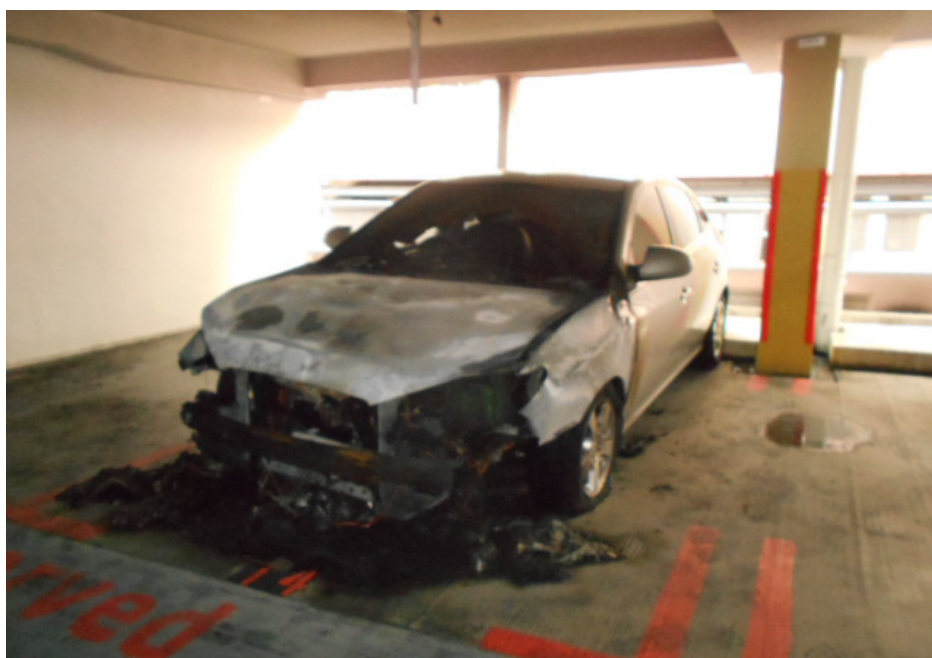
**Photo 2** shows a general view of the front left portion of the Insured Vehicle at the time of my inspection. The fire damage to the Insured Vehicle was observed to be relatively severe. Its front bumper, front bonnet, front left headlamp and front left fender were amongst the body parts that were found to have been affected as a result of the fire.

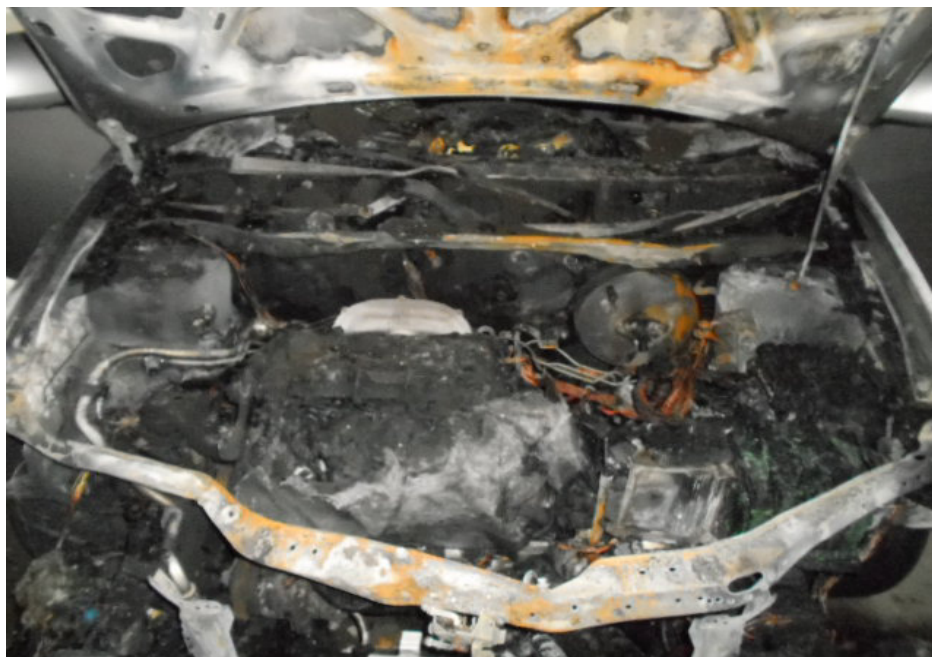
**Photo 3** shows the engine compartment of the Insured Vehicle at the time of my inspection. The entire engine compartment of the Insured Vehicle was observed to be severely burnt. Most of the parts inside the engine compartment were found to be burnt and/or melted as a result of the fire.

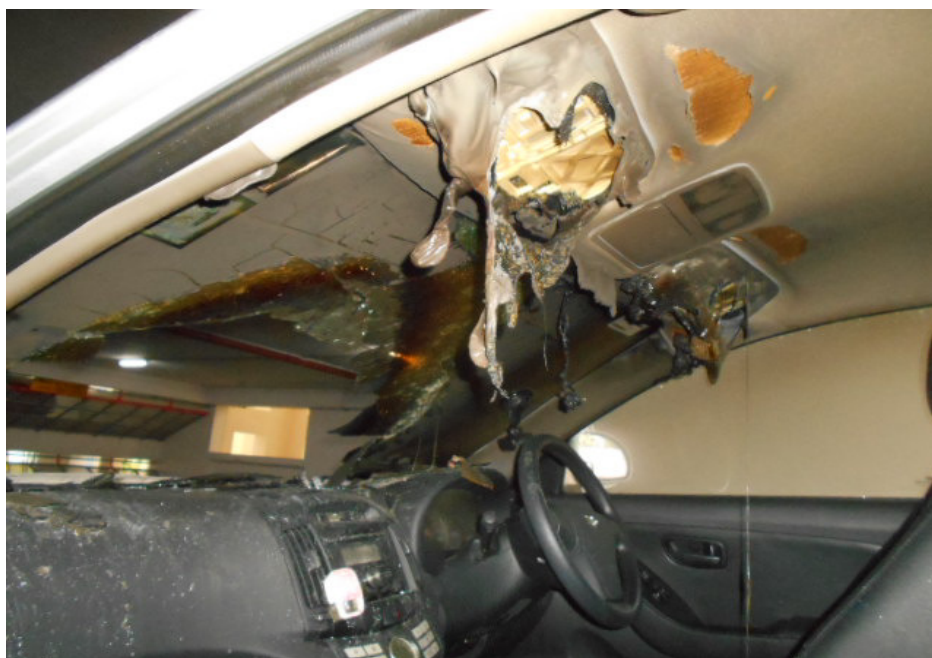
**Photo 4** shows the interior compartment of the Insured Vehicle, which was observed to be partially burnt and/or melted at the front area. The front windscreen, front dashboard, plastic trims and roof upholstery were amongst the parts that were found to have been burnt and/or melted as a result of the fire.

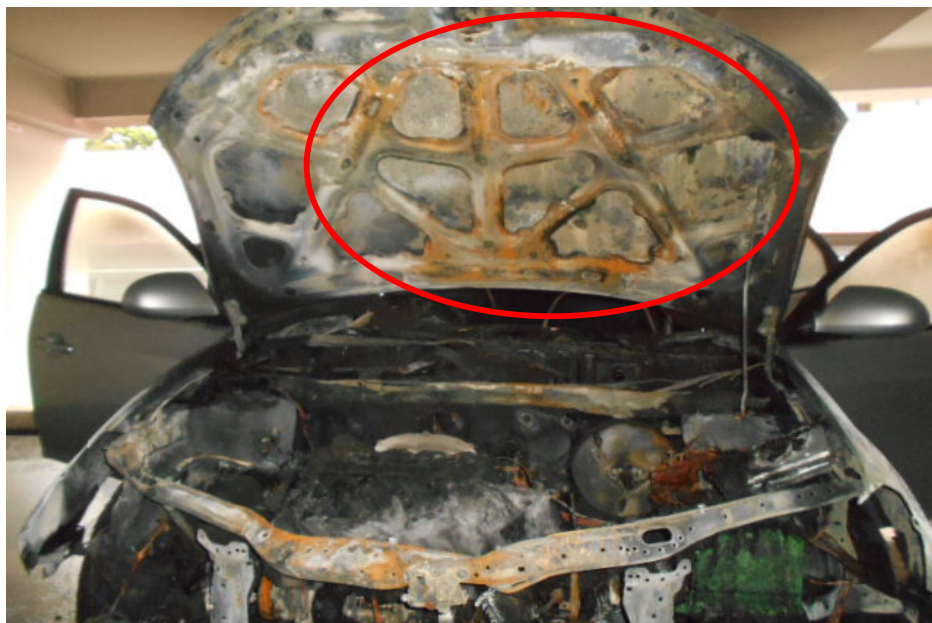
14. Firstly, the burn pattern and the rust that had developed on the underside of Insured Vehicle's front bonnet indicates that the fire had originated within the engine compartment of the Insured Vehicle, somewhere around the centre and towards the rear of the engine compartment.

15. The presence of rust on a steel/metal material body panel of a vehicle that was involved in a fire incident is a consequence of that body panel being exposed to natural environmental condition after layers of paint and its related compounds were melted due to prolong exposure of that particular body panel to high heat intensity. This follows the characteristic of heat rising upwards, and therefore exposing the underside of the Insured Vehicle's front bonnet to high heat intensity. I was hence able to identify the origin of fire basing on the physical evidence seen on the body panels of the Insured Vehicle, in particular from the development of rust that was seen on the underside of the Insured Vehicle's front bonnet. See photo 5 & 6 below.

**Photo 5** shows the rust (circled) that was found on the underside of the Insured Vehicle's front bonnet. The presence of rust on a steel/metal material body panel of a vehicle that was involved in a fire incident is a consequence of that body panel being exposed to natural environmental condition after the layers of paint and its related compounds were melted due to prolong exposure of high heat intensity to that body panel. Such physical evidence can normally indicate where the fire of a vehicle had originated.

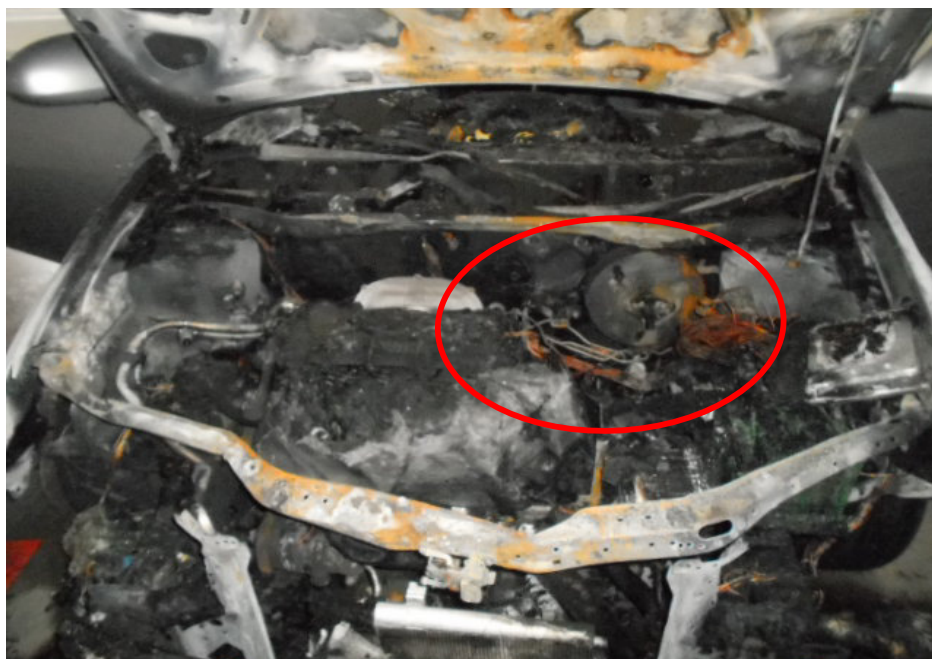
**Photo 6** shows a general view of where the fire to the Insured Vehicle had originated, which was somewhere around the centre and towards the rear of the engine compartment (circled). This was established from the burn pattern and the rust that had developed on the underside of Insured Vehicle's front bonnet, as well as taking into consideration the characteristic of heat rising upwards.

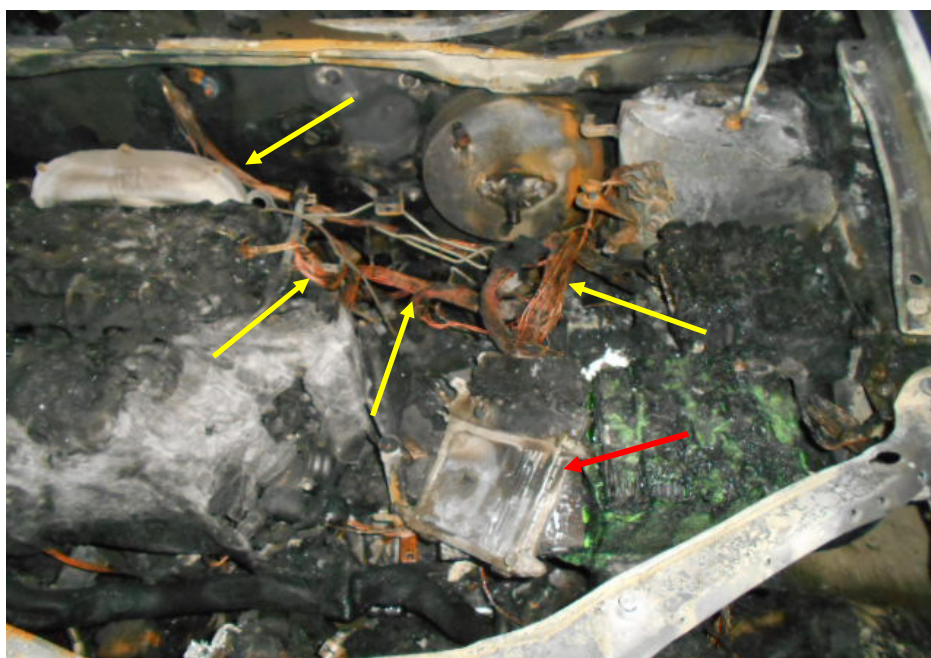
16. Upon examination of the area around the centre and towards the rear of the engine compartment, which was where the fire to the Insured Vehicle had originated, I had found several stretches of wirings that were completely burned to its bare copper state. These wirings were original wire harnesses connecting the Engine Control Module (ECM) of the Insured Vehicle to multiple sub-control units, sensors and actuators for vehicular operation. The bright reddish colour of the copper wires suggest that the wirings were exposed to high heat. Such condition normally indicates internal heating of copper wires which is a sign of an electrical short circuit occurring. This had suggested that the cause of fire to the Insured Vehicle was due to electrical in nature. See photo 7 – 10 below.

**Photo 7** shows the wirings around the centre and towards the rear of the engine compartment, which was where the fire to the Insured Vehicle had started. Several stretches of wirings (yellow arrow) were found to be burnt to its bare copper state. The bright reddish colour of the copper wires suggest that the wirings were exposed to high heat. Such condition normally indicates internal heating of copper wires which is a sign of an electrical short circuit. The wirings were original wiring harnesses connecting the Engine Control Module (ECM) (arrowed) of the Insured Vehicle to multiple sub-control units, sensors and actuators for vehicular operation.

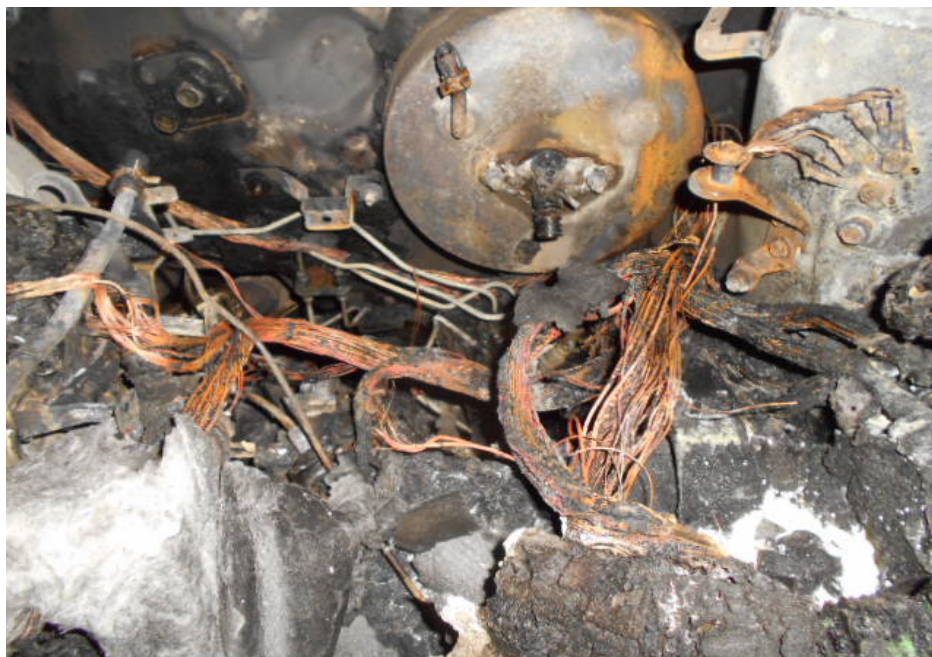
**Photo 8** shows a closer view of the wirings that were found to be burnt to its bare copper state. Such condition normally indicates internal heating of copper wires which is a sign of an electrical short circuit occurring. These wirings were all original wiring harnesses of the Insured Vehicle.

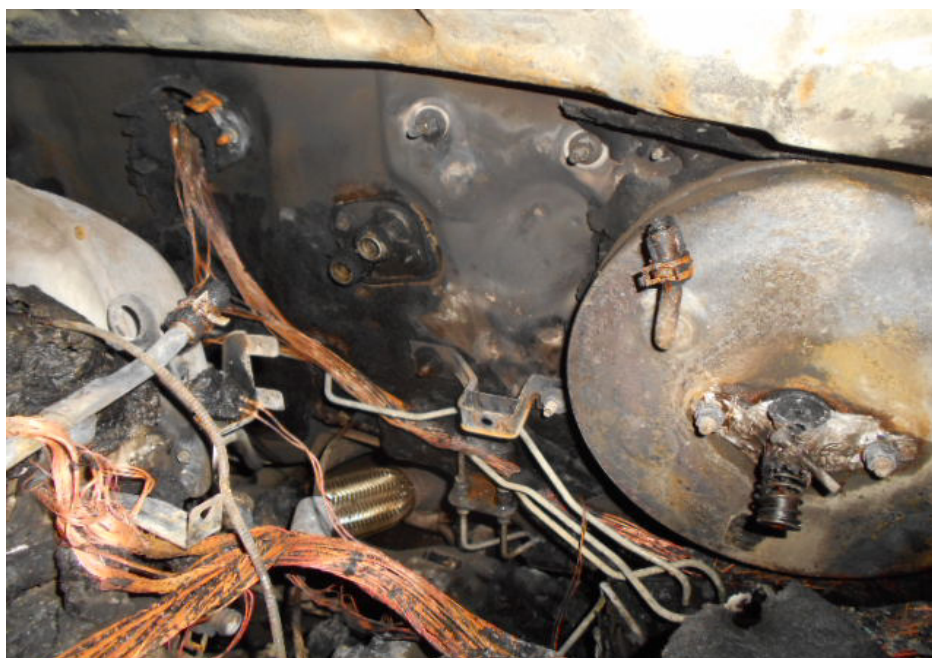
**Photo 9** shows a closer view of another stretch of bright reddish coloured copper wires that were found within the engine compartment of the Insured Vehicle. Such condition normally indicates internal heating of copper wires, which is a sign of an electrical short circuit. The wirings were original wiring harnesses of the Insured Vehicle.

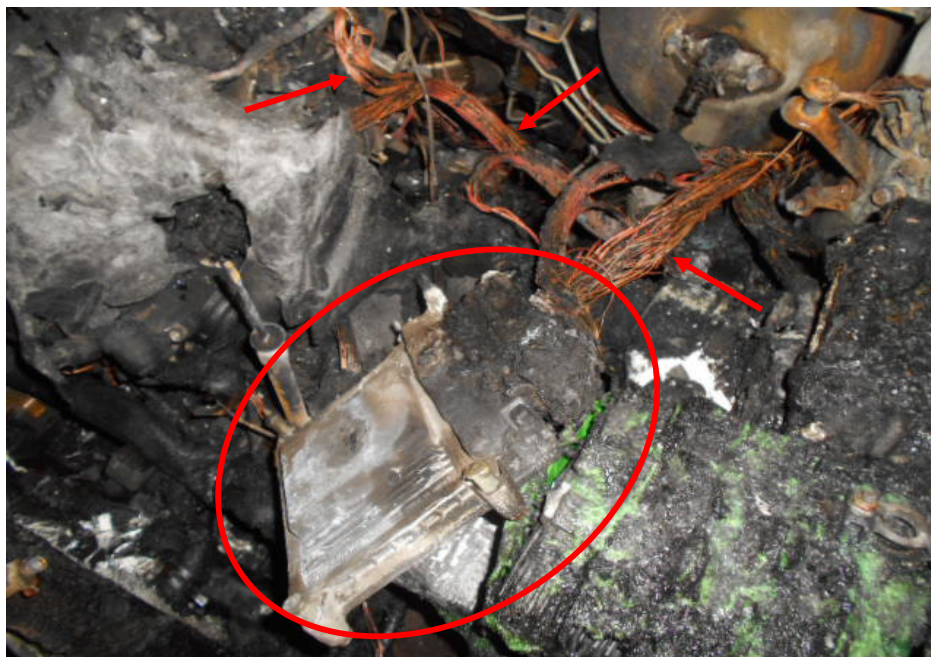
**Photo 10** shows a closer view of the wirings (arrowed) that were found to be burnt to its bare copper state. These wirings were all original wiring harnesses leading to the Engine Control Module (ECM) (circled) of the Insured Vehicle.
