From: Koh, Victor-CK <Victor-CK.Koh@aig.com>
Sent: Wednesday, 21 August 2019 11:49 am
To: Shirley Hiew (LKK Auto)
Cc: Fong, Andy-SY; SUR
Subject: RE: SGC2223L/2456745660SG

Subject: SGC2223L/2456745660SG

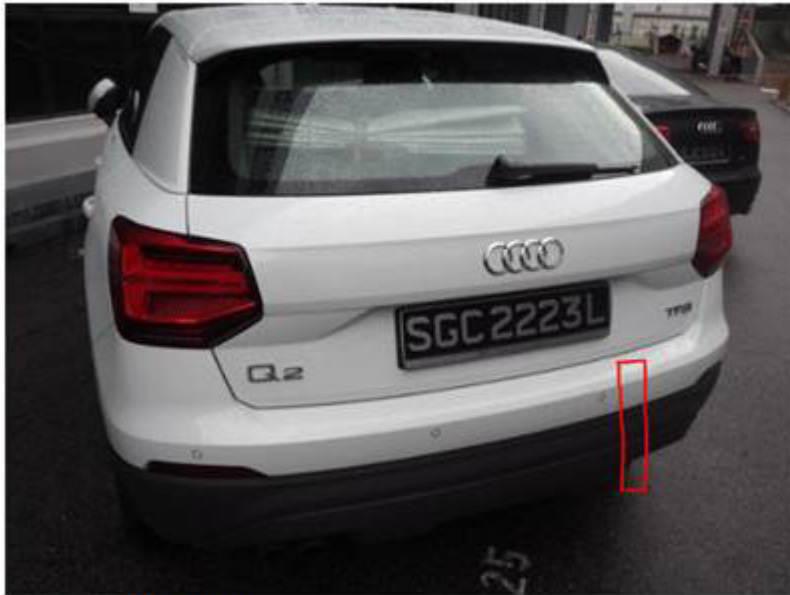
26/44: General View

So coincidentally the area of damage is the same as the lower bumper damage area (red circle and box)? Also the dent is on the top portion of the bumper (blue line area) how will this portion abrade against the floor?
Finally we need the surveyor to request Insured to show the exact spot of the accident occur and take photos of the scene to determine the consistency of the damage.

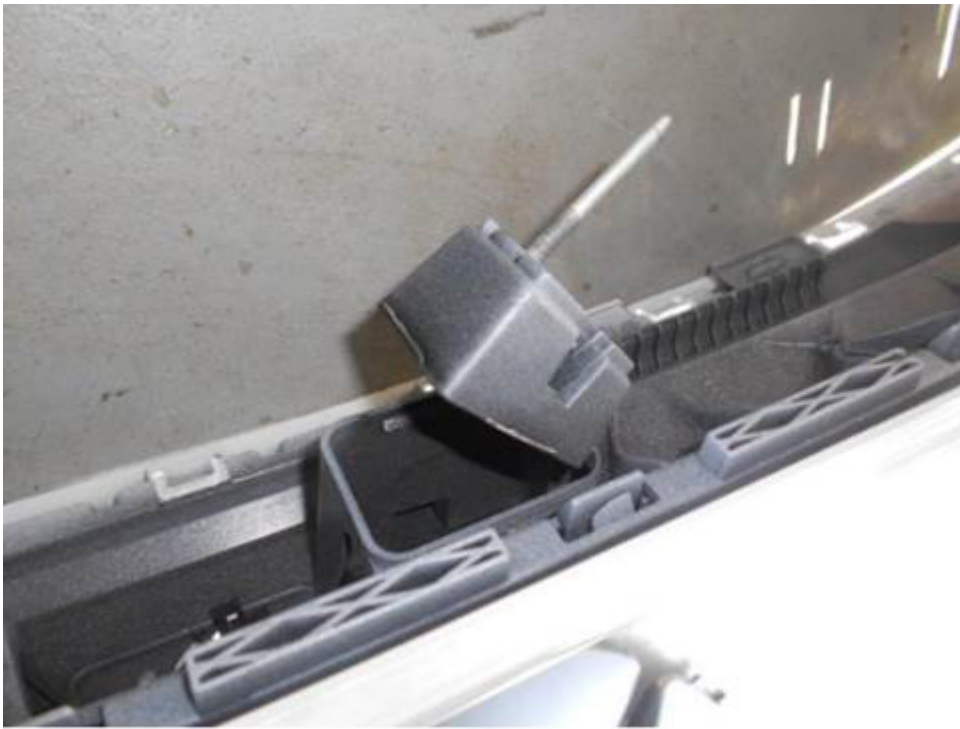
33/44: Reinspection Photo

After removal of rear bumper to replace the lower spoiler, a crack on the inner side of the rear bumper was detected. (Photo 33)

The position of crack occurs just above the area of damage of the lower spoiler.

Photos only show the internal bracket broken due to the impact at the dent area which is not consistent.

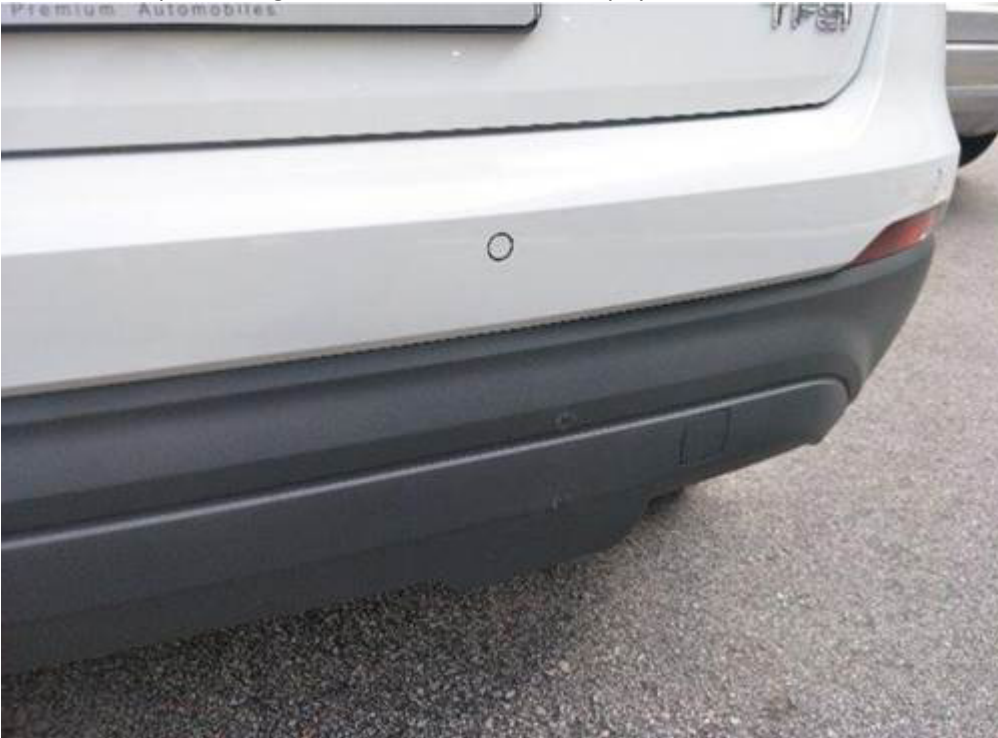
Reporting photo

There is no dent on the rear bumper as shown from reporting photos as compare to the re-inspection photos. As such the rear bumper damage is not consistent and not payable.
