VEHICLE APPRAISAL REPORT

Our Reference: TP19-038023-TWL
 Your Reference: -
 Vehicle Number: SGK5725T

Assessment of Vehicle No: SGK5725T
 Date of Accident: 15-Mar-19
 Date of Inspection: 20-Mar-19

Reg No:	SGK5725T	Make:	DAIHATSU
Reg Year:	2006	Model:	TERIOS 1.5L
Colour:	Yellow	Engine No:	-
Type:	-	Chassis No:	JDAJ200G001002678
Type of Claim:	-	Odometer No:	- km
Market Value:	-	Engine Cap.:	1495 cc

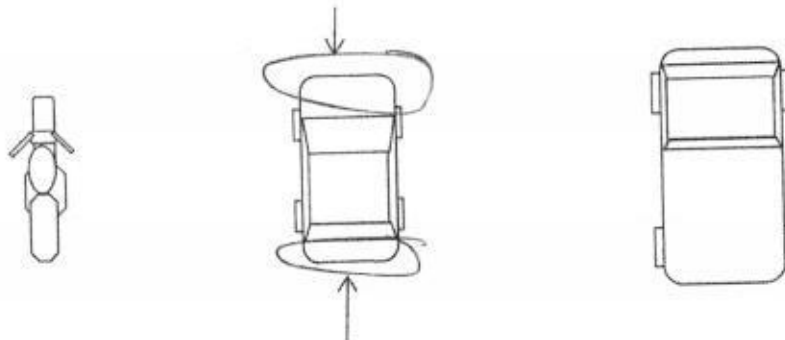
of inspection, this vehicle sustained damages to the **Front and Rear** portion. Please see attached details.

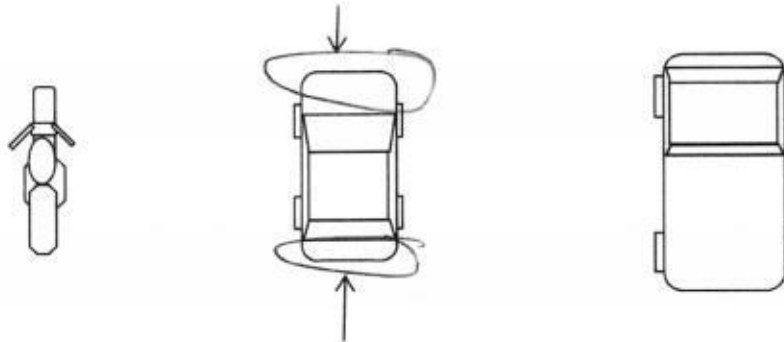
At the time of inspection, this vehicle sustained damages to the **Front and Rear portion**. Please see attached scheduled details.
