Your Ref: TP/IP/31357/2019
Our Ref : CI/TPD19011267/P

MECHANICAL INSPECTION REPORT OF MOTOR BUS CB 6563G

1. I refer to your request on 20th June 2019 to conduct a physical inspection of a Motor Bus bearing registration number CB 6563G (herein referred to as "**Motor Bus**"), which was involved in a fatal road traffic accident on 15th May 2019.
2. The objective of this inspection is to determine if there was any possible mechanical failure to the Motor Bus that may have contributed to the accident.
3. Following the request, I had carried out a physical inspection of the Motor Bus on 2nd September 2019 at the premises of Traffic Police vehicle pound, 517 Airport Road Singapore 539942. I now set out below my observations and comments with respect to this inspection.

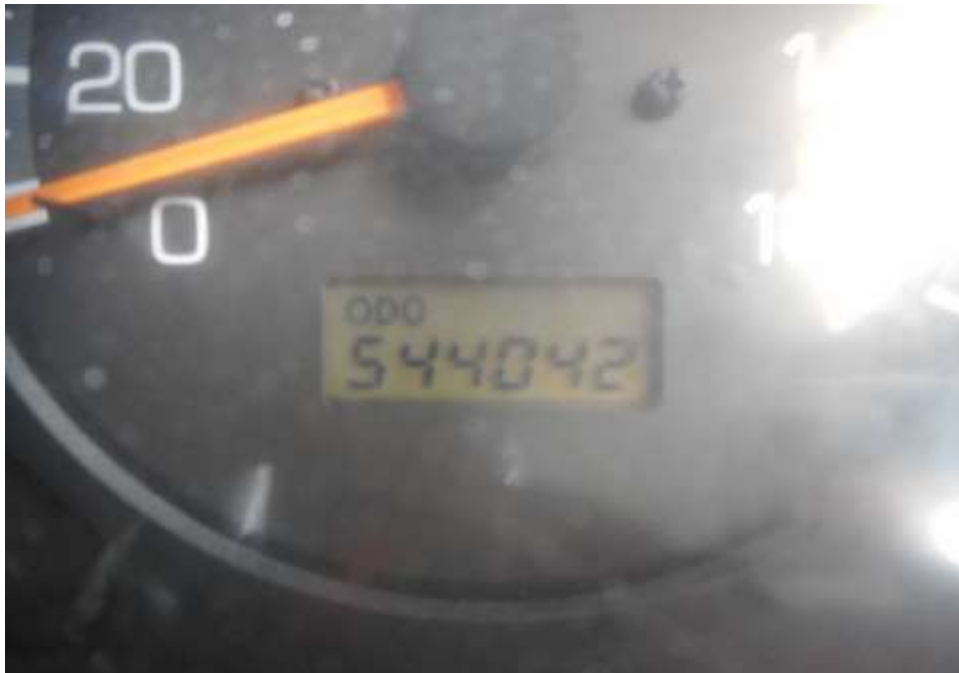
4. The mileage of the Motor Bus at the time of my inspection was 544,042km.
5. The Motor Bus was observed to have sustained moderate damages at its frontal portion. Its front windscreen and front body panel was damaged as a result of the accident at the time of my inspection.

Photo 1 shows a general view of the instrument cluster of the Motor Bus at the time of my inspection. The mileage of the Motor Bus was 544,042km

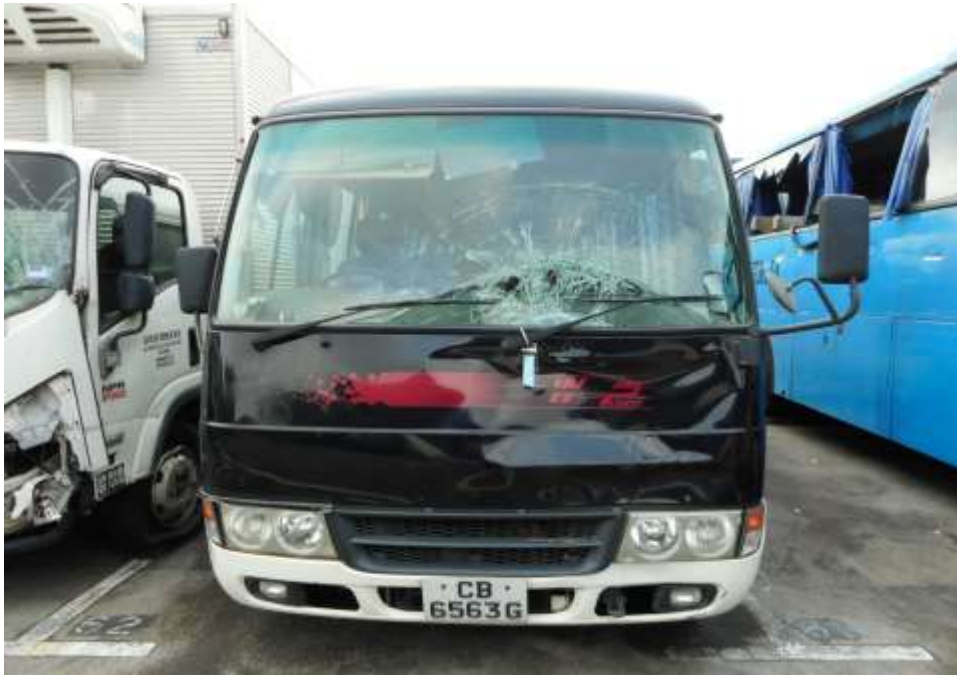
Photo 2 shows a general view of the frontal portion of the Motor Bus at the time of my inspection. The Motor Bus was observed to have sustained moderate damages at its frontal portion. Its front windscreen and front body panel was damaged as a result of the accident at the time of my inspection.

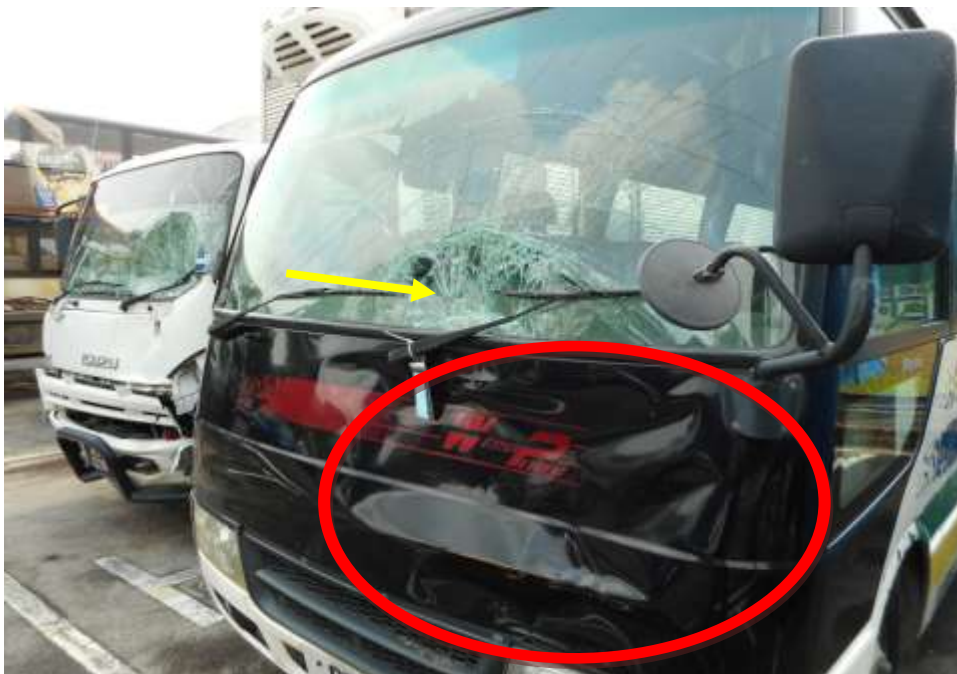
Photo 3 shows a close up view of the frontal portion of the Motor Bus at the time of my inspection. The Motor Bus was observed to have sustained moderate damages at its frontal portion. Its front windscreen (yellow arrow) and front body panel (circled) was damaged as a result of the accident at the time of my inspection.

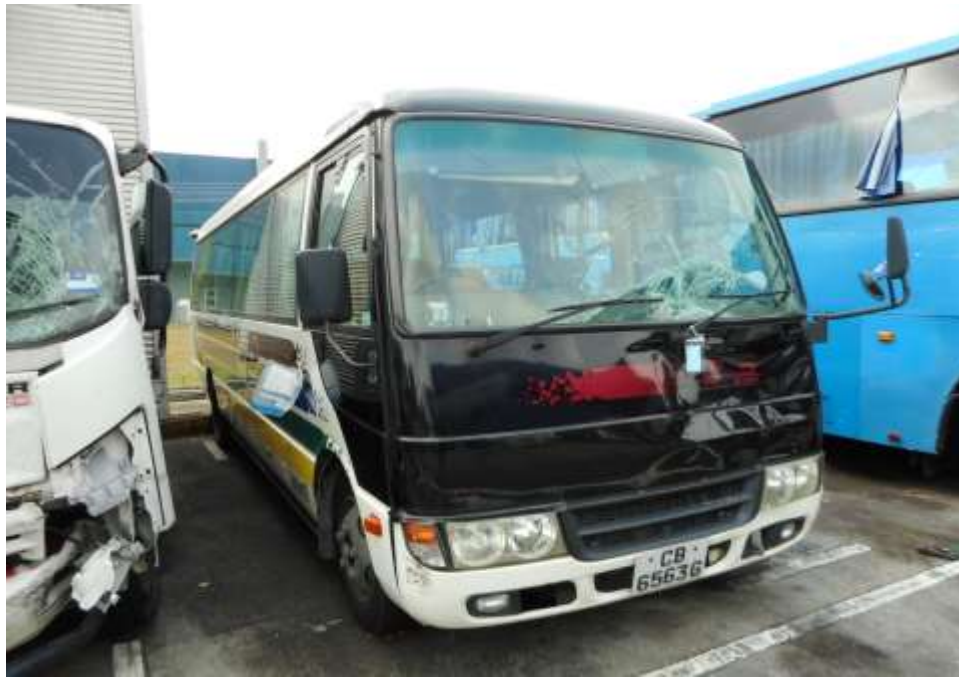
Photo 4 shows a general view of the right body of the Motor Bus at the time of my inspection. The Motor Bus was observed to be in good general condition and unaffected by the accident.

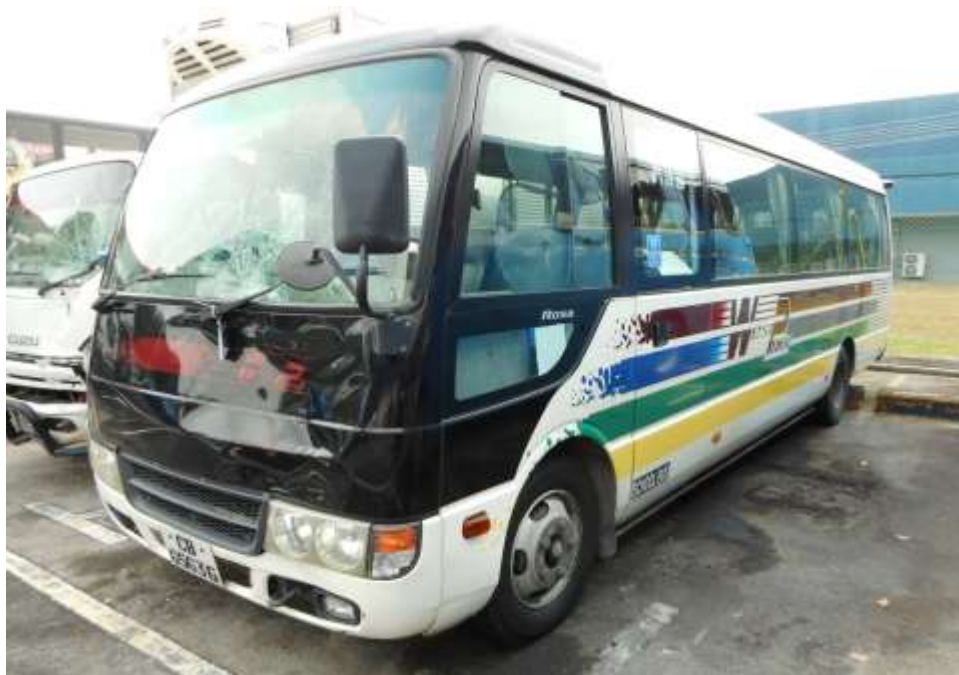
Photo 5 shows a general view of the left body of the Motor Bus at the time of my inspection. The Motor Bus was observed to be in good general condition and unaffected to by the accident.

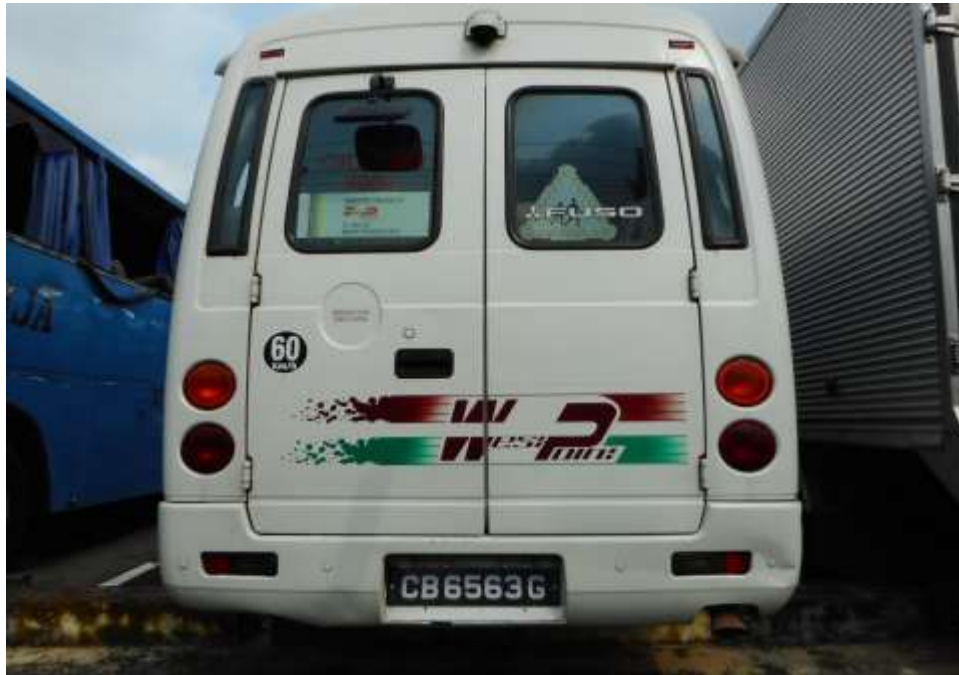
Photo 6 shows a general view of the Motor Bus's rear body at the time of my inspection. The Motor Bus was observed to be in good general condition and unaffected to by the accident.

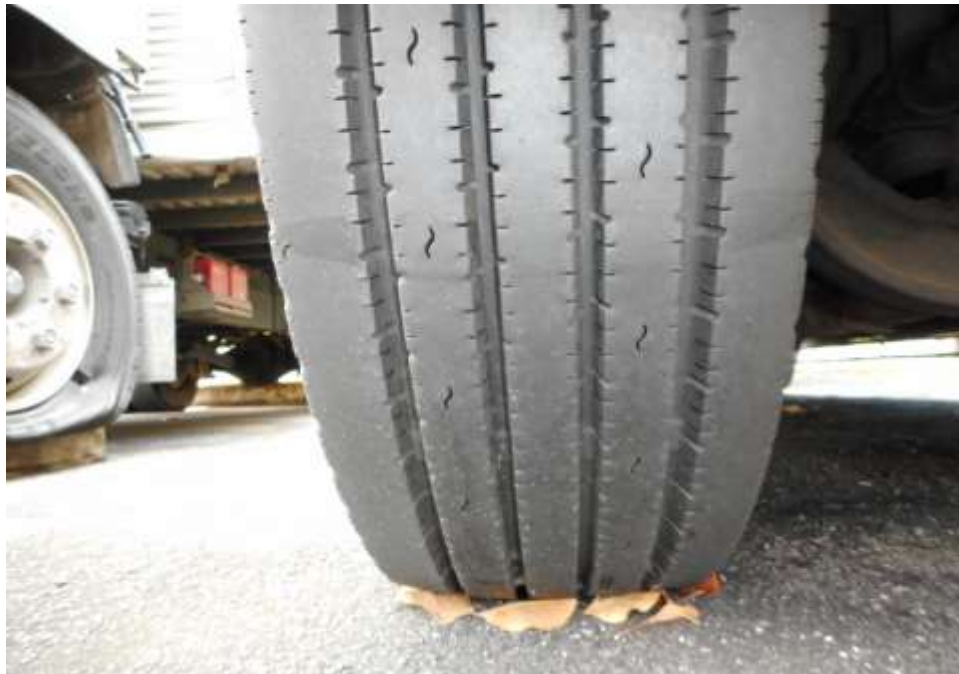
Photo 7 shows the condition of the front right tyre of the Motor Bus, which was observed to be in serviceable condition with remaining tread depth of approximately 10mm. The tyre, which was wrapped around standard steel wheel rim, was also observed to be sufficiently inflated for vehicular operation. There was no tear, cut or burst mark(s) on the outer and the inner sidewalls as well as across the tread of the 6 tyres that were fitted on the Motor Bus.

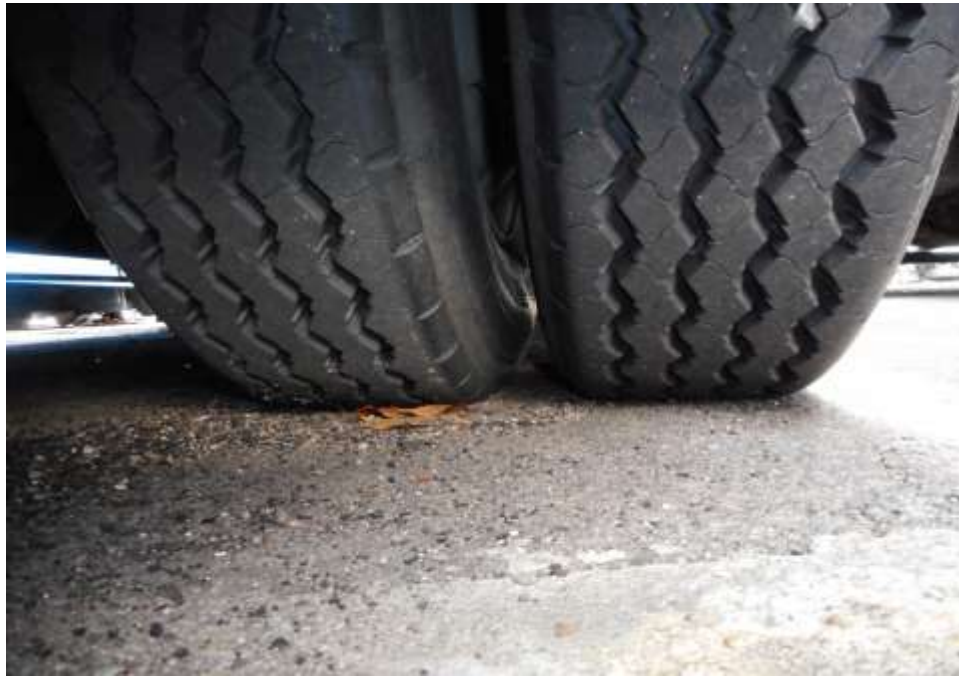
Photo 8 shows the condition of the rear right tyre of the Motor Bus, which was observed to be in serviceable condition with remaining tread depth of approximately 12.1mm. The tyre, which was wrapped around standard steel wheel rim, was also observed to be sufficiently inflated for vehicular operation.

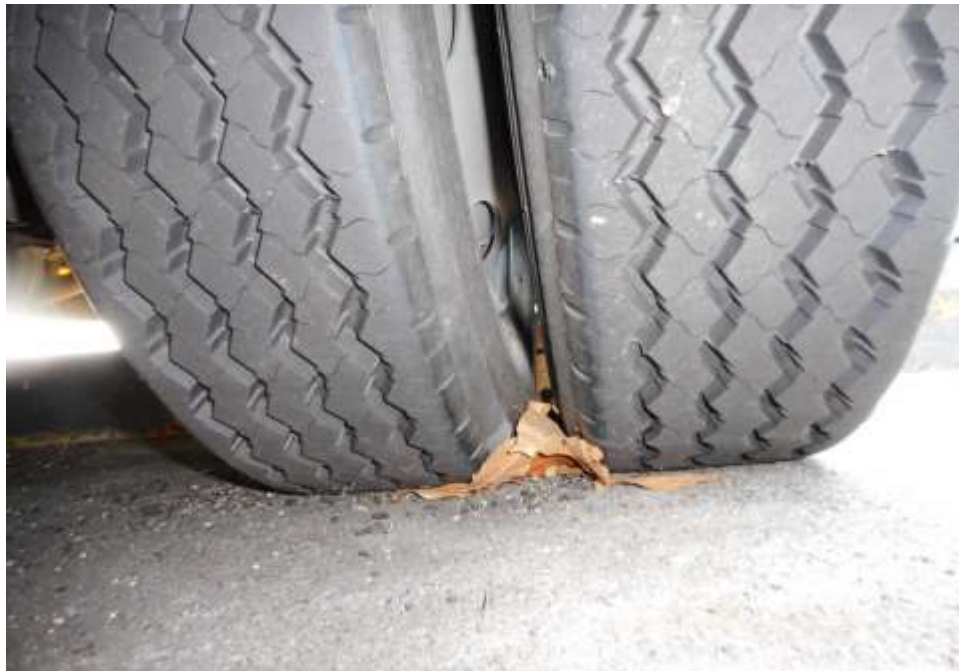
Photo 9 shows the condition of the rear left tyres of the Motor Bus, which was observed to be in serviceable condition with remaining tread depth of approximately 11.9mm. The tyres, which were wrapped around standard steel wheel rim, were also observed to be sufficiently inflated for vehicular operation. There was also no damage found on all 6 steel wheel rims of the Motor Bus.

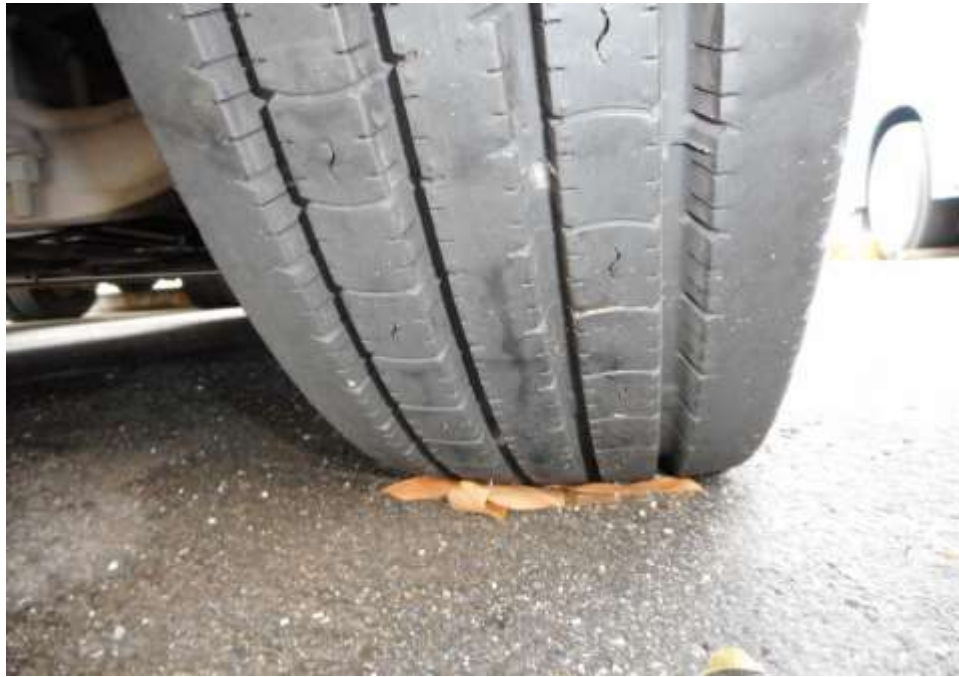
Photo 10 shows the condition of the front left tyres of the Motor Bus, which were observed to be in serviceable condition with remaining tread depth of approximately 11.6mm. There was also no tear, cut or burst mark(s) on the outer and the inner sidewalls as well as across the tread of the 6 tyres that were fitted on the Motor Bus.

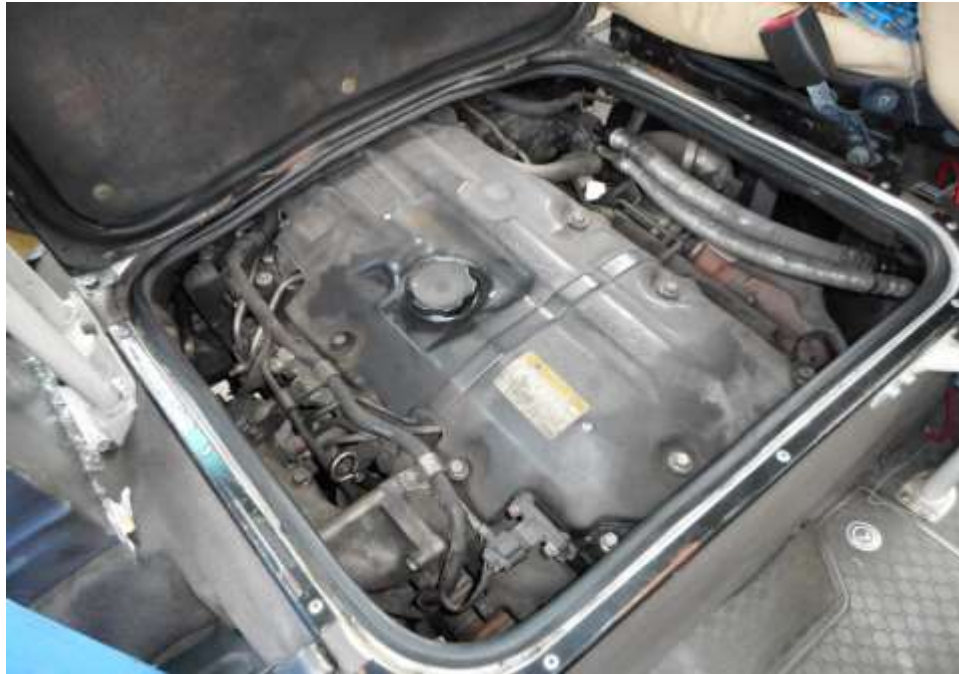
8. Upon examination of the Motor Bus's engine compartment, I had observed all the parts and components inside the engine compartment to be intact and unaffected by the accident. The brake fluid, engine oil, and engine coolant were all found to be of sufficient level for operating purposes. Visually, there was also no contamination found to these fluids. However the power steering fluid was not observed as its reservoir is located inside the front body panel which was damage as a result of the accident. (unable to open)

9. Further examination of the engine compartment revealed, there was no sign(s) or indication(s) of fresh fluid leakage and/or fluid stain within the engine compartment of the Motor Bus.

Photo 11 shows a general view of the Motor Bus's engine compartment, which was accessed in front cabin of the Motor Bus. The various parts and components inside the engine compartment were unaffected by the accident. There was also no sign(s) or indication(s) of fresh fluid leakage and/or fluid stain within the engine compartment

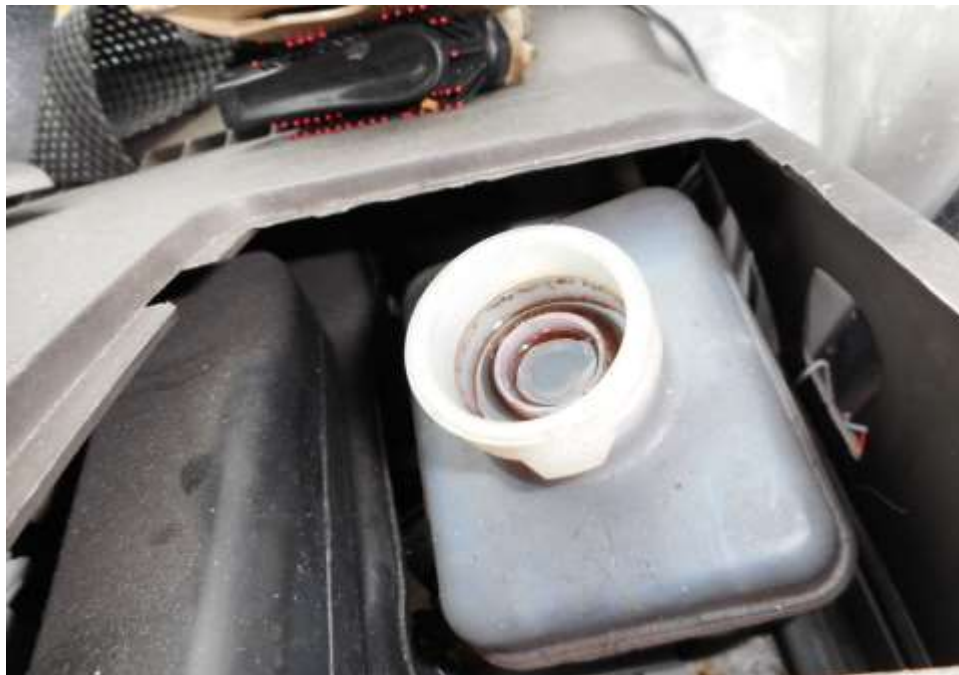
Photo 12 shows the brake fluid reservoir of the Motor Bus at the time of my inspection. The brake fluid was observed to be of sufficient level (arrowed) and without any visible contamination.

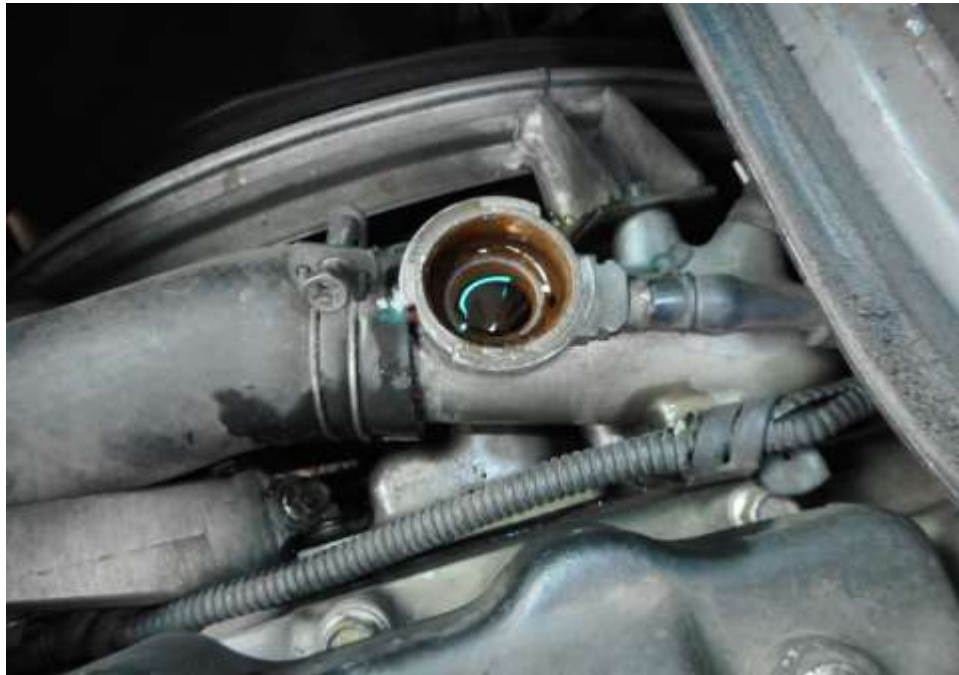
Photo 13 shows the engine coolant reservoir of the Motor Bus at the time of my inspection. The engine coolant was observed to be of sufficient level and without any visible contamination.

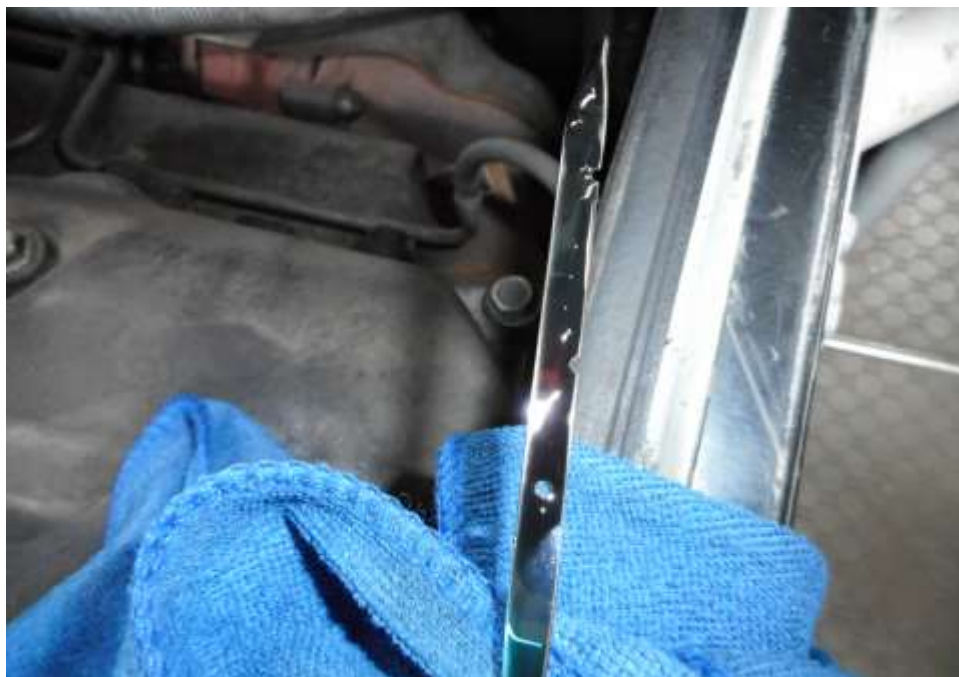
Photo 14 shows the engine oil dip stick system of the Motor Bus at the time of my inspection. The engine oil was observed to be of sufficient level for operation and without any visible contamination.

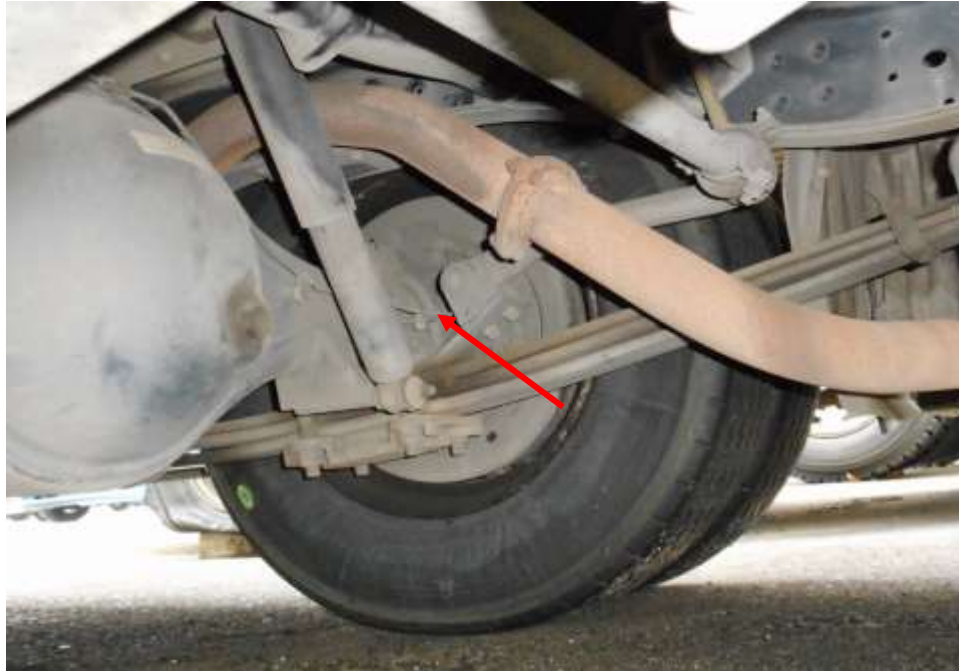
11. Static brake tests conducted on the Motor Bus revealed no abnormality. The air brake booster had responded well to the various tests conducted. There was also no abnormal movement of the brake pedal when it was depressed. In general, the static brake tests had suggested that there was no internal leakage of pressure/vacuum in the braking system of the Motor Bus. The braking system of the Motor Bus was likely to be in serviceable condition at the material time. This was also taking into consideration that the brake fluid was of sufficient level and also that there was no sign(s) of air leakage and fluid along the brake hoses and brake pipe.

Photo 15 shows the brake pipe (arrowed) at the rear right wheel of the Motor Bus. I did not observe any leakage of brake fluid at the time of my inspection of the Motor Bus. My static tests of the Motor Bus's braking system, along with my visual examination of the various mechanical components in the braking system, had indicated that there was no internal leakage of pressure/vacuum. Hence the braking system of the Motor Bus was likely to be in serviceable condition at the material time of accident.

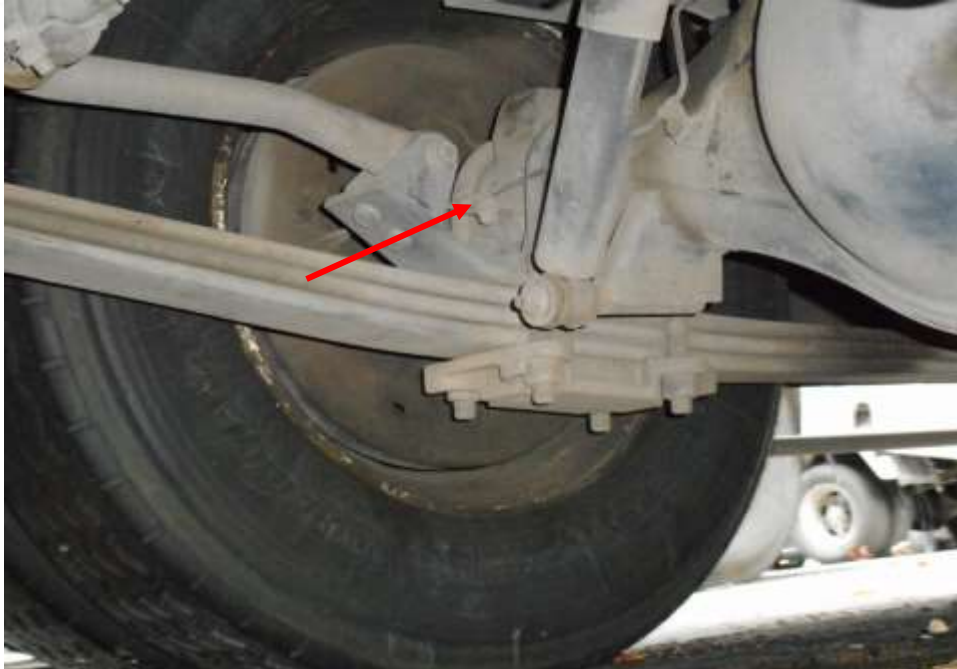
Photo 16 shows the brake pipe (arrowed) at the rear left wheel of the Motor Bus. I did not observe any leakage of brake fluid at the time of my inspection of the Motor Bus. My static tests of the Motor Bus's braking system, along with my visual examination of the various mechanical components in the braking system, had indicated that there was no internal leakage of pressure/vacuum. Hence the braking system of the Motor Bus was likely to be in serviceable condition at the material time of accident.

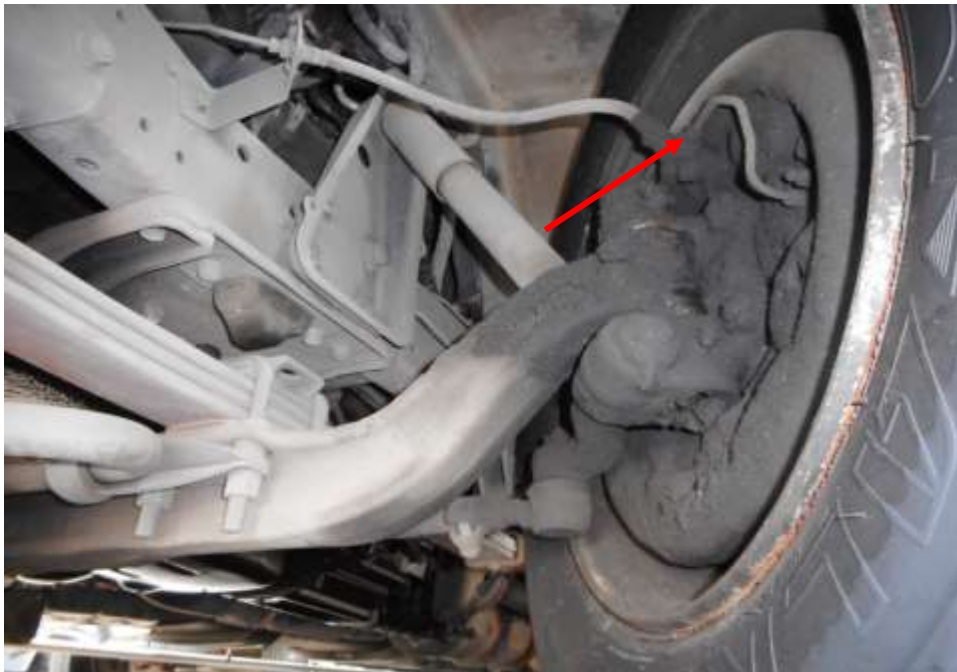
Photo 17 shows the brake pipe (arrowed) at the front right wheel of the Motor Bus. I did not observe any leakage of brake fluid at the time of my inspection of the Motor Bus. My static tests of the Motor Bus's braking system, along with my visual examination of the various mechanical components in the braking system, had indicated that there was no internal leakage of pressure/vacuum. Hence the braking system of the Motor Bus was likely to be in serviceable condition at the material time of accident.

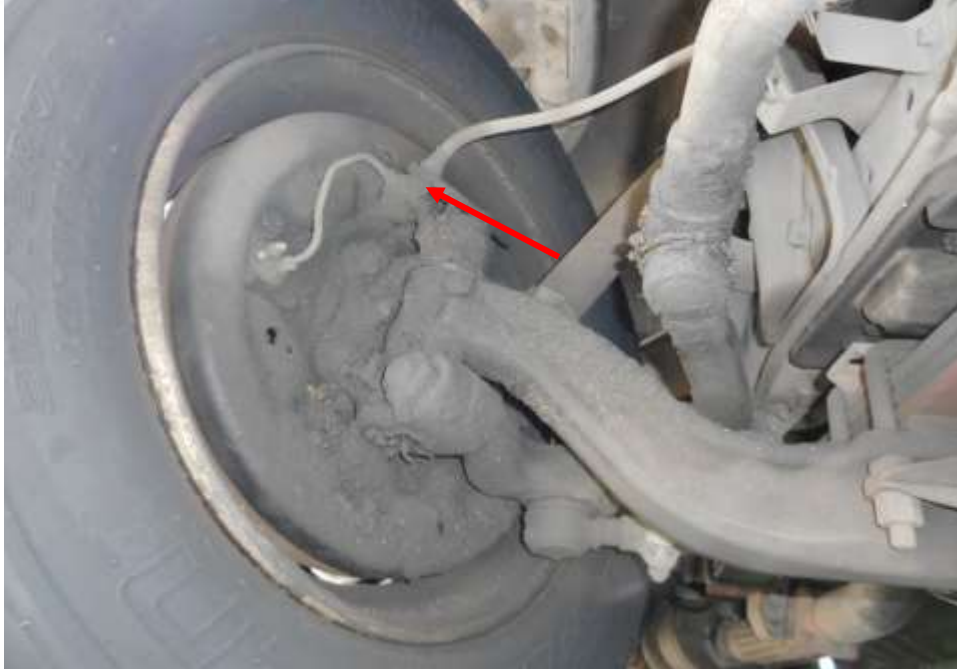
Photo 18 shows the brake pipe (arrowed) at the front left wheel of the Motor Bus. I did not observe any leakage of brake fluid at the time of my inspection of the Motor Bus. My static tests of the Motor Bus's braking system, along with my visual examination of the various mechanical components in the braking system had indicated that there was no internal leakage of pressure/vacuum. Hence the braking system of the Motor Bus was likely to be in serviceable condition at the material time of accident.

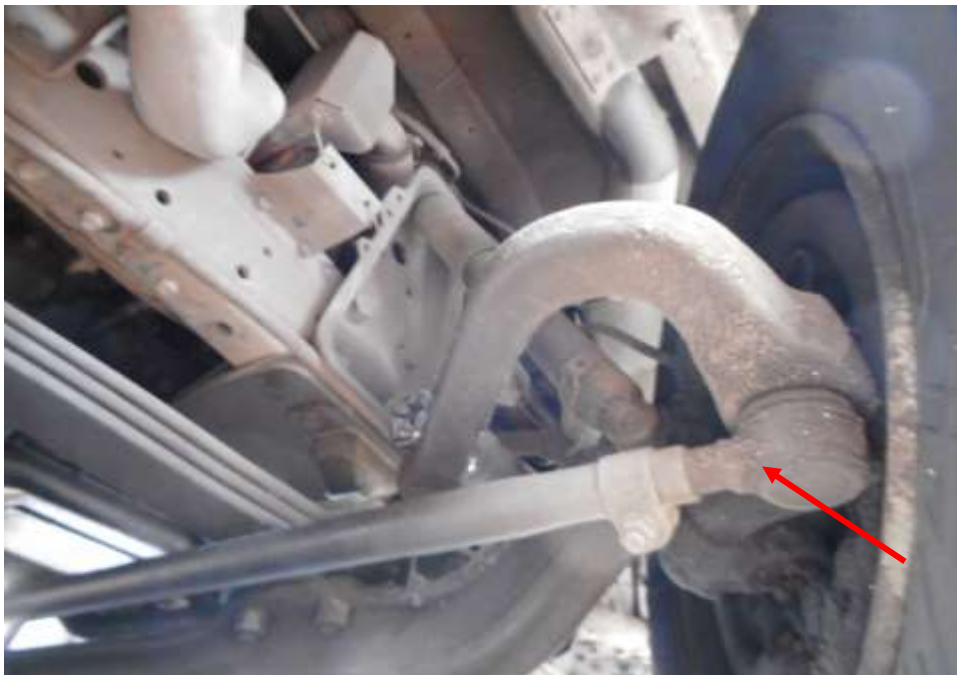
12. Static test on the steering system of the Motor Bus also revealed no abnormality to the steering system. I did not experience any abnormal free play and/or other resistance when turning the steering wheel left and right to full lock positions. My visual examination of the various steering components which had included the steering box, tie rods, tie rod ends and ball joints had revealed that these components were all generally in good condition. See photo 15 – 24 below.

Photo 19 shows the various undercarriage components at the front right wheel of the Motor Bus, in particular the steering tie rod end (arrowed). The various steering components were all found to be intact, suggesting that the steering system of the Motor Bus was likely to be in serviceable condition at the material time of accident. There was also no sign of fluid stain(s) observed on the various undercarriage components.

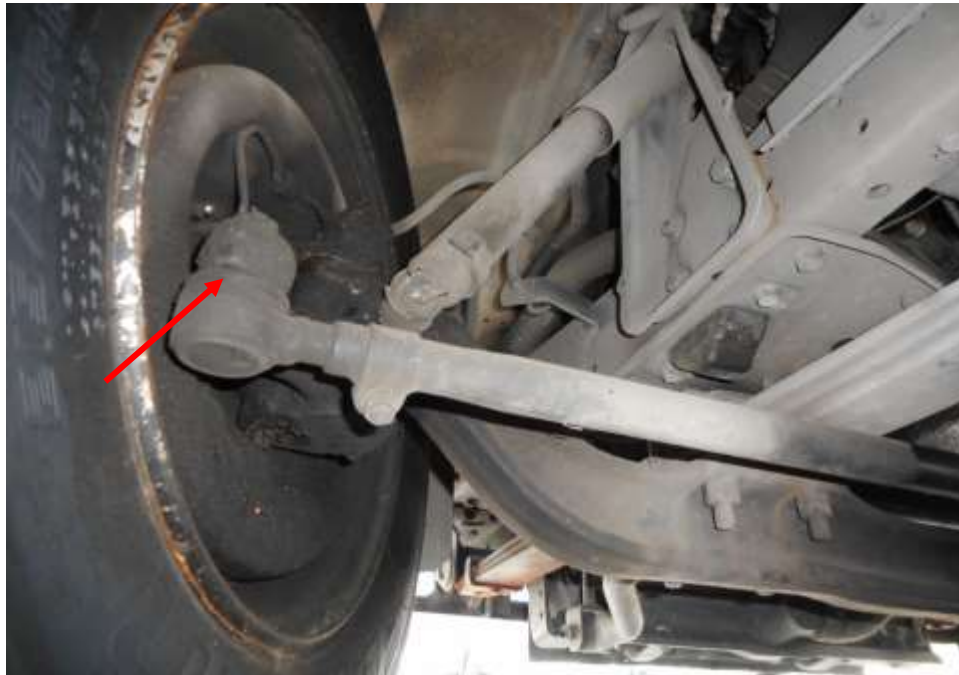
Photo 20 shows the various undercarriage components at the front left wheel of the Motor Bus, in particular the steering tie rod end (arrowed). The various undercarriage components of the Motor Bus were all found to be intact without any visible damage. There was also no sign of fluid stain(s) observed on the various undercarriage components.

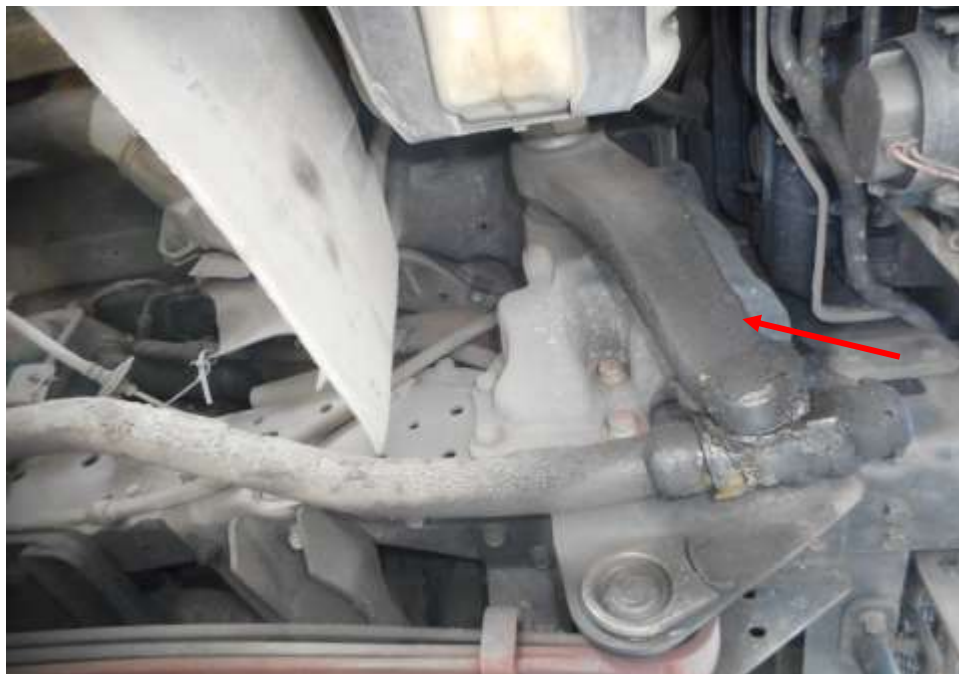
Photo 21 shows the steering box component (arrowed) at the undercarriage of the Motor Bus was found to be intact without any visible damage. There was also no sign of fluid stain(s) observed on the various undercarriage components.

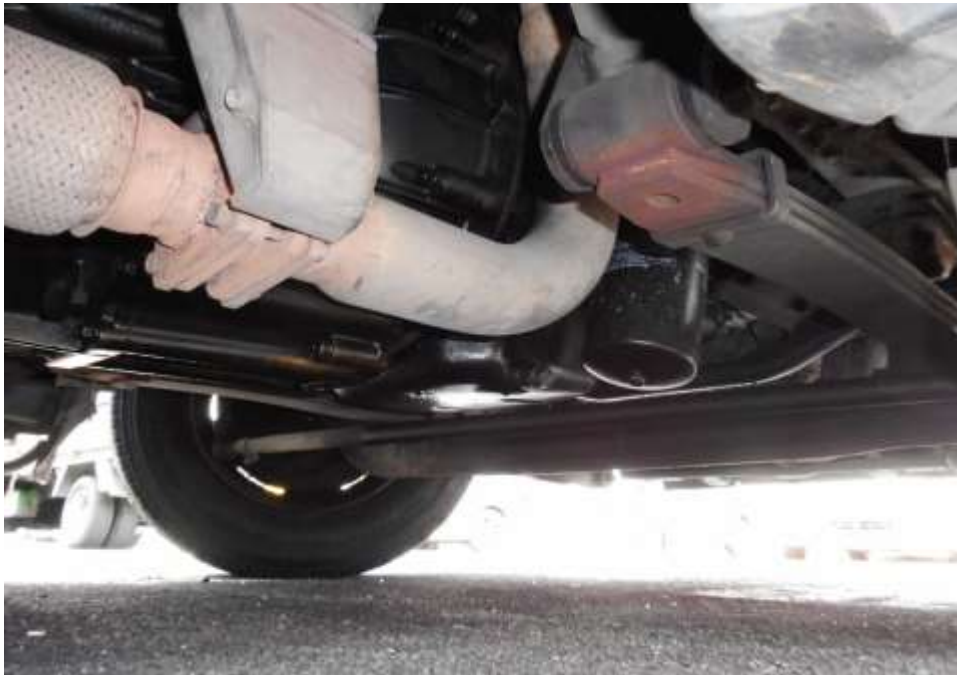
Photo 22 shows the undercarriage of the Motor Bus, at the area where the engine housing located. We observed minor fresh fluid stains on the surface of the engine oil sump. However the engine oils in the Motor Bus engine is sufficient and in serviceable condition.

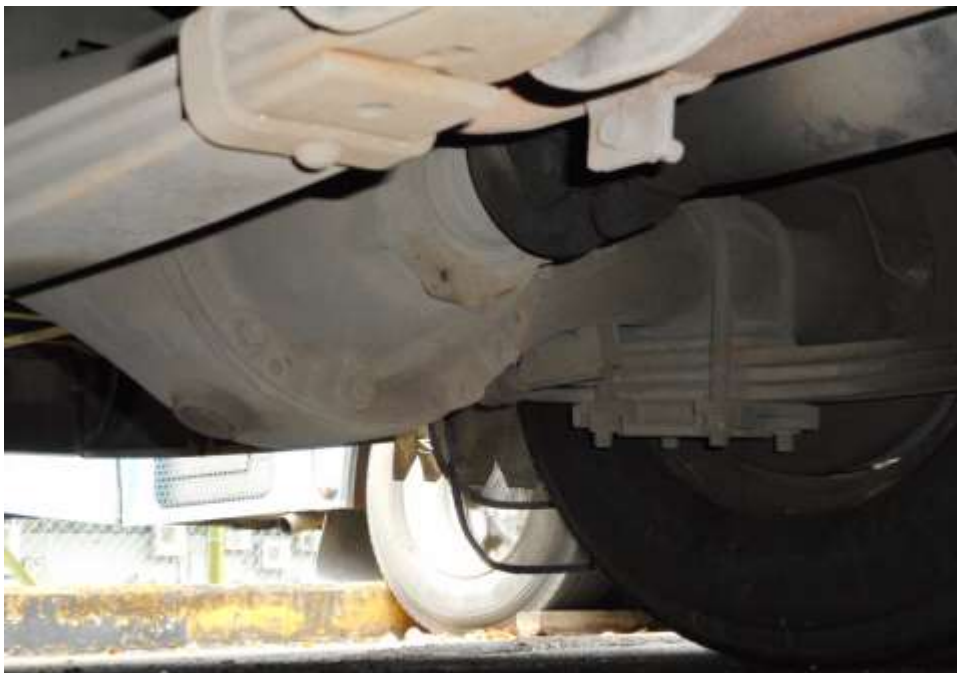
Photo 23 shows the undercarriage of the Motor Bus, at the area where the driveshaft housing is located. We observed it to be intact without any visible damage. There was also no sign of fluid stain(s) observed on the various undercarriage components.

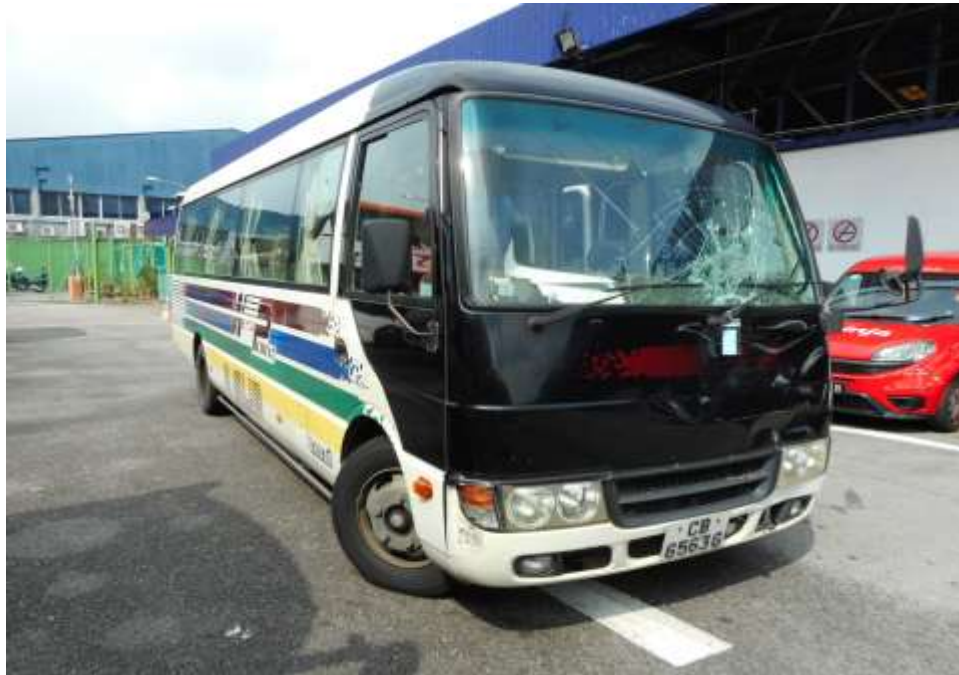
Photo 24 shows the front right wheel of the Motor Bus turned to its full left. During my steering system test, I did not experience any abnormal free play and/or resistance when I had turned the steering wheel towards full left and full right. This would suggest that the steering system of the Motor Bus was likely to be in serviceable condition at the material time of accident.

15. During the operational test, the various transmission gears of the Motor Bus were able to be engaged without any difficulty by stepping on the clutch pedal and manually shifting the gear lever. There were no abnormal sounds heard and/or abnormal behaviour of the Motor Bus's engine system. It was able to move forward and backward normally. The braking system was also found to be in working condition as the Motor Bus was able to slow down and come to a complete stop upon depressing of the brake pedal. Refer to photo 2 and 24.
