Your Ref: TP/IP/33089/2019
Our Ref : CI/TPD19011268/P

21st October 2019

MECHANICAL INSPECTION REPORT OF MOTOR LORRY GBB 5739K

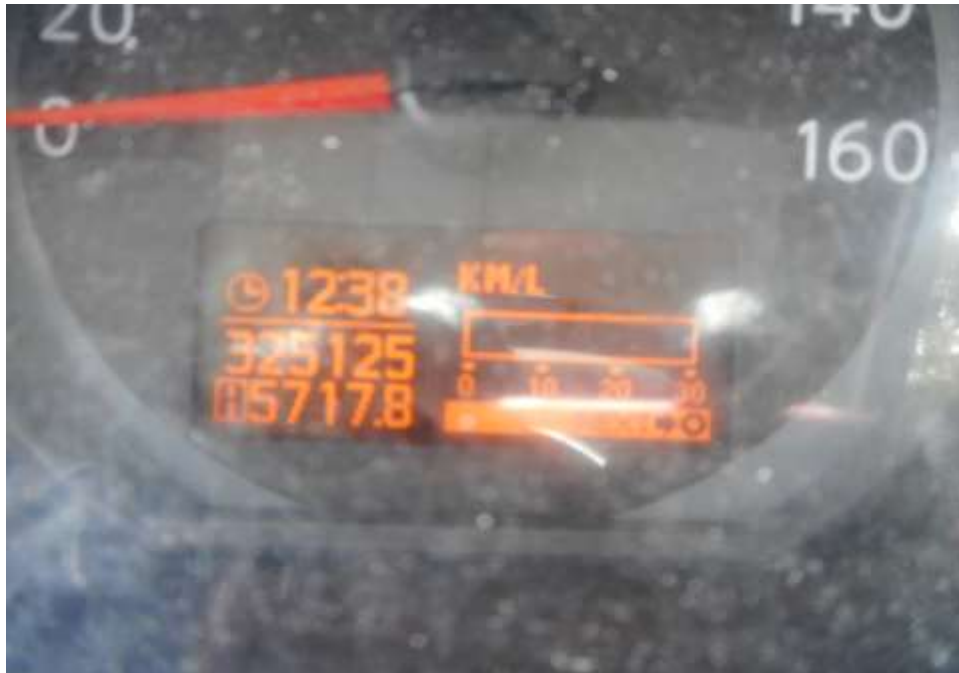
Photo 1 shows a general view of the instrument cluster of the Motor Lorry at the time of my inspection. The mileage of the Motor Lorry was 325,125km

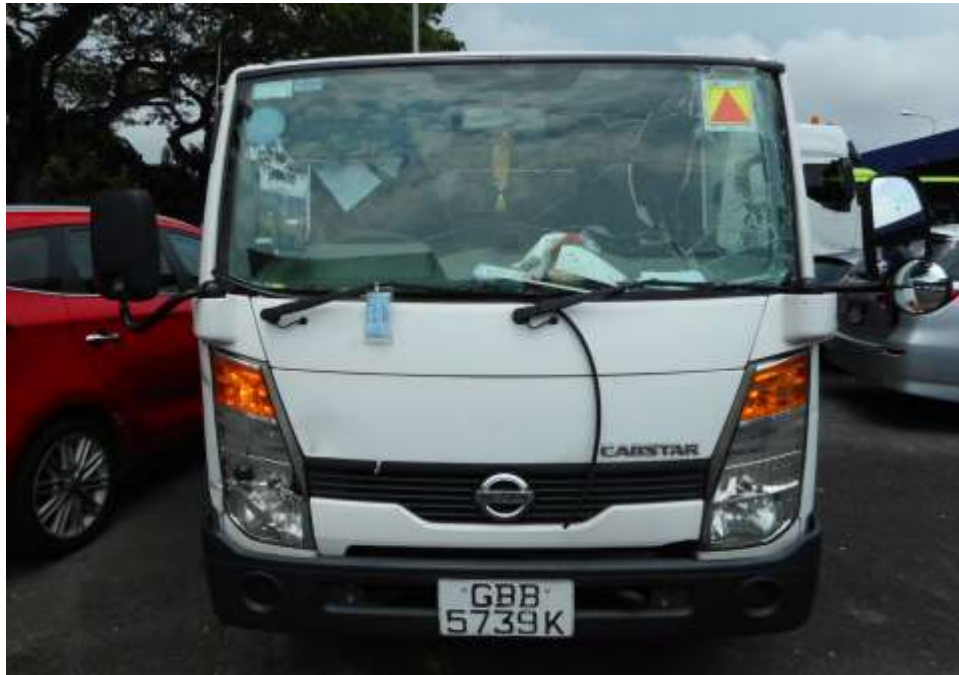
4. The mileage of the Motor Lorry at the time of my inspection was 325,125km.
5. The Motor Lorry appeared to have sustained moderate damage at its front portion. Its front windscreen, front right headlamp, left and right door panel were damage as a result of the accident at the time of my inspection.

Photo 2 shows a general view of the Motor Lorry's front portion at the time of my inspection. Its front windscreen, front right headlamp, left and right door panel were damage as a result of the accident at the time of my inspection

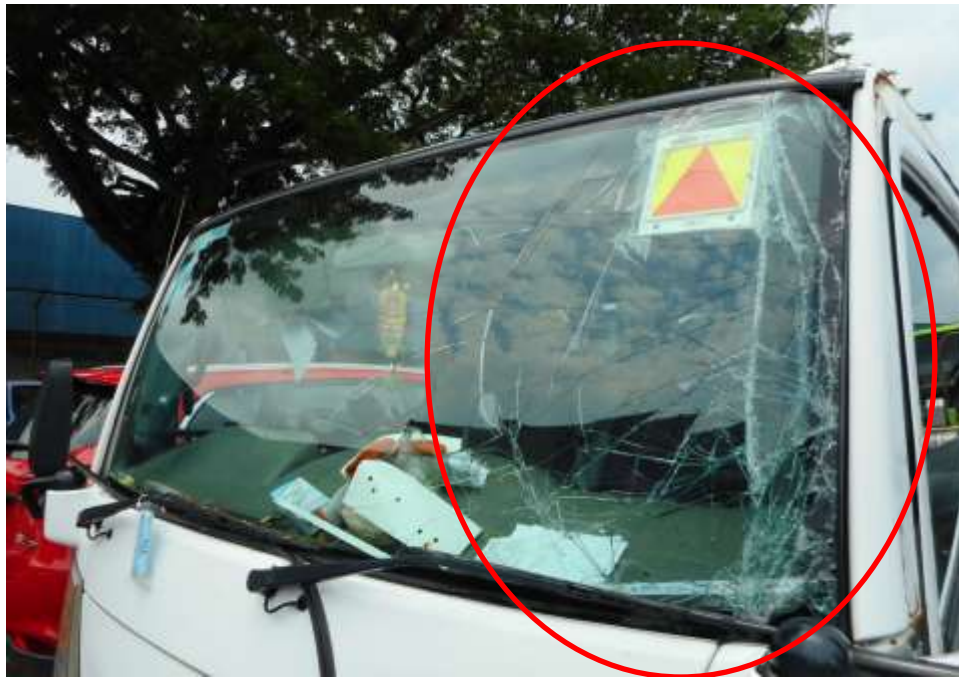
Photo 3 shows a close up view of the front portion of the Motor Lorry at the time of my inspection. Its front windscreen was damage as a result of the accident at the time of my inspection.

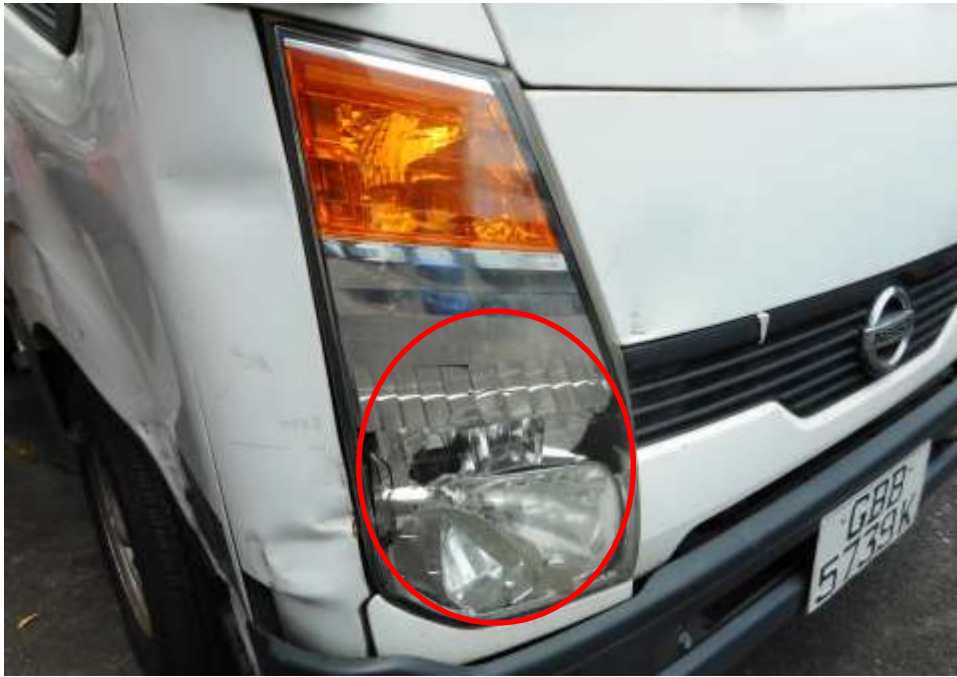
Photo 4 shows a close up view of the front portion of the Motor Lorry at the time of my inspection. Its front right headlamp was damage as a result of the accident at the time of my inspection.

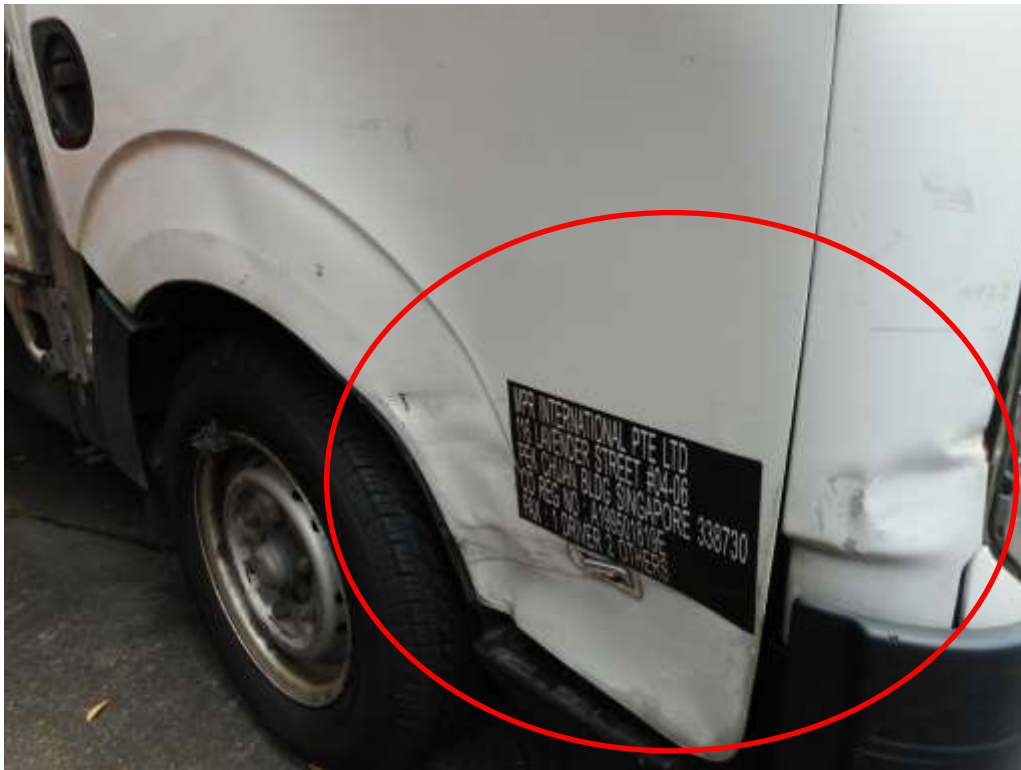
Photo 5 shows a close up view of the front portion of the Motor Lorry at the time of my inspection. Its right door panel was damage as a result of the accident at the time of my inspection.

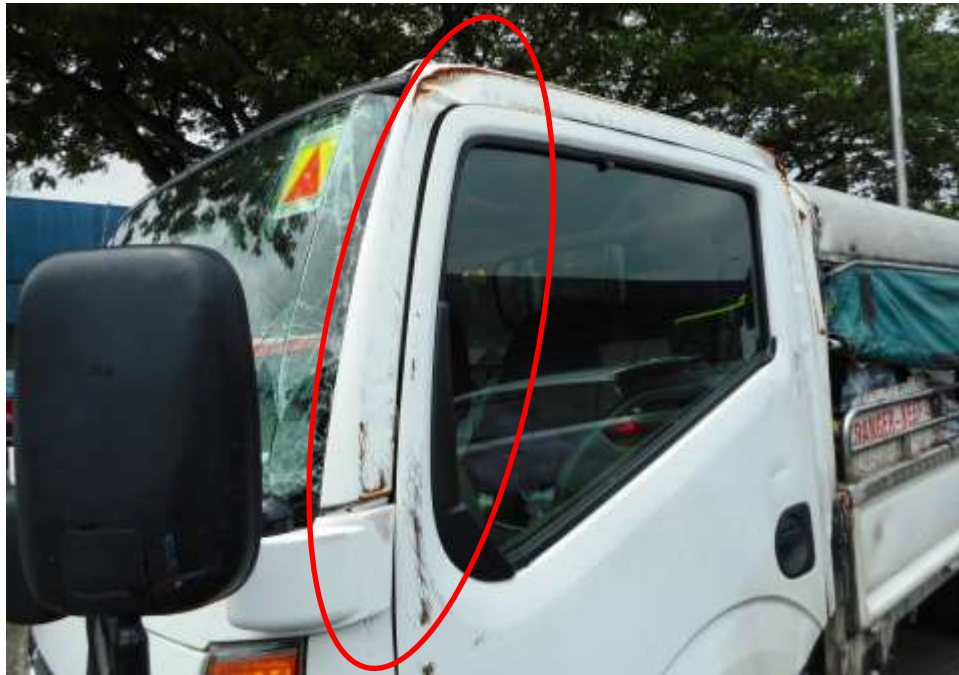
Photo 6 shows a general view of the left portion body of the Motor Lorry at the time of my inspection. Its left door panel was observed to be intact and unaffected by the accident.

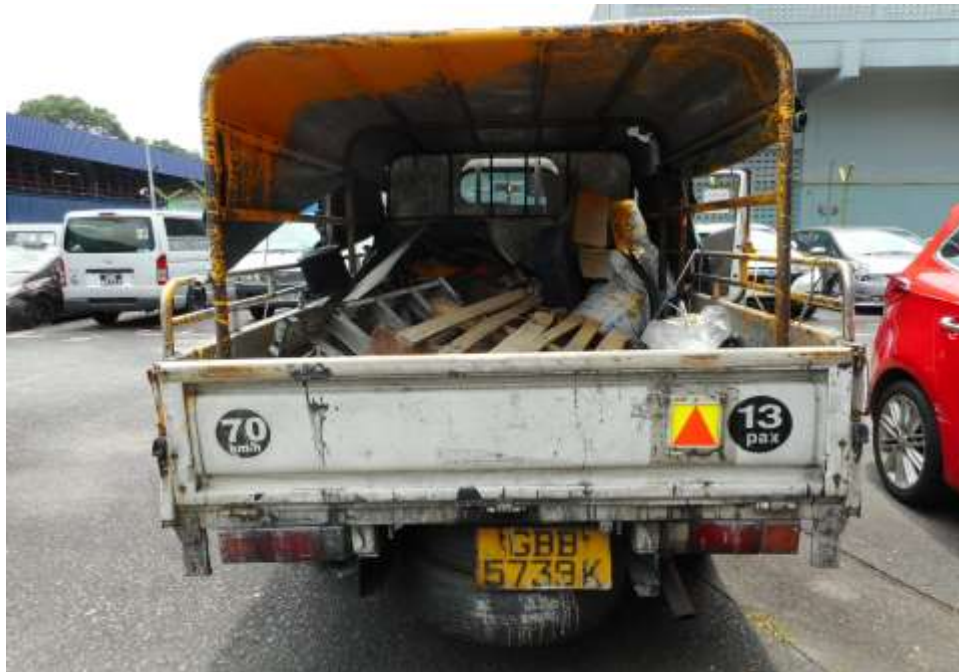
Photo 7 shows a general view of the rear portion body of the Motor Lorry at the time of my inspection. Its rear was observed to be intact and unaffected by the accident.

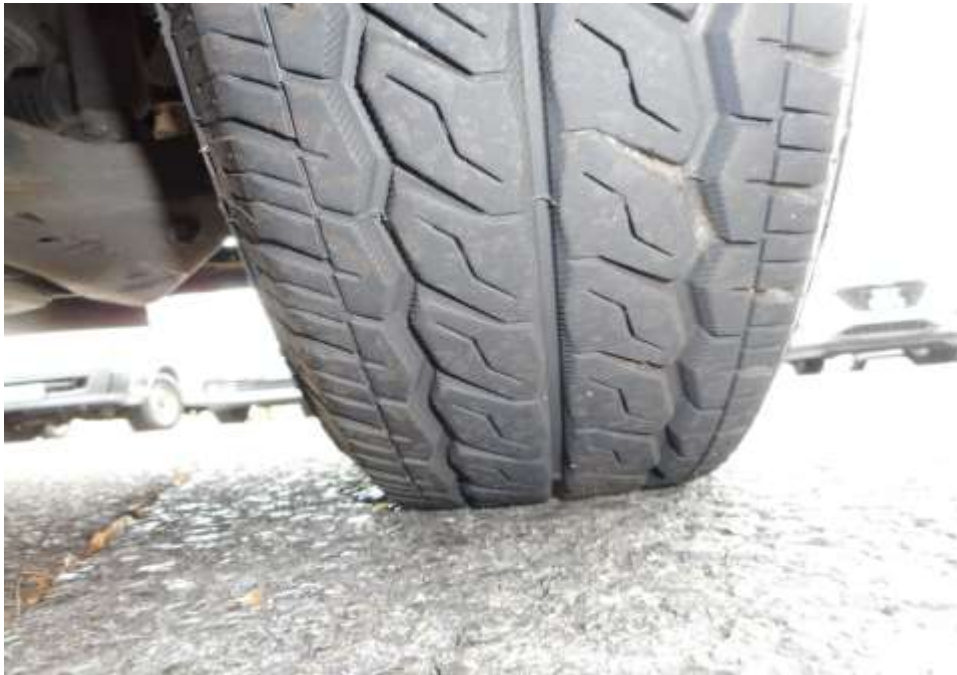
Photo 8 shows the condition of the front right tyre of the Motor Lorry, which was observed to be in serviceable condition with remaining tread depth of approximately 7.6mm. The tyre, which was wrapped around standard steel wheel rim, was also observed to be sufficiently inflated for vehicular operation. There was no tear, cut or burst mark(s) on the outer and the inner sidewalls as well as across the tread of the 6 tyres that were fitted on the Motor Lorry.

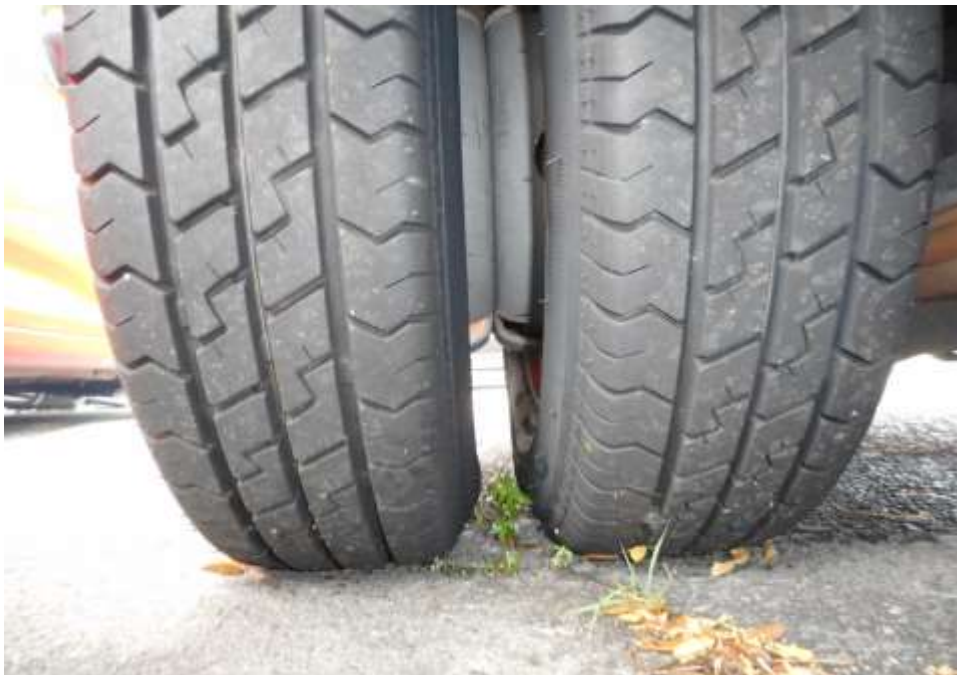
Photo 9 shows the condition of the rear right tyre of the Motor Lorry, which was observed to be in serviceable condition with remaining tread depth of approximately 7mm. The tyre, which was wrapped around standard steel wheel rim, was also observed to be sufficiently inflated for vehicular operation.

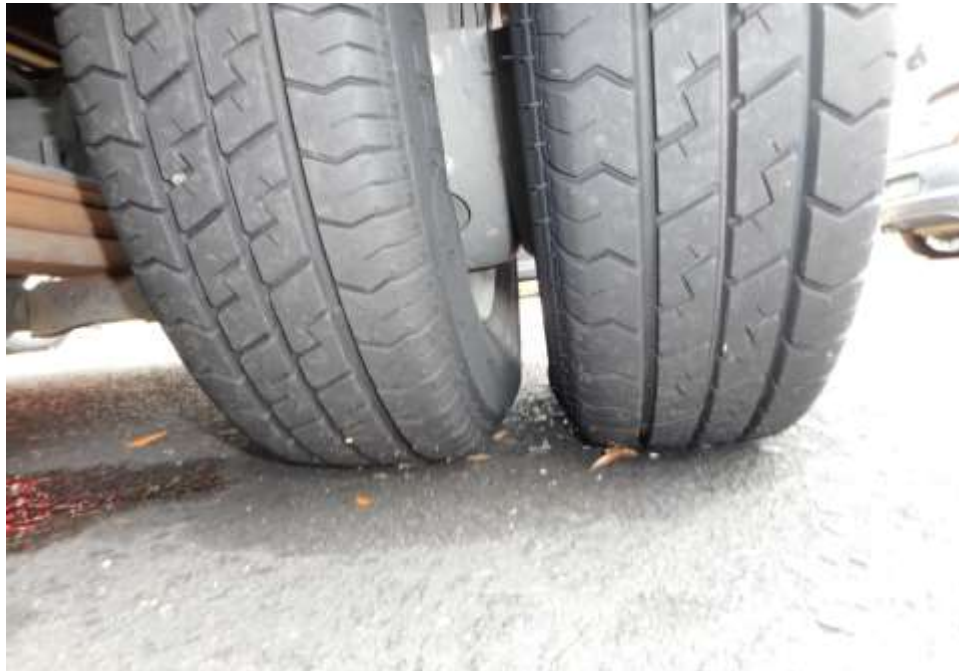
Photo 10 shows the condition of the rear left tyres of the Motor Lorry, which was observed to be in serviceable condition with remaining tread depth of approximately 7.3mm. The tyres, which were wrapped around standard steel wheel rim, were also observed to be sufficiently inflated for vehicular operation. There was also no damage found on all 6 steel wheel rims of the Motor Lorry.

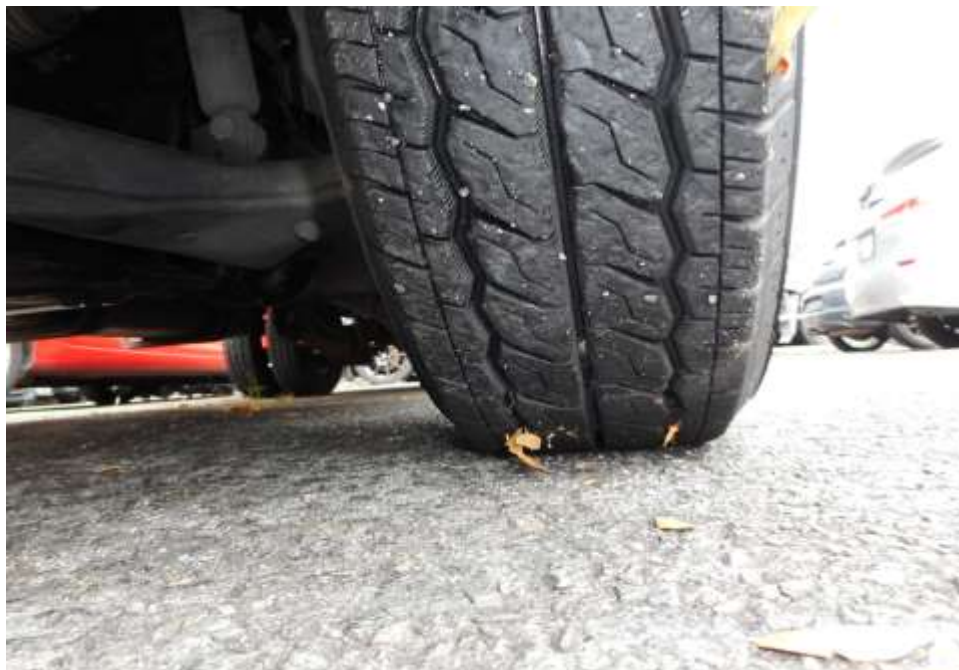
Photo 11 shows the condition of the rear right tyres of the Motor Lorry, which were observed to be in serviceable condition with remaining tread depth of approximately 7.7mm. There was also no tear, cut or burst mark(s) on the outer and the inner sidewalls as well as across the tread of the 6 tyres that were fitted on the Motor Lorry.

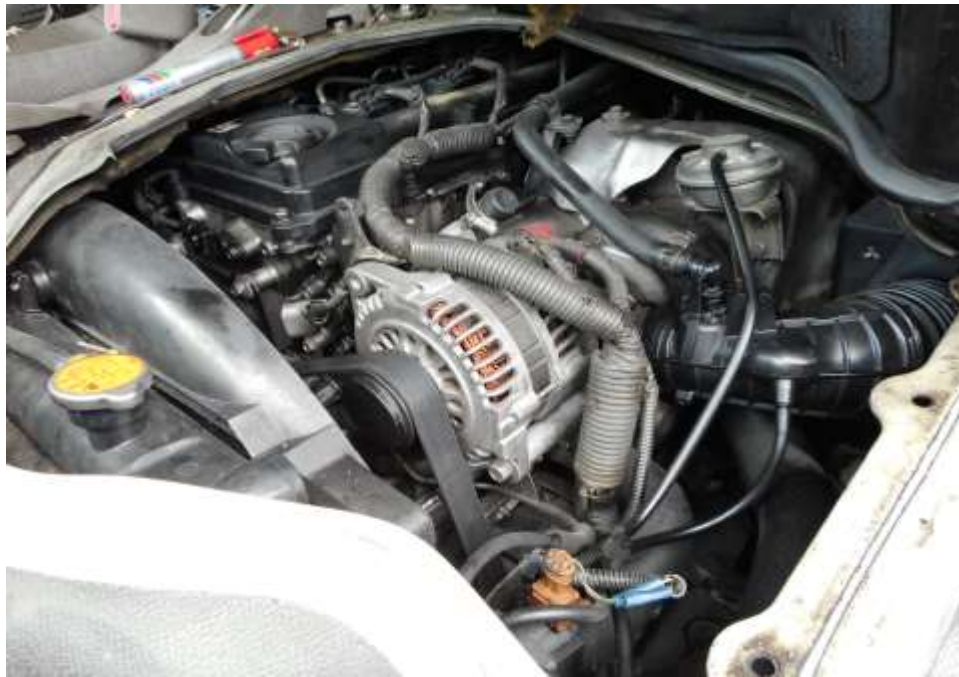
Photo 12 shows a general view of the Motor Lorry's engine compartment, which was accessed by lifting the front cabin of the Motor Lorry. The various parts and components inside the engine compartment were unaffected by the accident. There was also no sign(s) or indication(s) of fresh fluid leakage and/or fluid stain within the engine compartment (photograph shows the engine compartment as viewed from the right front side of the Motor Lorry).

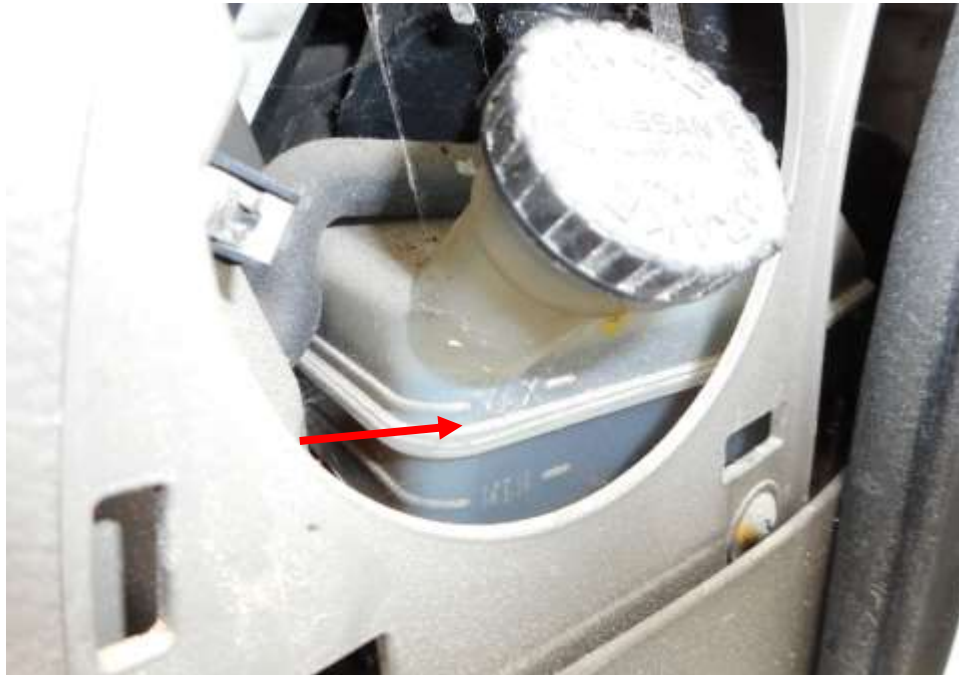
Photo 13 shows the brake fluid reservoir of the Motor Lorry at the time of my inspection. The brake fluid was observed to be of sufficient level (arrowed) and without any visible contamination.

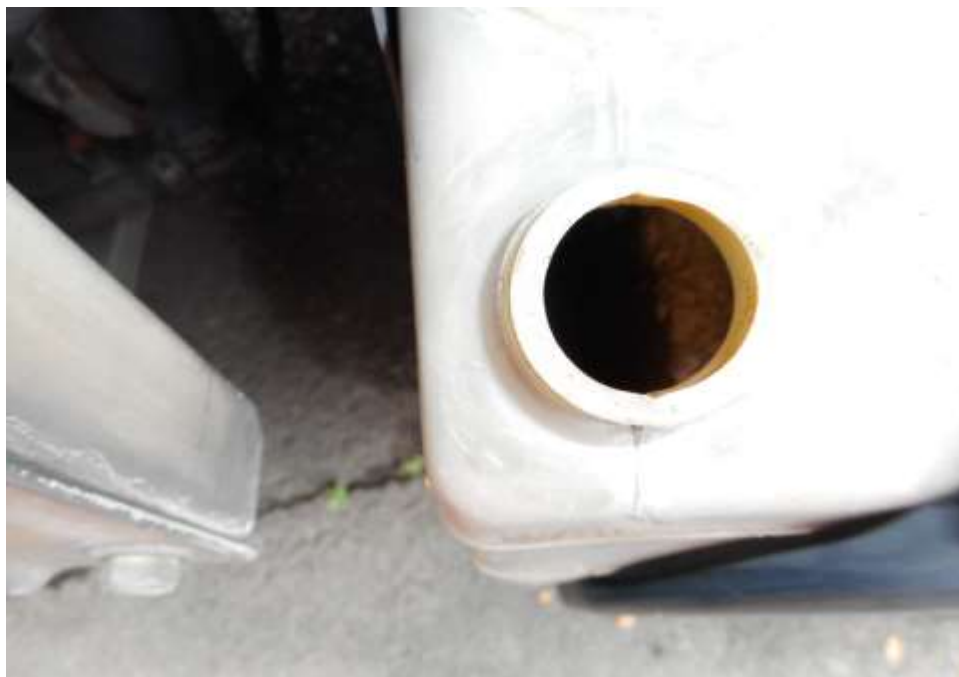
Photo 14 shows the engine coolant reservoir of the Motor Lorry at the time of my inspection. The engine coolant was observed to be of sufficient level and without any visible contamination.

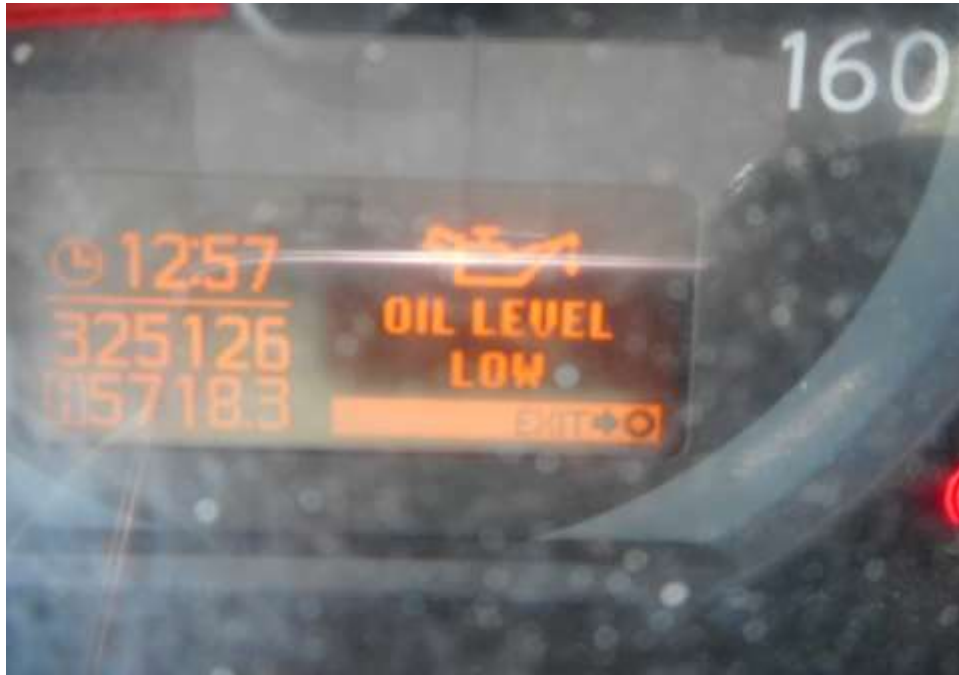
Photo 15 shows the engine oil dipstick of the Motor Lorry at the time of my inspection. The engine oil was observed to be low but sufficient level for operation and without any visible contamination.

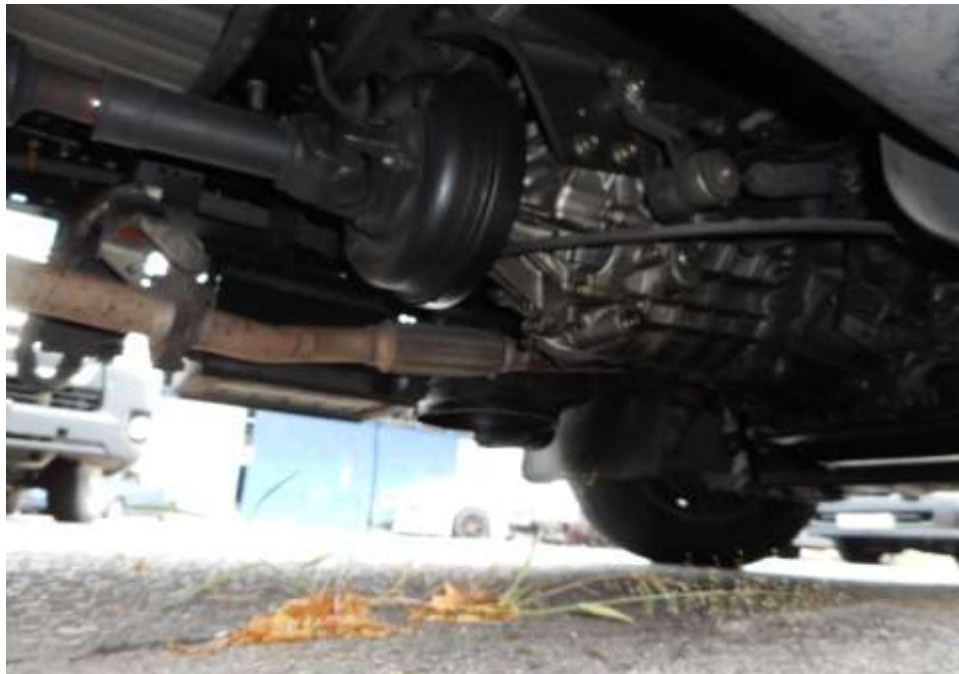
Photo 16 shows the undercarriage of the Motor Lorry, at the area where the engine housing and transmission housing are located. Observed was minor old engine oil stain on the housing of the engine oil sump

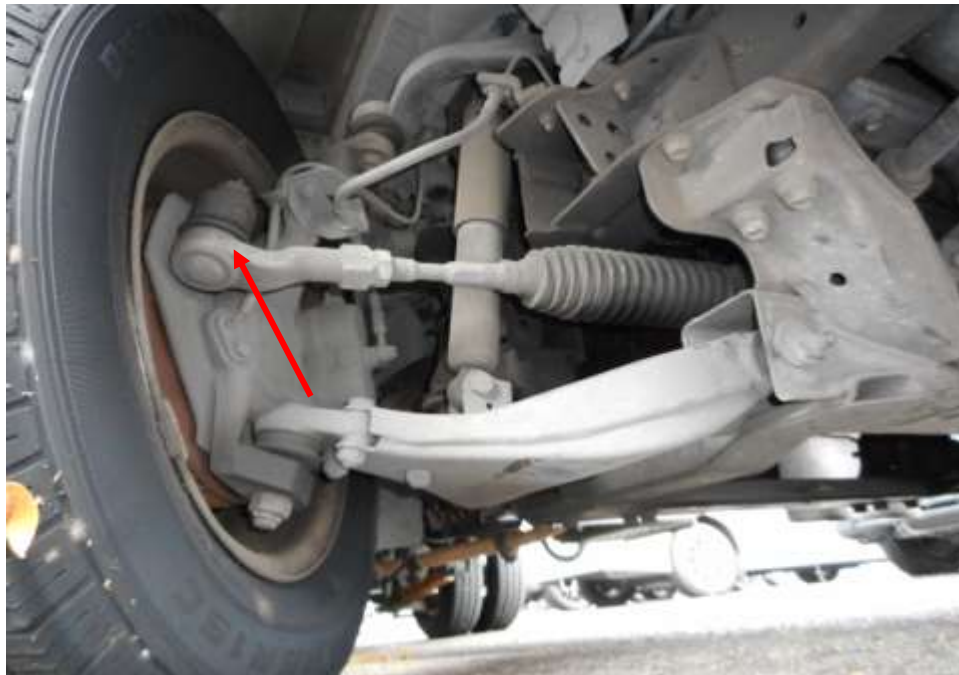
Photo 17 shows the various undercarriage components at the front right wheel of the Motor Lorry, in particular the steering tie rod end (arrowed). The various steering components were all found to be intact, suggesting that the steering system of the Motor Lorry was likely to be in serviceable condition at the material time of accident. There was also no sign of fluid stain(s) observed on the various undercarriage components.

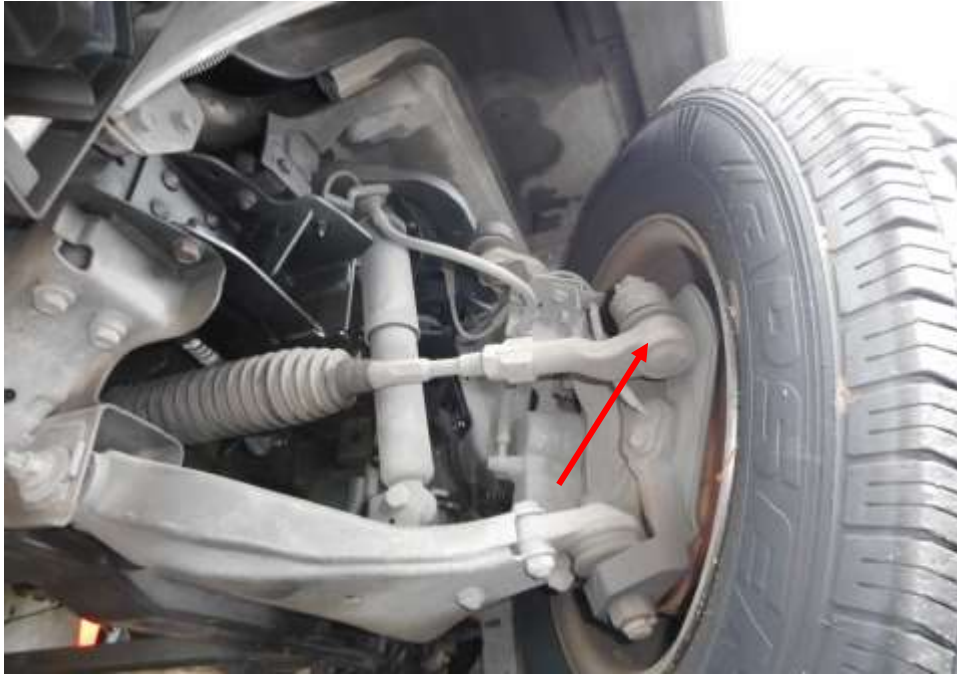
Photo 18 shows the various undercarriage components at the front left wheel of the Motor Lorry, in particular the steering tie rod end (arrowed). The various Undercarriage components of the Motor Lorry were all found to be intact without any visible damage. There was also no sign of fluid stain(s) observed on the various undercarriage components.

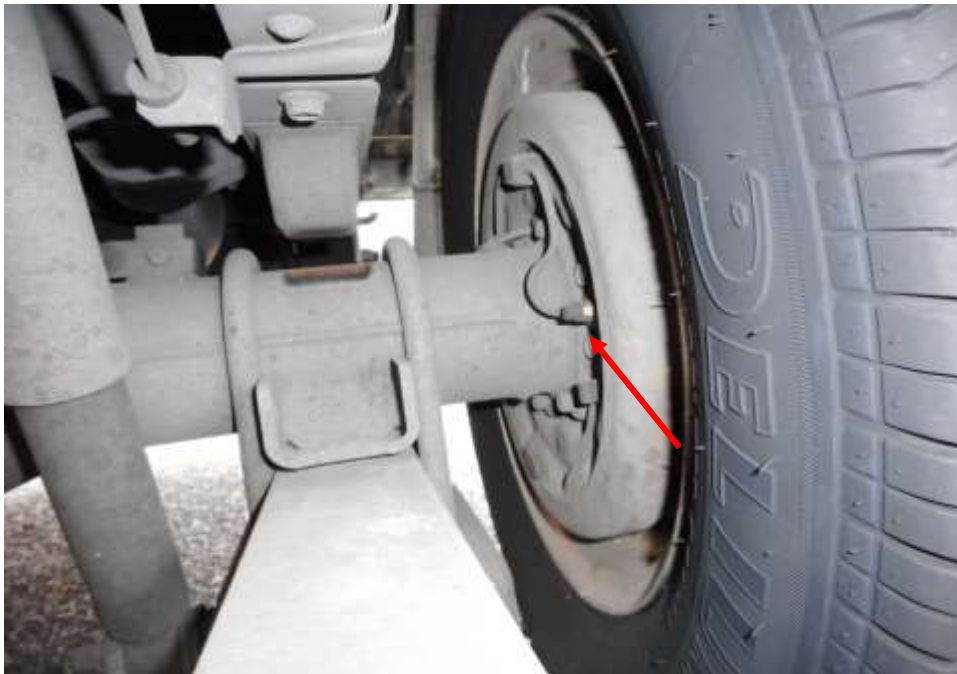
Photo 19 shows the brake pipe (arrowed) at the rear right wheel of the Motor Lorry. I did not observe any leakage of brake fluid at the time of my inspection of the Motor Lorry. My static tests of the Motor Lorry's braking system, along with my visual examination of the various mechanical components in the braking system, had indicated that there was no internal leakage of pressure/vacuum. Hence the braking system of the Motor Lorry was likely to be in serviceable condition at the material time of accident.

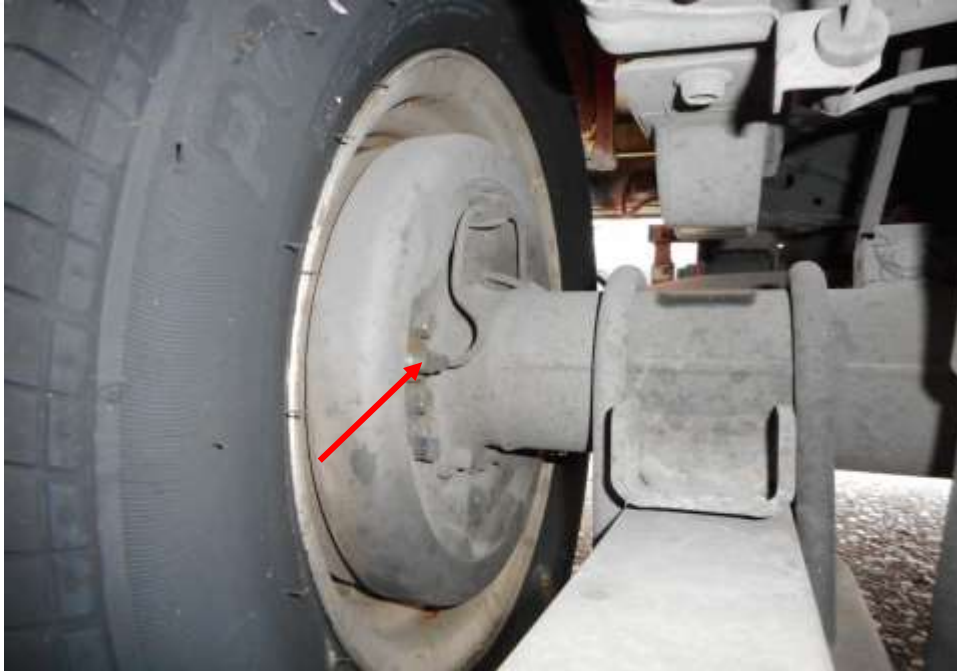
Photo 20 shows the brake pipe (arrowed) at the rear left wheel of the Motor Lorry. I did not observe any leakage of brake fluid at the time of my inspection of the Motor Lorry. My static tests of the Motor Lorry's braking system, along with my visual examination of the various mechanical components in the braking System had indicated that there was no internal leakage of pressure/vacuum. Hence the braking system of the Motor Lorry was likely to be in serviceable condition at the material time of accident.

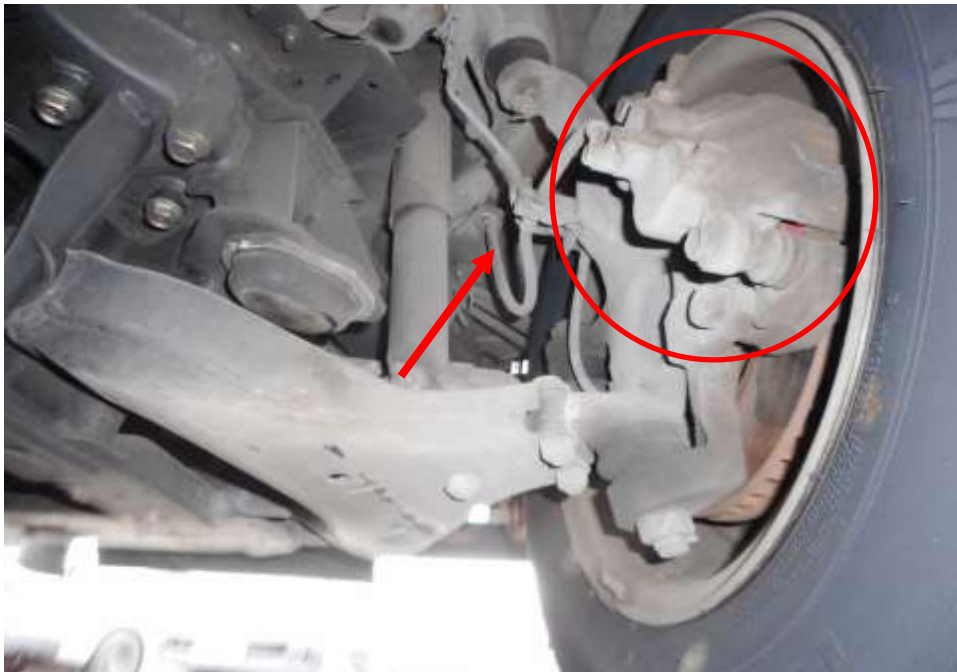
Photo 21 shows the brake hose/pipe (arrowed) at the front right wheel of the Motor Lorry. No leakage of brake fluid was observed. Visual examination of the various components of the braking system like the brake caliper (circled), brake booster, brake pedal etc had revealed all to be intact and without visible damage at the time of accident. There was also no sign of fluid stain(s) observed on the various undercarriage components.

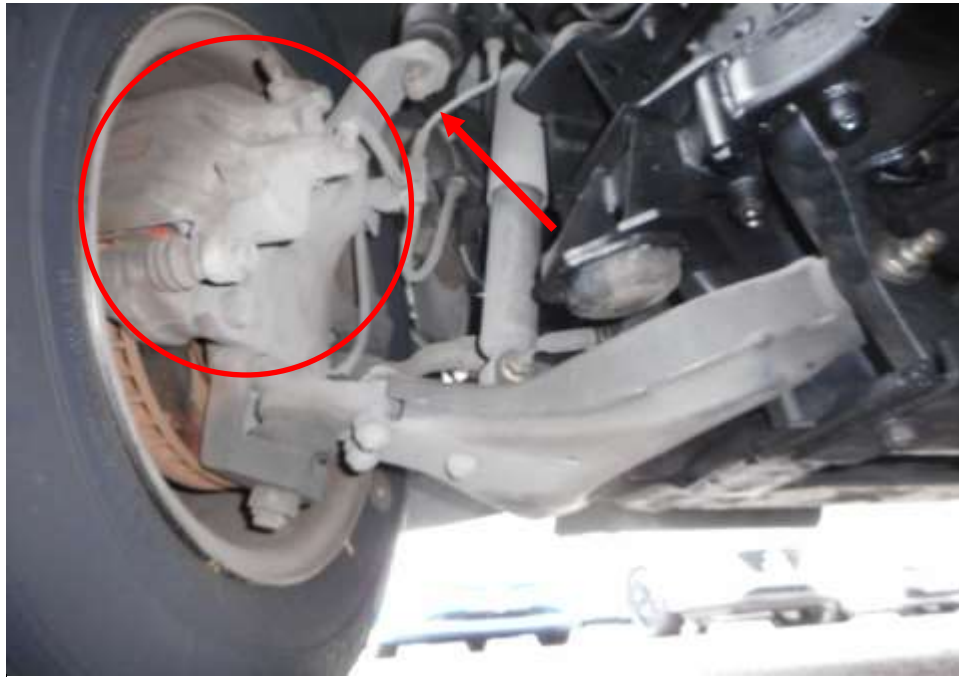
Photo 22 shows the brake hose/pipe (arrowed) at the front left wheel of the Motor Lorry. No leakage of brake fluid was observed. Visual examination of the various components of the braking system like the brake caliper (circled), brake booster, brake pedal etc had revealed all to be intact and without visible damage at the time of accident. There was also no sign of fluid stain(s) observed on the various undercarriage components.

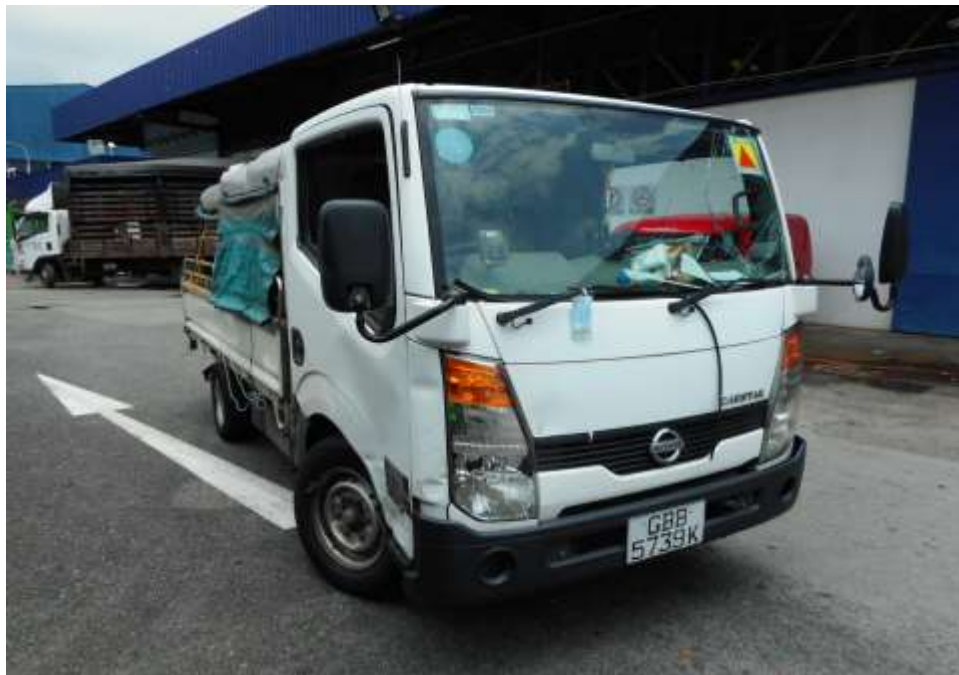
Photo 23 shows the front right wheel of the Motor Lorry turned to its full left. During my steering system test, I did not experience any abnormal free play and/or resistance when I had turned the steering wheel towards full left and full right. This would suggest that the steering system of the Motor Lorry was likely to be in serviceable condition at the material time of accident.

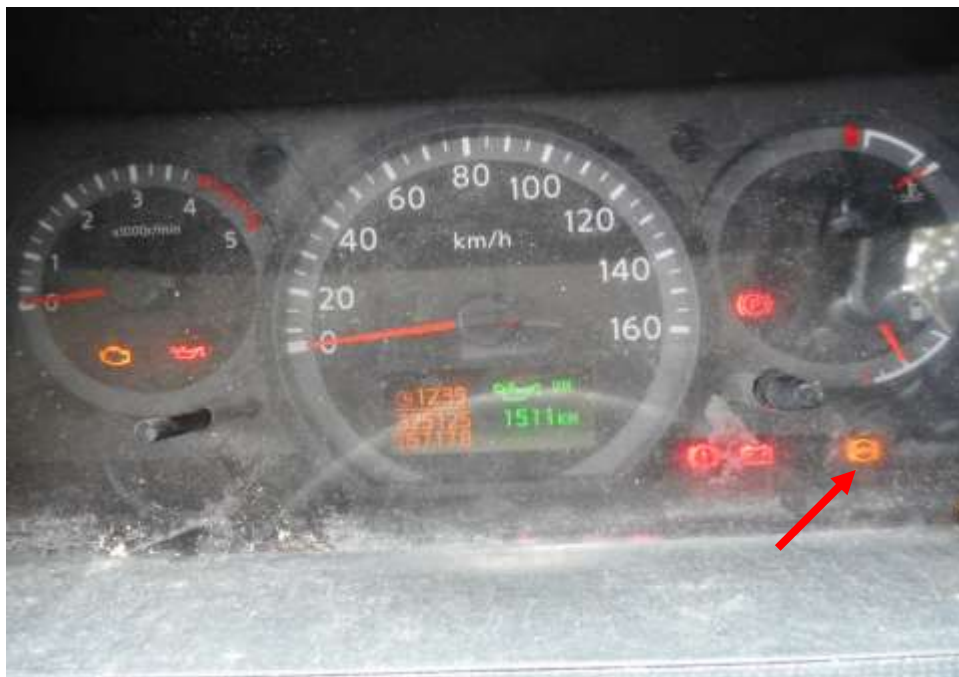
Photo 24 shows the warning light for Anti-Lock Brake System (ABS) (arrowed) appearing on the instrument panel of the Motor Lorry during the self-test of its various electronic operating system when its engine was cranked.

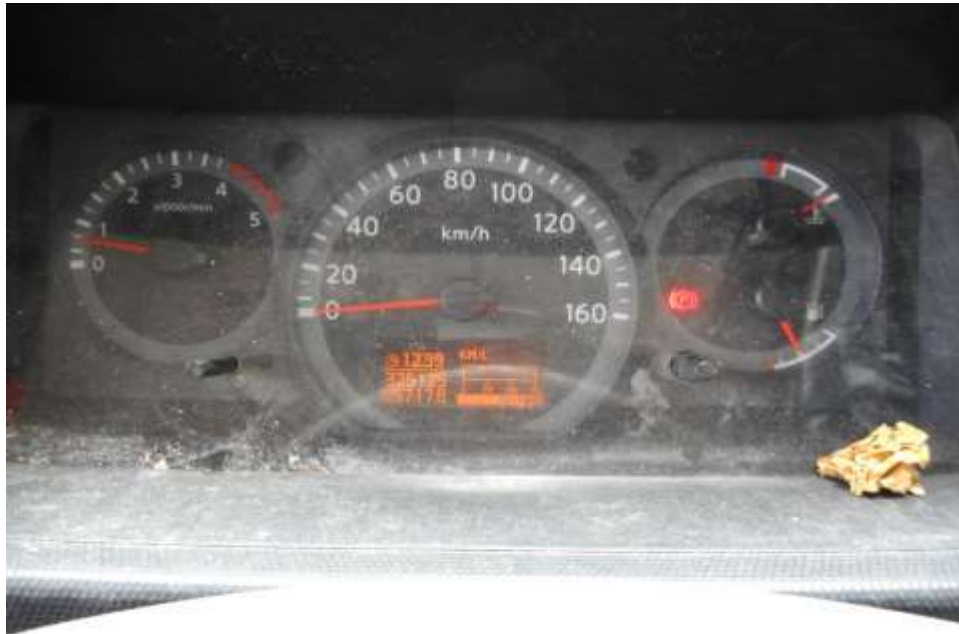
Photo 25 shows no warning lights illuminated on the instrument panel of the Motor Lorry after the engine was cranked. This would suggest that there was no abnormality to the various electronic operating system of the Motor Lorry, like the ABS and etc.

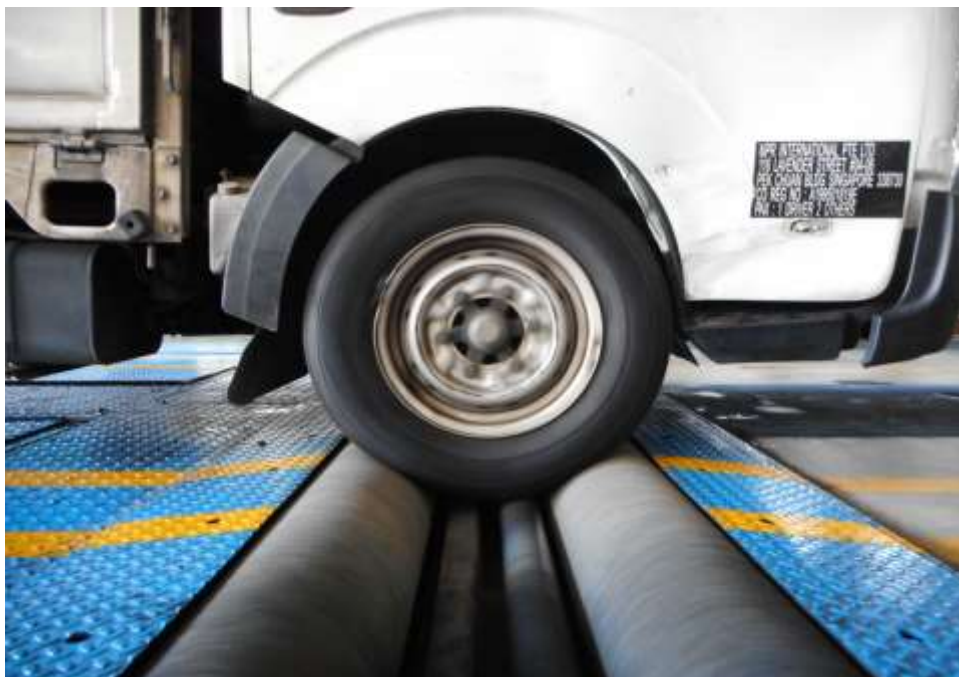
Photo 28 shows the Motor Lorry front right wheel on the roller brake test machine upon testing process. The purpose is to test the braking efficiency of the Motor lorry's braking system at the point of accident.

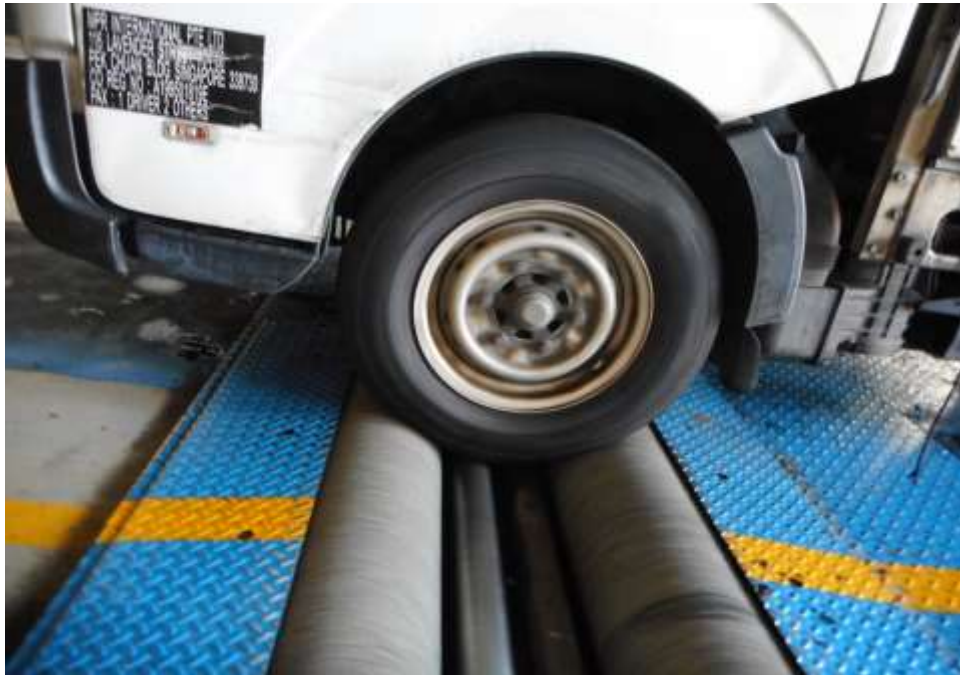
Photo 29 shows the Motor Lorry front left wheel on the roller brake test machine upon testing process. The purpose is to test the braking efficiency of the Motor lorry's braking system at the point of accident.

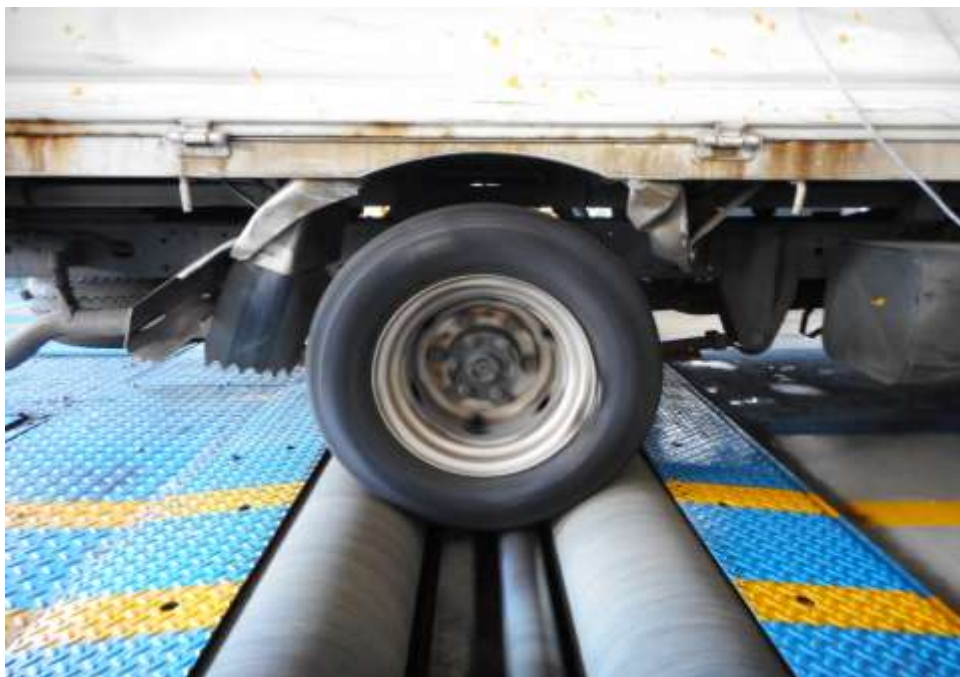
Photo 30 shows the Motor Lorry rear right wheel on the roller brake test machine upon testing process. The purpose is to test the braking efficiency of the Motor lorry's braking system at the point of accident.

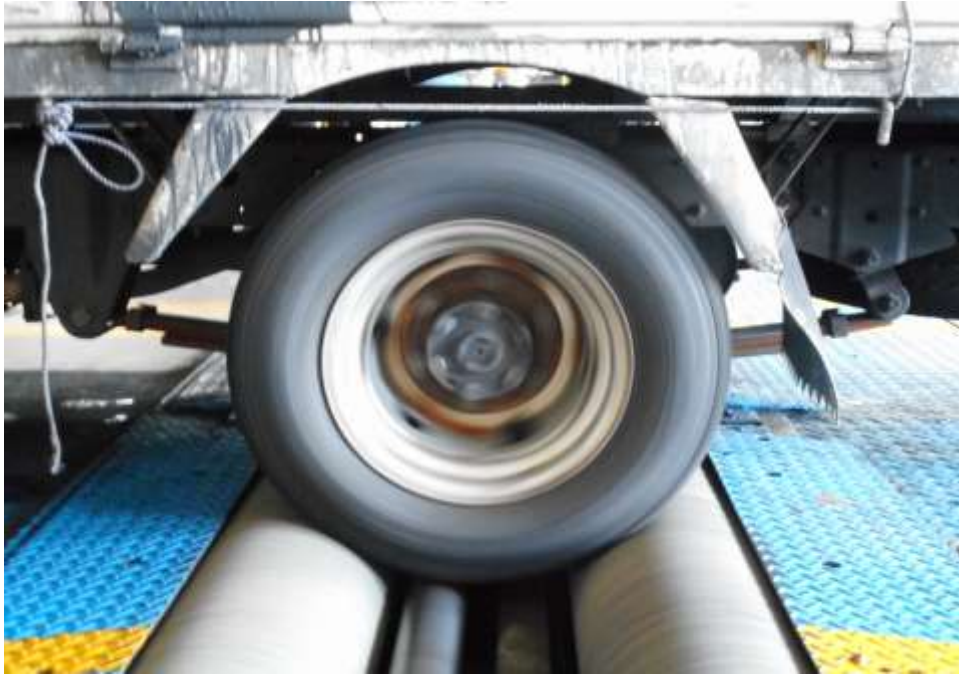
Photo 31 shows the Motor Lorry rear left wheel on the roller brake test machine upon testing process. The purpose is to test the braking efficiency of the Motor lorry's braking system at the point of accident.
