Your Ref: TP/IP/22305/2019  
Our Ref : CI/TPD19011270/P

**Fatal Accident Investigation Team**

**MECHANICAL INSPECTION REPORT OF MOTOR CAR SLT 9282X**

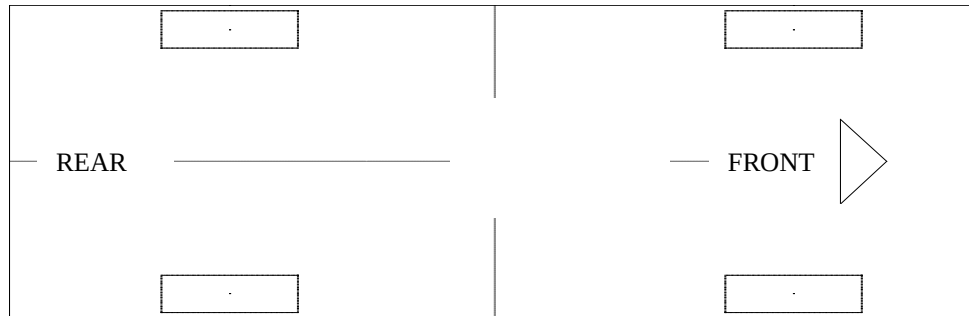
6. The condition of the Motor Car's 4 tyres was observed to be in serviceable condition. I did not find any tear, cut or burst mark(s) on the outer and the inner sidewalls as well as across the tread of the 4 tyres. The 4 tyres were also observed to be sufficiently inflated for vehicular operation. The tyre brand, tyre size and remaining tread depth of the 4 tyres were recorded as follows:-

Pirelli 215/55R17 (4.5mm)

Kinforest 215/55R17 (6.7mm)

Pirelli 215/55R17 (4.6mm)

Kinforest 215/55R17 (7.5mm)

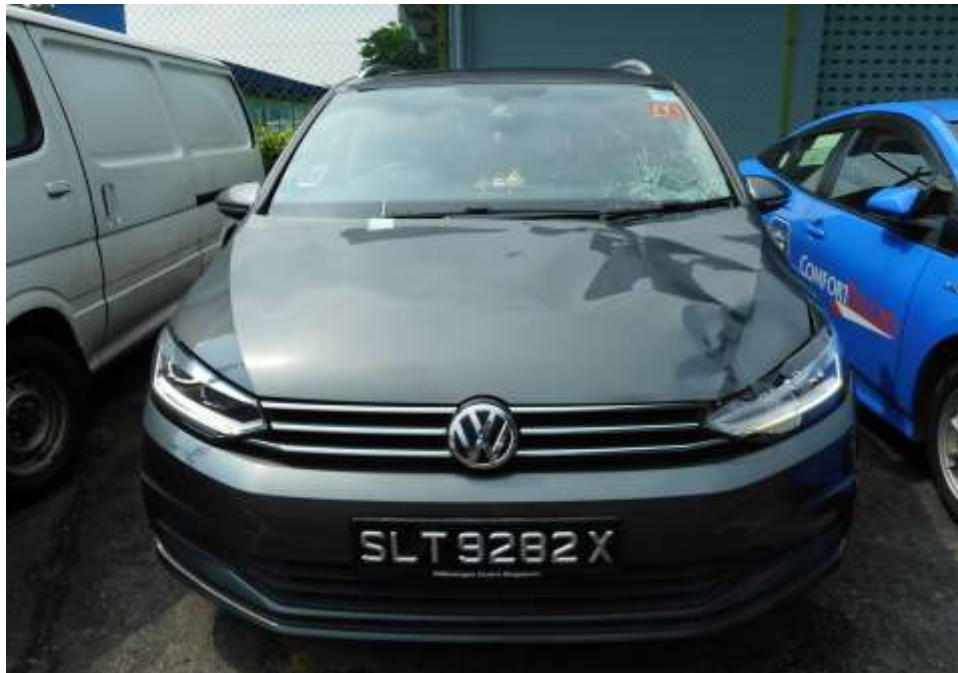
4. The mileage of the Motor Car at the time of my inspection was 51,171km.
5. The Motor Car was observed to have sustained damage at its front portion. Its front windscreen, front bonnet and front left headlamp were amongst the body parts that were damaged as a result of the accident.

**Photo 1** shows a general view of the Motor Car's front body at the time of my inspection. The Motor Car was observed to have sustained damage at its frontal portion. Its front windscreen, front bonnet and front left headlamp were amongst the body parts that were damaged as a result of the accident.

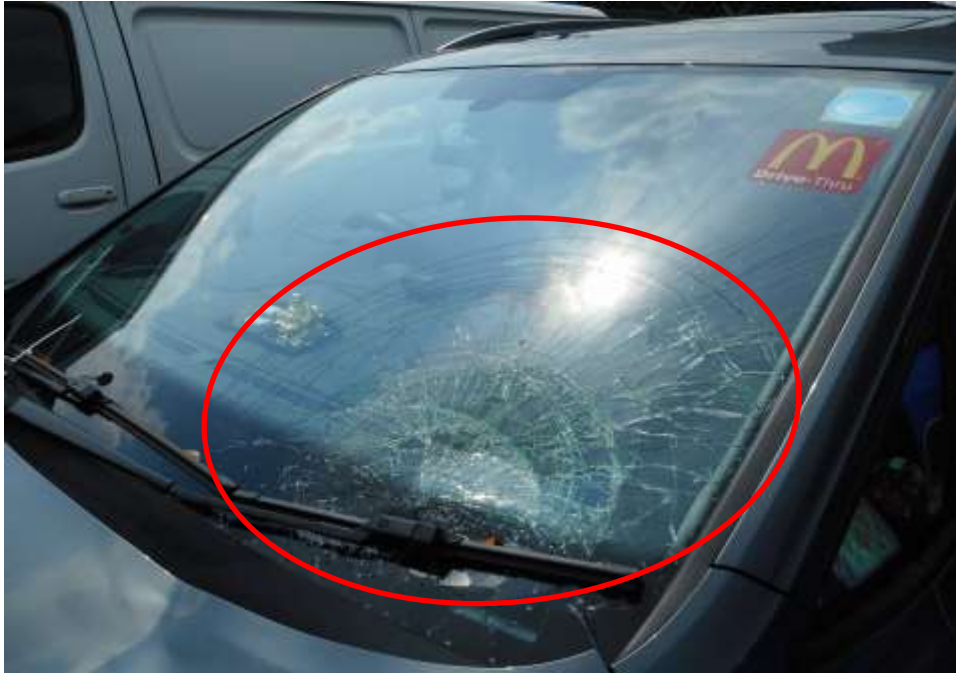
**Photo 2** shows the close up view of the Motor Car's front body at the time of my inspection. The Motor Car was observed to have sustained damage at its front windscreen (circled) as a result of the accident.

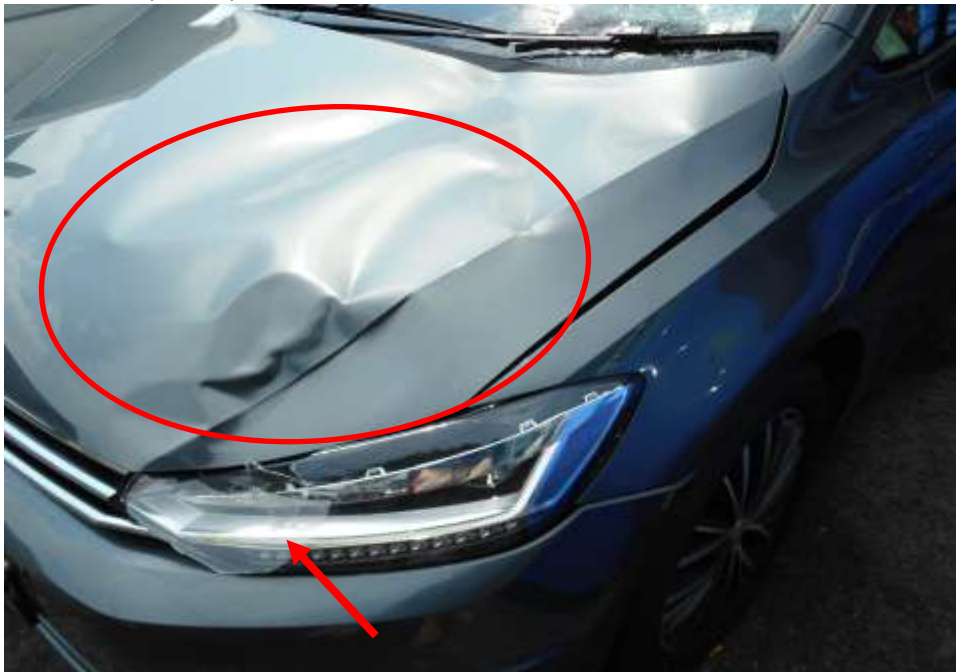
**Photo 3** shows the close up view of the Motor Car's front body at the time of my inspection. The Motor Car was observed to have sustained damage at its front bonnet (circled) and left headlamp (arrowed) as a result of the accident.

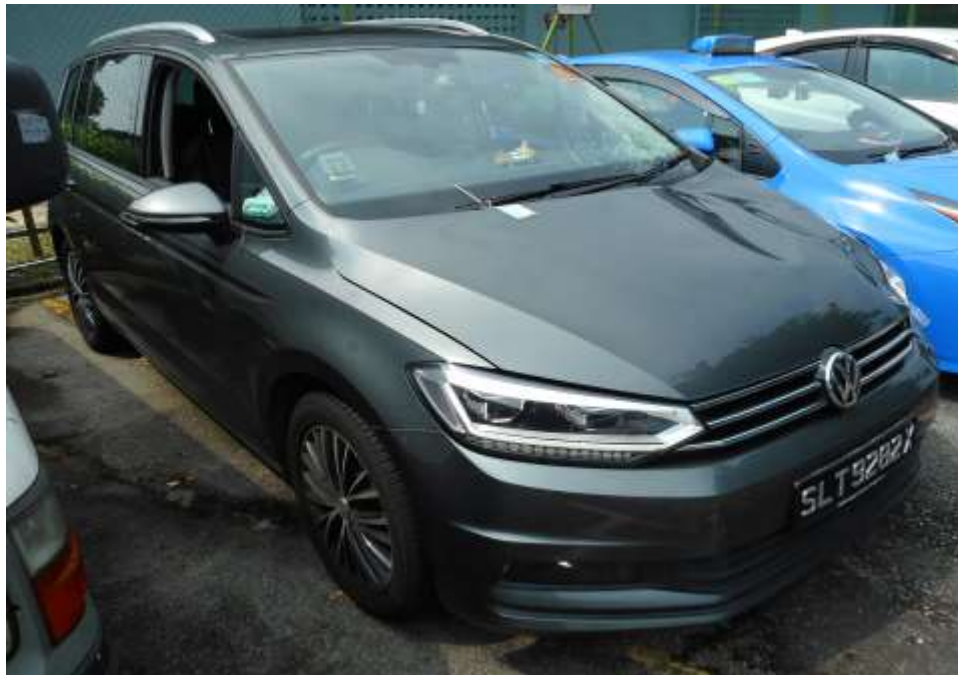
**Photo 4** shows a general view of the Motor Car's right body at the time of my inspection. The right portion of the Motor Car was observed to have been unaffected by the accident.

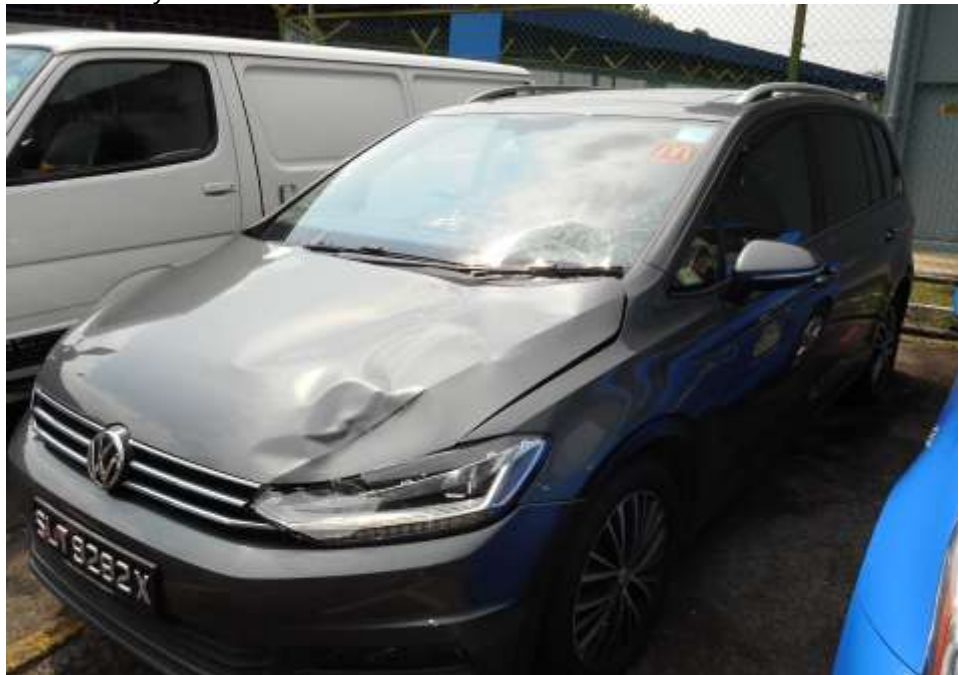
**Photo 5** shows a general view of the Motor Car's left body at the time of my inspection. The left portion of the Motor Car was observed to have been unaffected by the accident.

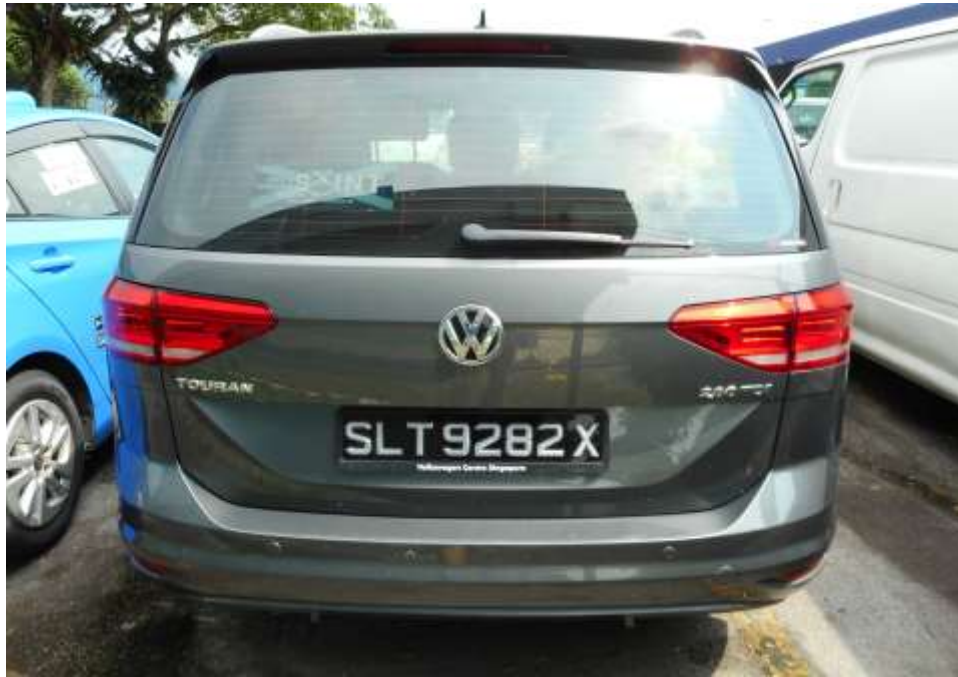
**Photo 6** shows a general view of the Motor Car's rear body at the time of my inspection. The rear portion of the Motor Car was observed to have been unaffected by the accident.

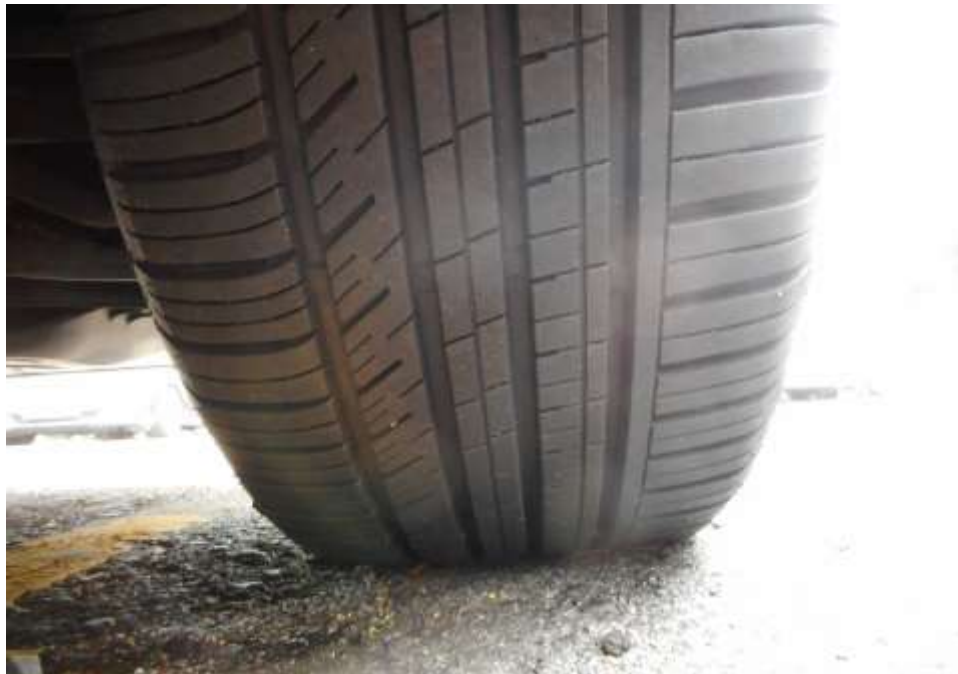
**Photo 7** shows the condition of the front right tyre of the Motor Car, which was observed to be in serviceable condition with remaining tread depth of approximately 7.5mm. The tyre was sufficiently inflated for vehicular operation with no tear, cut or burst mark(s) on the outer and the inner sidewalls as well as across the tread. The 4 tyres of the Motor Car were wrapped around standard alloy wheel rims without any damage.

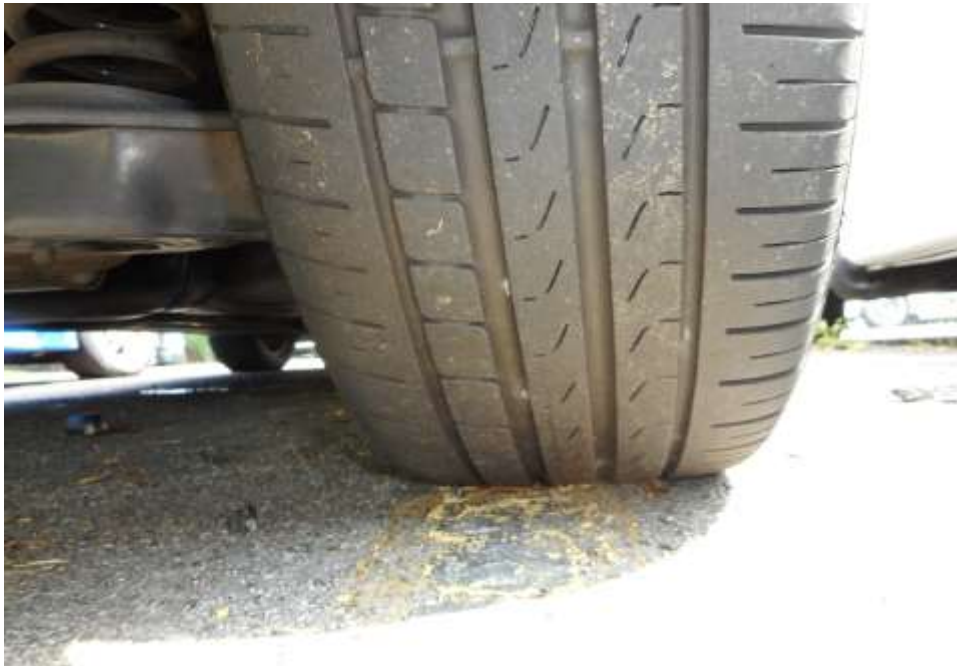
**Photo 8** shows the condition of the rear right tyre of the Motor Car, which was observed to be in serviceable condition with remaining tread depth of approximately 4.6mm. The tyre was also observed to be sufficiently inflated for vehicular operation with no tear, cut or burst mark(s).

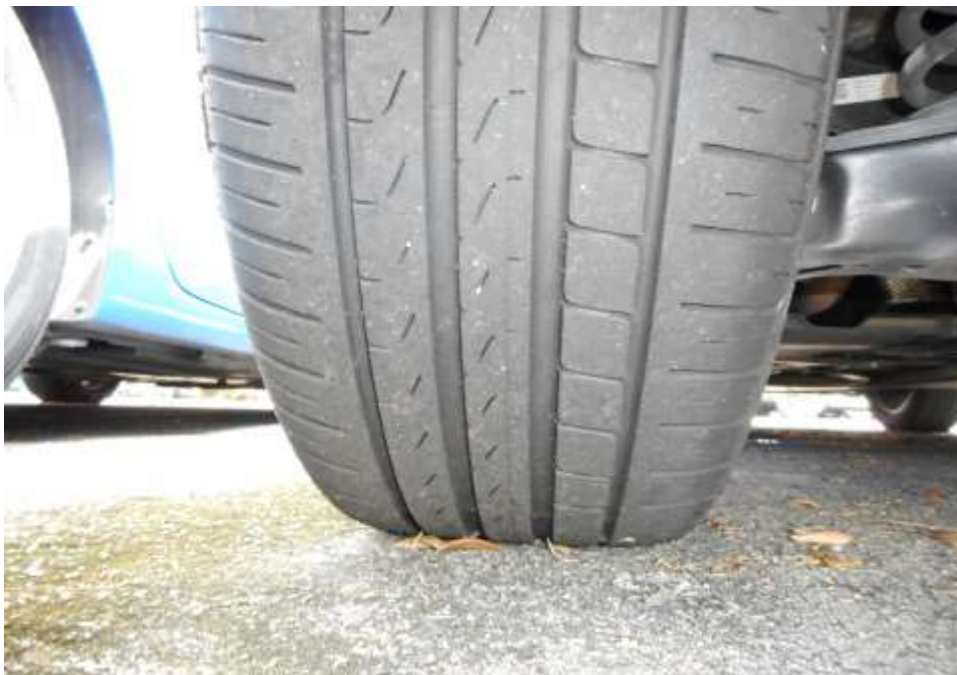
**Photo 9** shows the condition of the rear left tyre of the Motor Car, which was observed to be in serviceable condition with remaining tread depth of approximately 4.5mm. The tyre, which was wrapped around alloy wheel rim, was also observed to be sufficiently inflated for vehicular operation. The 4 tyres of the Motor Car were wrapped around standard alloy wheel rims.

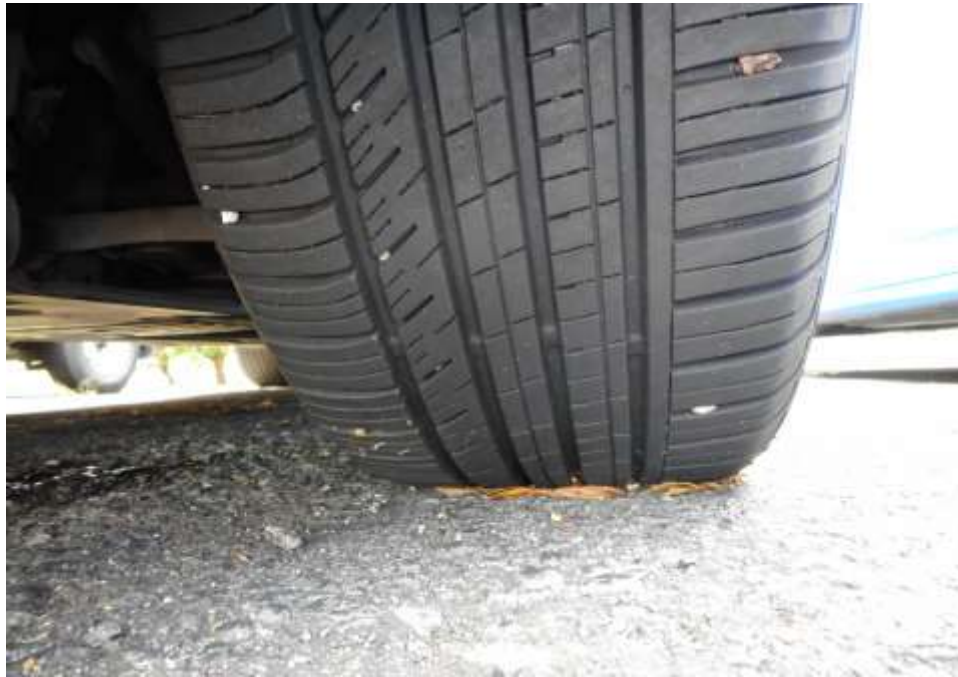
**Photo 10** shows the condition of the front left tyre of the Motor Car, which was observed to be in serviceable condition with remaining tread depth of approximately 6.7mm. There was also no tear, cut or burst mark(s) on the outer and the inner sidewalls as well as across the tread of the Motor Car's 4 tyres.

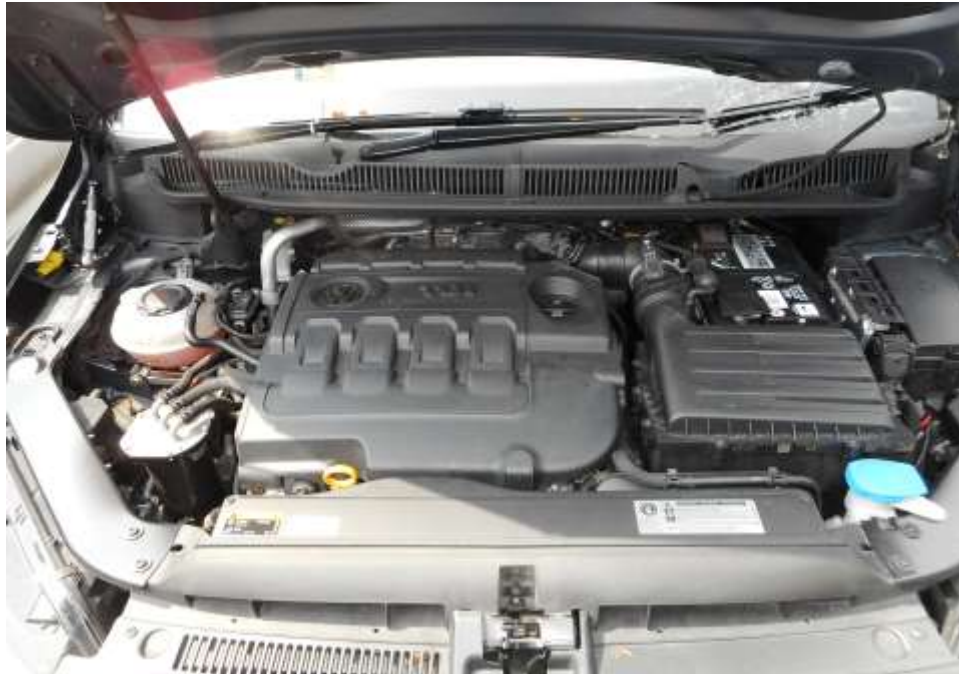
**Photo 11** shows a general view of the Motor Car's engine compartment. The various parts and components inside the engine compartment were unaffected by the accident. There was also no sign(s) or indication(s) of fluid leakage and/or fluid stain within the engine compartment.

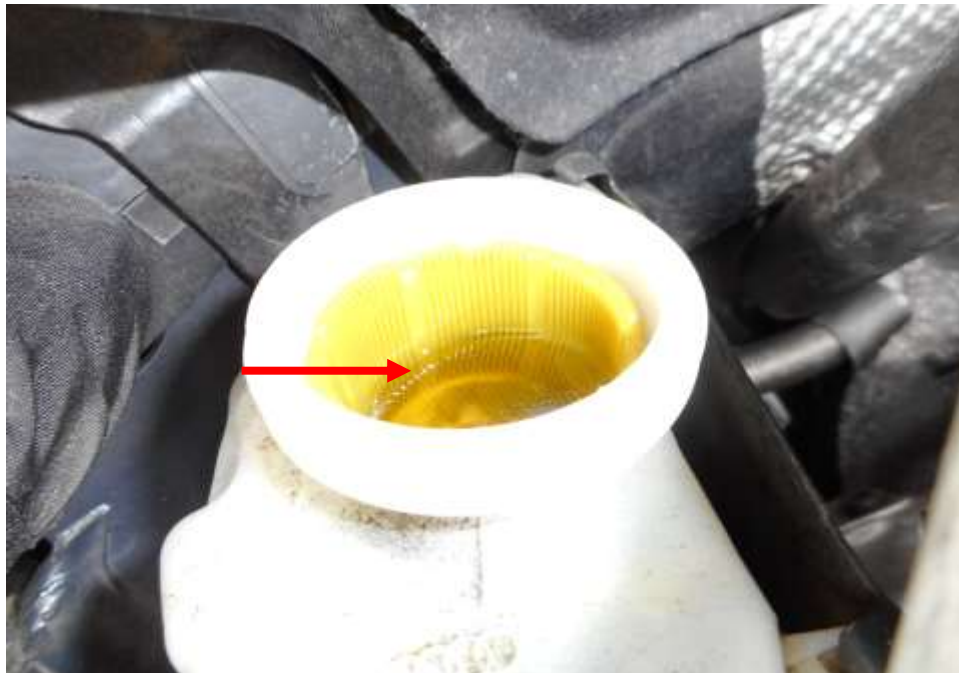
**Photo 12** shows the brake fluid reservoir of the Motor Car at the time of my inspection. The brake fluid was observed to be of sufficient level (arrowed) and without any visible contamination.

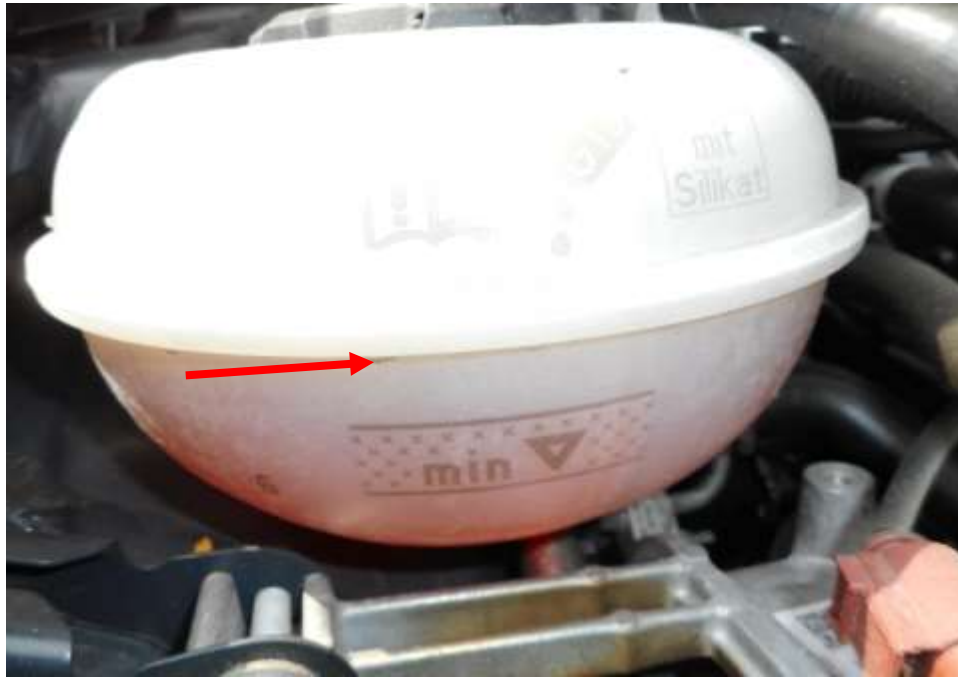
**Photo 13** shows checks being carried out to the engine coolant of the Motor Car at the time of my inspection. The engine coolant was observed to be of sufficient level (arrowed) and without any visible contamination.

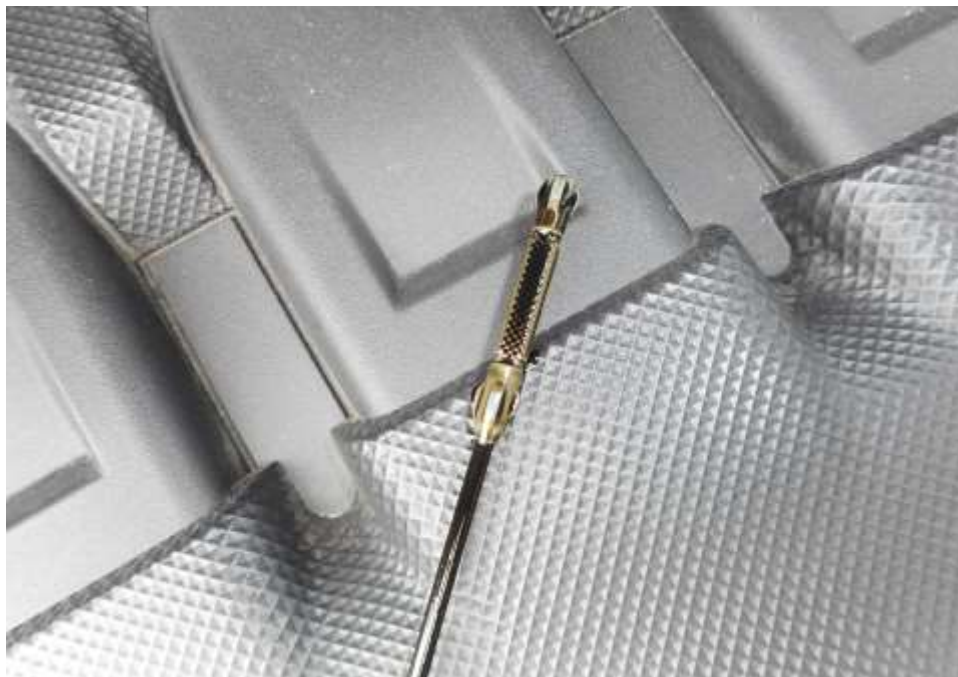
**Photo 14** shows the engine oil dip stick of the Motor Car at the time of my inspection. The engine oil was observed to be of sufficient level and without any visible contamination.

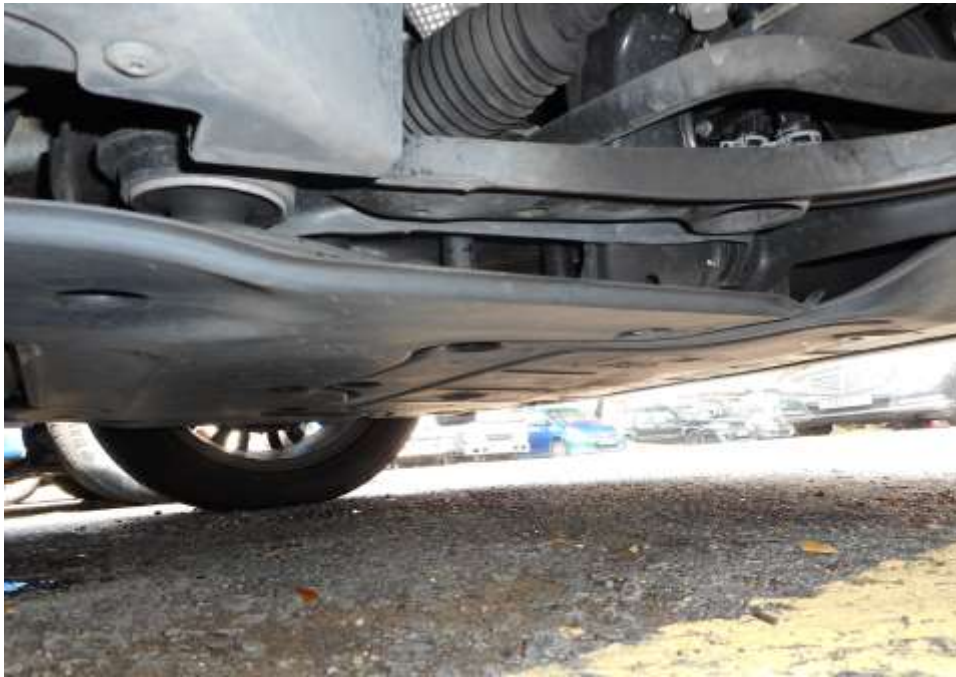
**Photo 15** shows the undercarriage of the Motor Car, at the area where the engine housing and transmission housing are located. I did not find any sign(s) or indication(s) of fluid leak and/or fluid stain(s) on the underside of the Motor Car.

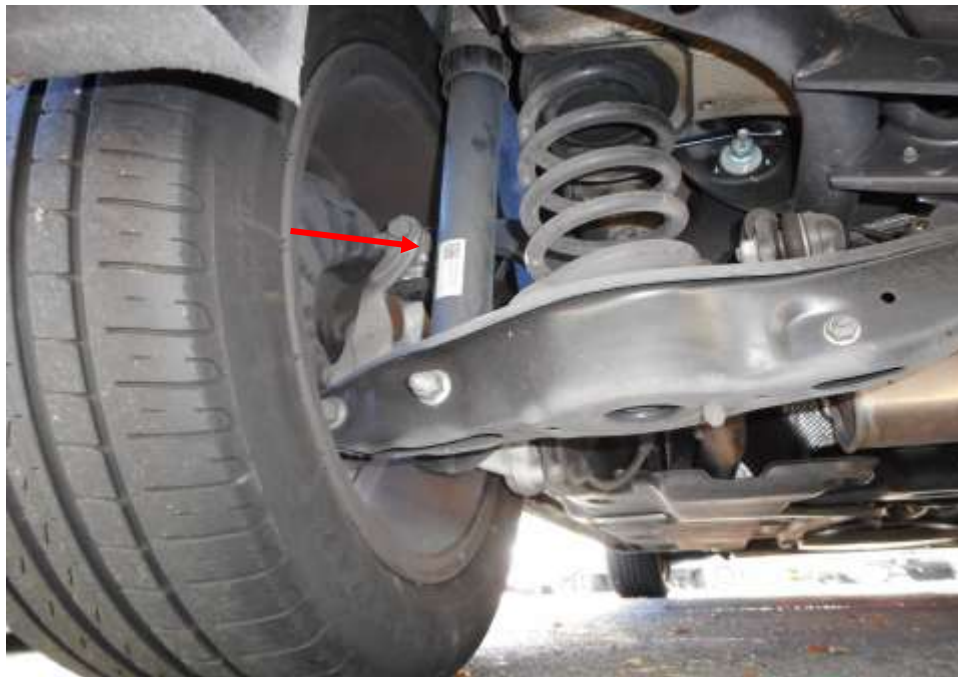
**Photo 16** shows the brake hose/pipe (arrowed) at the rear left wheel of the Motor Car. I did not observe any leakage of brake fluid at the time of my inspection of the Motor Car. Static tests of the Motor Car's braking system had indicated that there was no internal leakage of pressure/vacuum. The undercarriage components of the Motor Car were also all found to be intact and without any visible damage.

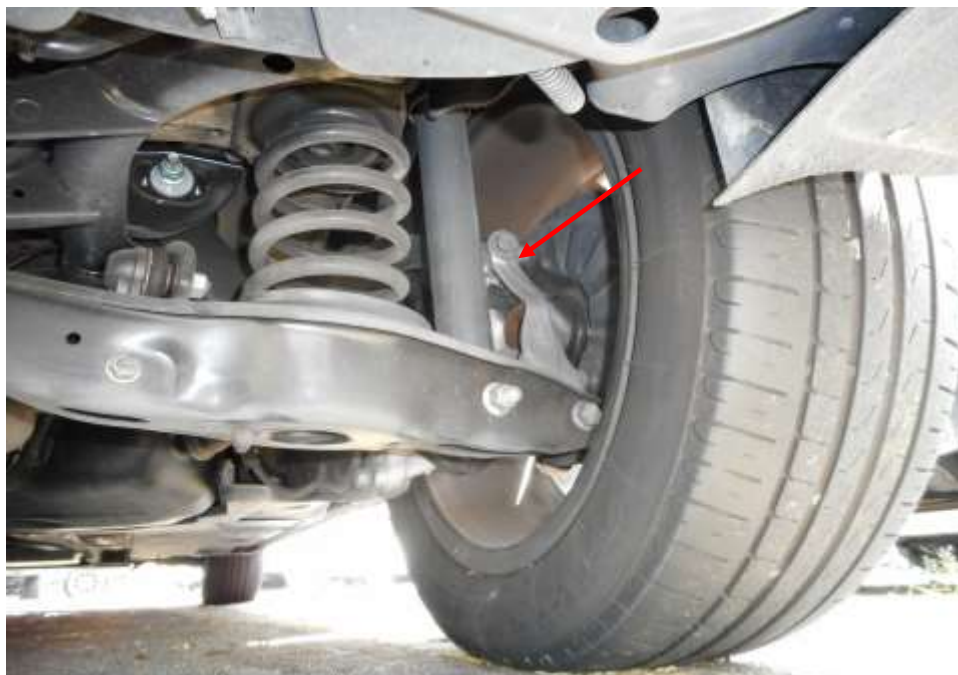
**Photo 17** shows the brake hose/pipe (arrowed) at the rear right wheel of the Motor Car. No leakage of brake fluid was observed. Visual examination of the various components of the braking system like the drum brake, brake booster, brake pedal etc had revealed all to be intact and without visible damage.

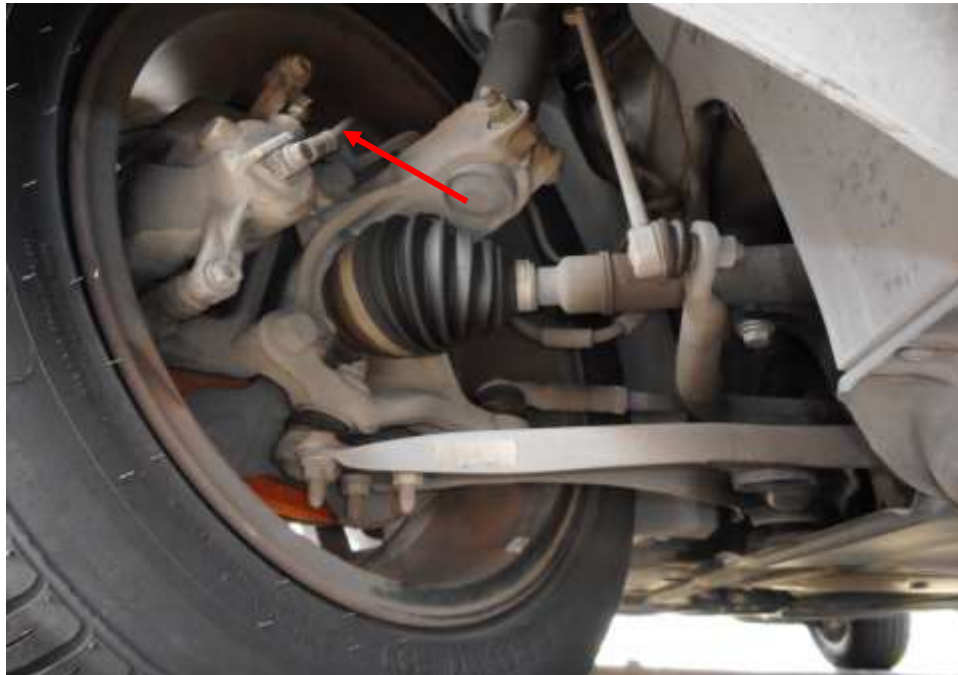
**Photo 18** shows the brake hose/pipe (arrowed) at the front right wheel of the Motor Car. I did not observe any leakage of brake fluid at the time of my inspection of the Motor Car. Static tests of the Motor Car's braking system had indicated that there was no internal leakage of pressure/vacuum. The undercarriage components of the Motor Car were also all found to be intact and without any visible damage.

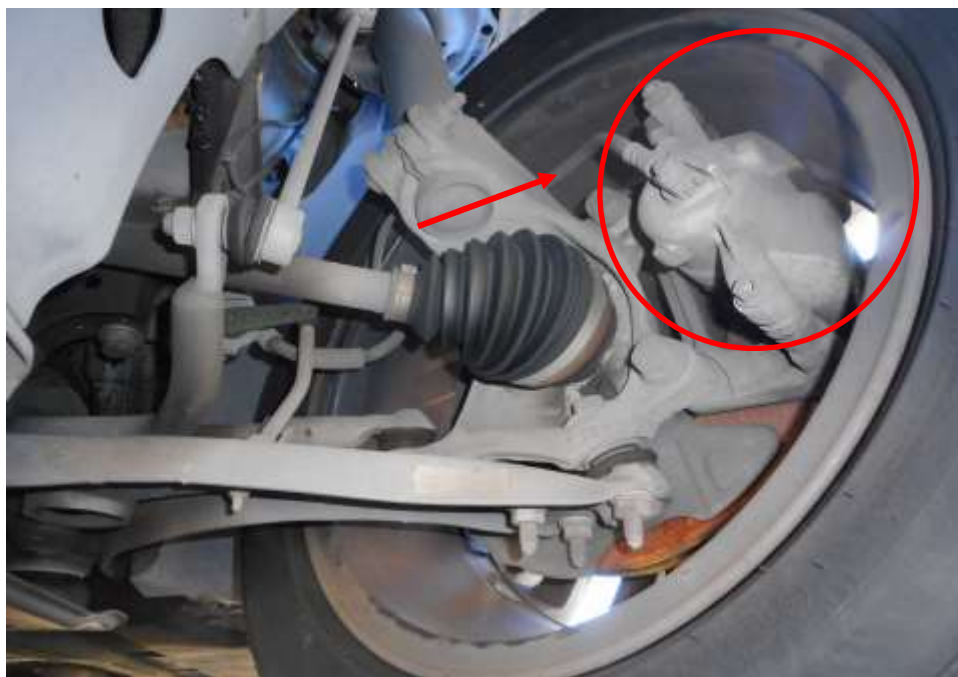
**Photo 19** shows the brake hose/pipe (arrowed) at the front left wheel of the Motor Car. No leakage of brake fluid was observed. Visual examination of the various components of the braking system like the brake caliper (circled), brake booster, brake pedal etc had revealed all to be intact and without visible damage.

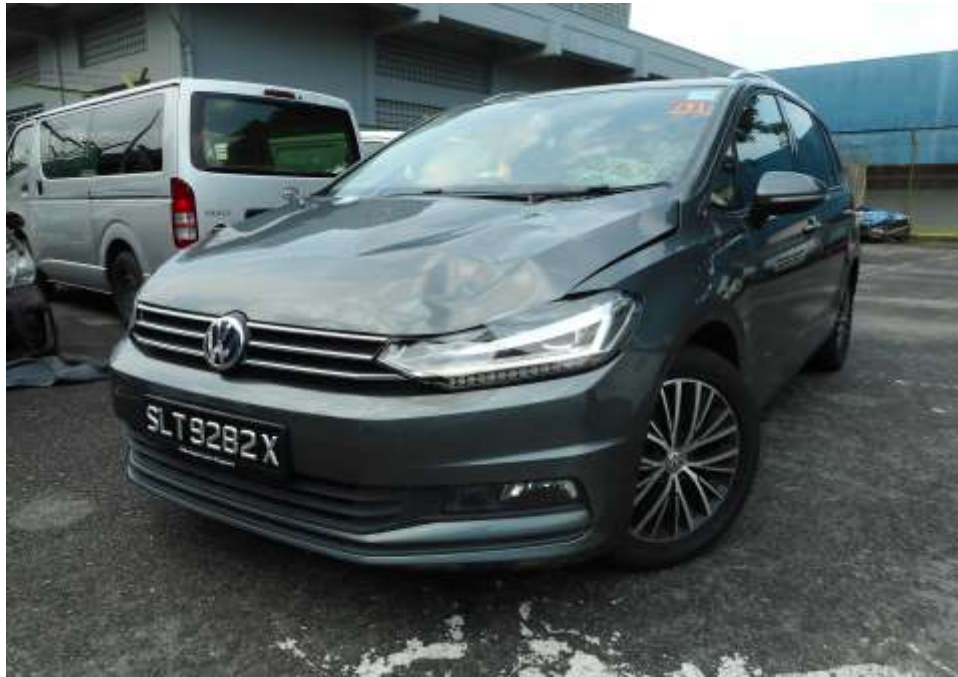
**Photo 20** shows the front left wheel of the Motor Car turned to its full right. During my steering system test, I did not experience any abnormal free play and/or resistance when I had turned the steering wheel towards the left and right. This would suggest that the steering system of the Motor Car was likely to be in serviceable condition at the material time of accident.

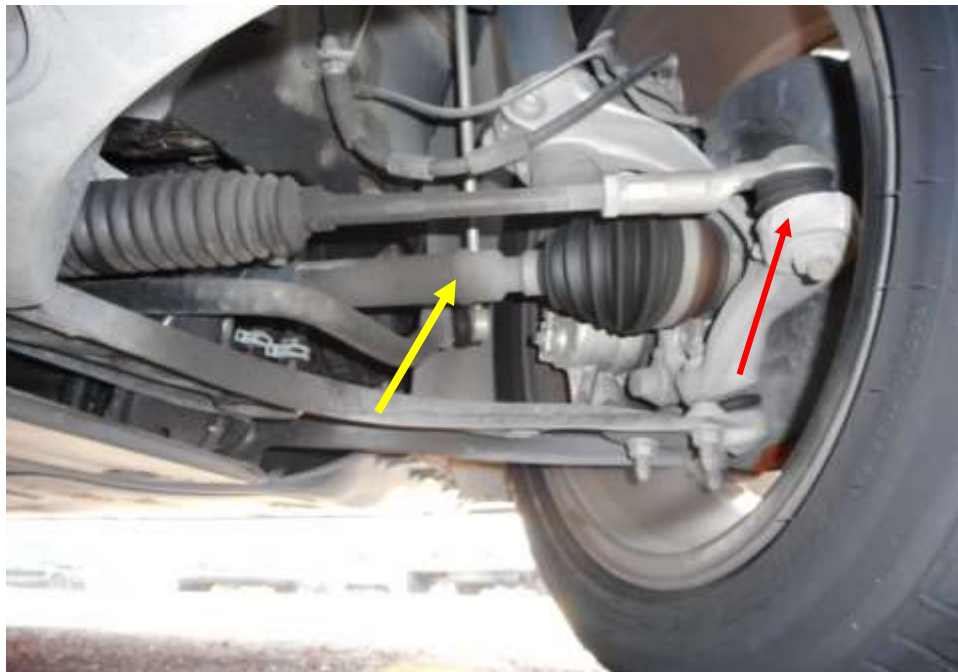
**Photo 21** shows the various undercarriage components at the front right wheel of the Motor Car, in particular the steering tie rod (red arrow) and drive shaft (yellow arrow). The various steering components were all found to be intact, suggesting that the steering system of the Motor Car was likely to be in serviceable condition at the material time of accident. There was also no sign of fluid stain observed on the various undercarriage components at the front right wheel of the Motor Car.

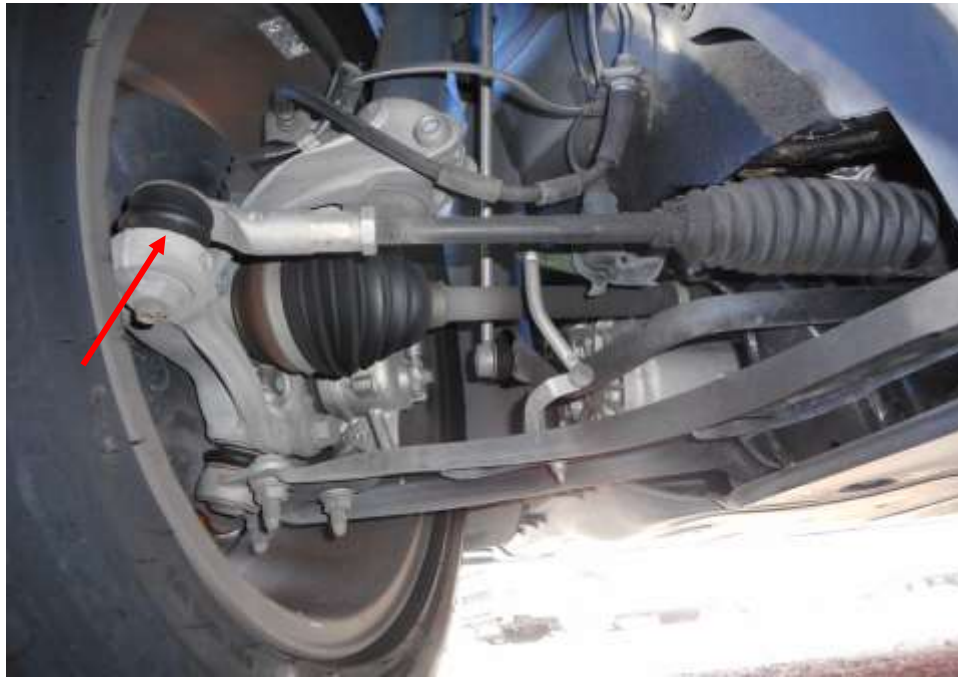
**Photo 22** shows the various undercarriage components at the front left wheel of the Motor Car, which had included the steering tie rod (red arrow). The various undercarriage components of the Motor Car were all found to be intact without any visible damage.

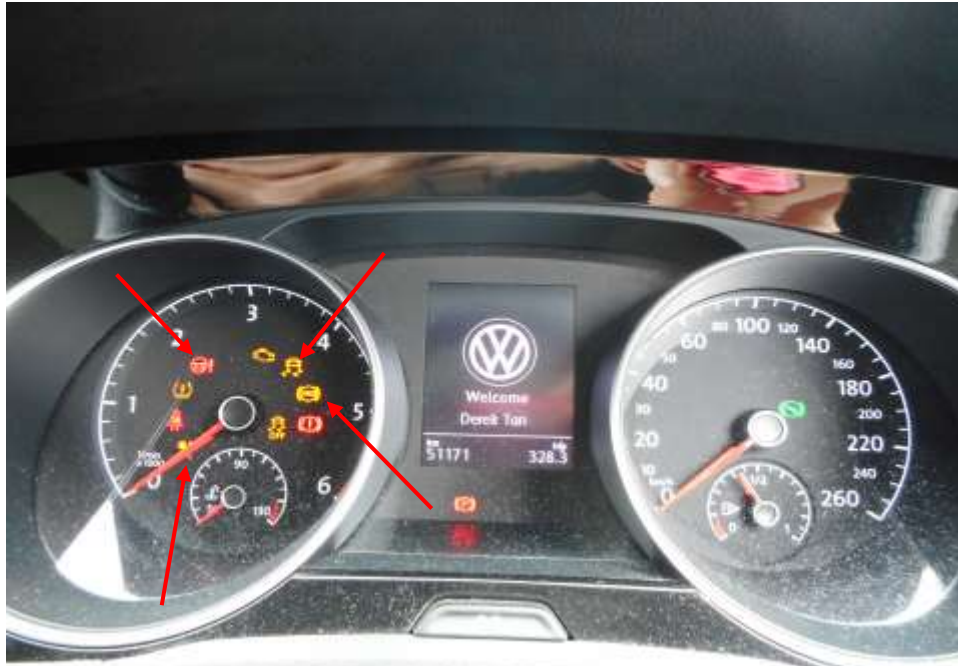
**Photo 23** shows the warning light for Anti-Lock Brake System (ABS) Traction Control System (TC), Electric Power Steering System (EPS) and Supplemental Restraint System (SRS) appearing on the instrument panel of the Motor Car during the self-test of its various electronic operating systems when its engine was cranked.

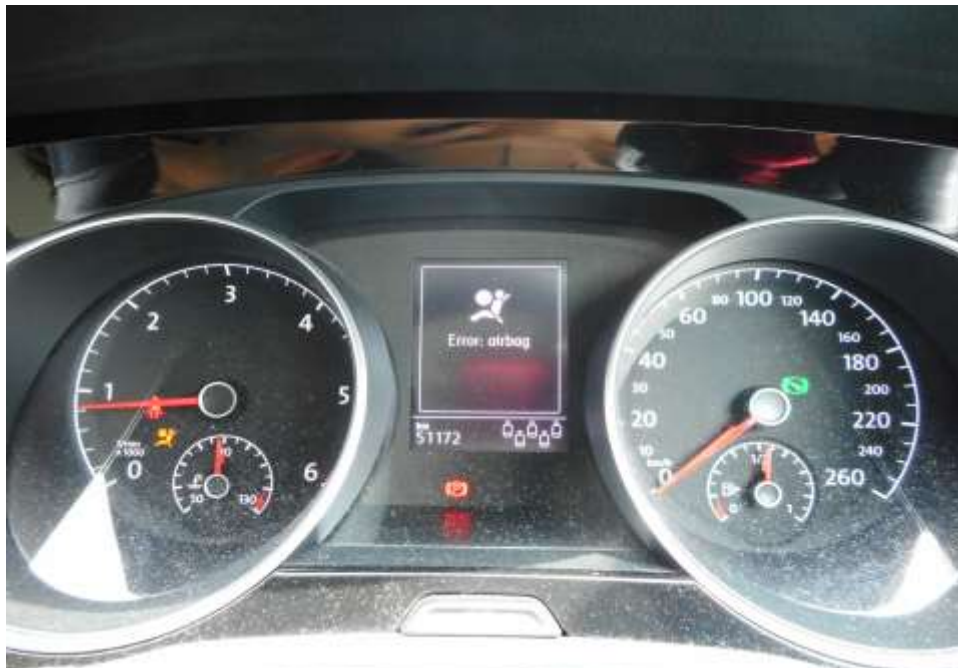
**Photo 24** shows the Supplemental Restraint System (SRS) warning lights illuminated on with an error warning message on the instrument panel of the Motor Car after the engine was cranked as a result of the accident. However the other warning light disappeared after cranking, this would suggest that there was no abnormality to the various electronic operating systems of the Motor Car, like the ABS, EPS and TC etc.
