Your Ref: TP/IP/23475/2019
Our Ref : CI/TPD19011272/P

Fatal Accident Investigation Team

MECHANICAL INSPECTION REPORT OF MOTOR PICK-UP GX 820R

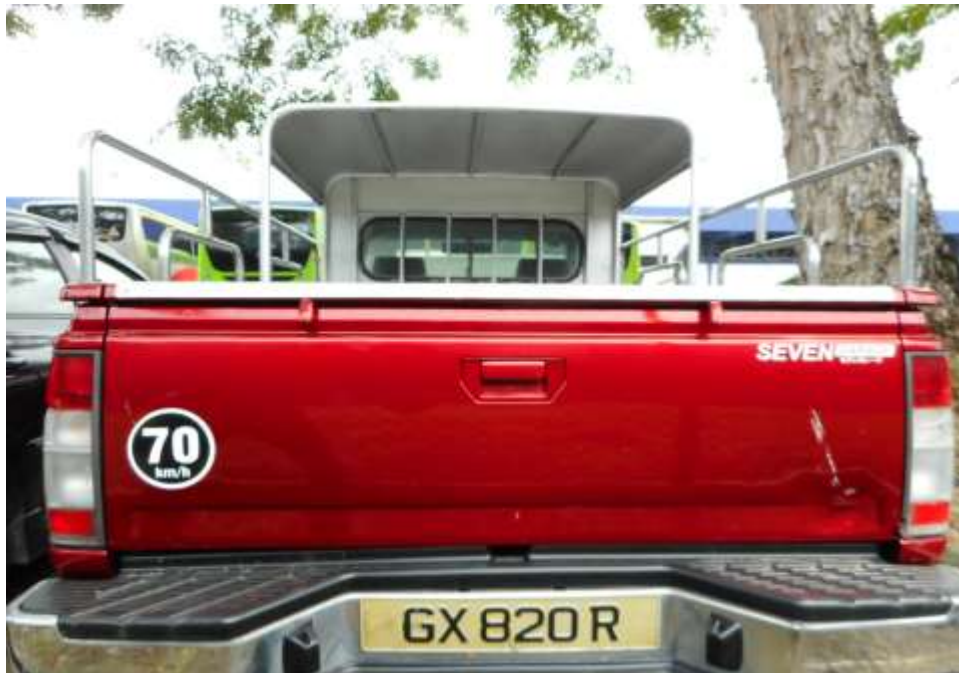
4. The mileage of the Motor Pick-Up at the time of my inspection was 277,560km.
5. The Motor Pick-Up was observed to have sustained damage at its rear portion. Its rear bumper and rear right brake lamp were amongst the body parts that were damaged as a result of the accident.

Photo 1 shows a general view of the Motor Pick-Up's rear body at the time of my inspection. The Motor Pick-Up was observed to have sustained damage at its rear portion. Its rear bumper and rear right brake lamp were amongst the body parts that were damaged as a result of the accident.

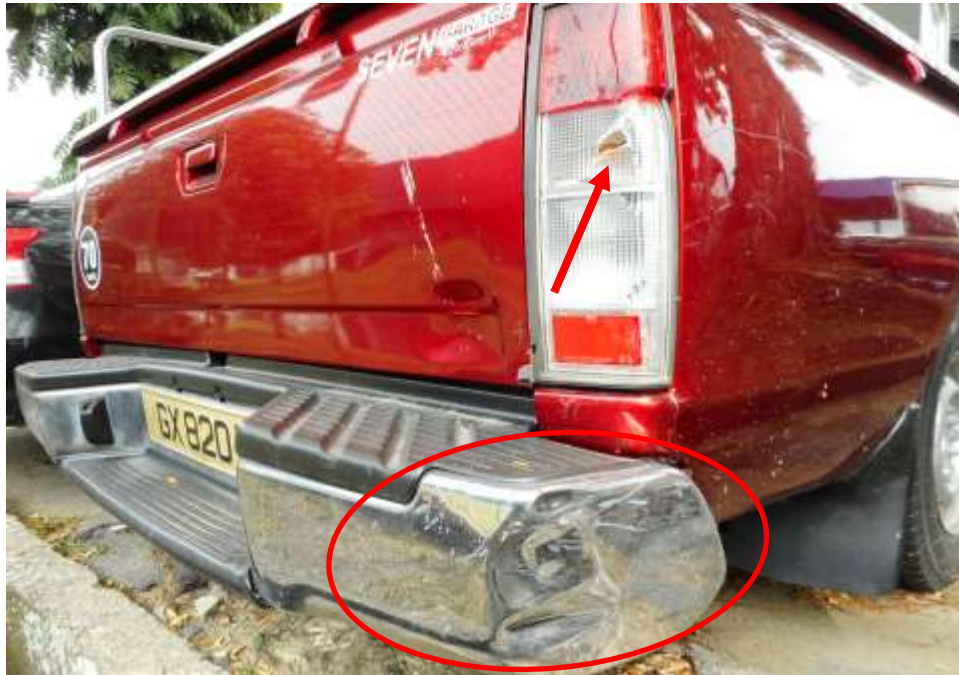
Photo 2 shows the close up view of the Motor Pick-Up's rear body at the time of my inspection. The Motor Pick-Up was observed to have sustained damage at its rear bumper (circled) and rear left brake lamp (arrowed) as a result of the accident.

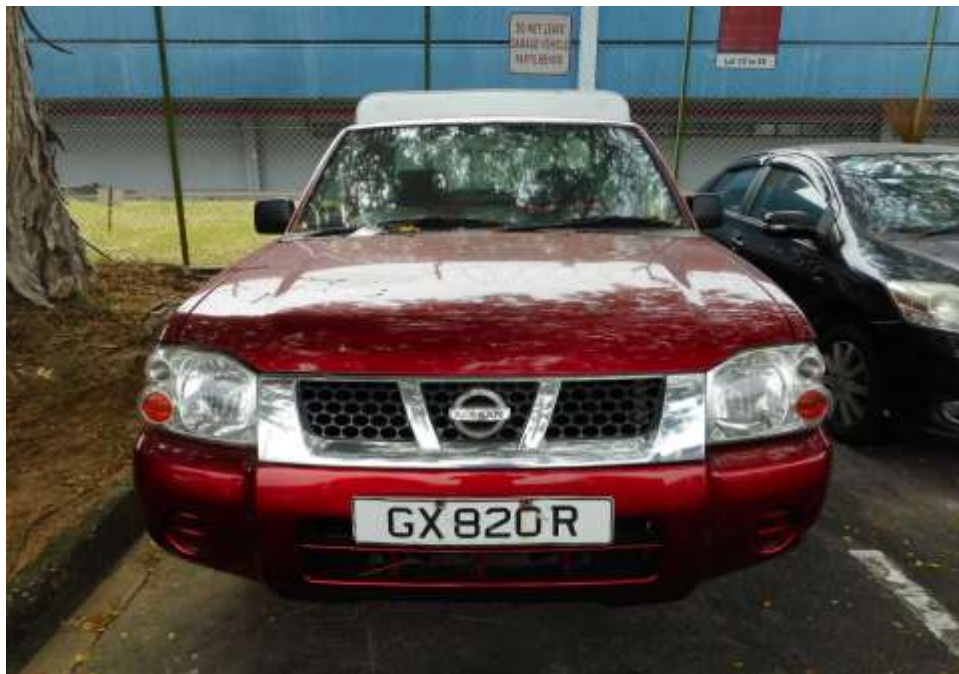
Photo 3 shows a general view of the Motor Pick-Up's front body at the time of my inspection. The front portion of the Motor Pick-Up was observed to have been unaffected by the accident.

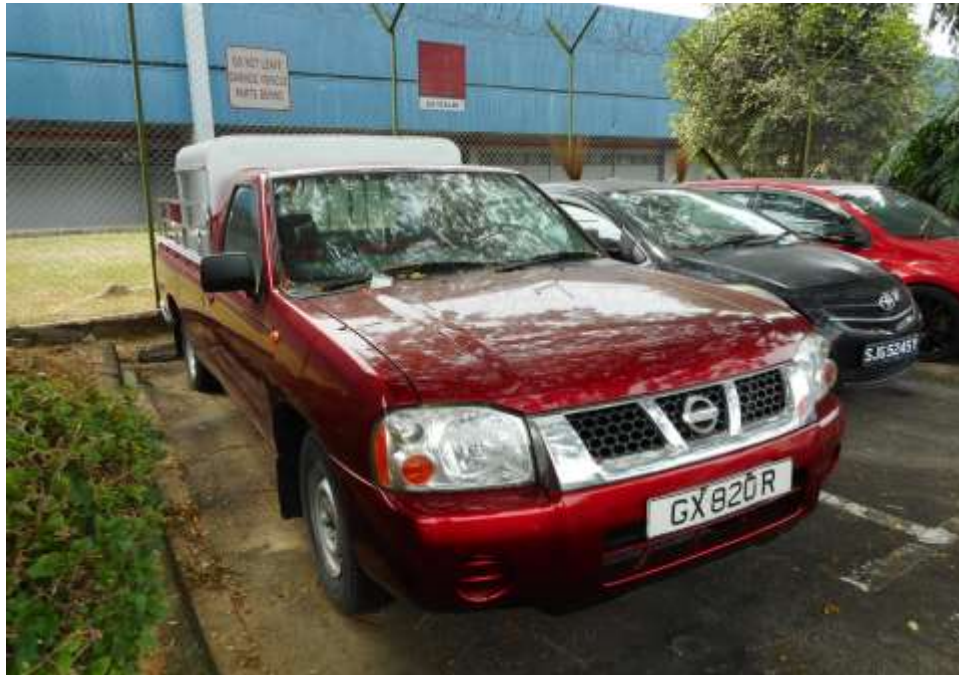
Photo 4 shows a general view of the Motor Pick-Up's right body at the time of my inspection. The right portion of the Motor Pick-Up was observed to have been unaffected by the accident.

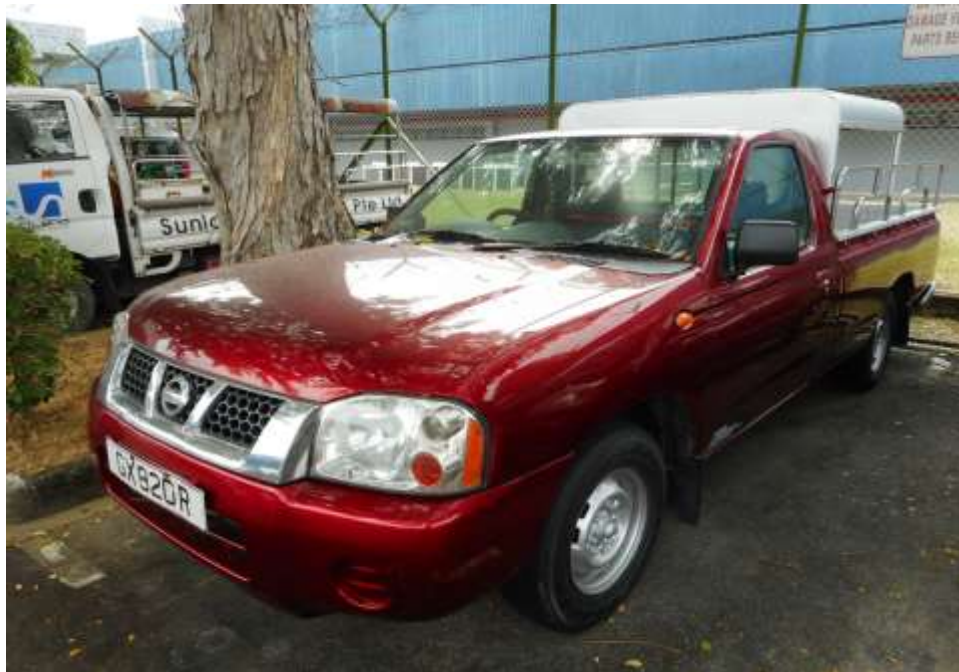
Photo 5 shows a general view of the Motor Pick-Up's left body at the time of my inspection. The left portion of the Motor Pick-Up was observed to have been unaffected by the accident.

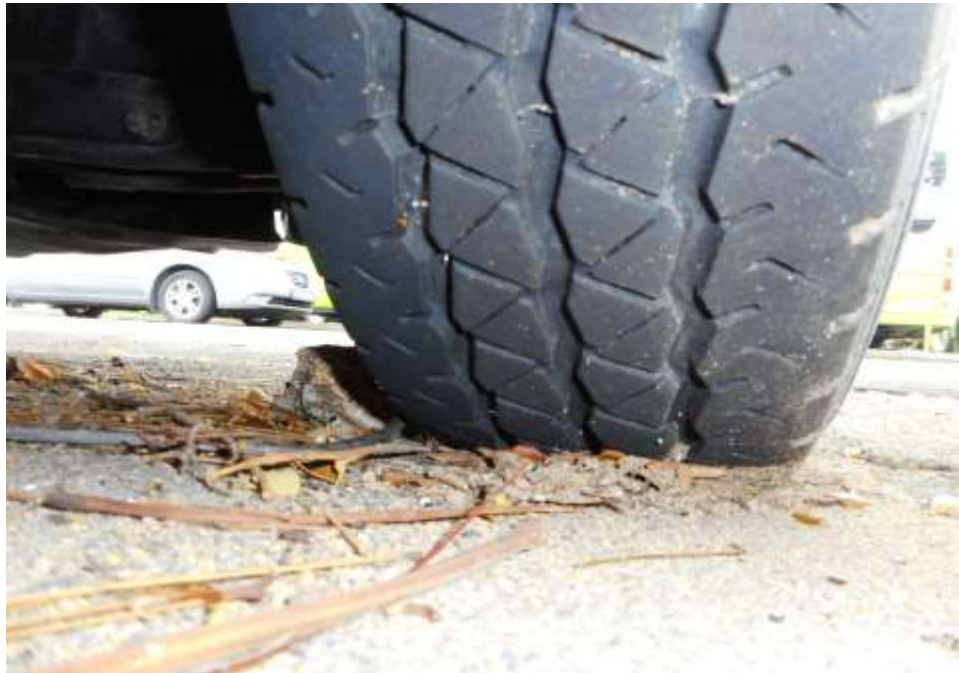
Photo 6 shows the condition of the front right tyre of the Motor Pick-Up, which was observed to be in serviceable condition with remaining tread depth of approximately 6.1mm. The tyre was sufficiently inflated for vehicular operation with no tear, cut or burst mark(s) on the outer and the inner sidewalls as well as across the tread. The 4 tyres of the Motor Pick-Up were wrapped around standard steel wheel rims without any damage.

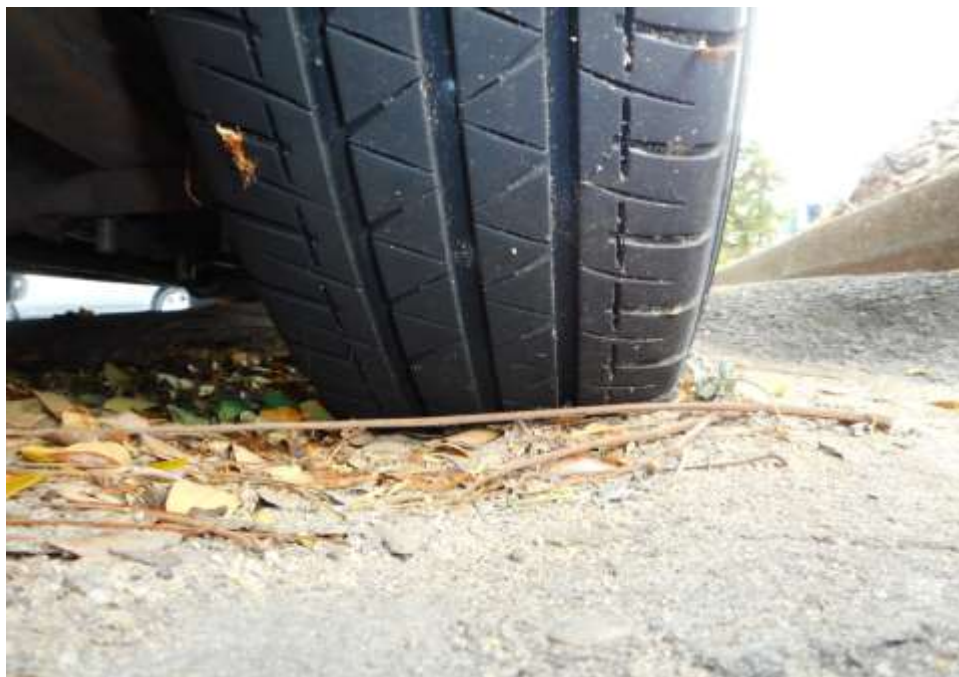
Photo 7 shows the condition of the rear right tyre of the Motor Pick-Up, which was observed to be in serviceable condition with remaining tread depth of approximately 7.1mm. The tyre was also observed to be sufficiently inflated for vehicular operation with no tear, cut or burst mark(s).

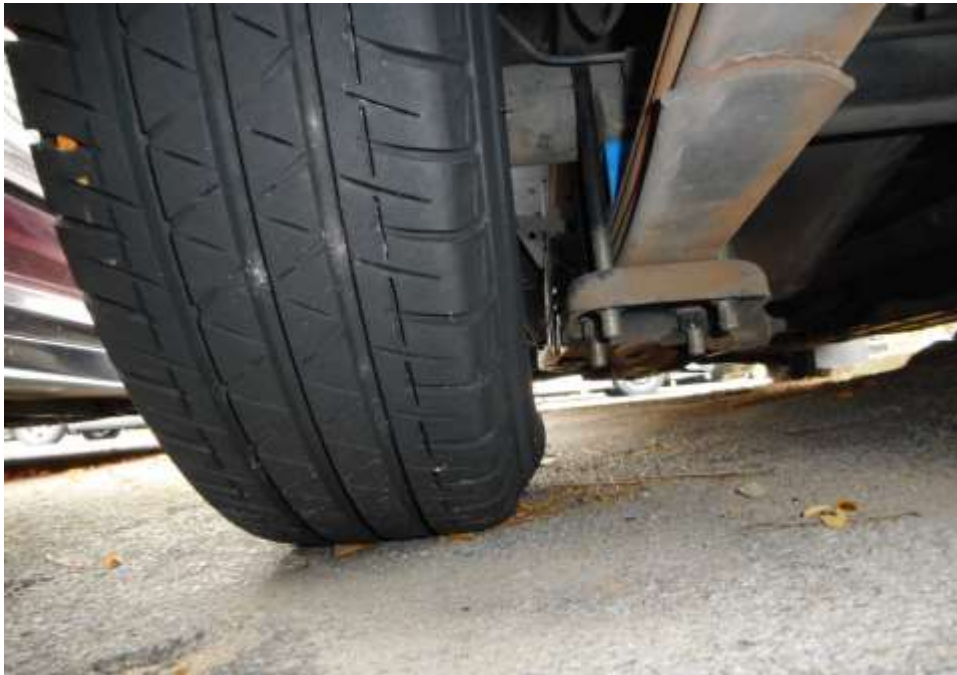
Photo 8 shows the condition of the rear left tyre of the Motor Pick-Up, which was observed to be in serviceable condition with remaining tread depth of approximately 7.3mm. The tyre, which was wrapped around steel wheel rim, was also observed to be sufficiently inflated for vehicular operation. The 4 tyres of the Motor Pick-Up were wrapped around standard steel wheel rims.

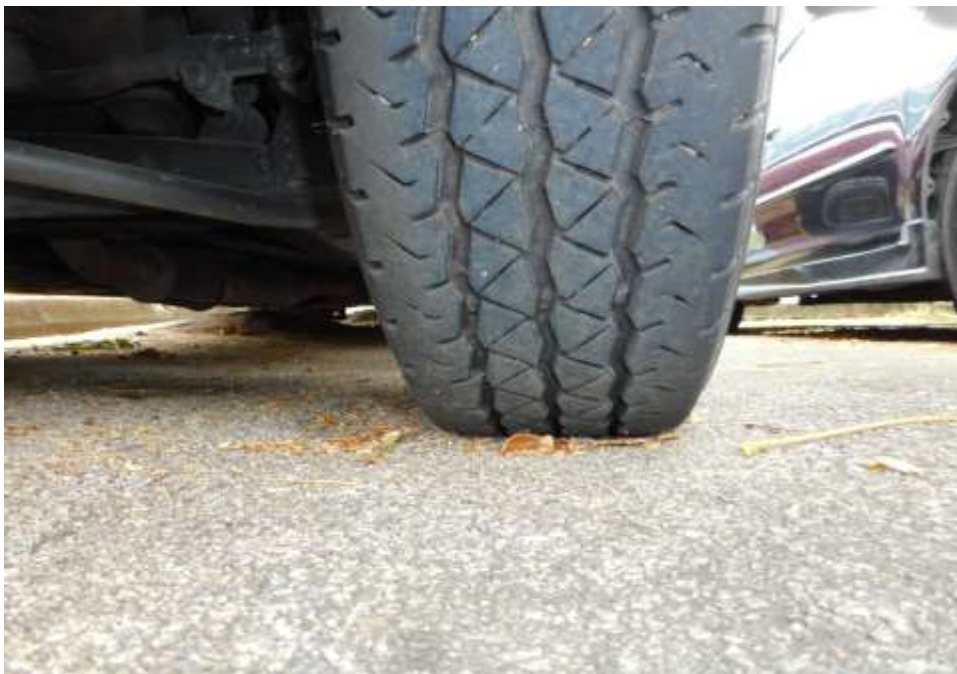
Photo 9 shows the condition of the front left tyre of the Motor Pick-Up, which was observed to be in serviceable condition with remaining tread depth of approximately 6.1mm. There was also no tear, cut or burst mark(s) on the outer and the inner sidewalls as well as across the tread of the Motor Pick-Up's 4 tyres.

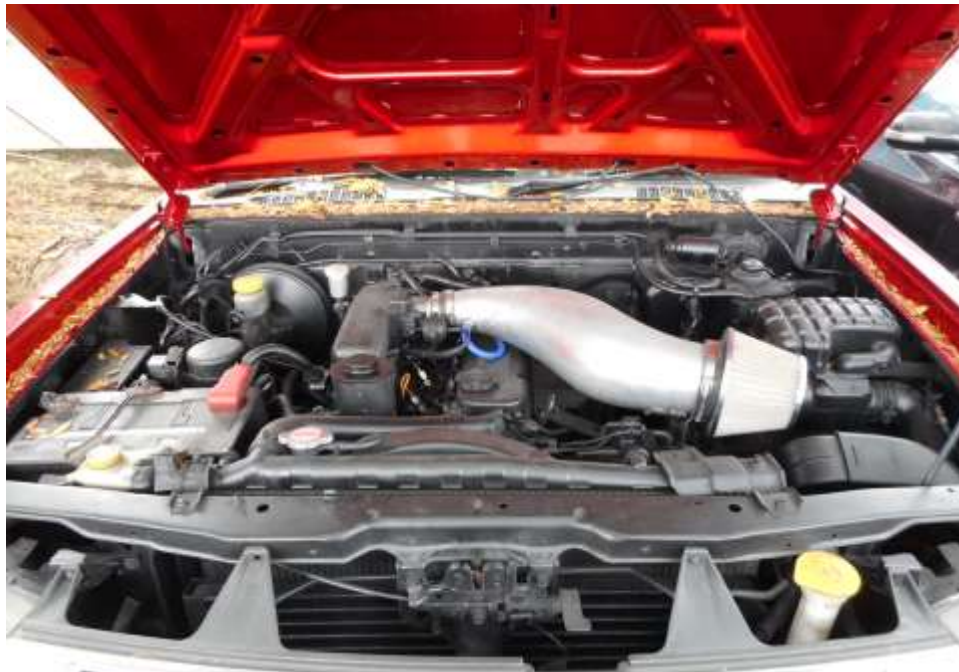
Photo 10 shows a general view of the Motor Pick-Up's engine compartment. The various parts and components inside the engine compartment were unaffected by the accident. There was also no sign(s) or indication(s) of fluid leakage and/or fluid stain within the engine compartment.

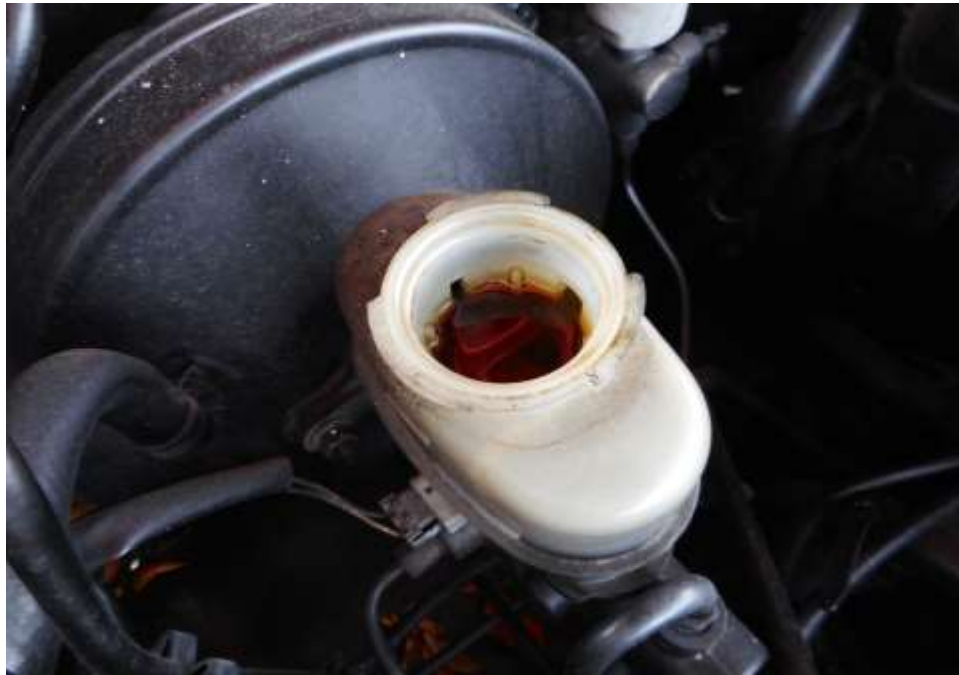
Photo 11 shows the brake fluid reservoir of the Motor Pick-Up at the time of my inspection. The brake fluid was observed to be of sufficient level and without any visible contamination.

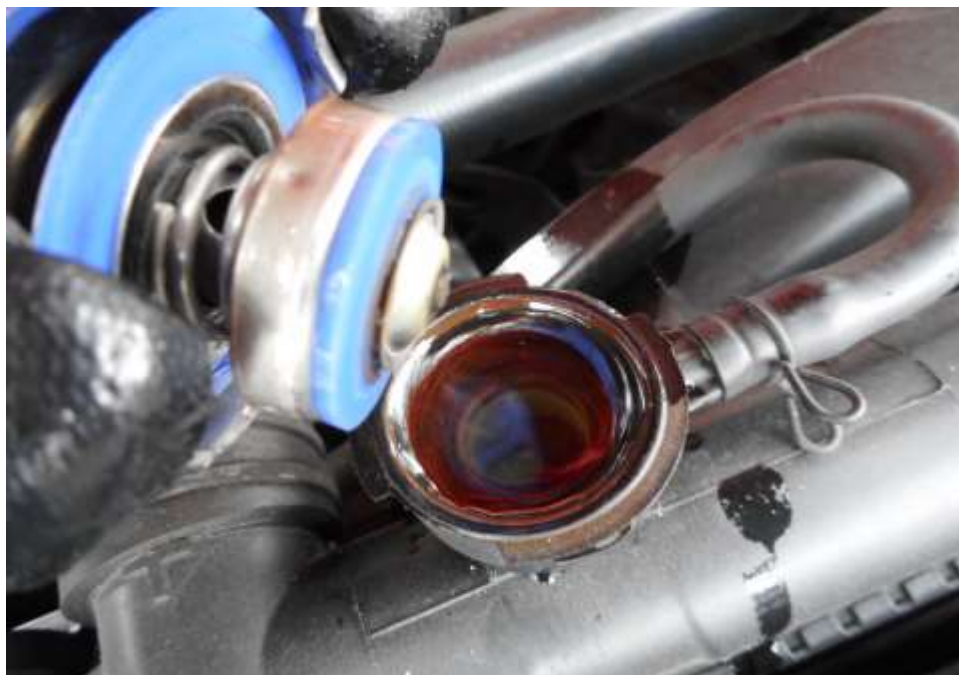
Photo 12 shows checks being carried out to the engine coolant of the Motor Pick-Up at the time of my inspection. The engine coolant was observed to be of sufficient level and without any visible contamination.

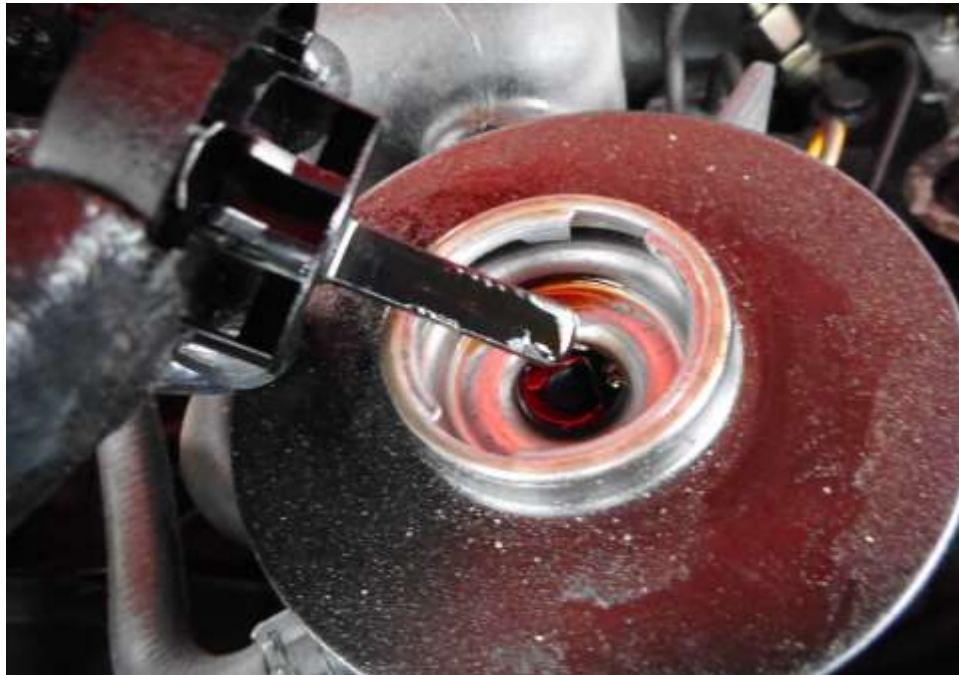
Photo 13 shows checks being carried out to the Power steering fluid of the Motor Pick-Up at the time of my inspection. The steering fluid was observed to be of sufficient level and without any visible contamination.

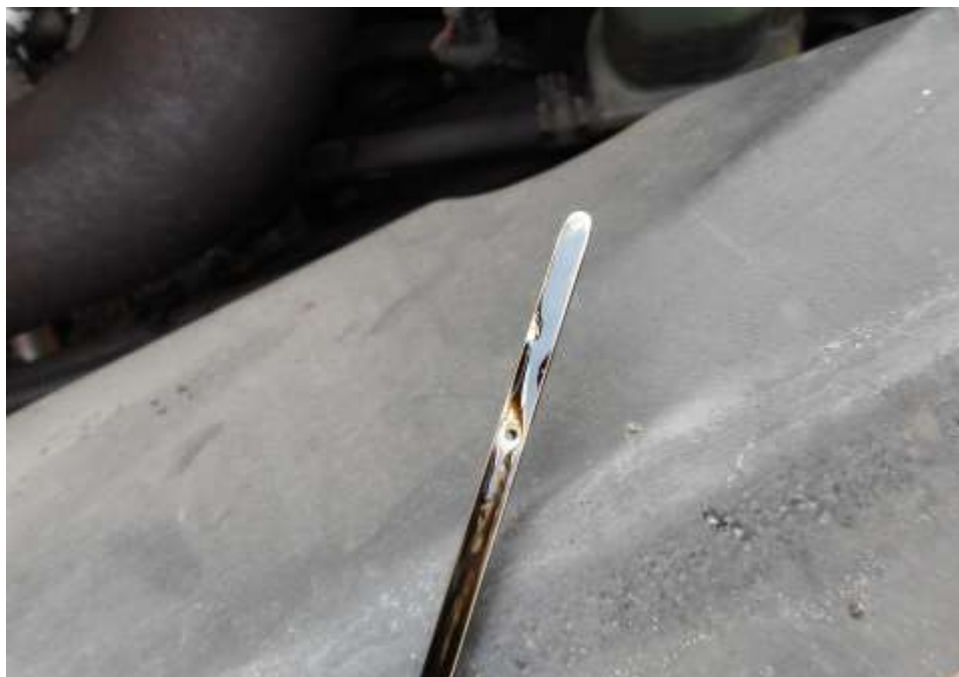
Photo 14 shows the engine oil dip stick of the Motor Pick-Up at the time of my inspection. The engine oil was observed to be of sufficient level and without any visible contamination.

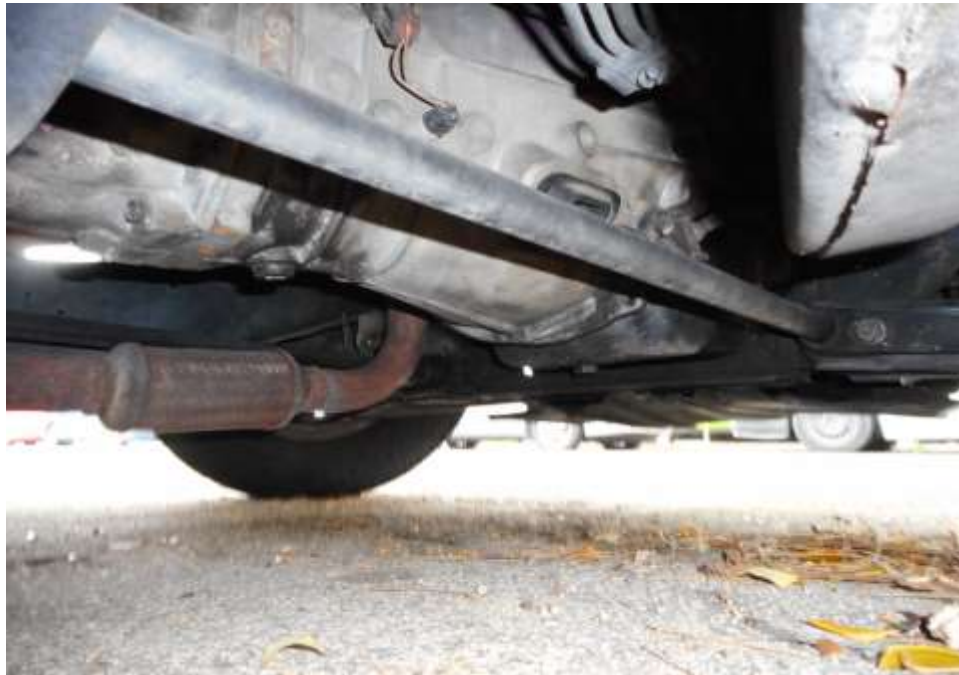
Photo 15 shows the undercarriage of the Motor Pick-Up, at the area where the engine housing and transmission housing are located. I did not find any sign(s) or indication(s) of fluid leak and/or fluid stain(s) on the underside of the Motor Pick-Up.

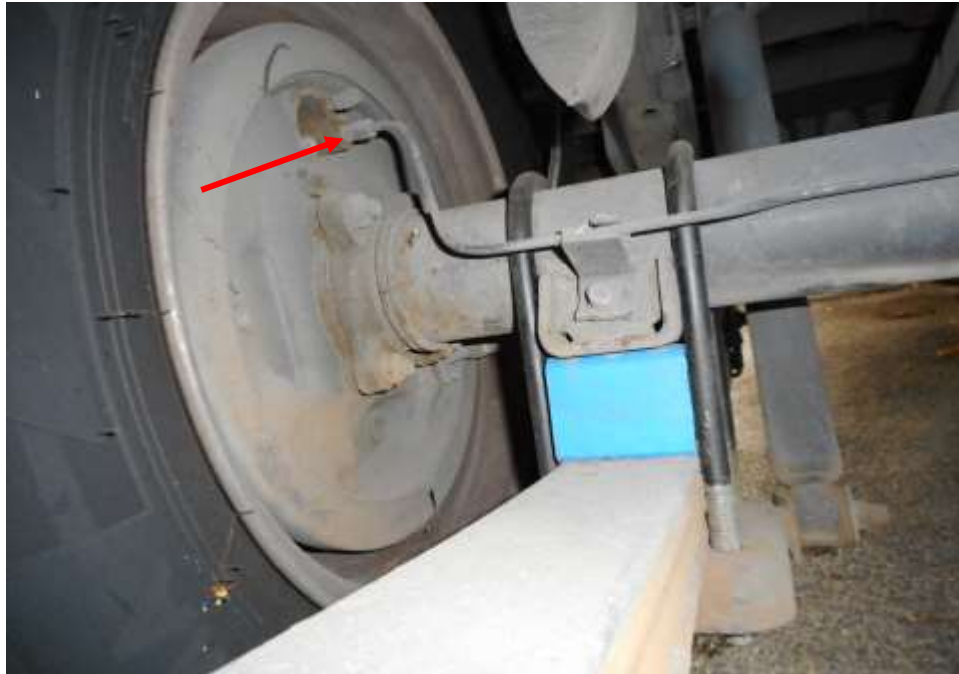
Photo 16 shows the brake hose/pipe (arrowed) at the rear left wheel of the Motor Pick-Up. I did not observe any leakage of brake fluid at the time of my inspection of the Motor Pick-Up. Static tests of the Motor Pick-Up's braking system had indicated that there was no internal leakage of pressure/vacuum. The undercarriage components of the Motor Pick-Up were also all found to be intact and without any visible damage.

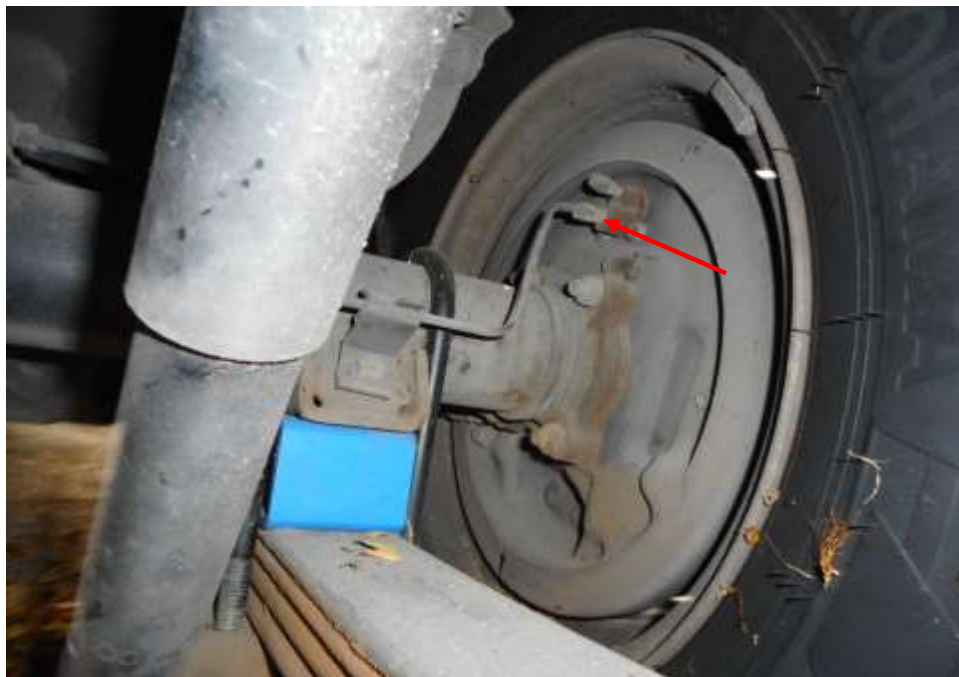
Photo 17 shows the brake hose/pipe (arrowed) at the rear right wheel of the Motor Pick-Up. No leakage of brake fluid was observed. Visual examination of the various components of the braking system like the drum brake, brake booster, brake pedal etc had revealed all to be intact and without visible damage.

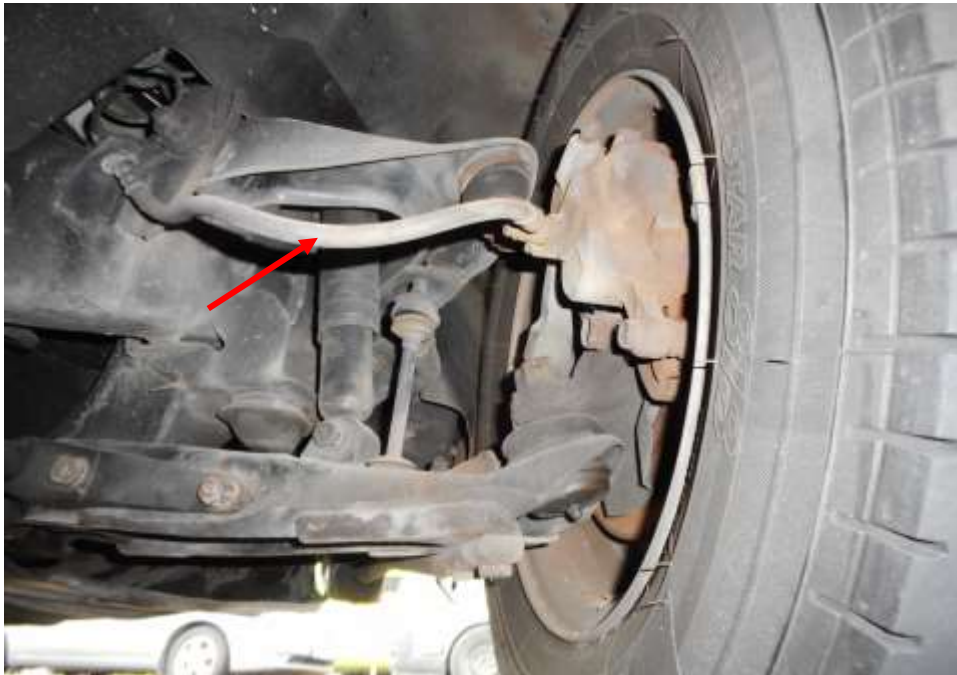
Photo 18 shows the brake hose/pipe (arrowed) at the front right wheel of the Motor Pick-Up. I did not observe any leakage of brake fluid at the time of my inspection of the Motor Pick-Up. Static tests of the Motor Pick-Up's braking system had indicated that there was no internal leakage of pressure/vacuum. The undercarriage components of the Motor Pick-Up were also all found to be intact and without any visible damage.

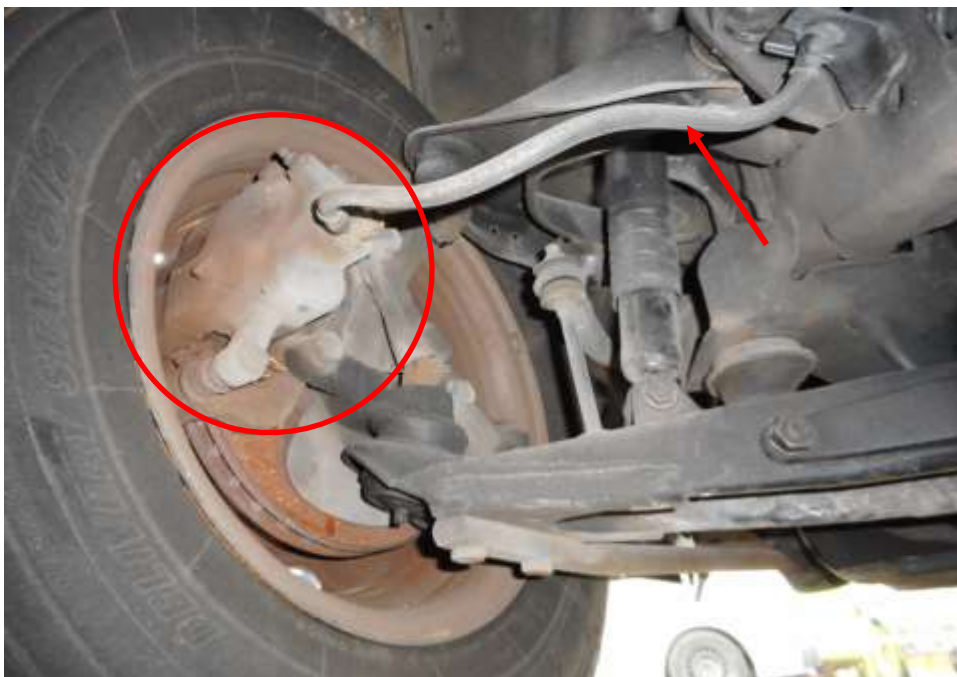
Photo 19 shows the brake hose/pipe (arrowed) at the front left wheel of the Motor Pick-Up. No leakage of brake fluid was observed. Visual examination of the various components of the braking system like the brake caliper (circled), brake booster, brake pedal etc had revealed all to be intact and without visible damage.

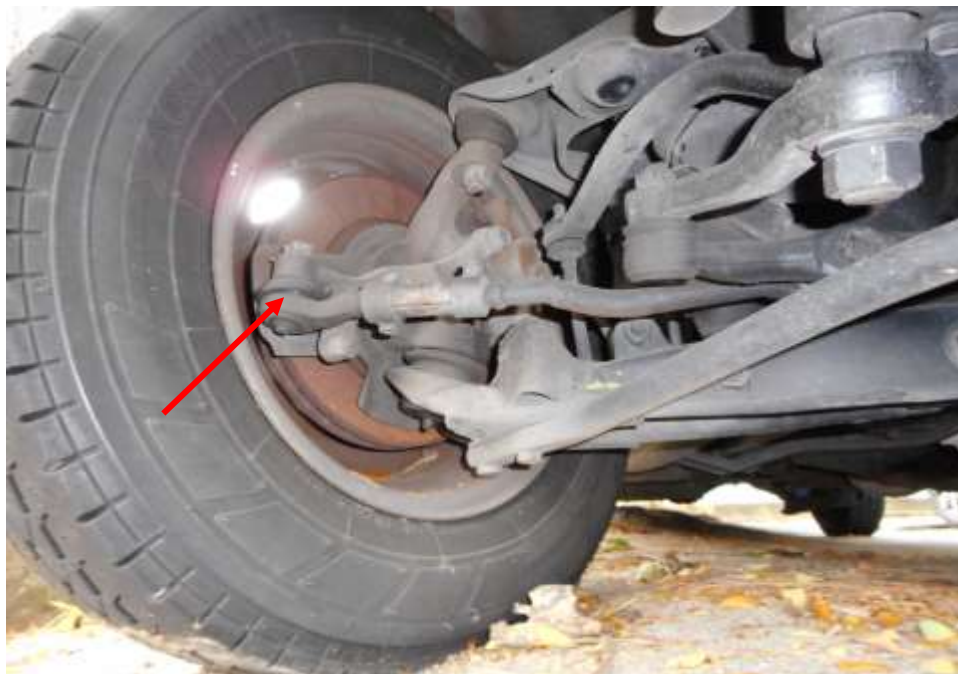
Photo 21 shows the various undercarriage components at the front right wheel of the Motor Pick-Up, in particular the steering tie rod (red arrow). The various steering components were all found to be intact, suggesting that the steering system of the Motor Pick-Up was likely to be in serviceable condition at the material time of accident. There was also no sign of fluid stain observed on the various undercarriage components at the front right wheel of the Motor Pick-Up.

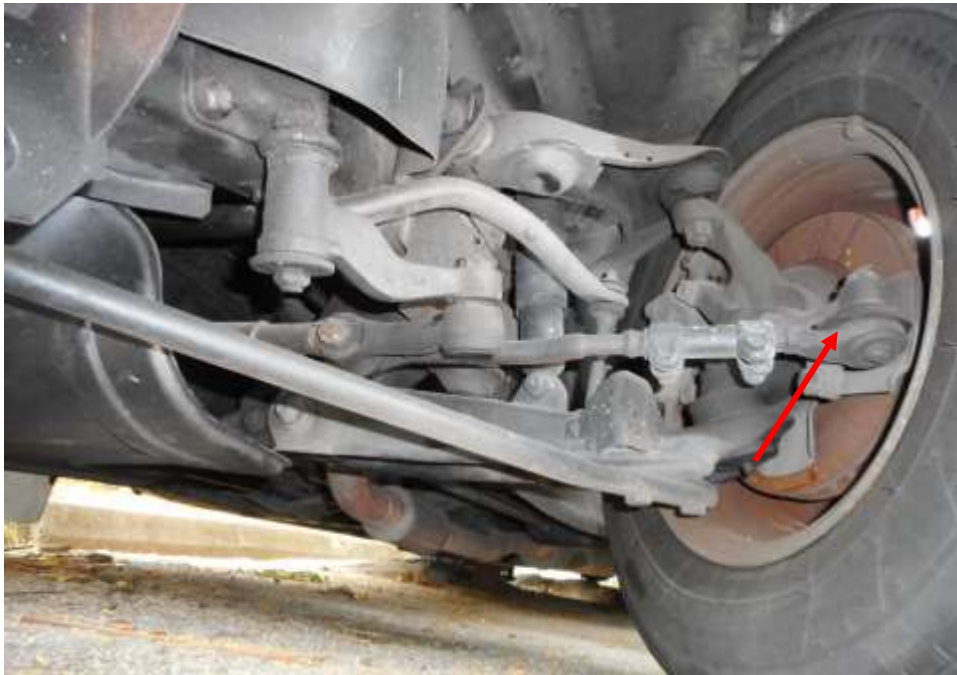
Photo 22 shows the various undercarriage components at the front left wheel of the Motor Pick-Up, which had included the steering tie rod (red arrow). The various undercarriage components of the Motor Pick-Up were all found to be intact without any visible damage.

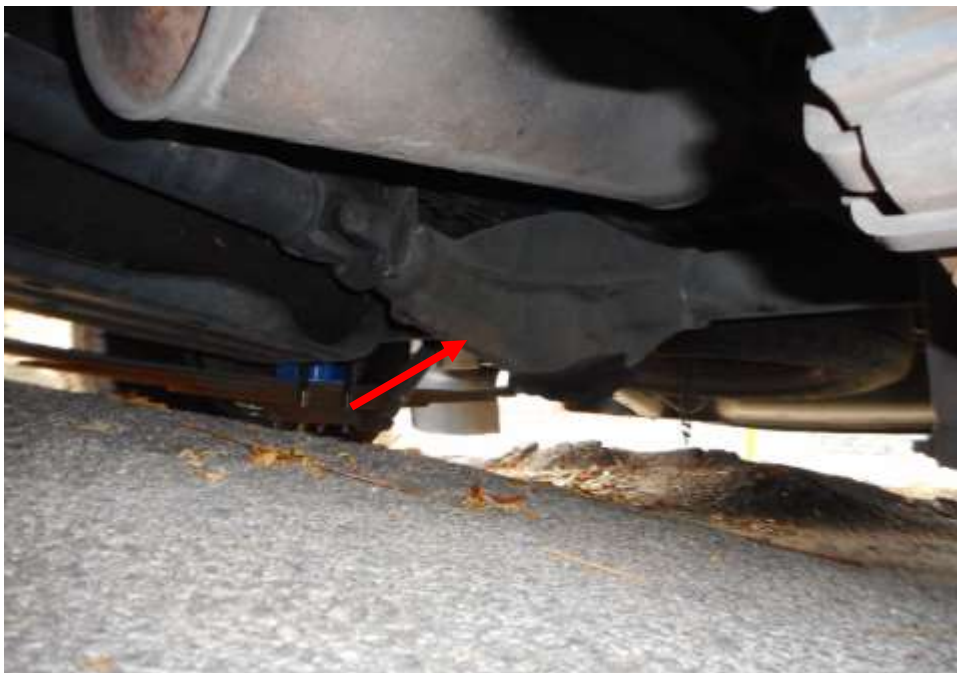
Photo 23 shows the various undercarriage components of the Motor Pick-Up, which had included the drive shaft (red arrow). The various undercarriage components of the Motor Pick-Up were all found to be intact without any visible damage.
