Your Ref: TP/IP/35751/2019
Our Ref : CI/TPD19011276/P

Fatal Accident Investigation Team

MECHANICAL INSPECTION REPORT OF MOTOR CAR SLA 1567C

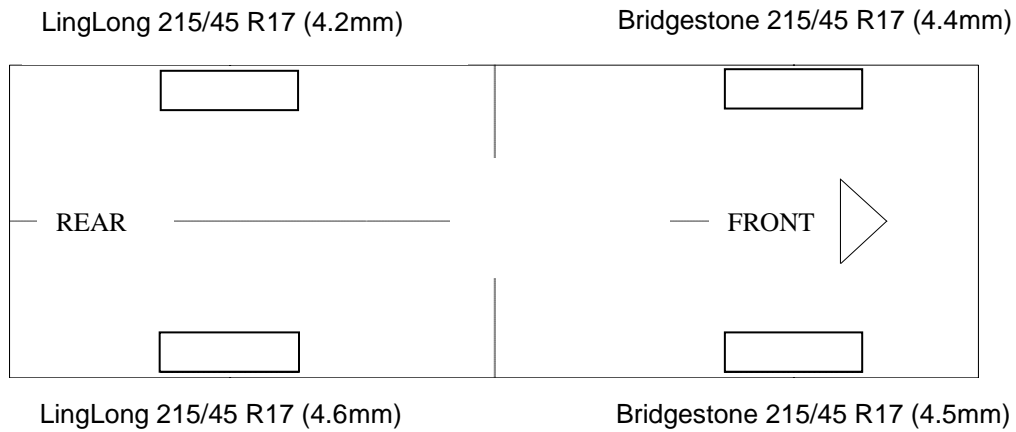
6. The 4 tyres of the Motor Car were observed to be in serviceable condition and sufficiently inflated for vehicular operation. I did not find any tear, cut or burst mark(s) on the outer and the inner sidewalls as well as across the tread of the 4 tyres. The tyre brand, tyre size and remaining tread depth of the 4 tyres of the Motor Car were recorded as follows:-

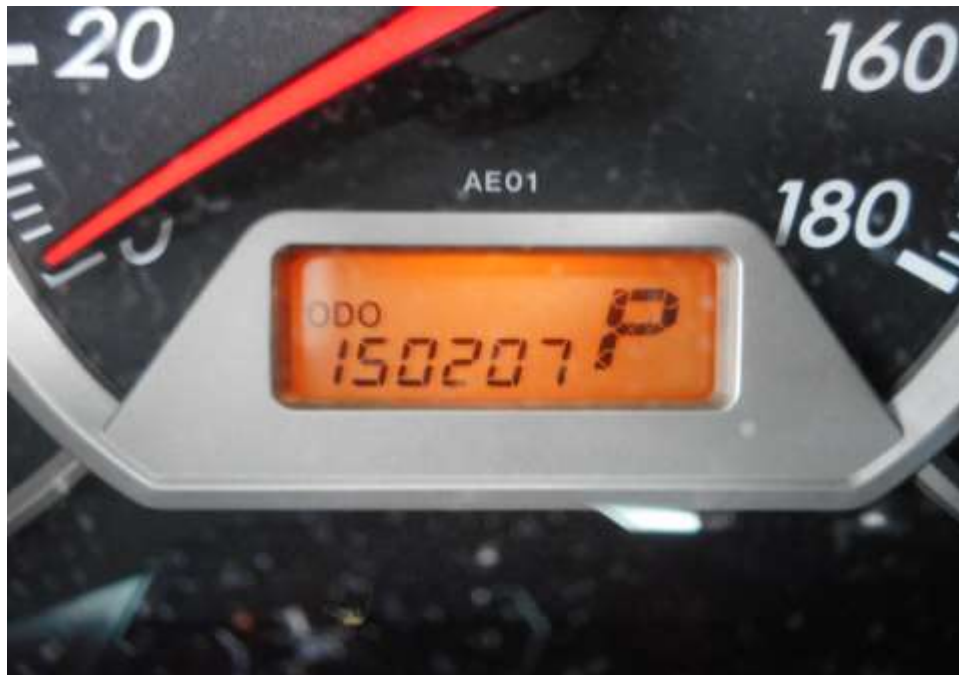
Photo 1 shows a general view of the instrument cluster of the Motor Car at the time of my inspection. The mileage of the Motor Car was 150,207km

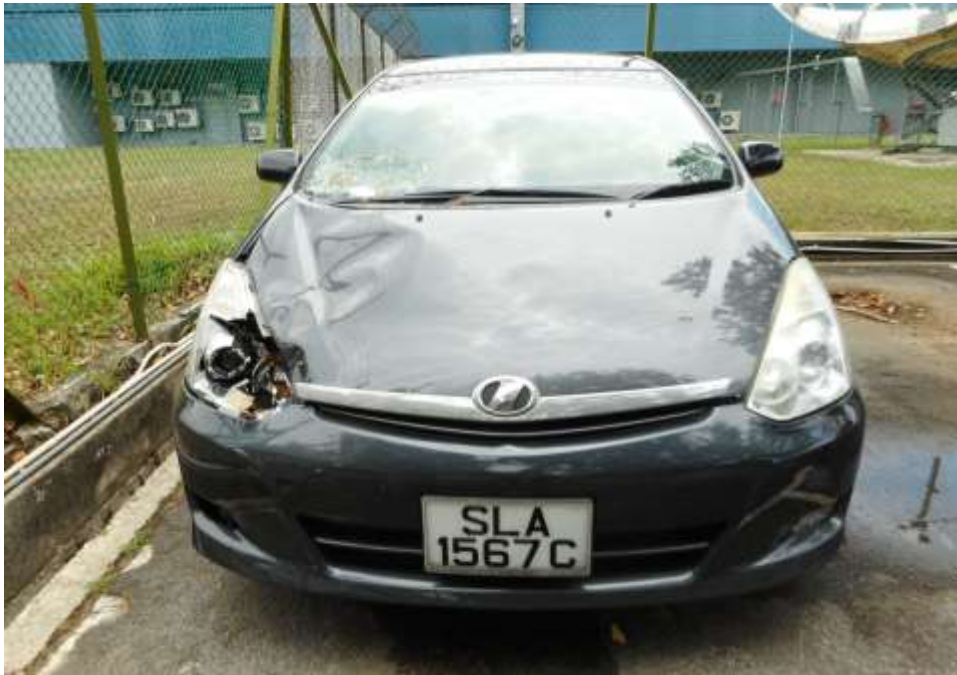
4. The mileage of the Motor Car at the time of my inspection was 150,207km.
5. The Motor Car appeared to have sustained moderate damage at its frontal portion. Its front windscreen, front bonnet, front bumper and front right headlamp were damaged at the time of my inspection.

Photo 2 shows a general view of the Motor Car's frontal portion at the time of my inspection. It appeared to have sustained moderate damage at its frontal portion. Its front windscreen, front bonnet, front bumper and front right headlamp were damage at the time of my inspection.

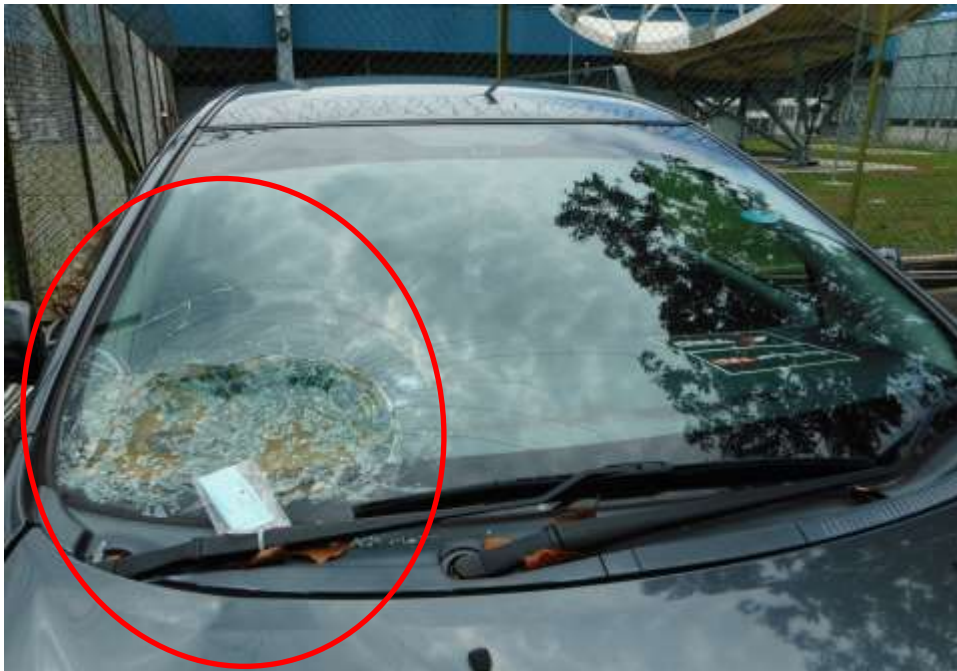
Photo 3 shows a close up view of the Motor Car's frontal portion at the time of my inspection. Its front windscreen (circled) was damage at the time of my inspection.

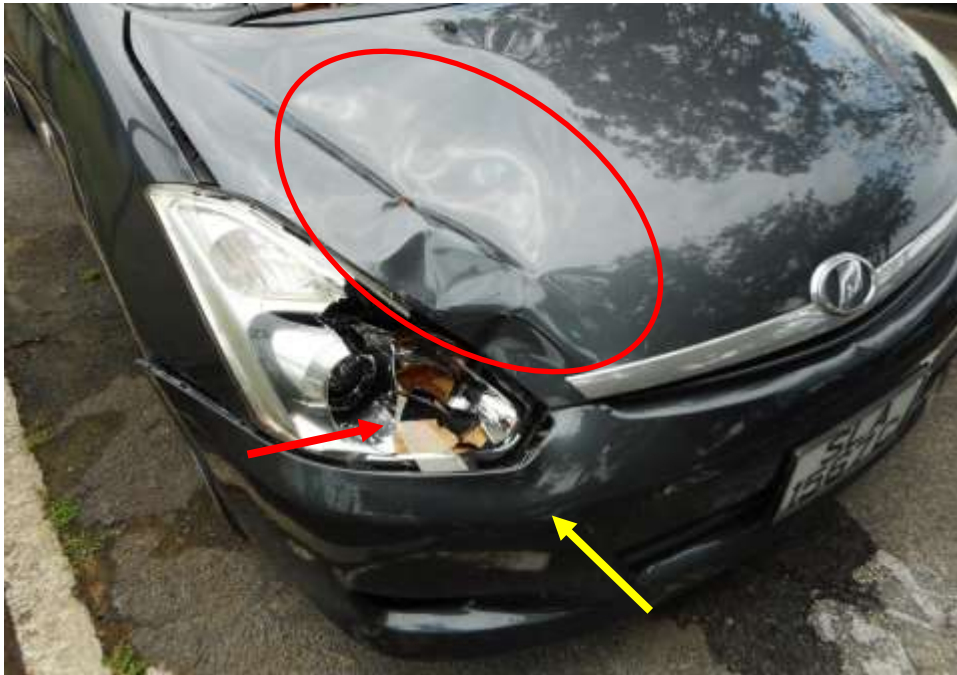
Photo 4 shows a close up view of the Motor Car's frontal portion at the time of my inspection. Its front bonnet (circled), front bumper (yellow arrow) and front right headlamp (red arrow) were damage at the time of my inspection.

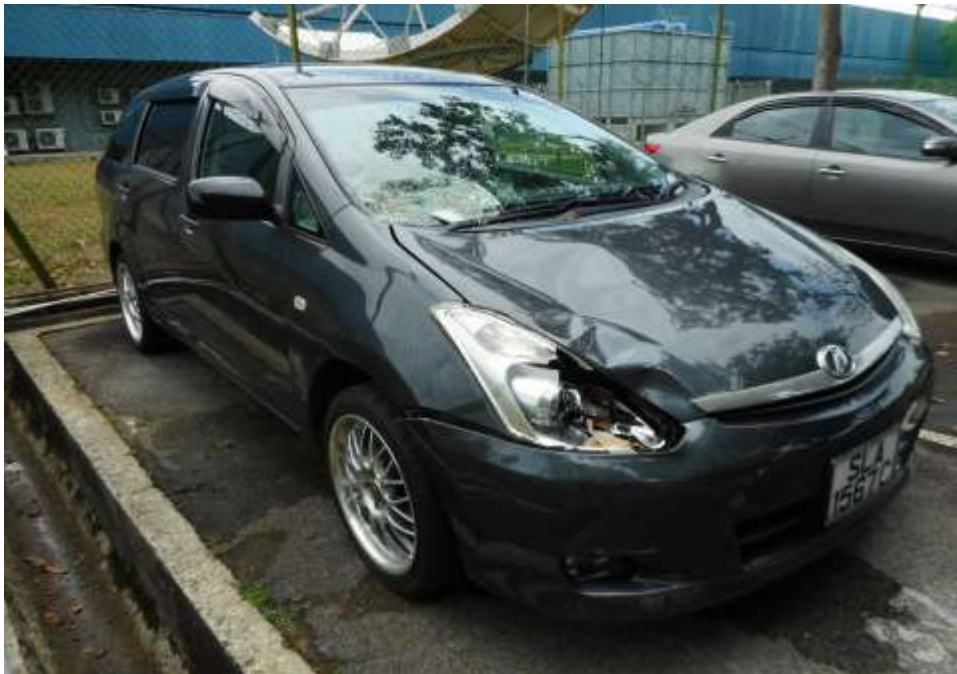
Photo 5 shows a general view of the front right body of the Motor Car at the time of my inspection. The Motor Car was observed to be intact and unaffected by the accident.

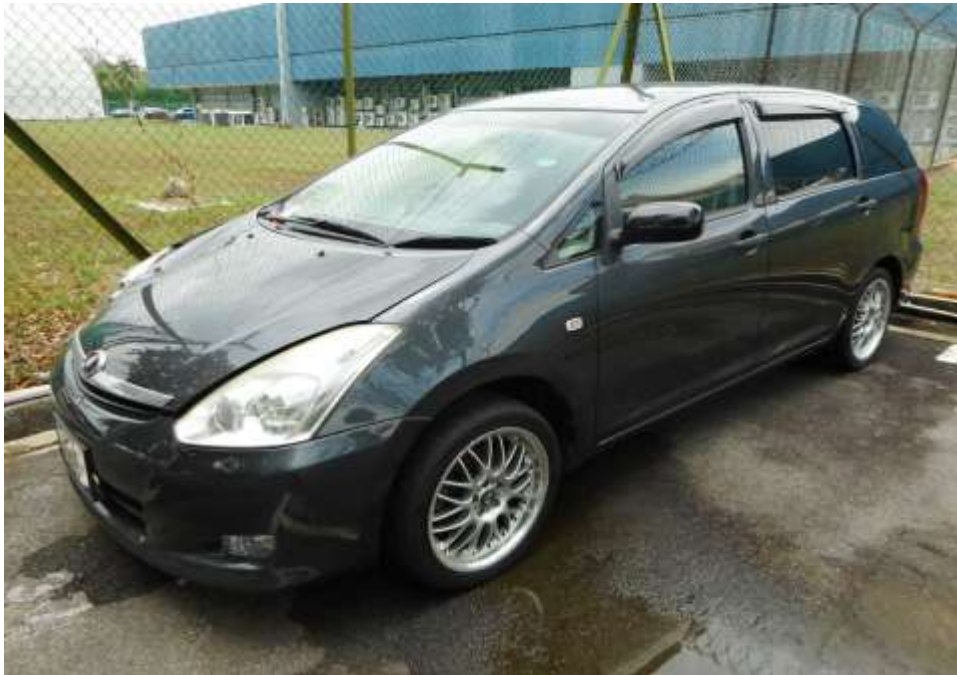
Photo 6 shows a general view of the front left body of the Motor Car at the time of my inspection. The Motor Car was observed to be intact and unaffected by the accident.

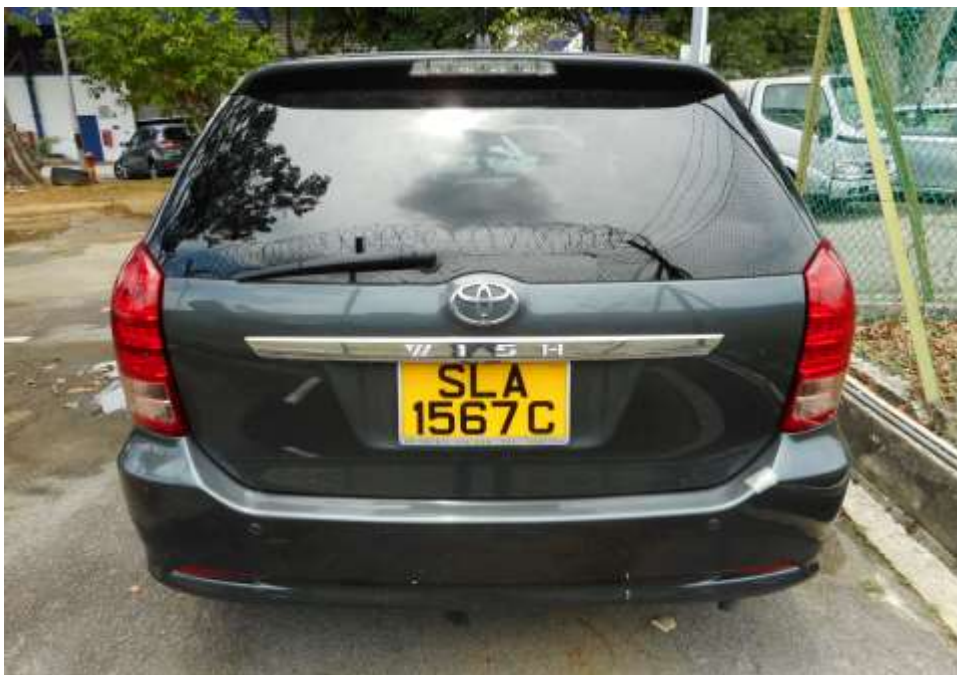
Photo 7 shows a general view of the rear body of the Motor Car at the time of my inspection. The Motor Car was observed to be intact and unaffected by the accident.

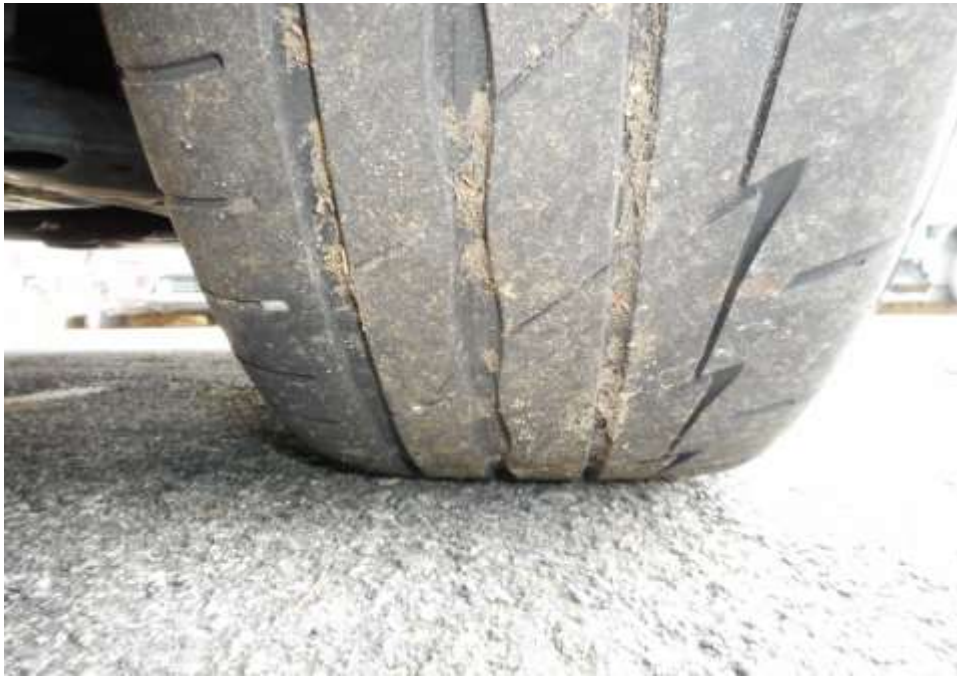
Photo 8 shows the condition of the front right tyre of the Motor Car, which was observed to be in serviceable condition with remaining tread depth of approximately 4.5mm. The tyre, which was wrapped around standard alloy wheel rim, was also observed to be sufficiently inflated for vehicular operation. There was no tear, cut or burst mark(s) on the outer and the inner sidewalls as well as across the tread of the 4 tyres that were fitted on the Motor Car.

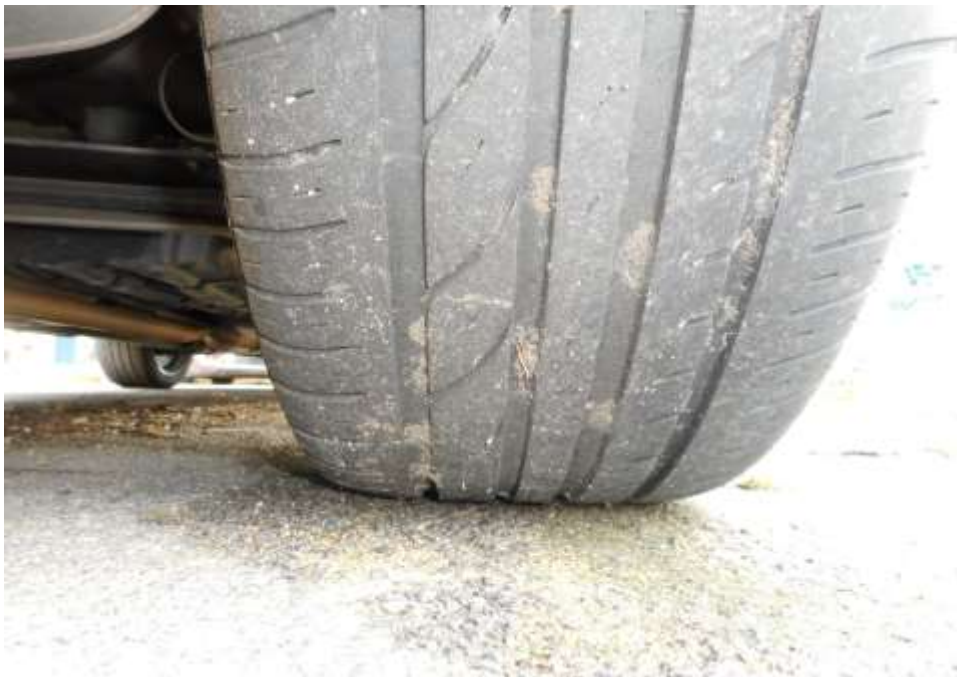
Photo 9 shows the condition of the rear right tyre of the Motor Car, which was observed to be in serviceable condition with remaining tread depth of approximately 4.6mm. The tyre, which was wrapped around standard alloy wheel rim, was also observed to be sufficiently inflated for vehicular operation.

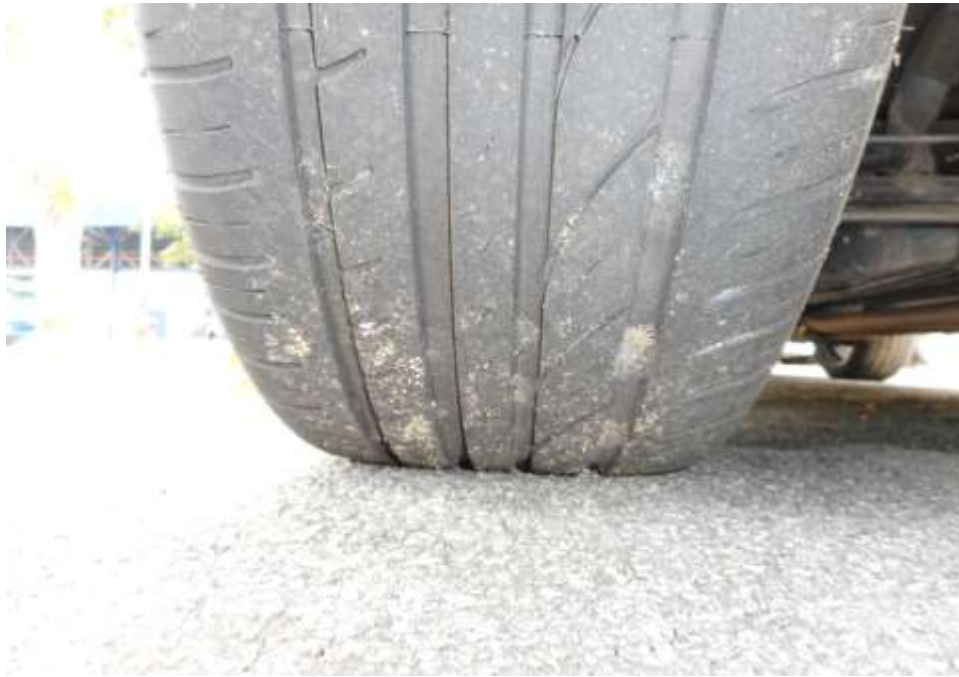
Photo 10 shows the condition of the rear left tyres of the Motor Car, which was observed to be in serviceable condition with remaining tread depth of approximately 4.2mm. The tyres, which were wrapped around standard alloy wheel rim, were also observed to be sufficiently inflated for vehicular operation. There was also no damage found on all 4 alloy wheel rims of the Motor Car.

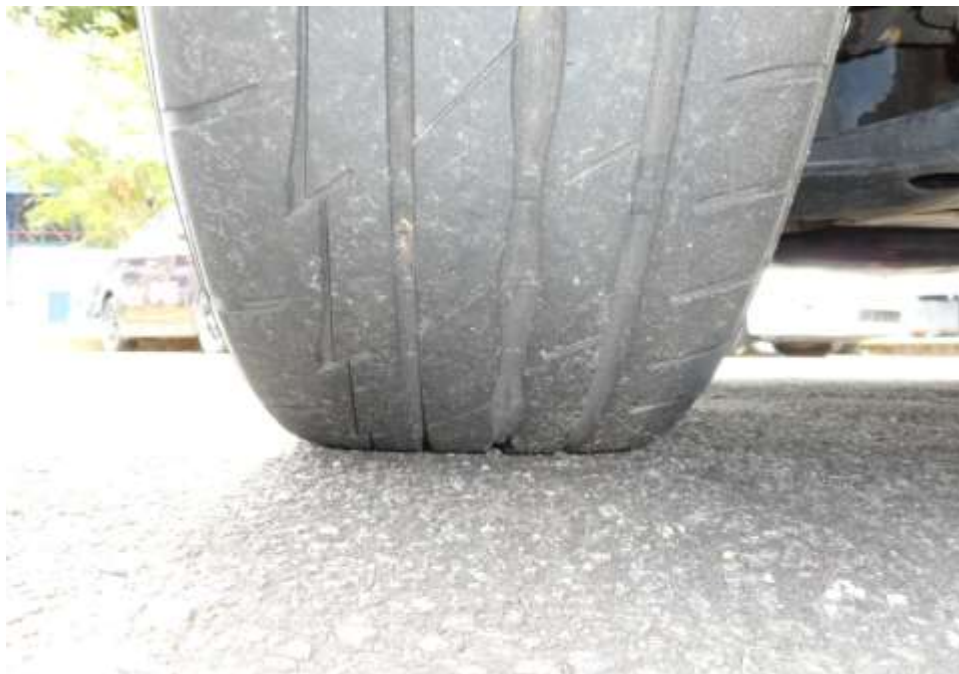
Photo 11 shows the condition of the rear right tyres of the Motor Car, which were observed to be in serviceable condition with remaining, tread depth of approximately 4.4mm. There was also no tear, cut or burst mark(s) on the outer and the inner sidewalls as well as across the tread of the 4 tyres that were fitted on the Motor Car.

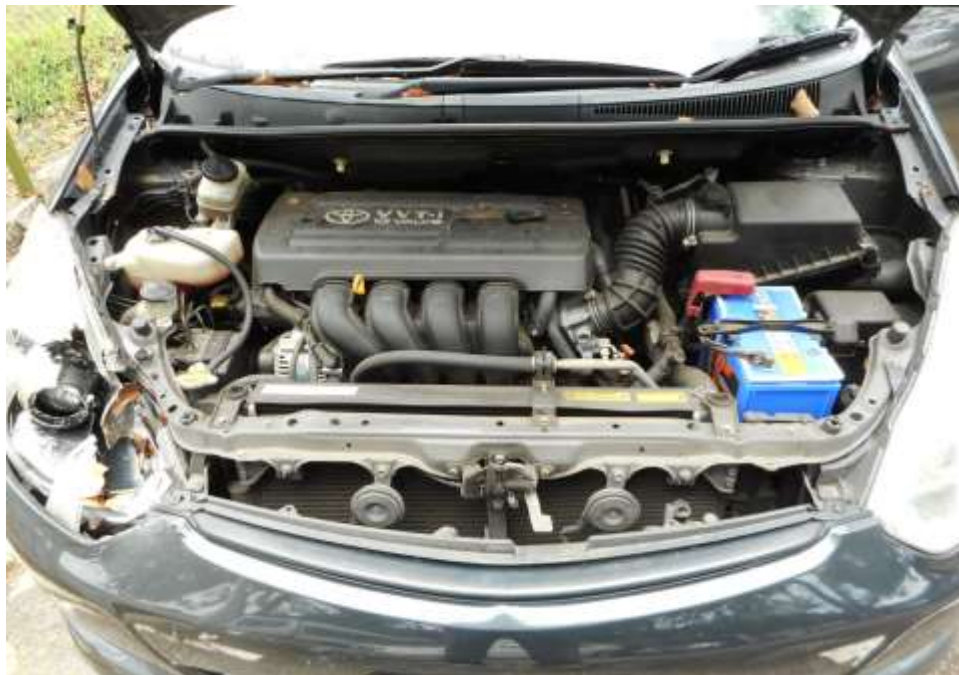
Photo 12 shows a general view of the Motor Car's engine compartment, which was accessed by lifting the front cabin of the Motor Car. The various parts and components inside the engine compartment were unaffected by the accident. There was also no sign(s) or indication(s) of fresh fluid leakage and/or fluid stain within the engine compartment

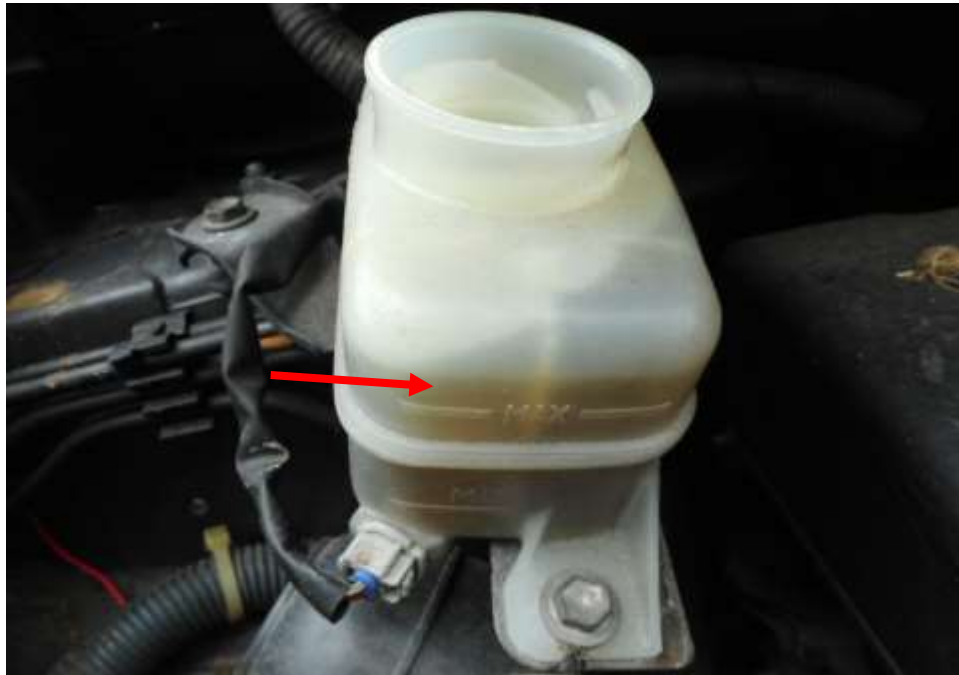
Photo 13 shows the brake fluid reservoir of the Motor Car at the time of my inspection. The brake fluid was observed to be of sufficient level (arrowed) and without any visible contamination.

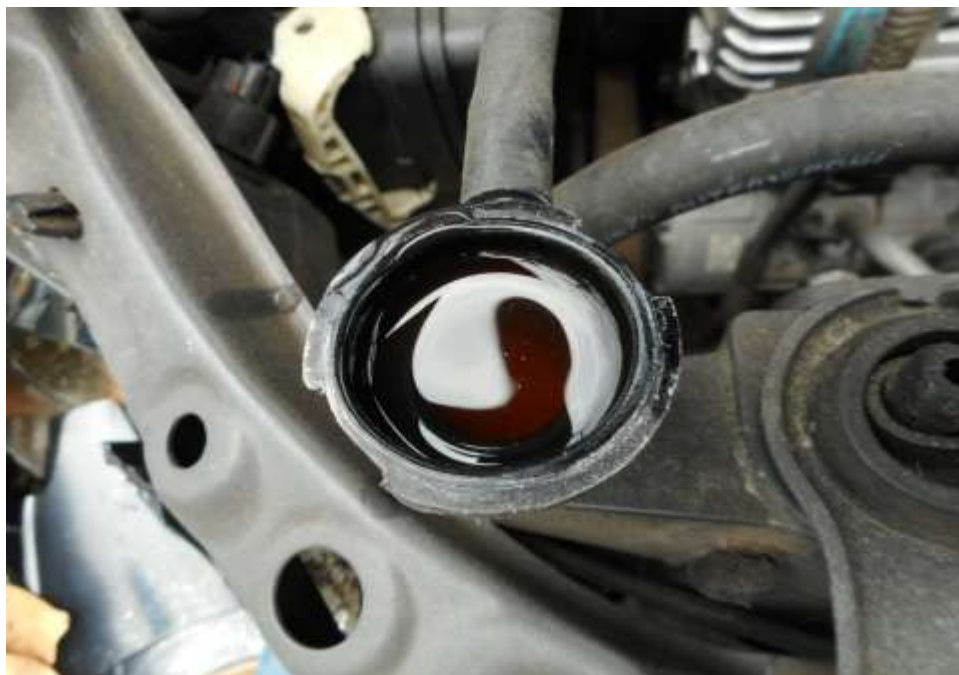
Photo 14 shows the engine coolant reservoir of the Motor Car at the time of my inspection. The engine coolant was observed to be of sufficient level and without any visible contamination.

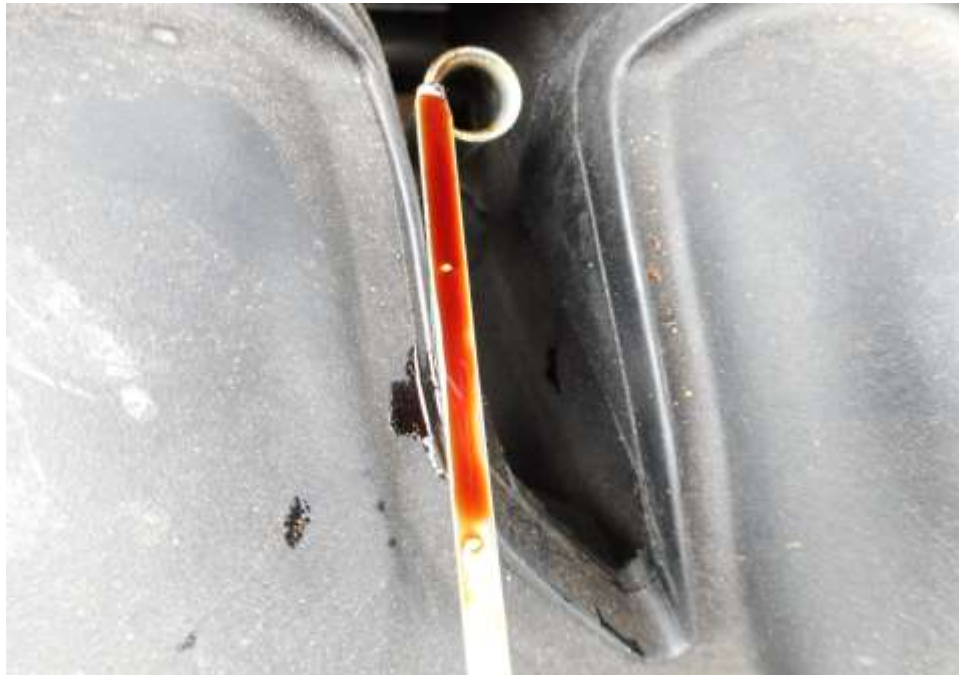
Photo 15 shows the engine oil dip stick of the Motor Car at the time of my inspection. The engine oil was observed to be of sufficient level and without any visible contamination.

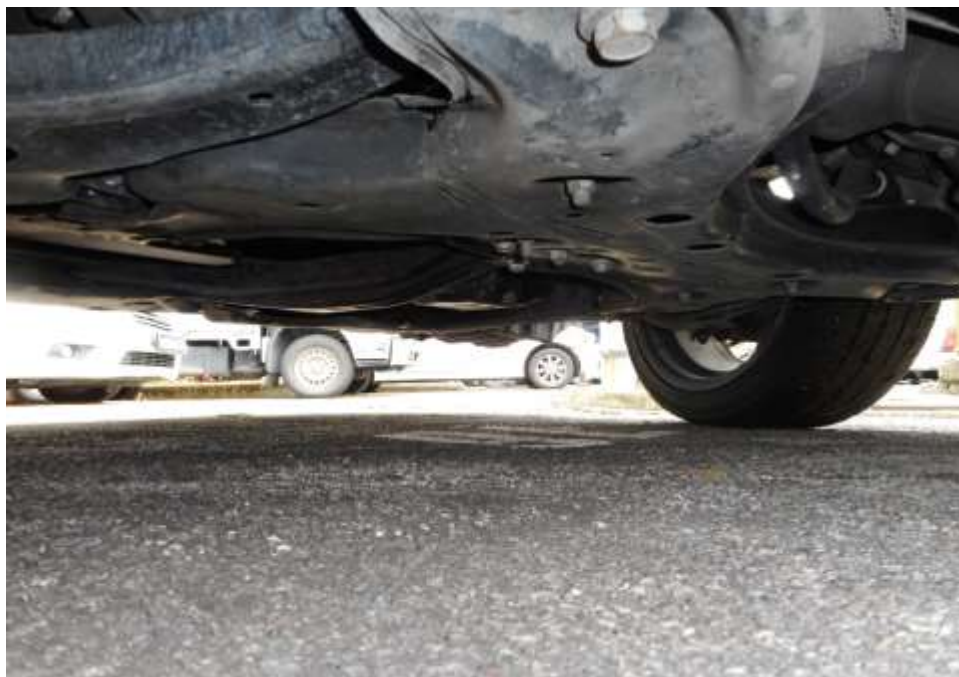
Photo 16 shows the undercarriage of the Motor Car, at the area where the engine housing and transmission housing are located. . I did not find any sign(s) or indication(s) of fluid leak and/or fluid stain(s) on the underside of the Motor Car.

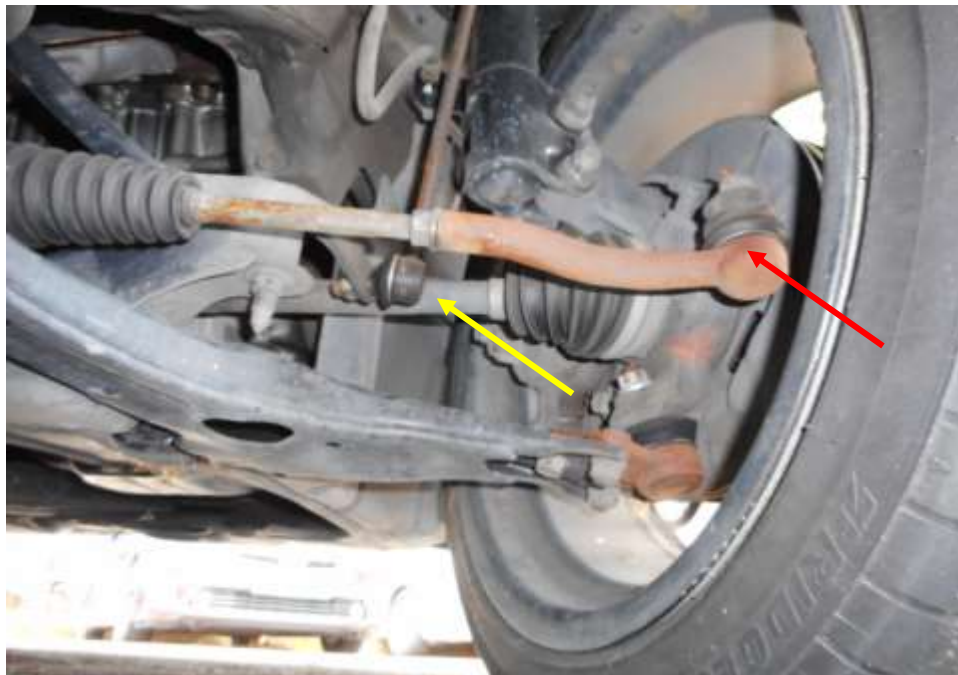
Photo 17 shows the various undercarriage components at the front right wheel of the Motor Car, in particular the steering tie rod end (arrowed) and drive shaft (yellow arrow). The various steering components were all found to be intact, suggesting that the steering system of the Motor Car was likely to be in serviceable condition at the material time of accident. There was also no sign of fluid stain(s) observed on the various undercarriage components.

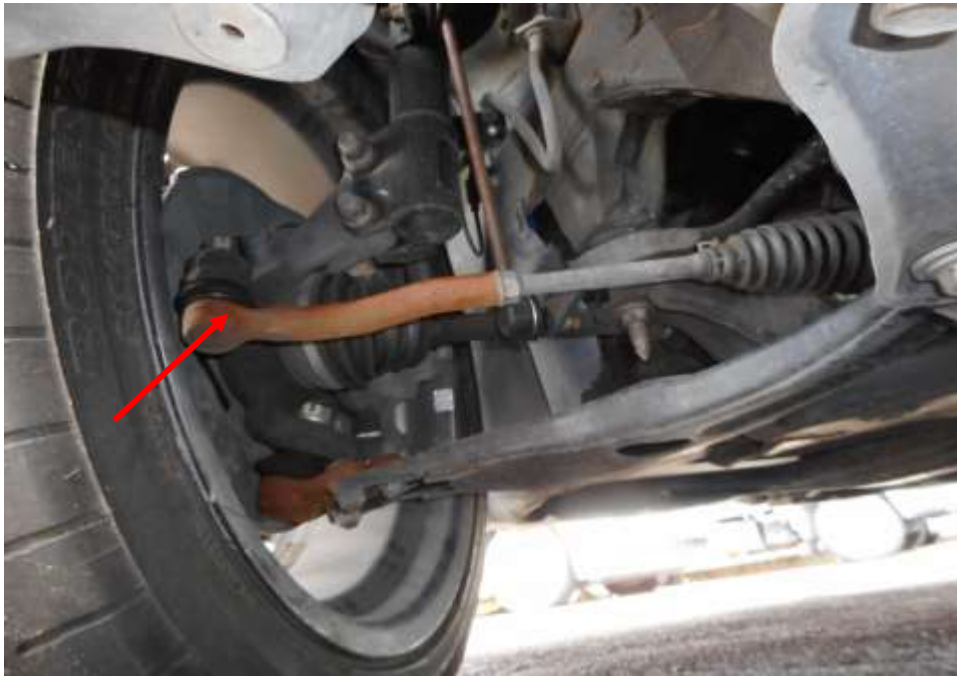
Photo 18 shows the various undercarriage components at the front left wheel of the Motor Car, in particular the steering tie rod end (arrowed). The various Undercarriage components of the Motor Car were all found to be intact without any visible damage. There was also no sign of fluid stain(s) observed on the various undercarriage components.

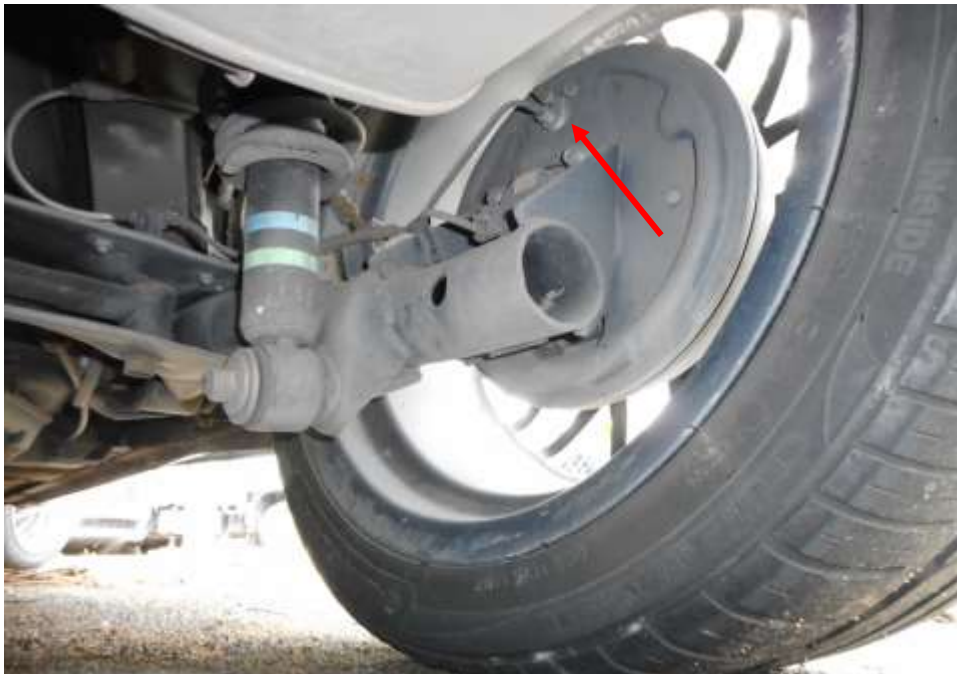
Photo 19 shows the brake pipe (arrowed) at the rear right wheel of the Motor Car. I did not observe any leakage of brake fluid at the time of my inspection of the Motor Car. My static tests of the Motor Car's braking system, along with my visual examination of the various mechanical components in the braking system, had indicated that there was no internal leakage of pressure/vacuum. Hence the braking system of the Motor Car was likely to be in serviceable condition at the material time of accident.

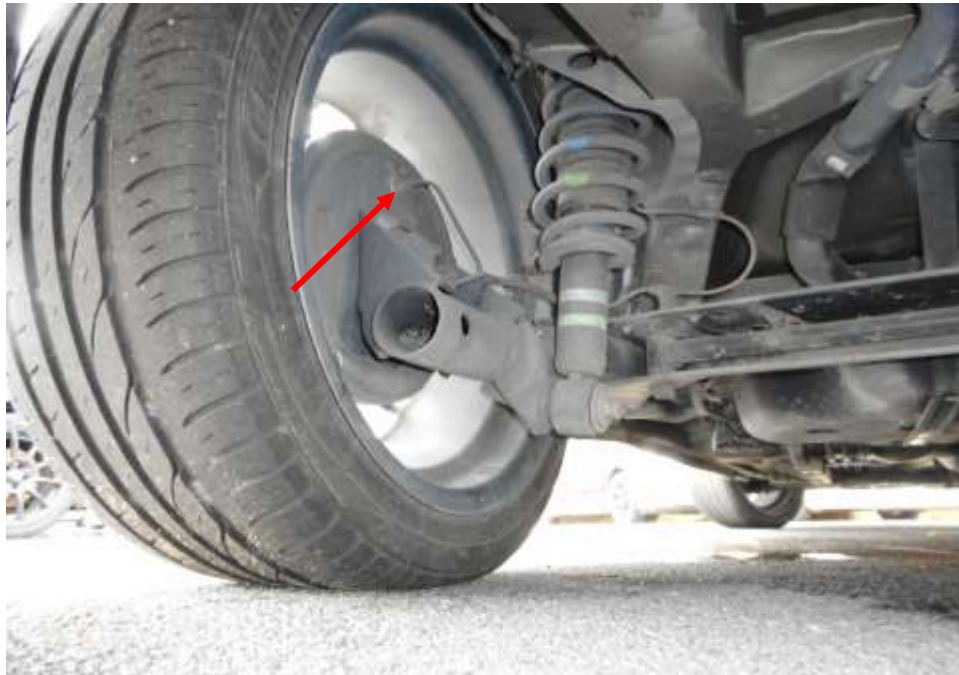
Photo 20 shows the brake pipe (arrowed) at the rear left wheel of the Motor Car. I did not observe any leakage of brake fluid at the time of my inspection of the Motor Car. My static tests of the Motor Car's braking system, along with my visual examination of the various mechanical components in the braking system had indicated that there was no internal leakage of pressure/vacuum. Hence the braking system of the Motor Car was likely to be in serviceable condition at the material time of accident.

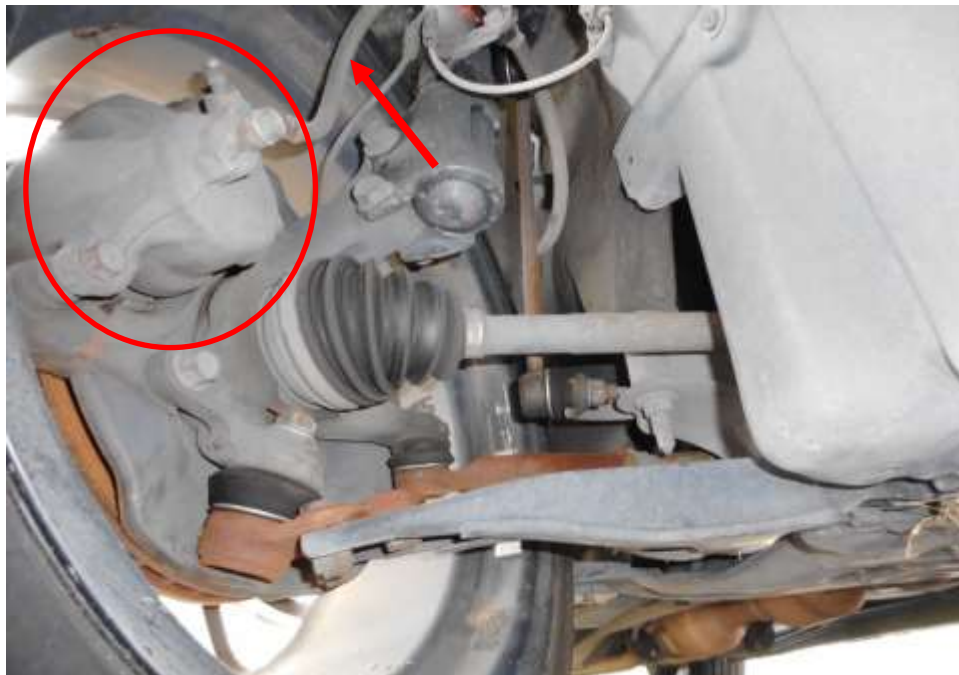
Photo 21 shows the brake hose/pipe (arrowed) at the front right wheel of the Motor Car. No leakage of brake fluid was observed. Visual examination of the various components of the braking system like the brake caliper (circled), brake booster, brake pedal etc had revealed all to be intact and without visible damage at the time of accident. There was also no sign of fluid stain(s) observed on the various undercarriage components.

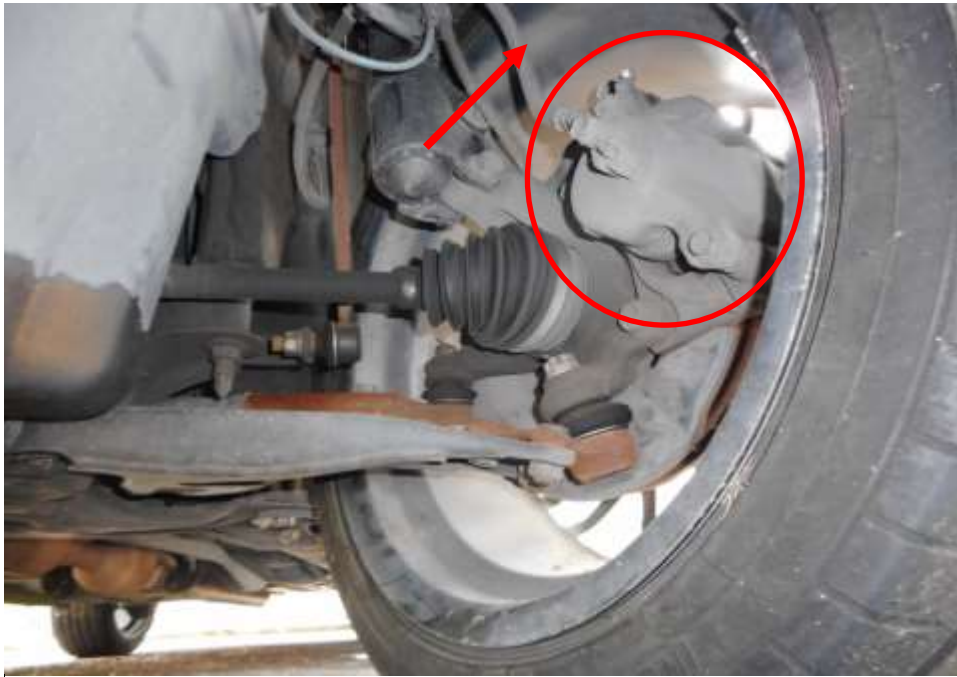
Photo 22 shows the brake hose/pipe (arrowed) at the front left wheel of the Motor Car. No leakage of brake fluid was observed. Visual examination of the various components of the braking system like the brake caliper (circled), brake booster, brake pedal etc had revealed all to be intact and without visible damage at the time of accident. There was also no sign of fluid stain(s) observed on the various undercarriage components.

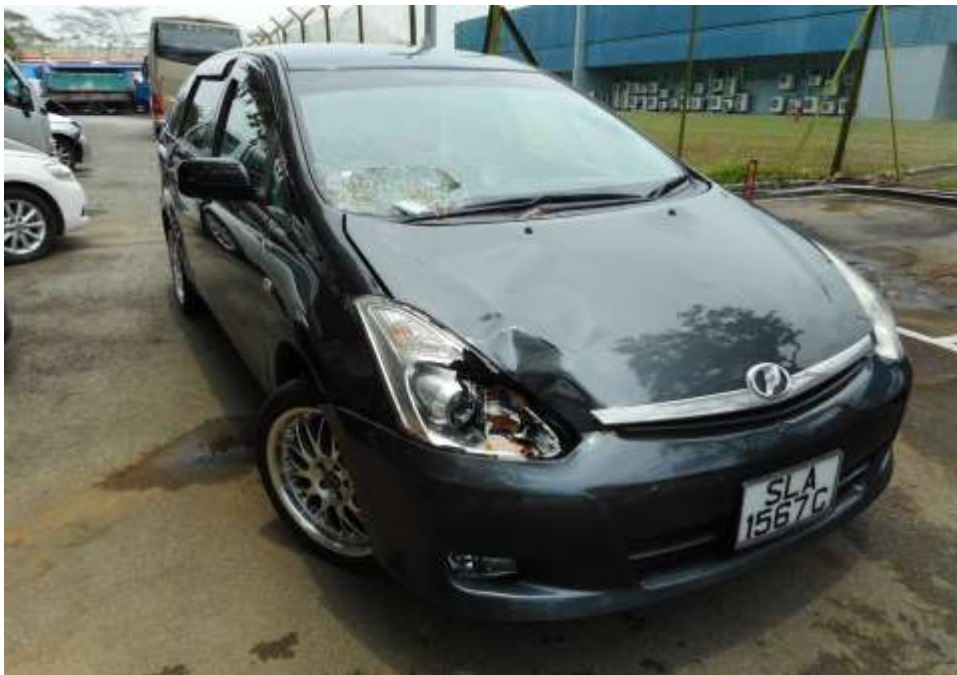
Photo 23 shows the front right wheel of the Motor Car turned to its full left. During my steering system test, I did not experience any abnormal free play and/or resistance when I had turned the steering wheel towards full left and full right. This would suggest that the steering system of the Motor Car was likely to be in serviceable condition at the material time of accident.

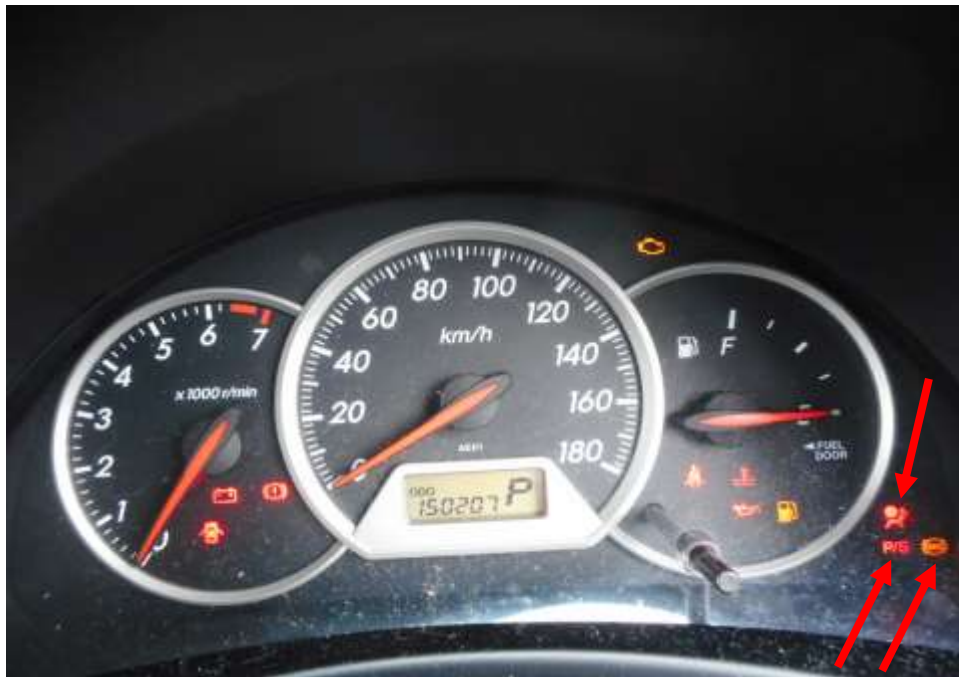
Photo 24 shows the warning light for Anti-Lock Brake System (ABS) and Supplemental Restraint System (SRS) and Electric Power Steering System (EPS) appearing on the instrument panel of the Motor Car during the self-test of its various electronic operating systems when its engine was cranked.

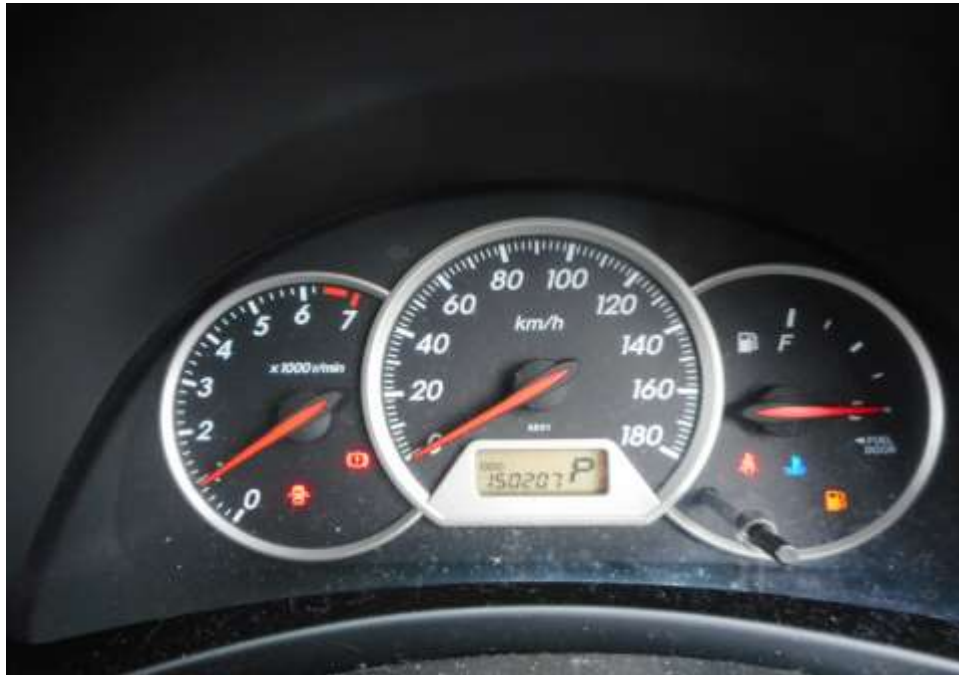
Photo 25 shows no warning lights illuminated on the instrument panel of the Motor Car after the engine was cranked. This would suggest that there was no abnormality to the various electronic operating systems of the Motor Car, like the ABS, SRS and EPS.
