Your Ref: TP/IP/36381/2019  
Our Ref : CI/TPD19011282/P

8<sup>th</sup> July 2019

**MECHANICAL INSPECTION REPORT OF MOTOR CAR SGQ 1003M**

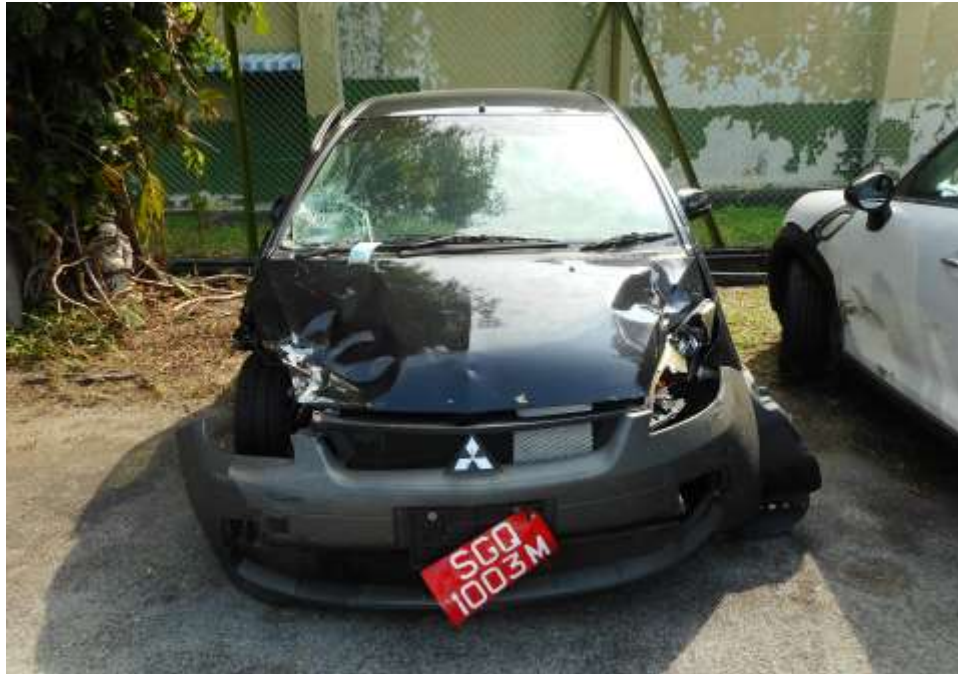
**Photo 1** shows a general view of the front portion of the Motor Car at the time of my inspection. The Motor Car was also observed to have sustained extensive damage at its frontal and undercarriage portion, damaged parts had included its front windscreen, front bonnet, front bumper, front number plate, left and right fenders, front left and right headlamp and Its undercarriage front right steering tie rod. were amongst the body parts that were observed to have been damaged as a result of the accident.

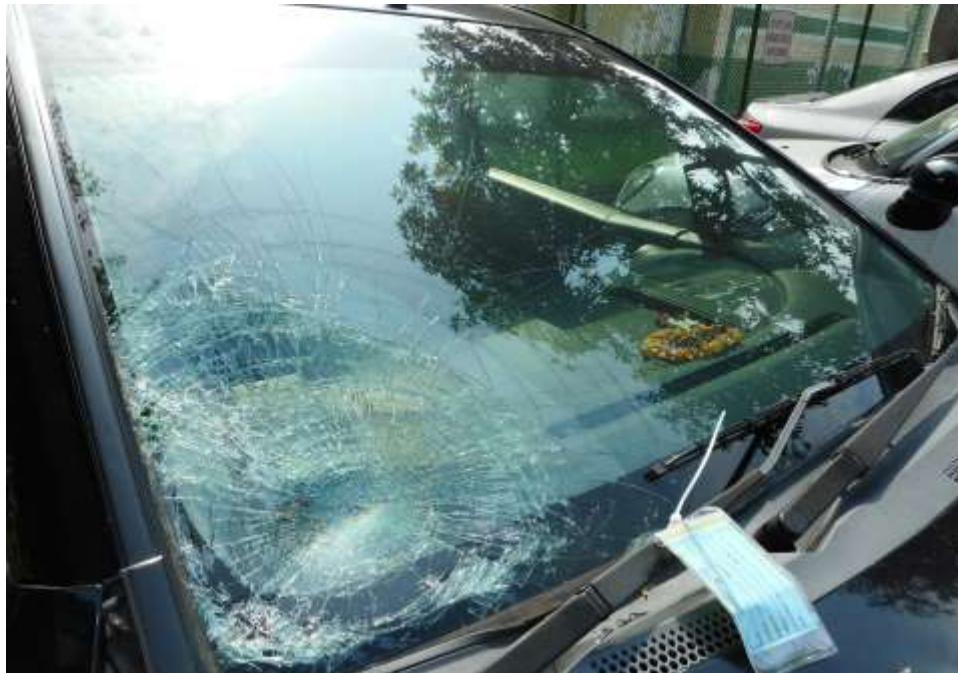
**Photo 2** shows a close up view of the front windscreen of the Motor Car at the time of my inspection. The front windscreen of the Motor Car was observed to have been damaged as a result of the accident

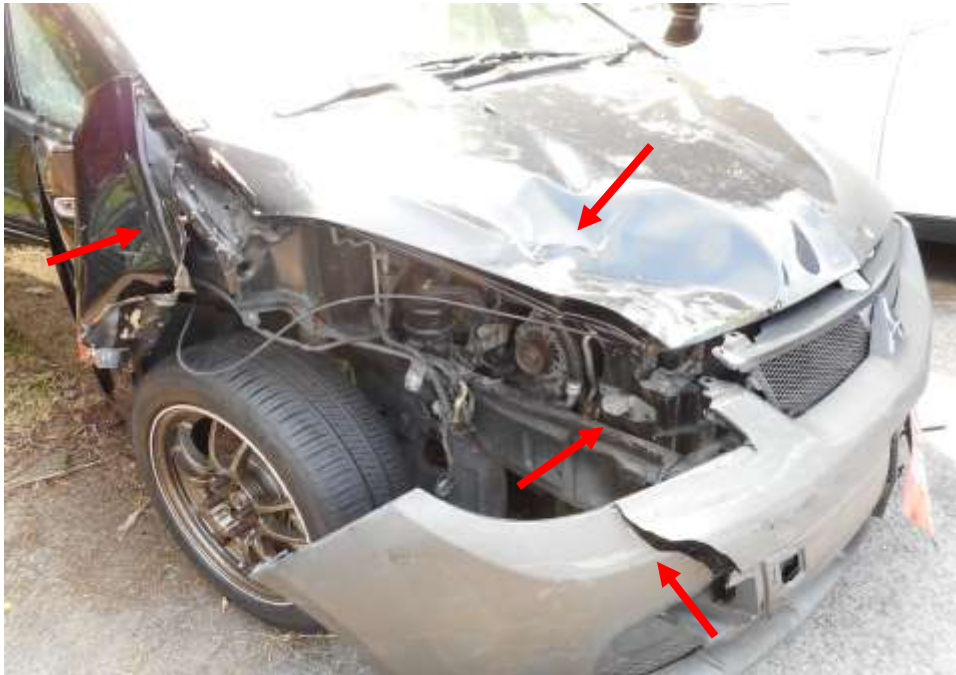
**Photo 3** shows a close up view of the front right portion of the Motor Car at the time of my inspection. The Motor Car was also observed to have sustained extensive damage at its frontal portal, damaged parts had included its, front bonnet, front bumper, right fender, front right headlamp (arrowed) were amongst the body parts that were observed to have been damaged as a result of the accident.

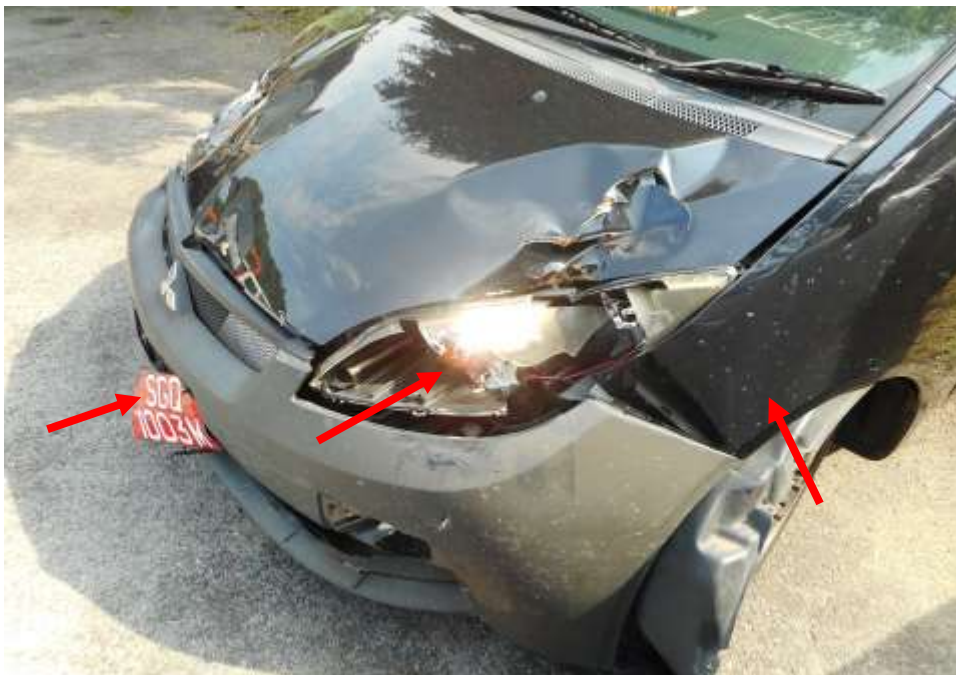
**Photo 4** shows a close up view of the front left portion of the Motor Car at the time of my inspection. The Motor Car was also observed to have sustained extensive damage at its frontal portal, damaged parts had included its, front bumper, left fender, front left headlamp and front number plate (arrowed) were amongst the body parts that were observed to have been damaged as a result of the accident.

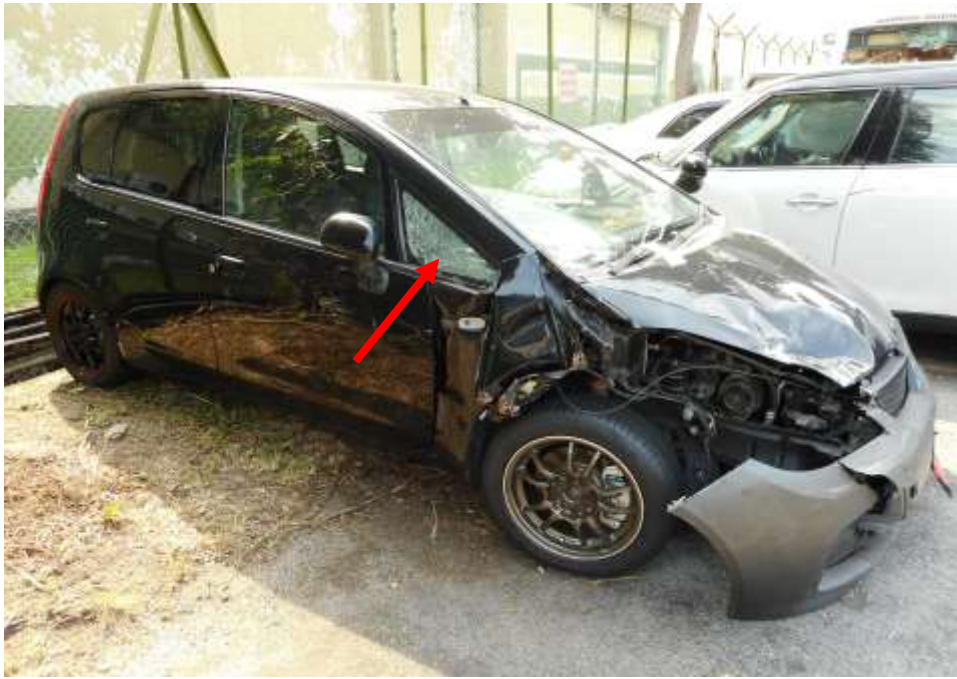
**Photo 5** shows a general view of the front right portion of the Motor Car at the time of my inspection. The right side windscreen (arrowed) of the Motor Car was observed to have been damaged as a result of the accident.

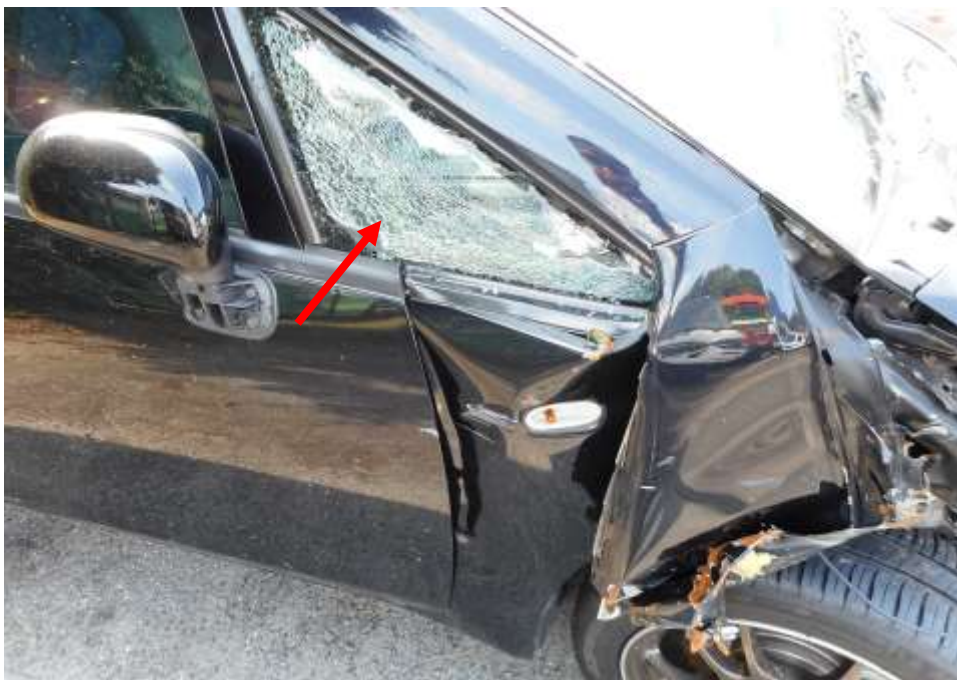
**Photo 6** shows a close up view of the right side windscreen (arrowed) portion of the Motor Car at the time of my inspection. of the Motor Car was observed to have been damaged as a result of the accident.

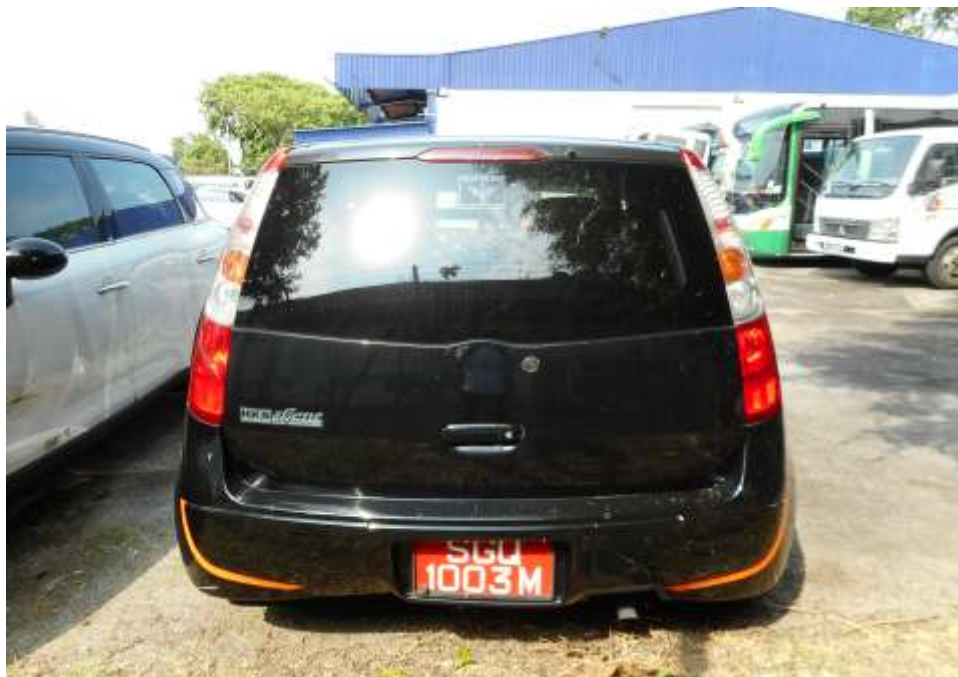
**Photo 8** shows a general view of the rear portion of the Motor Car at the time of my inspection. The rear portion of the Motor Car was observed to have been unaffected by the accident.

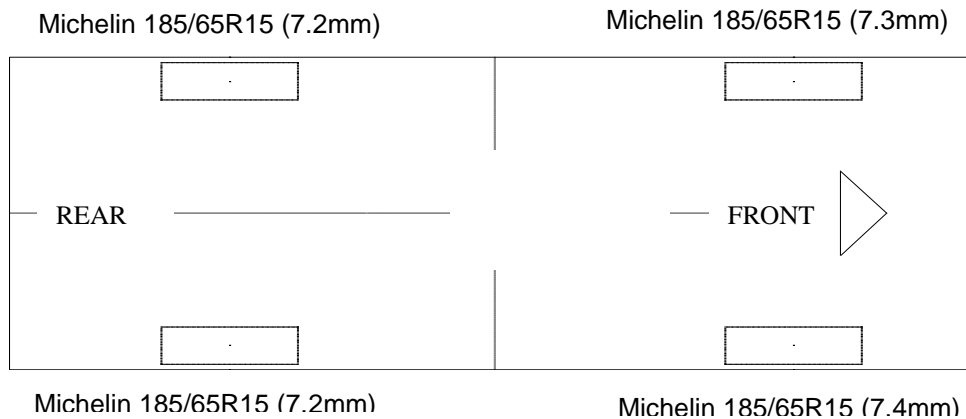
7. The condition of the Motor car's 4 tyres was observed to be in serviceable condition. I did not find any tear, cut or burst mark(s) on the outer and the inner sidewalls as well as across the tread of the 4 tyres. The 4 tyres were also observed to be sufficiently inflated for vehicular operation. The tyre brand, tyre size and remaining tread depth of the 4 tyres were recorded as follows:-

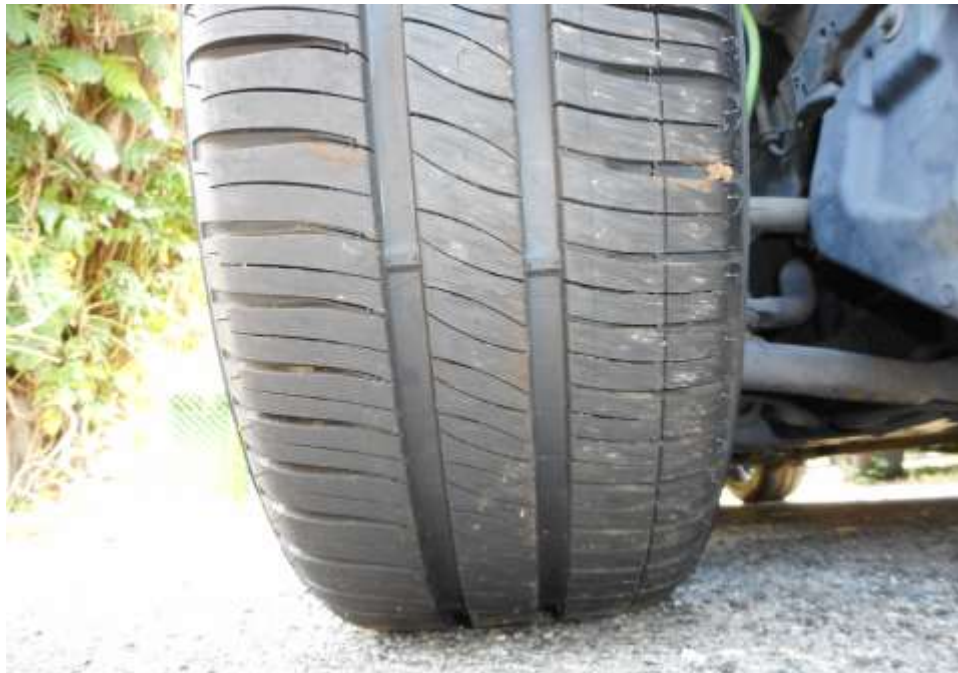
**Photo 9** shows the condition of the front right tyre of the Motor Car, which was observed to be in serviceable condition with remaining tread depth of approximately 7.4mm. There was no tear, cut or burst mark(s) on the outer and the inner sidewalls as well as across the tread of this tyre.

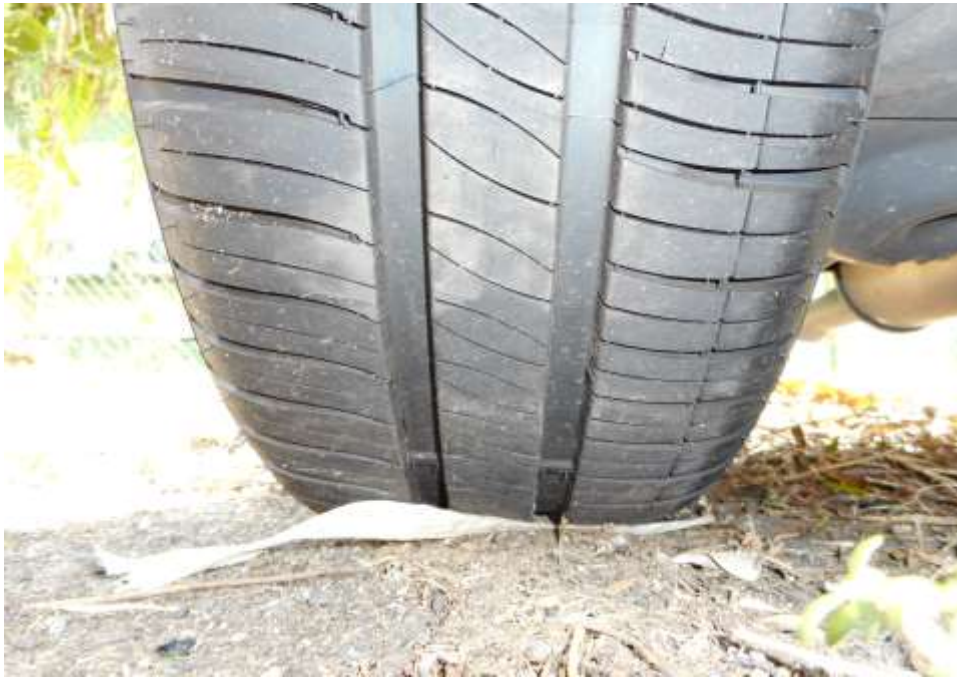
**Photo 10** shows the condition of the rear right tyre of the Motor Car, which was observed to be in serviceable condition with remaining tread depth of approximately 7.2mm. There was no tear, cut or burst mark(s) on the outer and the inner sidewalls as well as across the tread of this tyre.

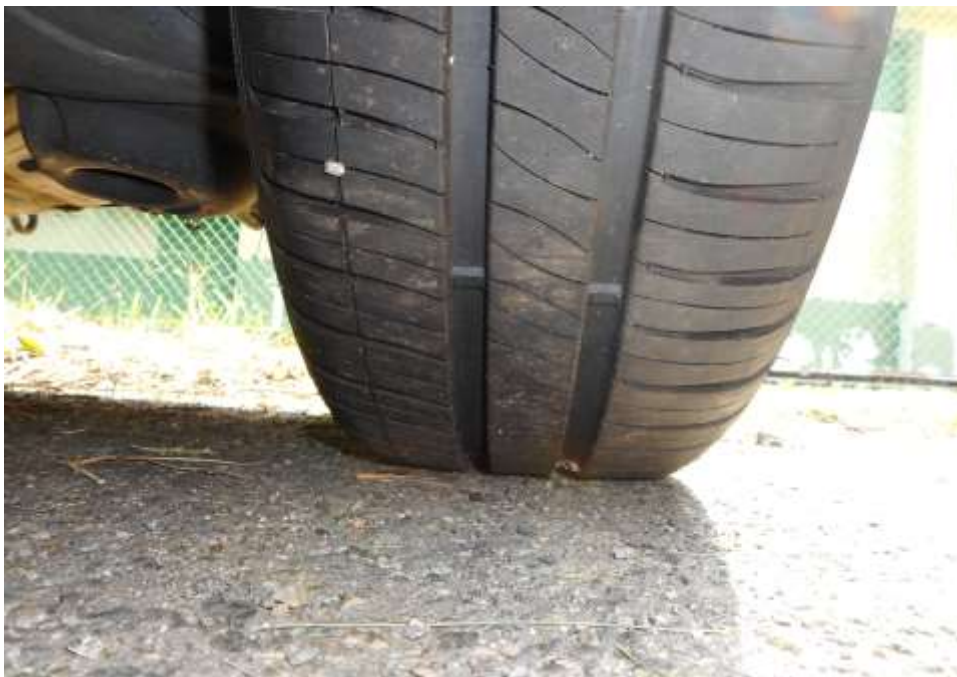
**Photo 11** shows the condition of the rear left tyre of the Motor Car, which was observed to be in serviceable condition with remaining tread depth of approximately 7.2mm. There was no tear, cut or burst mark(s) on the outer and the inner sidewalls as well as across the tread of this tyre.

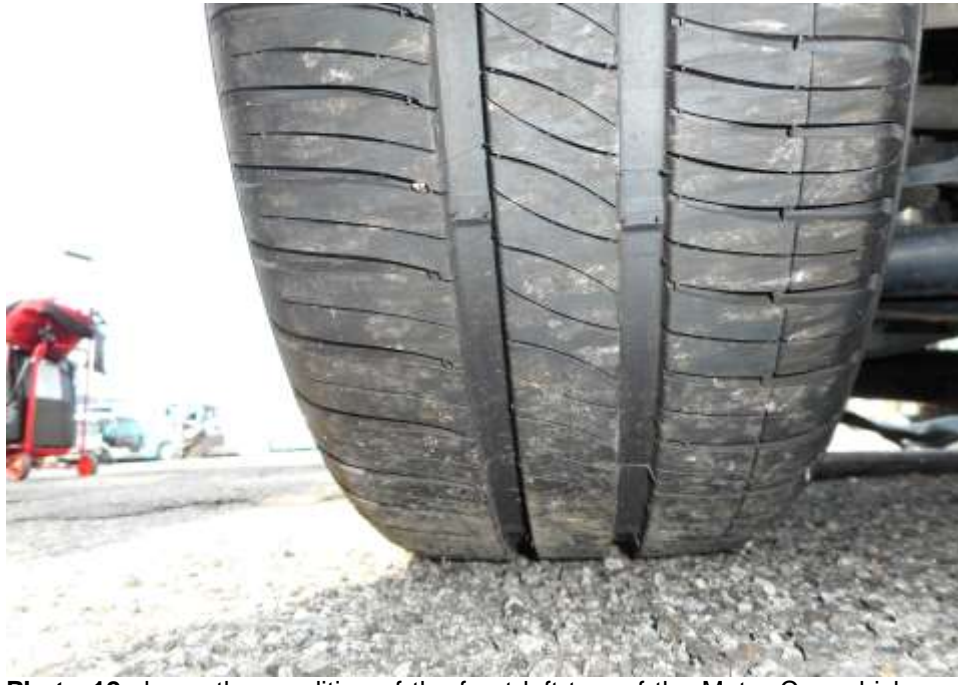
**Photo 12** shows the condition of the front left tyre of the Motor Car, which was observed to be in serviceable condition with remaining tread depth of approximately 7.3mm. There was no tear, cut or burst mark(s) on the outer and the inner sidewalls as well as across the tread of this tyre.

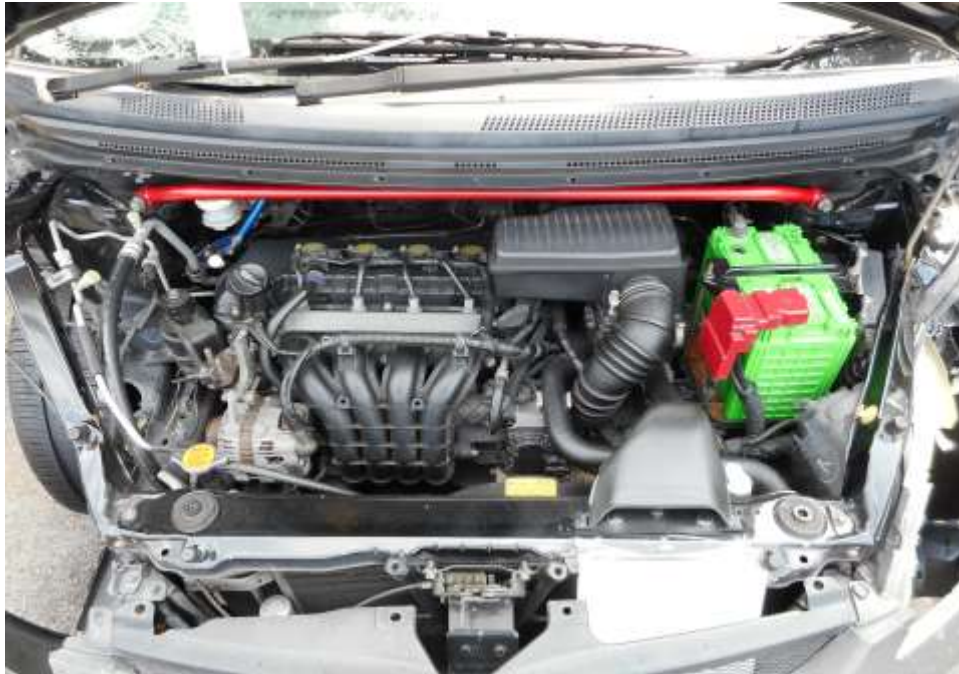
**Photo 13** shows a general view of the Motor Car's engine compartment. The various parts and components inside the engine compartment were unaffected by the accident. There was also no sign(s) or indication(s) of fluid leakage and/or fluid stain within the engine compartment.

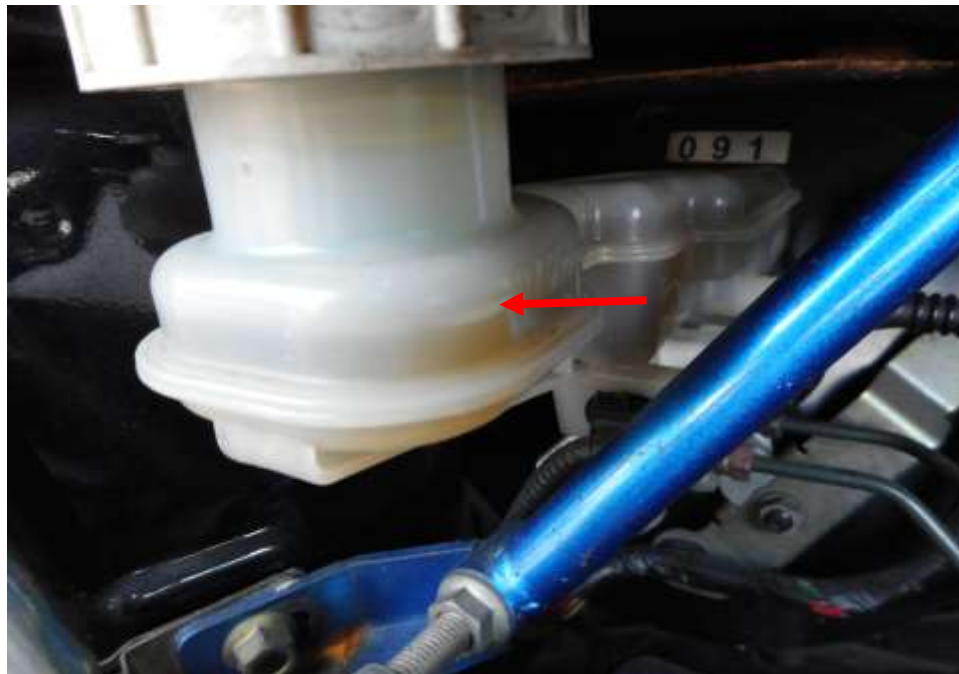
**Photo 14** shows the brake fluid reservoir of the Motor Car at the time of my inspection. The brake fluid was observed to be of sufficient level (arrowed) and without any visible contamination.

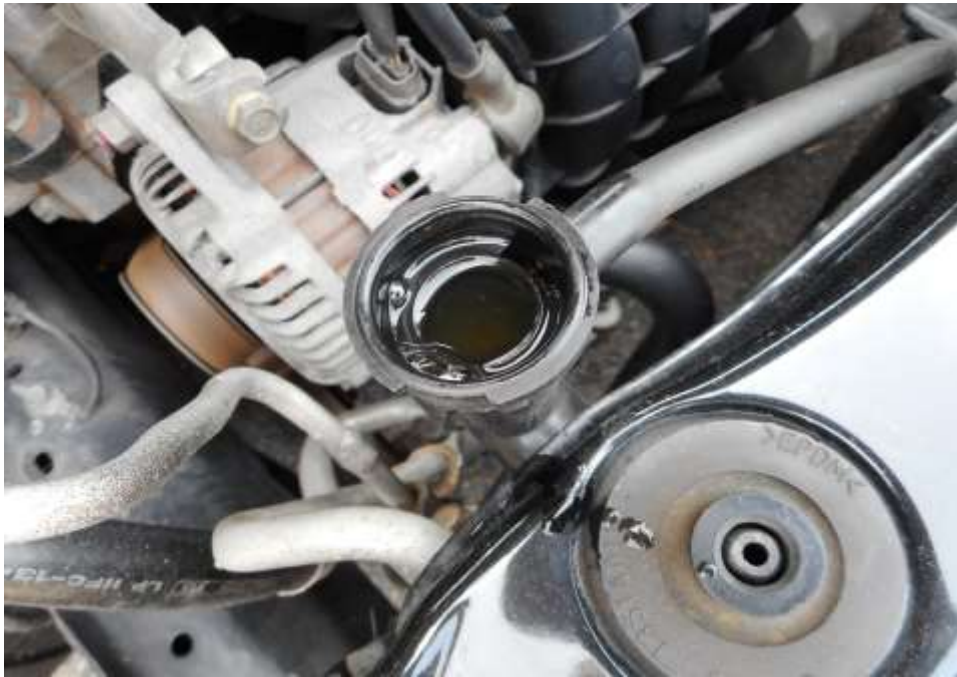
**Photo 15** shows checks being carried out to the engine coolant of the Motor Car at the time of my inspection. The engine coolant was observed to be of sufficient level (arrowed) and without any visible contamination.

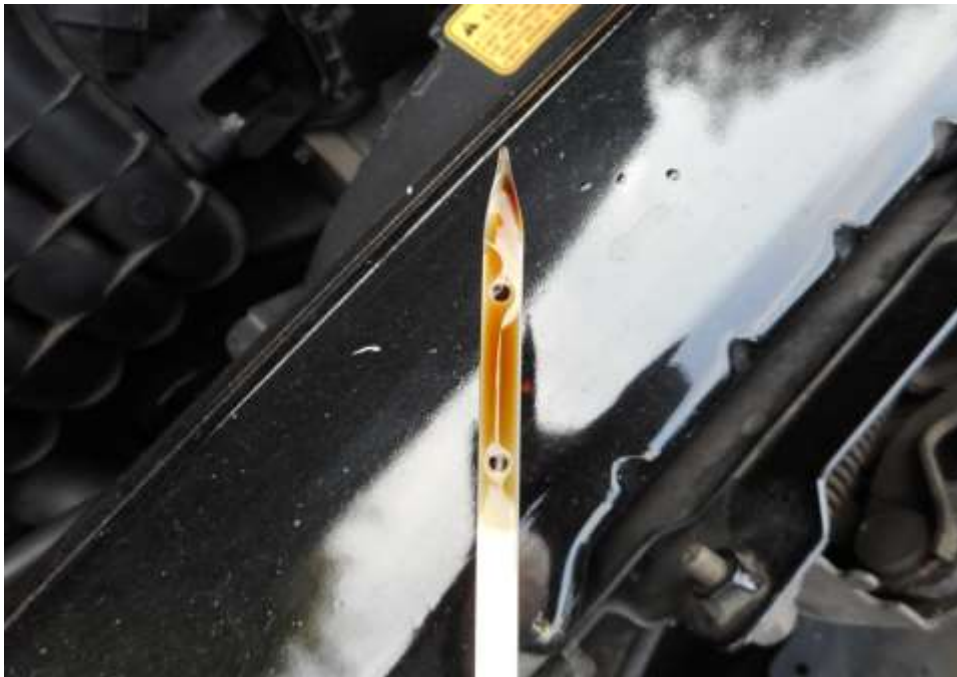
**Photo 16** shows the engine oil dip stick of the Motor Car at the time of my inspection. The engine oil was observed to be of sufficient level and without any visible contamination.

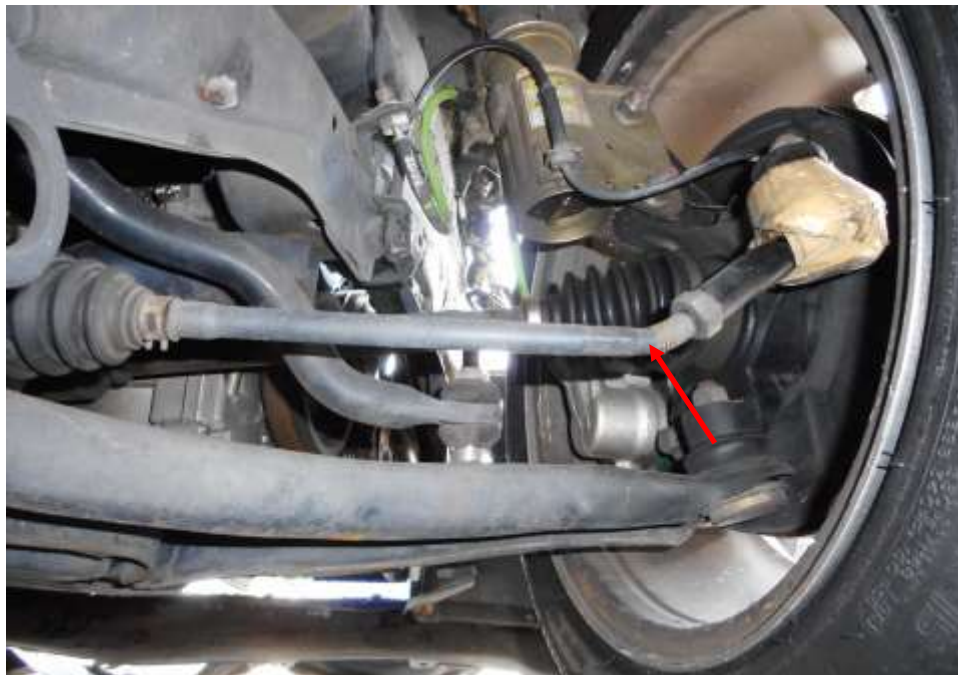
**Photo 17** shows the undercarriage components at the front right wheel of the Motor Car. My checks on the underside of the Motor Car revealed damage to the steering tie rod (arrowed) as a result of the accident.

18. With regard to the steering system, we were able to turn the steering wheel without any difficulty. However, the front wheels could not be turned to full lock position due to the bent front right tie rod due to the accident.

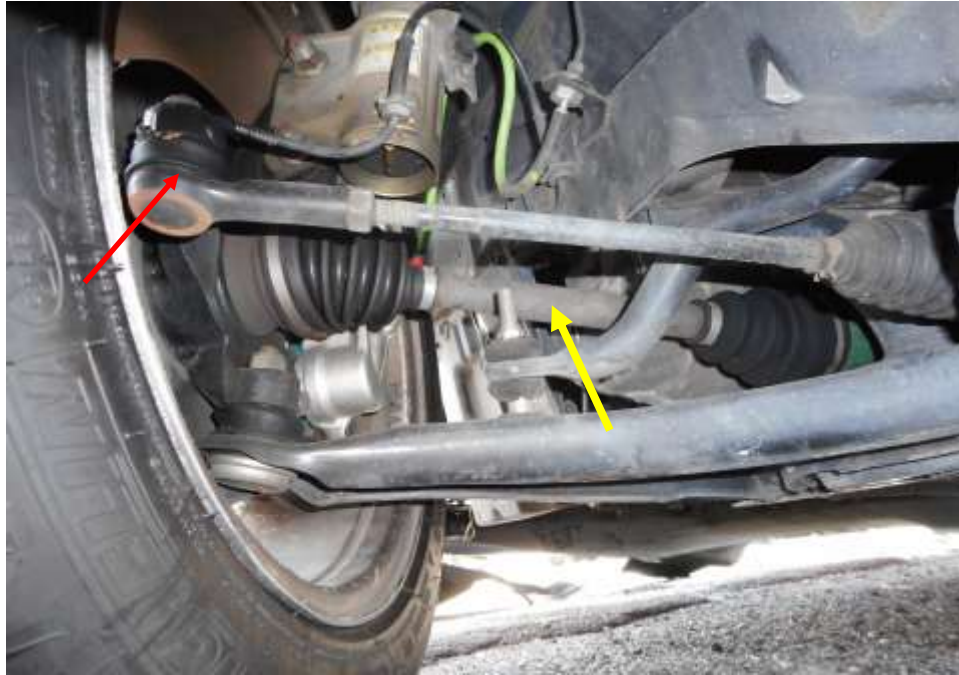
**Photo 18** shows the various undercarriage components at the front left wheel of the Motor Car, which had included the steering tie rod (red arrow) and front left drive shaft (yellow arrow). The various undercarriage components of the Motor Car were all found to be intact without any visible damage.

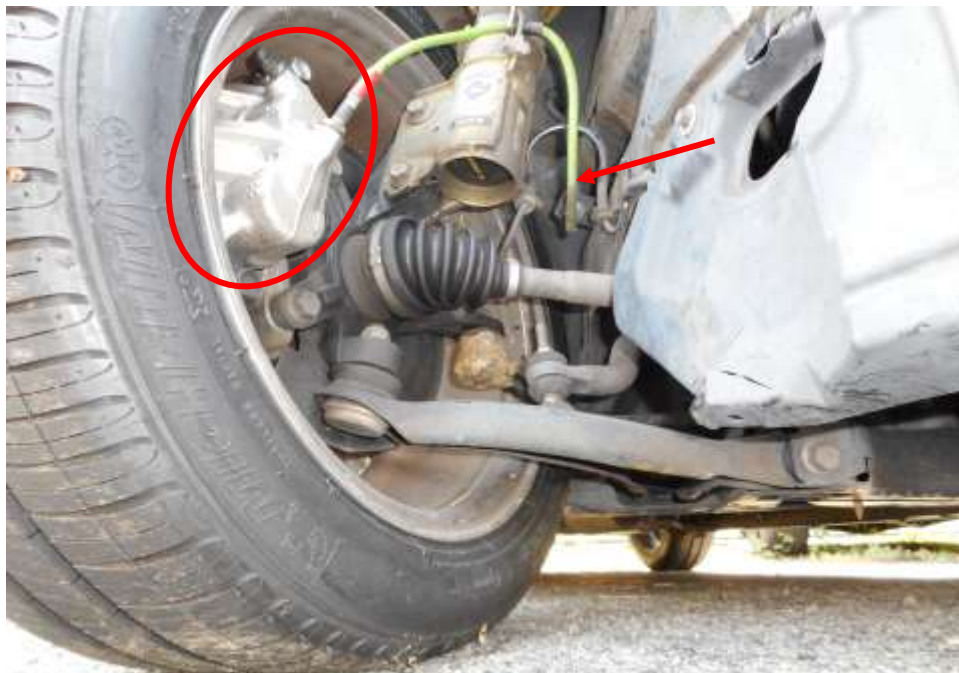
**Photo 19** shows the brake hose (arrowed) at the front right wheel of the Motor Car. I did not observe any leakage of brake fluid at the 4 wheels of the Motor Car. My visual inspection of the various mechanical components of the Motor Car's braking system, including its brake caliper (circled), revealed all to be intact and without visible damage.

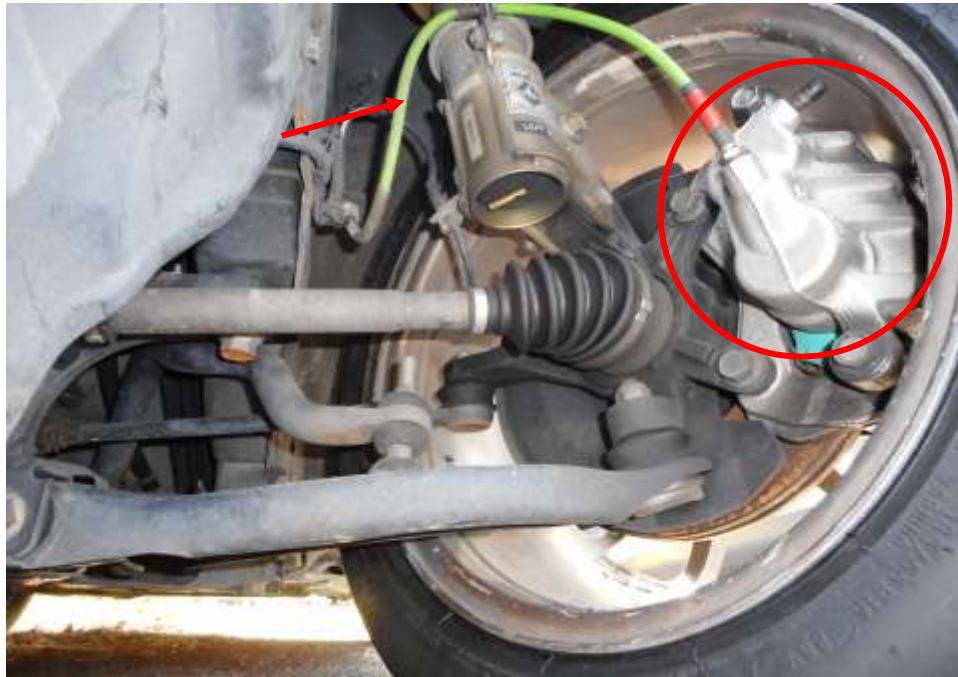
**Photo 20** shows the brake hose (arrowed) at the front left wheel of the Motor Car. I did not observe any leakage of brake fluid at the 4 wheels of the Motor Car. My visual inspection of the various mechanical components of the Motor Car's braking system, including its brake caliper (circled), revealed all to be intact and without visible damage.

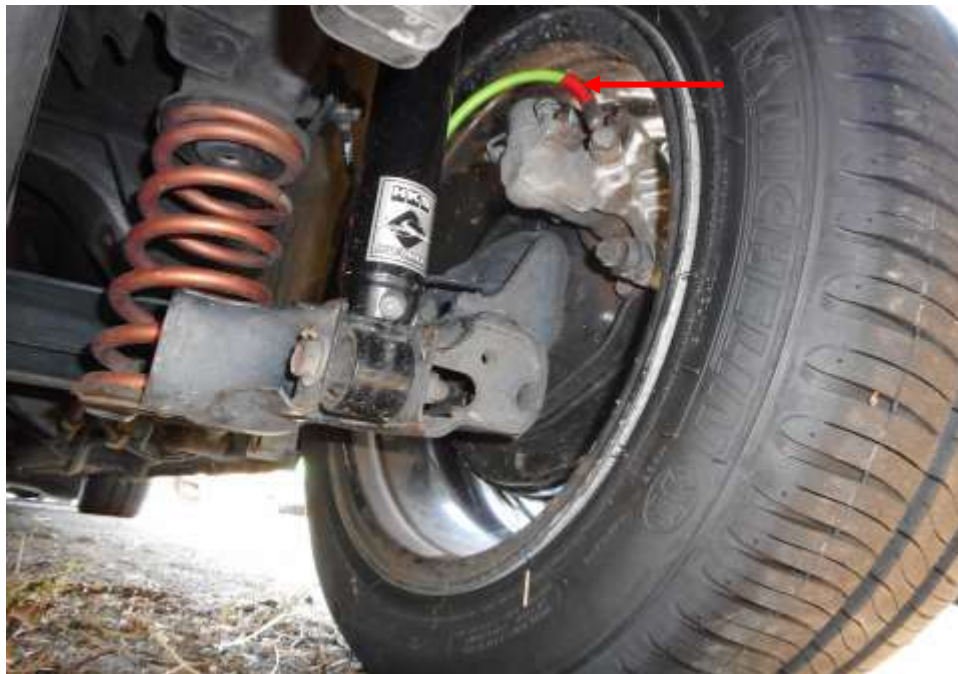
**Photo 21** shows the brake hose/pipe (arrowed) at the rear right wheel of the Motor Car. No leakage of brake fluid was observed. Visual examination of the various components of the braking system like the drum brake, brake booster, brake pedal etc had revealed all to be intact and without visible damage

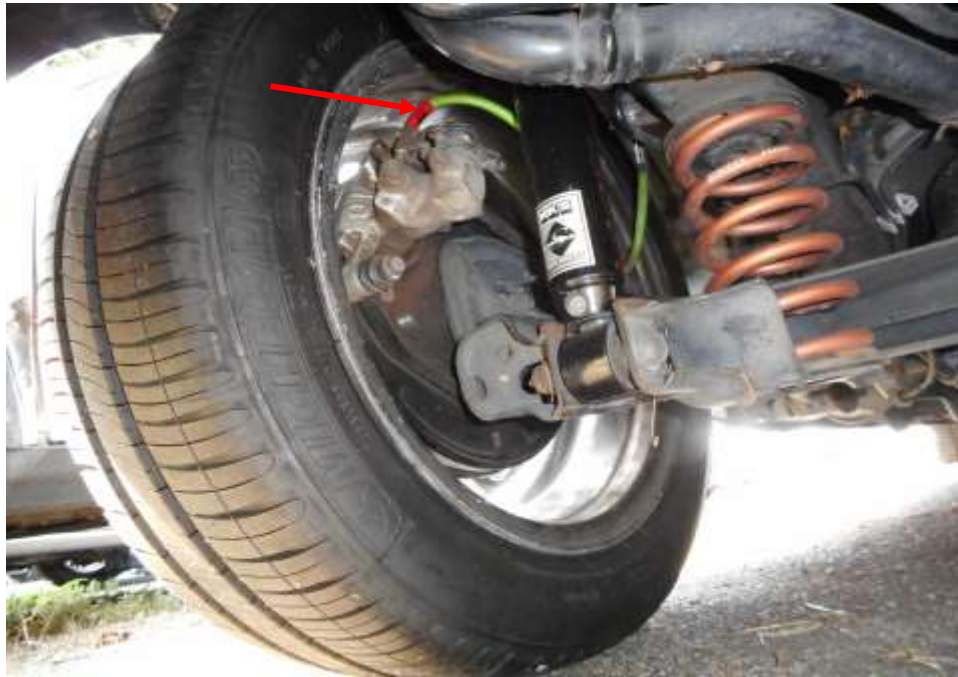
**Photo 22** shows the brake hose/pipe (arrowed) at the rear left wheel of the Motor Car. I did not observe any leakage of brake fluid at the time of my inspection of the Motor Car. Static tests of the Motor Car's braking system had indicated that there was no internal leakage of pressure/vacuum. The undercarriage components of the Motor Car were also all found to be intact and without any visible damage.

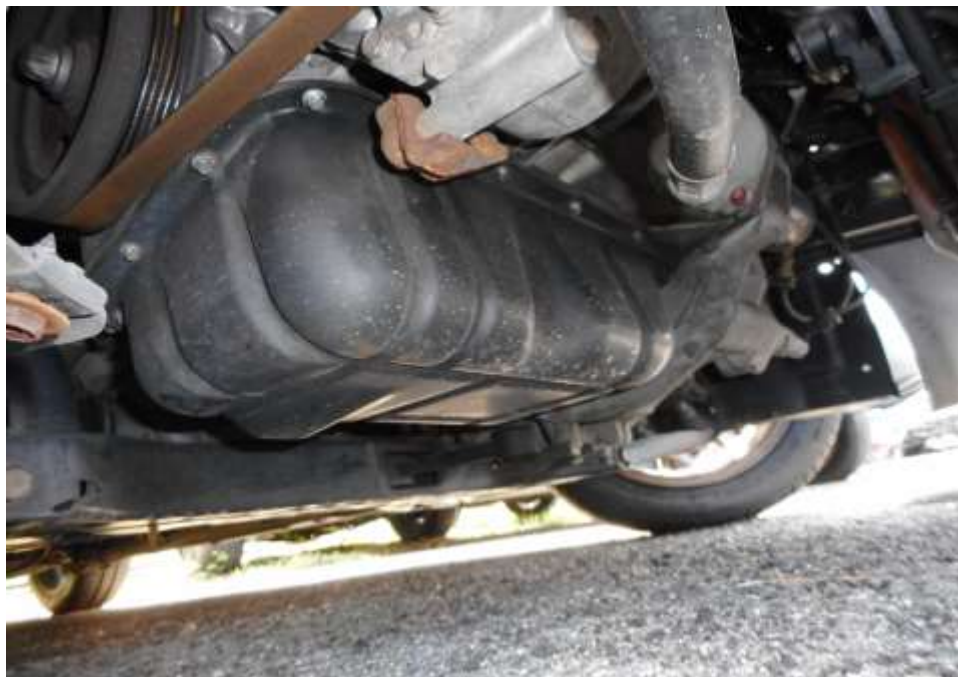
**Photo 23** shows the undercarriage of the Motor Car, at the area where the engine housing and transmission housing are located. I did not find any sign(s) or indication(s) of fluid leak and/or fluid stain(s) on the underside of the Motor Car.

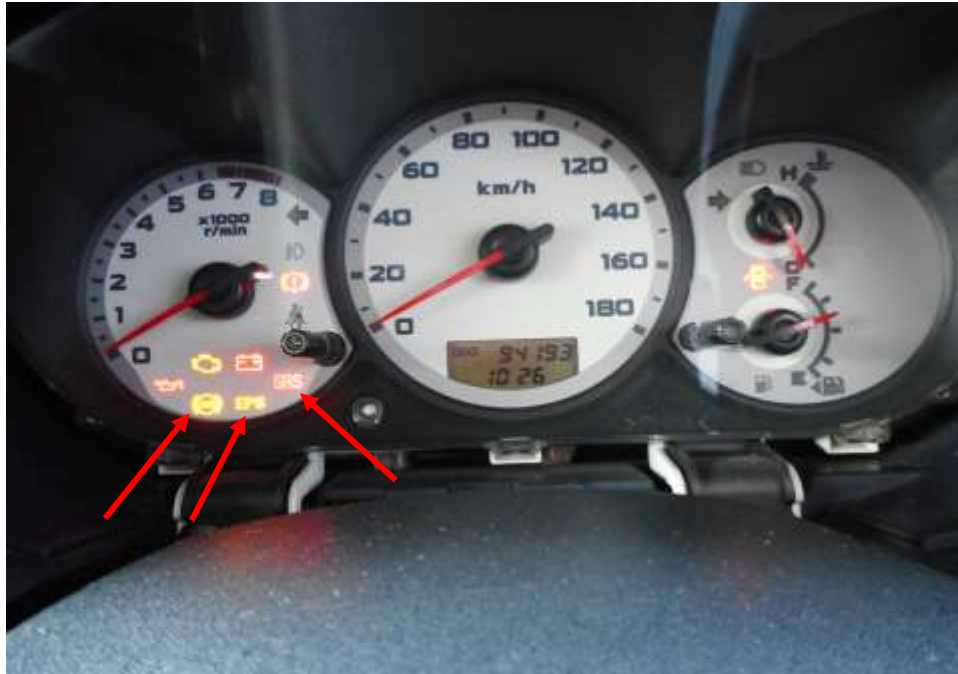
**Photo 25** shows the warning light for Anti-Lock Brake System (ABS), Electronic Power Steering (EPS) and Supplemental Restraint System (SRS) appearing on the instrument panel of the Motor Car during the self-test of its various electronic operating systems when its engine was cranked.

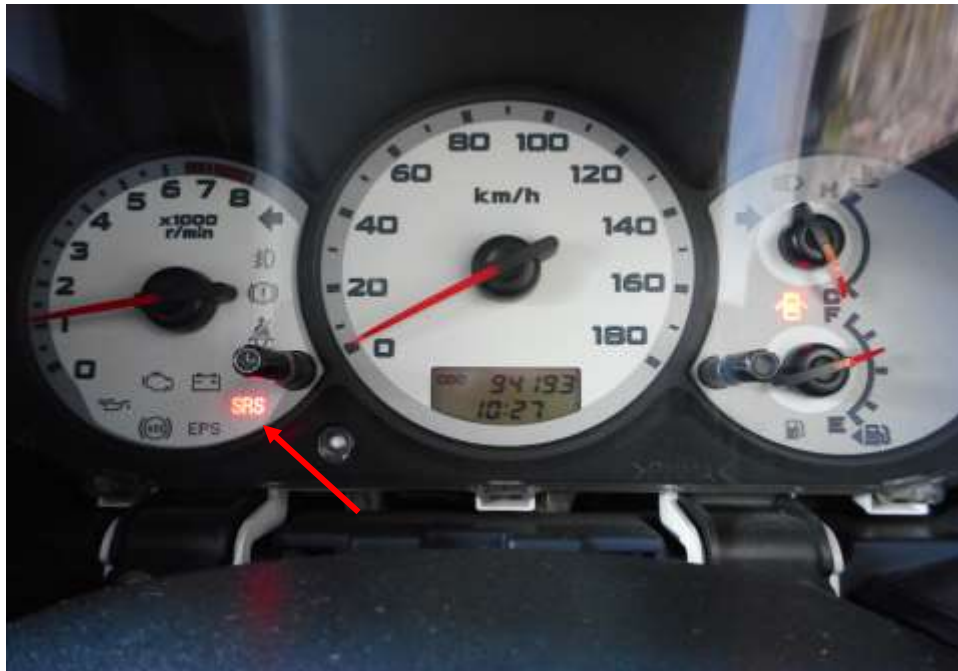
**Photo 26** shows only the Supplemental Restraint System (SRS) lights remained illuminated on the instrument panel of the Motor Car after the engine was cranked. However the ABS and EPS light disappear and this would suggest that there was no abnormality to this various electronic operating systems of the Motor Car.

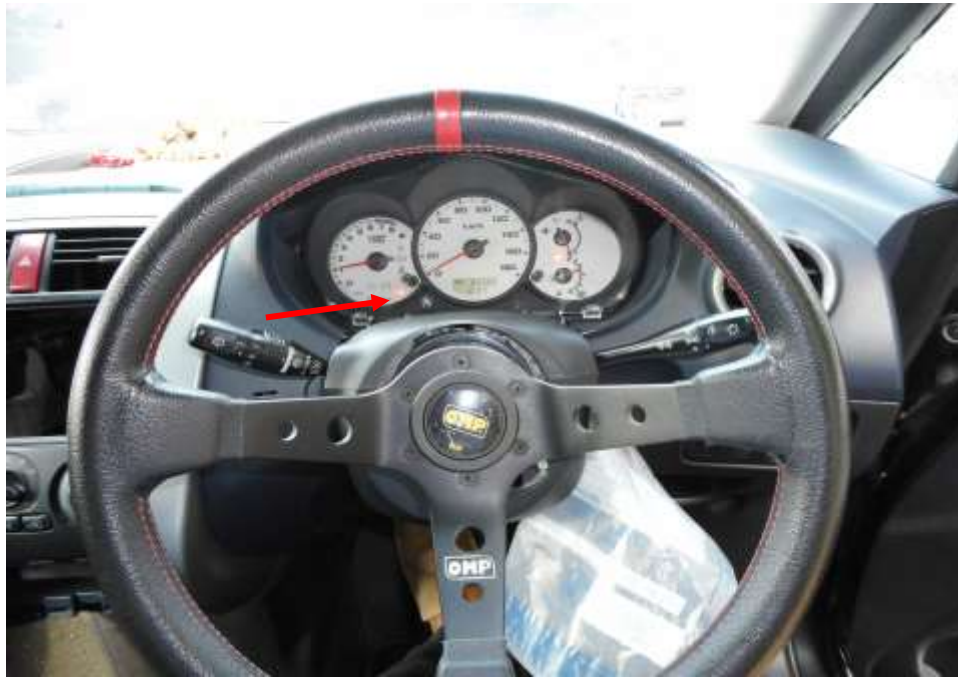
14. The Motor Car's automatic self-test of the functionality of its various electronic operating systems like the Anti-Lock Brake System (ABS) and Electric Power Steering System (EPS) during cranking of the engine had indicated that these systems were in working condition and without abnormality. This can be established from the warning lights disappearing from the instrument panel after the self-test. See photo 25 & 26 below.
15. However the Supplemental Restraint System (SRS) light remained illuminated on was due to the absence of the original steering wheel including its airbag component which caused the light to be triggered after cranking of the engine. See photo 27 below.

**Photo 27** shows the aftermarket steering without its airbag component which triggered the warning lights of the Supplemental Restraint System (SRS) to remain illuminated on the instrument panel (arrowed) of the Motor Car after the engine was cranked.
