Your Ref: TP/IP/36381/2019  
Our Ref : CI/TPD19011283/P

**MECHANICAL INSPECTION REPORT OF MOTOR CAR SJZ 1789X**

1. I refer to your request on 20<sup>th</sup> June 2019 to conduct a physical inspection of a motor car bearing registration number SJZ 1789X (herein referred to as "**Motor Car**"), which was involved in a road traffic accident on 9<sup>th</sup> June 2019.
2. The purpose of this inspection is to primarily determine if there was any possible mechanical failure to the Motor Car that may have contributed to the accident.
3. Following the request, I had carried out a physical inspection of the Motor Car on 4<sup>rd</sup> July 2019 at the premises of Traffic Police vehicle pound, 517 Airport Road Singapore 539942. I now set out below my observations and comments with respect to this inspection.

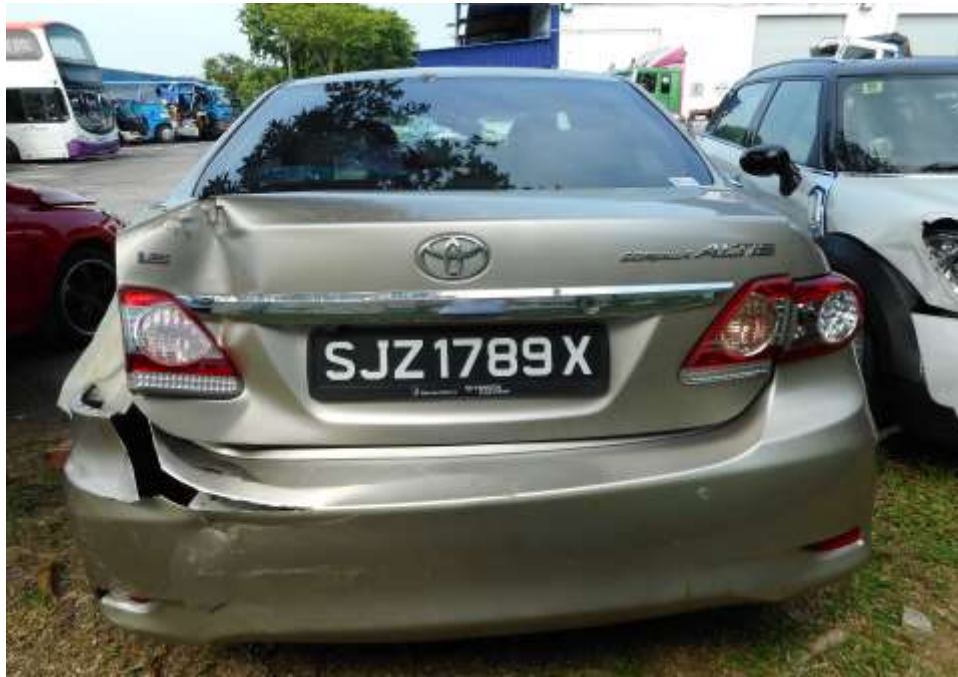
**Photo 1** shows a general view of the rear portion of the Motor Car at the time of my inspection. The rear portion of the Motor Car was observed to have been damaged by the accident.

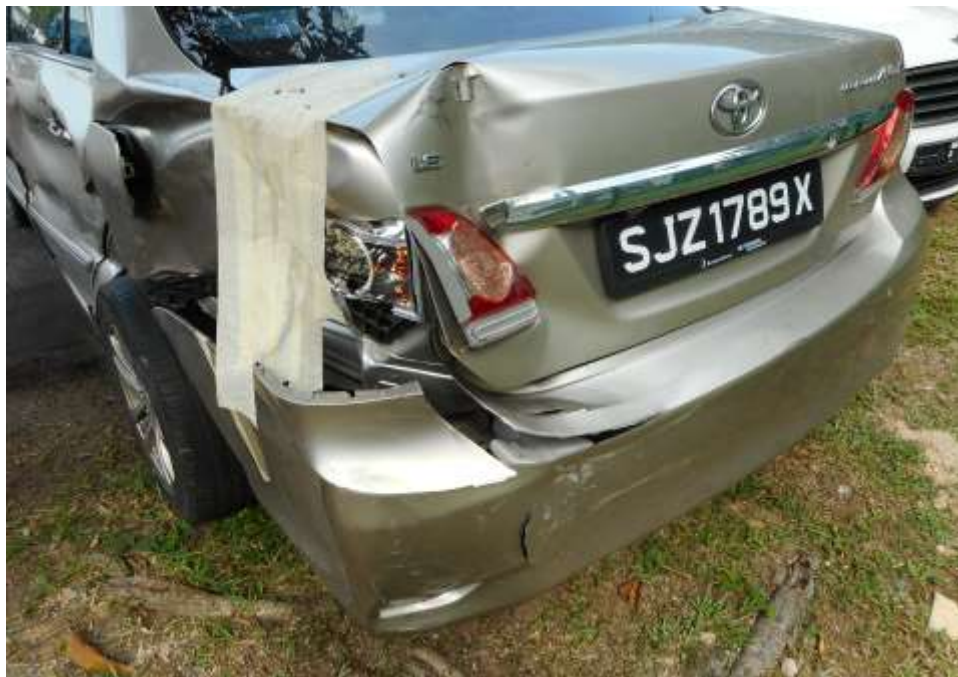
**Photo 2** shows a close up view of the rear portion of the Motor Car at the time of my inspection. The rear portion of the Motor Car was observed to have been damaged by the accident. Its bonnet, left brake lamp, left body panel and bumper as a result of the accident.

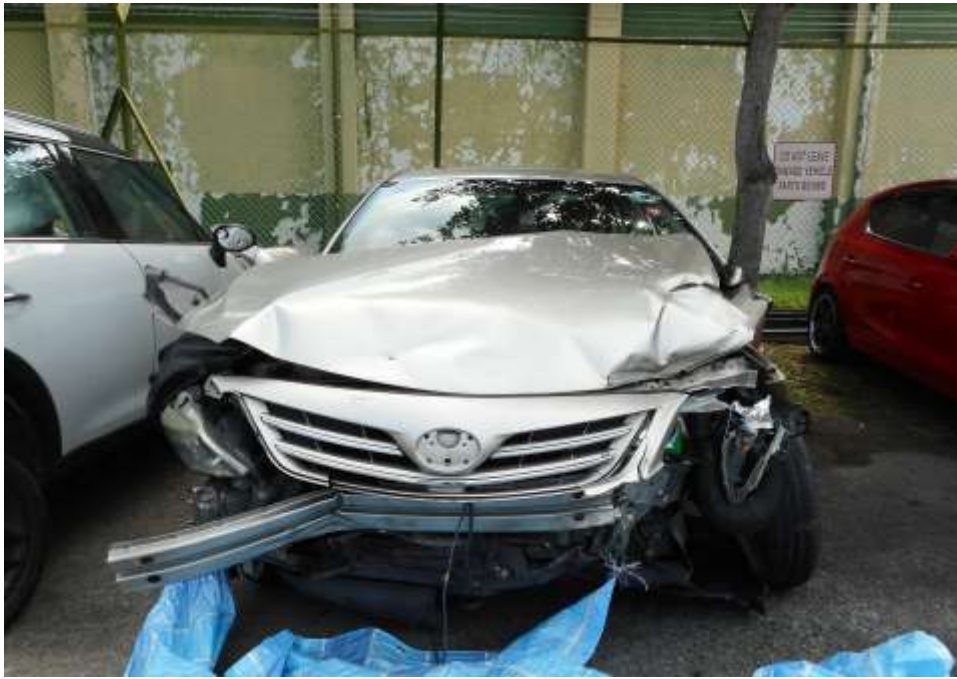
**Photo 3** shows a general view of the front portion of the Motor Car at the time of my inspection. The Motor Car was also observed to have sustained extensive impact damage at its frontal portion, damaged parts had included its front bonnet, both front bonnet hinges, bonnet lock mechanism, front bumper, front number plate, front reinforcement, left and right fenders, left side body panel, engine system, radiator, front left and right headlamp were amongst the body parts that were observed to have been damaged as a result of the accident.

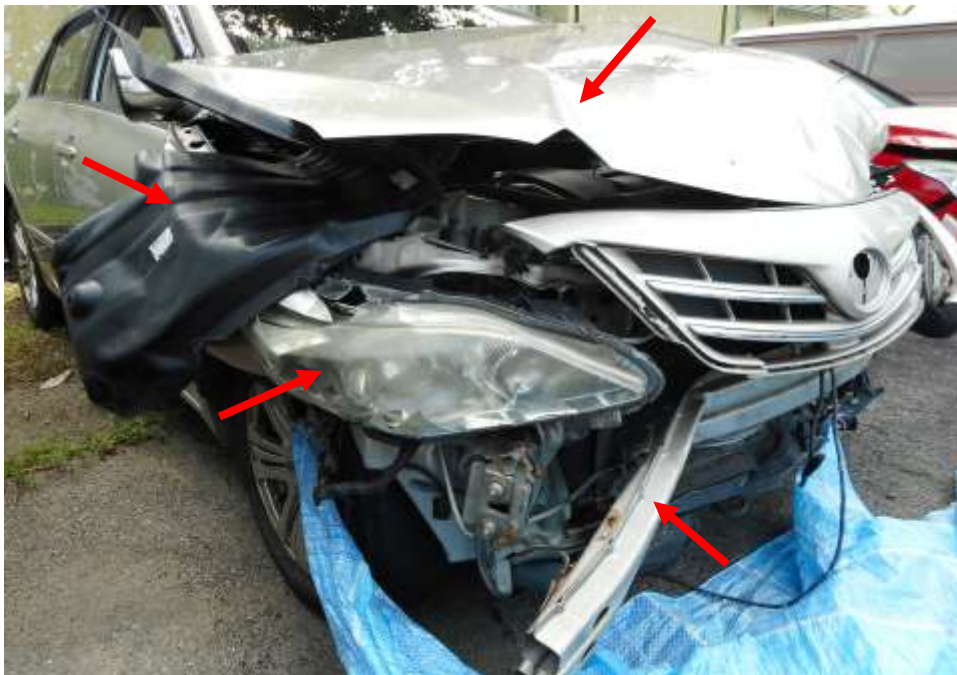
**Photo 4** shows a close up view of the front portion of the Motor Car at the time of my inspection. The bonnet, reinforcement, right fender and right head lamp (arrowed) of the Motor Car was observed to have been damaged as a result of the accident

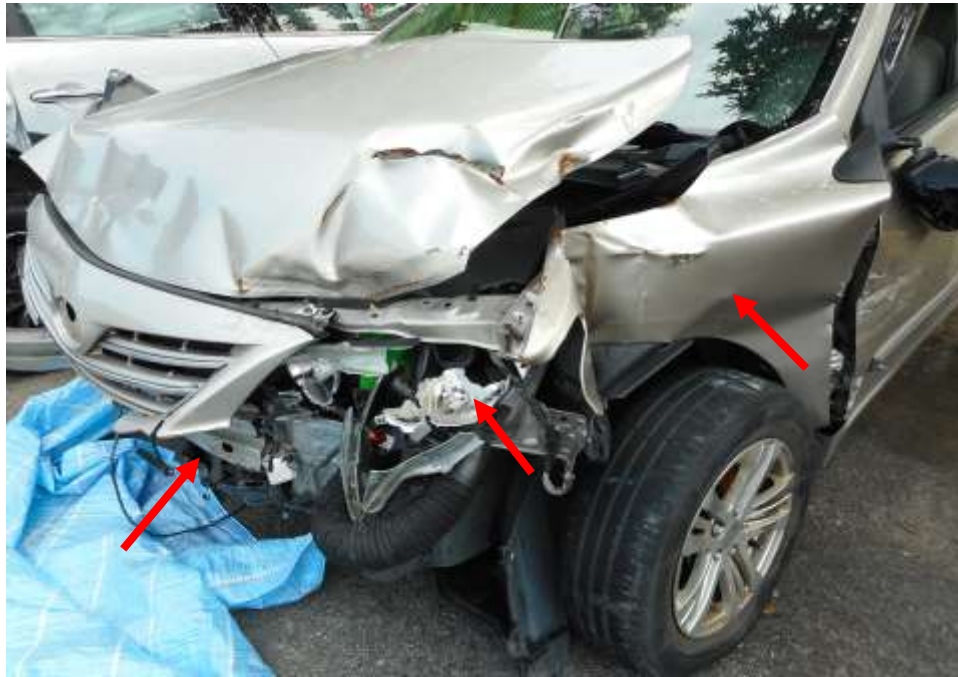
**Photo 5** shows a close up view of the front portion of the Motor Car at the time of my inspection. The bonnet, front bumper, front number plate right fender and right head lamp (arrowed) of the Motor Car was observed to have been damaged as a result of the accident

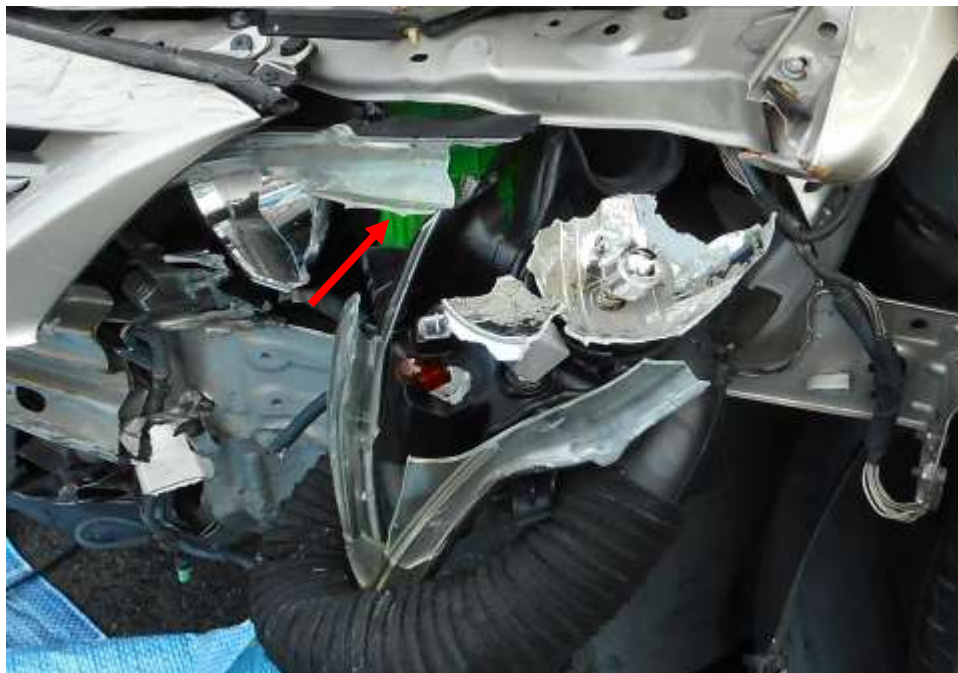
**Photo 6** shows a close up view of the front portion of the Motor Car at the time of my inspection. The battery and ignition system (arrowed) of the Motor Car was observed to have been damaged as a result of the accident

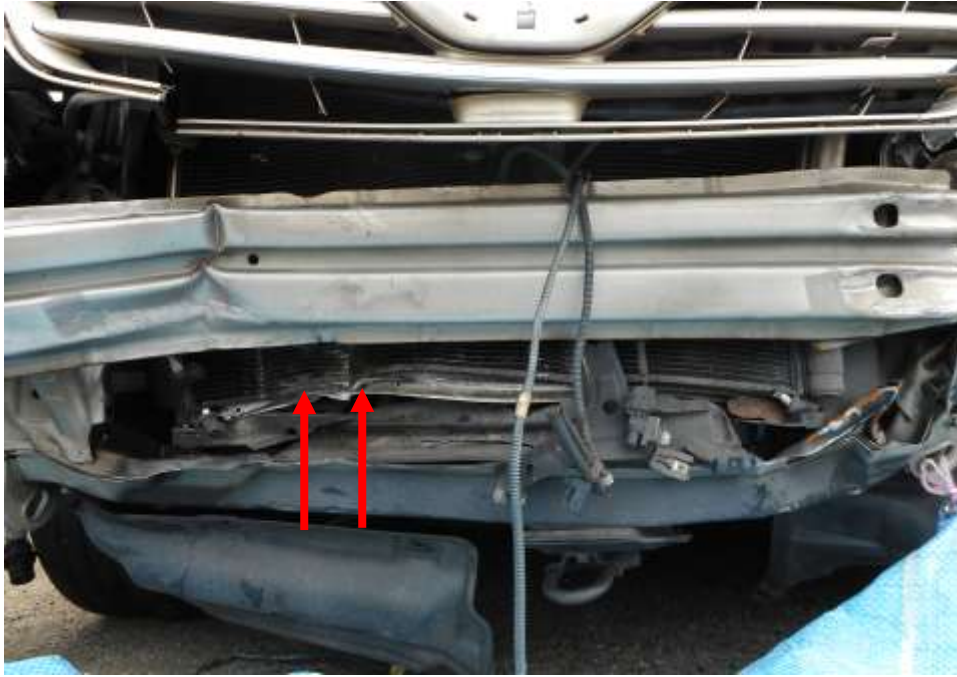
**Photo 7** shows a close up view of the front portion of the Motor Car at the time of my inspection. The radiator of the Motor Car was observed to have been damaged by an induced impact (arrowed) as a result of the accident

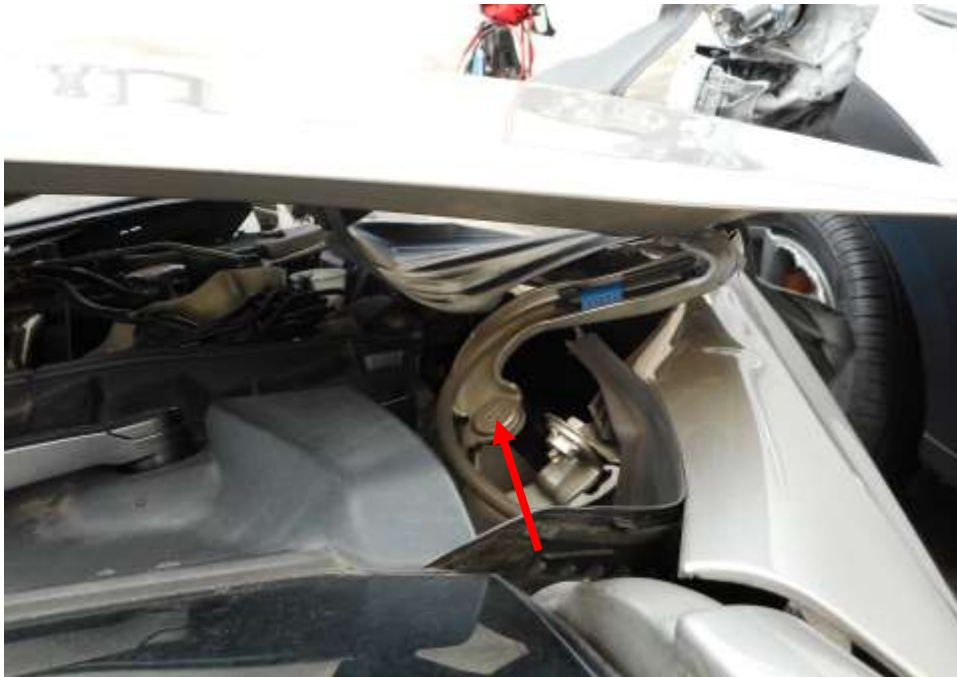
**Photo 8** shows a close up view of the right bonnet hinge of the Motor Car at the time of my inspection. The right bonnet hinge of the Motor Car was observed to have been damaged as a result of the accident. (arrowed)

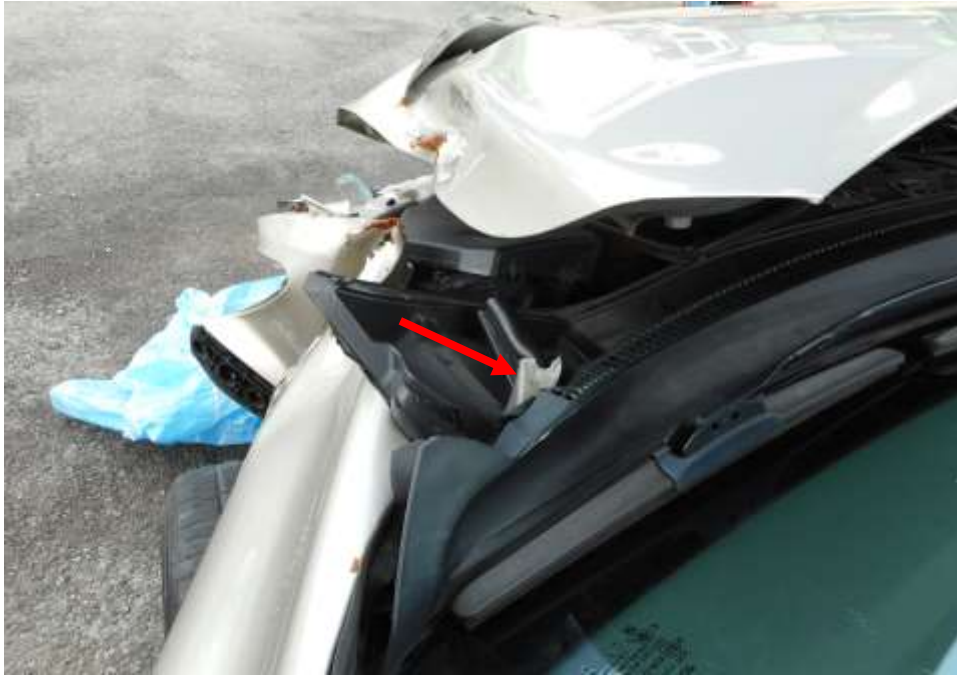
**Photo 9** shows a close up view of the left bonnet hinge of the Motor Car at the time of my inspection. The left bonnet hinge of the Motor Car was observed to have been damaged as a result of the accident. (arrowed)

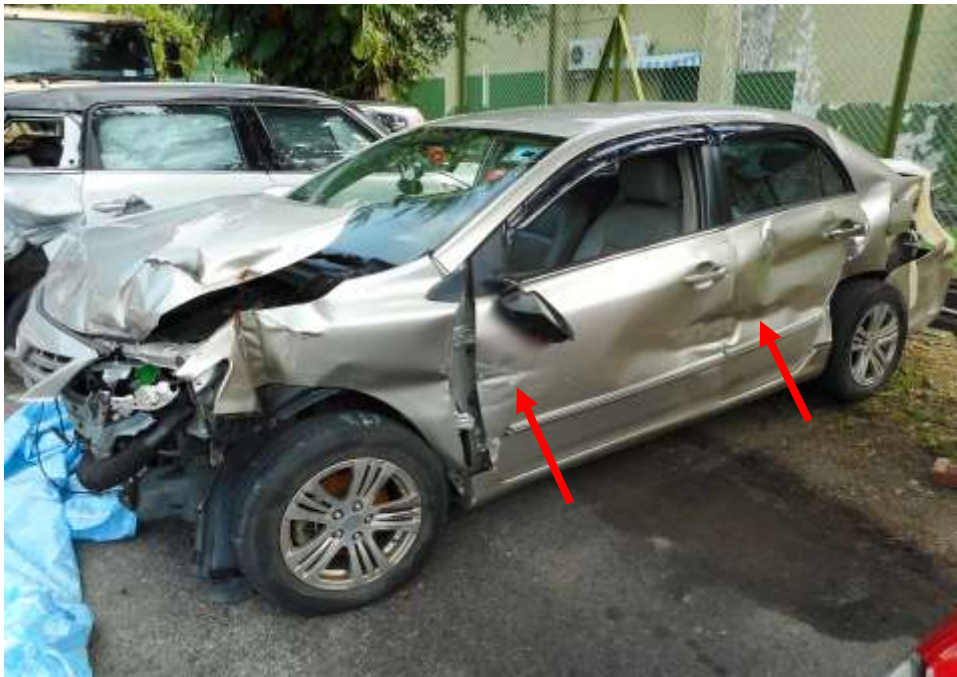
**Photo 10** shows a general view of the front left portion of the Motor Car at the time of my inspection. The left door panels (arrowed) of the Motor Car were observed to have been damaged as a result of the accident.

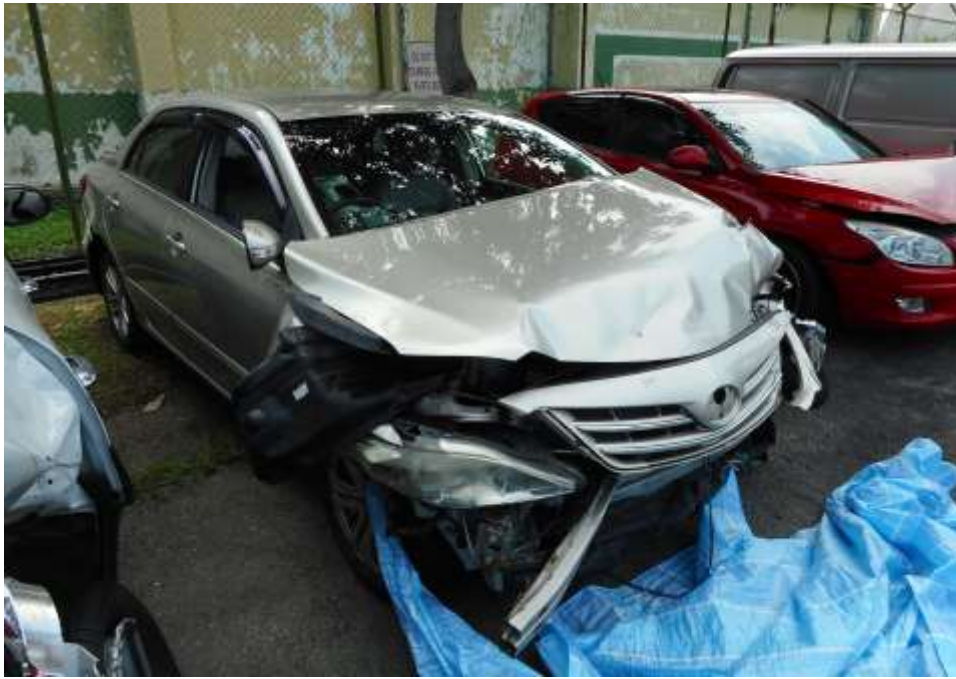
**Photo 11** shows a general view of the left portion of the Motor Car at the time of my inspection. The front right doors of the Motor Car was observed to have been undamaged by the accident.

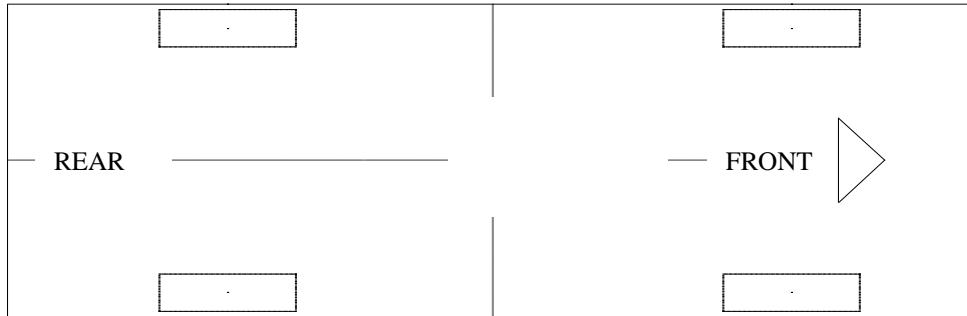
7. The condition of the Motor car's 4 tyres was observed to be in serviceable condition. I did not find any tear, cut or burst mark(s) on the outer and the inner sidewalls as well as across the tread of the 4 tyres. The 4 tyres were also observed to be sufficiently inflated for vehicular operation. The tyre brand, tyre size and remaining tread depth of the 4 tyres were recorded as follows:-
8. The 4 tyres were observed to be in good condition. I did not find any tear, cut or burst mark(s) on the outer and the inner sidewalls as well as across the tread of the 4 tyres and were observed to be wrapped around standard alloy wheel rims that were found to be without any damage. See photo 12 – 15 below.

Michelin 195/65R15 (3.3mm)

Michelin 195/65R15 (3mm)

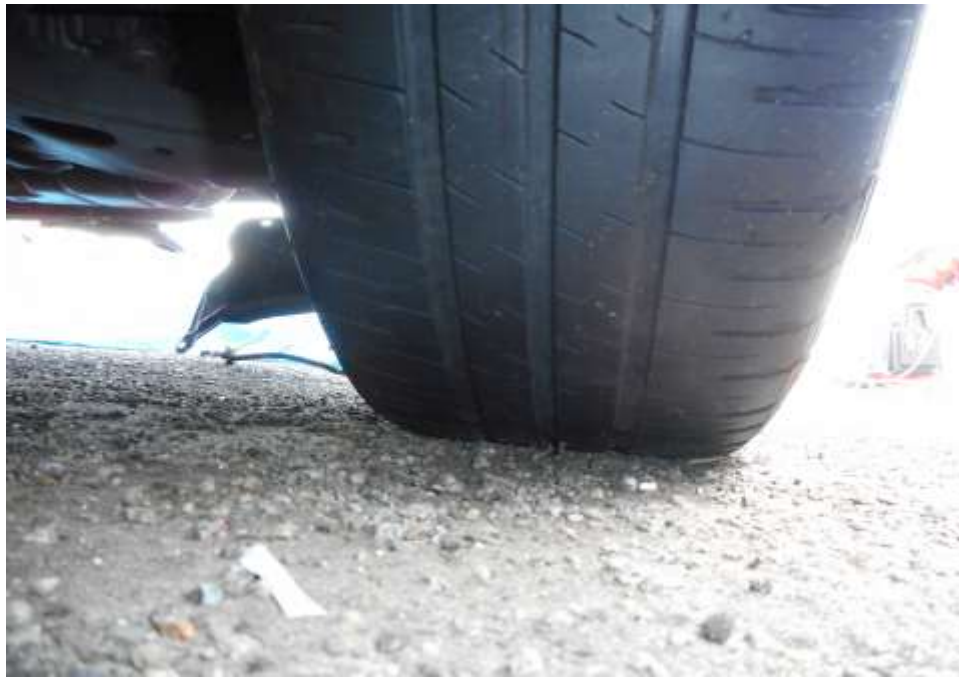
**Photo 12** shows the condition of the front right tyre of the Motor Car, which was observed to be in serviceable condition with remaining tread depth of approximately 3mm. The tyre was sufficiently inflated for vehicular operation with no tear, cut or burst mark(s) on the outer and the inner sidewalls as well as across the tread. The 4 tyres of the Motor Car were wrapped around standard alloy wheel rims without any damage.

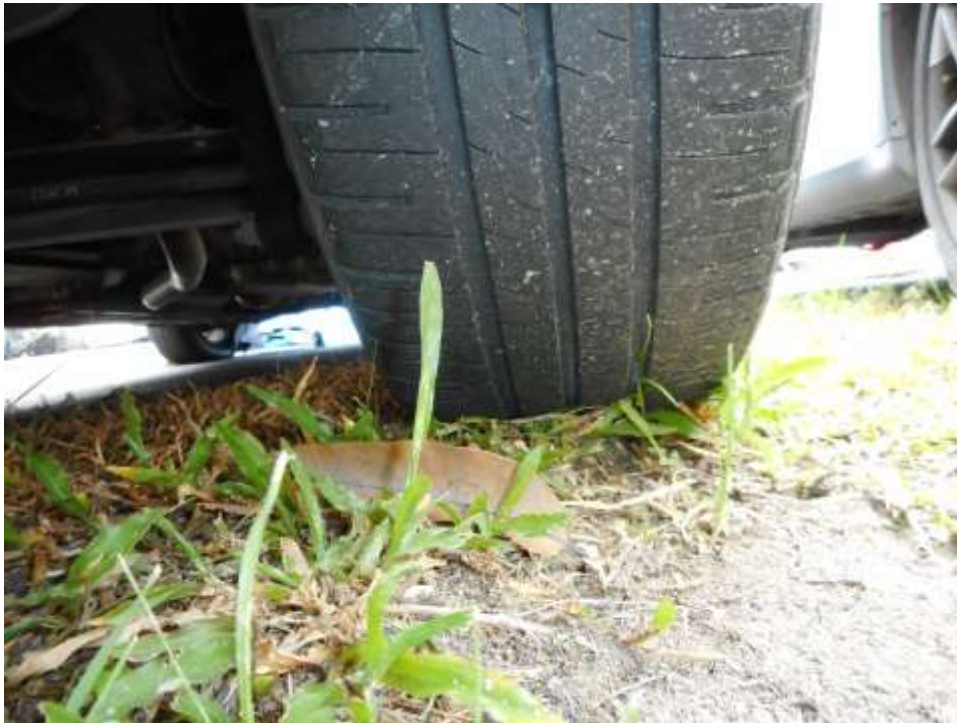
**Photo 13** shows the condition of the rear right tyre of the Motor Car, which was observed to be in serviceable condition with remaining tread depth of approximately 3.3mm. There was no tear, cut or burst mark(s) on the outer and the inner sidewalls as well as across the tread of this tyre.

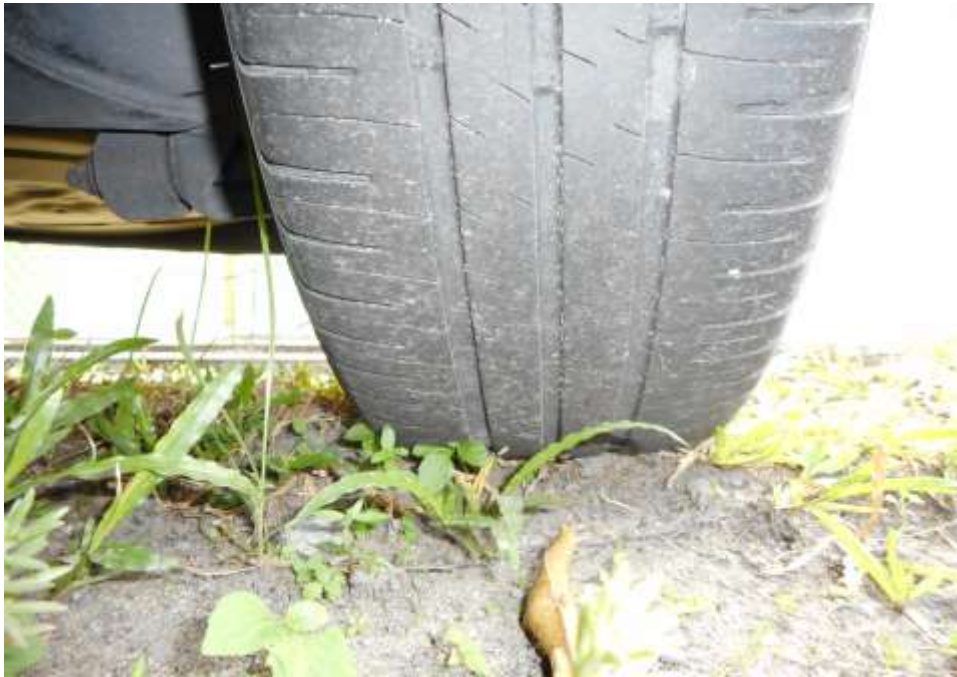
**Photo 14** shows the condition of the rear left tyre of the Motor Car, which was observed to be in serviceable condition with remaining tread depth of approximately 3.3mm. There was no tear, cut or burst mark(s) on the outer and the inner sidewalls as well as across the tread of this tyre.

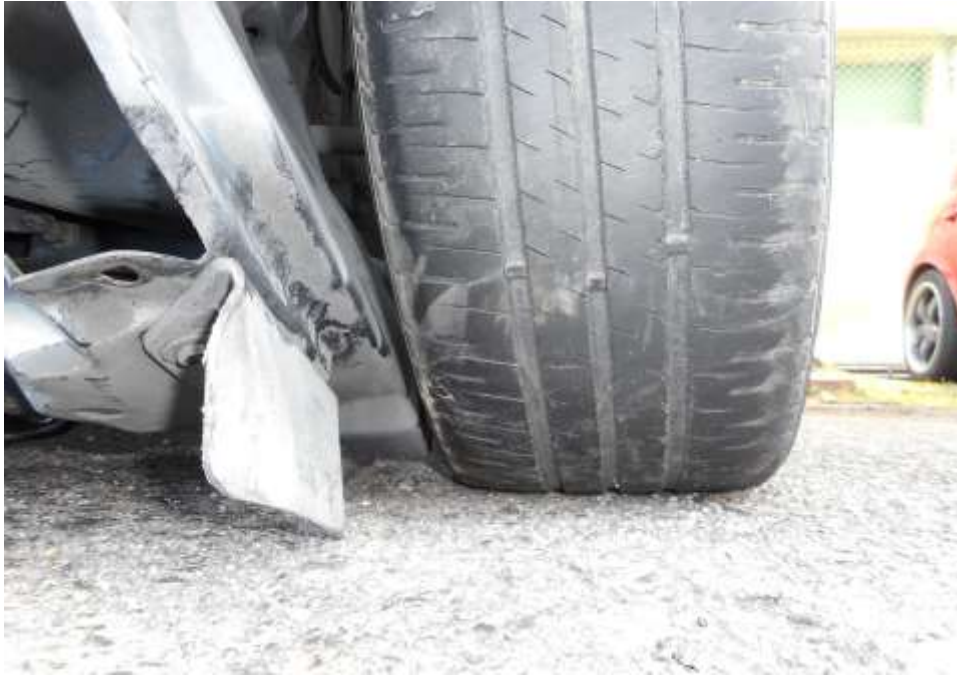
**Photo 15** shows the condition of the front left tyre of the Motor Car, which was observed to be in serviceable condition with remaining tread depth of approximately 3mm. There was no tear, cut or burst mark(s) on the outer and the inner sidewalls as well as across the tread of this tyre, however observed to be deflated due to damage to the rims.

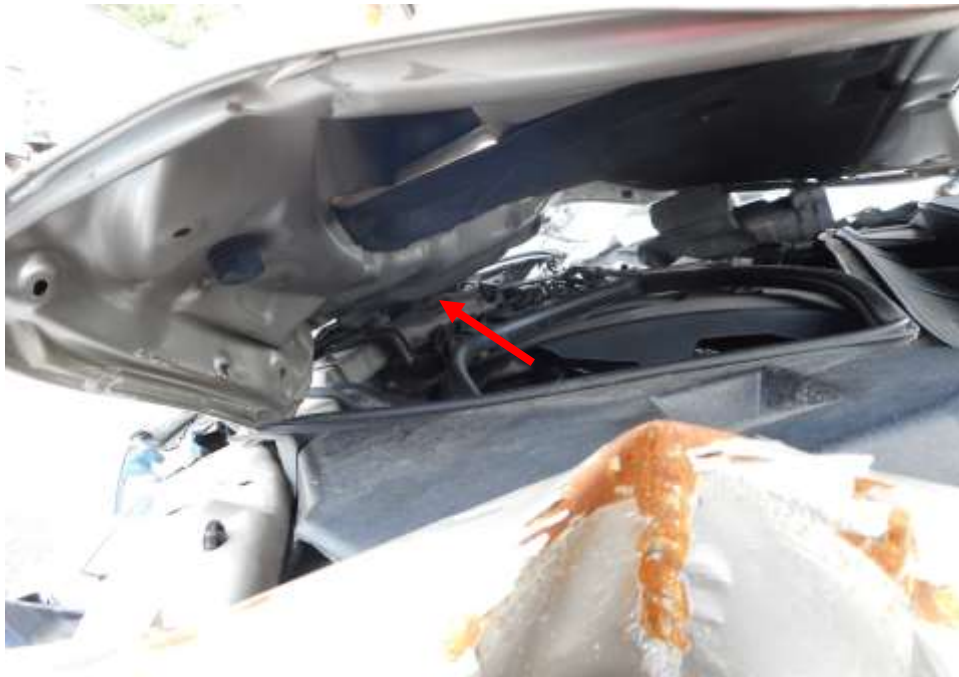
9. The impact from the collision had affected the engine compartment of the Motor Car. Parts towards the front of the engine compartment were observed to be damaged. The locking mechanism and the hinges of the Motor Car's front bonnet were also affected and I was unable to unlock and lift the front bonnet to carry out examination of the Motor Car's engine compartment. The various operating fluids like its engine coolant, brake fluid and transmission fluid etc were hence unable to be inspected. See photo 16 below.

**Photo 16** shows the damage to the locking mechanism (arrowed) Motor Car's front bonnet, rendering it unable to be unlocked and lifted up to carry out examination of the Motor Car's engine compartment as a result of the accident.

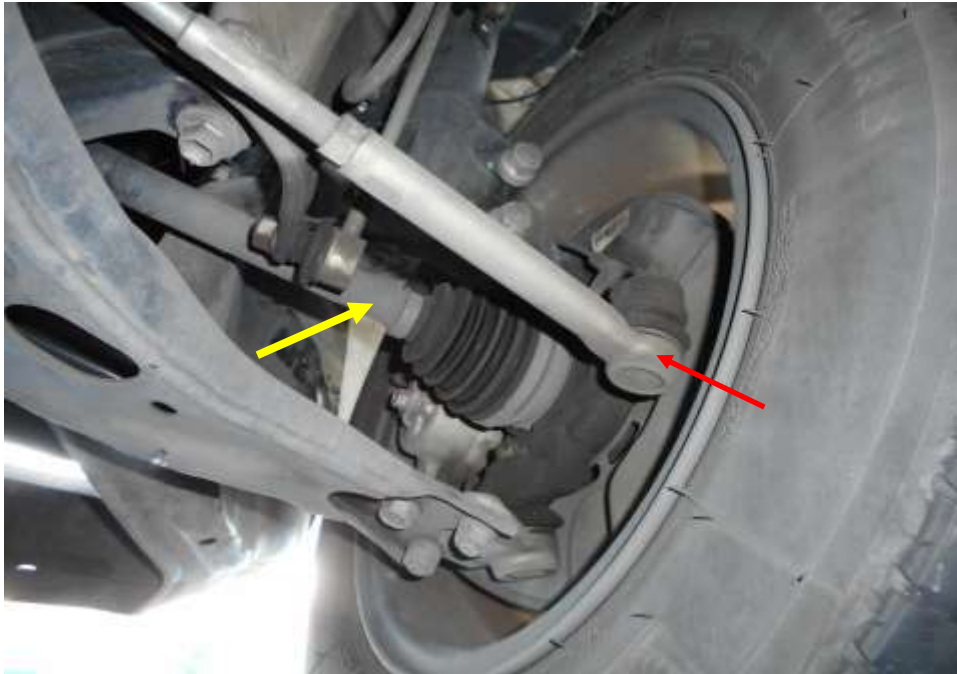
**Photo 16** shows the various undercarriage components at the front right wheel of the Motor Car, which had included the steering tie rod (red arrow) and front left drive shaft (yellow arrow). The various undercarriage components of the Motor Car were all found to be intact without any visible damage.

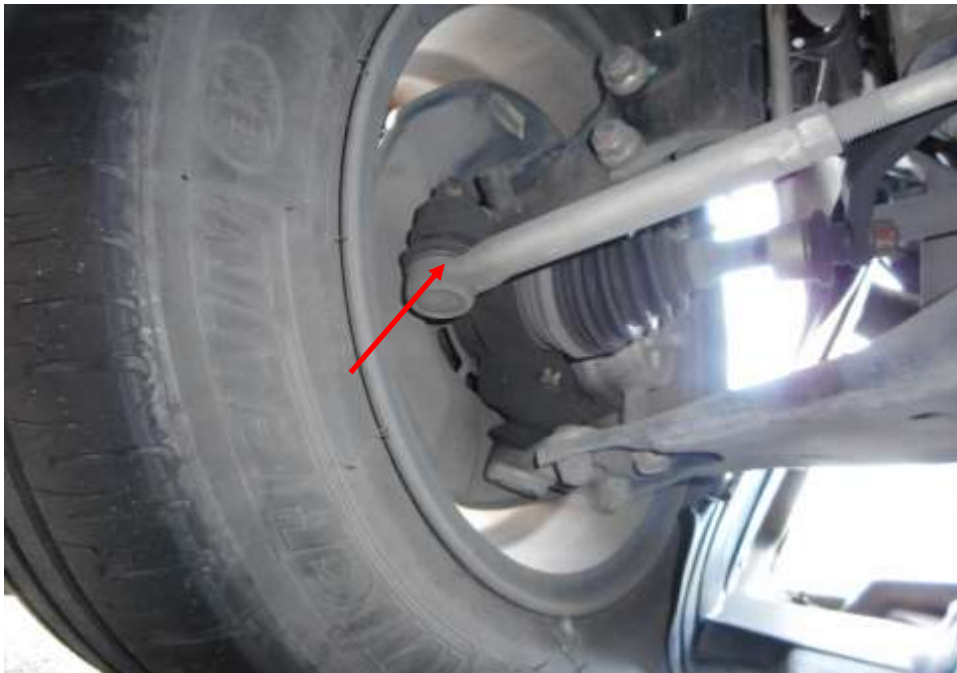
**Photo 17** shows the undercarriage components at the front left wheel of the Motor Car. My checks on the underside of the Motor Car revealed damage to the various undercarriage components, the steering rack and pinion, tie rods, tie rod ends and ball joints (arrowed) revealed that these components were all generally in good condition.

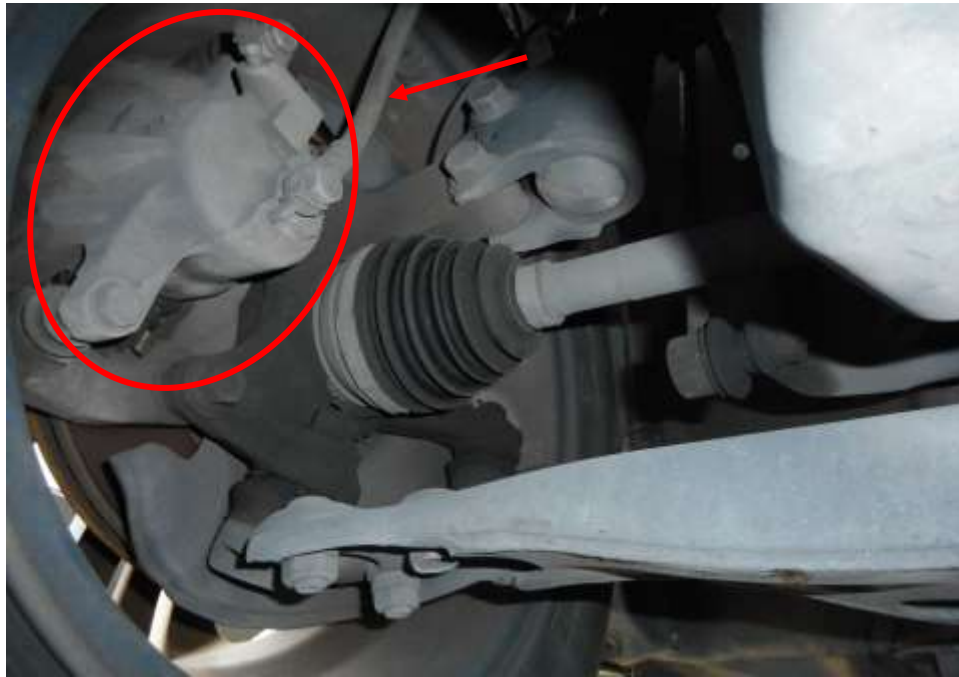
**Photo 18** shows the brake hose (arrowed) at the front right wheel of the Motor Car. I did not observe any leakage of brake fluid at the 4 wheels of the Motor Car. My visual inspection of the various mechanical components of the Motor Car's braking system, including its brake caliper (circled), revealed all to be intact and without visible damage.

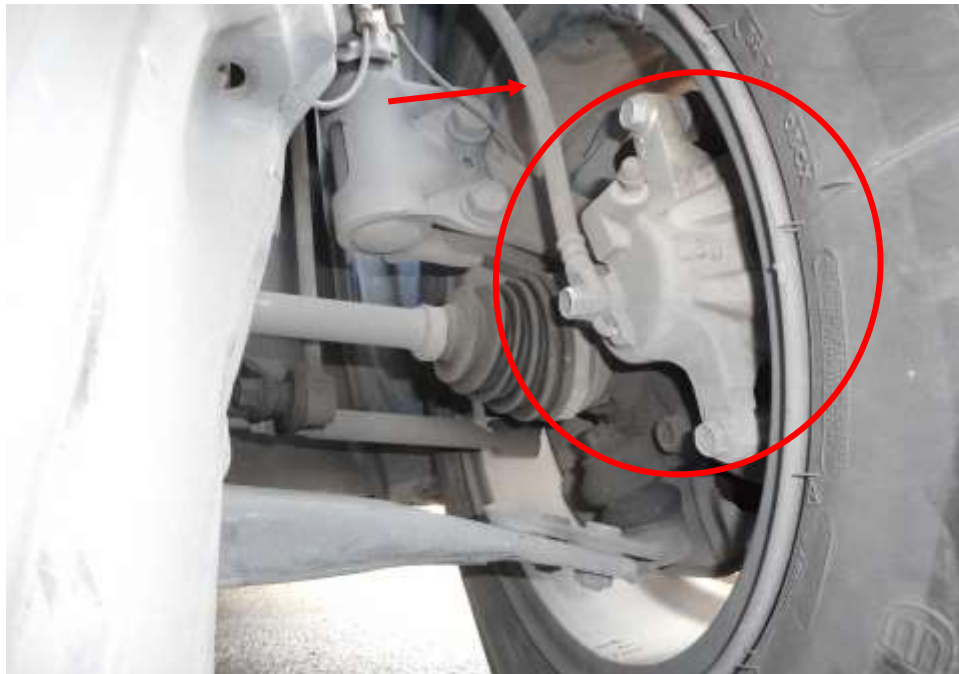
**Photo 19** shows the brake hose (arrowed) at the front left wheel of the Motor Car. I did not observe any leakage of brake fluid at the 4 wheels of the Motor Car. My visual inspection of the various mechanical components of the Motor Car's braking system, including its brake caliper (circled), revealed all to be intact and without visible damage.

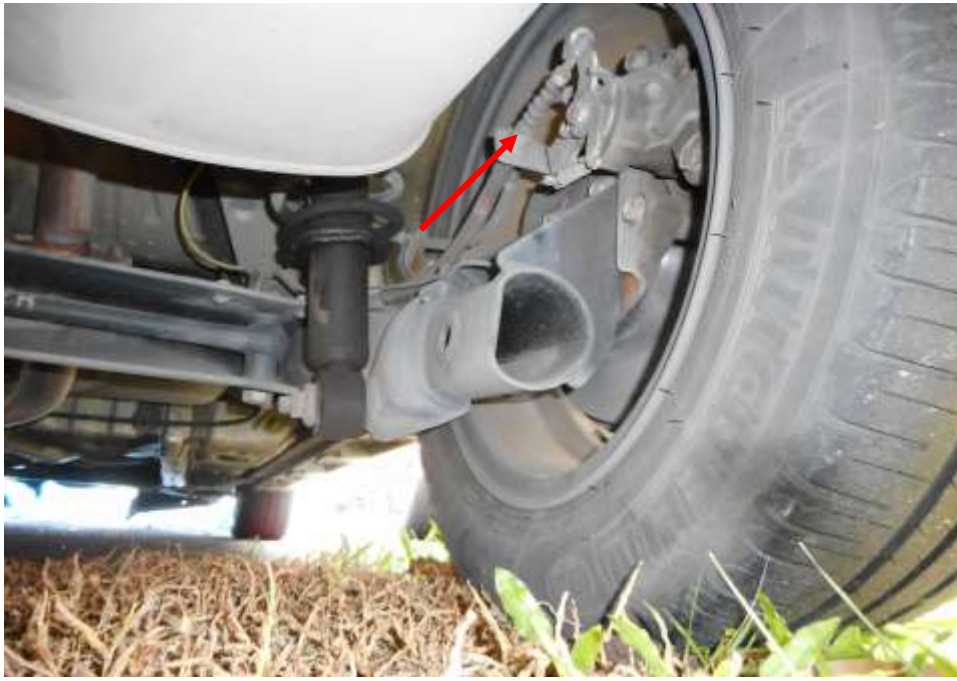
**Photo 20** shows the various undercarriage components at the rear right wheel of the Motor Car, in particular the brake hose (arrowed). I did not observe any leakage of brake fluid at the 4 wheels of the Motor Car. My visual inspection of the various mechanical components of the Motor Car's braking system revealed all to be intact and without visible damage.

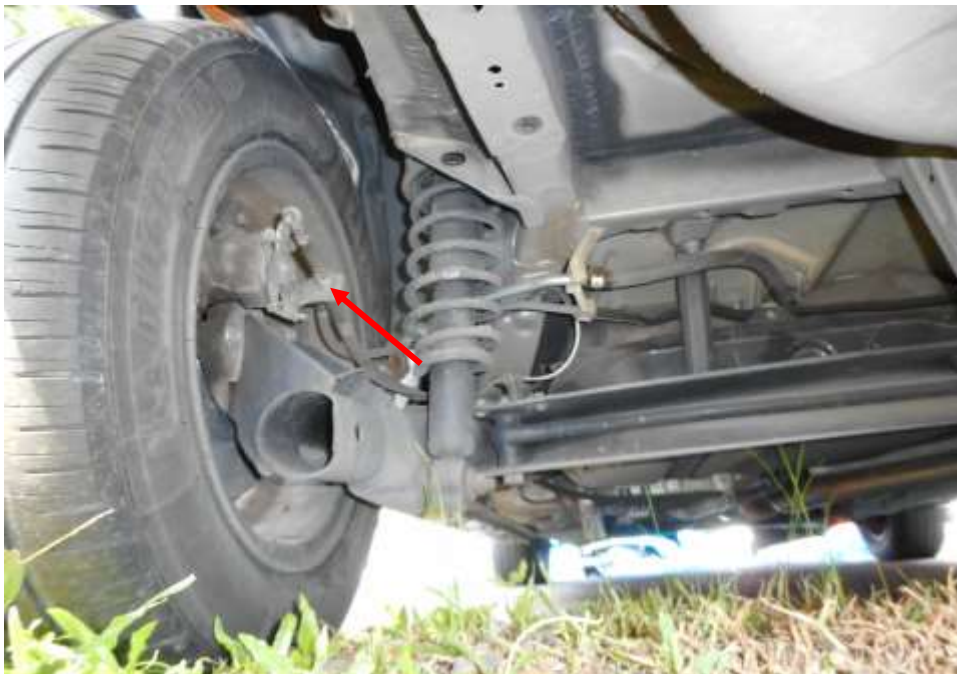
**Photo 21** shows the various undercarriage components at the rear left wheel of the Motor Car, in particular the brake hose (arrowed). I did not observe any leakage of brake fluid at the 4 wheels of the Motor Car. My visual inspection of the various mechanical components of the Motor Car's braking system revealed all to be intact and without visible damage.
