Your Ref: TP/IP/25257/2019
Our Ref : CI/TPD19011285/P

17th July 2019

MECHANICAL INSPECTION REPORT OF MOTOR CAR SJD 3446M

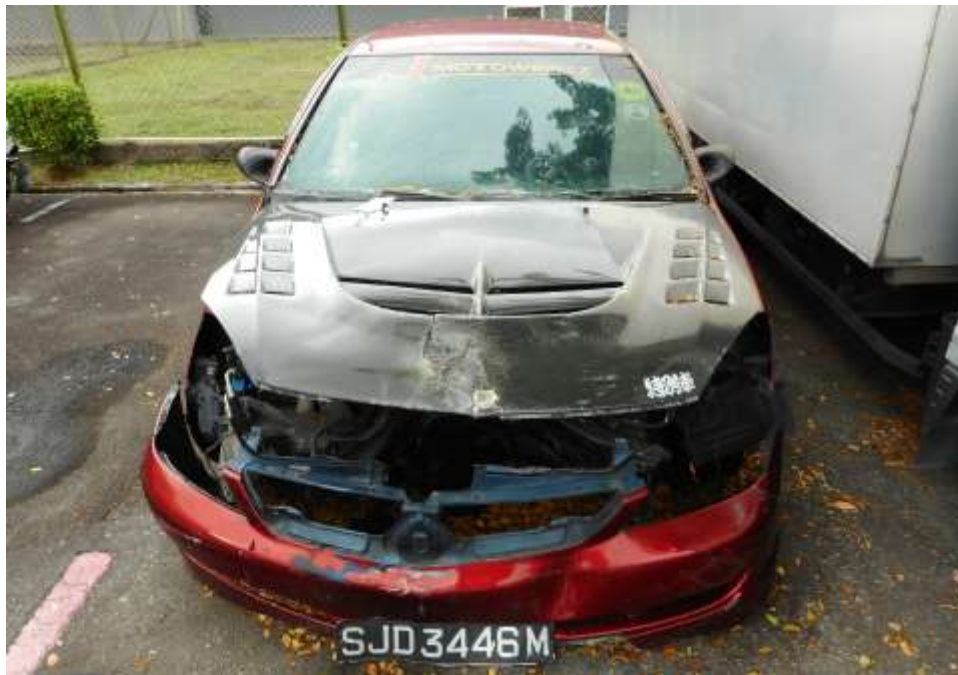
Photo 1 shows a general view of the Motor Car's front body at the time of my inspection. The Motor car was observed to have sustained moderate damage at its front portion. Its front windscreen, front bonnet, front bumper, front number plate, front reinforcement front radiator, engine system, ignition system and rear bumper was amongst the body parts that were damaged as a result of the accident.

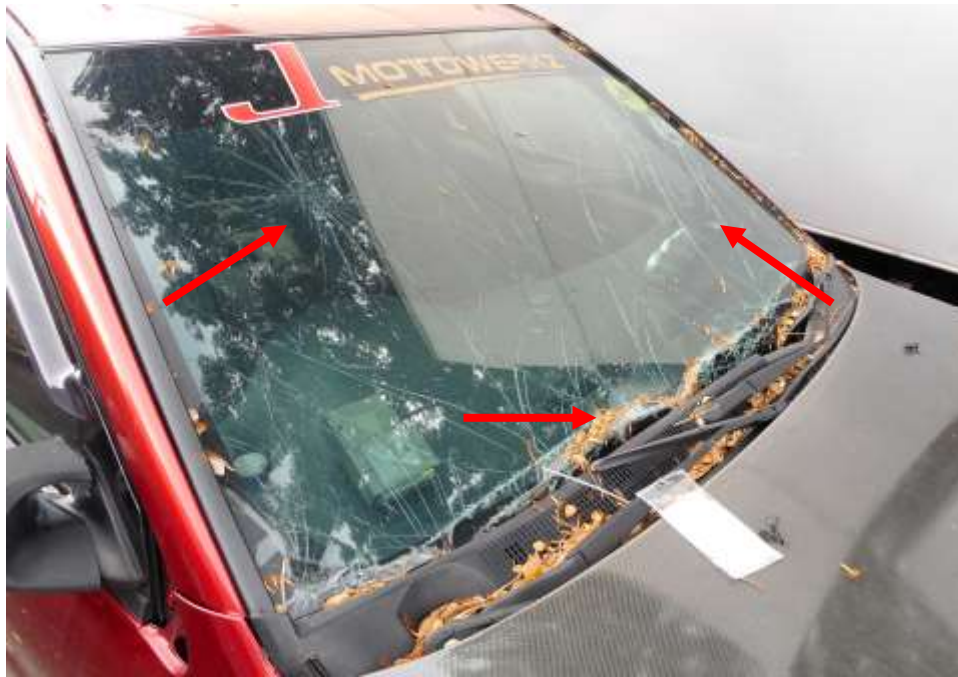
Photo 2 shows the close up view of the Motor Car's front body at the time of my inspection. The Motor car was observed to have sustained damage; its front windscreen (arrowed) as a result of the accident.

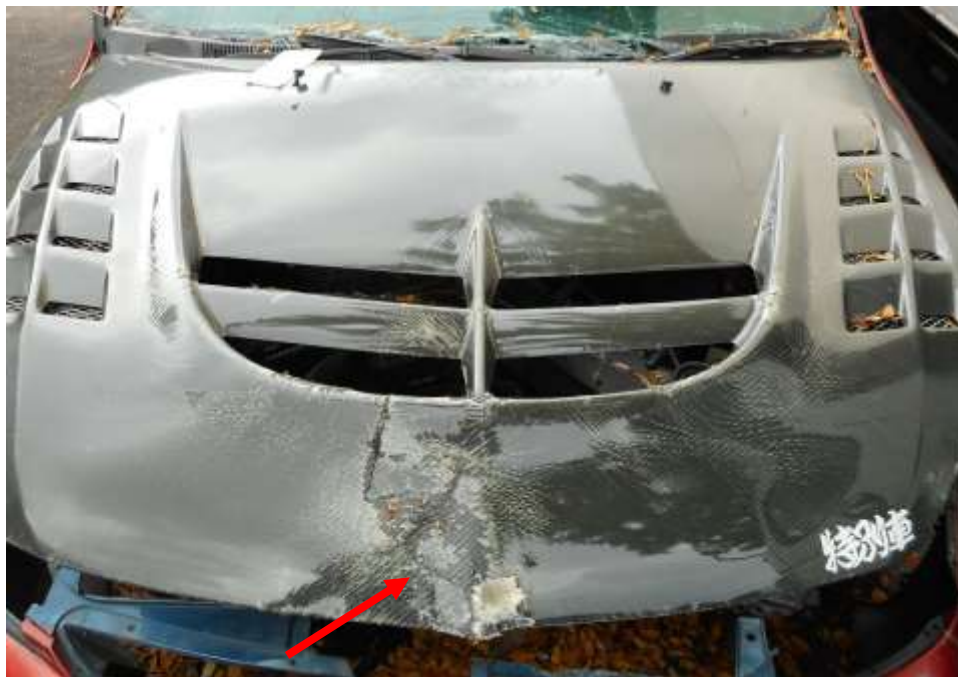
Photo 3 shows the close up view of the Motor Car's front body at the time of my inspection. The Motor car was observed to have sustained damage; its front bonnet (arrowed) was amongst the body parts that were damaged as a result of the accident.

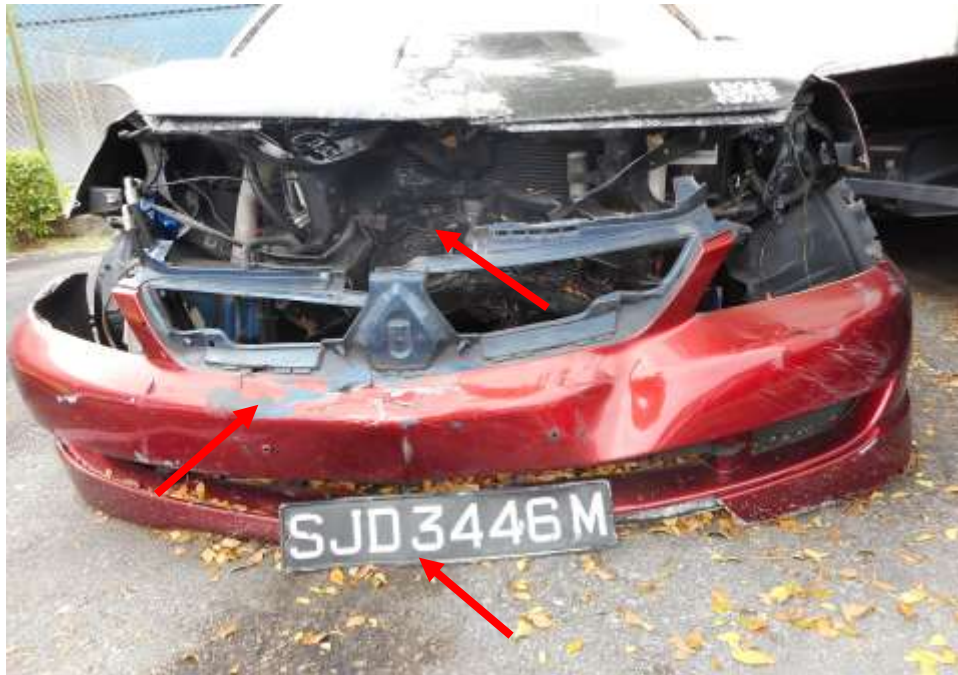
Photo 4 shows the general view of the Motor Car's front body at the time of my inspection. The Motor car was observed to have sustained damage, its front bumper; front number plate (arrowed) was amongst the body parts that were damaged as a result of the accident.

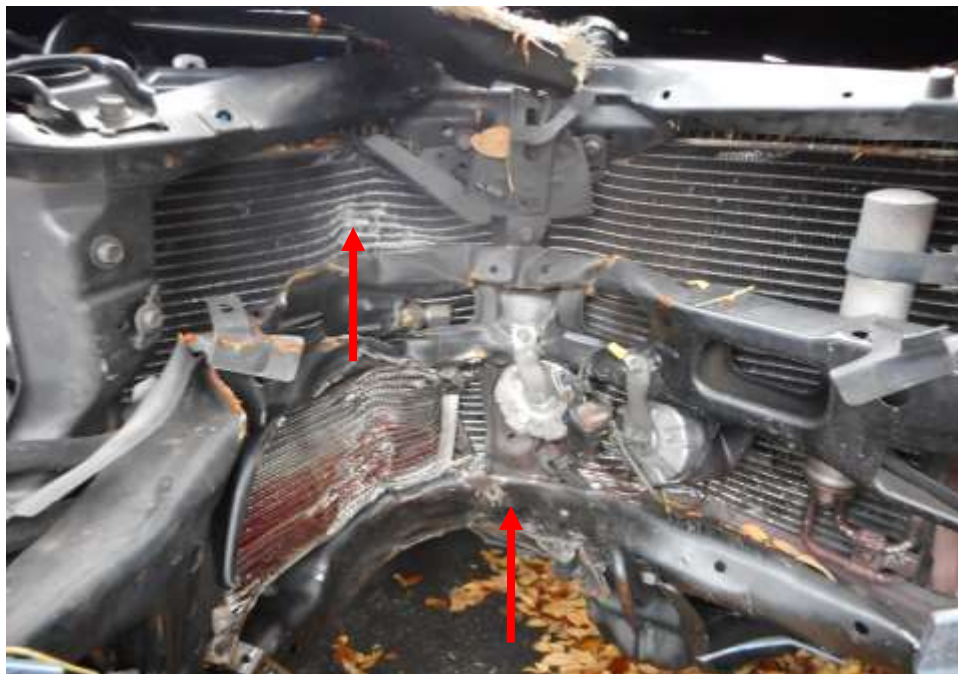
Photo 5 shows the close up view of the Motor Car's front body at the time of my inspection. The Motor car was observed to have sustained damage, its front radiator and front reinforcement (arrowed) was amongst the body parts that were damaged as a result of the accident.

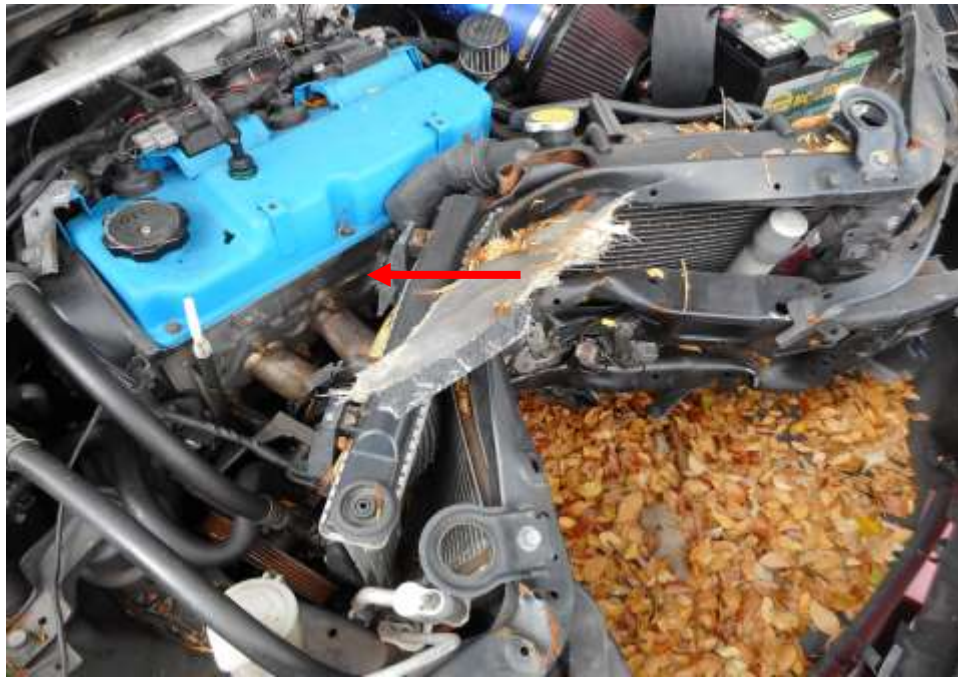
Photo 6 shows a close up view of the front portion of the Motor Car at the time of my inspection. The engine system (arrowed) of the Motor Car was observed to have been damaged by an induced impact as a result of the accident

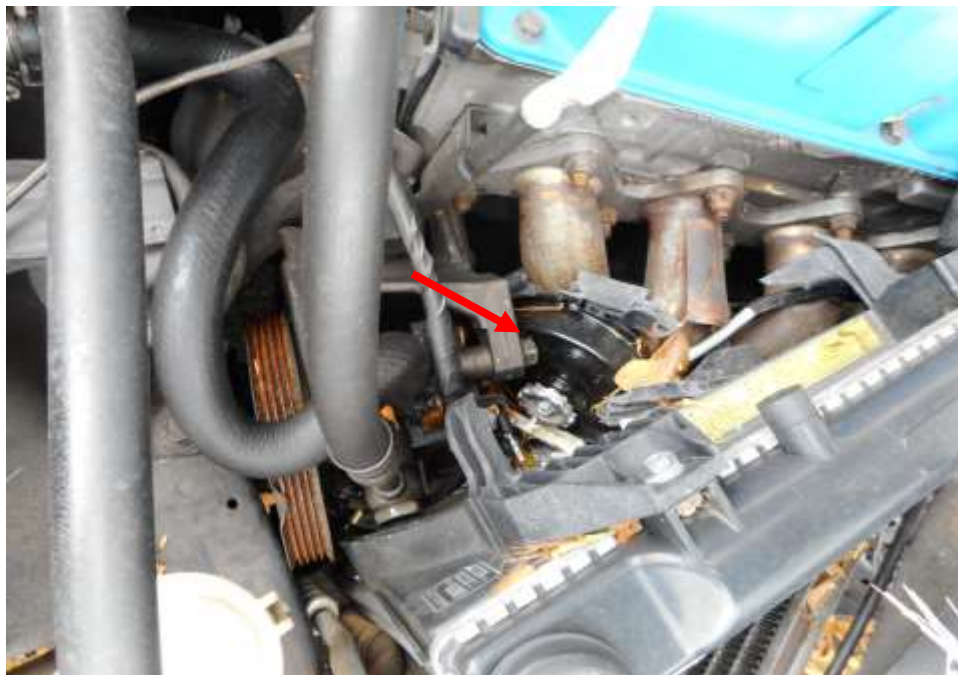
Photo 7 shows a close up view of the front portion of the Motor Car at the time of my inspection. The ignition system (arrowed) of the Motor Car was observed to have been damaged as a result of the induced impact as a result of the accident

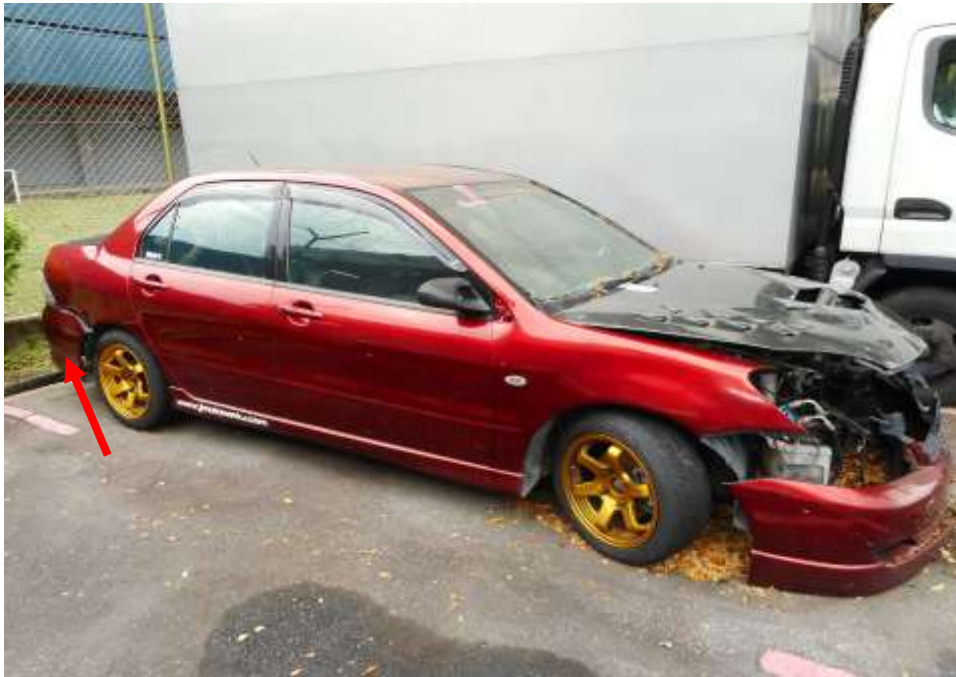
Photo 8 shows a general view of the Motor Car's right body panel at the time of my inspection. The rear bumper portion (arrowed) of the Motor Car was observed to have been damaged by the accident.

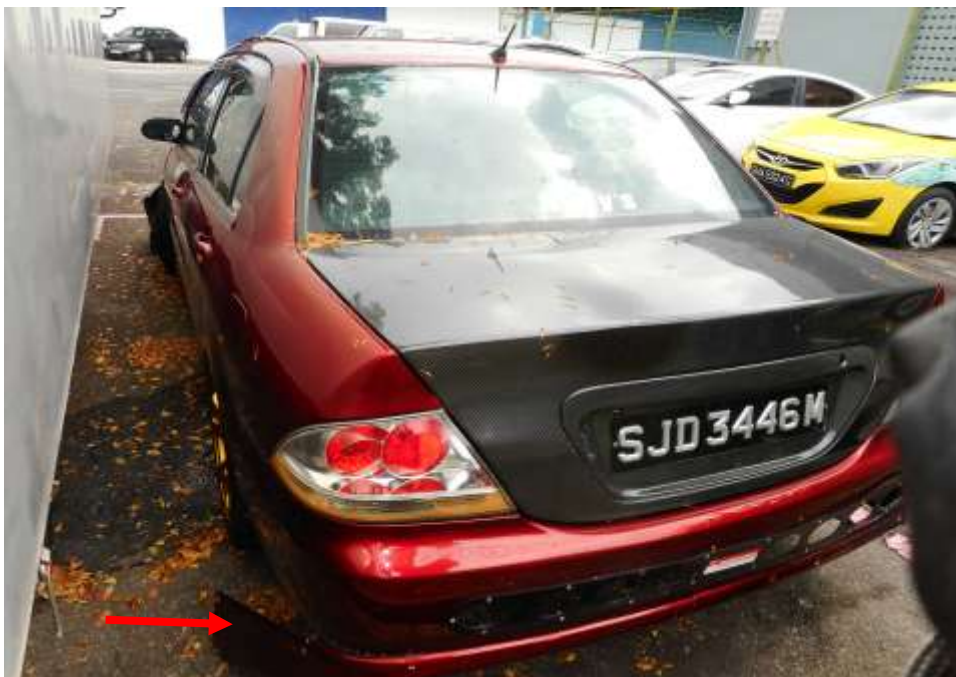
Photo 9 shows a general rear view of the Motor Car's left body panel at the time of my inspection. The rear bumper portion (arrowed) of the Motor Car was observed to have been damaged by the accident.

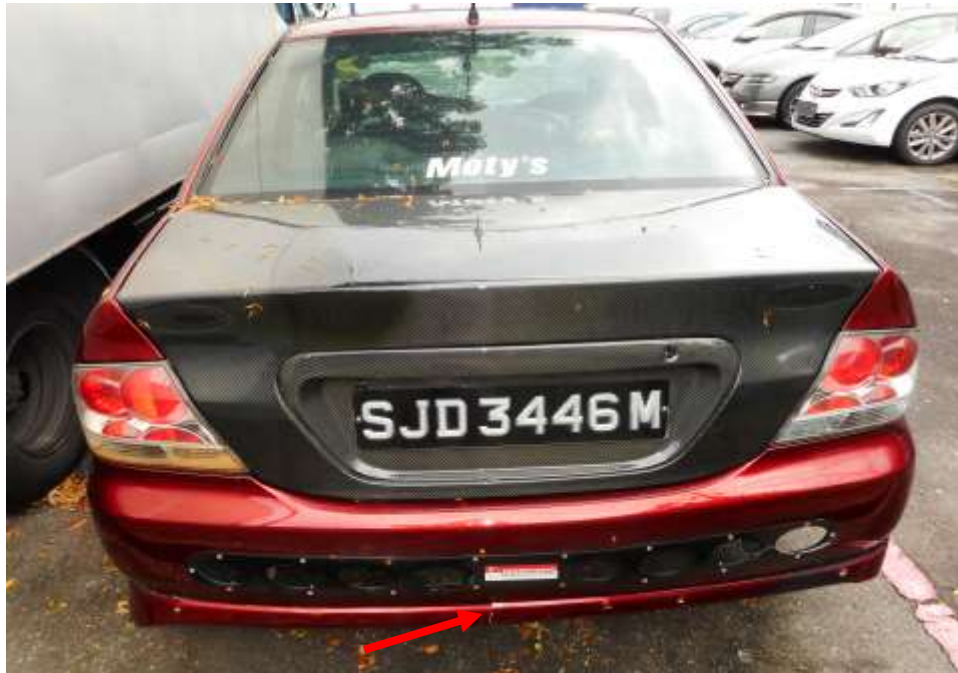
Photo 10 shows a general view of the Motor Car's rear body at the time of my inspection. The rear bumper portion of the Motor Car was observed to have been damaged by the accident.

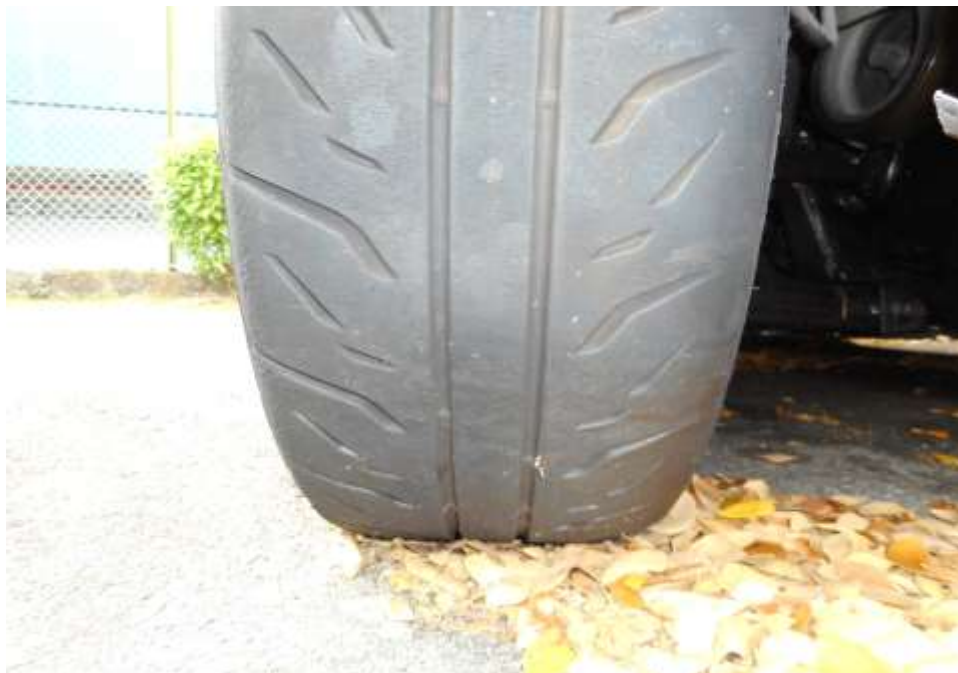
Photo 11 shows the condition of the front right tyre of the Motor Car, which was observed to be in serviceable condition with remaining tread depth of approximately 3.7mm. The tyre was sufficiently inflated for vehicular operation with no tear, cut or burst mark(s) on the outer and the inner sidewalls as well as across the tread. The 4 tyres of the Motor Car were wrapped around standard alloy wheel rims without any damage.

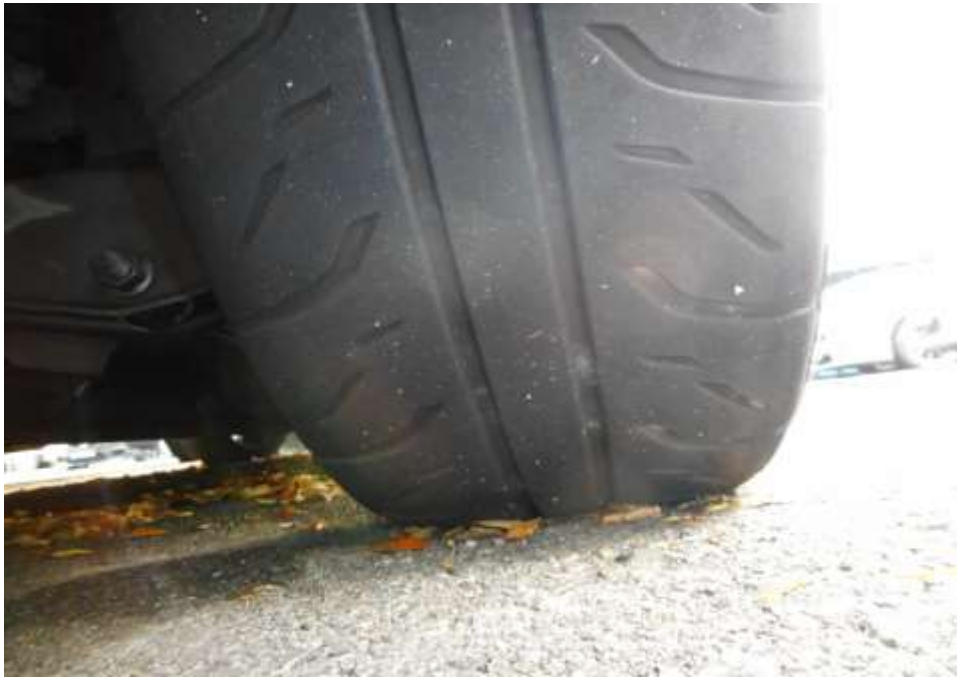
Photo 12 shows the condition of the rear right tyre of the Motor Car, which was observed to be in serviceable condition with remaining tread depth of approximately 4.5mm. The tyre was also observed to be sufficiently inflated for vehicular operation with no tear, cut or burst mark(s).

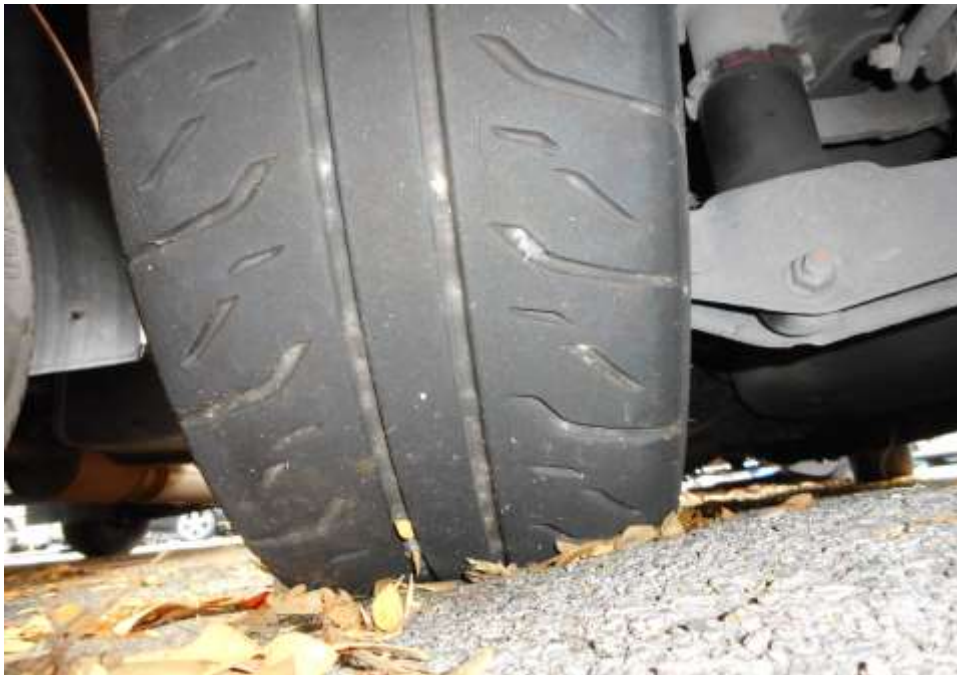
Photo 13 shows the condition of the rear left tyre of the Motor Car, which was observed to be in serviceable condition with remaining tread depth of approximately 4.6mm. The tyre, which was wrapped around alloy wheel rim, was also observed to be sufficiently inflated for vehicular operation. The 4 tyres of the Motor Car were wrapped around standard alloy wheel rims.

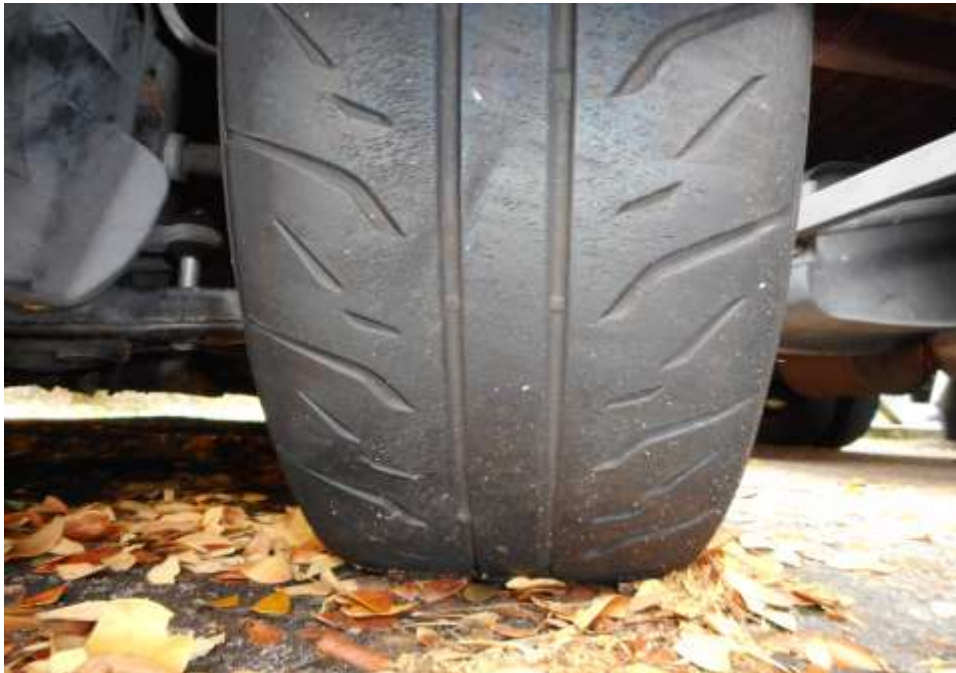
Photo 14 shows the condition of the front left tyre of the Motor Car, which was observed to be in serviceable condition with remaining tread depth of approximately 3.7mm. There was also no tear, cut or burst mark(s) on the outer and the inner sidewalls as well as across the tread of the Motor Car's 4 tyres.

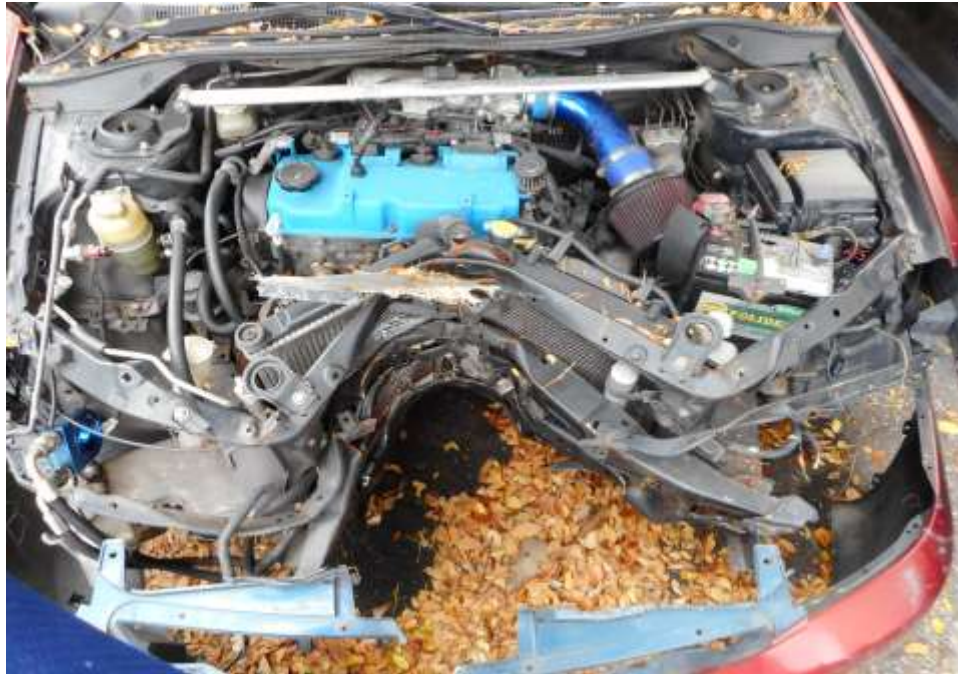
Photo 15 shows a general view of the Motor Car's engine compartment and the various parts and components inside the engine compartment. There was also no sign(s) or indication(s) of fluid leakage and/or fluid stain within the engine compartment.

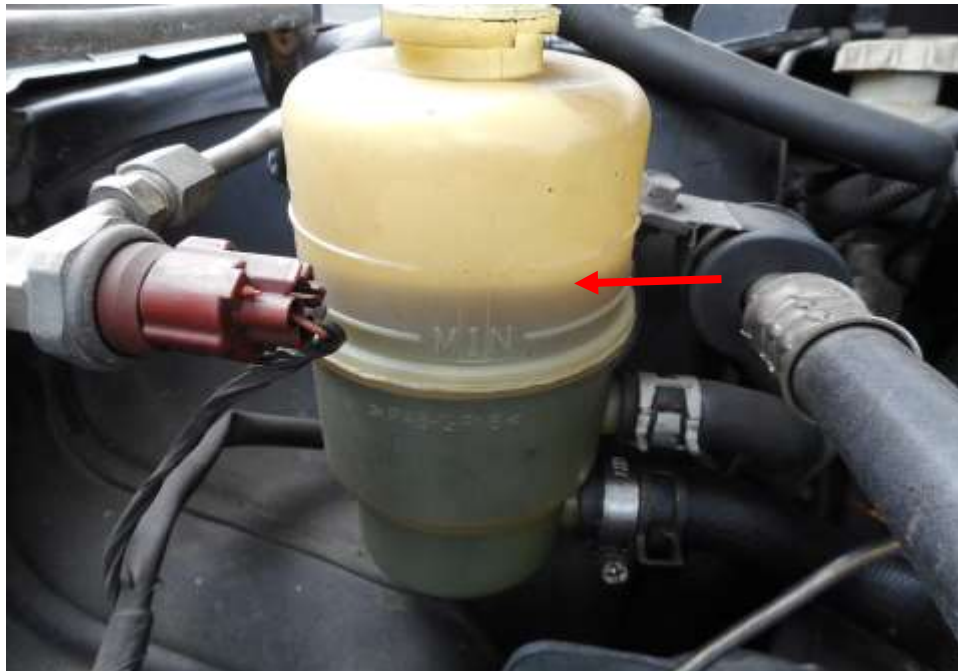
Photo 16 shows the brake fluid reservoir of the Motor Car at the time of my inspection. The brake fluid was observed to be of sufficient level (arrowed) and without any visible contamination.

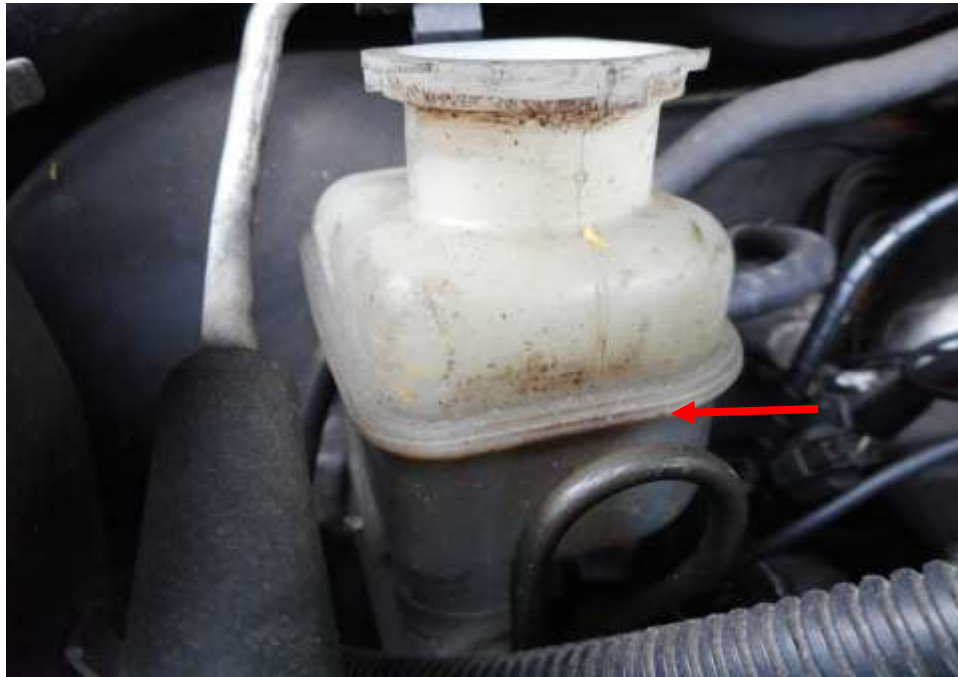
Photo 17 shows the power steering dip stick of the Motor Car at the time of my inspection. The power steering fluid was observed to be of sufficient level and with visible contamination.

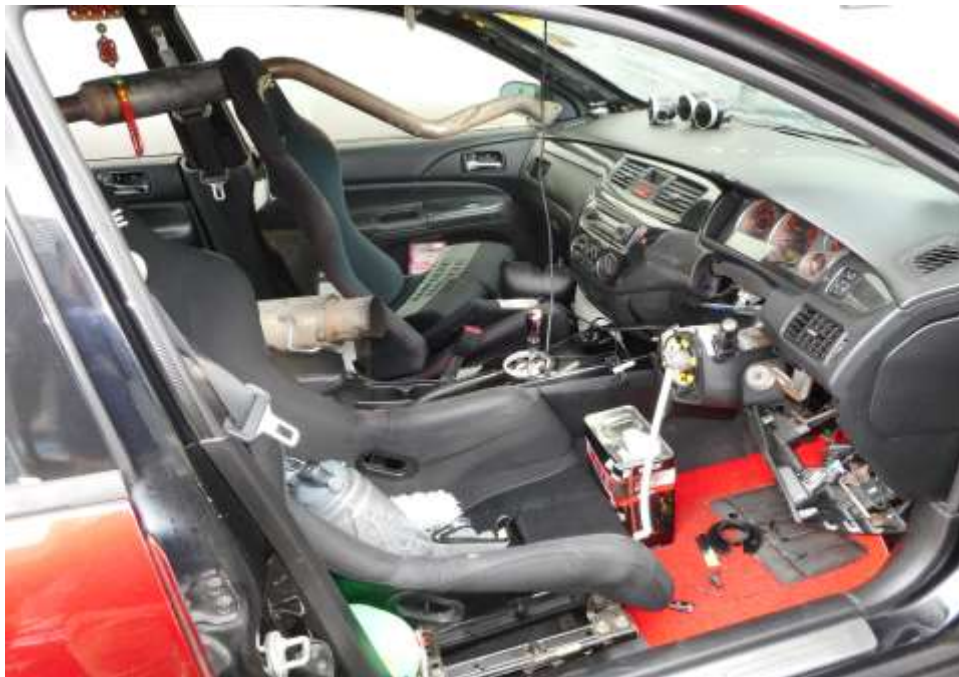
Photo 18 shows the interior cabin of the Motor Car. The steering wheel at time of my inspection of the Motor Car was observed to be damaged and missing as a result of the accident

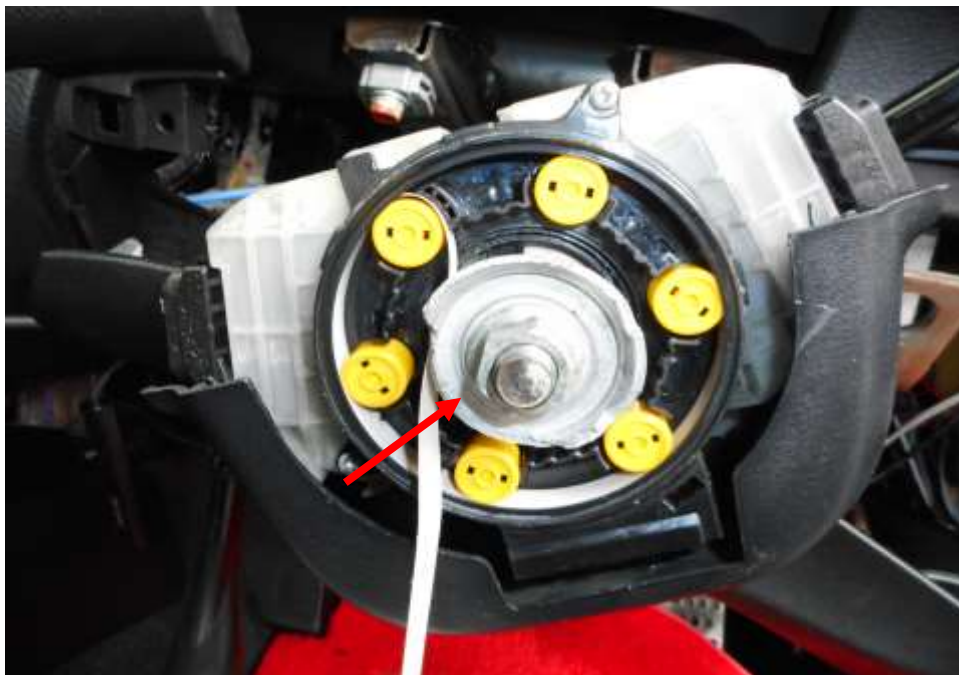
Photo 19 shows the close up view of the steering wheel of the Motor Car at time of my inspection of the Motor Car was observed to be damaged and missing (arrowed) as a result of the accident

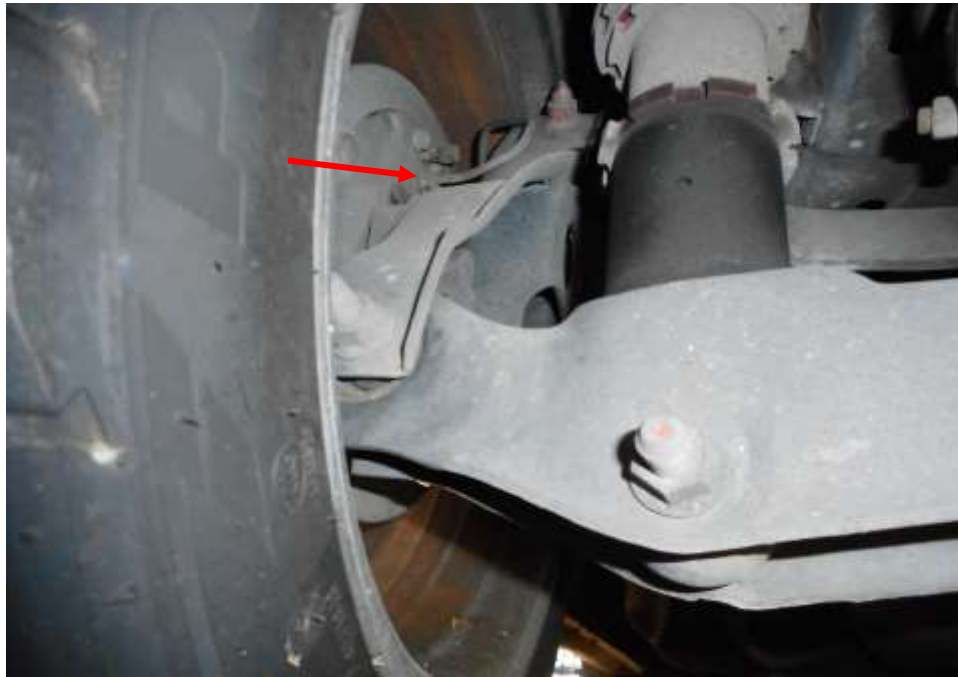
Photo 20 shows the brake hose/pipe (arrowed) at the rear left wheel of the Motor Car. I did not observe any leakage of brake fluid at the time of my inspection of the Motor Car. Static tests of the Motor Car's braking system had indicated that there was no internal leakage of pressure/vacuum. The undercarriage components of the Motor Car were also all found to be intact and without any visible damage.

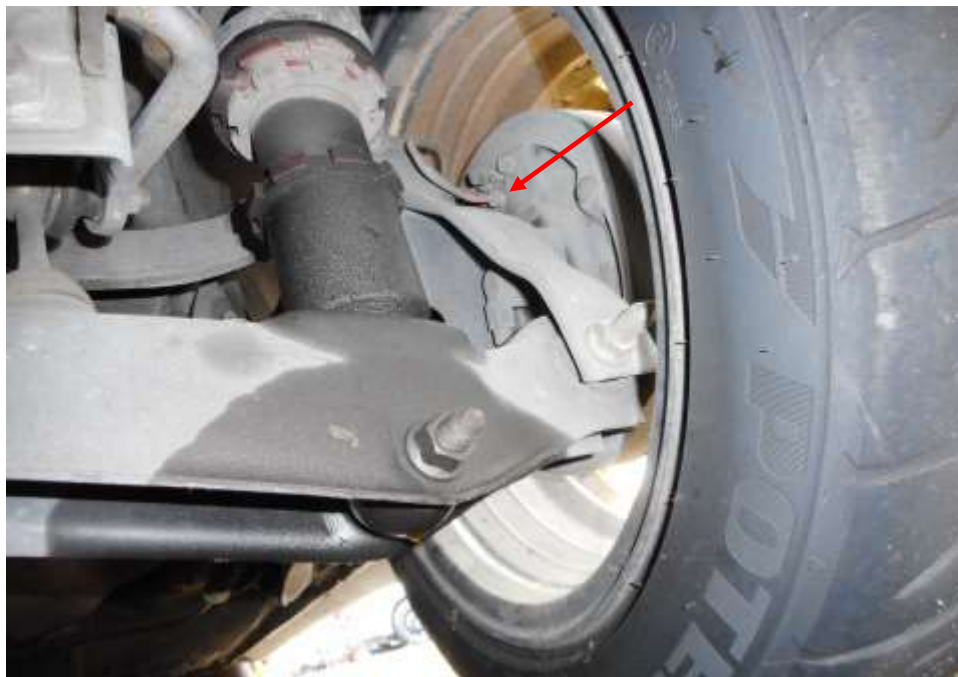
Photo 21 shows the brake hose/pipe (arrowed) at the rear right wheel of the Motor Car. No leakage of brake fluid was observed. Visual examination of the various components of the braking system like the drum brake, brake booster, brake pedal etc had revealed all to be intact and without visible damage.

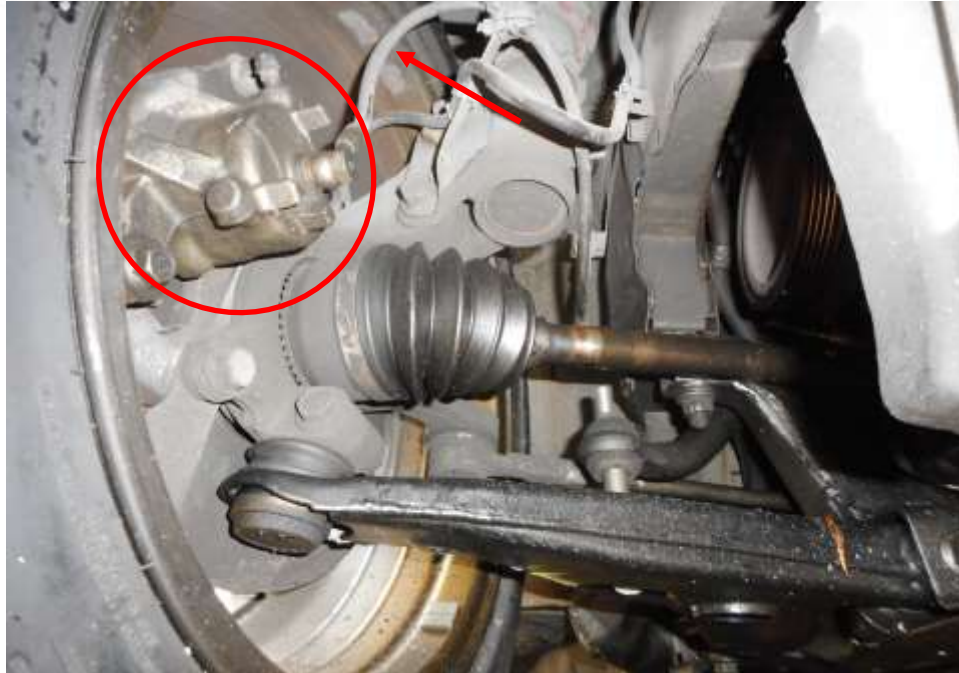
Photo 22 shows the brake hose/pipe (arrowed) at the front right wheel of the Motor Car. No leakage of brake fluid was observed. Visual examination of the various components of the braking system like the brake caliper (circled), brake booster, brake pedal etc had revealed all to be intact and without visible damage.

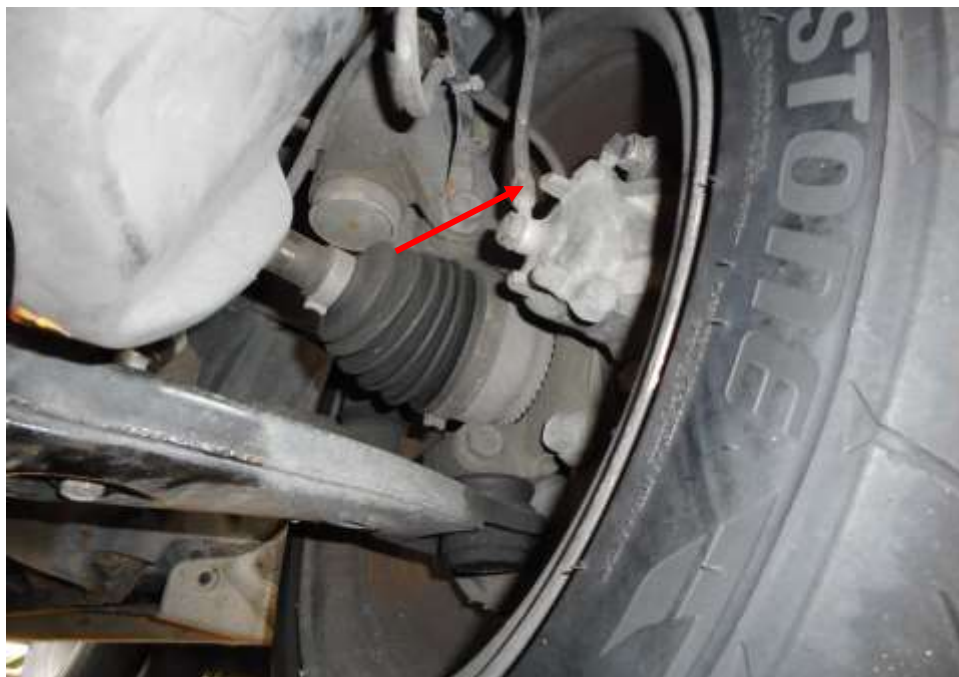
Photo 23 shows the brake hose/pipe (arrowed) at the front left wheel of the Motor Car. I did not observe any leakage of brake fluid at the time of my inspection of the Motor Car. Static tests of the Motor Car's braking system had indicated that there was no internal leakage of pressure/vacuum. The undercarriage components of the Motor Car were also all found to be intact and without any visible damage.

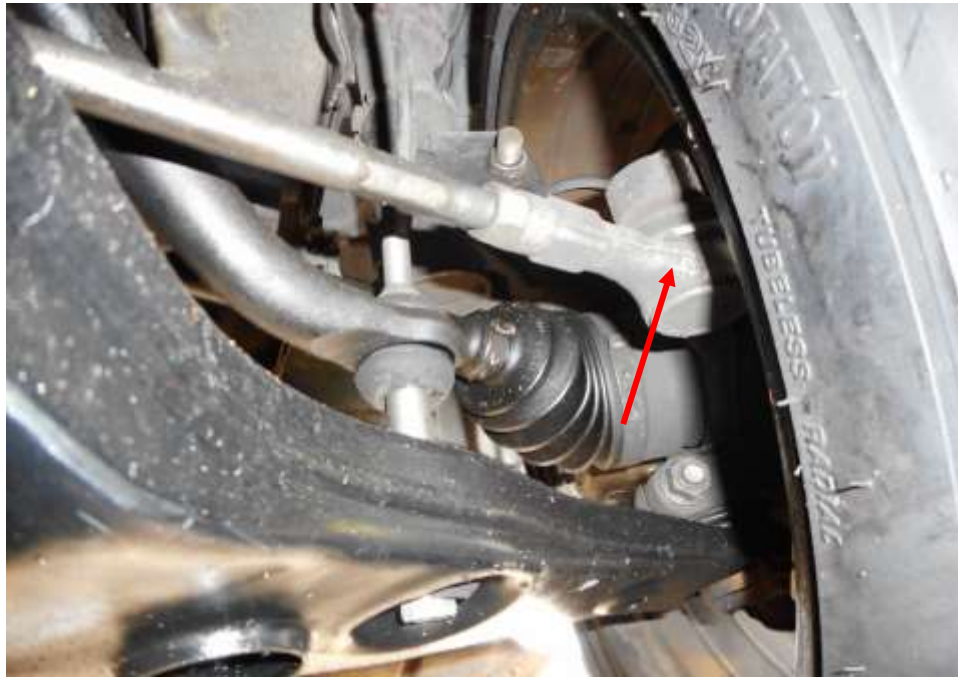
Photo 24 shows the various undercarriage components at the front right wheel of the Motor Car, which had included the steering tie rod (red arrow). The various undercarriage components of the Motor Car were all found to be intact without any visible damage.

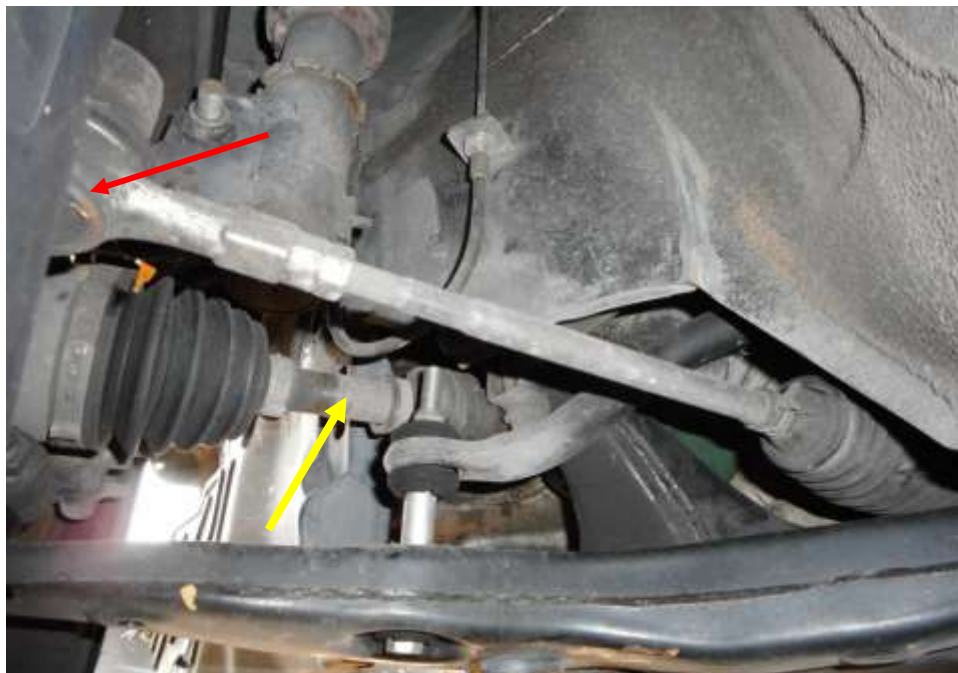
Photo 25 shows the various undercarriage components at the front left wheel of the Motor Car, in particular the steering tie rod (red arrow) and drive shaft (yellow arrow). The various steering components were all found to be intact, suggesting that the steering system of the Motor Car was likely to be in serviceable condition at the material time of accident. There was also no sign of fluid stain observed on the various undercarriage components at the front right wheel of the Motor Car.
