Your Ref: TP/IP/17453/2019
Our Ref : CI/TPD19011289/P

Fatal Accident Investigation Team

MECHANICAL INSPECTION REPORT OF MOTOR CAR SME 5202X

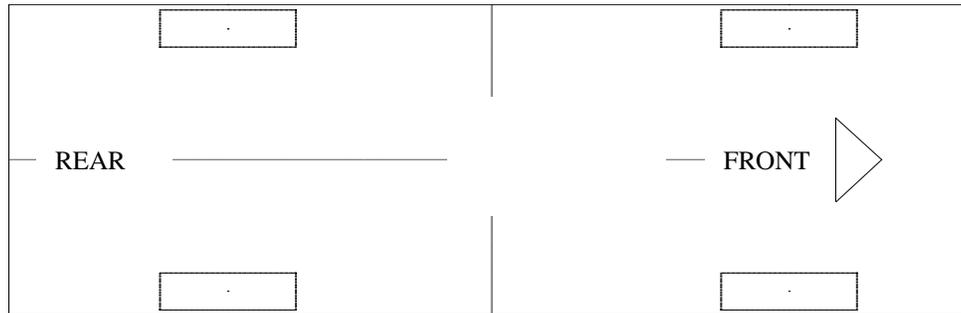
6. The condition of the Motor car's 4 tyres was observed to be in serviceable condition. I did not find any tear, cut or burst mark(s) on the outer and the inner sidewalls as well as across the tread of the 4 tyres. The 4 tyres were also observed to be sufficiently inflated for vehicular operation. The tyre brand, tyre size and remaining tread depth of the 4 tyres were recorded as follows:-

Michelin 215/55R17 (4.1mm)

Falken 215/55R17 (4.6mm)

Michelin 215/55R17 (4.8mm)

Falken 215/55R17 (5mm)

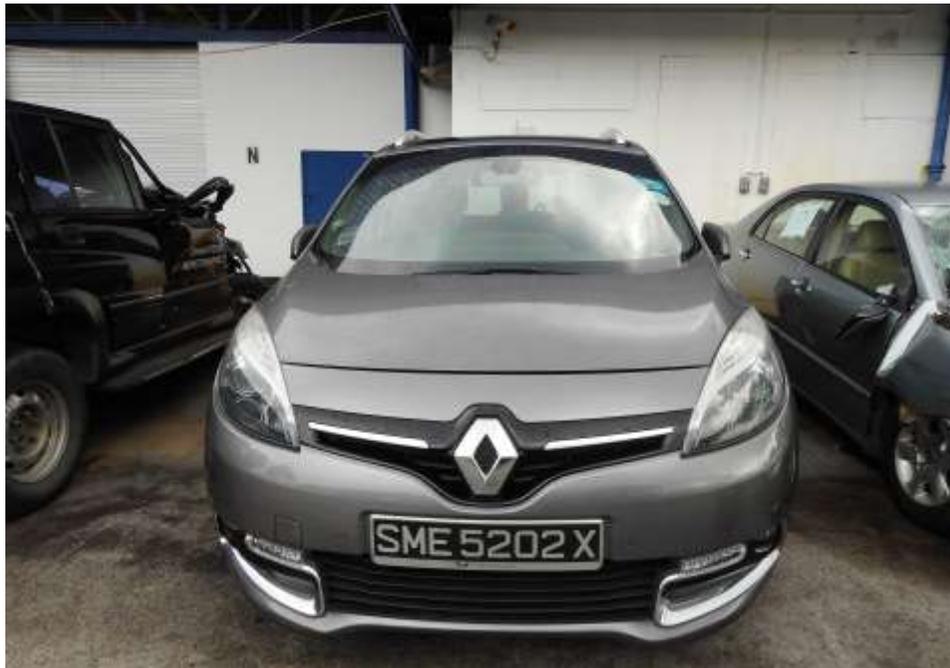
Photo 1 shows a general view of the Motor Car's at the time of my inspection. The front portion of the Motor Car was observed to have been unaffected by the accident. The mileage of the Motor Car at the time of my inspection was recorded to be 120,379km.

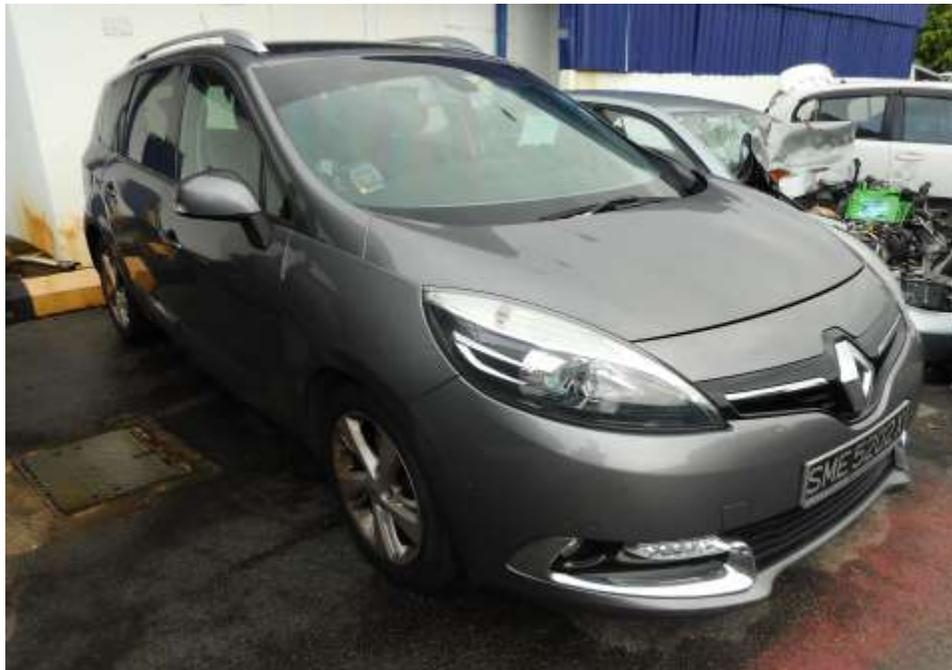
Photo 2 shows a general view of the Motor Car's right body at the time of my inspection. The right portion of the Motor Car was observed to have been unaffected by the accident.

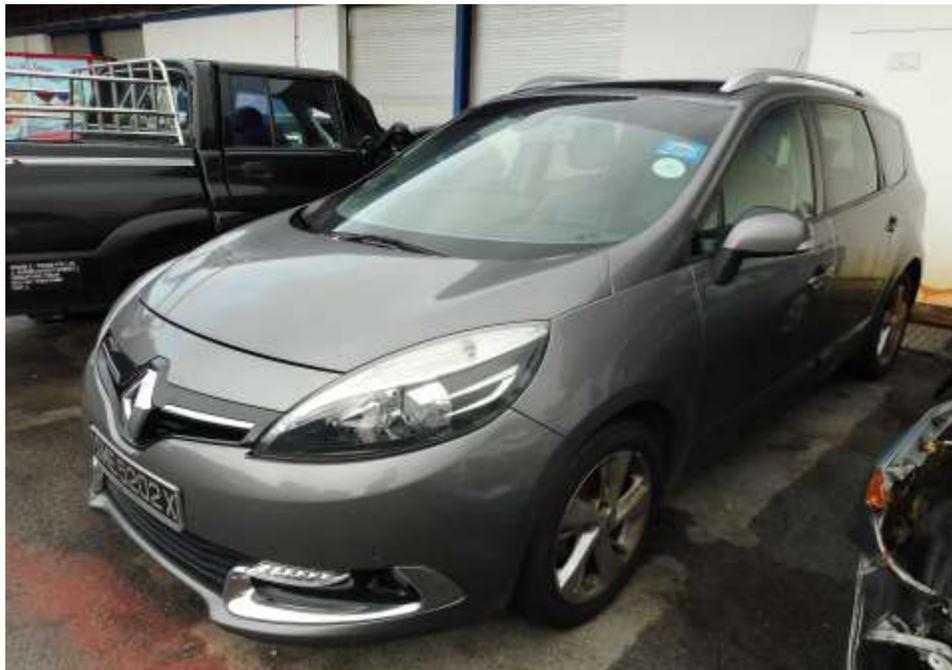
Photo 3 shows a general view of the Motor Car's left body at the time of my inspection. The left portion of the Motor Car was observed to have been unaffected by the accident.

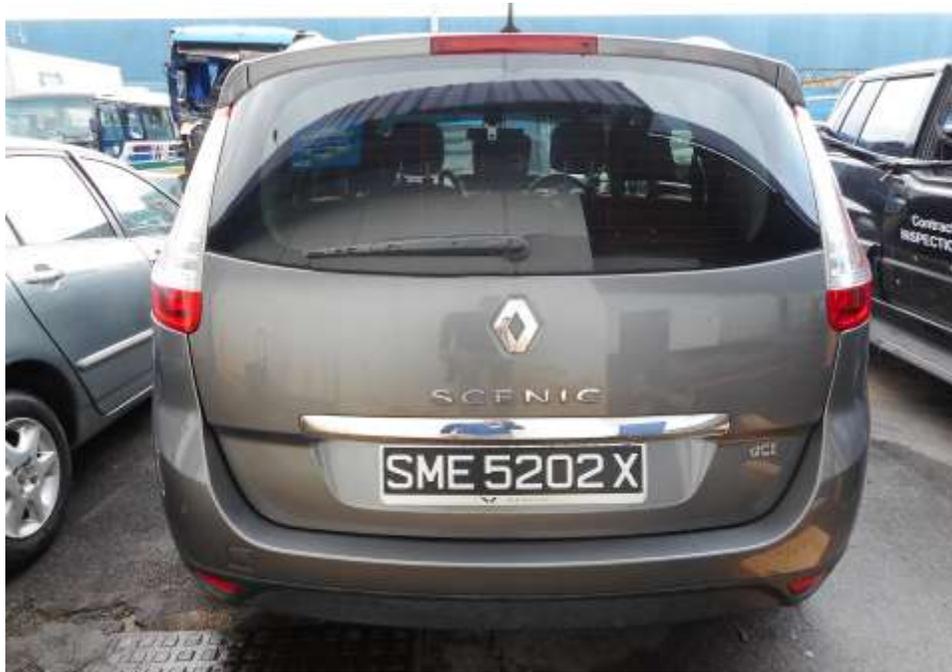
Photo 4 shows a general view of the Motor Car's rear body at the time of my inspection. The rear portion of the Motor Car was observed to have been unaffected by the accident.

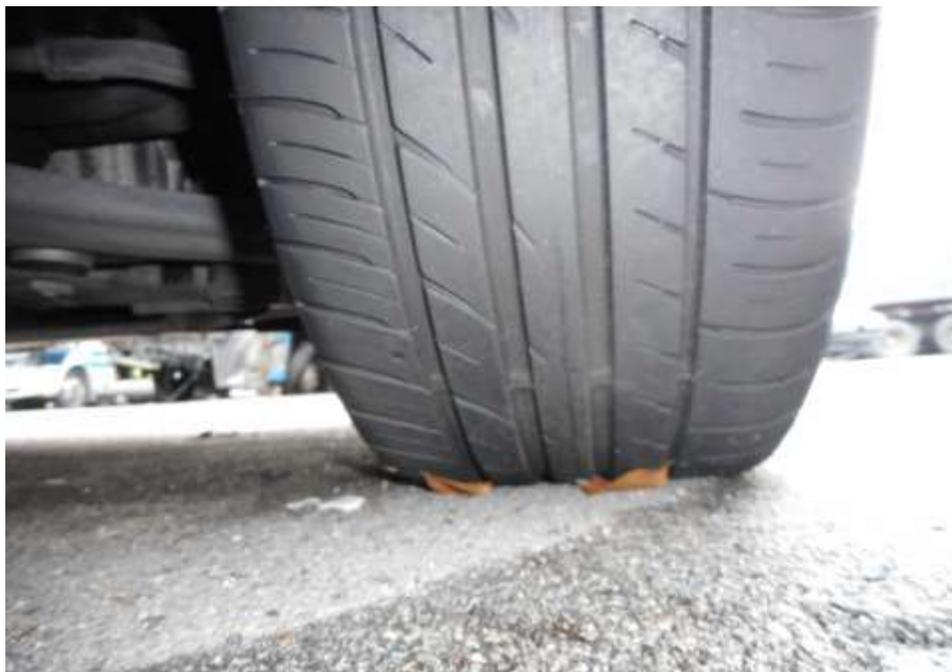
Photo 5 shows the condition of the front right tyre of the Motor Car, which was observed to be in serviceable condition with remaining tread depth of approximately 5mm. The tyre was sufficiently inflated for vehicular operation with no tear, cut or burst mark(s) on the outer and the inner sidewalls as well as across the tread. The 4 tyres of the Motor Car were wrapped around standard alloy wheel rims without any damage.

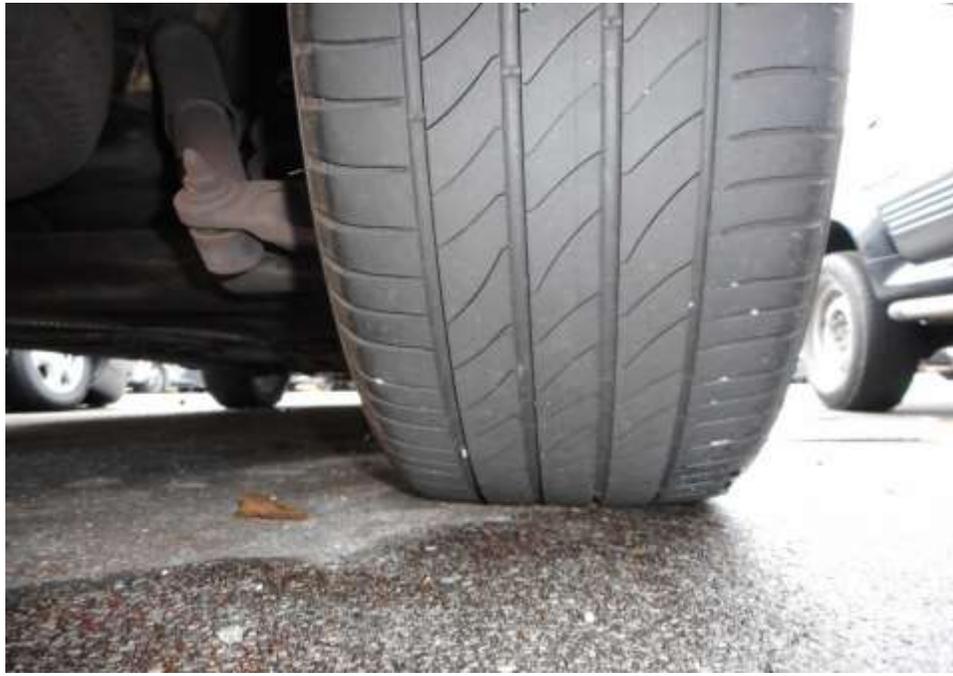
Photo 6 shows the condition of the rear right tyre of the Motor Car, which was observed to be in serviceable condition with remaining tread depth of approximately 4.8mm. The tyre was also observed to be sufficiently inflated for vehicular operation with no tear, cut or burst mark(s).

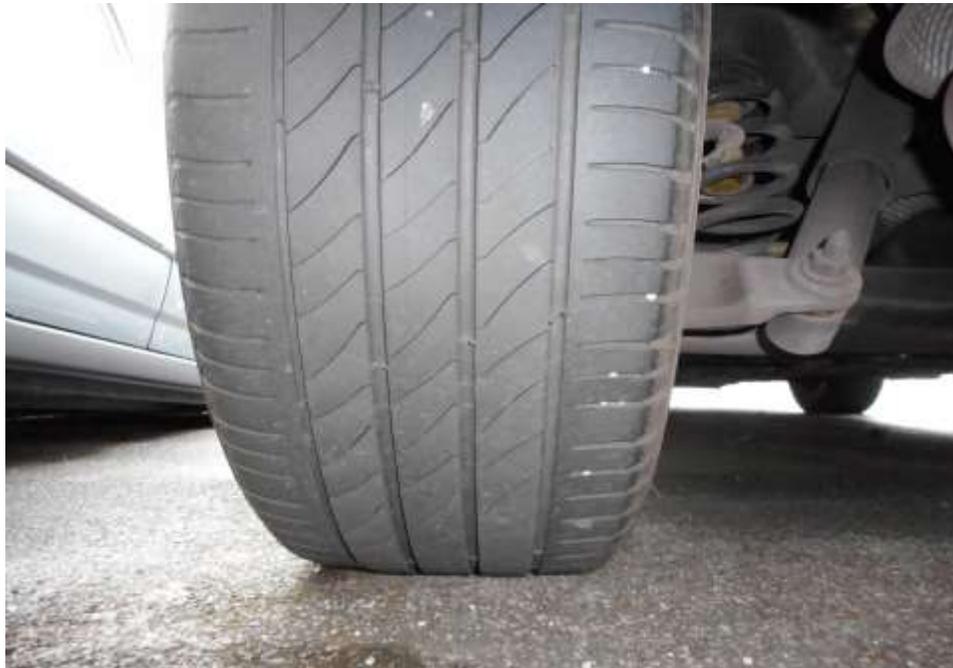
Photo 7 shows the condition of the rear left tyre of the Motor Car, which was observed to be in serviceable condition with remaining tread depth of approximately 4.1mm. The tyre, which was wrapped around alloy wheel rim, was also observed to be sufficiently inflated for vehicular operation. The 4 tyres of the Motor Car were wrapped around standard alloy wheel rims.

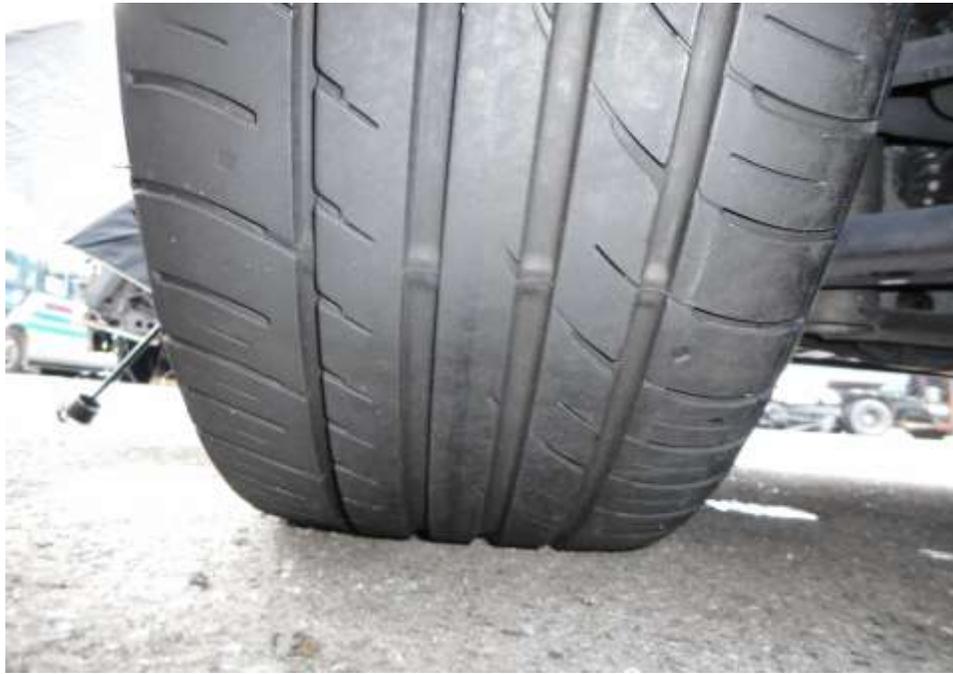
Photo 8 shows the condition of the front left tyre of the Motor Car, which was observed to be in serviceable condition with remaining tread depth of approximately 4.6mm. There was also no tear, cut or burst mark(s) on the outer and the inner sidewalls as well as across the tread of the Motor Car's 4 tyres.

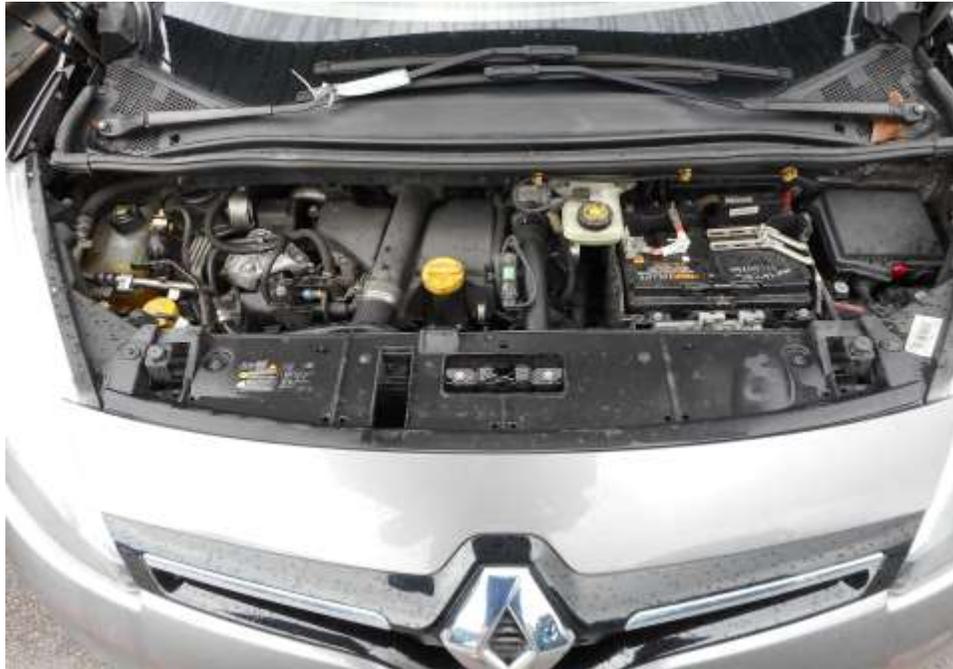
Photo 9 shows a general view of the Motor Car's engine compartment. The various parts and components inside the engine compartment were unaffected by the accident. There was also no sign(s) or indication(s) of fluid leakage and/or fluid stain within the engine compartment.

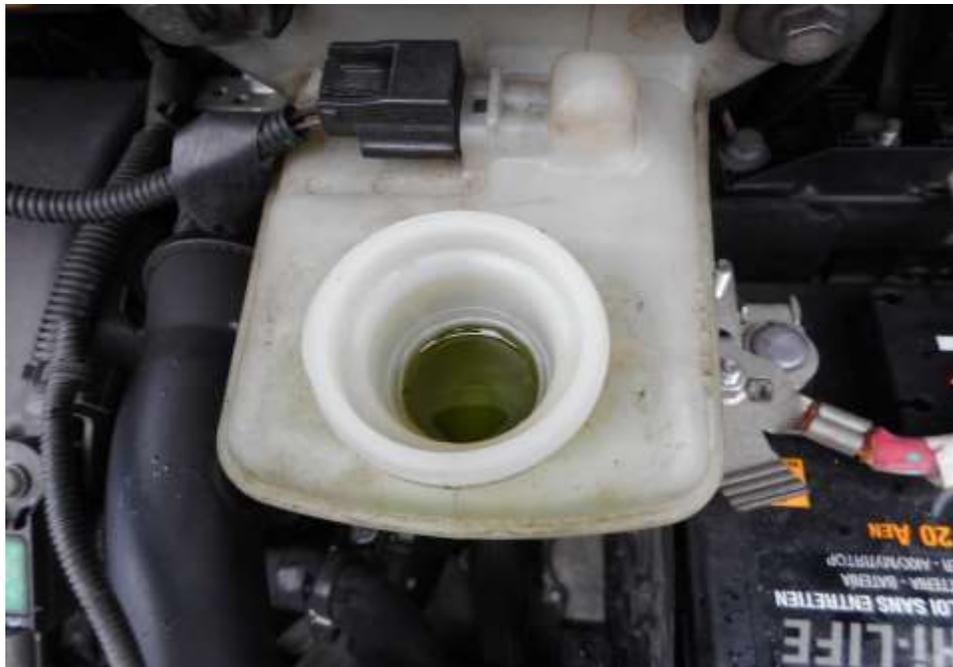
Photo 10 shows the brake fluid reservoir of the Motor Car at the time of my inspection. The brake fluid was observed to be of sufficient level (arrowed) and without any visible contamination.

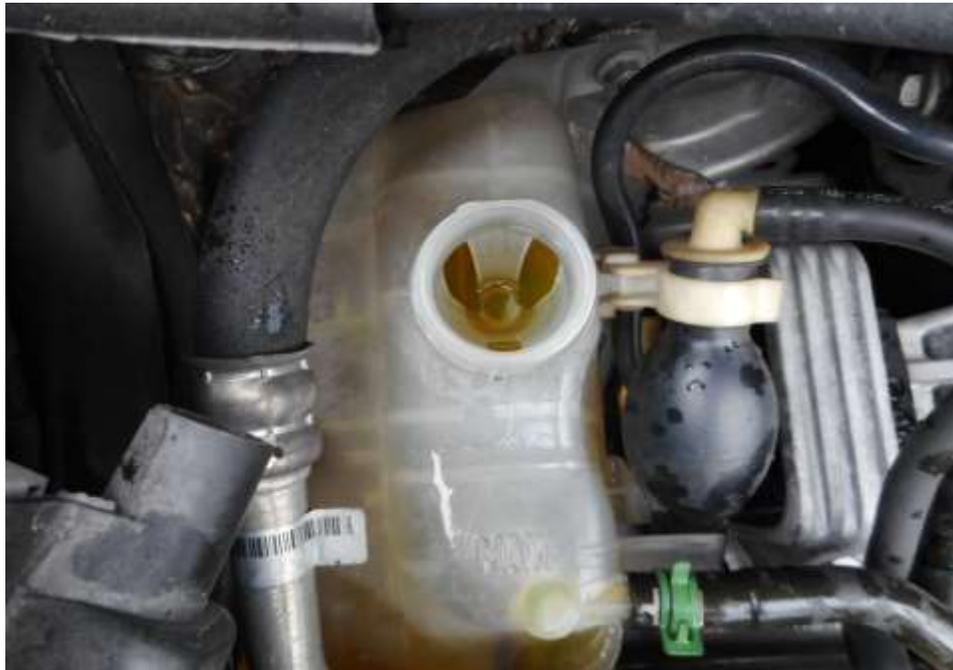
Photo 11 shows checks being carried out to the engine coolant of the Motor Car at the time of my inspection. The engine coolant was observed to be of sufficient level (arrowed) and without any visible contamination.

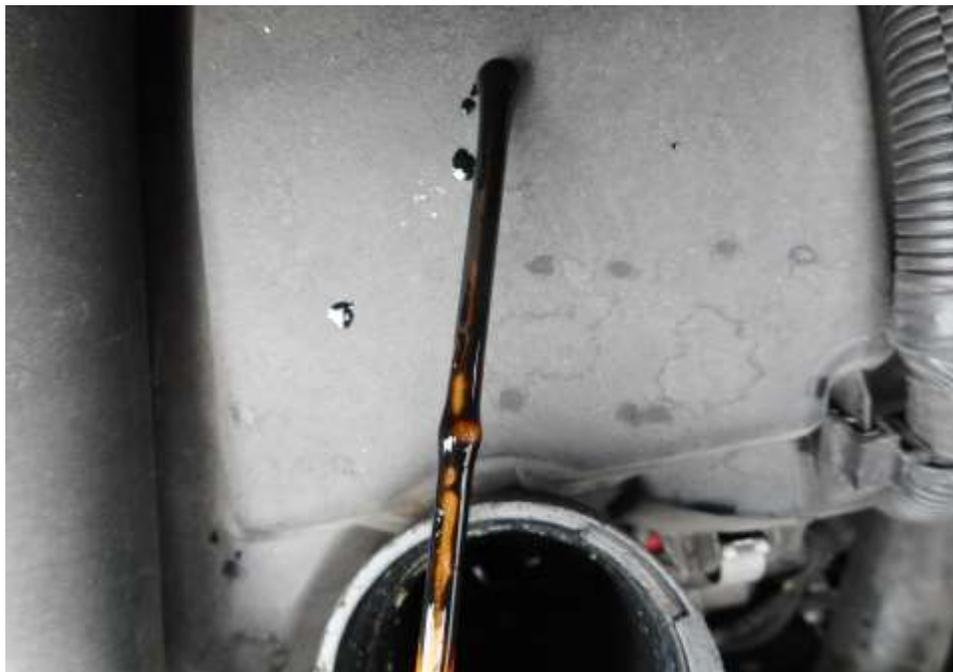
Photo 12 shows the engine oil dip stick of the Motor Car at the time of my inspection. The engine oil was observed to be of sufficient level and without any visible contamination.

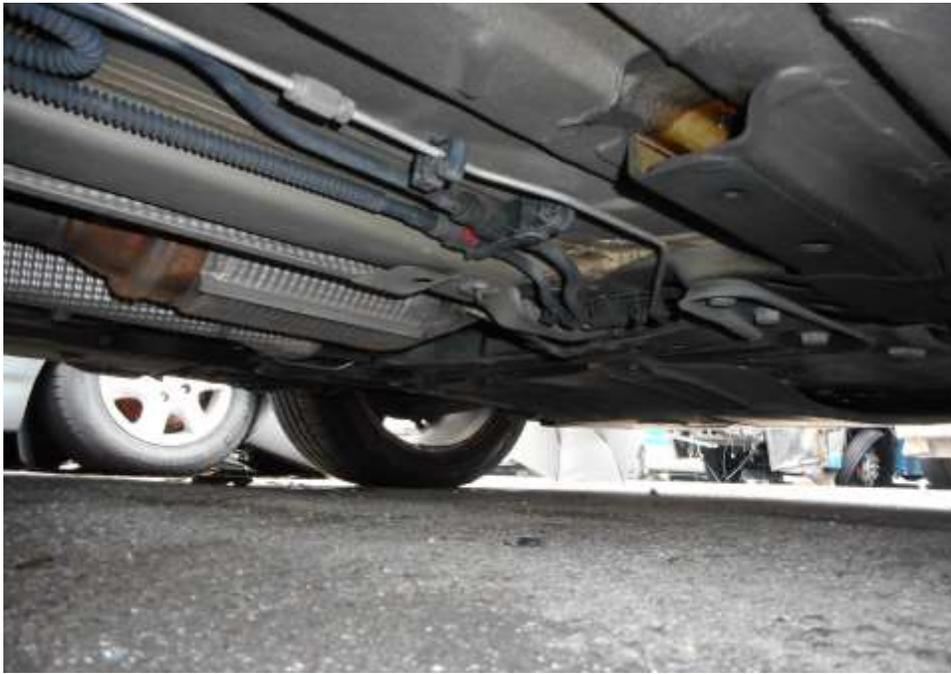
Photo 13 shows the undercarriage of the Motor Car, at the area where the engine housing and transmission housing are located. I did not find any sign(s) or indication(s) of fluid leak and/or fluid stain(s) on the underside of the Motor Car.

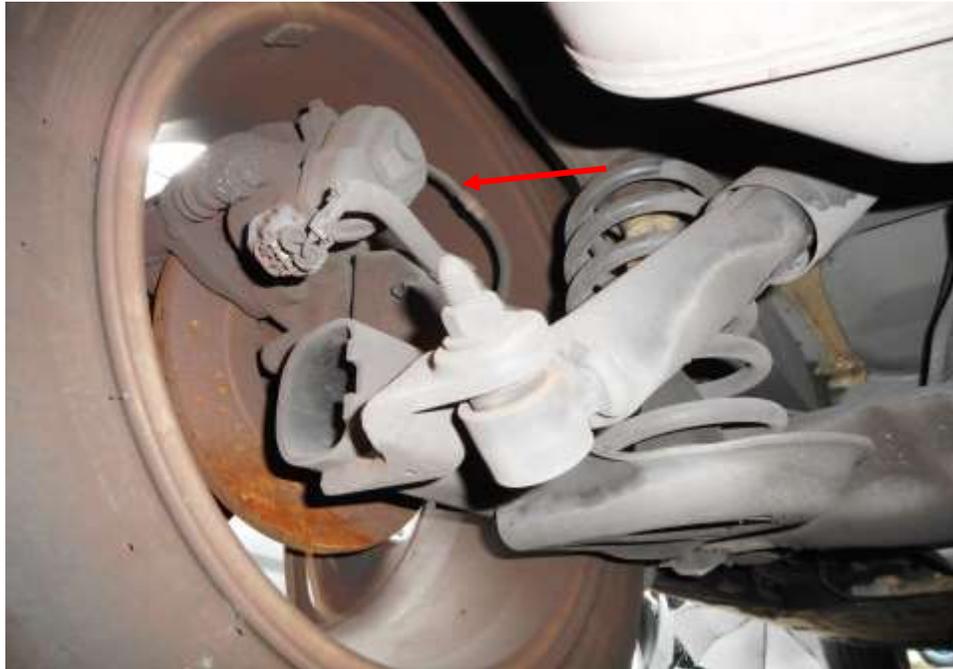
Photo 14 shows the brake hose/pipe (arrowed) at the rear left wheel of the Motor Car. I did not observe any leakage of brake fluid at the time of my inspection of the Motor Car. Static tests of the Motor Car's braking system had indicated that there was no internal leakage of pressure/vacuum. The undercarriage components of the Motor Car were also all found to be intact and without any visible damage.

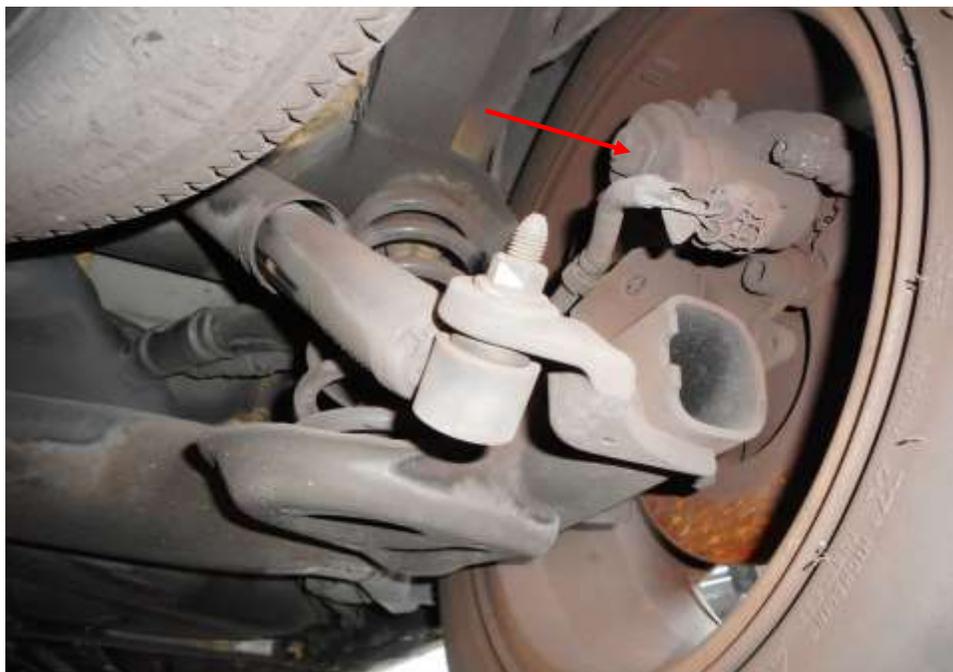
Photo 15 shows the brake hose/pipe (arrowed) at the rear right wheel of the Motor Car. No leakage of brake fluid was observed. Visual examination of the various components of the braking system like the drum brake, brake booster, brake pedal etc had revealed all to be intact and without visible damage.

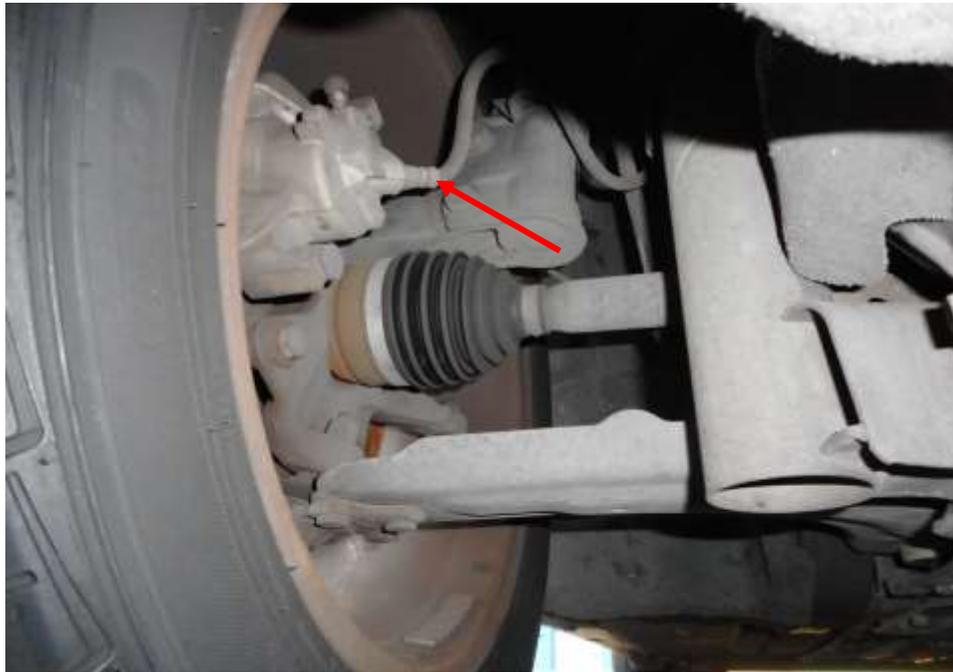
Photo 16 shows the brake hose/pipe (arrowed) at the front right wheel of the Motor Car. I did not observe any leakage of brake fluid at the time of my inspection of the Motor Car. Static tests of the Motor Car's braking system had indicated that there was no internal leakage of pressure/vacuum. The undercarriage components of the Motor Car were also all found to be intact and without any visible damage.

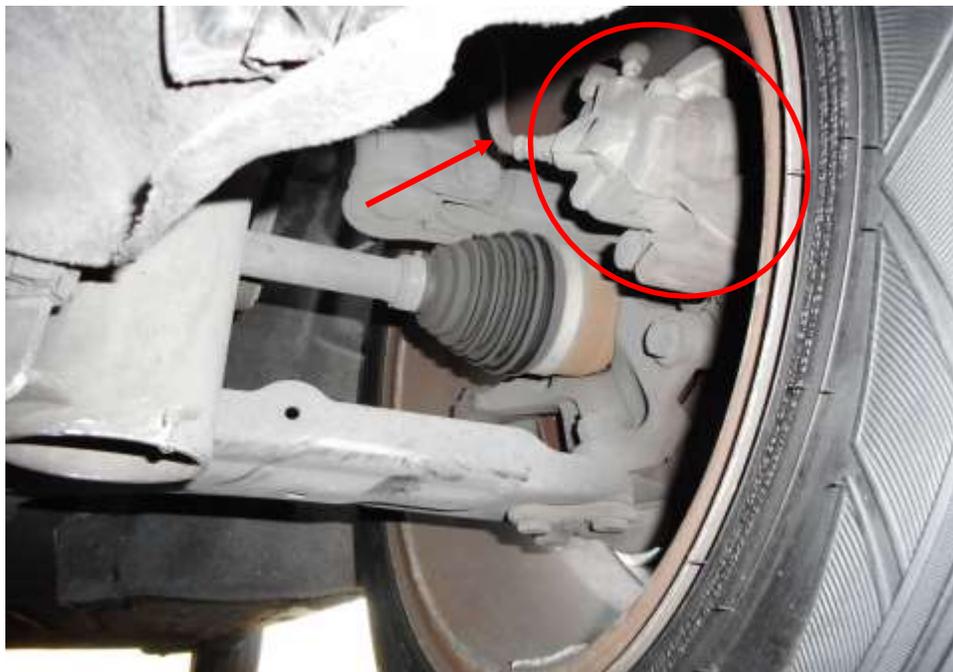
Photo 17 shows the brake hose/pipe (arrowed) at the front left wheel of the Motor Car. No leakage of brake fluid was observed. Visual examination of the various components of the braking system like the brake caliper (circled), brake booster, brake pedal etc had revealed all to be intact and without visible damage.

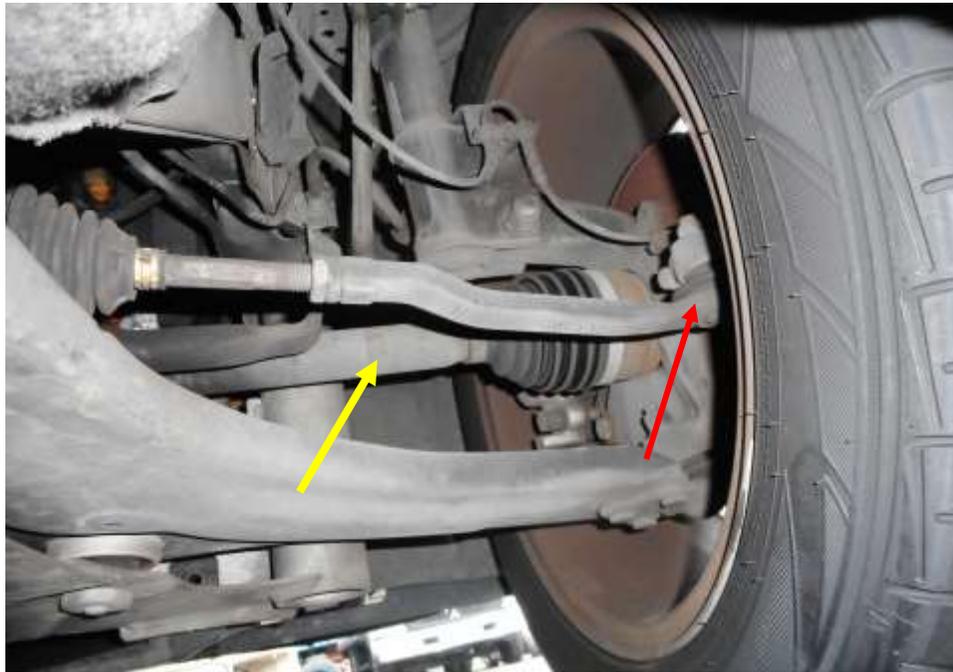
Photo 18 shows the various undercarriage components at the front right wheel of the Motor Car, in particular the steering tie rod (red arrow) and drive shaft (yellow arrow). The various steering components were all found to be intact, suggesting that the steering system of the Motor Car was likely to be in serviceable condition at the material time of accident. There was also no sign of fluid stain observed on the various undercarriage components at the front right wheel of the Motor Car.

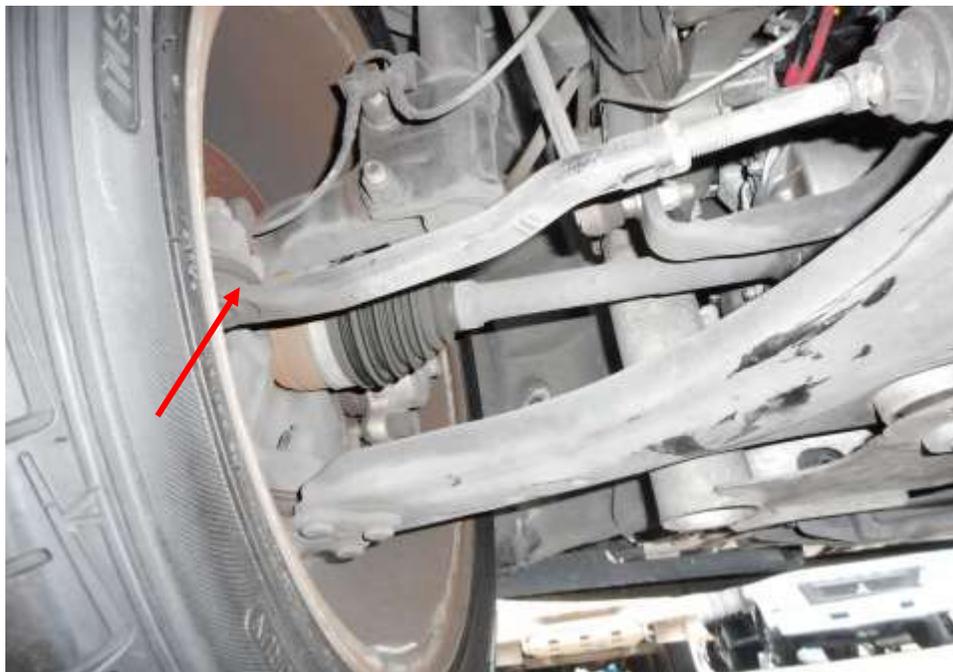
Photo 19 shows the various undercarriage components at the front left wheel of the Motor Car, which had included the steering tie rod (red arrow). The various undercarriage components of the Motor Car were all found to be intact without any visible damage.

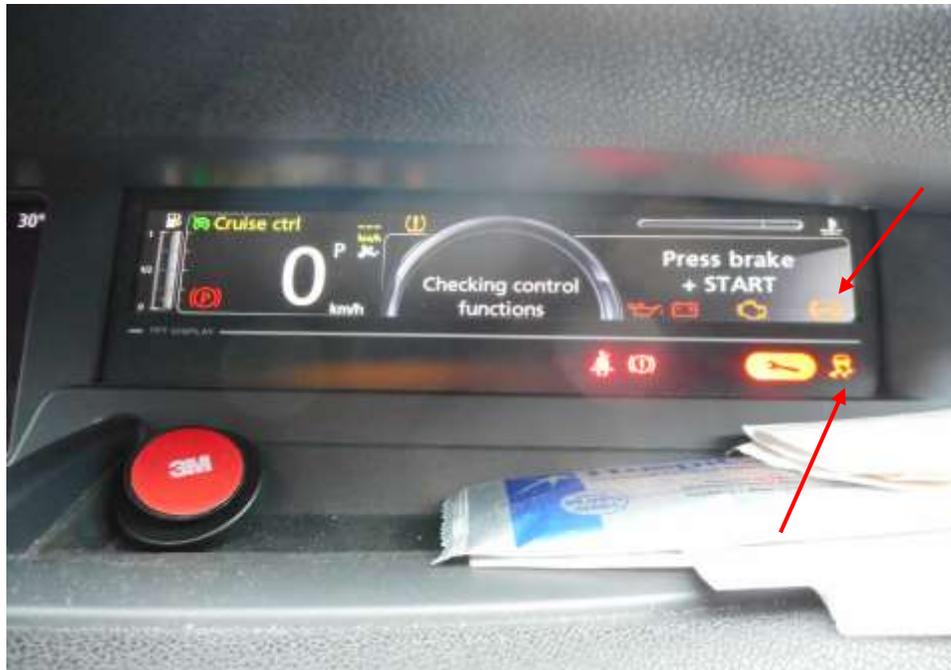
13. The Motor Car's automatic self-test of the functionality of its various electronic operating systems like the Anti-Lock Brake System (ABS) and Traction Control System (TC) when cranked. However the engine was unable to started despite multiple attempts in jump starting the vehicle. 20 & 21 below.

Photo 20 shows the warning light for Anti-Lock Brake System (ABS) and Traction Control System (TC) appearing on the instrument panel of the Motor Car during the self-test of its various electronic operating systems when its ignition was cranked.

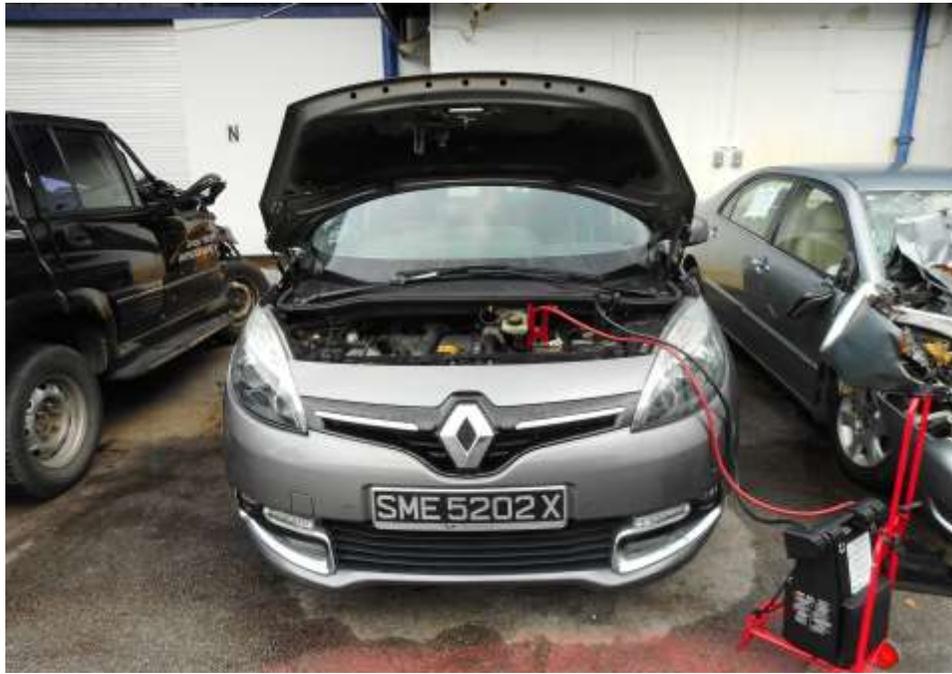
Photo 21 shows the jump starter used in jump starting the Motor Car at the time of my inspection. The Motor is unable to be started despite multiple attempts in cranking/starting the Car.
