Your Ref: TP/IP/24959/2019
Our Ref : CI/TPD19011291/P

12th July 2019

MECHANICAL INSPECTION REPORT OF MOTOR VAN GBE 4790B

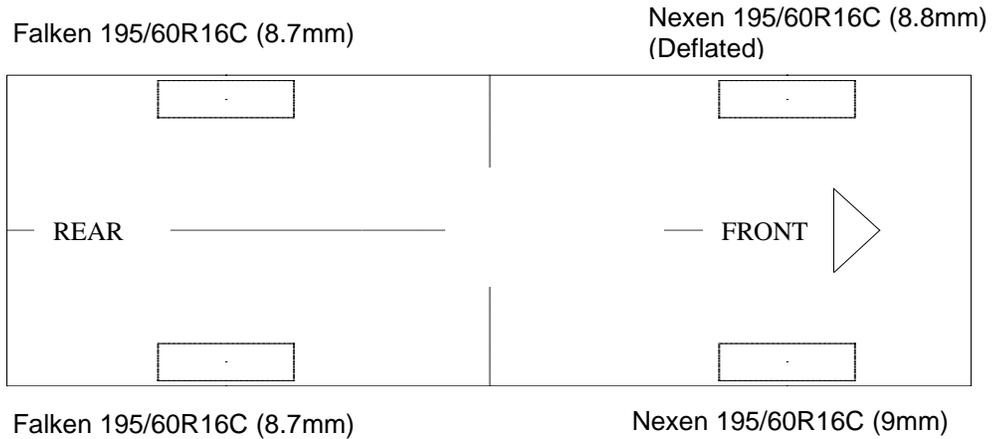
6. The front left tyre was observed to be dislodged from the rim and deflated. However the other 3 tyres of the Motor Van were observed to be in serviceable condition. I did not find any tear, cut or burst mark(s) on the outer and the inner sidewalls as well as across the tread of the 4 tyres. The 3 tyres were also observed to be sufficiently inflated for vehicular operation. The tyre brand, tyre size and remaining tread depth of the 4 tyres were recorded as follows:-

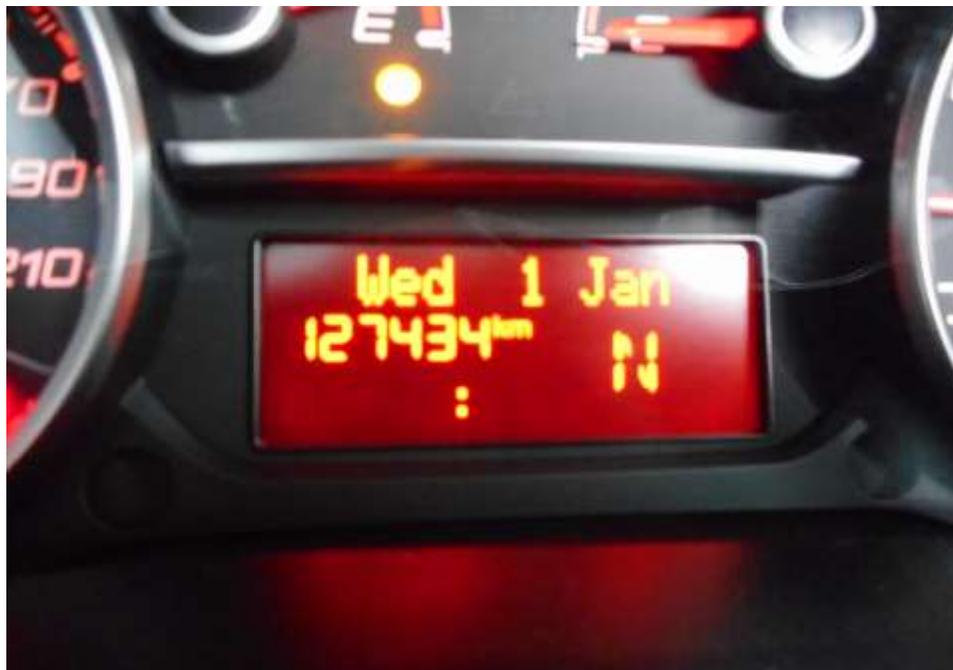
Photo 1 shows a general view of the instrument cluster of the Motor Van at the time of my inspection. The mileage of the Motor Van was 127,434km

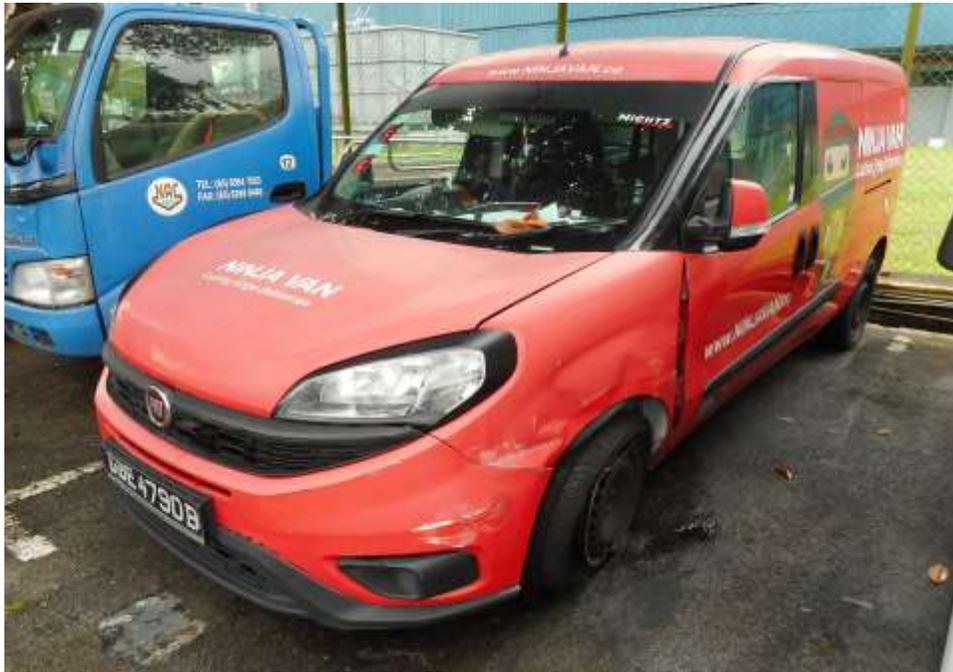
4. The mileage of the Motor Van at the time of my inspection was 127,434km.
5. The Motor Van appeared to have sustained moderate damage at its front portion. Its front bumper, left fender panel, front left wheel, its left steering tie rod, its left lower arm were damage and its front left wheel drive shaft was missing at the time of my inspection as a result of the accident.

Photo 2 shows a general view of the front left body of the Motor Van at the time of my inspection. The Motor Van was observed to have sustained moderate damage to its front bumper, left fender, and front left wheel at the time of my inspection.

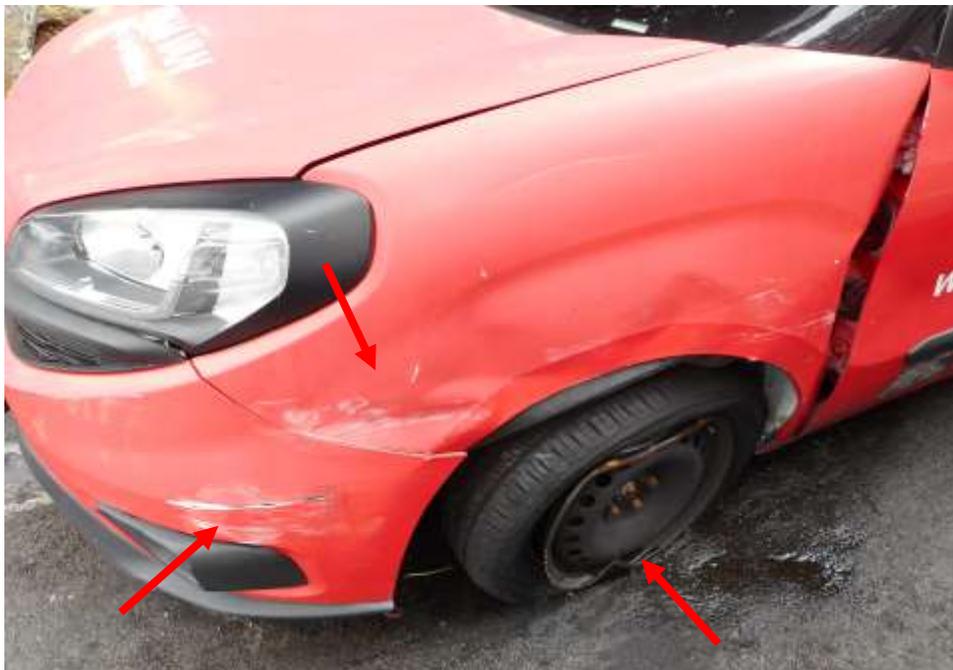
Photo 3 shows a close up view of the front left body of the Motor Van at the time of my inspection. The Motor Van was observed to have sustained moderate damage to its front bumper, left fender, and front left wheel (arrowed) at the time of my inspection.

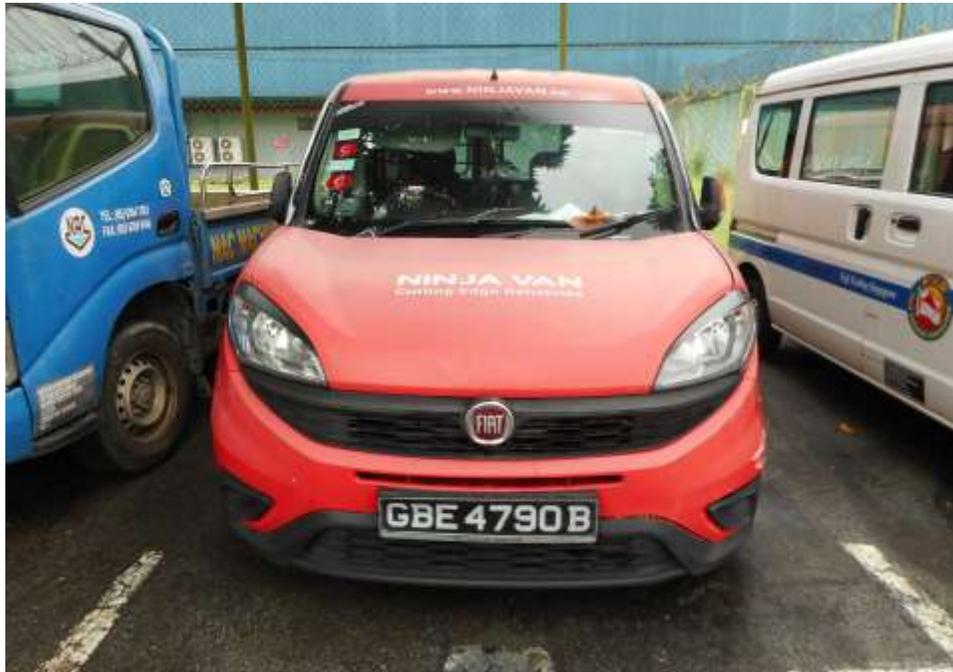
Photo 4 shows a general view of the front body of the Motor Van at the time of my inspection. The Motor Van was observed to be unaffected by the accident.

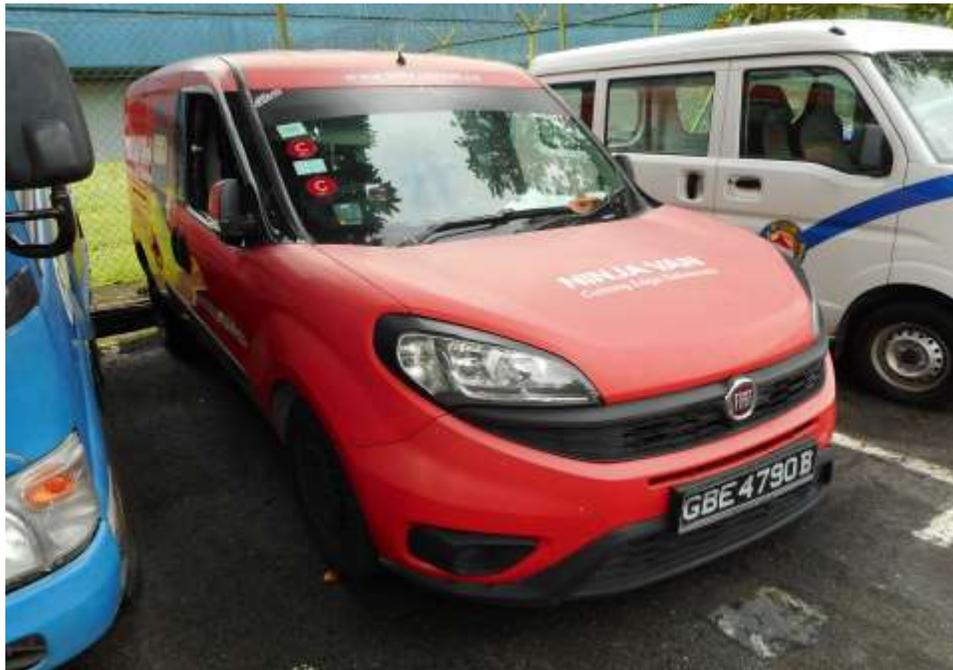
Photo 5 shows a general view of the front right body of the Motor Van at the time of my inspection. The Motor Van was observed to be unaffected by the accident.

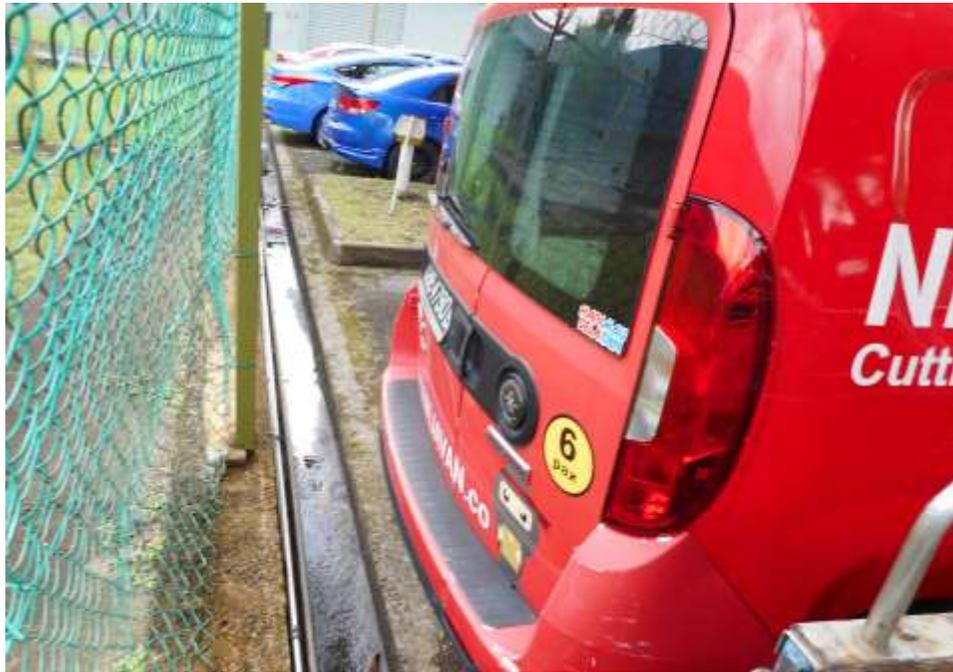
Photo 6 shows a general view of the rear body of the Motor Van at the time of my inspection. The Motor Van was observed to be unaffected by the accident.

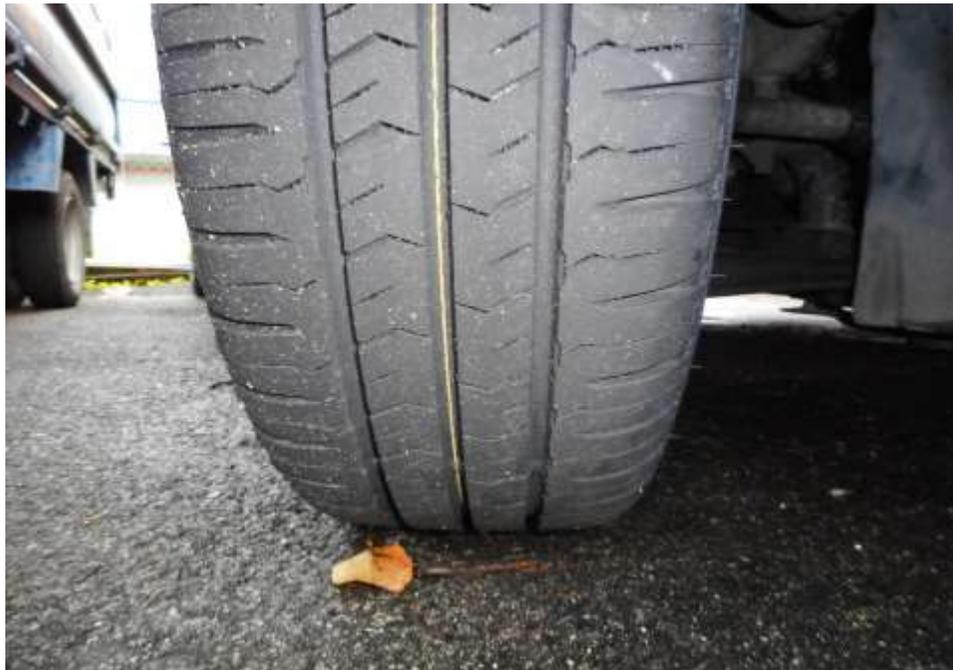
Photo 7 shows the condition of the front right tyre of the Motor Van, which was observed to be in serviceable condition with remaining tread depth of approximately 9mm. The tyre, which was wrapped around standard steel wheel rim, was also observed to be sufficiently inflated for vehicular operation. There was no tear, cut or burst mark(s) on the outer and the inner sidewalls as well as across the tread of the 4 tyres that were fitted on the Motor Van.

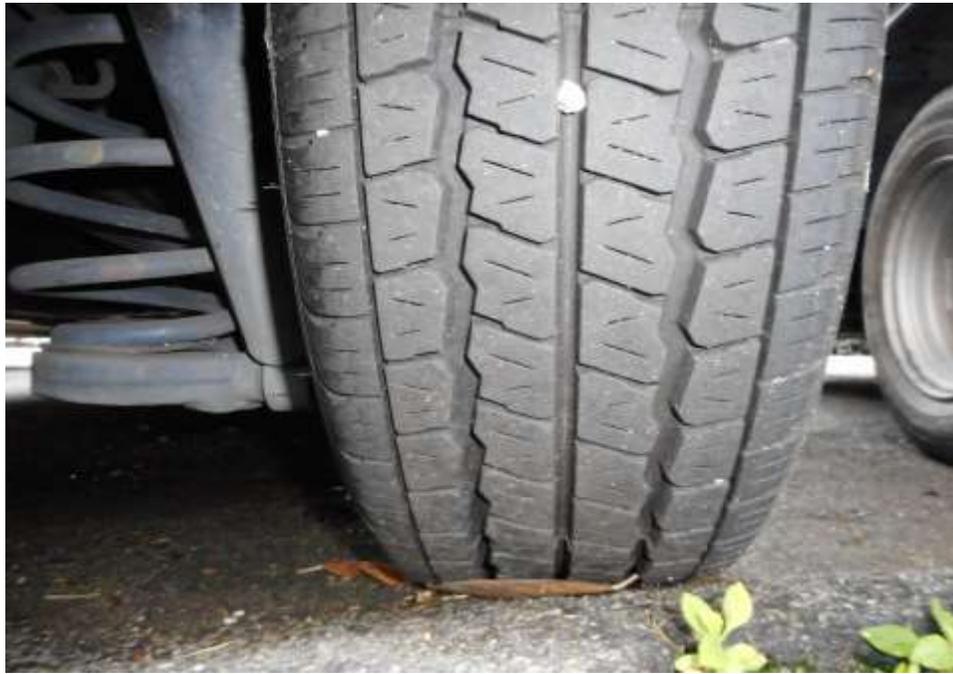
Photo 8 shows the condition of the rear right tyre of the Motor Van, which was observed to be in serviceable condition with remaining tread depth of approximately 8.7mm. The tyre, which was wrapped around standard steel wheel rim, was also observed to be sufficiently inflated for vehicular operation.

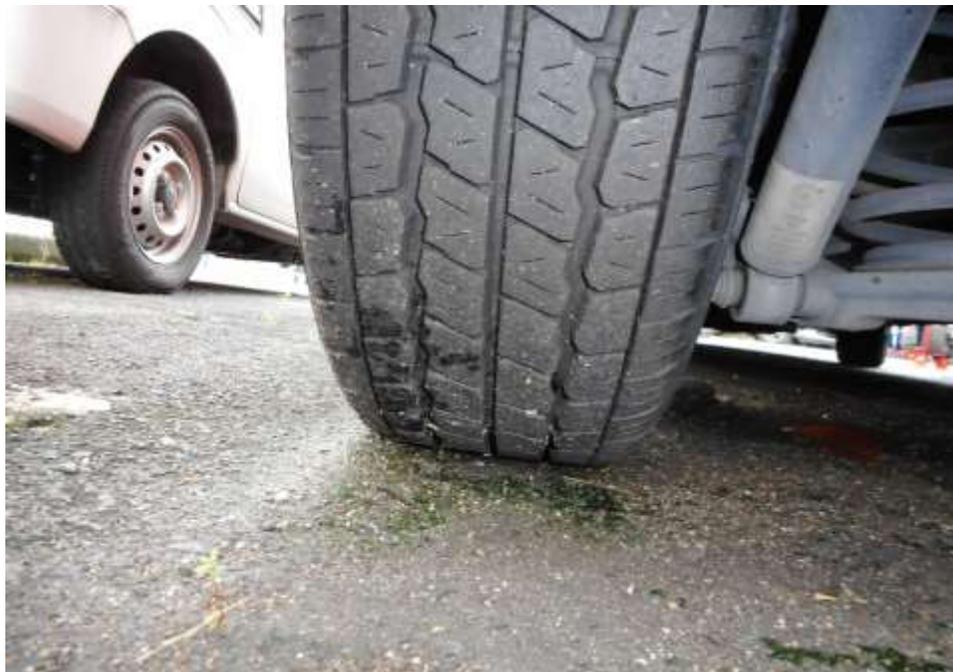
Photo 9 shows the condition of the rear left tyres of the Motor Van, which was observed to be in serviceable condition with remaining tread depth of approximately 8.7mm. The tyres, which were wrapped around standard steel wheel rim, were also observed to be sufficiently inflated for vehicular operation. There was also no damage found on all 4 steel wheel rims of the Motor Van.

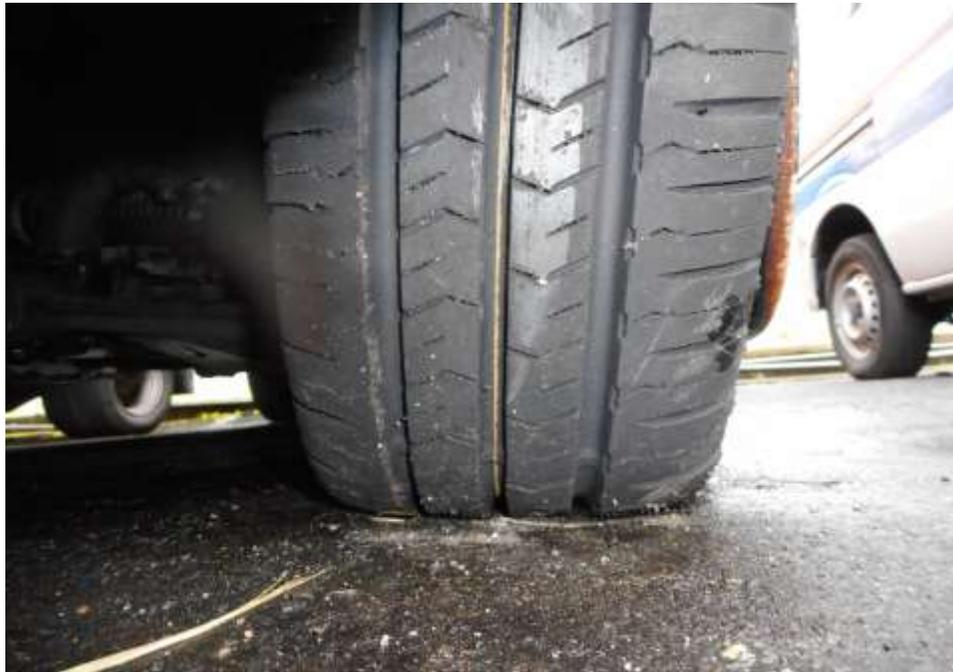
Photo 10 shows the condition of the front left tyres of the Motor Van, which were observed to be dislodged and deflated as a result of the accident with remaining tread depth of approximately 8.8mm. There was also no tear, cut or burst mark(s) on the outer and the inner sidewalls.

16. The front left tyre was observed to be dislodged from the rim and deflated and the other 3 tyres of the Motor Van was observed to be in serviceable condition and sufficiently inflated for vehicular operation. However I did not find any tear cut or burst mark(s) on the outer and the inner sidewalls as well as across the tread of the 4 tyres with remaining tread depth of approximately 8.7mm – 9mm.
17. Based on our observation, the front light tyre was deflated due to impact as there was no cut or burst mark(s) on the tyre that could have resulted in any sudden deflation (burst) for the driver to lose control of the Motor Van. Furthermore, the front left wheel rim was also found to be dented, a sign of an impact

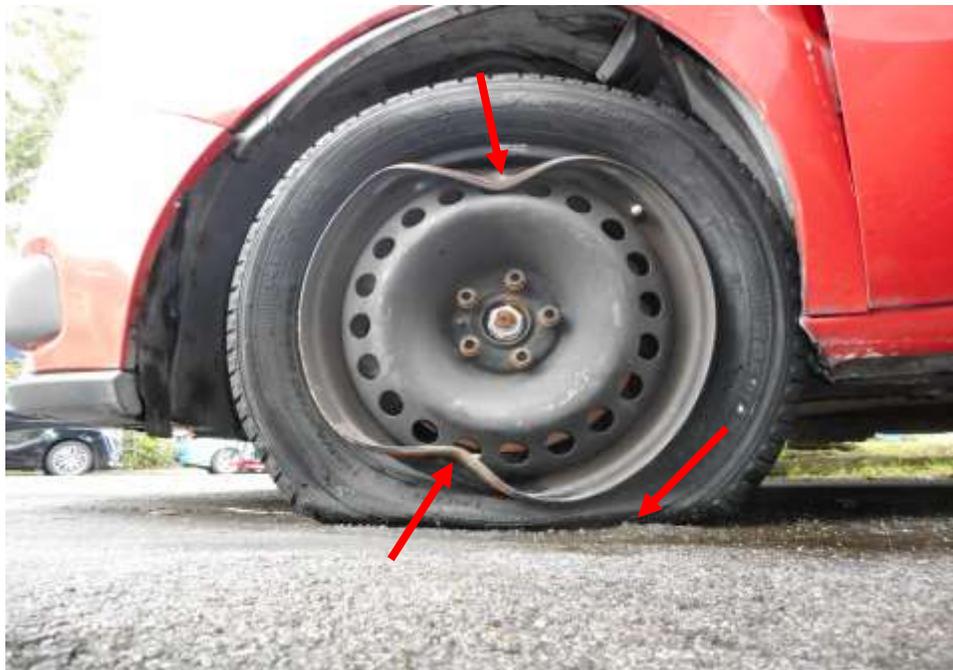
Photo 11 shows the close up view of the condition of the front left tyres and rims of the Motor Van, which were observed to be dislodged, deflated and its rims dented (arrowed) as a result of the accident.

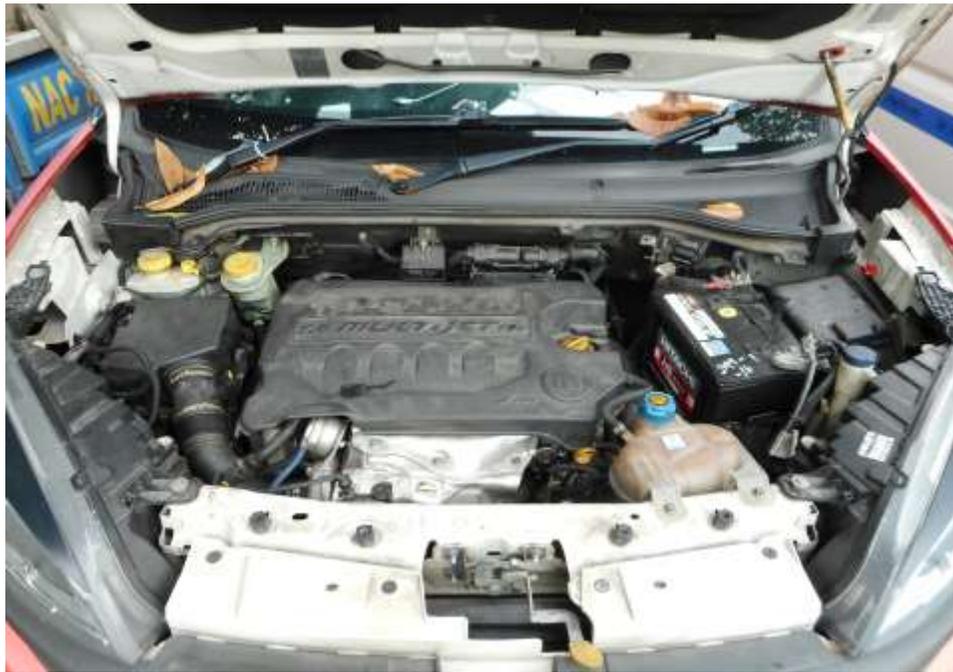
Photo 12 shows a general view of the Motor Van's engine compartment, which was accessed by lifting the front cabin of the Motor Van. The various parts and components inside the engine compartment were unaffected by the accident. There was also no sign(s) or indication(s) of fresh fluid leakage and/or fluid stain within the engine compartment.

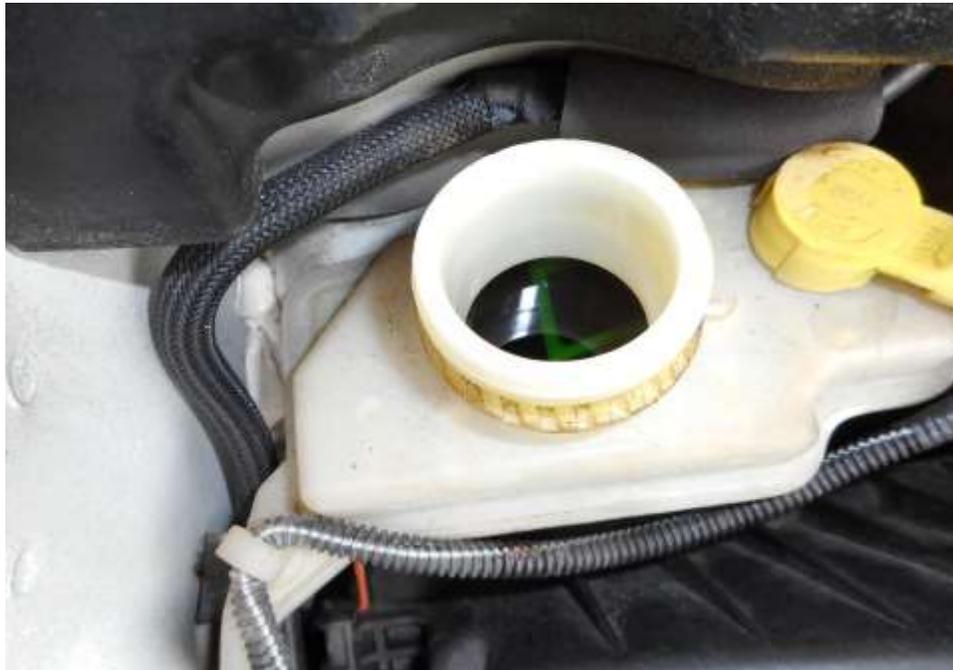
Photo 13 shows the brake fluid reservoir of the Motor Van at the time of my inspection. The brake fluid was observed to be of sufficient level (arrowed) and without any visible contamination.

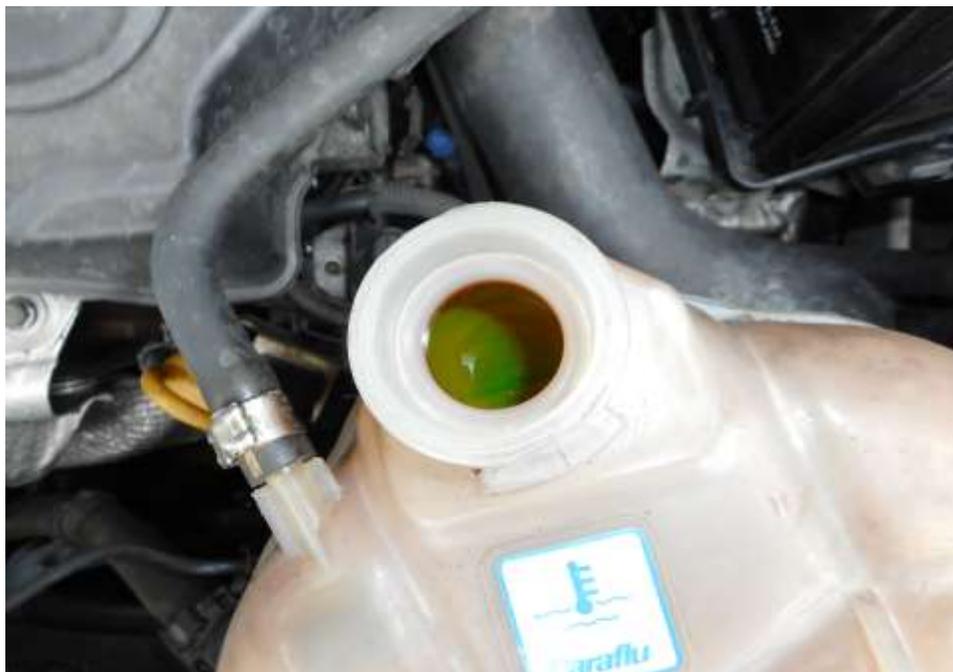
Photo 14 shows the engine coolant reservoir of the Motor Van at the time of my inspection. The engine coolant was observed to be of sufficient level and without any visible contamination.

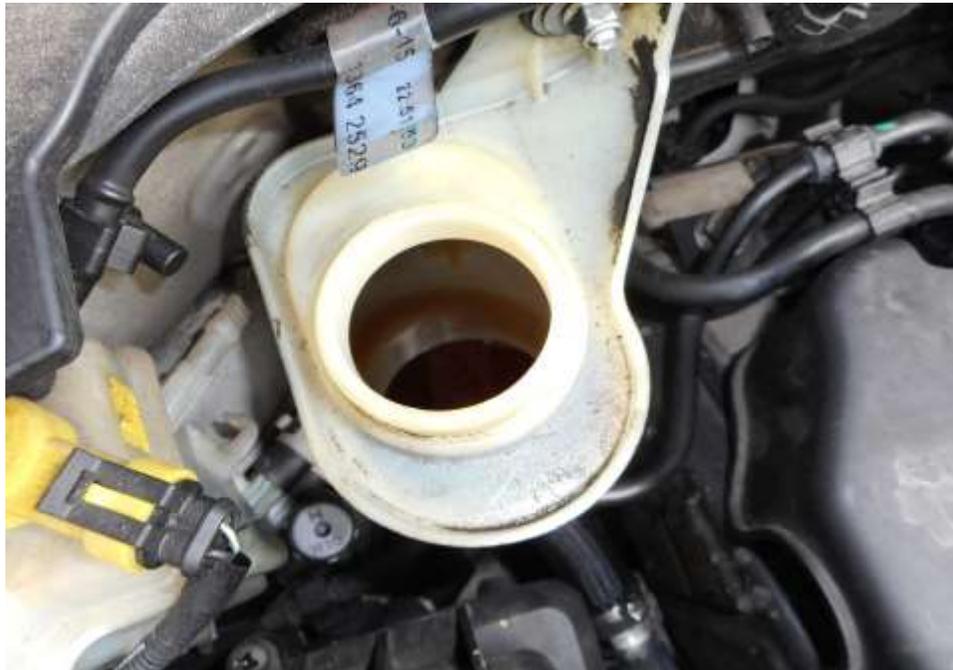
Photo 15 shows the power steering fluid reservoir of the Motor Van at the time of my inspection. The power steering fluid was observed to be of sufficient level (arrowed) and without any visible contamination.

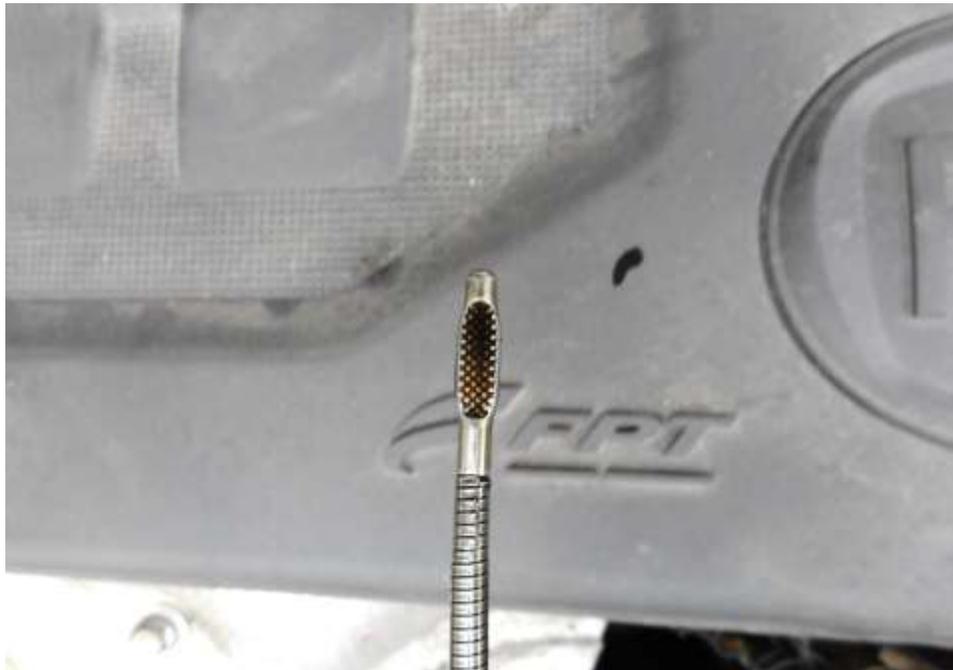
Photo 16 shows the engine dip stick of the Motor Van at the time of my inspection. The engine oil was observed to be of sufficient level and without any visible contamination.

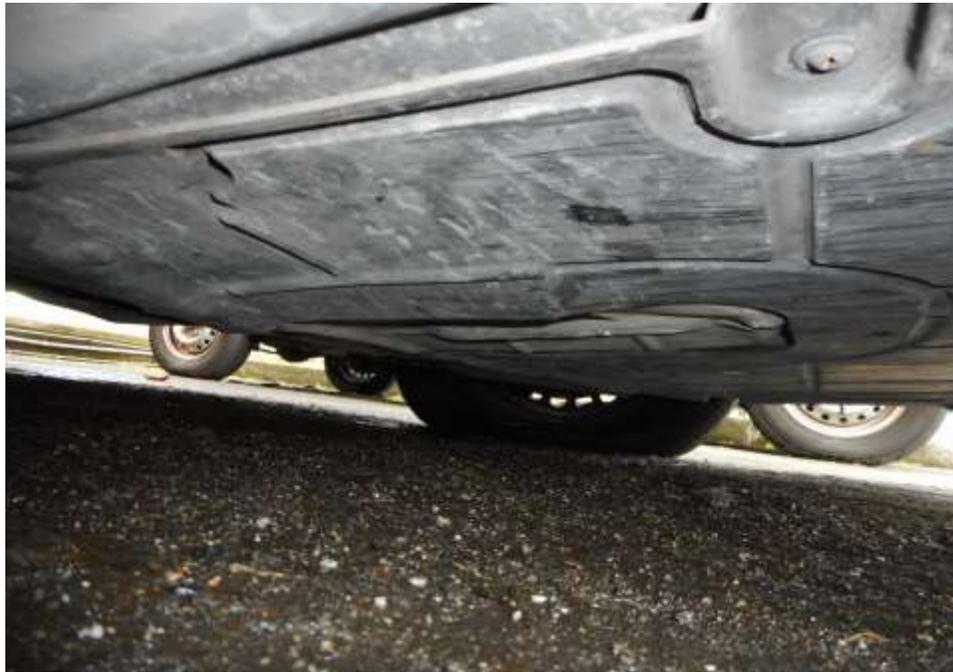
Photo 17 shows the undercarriage of the Motor Van, at the area where the engine housing and transmission housing are located. I did not find any sign(s) or indication(s) of fluid leak and/or fluid stain(s) on the underside of the Motor Van.

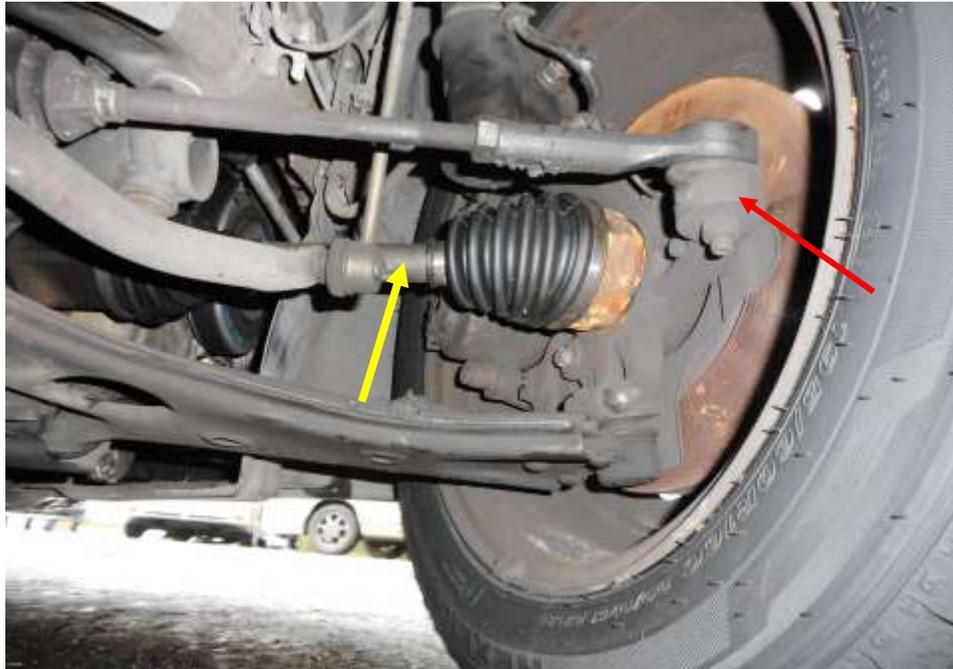
Photo 18 shows the various undercarriage components at the front right wheel of the Motor Van, in particular the steering tie rod end (arrowed) and drive shaft (yellow arrow). The various steering components were all found to be intact the various steering components were all found to be intact. There was also no sign of fluid stain(s) observed on the various undercarriage components.

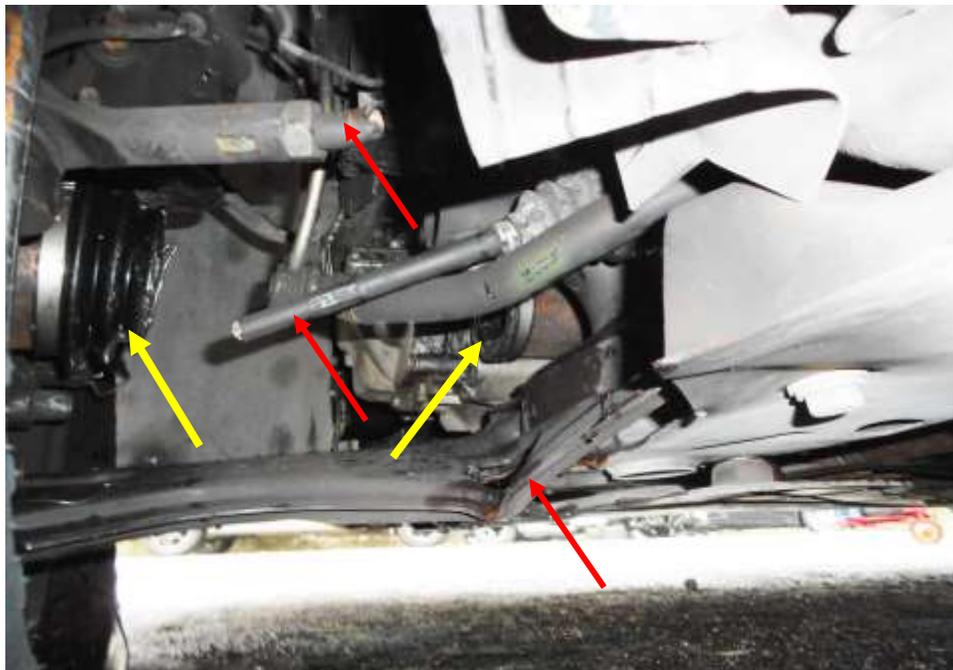
Photo 19 shows the various undercarriage components at the front left wheel of the Motor Van in particular the steering tie rod and the lower arm (red arrow) and drive shaft (yellow arrow) was observed to be damaged and missing as a result of the accident.

14. Operational test to primarily determine whether there was any abnormality to the engine system, transmission system and braking system of the Motor Van could not be conducted given the extent of damage that it had sustained (undercarriage components such as the steering tie rod and drive shaft affected).

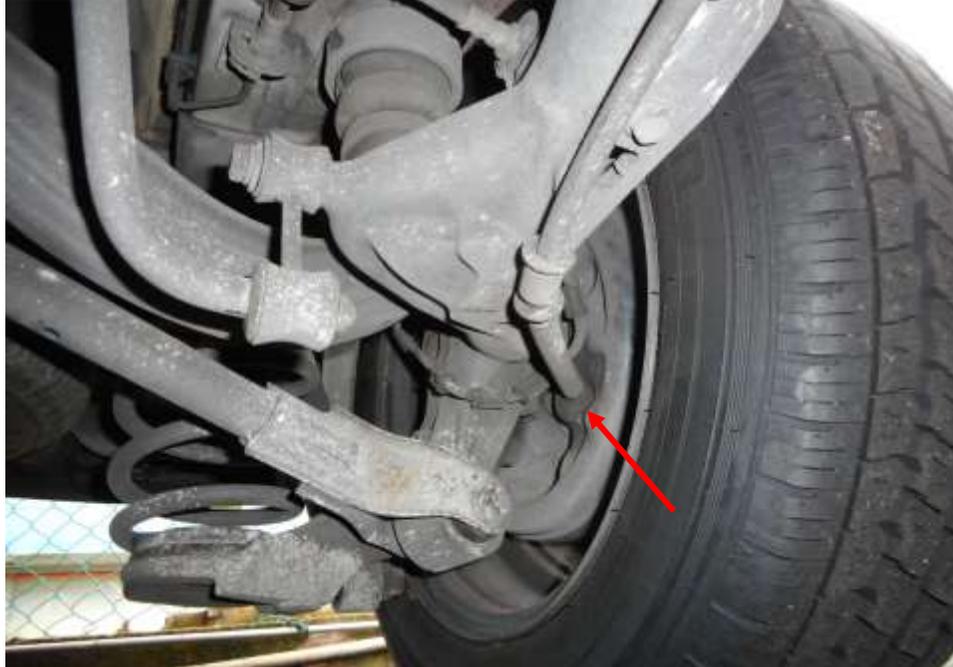
Photo 20 shows the brake pipe (arrowed) at the rear left wheel of the Motor Van. I did not observe any leakage of brake fluid at the time of my inspection of the Motor Van. My static tests of the Motor Van's braking system, along with my visual examination of the various mechanical components in the braking system, had indicated that there was no internal leakage of pressure/vacuum. Hence the braking system of the Motor Van was likely to be in serviceable condition at the material time of accident.

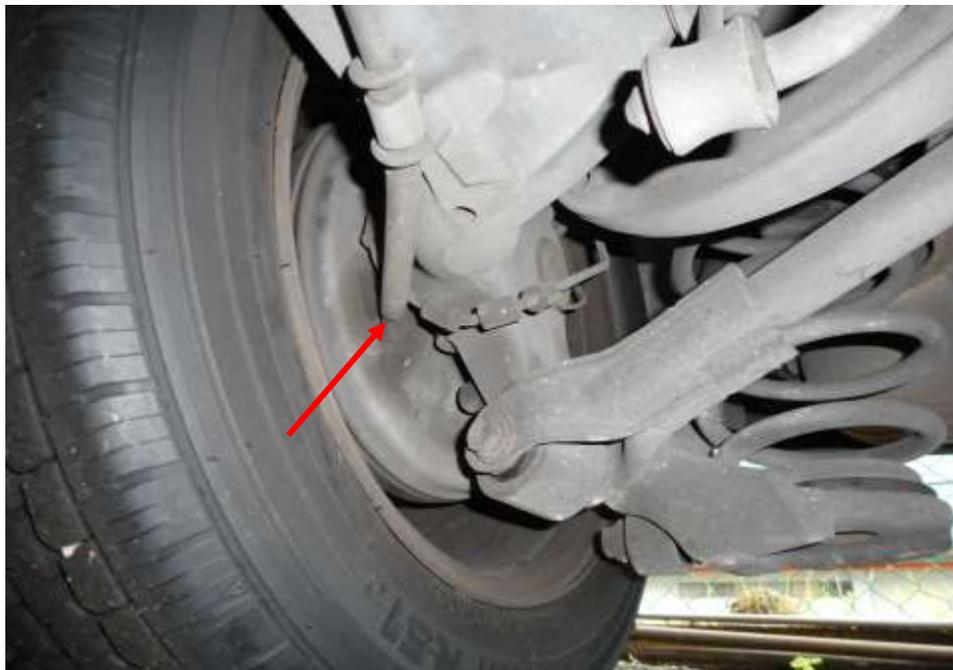
Photo 21 shows the brake pipe (arrowed) at the rear right wheel of the Motor Van. I did not observe any leakage of brake fluid at the time of my inspection of the Motor Van. My static tests of the Motor Van's braking system, along with my visual examination of the various mechanical components in the braking system had indicated that there was no internal leakage of pressure/vacuum. Hence the braking system of the Motor Van was likely to be in serviceable condition at the material time of accident.

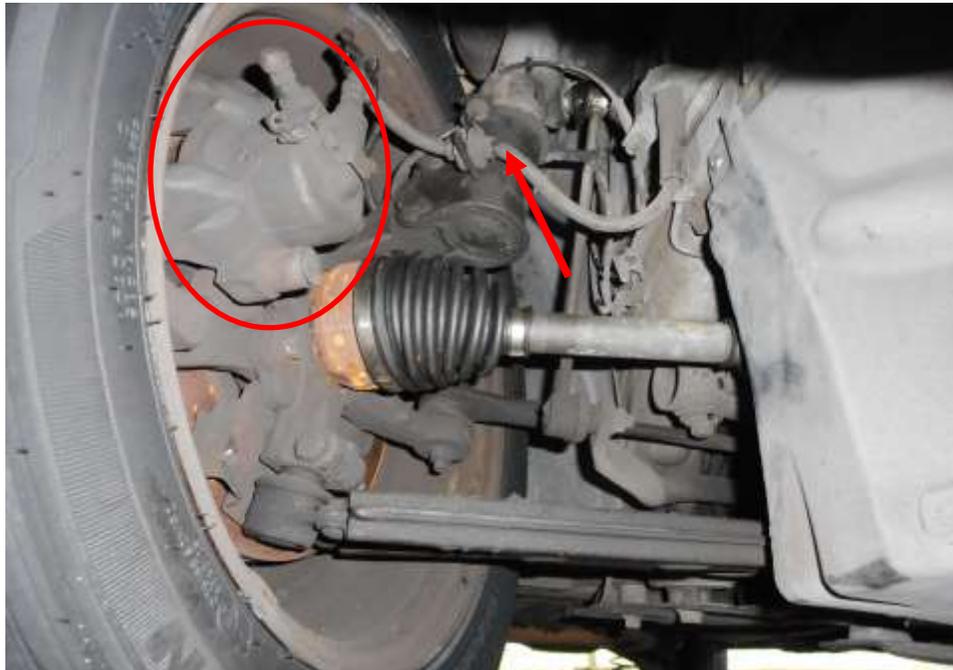
Photo 22 shows the brake hose/pipe (arrowed) at the front right wheel of the Motor Van. No leakage of brake fluid was observed. Visual examination of the various components of the braking system like the brake caliper (circled), brake booster, brake pedal etc had revealed all to be intact and without visible damage at the time of accident. There was also no sign of fluid stain(s) observed on the various undercarriage components.

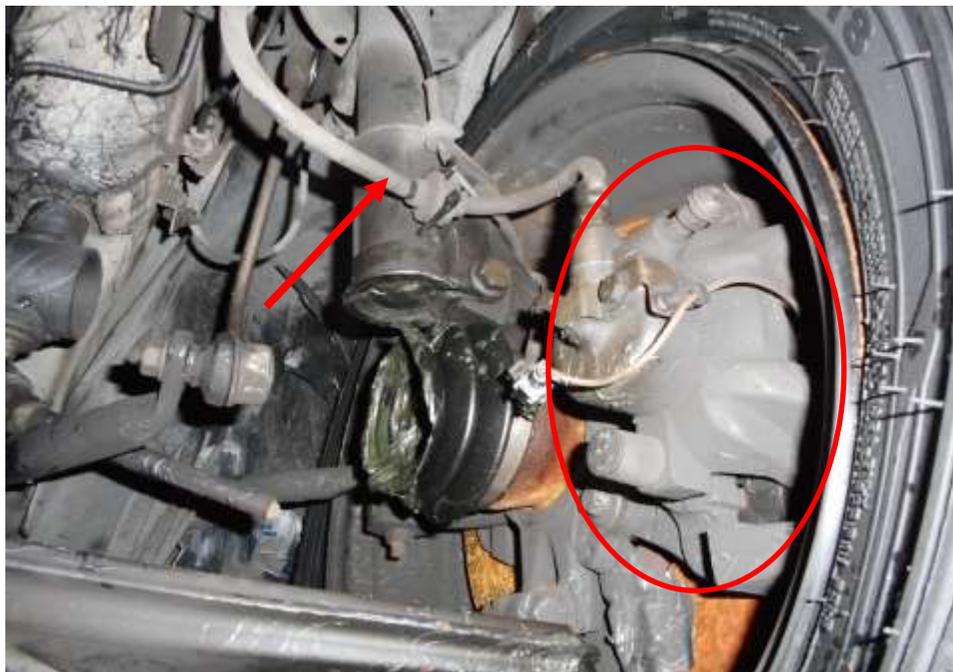
Photo 23 shows the brake hose/pipe (arrowed) at the front left wheel of the Motor Van. No leakage of brake fluid was observed. Visual examination of the various components of the braking system like the brake caliper (circled), brake booster, brake pedal etc had revealed all to be intact and without visible damage at the time of accident. There was also no sign of fluid stain(s) observed on the various undercarriage components.

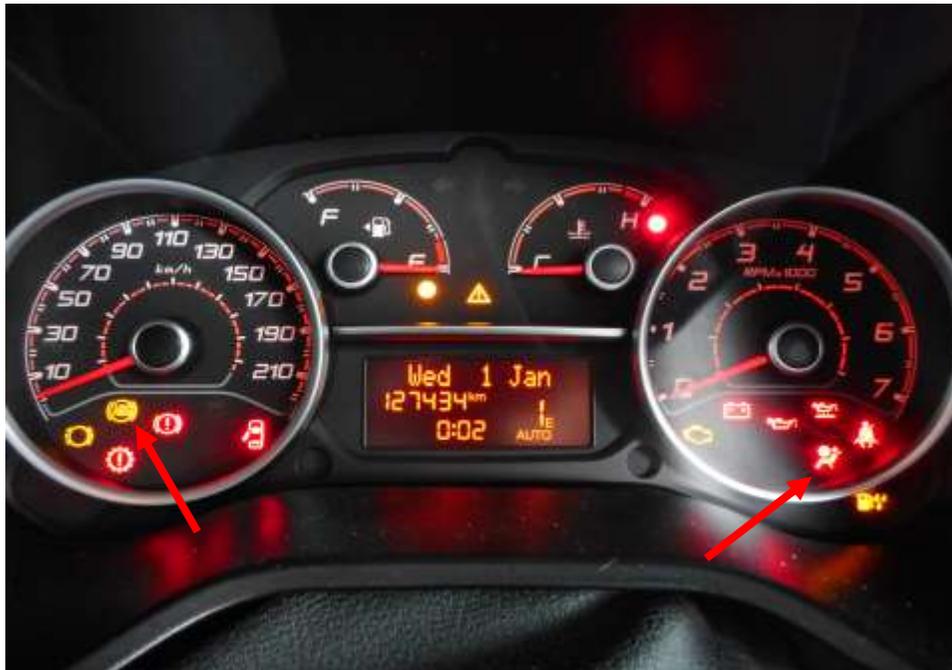
Photo 24 shows the warning light for Anti-Lock Brake System (ABS) and Supplemental Restraint System (SRS) appearing on the instrument panel of the Motor Van during the self-test of its various electronic operating systems when its engine was cranked.

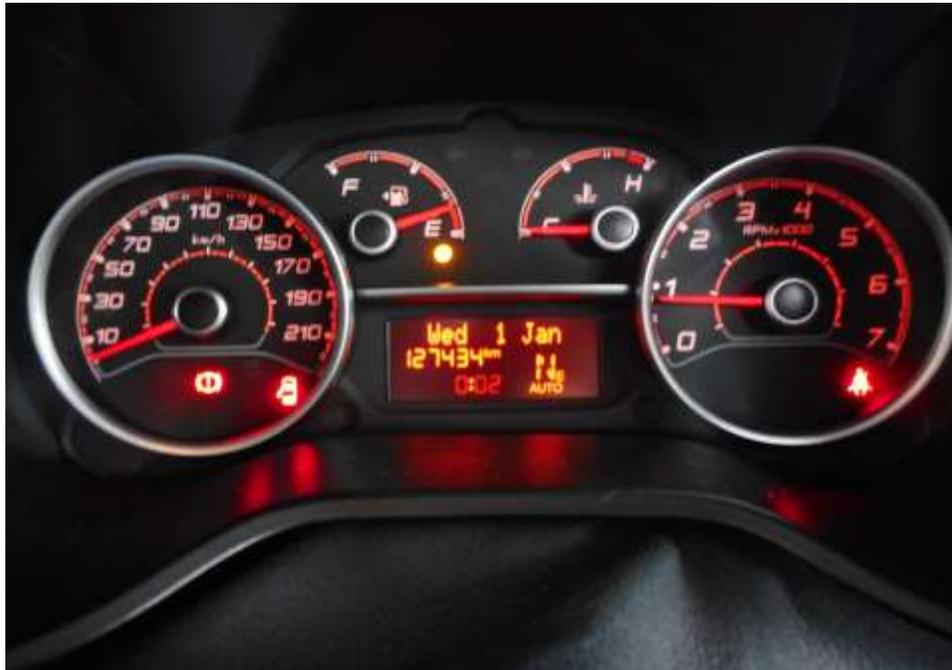
Photo 25 shows no warning lights illuminated on the instrument panel of the Motor Van after the engine was cranked. This would suggest that there was no abnormality to the various electronic operating systems of the Motor Van, like the ABS and SRS.
