Your Ref: TP/IP/28545/2019  
Our Ref : CI/TPD19011292/P

11<sup>th</sup> July 2019

**MECHANICAL INSPECTION REPORT OF MOTOR CAR SJW 3449E**

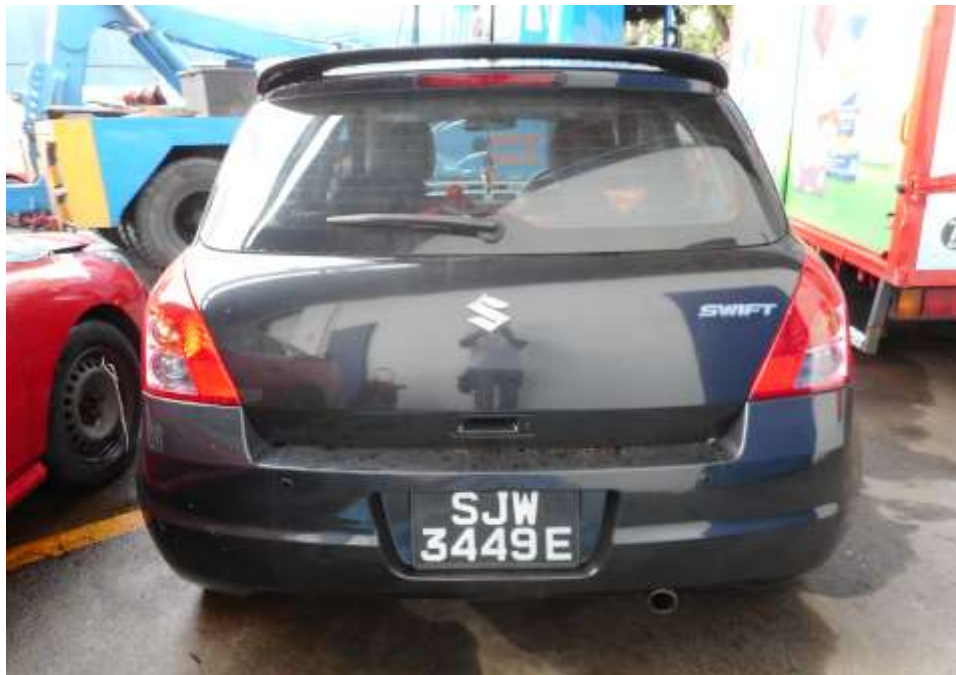
**Photo 1** shows a general view of the Motor Car's rear body at the time of my inspection. The rear portion of the Motor Car was observed to have been unaffected by the accident.

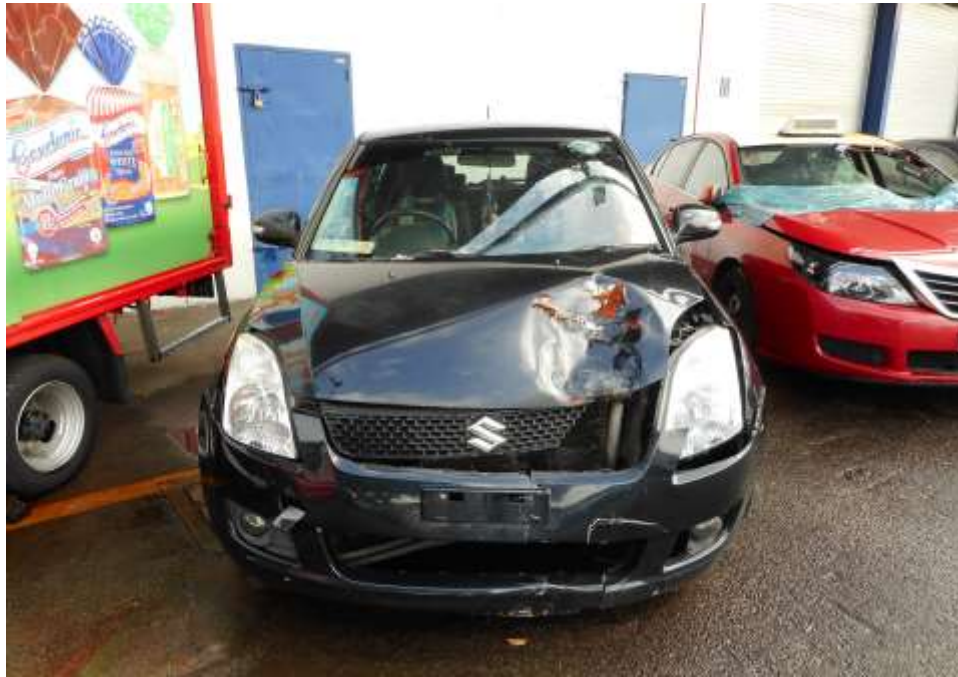
4. The mileage of the Motor car at the time of my inspection was not recorded due to the damage to the battery and engine system as a result of the accident.
5. The Motor car was observed to have sustained moderate damage at its front portion. Its front windscreen, front bonnet, bonnet locking mechanism, front bumper, front number plate, front reinforcement and radiator was amongst the body parts that were damaged as a result of the accident.

**Photo 2** shows a general view of the Motor Car's front body at the time of my inspection. The Motor car was observed to have sustained moderate damage at its front portion. Its front windscreen, front bonnet, bonnet lock mechanism, front bumper, front number plate, front reinforcement and radiator was amongst the body parts that were damaged as a result of the accident.

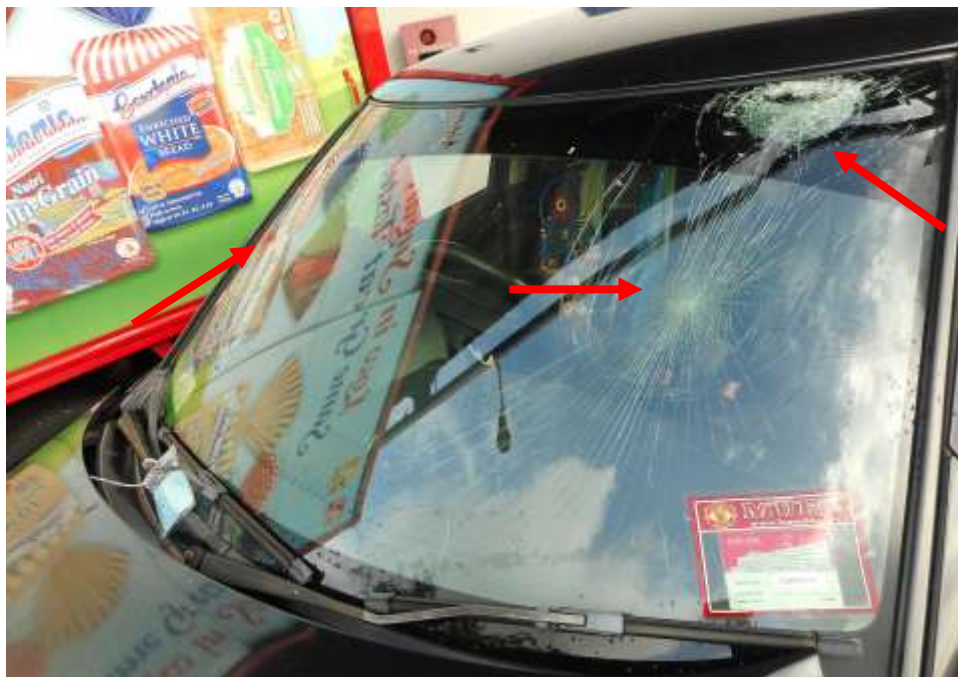
**Photo 3** shows the close up view of the Motor Car's front body at the time of my inspection. The Motor car was observed to have sustained damage its front windscreen (arrowed) as a result of the accident.

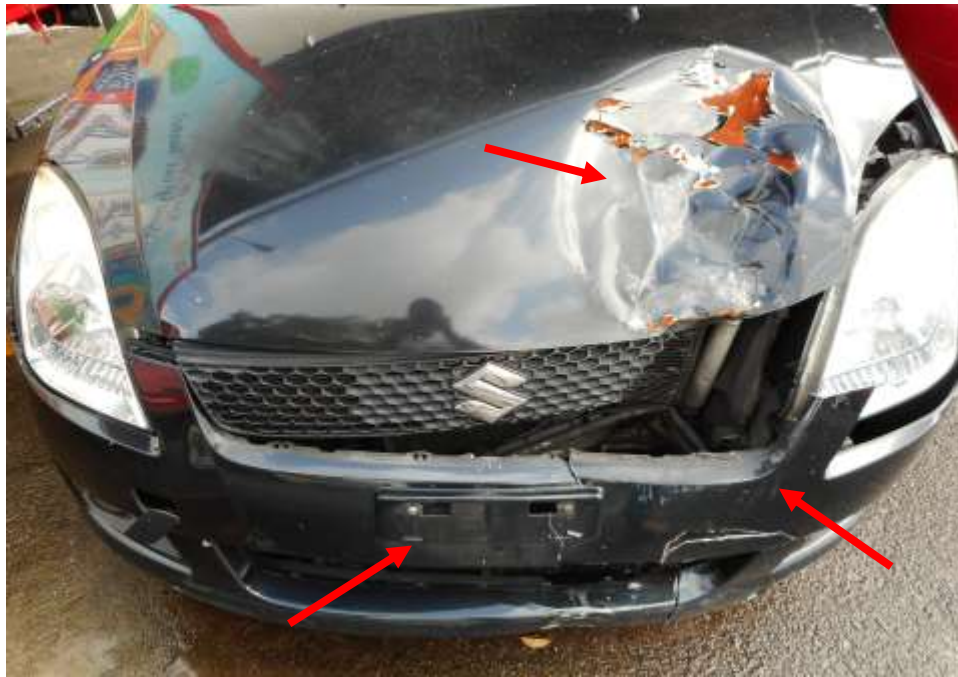
**Photo 4** shows the close up view of the Motor Car's front body at the time of my inspection. The Motor car was observed to have sustained damage, its front bonnet, front bumper; front number plate (arrowed) was amongst the body parts that were damaged as a result of the accident.

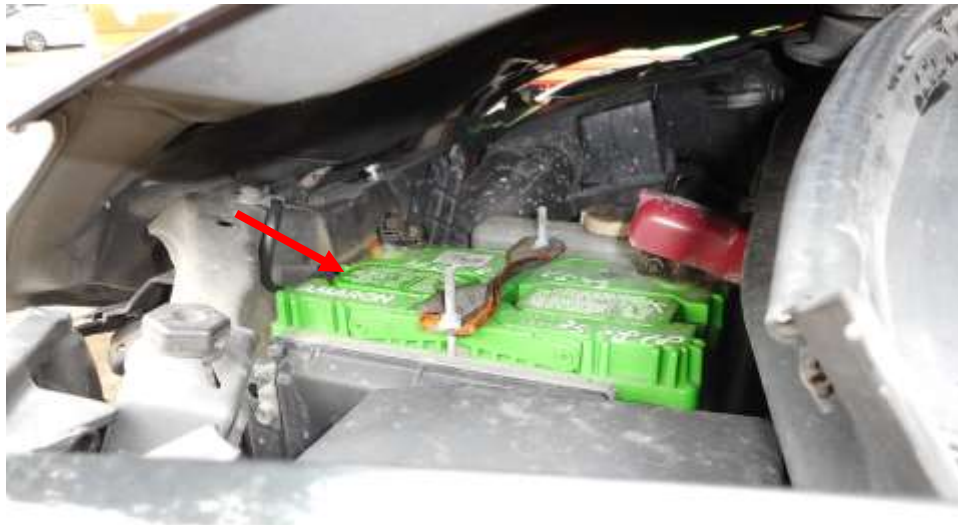
**Photo 5** shows a close up view of the front portion of the Motor Car at the time of my inspection. The battery (arrowed) of the Motor Car was observed to have been damaged as a result of the induced impact as a result of the accident

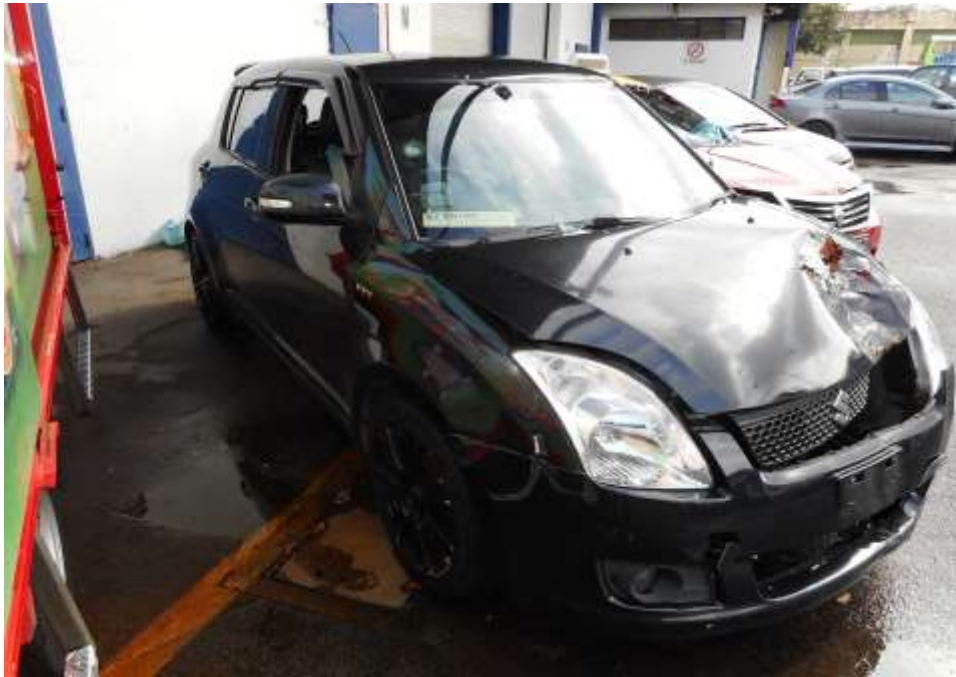
**Photo 6** shows a general view of the Motor Car's right body at the time of my inspection. The right portion of the Motor Car was observed to have been unaffected by the accident.

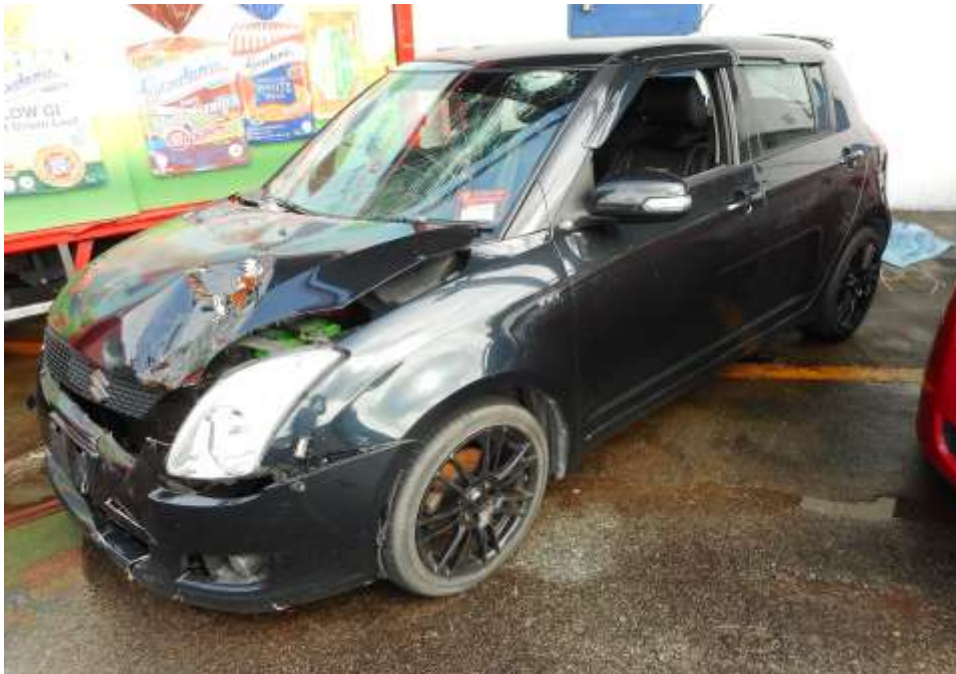
**Photo 7** shows a general view of the Motor Car's left body at the time of my inspection. The left portion of the Motor Car was observed to have been unaffected by the accident.

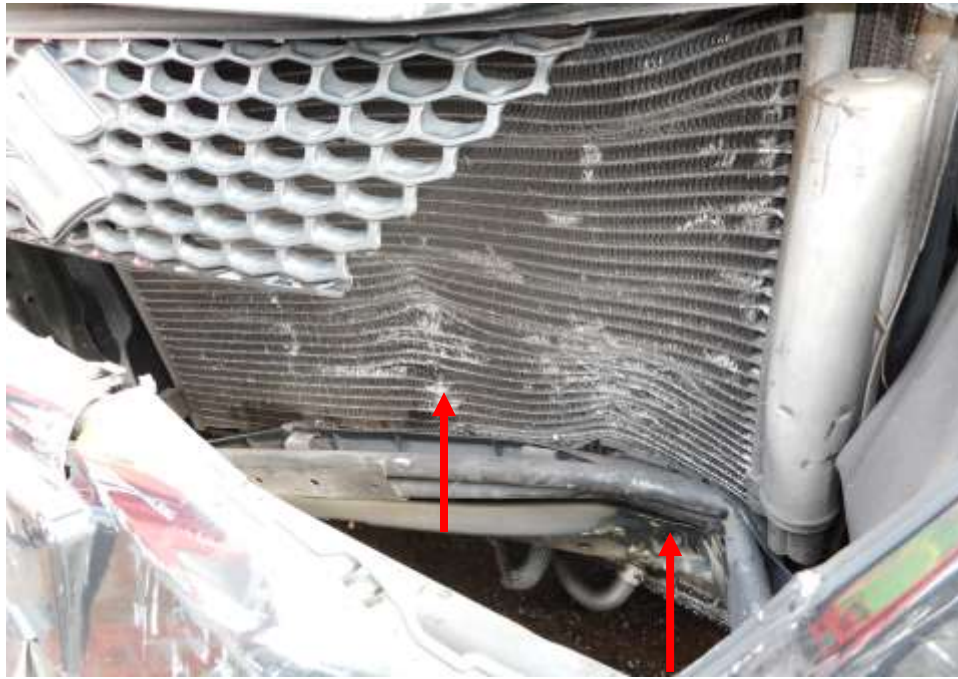
**Photo 8** shows a close up view of the front portion of the Motor Car at the time of my inspection. The radiator and the front reinforcement (arrowed) of the Motor Car was observed to have been damaged by an induced impact as a result of the accident

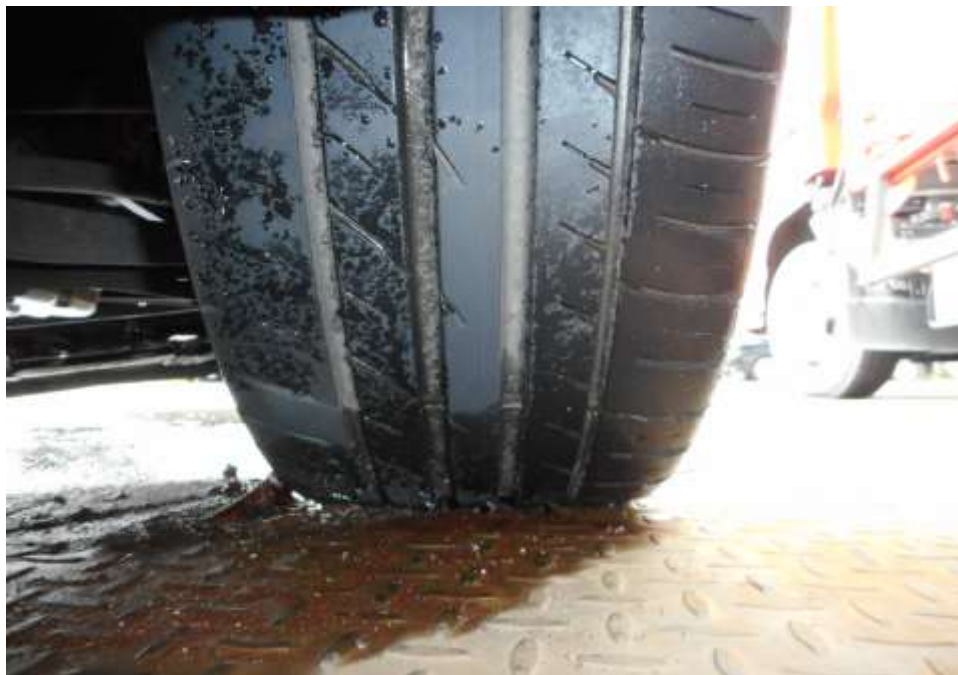
**Photo 9** shows the condition of the front right tyre of the Motor Car, which was observed to be in serviceable condition with remaining tread depth of approximately 4.9mm. The tyre was sufficiently inflated for vehicular operation with no tear, cut or burst mark(s) on the outer and the inner sidewalls as well as across the tread. The 4 tyres of the Motor Car were wrapped around standard alloy wheel rims without any damage.

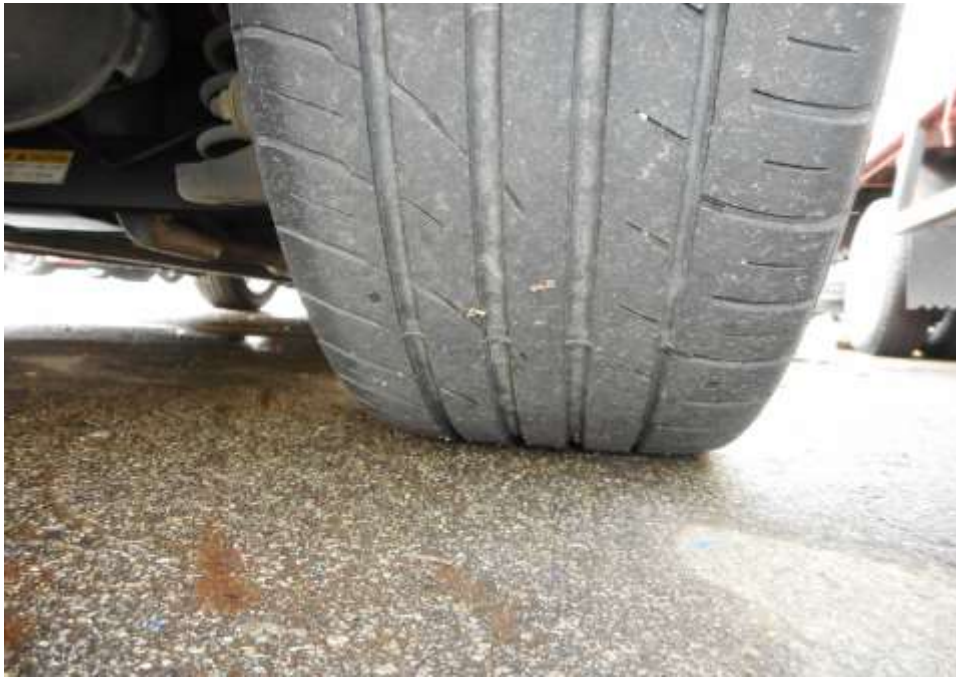
**Photo 10** shows the condition of the rear right tyre of the Motor Car, which was observed to be in serviceable condition with remaining tread depth of approximately 5.2mm. The tyre was also observed to be sufficiently inflated for vehicular operation with no tear, cut or burst mark(s).

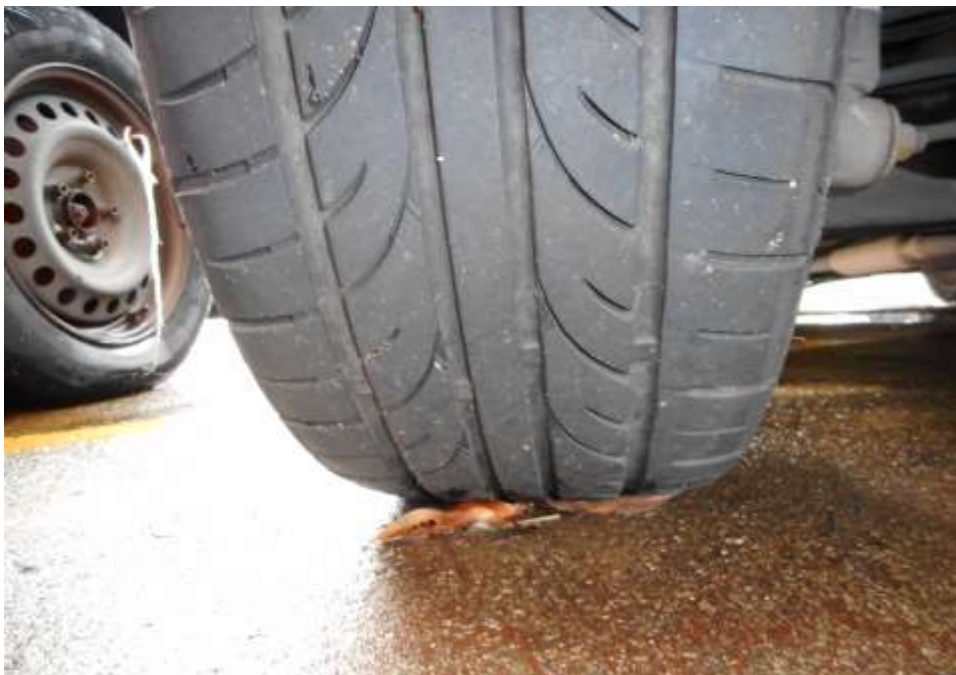
**Photo 11** shows the condition of the rear left tyre of the Motor Car, which was observed to be in serviceable condition with remaining tread depth of approximately 4.8mm. The tyre, which was wrapped around alloy wheel rim, was also observed to be sufficiently inflated for vehicular operation. The 4 tyres of the Motor Car were wrapped around standard alloy wheel rims.

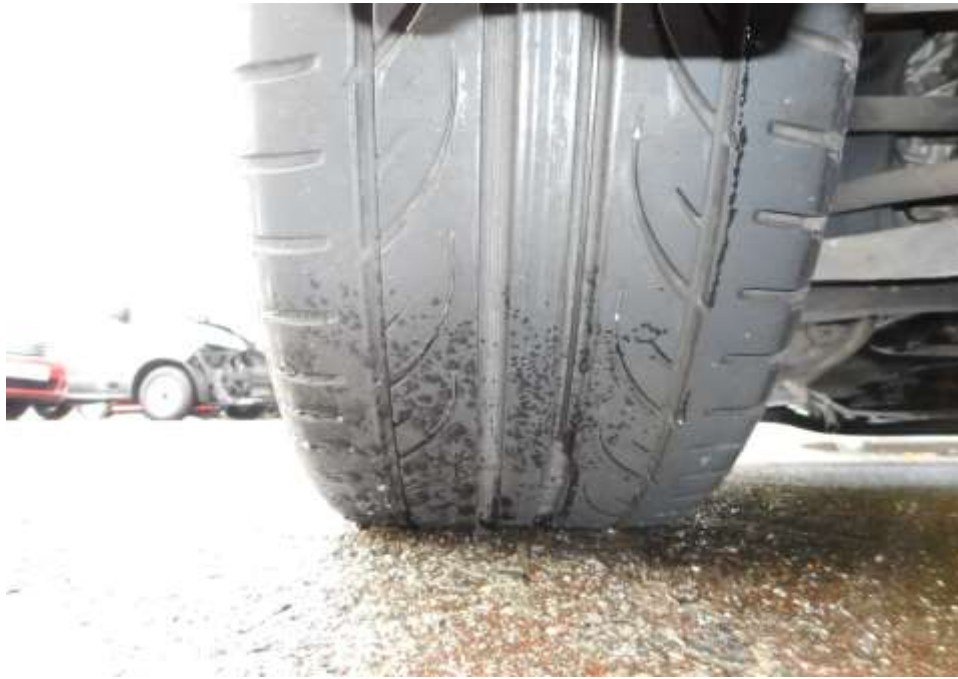
**Photo 12** shows the condition of the front left tyre of the Motor Car, which was observed to be in serviceable condition with remaining tread depth of approximately 4.5mm. There was also no tear, cut or burst mark(s) on the outer and the inner sidewalls as well as across the tread of the Motor Car's 4 tyres.

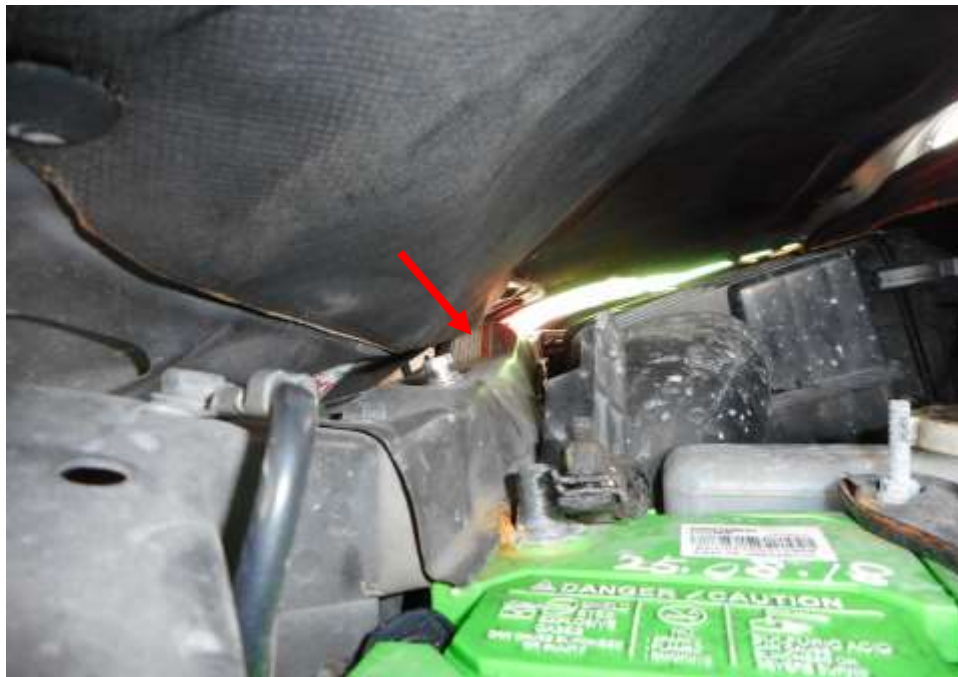
8. The impact from the collision had affected the engine compartment of the Motor Car. Parts towards the front of the engine compartment were observed to be damaged. The bonnet locking mechanism of the Motor Car's front bonnet was affected and I was unable to unlock and lift the front bonnet to carry out examination of the Motor Car's engine compartment. The various operating fluids like its engine coolant, brake fluid and transmission fluid etc were hence unable to be inspected. See photo 13 below.

**Photo 13** shows the damage to the locking mechanism (arrowed) Motor Car's front bonnet, rendering it unable to be unlocked and lifted up to carry out examination of the Motor Car's engine compartment as a result of the accident.

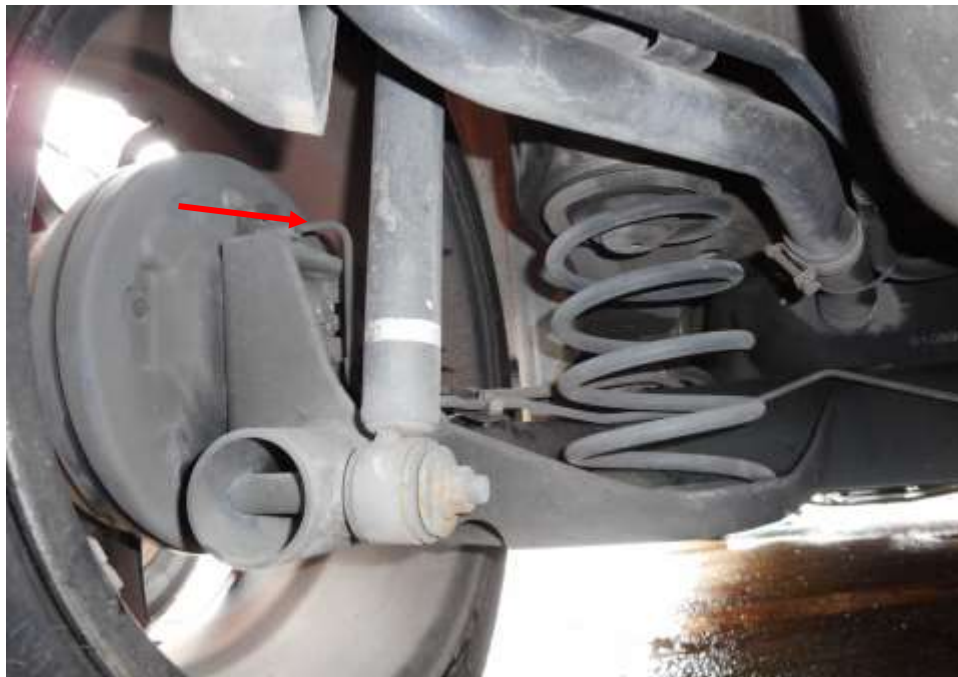
**Photo 14** shows the brake hose/pipe (arrowed) at the rear left wheel of the Motor Car. I did not observe any leakage of brake fluid at the time of my inspection of the Motor Car. Static tests of the Motor Car's braking system had indicated that there was no internal leakage of pressure/vacuum. The undercarriage components of the Motor Car were also all found to be intact and without any visible damage.

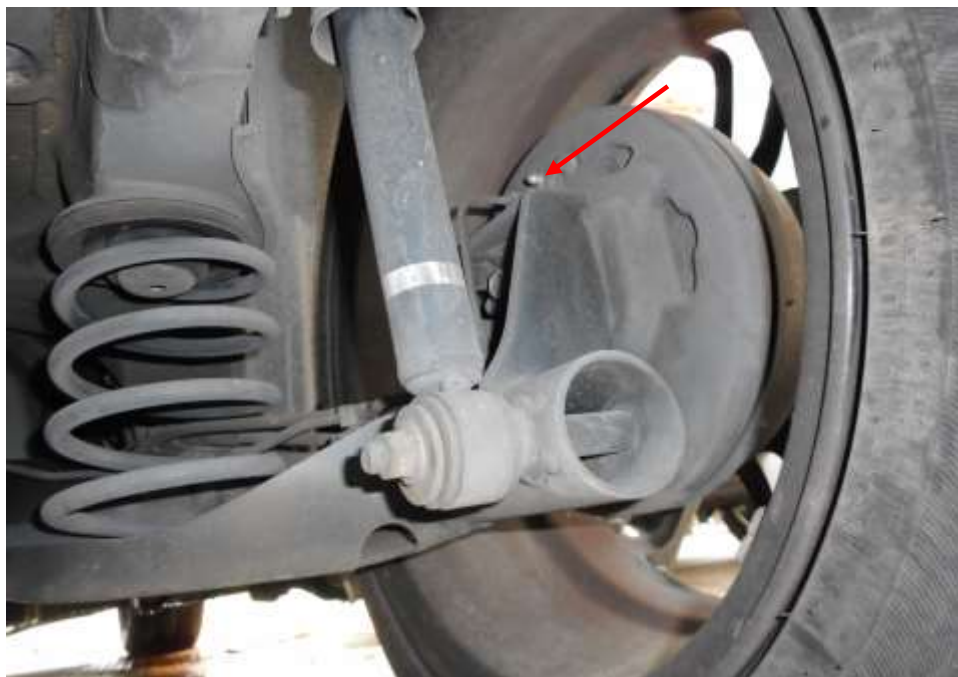
**Photo 15** shows the brake hose/pipe (arrowed) at the rear right wheel of the Motor Car. No leakage of brake fluid was observed. Visual examination of the various components of the braking system like the drum brake, brake booster, brake pedal etc had revealed all to be intact and without visible damage.

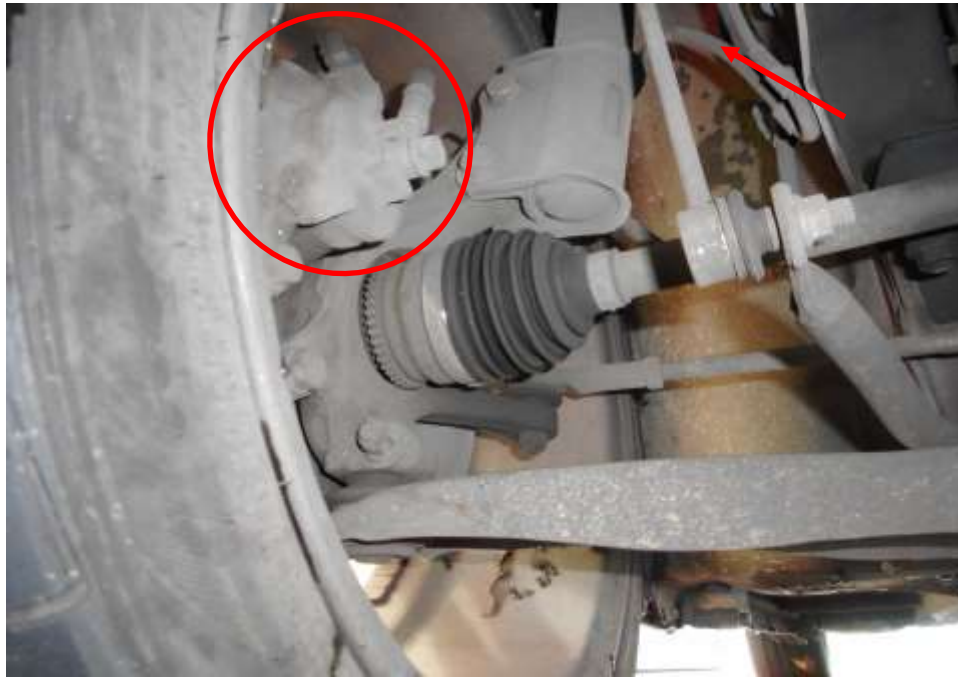
**Photo 16** shows the brake hose/pipe (arrowed) at the front right wheel of the Motor Car. No leakage of brake fluid was observed. Visual examination of the various components of the braking system like the brake caliper (circled), brake booster, brake pedal etc had revealed all to be intact and without visible damage.

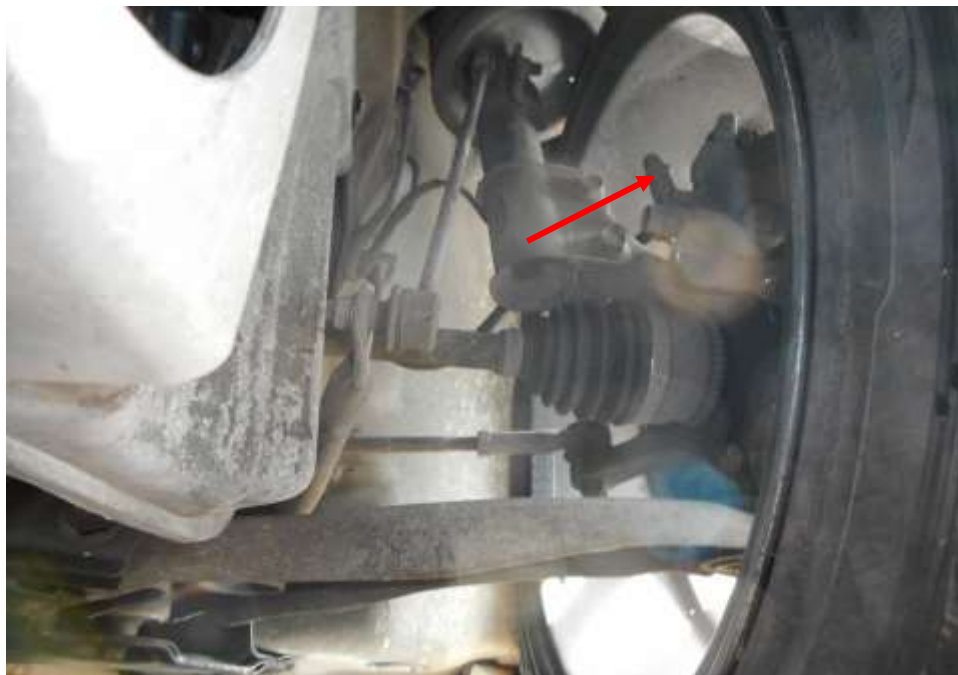
**Photo 17** shows the brake hose/pipe (arrowed) at the front left wheel of the Motor Car. I did not observe any leakage of brake fluid at the time of my inspection of the Motor Car. Static tests of the Motor Car's braking system had indicated that there was no internal leakage of pressure/vacuum. The undercarriage components of the Motor Car were also all found to be intact and without any visible damage.

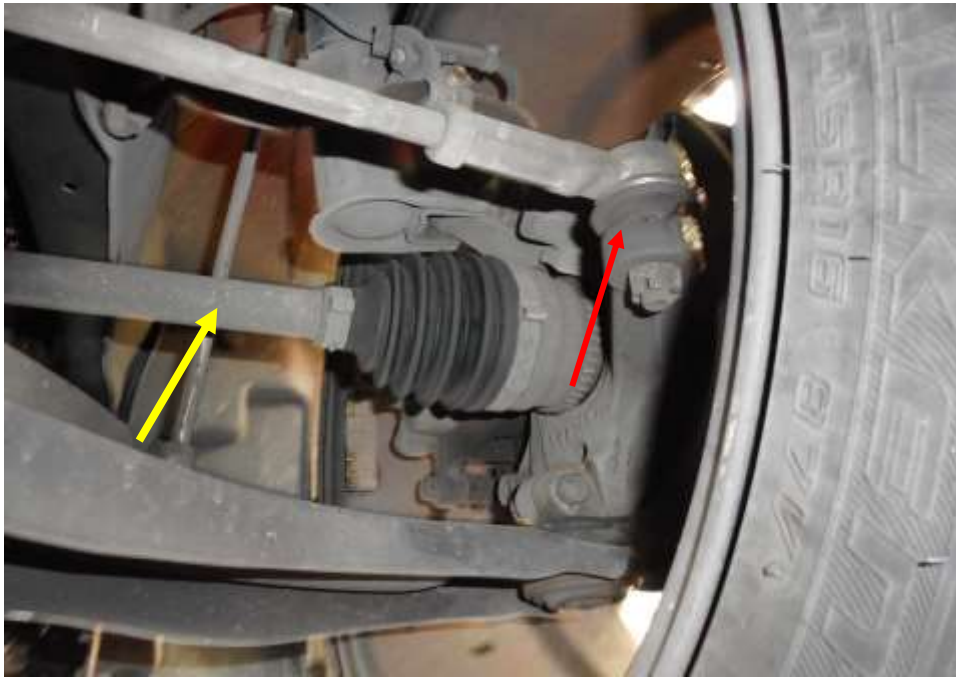
**Photo 18** shows the various undercarriage components at the front right wheel of the Motor Car, in particular the steering tie rod (red arrow) and drive shaft (yellow arrow). The various steering components were all found to be intact, suggesting that the steering system of the Motor Car was likely to be in serviceable condition at the material time of accident. There was also no sign of fluid stain observed on the various undercarriage components at the front right wheel of the Motor Car.

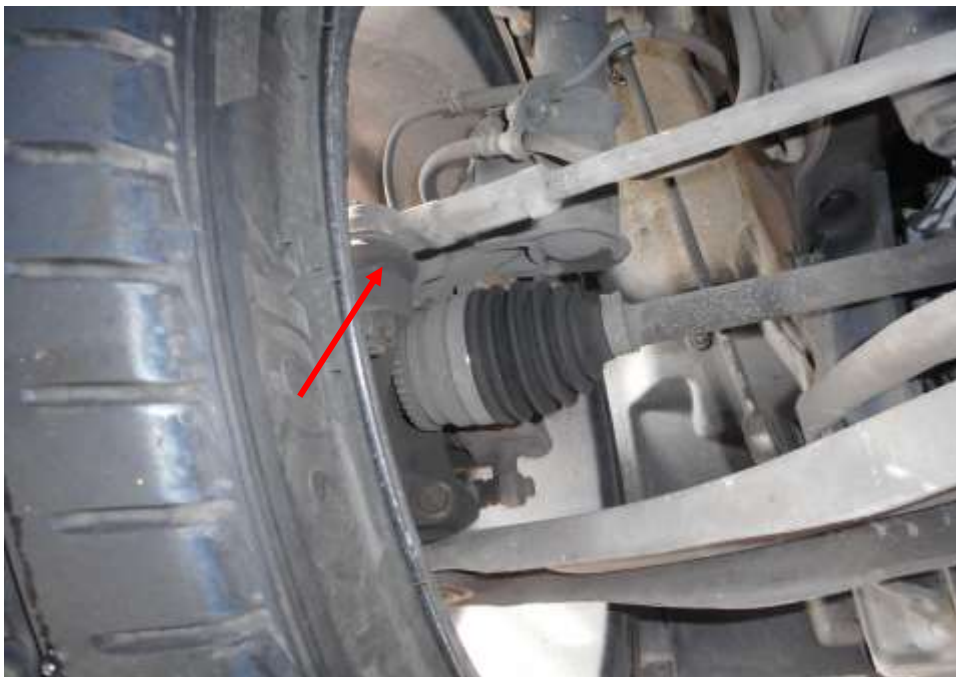
**Photo 19** shows the various undercarriage components at the front left wheel of the Motor Car, which had included the steering tie rod (red arrow). The various undercarriage components of the Motor Car were all found to be intact without any visible damage.
