**INITIAL INSPECTION REPORT OF VEHICLE NO SHA 5859G**

| Affiliated to Federation Internationale Des Experts En Automobile | | | | |
|---|---|---|---|---|
| Insured Veh. | SH 7268G | Veh. Inspected | SHA 5859G | |

## ADJUSTMENT ON REPAIR COST FOR VEHICLE NO. SHA 5859G

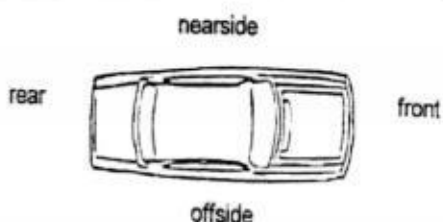
The vehicle sustained damages at the front and rear portion

Damages Consistent
