**Accident Claim for Vehicle No.GBJ 64 P , Involving Vehicle No.SKL 2487 Y.  
Accident on 28 JUNE 2019, AT EUNOS CRESCENT.**

### 1. Policy Particulars :- THIRD PARTY CLAIM

### 4. Description of Damages

## ADJUSTMENT ON REPAIR COST FOR VEHICLE NO. GBJ 64P

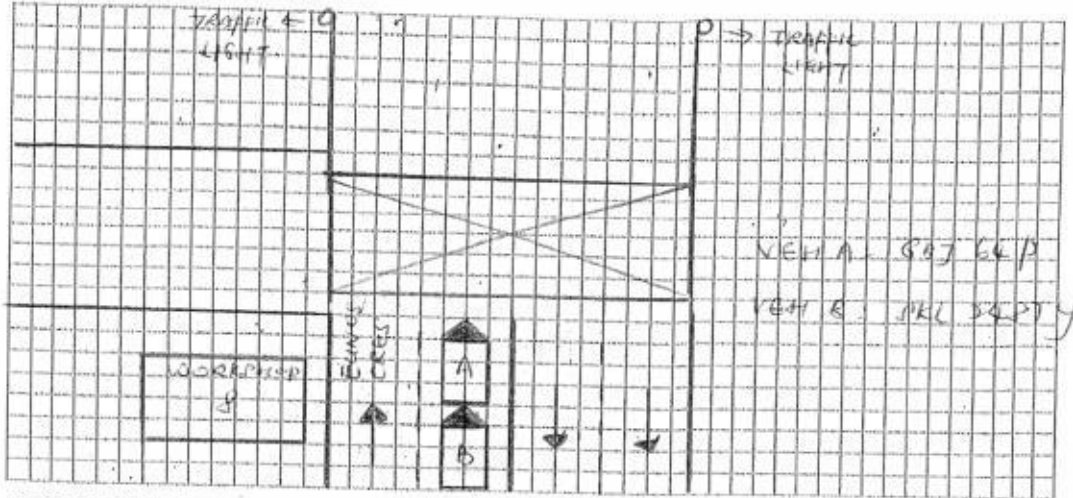
## SKETCH PLAN

I was stationary at Busar Cras, follow the front cars to line up for waiting traffic light to turn green. Suddenly, I felt an impact. Few second later, I notice that the vehicle B hit onto my rear portion.
