Your Ref: TP/IP/29367/2019  
Our Ref : CI/TPD19011809/P

13<sup>th</sup> August 2019

**MECHANICAL INSPECTION REPORT OF MOTOR LORRY JTE 7648**

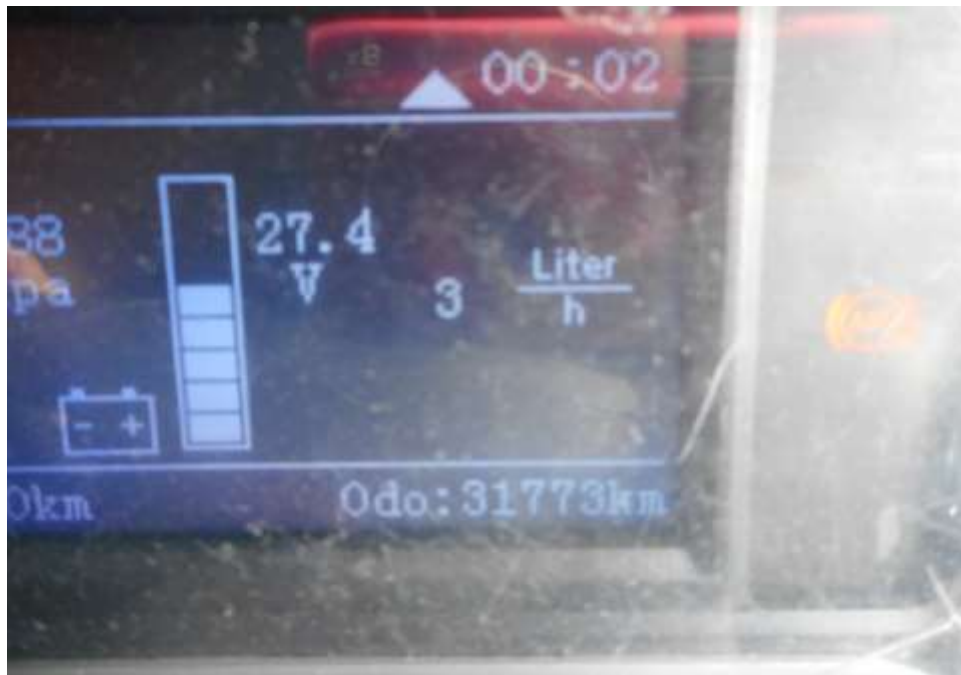
**Photo 1** shows a general view of the instrument cluster of the Motor Lorry at the time of my inspection. The mileage of the Motor Lorry was 31,773km

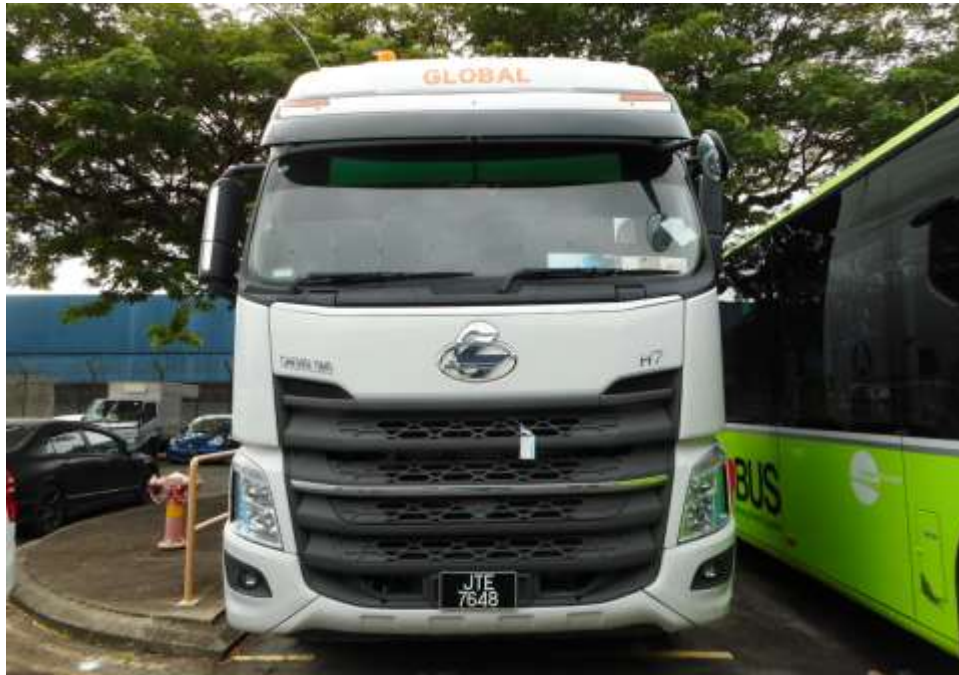
**Photo 2** shows a general view of the front left body of the Motor Lorry at the time of my inspection. The Motor Lorry was observed to have sustained minor damages at its front portion. Its front bumper was damaged as a result of the accident at the time of my inspection.

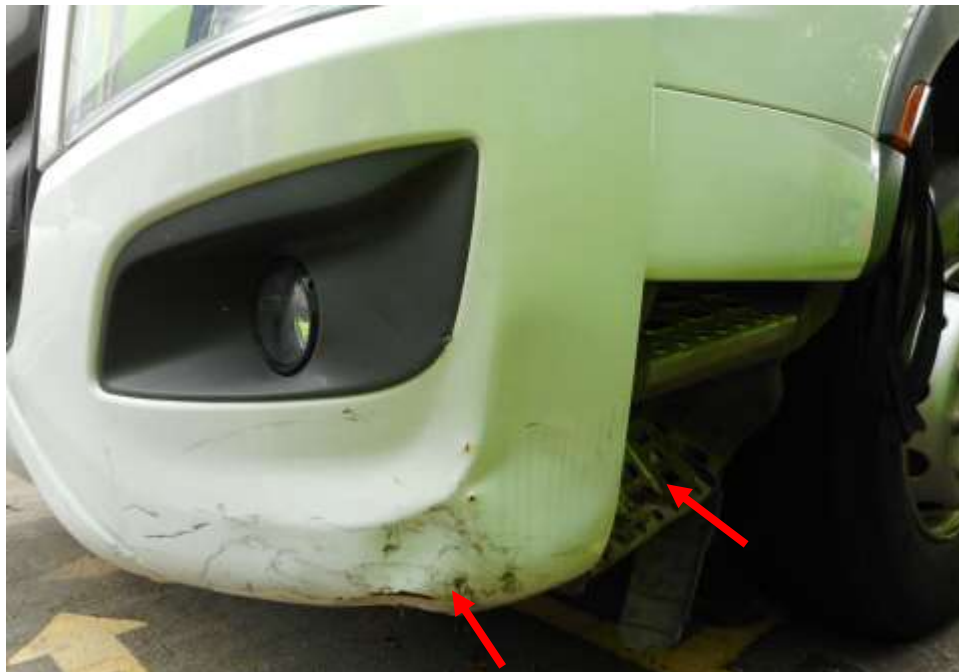
4. The mileage of the Motor Lorry at the time of my inspection was 31,773km.
5. The Motor Lorry was observed to have sustained minor damages at its left portion at the time of my inspection. Its front bumper and left bed steps were damaged as a result of the accident.

**Photo 3** shows a close up view of the front body of the Motor Lorry at the time of my inspection. The Motor Lorry was observed to have sustained minor damages at its left portion at the time of my inspection. Its front bumper and left bed steps (arrowed) were damaged as a result of the accident.

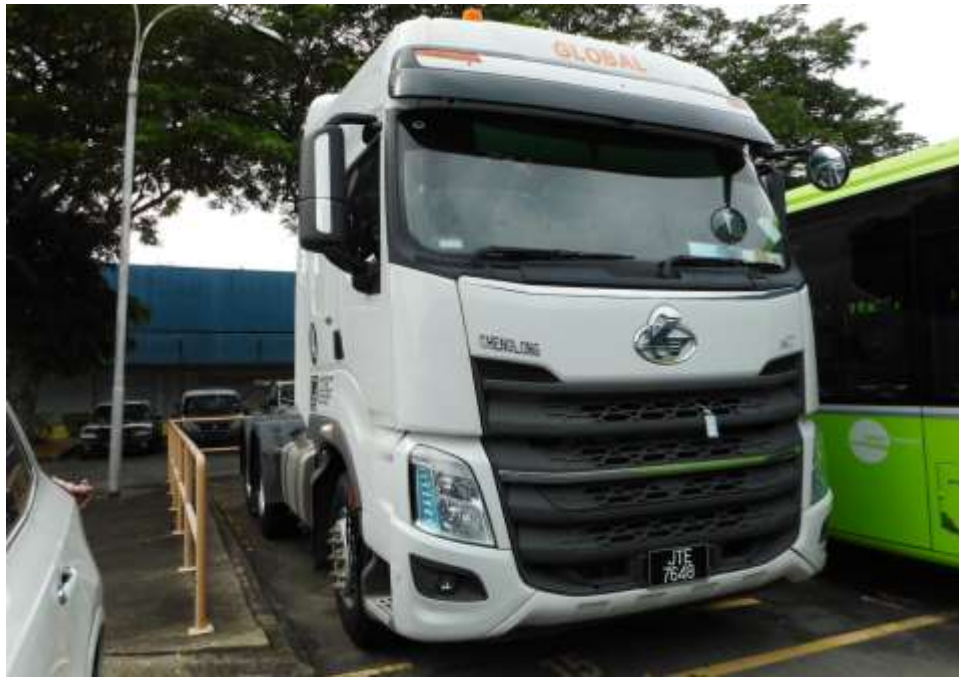
**Photo 4** shows a general view of the right body of the Motor Lorry at the time of my inspection. The Motor Lorry was observed to be in good general condition and unaffected by the accident.

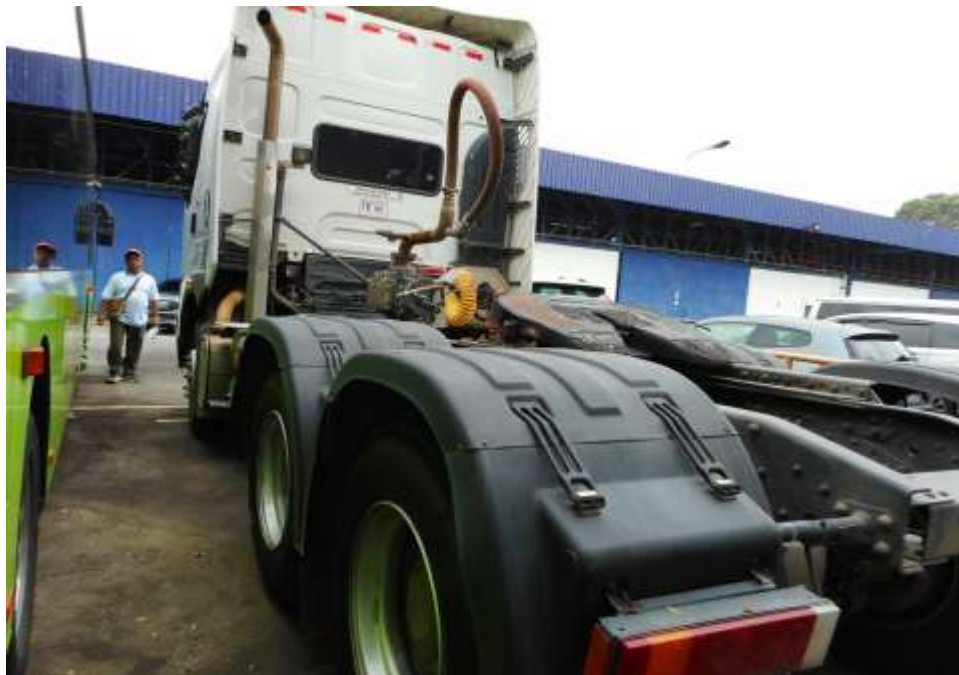
**Photo 5** shows a rear left view of the Motor Lorry at the time of my inspection. The Motor Lorry was observed to be in good general condition and unaffected to by the accident.

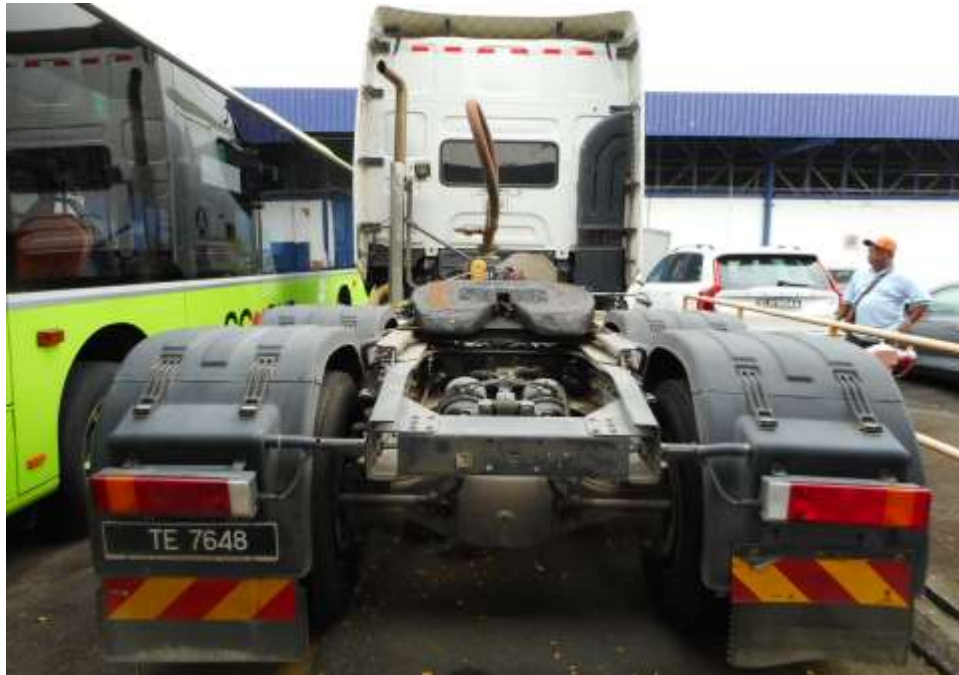
**Photo 6** shows a general view of the Motor Lorry's rear body at the time of my inspection. The Motor Lorry was observed to be in good general condition and unaffected to by the accident.

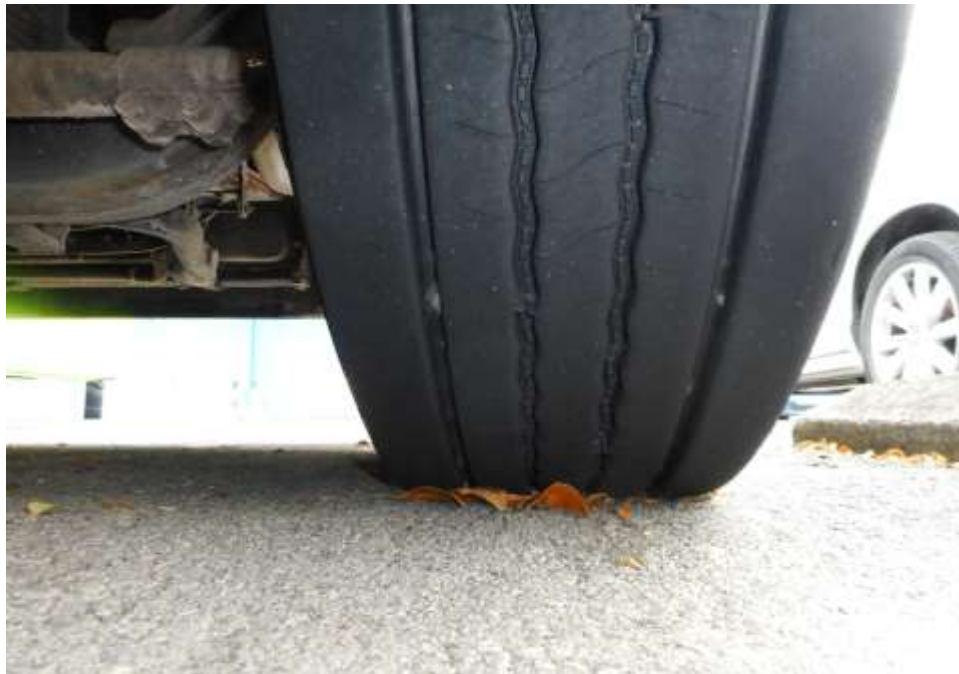
**Photo 7** shows the condition of the front right tyre of the Motor Lorry, which was observed to be in serviceable condition with remaining tread depth of approximately 8.4mm. The tyre, which was wrapped around standard steel wheel rim, was also observed to be sufficiently inflated for vehicular operation. There was no tear, cut or burst mark(s) on the outer and the inner sidewalls as well as across the tread of the 10 tyres that were fitted on the Motor Lorry.

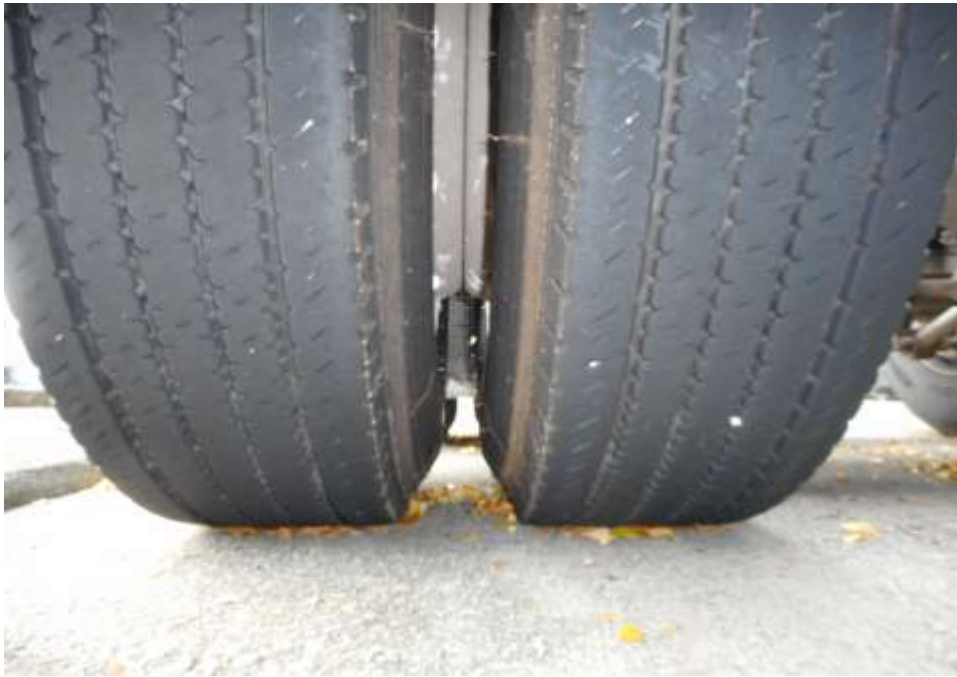
**Photo 8** shows the condition of the rear right tyre of the Motor Lorry, which was observed to be in serviceable condition with remaining tread depth of approximately 7.7mm. The tyre, which was wrapped around standard steel wheel rim, was also observed to be sufficiently inflated for vehicular operation.

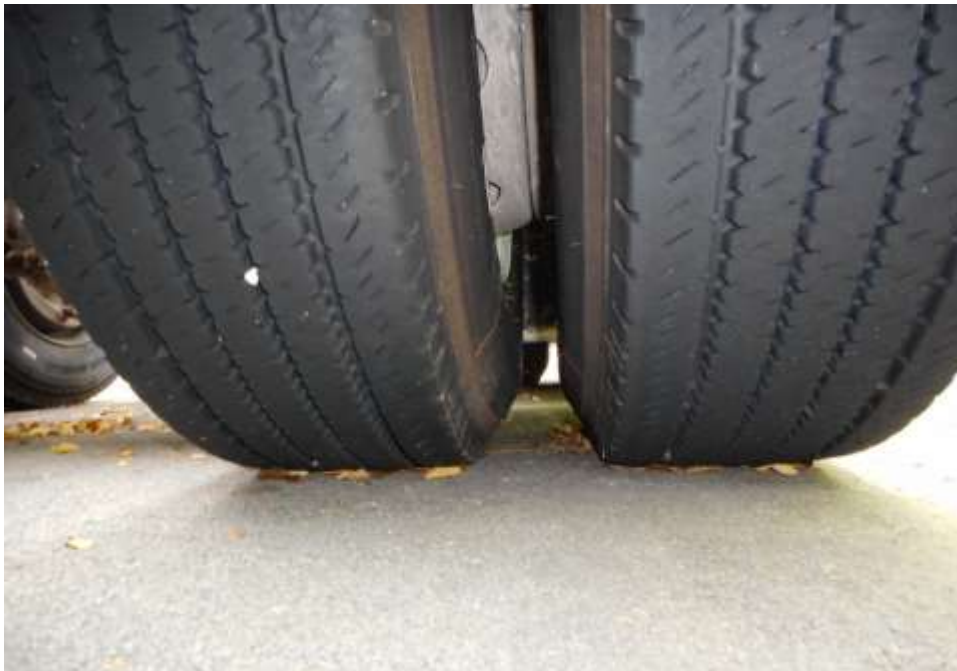
**Photo 9** shows the condition of the rear left tyres of the Motor Lorry, which was observed to be in serviceable condition with remaining tread depth of approximately 9mm. The tyres, which were wrapped around standard steel wheel rim, were also observed to be sufficiently inflated for vehicular operation. There was also no damage found on all 8 steel wheel rims of the Motor Lorry.

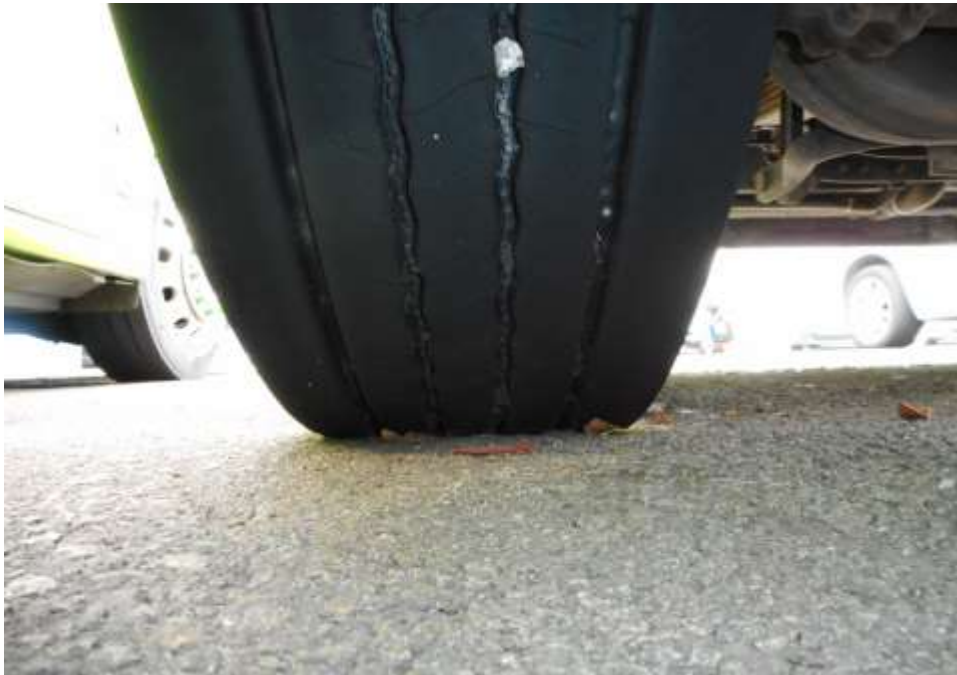
**Photo 10** shows the condition of the front left tyres of the Motor Lorry, which were observed to be in serviceable condition with remaining tread depth of approximately 8.9mm. There was also no tear, cut or burst mark(s) on the outer and the inner sidewalls as well as across the tread of the 8 tyres that were fitted on the Motor Lorry.

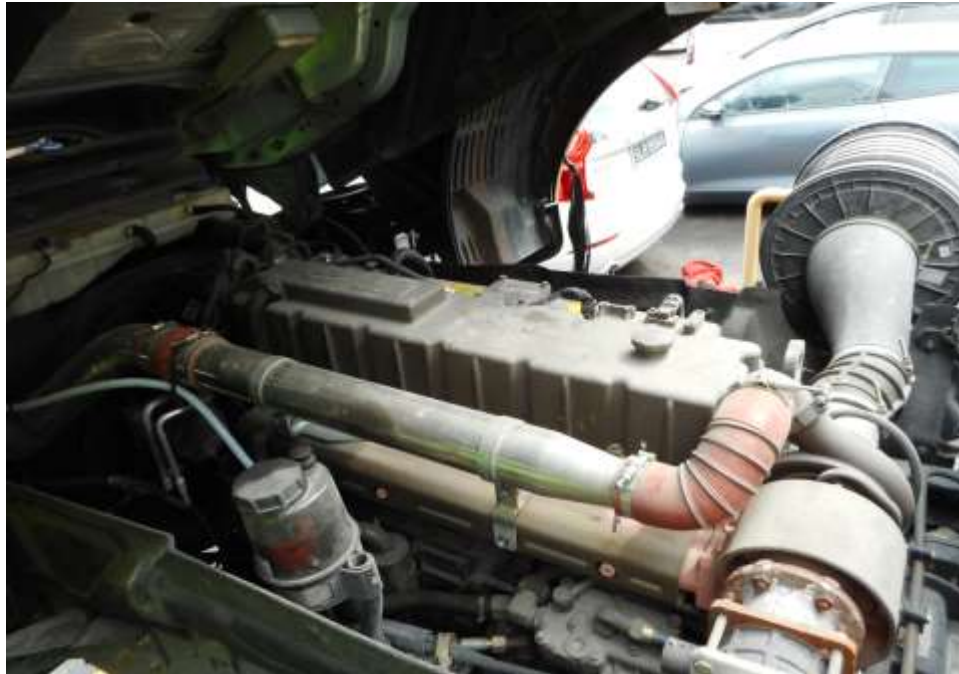
**Photo 11** shows a general view of the Motor Lorry's engine compartment, which was accessed by lifting the front cabin of the Motor Lorry. The various parts and components inside the engine compartment were unaffected by the accident. There was also no sign(s) or indication(s) of fresh fluid leakage and/or fluid stain within the engine compartment

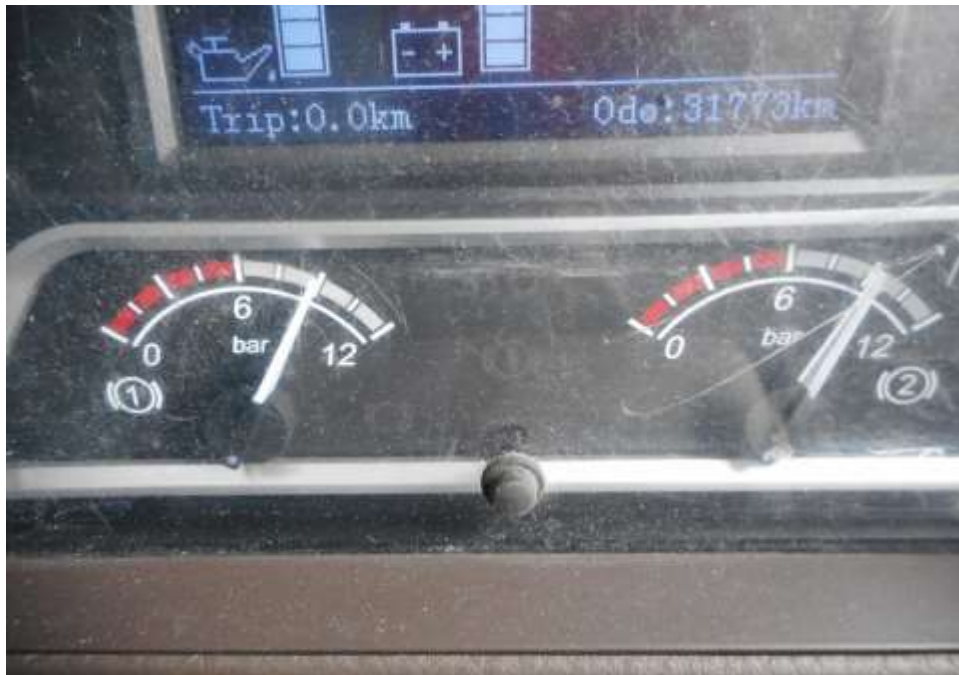
**Photo 12** shows the air in the air brake cylinder of the Motor Lorry at the time of my inspection. The air in the cylinder was observed to be of sufficient level & serviceable at the time of the accident.

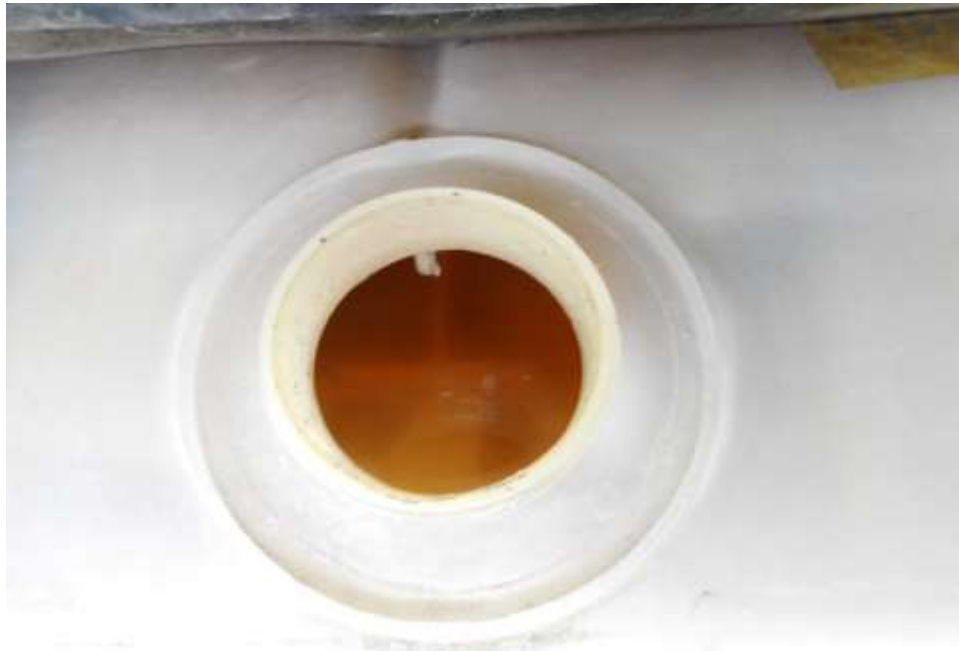
**Photo 13** shows the engine coolant reservoir of the Motor Lorry at the time of my inspection. The engine coolant was observed to be of sufficient level and without any visible contamination.

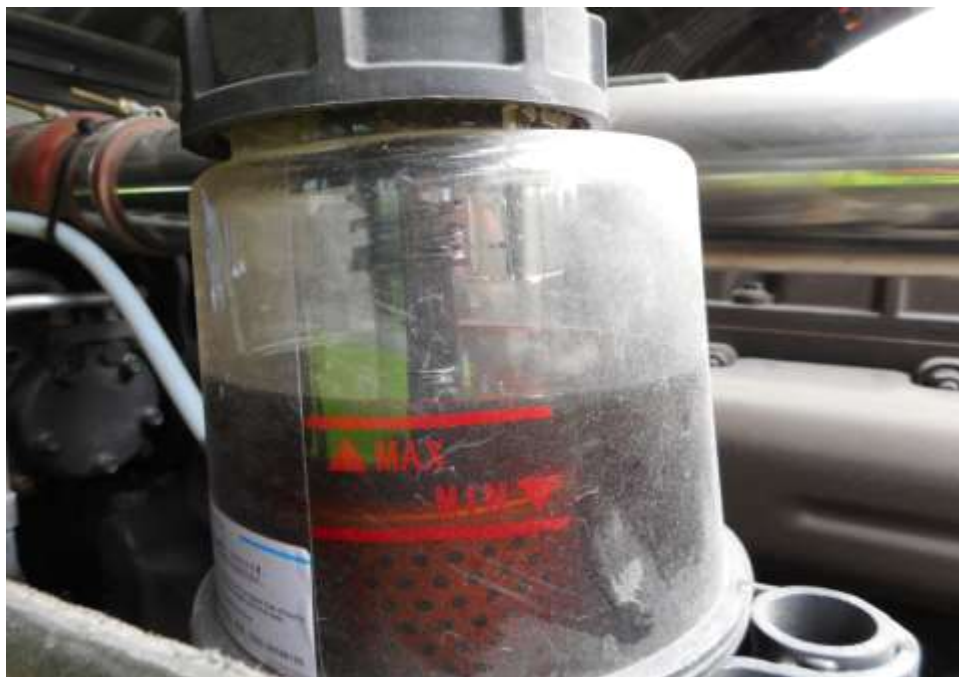
**Photo 14** shows the power steering fluid reservoir of the Motor Lorry at the time of my inspection. The power steering fluid was observed to be of sufficient level and without any visible contamination.

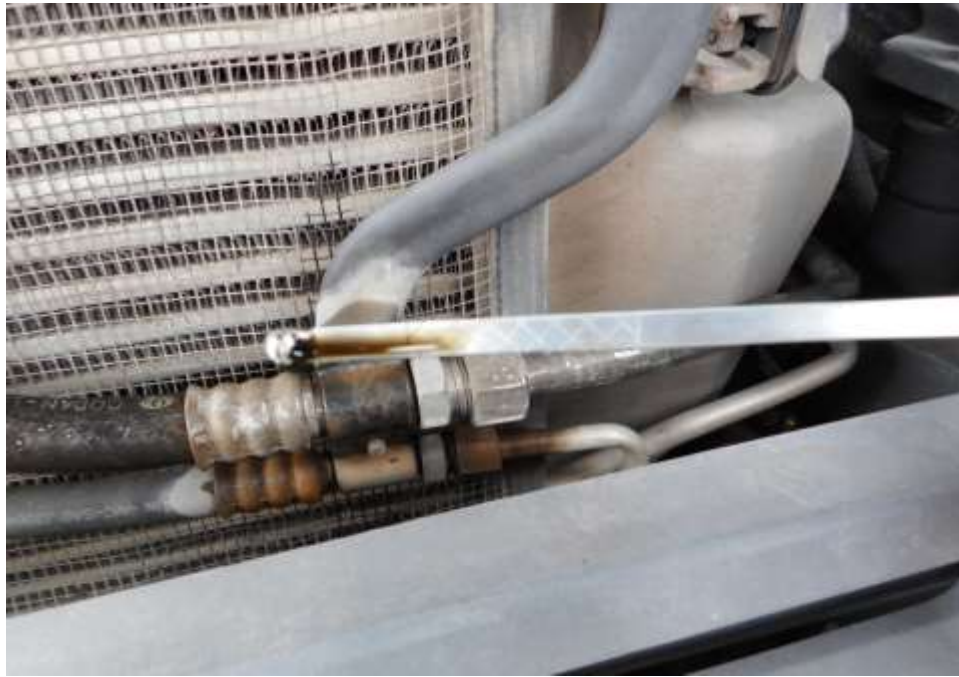
**Photo 15** shows the engine oil dip stick system of the Motor Lorry at the time of my inspection. The engine oil was observed to be of sufficient level without any visible contamination.

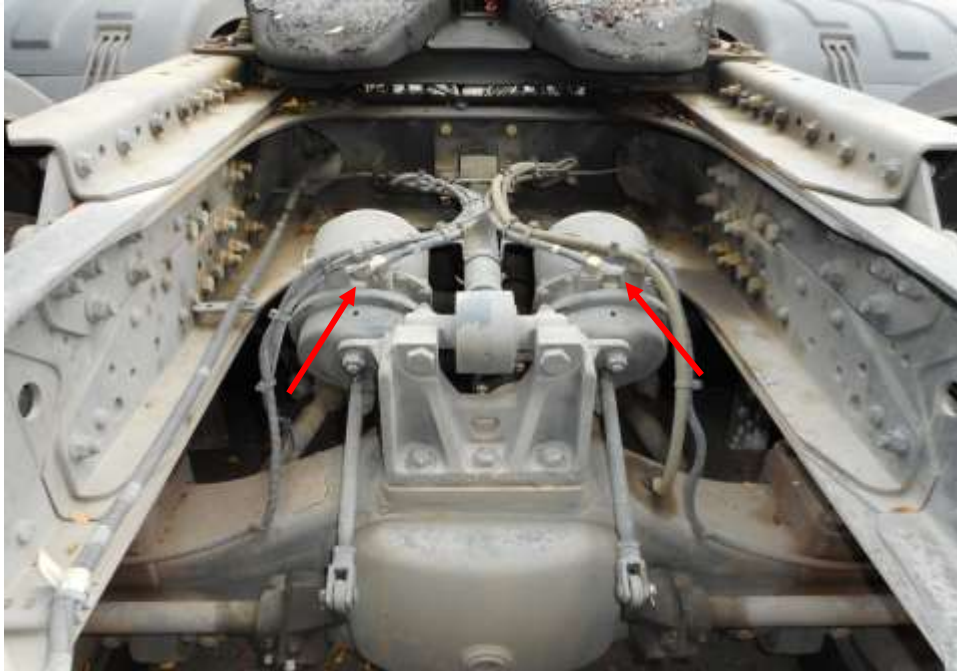
**Photo 16** shows the brake pipe (arrowed) at the left and rear right wheel of the Motor Lorry. I did not observe any leakage of brake fluid at the time of my inspection of the Motor Lorry. My static tests of the Motor Lorry's braking system, along with my visual examination of the various mechanical components in the braking system, had indicated that there was no internal leakage of pressure/vacuum. Hence the braking system of the Motor Lorry was likely to be in serviceable condition at the material time of accident.

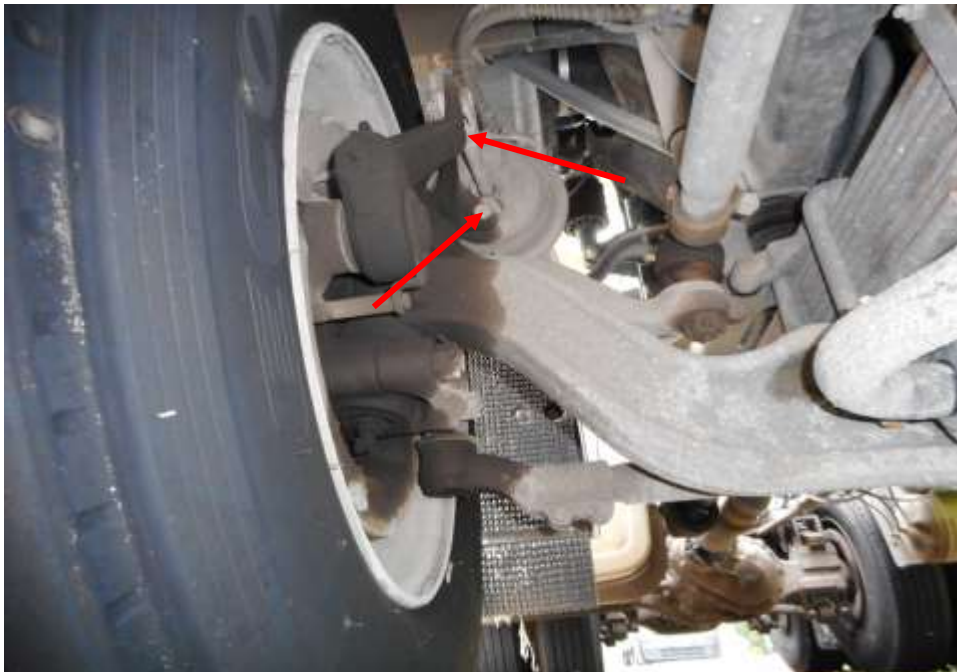
**Photo 17** shows the brake pipe (arrowed) at the front right wheel of the Motor Lorry. I did not observe any leakage of brake fluid at the time of my inspection of the Motor Lorry. My static tests of the Motor Lorry's braking system, along with my visual examination of the various mechanical components in the braking system, had indicated that there was no internal leakage of pressure/vacuum. Hence the braking system of the Motor Lorry was likely to be in serviceable condition at the material time of accident.

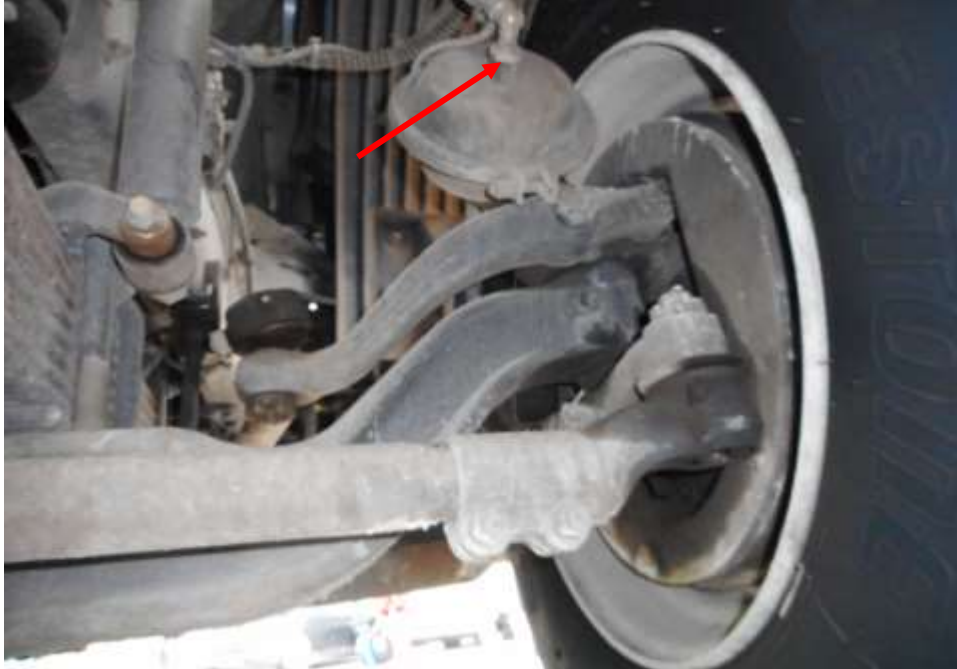
**Photo 18** shows the brake pipe (arrowed) at the front left wheel of the Motor Lorry. I did not observe any leakage of brake fluid at the time of my inspection of the Motor Lorry. My static tests of the Motor Lorry's braking system, along with my visual examination of the various mechanical components in the braking system had indicated that there was no internal leakage of pressure/vacuum. Hence the braking system of the Motor Lorry was likely to be in serviceable condition at the material time of accident.

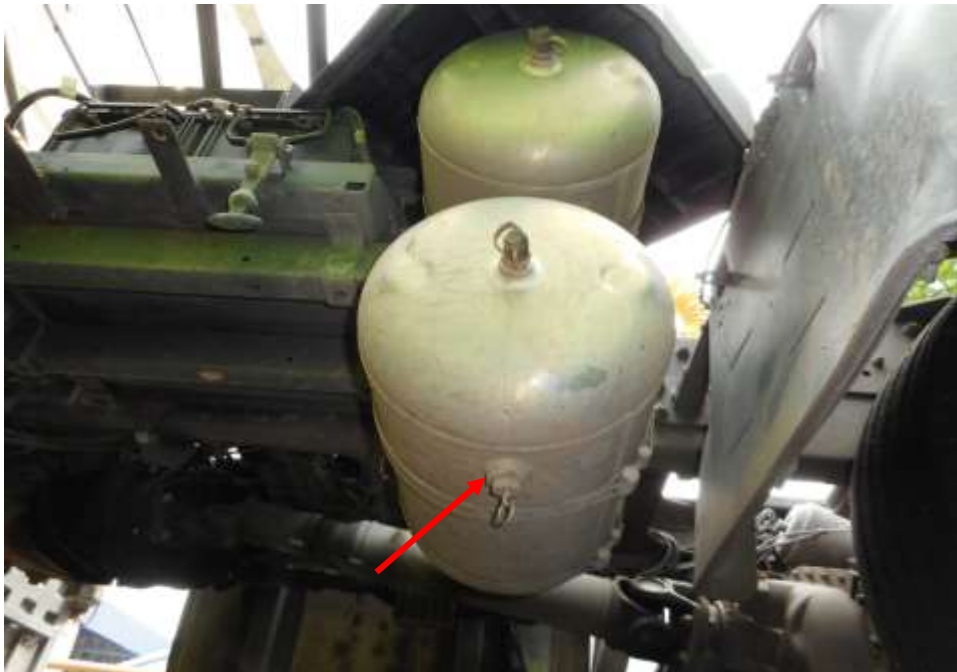
**Photo 19** shows the air brake cylinder (arrowed) at the undercarriage of the Motor Lorry. I did not observe any leakage of air brake fluid at the time of my inspection of the Motor Lorry. My static tests of the Motor Lorry's braking system, along with my visual examination of the various mechanical components in the braking system had indicated that there was no internal leakage of pressure/vacuum. Hence the braking system of the Motor Lorry was likely to be in serviceable condition at the material time of accident.

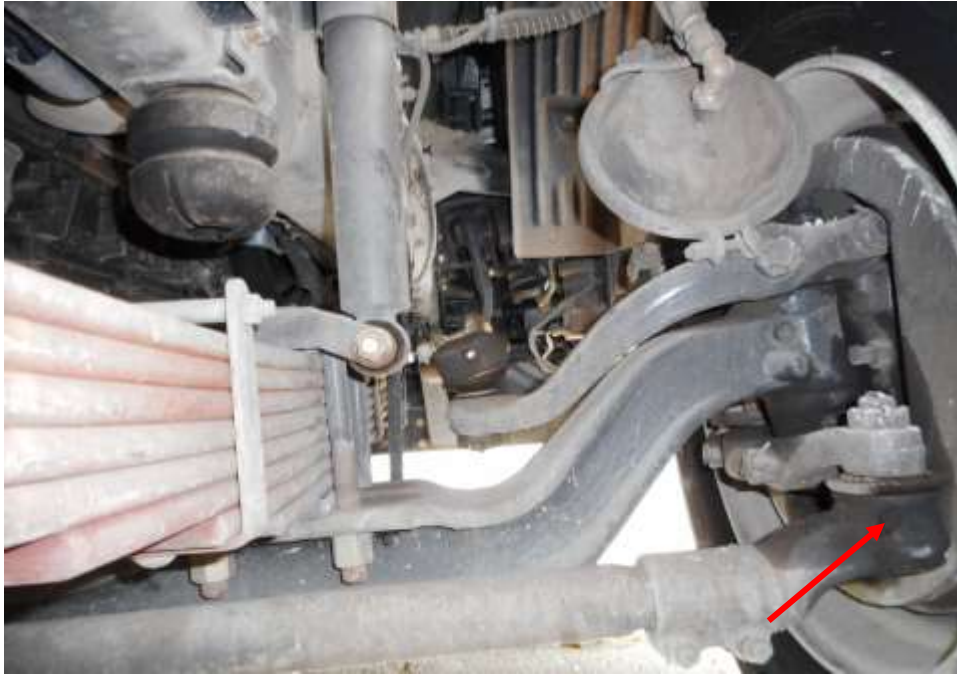
**Photo 20** shows the various undercarriage components at the front right wheel of the Motor Lorry, in particular the steering tie rod end (arrowed). The various steering components were all found to be intact, suggesting that the steering system of the Motor Lorry was likely to be in serviceable condition at the material time of accident. There was also no sign of fluid stain(s) observed on the various undercarriage components.

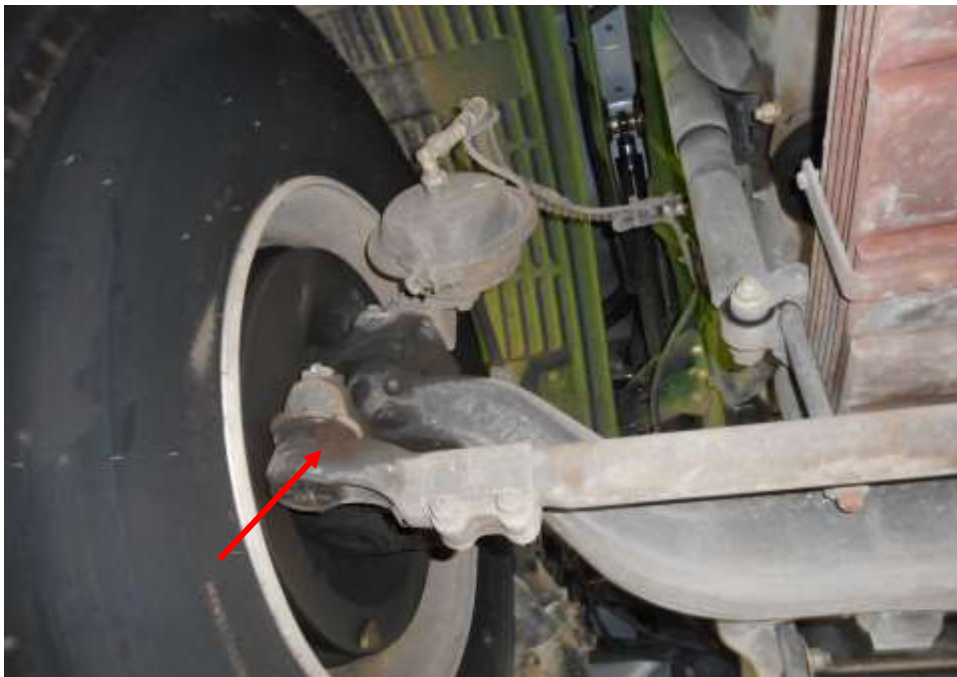
**Photo 21** shows the various undercarriage components at the front left wheel of the Motor Lorry, in particular the steering tie rod end (arrowed). The various undercarriage components of the Motor Lorry were all found to be intact without any visible damage. There was also no sign of fluid stain(s) observed on the various undercarriage components.

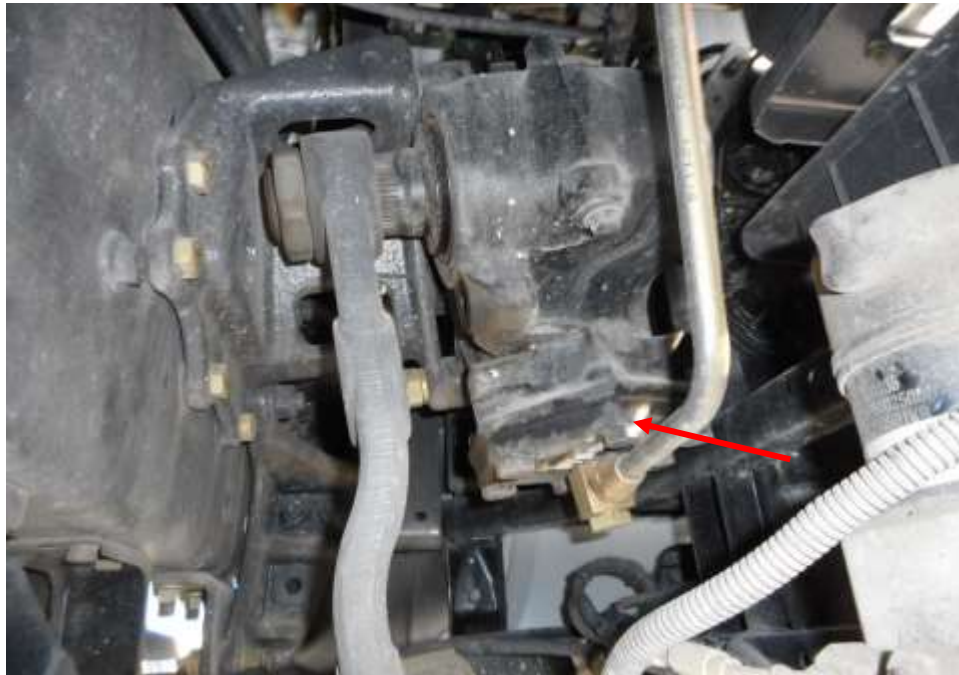
**Photo 22** shows the steering box component (arrowed) at the undercarriage of the Motor Lorry was found to be intact without any visible damage. There was also no sign of fluid stain(s) observed on the various undercarriage components.

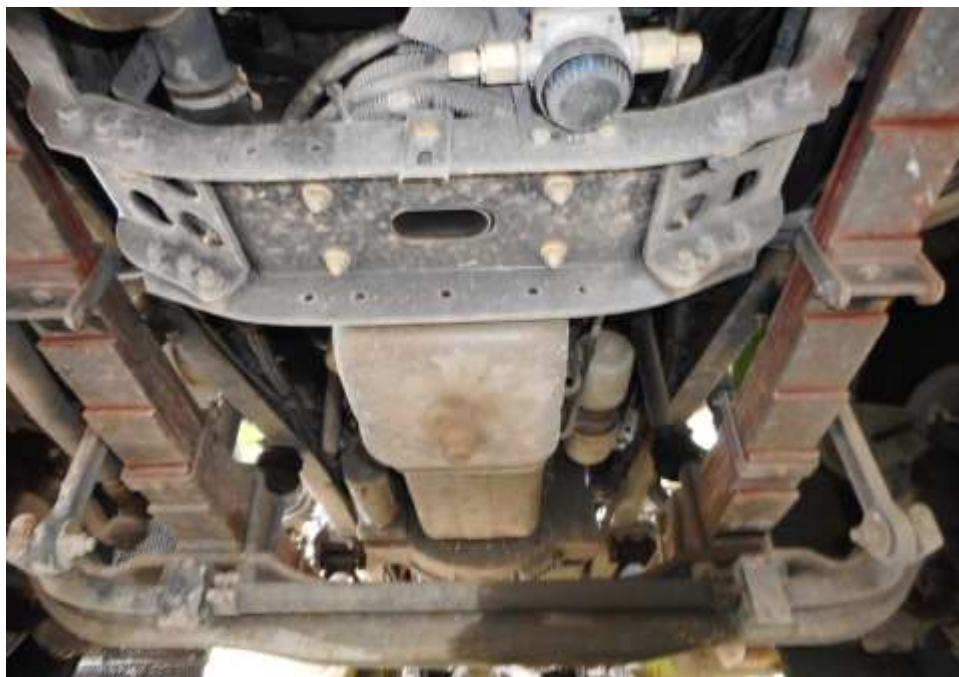
**Photo 23** shows the undercarriage of the Motor Lorry, at the area where the engine housing located. I did not find any sign(s) or indication(s) of fluid leak and/or fluid stain(s) on the underside of the Motor Lorry.

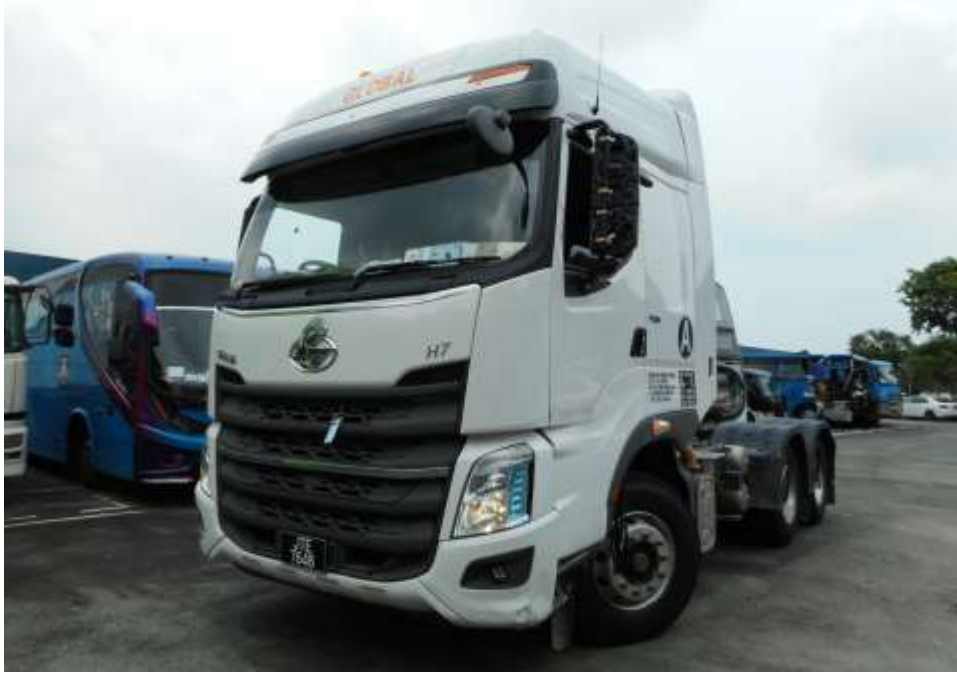
**Photo 24** shows the front left wheel of the Motor Lorry turned to its full right. During my steering system test, I did not experience any abnormal free play and/or resistance when I had turned the steering wheel towards full left and full right. This would suggest that the steering system of the Motor Lorry was likely to be in serviceable condition at the material time of accident.

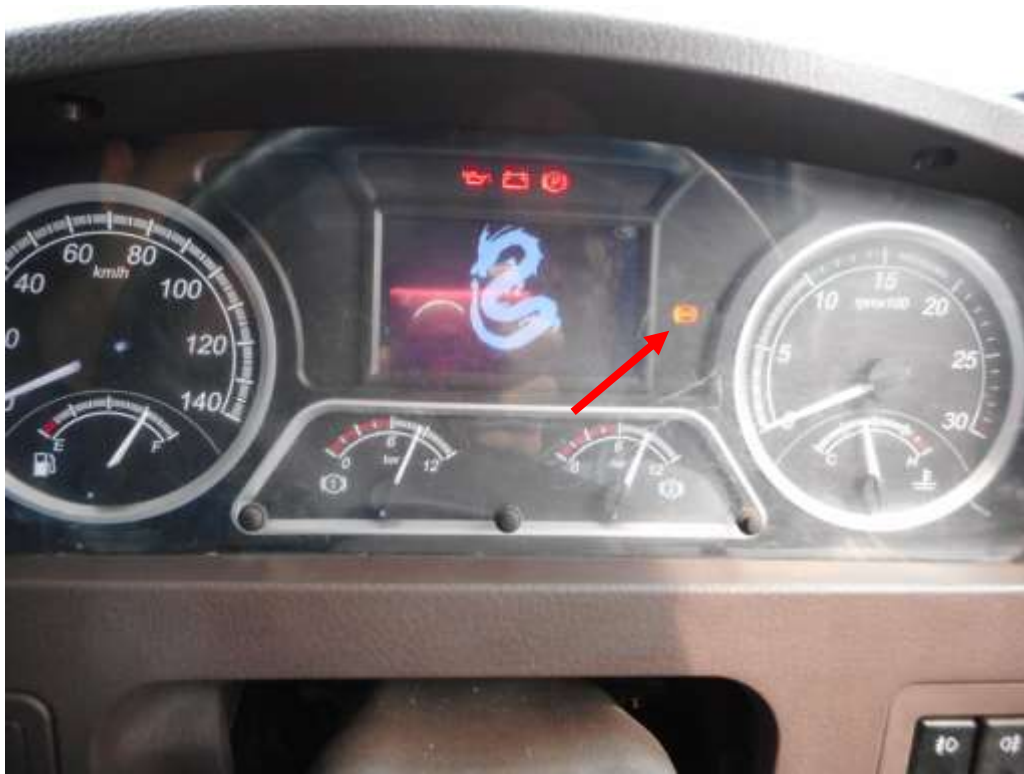
**Photo 25** shows the warning light for Anti-Lock Brake System (ABS) appearing on the instrument panel of the Motor Lorry during the self-test of its various electronic operating systems when its engine was cranked.

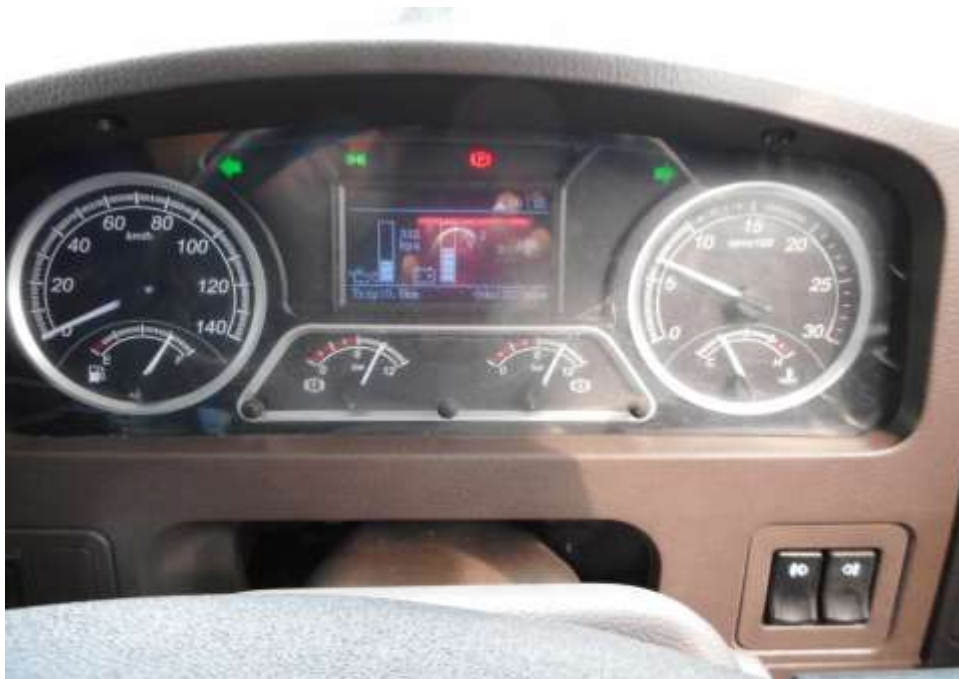
**Photo 26** shows no warning lights illuminated on the instrument panel of the Motor Lorry after the engine was cranked. This would suggest that there was no abnormality to the various electronic operating systems of the Motor Lorry, like the ABS
