Your Ref: TP/IP/38627/2019
Our Ref : CI/TPD19011811/P

Fatal Accident Investigation Team

MECHANICAL INSPECTION REPORT OF MOTOR BUS PZ 1144K

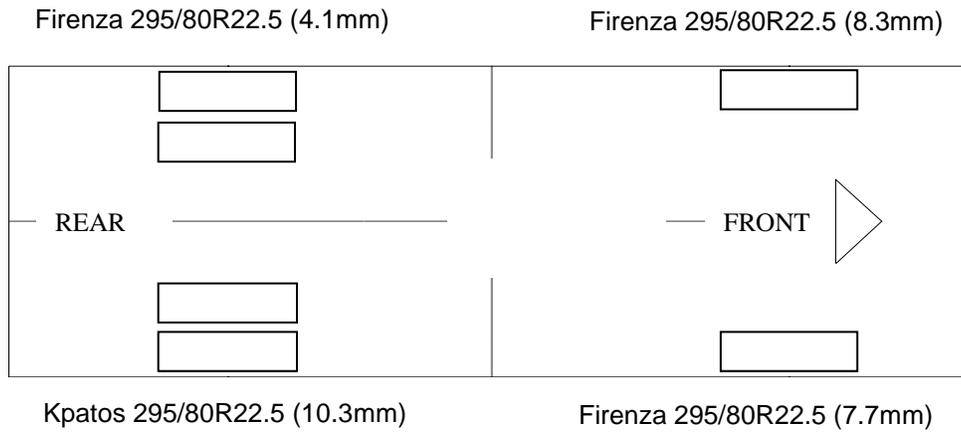
6. The 2 front tyres and 4 rear tyres of the Motor Bus were observed to be in serviceable condition and sufficiently inflated for vehicular operation. I did not find any tear, cut or burst mark(s) on the outer and the inner sidewalls as well as across the tread of the 6 tyres. The tyre brand, tyre size and remaining tread depth of the 6 tyres of the Motor Bus were recorded as follows:-

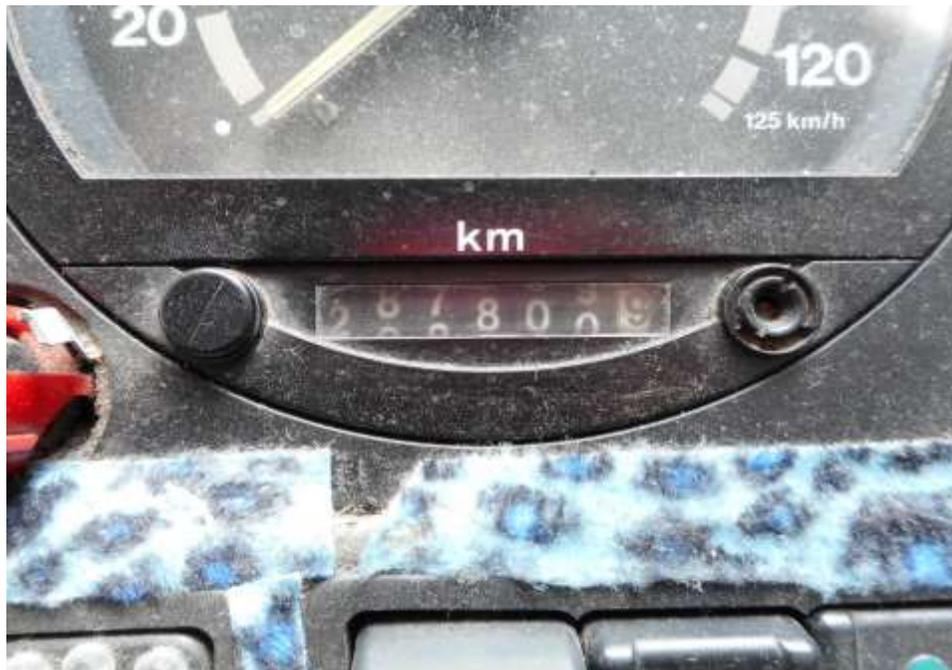
Photo 1 shows a general view of the instrument cluster of the Motor Bus at the time of my inspection. The mileage of the Motor Bus was 287,809km

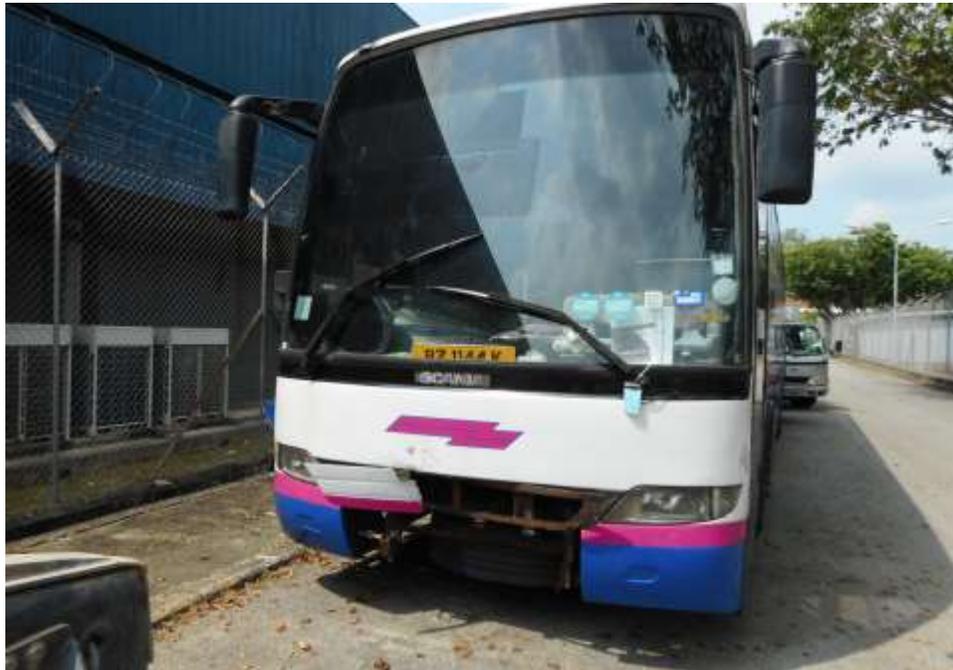
Photo 2 shows a general view of the front body of the Motor Bus at the time of my inspection. The Motor Bus was observed to sustain damage at its front portion. Its front bumper was damaged as a result of the accident.

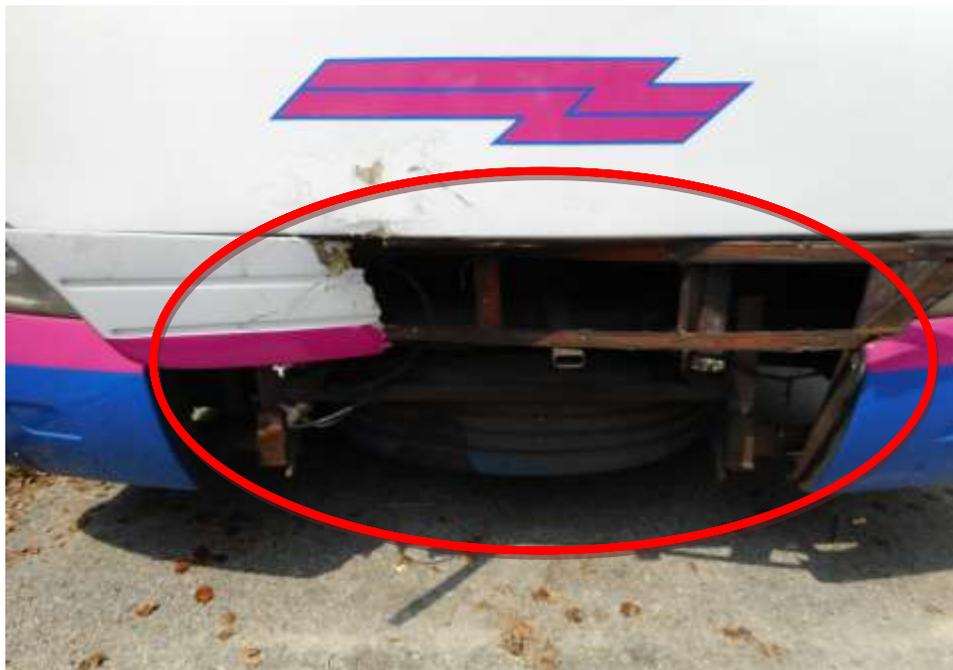
Photo 3 shows a close up view of the front body of the Motor Bus at the time of my inspection. The Motor Bus was observed to sustain damage at its front portion. Its front bumper (circled) was damaged as a result of the accident.

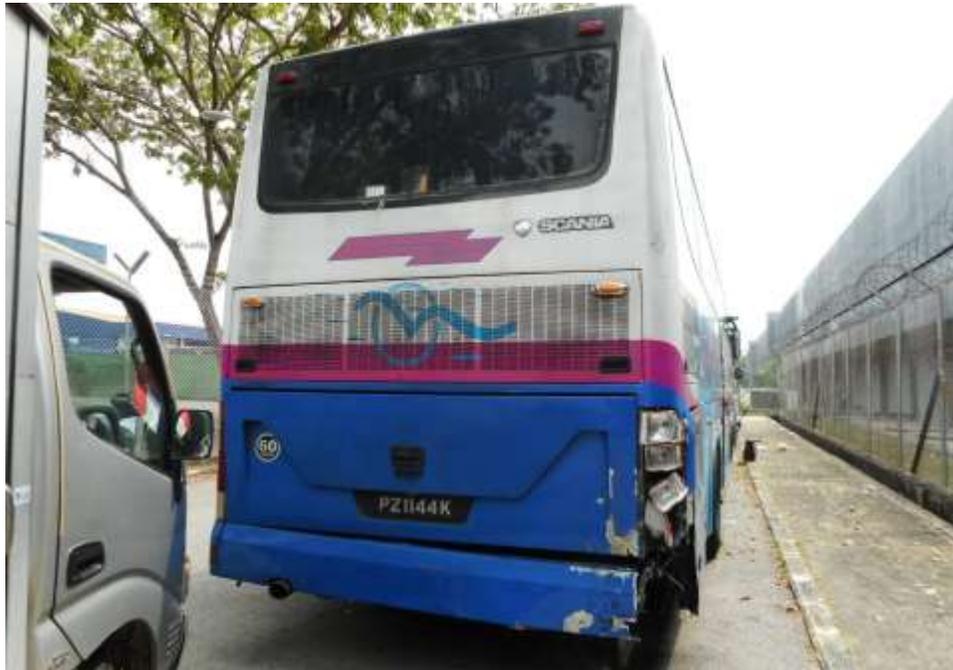
Photo 4 shows a general view of the Motor Bus's rear body at the time of my inspection. The Motor Bus was observed to sustained damage at its rear portion. Its rear right brake lamp, rear bonnet hinge and rear bumper was damaged as a result of the accident.

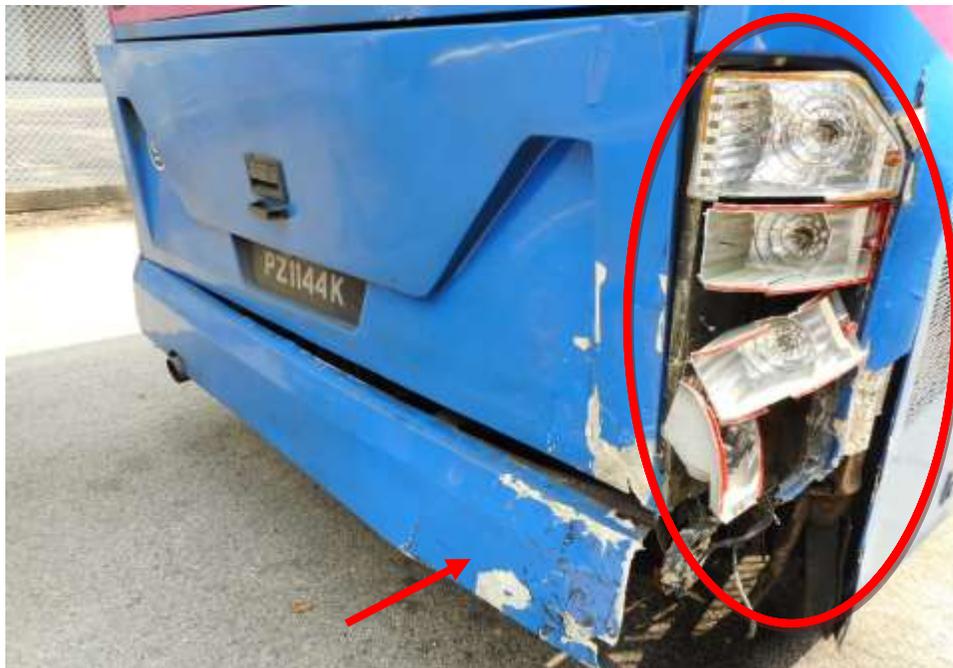
Photo 5 shows a close up view of the Motor Bus's rear body at the time of my inspection. The Motor Bus was observed to sustained damage at its rear portion. Its rear right brake lamp (circled) and rear bumper (arrowed) was damaged as a result of the accident.

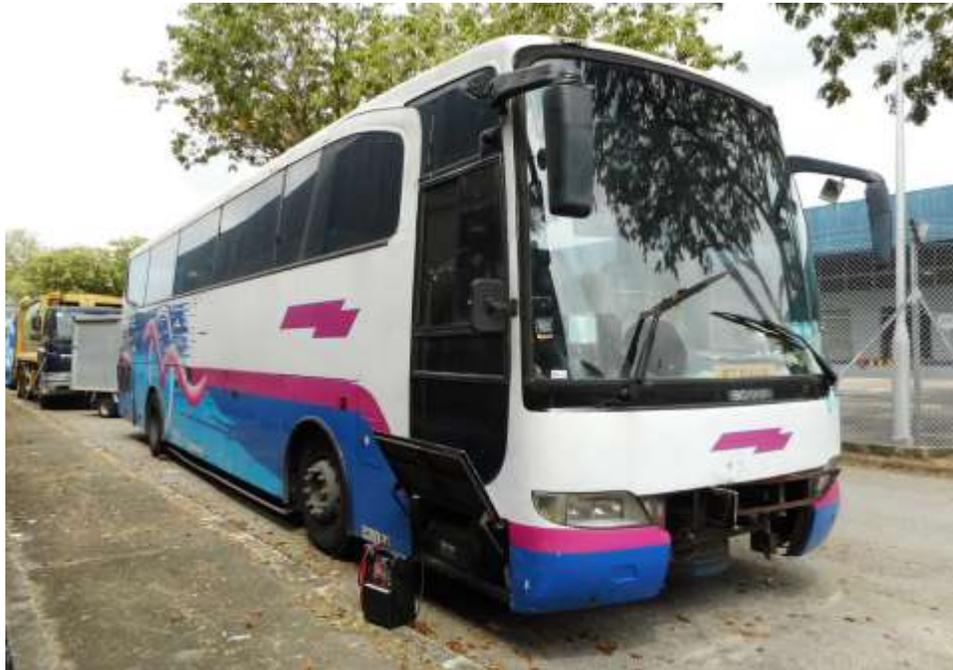
Photo 6 shows a general view of the right body of the Motor Bus at the time of my inspection. The Motor Bus was observed to be in good general condition and unaffected to by the accident.

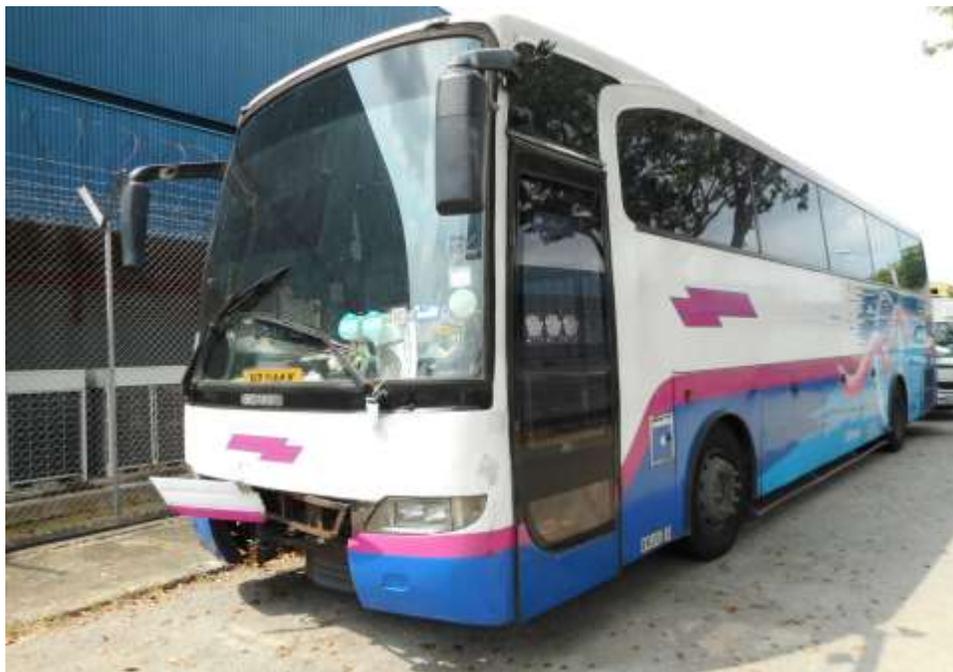
Photo 7 shows a general view of the left body of the Motor Bus at the time of my inspection. The Motor Bus was observed to be in good general condition and unaffected to by the accident.

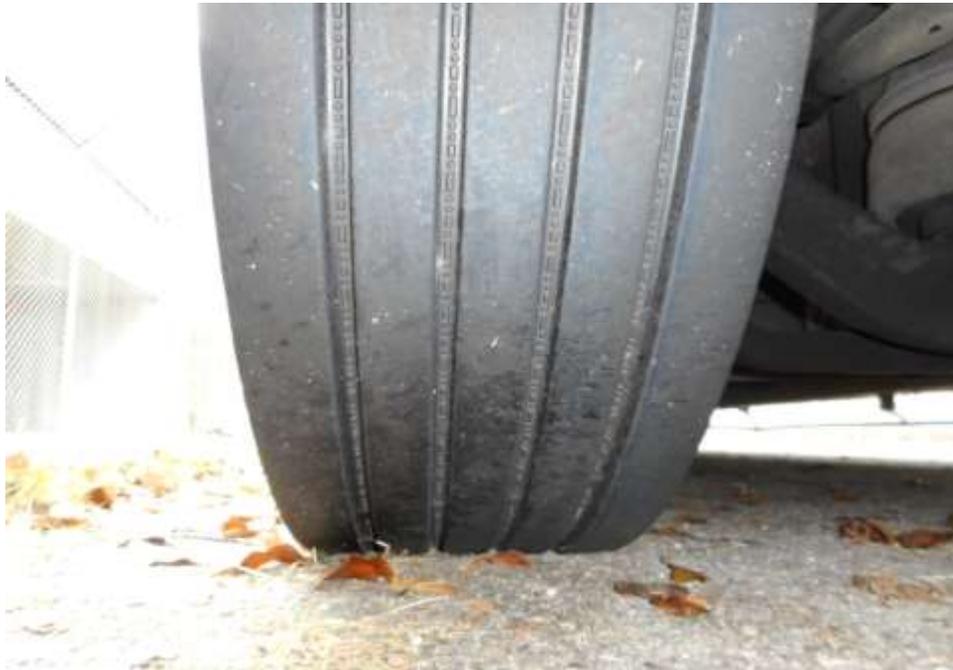
Photo 8 shows the condition of the front right tyre of the Motor Bus, which was observed to be in serviceable condition with remaining tread depth of approximately 7.7 mm. The tyre, which was wrapped around standard steel wheel rim, was also observed to be sufficiently inflated for vehicular operation. There was no tear, cut or burst mark(s) on the outer and the inner sidewalls as well as across the tread of the 6 tyres that were fitted on the Motor Bus.

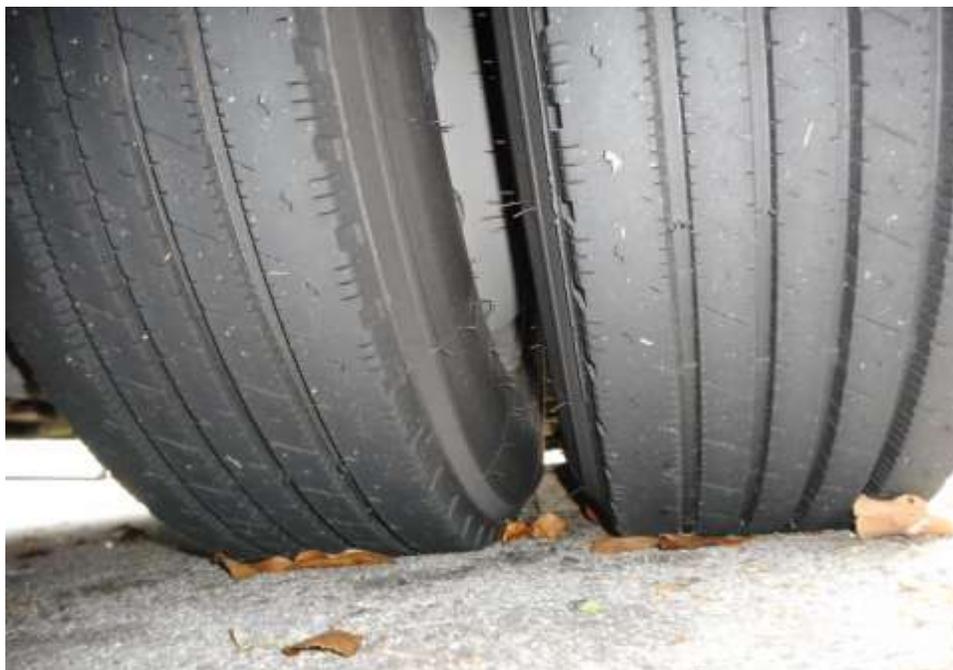
Photo 9 shows the condition of the rear right tyre of the Motor Bus, which was observed to be in serviceable condition with remaining tread depth of approximately 10.3mm. The tyre, which was wrapped around standard steel wheel rim, was also observed to be sufficiently inflated for vehicular operation.

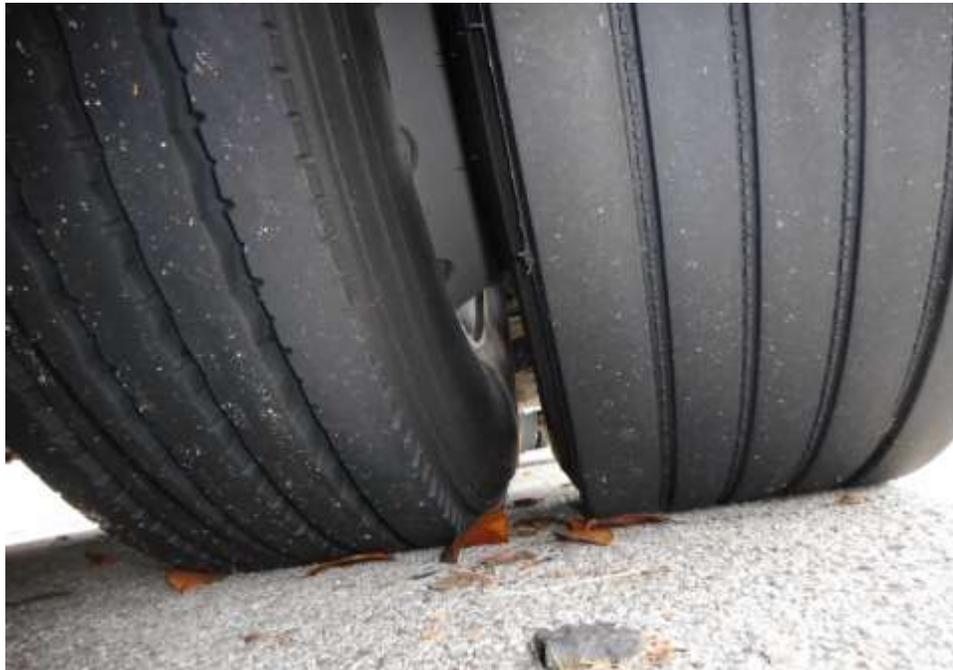
Photo 10 shows the condition of the rear left tyres of the Motor Bus, which was observed to be in serviceable condition with remaining tread depth of approximately 4.1mm. The tyres, which were wrapped around standard steel wheel rim, were also observed to be sufficiently inflated for vehicular operation. There was also no damage found on all 6 steel wheel rims of the Motor Bus.

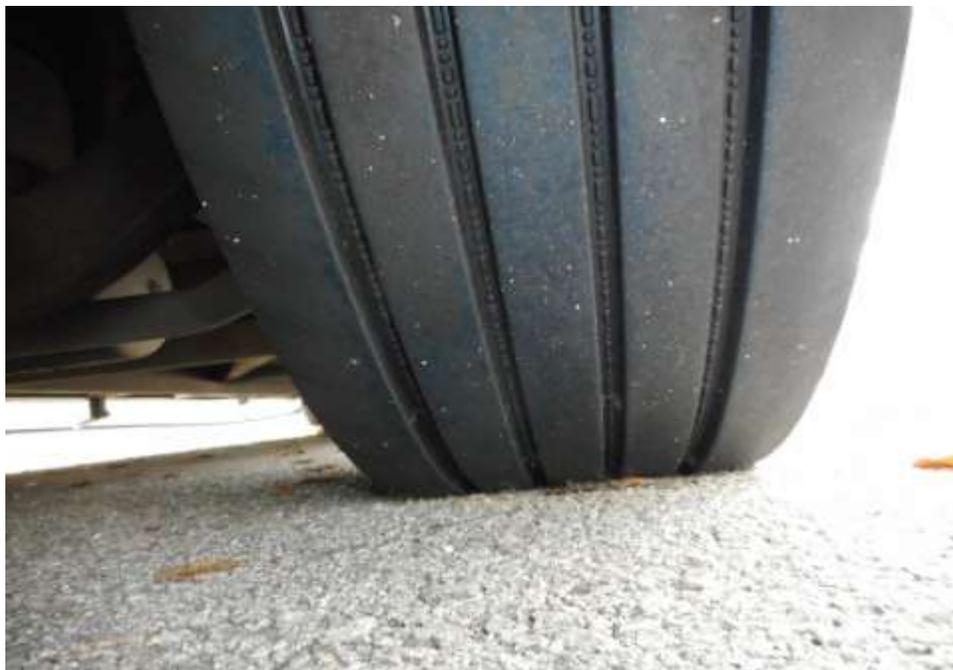
Photo 11 shows the condition of the front left tyres of the Motor Bus, which were observed to be in serviceable condition with remaining tread depth of approximately 8.3mm. There was also no tear, cut or burst mark(s) on the outer and the inner sidewalls as well as across the tread of the 6 tyres that were fitted on the Motor Bus.

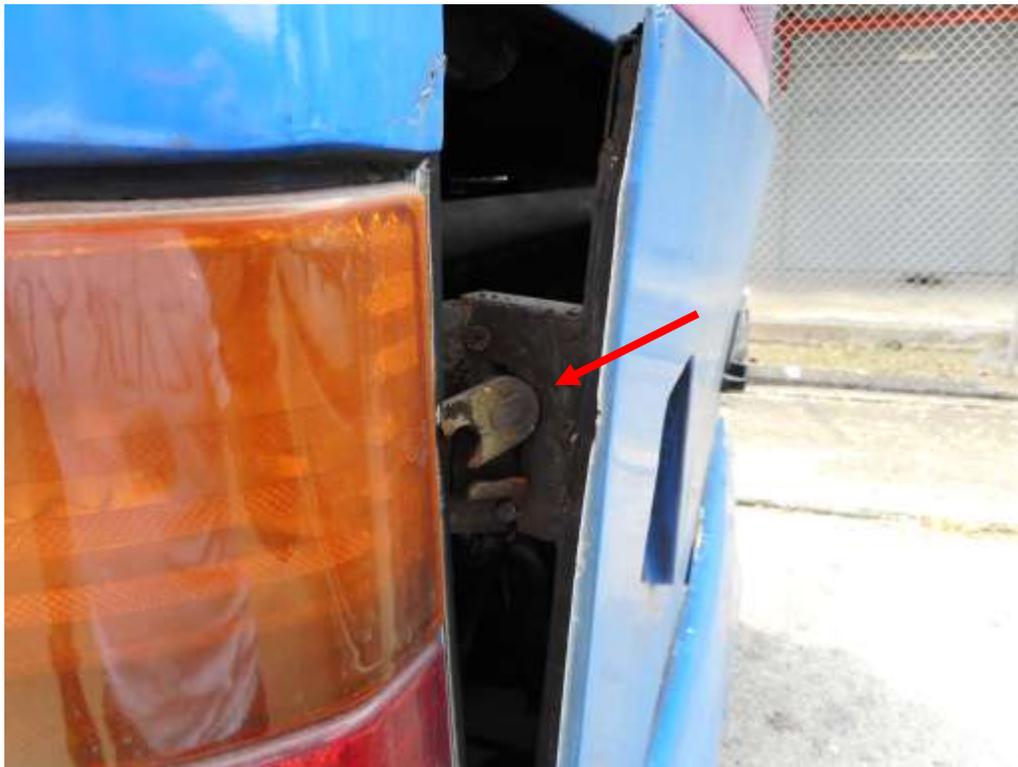
8. The impact from the collision had affected the engine compartment of the Motor Bus. Parts towards the rear of the engine compartment were observed to be damaged. The hinges of the Motor Bus rear bonnet were also affected and I was unable to unlock and lift the rear bonnet to carry out examination of the Motor Bus's engine compartment. The various operating fluids like its engine coolant, brake fluid and transmission fluid etc were hence unable to be inspected.
9. However the reading of air brake cylinder for the air brakes can be visually read on the instrument cluster of the Motor Bus. See photo 12 and 13 below.

Photo 12 shows the damage to the rear bonnet hinges (arrowed) Motor Bus rear bonnet, rendering it unable to be unlocked and lifted up to carry out examination of the Motor Bus engine compartment as a result of the accident.

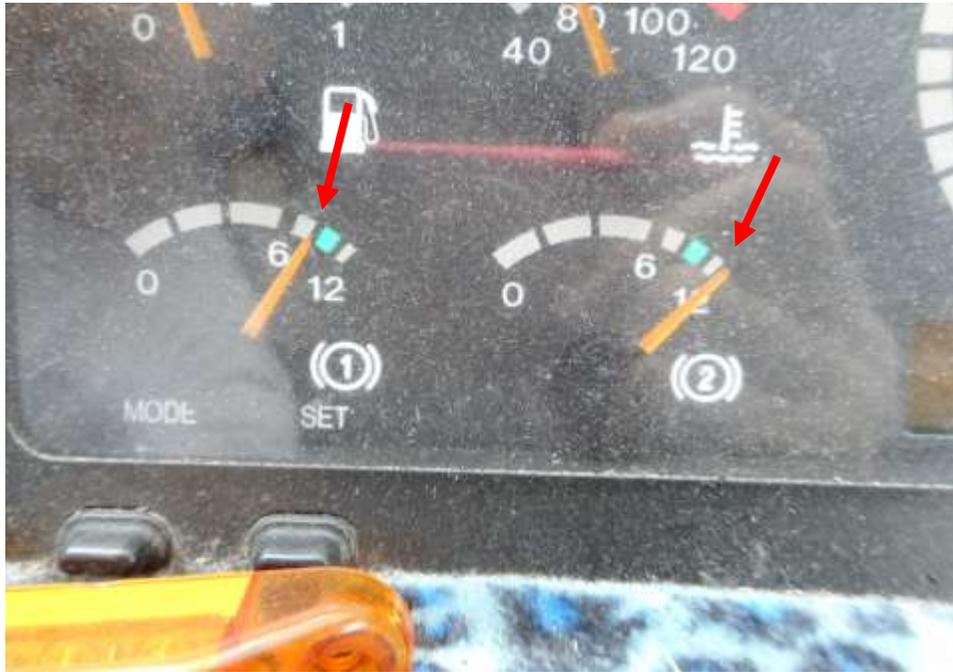
Photo 13 shows the air readings from the air brake cylinders of the Motor Bus at the time of my inspection. The air in the cylinder (arrowed) was observed to be of insufficient level at the time of my inspection

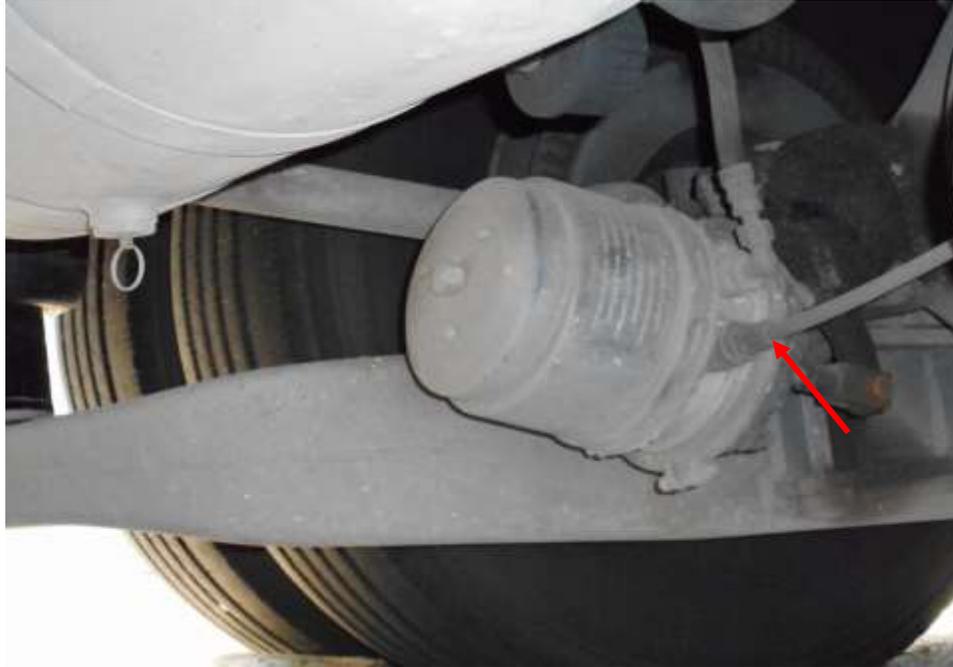
Photo 14 shows the brake pipe (arrowed) at the rear right wheel of the Motor Bus. I did not observe any leakage of brake fluid at the time of my inspection of the Motor Bus. My static tests of the Motor Bus's braking system, along with my visual examination of the various mechanical components in the braking system, had indicated that there was no internal leakage of pressure/vacuum. Hence the braking system of the Motor Bus was likely to be in serviceable condition at the material time of accident.

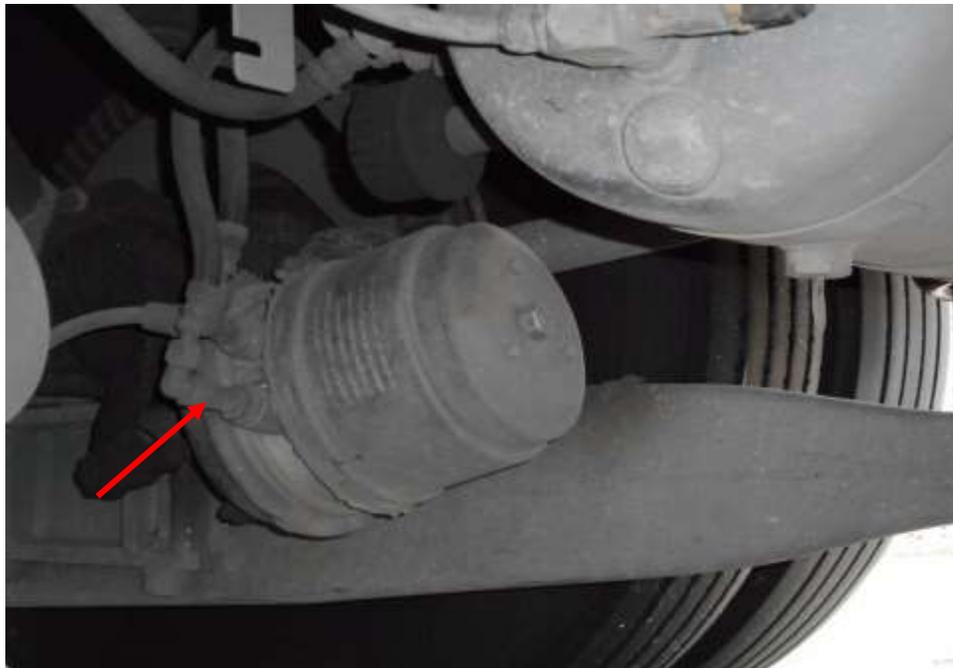
Photo 15 shows the brake pipe (arrowed) at the rear left wheel of the Motor Bus. I did not observe any leakage of brake fluid at the time of my inspection of the Motor Bus. My static tests of the Motor Bus's braking system, along with my visual examination of the various mechanical components in the braking system, had indicated that there was no internal leakage of pressure/vacuum. Hence the braking system of the Motor Bus was likely to be in serviceable condition at the material time of accident.

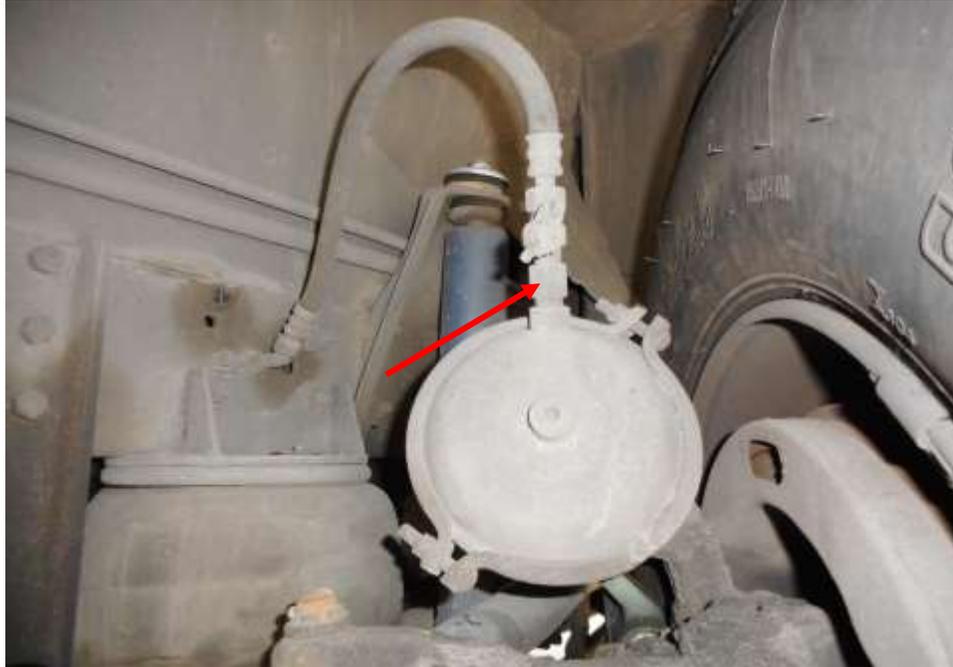
Photo 16 shows the brake pipe (arrowed) at the front right wheel of the Motor Bus. I did not observe any leakage of brake fluid at the time of my inspection of the Motor Bus. My static tests of the Motor Bus's braking system, along with my visual examination of the various mechanical components in the braking system, had indicated that there was no internal leakage of pressure/vacuum. Hence the braking system of the Motor Bus was likely to be in serviceable condition at the material time of accident.

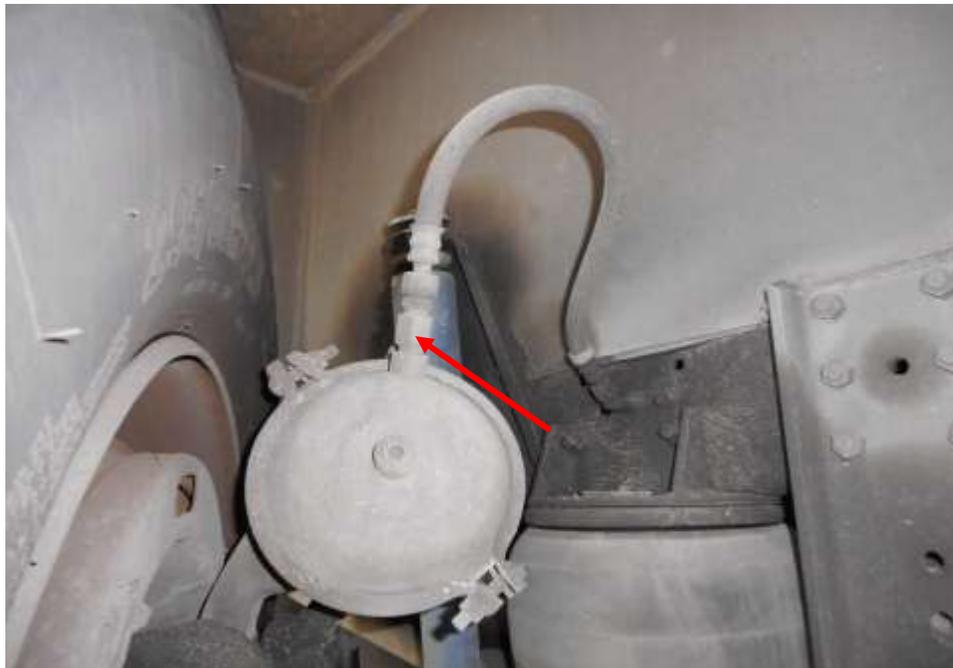
Photo 17 shows the brake pipe (arrowed) at the front left wheel of the Motor Bus. I did not observe any leakage of brake fluid at the time of my inspection of the Motor Bus. My static tests of the Motor Bus's braking system, along with my visual examination of the various mechanical components in the braking system had indicated that there was no internal leakage of pressure/vacuum. Hence the braking system of the Motor Bus was likely to be in serviceable condition at the material time of accident.

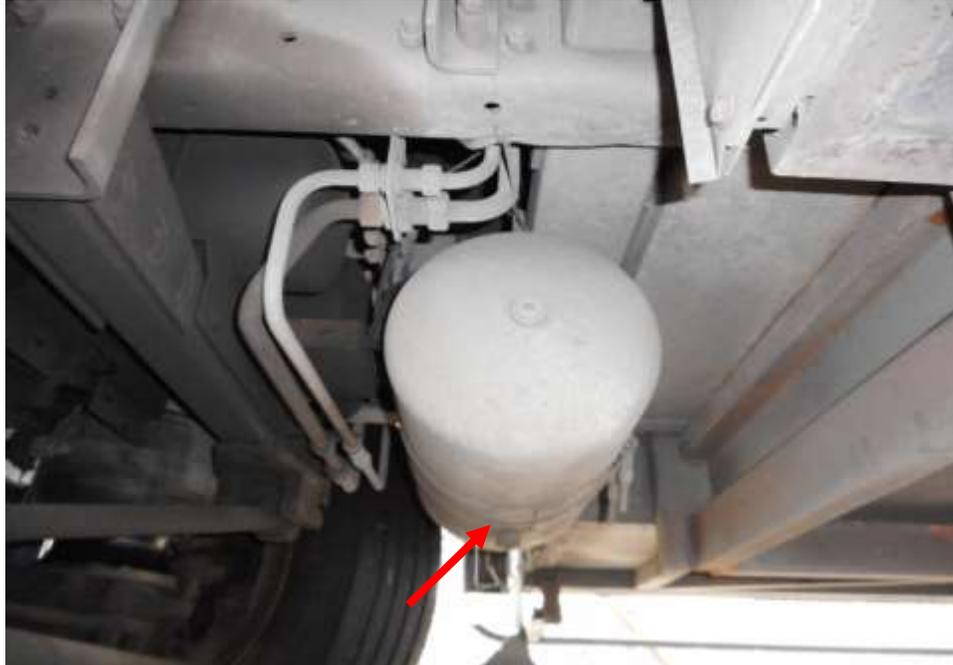
Photo 18 shows the air brake cylinder (arrowed) at the undercarriage of the Motor Bus. I did not observe any leakage of air brake fluid at the time of my inspection of the Motor Bus. My static tests of the Motor Bus braking system, along with my visual examination of the various mechanical components in the braking system had indicated that there was no internal leakage of pressure/vacuum. Hence the braking system of the Motor Bus was likely to be in serviceable condition at the material time of accident.

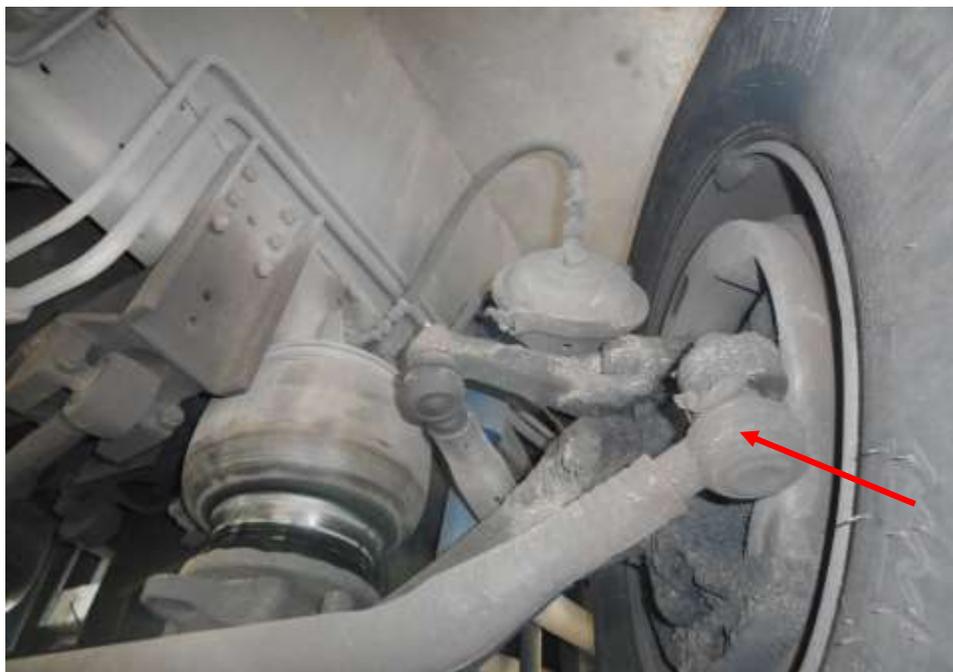
Photo 19 shows the various undercarriage components at the front right wheel of the Motor Bus, in particular the steering tie rod end (arrowed). The various steering components were all found to be intact, suggesting that the steering system of the Motor Bus was likely to be in serviceable condition at the material time of accident. There was also no sign of fluid stain(s) observed on the various undercarriage components.

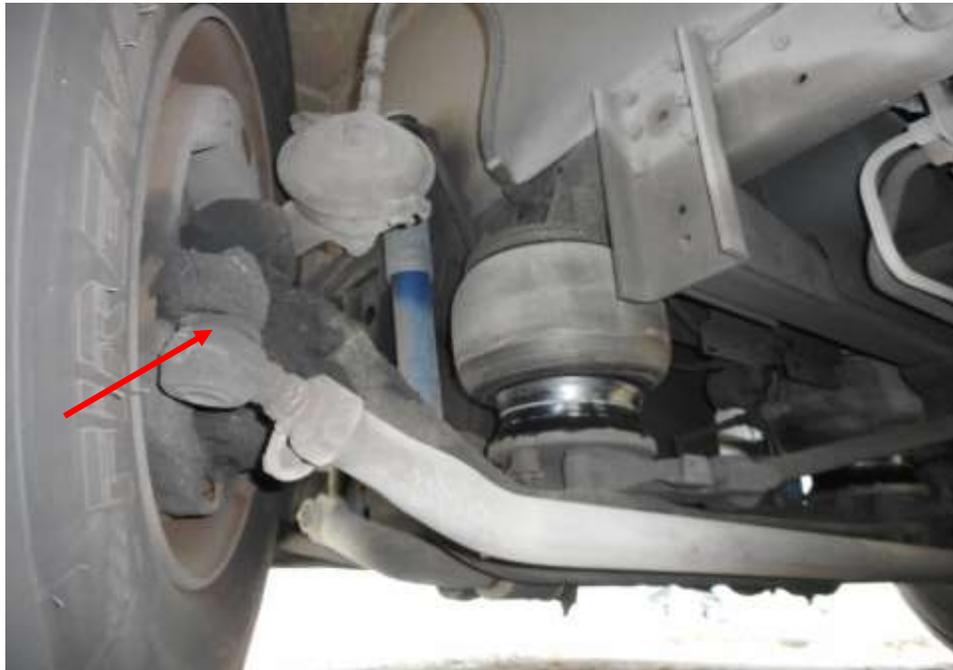
Photo 20 shows the various undercarriage components at the front left wheel of the Motor Bus, in particular the steering tie rod end (arrowed). The various undercarriage components of the Motor Bus were all found to be intact without any visible damage. There was also no sign of fluid stain(s) observed on the various undercarriage components.

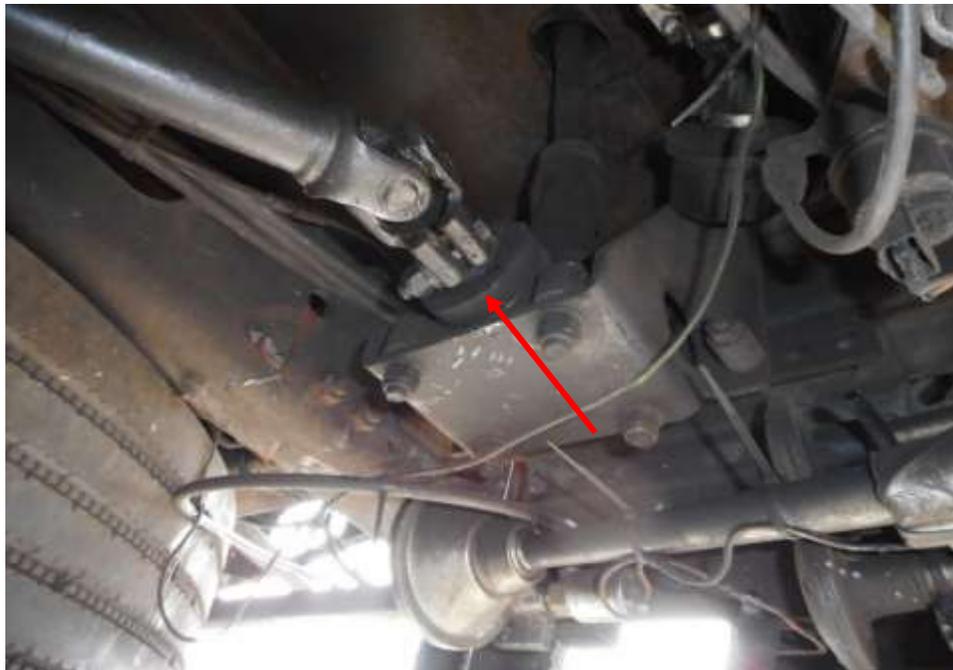
Photo 21 shows the steering box component (arrowed) at the undercarriage of the Motor Bus was found to be intact without any visible damage. There was also no sign of fluid stain(s) observed on the various undercarriage components.

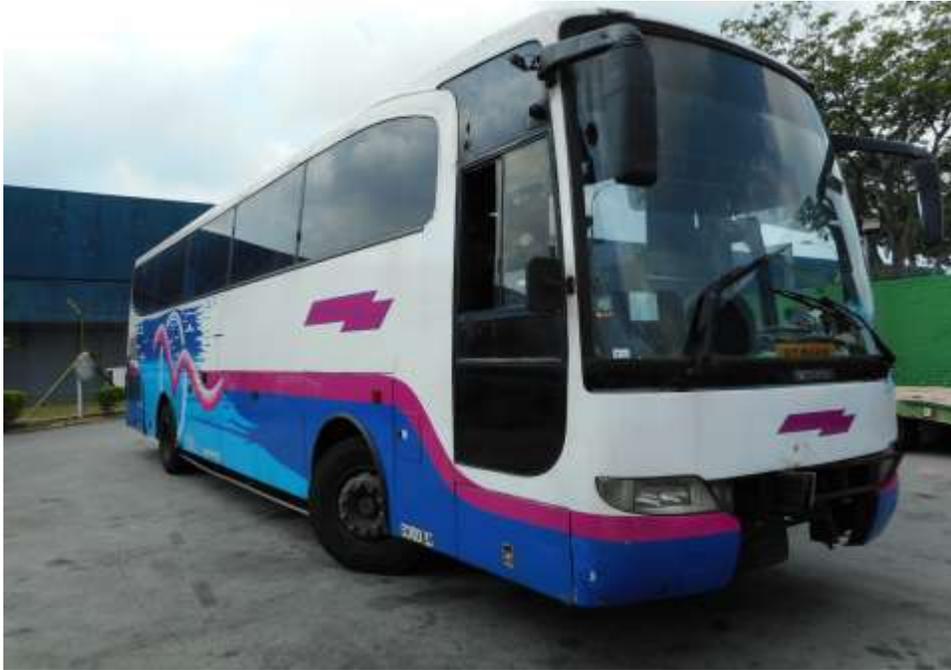
Photo 22 shows the front right wheel of the Motor Bus turned to its full left. During my steering system test, I did not experience any abnormal free play and/or resistance when I had turned the steering wheel towards full left and full right. This would suggest that the steering system of the Motor Bus was likely to be in serviceable condition at the material time of accident.
