Your Ref: TP/IP/37529/2019
Our Ref : CI/TPD19011812/P

Fatal Accident Investigation Team

MECHANICAL INSPECTION REPORT OF MOTOR BUS SBS 3351T

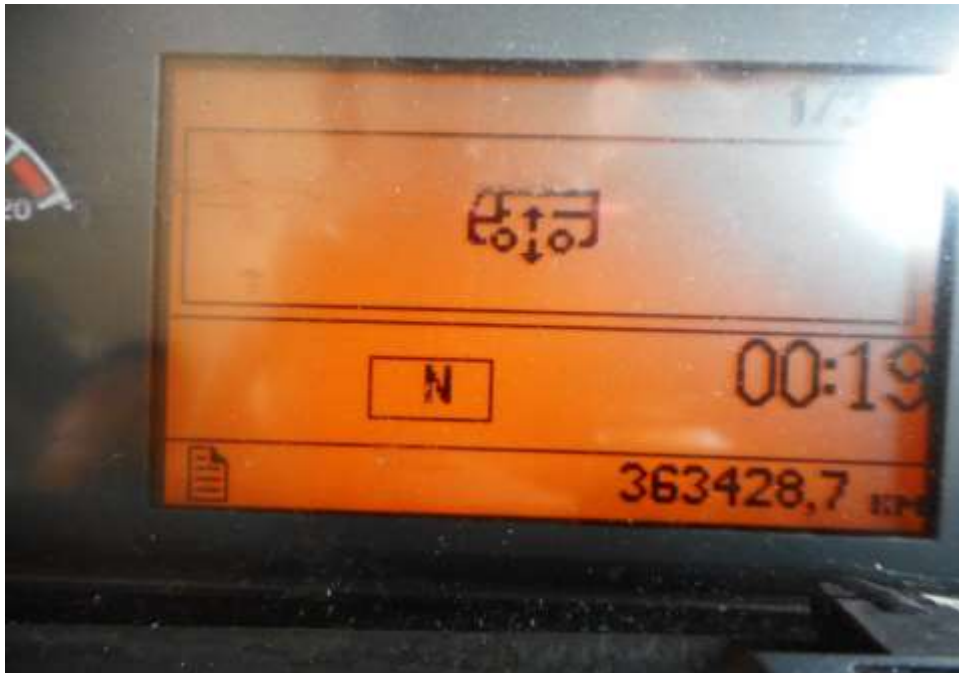
4. The mileage of the Motor Bus at the time of my inspection was 363,428km.
5. The Motor Bus was observed to have sustained damages at its front portion. Its front windscreen body panel, front body panel, front right bumper and front right headlight was damaged as a result of the accident at the time of my inspection.

Photo 1 shows a general view of the instrument cluster of the Motor Bus at the time of my inspection. The mileage of the Motor Bus was 363,428km

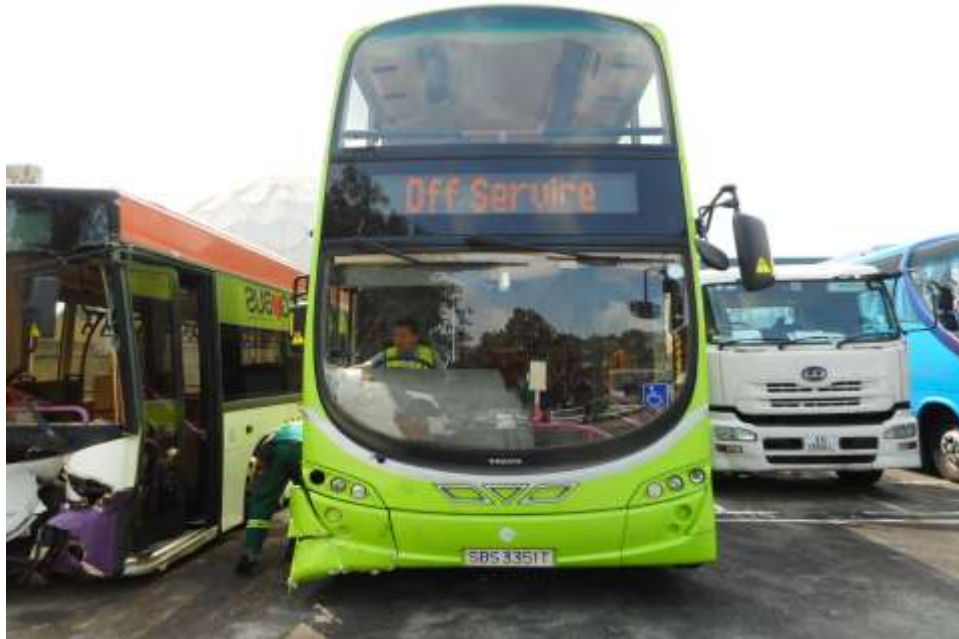
Photo 2 shows a general view of the front body of the Motor Bus at the time of my inspection. The Motor Bus sustained damages at its front portion. Its front windscreen, front body panel, front right bumper and front right headlight was damaged as a result of the accident at the time of my inspection.

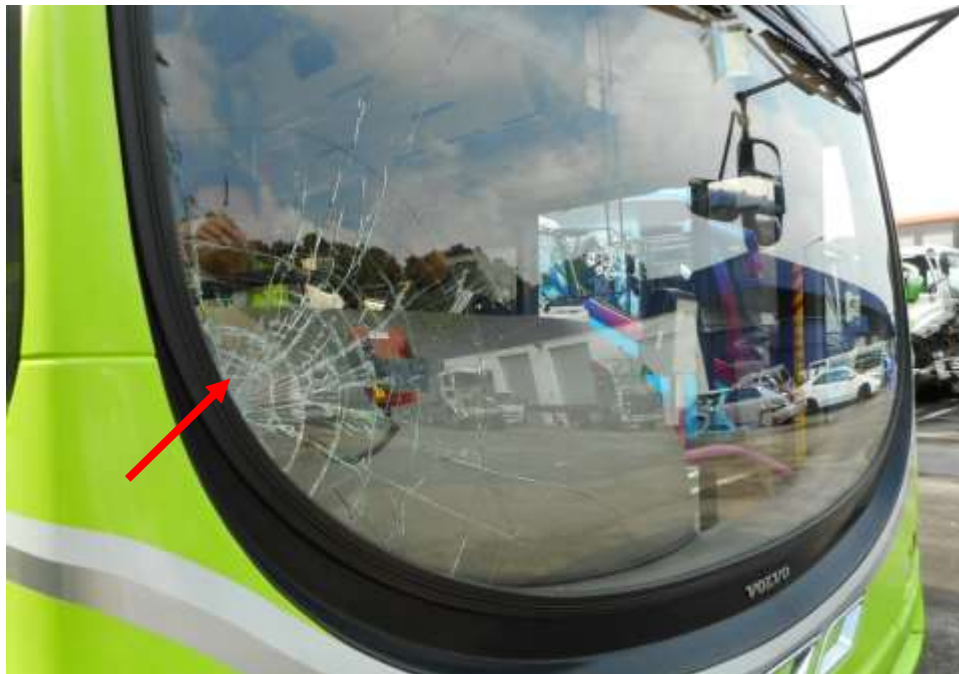
Photo 3 shows a close up view of the front body of the Motor Bus at the time of my inspection. Its front windscreen (arrowed) was damaged as a result of the accident at the time of my inspection.

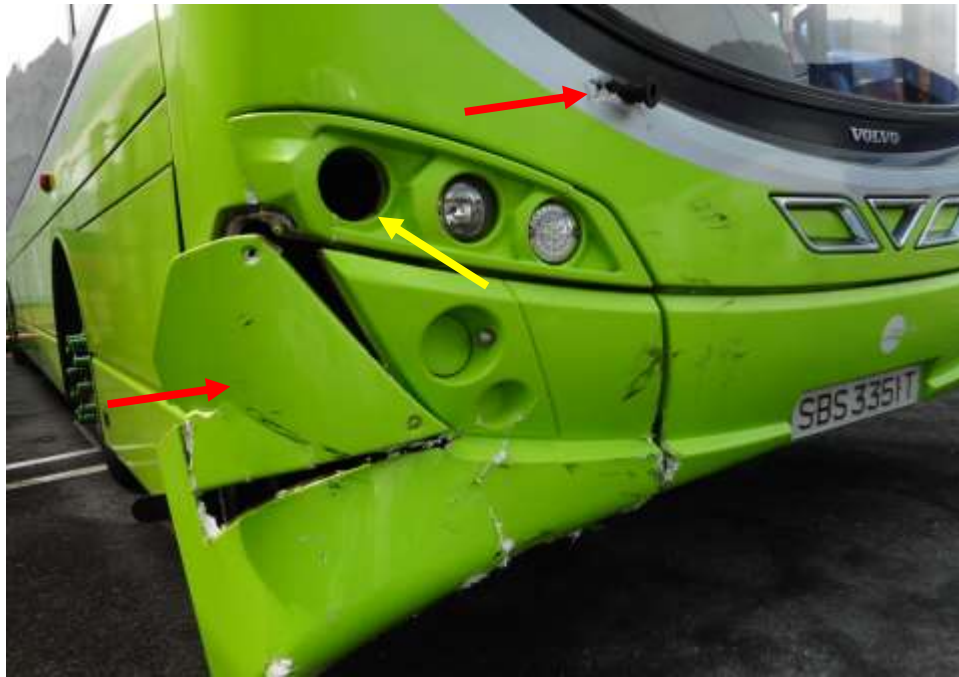
Photo 4 shows a close up view of the front left wheel of the Motor Bus at the time of my inspection. Its front body panel, front right bumper (red arrow) and front right headlight (yellow arrow) was damaged as a result of the accident at the time of my inspection.

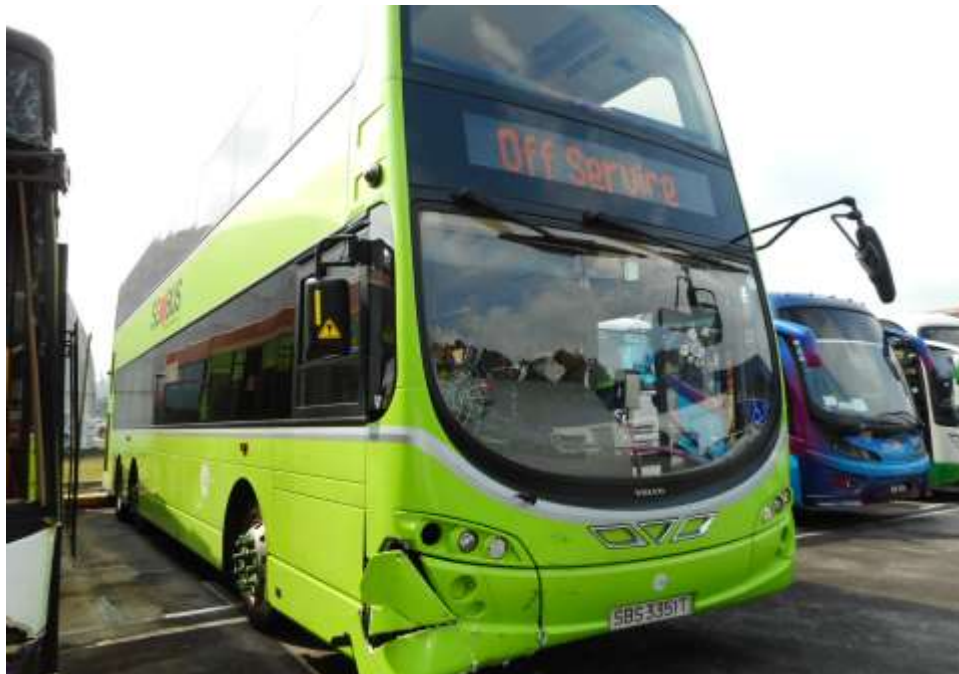
Photo 5 shows a general view of the right body of the Motor Bus at the time of my inspection. The Motor Bus was observed to be in good general condition and unaffected by the accident.

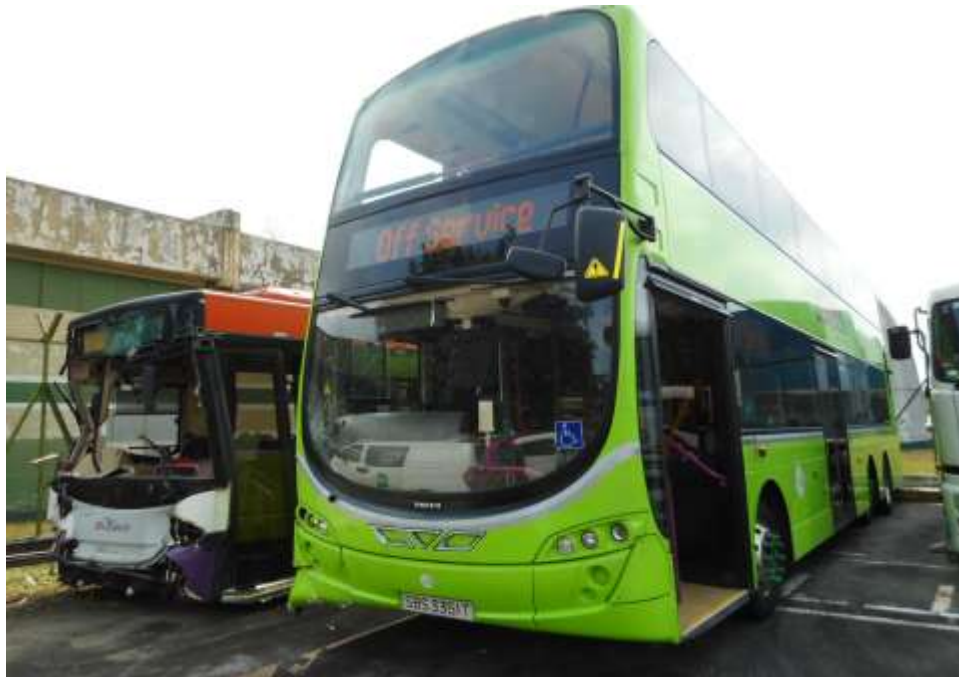
Photo 6 shows a general view of the left body of the Motor Bus at the time of my inspection. The Motor Bus was observed to be in good general condition and unaffected by the accident.

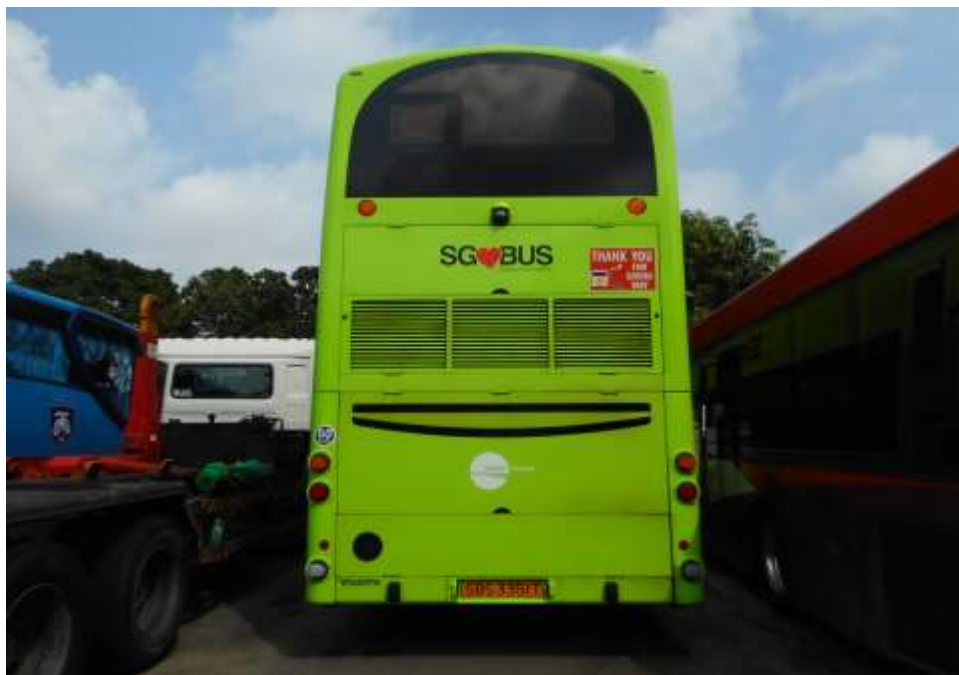
Photo 7 shows a general view of the Motor Bus's rear body at the time of my inspection. The Motor Bus was observed to be in good general condition and unaffected to by the accident.

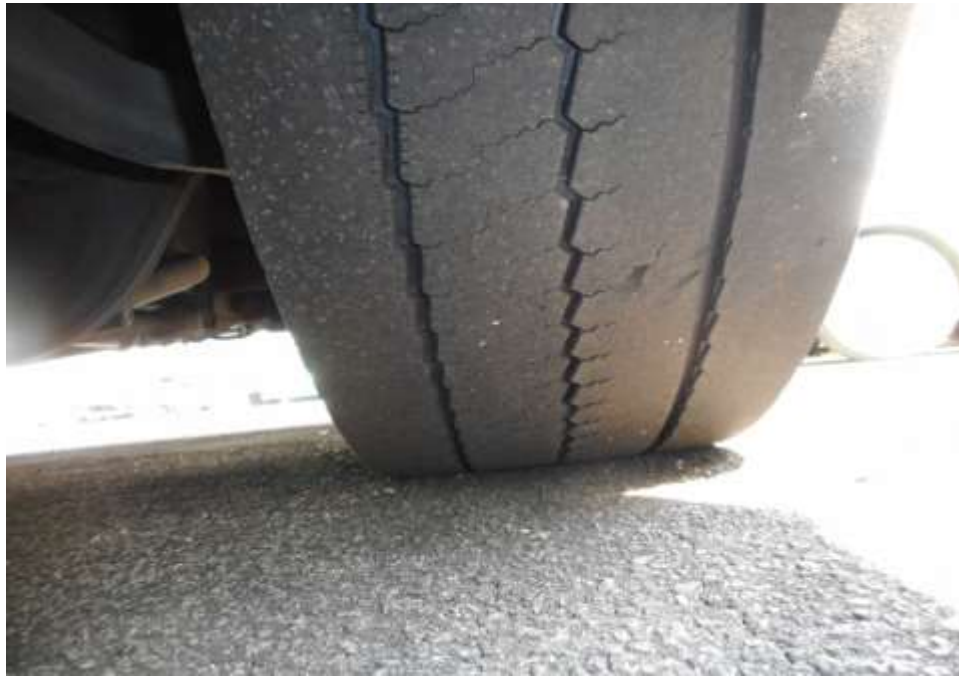
Photo 8 shows the condition of the front right tyre of the Motor Bus, which was observed to be in serviceable condition with remaining tread depth of approximately 6.9mm. The tyre, which was wrapped around standard steel wheel rim, was also observed to be sufficiently inflated for vehicular operation. There was no tear, cut or burst mark(s) on the outer and the inner sidewalls as well as across the tread of the 10 tyres that were fitted on the Motor Bus.

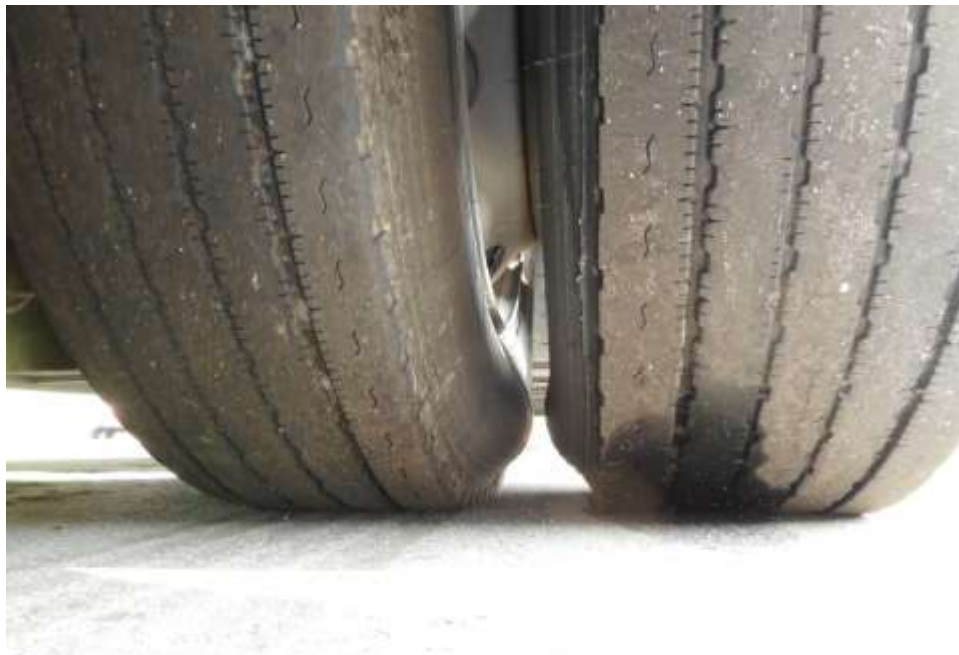
Photo 9 shows the condition of the rear right tyre of the Motor Bus, which was observed to be in serviceable condition with remaining tread depth of approximately 12.7mm. The tyre, which was wrapped around standard steel wheel rim, was also observed to be sufficiently inflated for vehicular operation.

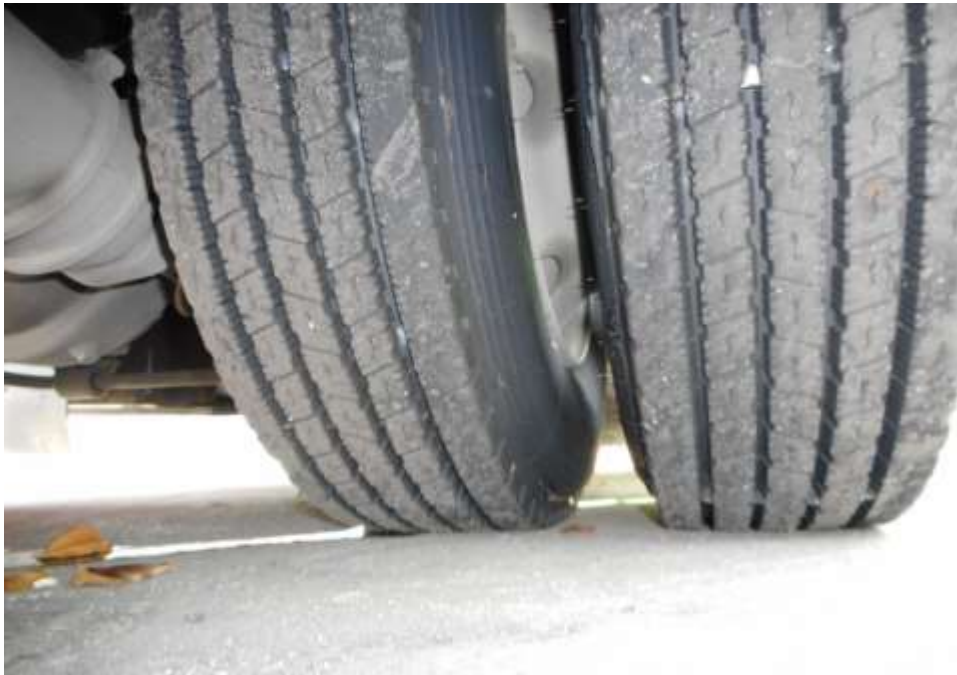
Photo 10 shows the condition of the rear left tyres of the Motor Bus, which was observed to be in serviceable condition with remaining tread depth of approximately 12.8mm. The tyres, which were wrapped around standard steel wheel rim, were also observed to be sufficiently inflated for vehicular operation. There was also no damage found on all 10 steel wheel rims of the Motor Bus.

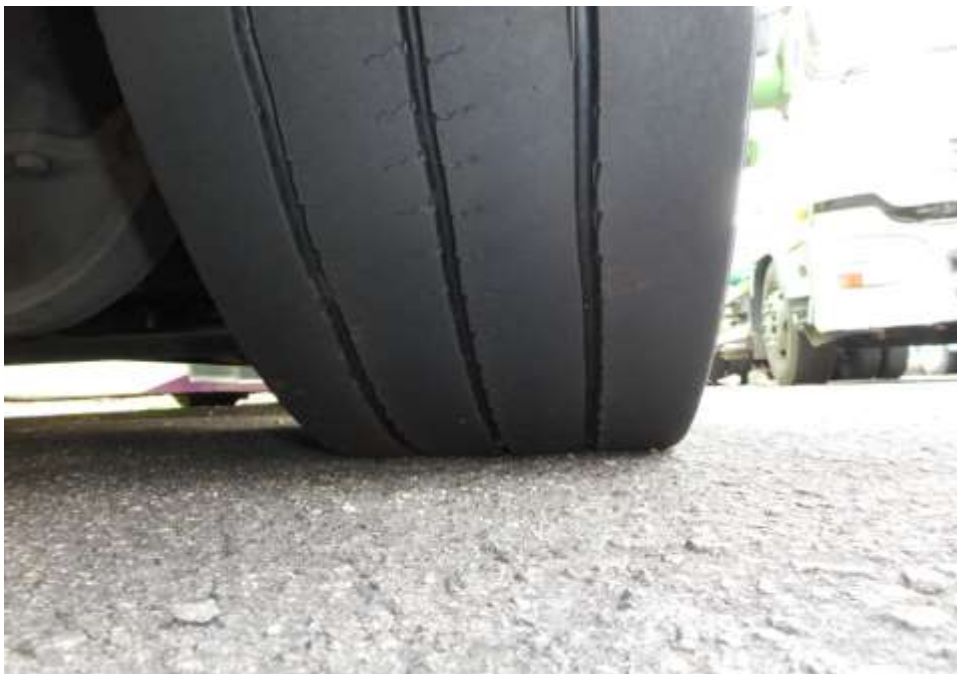
Photo 11 shows the condition of the front left tyres of the Motor Bus, which were observed to be in serviceable condition with remaining tread depth of approximately 7.3mm. There was also no tear, cut or burst mark(s) on the outer and the inner sidewalls as well as across the tread of the 10 tyres that were fitted on the Motor Bus.

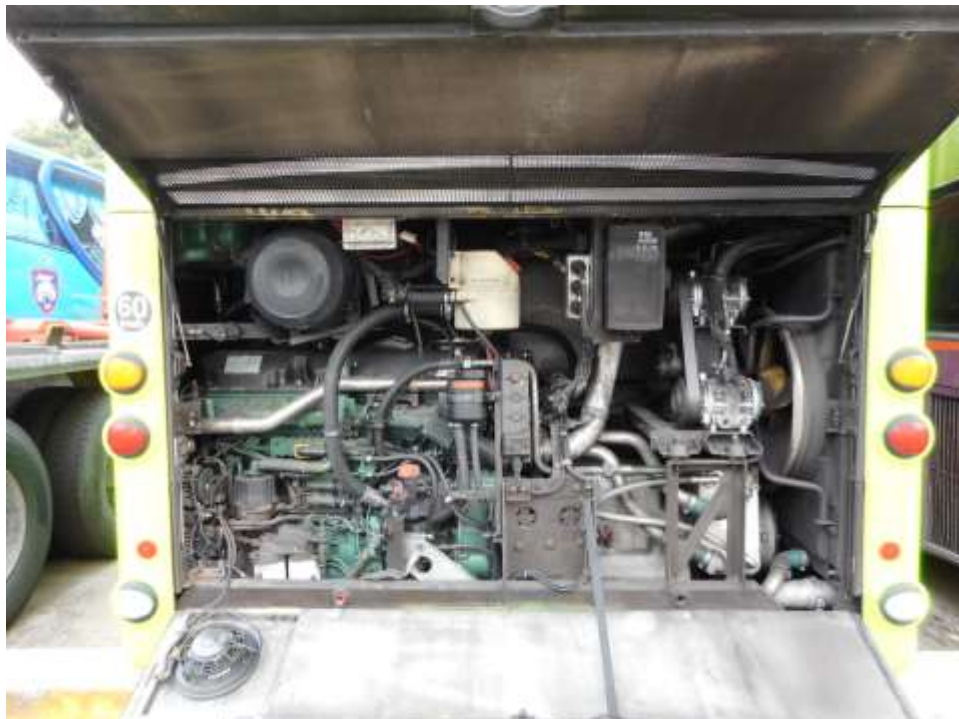
Photo 12 shows a general view of the Motor Bus's engine compartment, which was accessed by lifting the front cabin of the Motor Bus. The various parts and components inside the engine compartment were unaffected by the accident. There was also no sign(s) or indication(s) of fresh fluid leakage and/or fluid stain within the engine compartment

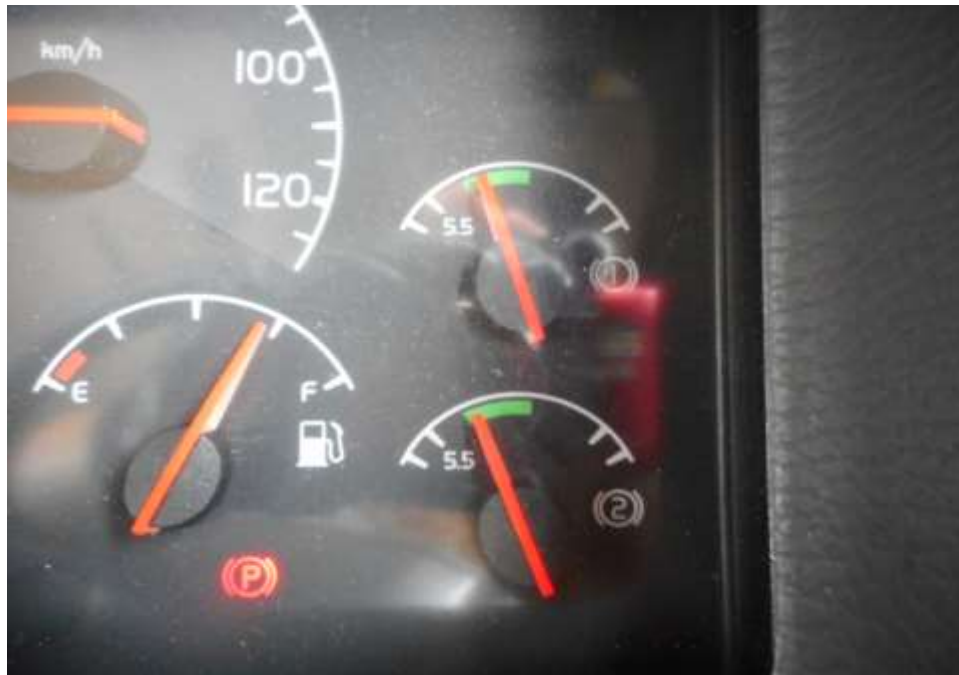
Photo 13 shows the air in the air brake cylinder of the Motor Bus at the time of my inspection. The air in the cylinder was observed to be of sufficient level & serviceable at the time of the accident.

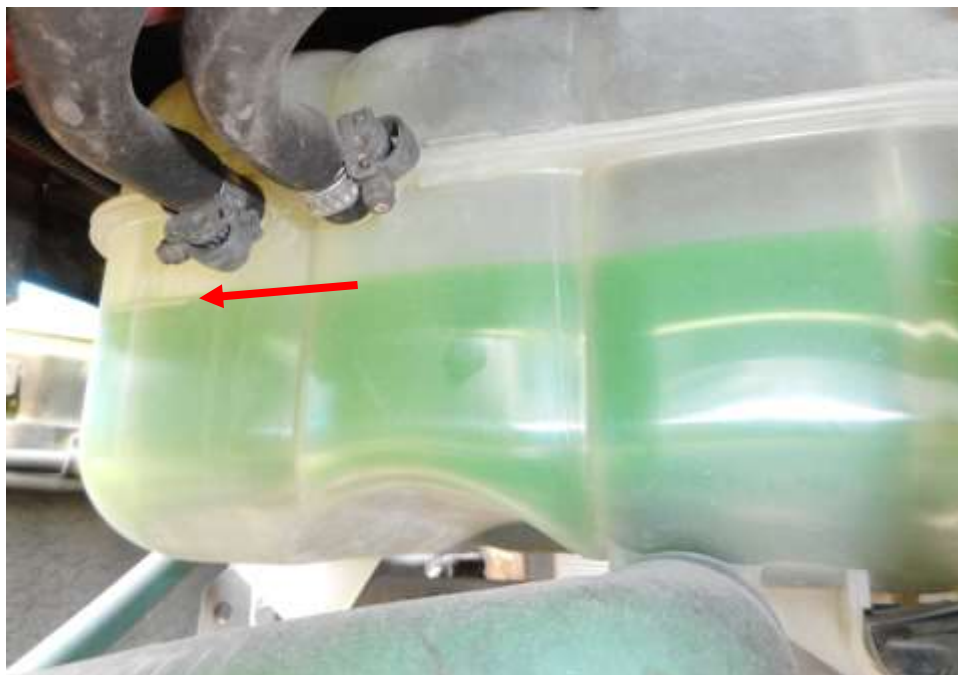
Photo 14 shows the engine coolant reservoir of the Motor Bus at the time of my inspection. The engine coolant was observed to be of sufficient level (arrowed) and without any visible contamination.

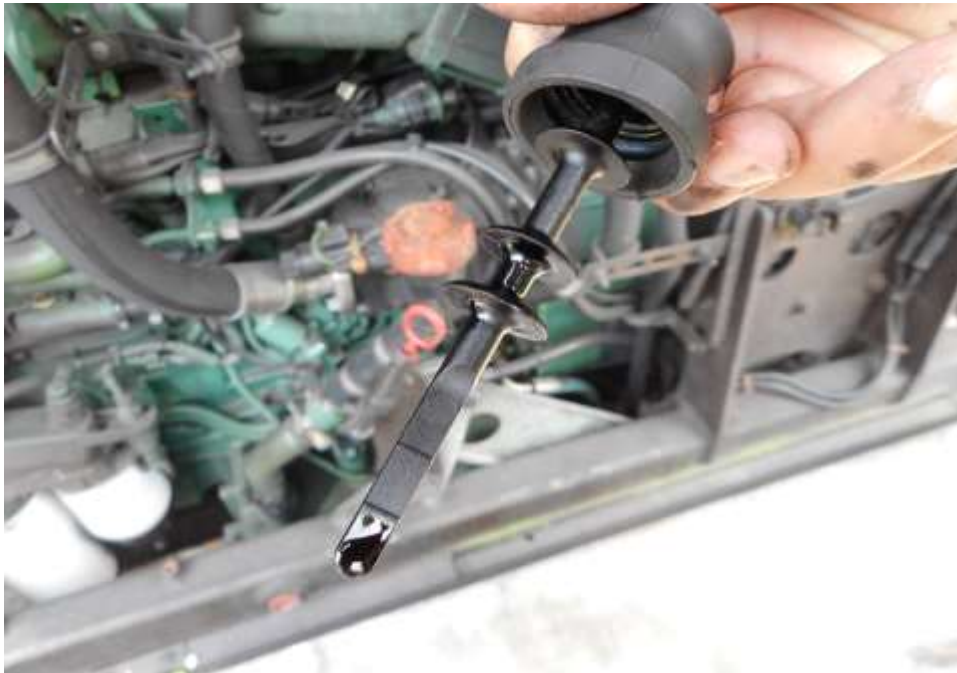
Photo 15 shows the power steering fluid reservoir of the Motor Bus at the time of my inspection. The power steering fluid was observed to be of sufficient level and without any visible contamination.

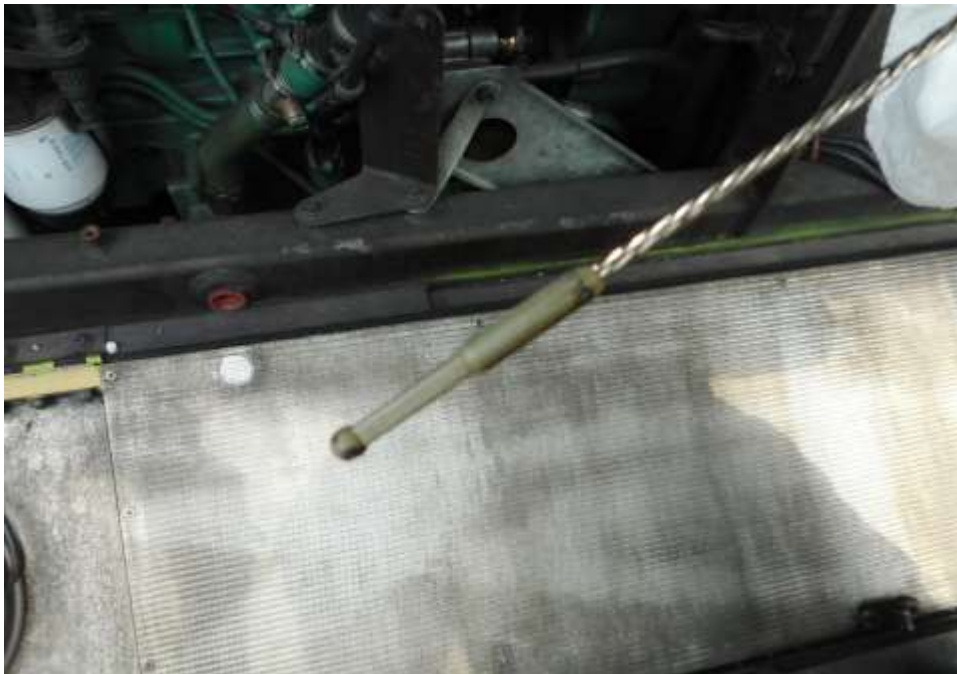
Photo 16 shows the engine oil dip stick system of the Motor Bus at the time of my inspection. The engine oil was observed to be of in the lower level but sufficient for operation and without any visible contamination.

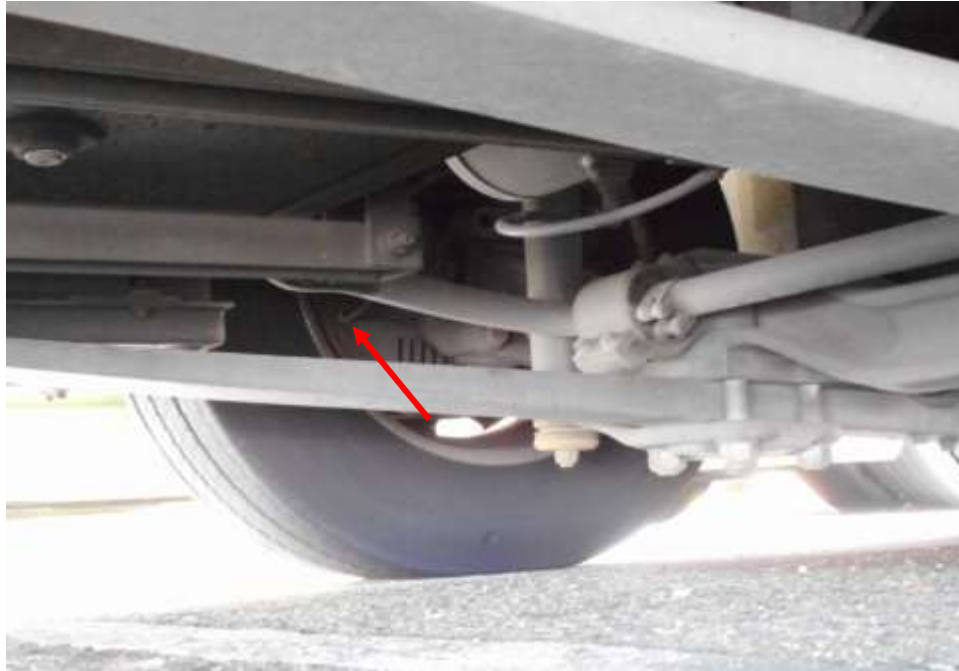
Photo 17 shows the brake pipe (arrowed) at the rear right wheel of the Motor Bus. I did not observe any leakage of brake fluid at the time of my inspection of the Motor Bus. My static tests of the Motor Bus's braking system, along with my visual examination of the various mechanical components in the braking system, had indicated that there was no internal leakage of pressure/vacuum. Hence the braking system of the Motor Bus was likely to be in serviceable condition at the material time of accident.

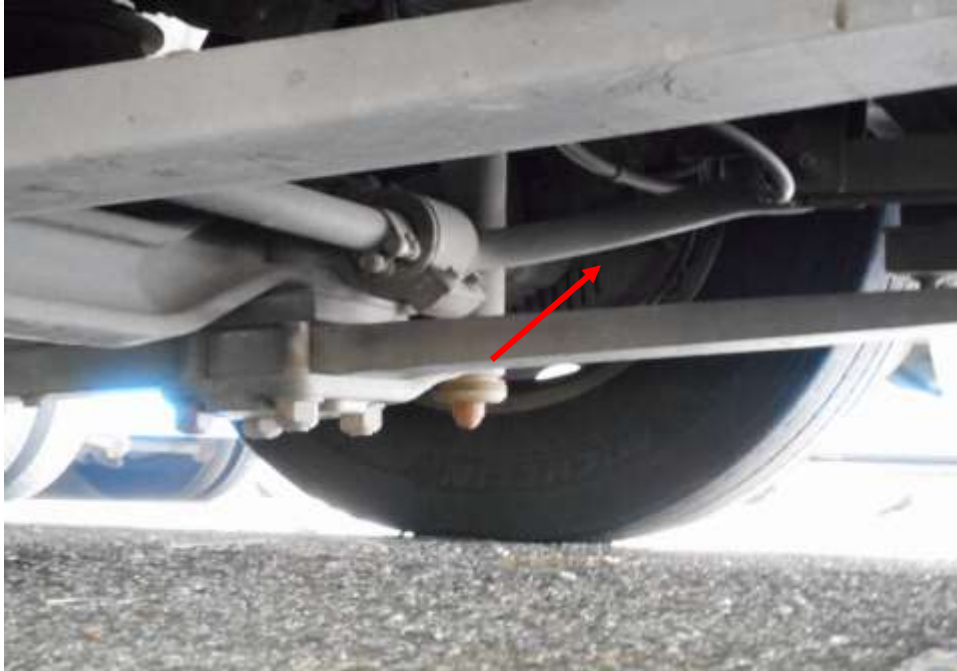
Photo 18 shows the brake pipe (arrowed) at the rear left wheel of the Motor Bus. I did not observe any leakage of brake fluid at the time of my inspection of the Motor Bus. My static tests of the Motor Bus's braking system, along with my visual examination of the various mechanical components in the braking system, had indicated that there was no internal leakage of pressure/vacuum. Hence the braking system of the Motor Bus was likely to be in serviceable condition at the material time of accident.

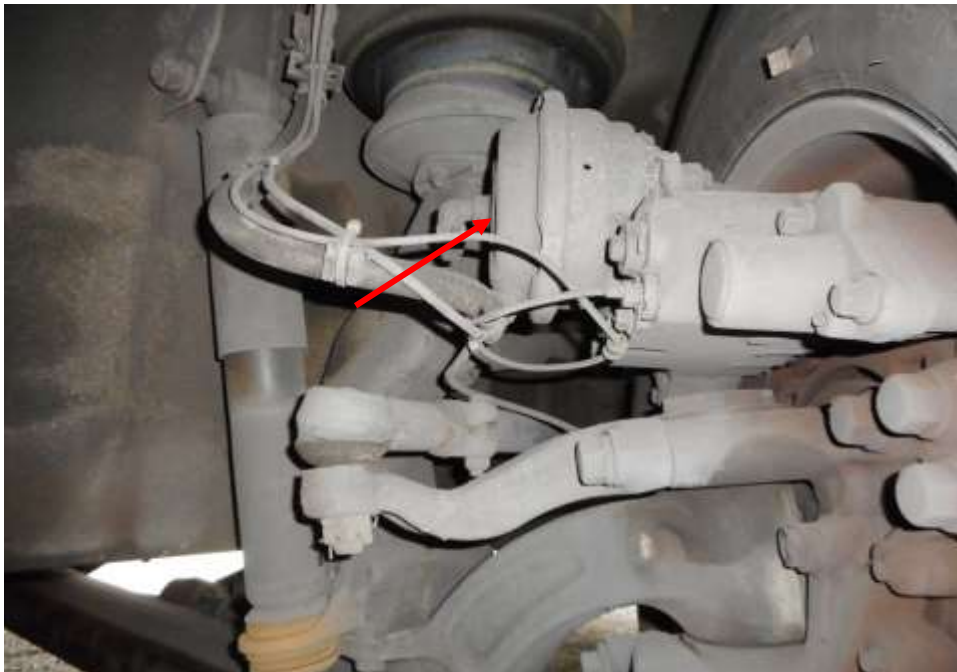
Photo 19 shows the brake pipe (arrowed) at the front right wheel of the Motor Bus. I did not observe any leakage of brake fluid at the time of my inspection of the Motor Bus. My static tests of the Motor Bus's braking system, along with my visual examination of the various mechanical components in the braking system, had indicated that there was no internal leakage of pressure/vacuum. Hence the braking system of the Motor Bus was likely to be in serviceable condition at the material time of accident.

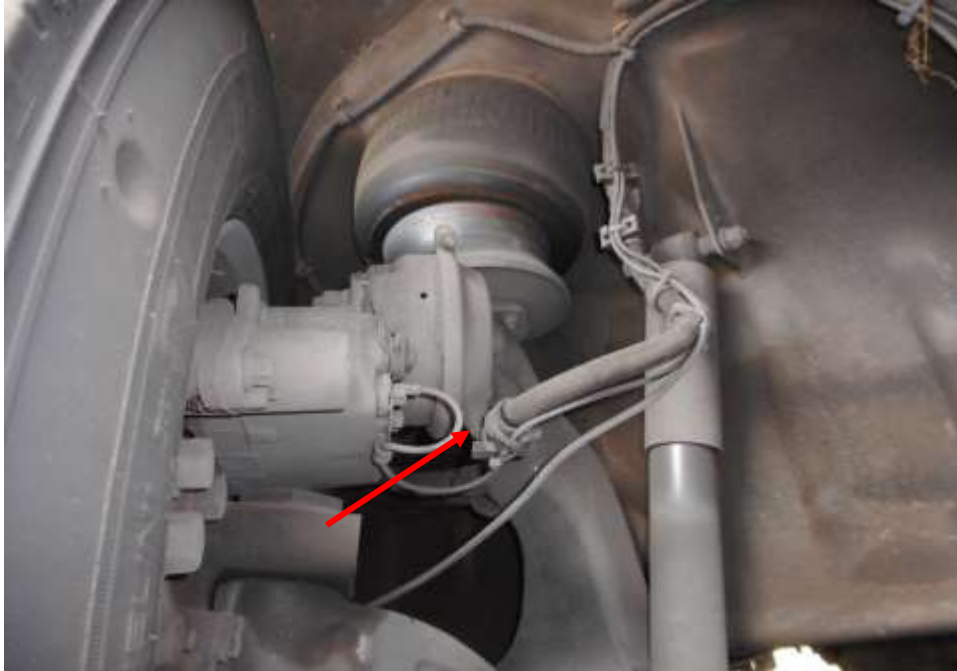
Photo 20 shows the brake pipe (arrowed) at the front left wheel of the Motor Bus. I did not observe any leakage of brake fluid at the time of my inspection of the Motor Bus. My static tests of the Motor Bus's braking system, along with my visual examination of the various mechanical components in the braking system had indicated that there was no internal leakage of pressure/vacuum. Hence the braking system of the Motor Bus was likely to be in serviceable condition at the material time of accident.

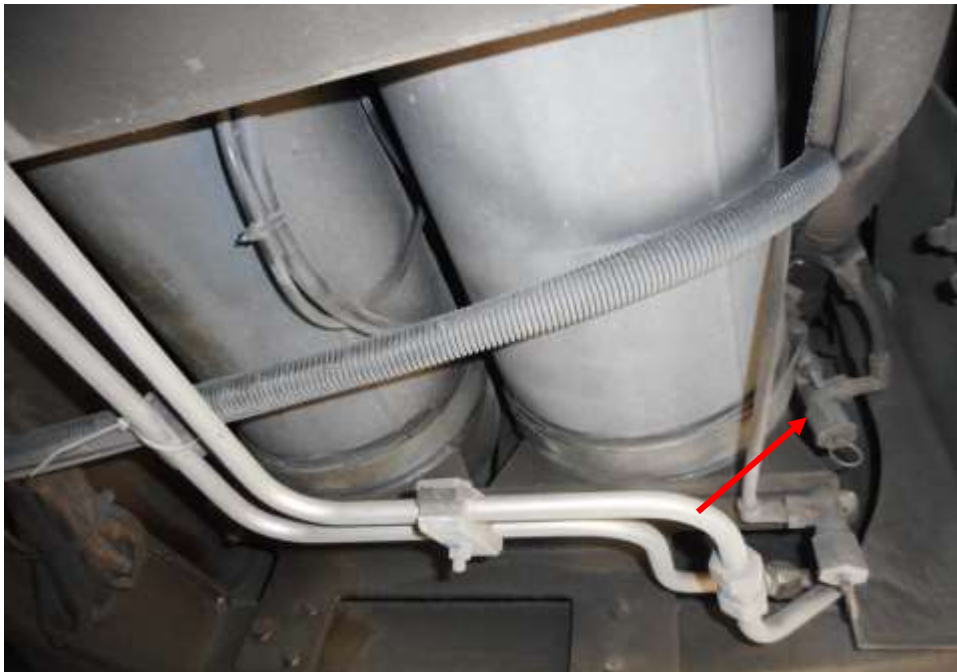
Photo 21 shows the air brake cylinder (arrowed) at the undercarriage of the Motor Bus. I did not observe any leakage of air brake fluid at the time of my inspection of the Motor Bus. My static tests of the Motor Bus's braking system, along with my visual examination of the various mechanical components in the braking system had indicated that there was no internal leakage of pressure/vacuum. Hence the braking system of the Motor Bus was likely to be in serviceable condition at the material time of accident.

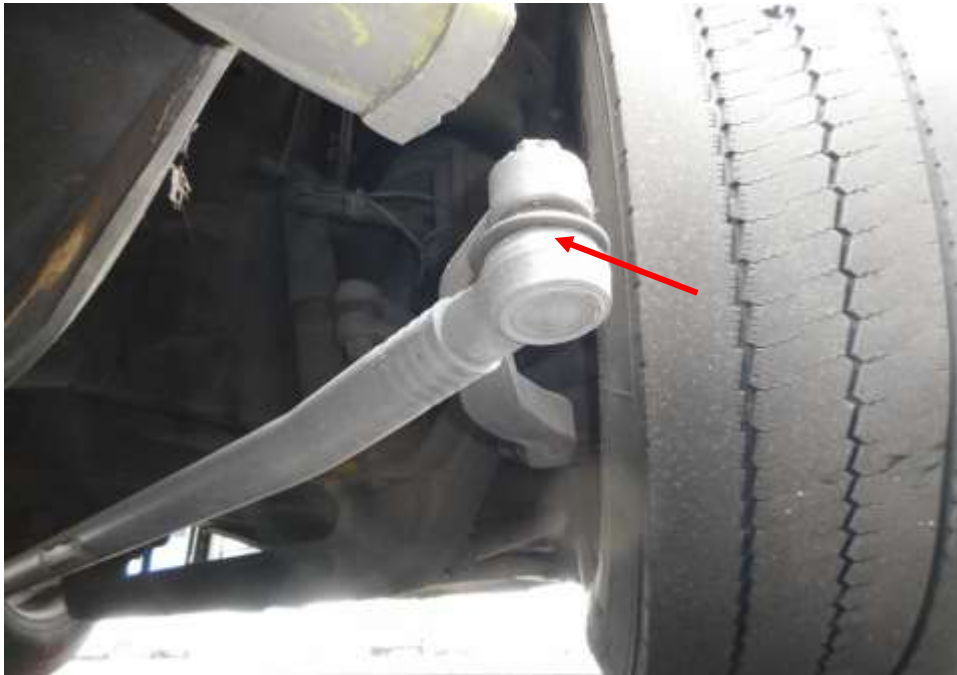
Photo 22 shows the various undercarriage components at the front right wheel of the Motor Bus, in particular the steering tie rod end (arrowed). The various steering components were all found to be intact, suggesting that the steering system of the Motor Bus was likely to be in serviceable condition at the material time of accident. There was also no sign of fluid stain(s) observed on the various undercarriage components.

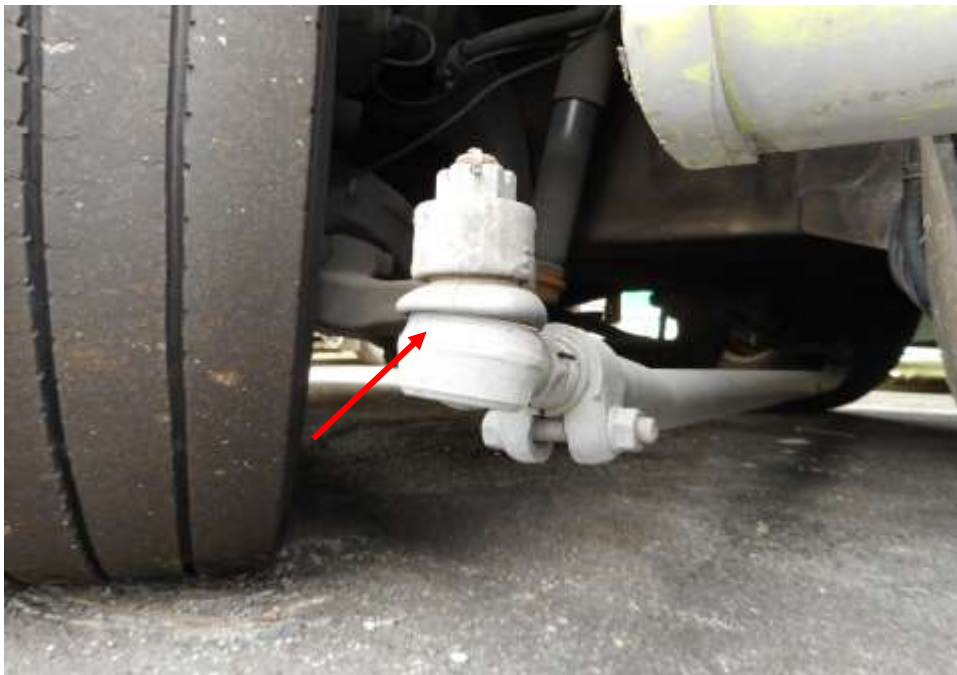
Photo 23 shows the various undercarriage components at the front left wheel of the Motor Bus, in particular the steering tie rod end (arrowed). The various undercarriage components of the Motor Bus were all found to be intact without any visible damage. There was also no sign of fluid stain(s) observed on the various undercarriage components.

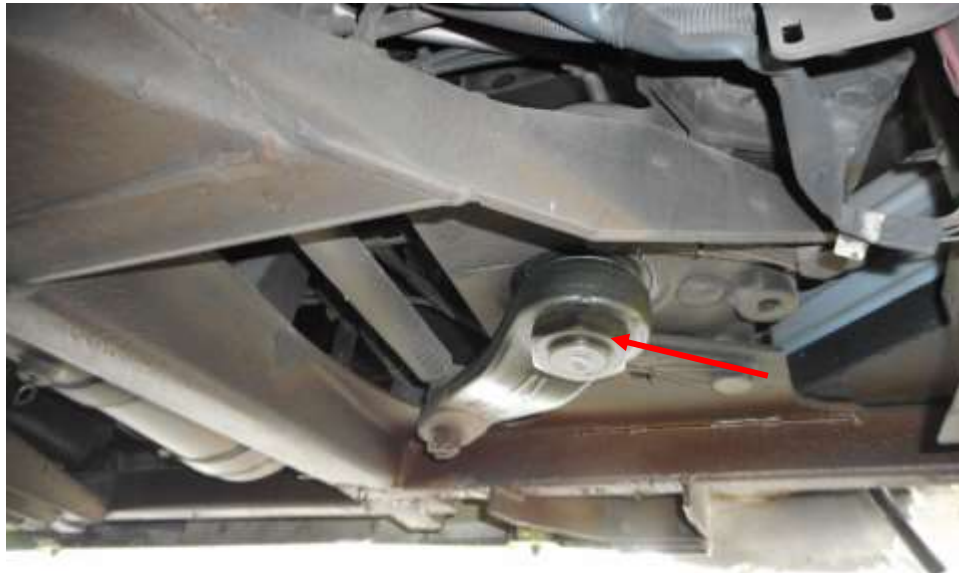
Photo 24 shows the steering box component (arrowed) at the undercarriage of the Motor Bus was found to be intact without any visible damage. There was also no sign of fluid stain(s) observed on the various undercarriage components.

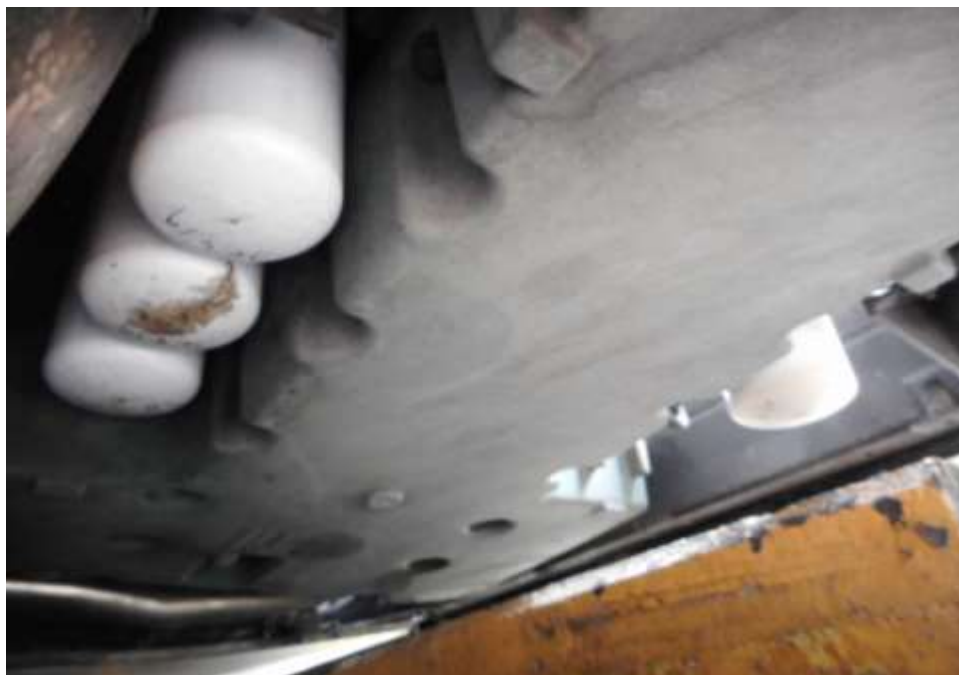
Photo 25 shows the undercarriage of the Motor Bus, at the area where the engine housing located. We observed minor fresh fluid stains on the surface of the engine oil sump. However the Motor Bus is still in serviceable condition.

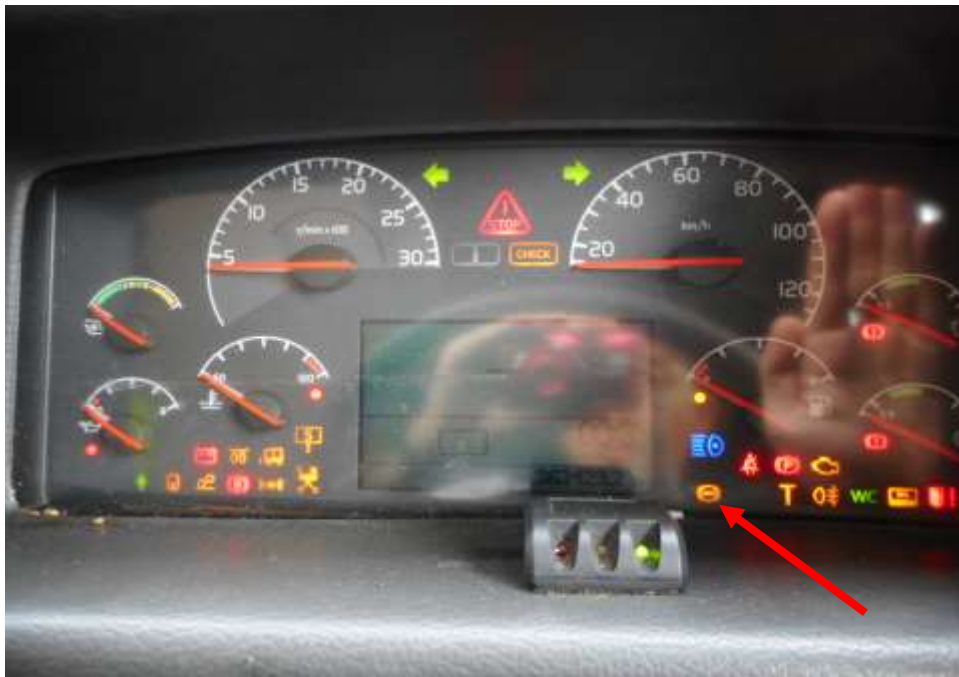
Photo 27 shows the warning light for Anti-Lock Brake System (ABS) appearing on the instrument panel of the Motor Lorry during the self-test of its various electronic operating systems when its engine was cranked.

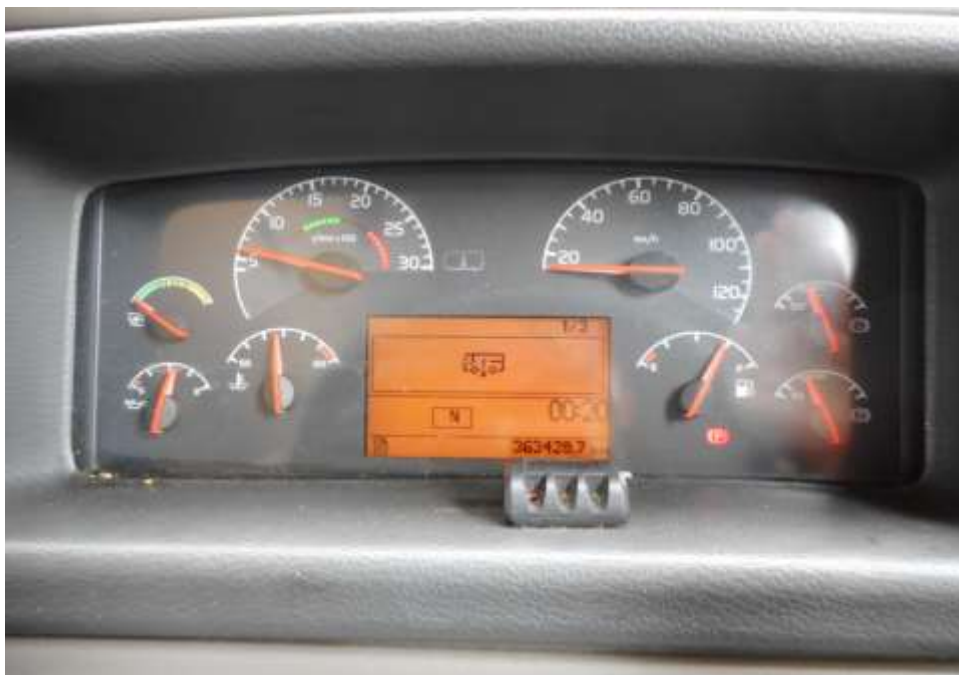
Photo 28 shows no warning lights illuminated on the instrument panel of the Motor Lorry after the engine was cranked. This would suggest that there was no abnormality to the various electronic operating systems of the Motor Lorry, like the ABS
