Your Ref: SBP 1898L
Our Ref : CI/TP19012272/D

AUTOMOBILE INSPECTION REPORT OF MOTOR CAR SBP 1898L

Vehicle Registration No.	: SBP 1898L
Make / Model	: Nissan 200SX
Chassis No	: RS13501587
Year of Registration	: 1990 (December)
Mileage	: 145,033km

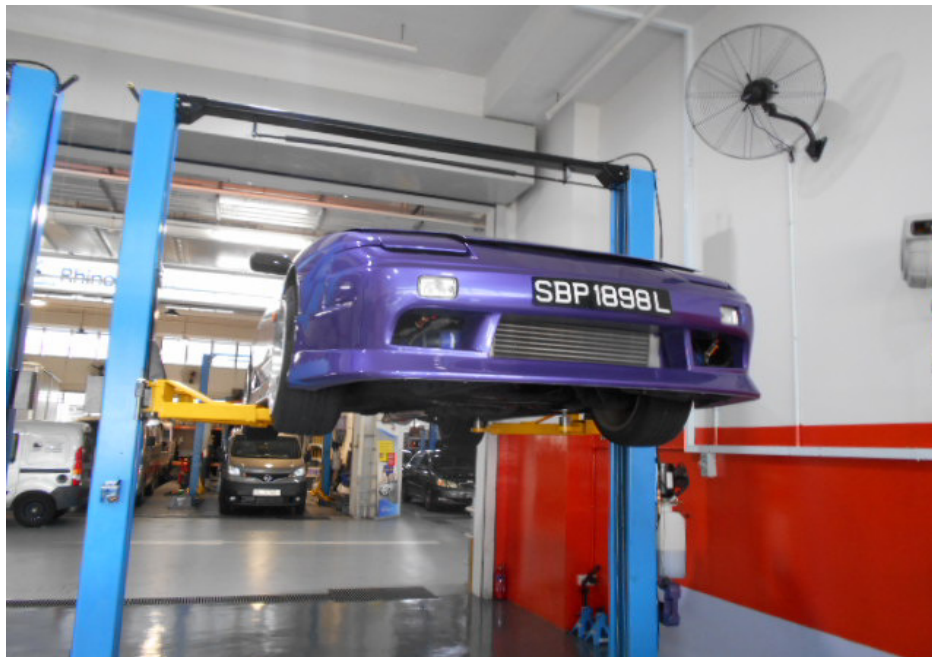
Photo 1 shows the Motor Car hoisted for checks on its undercarriage.

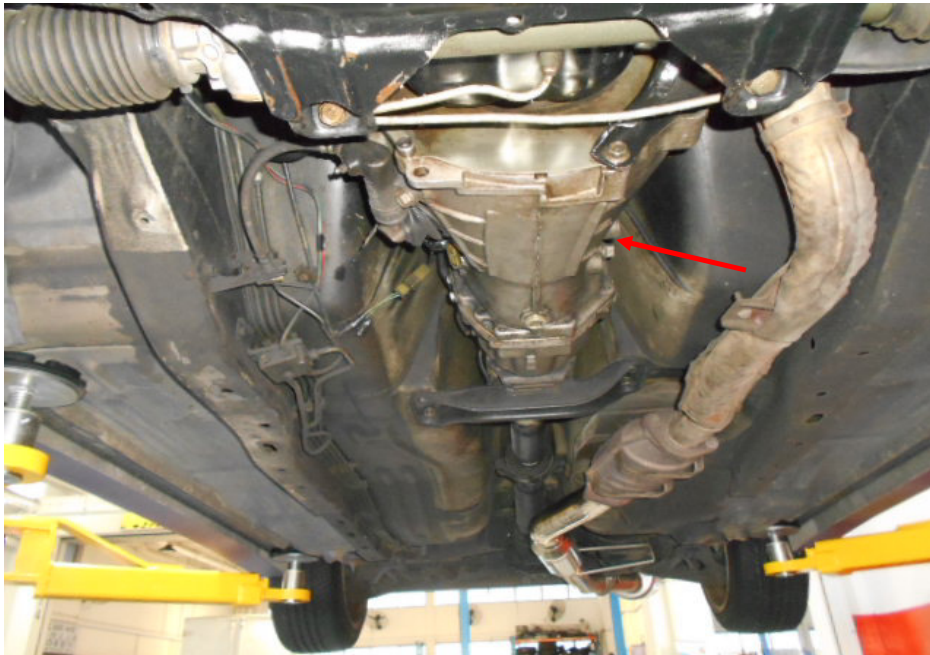
Photo 2 shows a general view of the transmission assembly (arrowed) that was fitted on the Motor Car. The front (input) side of the transmission is bolted to the crankshaft side of the engine block while the rear (output) side of the transmission was connected to the propeller shaft, which links to the rear axle of the Motor Car.

10. In general, the transmission assembly of the Motor Car was found to be secured properly. It was not mounted onto the chassis body or any integral body part of the Motor Car. The structural integrity of the Motor Car is not compromised by the fitment of this particular transmission assembly. Overall, the operating condition of the Motor Car's transmission system was satisfactory throughout the Motor Car's test drive.

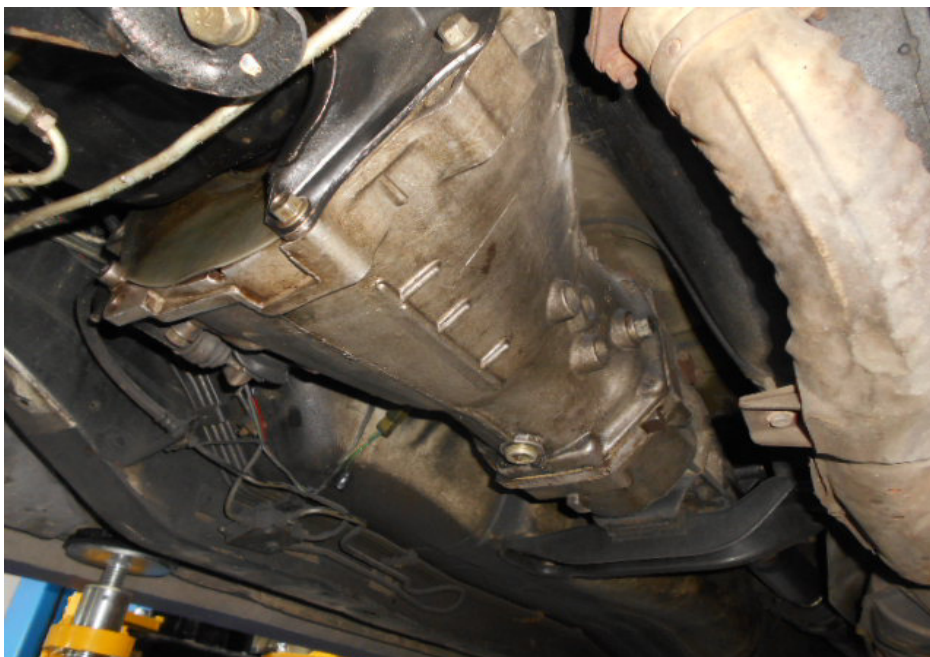
Photo 3 shows the front (input) side of the transmission, which is bolted to the crankshaft side of the Motor Car's engine block.

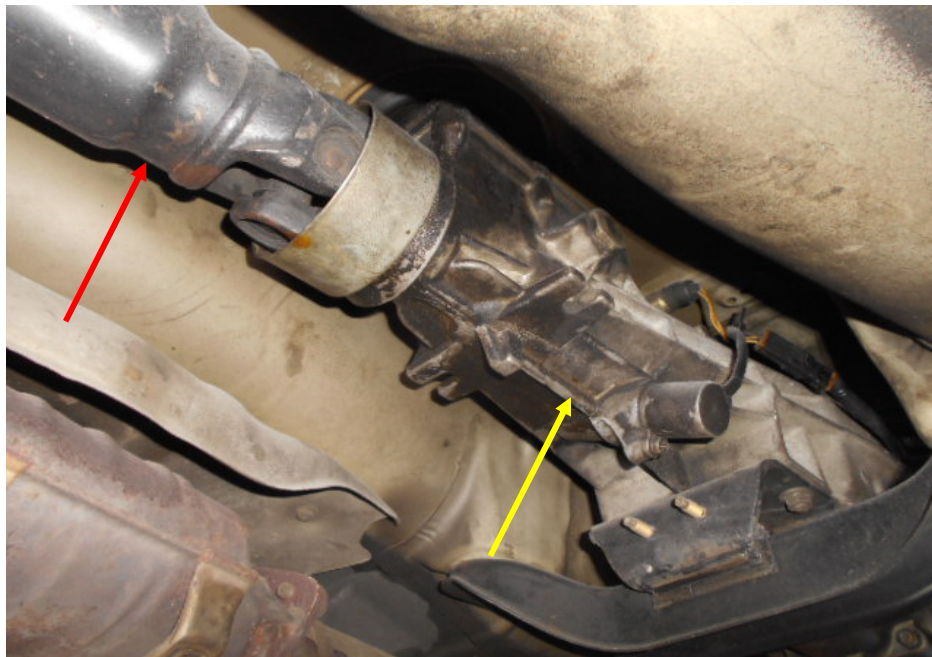
Photo 4 shows the rear (output) side of the transmission (yellow arrow), which connects to the propeller shaft (red arrow) that links to the rear axle of the Motor Car.

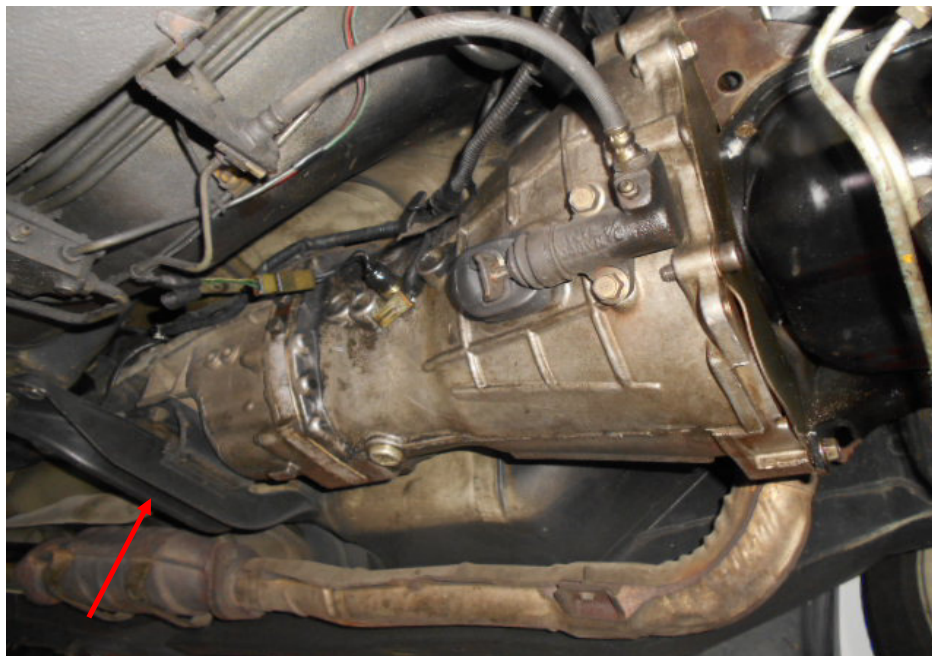
Photo 5 shows a general view of the bracket (arrowed) mounted to the underside of the floor board of the Motor Car, via bolts and nuts. The bracket supports the rear (output) side of the transmission.

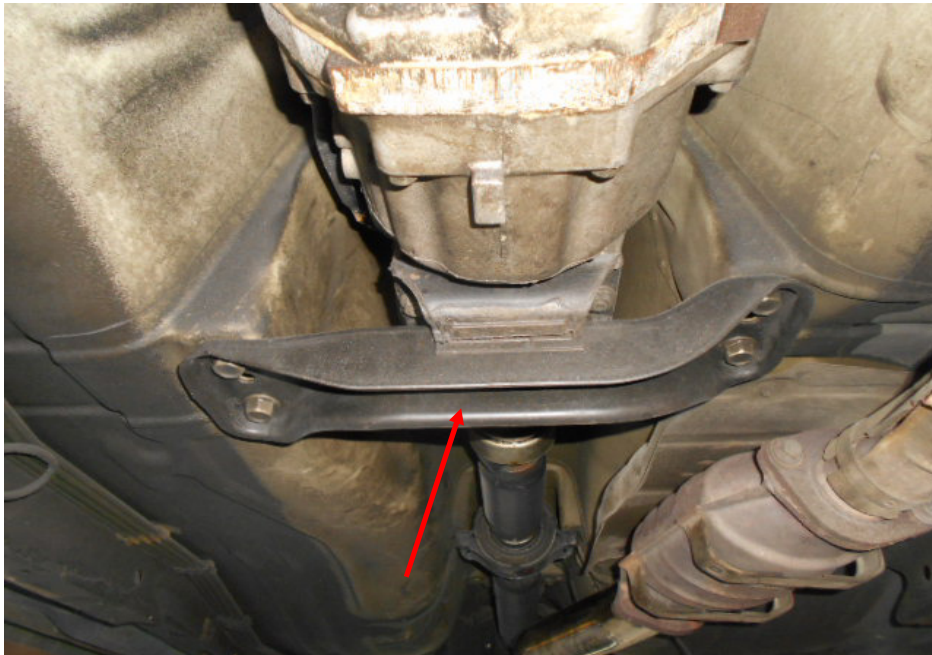
Photo 6 shows a closer view of the bracket (arrowed) mounted to the underside of the Motor Car's floor board, via bolts and nuts. The bracket supports the rear (output) side of the transmission. Rubber bushings absorb any vibrations arising from the rotation of the transmission gears, minimising any stress to the bracket.

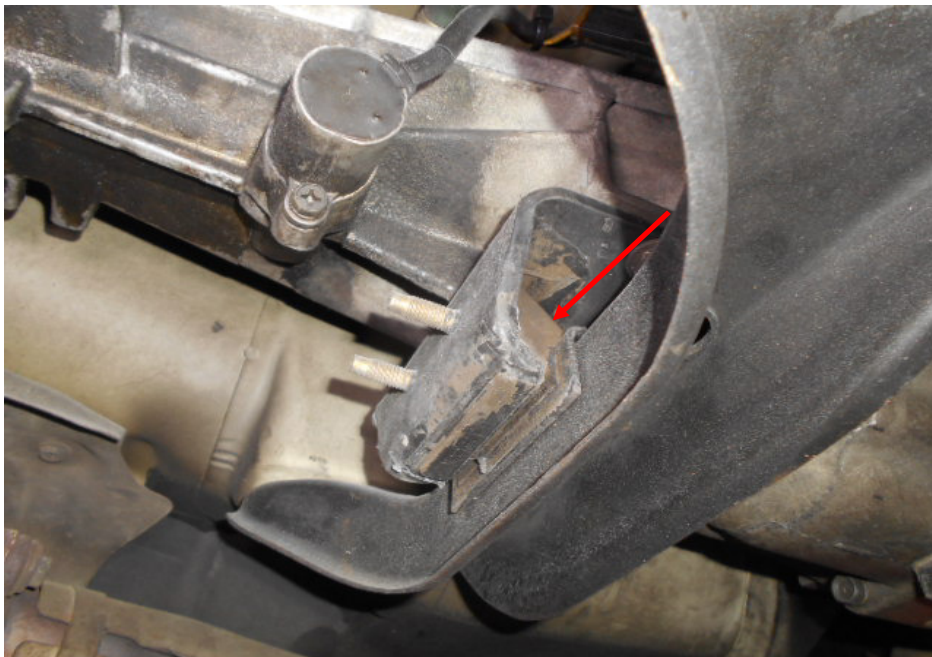
Photo 7 shows the rubber bushing (arrowed) that absorbs any vibrations arising from the rotation of the transmission gears, minimising any stress to the bracket.

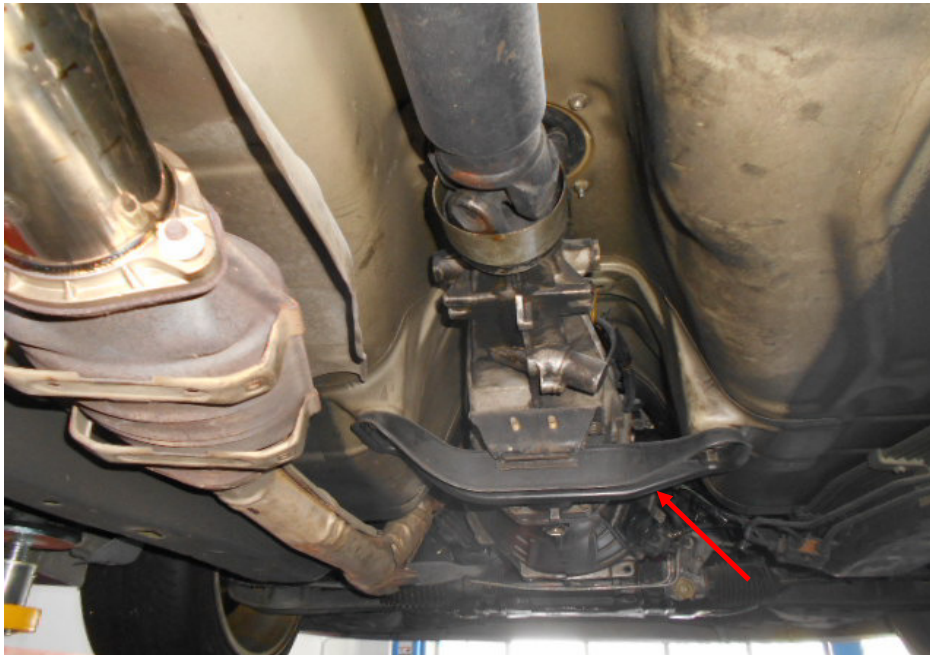
Photo 8 shows a general view of the transmission assembly that was fitted on the Motor Car, as viewed from the rear to front. The transmission assembly is supported by a bracket (arrowed) that is mounted on the underside of the floor board of the Motor Car, via bolts and nuts.

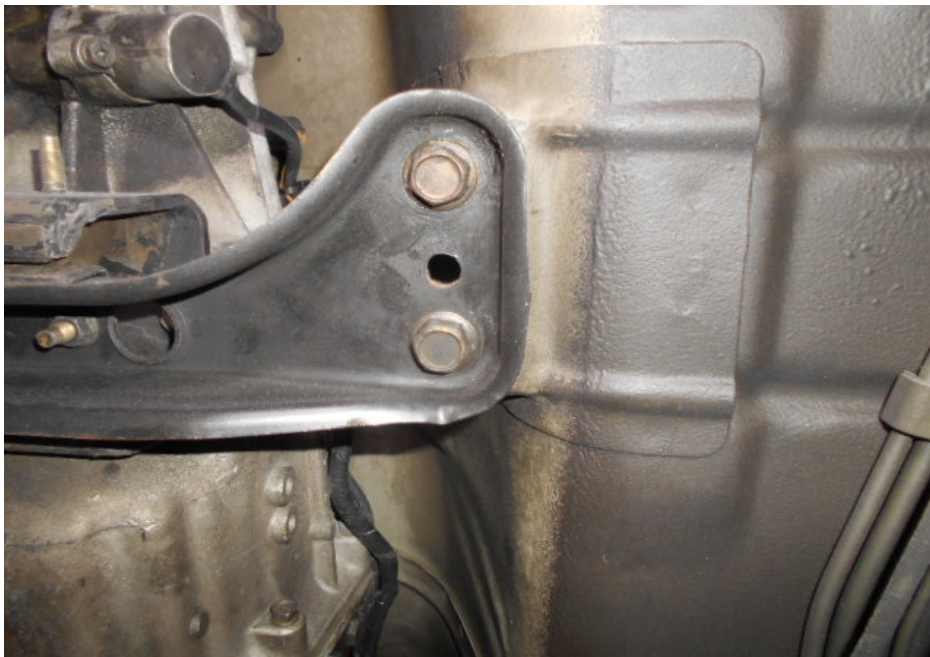
Photo 9 shows the bracket mounted on the underside of the Motor Car's floor board, via bolts and nuts.

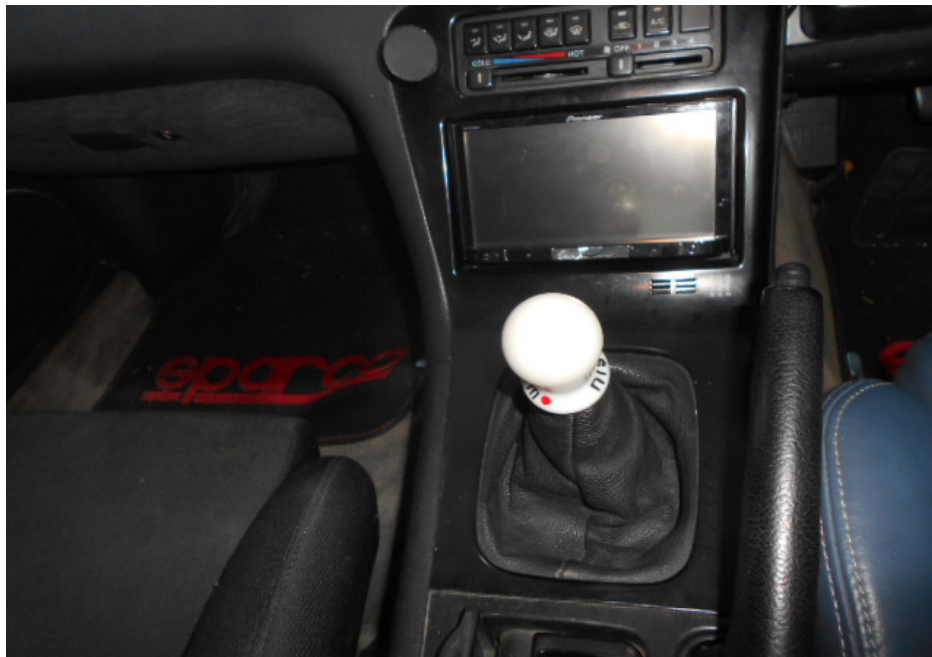
Photo 10 shows the manual gear shifter for manually selecting the transmission gear to be engaged.

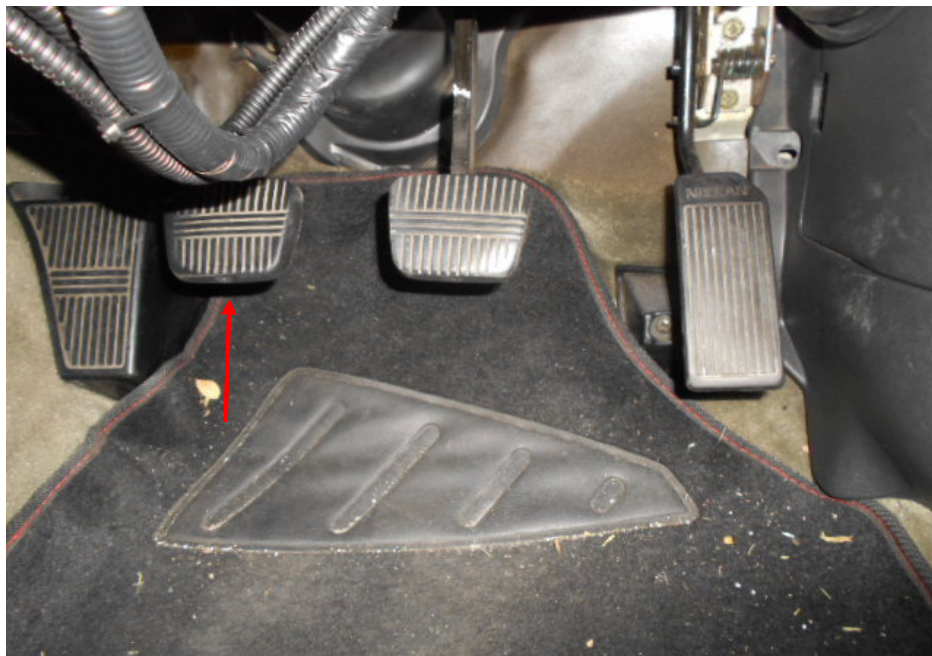
Photo 11 shows the clutch pedal (arrowed) for engaging and disengaging the transmission gears.
