Report Ref : TP19010005

THIRD PARTY SURVEY  
ACCIDENT OCCURED ON 25 JAN 2019

Registration No : SLH3311Z  
Model : TOYOTA HARRIER  
Year / Capacity : OCT 2016 / 1986 cc  
Chassis No : ZSU600084355

## ADJUSTMENT ON REPAIR COST FOR VEHICLE NO. SLH 3311Z

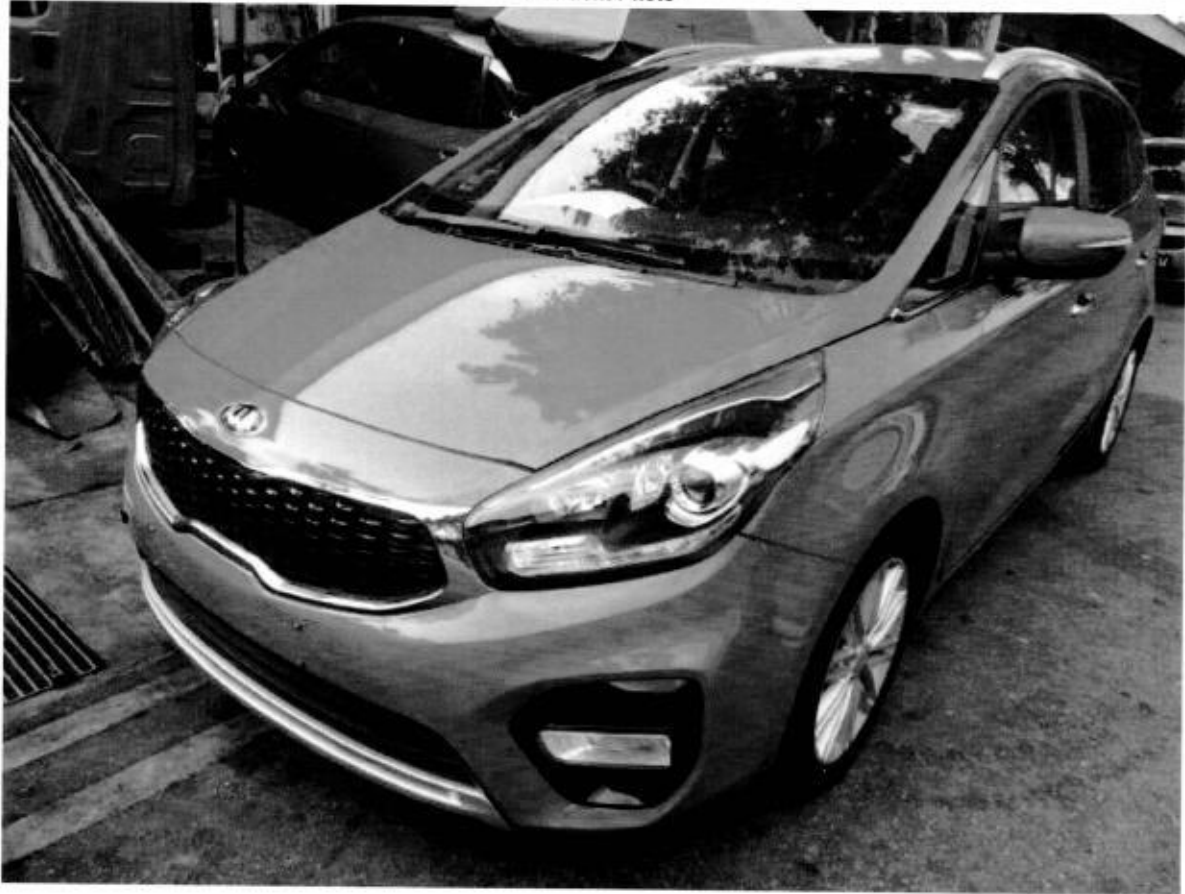
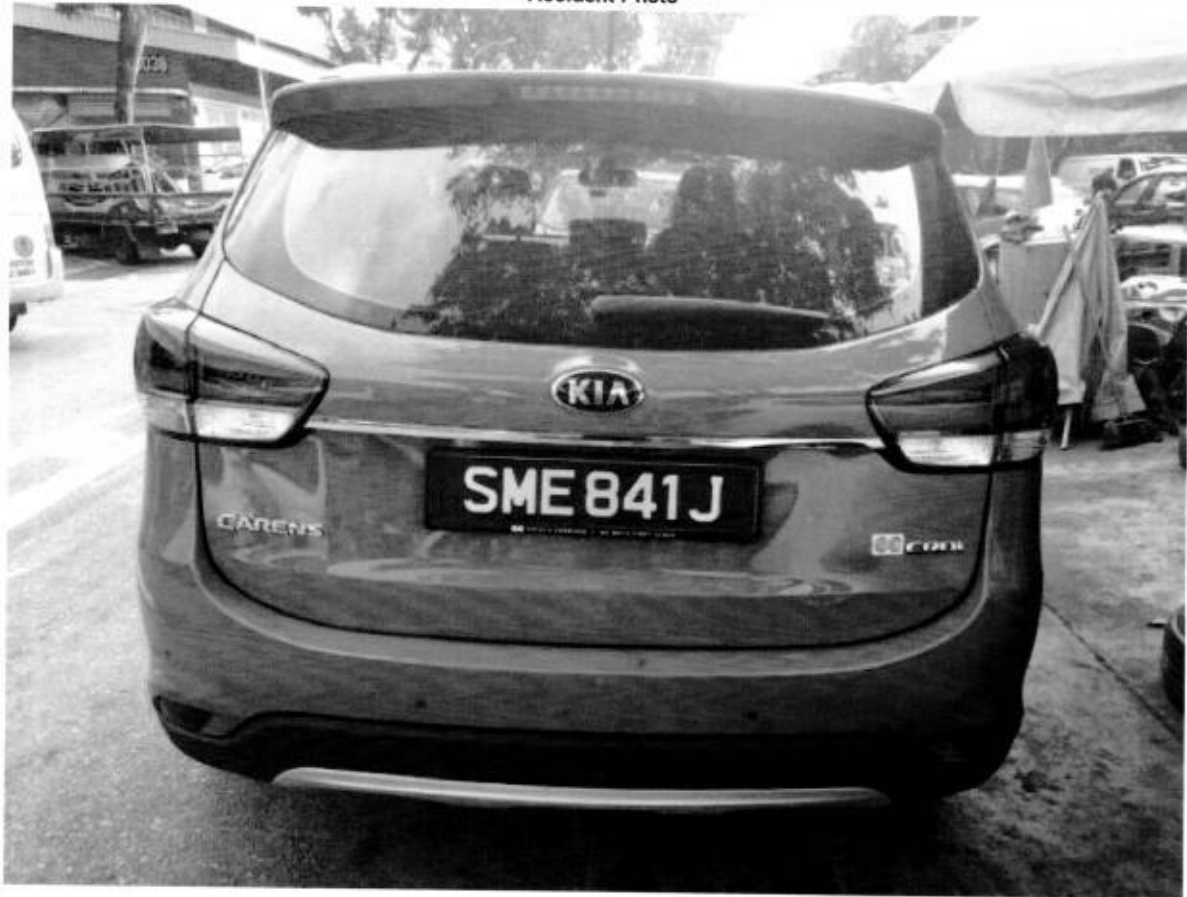
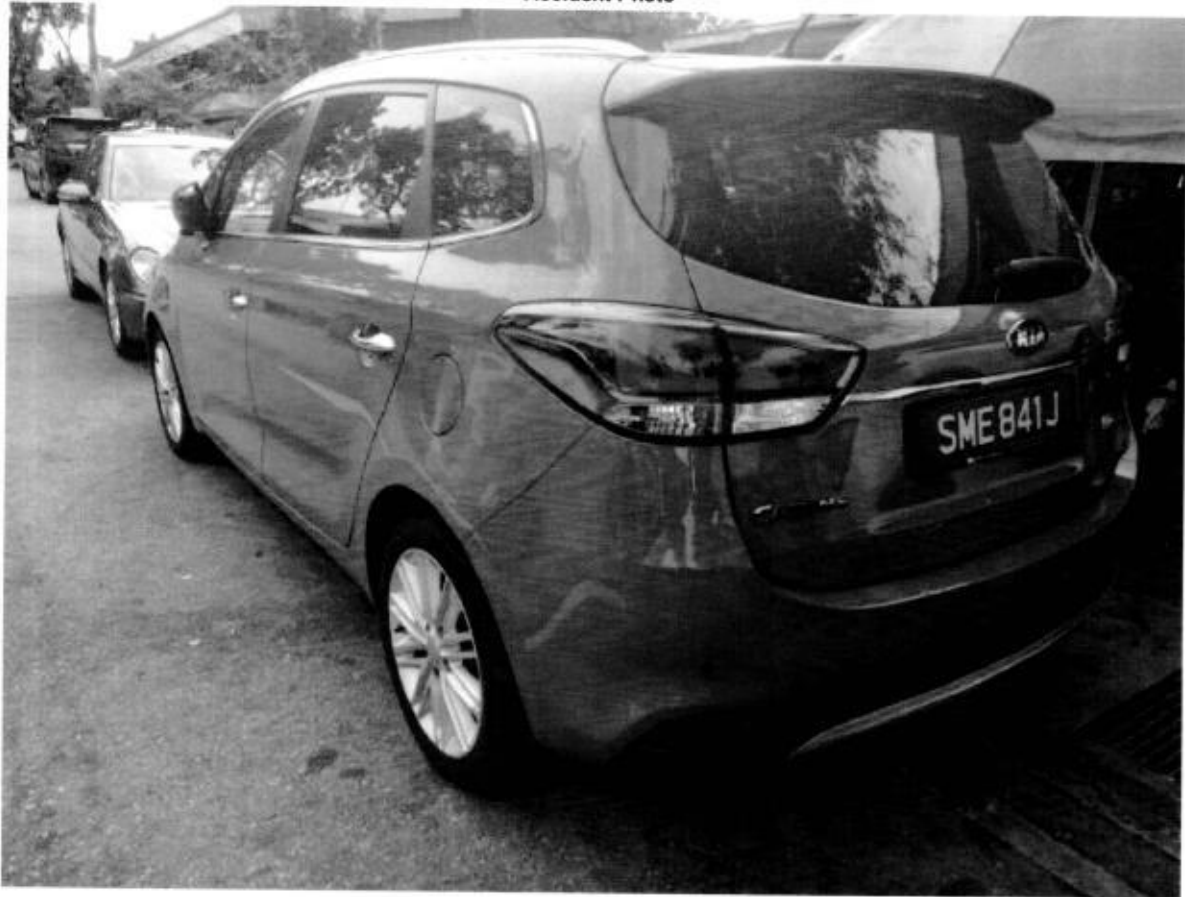
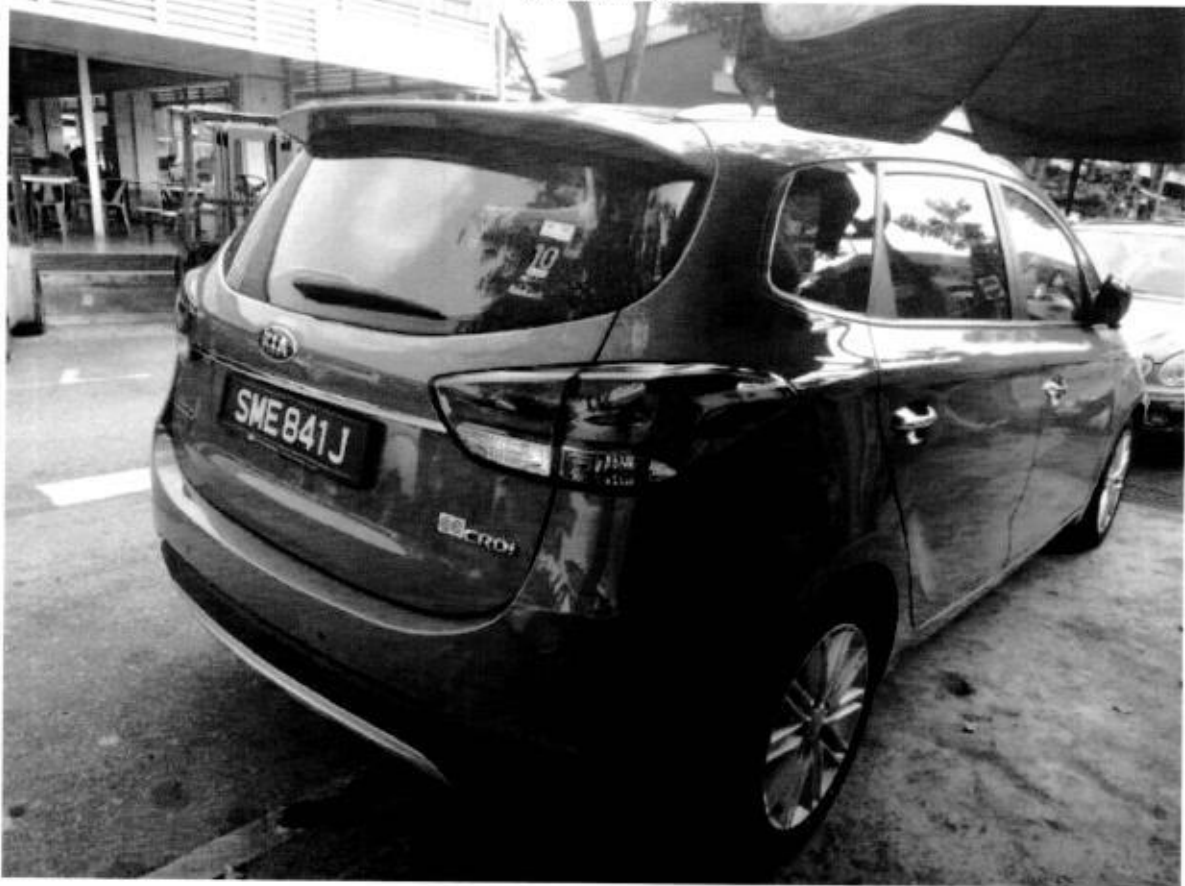
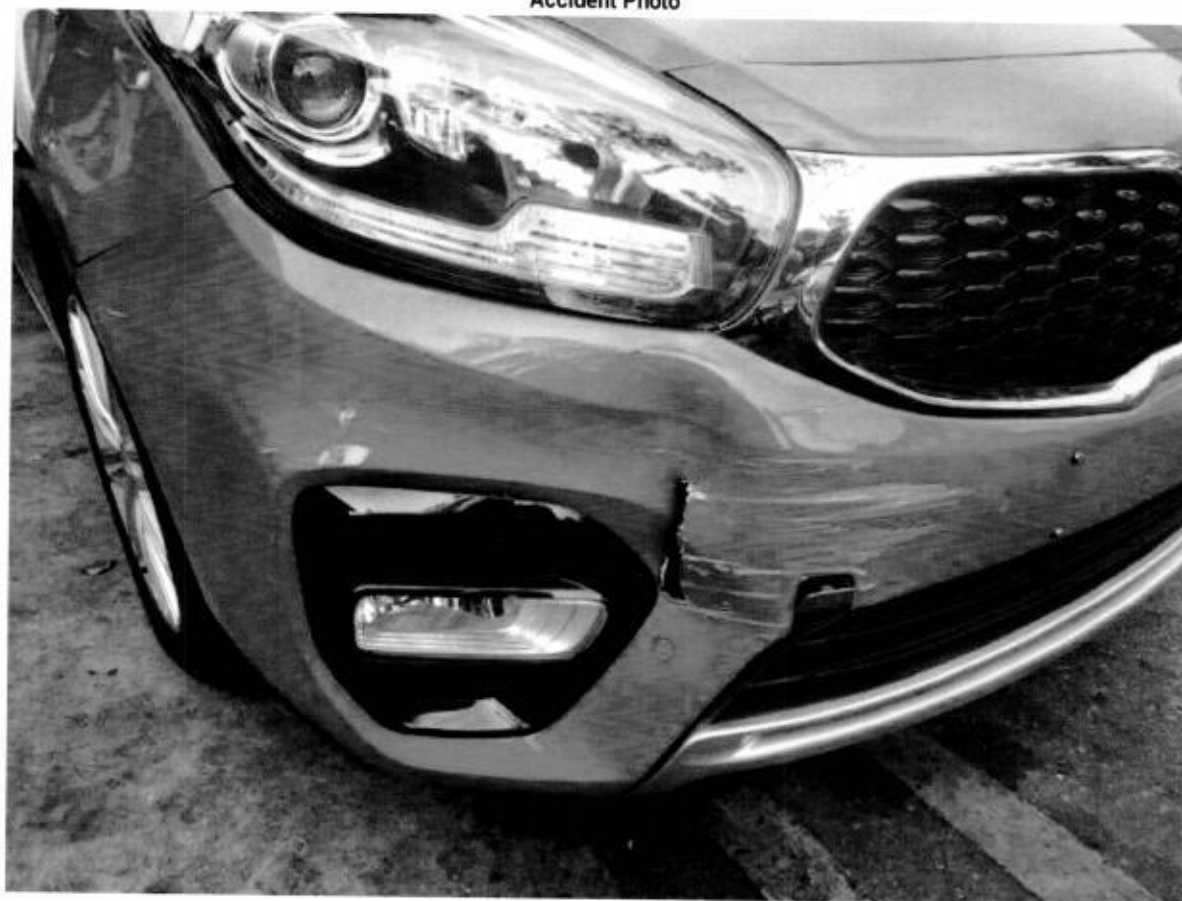
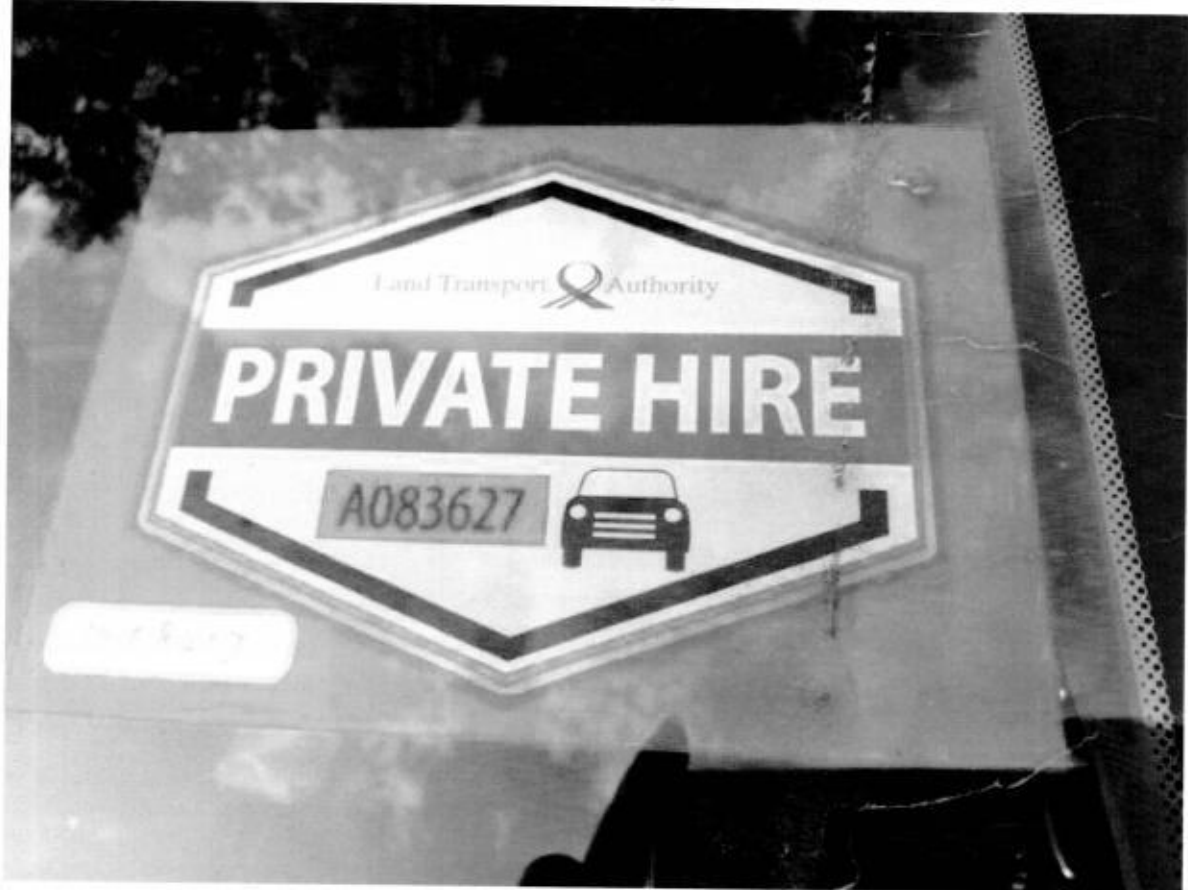
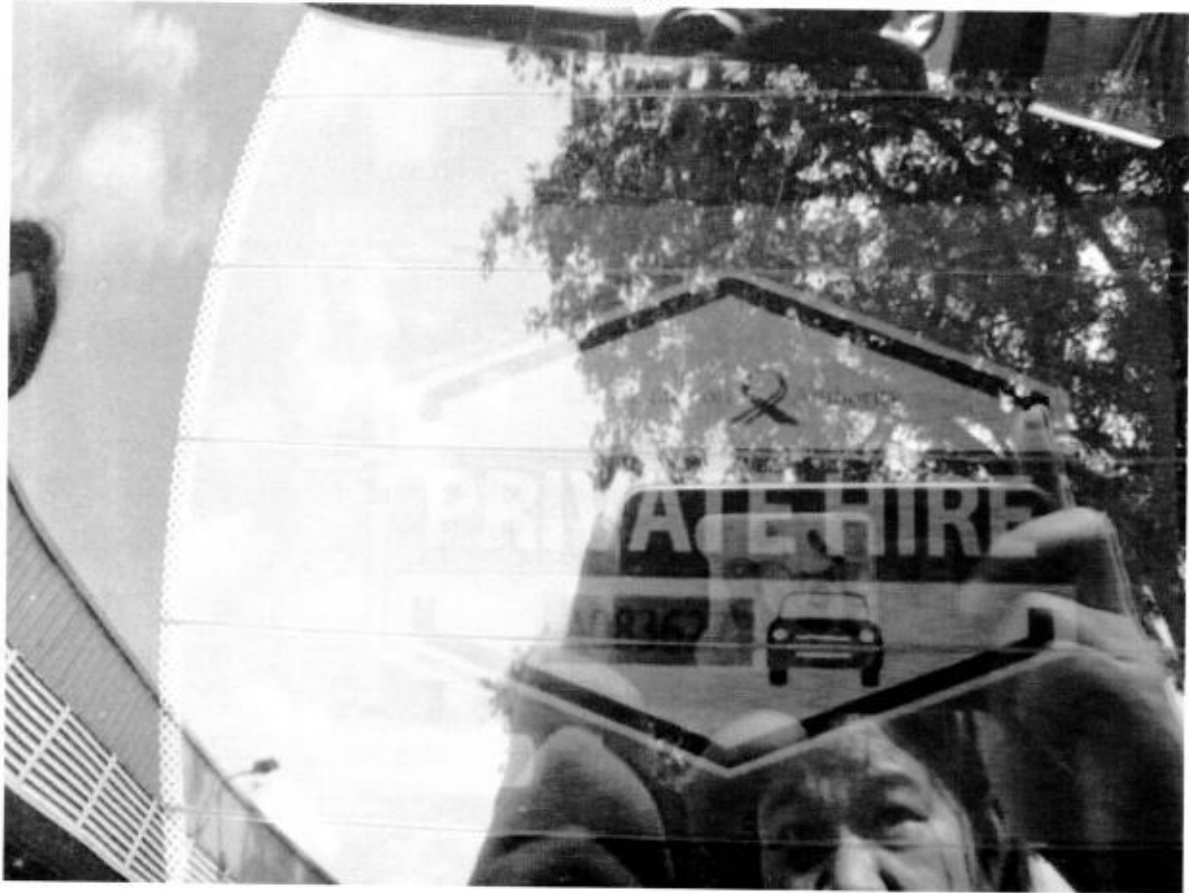
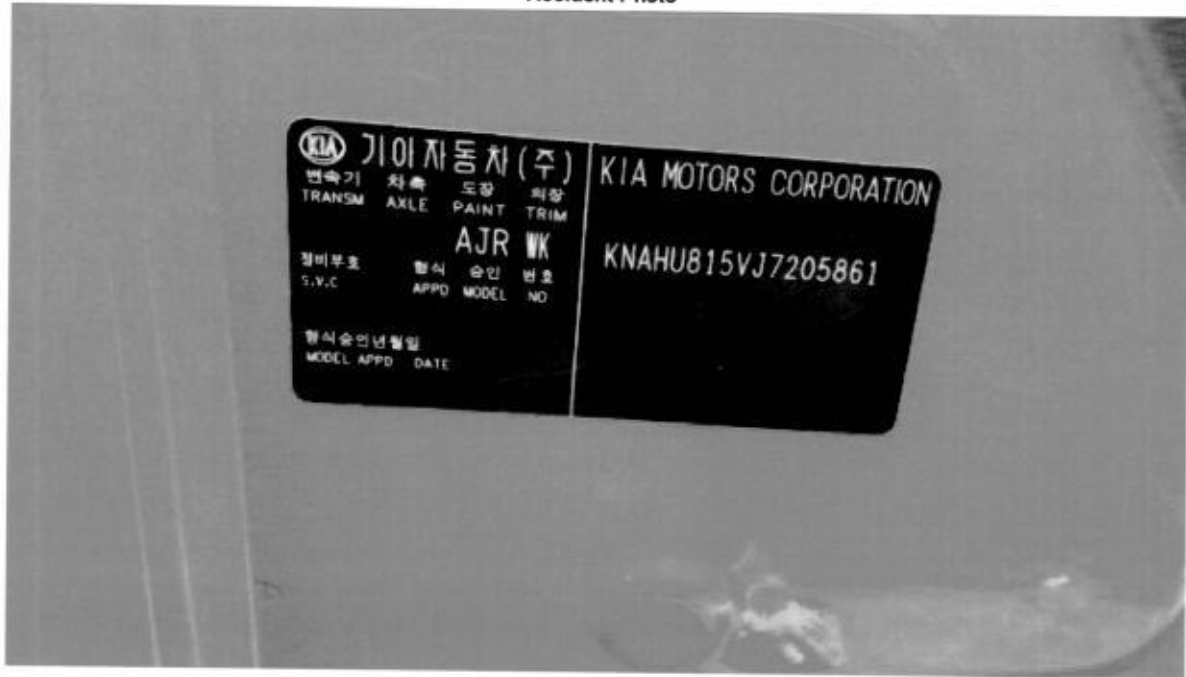
Accident Photo

At the time of inspection, we noted that the vehicle has sustained an impact damages on the side portion(s). For more detail of the damages, please see photograph attached.
