## VEHICLE INSPECTION REPORT

Registration Number	: GY 4971 G	Odometer Reading	: 447 861 Km
Make/Model	: Nissan Cabstar 3.0D	Radio/Cassette/CD	: Fitted
Year of Manuf/Reg	: 2005	Air Conditioner	: Fitted
Engine Number	: QD32205467	View Mirrors	: Fitted -O/s & n/s
Chassis Frame Number	: JN1SF423Z0854053	Seat Belts	: Fitted -Front only
Class/Type	: Lorry (Metal Body)	Other Accessories	
Colour	: Metallic Gold	(Specify)

## ADJUSTMENT ON REPAIR COST FOR VEHICLE NO. GY 4971G

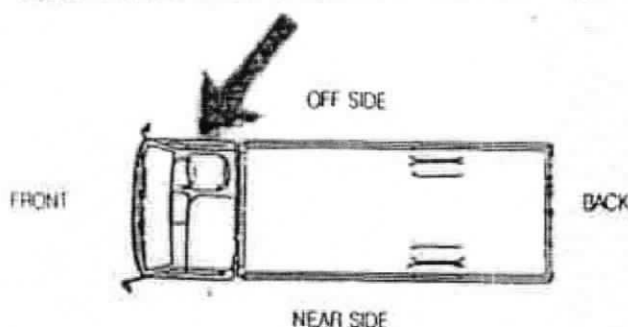
Direction of Impact (→)

Damages sustained were consistent with the subject vehicle being involved in a collision with another vehicle and the impact was delivered onto the o/s front portion of the vehicle. Apparently, the o/s front wheel was struck-upon, thus, damaging its o/s suspension members & steering mechanisms, thus misaligning its wheel camber/geometry
