Your Ref : TP /1201900020429
Our Ref : CS/FWD19012507/N

1 August 2019

**AUTOMOBILE TECHNICAL INVESTIGATION REPORT OF ACCIDENT
INVOLVING SLJ 4125C AND SKF 1199S ON 14 JULY 2019**

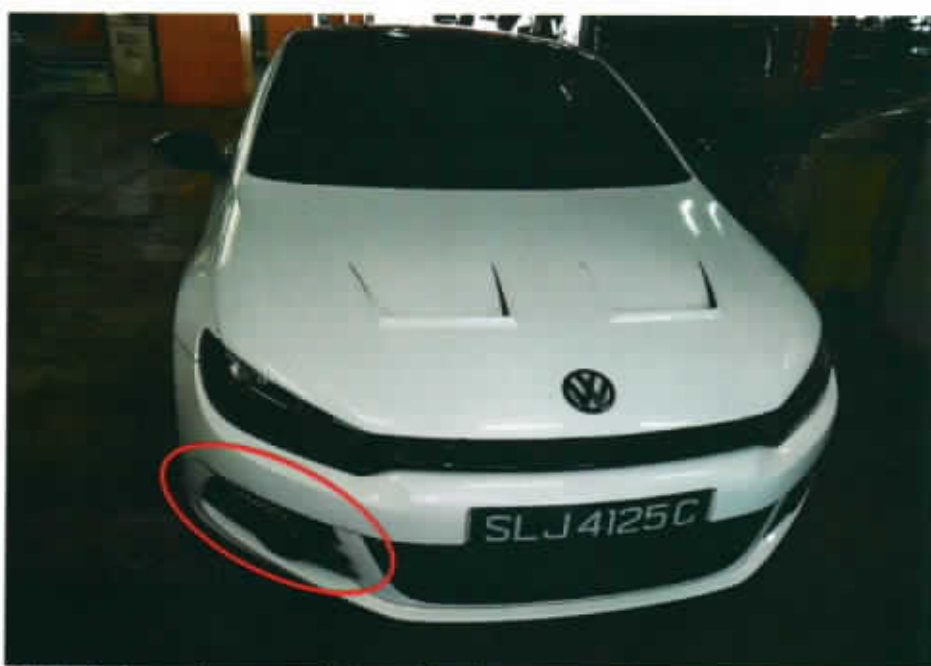
8. From our examination of the photographs taken during the Pre- Repair Survey conducted by LKK Auto Consultants Pte. Ltd. about 2 days after the accident, the damage to the VW was observed to be confined to its front right portion. We observed a horizontal crack on the lower right portion of the front bumper. We also found graze marks on the right fog light grille. See photos 1 - 4 below.

Photo 1 shows the general view of the front portion of the VW at the time of the Pre- Repair Survey conducted by LKK Auto Consultants Pte. Ltd. which was taken 2 days after the accident. The damages to the VW were observed to be confined to the front right portion, particularly to its front bumper (circled).

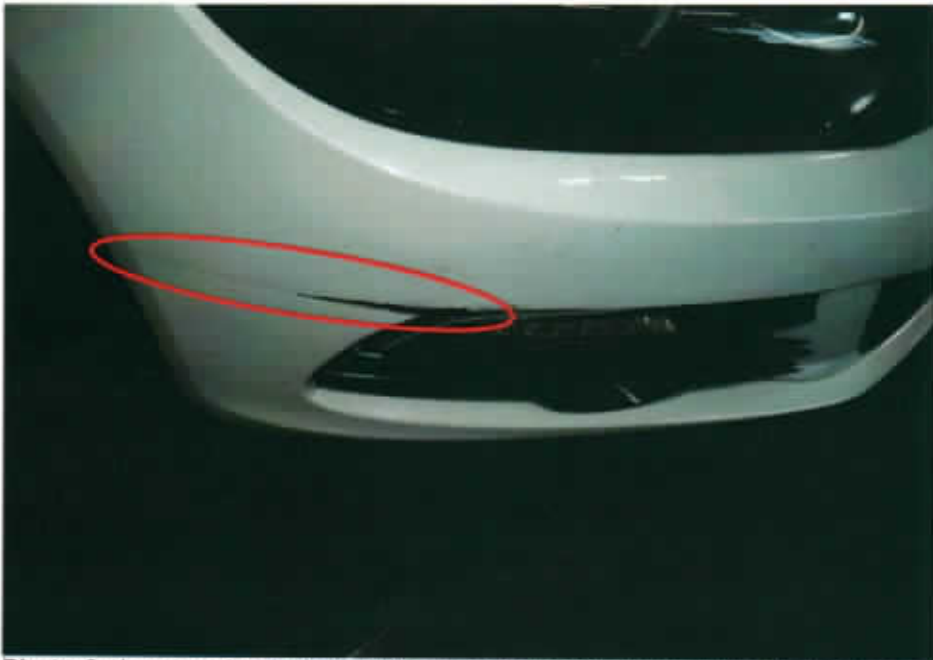
Photo 2 shows a closer view of the horizontal crack on the lower right portion of the front bumper of the VW (circled).

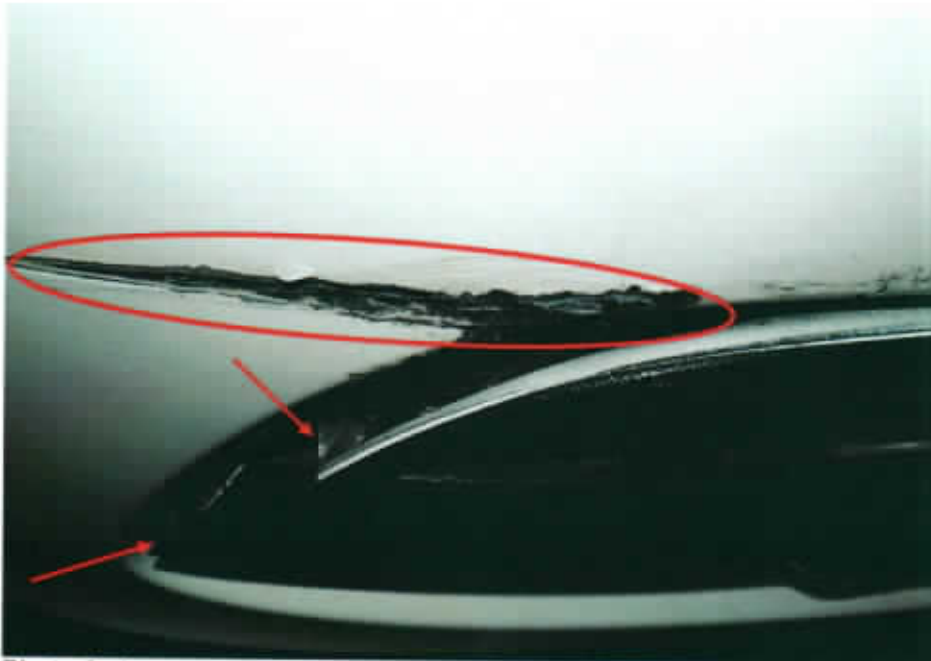
Photo 3 shows a close up view of the horizontal crack on the lower right portion of the front bumper of the VW (circled). The right fog light cover was also observed to be dislodged (arrowed).

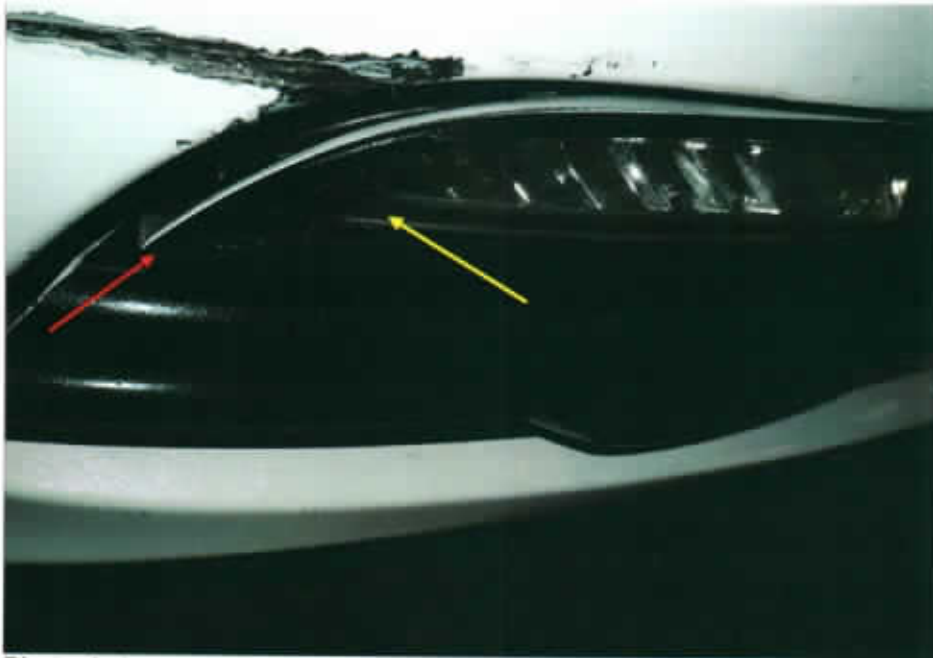
Photo 4 shows a close up view of the dislodged right fog light cover (red arrow) and right fog light (yellow arrow) of the VW.

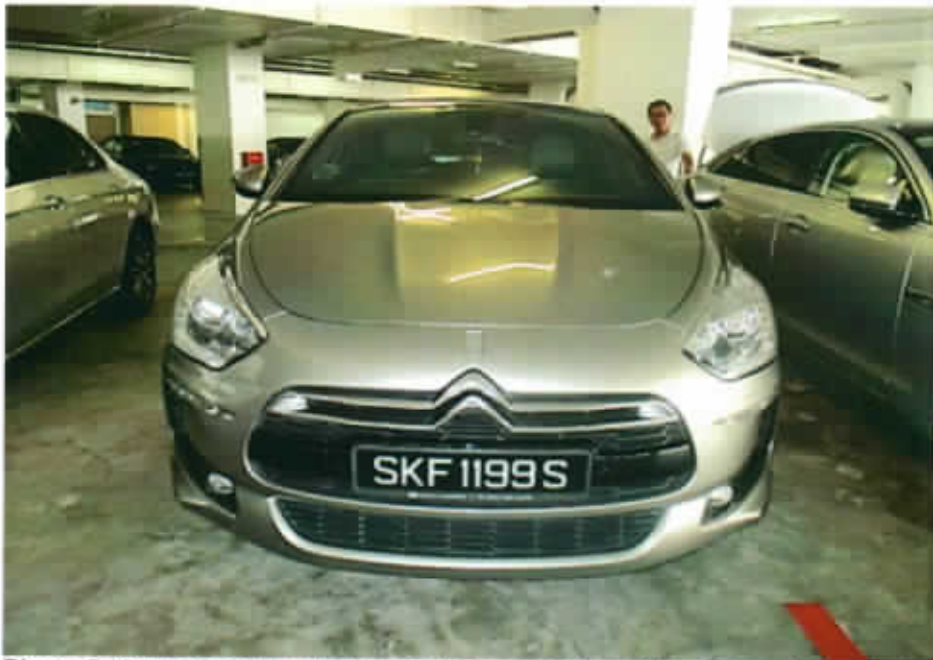
Photo 5 shows the general view of the front portion of the Citroen taken during our physical inspection. The mileage recorded was 114, 004km.

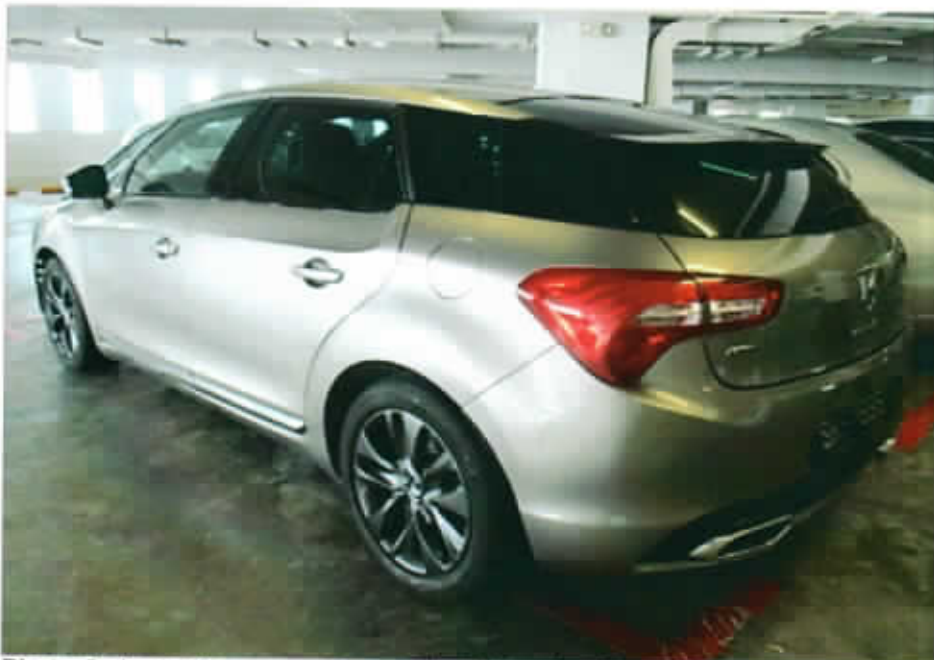
Photo 6 shows the general view of the left body of the Citroen taken during our physical inspection. The physical inspection carried out had primarily focused on the left rear portion of the Citroen as the driver of the VW had reported the accident to be of a head to left- side collision where the Citroen was beside the VW at the material time.

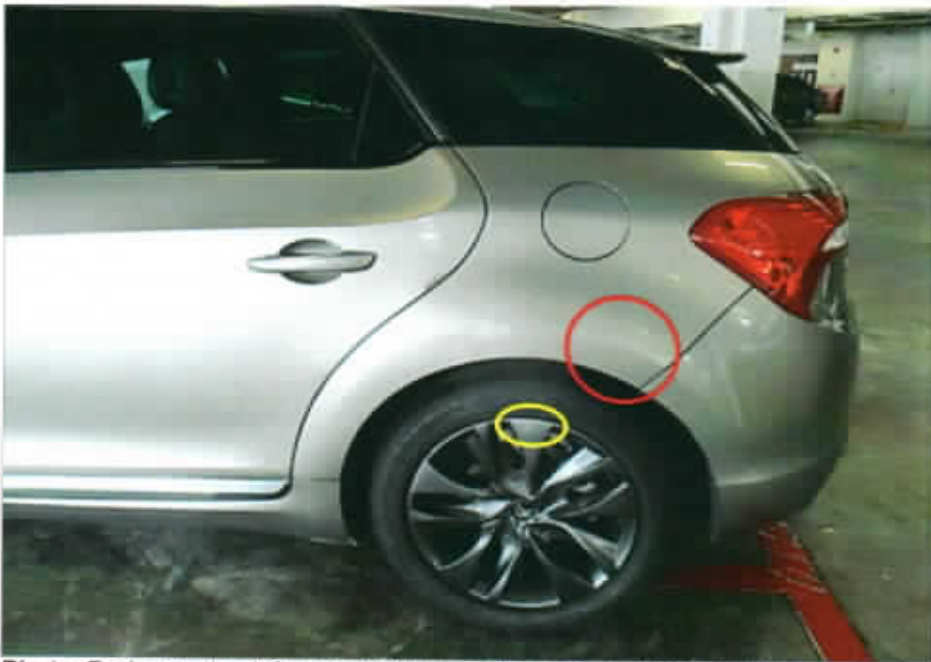
Photo 7 shows the left rear portion of the Citroen taken during our physical inspection. We observed marks of grazing nature on the left rear wheel rim of the Citroen (yellow circle). There were also black marks found above the rear left wheel fender (red circle).

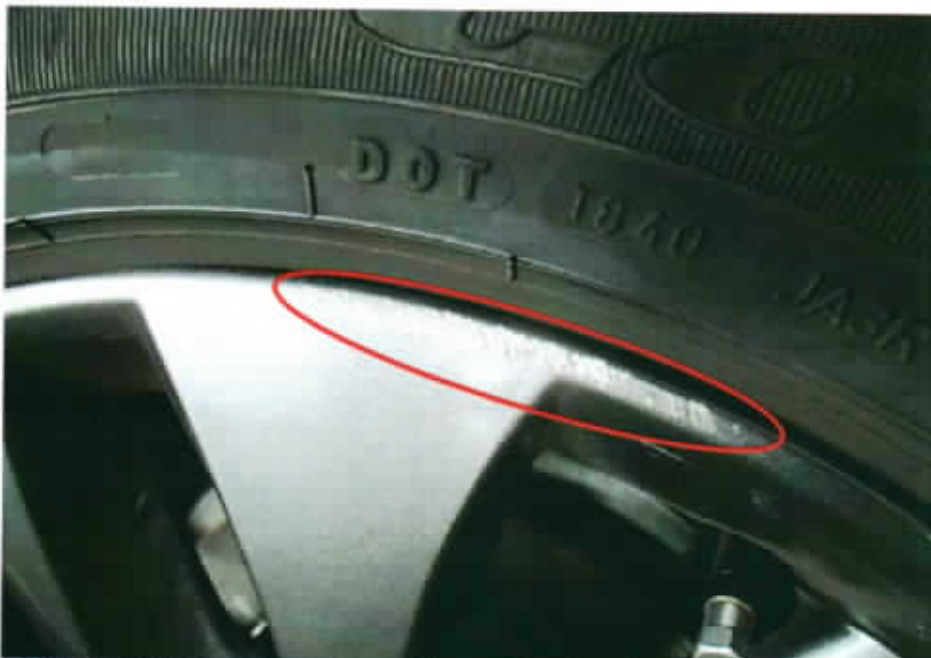
Photo 8 shows a close up view of the marks of grazing nature on the left rear wheel rim of the Citroen (circled).

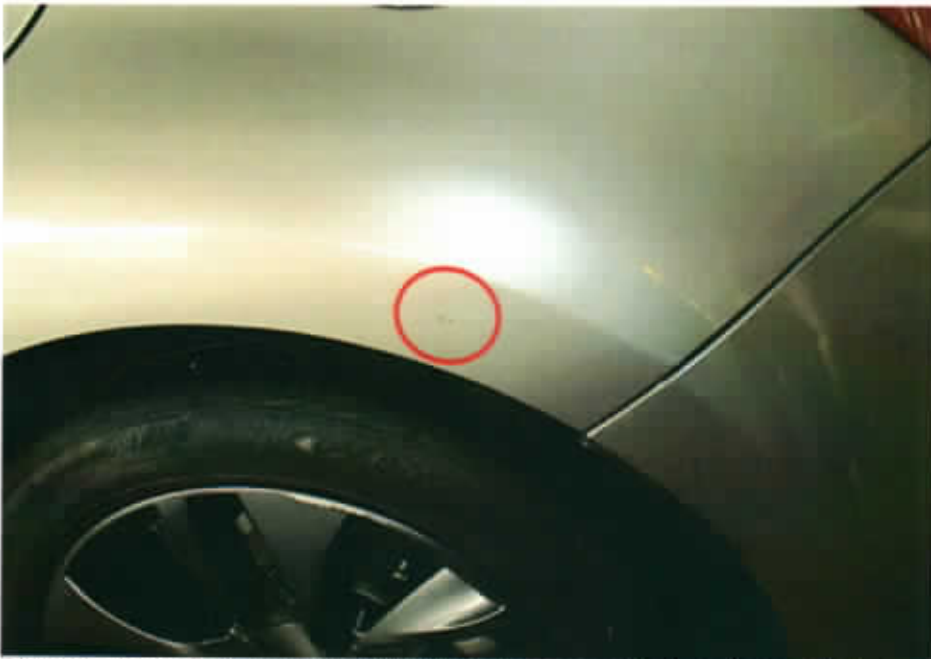
Photo 9 shows a closer view of the black marks found above the rear left wheel fender of the Citroen (circled).

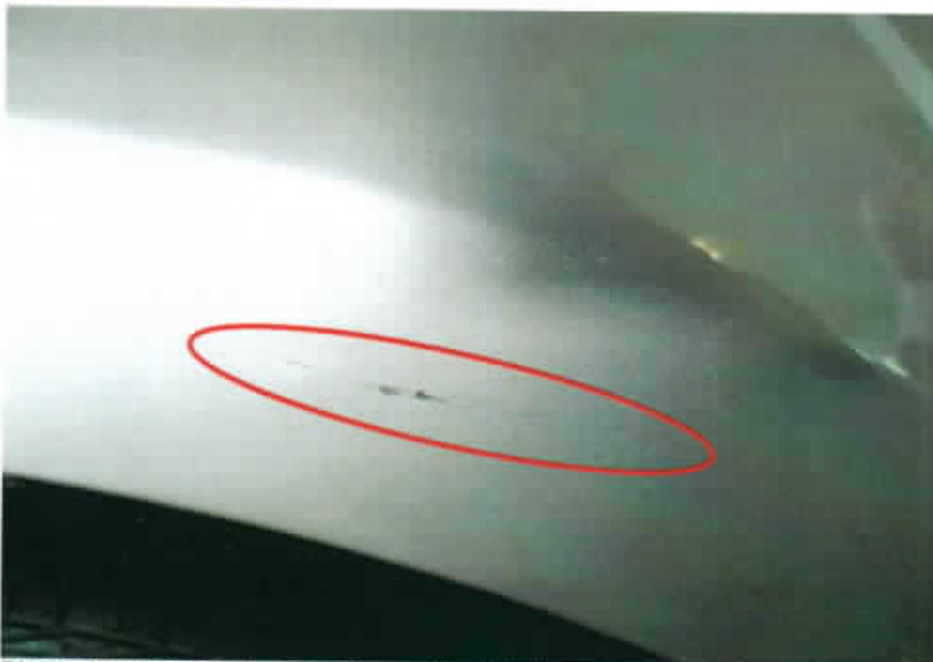
Photo 10 shows a close up view of the black marks found above the rear left wheel fender of the Citroen (circled).

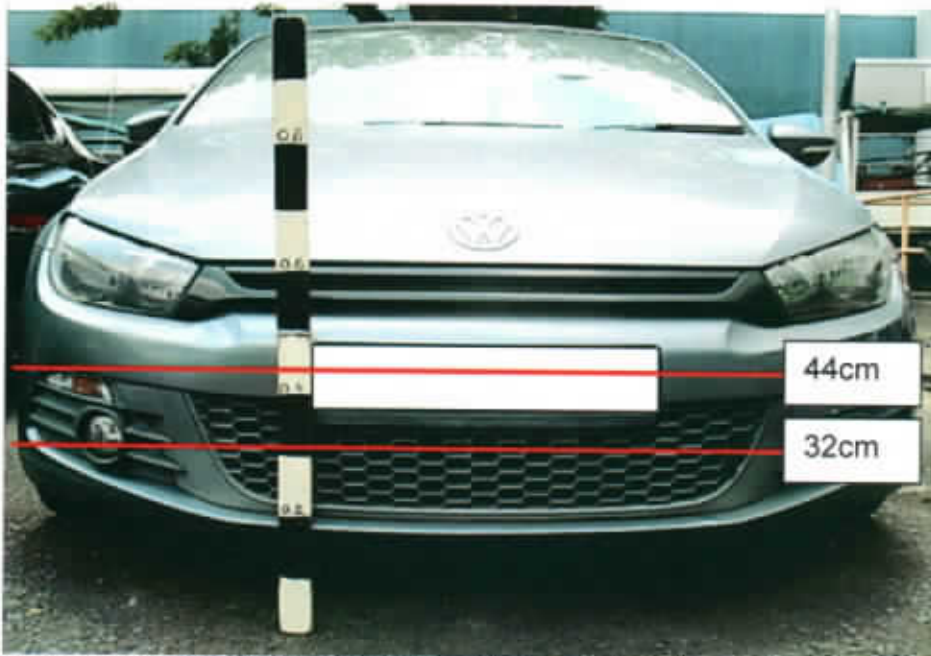
Photo 11 shows the height measurement being conducted on the front portion of the VW (using a similar make and model). The damages observed on the front bumper as well as right fog light cover of the VW were measured to be between the height ranges of 32cm to 44cm above ground level.

- a) the damages observed on the front bumper as well as the right fog light cover of the VW were measured to be between the height ranges of 32cm to 44cm above ground level;
- b) the marks of grazing nature found on the left rear wheel rim of the Citroen was measured to be 55cm above ground level;
- c) the graze marks found above the rear left wheel fender of the Citroen was measured to be 65cm above ground level;
- d) the height measurements appear to suggest that there was no possible contact between the front portion of the VW and the left rear portion of the Citroen. The damage observed on the front portion of the VW was not a result of this contact and does not correspond to the damage observed on the left rear portion of the Citroen.

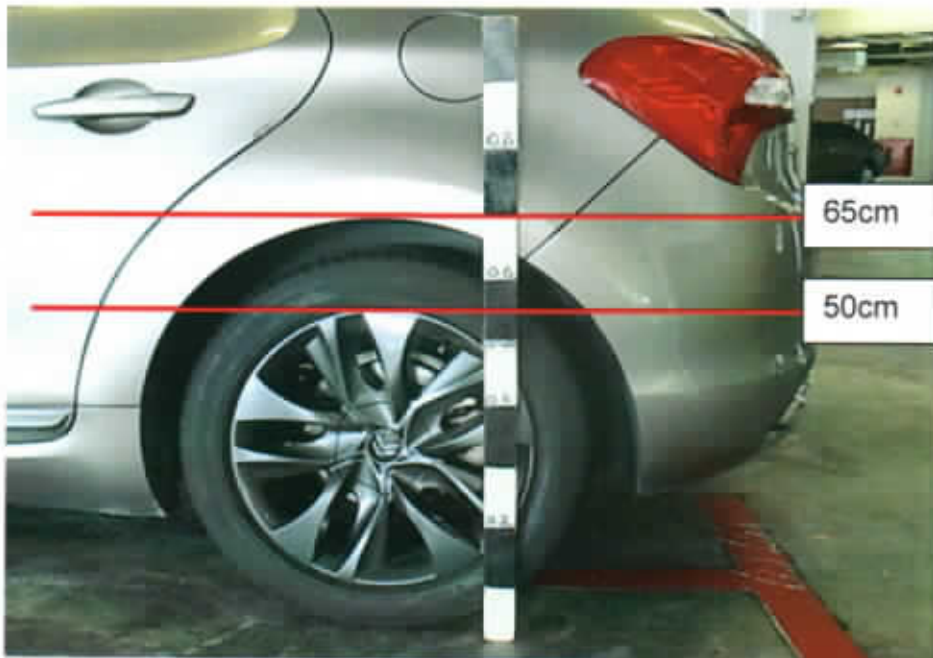
Photo 12 shows the height measurement being conducted on the left rear portion of the Citroen. The marks of grazing nature found on the left rear wheel rim was measured to be 55cm above ground level. The graze marks found above the rear left wheel fender was measured to be 65cm above ground level.
