**Vehicle Inspection Report**

Report No: AAS/2019/197

Registration no: SKC2363T  
Make/Model: BMW 318i (A)  
Year of registration: 2011  
Colour: Pearl White

## ADJUSTMENT ON REPAIR COST FOR VEHICLE NO. SKC 2363T

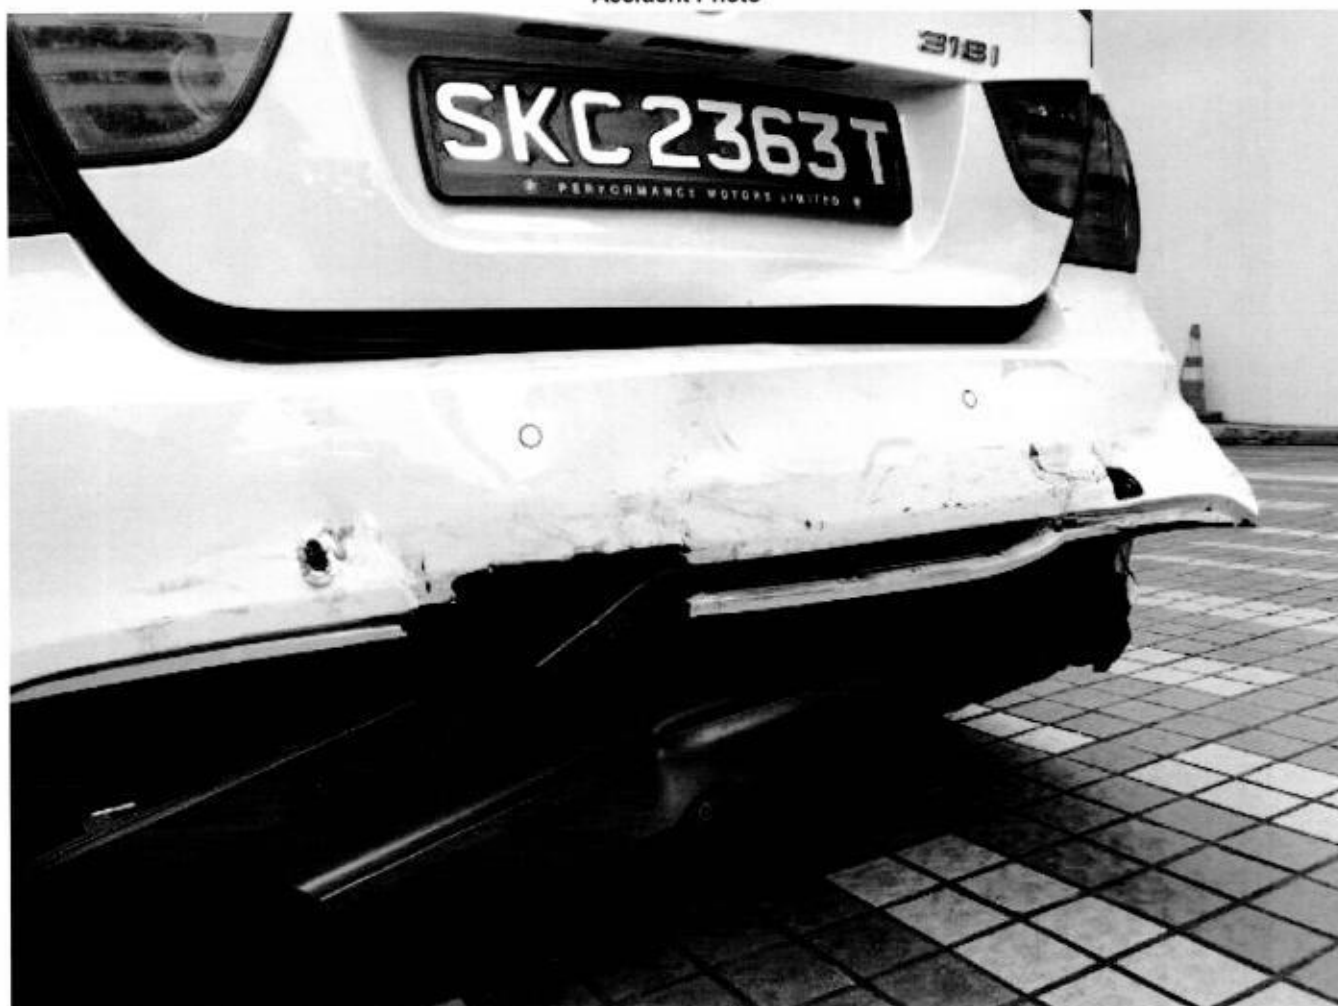
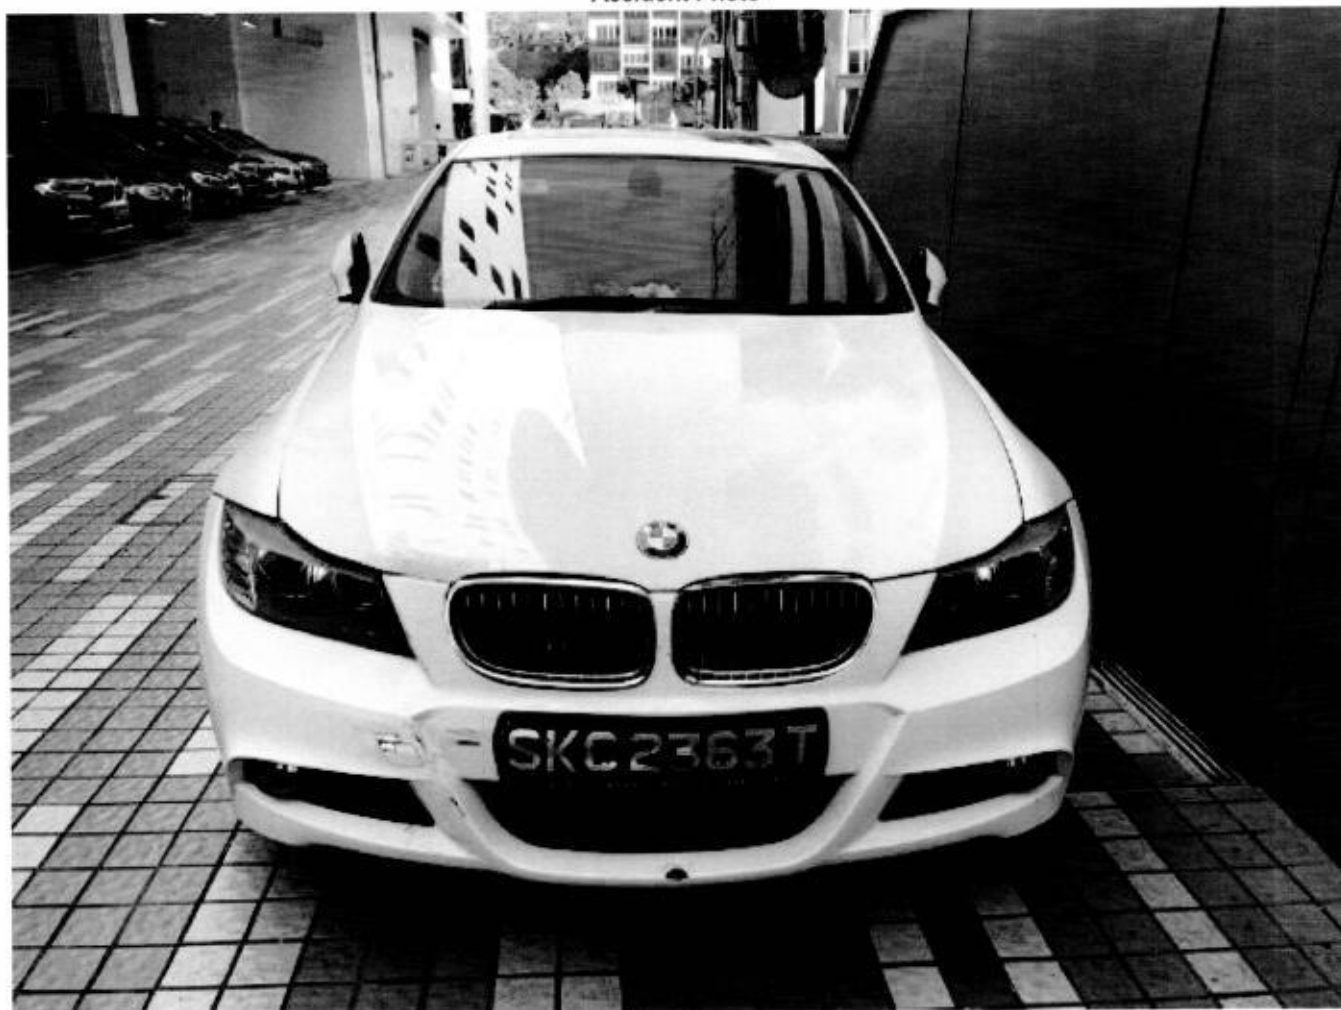
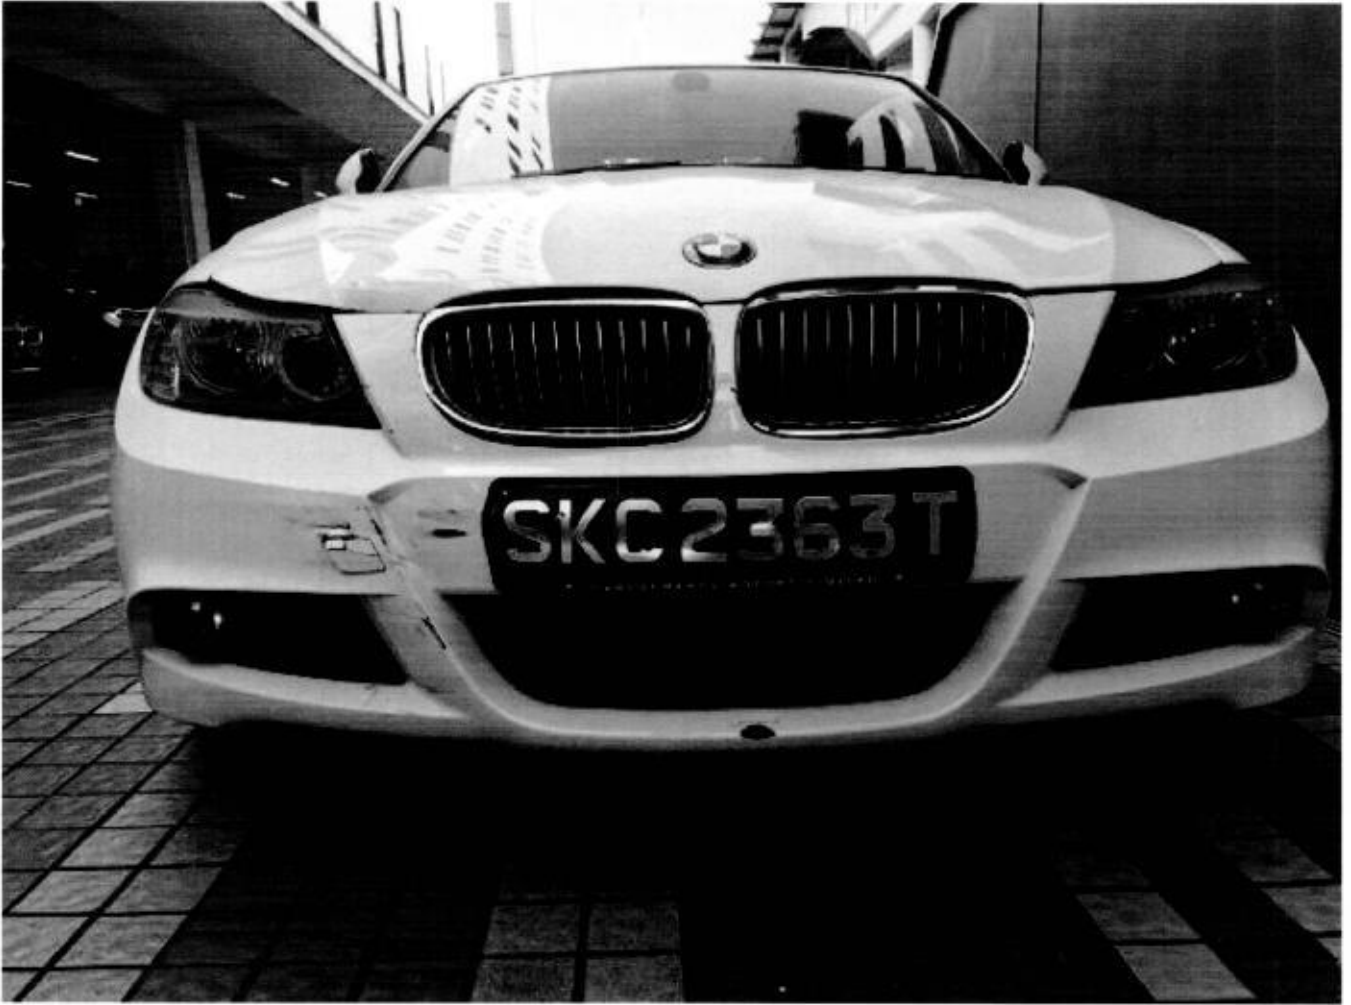
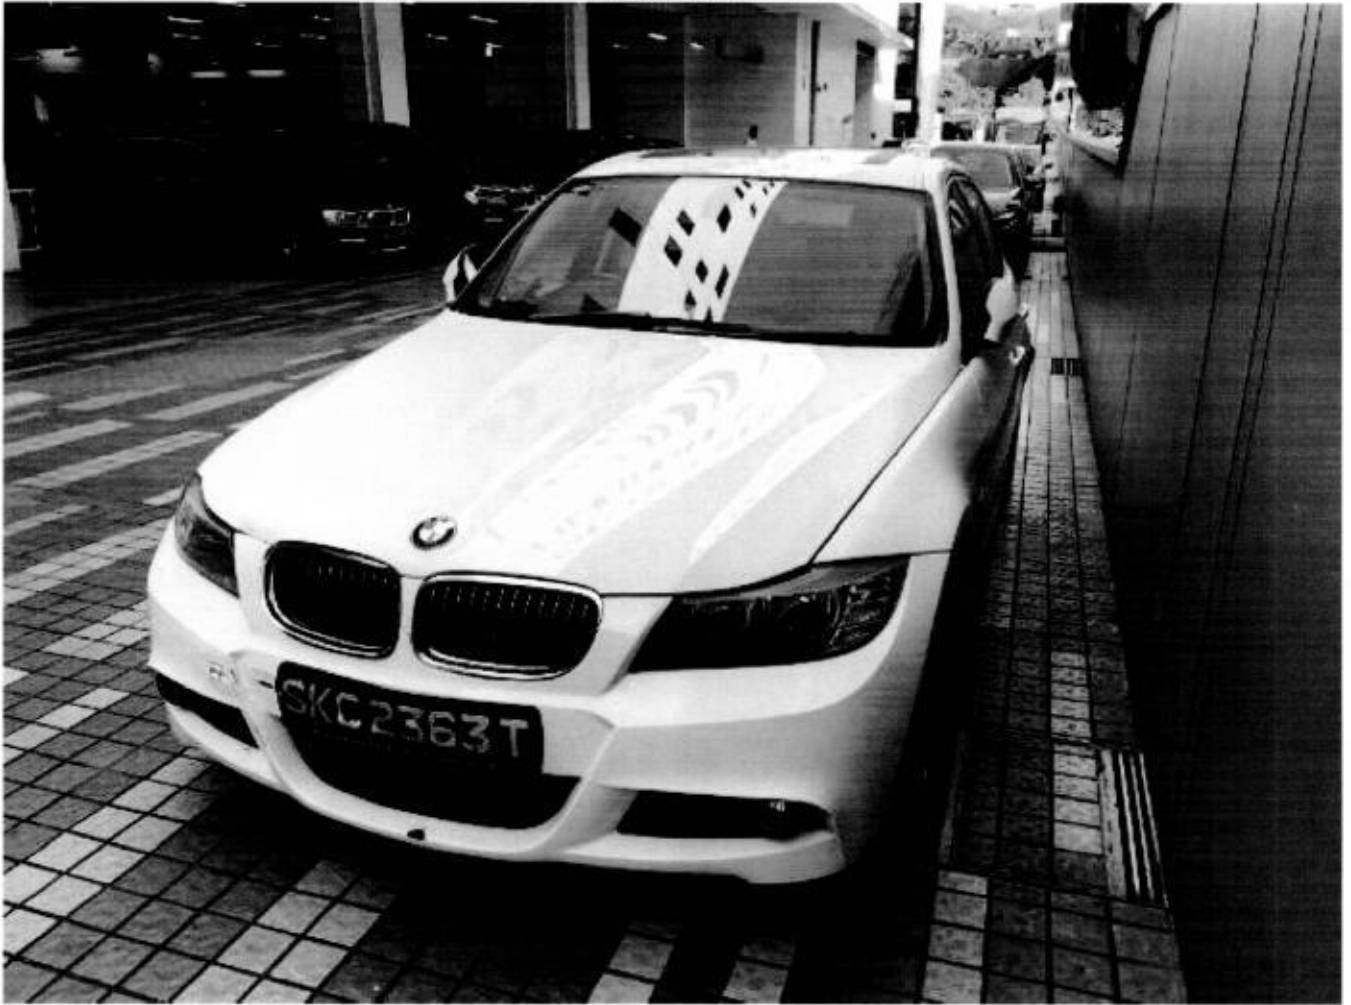
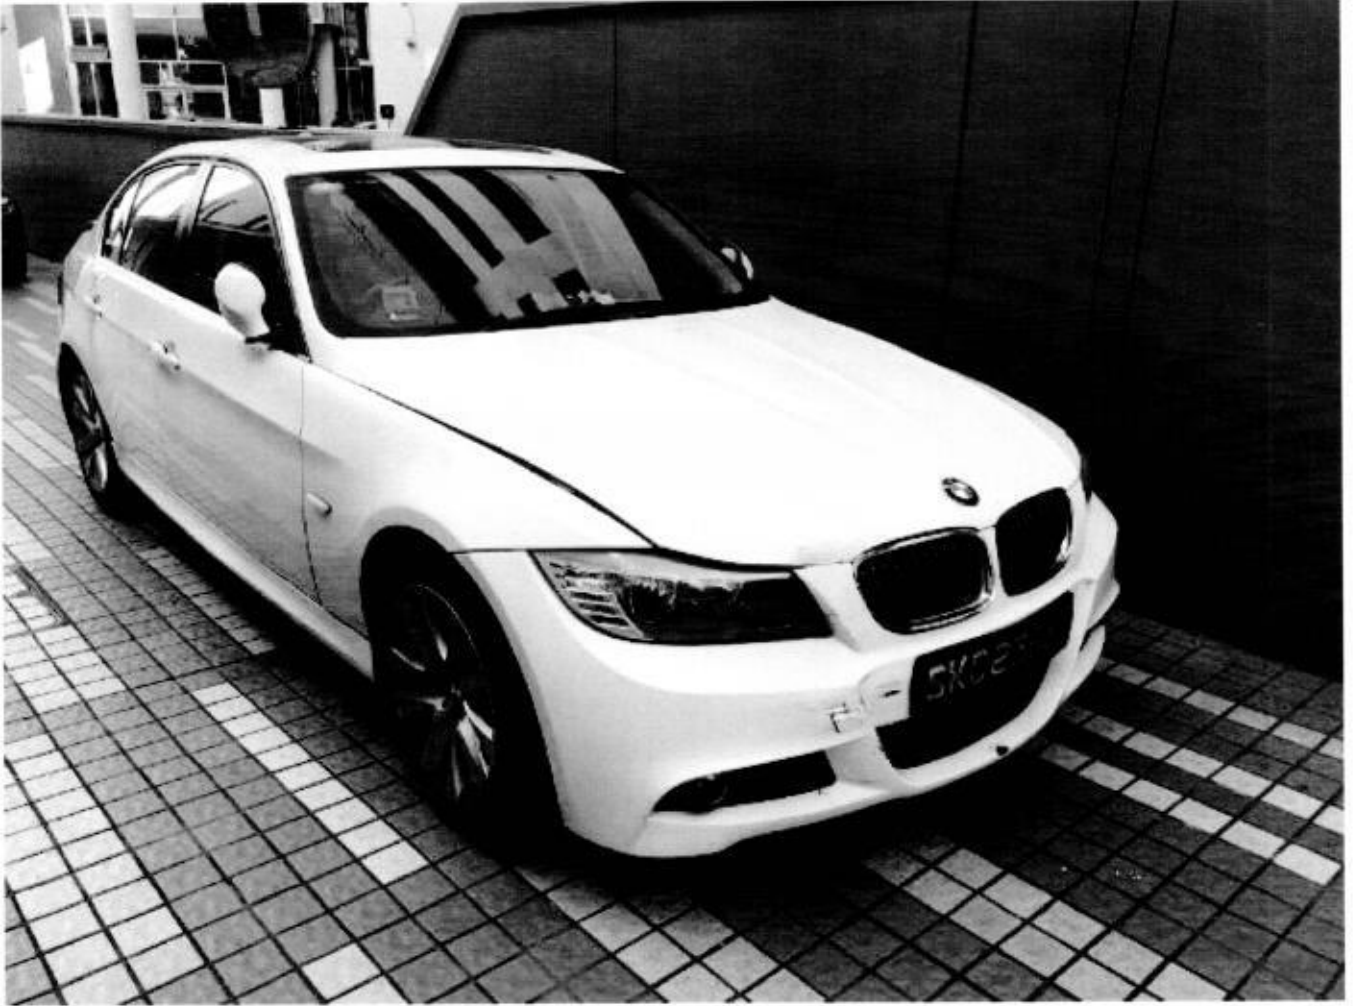
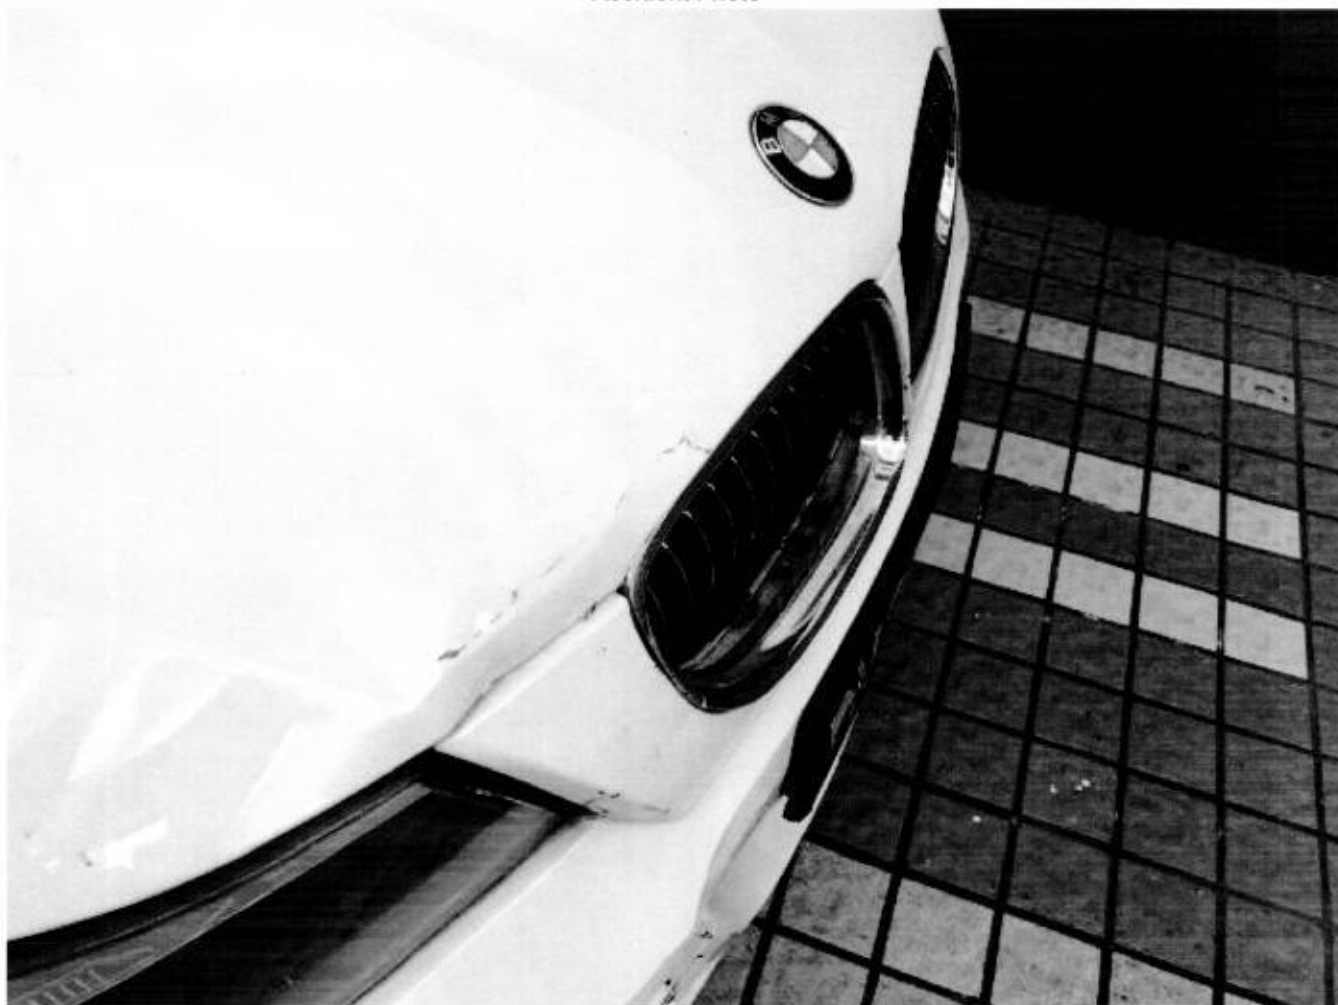
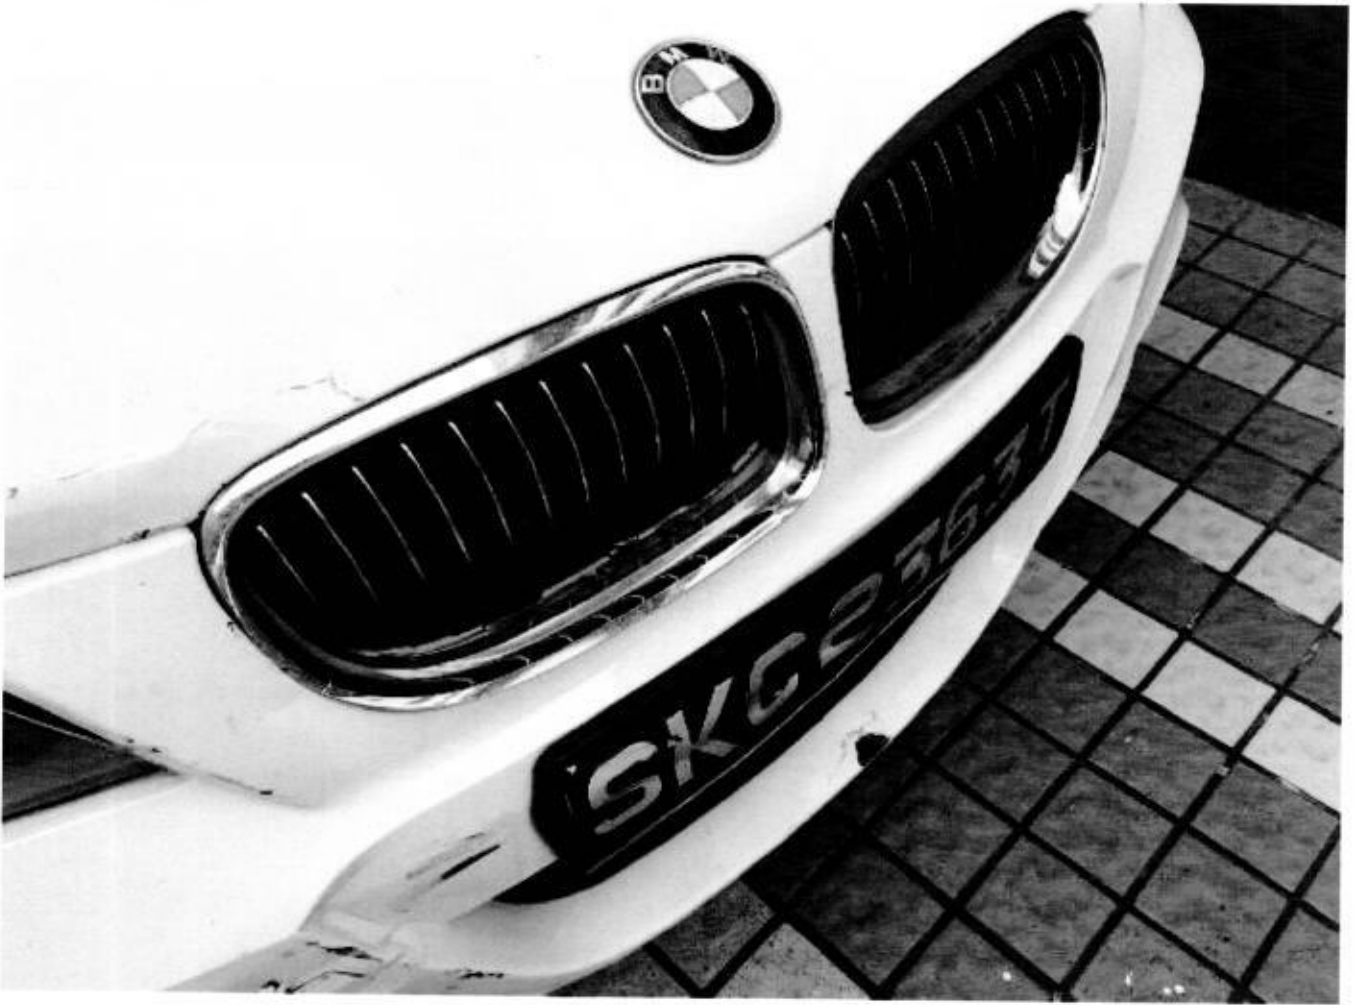
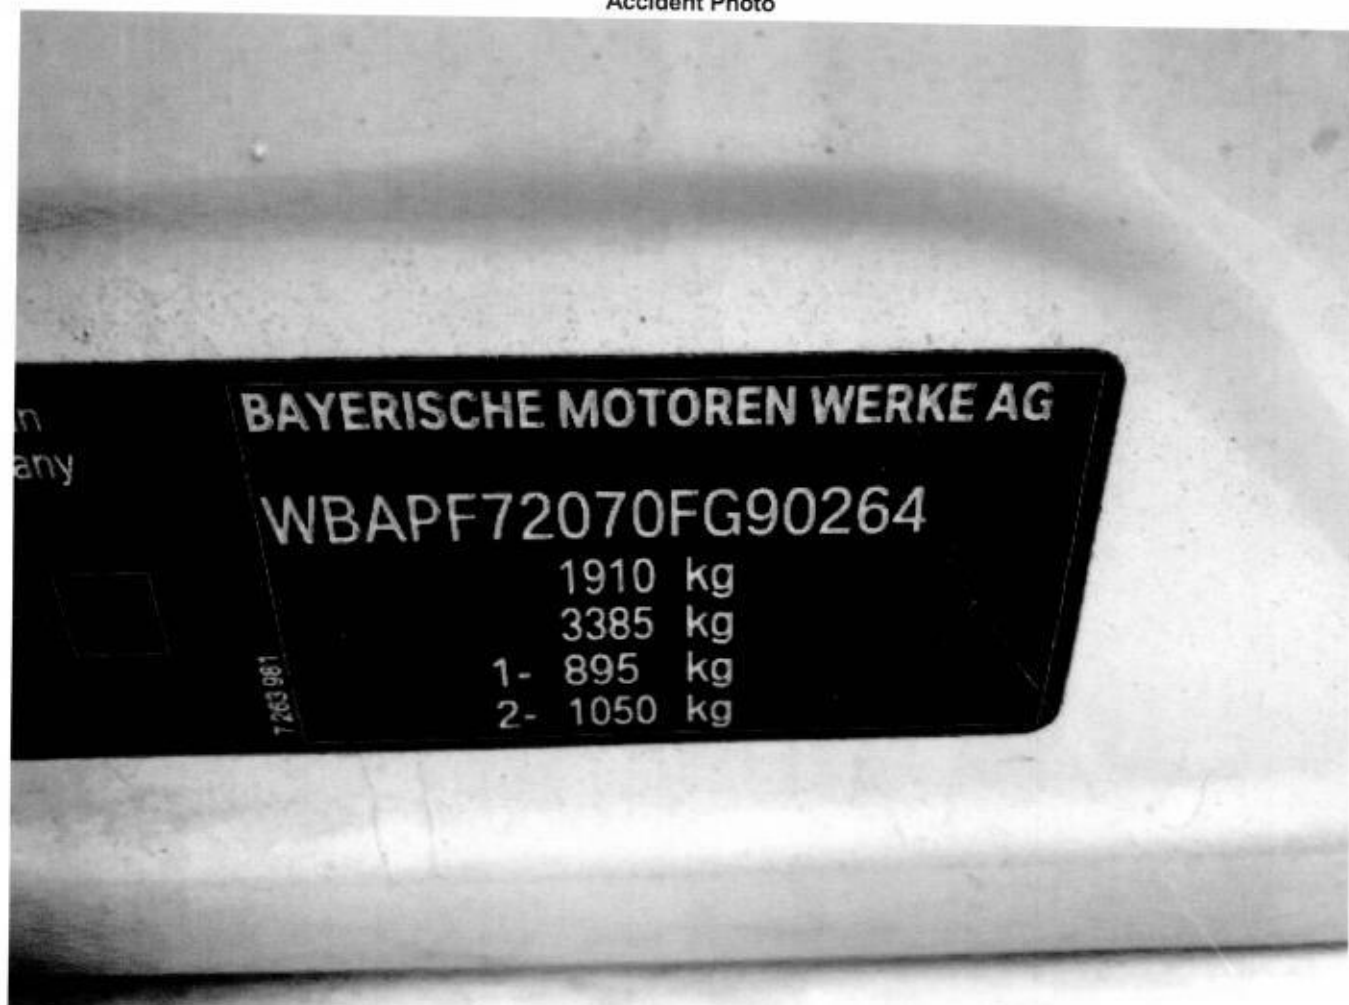
Accident Photo

At the front and rear portion.

The bonnet, front grille, headlamps, front bumper, front panel, boot lid, rear bumper, RHR quarter panel, rear end panel, floor panel, rear chassis member, exhaust muffler, exhaust pipe, etc.

The estimate cost of repair submitted by M/s Lian Heng Painter Company as per schedule attached have been revise and scrutinize. We list the breakdown of our findings and recommendation as per attached.

The repairer has agreed to undertake the repair at a lumpsum of SGD \$19,550.00
